IPR-08-05

Äspö Hard Rock Laboratory

Validation of the ultrasonic borehole investigation in the TASQ tunnel

February 2008

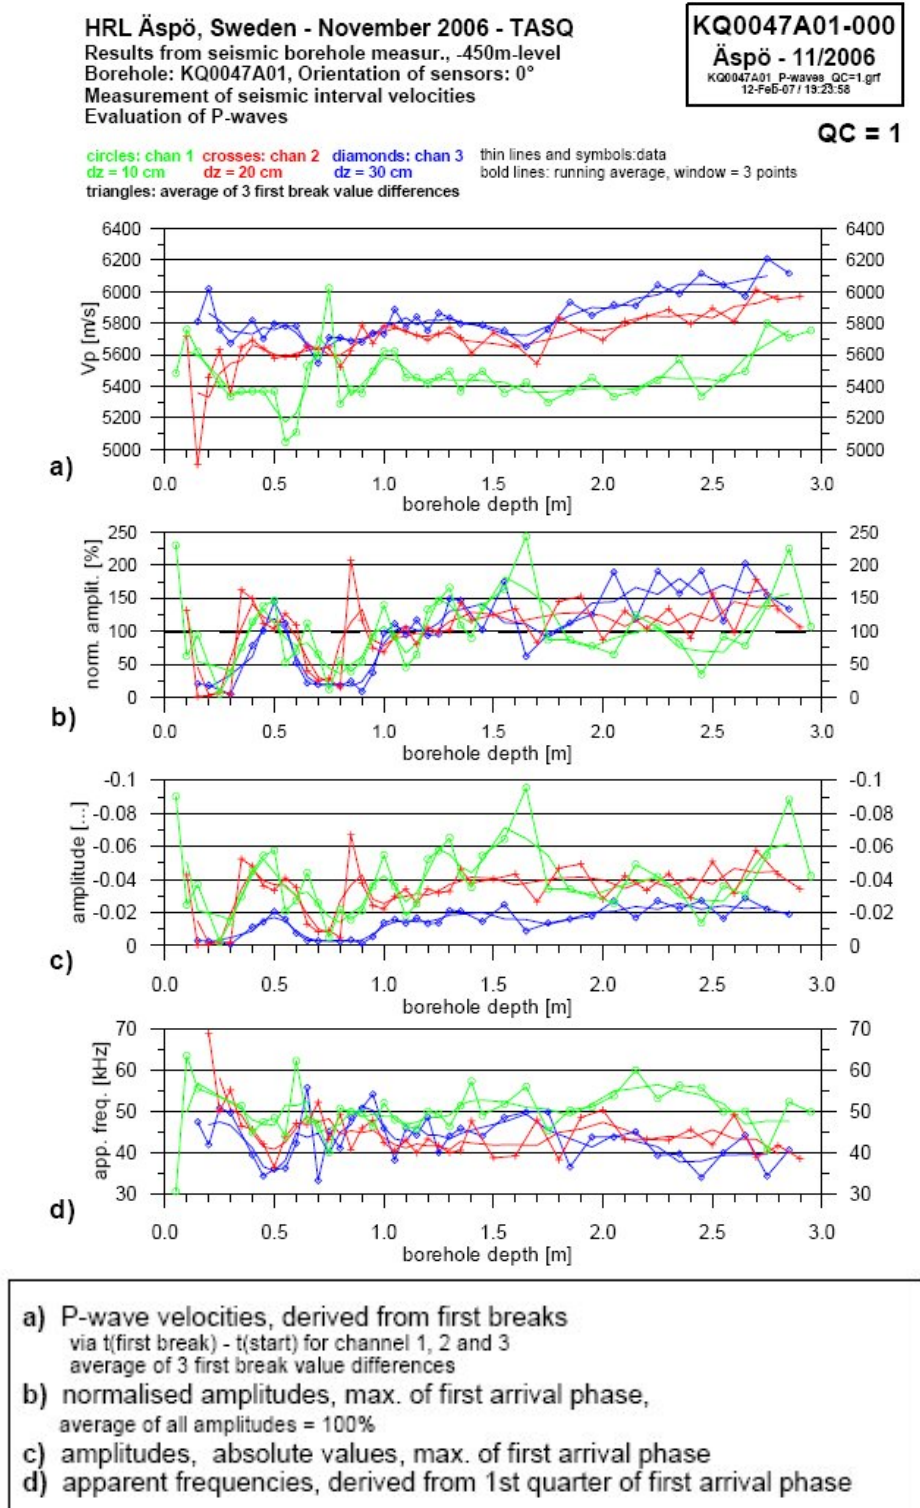
Figure 5–9. The results from the seismic investigation of borehole KQ0047A01 /Schuster, 2007/.

In this borehole the fractures are indicated at depth 0.2-0.25 m and 0.7-0.75 m according to the seismic measurements (Figure 5-9).

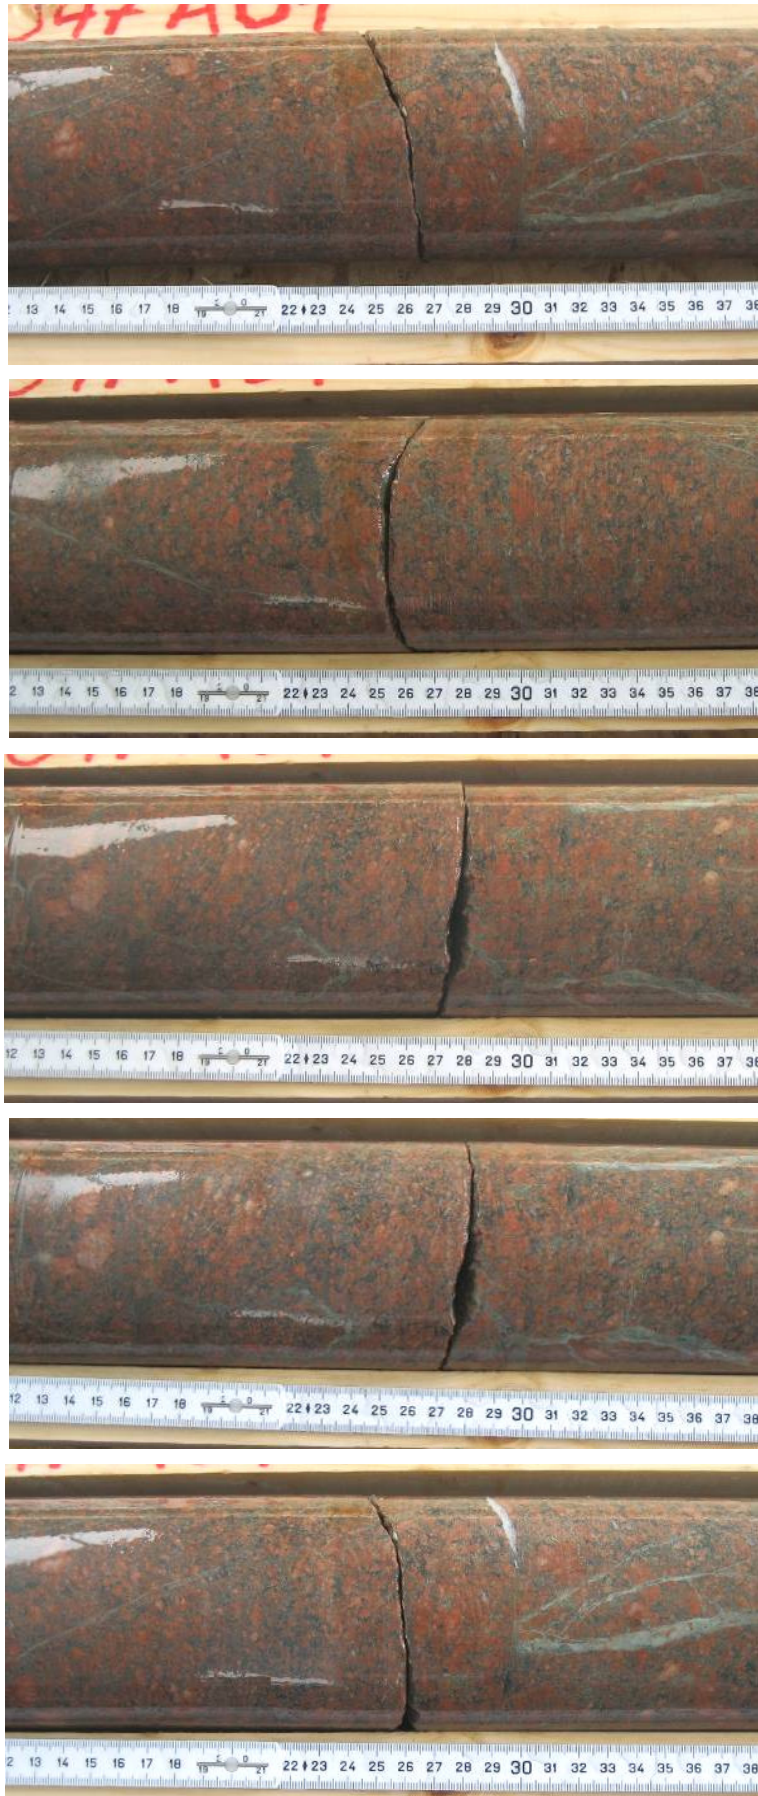
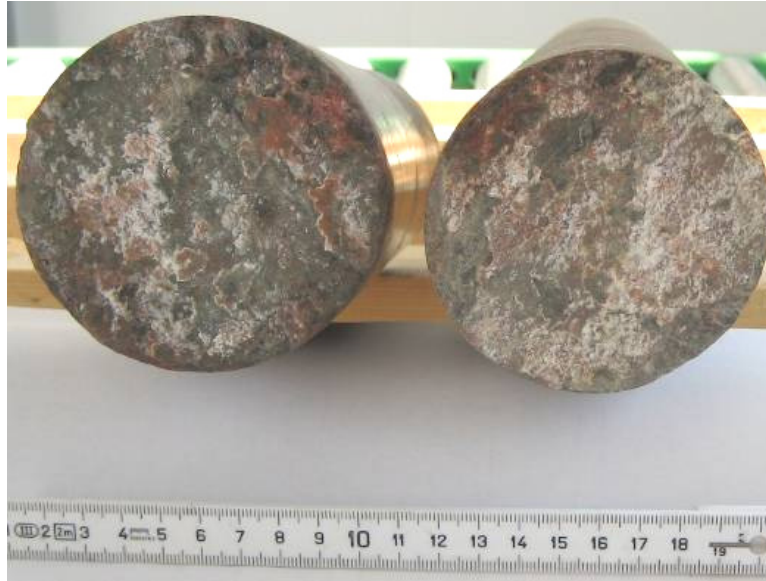
In section 0.2-0.25 m (Table 5-1), a fracture exist which is also visible in the BIPS image from the borehole wall (see also Appendix A.1.). This fracture is located 0.248 m into the borehole. As seen in Figure 4-2, this borehole is a sub-horizontal borehole into the WNW wall at a level of about 3 m above the roadbed in the tunnel. The fracture is filled with four minerals according to the core-mapping made by Berglund /Jonsson et al., 2008/. Its surface is described as irregularly rough, (see also Figure 5-10 and Figure 5-11).

The minerals coating the fracture surface are in order of decreasing amount: adularia, calcite, laumontite and prehnite. Its width (including the fracture filling minerals) is 1.5 mm and its aperture is 1 mm. This fracture can be found in the BIPS image of the borehole wall (Appendix. A.1.).

Figure 5–10. The section including 0.2-0.25 m from the core. In different rotation.

Figure 5–11. The fracture surface at 0.248 m from the core in dry condition.

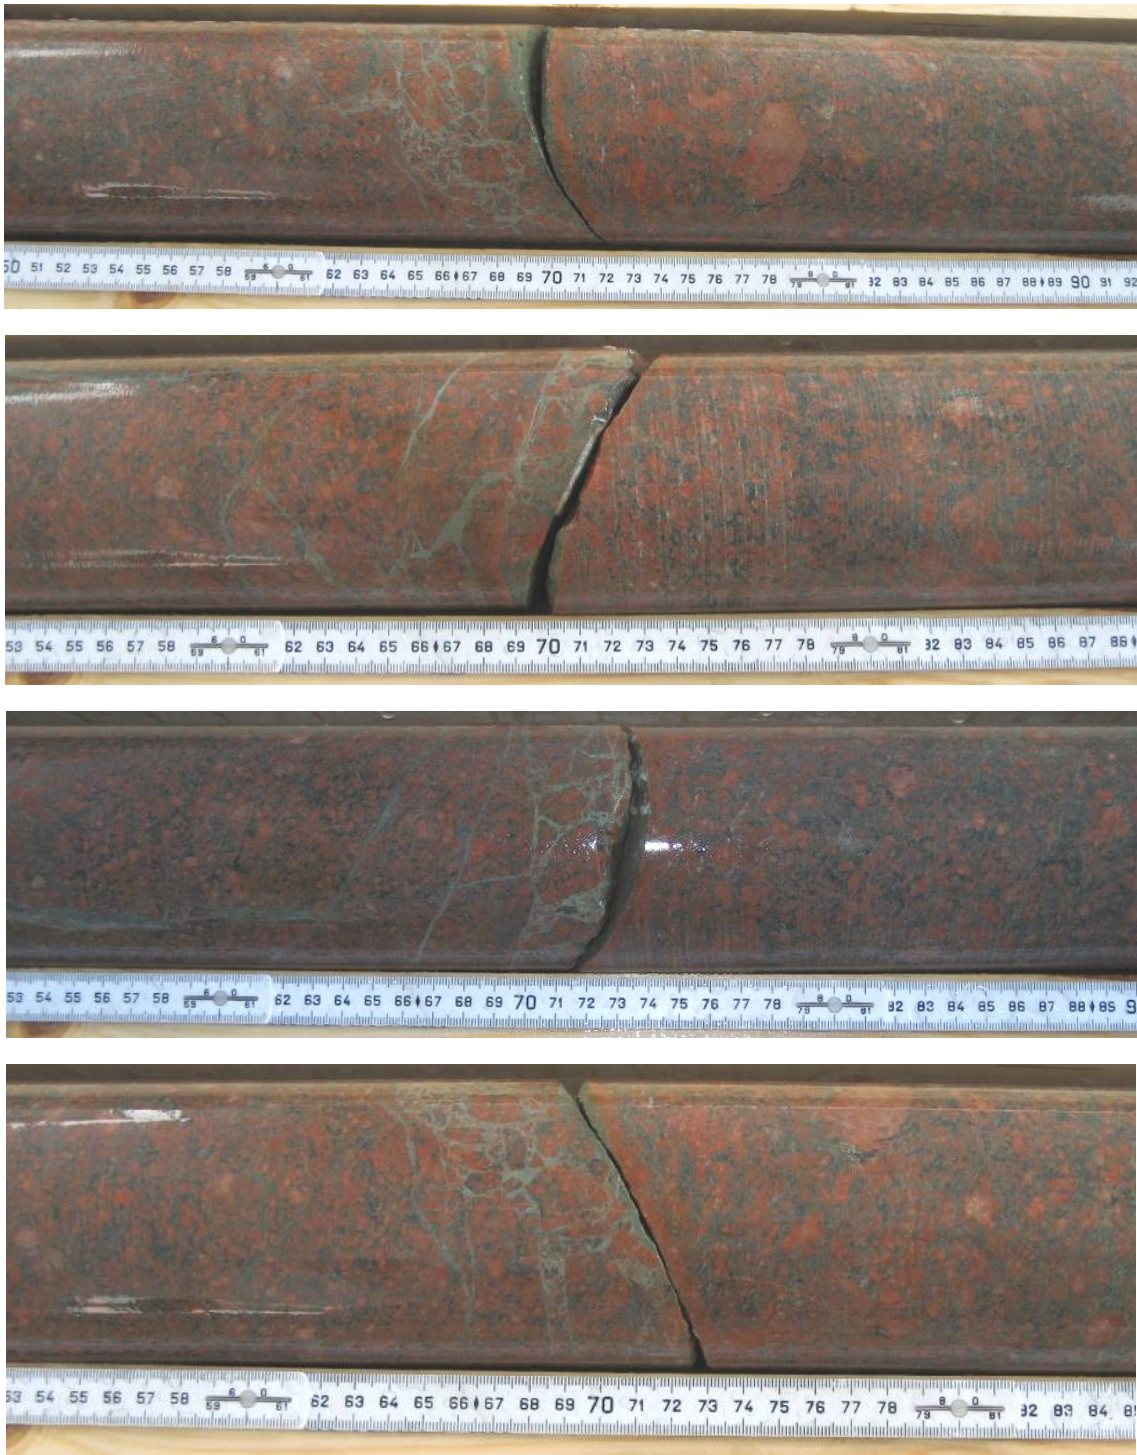
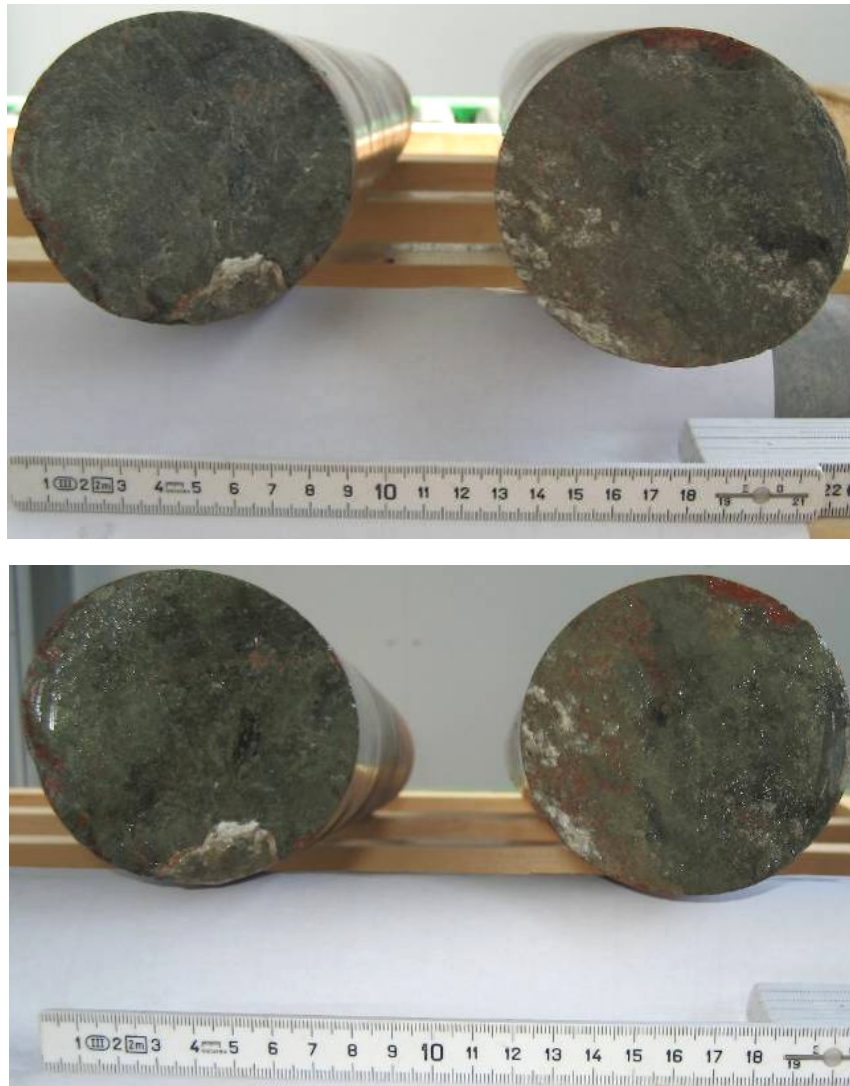
The next section suggested to include a fracture is the area 0.70-0.75 m (Table 5-1). At this location, an open fracture with the fracture minerals: calcite, prehnite, chlorite and adularia is found. These fracture surfaces is planar and smooth which, together with the existence of fracture minerals, implies that this fracture is a reopened fracture (Figure 5-12 and Figure 5-13). The fracture was likely located in the rock mass when it was reopened because it can be seen as opened in the BIPS image (see appendix A.1.). It is therefore likely that this is a genuine open fracture in the rock mass surrounding the tunnel and it has been identified with the seismic measurements.

Figure 5–12. The section including 0.7-0.75 m from the core. In different rotation.

Figure 5–13. *The fracture surface for the fracture at 0.743 m in the core. Dry and wet surface.*

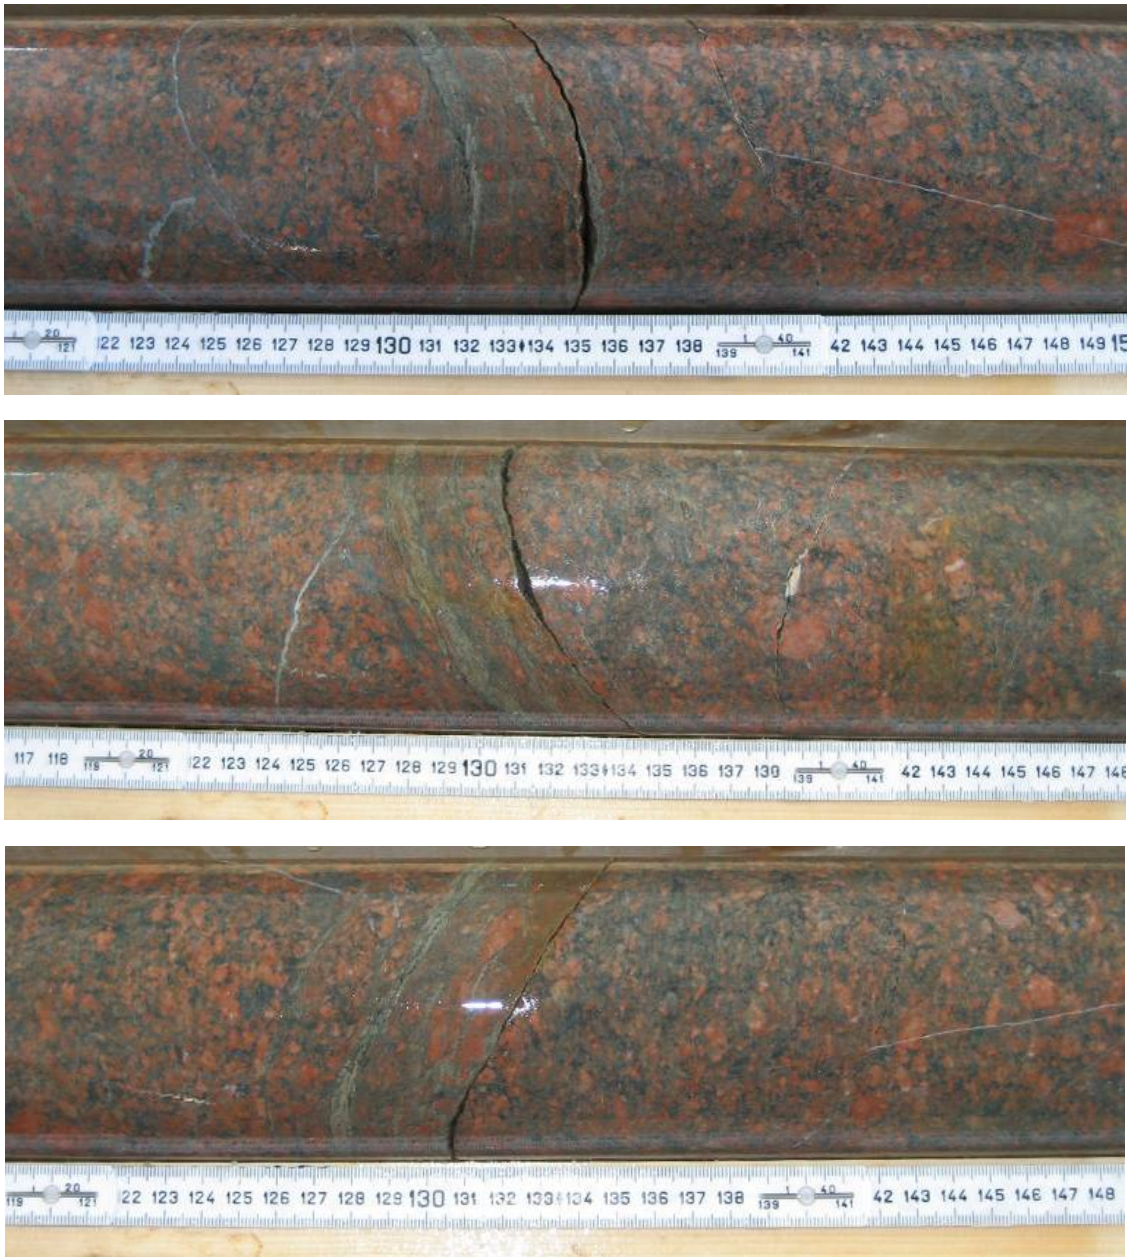
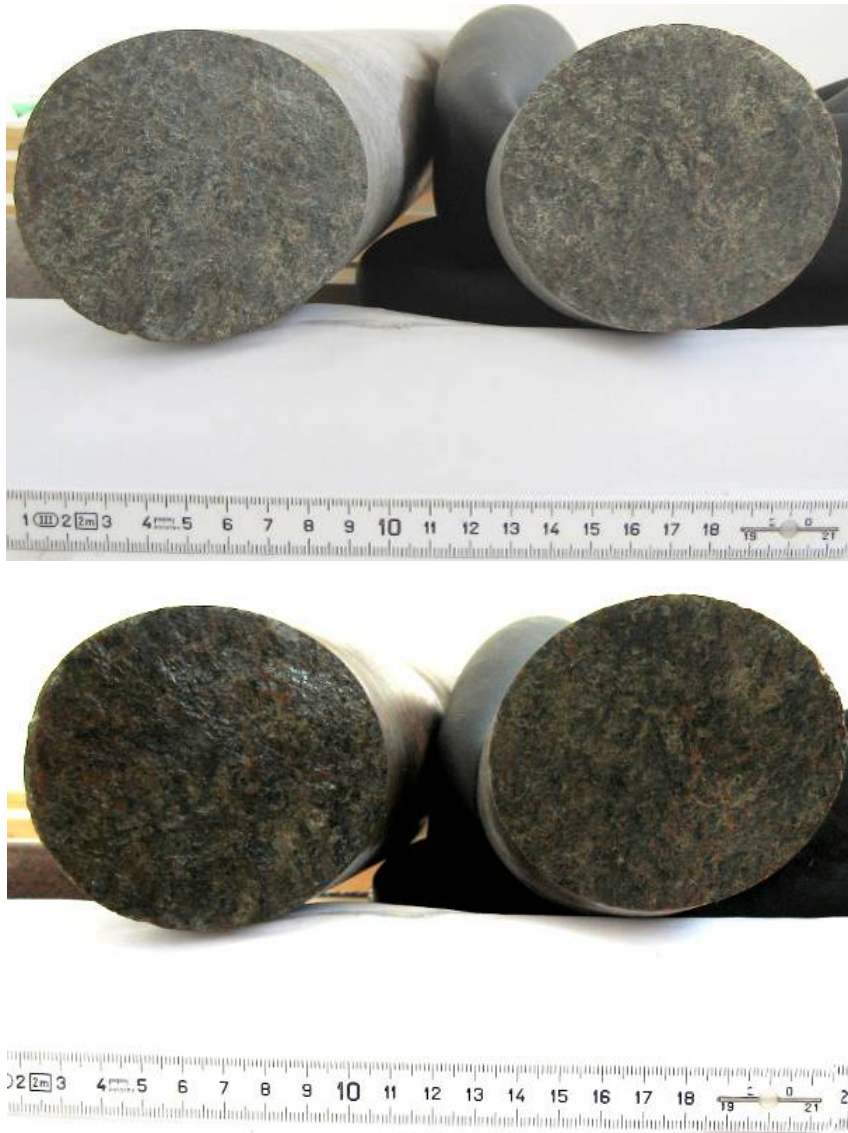
In this core three other fractures have been reported in the geological mapping although they were not identified in the seismic measurements. It is fractures that can have been reopened by the core handling. They are all reported as possible or probable in the geological mapping, and not certain. As an example, one of them, at depth 1.327 m has been presented in Figure 5-14. It is likely that this is a reopening of a fracture in a sealed fracture network due to core handling or drilling. This fracture is filled with chlorite and calcite as seen in Figure 5-15. The fracture surface is described as a rough surface with an irregular roughness. In the BIPS images this fracture is not opened like the two previous fractures (Appendix. A.1). The fact that the fracture can not be identified as opened in the BIPS image and that the surface is quite rough implies that this fracture have been opened by the core handling, and thus would not be seen in the seismic measurements in the borehole wall.

Figure 5–14. The fracture at 1.327 m depth from the core. In different rotation.

Figure 5–15. The fracture surface for the fracture at 1.327 m in the core. Dry and wet surface.

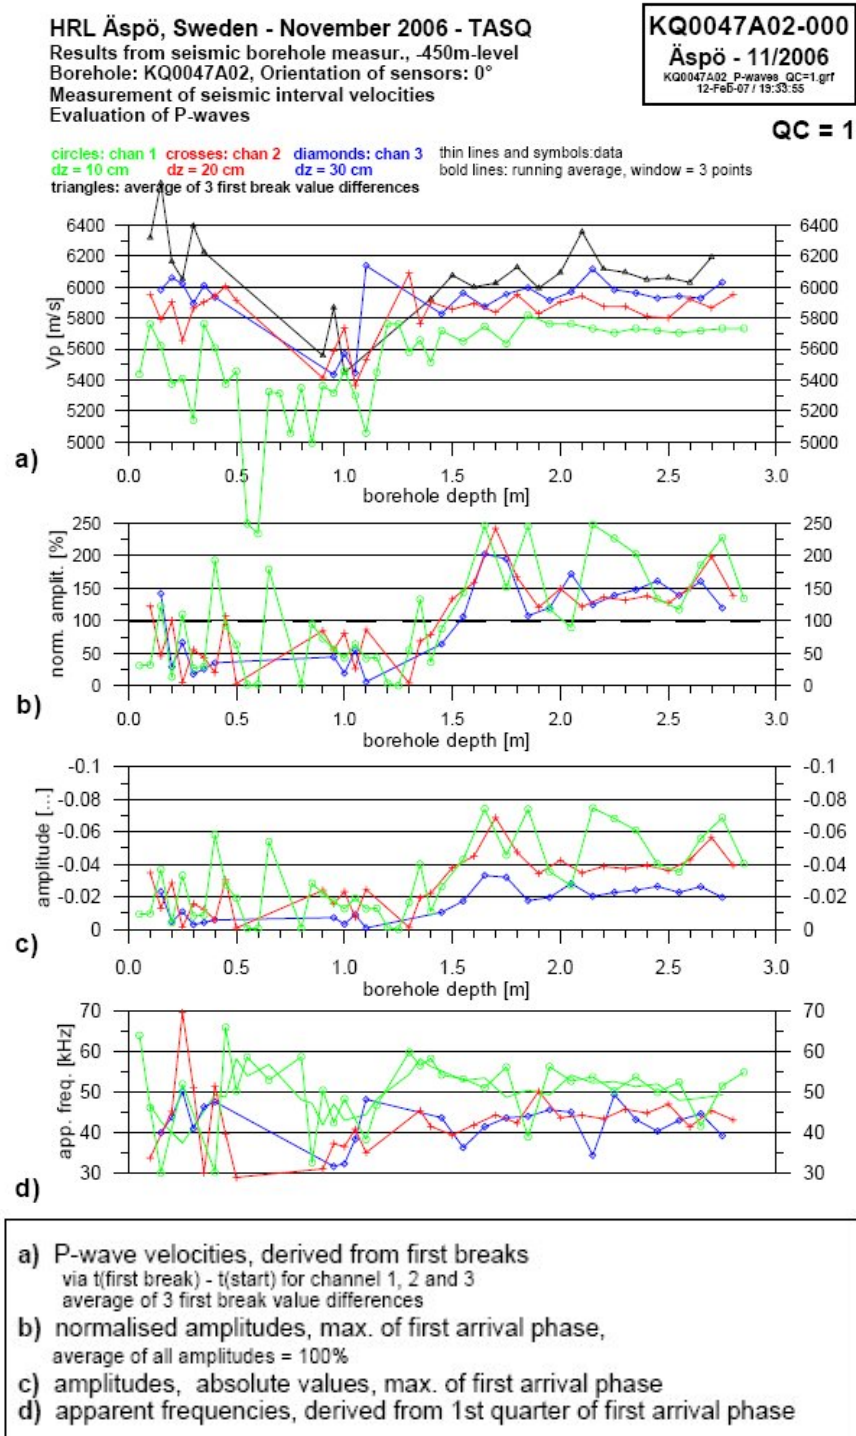
Figure 5–16. The results from the seismic investigation of borehole KQ0047A02 /Schuster, 2007/.

In this borehole, the fractures are indicated at depth 0.55-0.6 m, 0.70-0.8 m and 1.20-1.25 m according to the seismic measurements (Figure 5-16). When investigating the section between 0.55-0.6 m, a fracture can be found in the drillcore. The fracture at 0.592 m is filled with phrenite and the surface is smooth according to the geological mapping by Berglund (Figure 5-17 and Figure 5-18). A clear open fracture can be seen in the BIPS image of this borehole (see appendix A.2.).

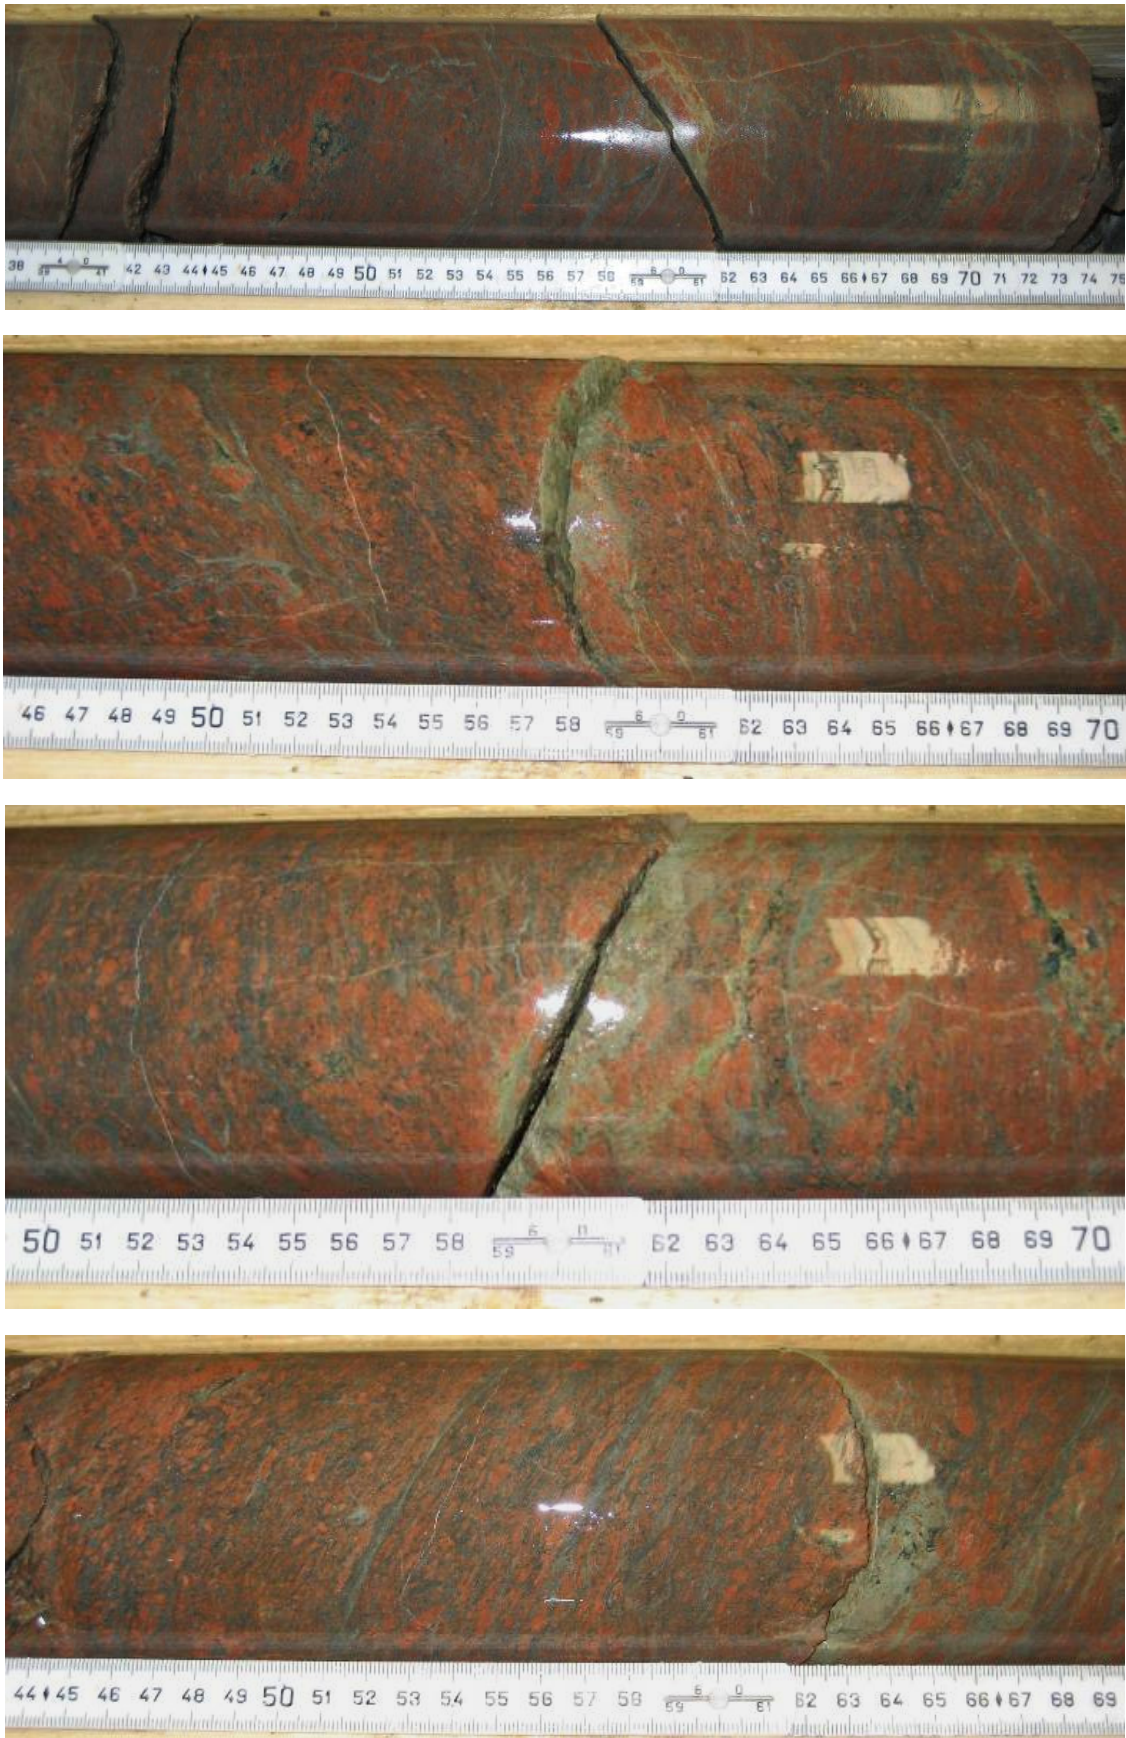
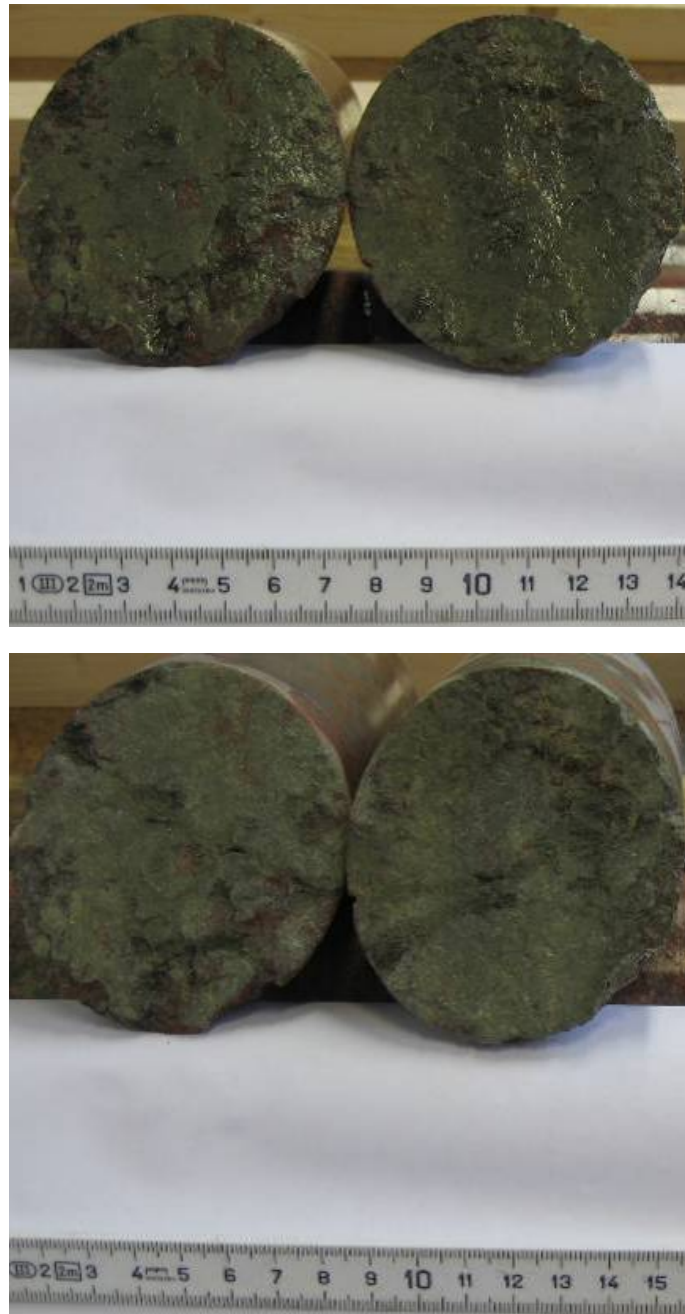
Figure 5–17. Section containing 0.55-0.6 m from the core. In different rotation.

Figure 5–18. *The fracture surface for the fracture at 0.592 m in the core. Dry and wet surface.*

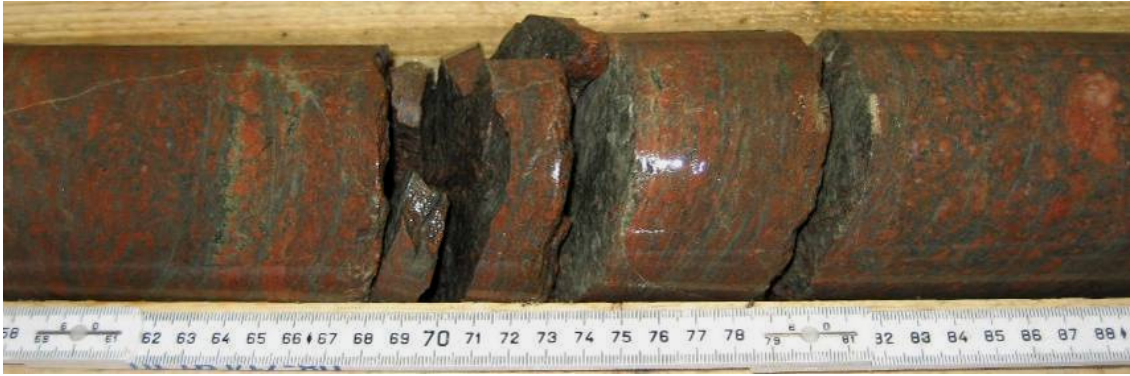
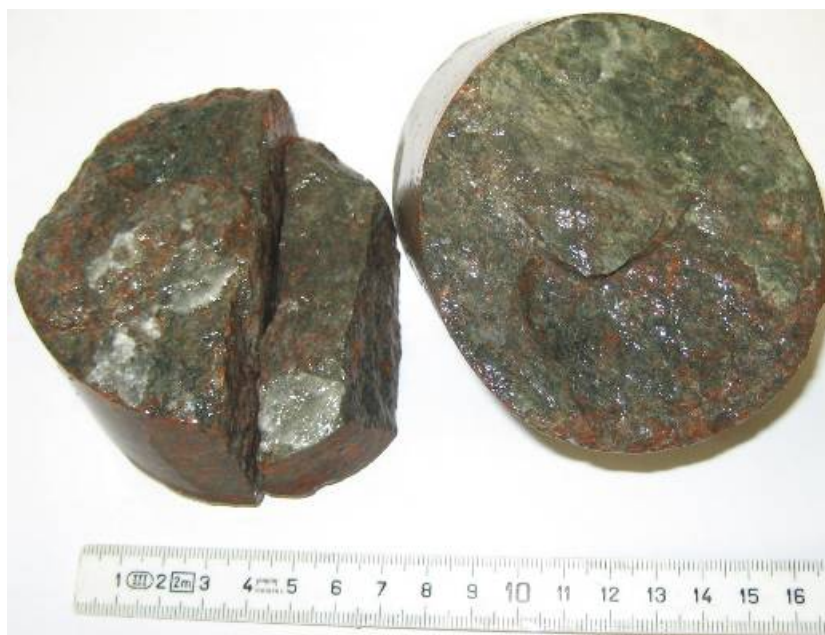
In section 0.7-0.8 m the core was so broken that any rotation of the core would not supply the investigation with further information however, a rotation would rather cause the core to be more destroyed, therefore this was deferred from. Several fractures has been mapped in this section according to the geological mapping by Berglund /Jonsson et al., 2008/ and in the BIPS image there are two strong indications of opened fractures in this section (Appendix. A.2.). One of them, the fracture at 0.734 m, is seen as fracture 3 from the left in Figure 5-19. This fracture is described as filled with chlorite and calcite with a slight alteration (Figure 5-20) and its surface is rough and irregular.

Figure 5–19. Section containing 0.7-0.8 m from the core.

Figure 5–20. The fracture surface for the fracture at 0.734 m in the core. Wet surface.

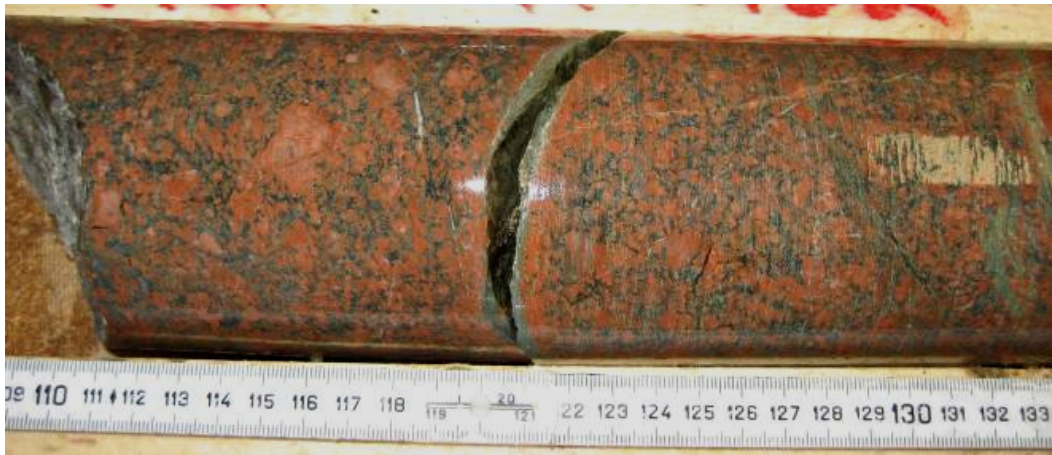
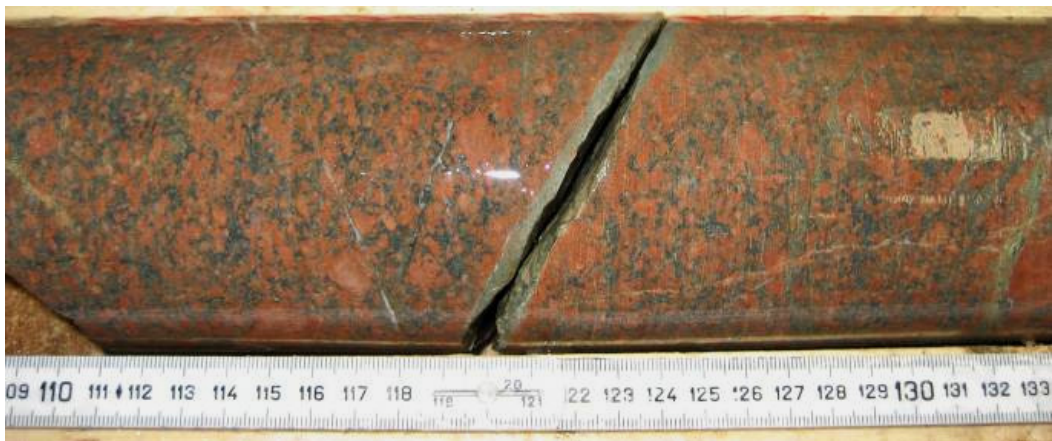
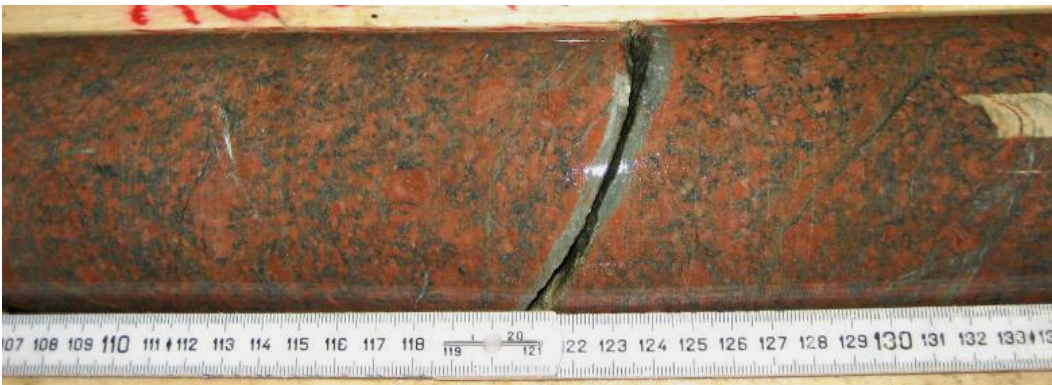
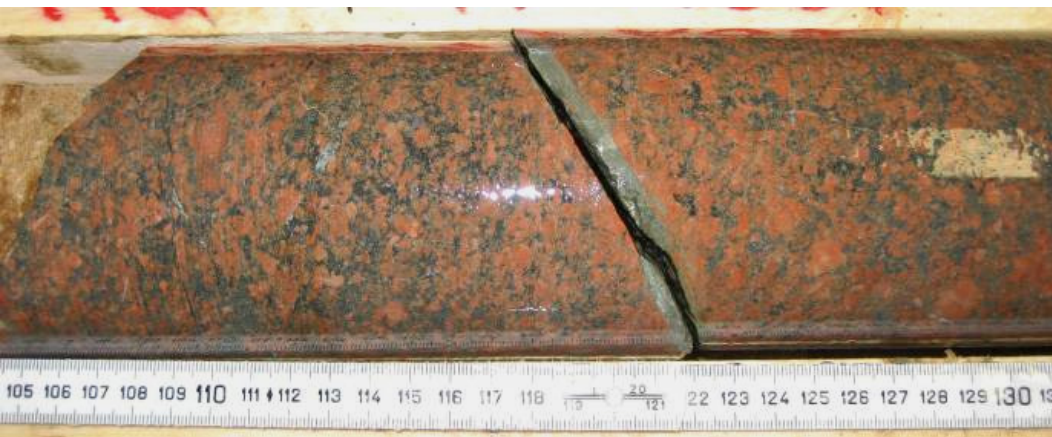
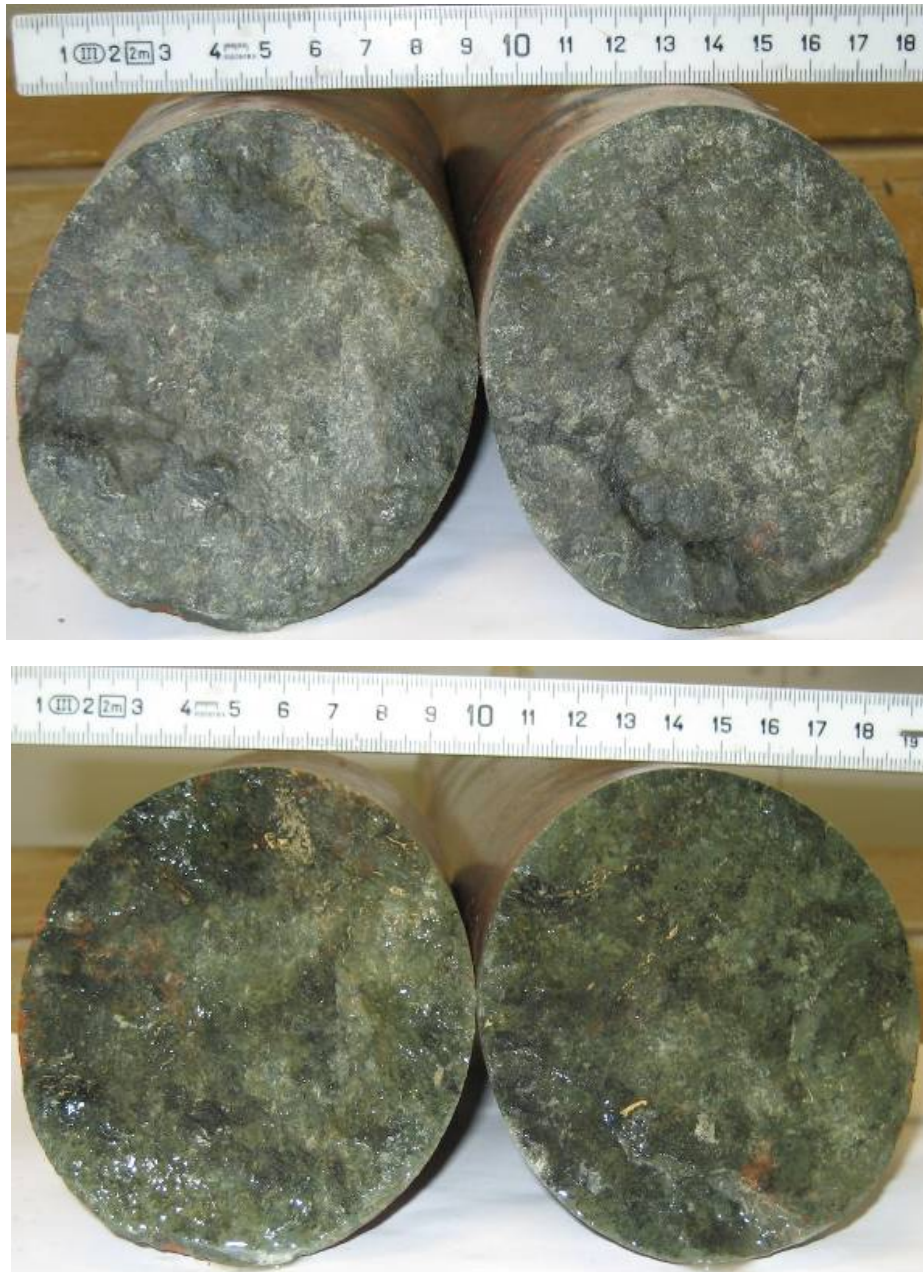
The seismic investigation also indicates a fracture at about 1.20-1.25 m. In this section at 1.212 m, a fracture is found in the geological mapping and in the BIPS image of the borehole (Figure 5-21 and appendix A.2.). The fracture is filled with prehnite, chlorite and calcite and the fracture surface is slightly altered (Figure 5-22). In the geological mapping 12 opened fractures are found and five of them can be found as strong indications in the BIPS image. Of the five fractures indicated in the BIPS image and commented on as certain in the geological mapping, four are identified by the seismic investigation, (the fracture at 0.592 m in section 0.55-0.6 m, 0.763 m and 0.828 m in section 0.7-0.8 m and 1.212 in section 1.2-1.25 m).

Figure 5–21. Section containing 1.2-1.25 m from the core. In different rotation.

Figure 5–22. *The fracture surface for the fracture at 1.212 m in the core. Dry and wet surface.*

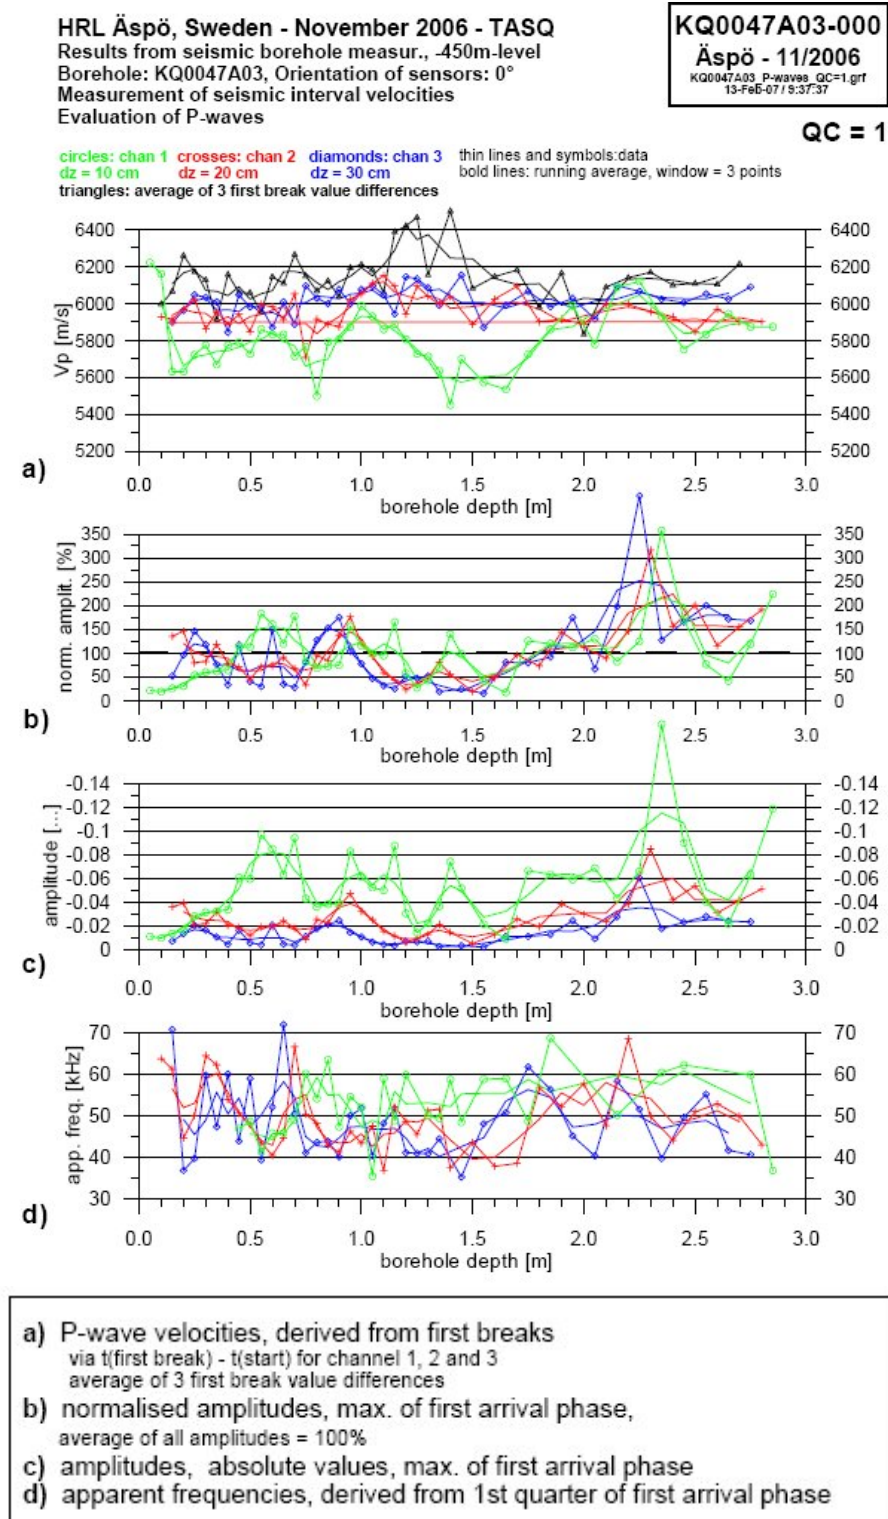
Figure 5–23. The results from the seismic investigation of borehole KQ0047A02 /Schuster, 2007/.

In this borehole an uncertain indication of a discontinuity has been identified at depth 1.55-1.65 m according to the seismic measurements. This uncertainty is because the response in the different parameters from the seismic investigation is quite ambiguous (Figure 5-23).

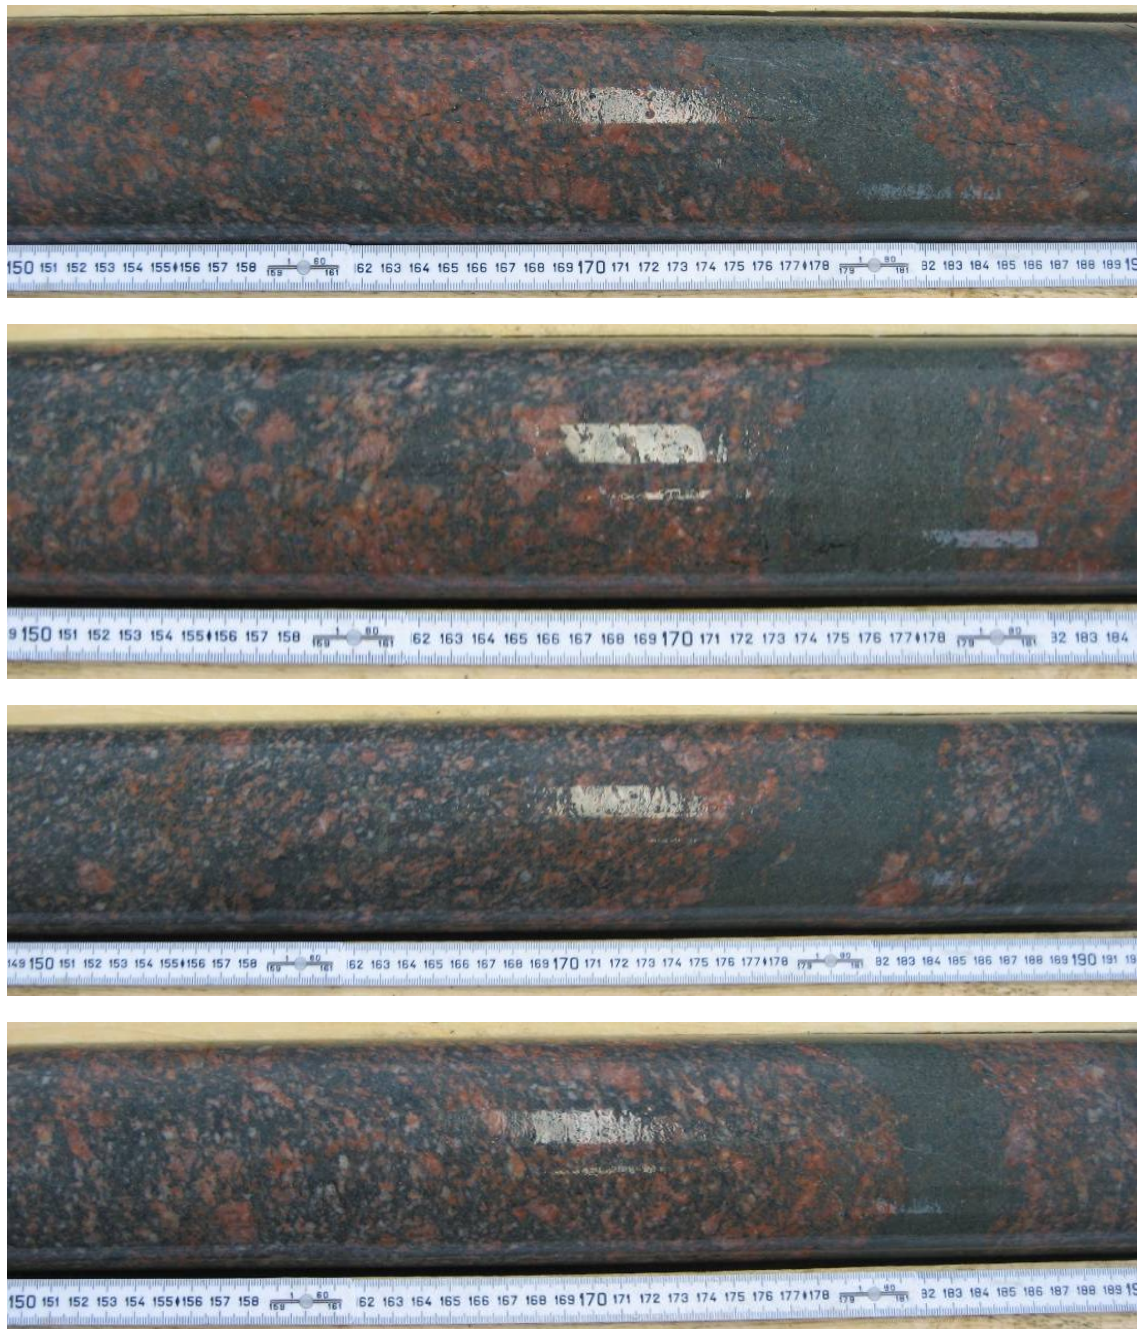
Figure 5–24. Section containing 1.55-1.65 m from the core. In different rotation.

When investigating the core, the information from the mapping by Berglund /Jonsson et al., 2008/, indicates a total of 7 fractures where the core has been broken. There is an indication of a fracture at 1.991 m depth, but this distance is too far away from the area indicated to be considered as the source of the anomaly in the seismic measurements. At about 1.75 m depth, a change in rock type can be discerned as a dark band encircling the core. This contact is located at 0.1 m from the indicated section in the seismic measurements. The indication from the seismic measurements is commented as uncertain, and no fractures are found. A change of density at about this section is the only indication in the core that might be interpreted as the uncertain indication.

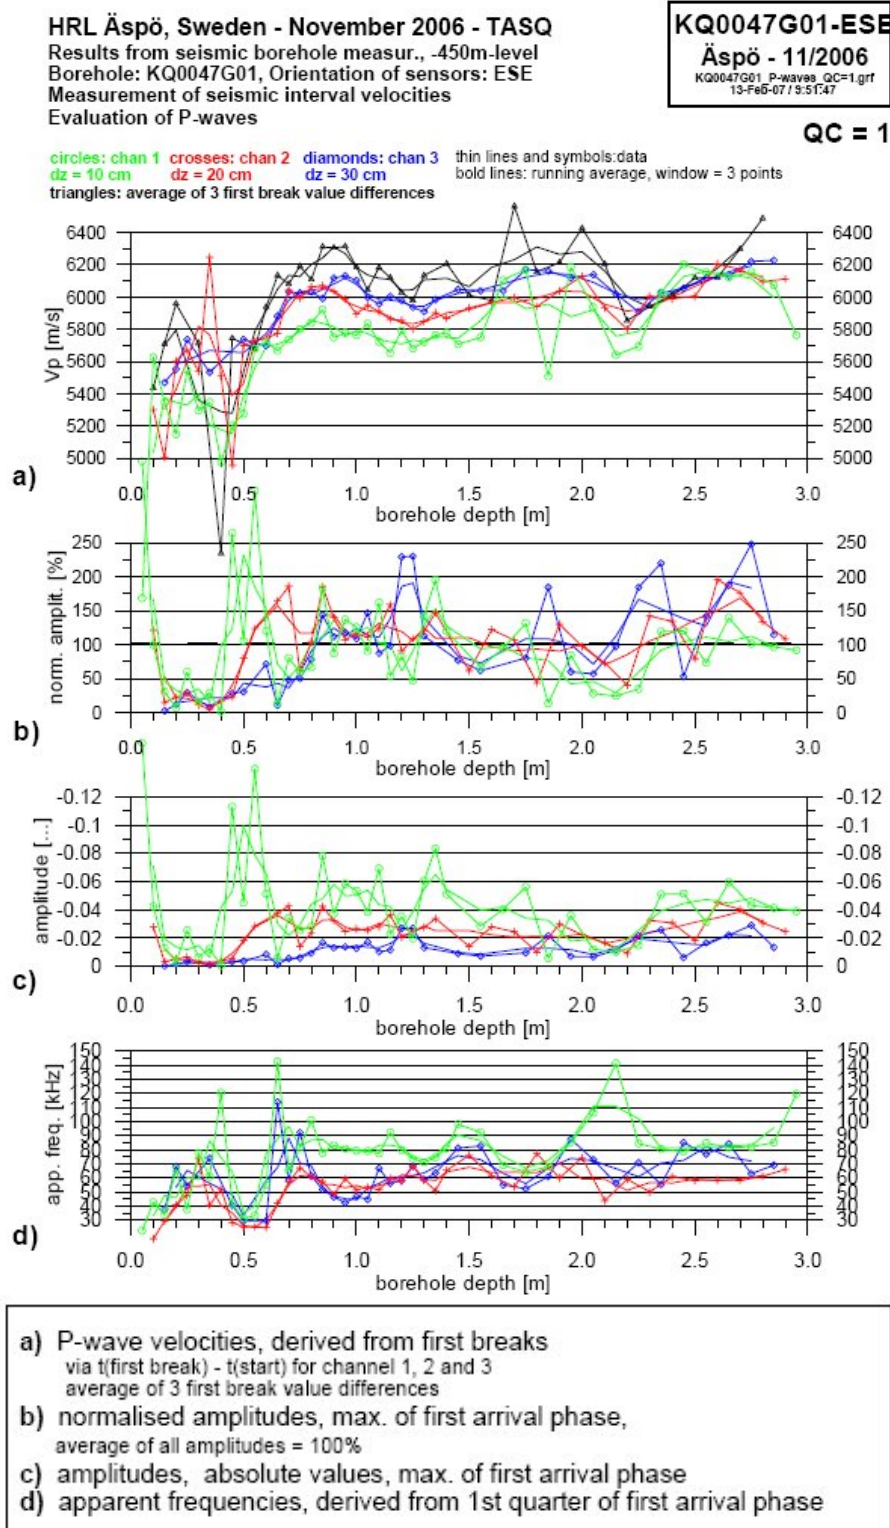
Figure 5–25. The results from the seismic investigation of borehole KQ0047G01 /Schuster, 2007/.

In this borehole the fractures are indicated at depth 0.4 m and uncertain fracture indications are found in the section 0.15-0.4 m and 2.05-2.15 m according to the seismic measurements (Figure 5-25).
