IPR-08-05

Äspö Hard Rock Laboratory

Validation of the ultrasonic borehole investigation in the TASQ tunnel

February 2008

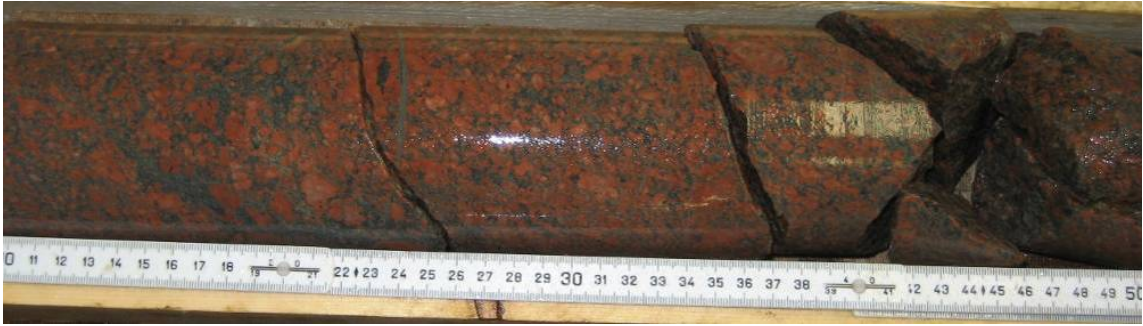
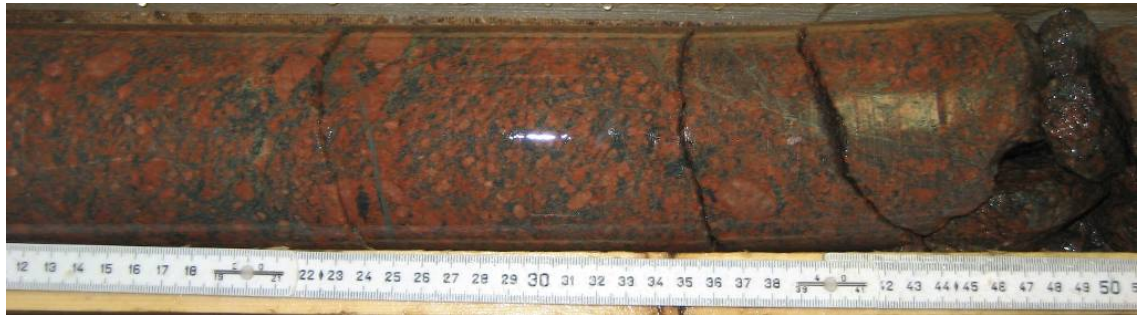
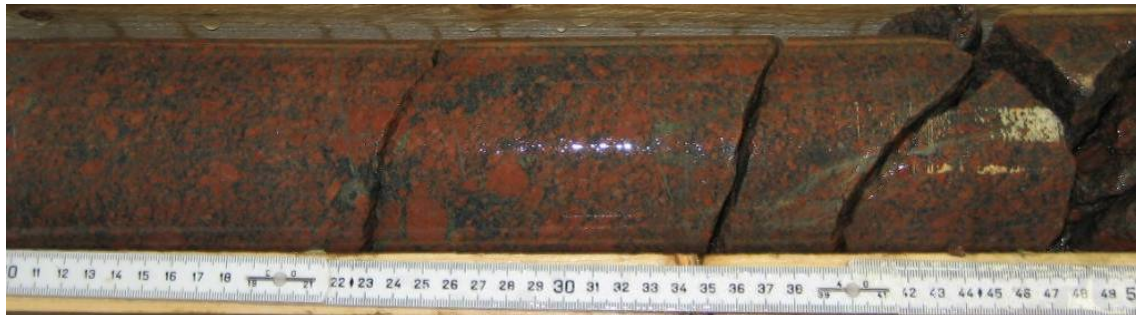
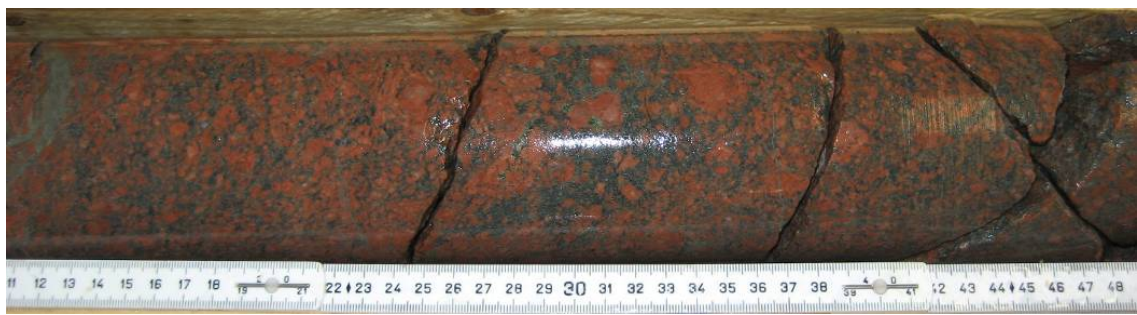
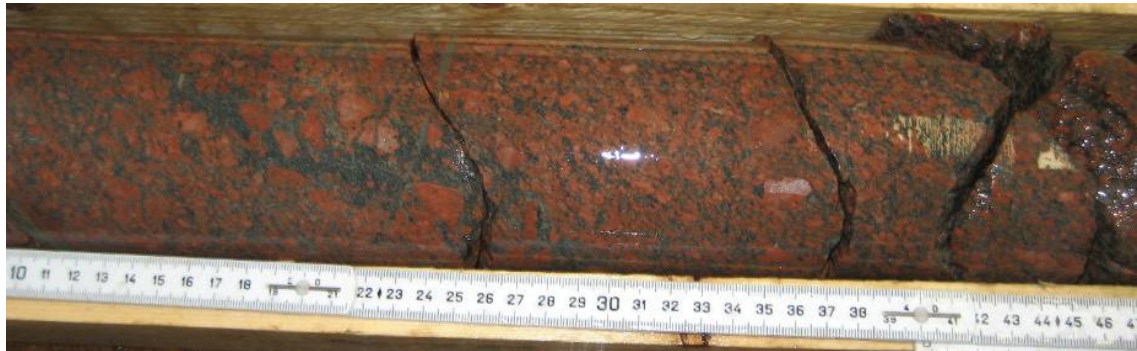
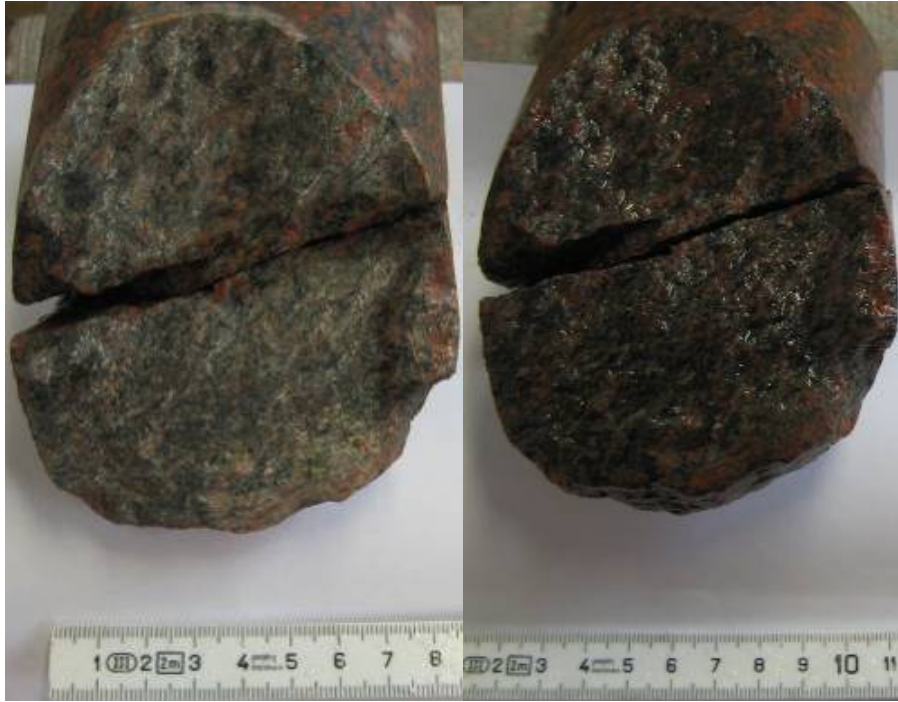
In the section at 0.15 m to 0.4 m there are 3 fractures indicated as opened in the geological mapping by Berglund /Jonsson et al., 2008/ which can be found in the BIPS image from the borehole (appendix A.6). These fractures are located at 0.209 m, 0.330 m and 0.394 m depth in the borehole (Figure 5-26). None of them have any fracture mineral, although their surfaces are slightly altered (Figure 5-27). The fracture indicated in the seismic measurement with certainty is at about 0.4 m depth which is consistent with the fracture at 0.394 m depth. The surface of this fracture can be seen in wet and dry condition in Figure 5-27

Figure 5–26. Section containing 0.15-0.4 m from the core. In different rotation.

Figure 5–27. *The fracture surface for the fracture at 0.394 m in the core. Dry and wet surface.*

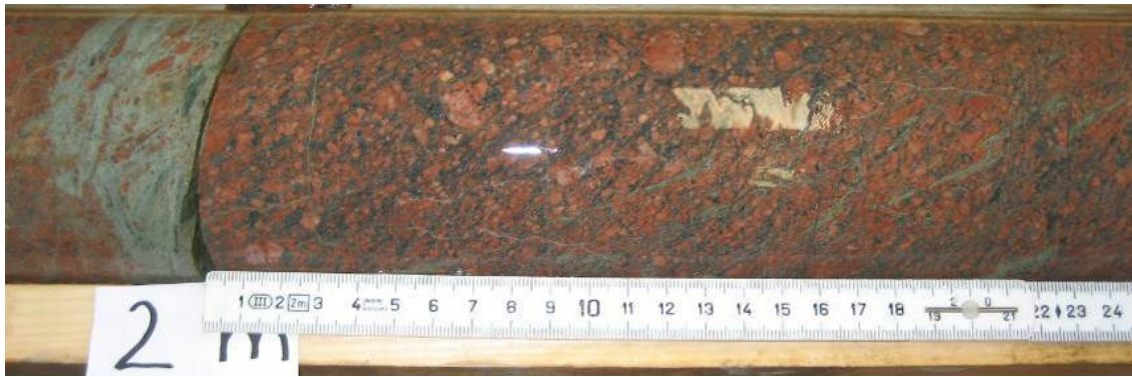
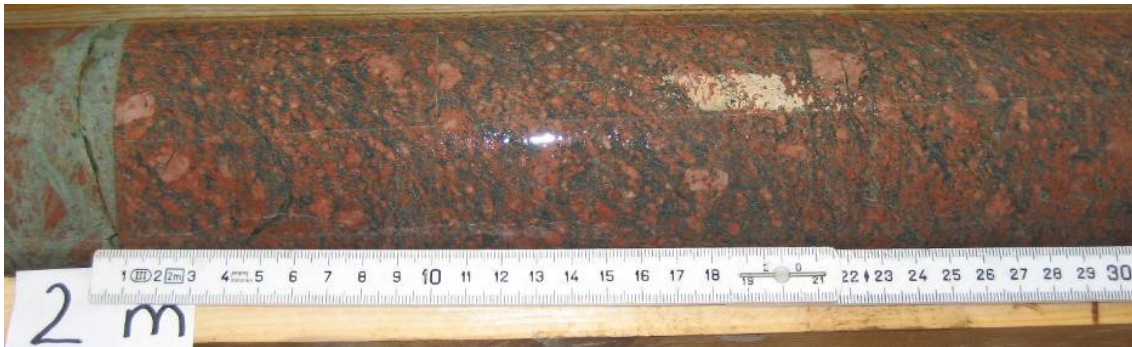
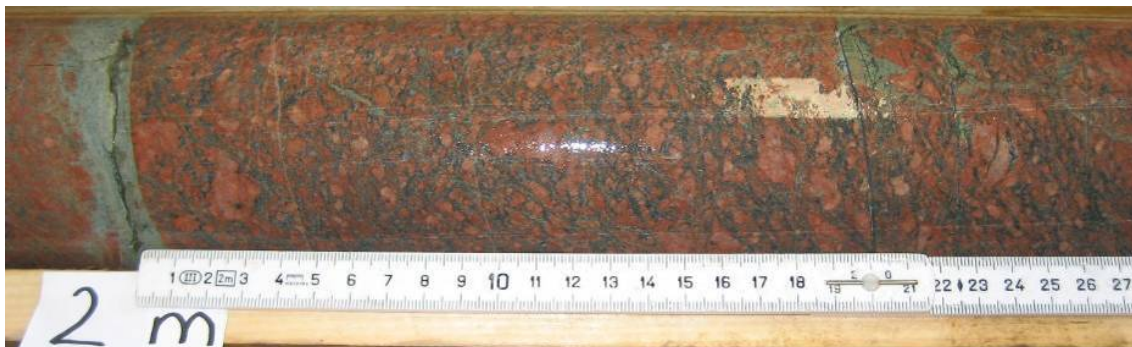
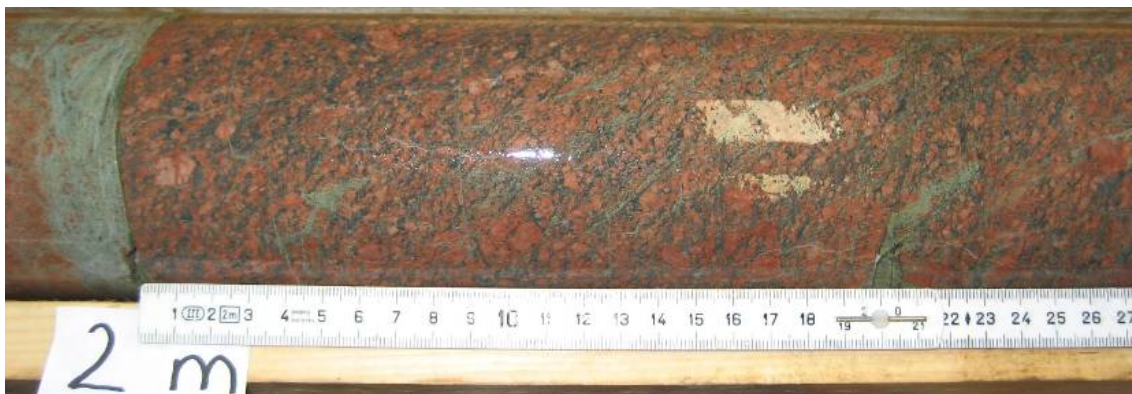
Figure 5–28. Section containing 2.05-2.15 m from the core. In different rotation.

The section containing the area indicated as uncertain fractures (2.05 m - 2.15 m) starts with a core break at about 2 m. However, no opened fractures are indicated either in the geological mapping by Berglund /Jonsson et al., 2008/ or in the BIPS image (Appendix A. 6.). It is in the closed fracture network containing chlorite that this core break occurs; the fracture network has a width in the core ranging from about 1 cm to 5 cm. This sealed fracture network can be the structural change that is indicated in the seismic measurements (Figure 5-28).

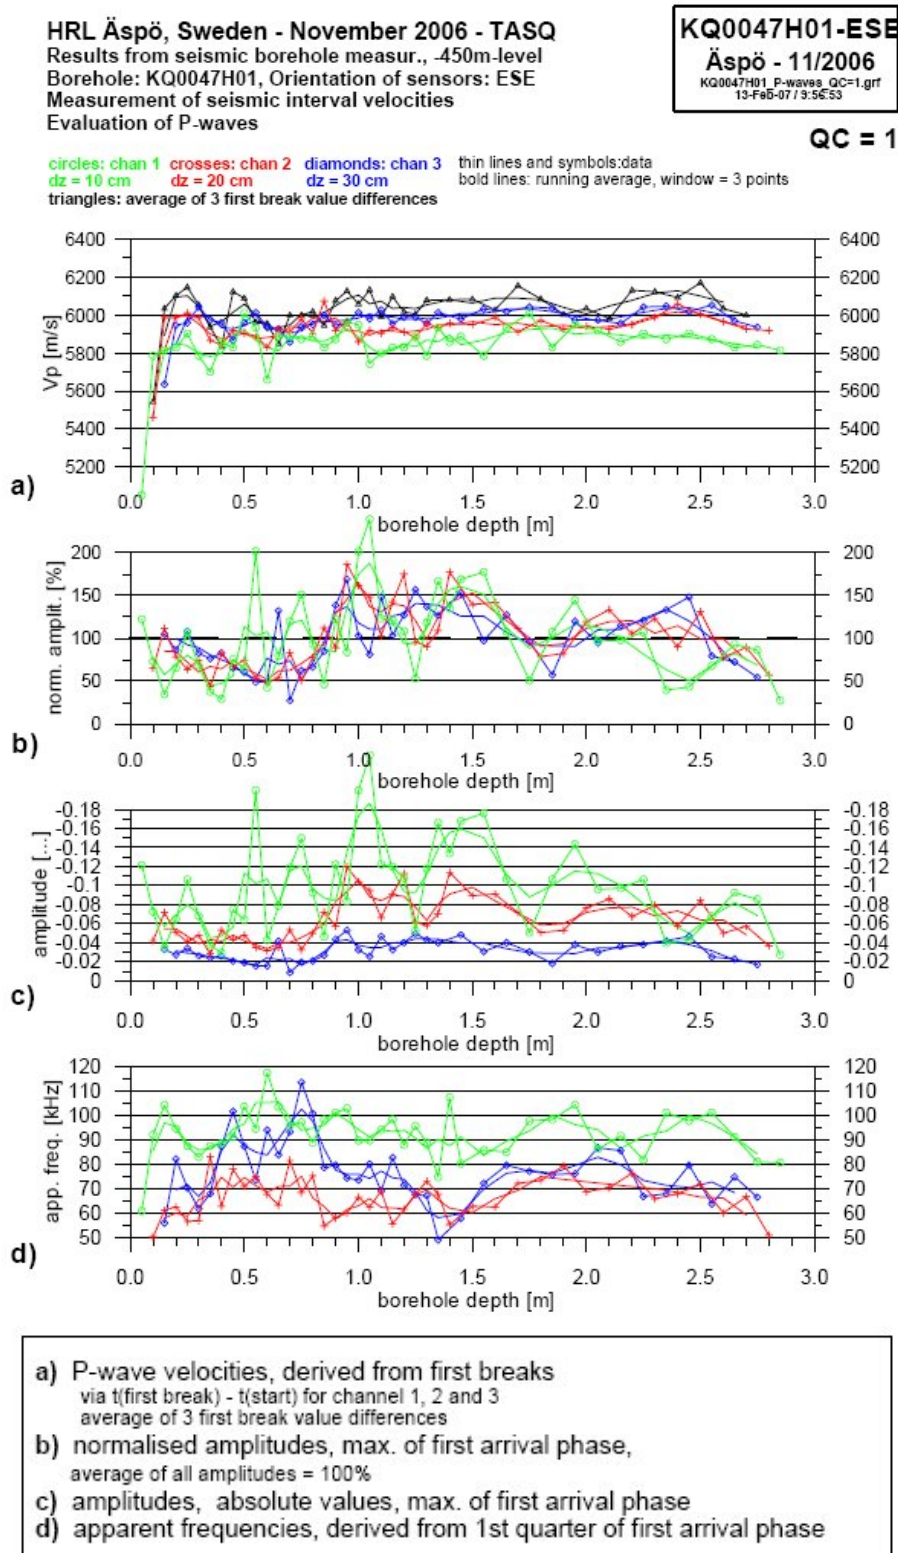
Figure 5–29. The results from the seismic investigation of borehole KQ0047H01 /Schuster, 2007/.

In this borehole, two indications of uncertain fractures are found; one at depth 0.1-0.2 m and the other at 1.7 m. These indications are uncertain according to the parameters derived from the seismic measurements (Figure 5-29) and the seismograms.

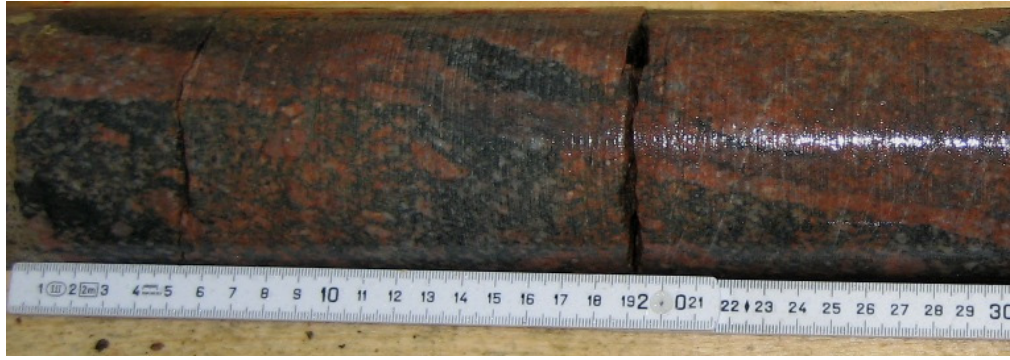
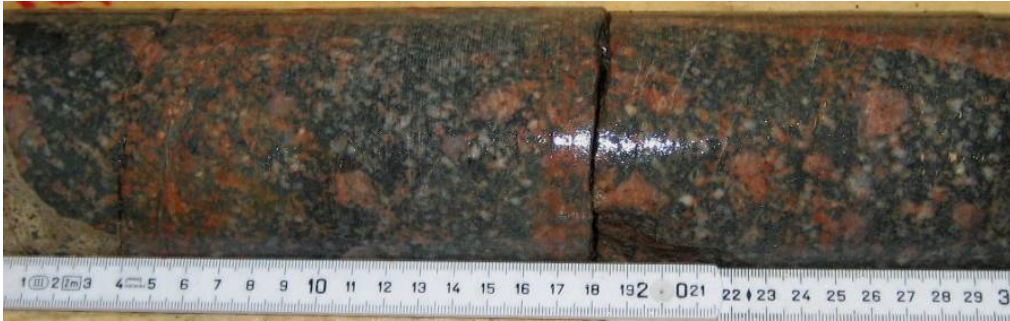
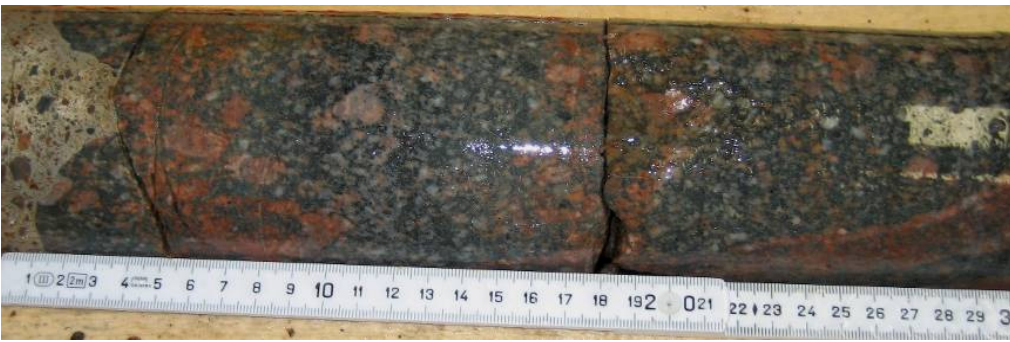
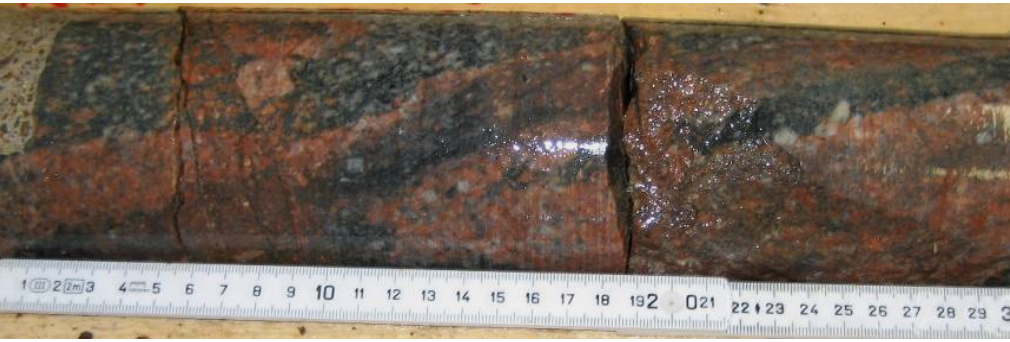
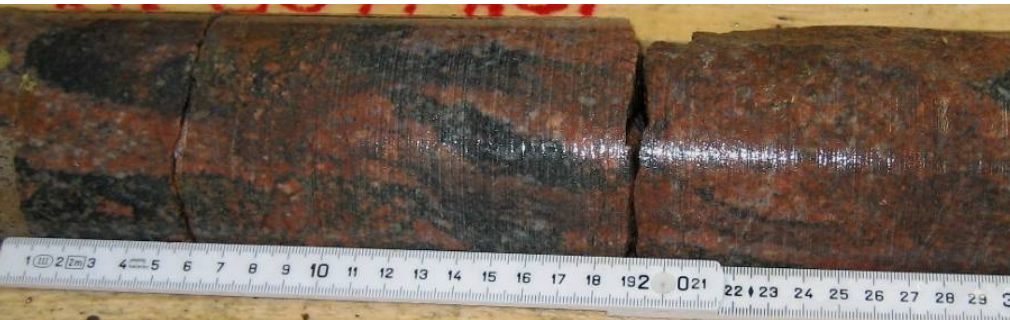
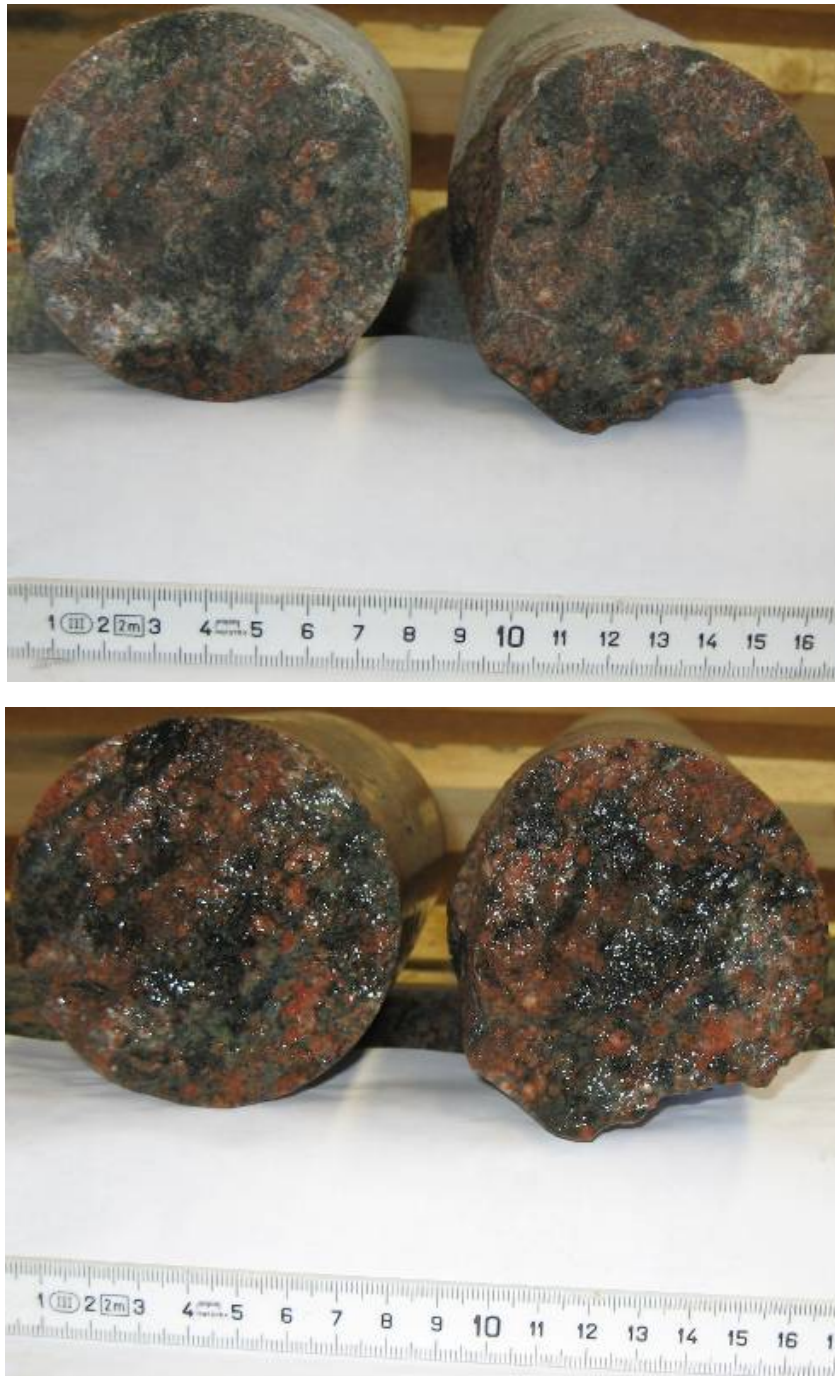
In the section between 0.1-0.2 m a fracture is found. The surface of this fracture which is located at 0.199 m, and seen in Figure 5-30, does not show any alteration. The main filling material in the fracture is chlorite according to the geological mapping. The surface of the fracture can be seen in Figure 5-31. This fracture cannot be identified in the BIPS image from the borehole, seen in appendix A. 7 and it is determined in the geological mapping as probable. The rock material in this section is quite variable from “low density” to “high density” minerals. This might have caused a mixed signal in the seismic record.

Figure 5–30. Section containing 0.1-0.2 m from the core. In different rotation.

Figure 5–31. The fracture surface for the fracture at 0.199 m in the core. Dry and wet surface.

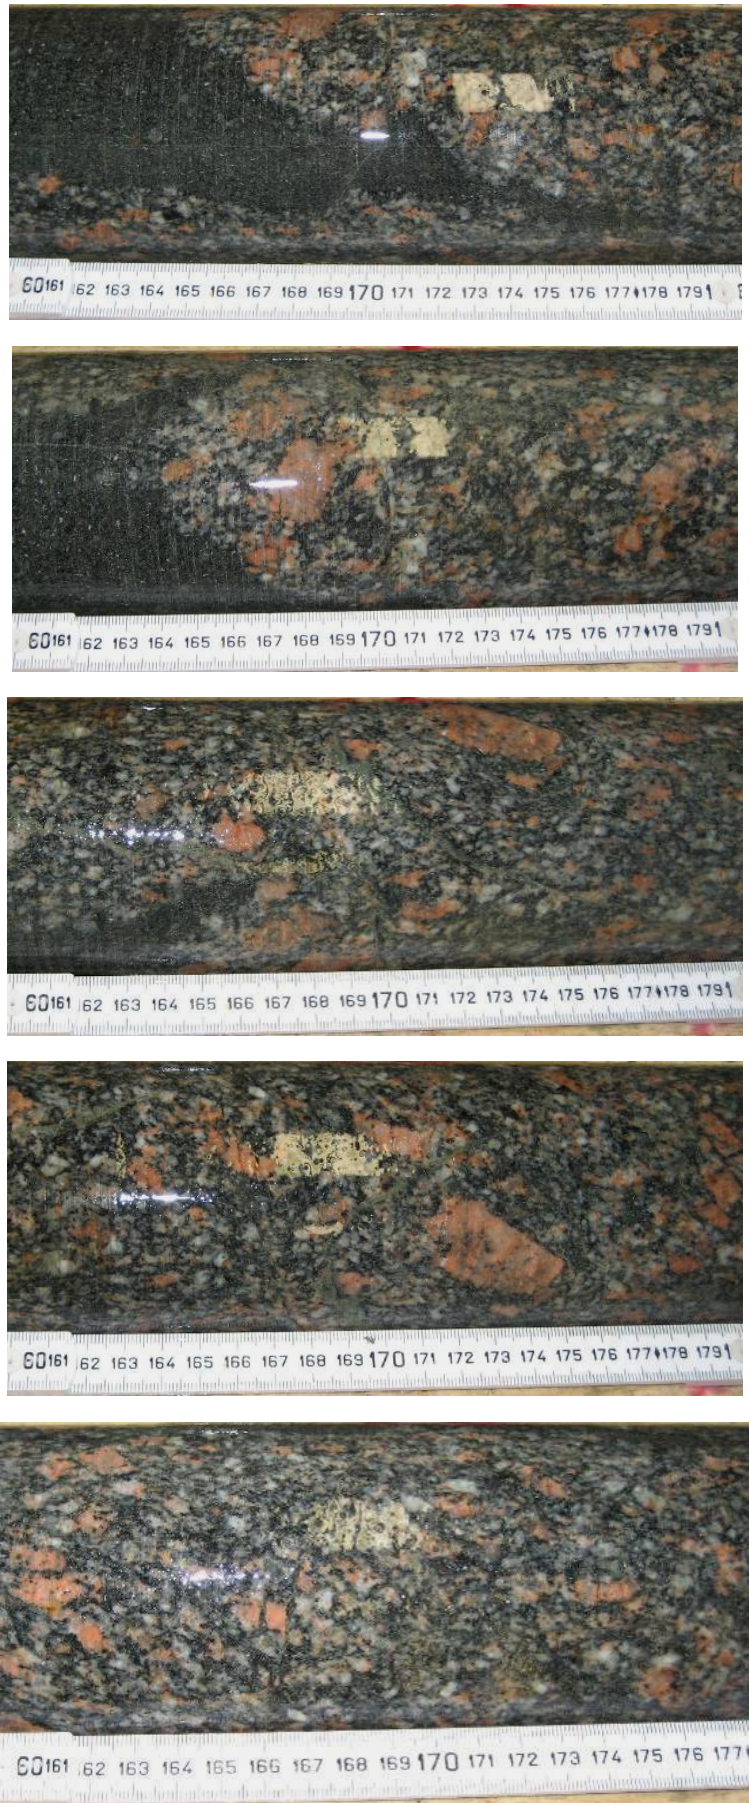
Figure 5–32. Section containing 1.7 m from the core. In different rotation.

In the section at 1.7 m depth in the borehole, an uncertain fracture indication is found in the seismic measurement. No fracture can be identified at this depth in the core or the BIPS image. The only structural indication in the core is an area with dark minerals, which indicate minerals with a higher density than the surrounding rock (Figure 5-32). This is similar to what has been identified in borehole KQ0047A03. In this core, the volume with the high density minerals can be found only in half the core profile. This implies that the indicators would not have been found if the probe were oriented in the opposite direction and not into the volume with high density minerals.

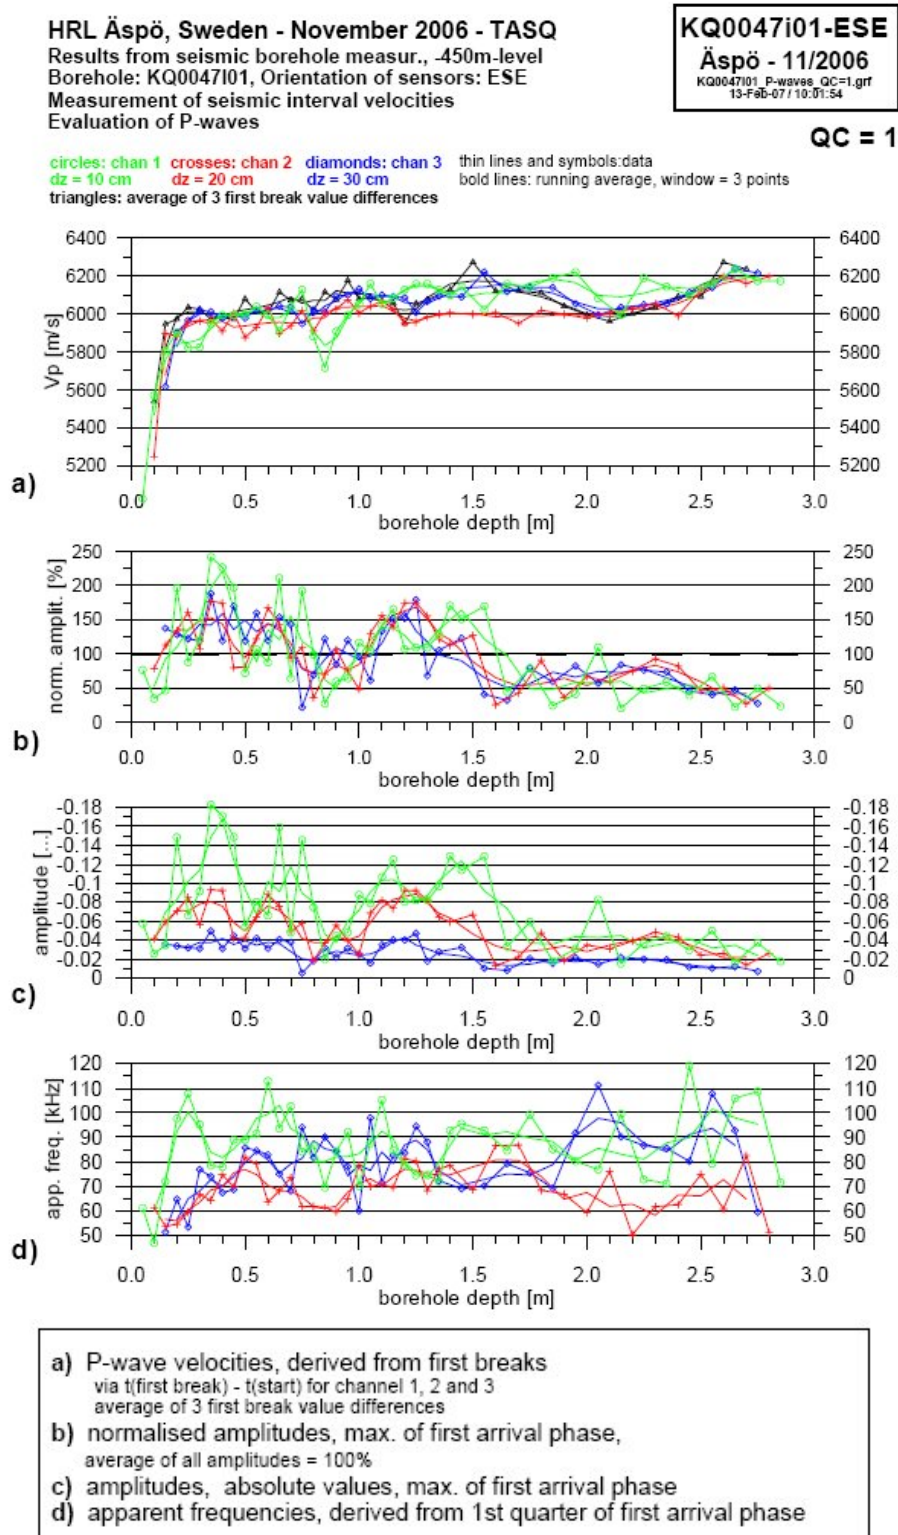
Figure 5–33. The results from the seismic investigation of borehole KQ0047101 /Schuster, 2007/.

In this borehole the possible fractures are indicated at depth 0.05-0.1 m and an uncertain possible fracture at 0.85-0.9 m according to the parameters derived from the seismic measurements (Figure 5-33) and the seismograms.

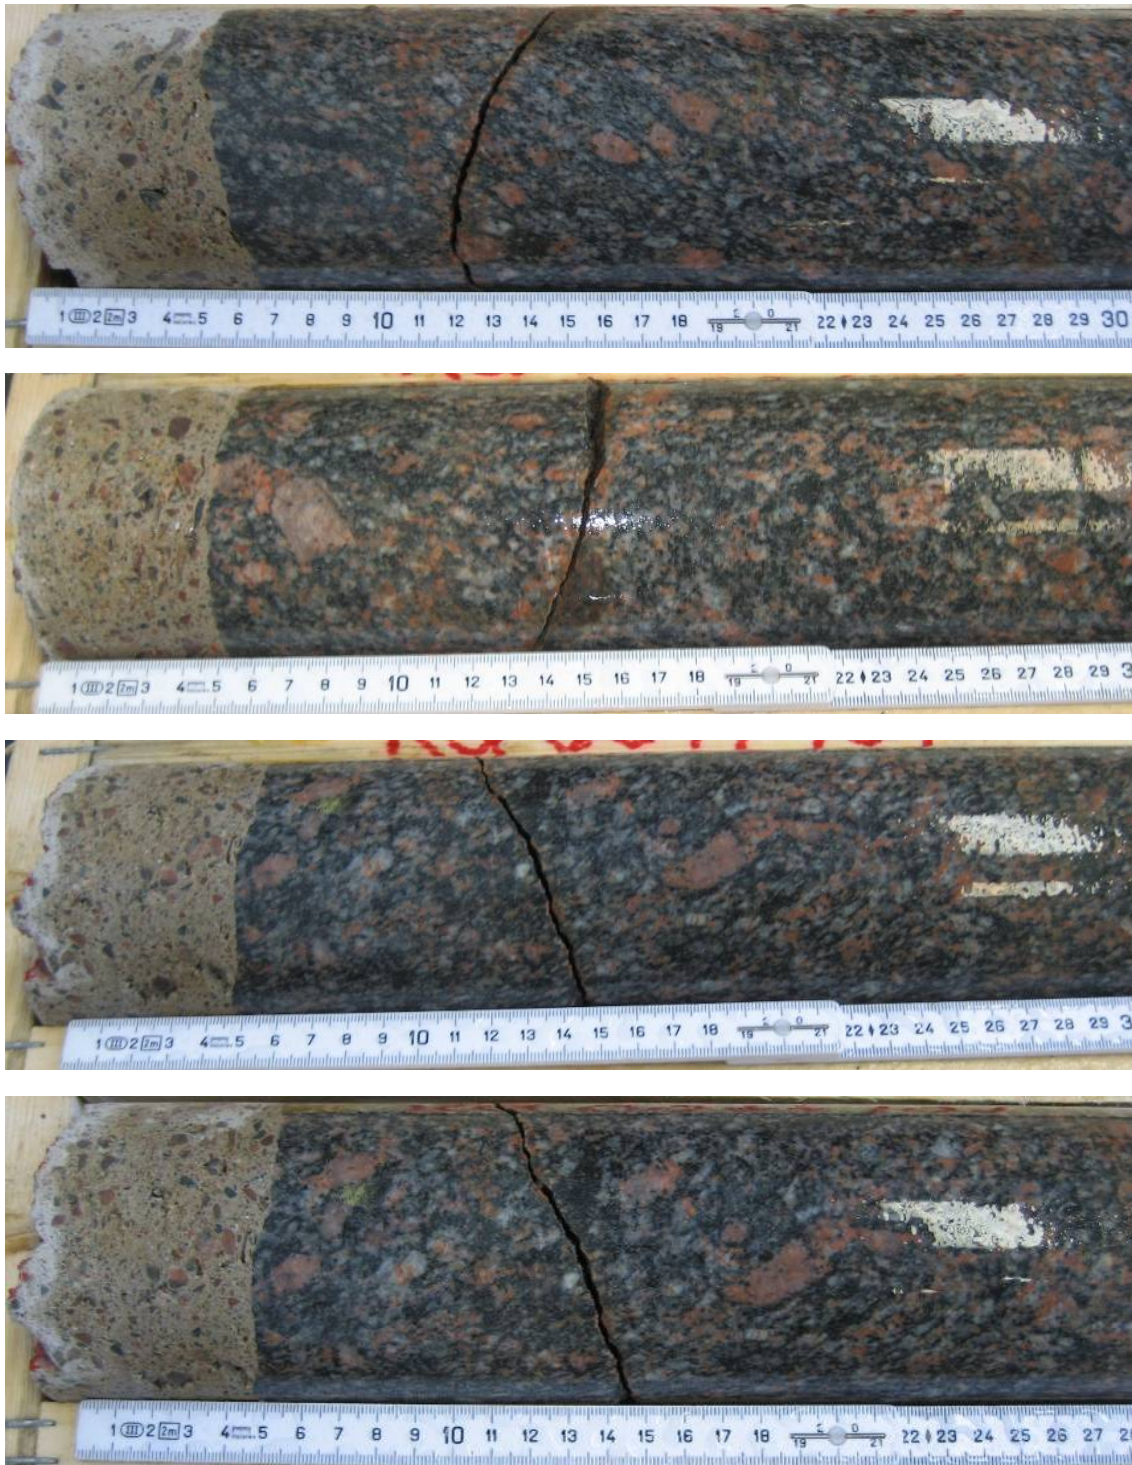
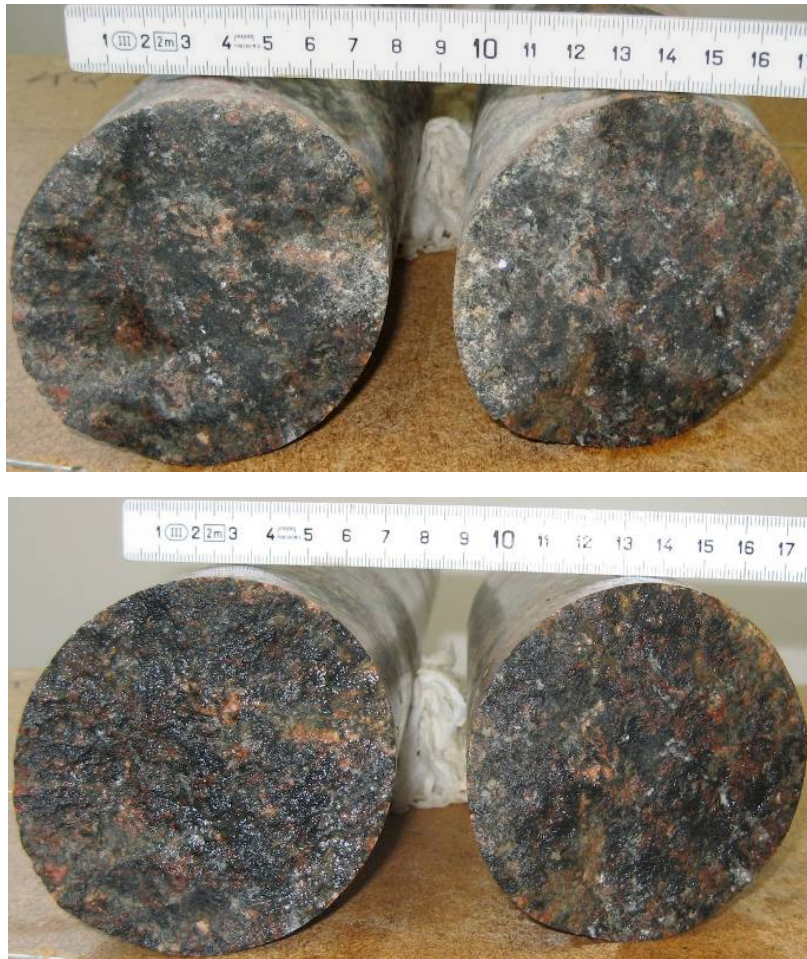
In the interval 0.05-0.1 m no fracture can be found but at 0.14 m a fracture with oxidized fracture surfaces can be found in the core by Berglund /Jonsson et al., 2008/. However, this fracture cannot be seen in the BIPS image (Figure 5-34), hence it is mapped as possible. Its surface is oxidized and irregular and can be seen in Figure 5-35.

Figure 5–34. Section containing 0.05-0.1 m from the core. In different rotation

Figure 5–35. The fracture surface for the fracture at 0.14 m in the core. Dry and wet surface.

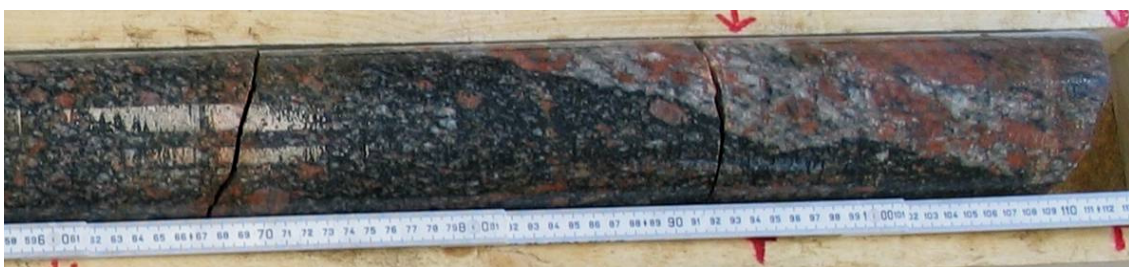
Figure 5–36. Section containing 0.85-0.9 m from the core.

In the interval 0.85-0.9 m no open fracture is found in the geological mapping or on the BIPS image. The closest fracture is found in the core at 0.681 m. The quality of the BIPS image of this borehole is quite poor, which makes the identification of fractures difficult. No indication of a fracture in the BIPS image can be found at the depth of the fracture found in the core. As can be seen in Figure 5-36, a significant change in rock type occur at about 0.8-1.1 m. Depending on the location of the seismic measurement in the wall, this change in rock type could be the density change that the seismic measurement reacts to.

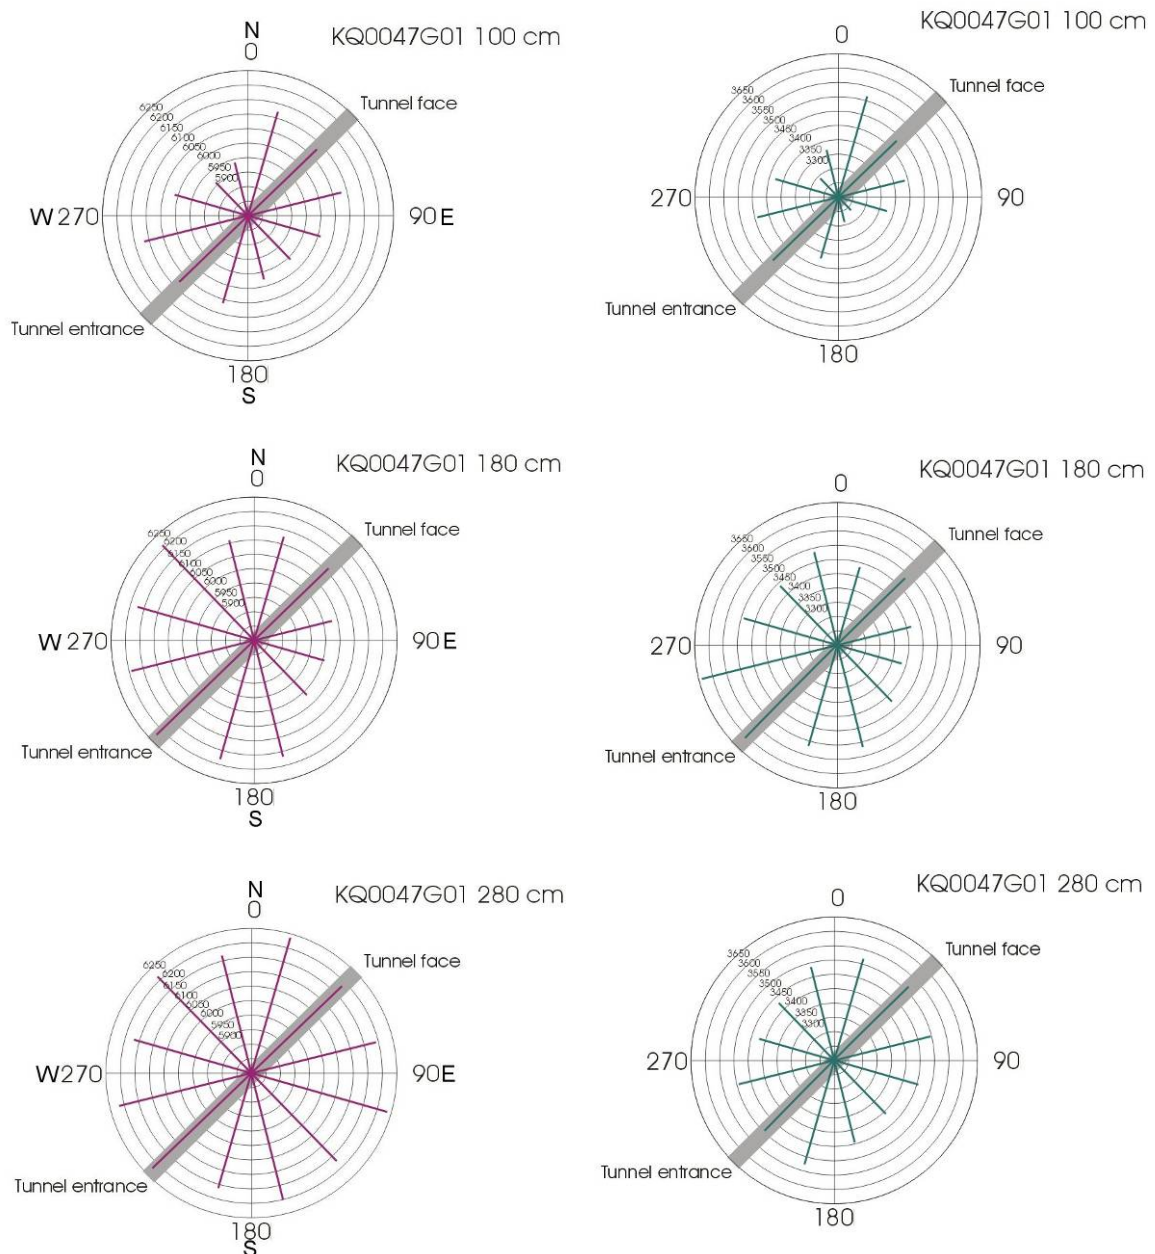
The resulting P-wave velocity has been plotted on a circular diagram with the length of the bars indicating the velocities. As seen in Figure 6-3, the P-wave velocity is largest in the NE to the SW and smallest in the NW to SE direction. At 1 m depth, a strong anisotropy with highest velocity is found in the tunnel axis direction at this depth. The results at 1.8 m depth are quite scattered and non-uniform with the highest P-wave velocity to the W-SW and the lowest orthogonally to the E. The deepest measurement is rather isotropic, at 2.8 m depth. When investigating the velocities from different depth it can be seen that the velocities increase with increasing distance from the floor.

Figure 6–3. Results from the velocity measurements in the borehole KQ0047G01 (in the floor) where the velocity is represented by bars in a 360° circular plot. The longer the bar the higher the velocity. Left: Compressional wave (P-wave) results. Right: Shear wave (S-wave) results .

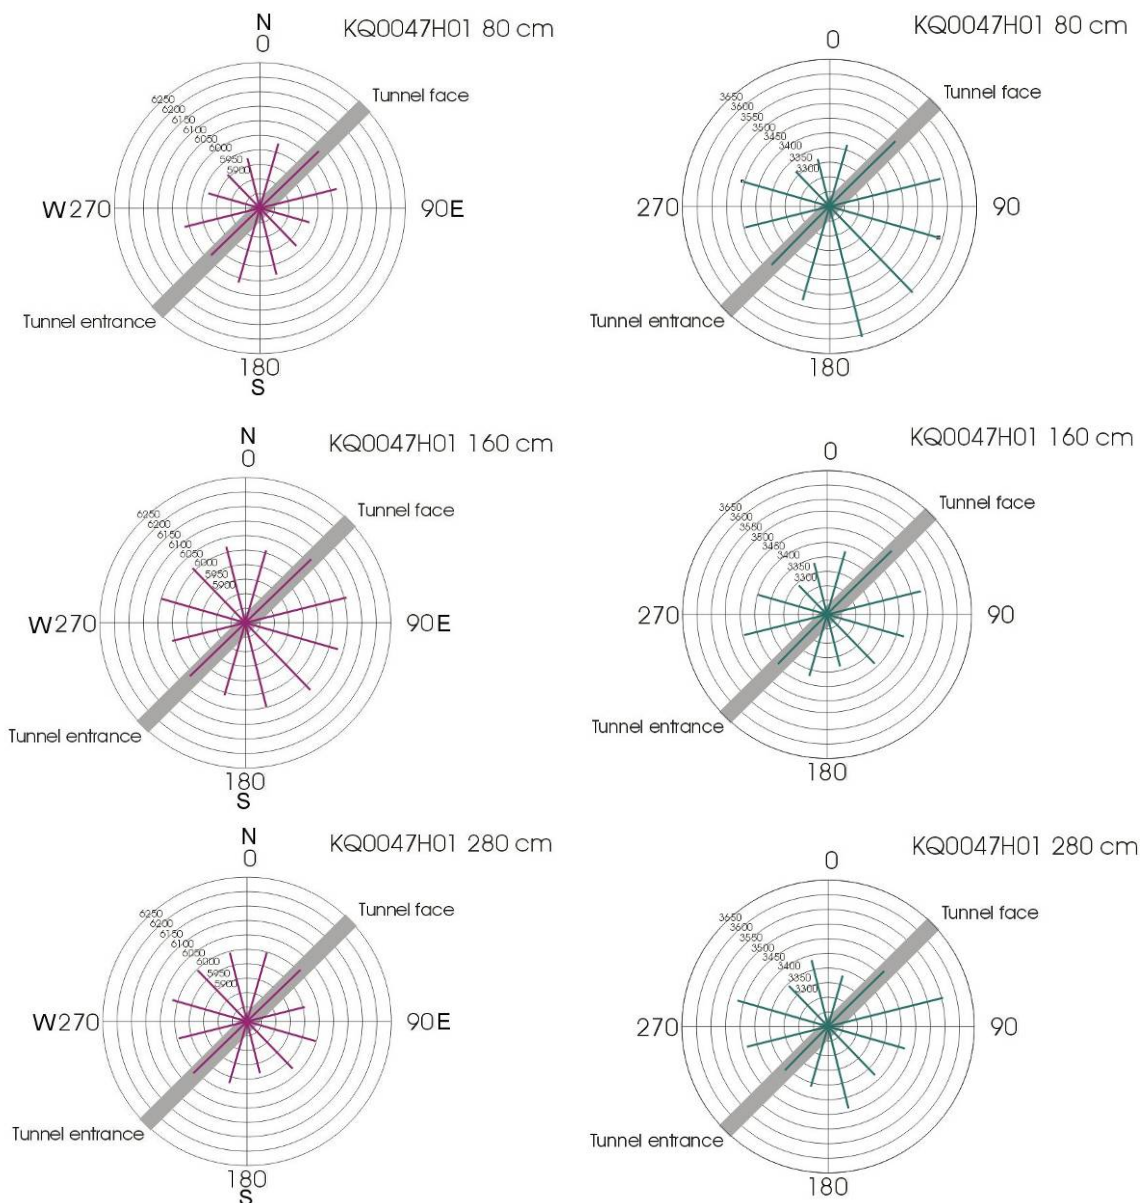
Similar to the shallow measurement in borehole KQ0047G01, the P-wave velocity of the rotational measurement in the 0.8 m deep measurement of KQ0047H01 show a higher velocity in the NE-SW direction. This is the same direction as the tunnel axis. At a depth of 1.6 m, the P-wave velocity is non-uniform, however this measurement show a more pronounced 180°-periodicity than the measurement 1.8 m under the floor (Figure 6-3, middle). The highest velocity in the E-W direction is directed about 60° to the east compared to the highest velocity in the 0.8 m measurement. At largest depth in the roof (2.8 m) the P-wave velocity is quite homogenously dispersed although the velocity is generally lower at 2.8 m depth compared to 1.6 m. A very small velocity increase can be discerned in the ESE direction. This could indicate a rotation of the velocity as one move away from the tunnel into the rock mass.

Figure 6-4. Results from the velocity measurements in the borehole KQ0047H01 (in the roof) where the velocity is represented by bars in a 360° circular plot. The longer the bar the higher the velocity. Left: Compressional wave (P-wave) results. Right: Shear wave (S-wave) results.
