Oskarshamn site investigation

Investigations of goethite-bearing fractures in cored boreholes Laxemar subarea

Henrik Drake, Isochron Geoconsulting HB
Eva-Lena Tullborg, Terralogica AB

March 2009

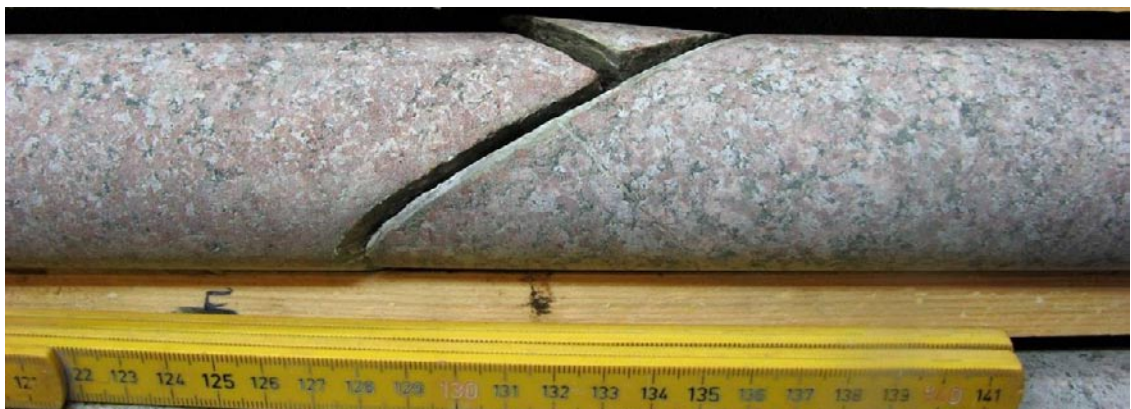
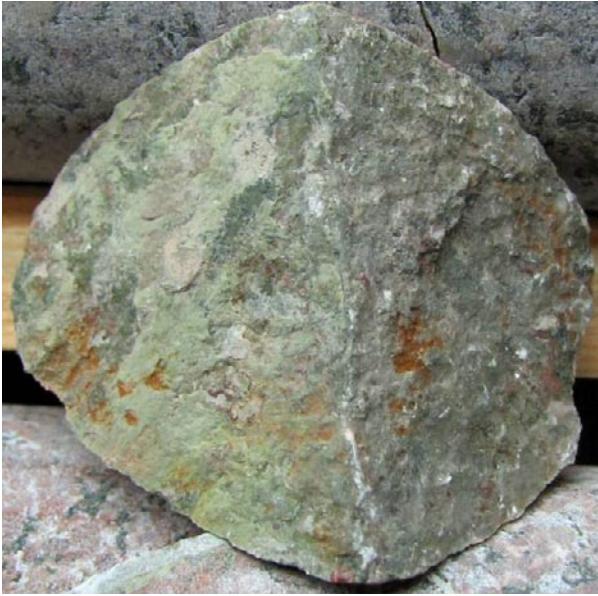
Description: The mapped goethite occurrence is found in an open fracture (Figure 5-1) as a fine-grained, brown powder on the fracture surface (Figure 5-2). The powder is made up of fine-grained, angular mineral fragments (Figure 5-3), which in turn are made up of common rock forming minerals such as quartz and feldspars but also of chlorite, clay minerals and Fe-oxides (which give the colouration). EDS analyzes indicate a significant amount of Zn, Mn, C and Cl on the surface of these minerals (especially related to Fe-oxides and Fe-rich chlorite/clay minerals). Zn, Mn, as well as C might originate from the drilling equipment and Cl may be a remnant from the mapping (i.e. HCl used for calcite identification). Individual fragments of native Zn or Zn-oxide are also observed. This fine-grained powder is only found in morphological depressions of the fracture surface, which indicates that it has been emplaced after the drilling (and not precipitated on the fracture surface). These observations indicate that the fine-grained powder mapped as goethite, is drilling induced and is therefore recommended to be removed from the mapping data. As described below for other samples, significant peaks for Zn, Cl, Mn and C in the spectra are typical for fine-grained, brown coloured powder, which is interpreted to be drilling induced. In contrast, most other fracture coating minerals identified in this and in other samples show no peaks for Cl, C, Mn and Zn.

Figure 5-1. Photograph of fracture KLX08: 388.349 m.

Figure 5-2. Photograph of fracture KLX08: 388.349 m.

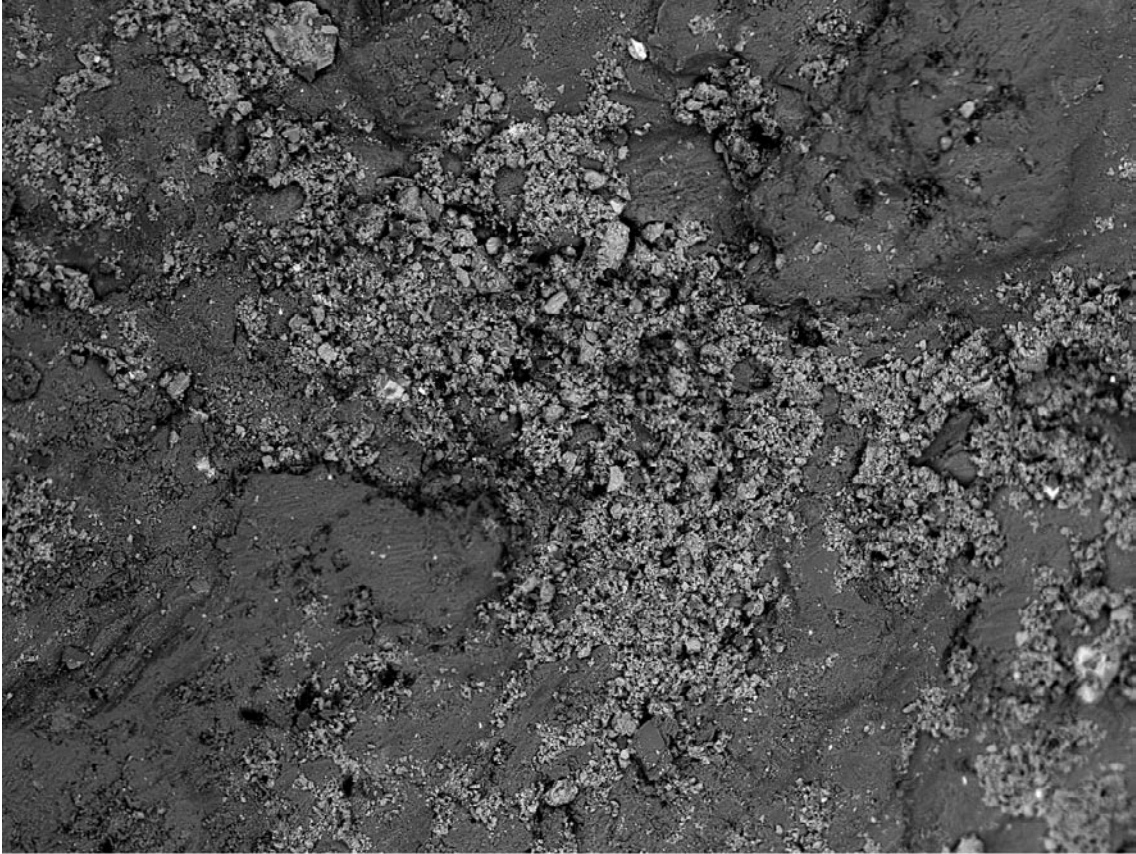
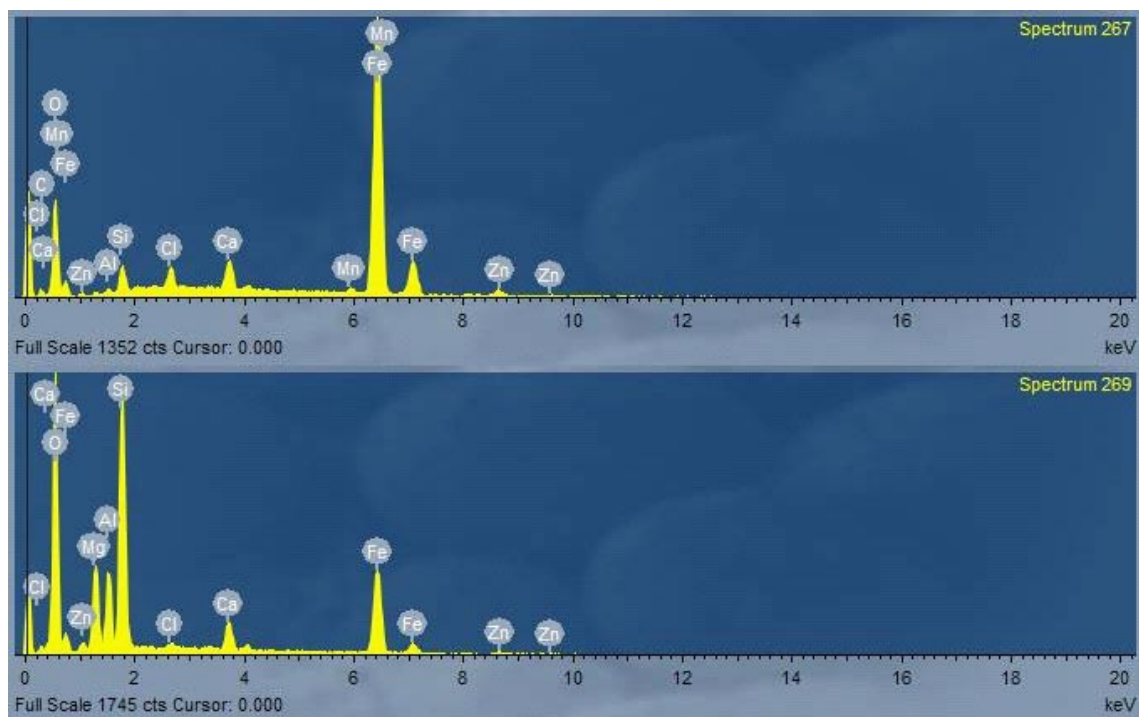
Figure 5-3. Back-scattered SEM-image of fine-grained, brown-coloured powder on the smooth fracture surface of open fracture KLX08: 388.349 m.

Figure 5-4. EDS-spectra for Fe-oxide (Spectrum 267) and Fe-rich chlorite/clay mineral (Spectrum 269) from open fracture KLX08: 388.349 m. Note the peaks for C, Cl, Zn and Mn.

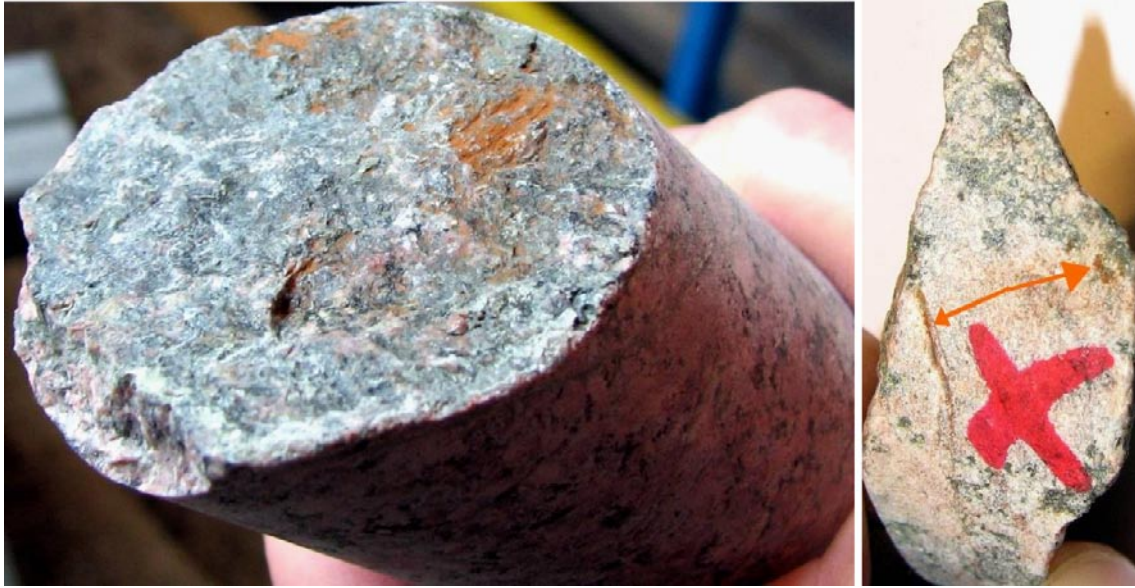
Description: The mapped goethite occurrence is found in an open fracture as a fine-grained, brown powder on the fracture surface and on the fresh drill core surface (Figure 5-5). The powder is made up of fine-grained, angular mineral fragments of common rock forming minerals such as quartz and feldspars but also of chlorite, clay minerals and Fe-oxides (which give the colouration, Figure 5-6 and Figure 5-7). EDS analyzes indicate a significant amount of Zn, Mn, C, Si and Cl on the surface of these minerals (especially related to Fe-oxides and Fe-rich chlorite/clay minerals, Figure 5-8). Zn, Mn, as well as C and Si might originate from the drilling equipment and Cl may be a remnant from the mapping (HCl used for calcite identification). This fine-grained powder is only found in morphological depressions on the fracture surface, which indicate that it has been emplaced after the drilling (and have not been precipitated on the fracture surface). These observations indicate that the fine-grained powder mapped as goethite, is drilling induced and is recommended to be removed from the mapping data. Additional minerals to be included in the mapping file are pyrite and chalcopyrite.

Figure 5-5. Photographs of fracture KLX08: 388.561 m. Arrows show drilling induced mineral fragments on the side of the drill core.

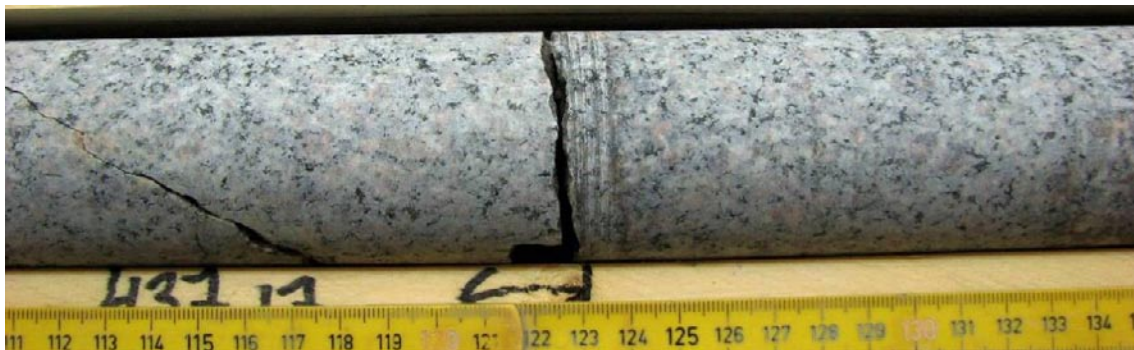
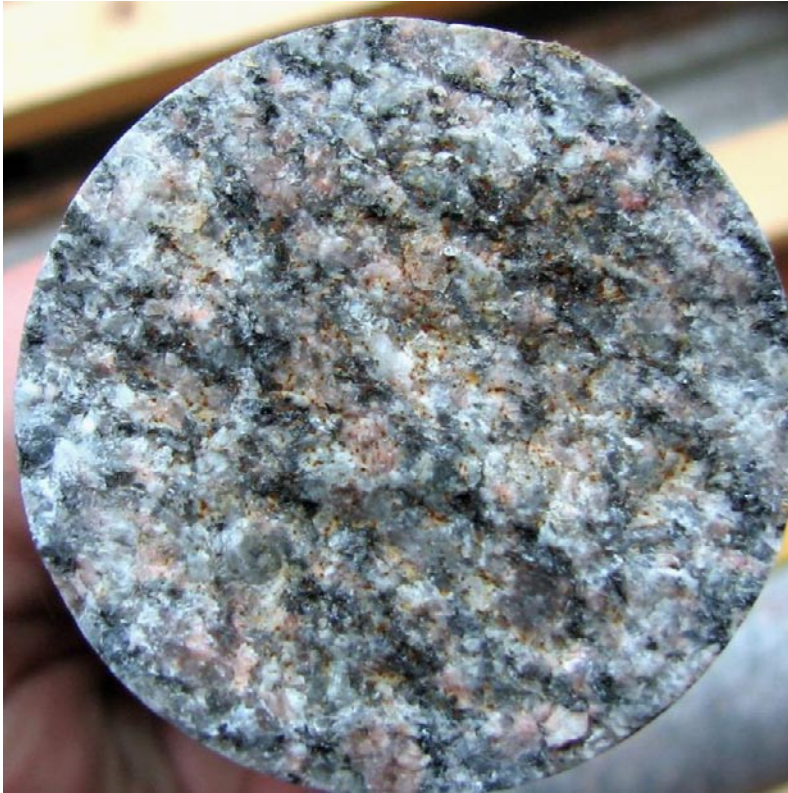
Description: The mapped goethite occurrence is found in an open fracture (Figure 5-9) as fine-grained, scattered spots with metallic lustre (Figure 5-10). The spots are partly corroded. They are interpreted to be fragments from the drilling equipment because they resemble metallic fragments which have corroded (as shown in the SEM-images Figure 5-11, Figure 5-12). In addition, the EDS-analyses show that these fragments are made up of Fe mainly, but include some Si, Zn, Mn, S, Mo, C and Cl as well (Figure 5-13). This further supports an origin from the drilling equipment, which is Fe-dominated and have trace amounts of e.g. Mn, Mo and Si. Furthermore, metallic markings on the core, resulting from drill wear, adjacent to this fracture (Figure 5-9) indicate that the drilling has been experiencing some difficulties at this stage and it is therefore even more likely that fragments from the drilling equipment has been emplaced on the fracture surface. During the drill core mapping, these metallic spots were identified as pyrite crystals, which have been partly altered to goethite. SEM-investigations show that no pyrite is present. Instead, the spots are interpreted to be fragments from the drilling equipment and both pyrite and goethite should therefore preferably be removed from the mapping data.

Figure 5-9. Photograph of fracture KLX09: 437.210 m.

Figure 5-10. Photograph of fracture surface from open fracture KLX09: 437.210 m.

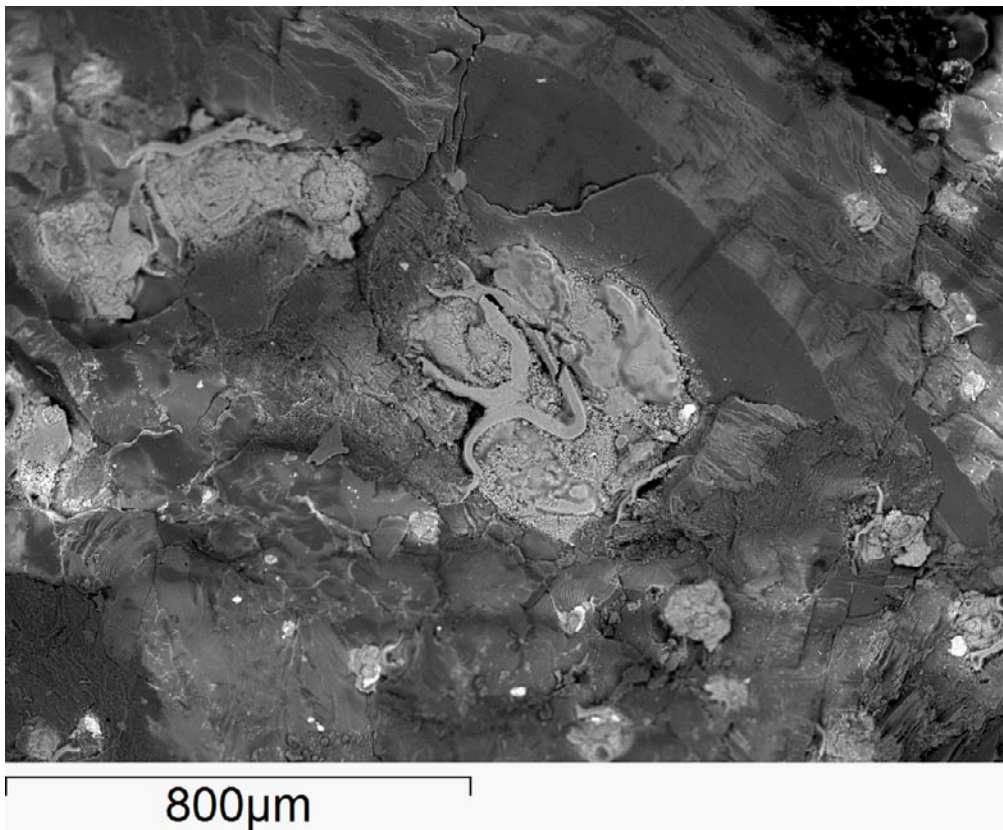
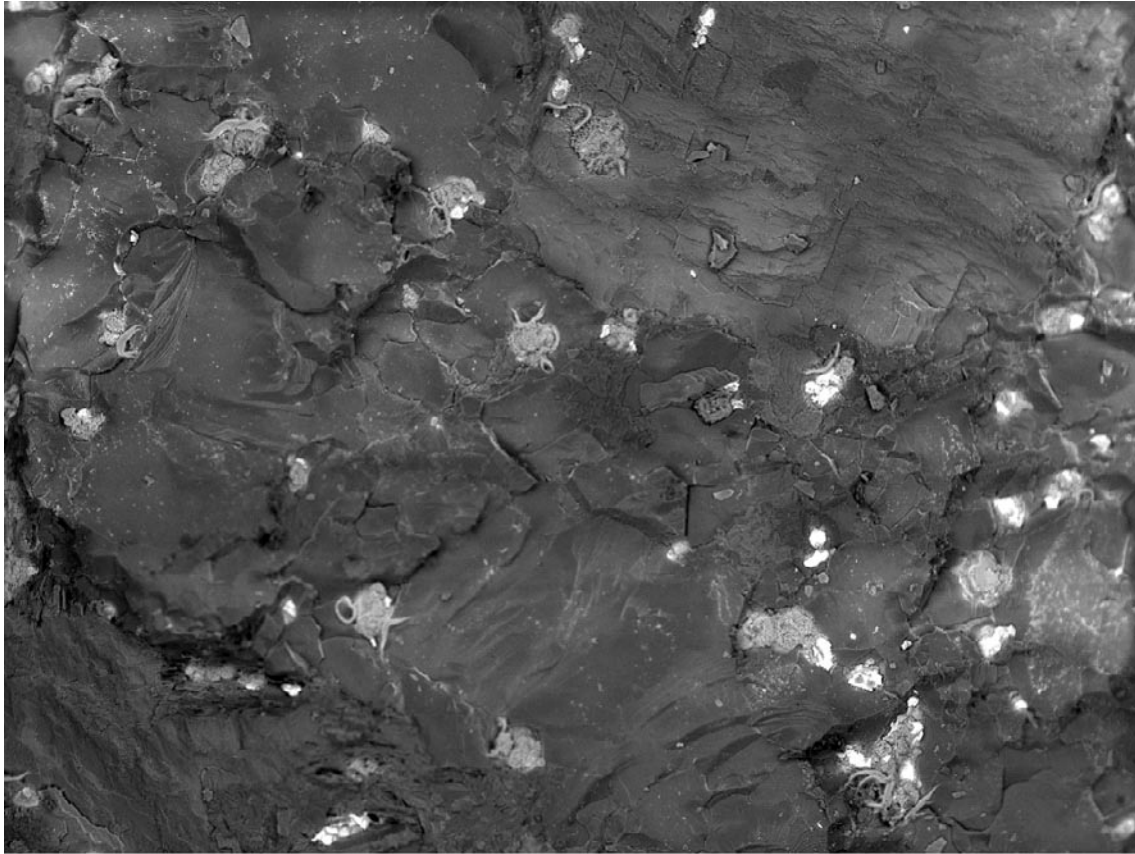
Figure 5-11. Back-scattered SEM-image of metallic fragments on the surface of open fracture KLX09: 437.210 m.

Figure 5-12. Back-scattered SEM-image of metallic fragments on the surface of open fracture KLX09: 437.210 m.

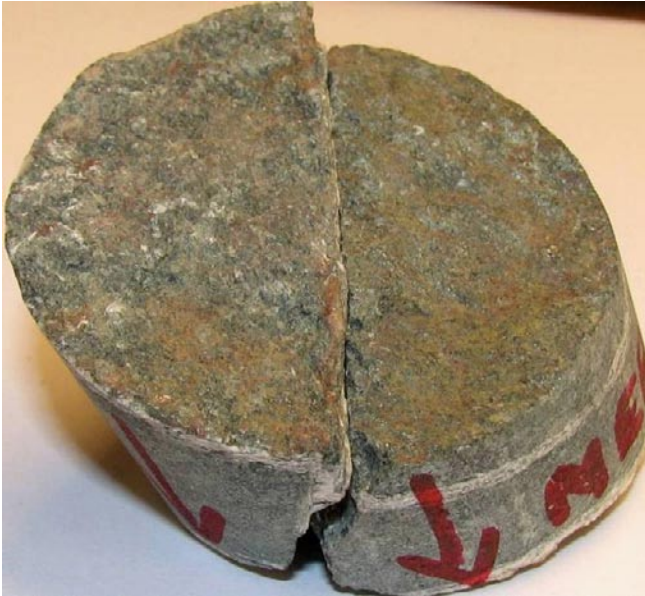
Description: The mapped goethite occurrence is found in an open fracture as a fine-grained, brown powder on the fracture surface, especially around the drill core edges, which may indicate that it is drilling induced powder (Figure 5-15). The powder consists of fine-grained, angular mineral fragments (Figure 5-16 and Figure 5-17). These fragments are made up of common rock forming minerals such as quartz and feldspars but also of chlorite, clay minerals and Fe-oxides (which give the colouration). EDS analyzes indicate a significant amount of V, Ti, Ca, Cl on the surface of these minerals (especially related to Fe-oxides and Fe-rich chlorite/clay minerals, Figure 5-8). Some of these elements might originate from the drilling equipment. Some of the parts of the filling show typical hematite colour (cf. /Drake and Tullborg 2004, 2007/, and hematite is therefore suggested to replace goethite in the mapping data, because goethite is probably emplaced as a drilling induced powder on the fracture surface. This interpretation is based on the angular fragments of this coating and by the position of the powder on the fracture surface, i.e. mostly at the drill core rim, as well as partly by the chemistry of the powder, i.e. rich in elements which generally are rare in fracture coatings cf. /Drake and Tullborg 2008abc/).

Figure 5-15. Photograph of open fracture KLX10: 331.987 m.

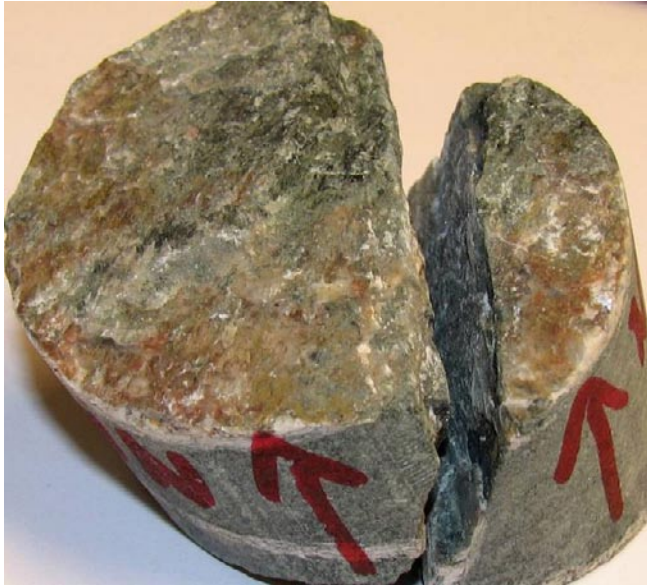
Description: The mapped goethite occurrence is found in an open fracture as a fine-grained, brown powder on the fracture surface especially around the drill core edges, which may indicate that it is drilling induced powder (Figure 5-18). The powder consists of fine-grained, angular mineral fragments (Figure 5-19 and Figure 5-20). These fragments are made up of quartz and feldspars but also of chlorite, clay minerals and Fe-oxides (which give the colouration). EDS analyzes indicate a significant amount of Mn, Ti, Ca, Cl on the surface of these minerals (especially related to Fe-oxides and Fe-rich chlorite/clay minerals, Figure 5-8). Some of these elements (e.g. Mn) may originate from the drilling equipment. Parts of the filling show typical hematite colour (cf. /Drake and Tullborg 2004, 2007/). Goethite is interpreted to have been emplaced as a drilling induced powder on the fracture surface (as indicated by the angular fragments of this coating and by the position of the powder on the fracture surface, i.e. at the drill core rims and where originally present minerals have been damaged and removed during drilling, as well as partly by the chemistry of the powder, i.e. rich in elements which are rare in fracture coatings otherwise, cf. /Drake and Tullborg 2008abc/). Furthermore, fresh unaltered pyrite is present on the fracture surface, indicating prevailing reducing conditions in the fracture. These observations indicate that the fine-grained powder mapped as goethite, is drilling induced and is therefore recommended to be removed from the mapping data. Clay minerals and pyrite should be included in the mapping data.

Figure 5-18. Photograph of open fracture KLX10: 332.012 m.

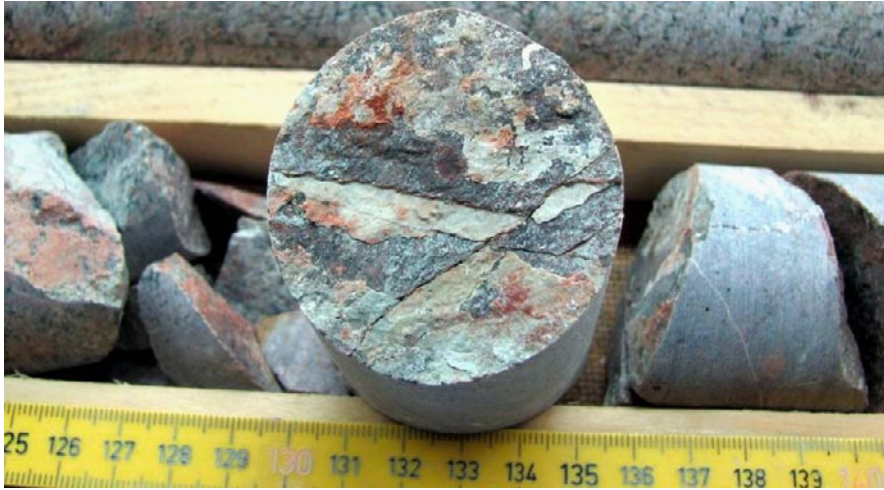
Description: The mapped goethite occurrence is found in an open fracture as a fine-grained, brown powder on the surface of an older fracture mineral coating (Figure 5-21). Detailed SEM-EDS investigations reveal that no Fe-rich minerals (except fresh pyrite) are present in the coating. Most of the coating is made up of calcite, illite and adularia (possibly hematite-stained, but no hematite was identified) with minor amount of pyrite (Figure 5-22). Therefore it is suggested that goethite is removed from the mapping data.

Figure 5-21. Photograph of sample KLX10: 704.32–704.44 m with fracture surface of open fracture KLX10: 704.339 m shown.

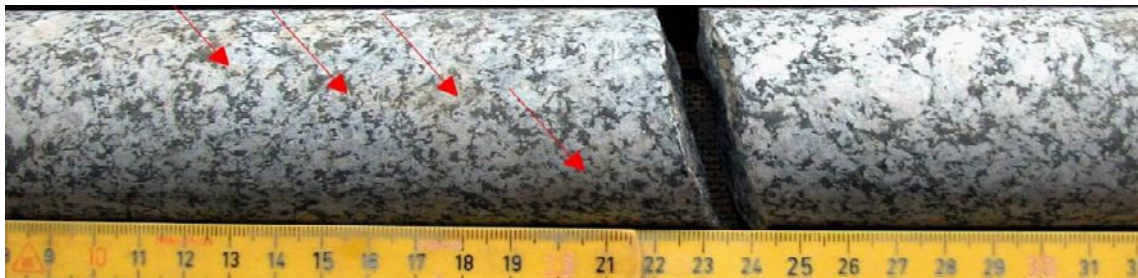
Description: The mapped goethite occurrence is found in an open fracture as a fine-grained, brown powder on the fracture surface, as well as on the side of drill core and at the fracture-drill core edges, which may indicate that it is drilling induced powder (Figure 5-23 and Figure 5-24). The powder consists of fine-grained, angular mineral fragments (Figure 5-25 and Figure 5-26). These fragments are made up of common rock forming minerals such as quartz and feldspars but also of chlorite, clay minerals and Fe-oxides (which give the colouration). EDS-analyses indicate a significant amount of e.g. Mn, Ca, Si on the surface of these minerals (especially related to Fe-oxides and Fe-rich chlorite/clay minerals). Goethite is interpreted to have been emplaced as a drilling induced powder on the fracture surface (as indicated by the angular fragments of this coating and by the position of the powder on the fracture surface, i.e. at the fracture-drill core rims and at the drill core side). Furthermore, fresh pyrite is present on the fracture surface indicating prevailing reducing conditions in the fracture. These observations indicate that the fine-grained powder mapped as goethite, is drilling induced and is recommended to be removed from the mapping data and that pyrite should be included instead.

Figure 5-23. Photograph of drill core sample KLX12A: 332.17–332.25 m. Arrows indicate oxidized metallic markings on the core, resulting from drill wear (consisting of a fine-grained powder similar to that on the fracture surface).

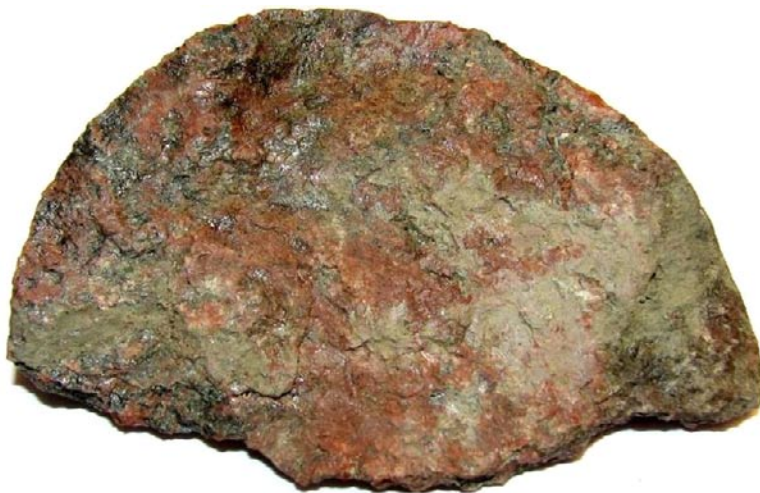
Description: Open fracture with a fracture coating consisting of chlorite, clay minerals, hematite and pyrite (Figure 5-28). The red-staining of the fracture is due to hematite-staining of feldspars and chlorite, as shown by the typical colour (cf. /Drake and Tullborg 2004, 2005, 2006, 2007, 2008abc/), which is darker than the colour of goethite (cf. /Drake and Tullborg 2008d/). Furthermore, fresh pyrite is present on the fracture surface (younger than hematite) indicating prevailing reducing conditions in the fracture. Chlorite dominates the coating and is quite Mg-rich (Figure 5-29). It is therefore recommended that goethite is changed to hematite in the mapping data and that pyrite is included as well.

Figure 5-28. Photograph of the fracture surface of open fracture KLX13A: 550.762 m.

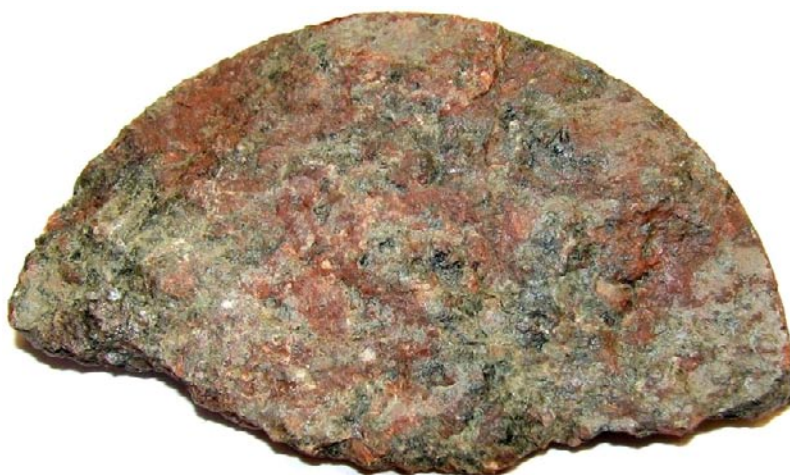
Description: Open fracture with a fracture coating consisting of chlorite, clay minerals, hematite and pyrite (Figure 5-30). The red-staining of the fracture is due to hematite-staining of feldspars and chlorite, as shown by the typical colour (cf. /Drake and Tullborg 2004, 2005, 2006, 2007, 2008abc/), which is darker than the colour of goethite (cf. /Drake and Tullborg 2008d/). Just as in fracture KLX13A: 550.762 m, chlorite dominates the coating and is quite Mg-rich. The most common clay mineral is illite. It is recommended that goethite is changed to hematite in the mapping data and that calcite is included as well.

Figure 5-30. Photograph of the fracture surface of open fracture KLX13A: 550.766 m.

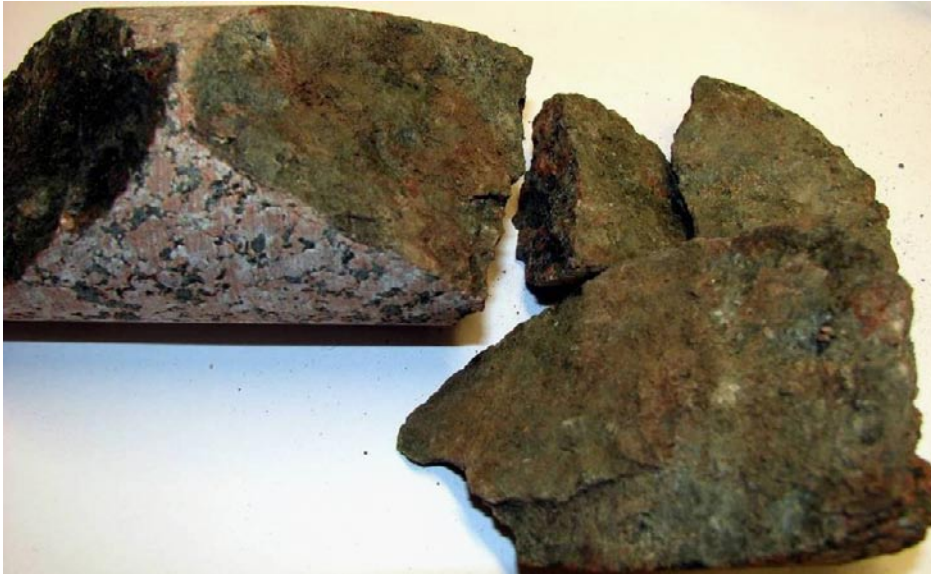
Description: This open fracture is located in a highly fractured section in KLX13A (Figure 5-31). The coating is dominated by clay minerals and chlorite, with their characteristic dark green to green colour. Some parts of the filling are more brownish, similar to hematite-stained fracture coatings described in other samples above and from earlier studies in the area (cf. /Drake and Tullborg 2004, 2005, 2006, 2007, 2008abc/). This colouration is darker than the colour of goethite, and is mainly due to hematite-staining/pigmentation of fracture chlorite (cf. /Drake and Tullborg 2008d/). Therefore it is suggested that hematite, should replace goethite in the mapping file. The amount of hematite is very small, even in the brown coloured parts of the coating. Figure 5-32 shows an SEM-image on a related EDS-spectrum of Mg-rich chlorite in a brown coloured part of the filling. Very few, if any, Fe-rich spots (hematite) are visible. Other minerals to be included in the mapping data are calcite, pyrite and barite.

Figure 5-31. Photograph of drill core sample KLX13A: 551.30–551.41 m.

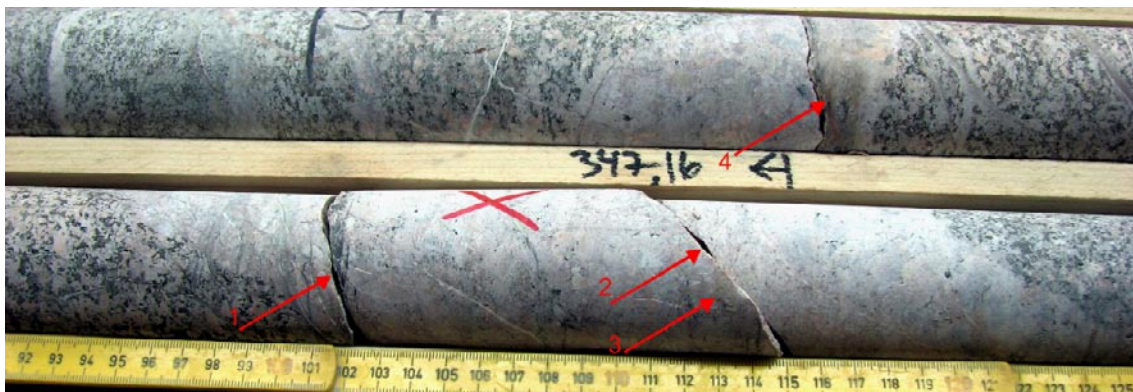
Figure 5-37. Photograph of drill core sample KLX16A: 348.01–348.14 m (X), 1) fracture 348.067 m, 2) 348.173, 3 and 4) oxidized metallic markings on the core, resulting from drill wear.

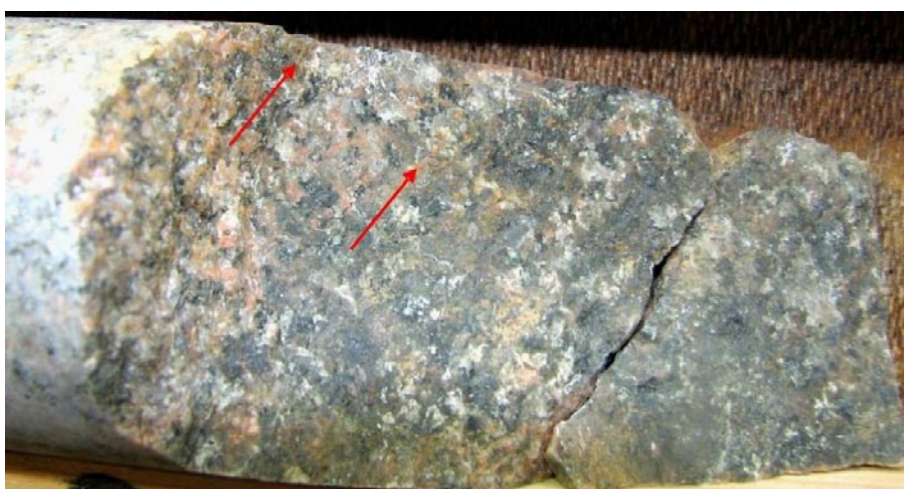
Figure 5-49. Photograph of drill core sample KLX07A: 432.15–432.27 m with open fracture KLX07A: 432.144 m. Arrows indicate powder mapped as goethite.

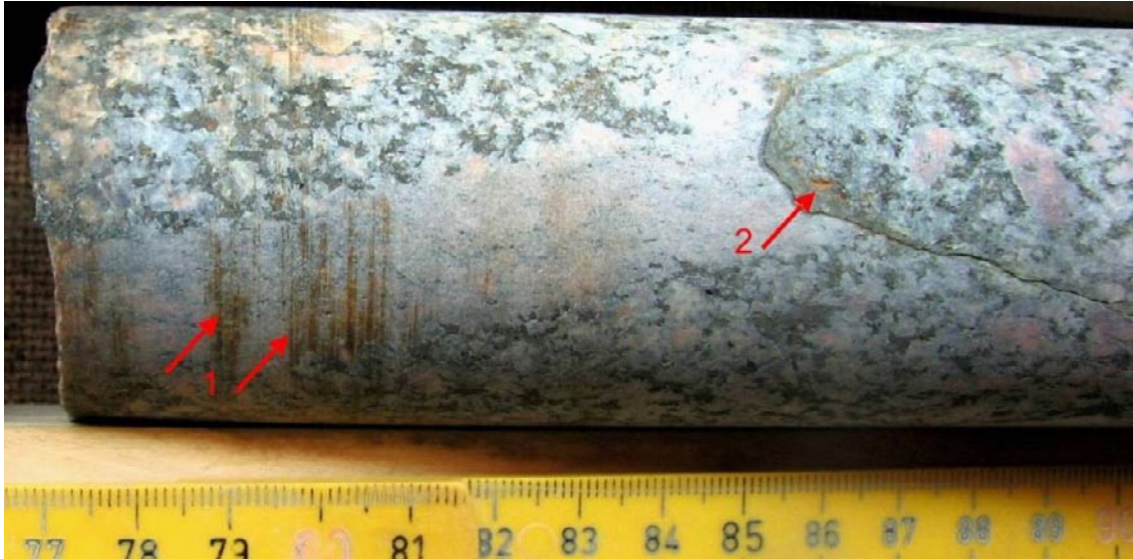
Photograph of sealed fracture KLX12A: 313.853 m (“2”) and adjacent metallic markings on the core, resulting from drill wear (“1”).

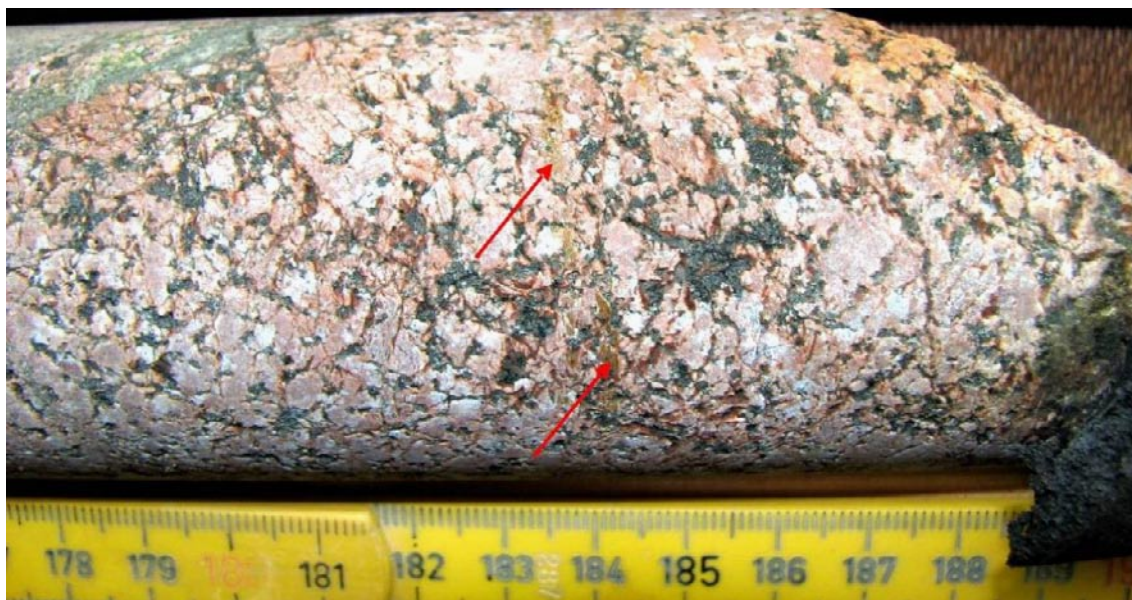
Photograph of sealed network section KLX13A: 576.768–576.897 m. Arrows indicate metallic markings on the core, resulting from drill wear.
