Assessment of fractures classified as non-mineralised in the Sicada database

Lillemor Claesson Liljedahl, Raymond Munier
Svensk Kärnbränslehantering AB

March 2011

Svensk Kärnbränslehantering AB

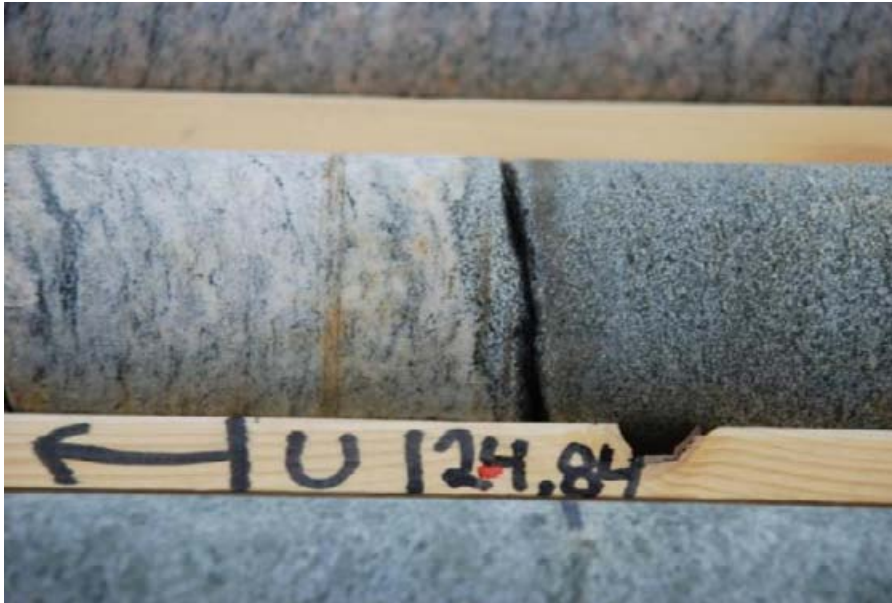
Group 2 includes fractures (Figure 5-5) that clearly bear signs of drilling (e.g. the fracture existed close to core polishing marks or in the vicinity of core uptake, which is seen as a brownish circular mark on the core).

Figure 5-5. Photo of core KFM02A (fracture ID E8D242D98A31E7B6). This fracture is a typical Group 2 fracture, as it coincides with or is affected by drilling disturbances. In this example the fracture coincides with a change in lithology at the uptake of the drill core. The diameter of the drill cores is 50 mm.

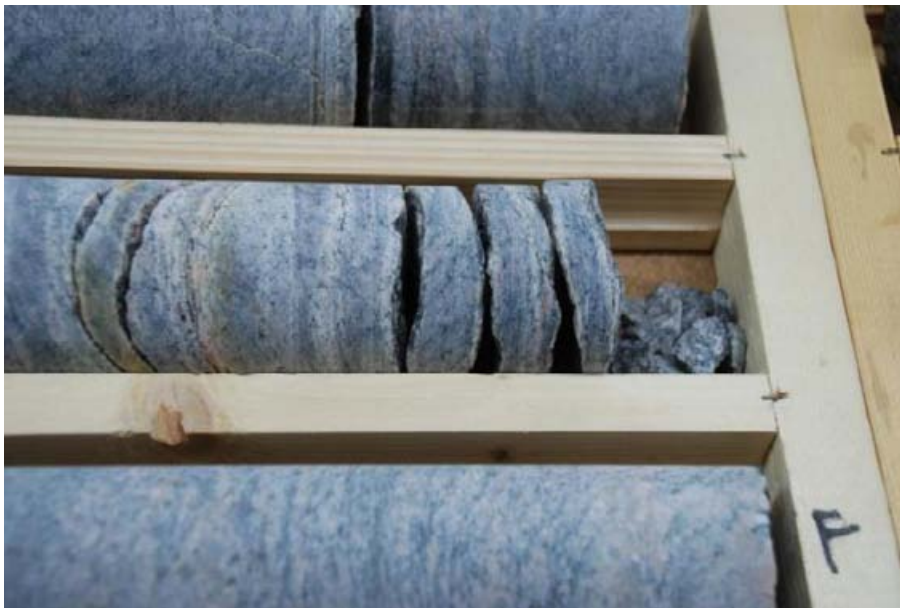
Group 3 includes fractures coinciding with signs of core dishing (e.g. saddle-shaped fracture surfaces) and lack of evidence of a fracture in the BIPS image (Figure 5-6). These fractures were likely misinterpreted during core logging and have been erroneously registered as visible in BIPS and as true fractures in Sicada.

Figure 5-6. Photo of core KFM10A (fracture ID 25D046D98A15B32C). These fractures are typical Group 3 fractures and display strong indications of core dishing. The core dishing appear to coincide with nearby bands of micro-fractures. The diameter of the drill cores is 50 mm.

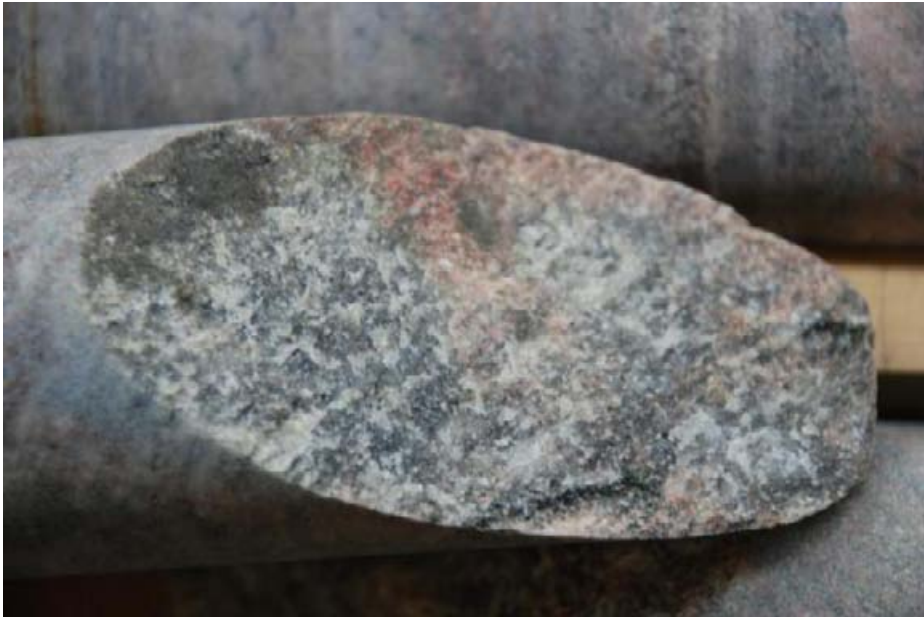
Group 4 represents erroneously logged fractures, for they most likely are mineral coated (Figure 5-7). However, the coating was too thin to allow for mineral identification by the unaided eye.

Figure 5-7. Photo of core KFM06C (fracture ID 7C9642D9881B5146). This fracture is a typical Group 4 fracture, with indications of mineral coating but the coating is too thin to distinguish the minerals forming the coating with the unaided eye. This fracture was sampled for further mineralogical analyses. The diameter of the drill cores is 50 mm.

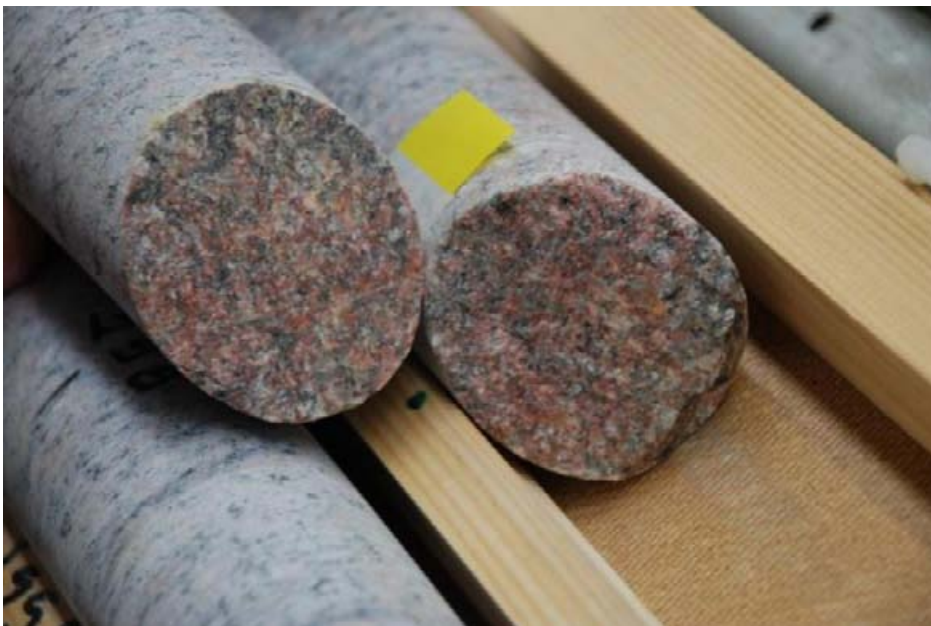
Group 5 represents non-mineralised fractures, where no mineral coating could be observed (Figures 5-8 and 5-9). We consider these fractures to have been correctly logged.

Figure 5-8. Photo of core KFM06A (fracture ID 945642D98A3485D4). This fracture is a typical Group 5 fracture, with no indications of mineral coating (i.e. a non-mineralised fracture by definition). This is a PFL-f fracture which was sampled for further mineralogical analyses. No signs of mineral coating were detected using SEM-EDS. Figure 5-9 shows the BIPS image of the same fracture. The diameter of the drill cores is 50 mm.

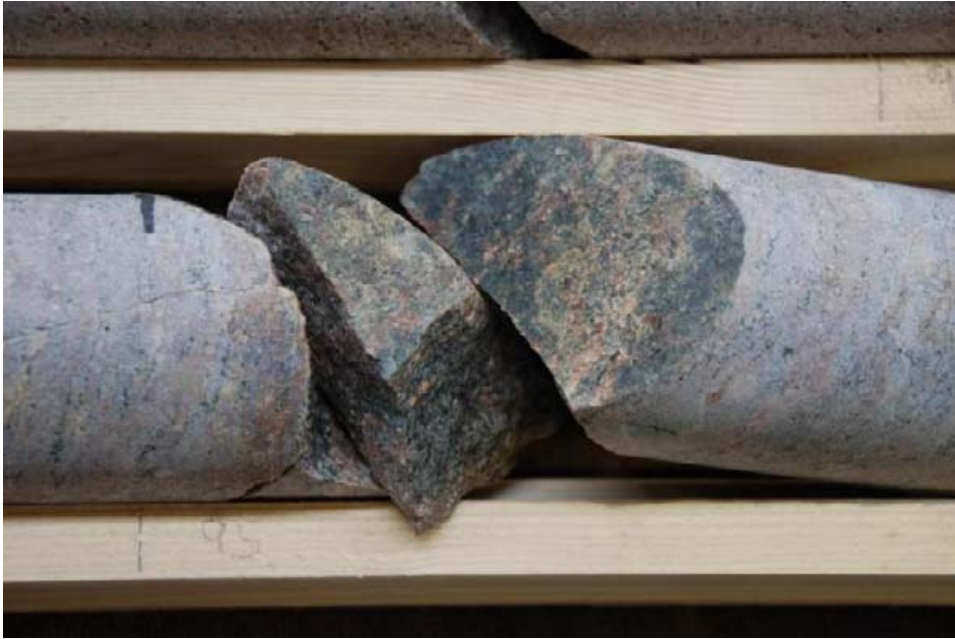
Group 6 include fractures with mineral coating that were readily visible to the unaided eye (Figure 5-10). We consider these to have been erroneously logged.

Figure 5-10. Photo of core KFM10A (fracture ID BF5046D98A11738D). This fracture is a typical Group 6 fracture, with clear indications of mineral coating. This fracture was sampled for further mineralogical analyses. The diameter of the drill cores is 50 mm.

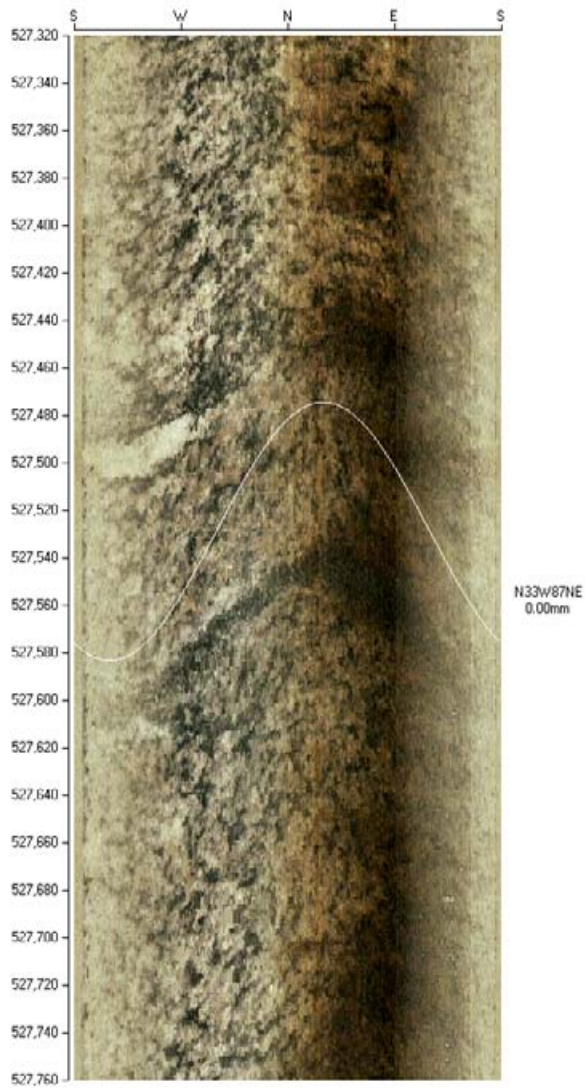
Group 7 denotes fractures that were very difficult or impossible, to detect in the BIPS image (Figure 5-11). We consider these to have been erroneously registered in Sicada. These fractures might reflect core breakage from the core handling (Figure 5-12).

Figure 5-11. BIPS image of core KFM01D (fracture ID 521142D98F180CA9). This BIPS image shows no clear signs of a fracture.

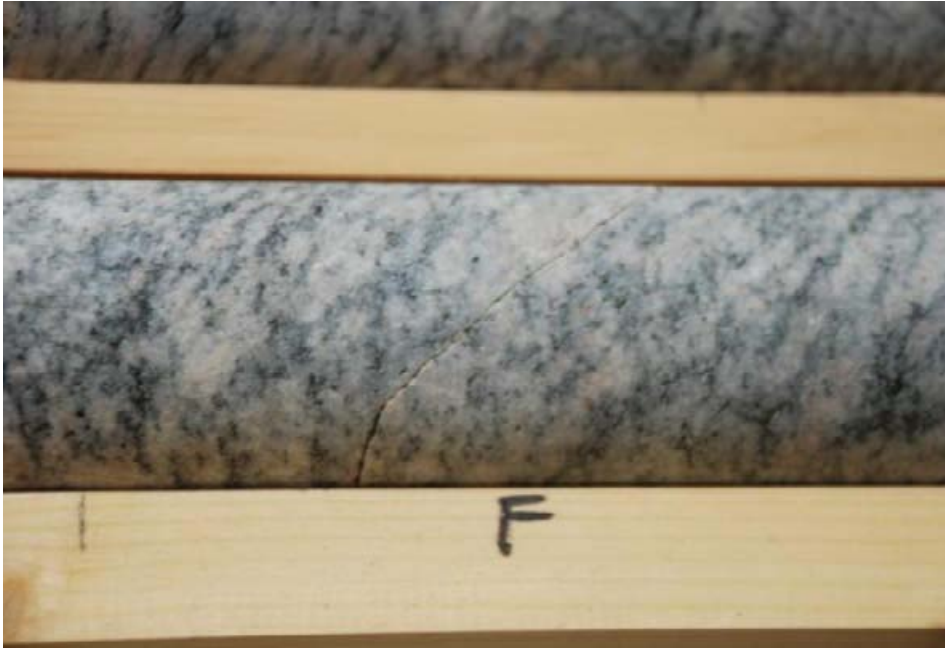
Figure 5-12. Photo of core KFM01D (fracture ID 521142D98F180CA9). F indicates that this break occurred during handling of the core. This fracture is a typical Group 7 fracture; it is not visible in BIPS (see Figure 5-11), and was erroneously logged as an in situ fracture. The diameter of the drill cores is 50 mm.

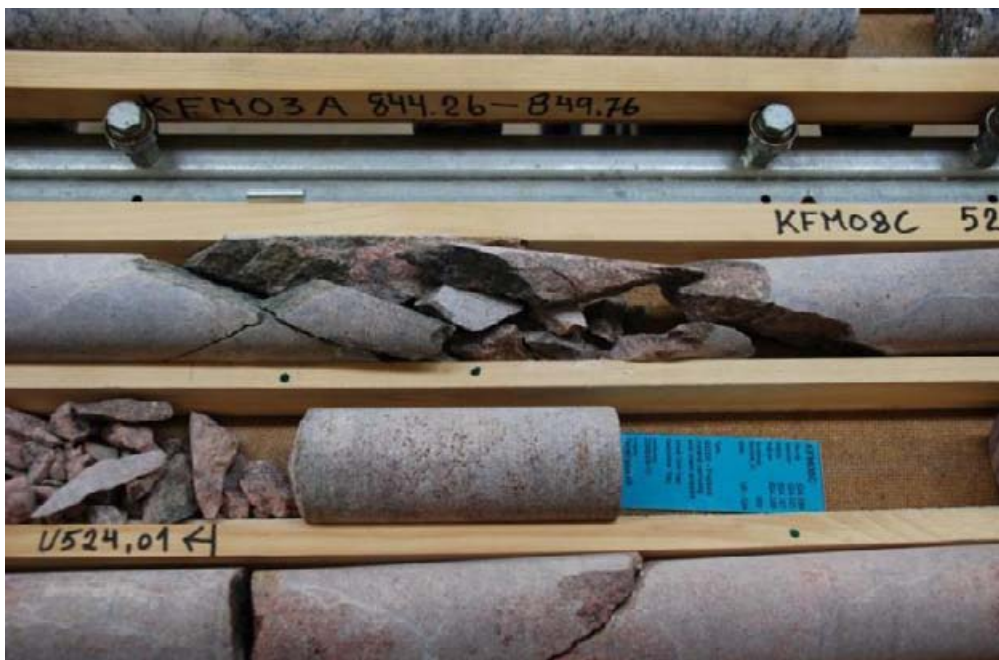
Group 8 corresponds to features that could not be located in the core (Figure 5-13). The reason for the unfeasibility to identify the fracture was related to complex fracturing (a crush zone) where the part of the core where the fracture was supposed to occur was heavily fractured.

Figure 5-13. Photo of core KFM08C (fracture ID 849842D988280291). White rectangle frames a crush zone. Some of the fracture surfaces in this section are coated by minerals whereas some are not. Difficult to identify the specific fracture among the number of fractures. It cannot be excluded that some of these are drilling induced fractures. The diameter of the drill cores is 50 mm.

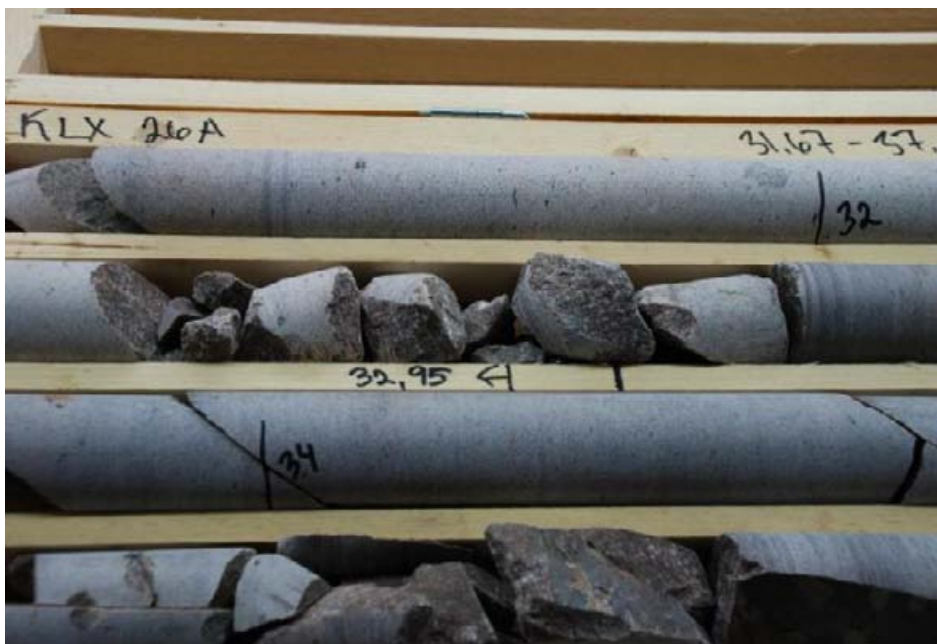
Group 2 includes fractures in a section of the core that is clearly affected by drilling disturbances (e.g. the logged fracture location was close to core polishing marks or in the vicinity of core uptake, which is seen as a brownish circular mark on the core) (Figure 5-19).

Figure 5-19. Photo of core KLX26A (fracture ID:s C0964B8B0A1080C3; 20964B8B0A1080F4; 40964B8B0A1081A9). This photo shows several fractures typical of Group 2 fractures, where core/fracture and/or material is missing due to drilling disturbances. The diameter of the drill cores is 50 mm.

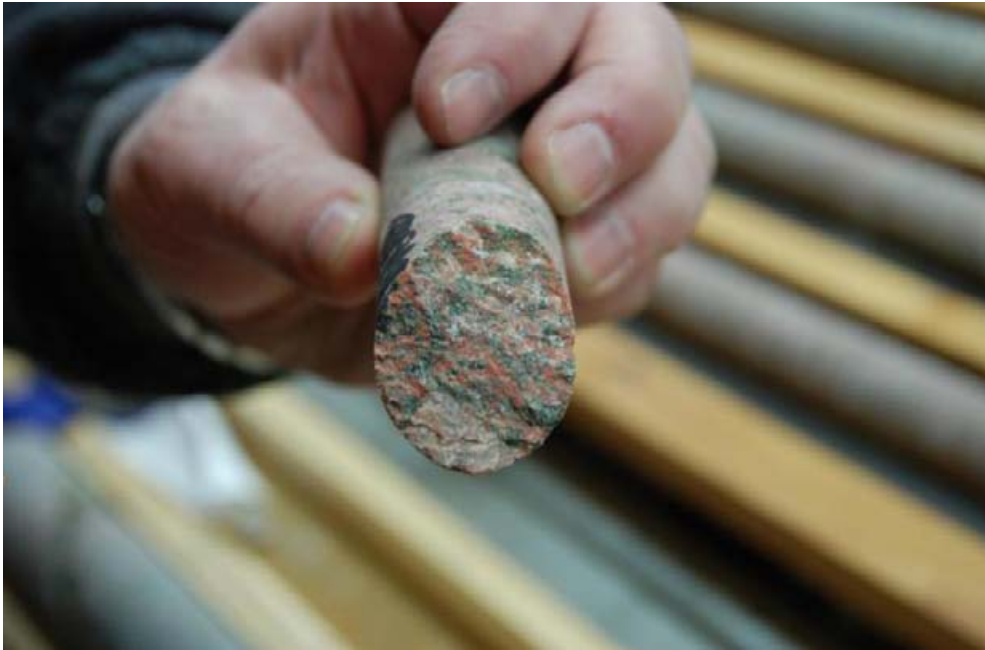
Group 4 represents erroneously logged fractures, for they most likely are mineral coated (Figure 5-20). However, the coating was in most instances too thin to allow for mineral identification by the unaided eye.

Figure 5-20. Photo of KLX08A (fracture ID: 4CD8438B2B149FB3) showing a Group 4 fracture with indications of mineral coating. The diameter of the drill cores is 50 mm.

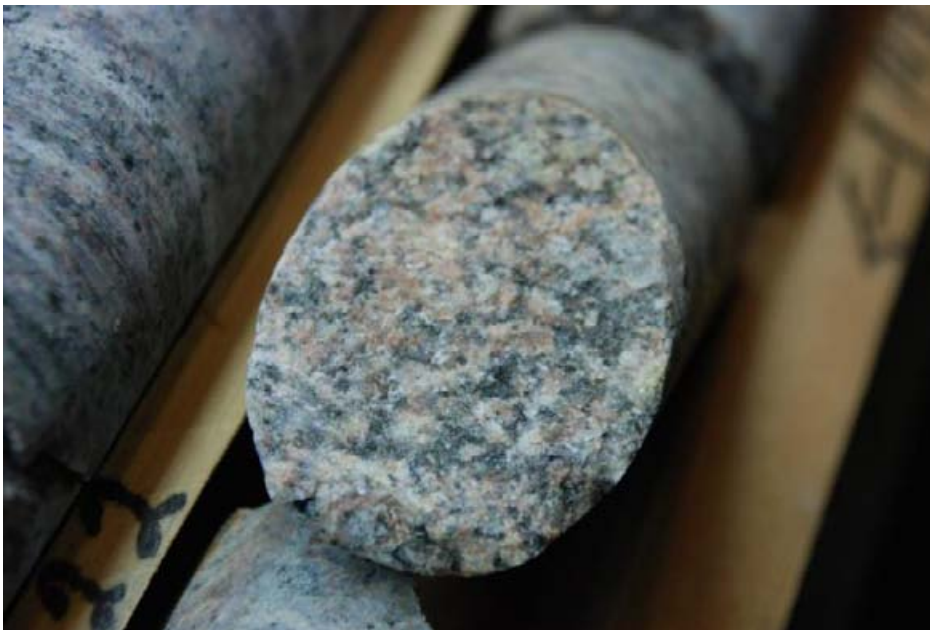
Group 5 represents non-mineralised fractures, where no mineral coating could be observed (Figure 5-21). We consider these fractures to have been correctly logged.

Figure 5-21. Photo of KLX05 (fracture ID: 6B95438B2B12310C) showing a Group 5 fracture with no signs of mineral coating (i.e. a non-mineralised fracture). The diameter of the drill cores is 50 mm.

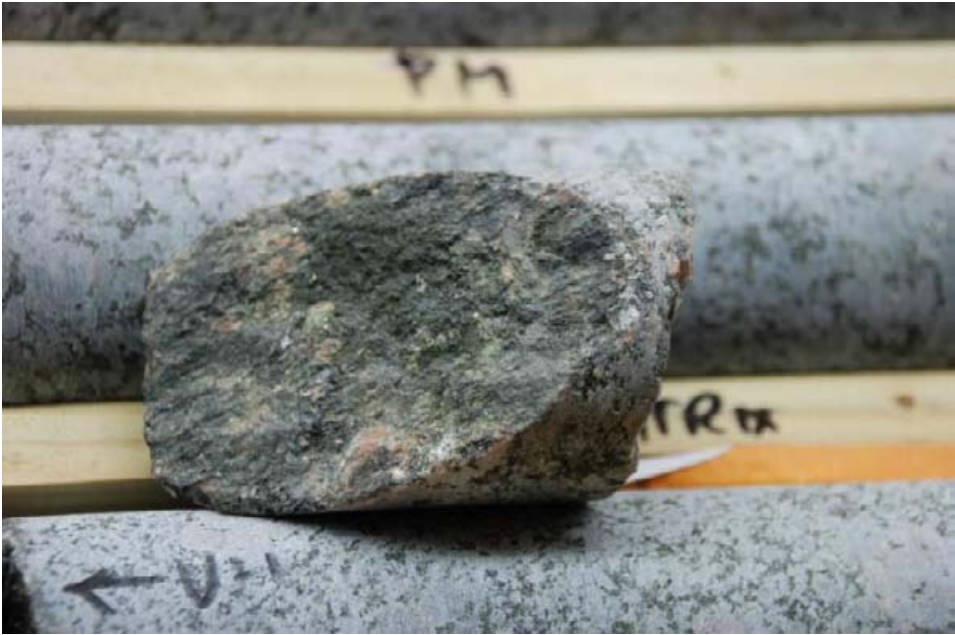
Figure 5-22. Photo of KLX17A (fracture ID: 3497478B0A21F03D) showing a typical Group 6 fracture with clear signs of mineral coating (in this case chlorite, calcite and pyrite). The diameter of the drill cores is 50 mm.

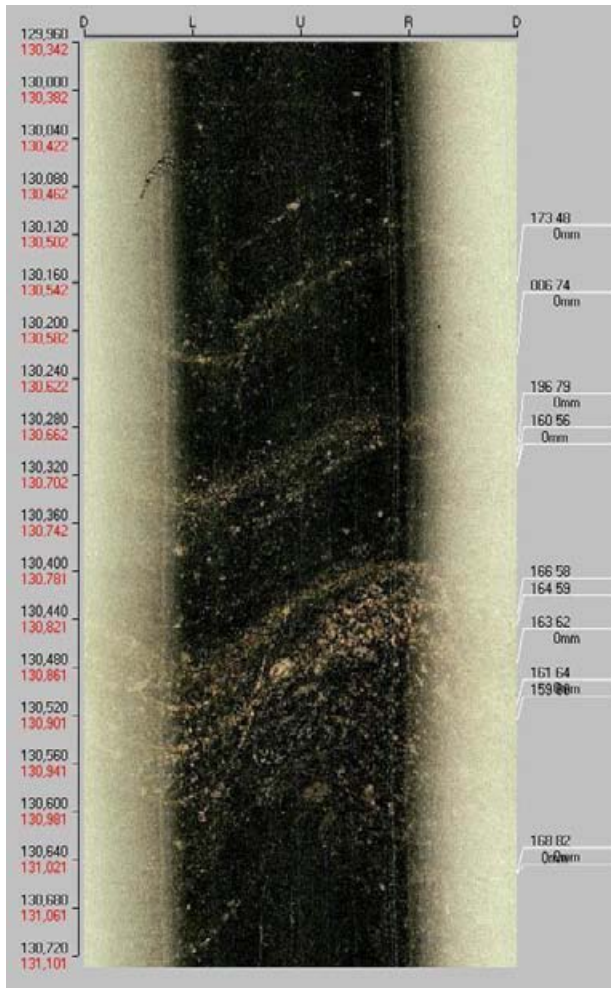
Figure 5-23. BIPS image of the part of KLX17A where a fracture has been logged (fracture ID: A997478B0A21FE38). However, it was impossible to locate this fracture both in the BIPS and in the core, i.e. this is most likely a misinterpreted fracture.

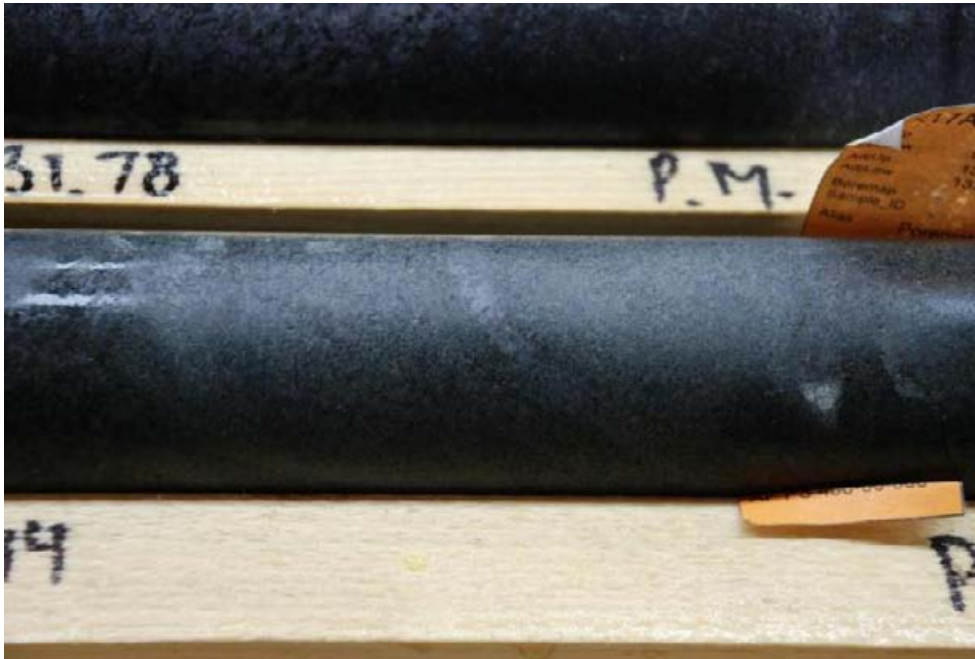
Group 8 includes sections with features that could not be located in the core (Figure 5-24).

Figure 5-24. Photo of KLX17A (fracture ID: 3417478B0A220456) showing a Group 8 fracture, i.e. a part of the core where it is impossible to locate any fracture. The diameter of the drill cores is 50 mm.

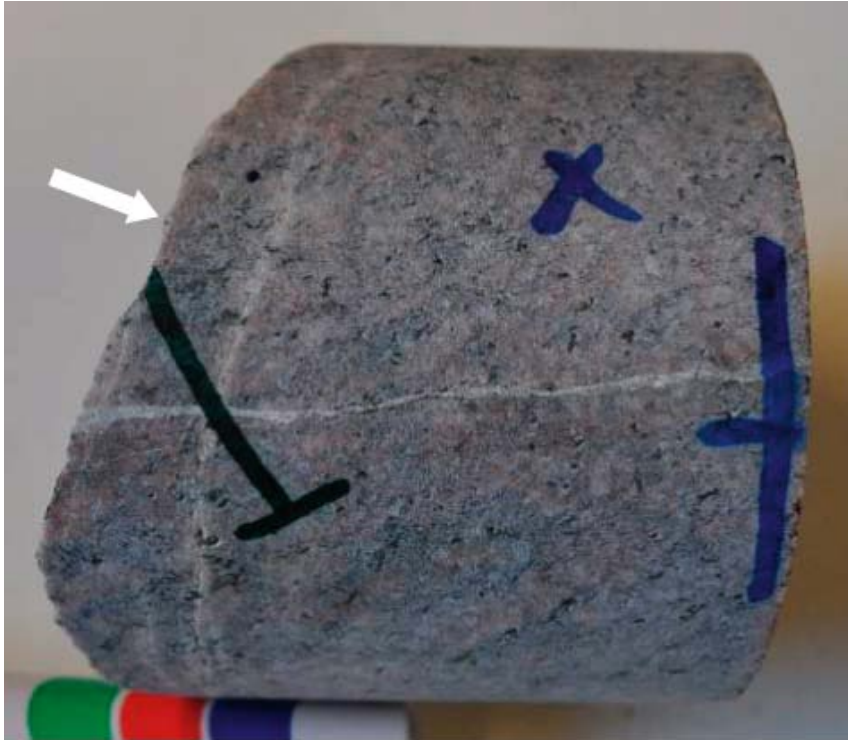
Figure 6-3. Photo of the identified non-mineralised fracture KFM05A 166.372 m, showing typical bands of micro-fractures occurring sub-parallel to the non-mineralised fracture (indicated by white arrow). The sub-parallel bands of micro-fractures contain fracture-sealing calcite, quartz and adularia. The diameter of the core is c. 5 cm.
