Iron hydroxide occurrences and redox capacity in bedrock fractures in the vicinity of SFR

December 2014

SKB R-12-11

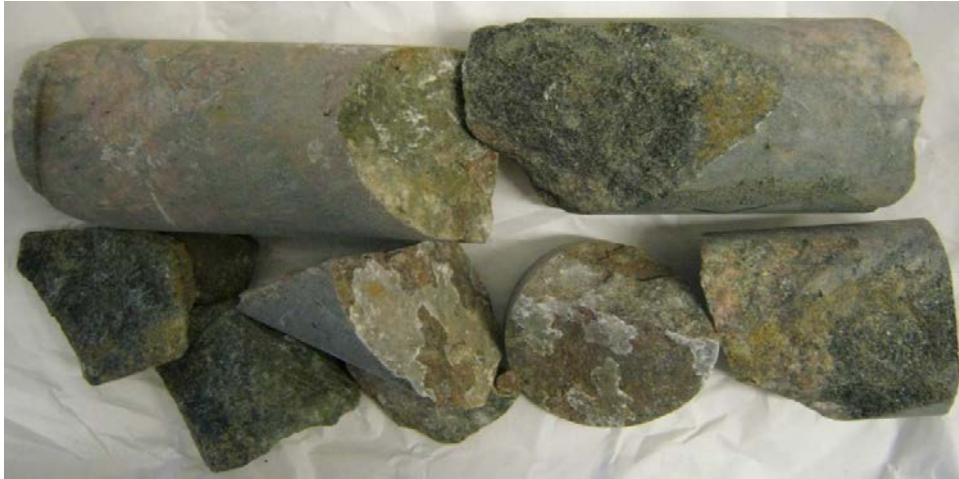
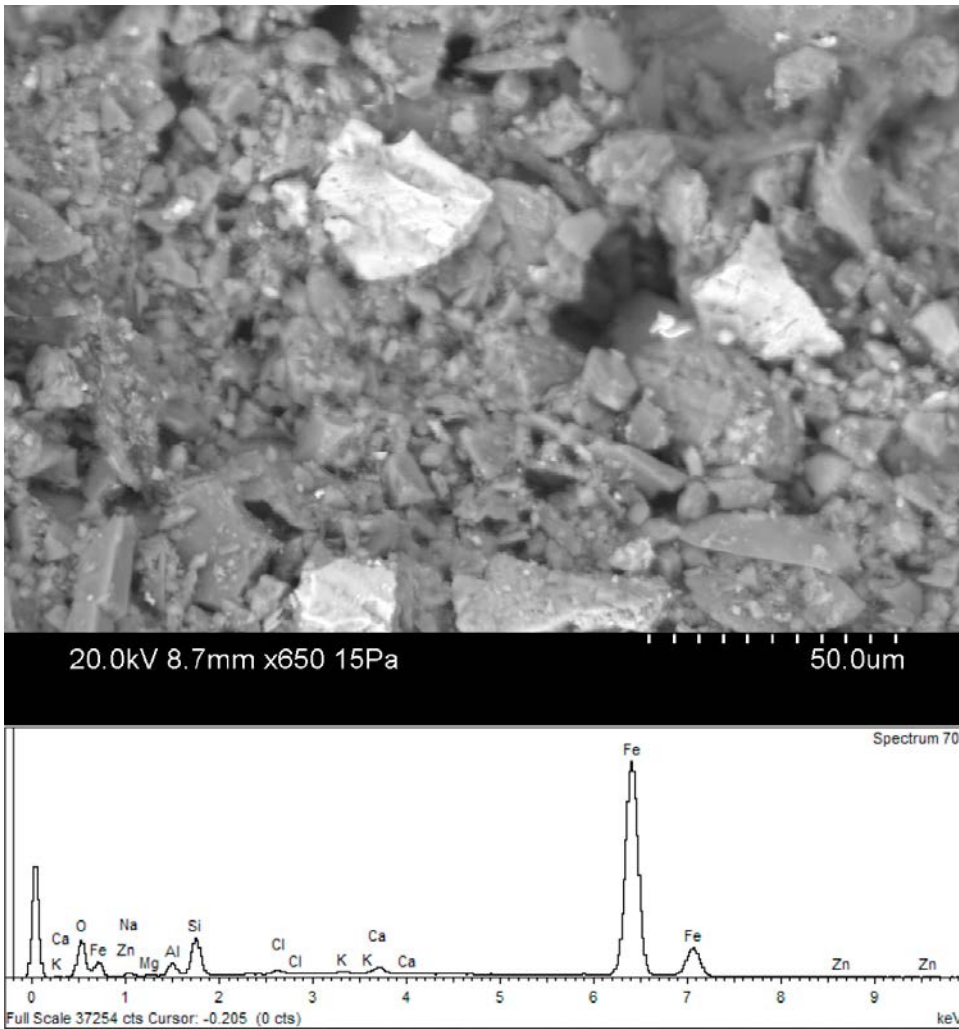
Figure 5-3. Fracture from KFR102B 113.56–113.88 m. The rust-brown coating mapped as iron hydroxide in Sicada consists of fragments of metallic iron from the drilling process.

Figure A1-6. Photo of the sampled fractures from KFR102B 113.56–113.88 m.

Figure A1-7. BSE-image and EDS-spectrum of angular Fe-rich grains (bright) on fracture surface from KFR102B 113.56–113.88 m dominated by clay mineral, albite and quartz.

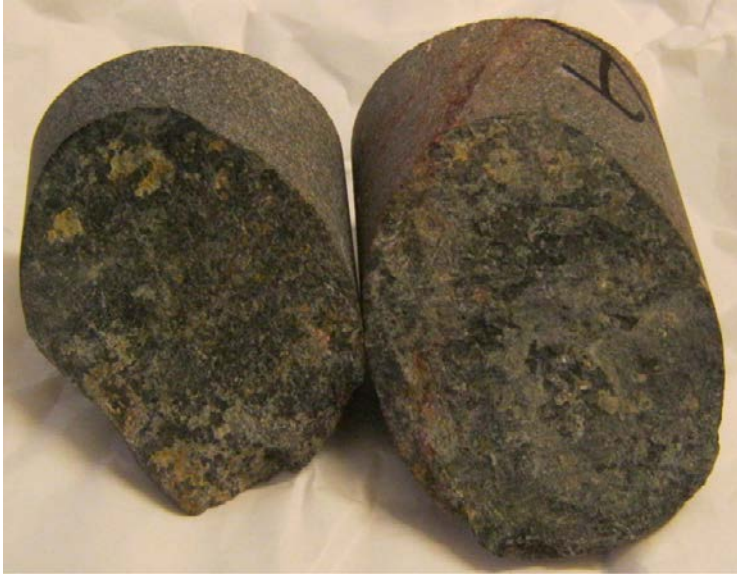
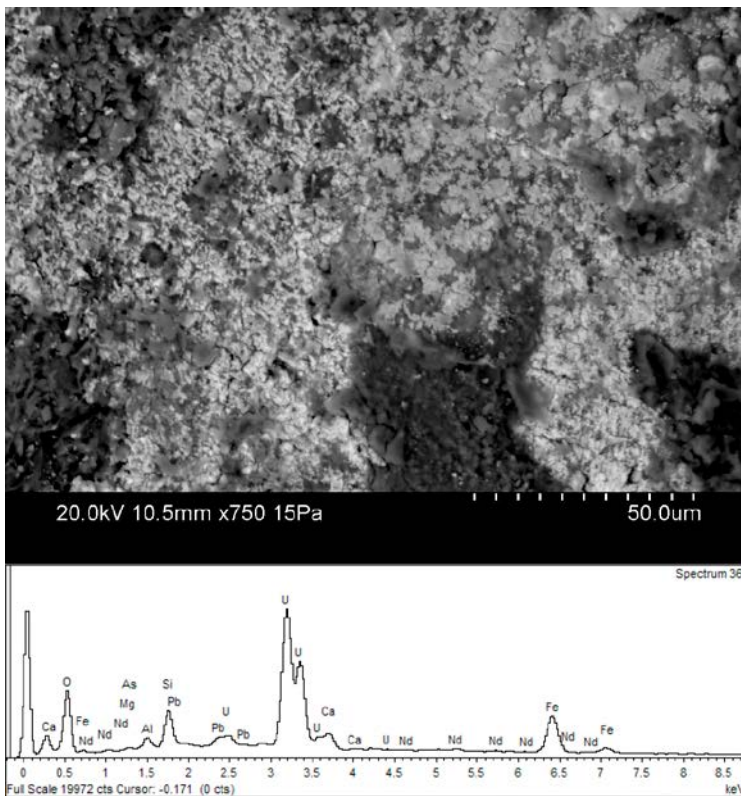
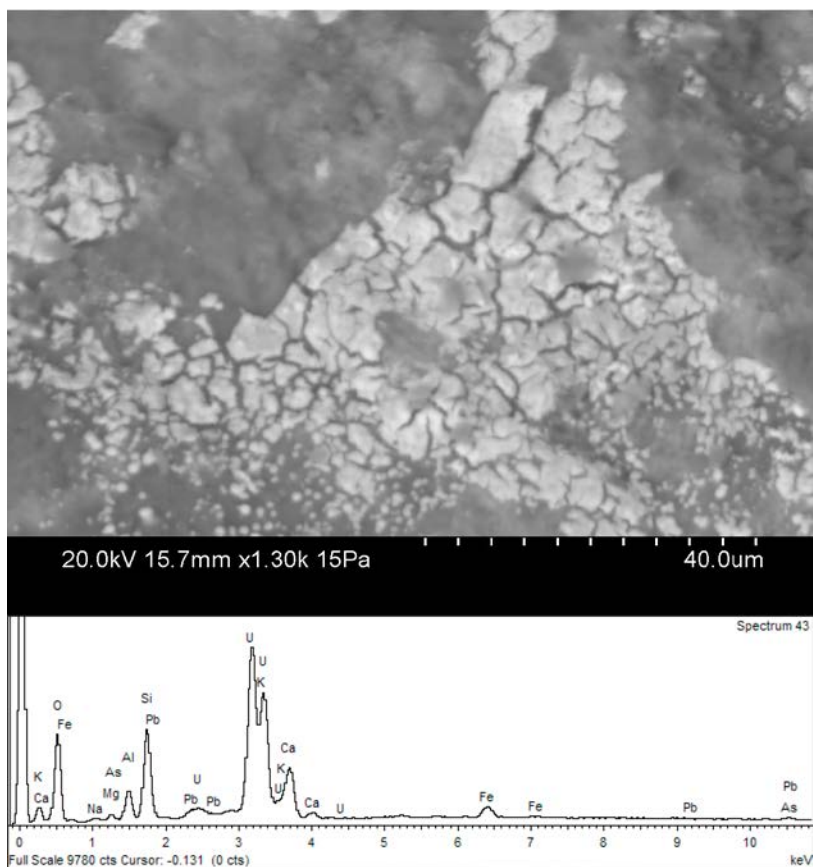
Figure A1-8. Photo of the sampled fracture from KFR104 21.44–21.52 m.

The fracture surface is dominated by mixed layer clay (corrensite). U-silicate also occurs on the fracture surface as a green-brown precipitate. It contains Fe, Ca and small amounts of Pb. No iron hydroxide was found in the fracture.

Figure A1-9. BSE-image and EDS-spectra of U-silicate (bright) on fracture surface from KFR104 21.44–21.52 m coated with clay mineral (dark). The brighter parts of the U-mineral in the BSE-image are more Pb-rich.

Figure A1-10. BSE-image and EDS-spectra of U-silicate (bright) on fracture surface from KFR104 21.44–21.52 m coated with clay mineral (dark).

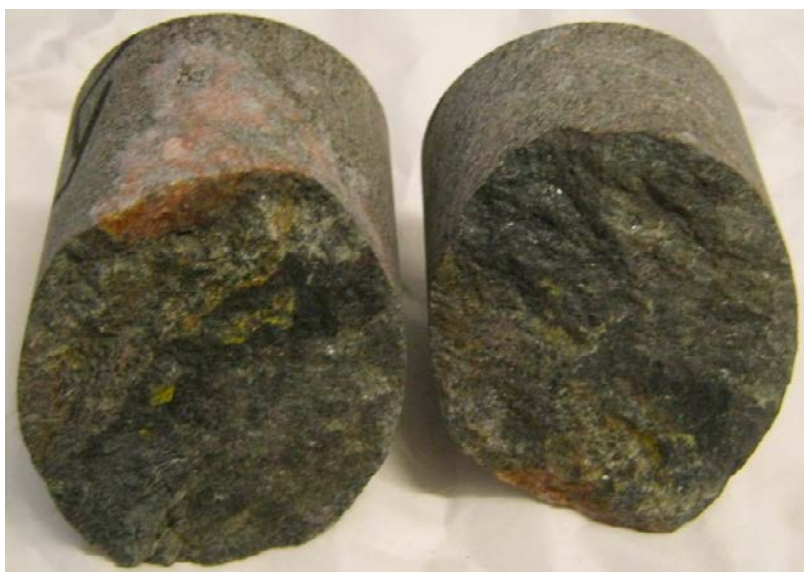
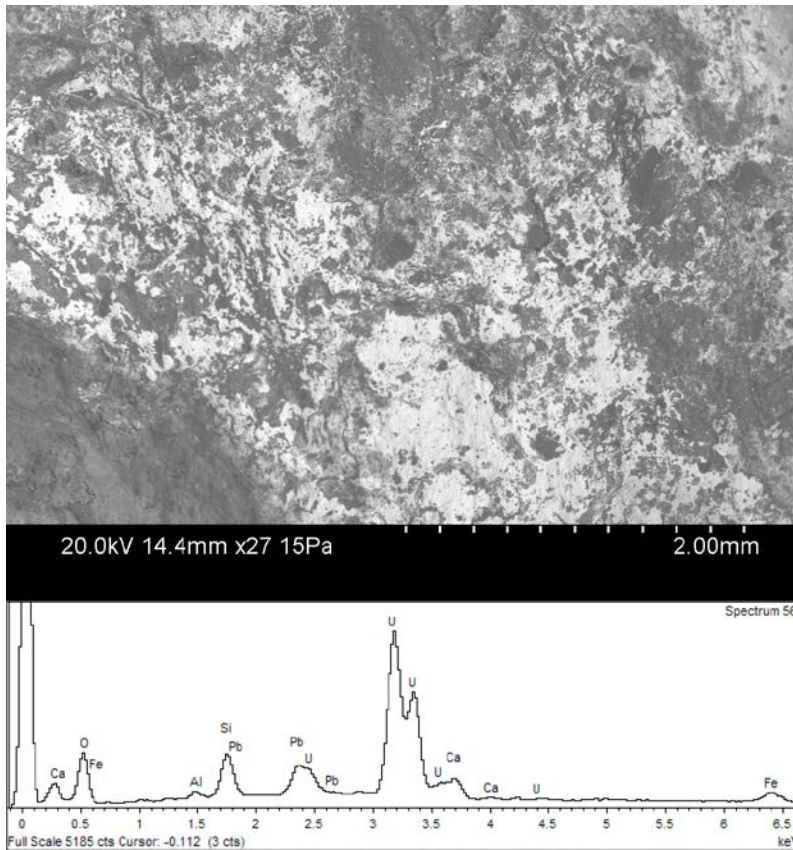
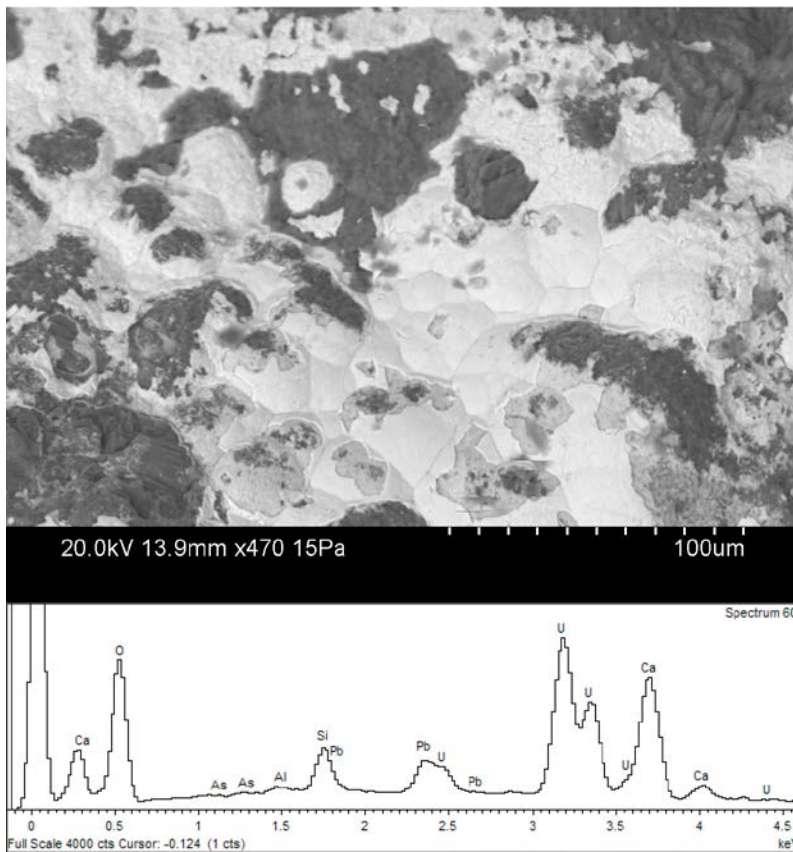
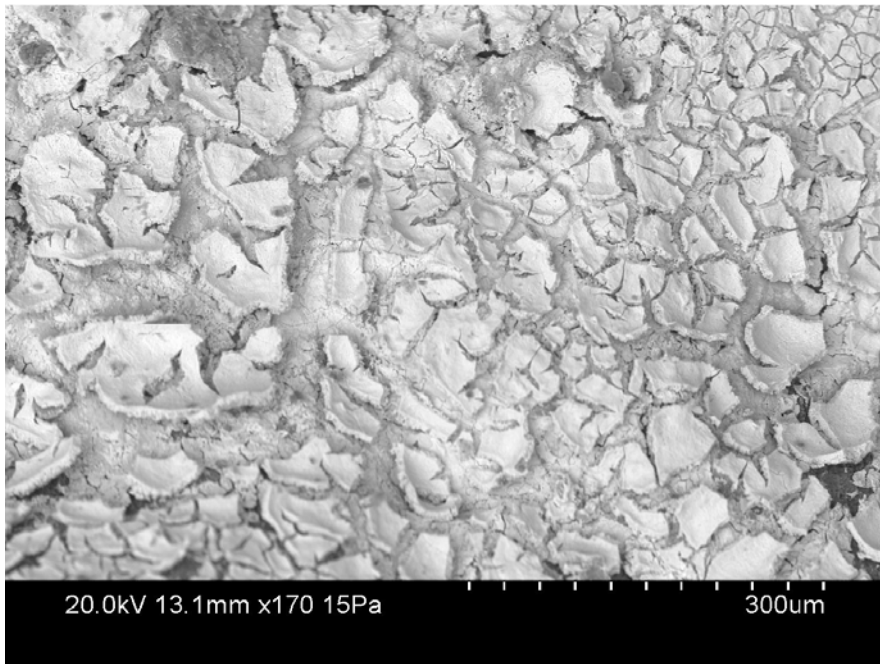
Figure A1-11. Photo of the sampled fracture from KFR104 21.57–21.66 m.

Figure 5-2. Fracture from KFR104 21.57–21.66 m. The green-yellow mineral mapped as iron hydroxide in Sicada is an (U,Ca)-oxide.

The fracture surface is dominated by mixed layer clay (corrensite). The green-yellow coating seen on the surface consists of U-silicate. The U-silicate is cogenetic with barite and contains Ca, Pb and Fe. No iron hydroxide was found in the fracture.

Figure A1-12. BSE-image and EDS-spectra of U-silicate (bright) on fracture surface from KFR104 21.57–21.66 m coated with clay mineral (dark).

Figure A1-13. BSE-image and EDS-spectra of a (Ca)U-silicate (bright) on fracture surface from KFR104 21.57–21.66 m coated with clay mineral (dark).

Figure A1-14. BSE-image of U-oxide (bright) on fracture surface from KFR104 21.57–21.66 m coated with clay mineral (dark).

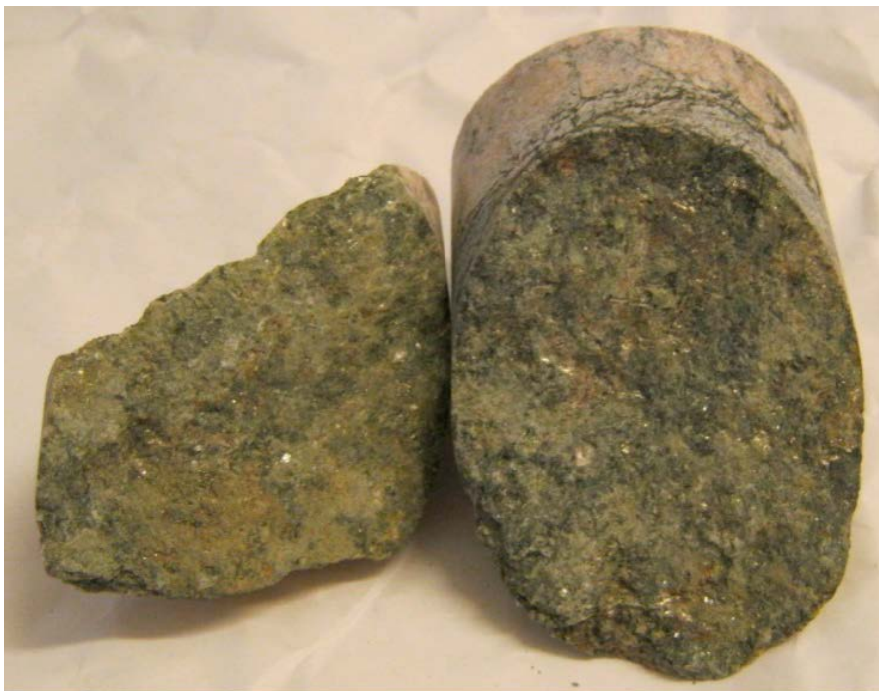
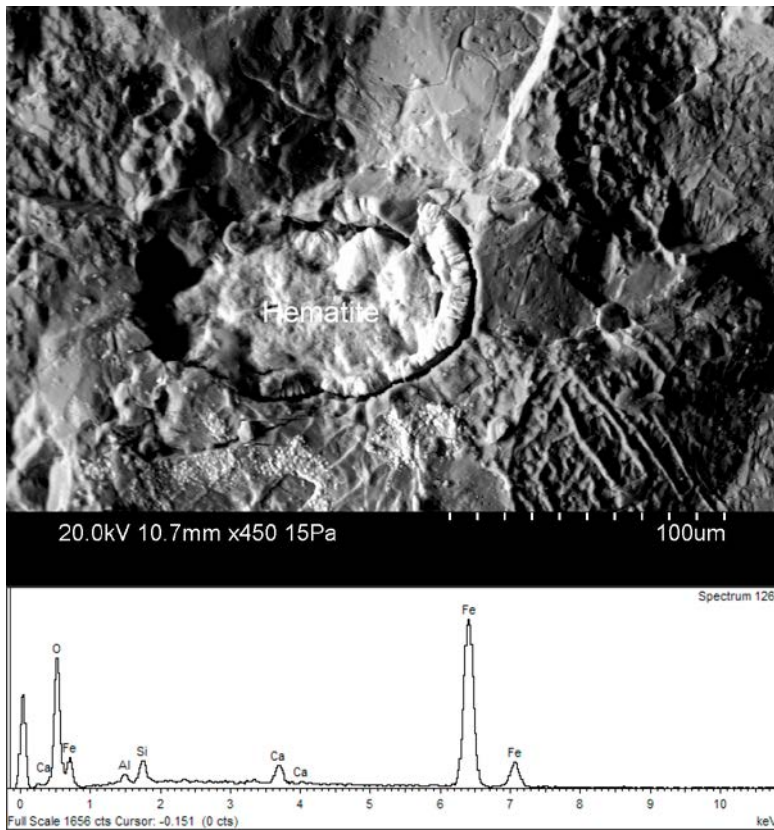
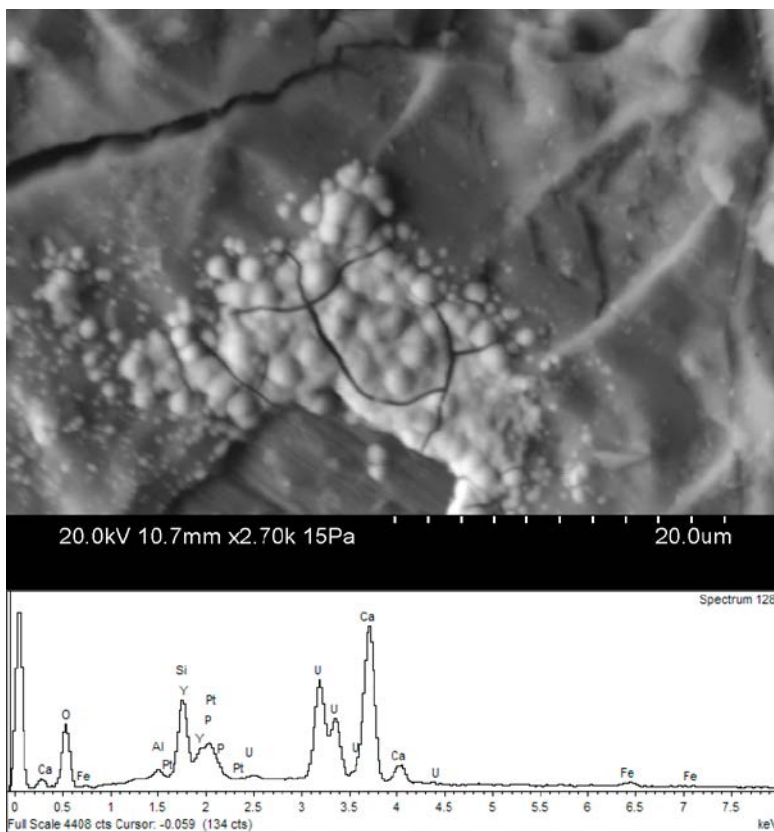
Figure A1-15. Photo of the sampled fracture from KFR104 24.80–24.88 m.

The fracture surface is coated with mixed layer clay, calcite, illite, hematite, U-phosphate. No iron hydroxide was found in the fracture.

Figure A1-16. BSE-image and EDS-spectra of hematite grain on fracture surface from KFR104 24.80–24.88 m.

Figure A1-17. BSE-image and EDS-spectra of U-phosphate on fracture coating calcite from KFR104 24.80–24.88 m. The Ca peak is from calcite beneath the U-phosphate.

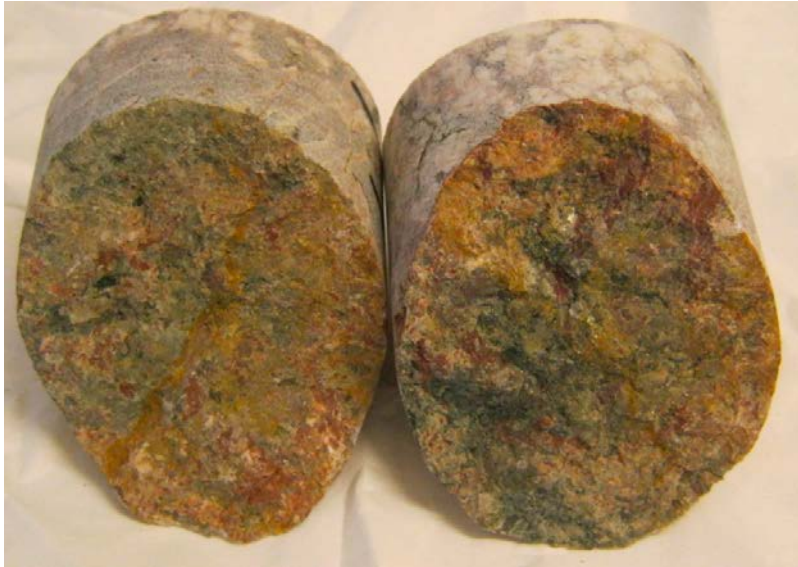
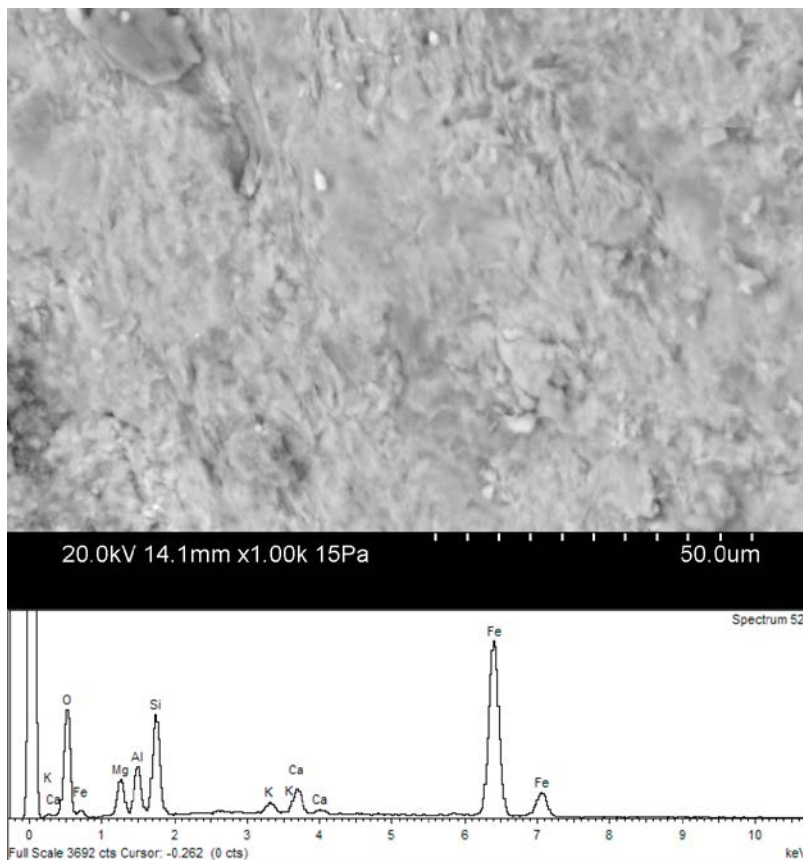
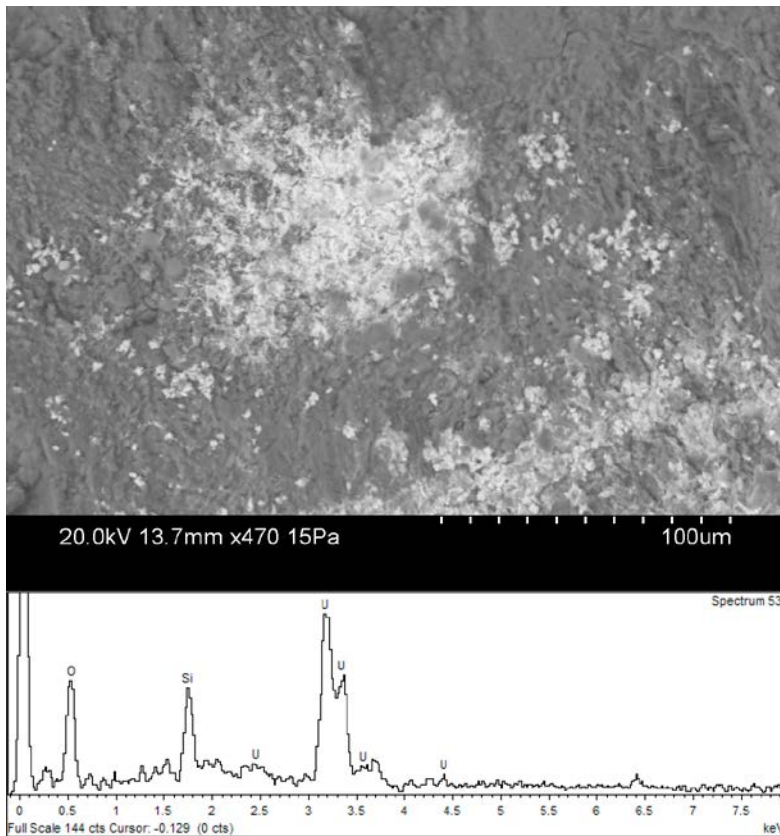
Figure A1-18. Photo of the sampled fracture from KFR104 25.03–25.09 m.

Figure 5-1. Fracture from KFR104 25.03–25.09 m. The rust-brown mineral mapped as iron hydroxide in Sicada is a Fe-rich mixed layer clay.

The fracture surface is dominated by mixed layer clay and adularia. A few small occurrences of U-silicate were also identified. The rust-brown parts of the fracture consist of Fe-rich mixed layer clay. No iron hydroxide was detected on the fracture surface.

Figure A1-19. BSE-image and EDS-spectra of Fe-rich mixed layer clay on fracture surface KFR104 25.03–25.09 m.

Figure A1-20. BSE-image and EDS-spectra of U-silicate on fracture surface from KFR104 25.03–25.09 m coated with clay mineral.

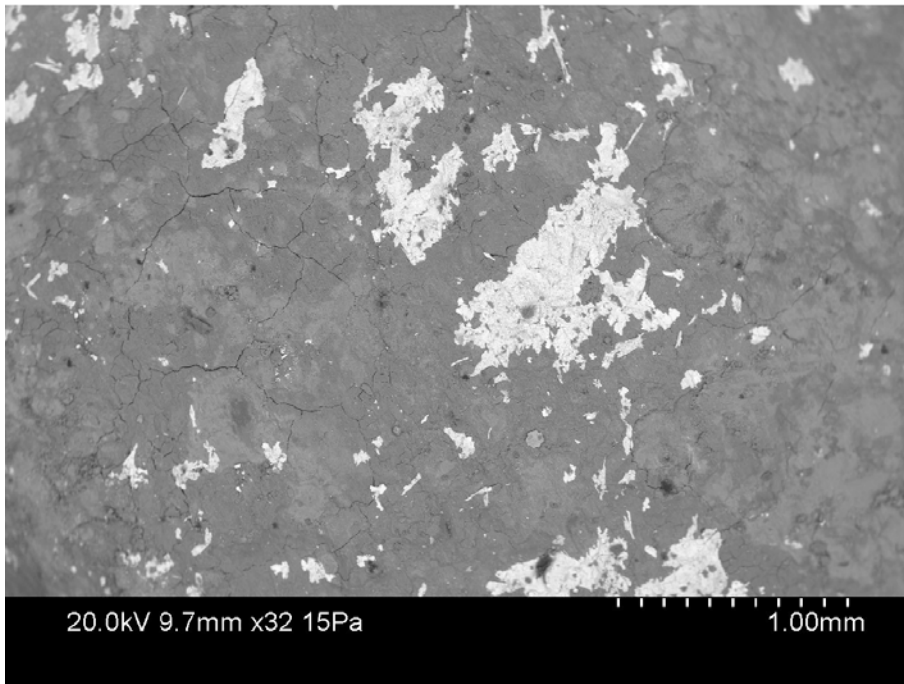
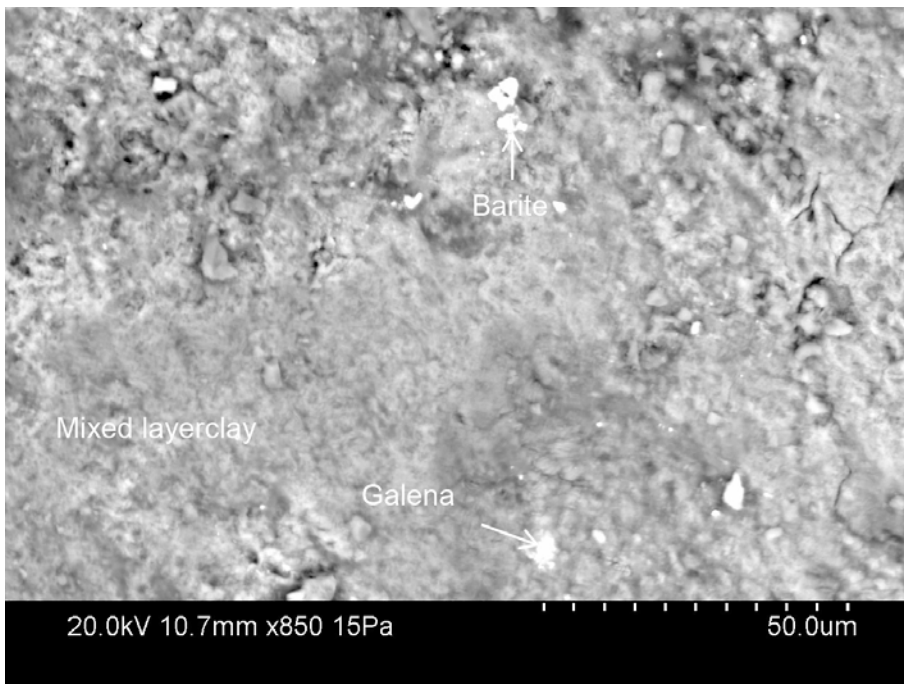
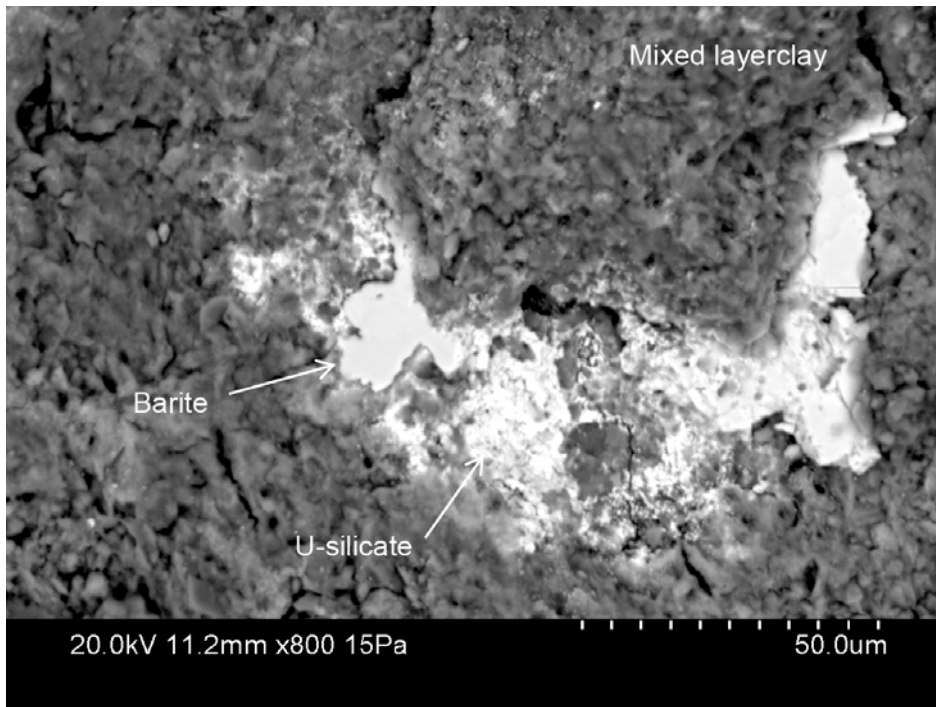
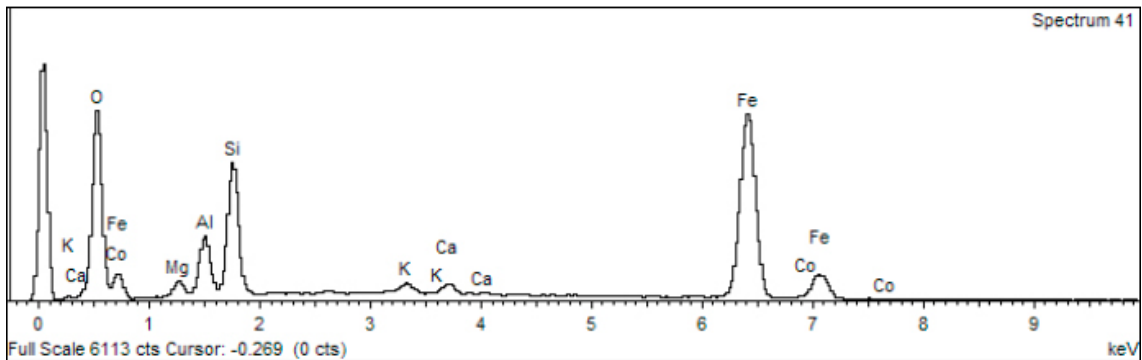
Figure A1-22. BSE-image of barite (bright) on fracture surface from 25.51–25.62 m coated with mixed layer clay.

Figure A1-23. BSE-image of small precipitates of galena and barite on fracture surface from 25.51–25.62 m coated with mixed layer clay.

Figure A1-24. BSE-image of U-silicate together with barite on fracture surface from 25.51–25.62 m coated with mixed layer clay.

Figure A1-25. EDS-spectra of Fe-rich mixed layer clay from 25.51–25.62 m.

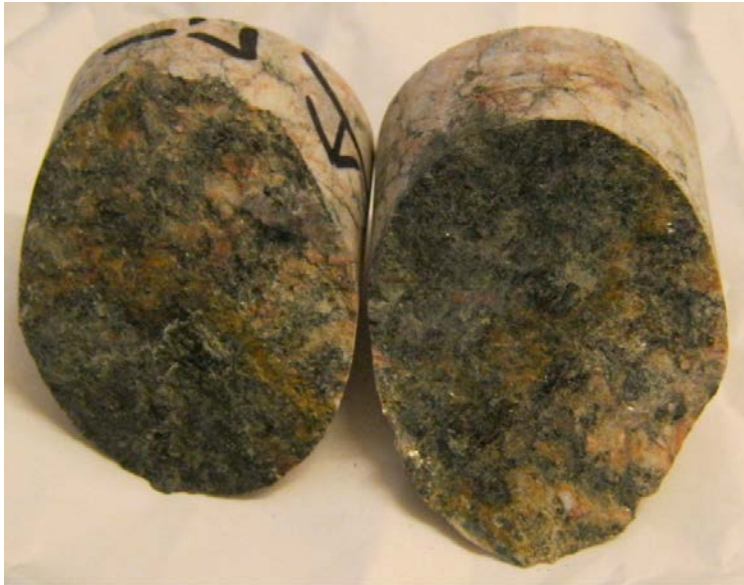
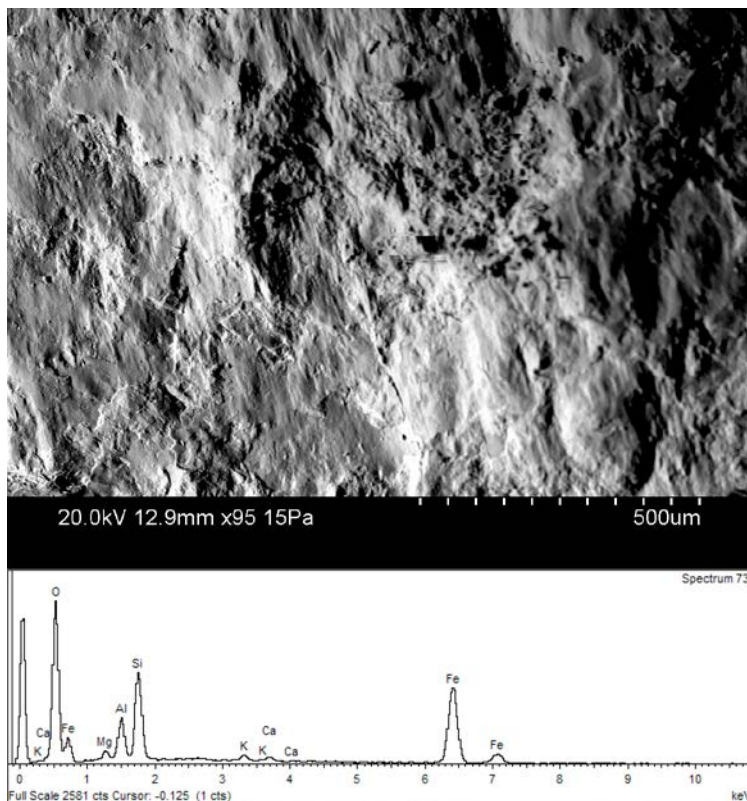
Figure A1-27. Photo of the sampled fracture from 27.04–27.11 m.

The fracture surface is coated with mixed layer clay and illite, the rust-brown parts of the fracture consists of Fe-rich mixed layer clay. No iron hydroxide was found in the fracture.

Figure A1-28. SEM image and EDS-spectra of U-silicate on fracture surface from KFR104 27.04–27.11 m coated with clay mineral.

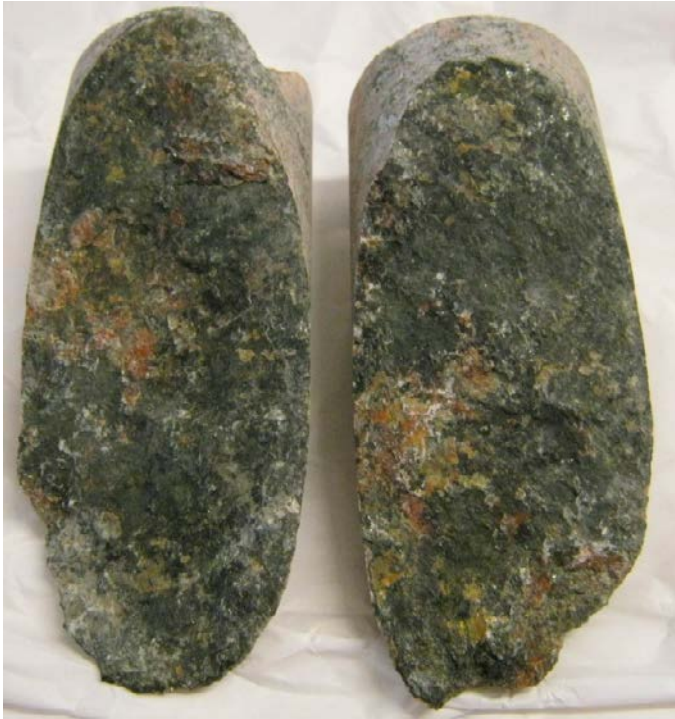
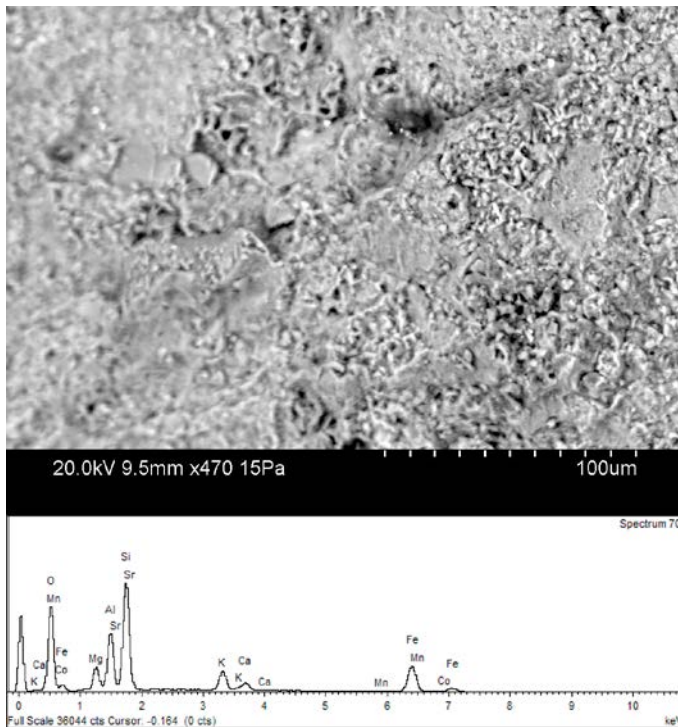
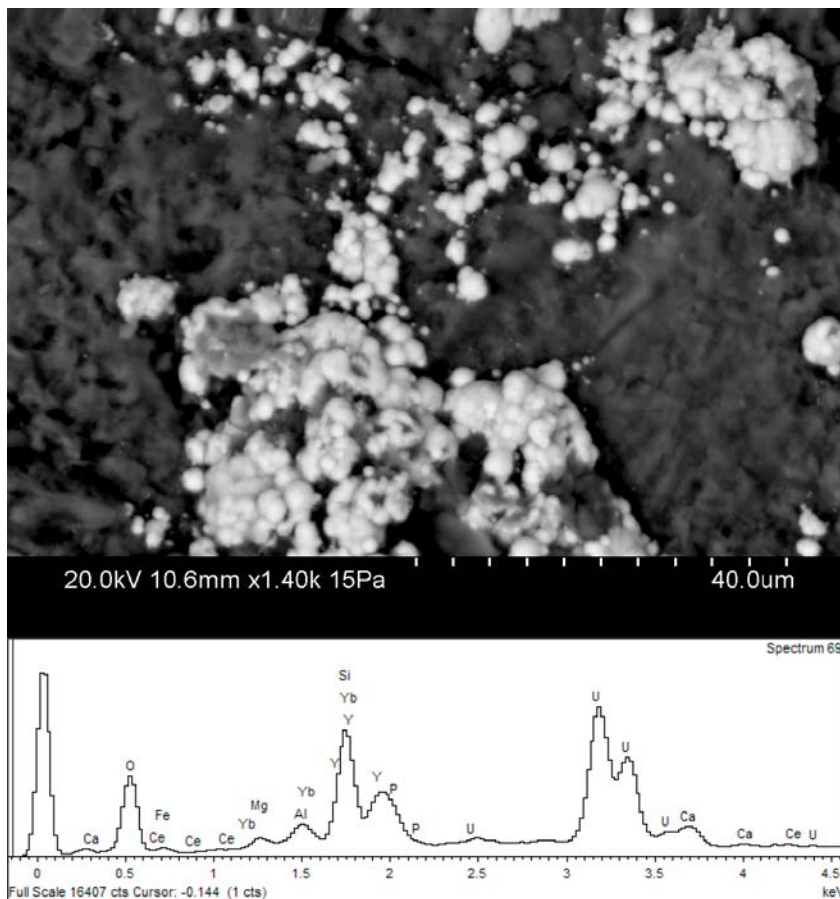
Figure A1-29. Photo of the sampled fracture from KFR104 29.80–29.93 m.

The fracture surface is dominated by mixed layer clay and adularia. A few small occurrences of barite and U-phosphate were also found on the surface. No iron hydroxide was found in the fracture

Figure A1-30. BSE-image and EDS-spectra of clay mineral coating on fracture surface from KFR104 29.80–29.93 m.

Figure A1-31. BSE-image and EDS-spectra of U-phosphate on fracture from KFR104 29.80–29.93 m coated with clay mineral.

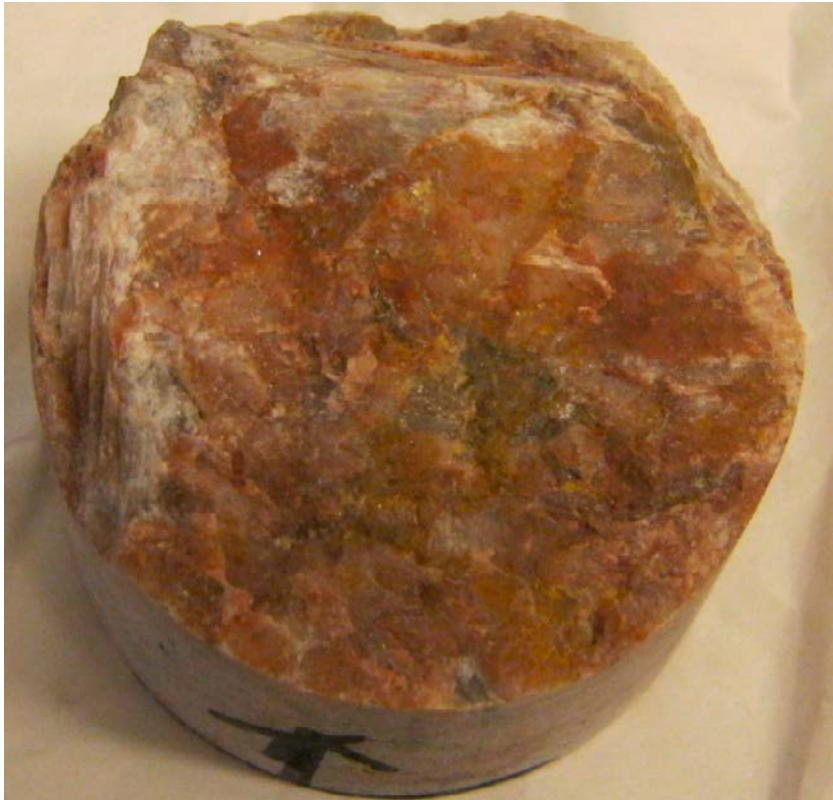
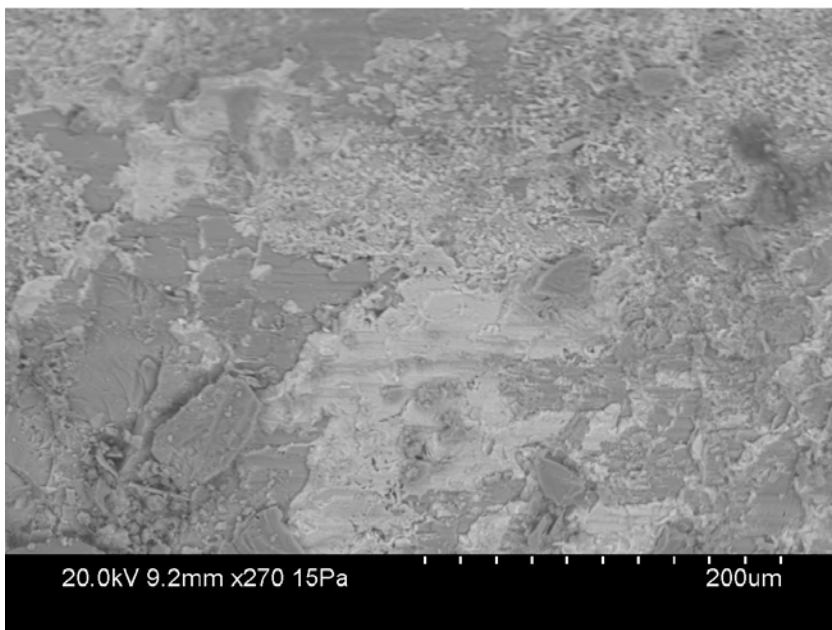
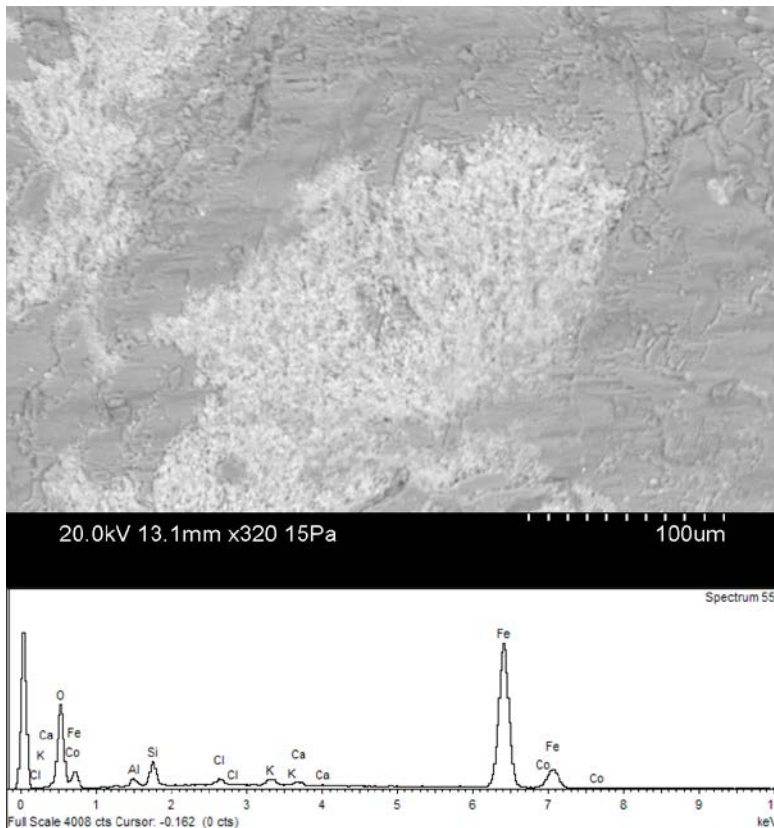
Figure A1-39. Photo of the sampled fracture from KFR104 59.21–59.25 m.

Figure A1-40. BSE-image of hematite on fracture surface from KFR104 59.21–59.25 m.

Figure A1-41. BSE-image and EDS-spectra of Fe-oxide or possibly Fe hydroxide from KFR104 59.21–59.25 m.

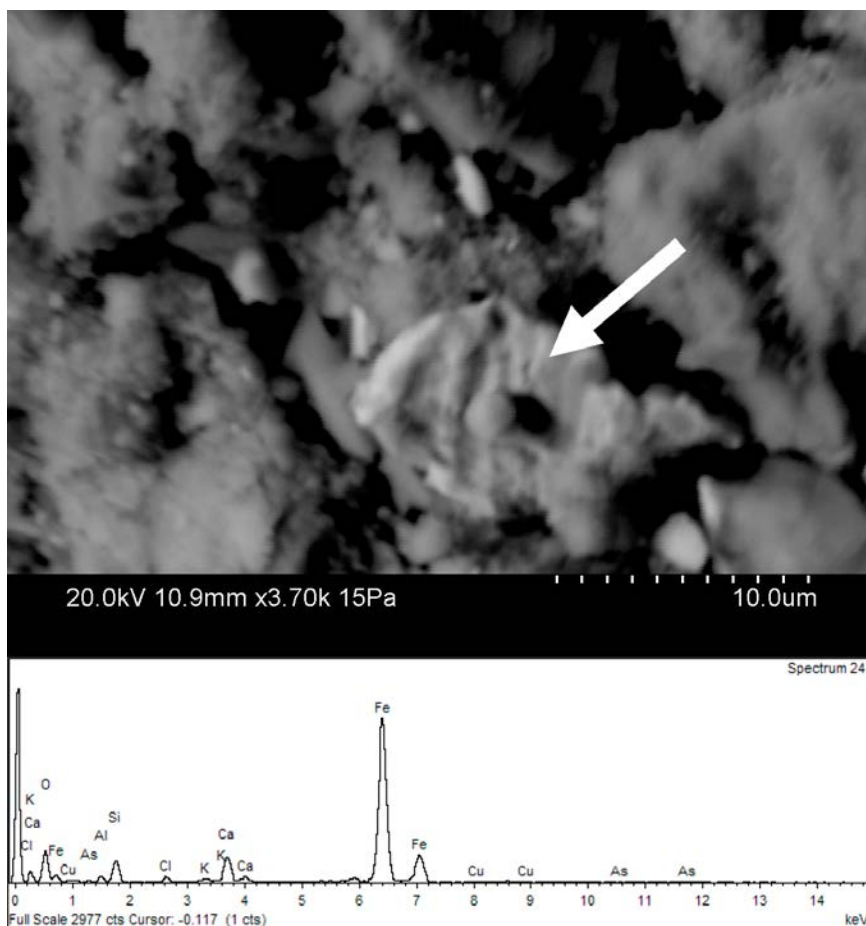
Figure A1-43. BSE-image and EDS-spectra of metallic Fe grain from KFR104 59.71–59.75 m.

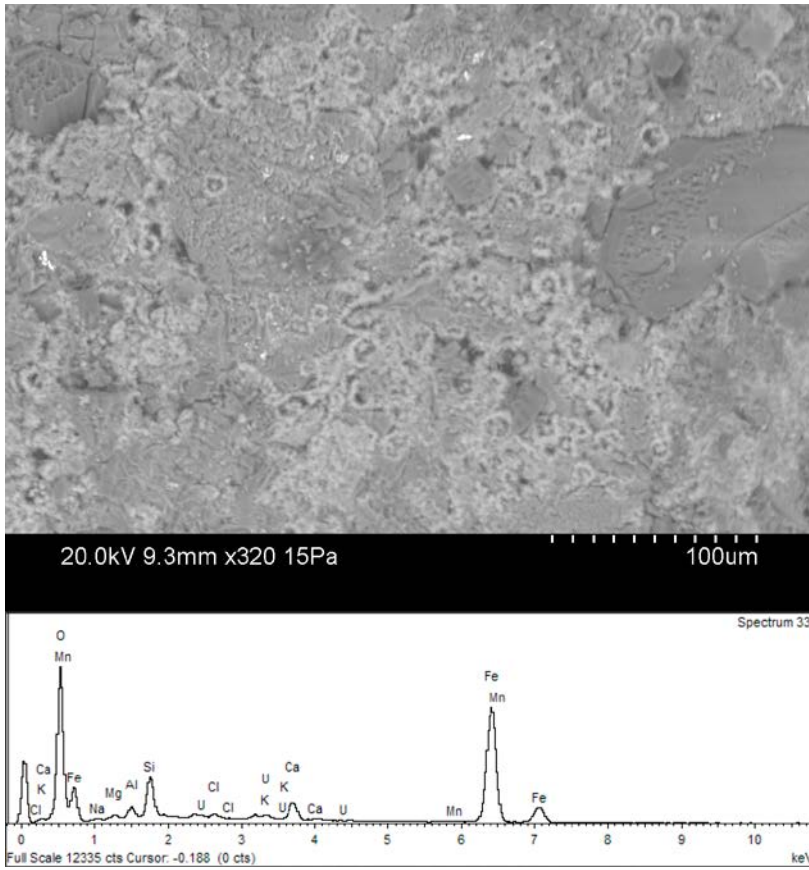
Figure 5-4. Fracture from KFR104 99.32–99.42 m. The rust-brown precipitate may be iron hydroxide.

Figure A1-48. BSE-image and EDS-spectra of Fe hydroxide from KFR104 99.32–99.42 m.

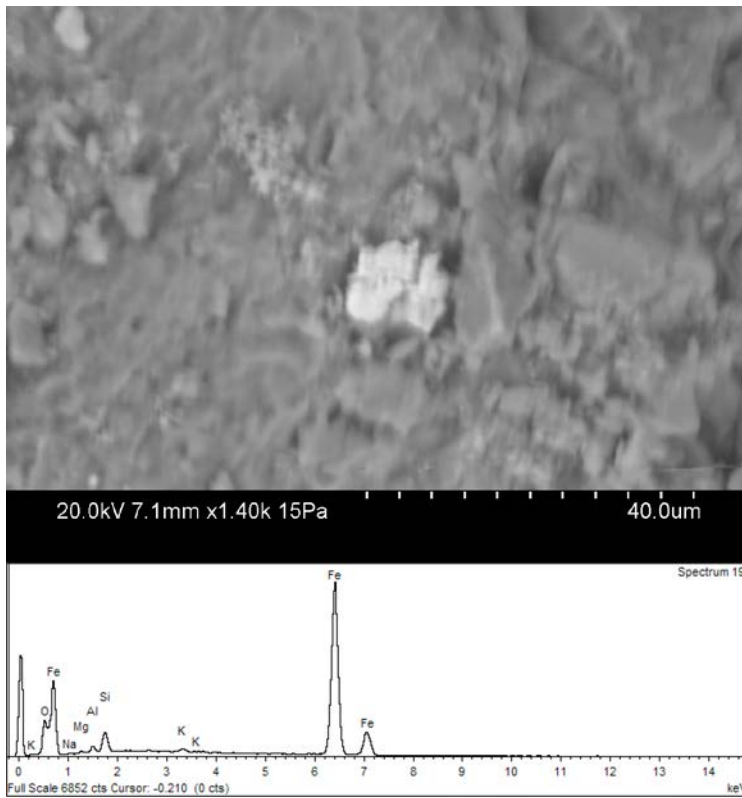
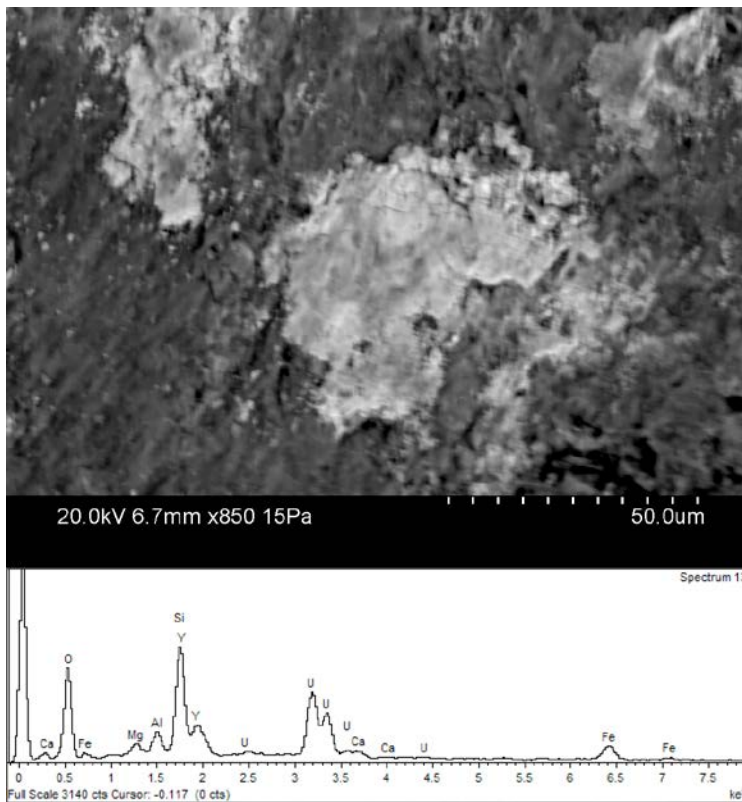
Figure A1-66. BSE-image and EDS-spectra of small grain of metallic iron on fracture coated with mixed layer clay from KFR104 389.97–390.03 m.

Figure A1-67. BSE-image and EDS-spectra of U-silicate on mixed layer clay from KFR104 389.97–390.03 m.
