Metallographic Analysis of SKB MiniCan Experiment 3

Nicholas Smart, Simon Rose, David Nixon, Andrew Rance
AMEC

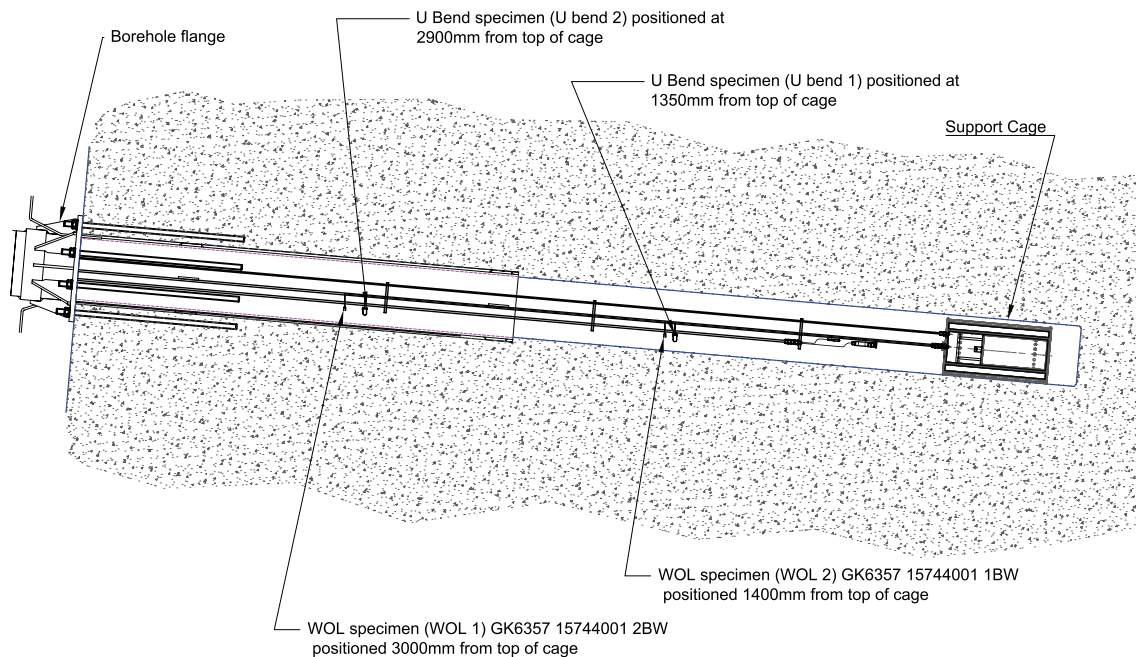
Figure 2-1. Location of U-bend and WOL specimens in MiniCan borehole relative to the position of the support cage containing the MiniCan experiment and the borehole flange.

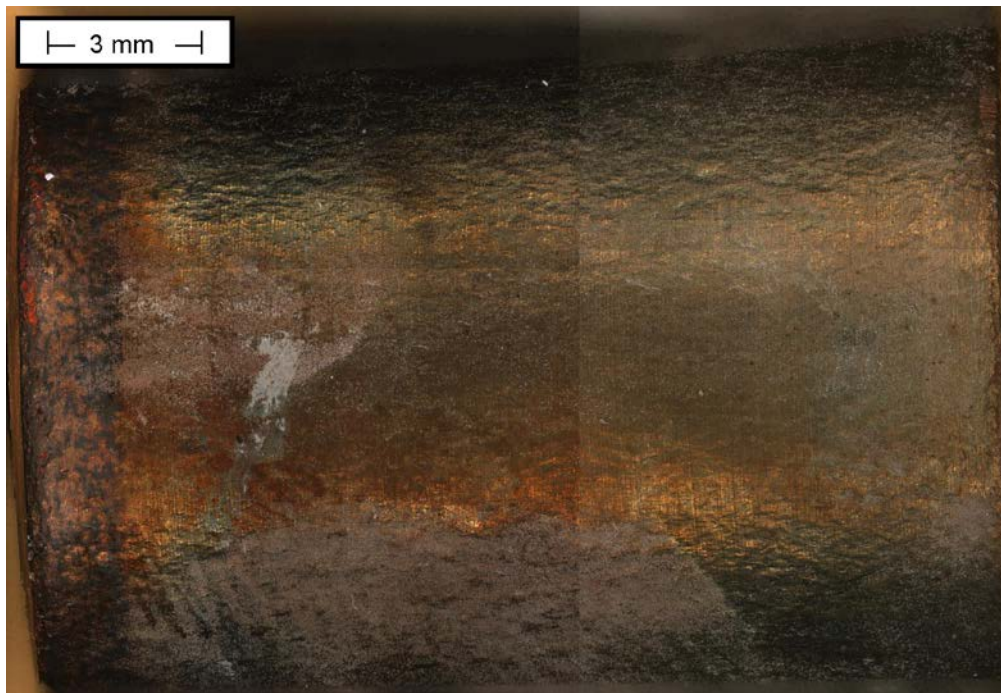
Figure 3-1. Photograph of curved surface of U-bend specimen 1 (near support cage) prior to metallographic analysis.

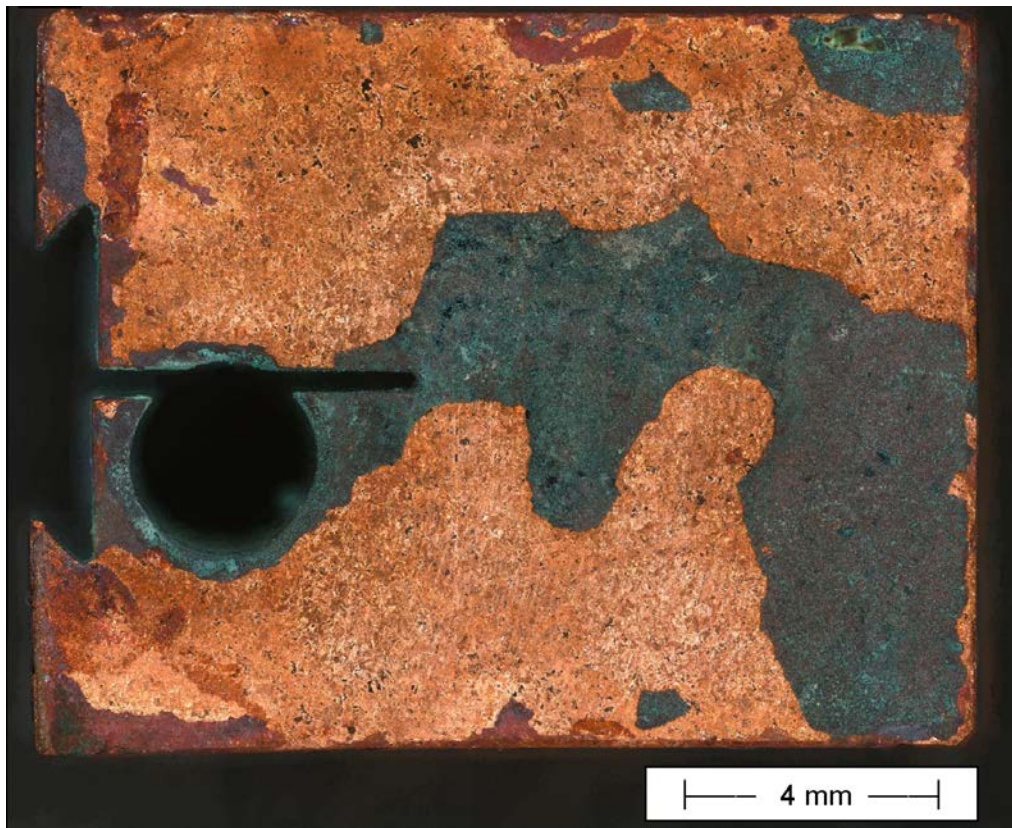
Figure 3-12. Optical micrograph of face 1 of WOL specimen 1 (near borehole flange) produced using Alicona 3D microscope.

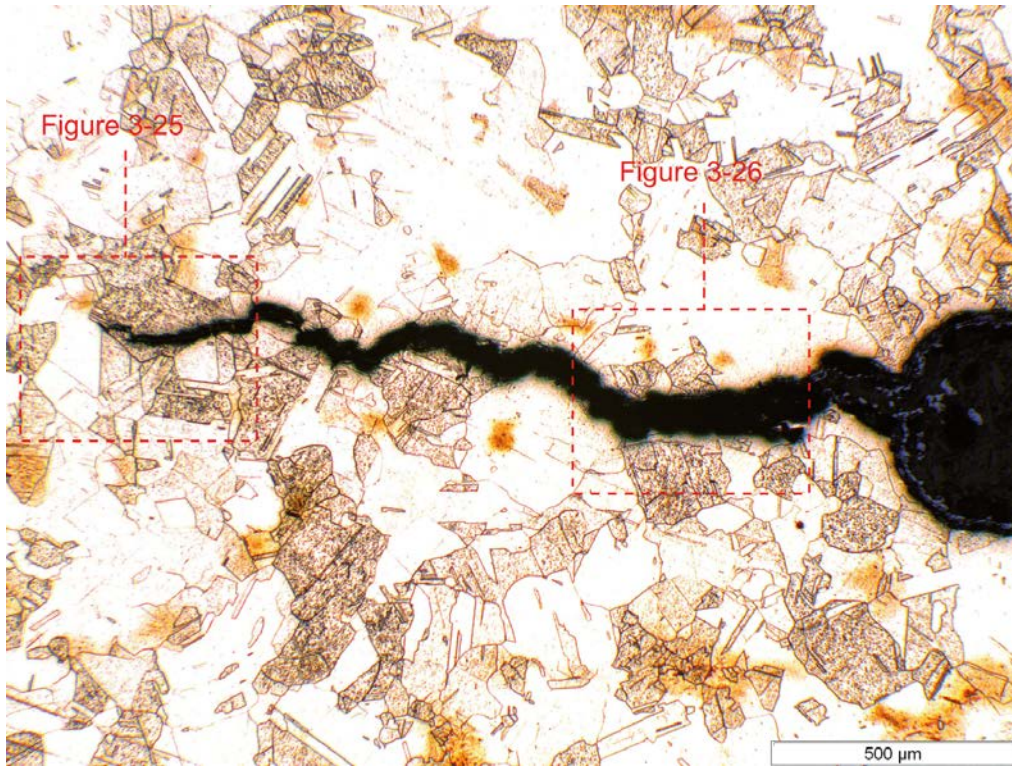
Figure 3-24. Optical micrograph of cross-section through WOL specimen 2 (near support cage) in the region of the fatigue pre-crack, showing regions of higher magnification images in Figure 3-25 and Figure 3-26.

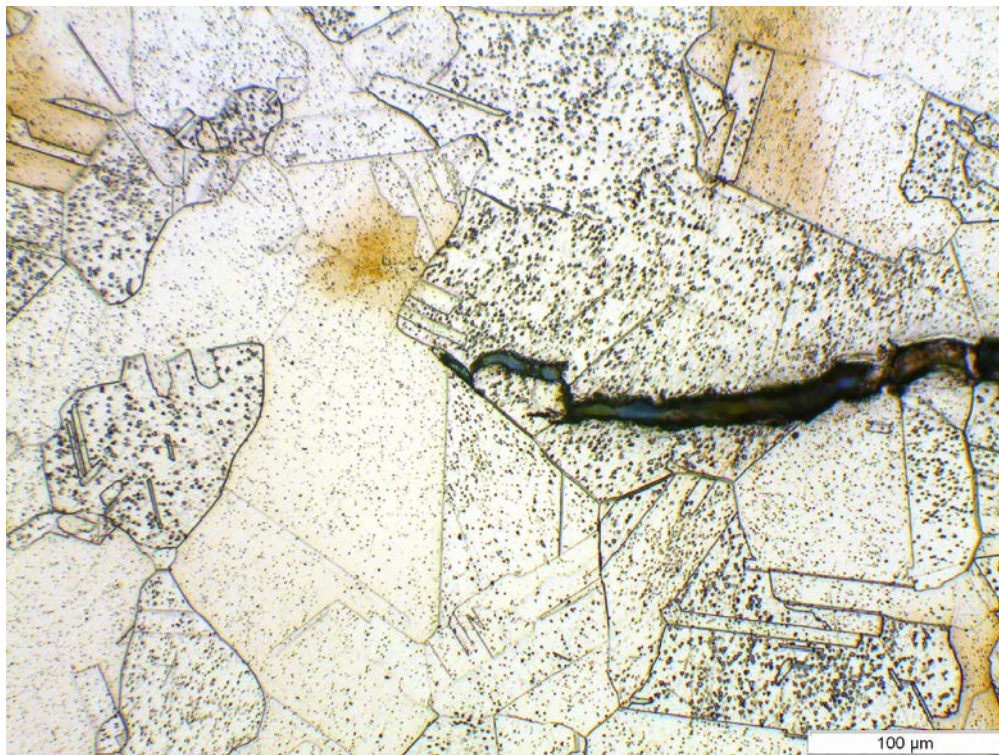
Figure 3-25. Optical micrograph of cross-section through WOL specimen 2 (near support cage)

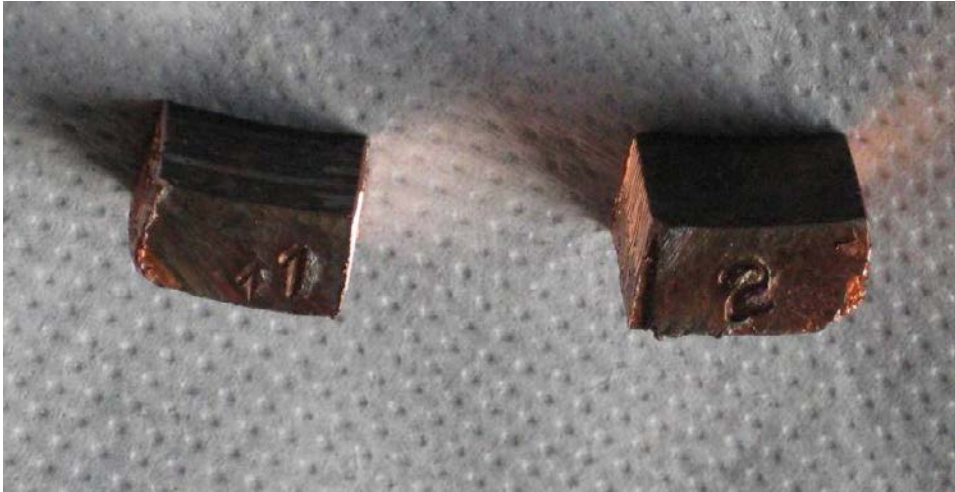
Figure 3-29. Specimens 1 and 2, which were cut from approximately half way up the wall of the canister.

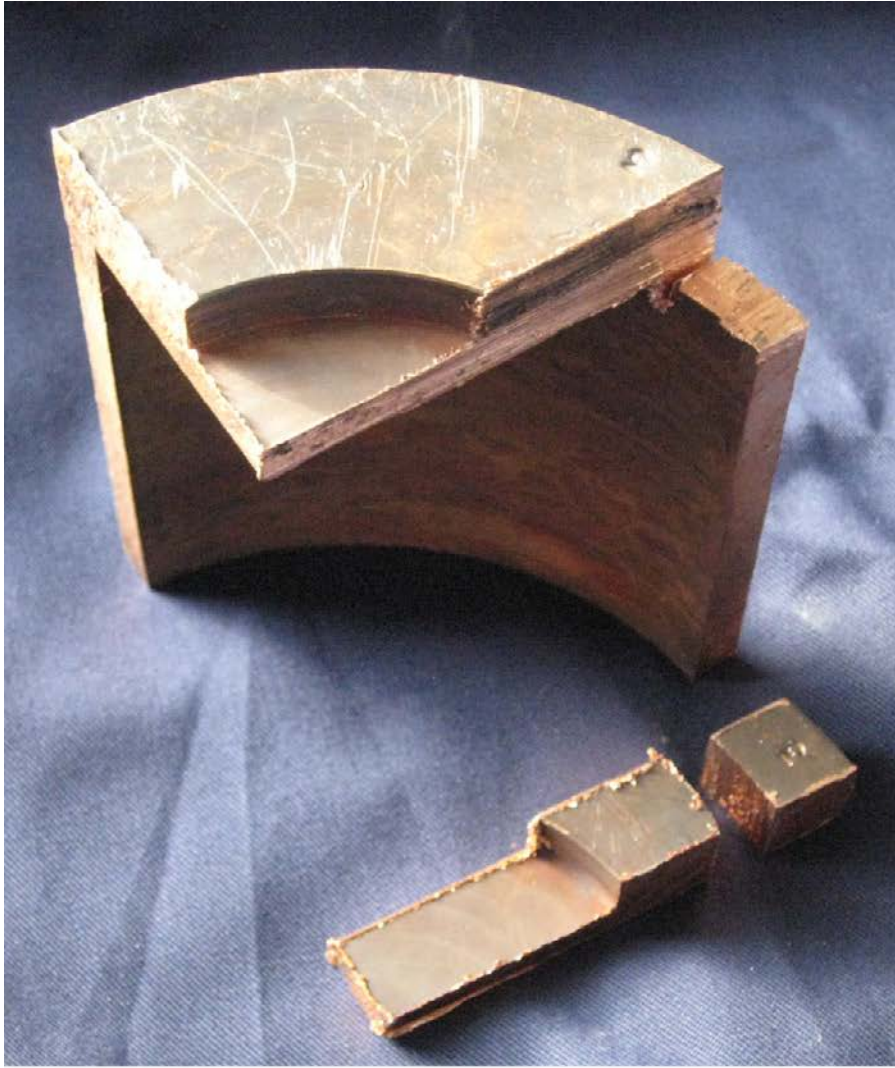
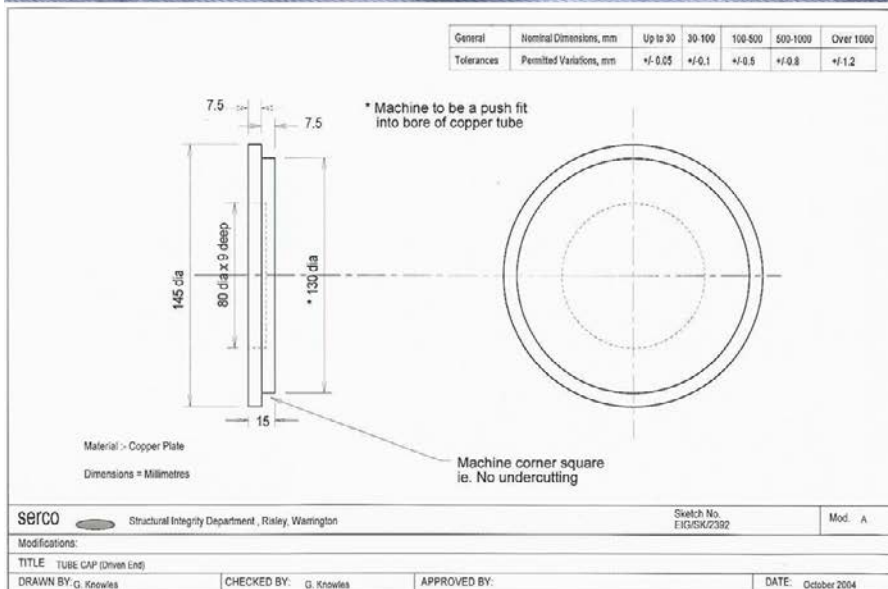
Figure 3-43. Photograph showing position of Specimen 3 cut from bottom weld area prior to metallurgical analysis and design drawing for base of canister.
