Comparison of Artificial Fracture Test Results and Other Matters

Tim Schatz

B+Tech Oy

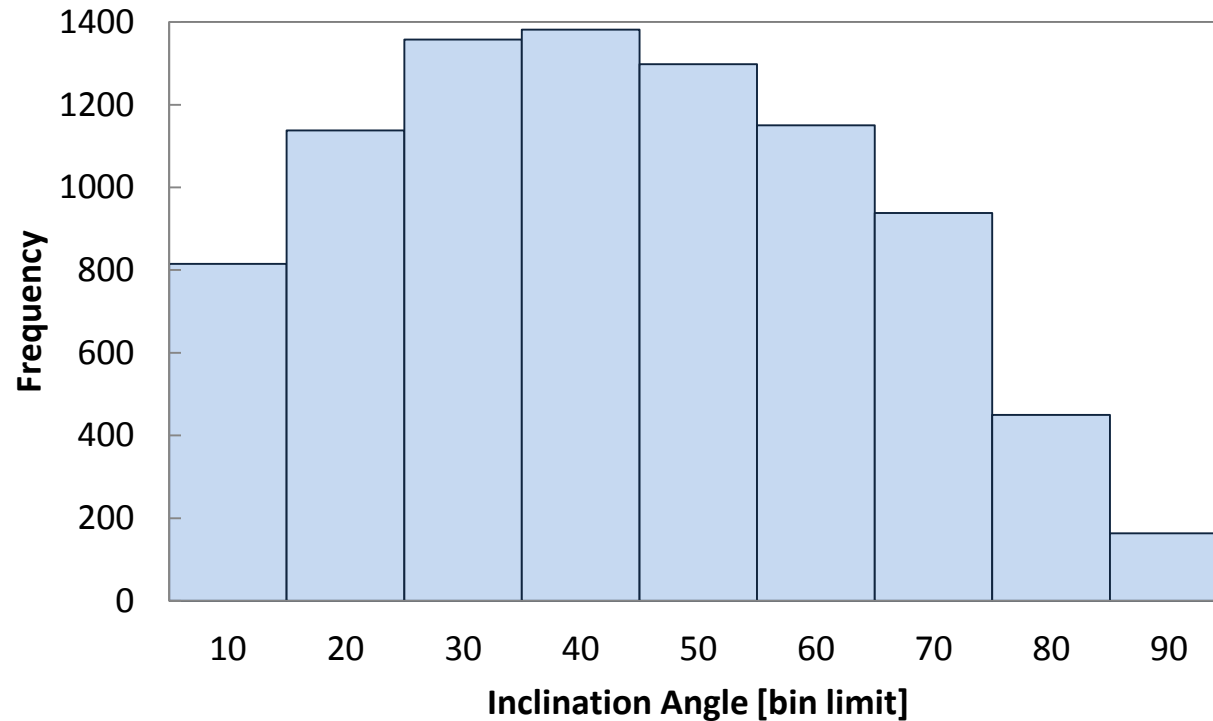
Fracture Inclinations

❑ Single realization for Olkiluoto site; N=8692

❑ Drifts are most frequently intersected by fractures with inclinations from 30° to 60°.

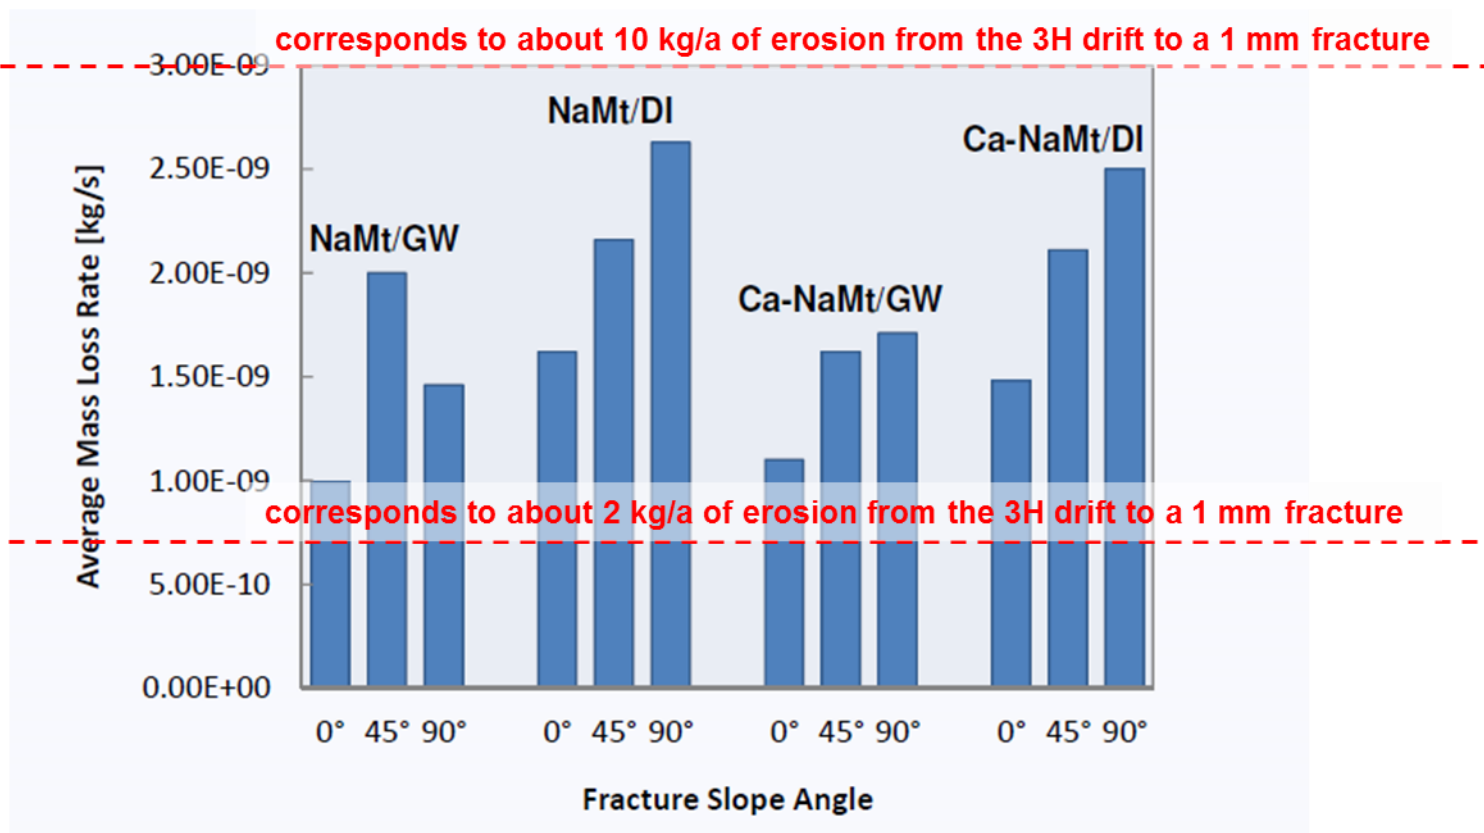
Scaled Results

Scaling needs to be verified!

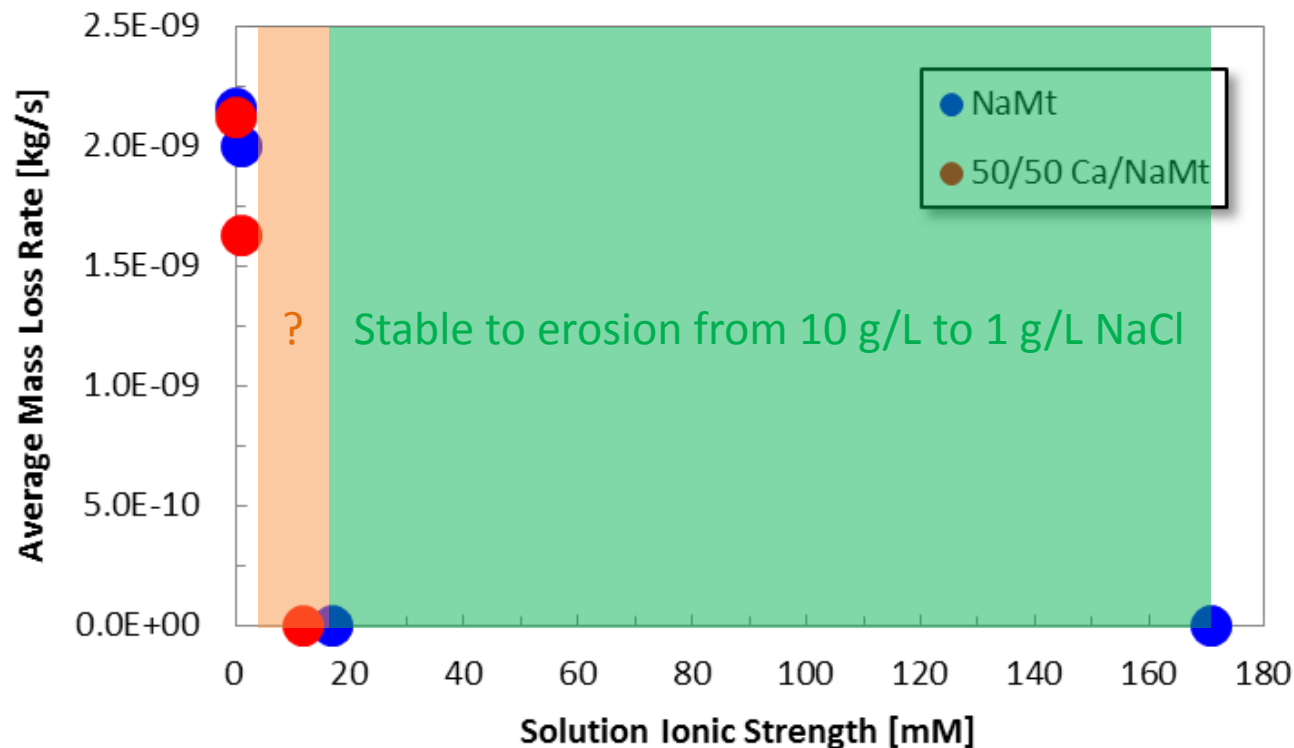
Erosion Stability in Sloped Fractures

- ❑ Similar stability to that observed in horizontal fracture tests.
- ❑ However, currently running tests show evidence of mass loss at 0.5 g/L NaCl.

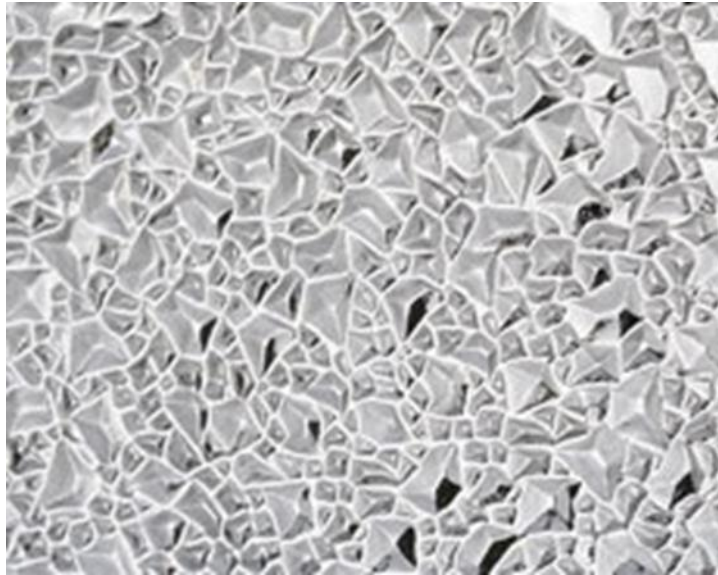
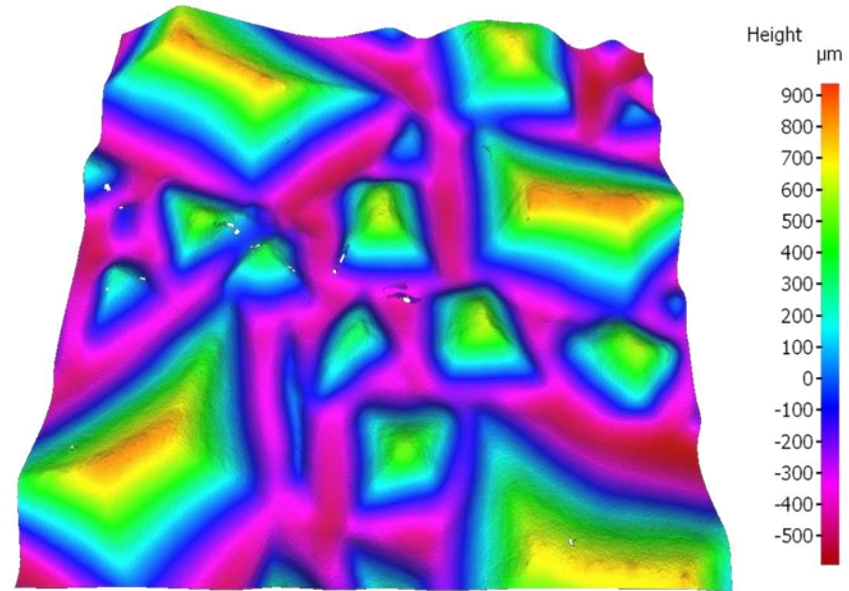
Rough-Walled Fracture System

- ❑ Rough-walled, artificial fracture system with topographical features from micron to millimeter scale.
- ❑ Average aperture = 0.95 mm.

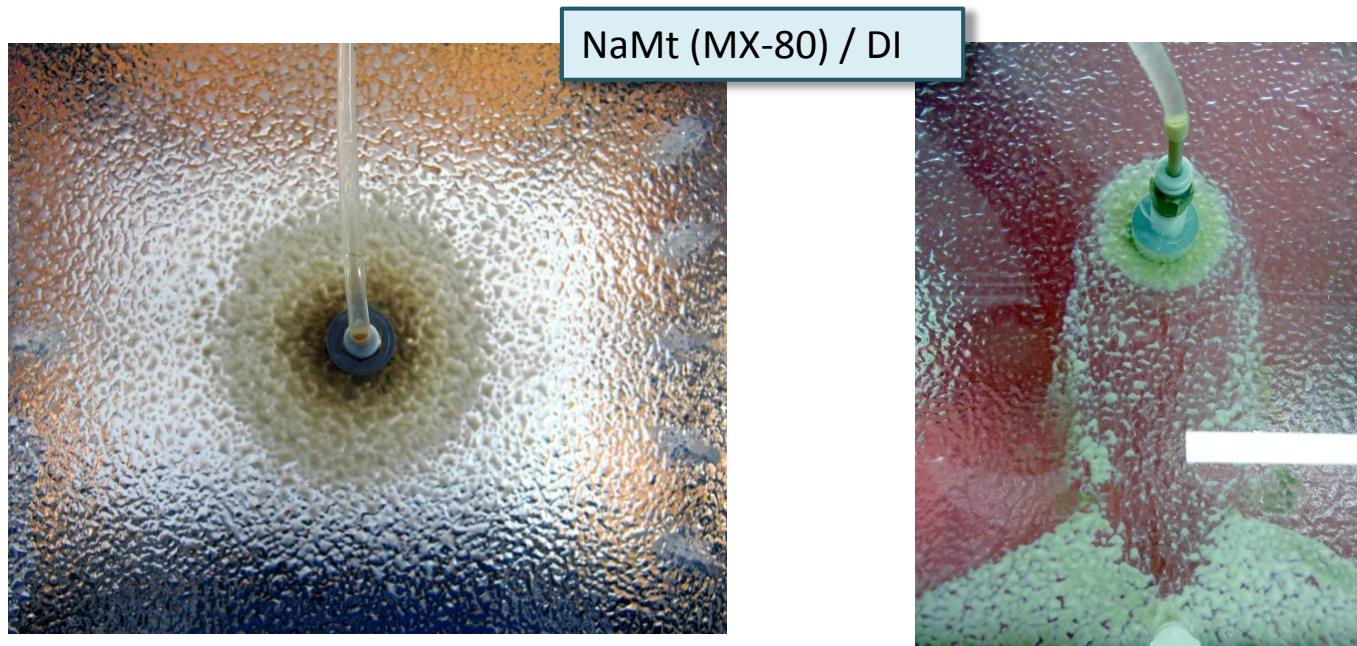
Rough-Walled Fracture Tests

- ❑ Compared to tests in smooth-walled fracture at 1 mm aperture with the same material, solution and inflow rate:
- average mass loss rates are lower by more than a factor of 2 in a horizontal position but equivalent in sloped fractures.

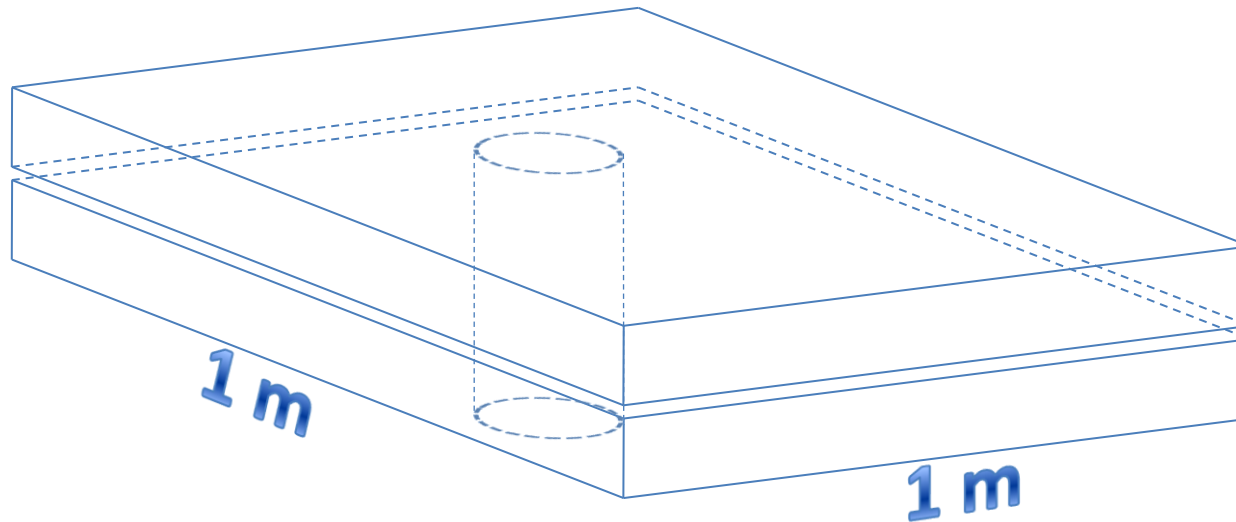
Larger Fracture System Test

Initial Sample Volume = 98.2 cm^3

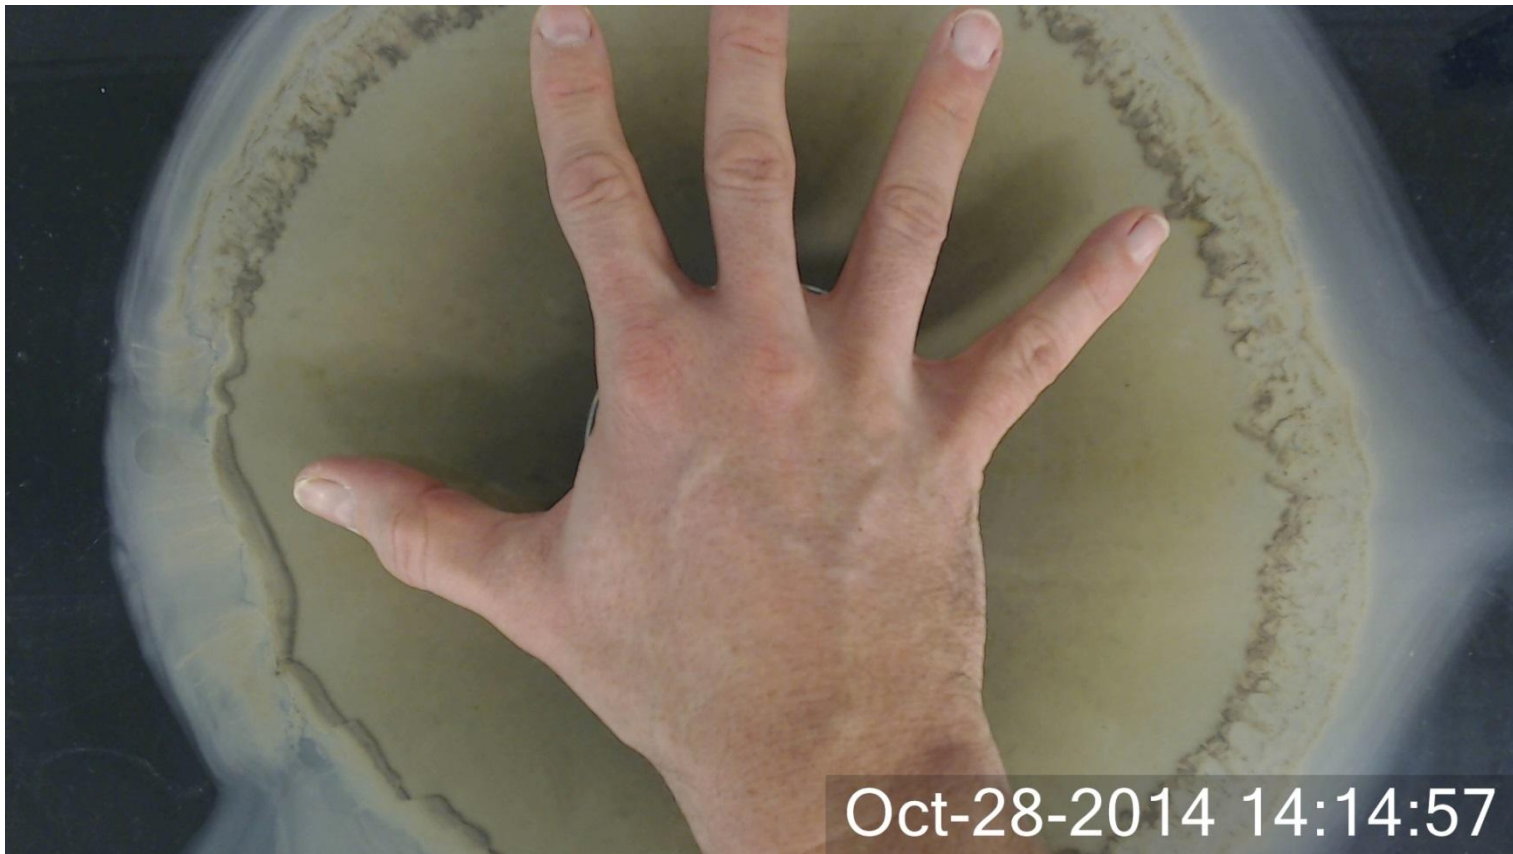
Current Status

- ❑ **Test running for six months:**
 - **extrusion diameter of ~330 mm.**
 - **continuous erosion observed over duration.**

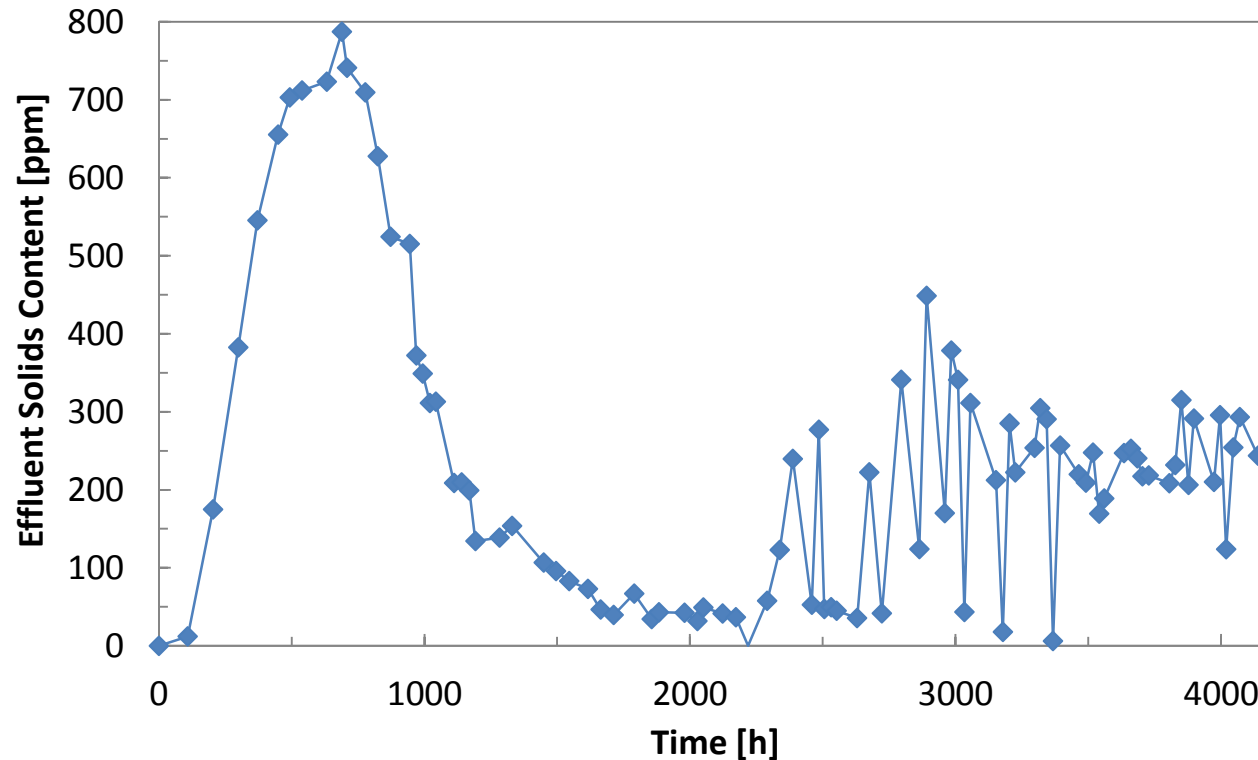
Larger Fracture Test Results

- ❑ Current test will be stopped next week.
- ❑ Next up will be a sloped fracture test.
