Forsmark site investigation

Detailed fracture and bedrock mapping, Quaternary investigations and GPR measurements at excavated outcrop AFM001264

December 2007

Svensk Kärnbränslehantering AB

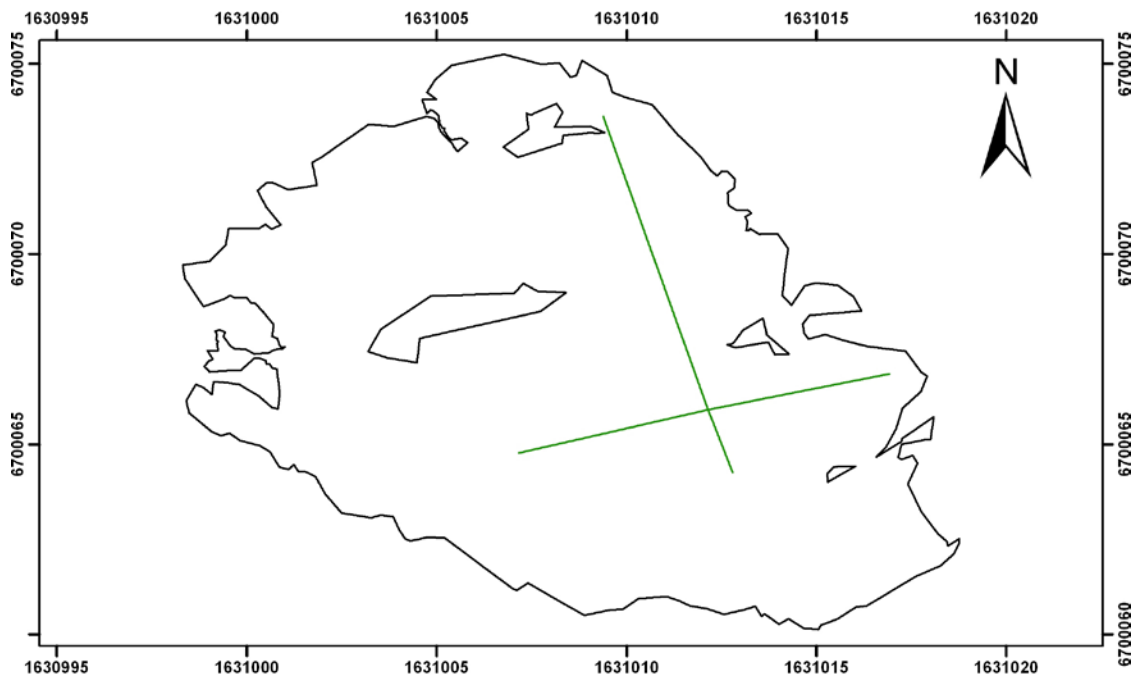
Figure 5-1. Outcrop AFM001264. Outcrop contour and scan line traces LFM000909 and LFM000910.

Figure 5-1 shows the outcrop with scan line traces at site, and Figure 5-2 demonstrates the fracture trace map of the outcrop.

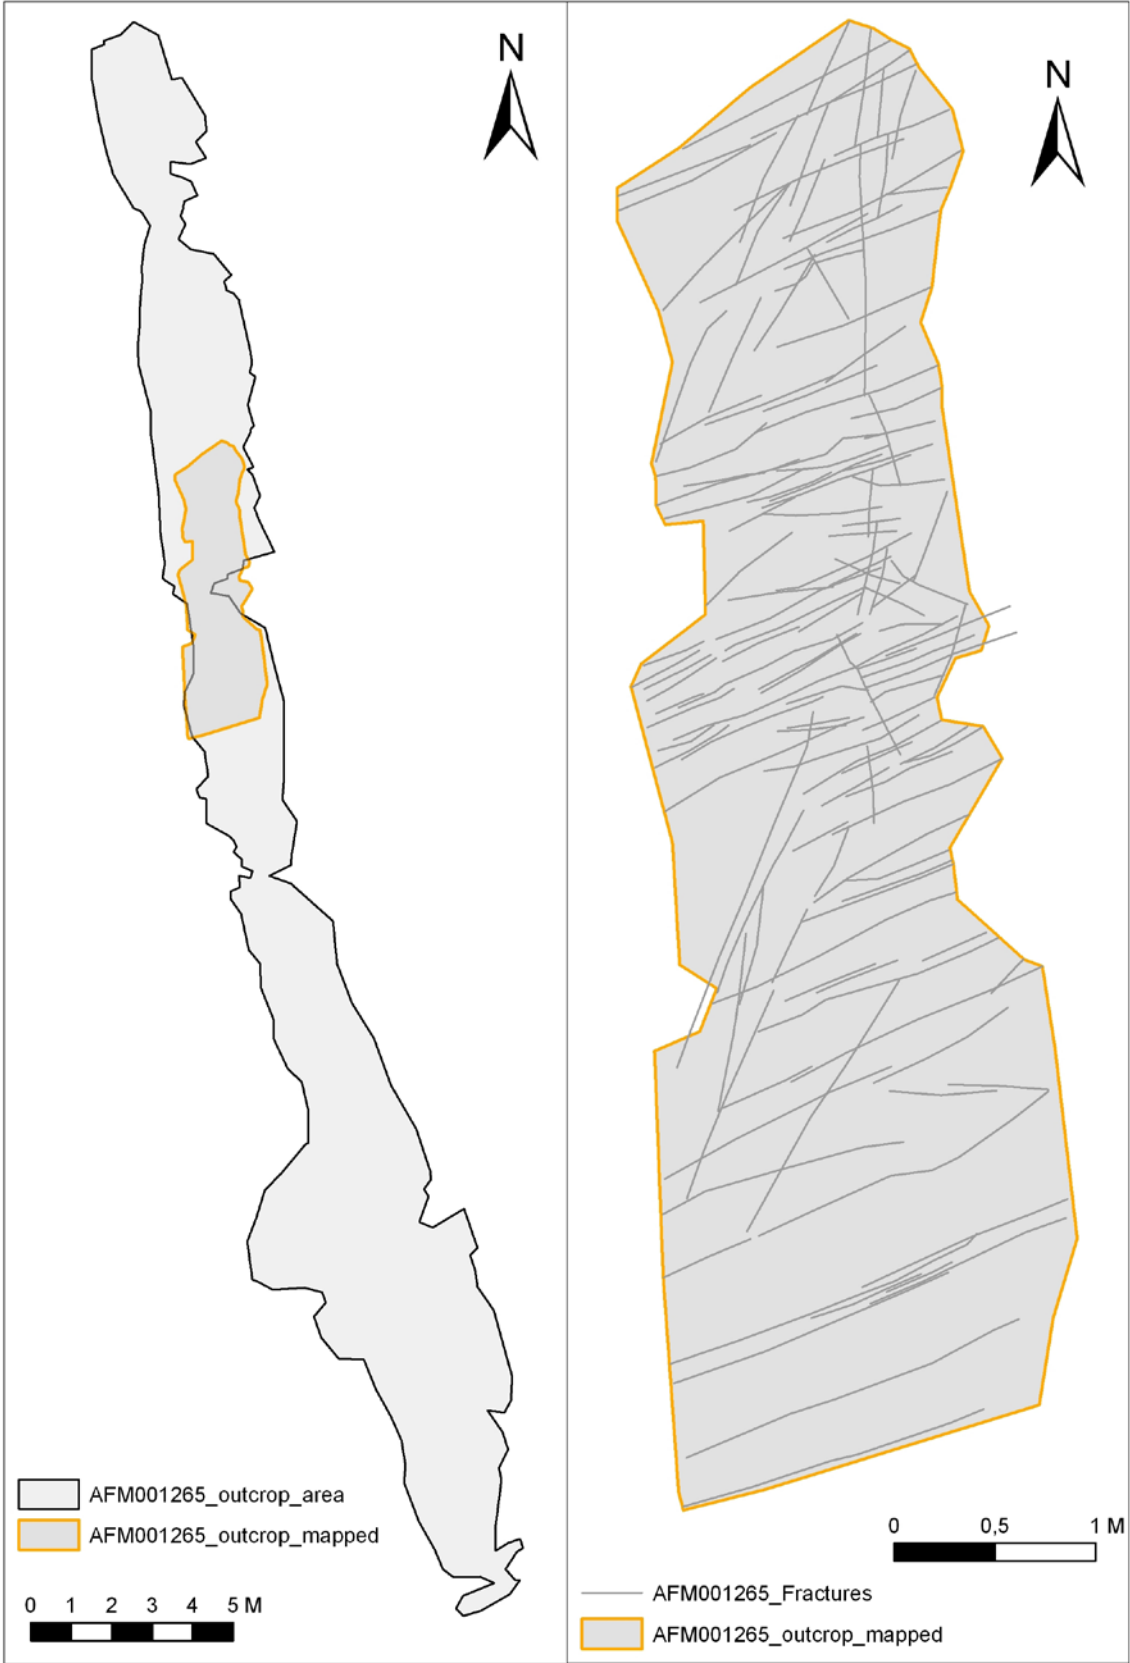
Figure 5-3. Fracture trace map of the fracture zone in the AFM001265 trench.

Figure 5-3 is showing the mapped area and a trace map of trench AFM001265. The description of the detailed geological mapping is presented in /1/.

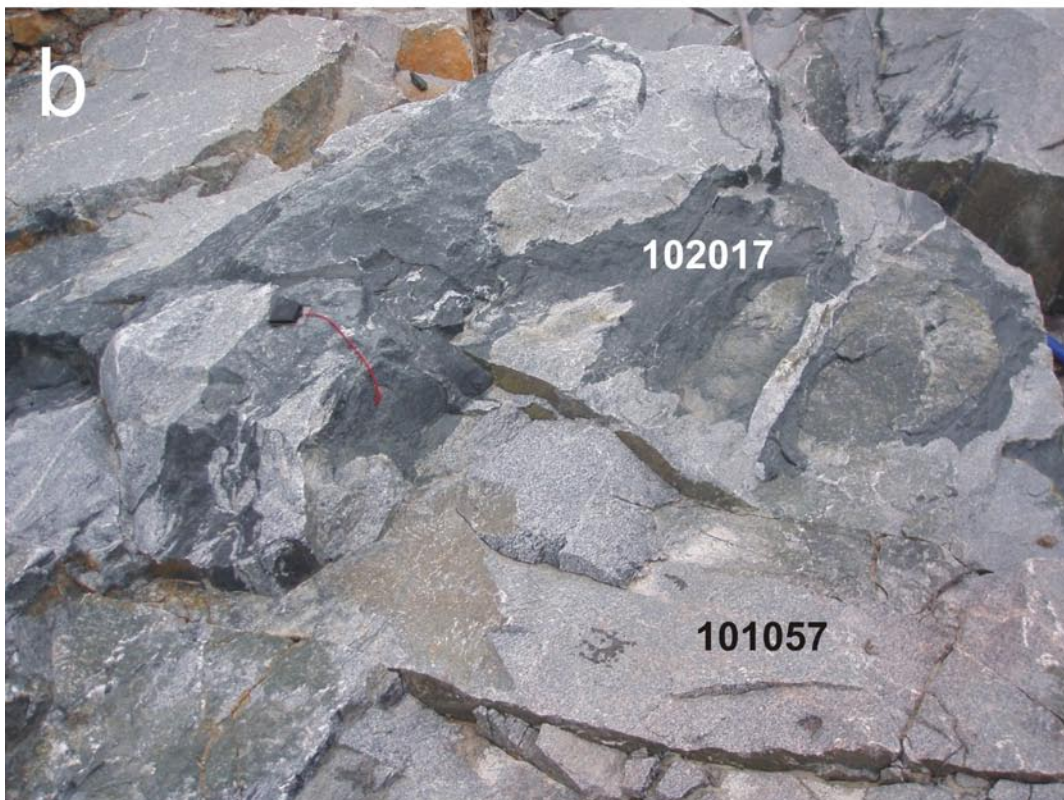
Figure A-2. Photographs of two amphibolite (102017) occurrences that suffered from intense ductile deformation. (a) A NNW striking, dyke-like occurrence and (b) a more irregular with cusped-lobate contacts towards the surrounding medium-grained metagranite (101057). Size of the compass used as scale is 6.4×10 cm.

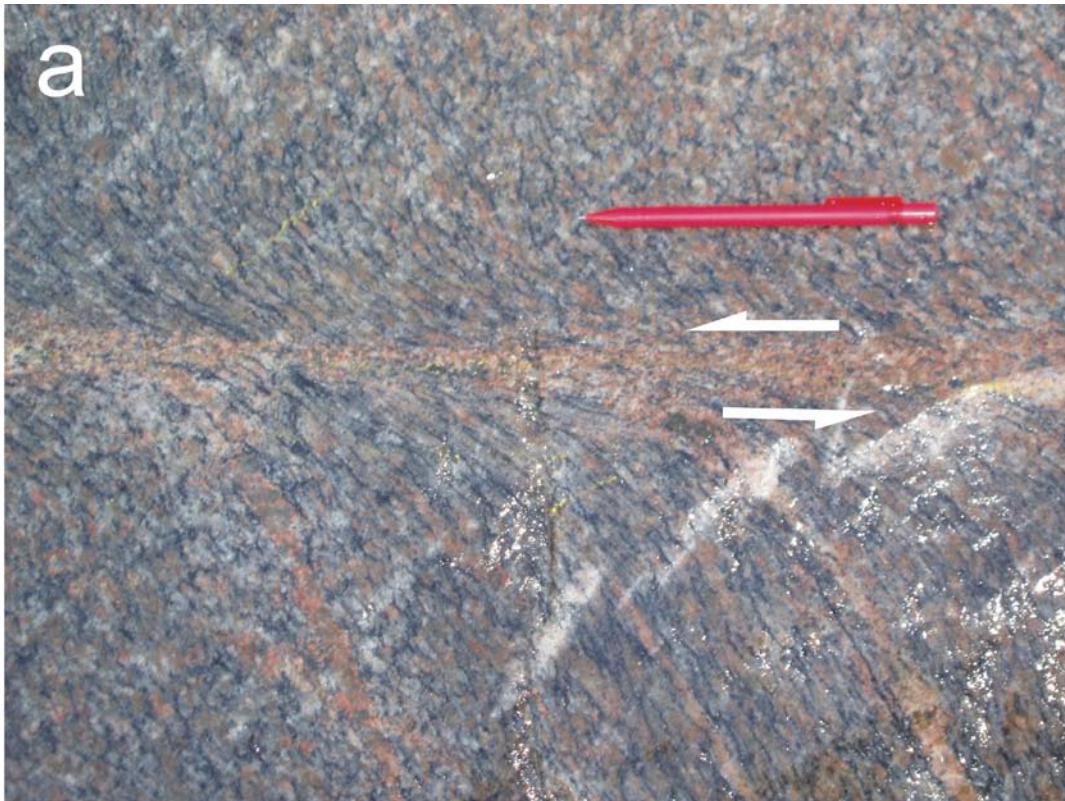
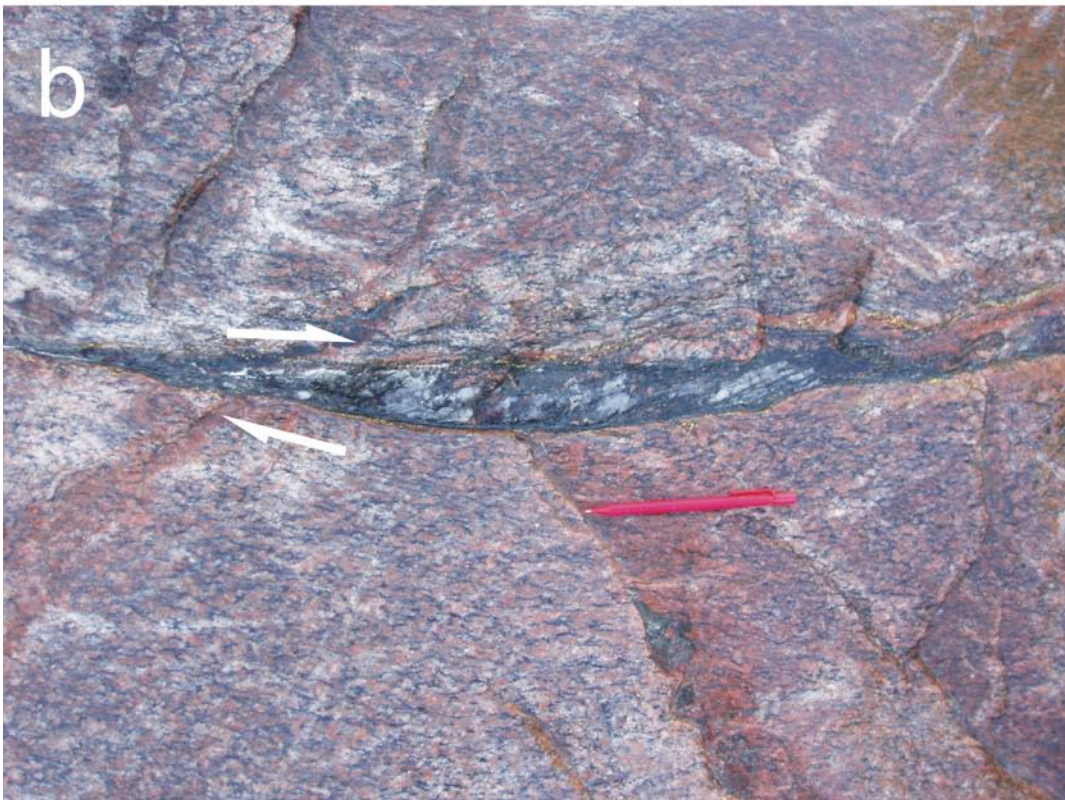
Figure A-3. Photographs of (a) a localized sinistral shear zone in the medium-grained metagranite (101057), and (b) a well-defined section of a brittle-ductile deformation zone; note the internal foliation planes, indicating a dextral movement. Length of the pencil used as scale is 14 cm.

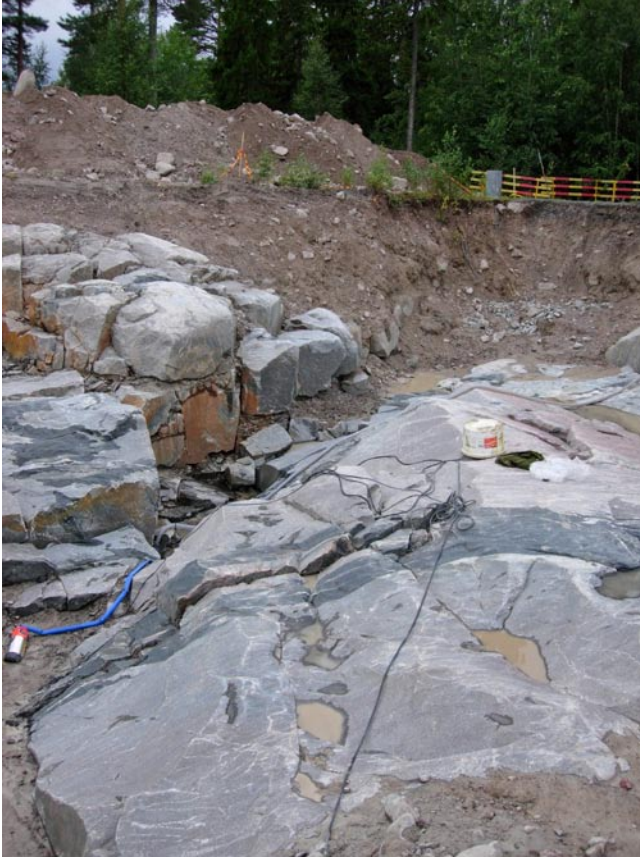
Figure B-1. View of the excavated area from the east. Note the difference in the fracture pattern N and S of the trench, respectively.

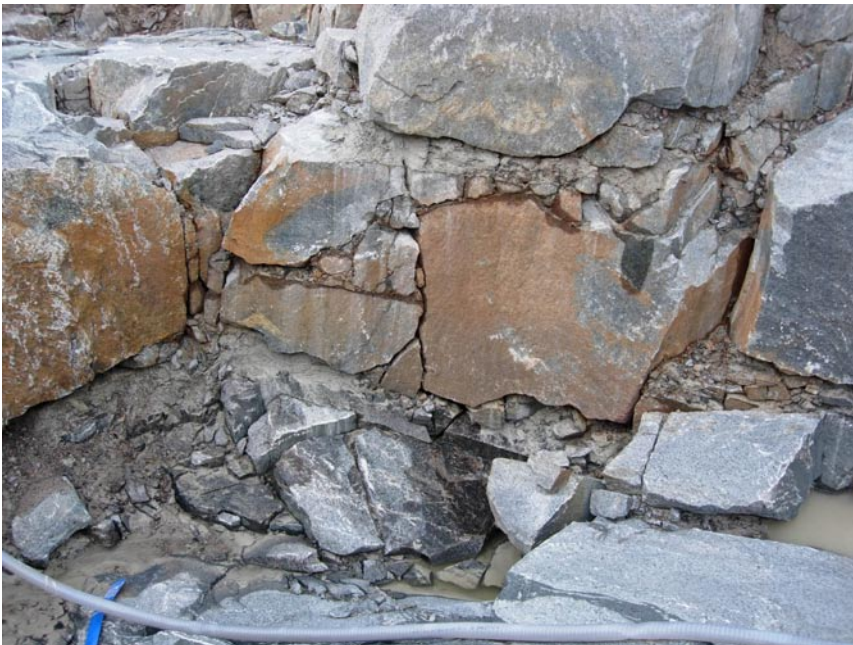
Figure B-2. Heavily fractured bedrock. Two subhorizontal sediment-filled fractures can be distinguished.

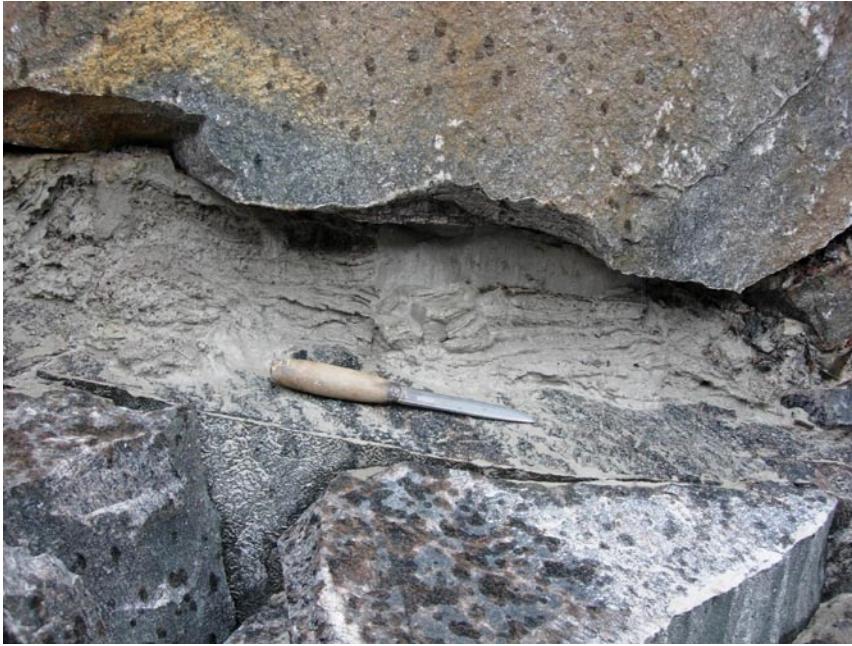
Figure B-3. Sandy and silty sediment-fill in one of the sub-horizontal fractures. To the right sharp-edged bedrock fragments.

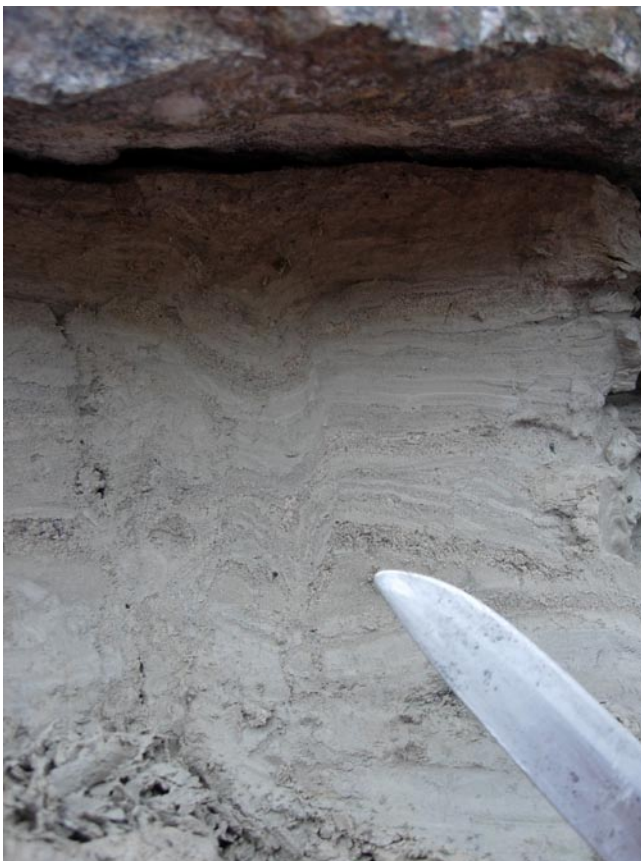
Figure B-4. Small-scale collapse structures within the sediment-fill. These graben structures are probably caused by percolating water in nearby fractures.

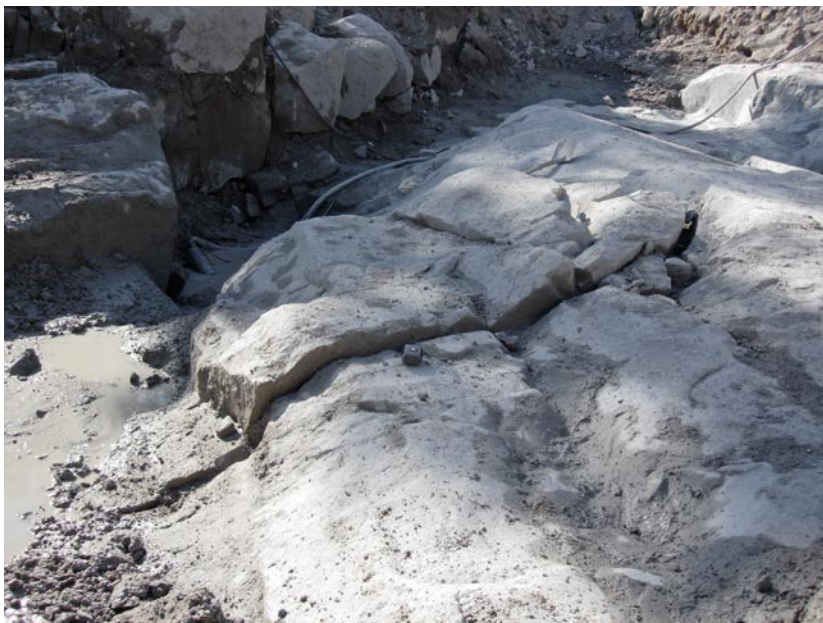
Figure B-5. A chunk of bedrock has been lifted and rotated by a moving ice sheet.

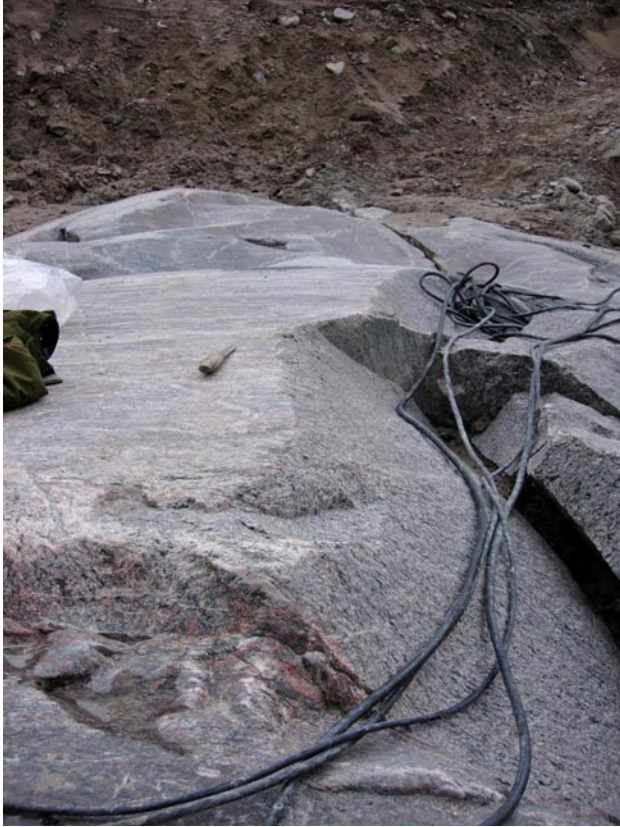
Figure B-6. Polished and striated bedrock surface. Note the distinct lee-side edge.

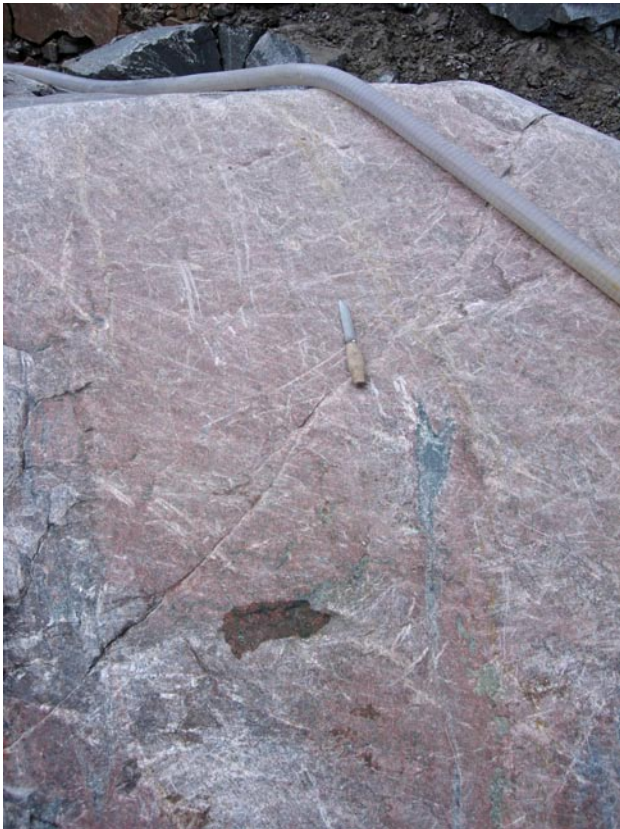
Figure B-7. Striation pattern at lower parts of the bedrock surface. Several directions can be distinguished. The striation may at least partly originate from construction work and excavation of the bedrock.

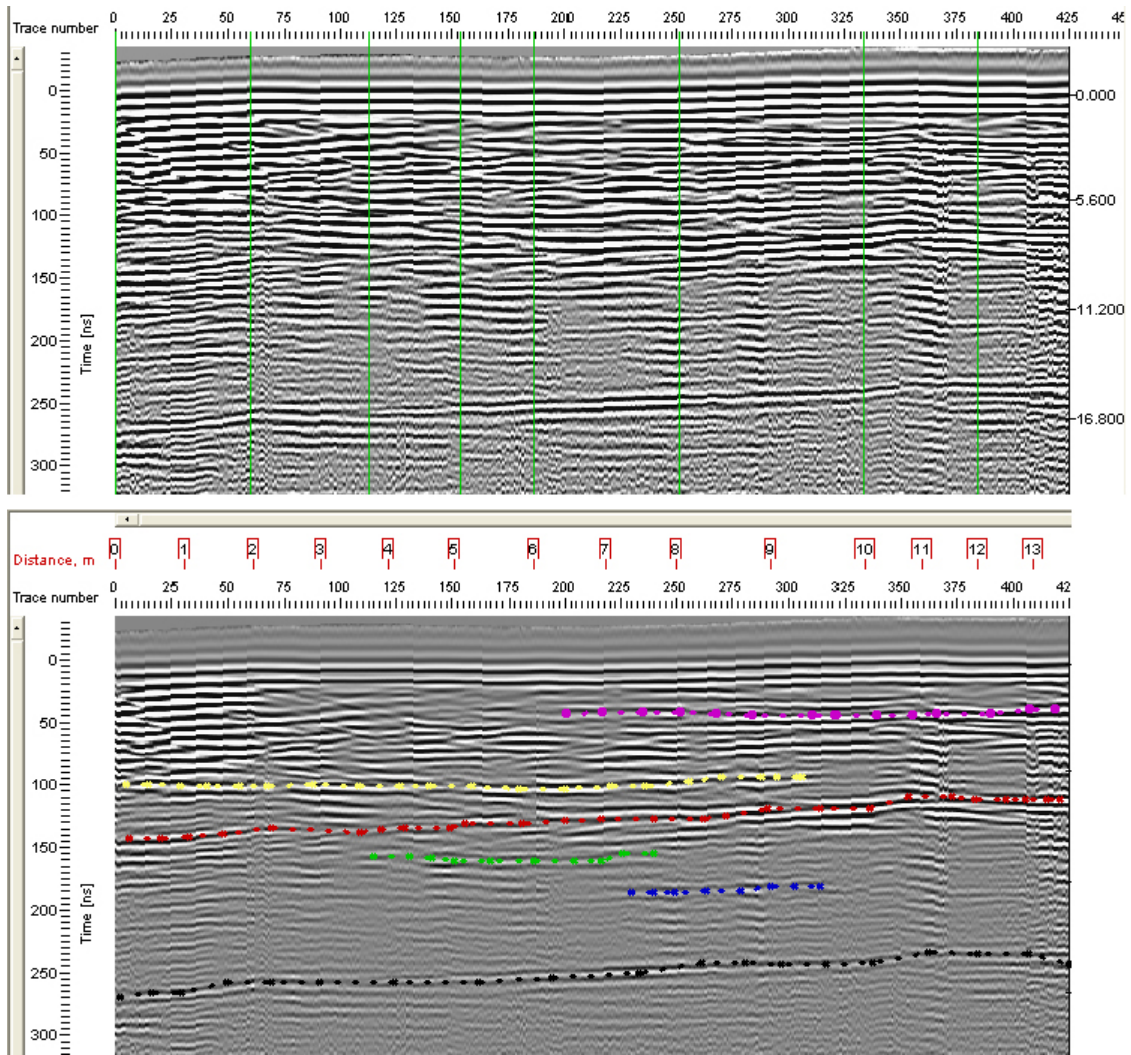
Figure C-4. The results from LFM000922 (from R21 to R26), 100 MHz data without interpretation (upper radargram) and with interpretation (lower radargram).

In the profile LFM000922 several reflectors are seen at a depth of 5 to 6 m (see Figure C-4). Weaker reflectors can also be identified. In this profile a quite strong reflector is also identified at approximately 16 m depth.
