International
Progress Report

IPR-99-05

Äspö Hard Rock Laboratory

Experience from design
and construction

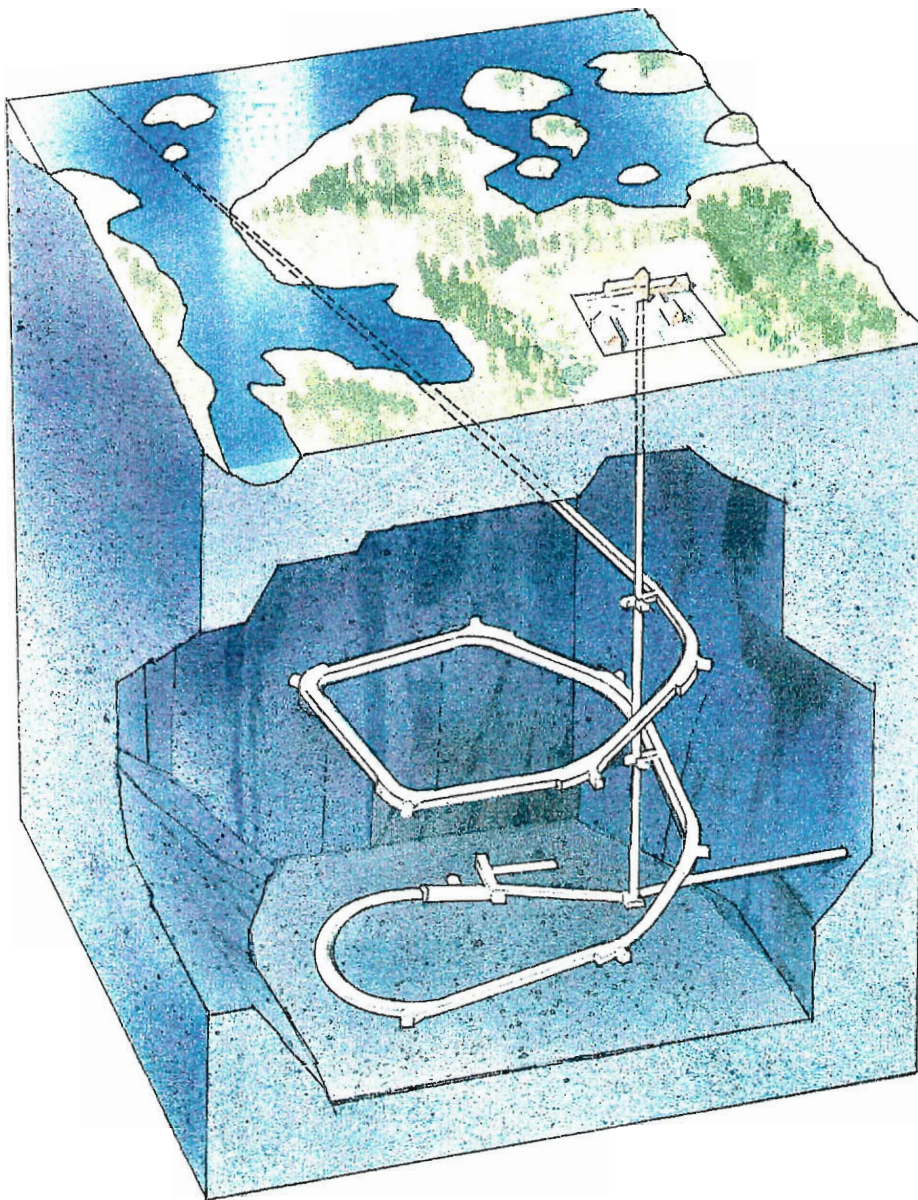
Figure 1-2 Overview of the plant layout.

The design and construction of the Äspö Hard Rock Laboratory has comprised several parts and stages. An overview of the plant layout is shown in Figure 1-2. A tunnel ramp was excavated from the Simpevarp peninsula 1.5 km out under the island Äspö. The descent to the tunnel is situated in the vicinity of the Oskarshamn nuclear power plant. The tunnel reaches the island Äspö at a depth of 200 m and then continues in a hexagonal spiral down to a depth of 340 m below the sea level. The tunnelling of this first construction part was entirely done by means of conventional drill and blast methods. For the second part of the spiral (from -340 to -450 m level), full-face boring with a tunnel boring machine, TBM, has been tested. Also the first part of the second spiral follows the hexagonal shape and was done by drilling and blasting. The tunnel then goes down to the -450 m level close to the shafts and continues horizontally westward to an experimental rock volume.

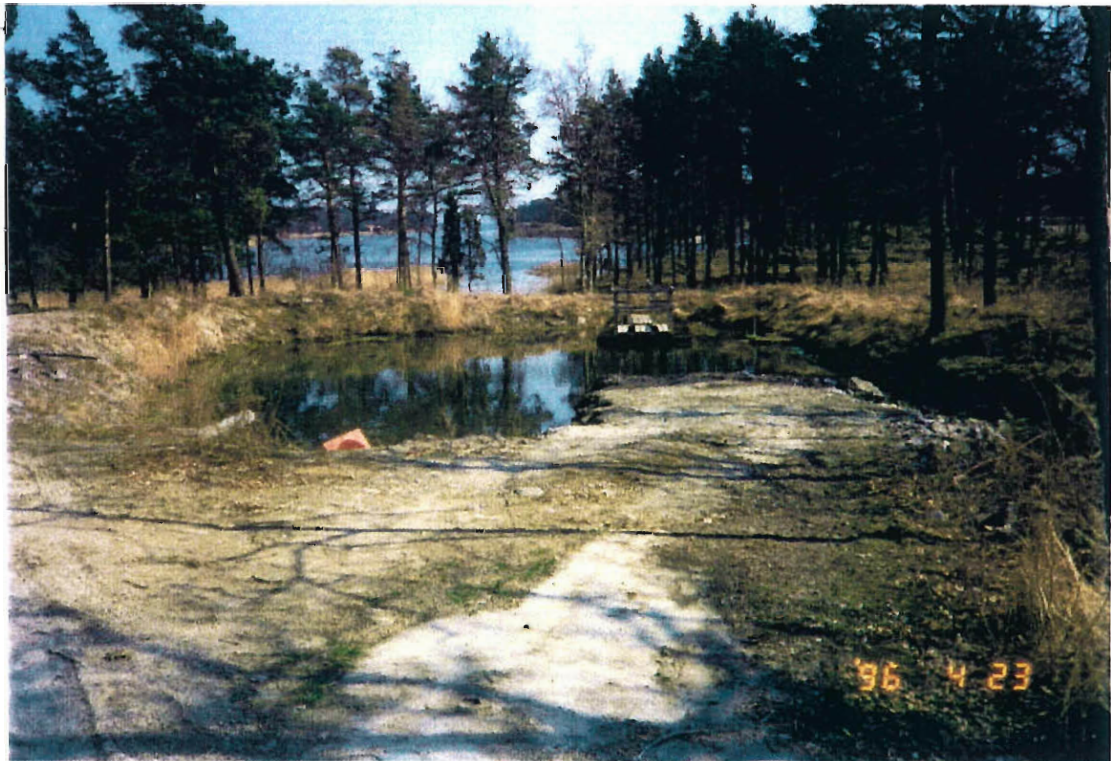
Figure 2-3 Slurry basin at the outlet.

The statutes on water-rights restrict the amount of water pumped out from the underground facility to 50 l/s, or 180 m³/h. Furthermore, the water may not be let out in the vicinity of Äspö, but has to be led out to the sea close to the outlet of cooling water from the Oskarshamn nuclear power station. High standards have been imposed on the measuring of water leakage. Scientists have decided on locations in the facility where sealing dams and gauging equipment equipped with a Thomson overflow had to be installed. The procedure has worked well.

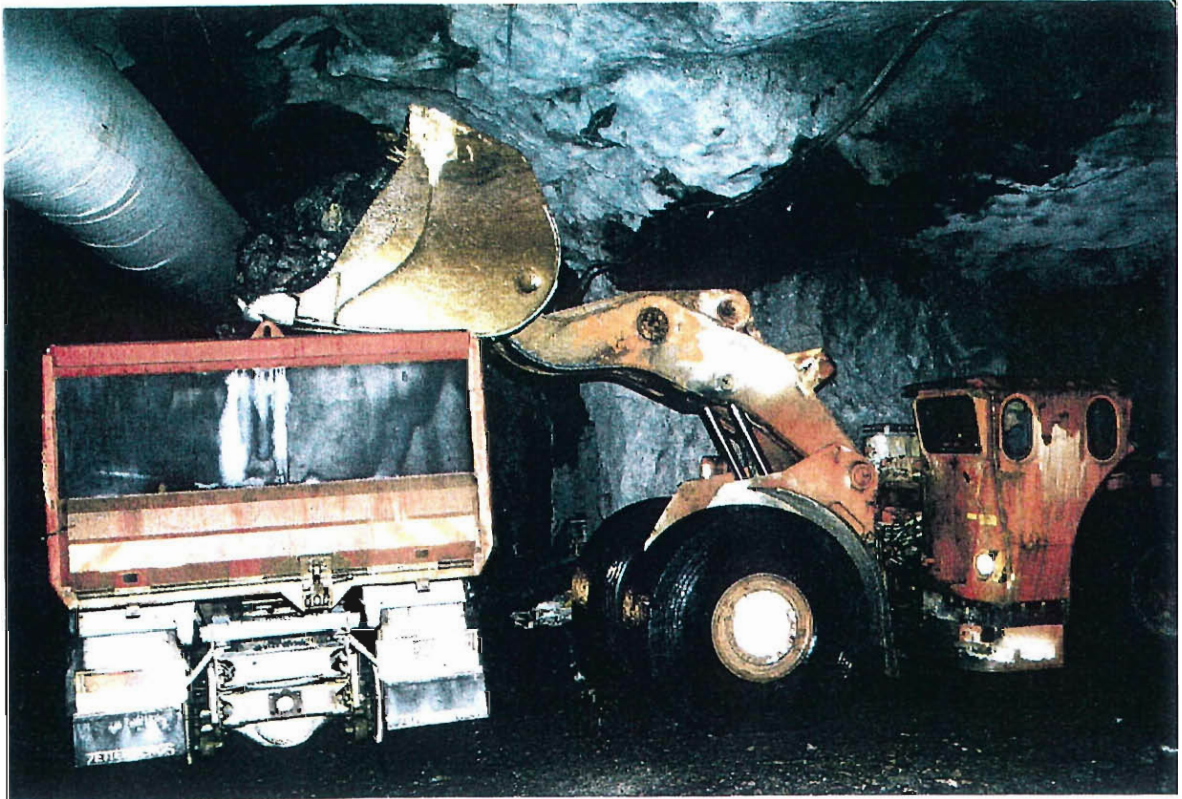
Figure 3-3 Loading onto a truck.

Mucking out was done by an electric Load Haul Dump (LHD) which loads the muck onto trucks that carry their load to a dump on the ground level. Electric loaders had earlier been used in mines but not in tunnels since they are less mobile compared to diesels. The electric loader type was chosen mainly due to environmental reasons. It was a typical mine-LHD, a Toro 500E, extremely low and compact. The bucket has a volume of 7 m³ (approximately 18 000 kg of blasted rock).

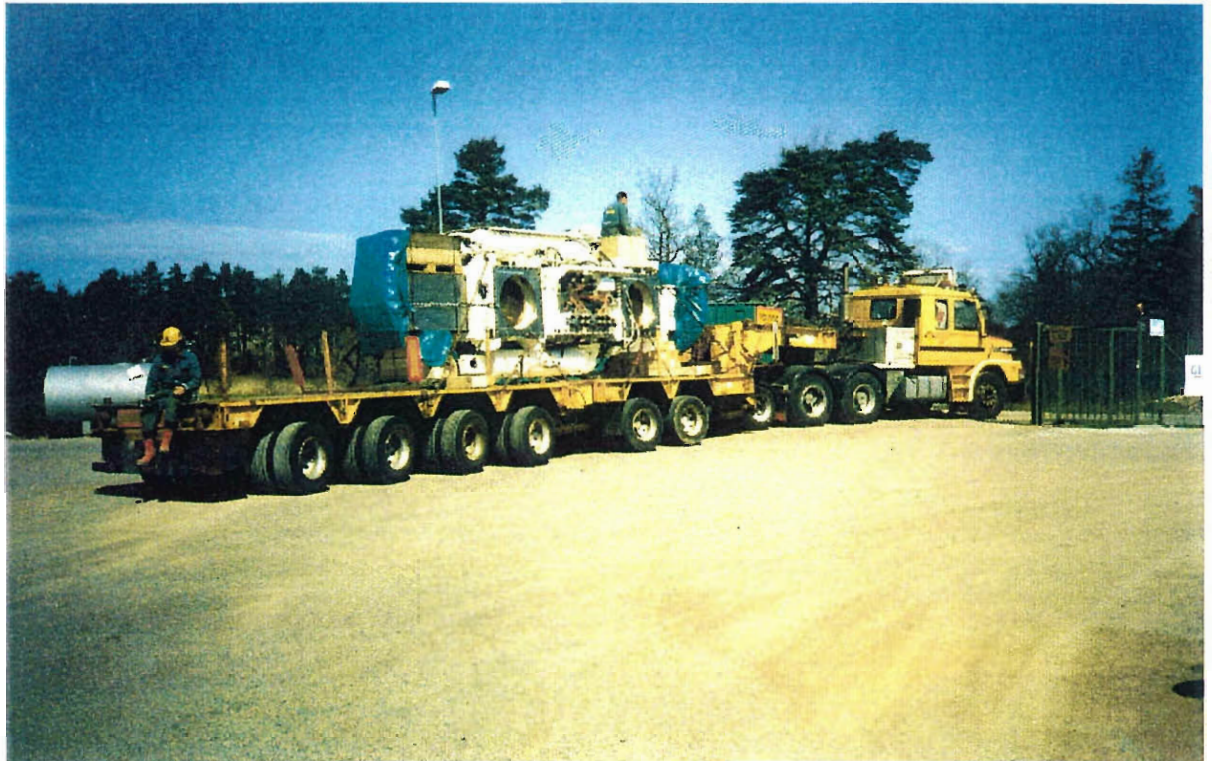
Figure 3-8 The 50 metric ton "main body" on a trailer at site.

The TBM was first assembled at the manufacturer's workshop and after a functional testing it was disassembled and sent to the site. The final assembly was done in a rock cavern situated at the -420 m level. The transport was carried out in as large pieces as possible. The largest part was the "main body", weight 50 tonnes, and the "centre section", weight 30 tonnes. For the transport down through the tunnel a low built trailer with hydraulic steering on all wheels was used. The back up rig was mainly assembled at the site. The transport down the tunnel was done stepwise with one deck at a time. For the assembly work a 50 tonnes overhead crane was established in the assembly cavern.

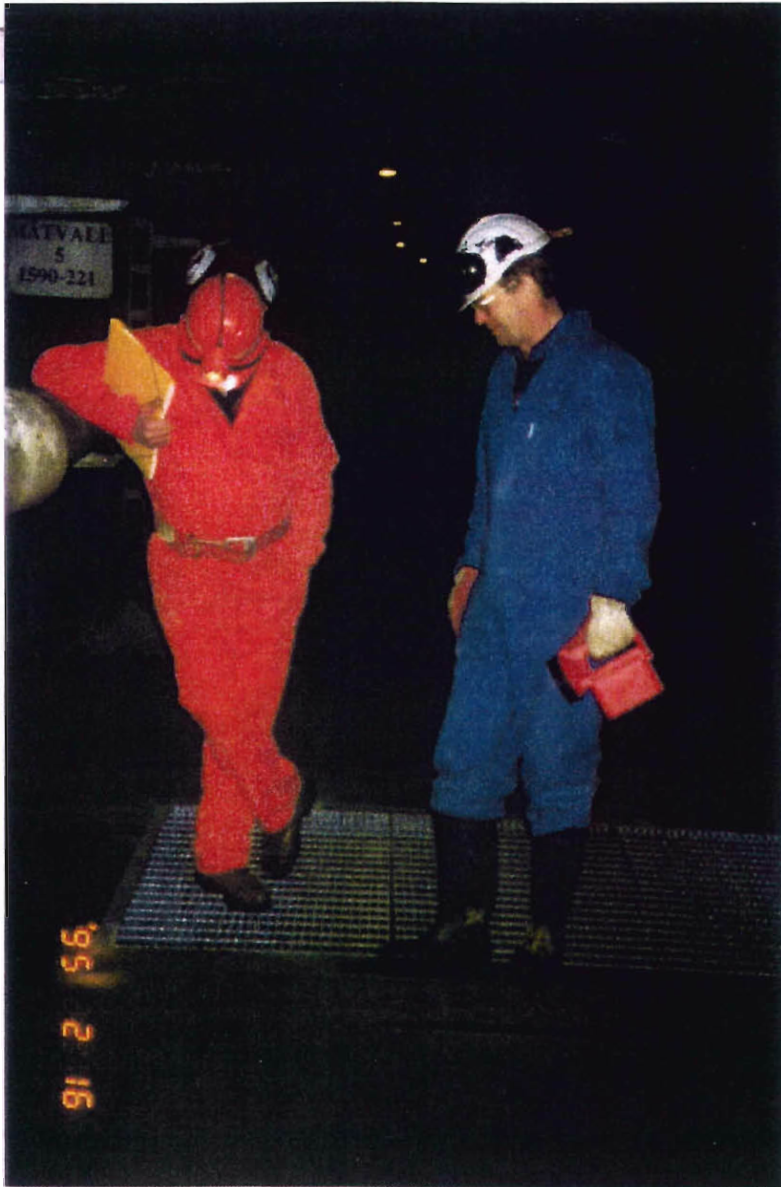
Figure 4-6 Grating on top of a sealing dam.

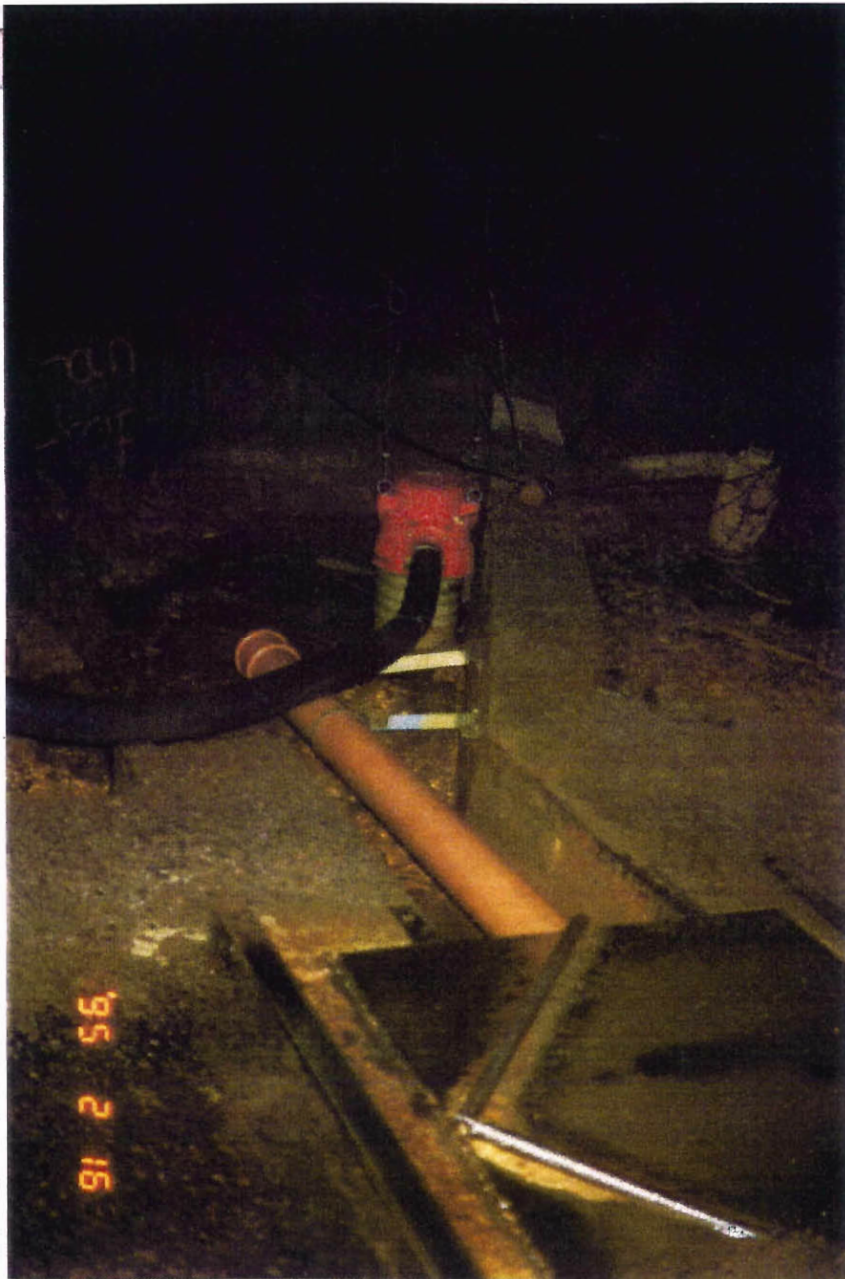
Figure 4-7 Collecting dam and pump at section 1/033.

A collecting dam in section 1/033 was constructed during the excavation of the tunnel in order to retain the water from the discontinuity NE-3 on the tunnel face. The immersed pump of a standard design that was put there during the construction phase has been left there afterwards. This decreases the cost of pumping up the water. The alternative would be to let the water flow freely down to the sump PG3 to be pumped up. It would be advisable to place collecting dams downstream any larger leakage spots, partly to decrease the amount of water on the tunnel face during the blasting of the tunnel, and partly to decrease the cost of pumping during the operational phase. The latest is especially important if the downstream pump sump is located at a long distance from the problem area.

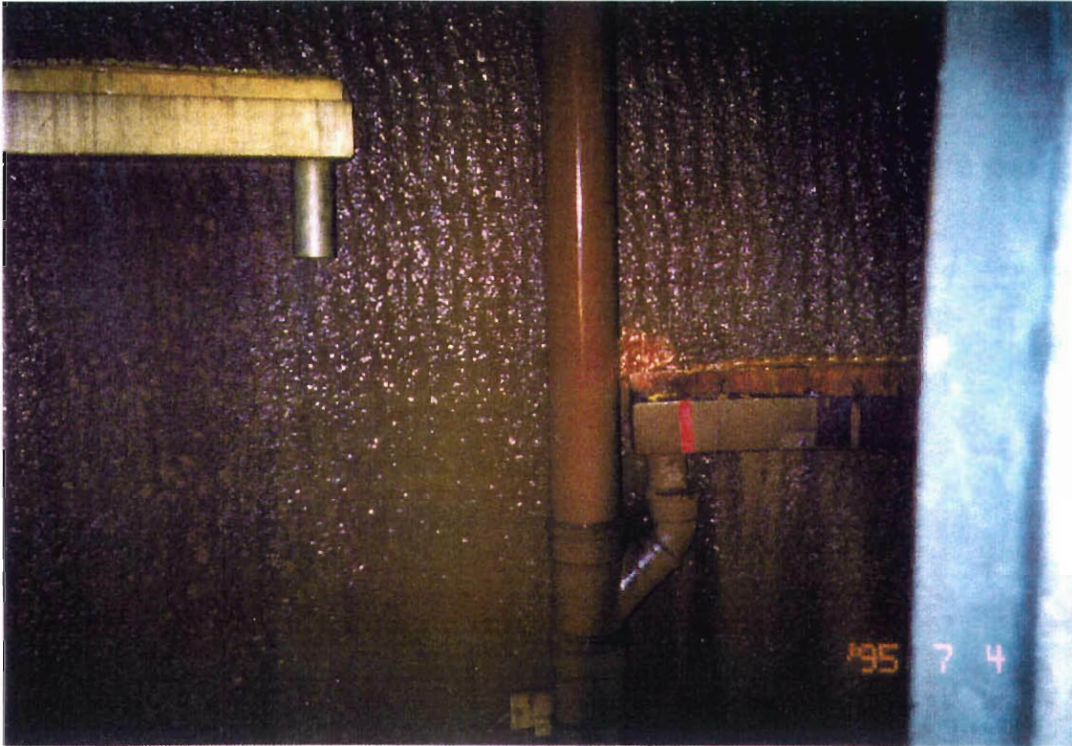
Figure 4-11 Collection of water in the lift shaft.

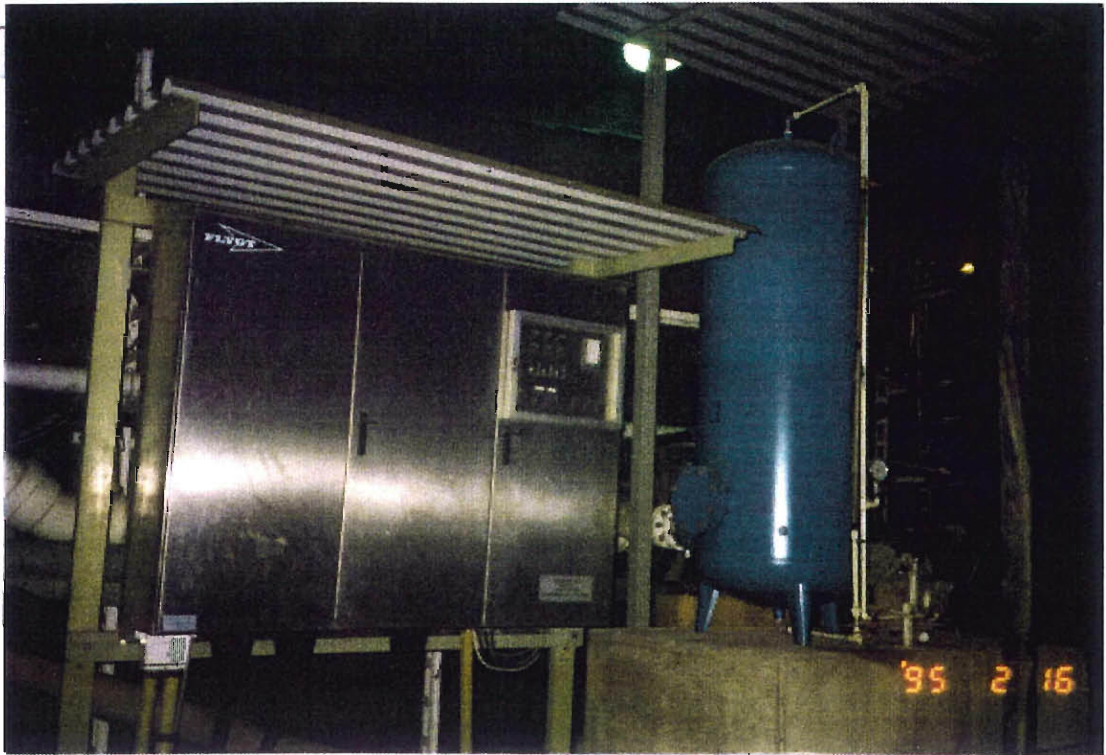
Figure 4-14 Pent-roofs and pressure tank at PG3.

The installed alternative solution, using a pneumatic or electrical valve, has up until now worked just as well. The valves operate automatically and need less surveillance than pressure tanks. Using valves involves the requirement of a delayed operational start up of the pumps following a power failure, so that the backwards-rushing water does not cause the pump to rotate backwards when started up again. The operational function of pressure percussions, pressure tanks, pneumatic valves and electrical valves, has to be further studied so that a suitable system solution can be chosen for the Deep Repository.

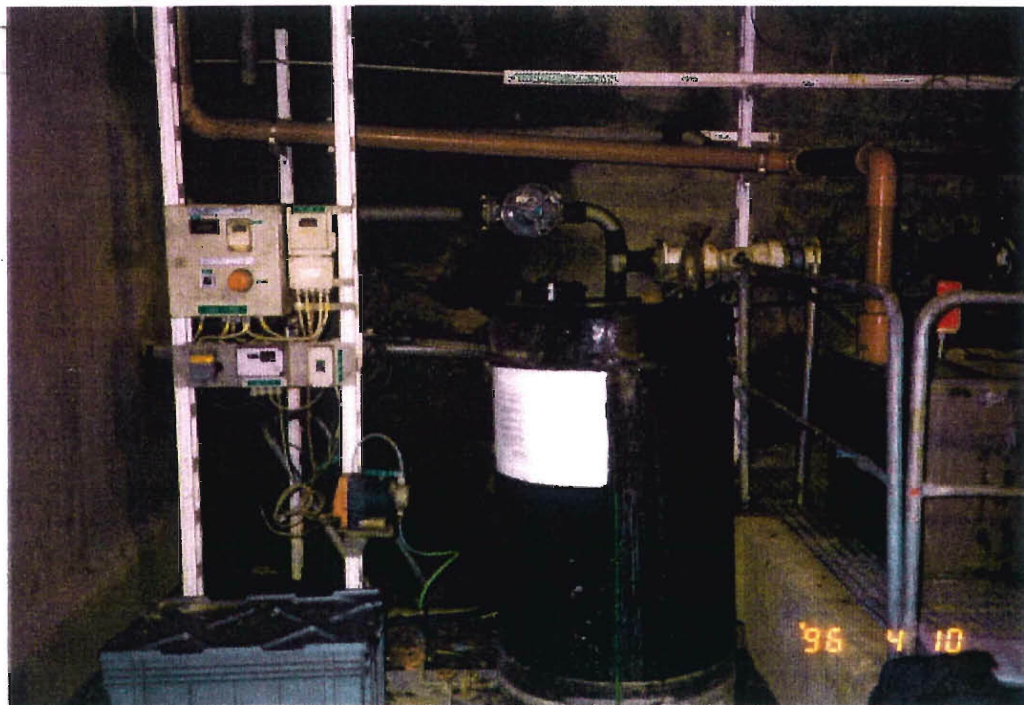
Figure 4-19 Uranine dosage equipment.

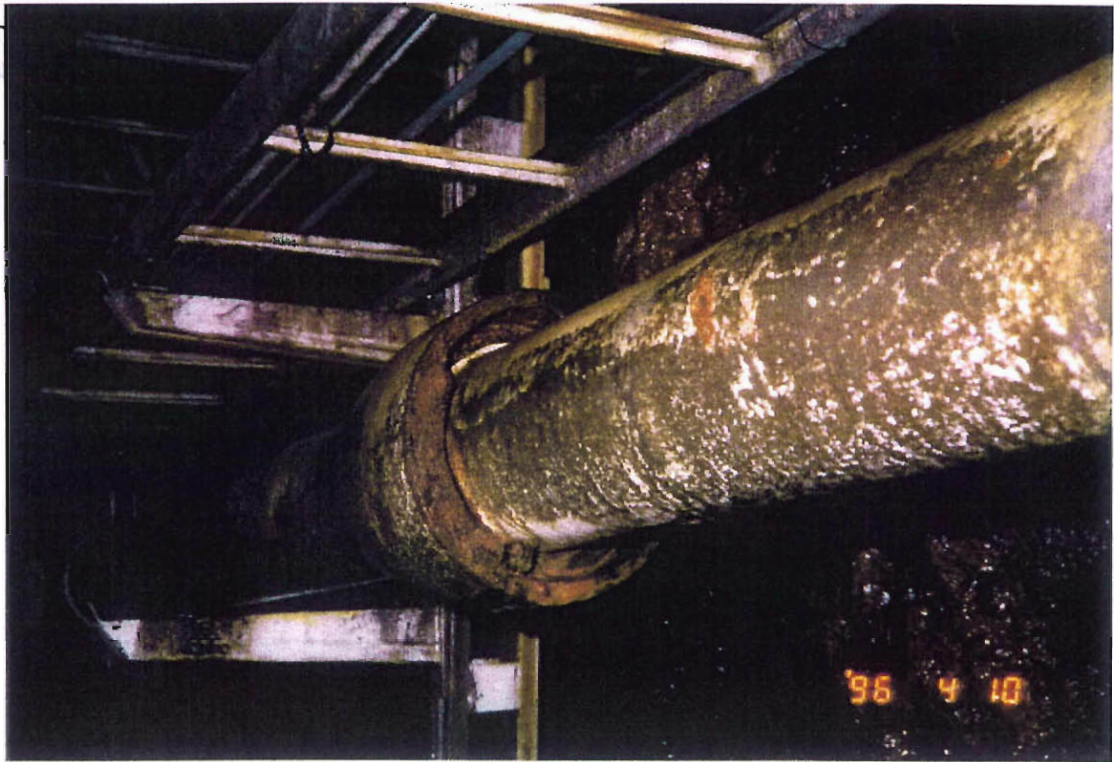
Figure 4-25 Corrosion damaged joint on a VRS-pipe.

The joints are a major corrosion problem as they have no protection whatsoever against the environment. This is especially true of the pipe joints equipped with clamping rings whose function could be endangered even in the case of a very mild corrosion damage. The manufacturer recommends the joints to be wrapped up in sealing insulating tape, which would stop the oxygen from getting in and thereby stop the corrosion process.
