**IPR-07-18**

## Äspö Hard Rock Laboratory

### Core dinking study in the TASQ (APSE) tunnel, Äspö HRL

November 2007

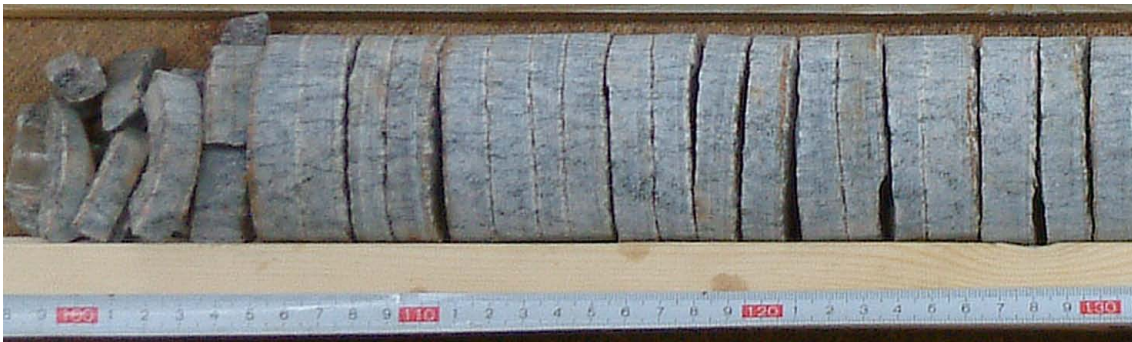
**Figure 1-1.** Example of ring disking observed during overcoring rock stress measurements in borehole KFM01B (test no. 2:10:1 at 474.25 m depth) /Lindfors et al., 2005/.

Both core disking and ring disking has been observed within the site investigation program of SKB, most notably at the Forsmark site. This has posed to be a limitation of the applicability of overcoring stress measurements, as the measurement results are no longer reliable once disking is occurring. In extreme cases, it is not possible to take any measurements at all, due to severe ring disking, see Figure 1-1.

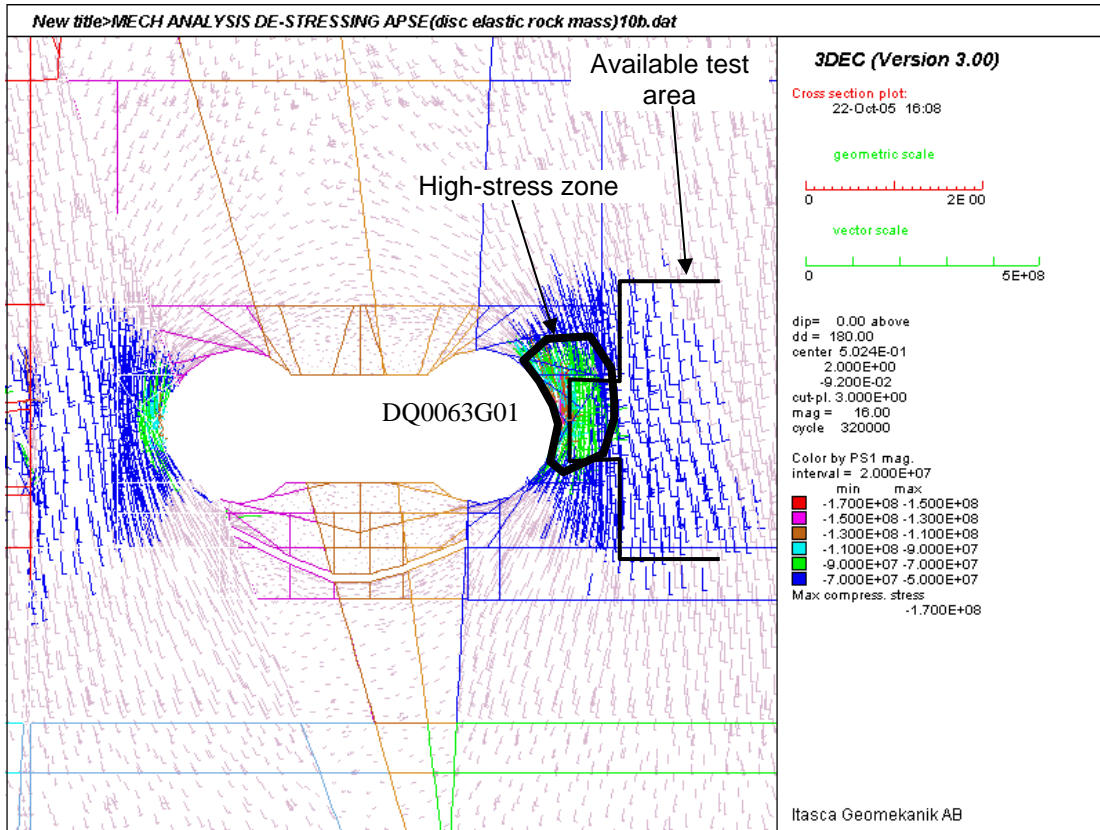
**Figure 3-4.** Example of calculated stresses around deposition holes. Horizontal section at 1 m depth (below tunnel floor) showing projections of the principal stress vectors, colored with respect to magnitude of the major principal stress.

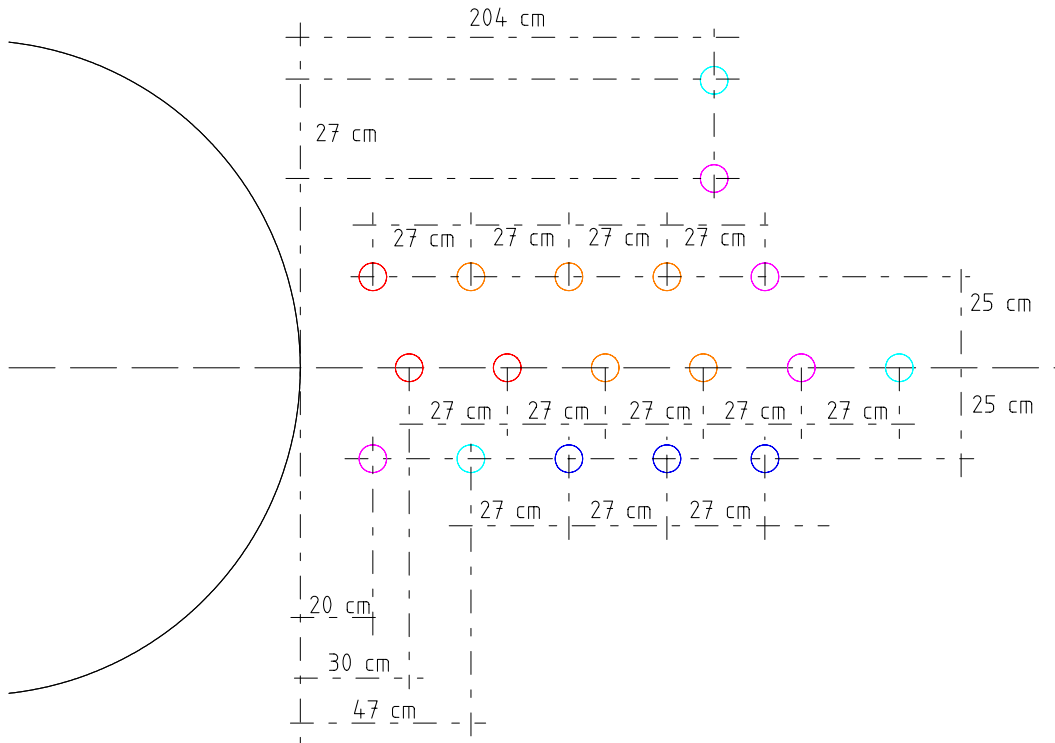
**Figure 3-6.** Proposed hole locations and distances for core disking study (holes colored by priority).

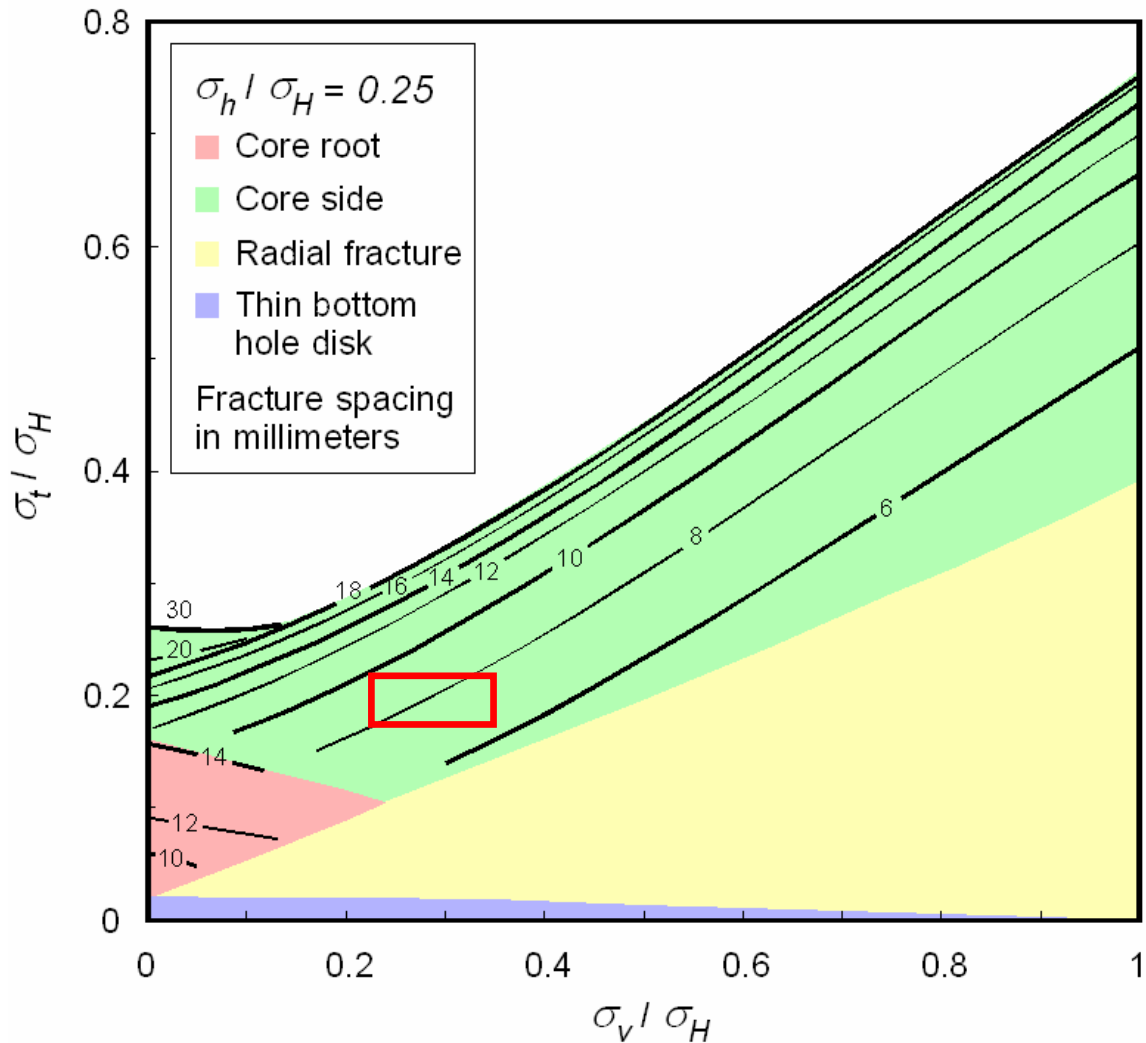
**Figure 3-8.** Estimation of core disk (solid core) potential based on calculated stresses along borehole A1 (cf. Figure 3-5 and Figure 3-7). The red box shows the range of anticipated disk thickness in this borehole, based on assumed values on in situ stress and tensile strength.

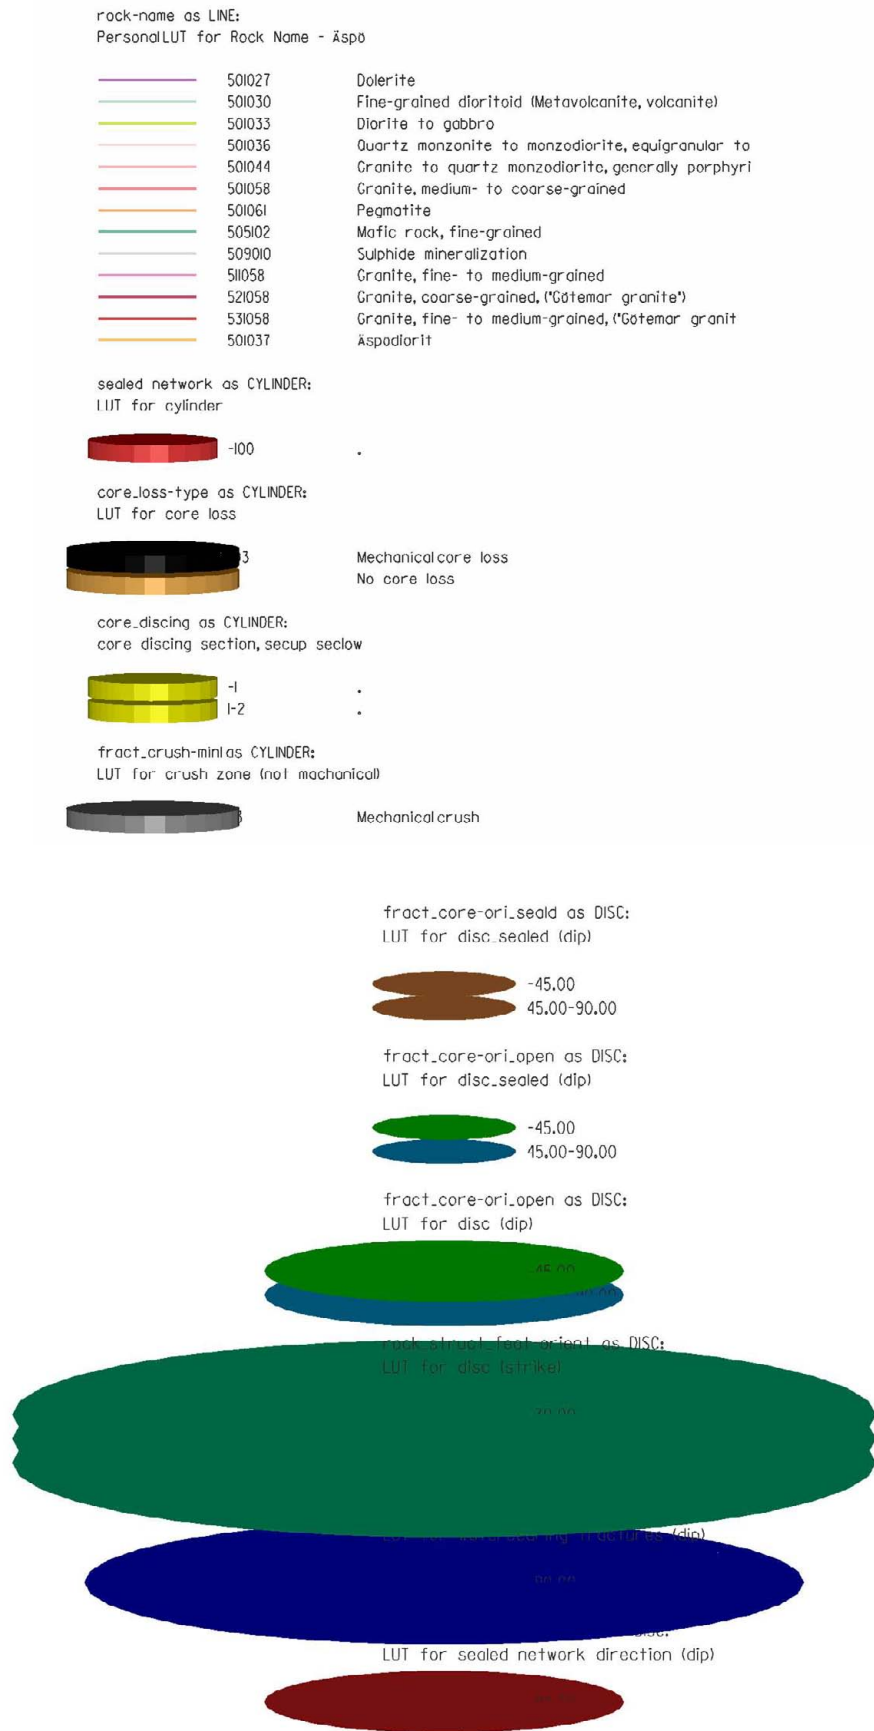
Figure 3-13. Legend for visualized parameters in the boreholes.

The visualization of fractures in cored boreholes has been done by representing them by slightly exaggerated, planar spherical discs, centered at the position of each mapped fracture. Fractures interpreted (in the Boremap system) to have an aperture were color coded so that fractures dipping 0-45° are green and steeper fractures are light blue in color, see also Figure 3-13 for legend.

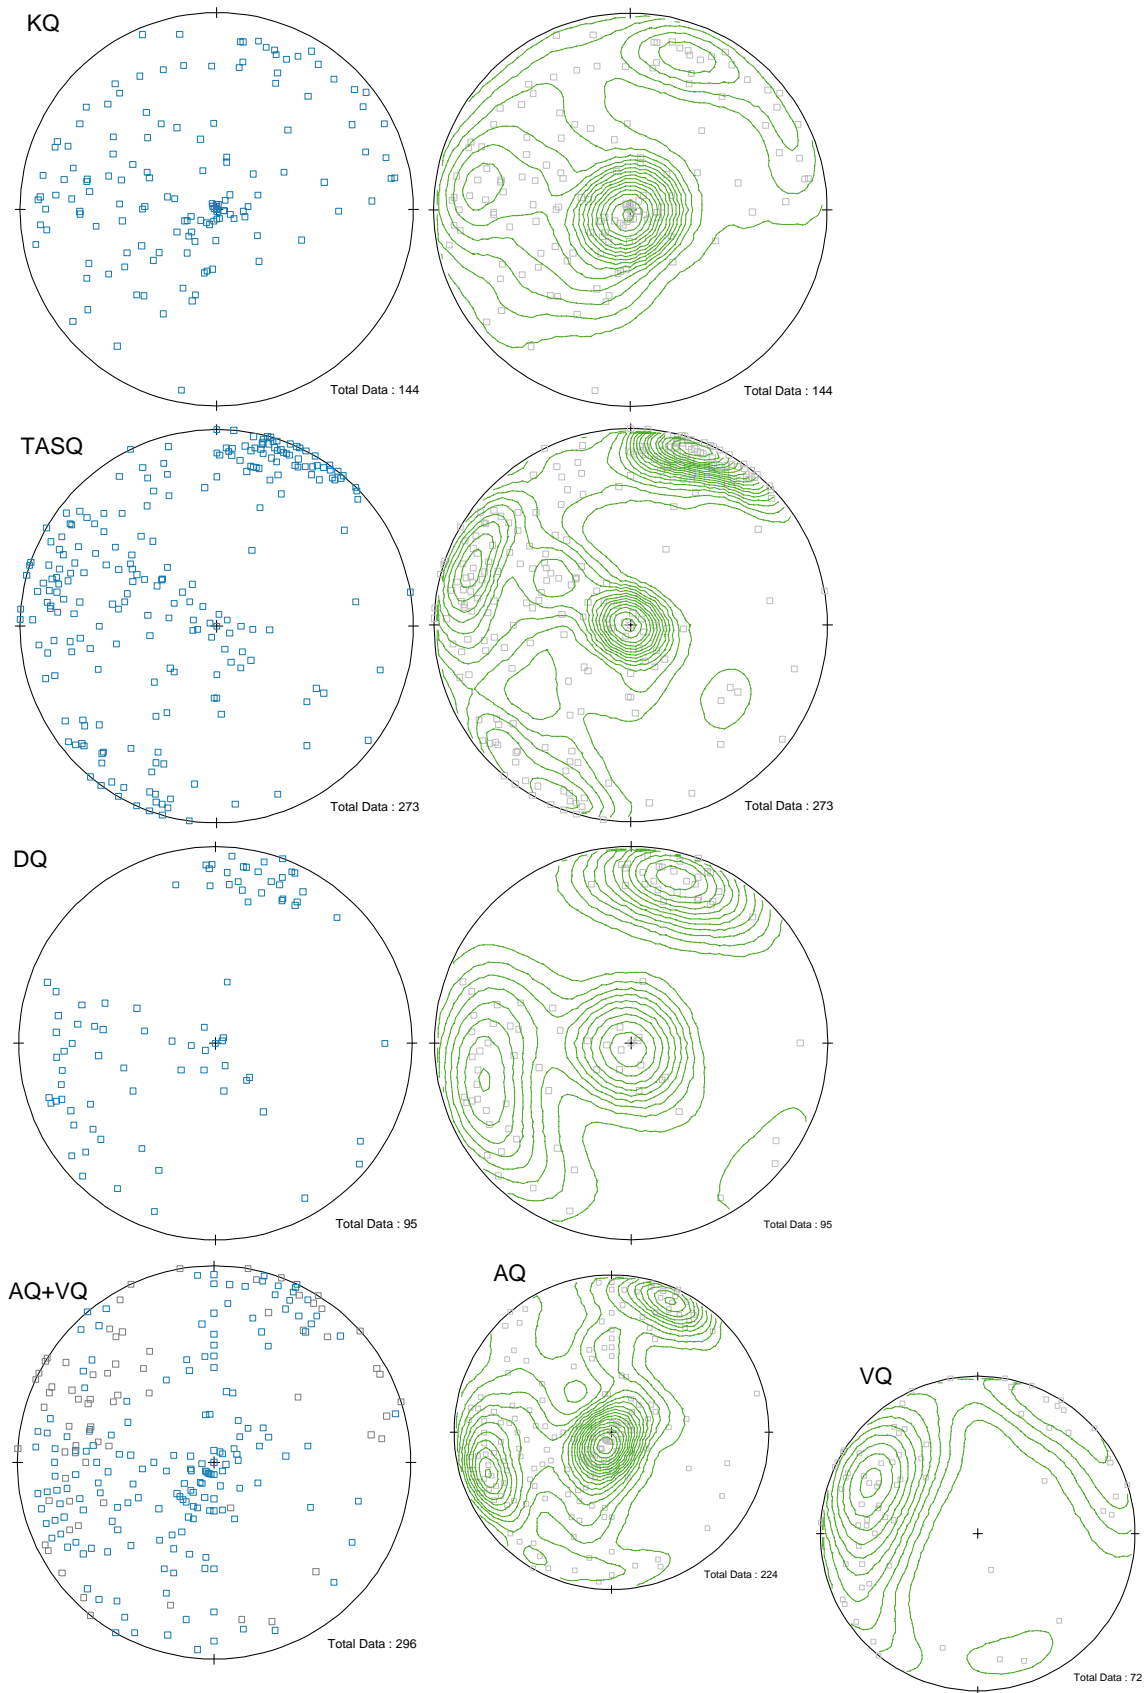
**Figure 4-1.** Stereographic projection (lower hemisphere, equal area) showing poles to fractures in the separate areas in the TASQ tunnel (Core diskings boreholes=KQ, Tunnel=TASQ, Deposition holes=DQ, Pillar wall=AQ and Pillar wall=VQ). To the right, Kamb contour plots of the same data.

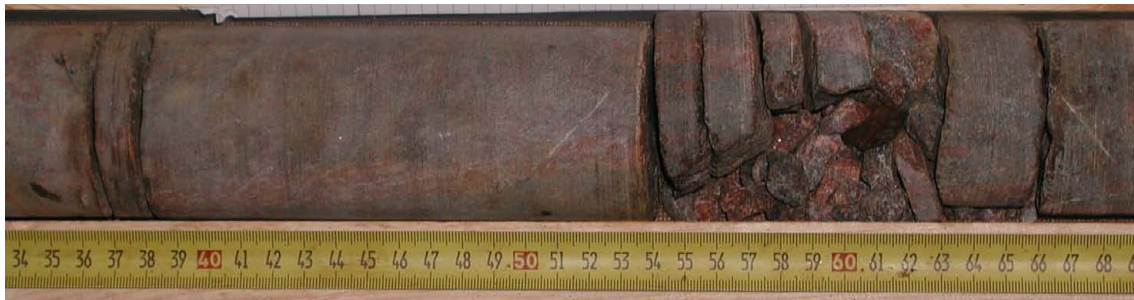
*Figure 4-2. Observed core diking in borehole KQ0062G06 at 0.56–0.64 m depth.*

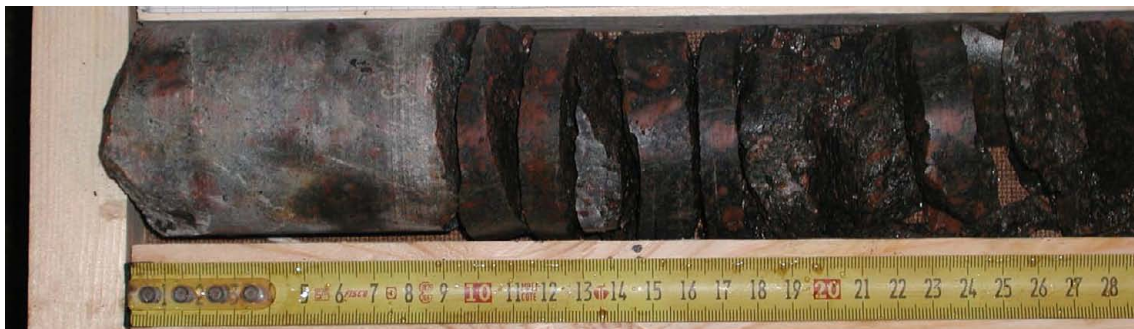
*Figure 4-3. Observed core diking in borehole KQ0062G06 at 2.51–2.67 m depth.*

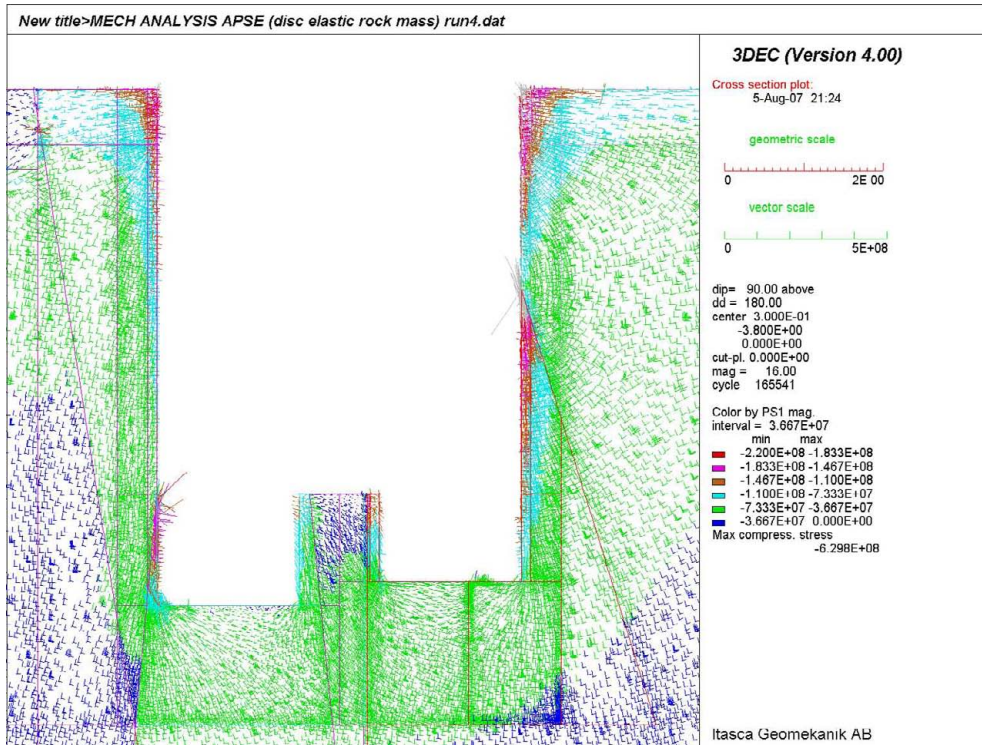
**Figure 6-7.** Vertical cross-section showing the projected principal stress along the axis of the tunnel after the central pillar has been removed for case Run4 (Colors by magnitude of  $\sigma_1$ ).

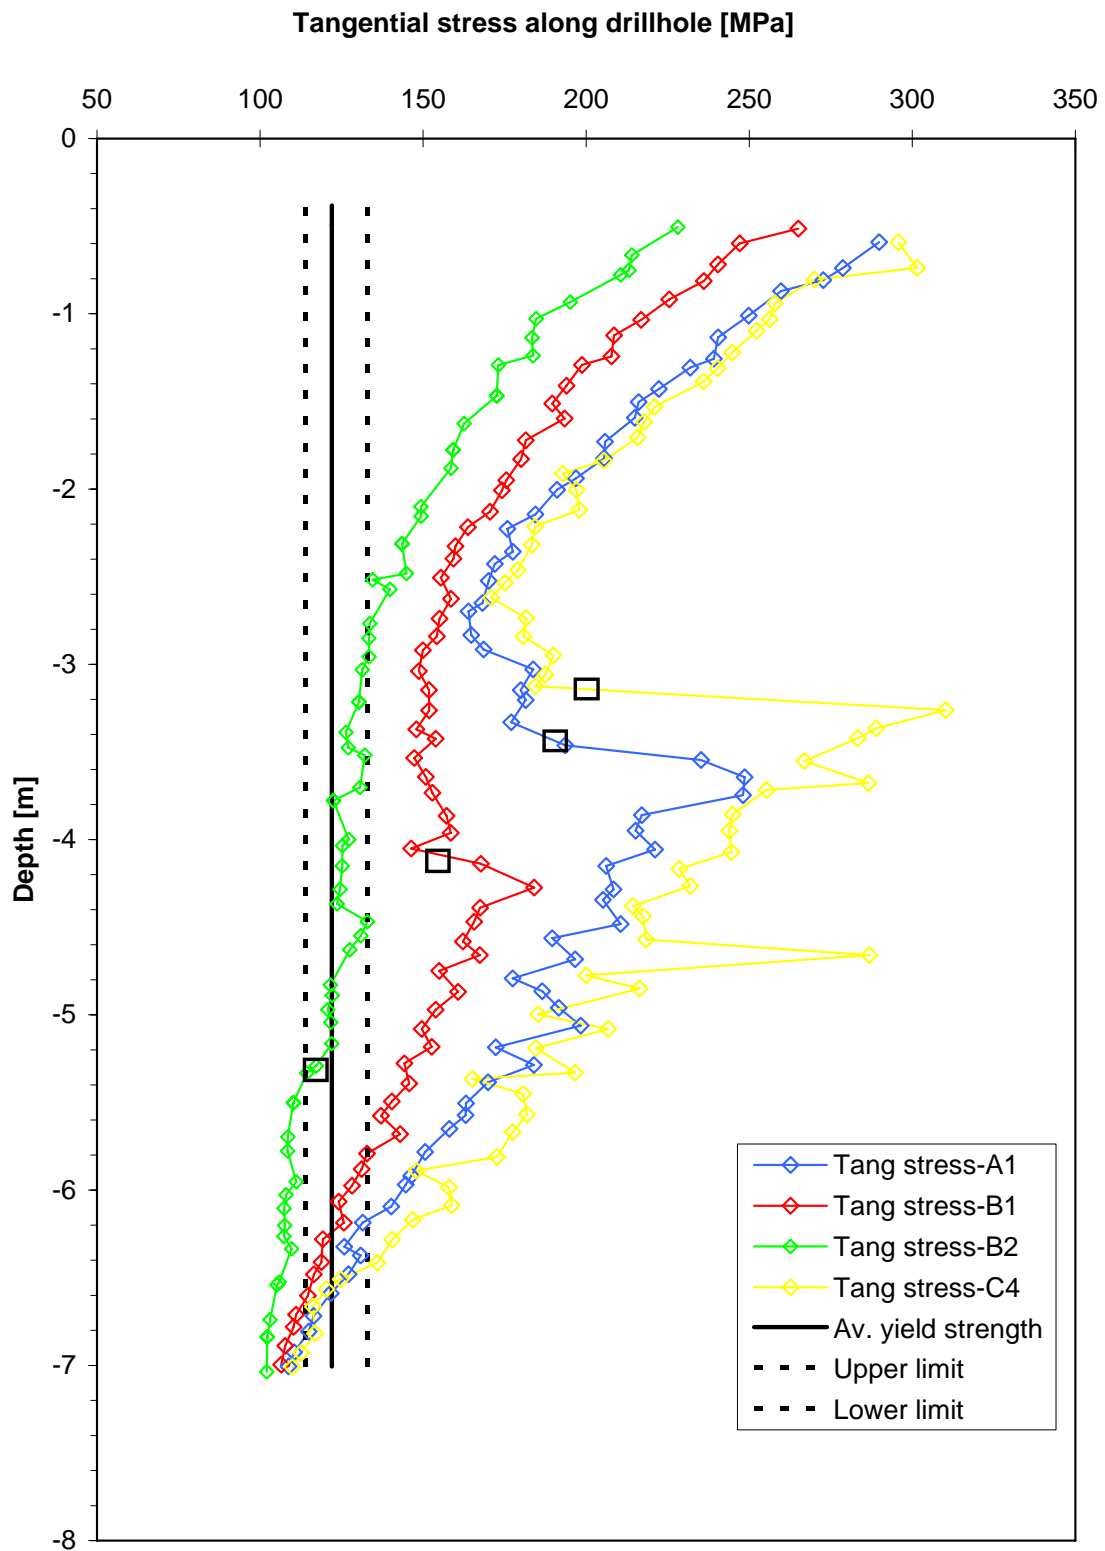
**Figure 6-19.** Tangential stresses in the location of boreholes KQ0062G05 (A1), KQ0062G04 (B1), KQ0061G10 (B2), and KQ0062G06 (C4), for simulation Run4 shown together with the mean yield strength from /Andersson 2007/. The black quadrangles represent the approximate intersection with the core discing fracture in Figure 3.2.

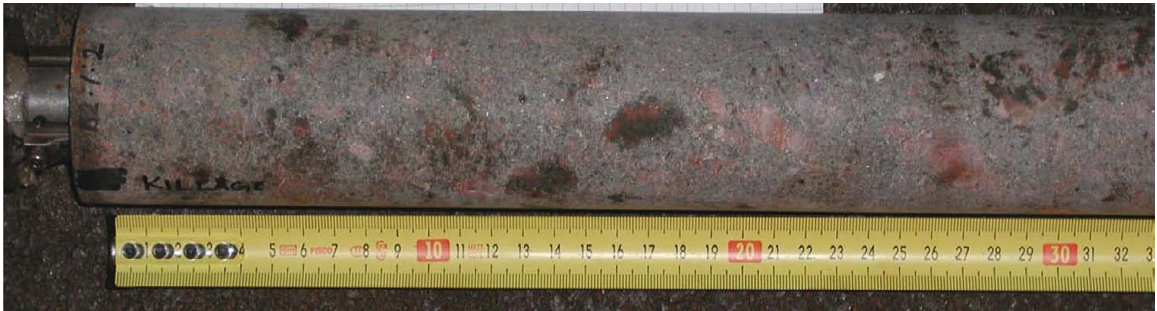
**KQ0061G10:2:1, 5.18 m — pilot core (30 cm shown)**

*Figure G1. Photos of pilot core and overcore sample for borehole KQ0061G10.*
