Rock mechanical conditions at the Äspö HRL

A study of the correlation between geology, tunnel maintenance and tunnel shape

Christer Andersson
Svensk Kärnbränslehantering AB

December 2001

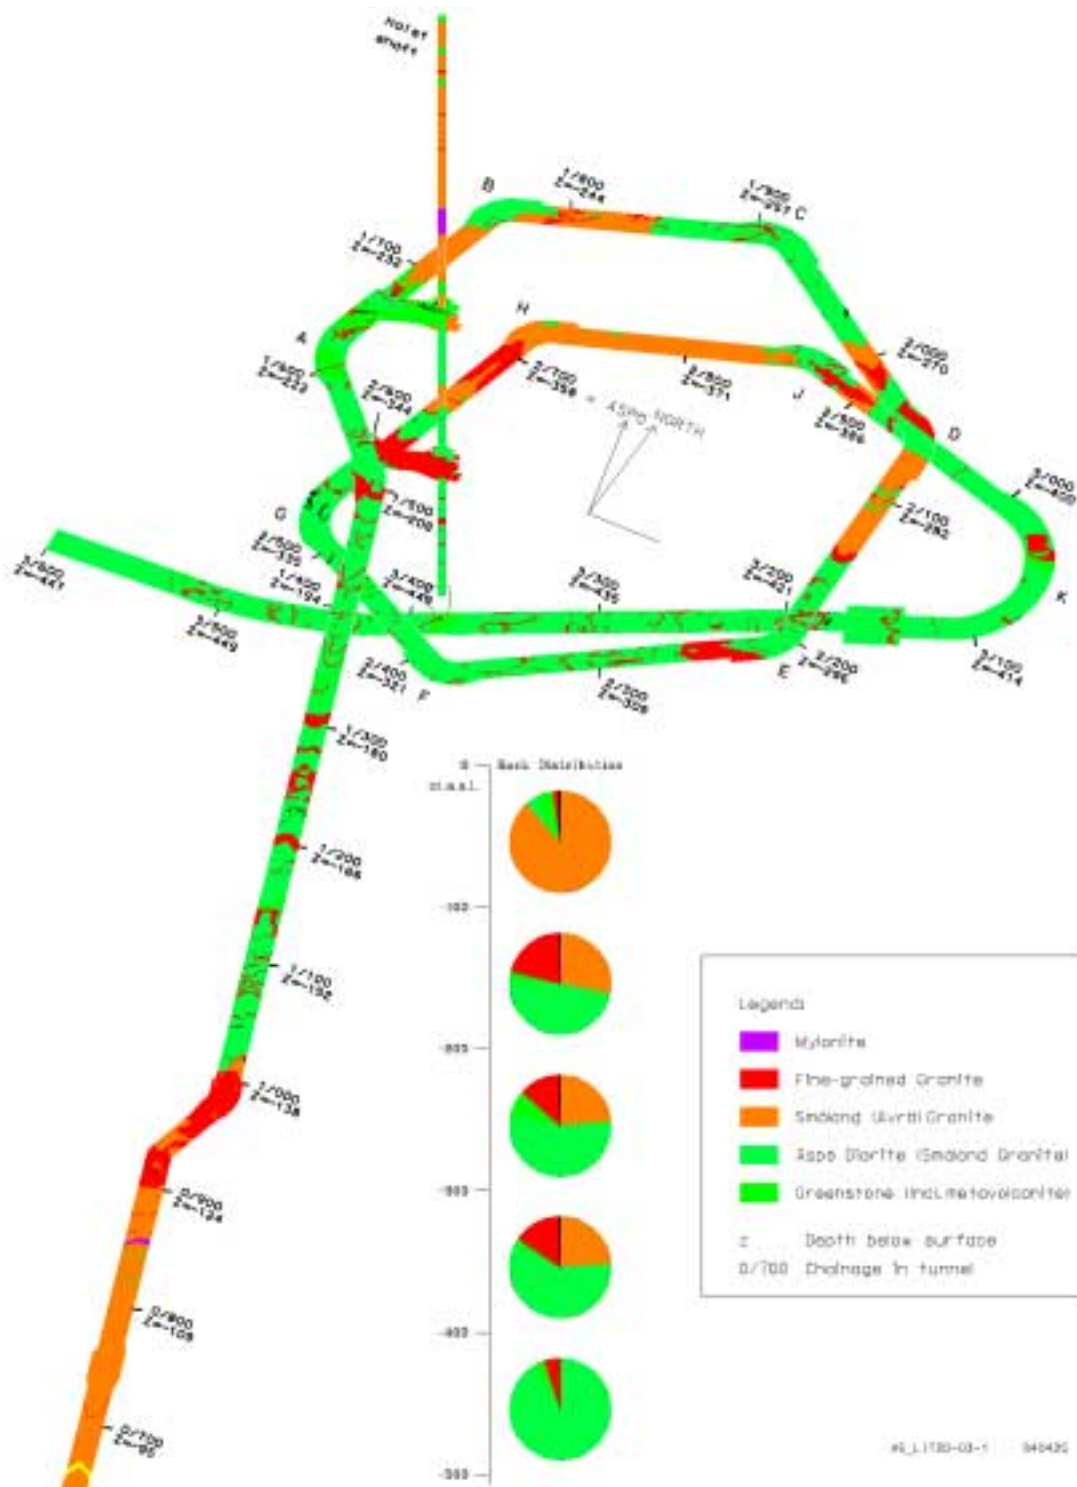
Figure 2-2. Compilation of the approximate rock distribution at different levels of the tunnel.

The numerically modelled parts of the tunnel system have a Äspö diorite content of approximately 95% of the volume. Hence, when modelling different tunnel areas the property of the Äspö diorite is used.

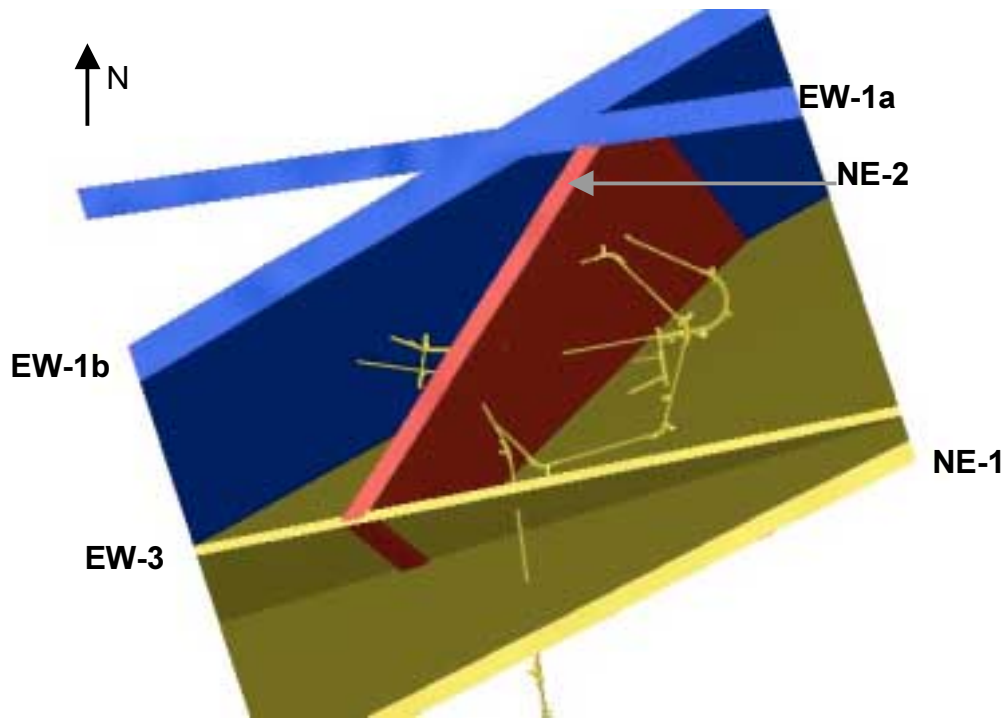
Figure 2-3. Top view of the larger deformation zones adjacent to Äspö HRL.

These deformation zones make Äspö HRL located in a wedge with borders defined by EW-1b and NE-1. The HRL is further divided into one eastern part and one western part by NE-2. A top view of these zones is presented in Figure 2-3.

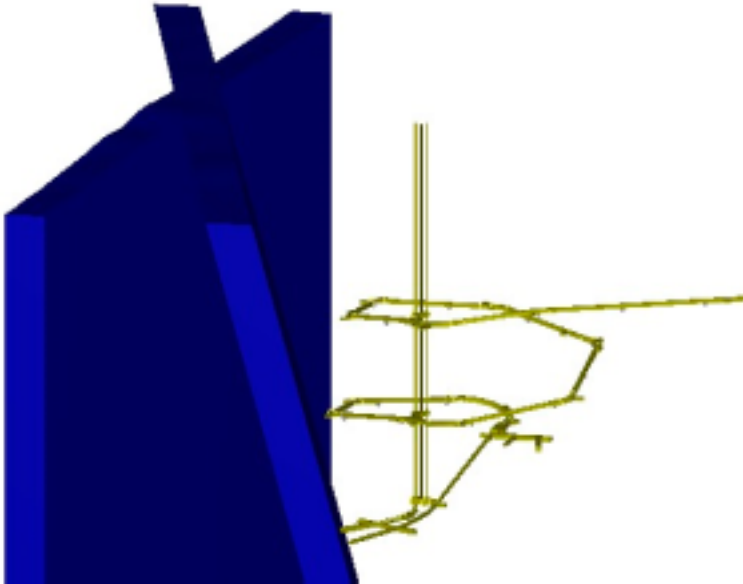
Figure 2-5. Location of the deformation zones EW-1a and EW-1b in relation to the tunnels, iso view.

The thickness of the deformation zones EW-1a and EW-1b are approximately 50 m each and they were formed by early ductile/semi ductile deformation. Later brittle reactivation has also taken place. The strike/dip is 082/90 and 060/75 degrees respectively. The deformation zones, in relation to the tunnels, are shown in Figure 2-5.

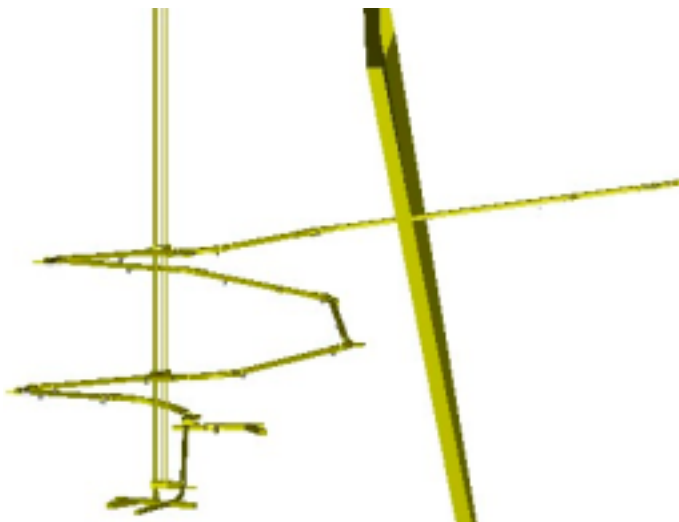
Figure 2-6. Location of deformation zone EW-3 in relation to the tunnels, iso view.

EW-3 has a 2–3 m wide crushed central section surrounded by 5–10 m of highly fractured Äspö diorite. The strike/dip is 079/79 degrees. The deformation zone is truncated against NE-1. EW-3's relation to the tunnels is shown in Figure 2-6.

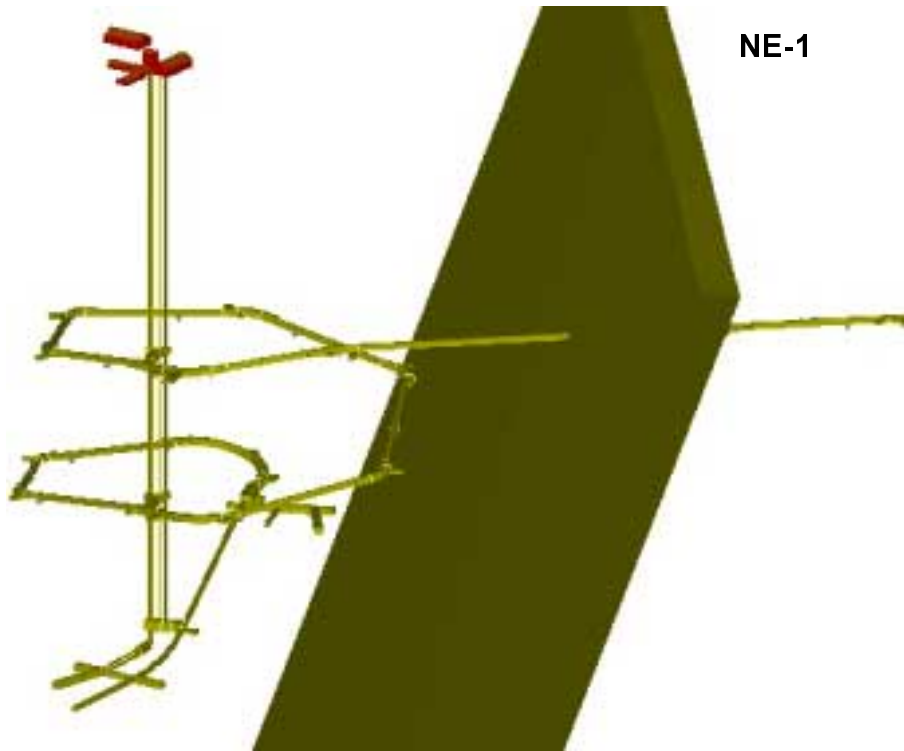
Figure 2-7. Location of deformation zone NE-1 in relation to the tunnels, iso view.

NE-1 is approximately 60 m wide, consisting of three branches. The northern branch is the most intense of the three branches and has an 8 m wide central part with centimetre wide open fractures and cavities. Another 10–15 m wide sections with more fractured rock on both sides surrounds the northern branch. The strike/dip is 243/70 degrees. NE-1's relation to the tunnels is shown in Figure 2-7.

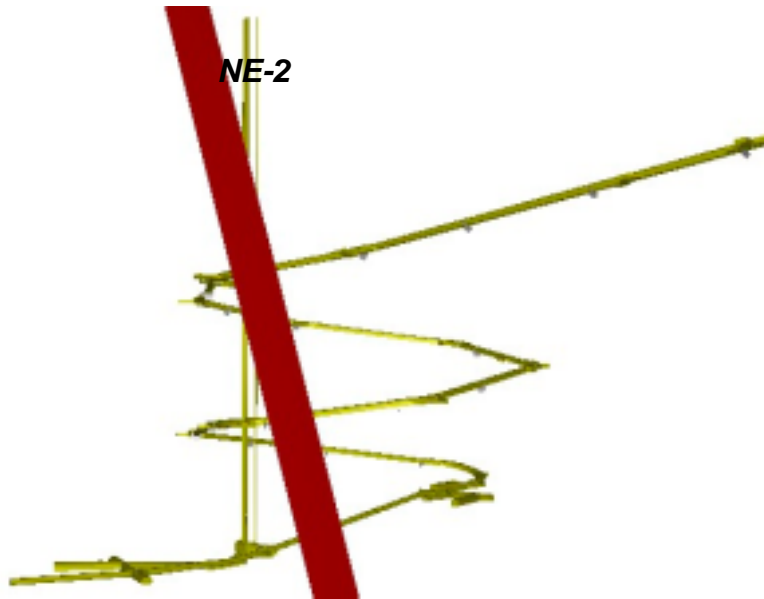
Figure 2-8. Location of deformation zone NE-2 in relation to the tunnels, iso view.

The Äspö HRL is located in a wedge with borders defined by EW-1b and NE-1. The HRL is further divided into one eastern part and one western part by NE-2.

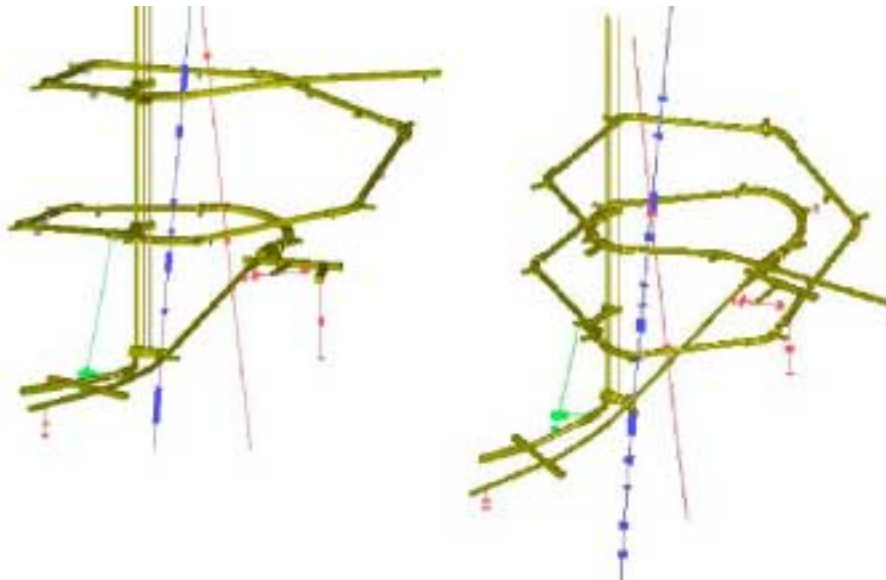
Figure 2-9. Location of performed stress measurements indicated by thick markers. Red markers – overcoring, Blue markers – hydraulic fracturing, Green markers – both hydraulic fracturing and overcoring.

Extensive rock stress measurement programs have been carried out at Äspö HRL. Locations of the stress measurements which results are presented in this section are shown in Figure 2-9.

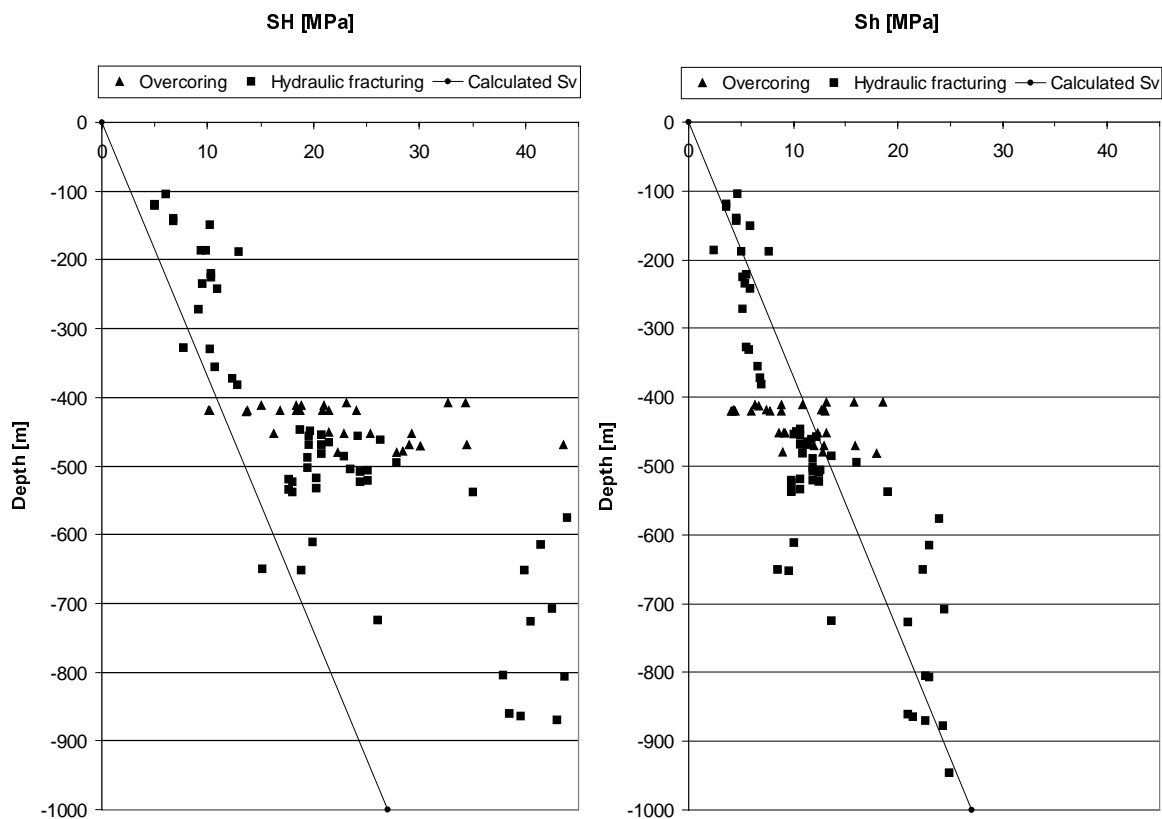
Figure 2-10. Major and minor measured horizontal stresses at Äspö HRL at different depths.

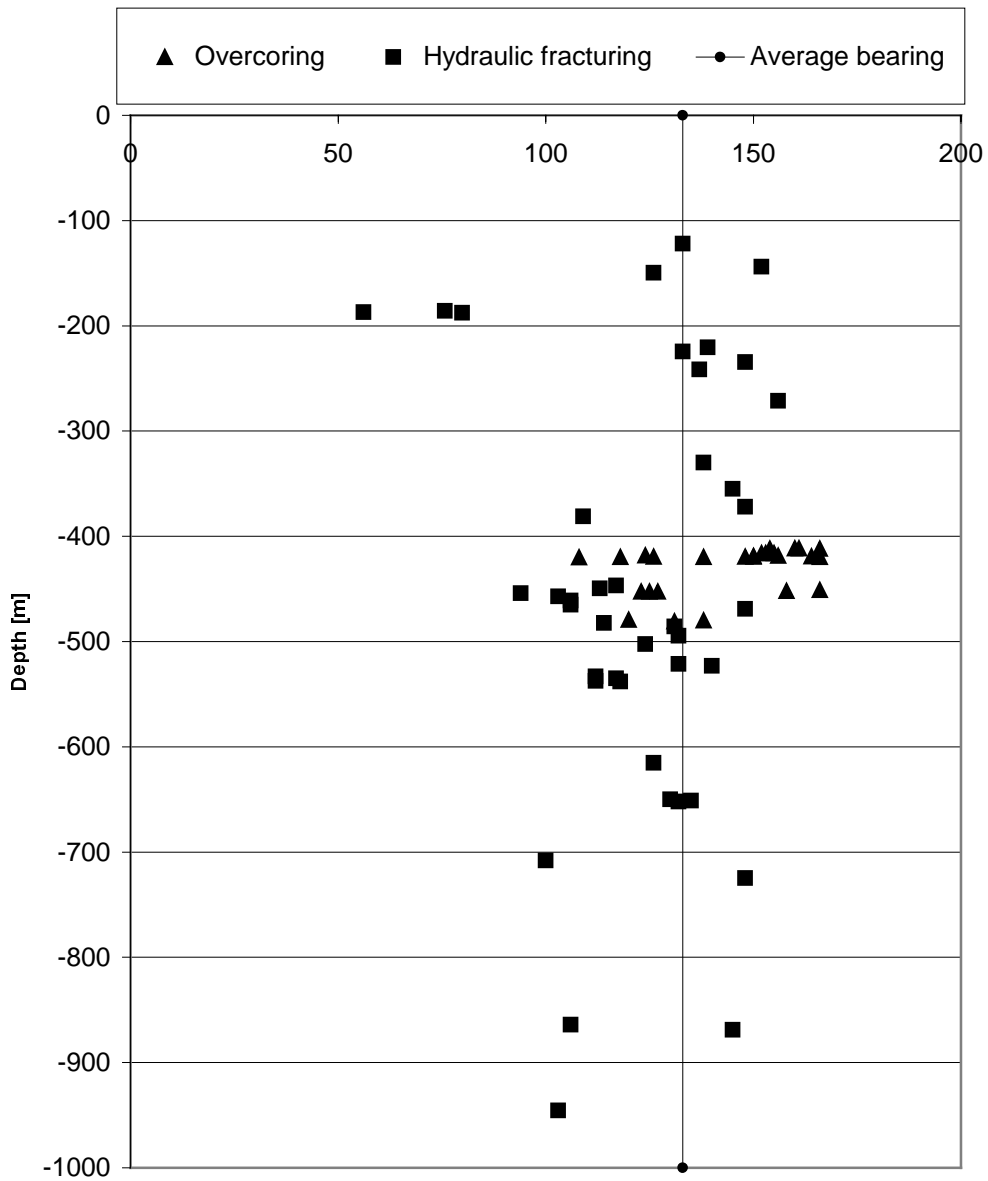
Figure 2-11. Bearing of measured maximum horizontal stresses at Äspö HRL at different depths including the average bearing used for the numerical modelling (vertical line).

The measured bearings for the horizontal stresses are presented in Figures 2-11 and 2-12. The results originate from both the overcoring and hydraulic fracturing techniques. The average bearing used for the numerical modelling is included as a vertical line in Figure 2-11.

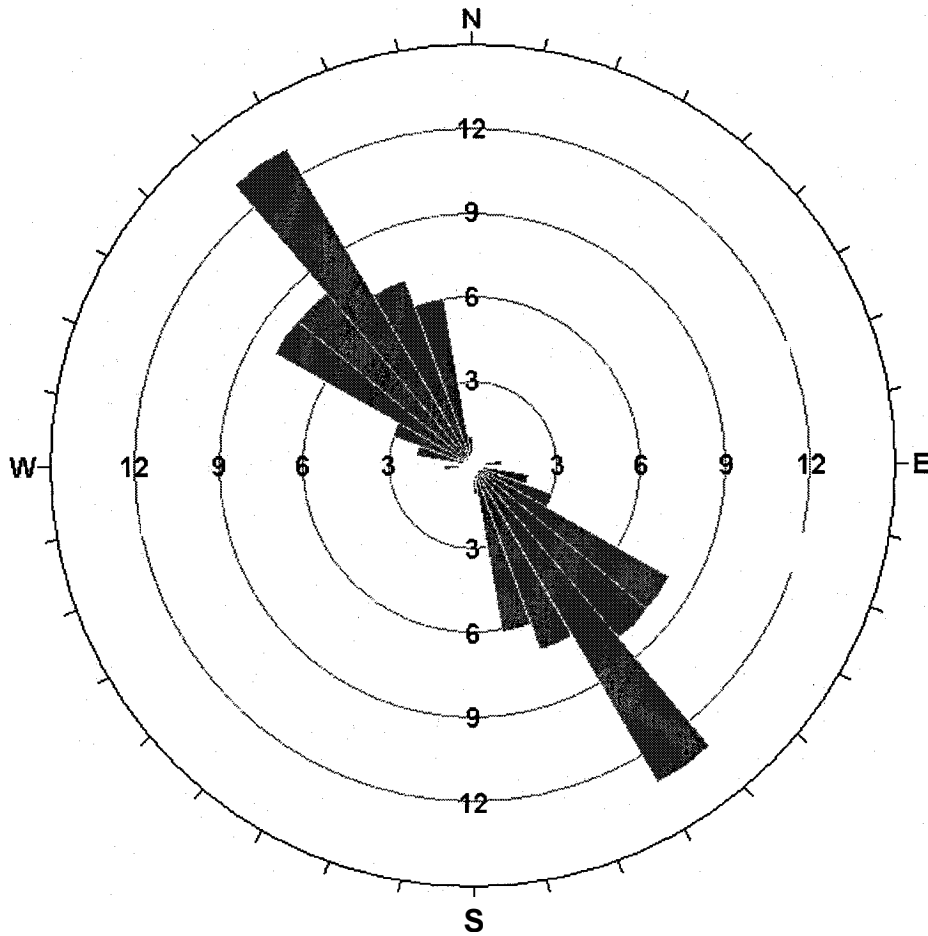
Figure 2-12. Rose diagram of maximum principal stress orientation. Data from hydrofracture tests in borehole KAS02 and mean values from all overcoring tests /Makurat et al., 2002/.

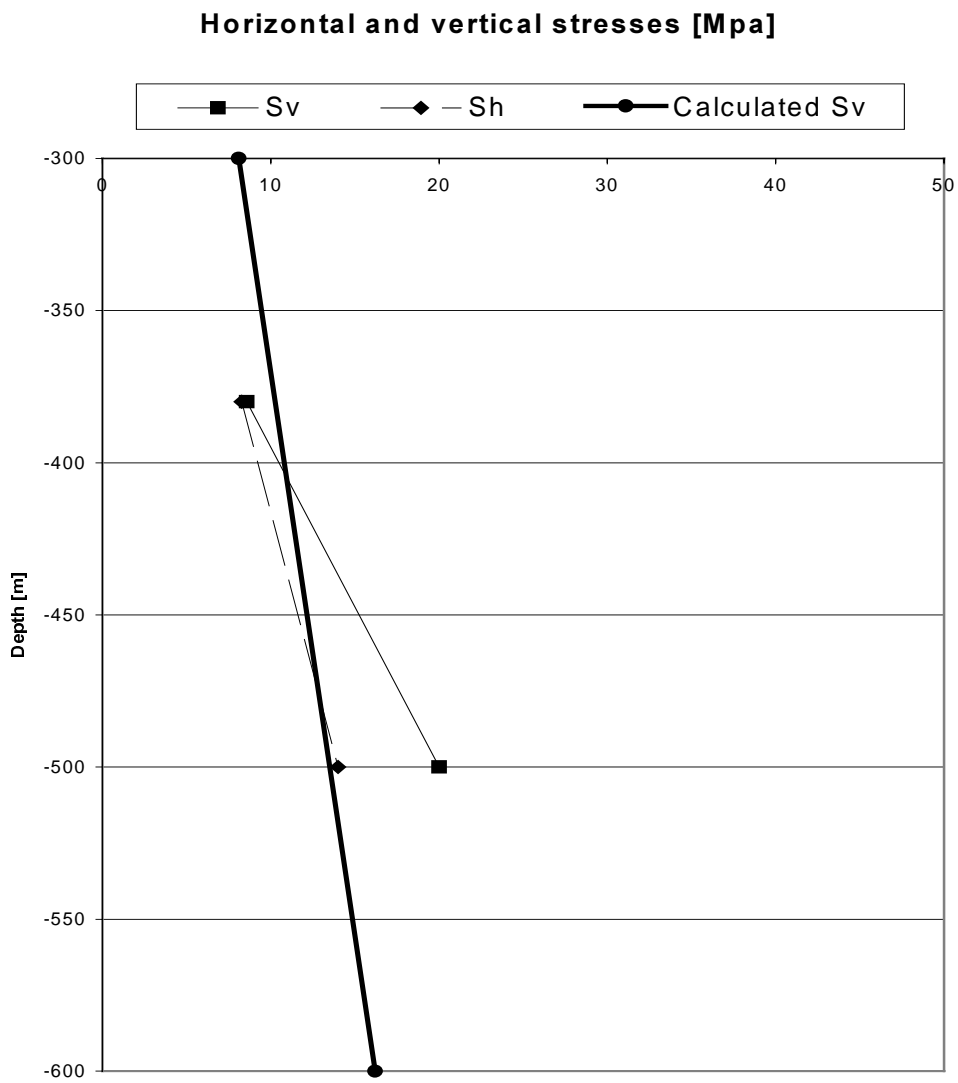
Figure 2-13. Regression lines for the measured minor horizontal and vertical stresses in relation to the theoretical vertical stress. Makurat /2002/.

Earlier rock stress measurements indicate that the minor principal stress component's bearing changes from vertical to a dip more horizontal than the intermediate principal stress. Hence, the vertical stress becomes higher than the minor horizontal stress. Figure 2-13 is based on Makurat et al. /2002/ and shows regression lines for the average measured minor horizontal and vertical stresses in relation to the theoretical vertical stress using the density 2.7 g/cm^3 . Results from both overcoring and hydraulic fracturing have been used. Recent rock stress measurements by hydrofracturing performed in October 2001 gives the same indication, Rummel et al. /2002/. These observations are also supported by the fact that the most conductive fractures in the HRL are parallel to the major principal stress. If the intermediate stress component is steeper dipping than the minor stress component the fractures parallel to the major principal stress will be opened instead of closed by the rock stresses. A rose diagram showing the direction of the water bearing fractures in TASF is presented in Figure 2-14. The average dip for the presented fractures is 80 degrees from horizontal.

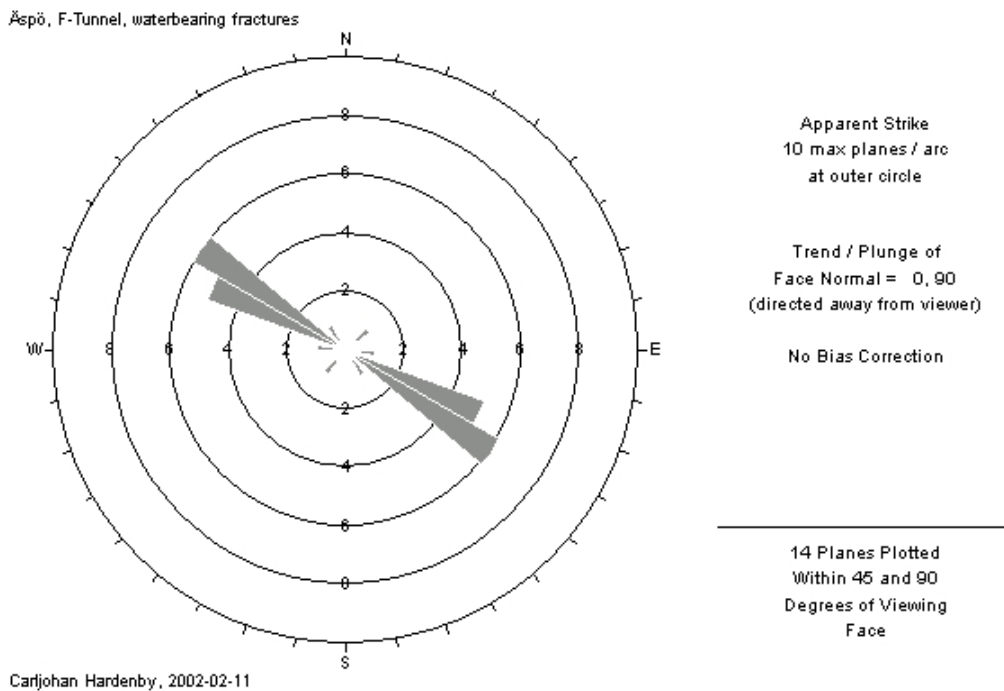
Figure 2-14. Rose diagram showing the direction of the waterbearing fractures. The fractures have an average dip of 80 degrees from horizontal. Note that the strike is related to magnetic north.

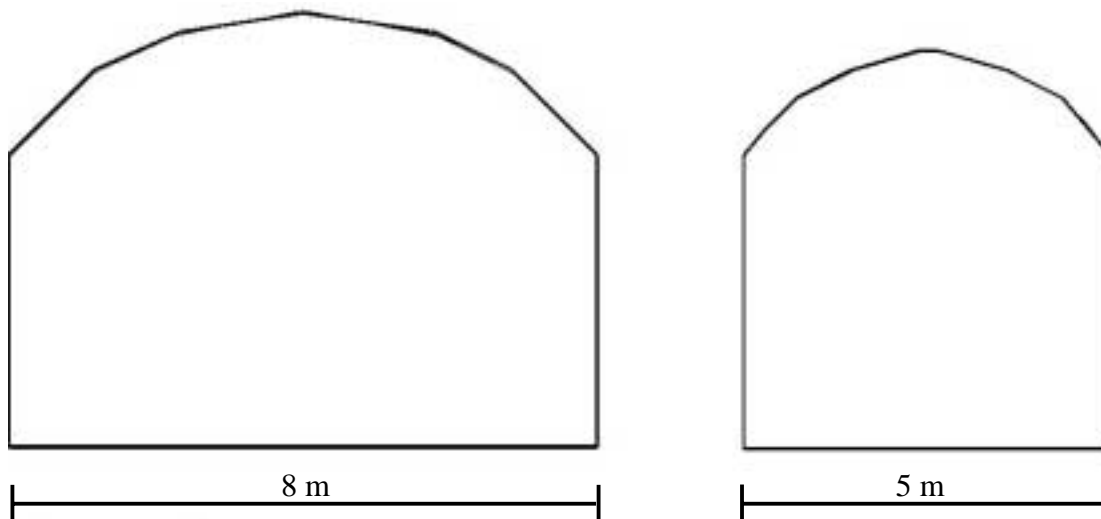
Figure 2-15. Drawing of the 42 m² tunnel profile to the left and the 25 m² tunnel profile to the right.

The tunnel should be able to host vehicles with a height and width profile of 3.5 respective 3.0 m. The section chosen was a 25 m² 5 m wide cross sectional area down to 340 m. It was there narrowed down to a width of 4.8 m since there are less rack for installations in that part of the tunnel. In curves and passing places the tunnel has been widened to 8 m which gives a cross sectional area of 42 m². Figure 2-15 illustrate the tunnel profiles in the curves and the straight part of the ramp.

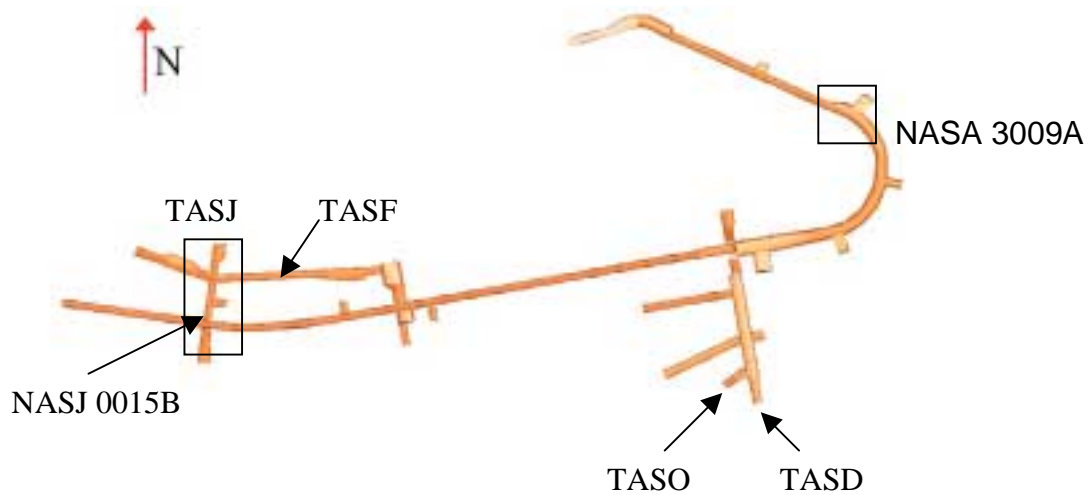
Figure 3-1. Areas in the tunnels needing additional maintenance according to interview.

The location of these areas in the tunnels is illustrated in Figure 3-1.

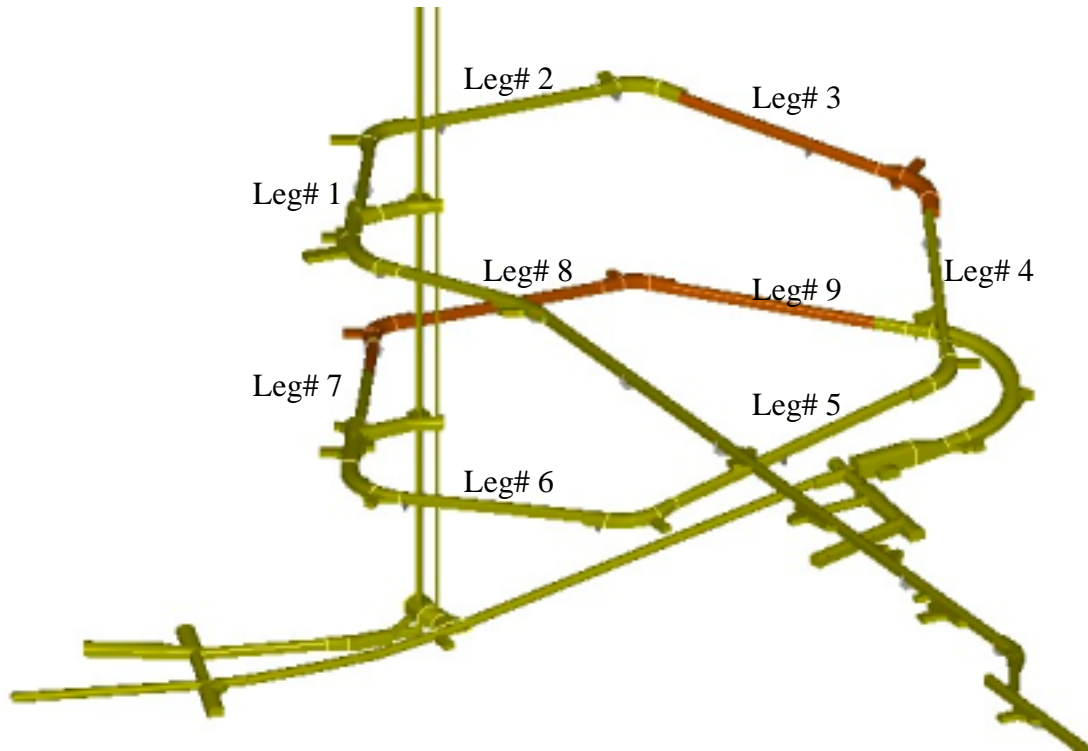
Figure 3-2. The nine different tunnel legs and the parts of the tunnel classified as fair rock (RMR 40–60) coloured red. The rest of the tunnel within the legs is classified as good rock (RMR 60–80).

The chainage for the legs are presented in Table 3-1. The chainage starts at the tunnel entrance.

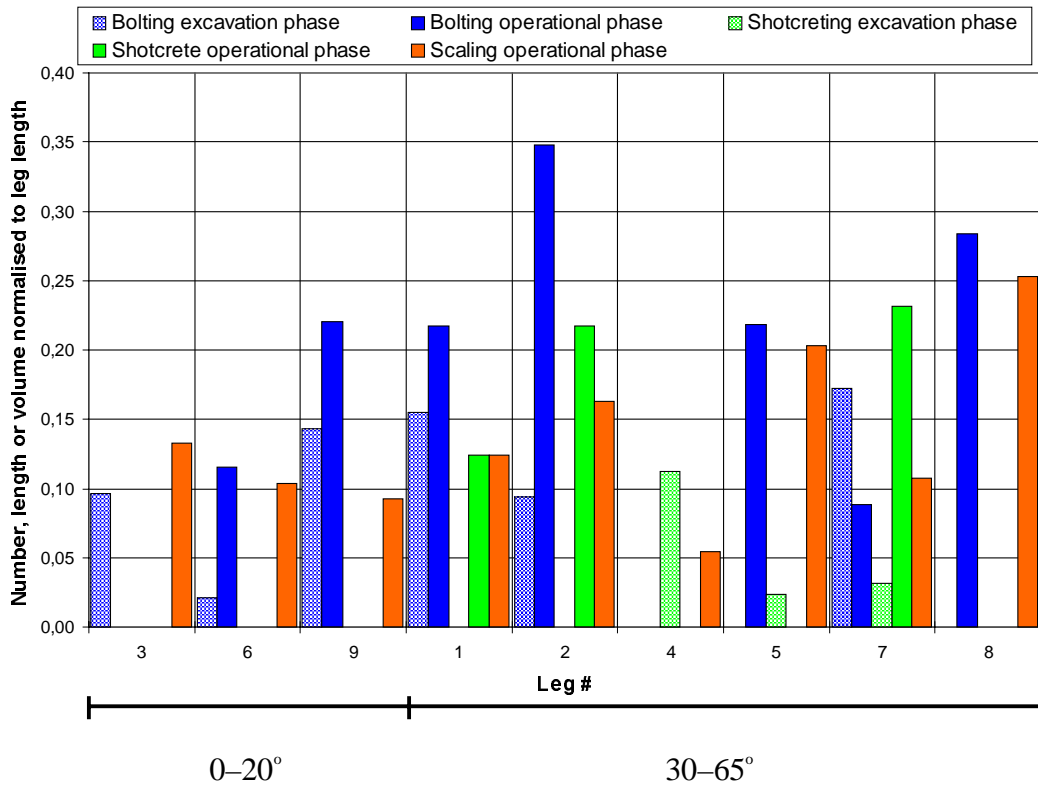
Figure 3-3. Compilation of records for scaling, bolting and shotcreting for the different tunnel legs and their relation to the major principal stress.

All of the bolting in leg# 1 has been done in the last part of the widened curve from 1620–1680 m down the ramp. The geology there is a mixture of Äspö diorite, Greenstone, Fine-grained granite and some Pegmatite. No increased fracturing is mapped. The shotcreting have been done in the same area. The major part of the scaling has been done from 1650–1680 m down the ramp.

The bolting and shotcreting in leg# 2 have been done in the widened curve from 1750–1780 m down the tunnel. The geology consists of rather homogeneous Äspö diorite with a thin mylonite zone following the tunnel in the roof. Approximately 65% of the scaling have been performed from 1820–1883m. Half of this length consists of Småland granite and the other half of Äspö diorite, both with veins of Fine-grained granite. The part with Småland granite includes some smaller fracture zones along the roof.

In leg#3 the bolting has been done partly in a contact between Småland granite and Fine-grained granite and partly in homogenous Äspö diorite. The bolting is located in a fracture zone. The scaling volumes are very evenly distributed along the leg.

In leg# 4 75% of the shotcreting have been done from 2120–2178m down the ramp. Half of this shotcreted length has covered homogenous Småland granite and the rest an area of Äspö diorite with veins of Fine-grained granite. The scaling volumes are very evenly distributed along the leg.

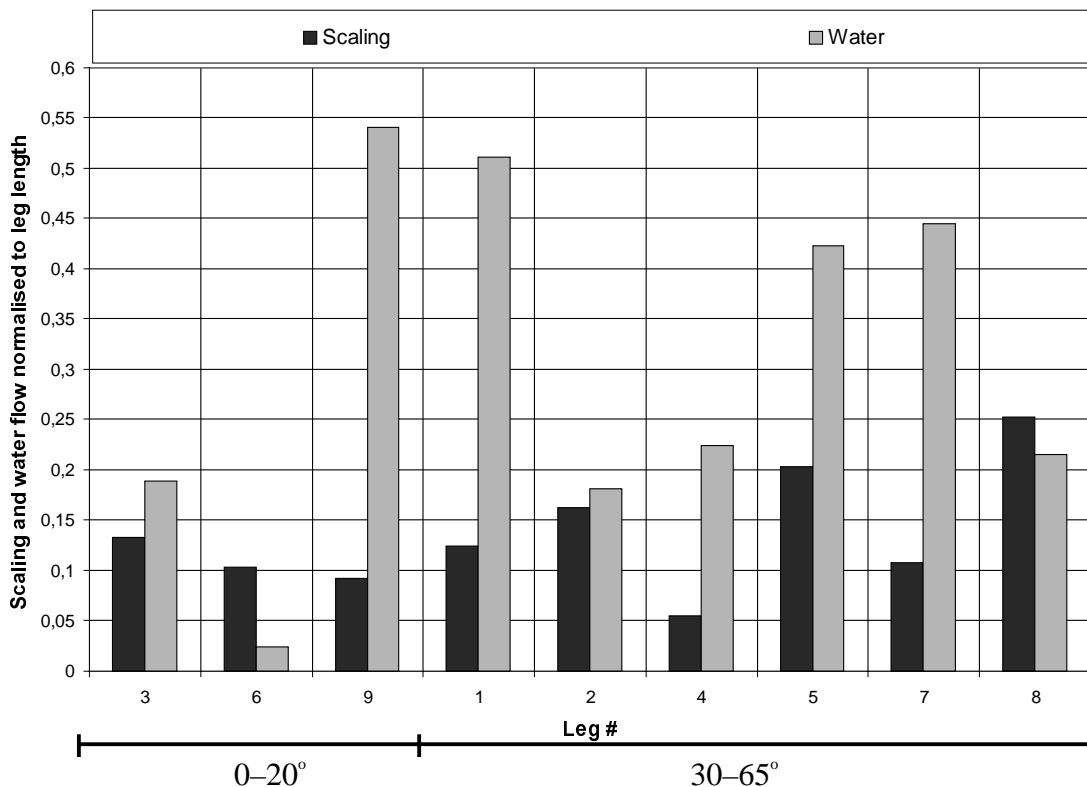
Figure 3-4. Compilation of records for scaling and water inflow for the different tunnel legs and their relation to the major principal stress.

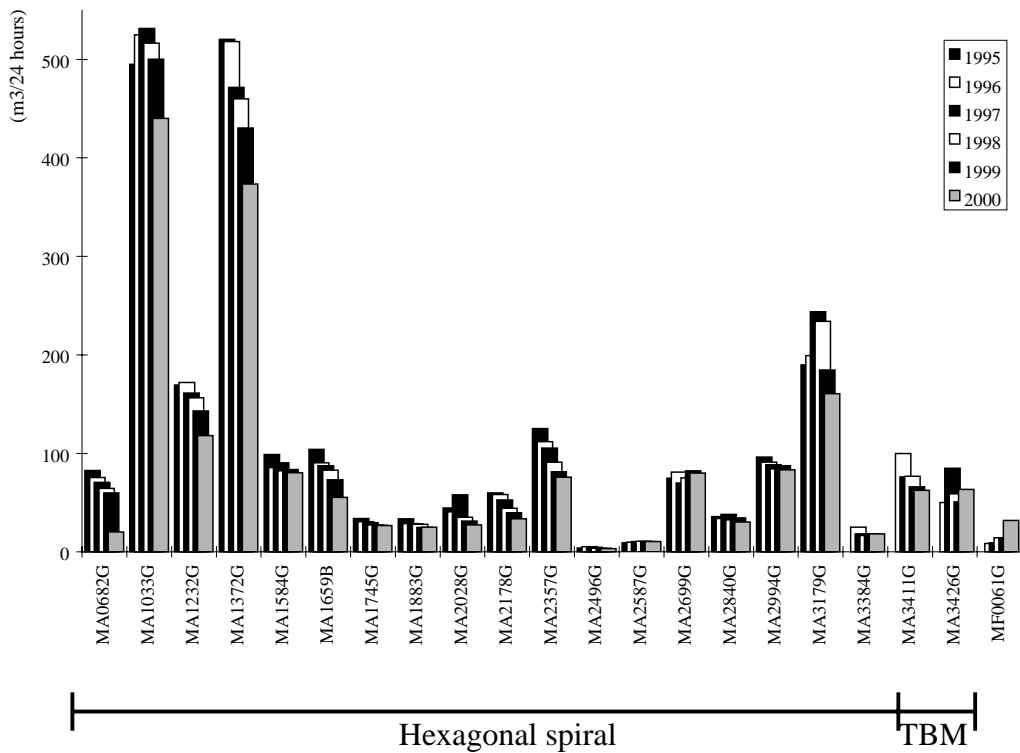
Figure 3-5. Average water flow through the weirs during five years. The measurements are made from October to December each year.

When studying the water inflow records for the operational phase there is a remarkable uniform decrease in almost all of the weirs. Figure 3-5 is a compilation of the average water flow from October to December through the weirs from 1995 to 2000. The legend “MA****” below the X-axis means Measurement in the main tunnel (TASA) and the numbers indicates the chainage. The weirs from MA0682G to MA3179G are located in the spiral. The rest of the boxes are located in the TBM-tunnel except for MF0061G that is located in the TASF-tunnel.

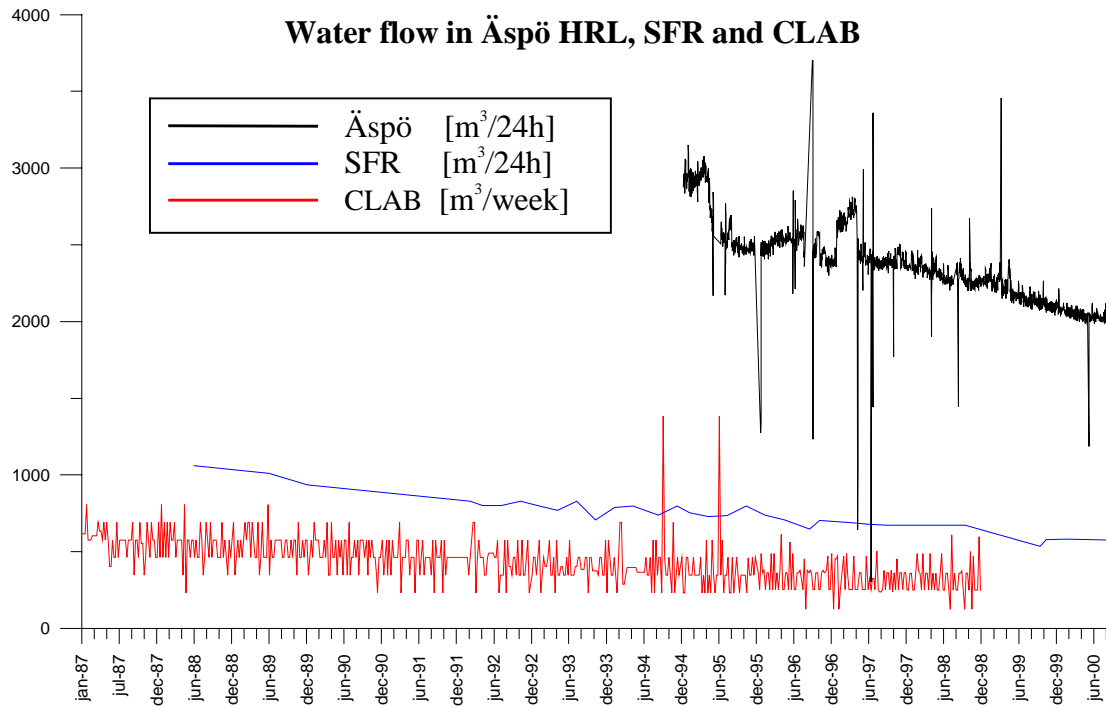
Figure 3-6. A comparison of the water flow rates and its decrease at Äspö HRL, SFR and CLAB.

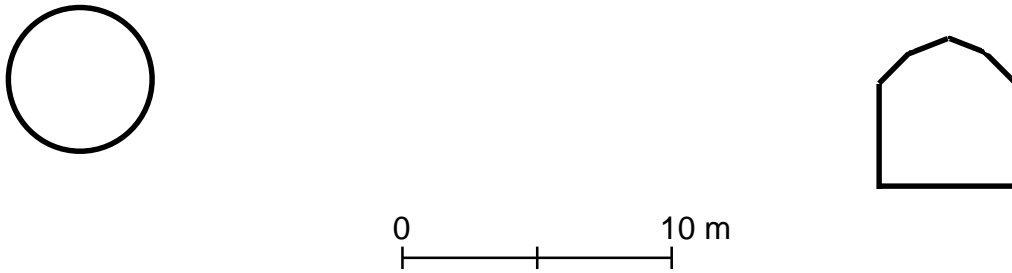
Figure 3-7. Section of TASF and the TBM-tunnels relative location.

Äspö HRL offers a unique possibility to compare the need for maintenance in TBM and drill and blast tunnels. At 450 m depth the bored part of the main tunnel lies parallel to a D&B tunnel (TASF) only 27m apart, see Figure 3-7. The geology is almost identical in the TBM tunnel and the first half of TASF. The TASF-tunnel though, has some fine-grained granite areas in the first half. The second half of TASF is excavated in Småland granite, which is more brittle than the Äspö diorite in its first half. The scaling record indicates a rather uniform scaling volume for the different parts of the tunnel. When normalising the TASF records using the same principle as with the tunnel legs the normalised scaling for TASF is 0.5 and the normalised bolting 0.25. During the winter

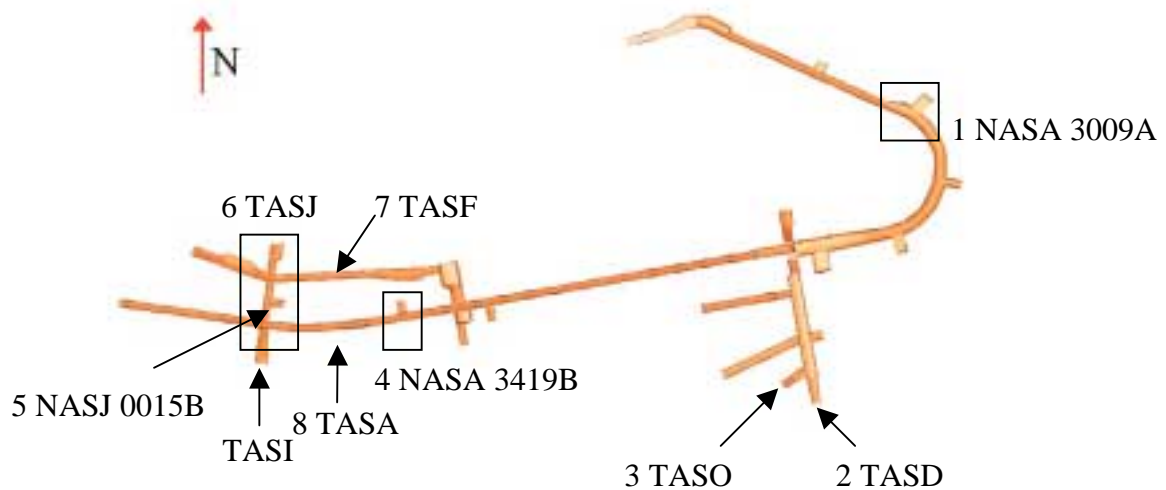
Figure 4-2. Final areas selected for numerical modelling.

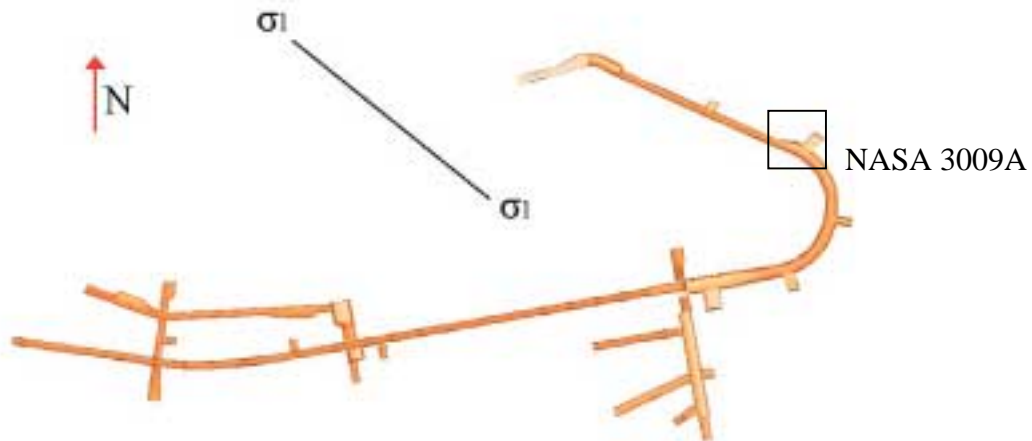
Figure 4-3. Location of NASA 3009A and a horizontal projection of the bearing of the major principal stress, σ_1 .

Figure 4-3 shows the location of the niche NASA 3009A in the tunnel system.

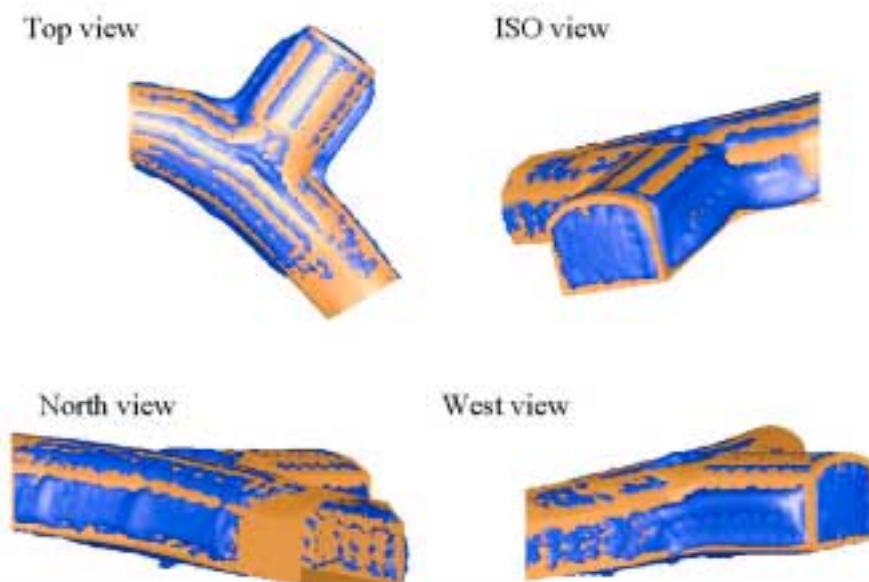
Figure 4-4. Isosurface of 0 MPa confinement at niche 3009A. North is up in the top view.

Scaling has been performed several times in the upper front and microseismic events were once heard during scaling. The roof and upper part of the front has been shot-creted. The isosurface for a σ_3 of 0 MPa confinement is presented in Figure 4-4.

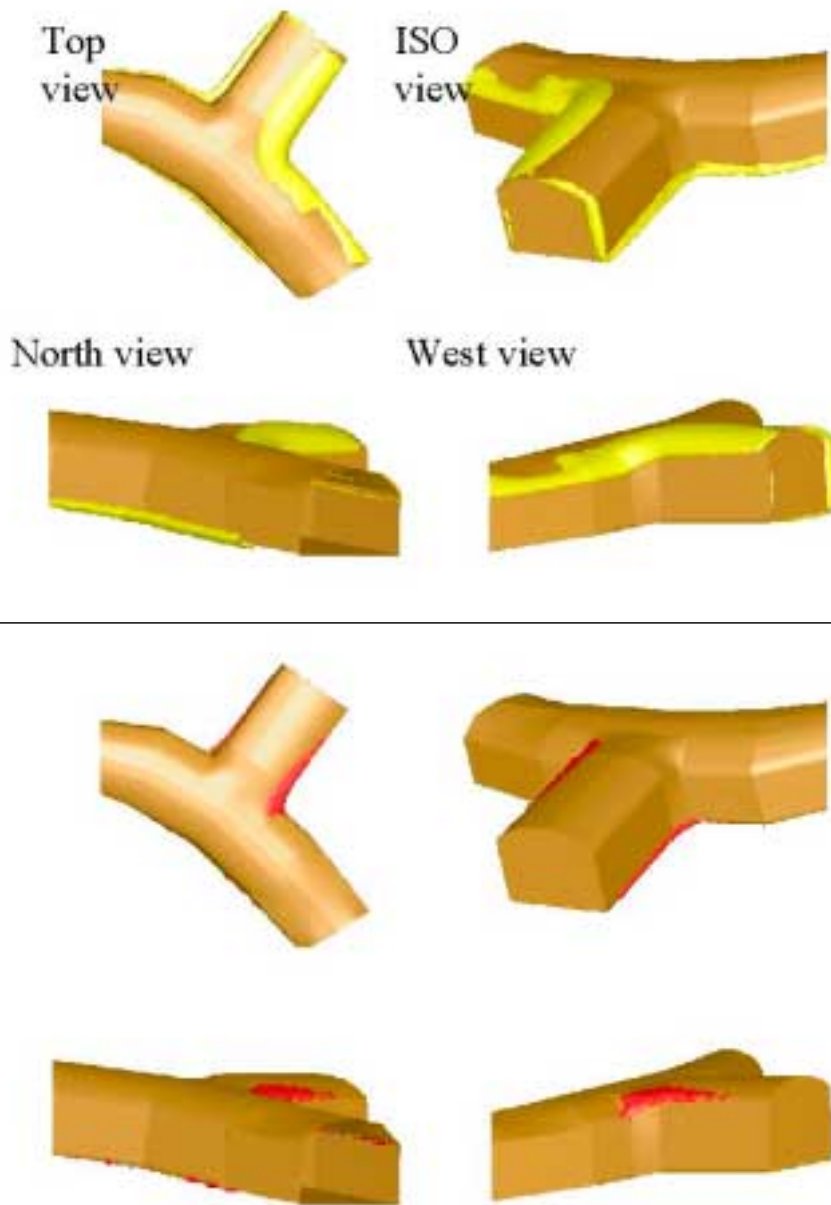
Figure 4-5. Isosurfaces for k -values of 50 MPa (yellow) and 70 MPa (red) at niche 3009A. North is up in the top view pictures.

The 50 MPa isosurface covers the west front edge of the niche and the East side of the roof. The 70 MPa surface is less pronounced which indicates that there are not that large deviatoric stresses around the niche. The low confinement in the front combined with the deviatoric stresses around the front's edge might cause the microseismic events heard. It is also probable that the scaling in the upper front depends on these factors.

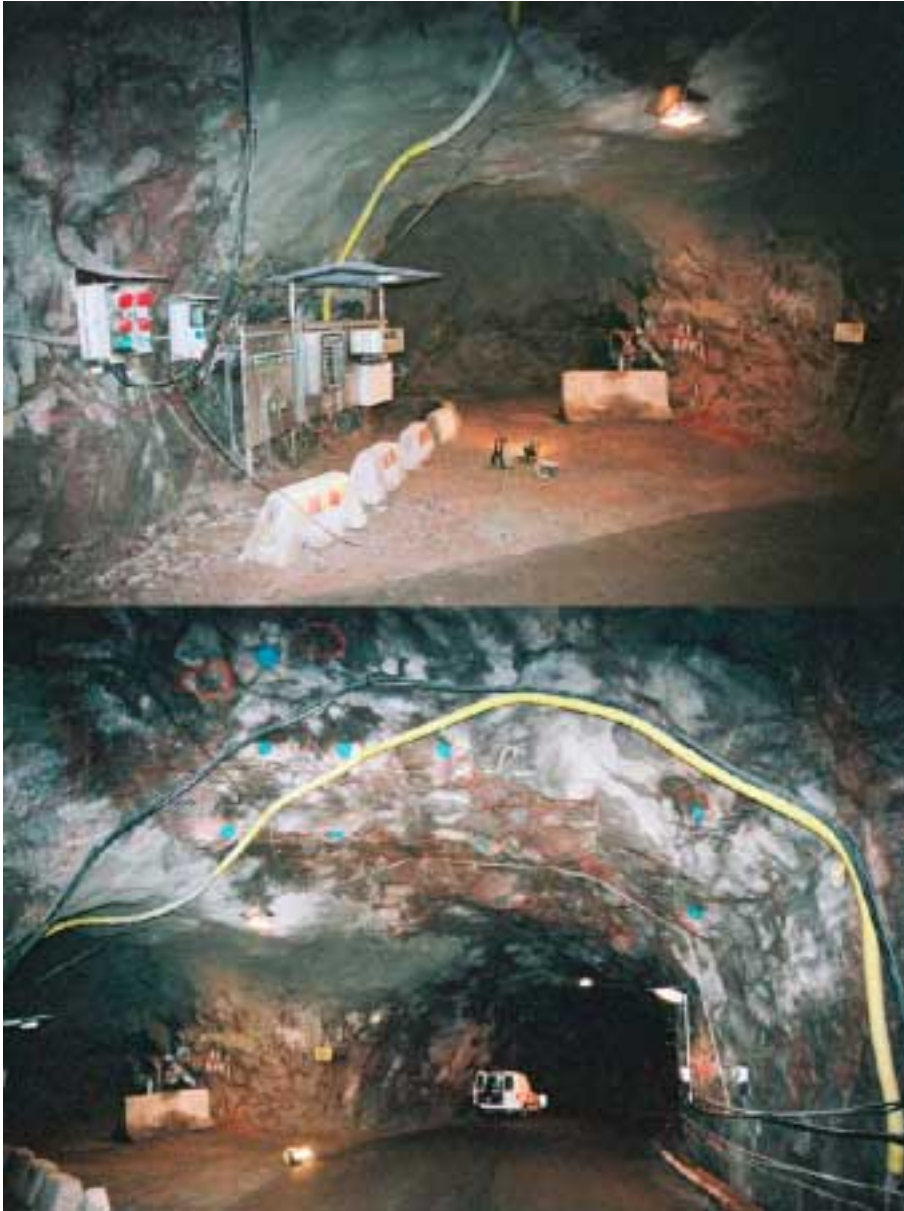
Figure 4-6. Top photograph shows the entrance to NASA 3009A indicating the dull corners. Bottom photograph is taken down the main tunnel with the niche to the left. The blue discs are washers to the rock bolts.

Figure 4-6 shows pictures taken into the niche and down the main tunnel with the niche to the left. The need for bolts and shotcrete in the roof is probably a result of low confinement and gives some validation to the numerical results. Notice that the actual contour illustrated in Figure 4-6 is not fully implemented in the simplified numerical model. The modelling results though does not clearly indicate the microseismic events heard and the rather large scaling volumes removed.

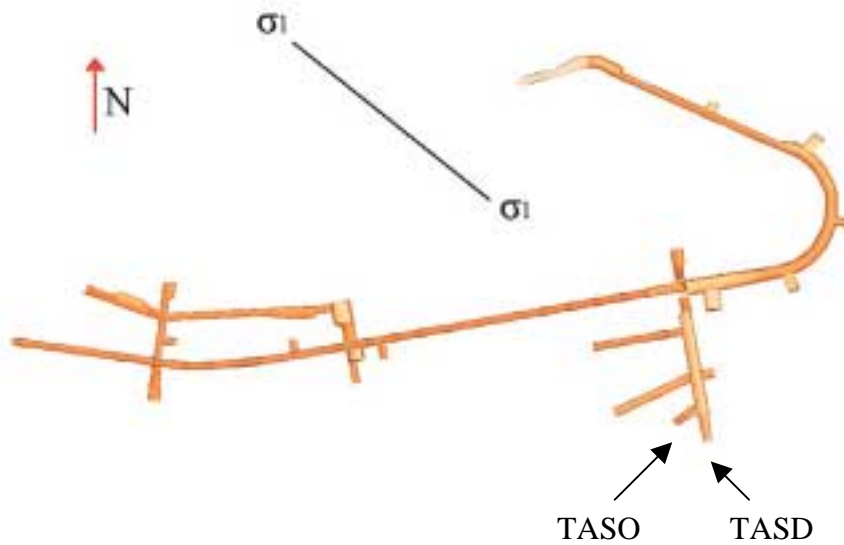
Figure 4-7. Location of T ASD and T ASO and a horizontal projection of the bearing of the major principal stress, σ_1 .

Figure 4-7 shows the location of T ASD and T ASO in the tunnel system.

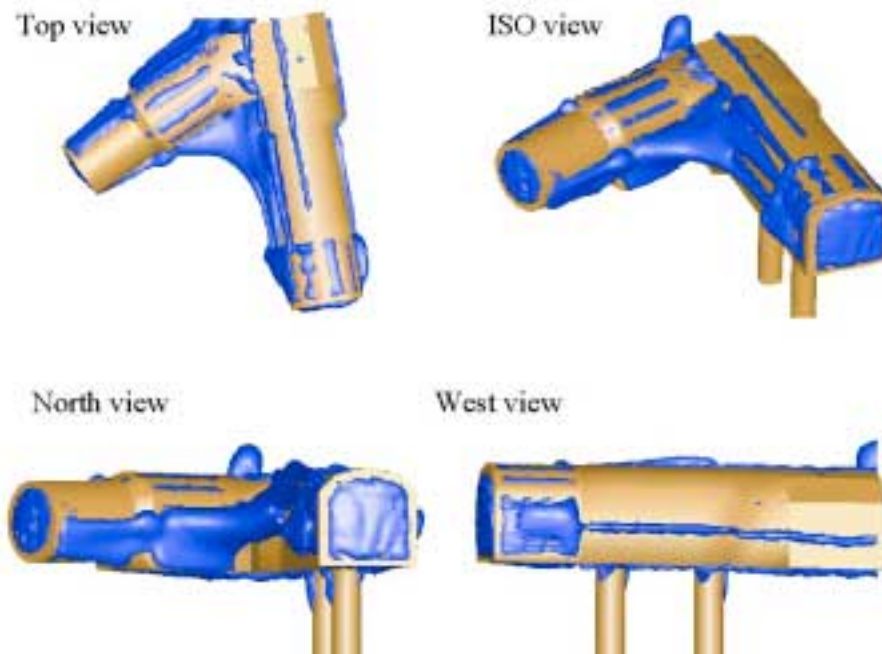
Figure 4-8. Isosurface of 0 MPa confinement at T ASO, the circular tunnel and T ASD, the horseshoe shaped tunnel. North is up in the top view.

Both in the T ASD- and T ASO-tunnels microseismic events have been heard and repeated scaling carried out. Rock pieces fell from the roof in T ASO when a vibrating machine was used for compaction of backfill material in the tunnel. The isosurface for a σ_3 of 0 MPa confinement is presented in Figure 4-8.
