Rock mechanical conditions at the Äspö HRL

A study of the correlation between geology, tunnel maintenance and tunnel shape

Christer Andersson
Svensk Kärnbränslehantering AB

December 2001

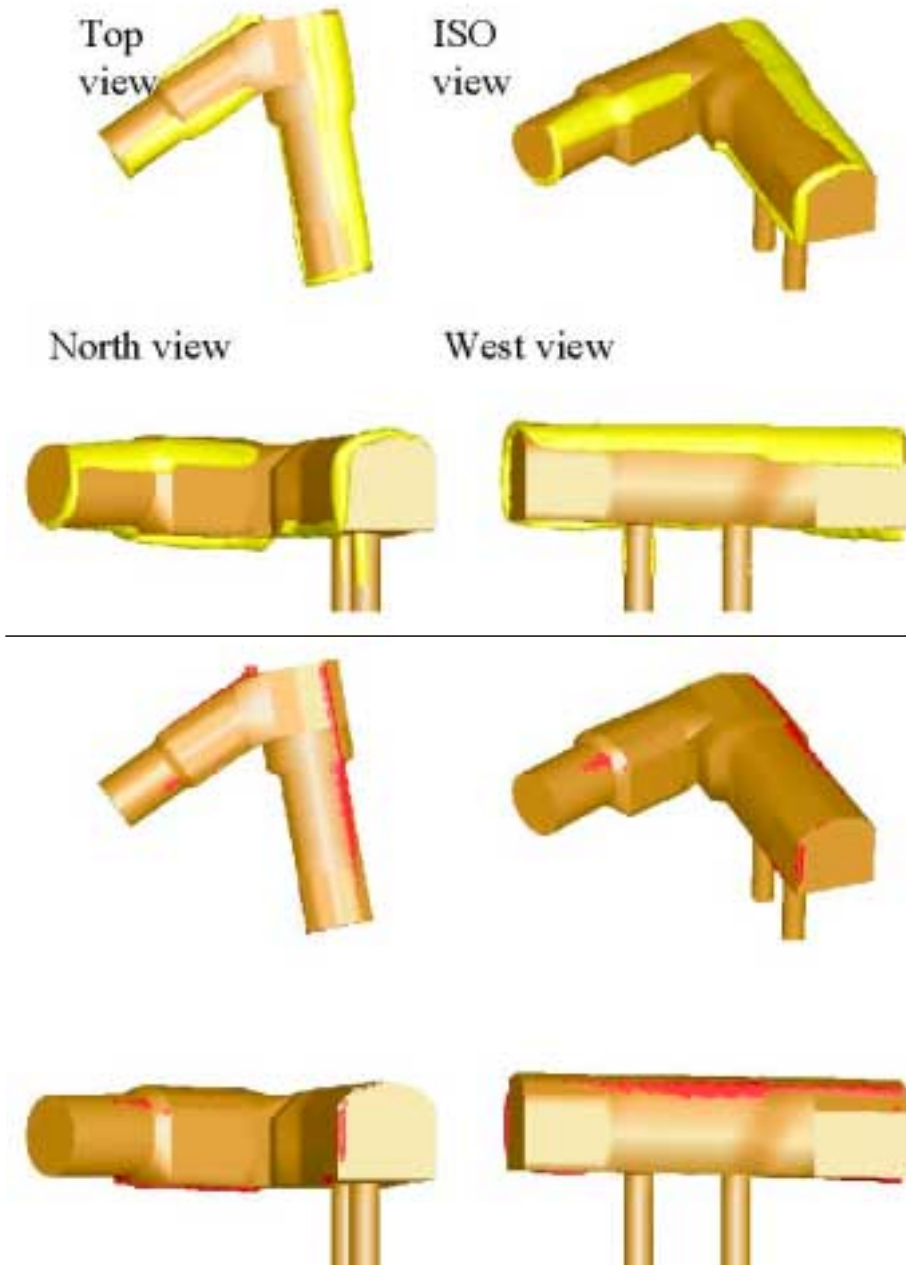
Figure 4-9. Isosurfaces for k -values of 50 MPa (yellow) and 70 MPa (red) at the O- and D-tunnels. North is up in the top view pictures.

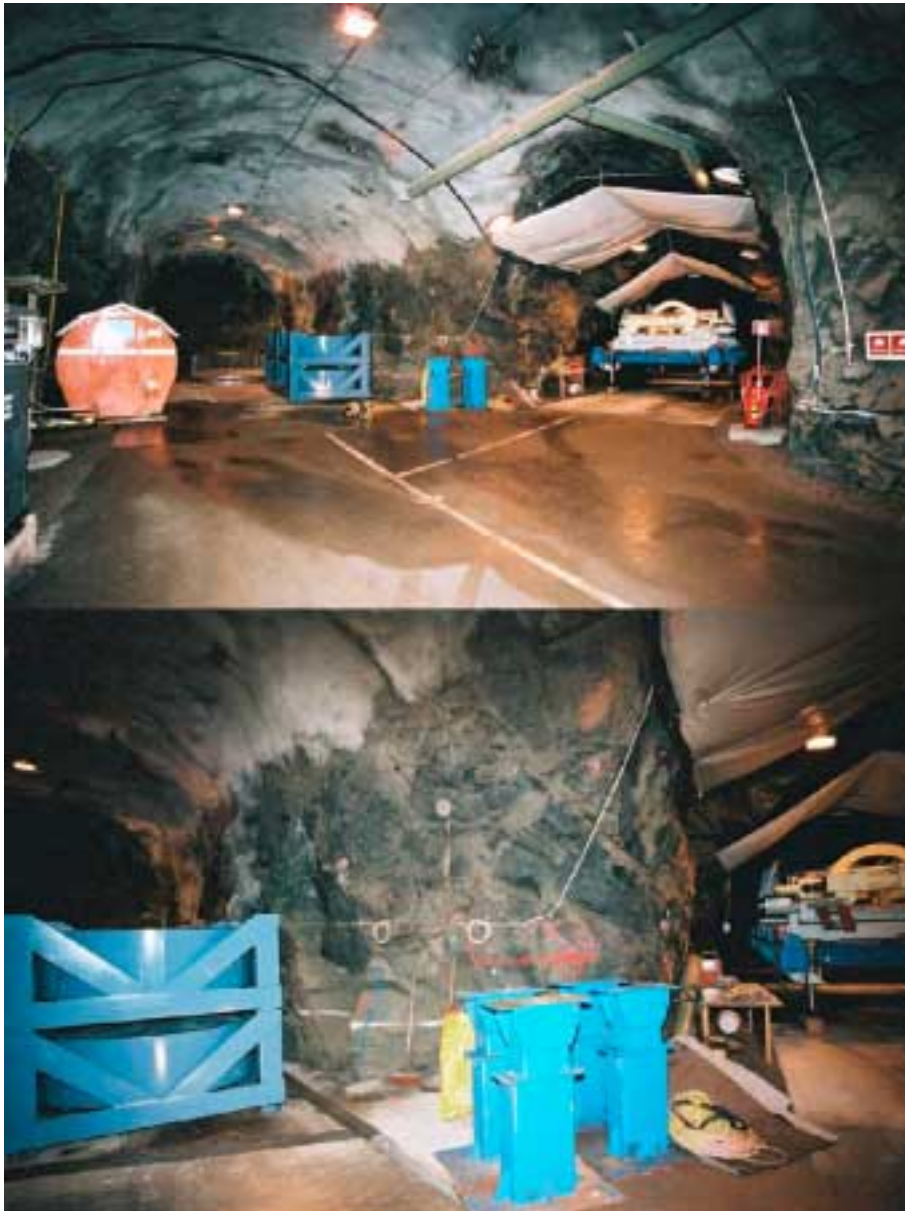
Figure 4-10. Photograph of the T ASD-tunnel to the left and T ASO-tunnel to the right. Bottom picture is a close-up on the pillar between the tunnels. The pillar is rather unaffected by its low confinement and is sparsely bolted.

The low confinement in the pillar between the tunnels has not led to additional scaling and the corner is still pretty sharp. The reason for this is probably sparse fracturing in combination with favourable fracture orientations. Figure 4-10 shows the T ASD-tunnel to the left and the T ASO-tunnel to the right. Figure 4-11 is a photograph of the support in the front of the T ASD-tunnel. The support is highly over dimensioned since a long-term experiment is carried out in the tunnel.

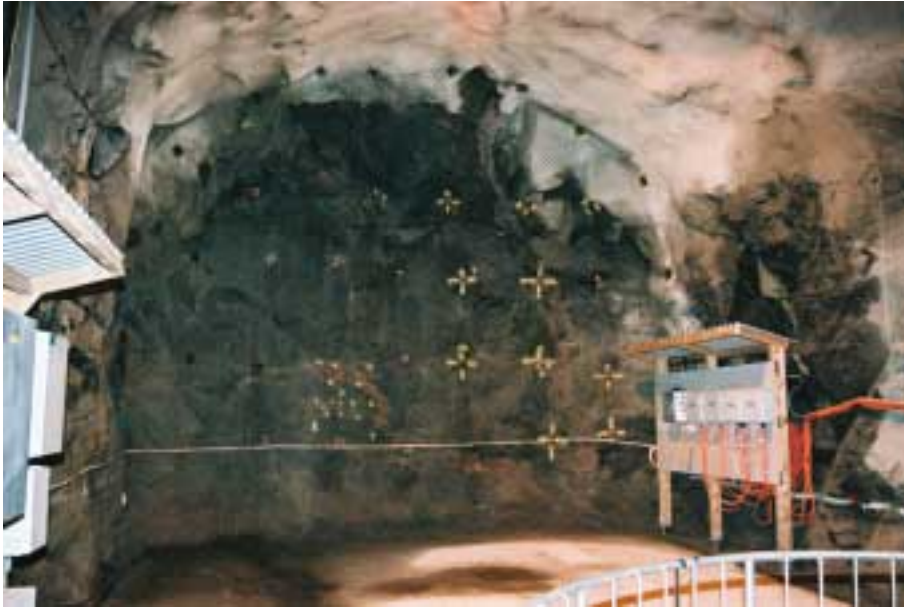
Figure 4-11. Photograph of the front of the D-tunnel and its support.

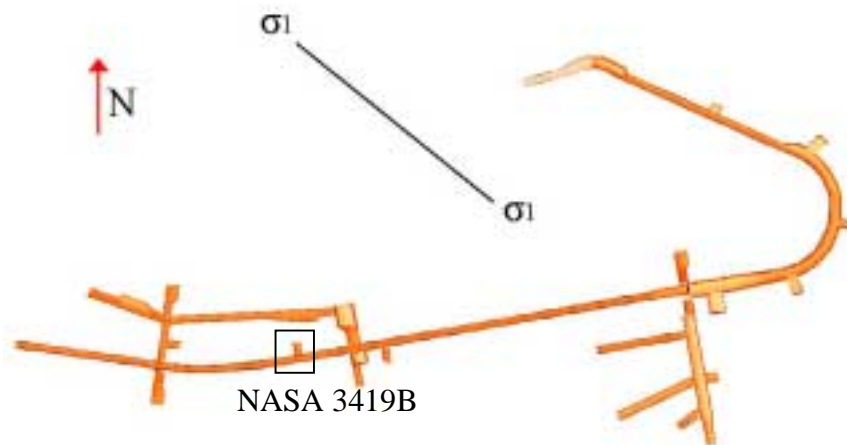
Figure 4-12. Location of NASA 3419B and a horizontal projection of the bearing of the major principal stress, σ_1 .

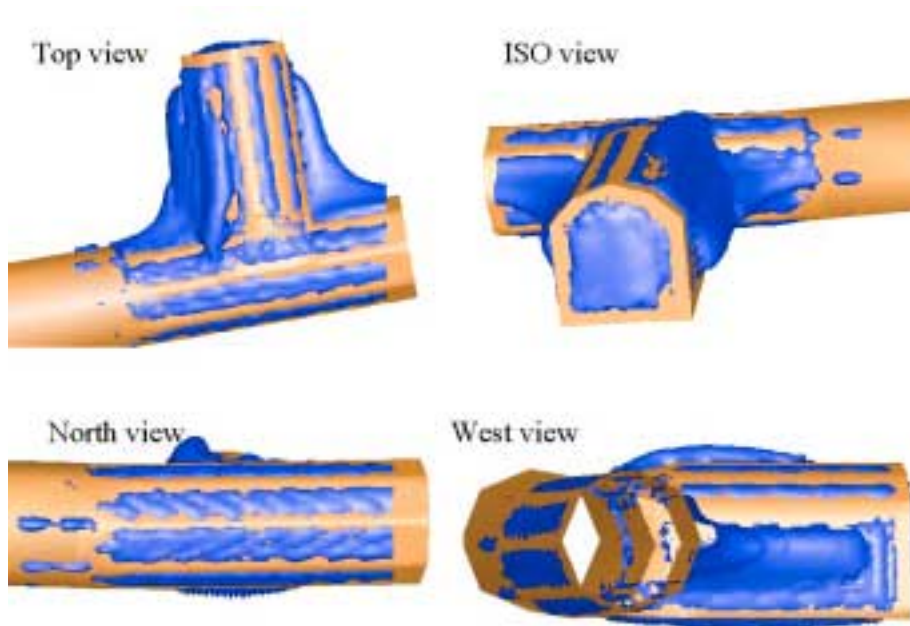
Figure 4-13. *Isosurface of 0 MPa confinement at NASA 3419B. North is up in the top view.*

This niche was selected since additional scaling had to be done after heating of the roof due to the use of a compressor. The isosurface for a σ_3 of 0 MPa confinement is presented in Figure 4-13.

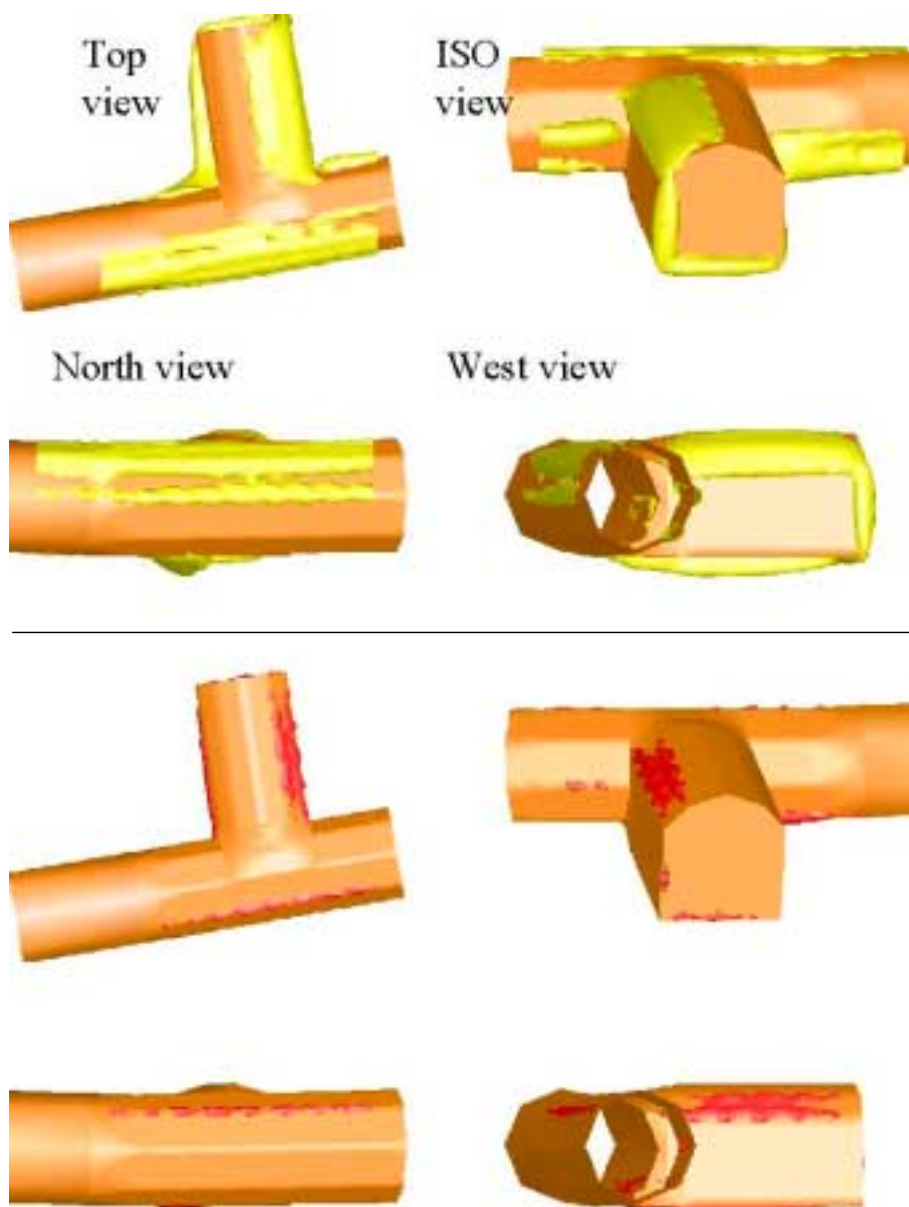
Figure 4-14. Isosurfaces for k -values of 50 MPa (yellow) and 70 MPa (red) at niche NASA 3419B. North is up in the top view pictures.

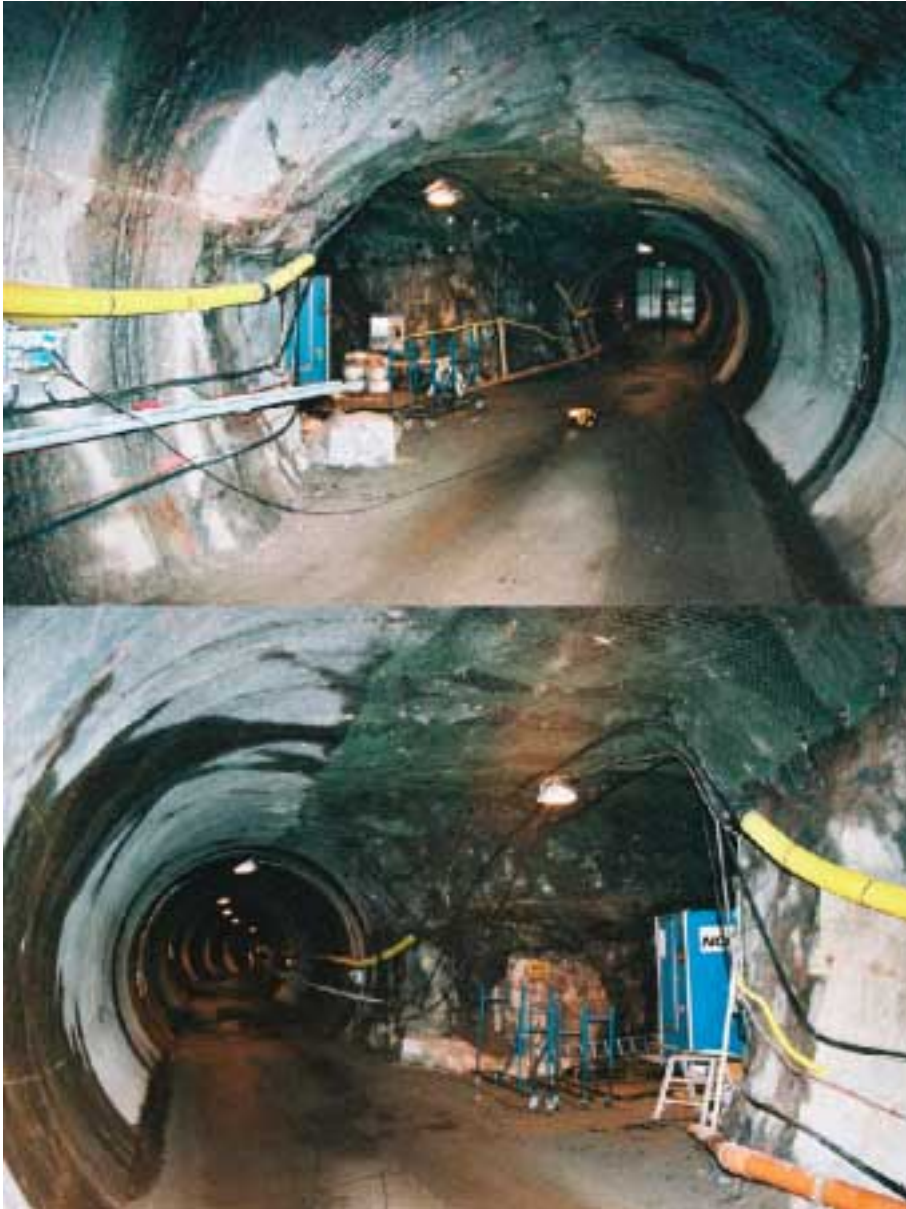
Figure 4-15. Top photograph taken looking east and bottom photograph taken looking west shows the entrance of niche 3419B. Note the intact TBM-tunnel on both sides of the niche.

Figure 4-15 shows photographs of the niche taken looking east and west. The scaling in the corners was made during excavation but supports the result indicating low confinement close to the TBM tunnel. The rather high stresses in the tunnel roof makes it probable that the heating from the compressor have accelerated the need for scaling. Approximately 2 m^3 was scaled after the compressor had been used. It is therefore likely that spalling is taking place in the right wall and loosening of rock by gravitational forces in the left wall. The scaling volumes are approximately the same in each of the walls and the roof.

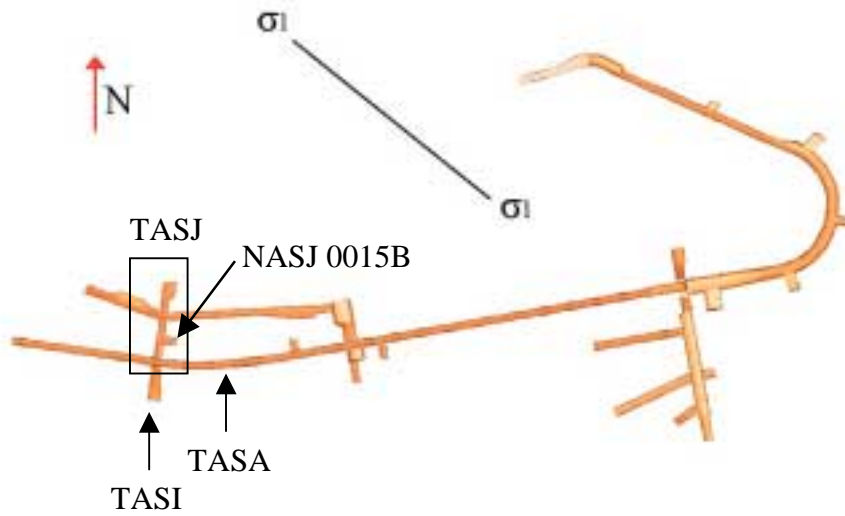
Figure 4-16. Location of TASJ, TASA, TASI and a horizontal projection of the bearing of the major principal stress, σ_1 .

Figure 4-16 shows the location of TASJ in the tunnel system.

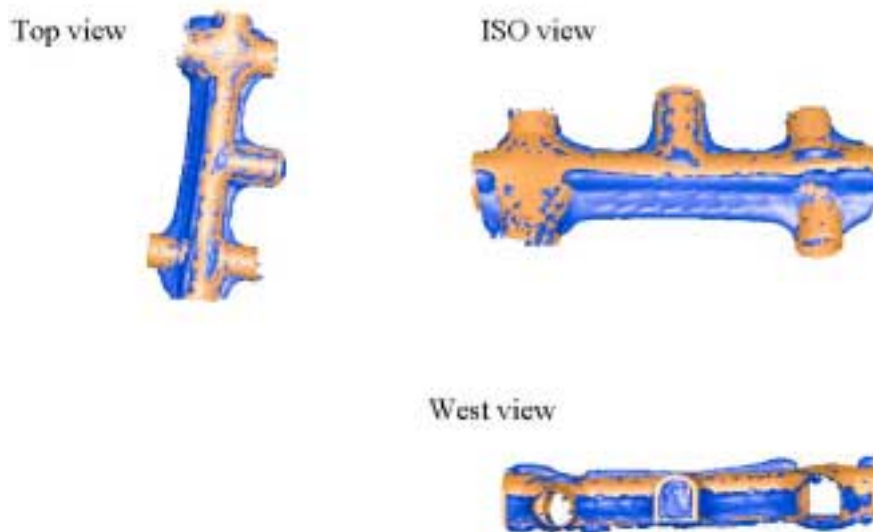
Figure 4-17. Isosurface of 0 MPa confinement at the J-tunnel. North is up in the top view.

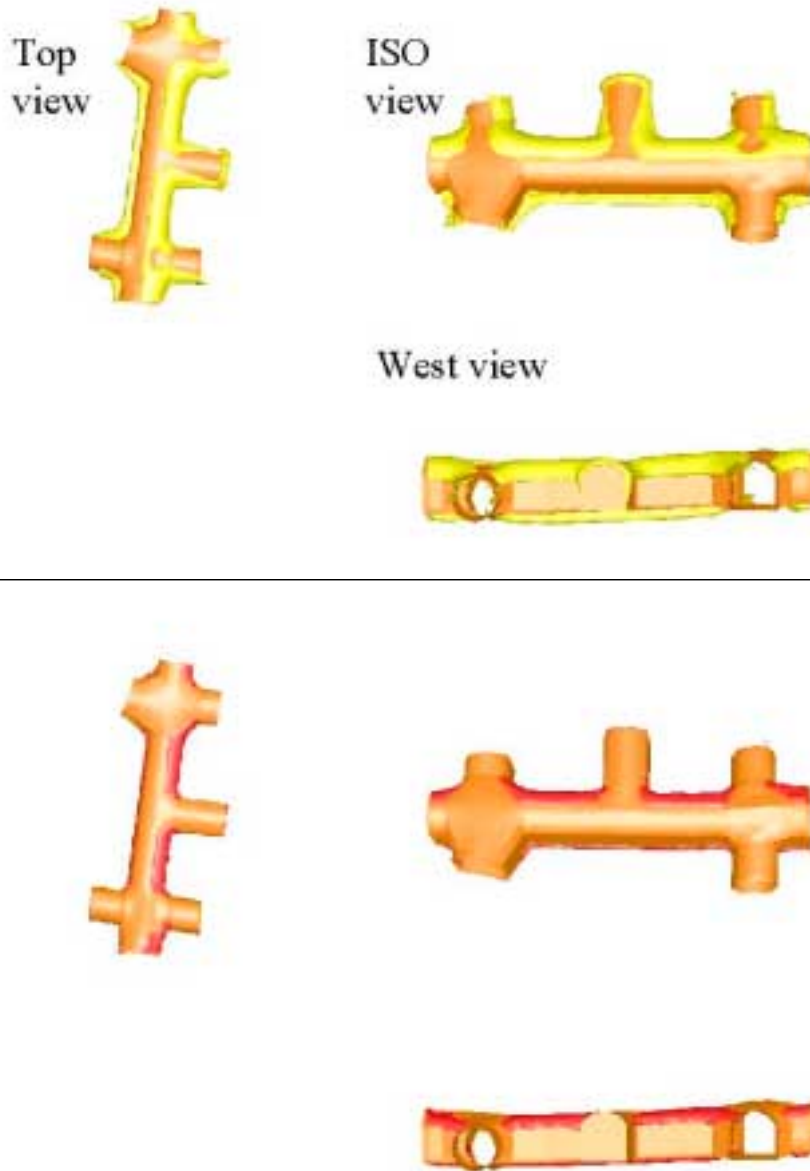
Figure 4-18. Isosurfaces for k -values of 50 MPa (yellow) and 70 MPa (red) at the J-tunnel. North is up in the top view pictures.

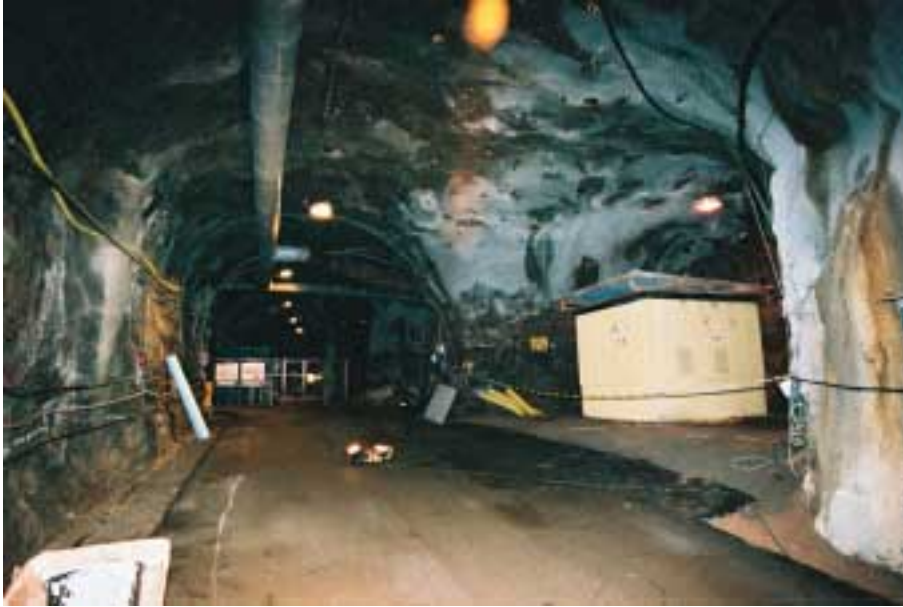
Figure 4-19 shows a photograph of TASJ with the niche NASJ 0015B to the right. The photograph is taken standing in the crossing between TASA, TASI and TASJ.

Figure 4-19. TASJ with NASJ 0015B to the right.

Figure 4-23 shows two photographs from different parts of the tunnel front. The brittle Småland granite together with the large deviatoric stresses around the front's edge and the rather large unconfined volume in the front could very well explain the need for additional scaling. The entrance of the niche is shown in Figure 4-19.

The unloaded volume in the front of niche NASJ 0015B (section 4.3.5) is rather large. Most of the scaling in this niche has been performed here. There are also higher deviatoric stresses in the upper part of the front and the upper part of the entrance corners. When looking at Figure 4-19 one can see that the area with large deviatoric stresses in the upper entrance corners has been scaled.

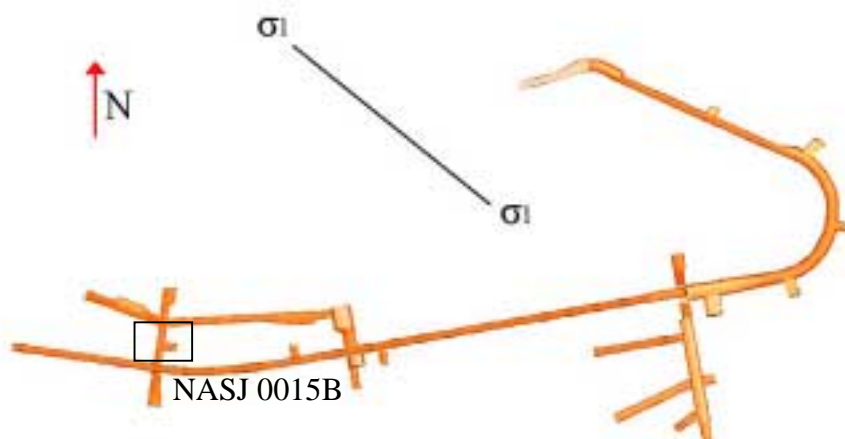
Figure 4-20. Location of NASJ 0015B and a horizontal projection of the bearing of the major principal stress, σ_1 .

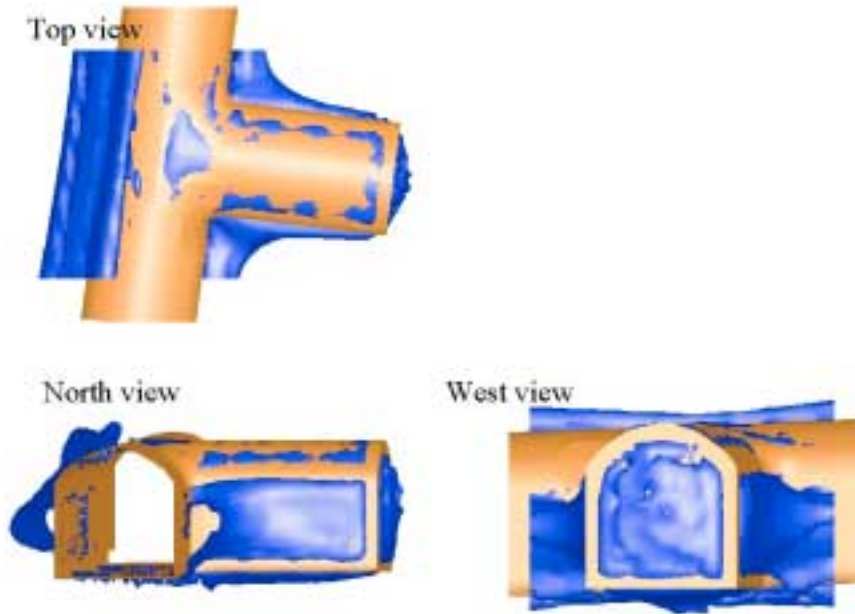
Figure 4-21. Isosurface of 0 MPa confinement at niche NASJ 0015B. North is up in the top view.

The front of NASJ 0015B has been scaled several times. The scaling has been performed in the front of the niche. The geology of the niche consists of fractured Småland granite. The isosurface for a σ_3 of 0 MPa confinement is presented in Figure 4-21.

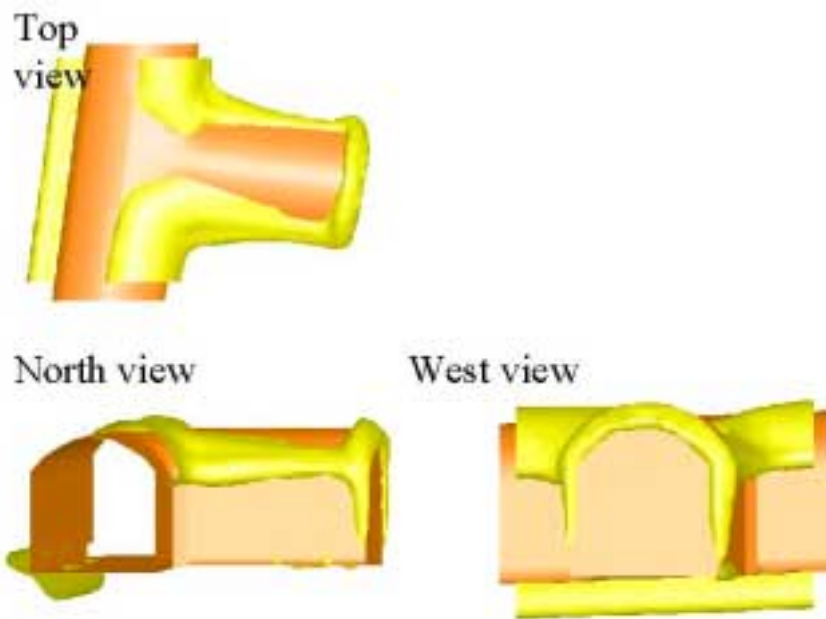
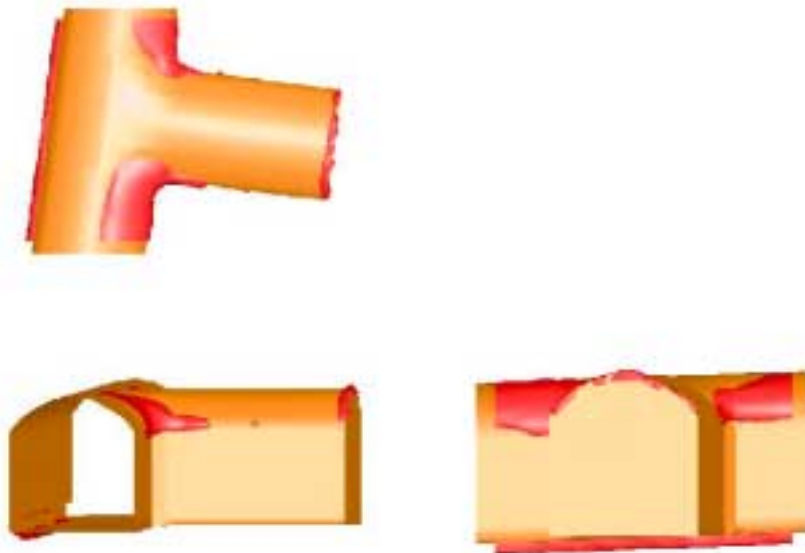
Figure 4-22. Isosurfaces for k -values of 50 MPa (yellow) and 70 MPa (red) at niche NASJ 0015B. North is up in the top view pictures.

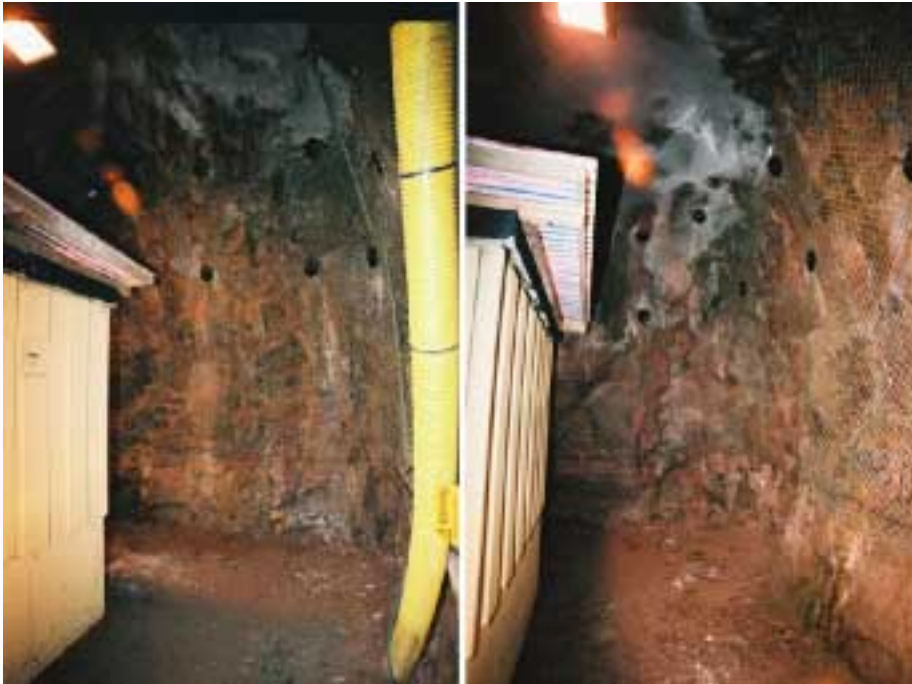
Figure 4-23. Two photographs of the front of niche NASJ 0015B.

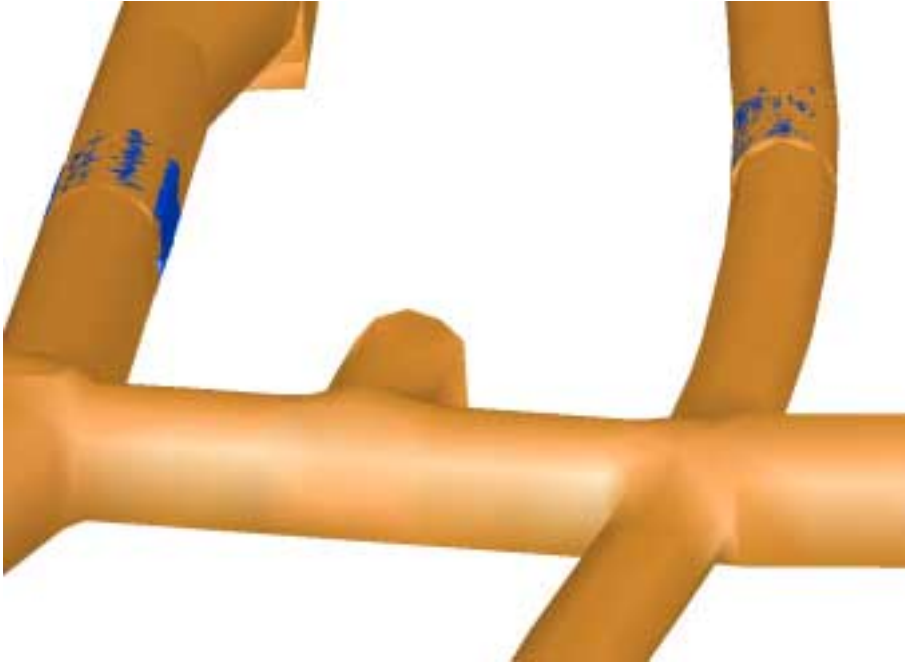
Figure 4-25. *Isosurfaces of 0 MPa at TASF, left and the TBM-tunnel, right. NASJ 0015B is the niche between the tunnels.*

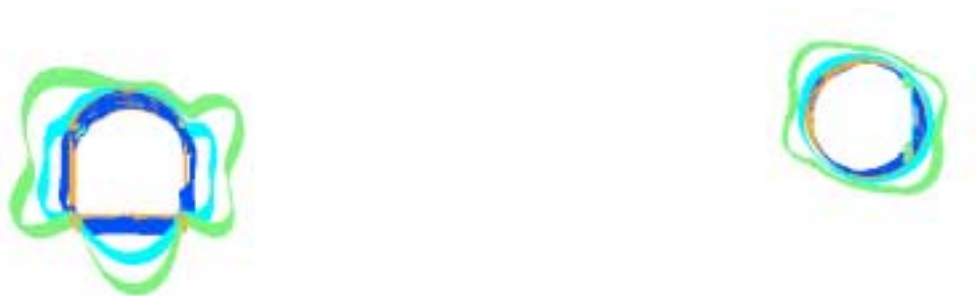
Figure 4-26. *Isosurfaces of the minor principal compressive stress at magnitudes of 0 MPa (dark blue), 3 MPa (light blue) and 6 MPa (green). TASF to the left and the TBM-tunnel to the right.*

The probable reason for the maintenance need in the D&B-tunnel is the combination of low confinement, fractured granites and gravitational forces.

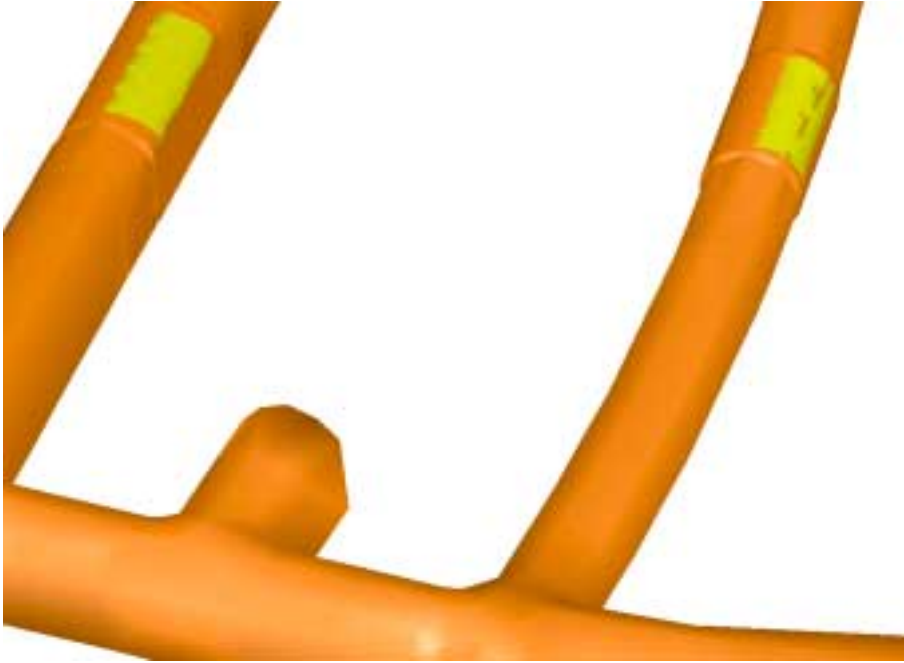
Figure 4-27. Isosurfaces for a k-value of 50 MPa. TASF to the left and the TBM-tunnel to the right.

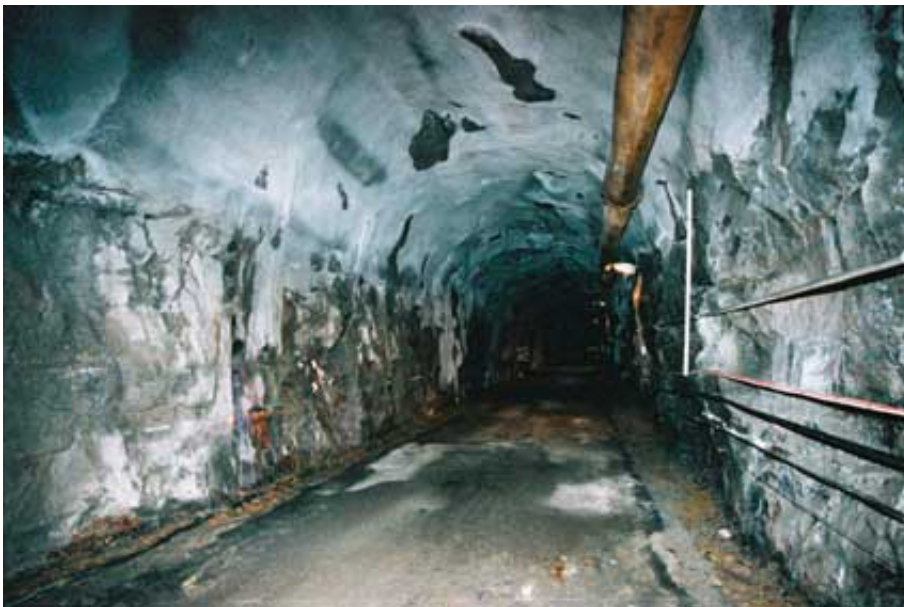
Figure 4-28. Top photograph is taken down the TASF-tunnel.

As indicated by Figure 4-25 to Figure 4-27 the volume of rock with low confinement is much larger in the D&B tunnel than in the TBM tunnel. The deviatoric stresses close to the two tunnels are quite low. The 60 MPa isosurface is hardly visible if plotted. Figure 4-28 is a photograph of the TASF-tunnel.

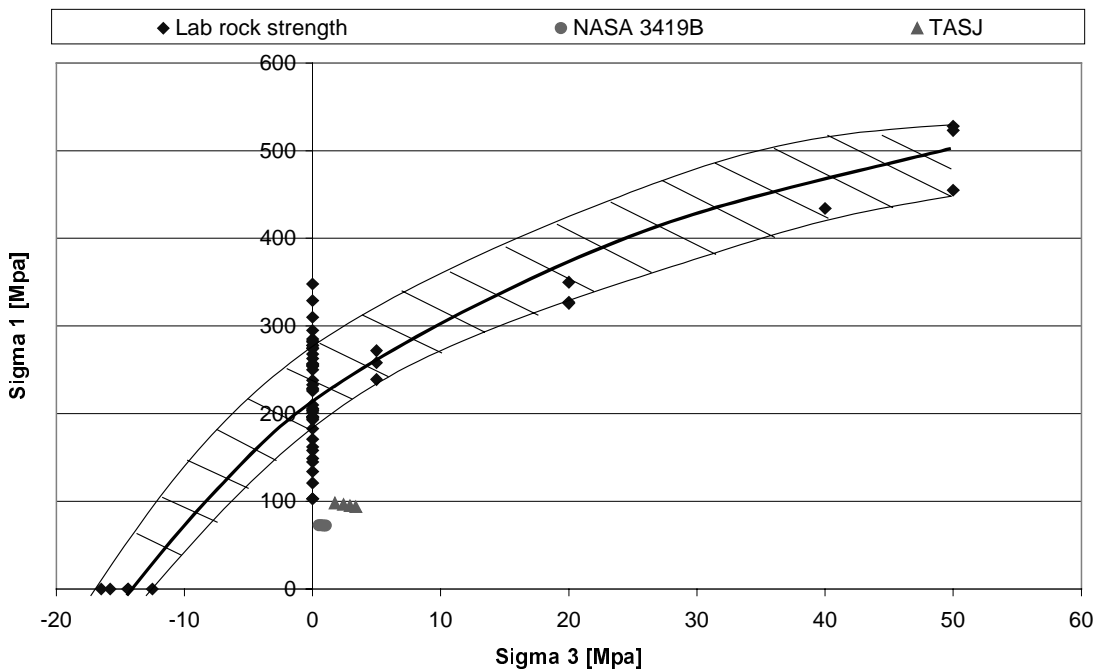
Figure 5-1. Compilation of lab rock strength measurements and results from highly stressed areas according to the numerical modelling.

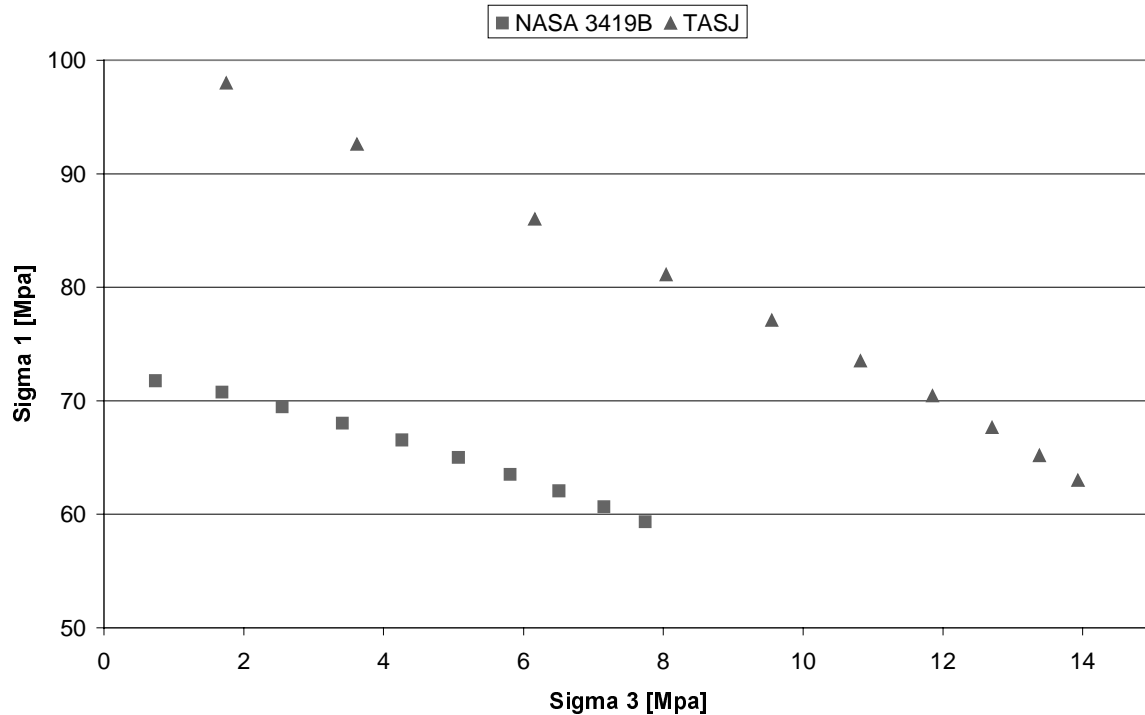
Figure 5-2. The stress situation in the 50 cm of rock closest to the tunnel contours in NASA 3419B and TASJ.
