Technical Report
TR-10-36

**Fault Rock Zones Characterisation
– Final report**

TRUE-1 Continuation Project

November 2010

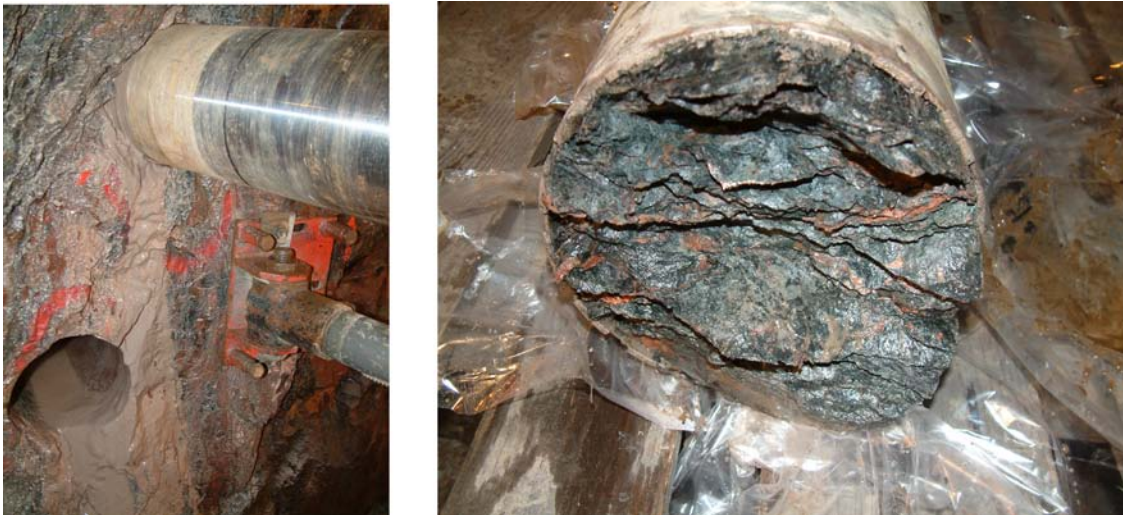
Figure 2-1. Left : Coring with 200 mm barrel in zone NE-2 (zone '1/600'), Right : Example of resulting core.

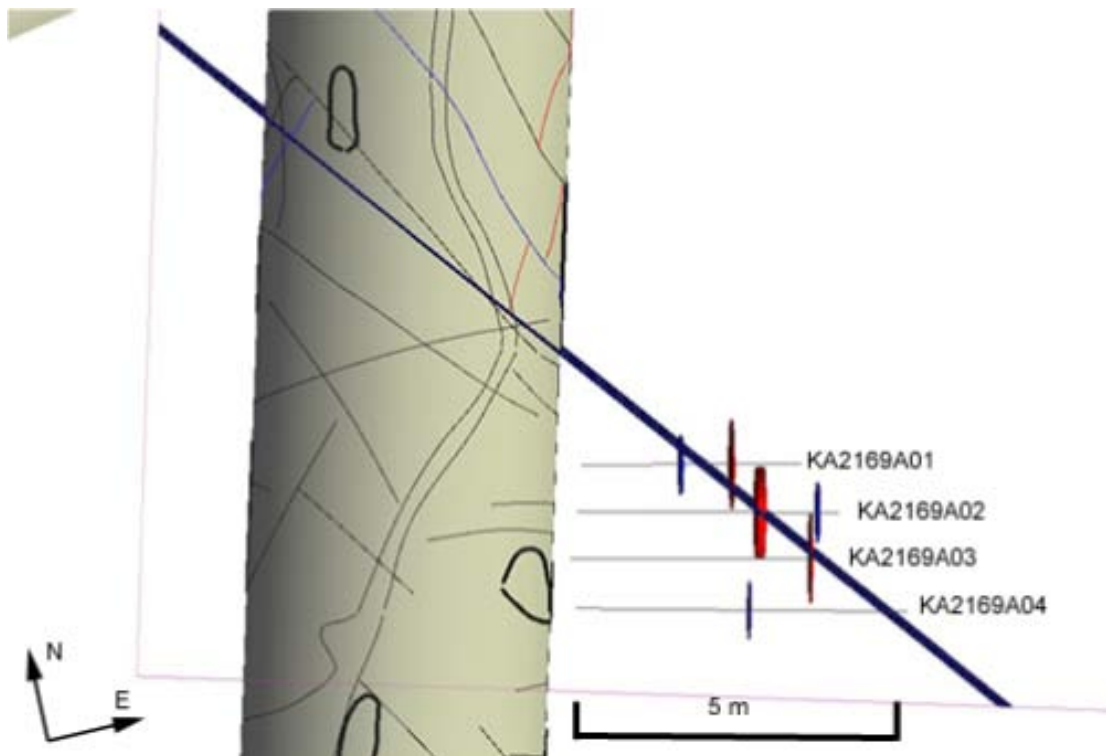
Figure 3-3. RVS model C with borehole and fault geometry. The red discs are indications of 'zone 2163'. The smaller blue discs are indications of zones not associated with the main structure (Mærsk Hansen et al. 2003).

identified in KA2169A04 does not fit very well with 'zone 2163' in the tunnel. Hence this structure is considered to be essentially dominated by a single fracture (red in Figure 3-3). Two other single fractures (blue in Figure 3-3) are identified in KA2169A01 and KA2169A02.

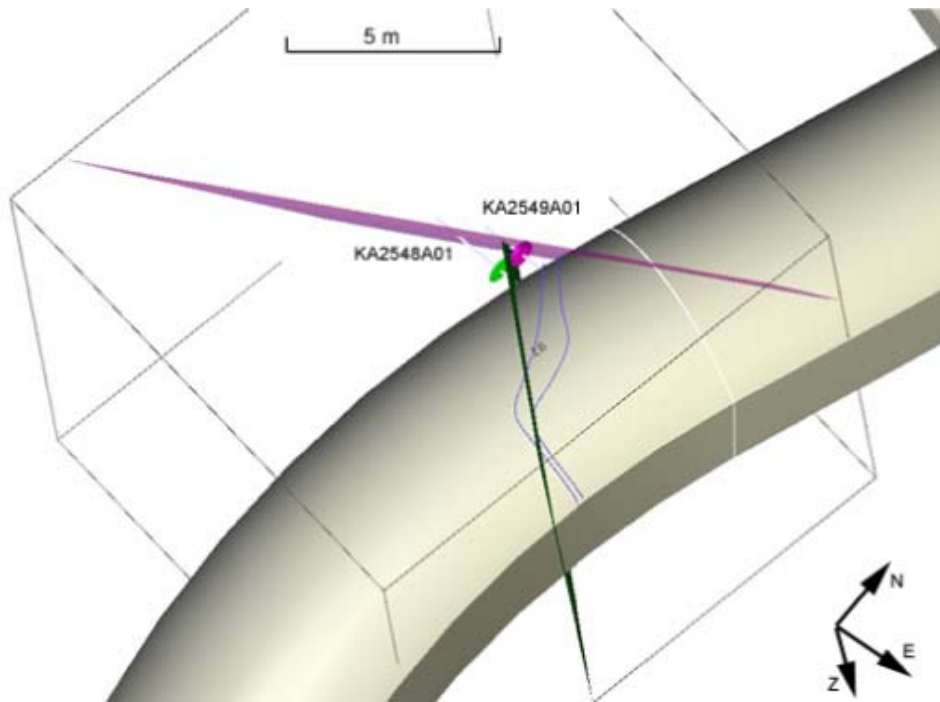
Figure 3-9. RVS model A with borehole and fault geometry. View along ‘zone 2545’ intersection axis (crest of the tunnel, chainage 2/545 m). The purple disc shows an indication of the NNE shear zone, the green disc is an indication of a NW-striking feature.

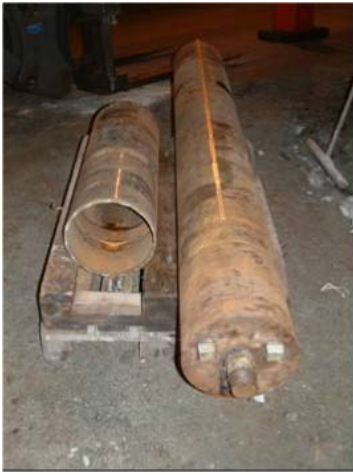
Figure 5-1. 300 mm core barrels with space for 0.76 m and 2.25 m core length, respectively. Scale bar on top of leftmost barrel is 2 m.

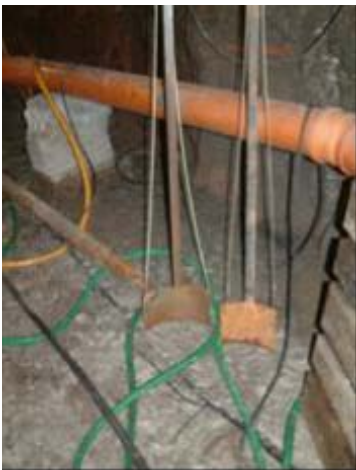
Figure 5-2. Tools for core breakage.

- 4) In many cases, the core will break due to an existing natural fracture, but when required, core breaks were induced by means of a curved, flat “steel flask” in the annular slot between the core and the borehole wall, expanded by means of hydraulic oil, applied some 0.4 m from the bottom of each drill round. The *in situ* core was acting as a lever to break (itself) at its base inside the drill hole (Figure 5-2 and Figure 5-3).

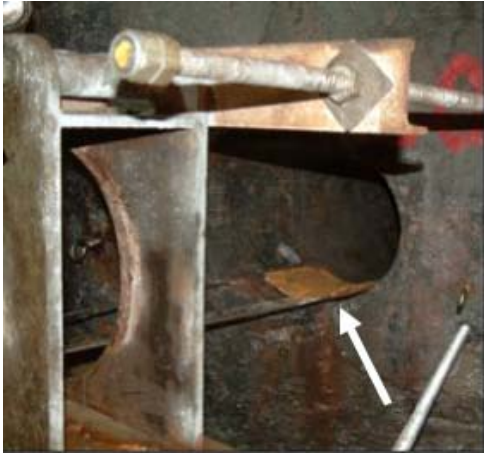
Figure 5-3. Insertion of tool for core breakage.

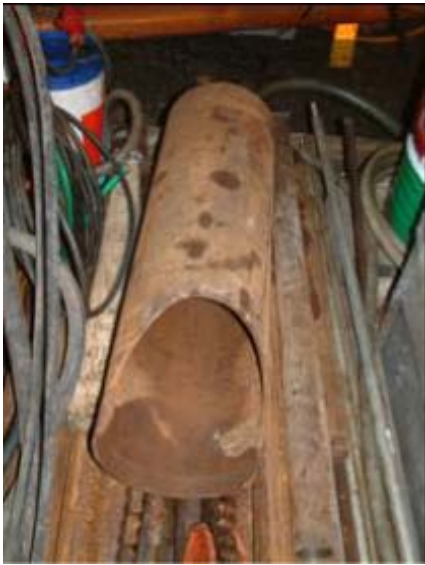
Figure 5-4. Core recovery tool.

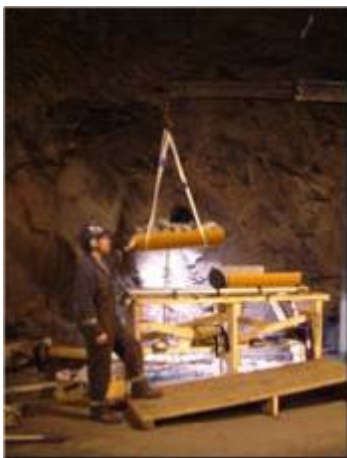
Figure 5-5. Core lifting.

- 5) Drilling of each 0.75 m round was followed by careful recovery of the core by means of a specific core recovery tool (Figure 5-4).
- 6) The target zone recovery coring section was defined as 0.1 m before the target zone to 0.5 m beyond, the latter to avoid excessive and detrimental stress on the target zone during application of the core breaking tool. The target zone recovery was enabled using a single core barrel of 2.25 m length, aiming to recover the remaining core, including the target zone, in one single piece (Figure 5-1). Breakage, if required and recovery was aimed to be carried out using the same method as for the shorter drill rounds.
- 7) Core orientation, labelling and sawing into manageable pieces.
- 8) Due to the large core diameter, giving a weight of 150–170 kg per metre of core, handling of the core had to be done with a tractor equipped with a crane (Figure 5-5).

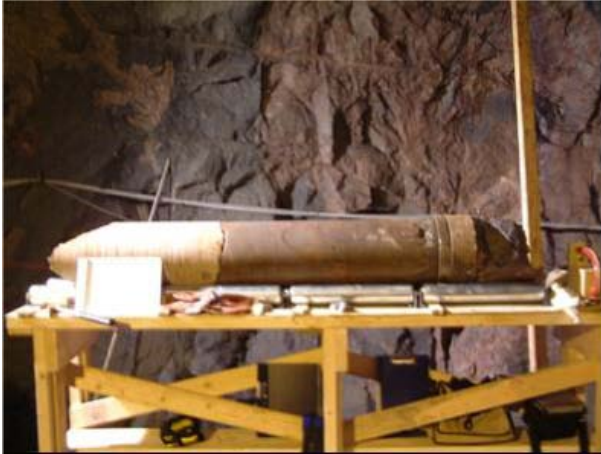
Figure 5-6. Core logging table with rotating cylindrical supports.

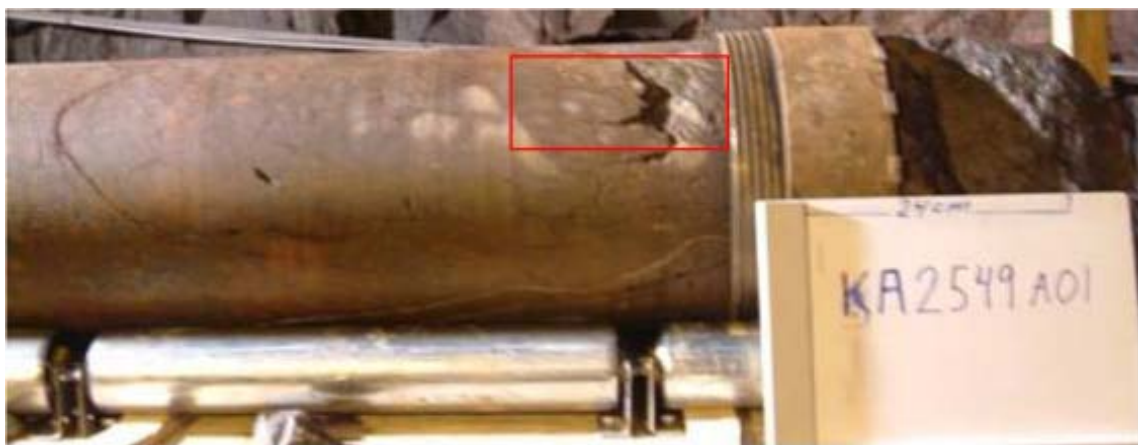
Figure 5-7. KA2549A01. Recovered core with target zone close to metal core bit, and outline (red) of area shown enlarged in Figure 5-8.

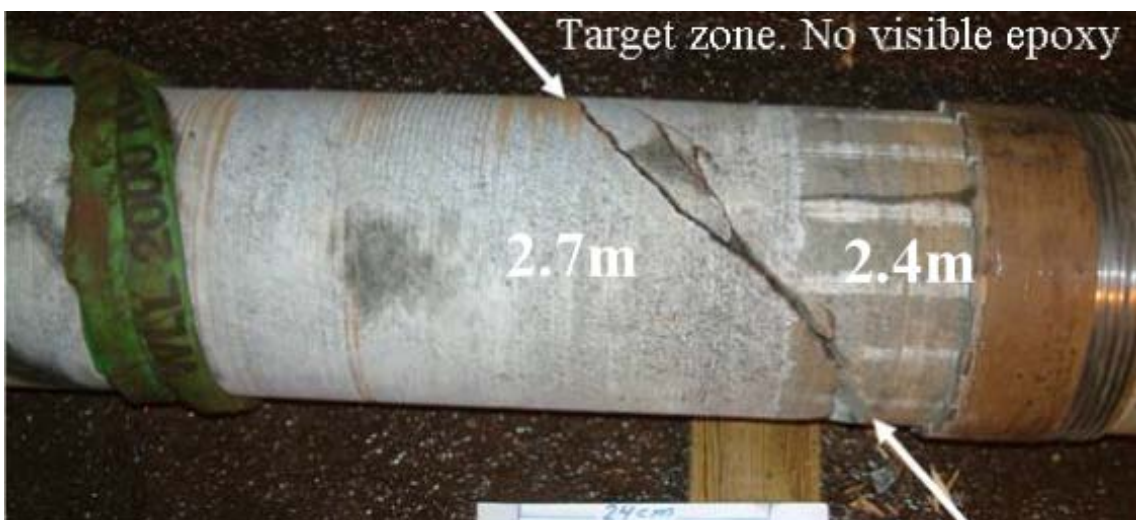
Figure 5-10. KA2169A01. Recovered core with target zone at L=2.5 metres, with no visible epoxy. Hidden under the drill bit (at far right) are epoxy-filled fractures at L=2.10–2.35 metres (cf. Figure 5-11).

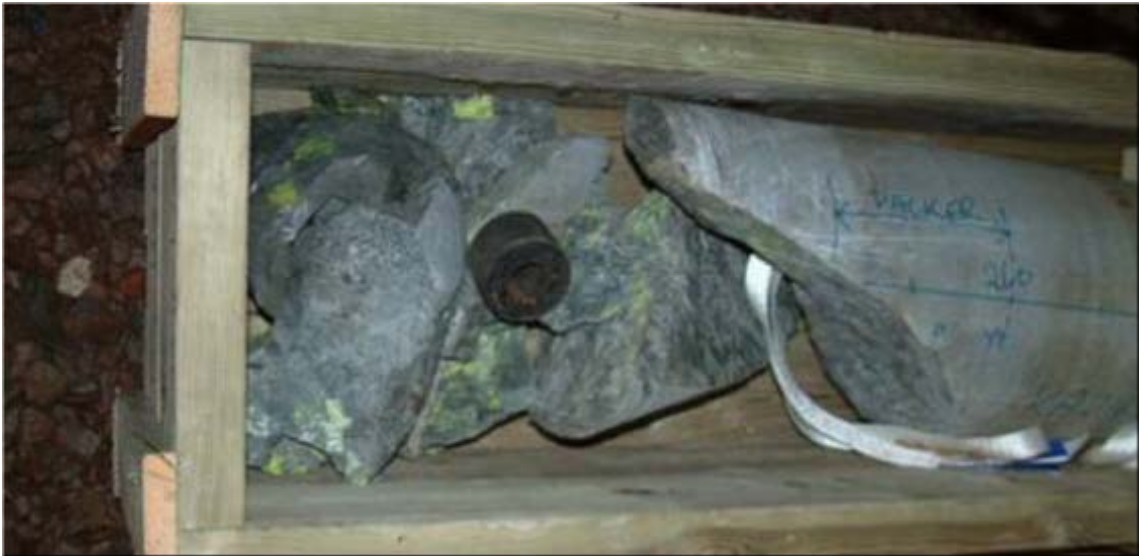
Figure 5-13. KA2169A02. Epoxy patches on fracture surfaces of recovered core segments.

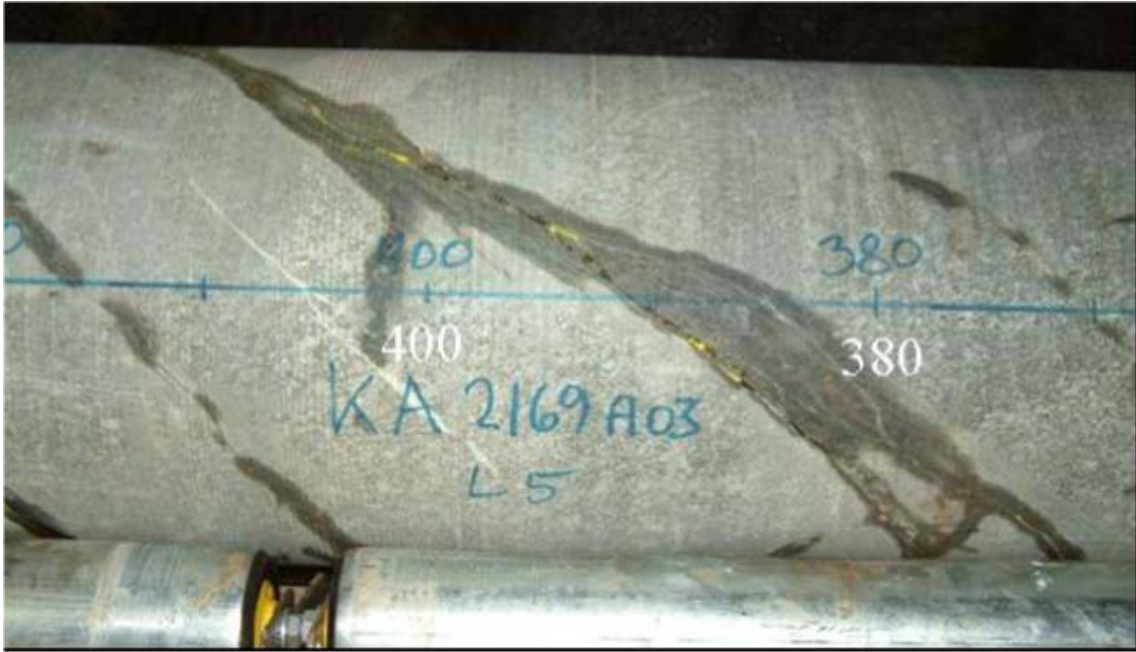
Figure 5-14. KA2169A03. Recovered core with target zone at L=3.90 metres, with many indications of epoxy (yellow streaks along the diagonally oriented fracture in the centre of the photograph). An enlargement of the area at the L=4.00 metre mark is shown in Figure 5-15.

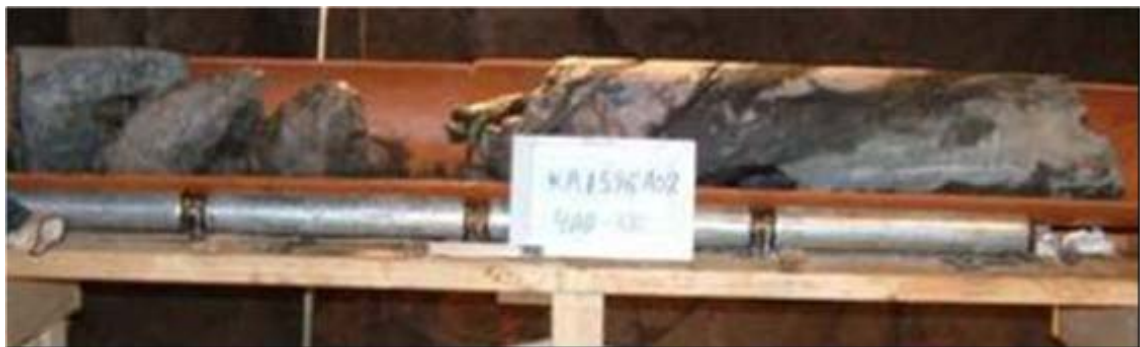
Figure 5-18. KA1596A02. Recovered core with target zone at c. 4.6 metres. Apologies for poor quality in photograph.

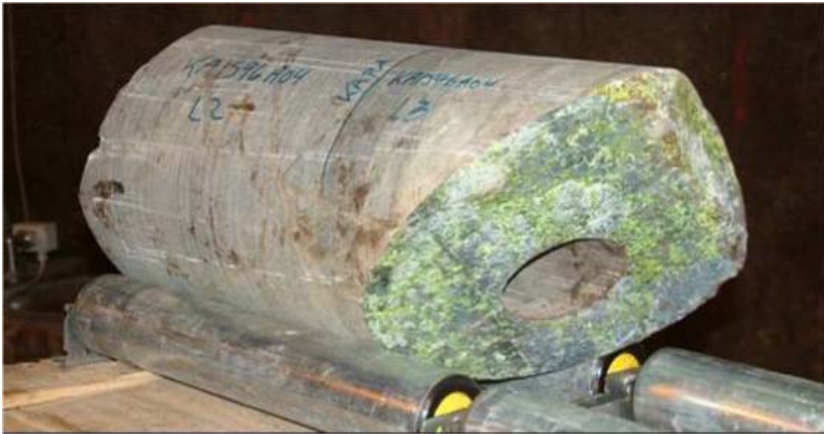
Figure 5-19. KA1596A04. Recovered core with epoxy at L=1.9 metres with face of epoxy impregnated fracture (0°/63°) at L=1.9 metres.

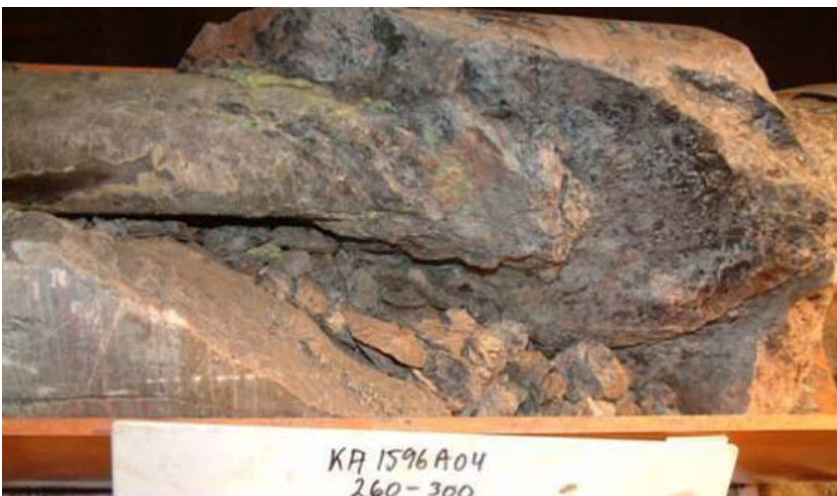
Figure 5-20. KA1596A04. Zone with fault gouge, partially impregnated with epoxy at L=1.9–3.0 metres. No epoxy seen on cylindrical surface of the overcore. Centimetre-sized breccia pieces seen in the lower part of the picture (centre).

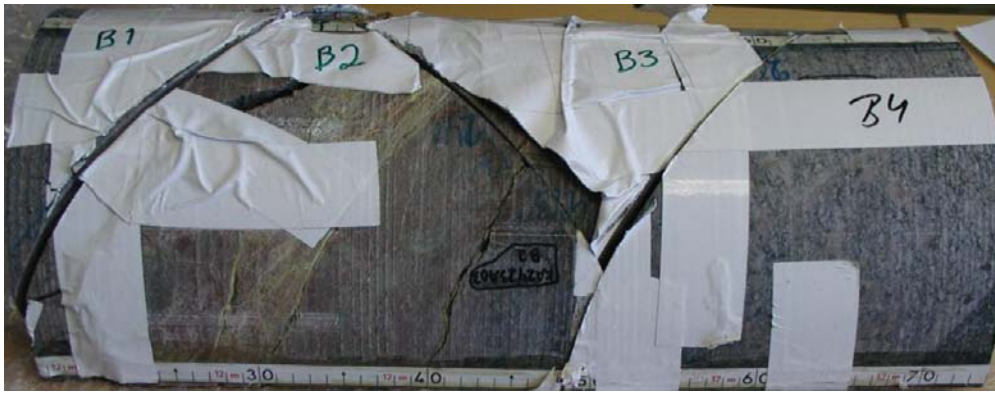
Figure 5-21. The core was cut along the core axis into two halves. Only one half (upper half) was used in the current study. This image shows samples B1, B2, B3 and B4 from borehole KA2423A03. The left side of the core is positioned closest to the tunnel (borehole collar).

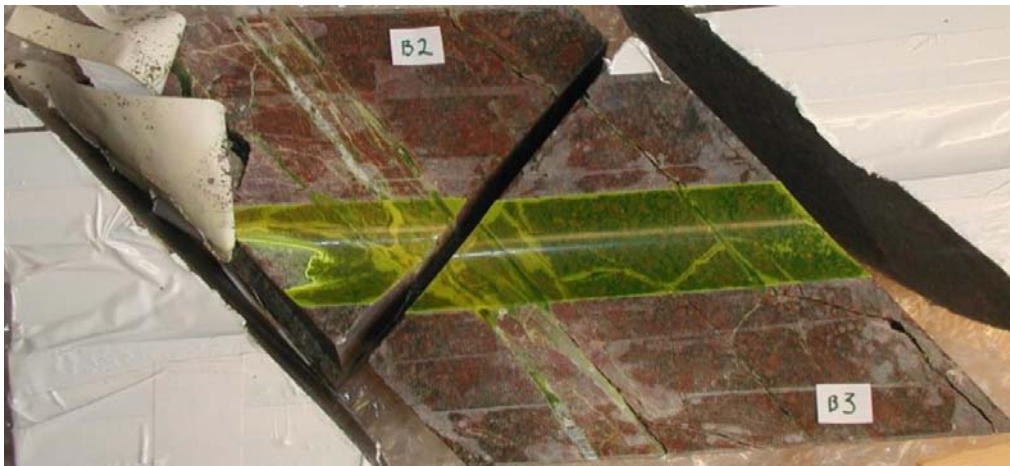
Figure 5-22. This figure is similar to Figure 5-21, but the samples (B2 and B3 from borehole KA2423A03) are rotated such that the cut surfaces are seen. The trace of the 76 mm injection hole may be noted in the centre of the photograph (light green epoxy). (Vertical up direction is normal to the image, directed inwards.)

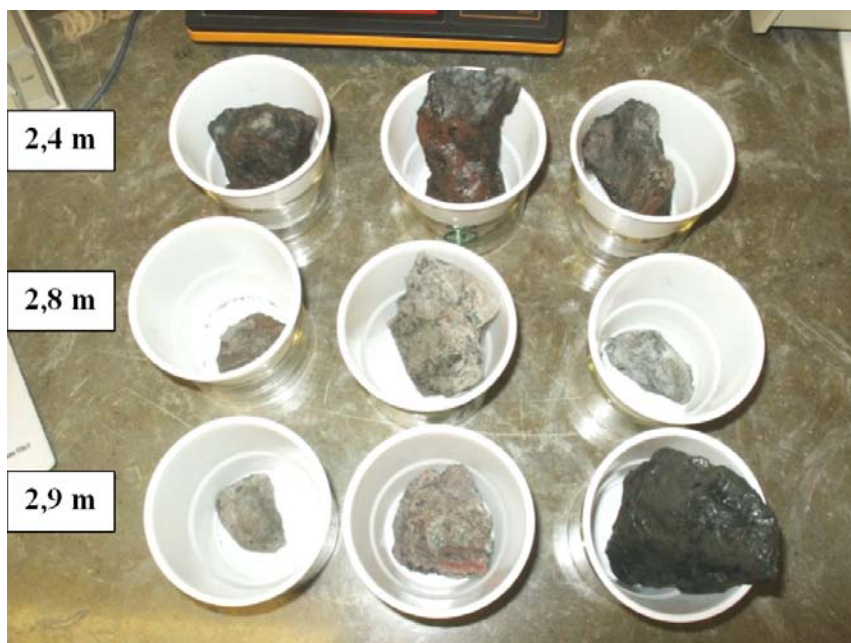
Figure 6-1. Photographs of fault gouge samples (wet state) from the overcore of borehole KA1596A04. Samples denoted A1–A3 (L=2.4m), A4–A6 (L=2.8m), cf. Table 6-1.

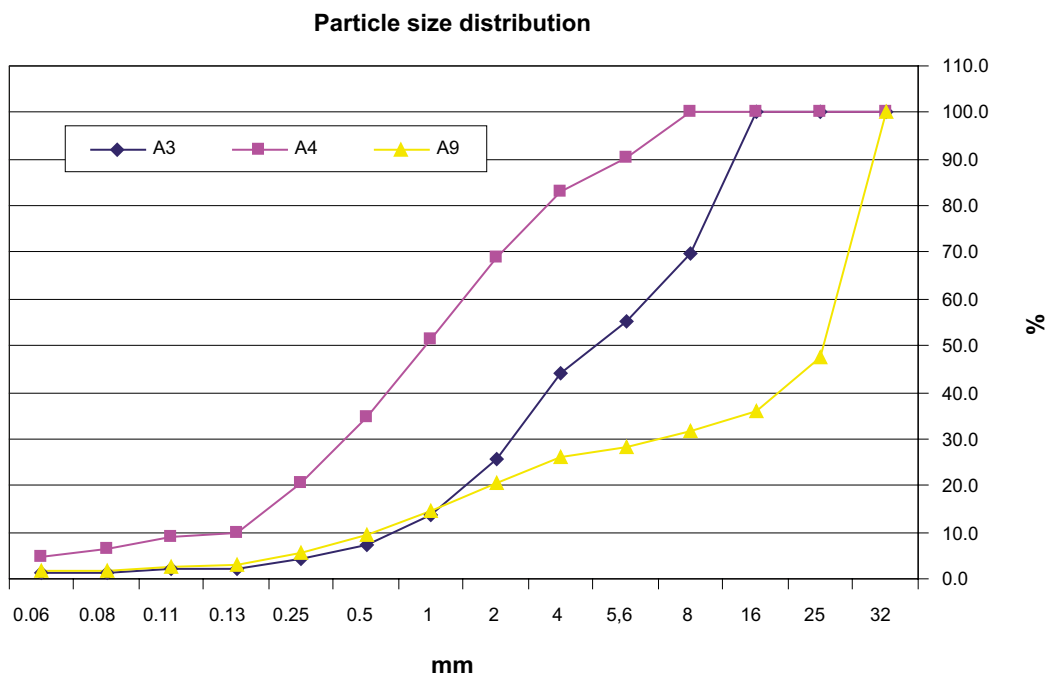
Figure 6-2. Particle size distribution related to samples A3 ($L=2.4$ m), A4 ($L=2.8$ m) and A9 ($L=2.9$ m) from the KA1596A04 overcore.

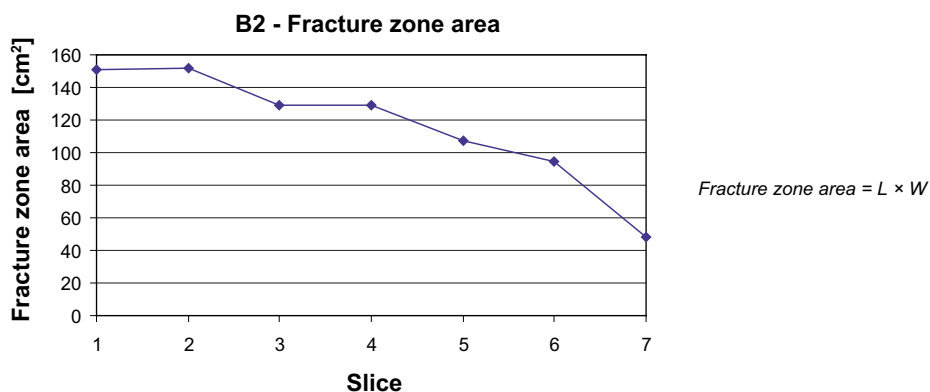
Figure 7-12. B2 – variation in fracture zone (Ferret Box) area.

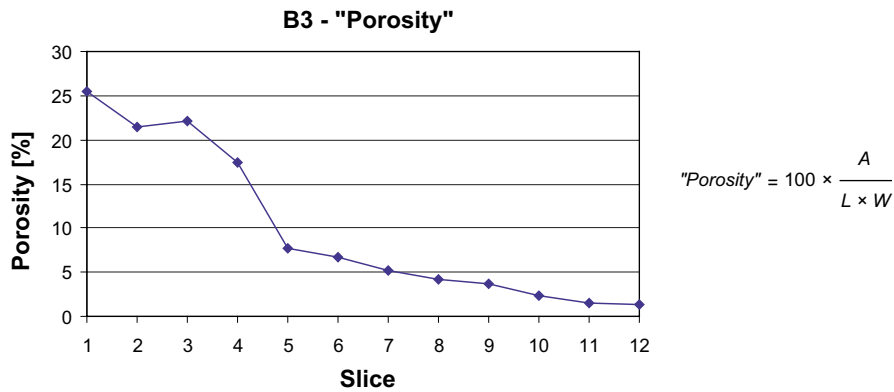
Figure 7-16. B3 – variation in apparent porosity (%) of analysed slices.

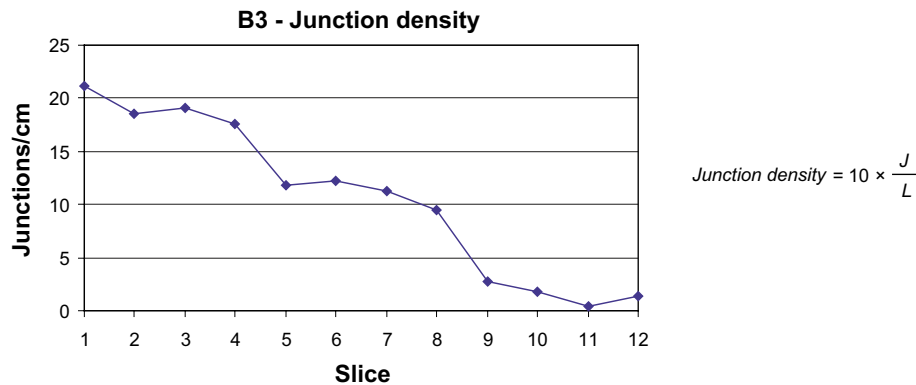
Figure 7-17. B3 – variation in junction density (cm^{-1}).
