TR-13-22

Prototype Repository

Opening and retrieval of outer section of Prototype Repository at Äspö Hard Rock Laboratory

Summary report

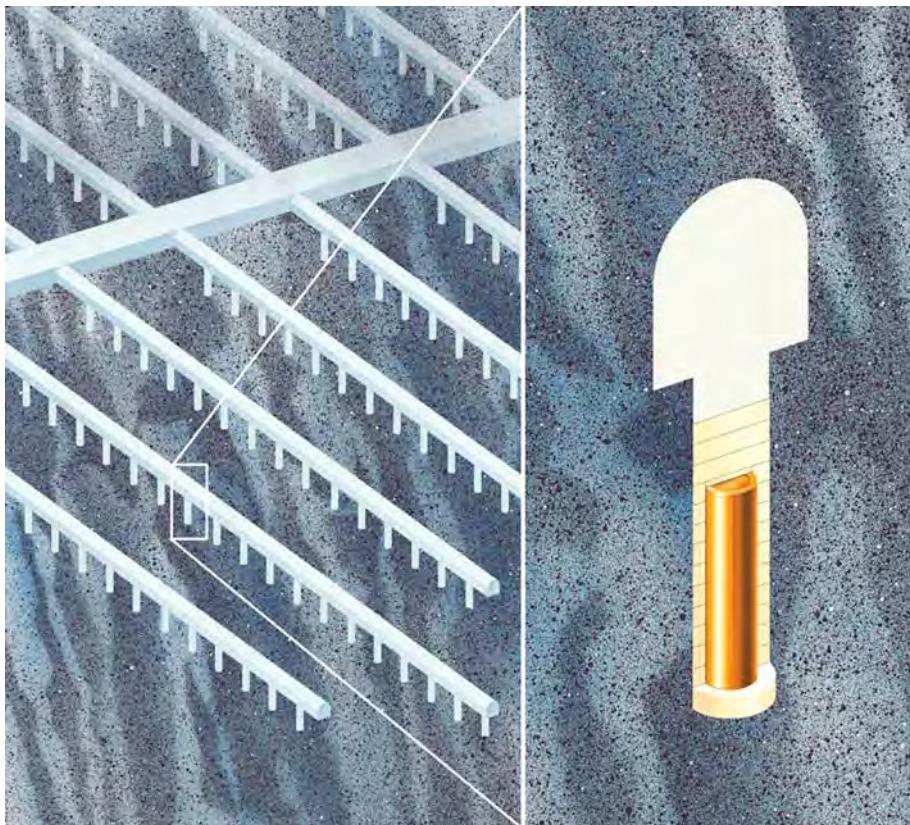
Figure 1-1. Illustration of the KBS-3V method at a depth of about 500 m in the Swedish bedrock. To the left: layout of deposition tunnels. To the right: layout of a deposition hole. (The vertical (V) emplacement mode was distinguished from the horizontal (H) emplacement mode first in the early 2000ies.)

SKB's reference concept for final disposal of spent nuclear fuel – the KBS-3V method with copper canisters emplaced in a vertical mode – has been developed through studies of different parts, in different scales since 1976, when the first outline of an in-hole placement concept deep down in the Swedish bedrock was presented (SKBF/KBS 1977, 1978). An improved design with a copper canister surrounded by a bentonite buffer in a vertical deposition hole placed in crystalline rock at a depth of approximately 500 m, and with carefully backfilled deposition tunnels – the KBS-3 method (SKBF/KBS 1983) – was in 1983 approved by the Swedish Government to fulfill the then applicable Swedish law (Nuclear Activities Act) as “*a method for final disposal of spent nuclear fuel, which can be accepted with respect to safety and radiation protection*”. This approval was one requirement set forth by the Government to authorize the two utilities Swedish State Power Board and Sydkraft (now E.ON) to charge the two Swedish nuclear power units Forsmark III and Oskarshamn III with nuclear fuel. The general design of this KBS-3V method is illustrated in Figure 1-1.

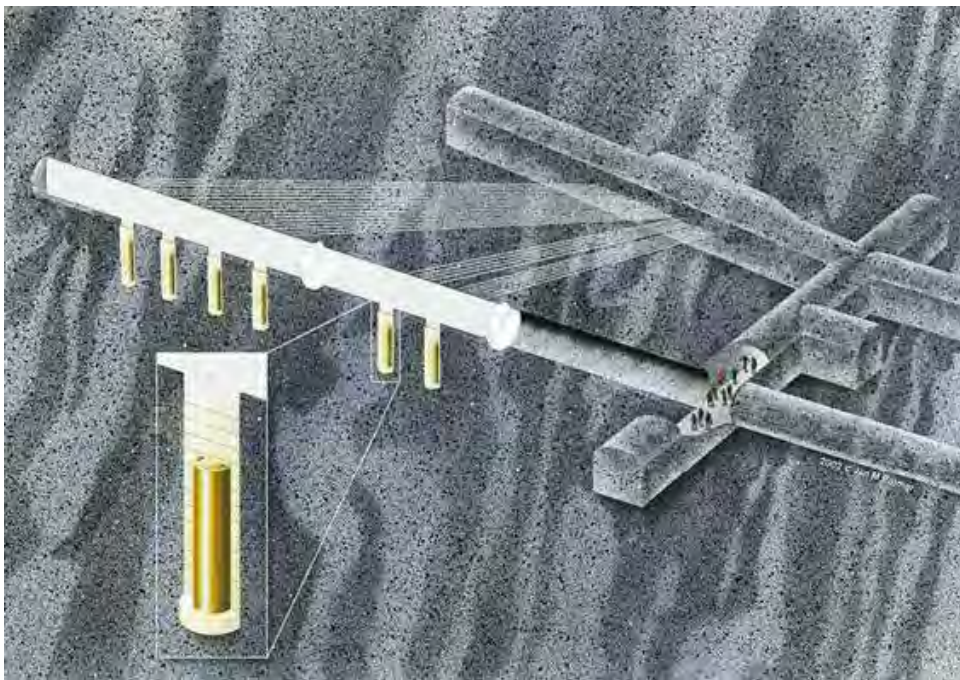
Figure 1-2. Artist's view of the Prototype Repository. The adjacent tunnel to the right in the figure (denoted G-tunnel in Figure 2-2) contains the instrument panels. Bright streaks between the Prototype Repository tunnel and the G-tunnel denote lead-through pipes. In total 32 lead-through pipes were required in order to host all cables from the Prototype Repository. In addition, two lead-through pipes were installed in the outer plug in order to facilitate on-line sampling of gas and water from the outer section.

Figure 1-2 shows an artist's view of the Prototype Repository. It covers 64 m of the Äspö HRL ramp, a part which was excavated with a TBM and has two sections, one inner section with four deposition holes and one outer section with two deposition holes. The two sections are separated from each other by a stiff and watertight concrete plug, and the whole Prototype Repository is separated from the rest of the Äspö HRL by a cast plug of the same design as the inner one.

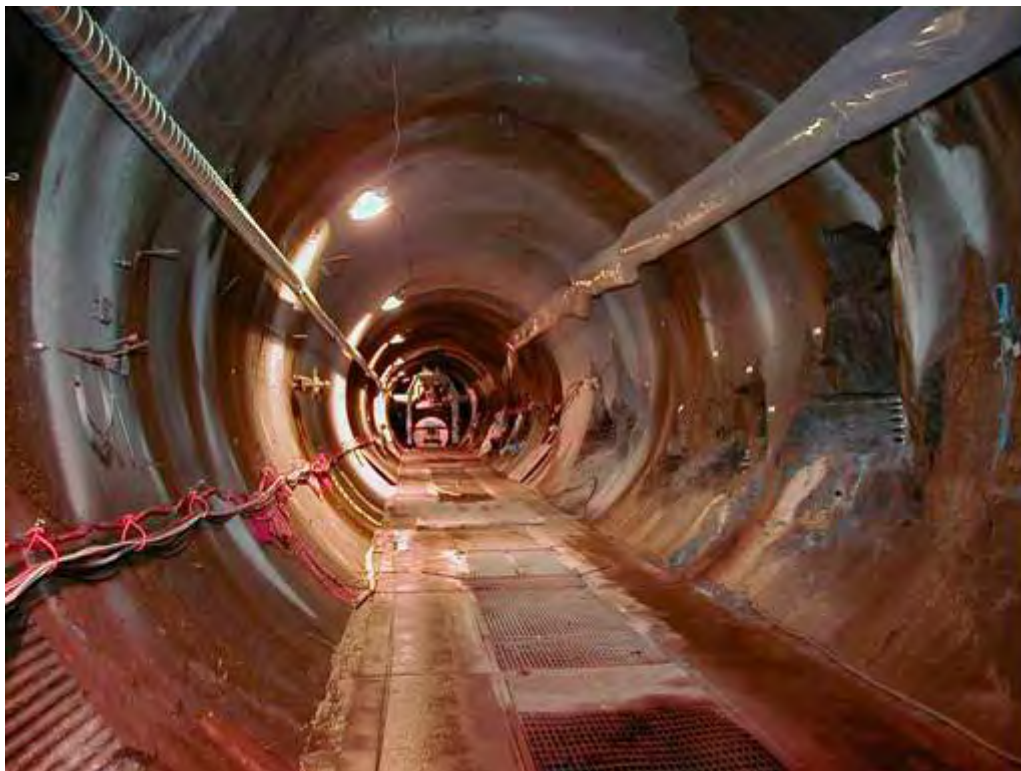
Figure 2-3. Prototype Repository tunnel with installed roadbed.

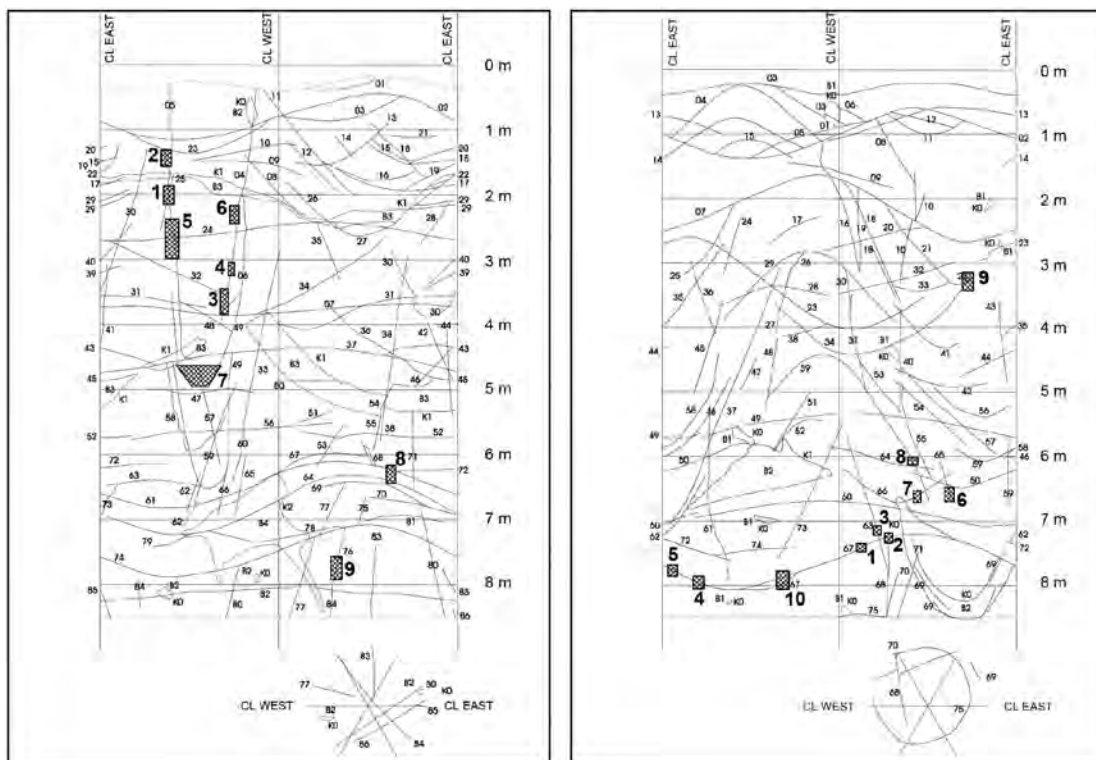
Figure 2-10. Fracture mapping in deposition hole No 5 (left) and No 6 (right). Water-bearing features are marked with shaded areas. (Figures 2-6 and 2-7 in Pusch and Andersson 2004.)

Each finished deposition hole was carefully mapped. Figure 2-10 visualizes the fracture pattern in the two deposition holes in the outer section.

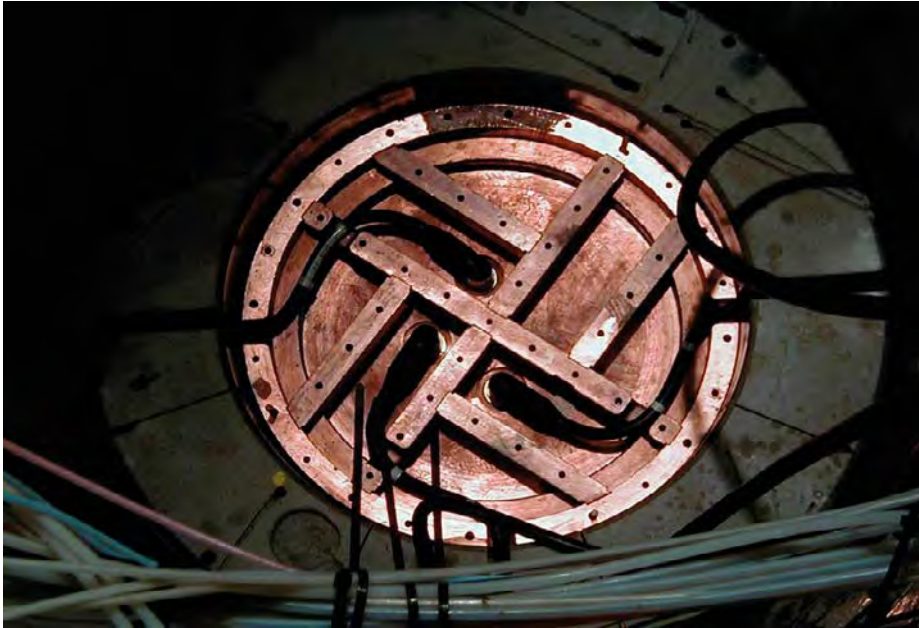
Figure 2-12. Connection of power supply cables to the canister lid. Supporting bars were mounted and on top of them a second lid in order to avoid any major swelling pressure on the cables.

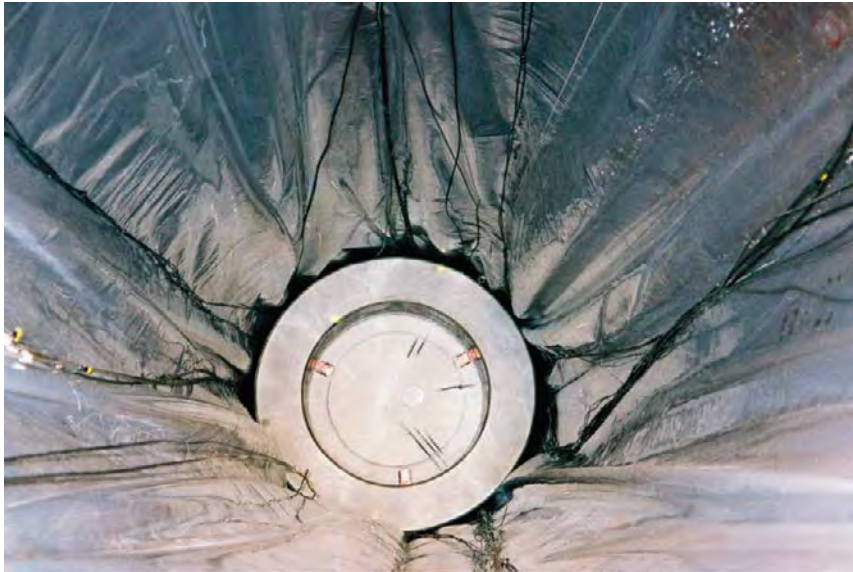
Figure 2-15. Buffer protection sheet seen from above. The bottom bentonite cylinder and the first ring have already been emplaced. (Figure 1-3 in Wimelius and Pusch 2008.)

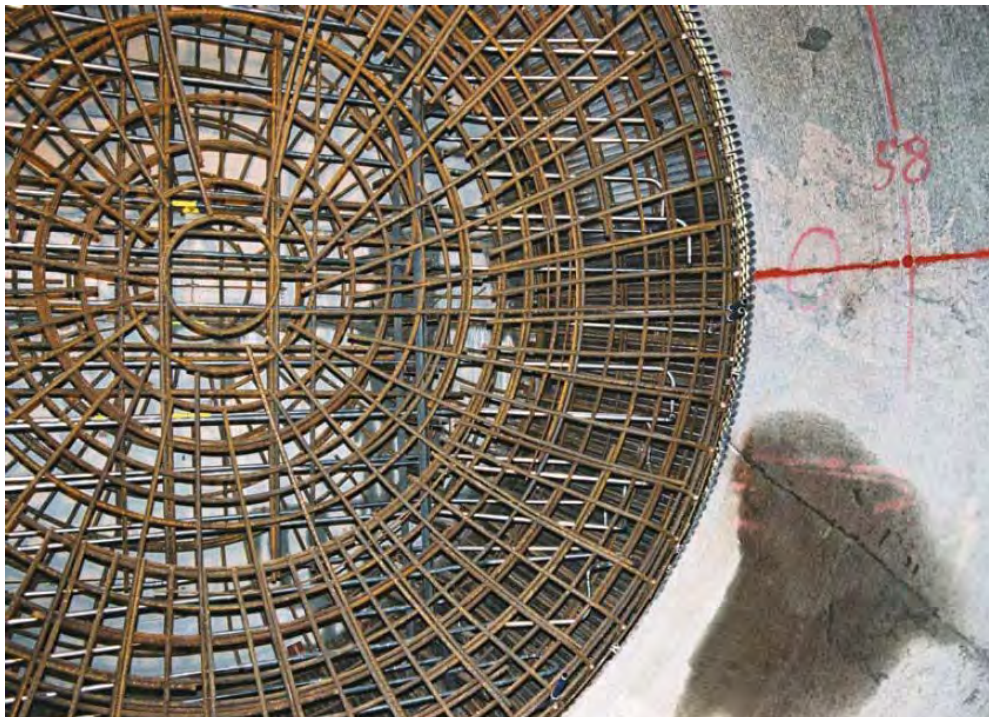
Figure 2-19. The outer reinforcement of the plug. (Figure 6-4 in Johannesson et al. 2004.)

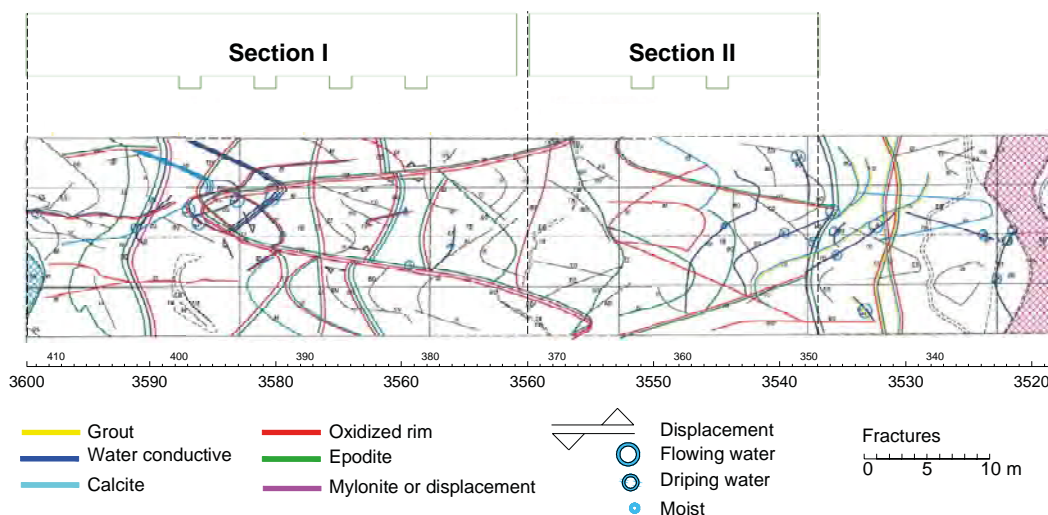
Figure 2-22. View of fractures and water-bearing features mapped by standard mapping procedure View of a projection being unfolded from the center line of the roof, and seen from above. The positions of the six deposition holes are indicated by the upper figure. More precisely the deposition holes No 5 and No 6 have their center positions at chainages 3551 m (i.e. at the position 3,551 m from the ramp portal at ground surface) and 3545 m respectively. (From Figure 7-3 in Johannesson 2014.)

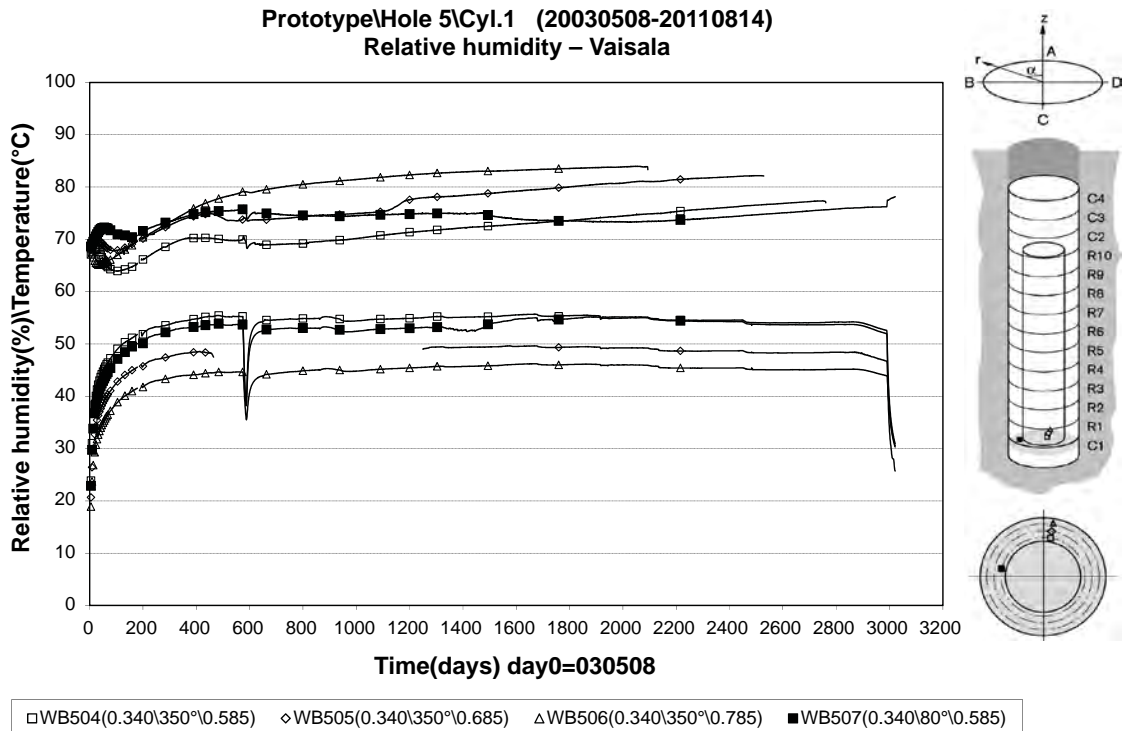
Figure 2-32. RH and temperature registered by four Vaisala sensors in block C1. The humidity is shown by the top graphs and the temperature by the bottom ones. The sensors' names are explained in the figure caption to Figure 2-31. (Figure at bottom on p 127 in Goudarzi 2014.)

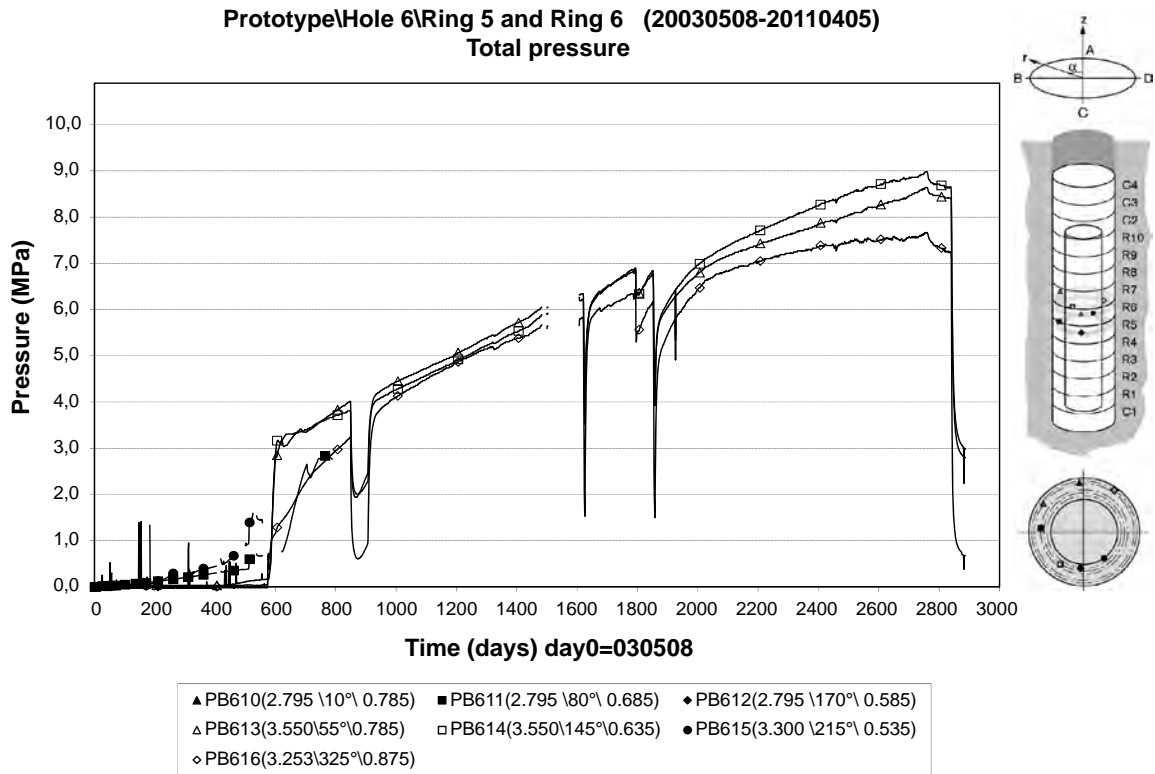
Figure 2-35. Total pressure registered by three Kulite (PB610, PB611 and PB612) and four Geokon (PB613, PB614, PB615 and PB616) sensors in blocks R5 and R6. All three Kulite and one Geokon sensors failed before day800. The sensors' names are explained in the figure caption to Figure 2-29. (Figure at top of p 146 in Goudarzi 2014.)

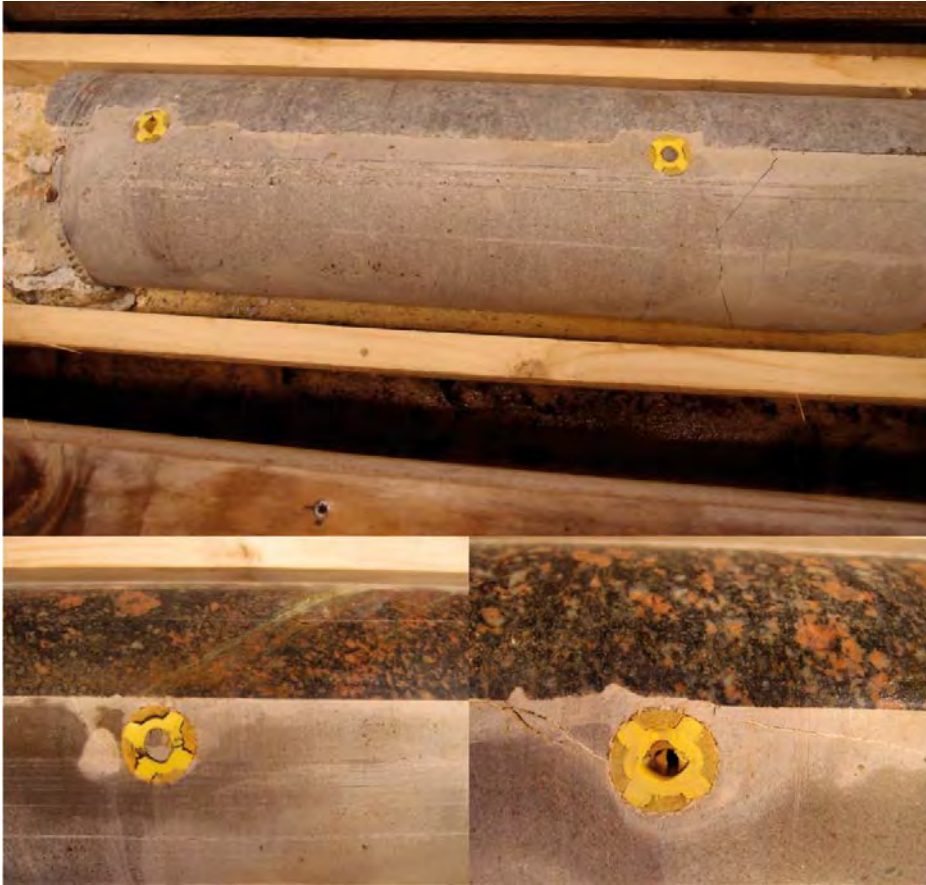
Figure 4-2. Close up pictures of the cores taken from the interface between concrete plug and rock. The yellow grouting tubes are embedded in grout. (Figure 2-6 in Johannesson and Hagman 2013.)

The visual inspection performed on the core samples showed that the contact grouting made after casting of the plug filled the gap between the concrete and the rock surface very well, see photos in Figure 4-2.

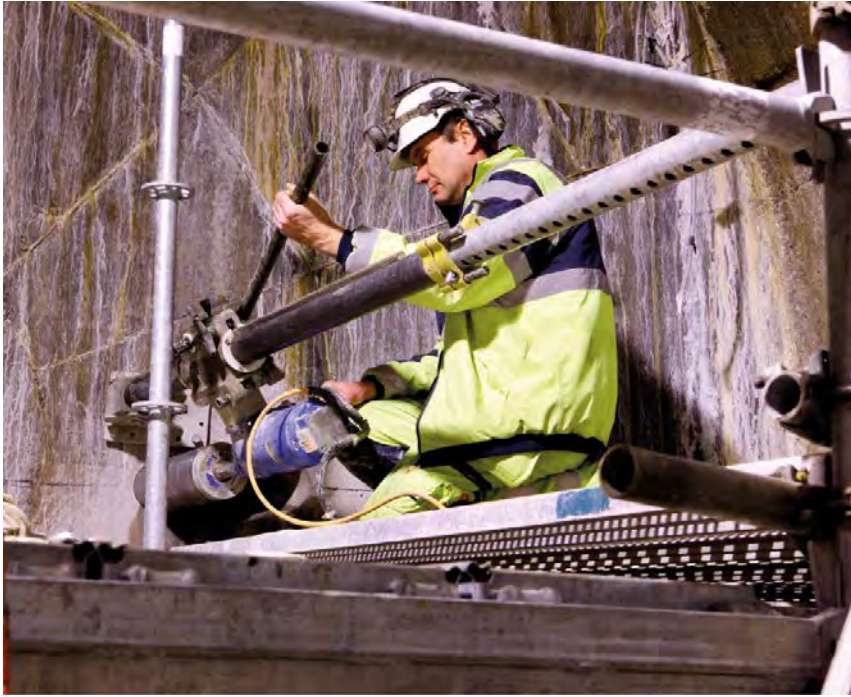
Figure 4-3. The rig used for core drilling through the concrete dome. (Figure 2-5 in Johannesson and Hagman 2013.)

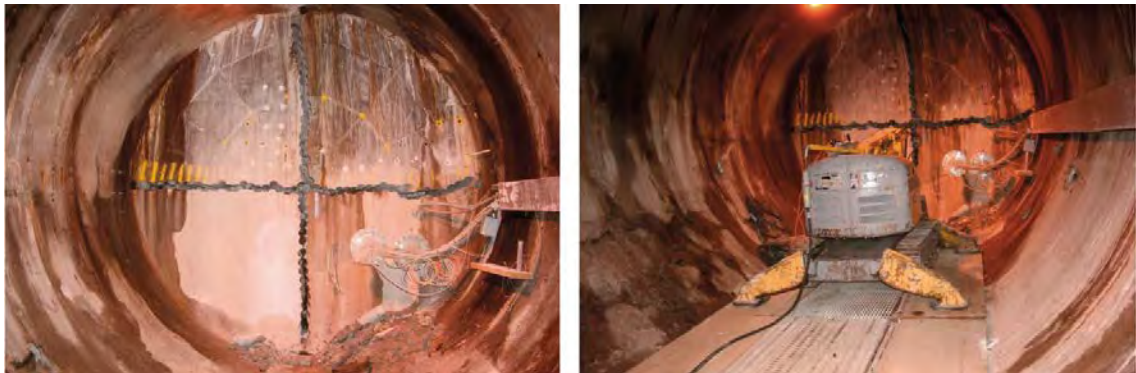
Figure 4-4. Left: The cross-like pattern of the core drilled holes through the plug. Right: The machine used for demolition of the concrete plug. (Figure 2-2 in Johannesson and Hagman 2013.)

The technique used to breach the plug was to first core drill through the outer part of the plug towards the retaining wall, see Figure 4-3. The boreholes were placed in an overlapping cross-like pattern, as shown by Figure 4-4. After the drilling, the breaching continued by mechanical demolition using a hydraulic breaker and a hydraulic hammer. The hydraulic breaker was vibrated into the concrete and then hydraulically expanded in order to create fractures in the concrete dome. After fracturing the plug was further demolished with the hydraulic hammer. When reinforcement became visible it was cut off by the use of a cutting blowpipe. Finally, the remaining of the plug was transported out from the tunnel with a front loader.

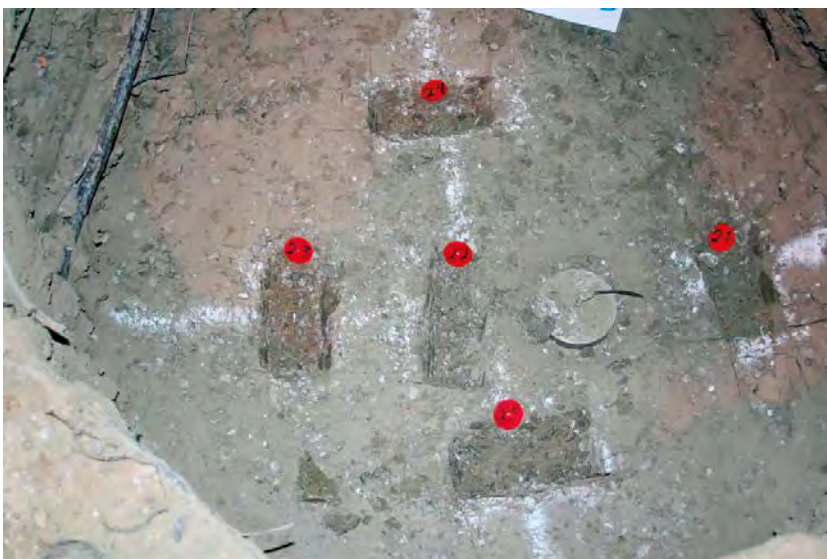
Figure 4-6. Samples taken from the tunnel backfill inside a deposition hole together with an installed sensor. (Figure 3-6 in Johannesson and Hagman 2013.)

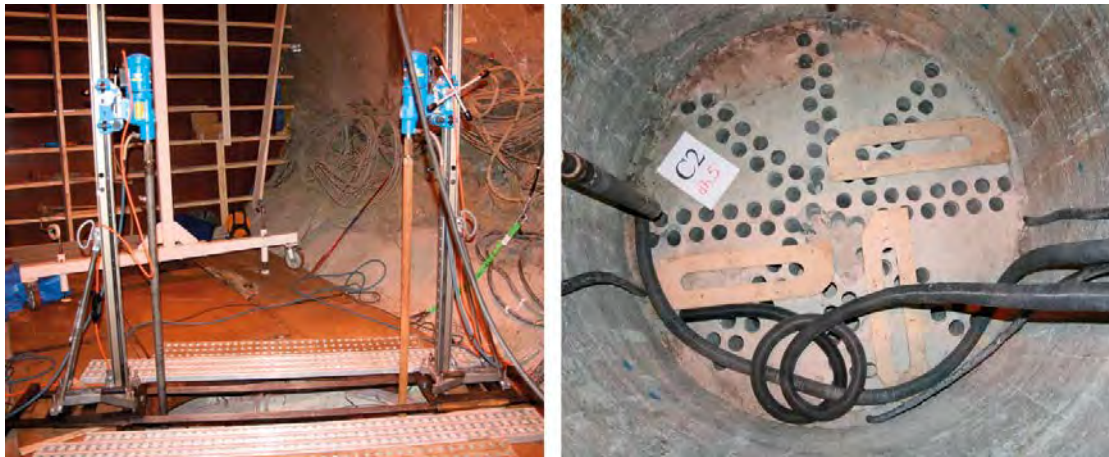
Figure 4-7. Left: The core drilling machines standing on the tunnel floor. Right: Holes from cores taken from a buffer block. Wooden templates were used to position the drill bit. (Figure 4-1 in Johannesson and Hagman 2013.)

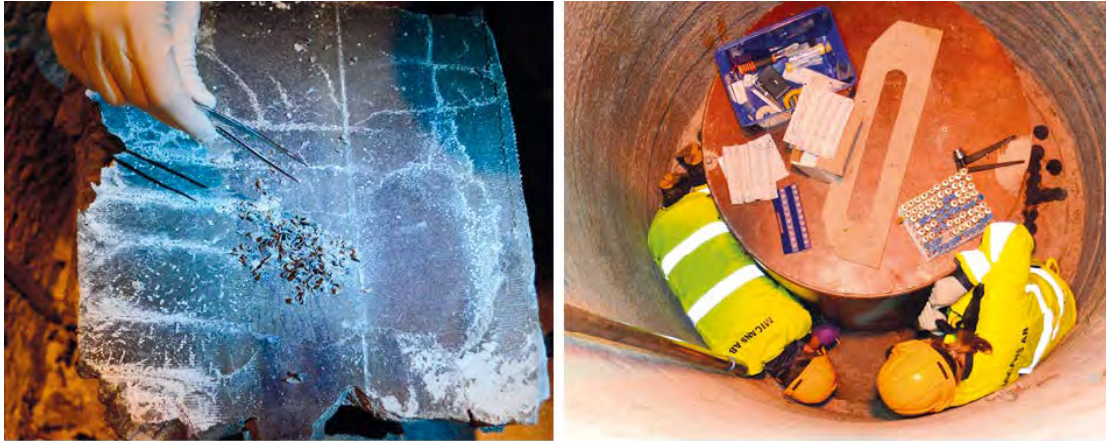
Figure 4-9. Left: The method whereby, using a sterile scalpel, bentonite samples were scraped off the buffer surface that had been in close contact with the copper canister. Right: The sampling site in deposition hole No 6. (Figure 2-2 in Arlinger et al. 2013.)

Microbial and molecular samples were taken also from the canister surfaces in deposition holes No 5 and No 6, (Arlinger et al. 2013). Two different methods were used: scraping off with a sterile scalpel and swabbing off with deoxyribonucleic acid /ribonucleic acid (DNA/RNA)-free cotton swabs soaked in sterile phosphate buffered saline (PBS). Figure 4-9 shows the sampling. The results of these analyses have been presented by Arlinger et al. (2013). A summary of the results is presented in Section 5.4.

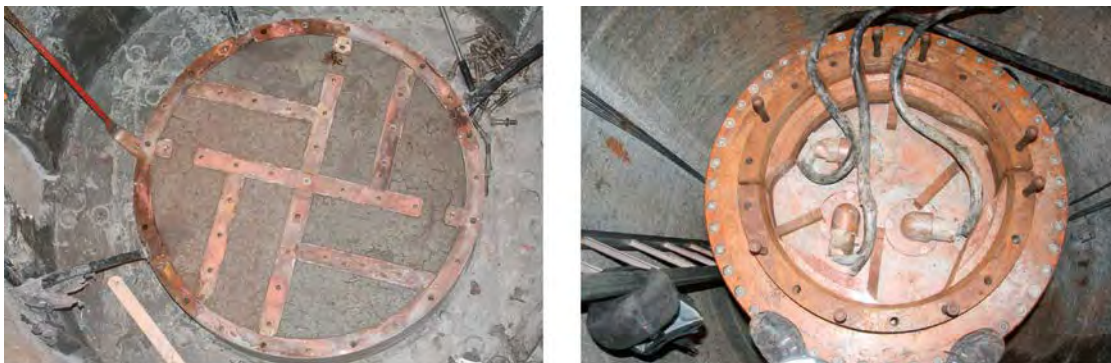
Figure 4-12. Left: After removal of the upper lid. Right: After removal of the bentonite/sand mixture and uncovering of the cables and their connections on the lower canister lid. (Figure 4-7 in Johannesson and Hagman 2013.)

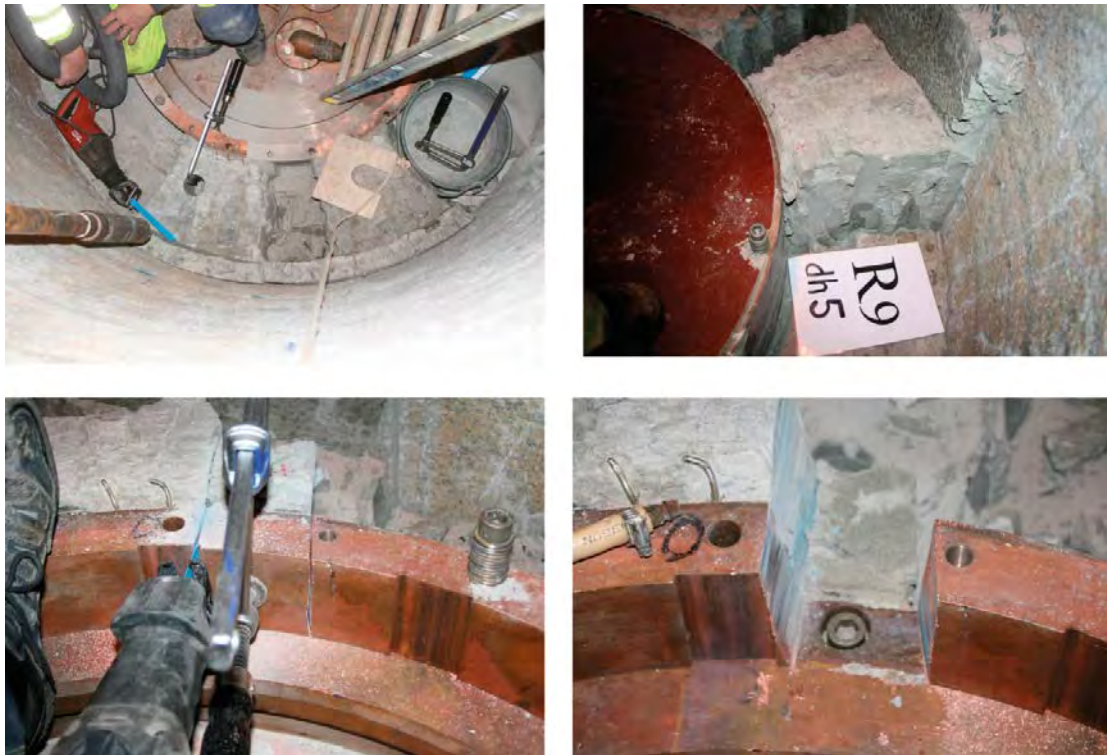
Figure 4-16. Sample taken of the canister in deposition hole No 5. Top left: Saved part of the buffer seen from above. Top right: Saved part of the buffer seen from the side. Bottom left: Sawing of the copper ring. Bottom right: Copper ring after the sample was taken. (Figure 5-7 in Johannesson and Hagman 2013.)

The sample taken from the upper part of the canister in deposition hole No 5 (Figure 4-16) was cut into smaller samples for various analyses (Taxén 2013). The samples taken from the canister in deposition hole No 6 were never used for corrosion examinations, only metallographic documentation, see Section 5.5.4.

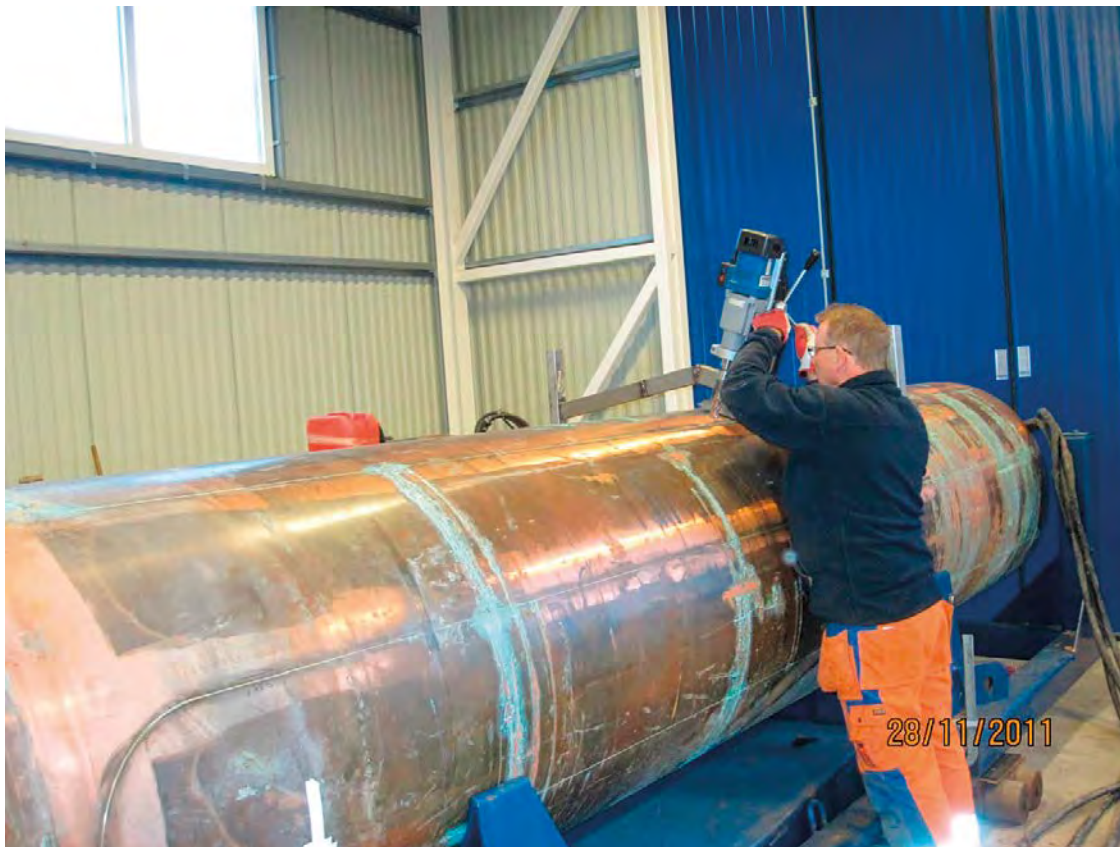
Figure 4-17. Sampling of the canister in deposition hole No 6 by drilling of 28 mm cores through the 50 mm thick copper shell. (Figure 2-2 in Taxén et al. 2012.)

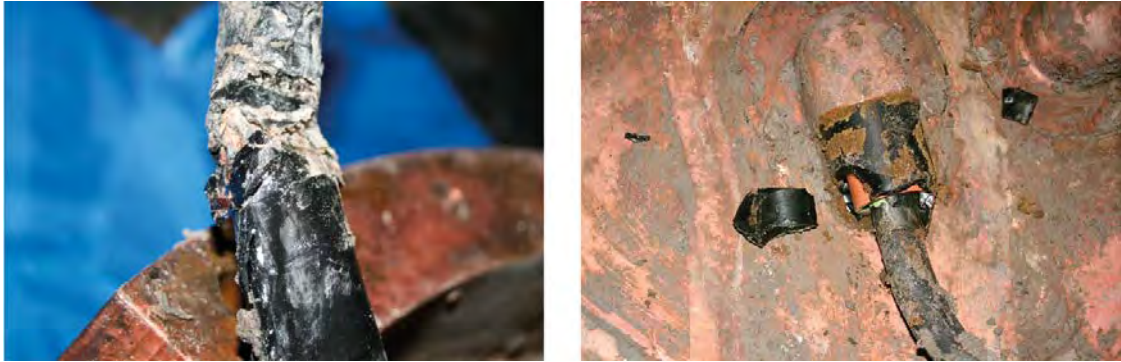
Figure 4-18. *Left: Damages observed close to the periphery of the canister. Right: Damages observed where the cables were going through the lower canister lid. (Figure 4-8 in Johannesson and Hagman 2013.)*

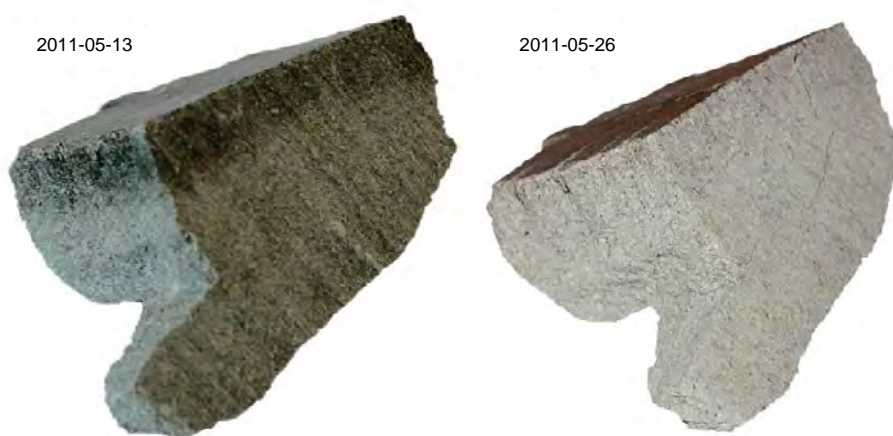
Figure 5-9. Bentonite sample from block R10 in deposition hole No 6. (Block position is shown in Figure 2-14). Left: Parts of the innermost 10 mm in the buffer block were dark at removal. Right: The darkness disappeared irreversibly upon drying. (Figure 3-56 in Olsson et al. 2013.)

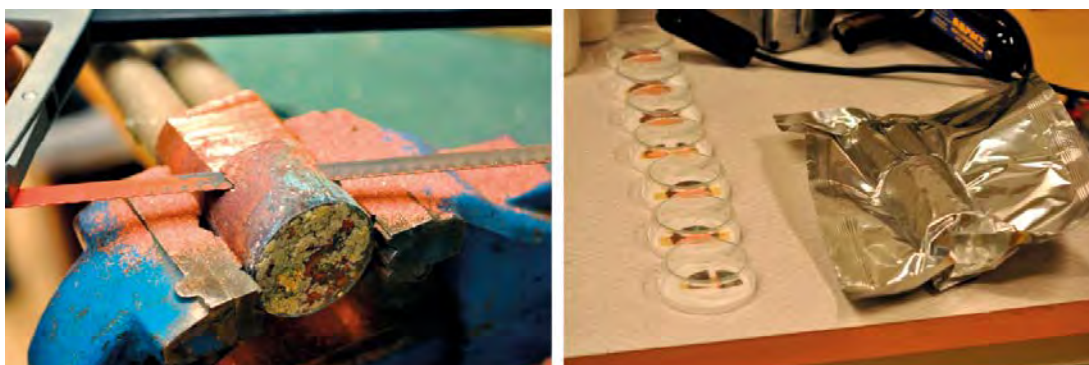
Figure 5-42. Left: Cutting out samples from the copper electrode “Black”. Right: Temporary storage of samples from the copper electrode “Black”. (Figure 2-4 in Rosborg 2013b.)

Copper electrode “Black” was removed from the small bentonite block by breaking loose small pieces of bentonite for later examination (Rosborg 2013b). One of the photographs in Figure 5-41 shows the copper electrode still in place in the bentonite block after removal of bentonite pieces, and the other shows the electrode during removal from the bentonite block. When the electrode had been removed, it was cut in a number of samples for further examination. The copper electrode was tightly fastened in a vice, see Figure 5-42, and a horizontal cut was made by a handsaw. Step by step vertical cuts were made to release samples of suitable size.

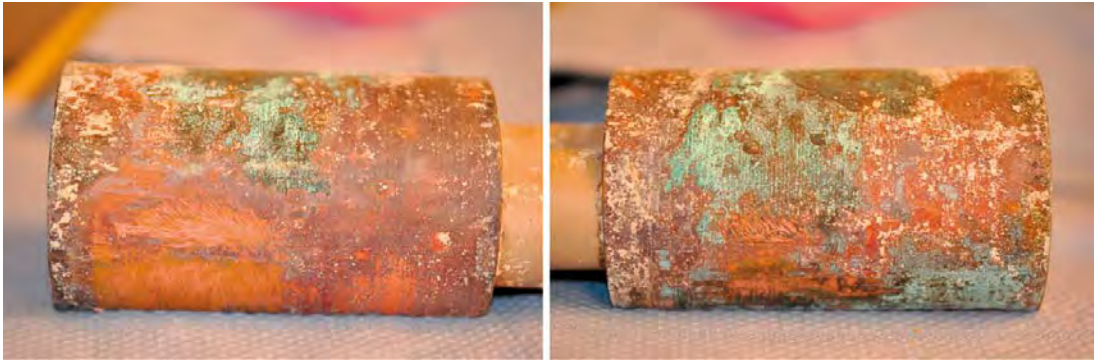
Figure 5-43. The two photographs show where corrosion products were scraped off from copper electrode “Black”. Left: the sample area termed “H” where mainly brownish corrosion products existed. Right: the sample area termed “V” where mainly blue-green corrosion products were sampled. (Figure 2-5 in Rosborg 2013b.)

XRD measurements, FTIR spectroscopy, and Raman spectroscopy were employed by Rosborg (2013b) to identify corrosion products on the copper electrode. Corrosion products for XRD measurements and FTIR spectroscopy were scraped off from two surface areas of the copper electrode “Black”, see Figure 5-43. One area (termed “H”) contained mainly brownish, and one area (termed V) mainly blue-green corrosion products. FTIR and Raman spectroscopy were also applied on corrosion products remaining on the surface of electrode “Black”.

A USB microscope (digital microscope which connects to a computer via a USB port) was used to examine the surface on the copper electrode (seen in Figure 5-43) at a magnification of about 50x. Some areas were also viewed at a higher magnification. SEM was used to examine areas of the surface in more detail. A Nova 600 NanoLab DualBeam™ SEM/FIB instrument was used to prepare a few “micro-cross sections” through the electrode surface by means of focused ion beam milling to examine and characterize the corrosion product layer on the electrode (Rosborg 2013b).

The performed FTIR and Raman spectroscopy confirmed the observation (Rosborg 2013b). The FTIR spectra from the KBr transmission measurements on corrosion products from sample areas “V” and “H” (see explanation to labels “V” and “H” in caption to Figure 5-43) were dominated by bands from bentonite, but the spectra had also bands from malachite and cuprite. Malachite was

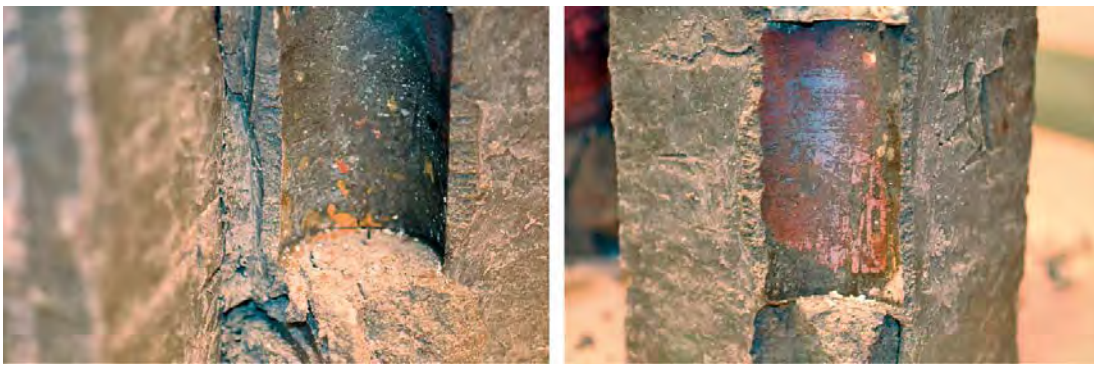
Figure 5-44. Corrosion products still remaining on adjacent bentonite after removal of the electrode. (Figure 3-1 in Rosborg 2013b.)

Rosborg (2013b) suggested from the appearance of the copper electrode, when part of the surrounding bentonite had been removed, see Figure 5-44, that both Cu(I) and Cu(II) corrosion products existed on the electrode surface and that they had been formed during the seven years of exposure. The blue-green corrosion material, suggested to be Cu(II) products, was unevenly distributed on the surface of the electrode (electrode “Black”). They were more abundant on some parts of the electrode. Corrosion products were also found on the adjacent bentonite after removal of the copper electrode from the bentonite block, see Figure 5-44, thus revealing a better adherence to the bentonite on that part of the surface. Four photographs of the electrode, after it had been removed from the bentonite block, are shown in Figure 5-45.

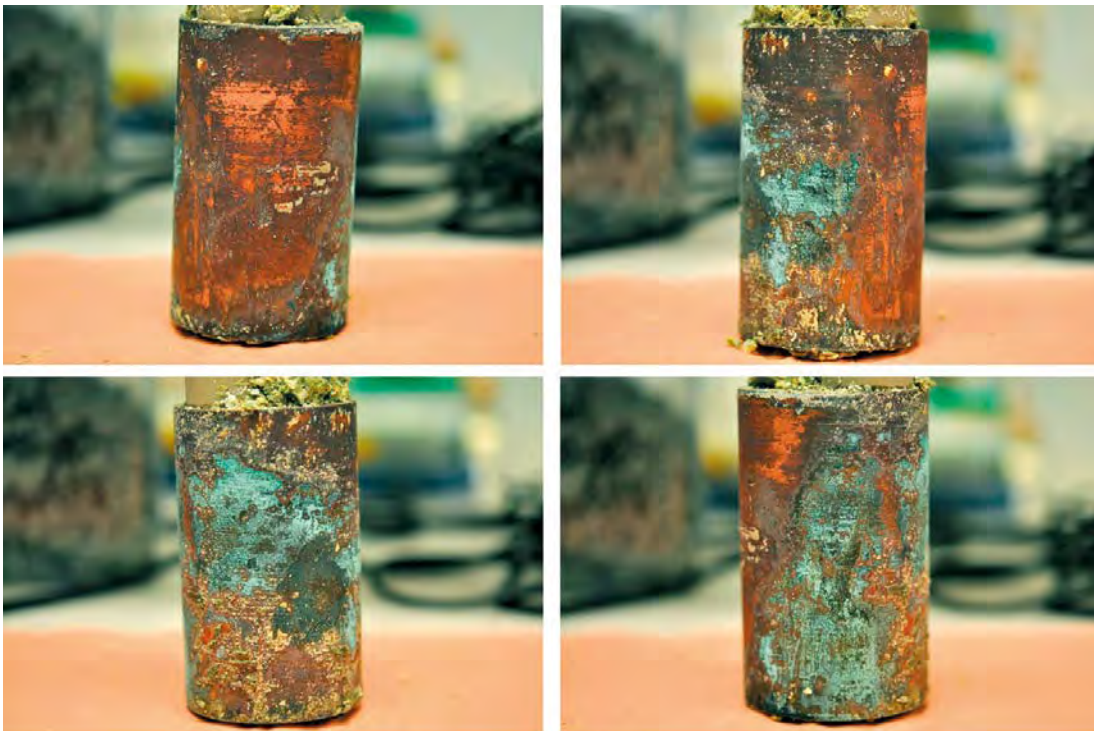
Figure 5-45. Appearance of copper electrode “Black” immediately after removal from the bentonite block. The top pictures show the two sample areas termed “H” (left) and “V” (right) in Figure 5-43. (Figure 3-2 in Rosborg 2013b.)

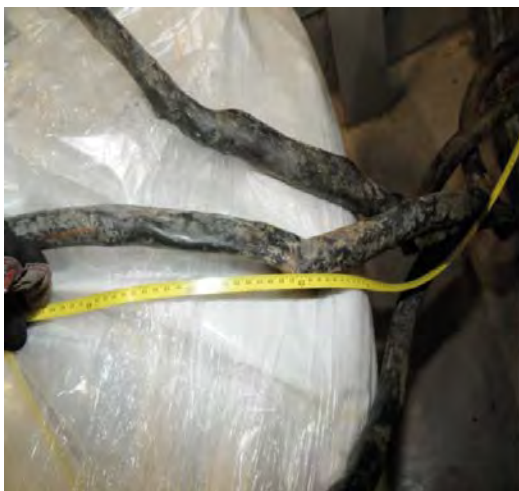
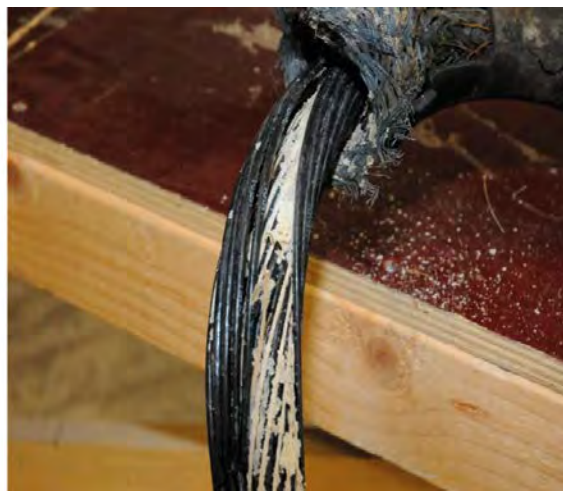
Figure 5-46. Damaged cable in deposition hole No 6.

Deformed cable from canister in deposition hole No 6.

Stripped cable from canister in deposition hole No 6 with exposed wires.

Each cable was cut at 3–4 meters distance from the canister and a first visual inspection indicated extensive damage because of the major deformation and external damage to the insulation, see Figure 5-51 (left picture). The insulation was stripped at the ends so that the wires could be identified and then measured for each pair of earth resistance and insulation, see Figure 5-46 (right picture). The grounding wire was oxidized which also was a result of the damaging of the outer insulation.

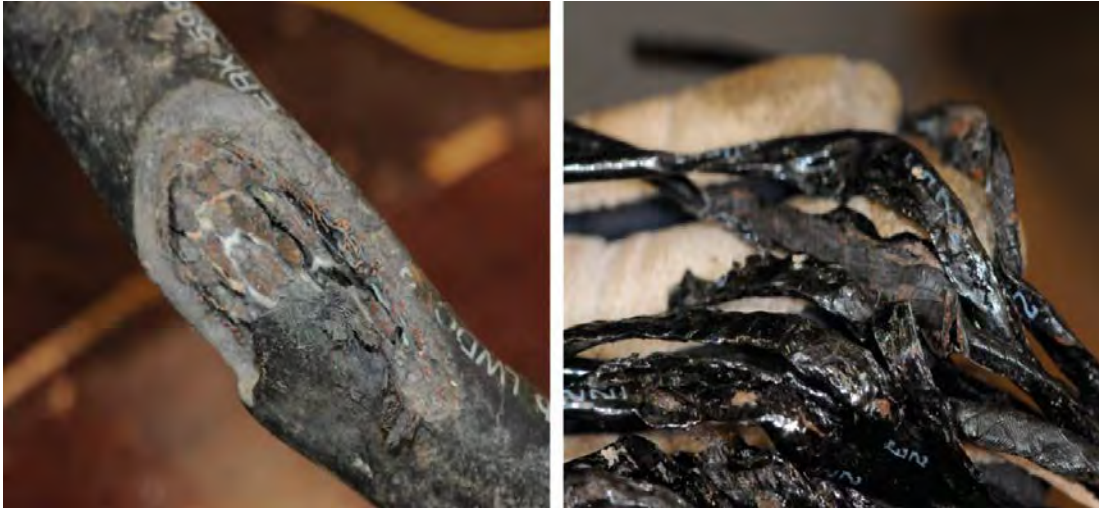
Drill damage on cable from canister in deposition hole No 6.

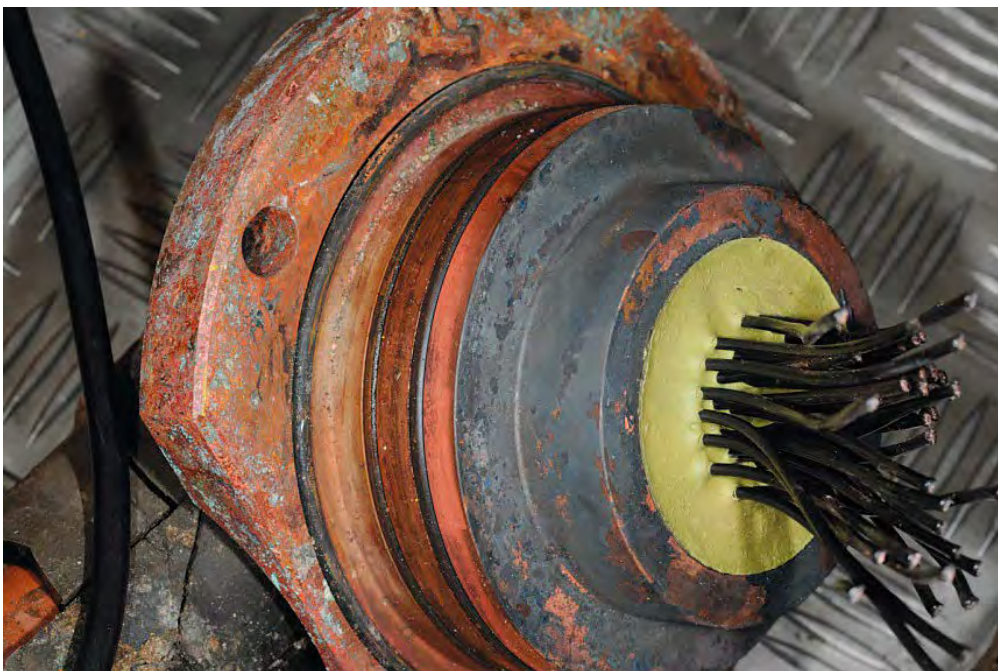
Figure 5-48. "Nose" for electrical wire penetrations. Corrosion products were found only inside the first O-ring.

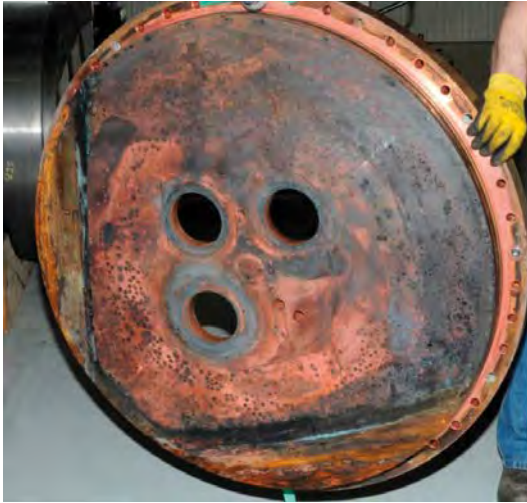
Corrosion products on the inside of the lid of the canister in deposition hole No 6. Corrosion have turned the copper surface black

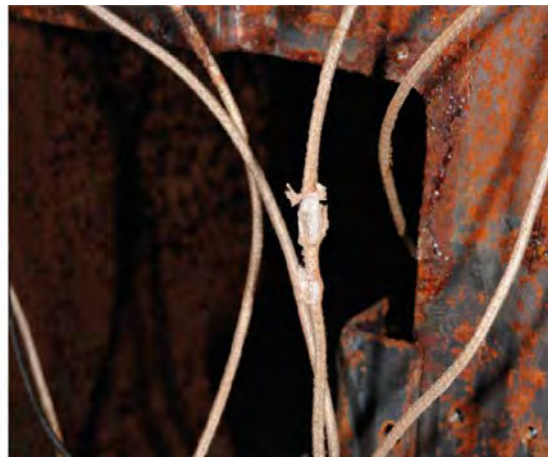
Figure 5-52. Examples of damage to wires to heaters in the canister in deposition hole No 6.

Chafed insulation on wire to the canister.

Resistance measurements showed good results with respect to wire to wire, but no good result with respect to resistance to ground, which was low and indicated ground faults. A few errors on single wires were also noted due to abraded or frayed insulation. Figures 5-52 shows example of damage observed on wires of heaters in the canister in deposition hole No 6.

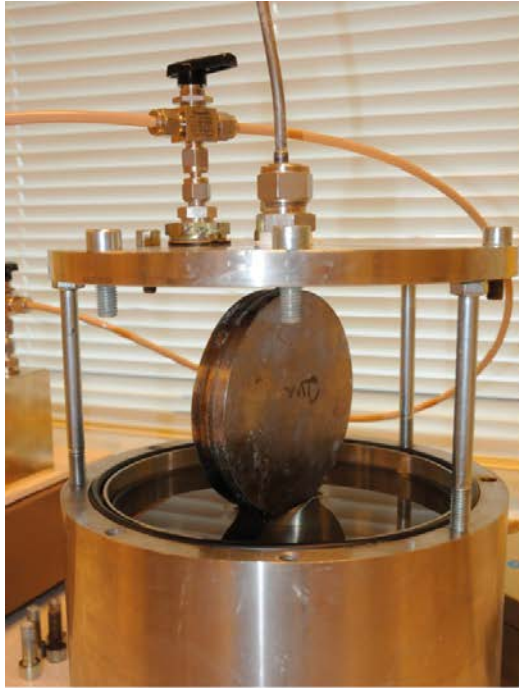
a) Test cell with a total pressure sensor before immersion into water.
