**P-16-12**

Äspö Hard Rock Laboratory

# Long Term Sorption Diffusion Experiment (LTDE-SD)

## Over-core drilling and extraction of core samples

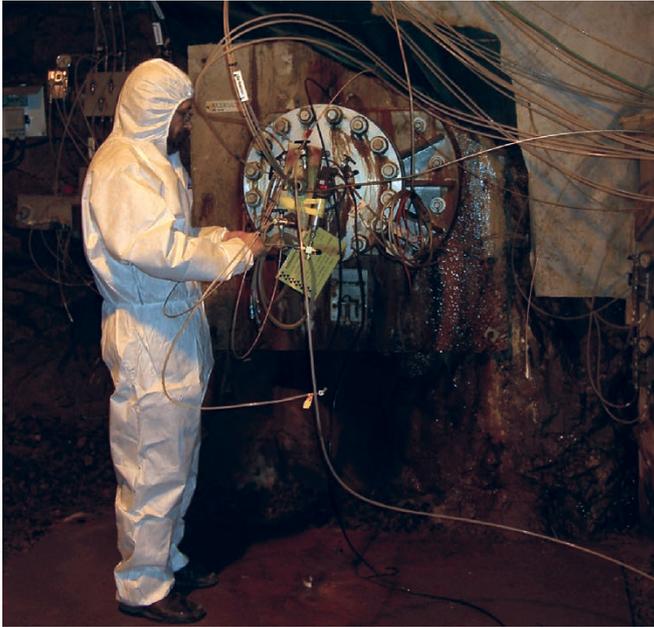
*Figure 2-4. Cutting circulation tubes under pressure at initial phase of epoxy resin injection.*

The epoxy injection started on 12 April 2007 at 20:50 hours, after cutting the tubes under pressure as close to the borehole as possible using a specially developed technique (Appendix 3; Figure 2-4). The purpose of cutting the tubes was to ensure that filling up of the borehole sections with Epoxy resin would be obtained before it had cured and to reduce the pressure due to flow friction.

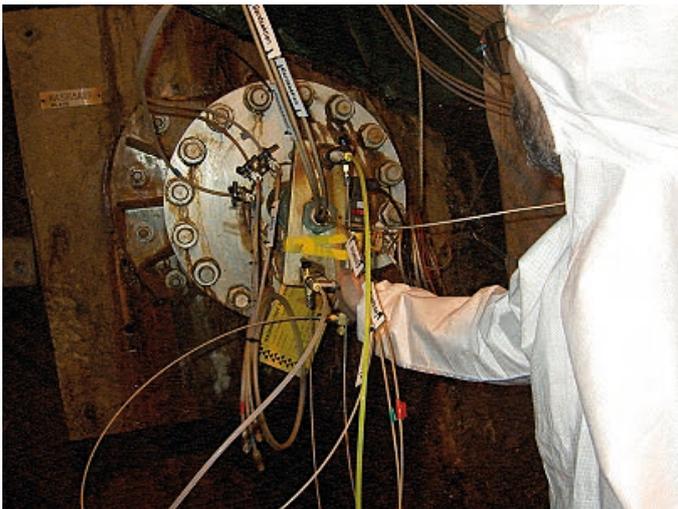
*Figure 2-5. The yellow coloured (EpoDye) epoxy resin being injected at the KA3065A03 borehole collar.*

The injection (Figure 2-5) continued for about five hours, see Table 2-4. As expected the injection flow rate was reduced with time as the epoxy resin cured. At 23:48 hours a clearly visible epoxy front was noticed in the outgoing tube. (A mixture of isopropanol and Epoxy is present in the bottle in Figure 2-6). An increased g-dose rate was indicated in the front between the isopropanol and the Epoxy resin, measured using portable equipment. Targeted measurements indicated that the activity was not in the Epoxy resin in the bottom of the sampling bottle, but in the entire bottle, thus indicating that the activity was transported in the Epoxy front in contact with the isopropanol.

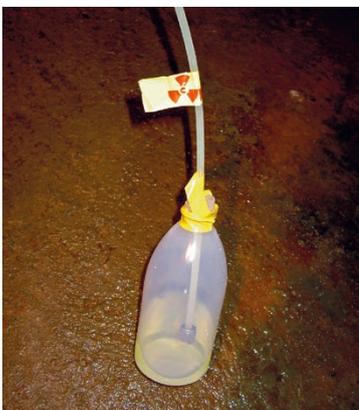
*Figure 2-6. Mixture of isopropyl alcohol and yellow coloured epoxy resin collected at KA3065A03 outlet tube during epoxy resin injection.*

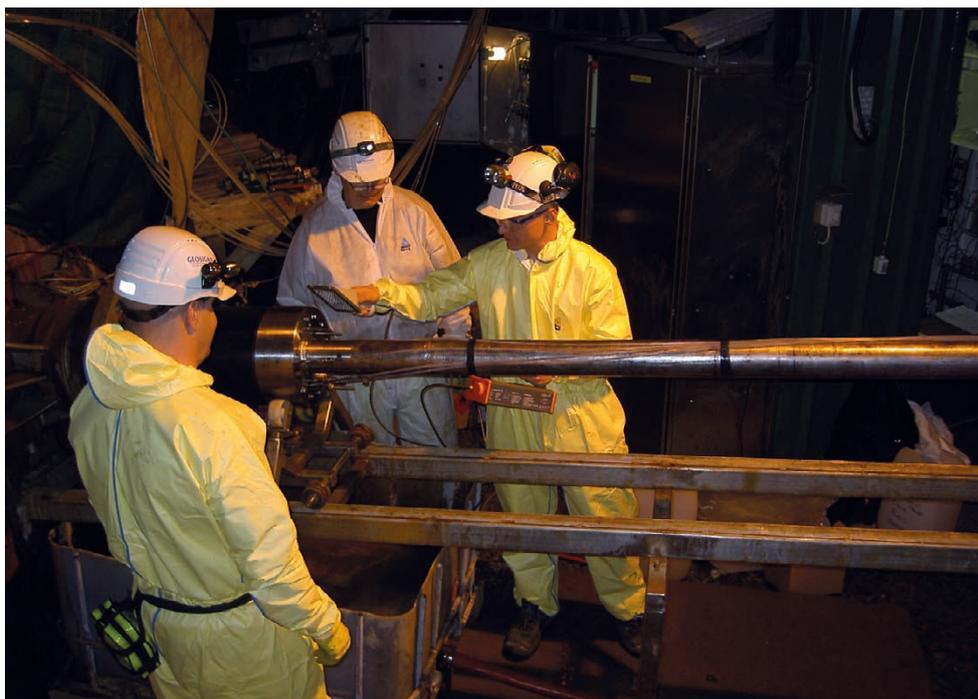
*Figure 2-8. Measurement of radioactivity by scintillation detector during the procedure of removal and dismantling.*

A scintillation detector was used to measure the radioactivity during the procedure of removal and dismantling, with most borehole equipment showing no rise above the background (10–15 cps = counts per second). The hydraulic packers and the supporting steel plate for the PEEK lid gave values of about 20–25 cps (Figure 2-8). This may be a result of extra Rn daughters accumulating on the borehole walls sticking to these larger objects as they were slowly hauled out of the borehole. The smaller pipes that didn't touch the walls gave lower count rates. Smear testing by Clab (intermediate storage for spent nuclear fuel in Oskarshamn) radiation safety personnel cleared the entire equipment for storage.

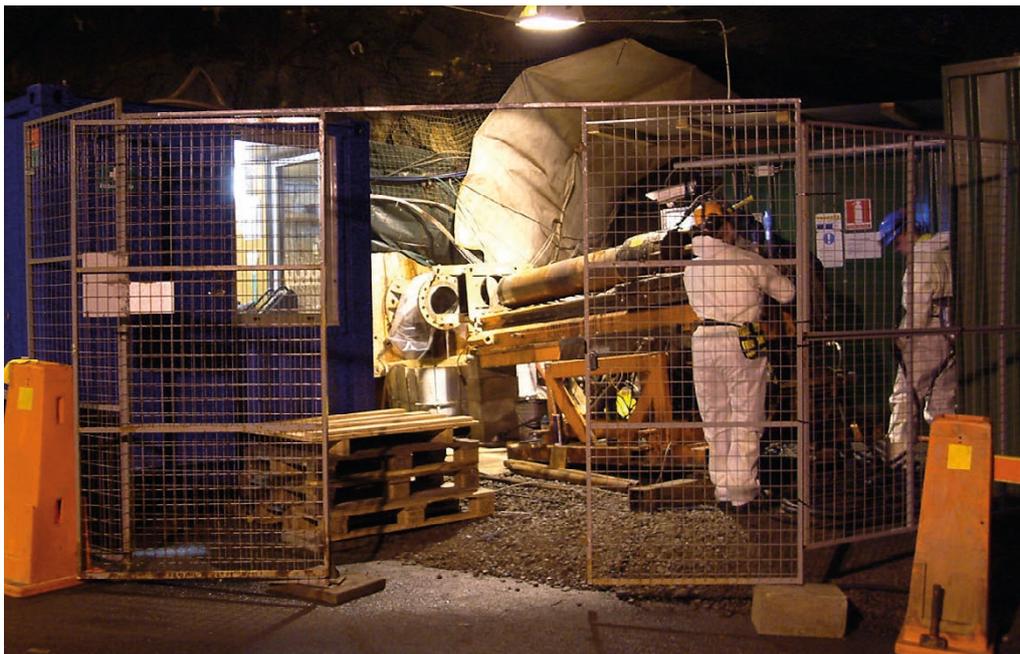
*Figure 2-11. Drilling machine (Onram 1000) with 300 mm diameter drillbit and core barrel are checked prior to over-core drilling borehole KA3065A03.*

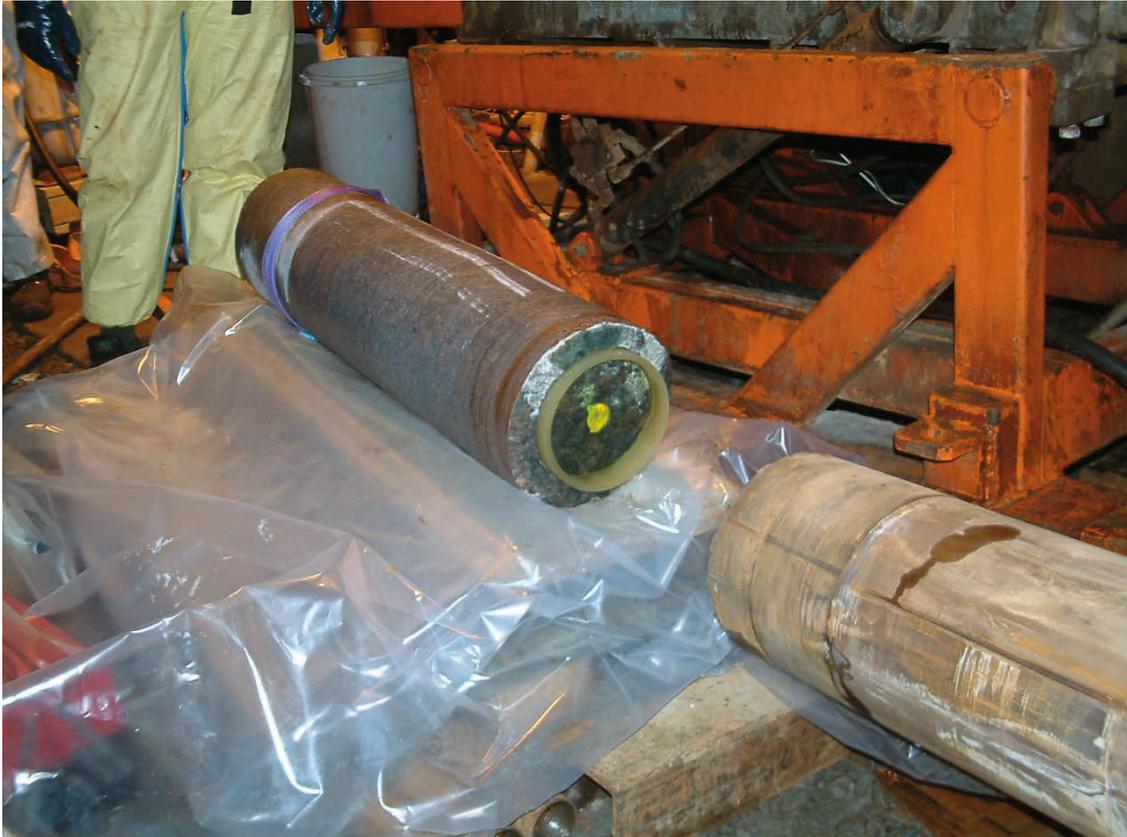
*Figure 2-13. One piece, 278 mm diameter, 10.74–11.82 m core retrieved from over-core drilling of borehole KA3065A03. Target fracture with the 177 mm diameter core stub inside the cylindrical PU sealing where radionuclide tracers were circulated.*

Overall, the effective drilling time was approximately 5.5 hours for the drilling from stub surface on target fracture at 10.74 m borehole length to stop of drilling at 12.11 m. Flushing water flow was 40 litres per minute, giving a total of 13.3 cubic meters of flushing water flowed past the stub surface and outer surfaces of the large 270 mm diameter core until it was retrieved from the borehole. As described above HPGe measurement of water samples showed occasional radionuclides from the experiment in the water flowing out of the borehole. This was caused by desorption of radionuclides from the stub surface due to the flushing during drilling. As a consequence, radionuclides may have sorbed on core surfaces outside the initially sealed stub surface exposed to radionuclide tracers during the experiment.

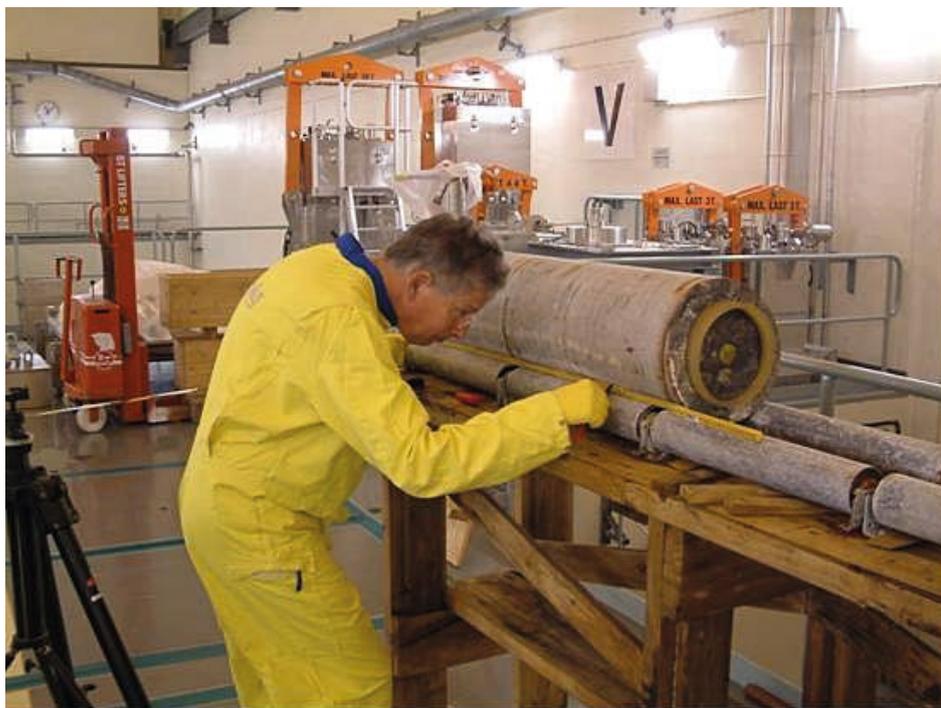
*Figure 3-1. Marking of core lengths starting from zero at top of core.*

- A. With a line along the core axis marked in cm, with chainage zero at top end of core (Figure 3-1 and Figure 3-2).
- B. With 8 letters from A at chainage line, to H, all approximately equally distributed clockwise (as viewed from core top) around the perimeter of the core at top end.
- C. Two probable pinch bar marks end of core were marked with double rings, and the two uncertain with single rings (Figure 3-4).

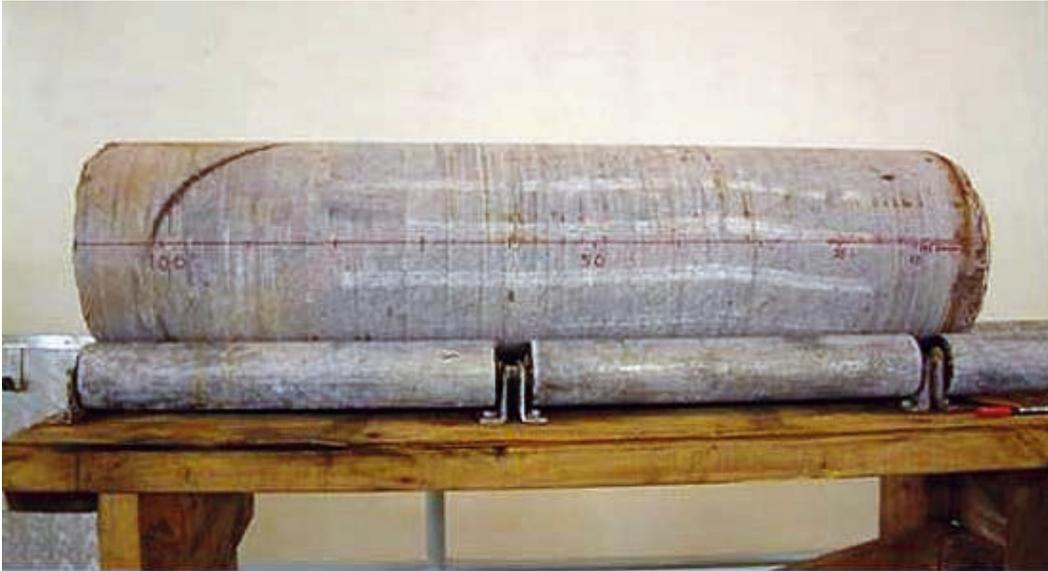
*Figure 3-2. Drill core with chainage markings.*

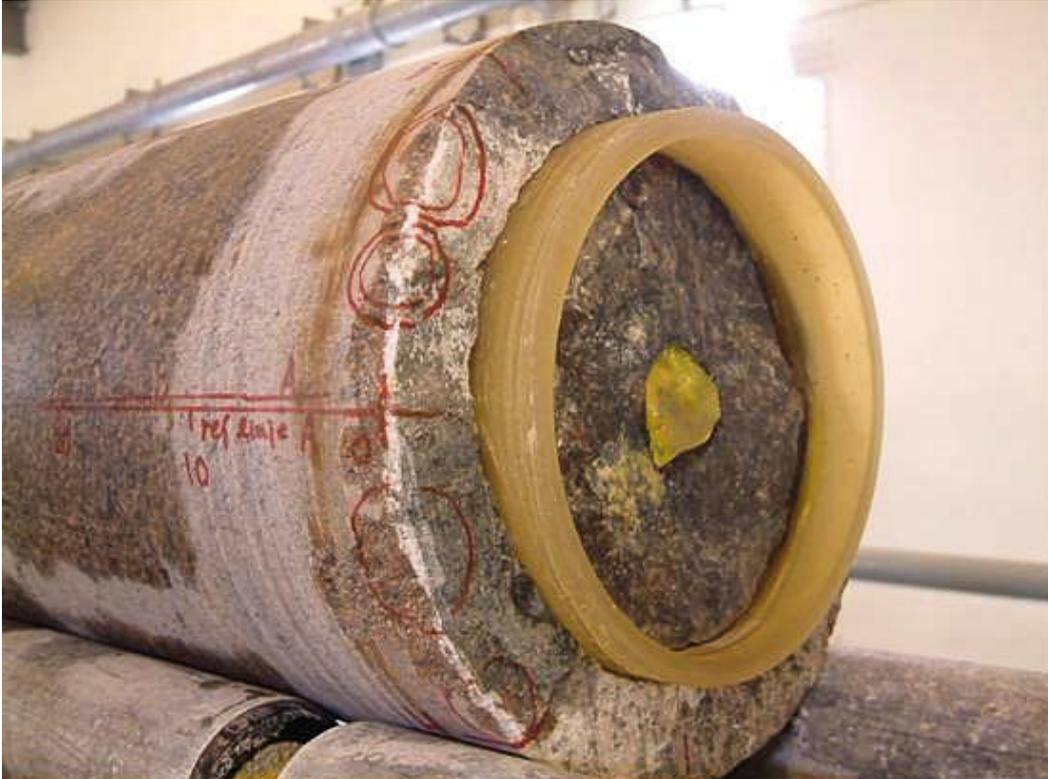
*Figure 3-3. Upper end of core with PU cylindrical sealing and epoxy filled 36 mm pilot centre hole.*

The drill core was hoisted to the core-logging desk by means of a fork lift and a travelling crane. The drill core was covered with plastic foil, which was removed and the core was examined for radiation by means of a scintillation meter. Only at the upper end (Figure 3-3) minor radiation was detected. Before drilling, the core top end had been punched twice at hole invert by means of a pinch bar, for core orientation purpose. Top end of core was examined for these marks. Two probable punch marks and two uncertain marks were identified. Additional information concerning the assumed orientation of the drill core is presented in Section 4.1.1.

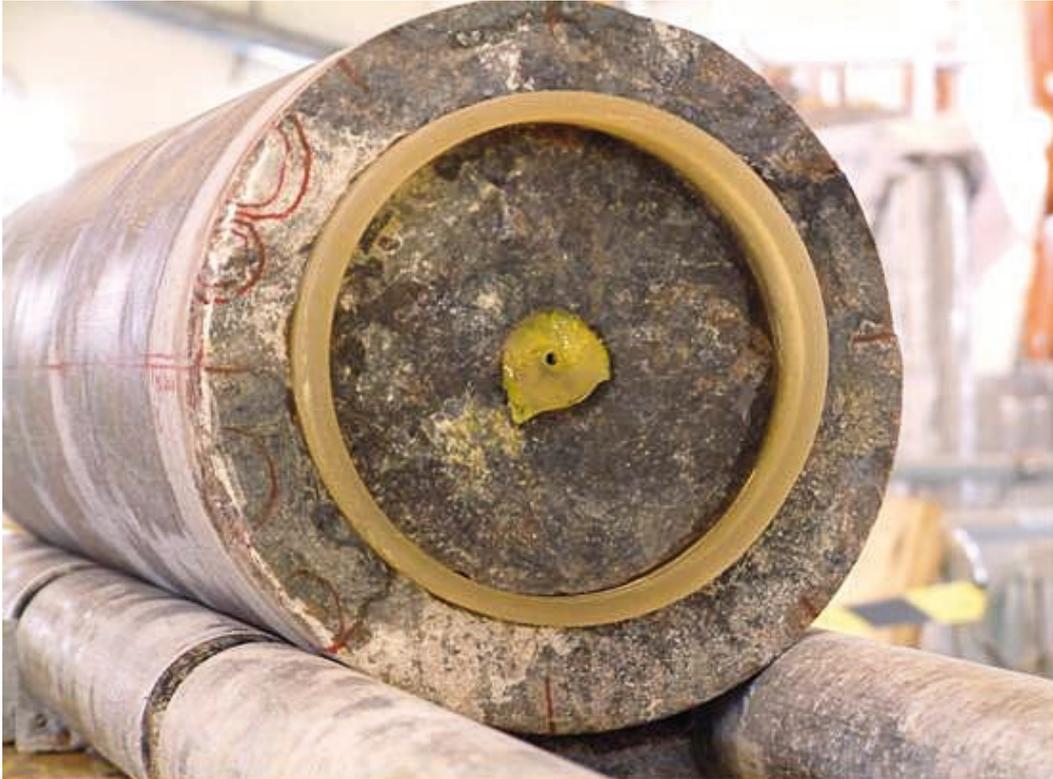
*Figure 3-4. Pinch bar marks highlighted on upper end of core. Double rings indicate probable marks, single rings indicate uncertain marks.*

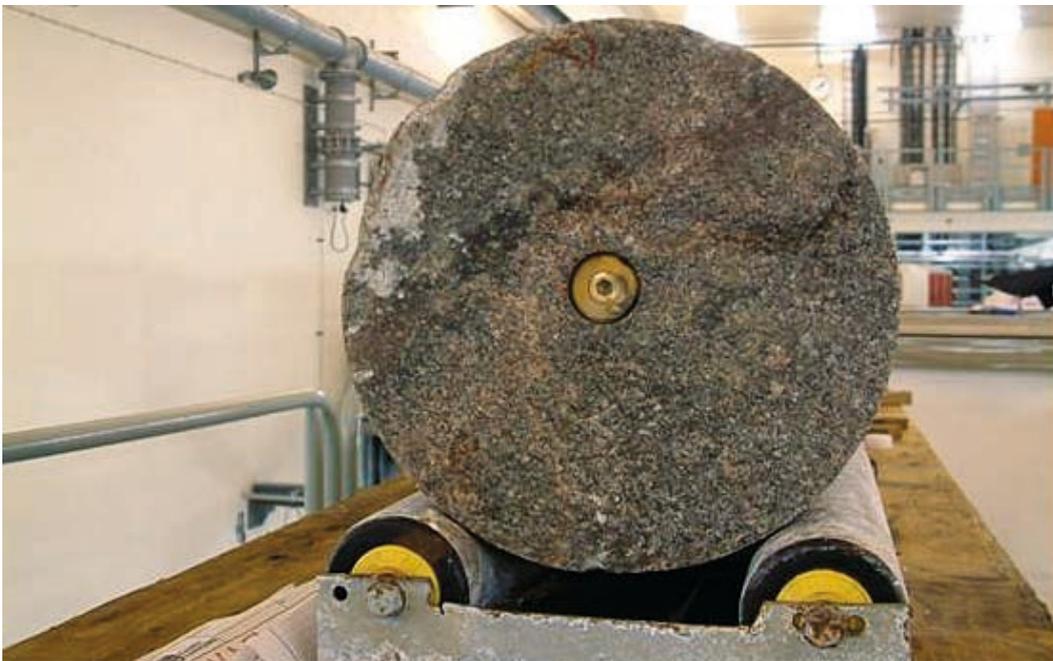
*Figure 3-5. Induced breakage of down end of drill core also showing the 36 mm extension hole filled with equipment for sealing test section.*

The induced breakage of down end of the drill core is shown in Figure 3-5.

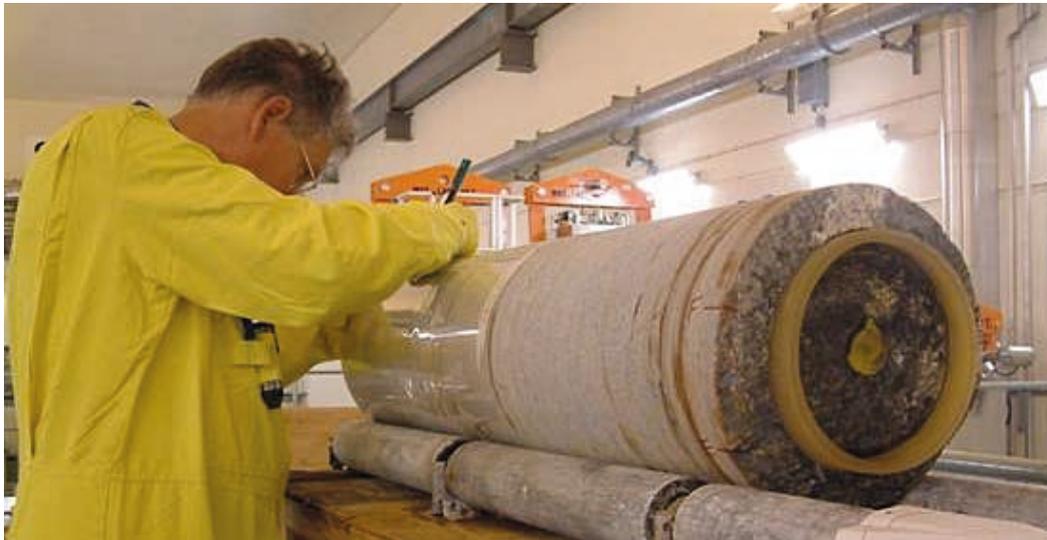
*Figure 3-6. Mapping fracture traces on core.*

Rock type was described by means of unaided eye inspection. Subsequently, the core envelope surface was covered with transparent drawing film, on which fracture traces were drawn (Figure 3-6).

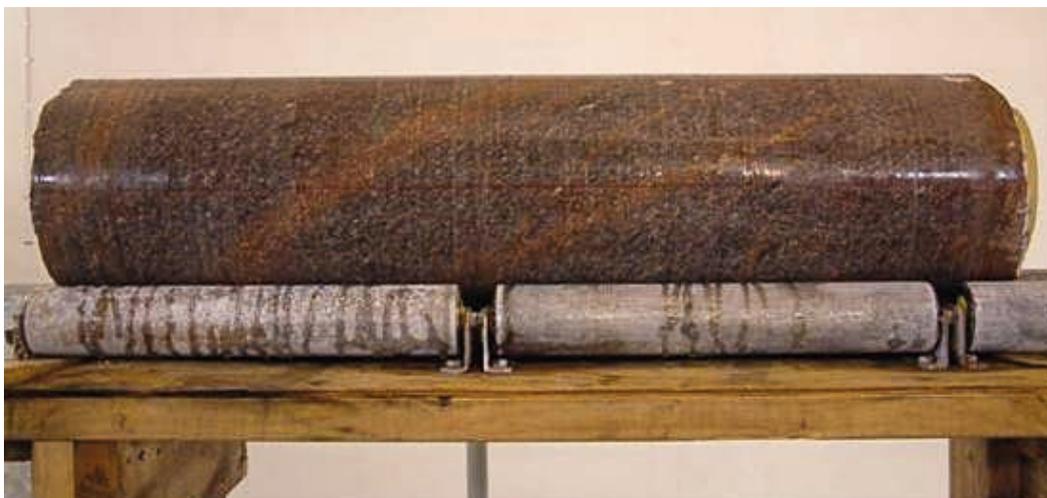
*Figure 3-7. Drill core rotated to position A (chainage line) facing camera lens. Rock is a so-called Ävrö granite with a diffuse foliation or lineation. Reddish miscolouring is aligned with fractures sealed with quartz or another hard mineral.*

The rock type is a so-called Ävrö granodiorite with lineation or a slight foliation. The grain size is medium to coarse, and the colour is greyish red. Along three fractures sealed with a hard mineral (quartz?) the rock is miscoloured in red about 2 cm on either side of the fractures (Figure 3-7).

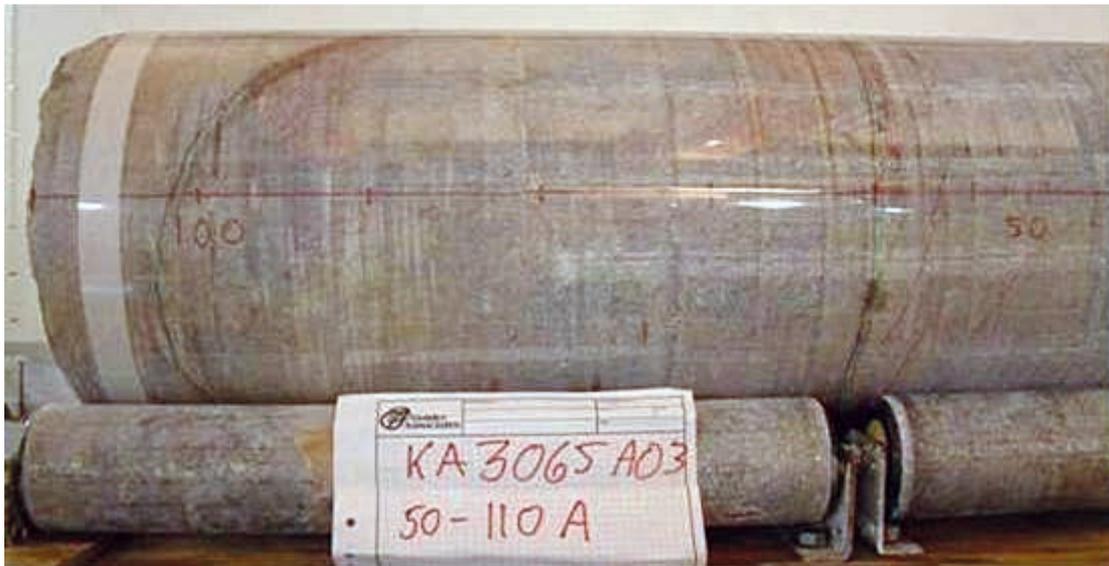
**Figure 3-8.** Down part of core 50–110 cm rotated to position A. Two traces of open fractures are marked with green and three short sealed fractures marked with red. The open fracture at 60 cm intersects the core with an angle of 90°, and the other at 80 cm has an angle with core axis of 45°.

Figure 3-8 to Figure 3-11 show the down end of the core, chainage 50–110 cm, wrapped with drawing film with mapped fractures of the first two types. As can be seen from the figures, the fractures do not propagate continuously through the core, which explains why the fractures failed to break during drilling.

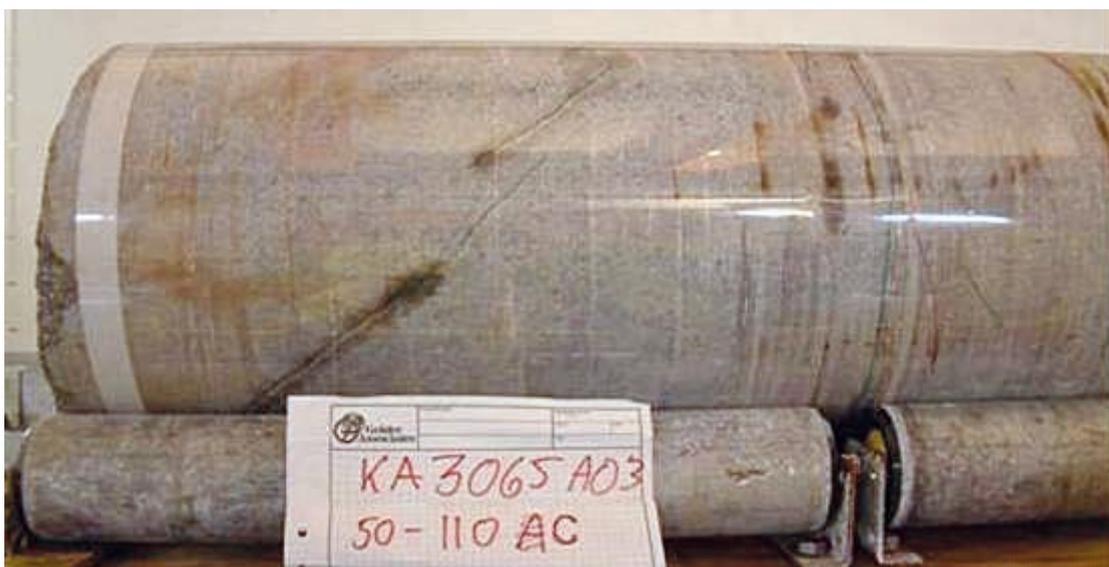
**Figure 3-9.** Down part of core 50–110 cm rotated to position C, showing that the open fracture at 80 cm with 45° to core axis is not continuous.

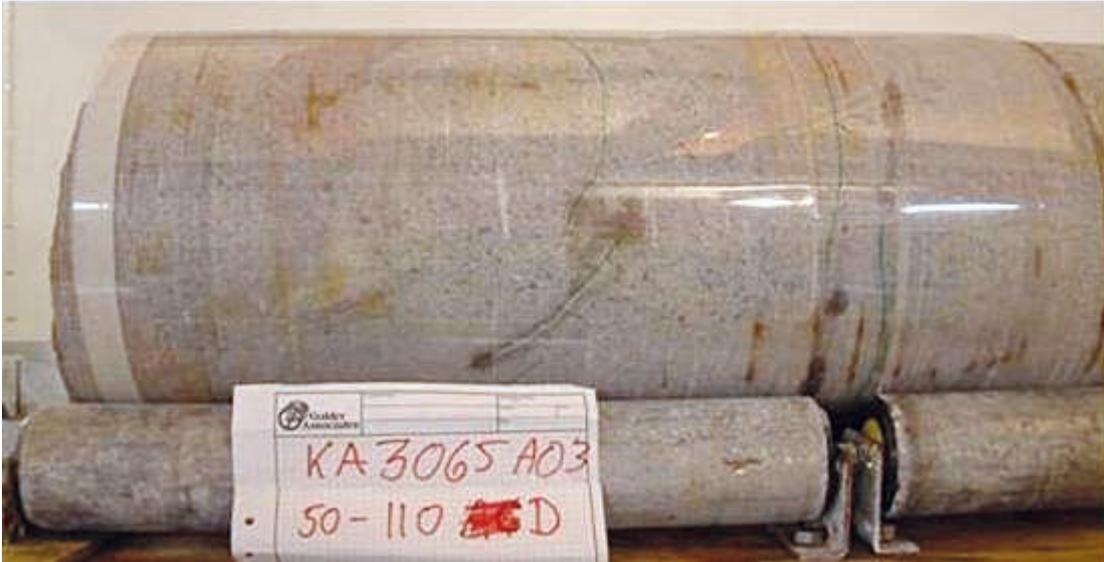
*Figure 3-10. Down part of core 50–110 cm rotated to position D, showing another view of the non-continuous open fracture at 80 cm.*

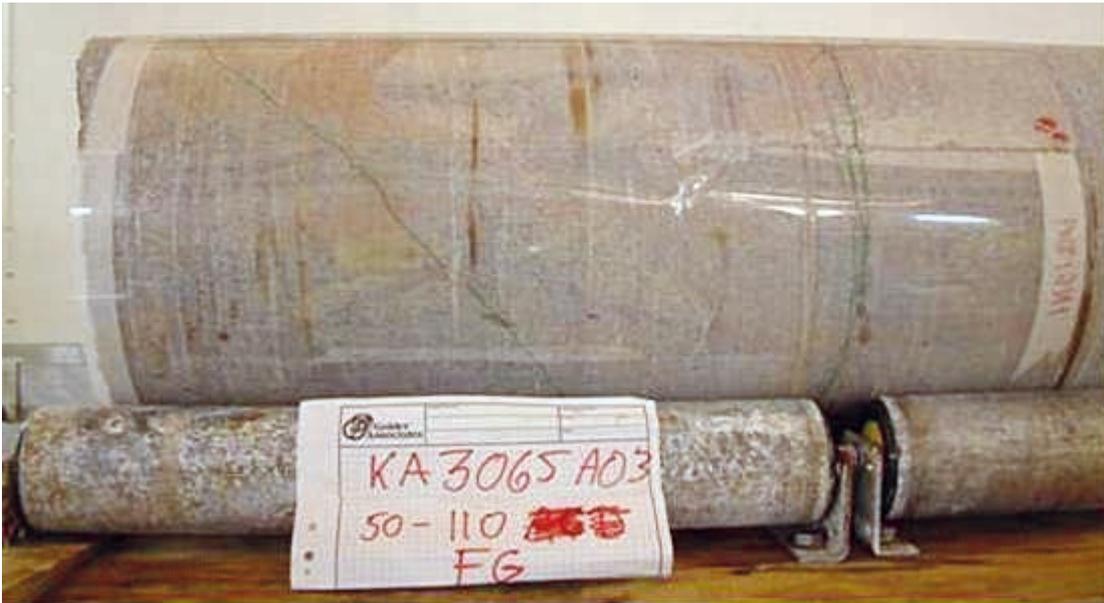
*Figure 3-11. Down part of core 50–110 cm rotated to position between F and G, showing that the open fracture at 60 cm with 90° to core axis is also not continuous.*

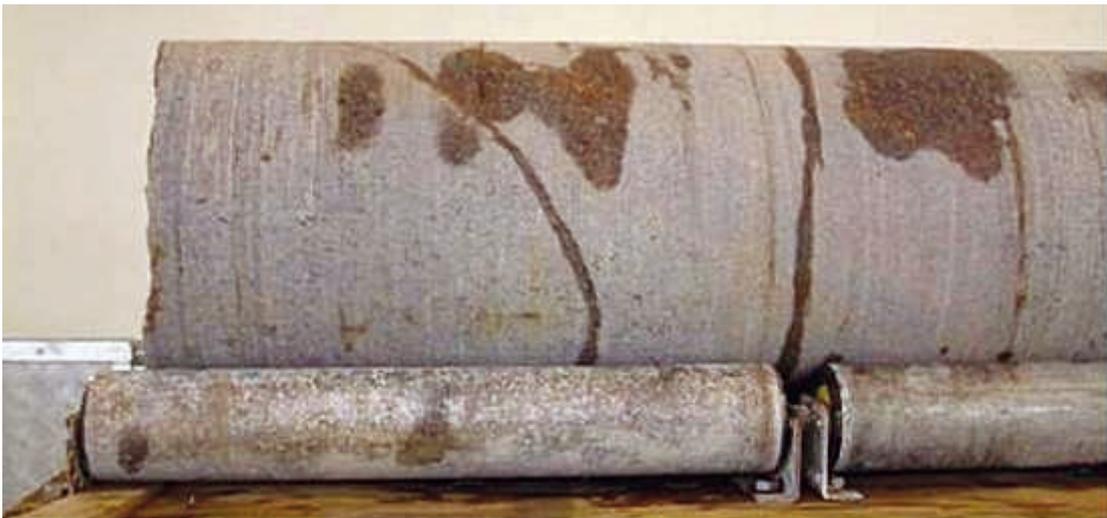
**Figure 3-13.** Drill core with open, continuously looking (which they are not) fractures at 60 cm (left of centre) and 80 cm (right of centre) from the upper core end. Core rotated to position G.

After photography in wet condition, the core surface was left to dry for about half an hour. It was then detected that the rock along the open fractures dried more slowly, which gave an opportunity to see the open fractures more clearly. The cores were photographed in this stage and the results are shown in Figure 3-12 to Figure 3-16. It can be clearly seen that the fracture at 60 cm (chainage 11.3–11.4) is discontinuous, the same being the case for that at 80 cm (chainage 11.6). It is obviously seen why these fractures did not break spontaneously during drilling (Figure 3-12). Seen from the opposite side of the core (Figure 3-13), these fractures appear to be continuous as was the case for the core from the 36 mm extension hole. Figure 3-14, Figure 3-15, and Figure 3-16 show other views of the fractures.

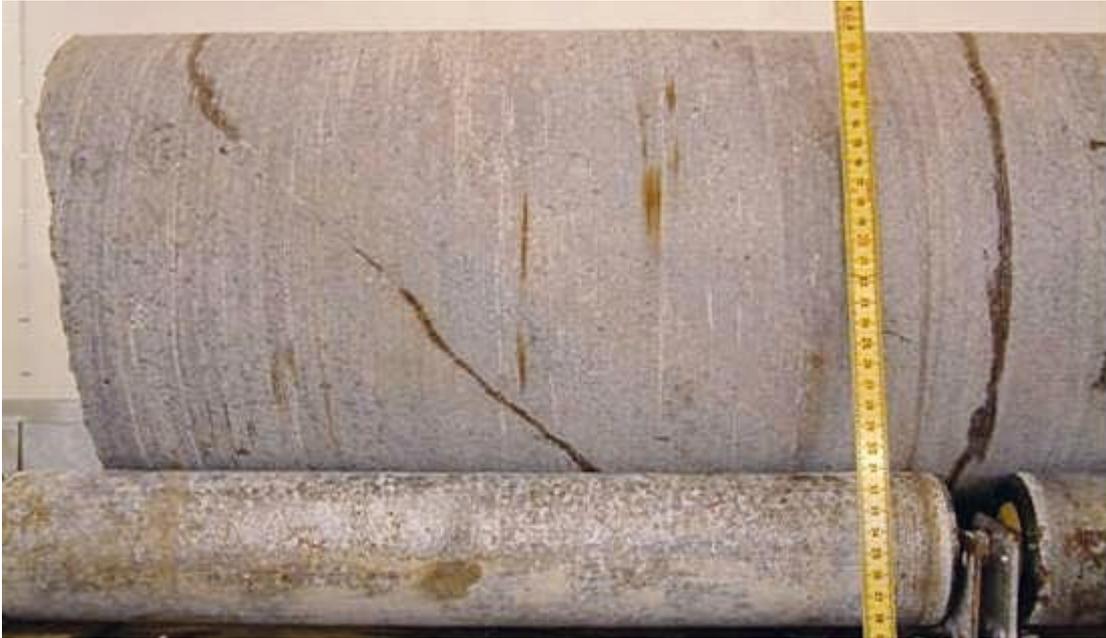
**Figure 3-14.** Drill core with open fractures at 60 cm and 80 cm (dark streaks, caused by moist) from the right hand side. Core rotated to position F.

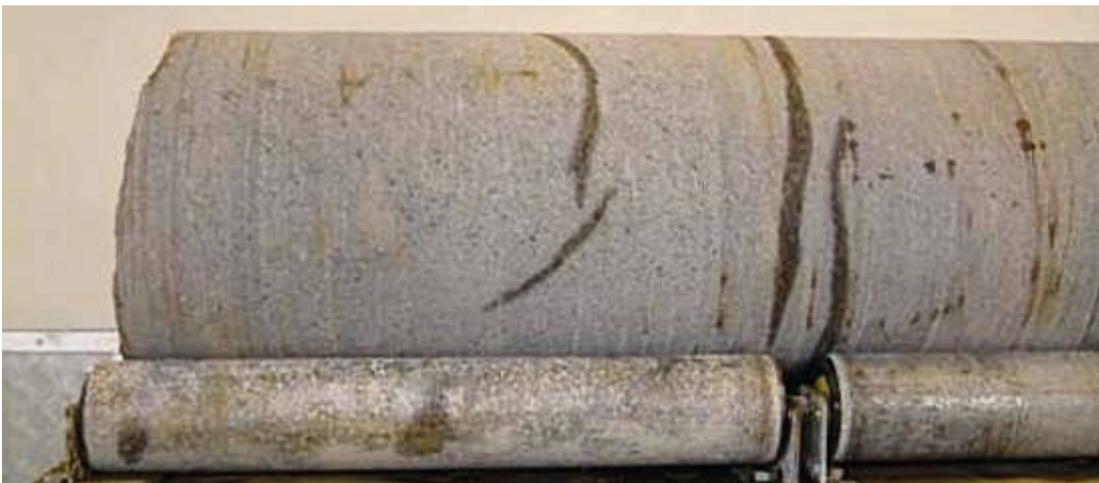
**Figure 3-15.** Drill core with open, discontinuous fractures at 60 cm and 80 cm (dark streaks, caused by moist) from the right hand side. Core rotated to position C.

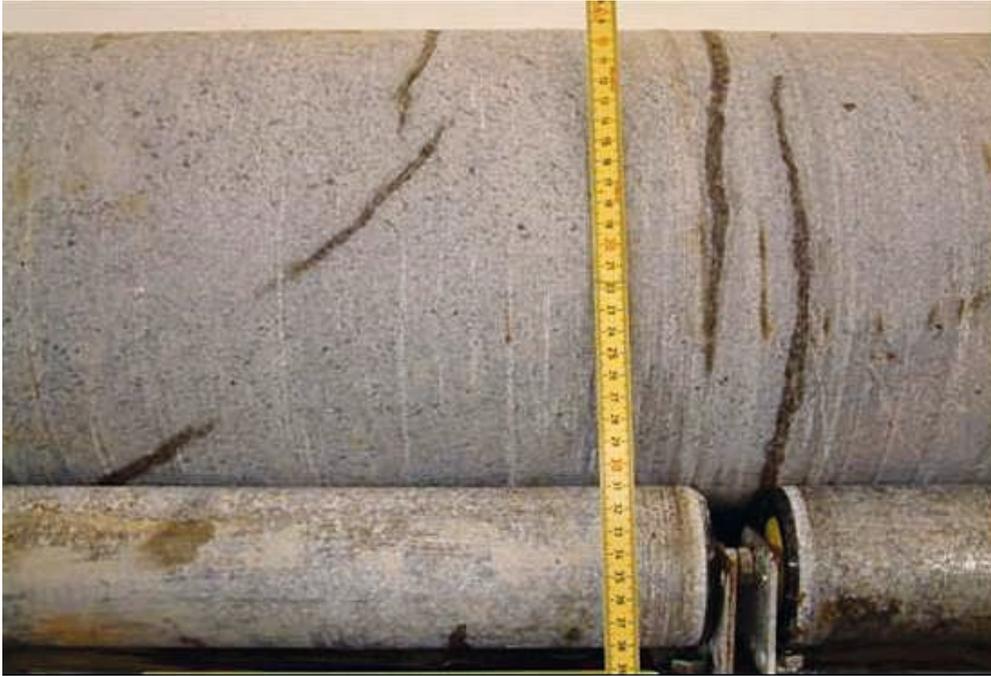
*Figure 3-16. Drill core with open, discontinuous fractures at 60 cm and 80 cm (dark streaks, caused by moist) from the right-hand side. Core rotated to position B, detail.*

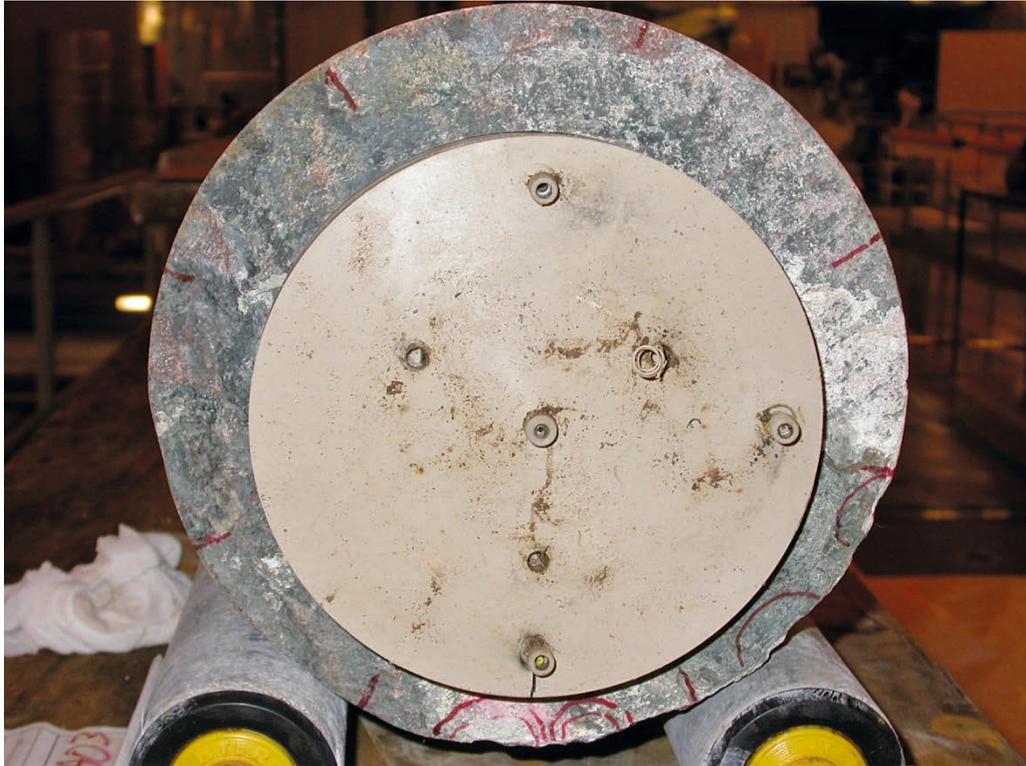
**Figure 4-1.** The PEEK lid matched to the fracture surface on the core stub. The core and PEEK lid having same orientation as in the borehole KA3065A03 during the in situ experiment. The eccentricity of over-core relative core stub is 4.5 mm but the angle of the view makes it look larger.

A more precise orientation was done before drilling of the core samples. The over core was then orientated by means of the PEEK lid used to seal the test section in front of the core stub, i.e. the natural fracture at core top end. The PEEK lid can be matched only in one position to the fracture surface and the position of the PEEK lid in the borehole during the in situ test is known; see Figure 4-1. Using this method for orientation the low side of the core was determined in between the two punch marks judged as probable low side of core (marked with double rings in red colour). The low side of the core was marked with a black line on the cylindrical PU sealing and a black line on the drill core perimeter; see Figure 4-2. The orientation is also consistent with the scaling of the core stub made in the borehole prior to instrumentation for the in situ test (Winberg et al. 2003b). Photographs to show the orientation of the target fracture at core top end, as in the borehole during the in situ experiment are presented in Appendix 10.

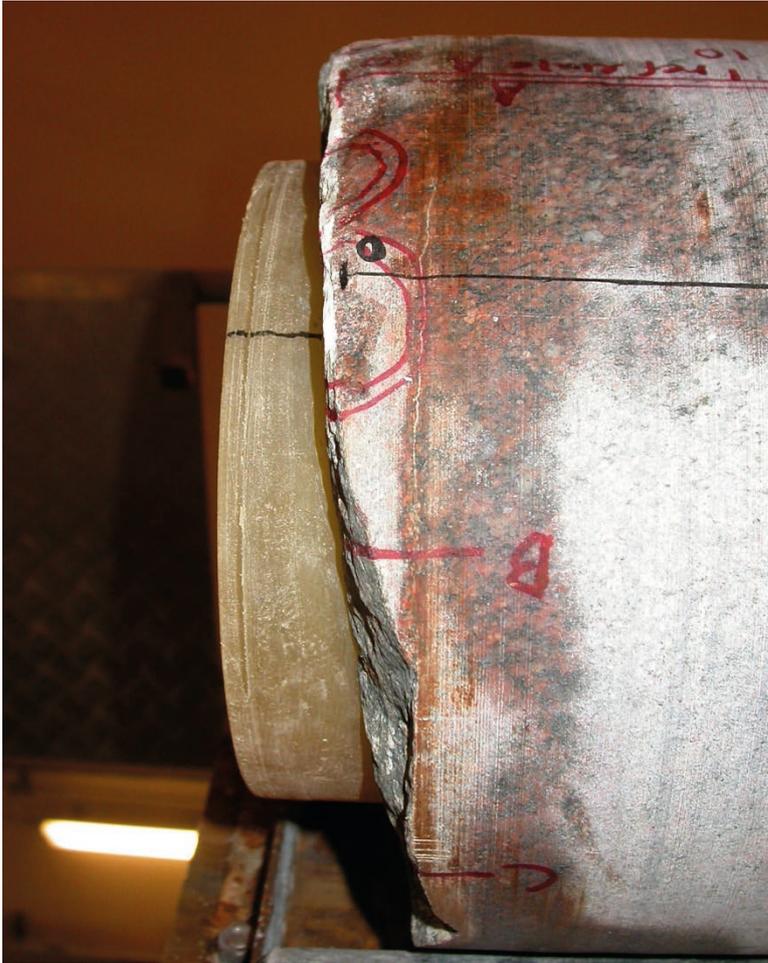
**Figure 4-2.** New length reference chainage zero (scaling 2007-06-08), based on position of borehole equipment in the 36 mm diameter extension borehole. The black line marks the lower side of the core, as it was oriented in the rock during the in situ experiment. The end mark of this line next to the black “0” on the stub marks the new length reference chainage.

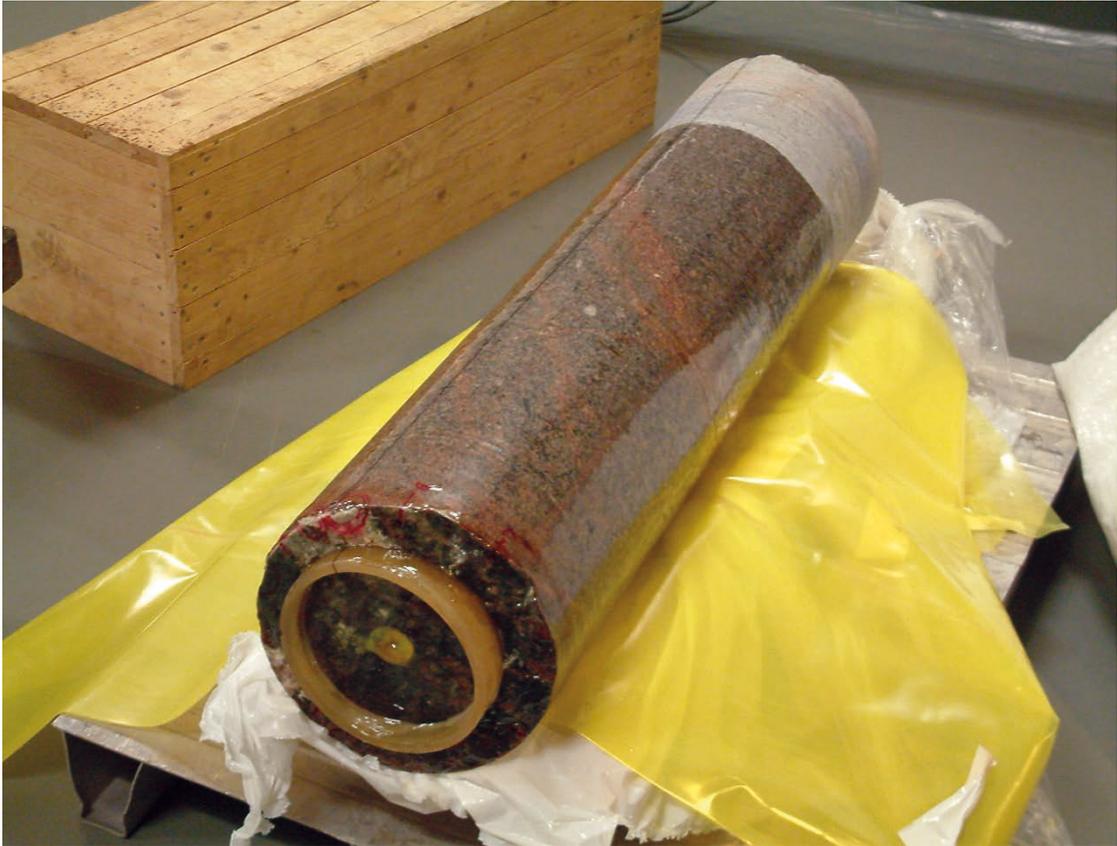
*Figure 4-4. The Epoxy coated 278 mm diameter core before cutting.*

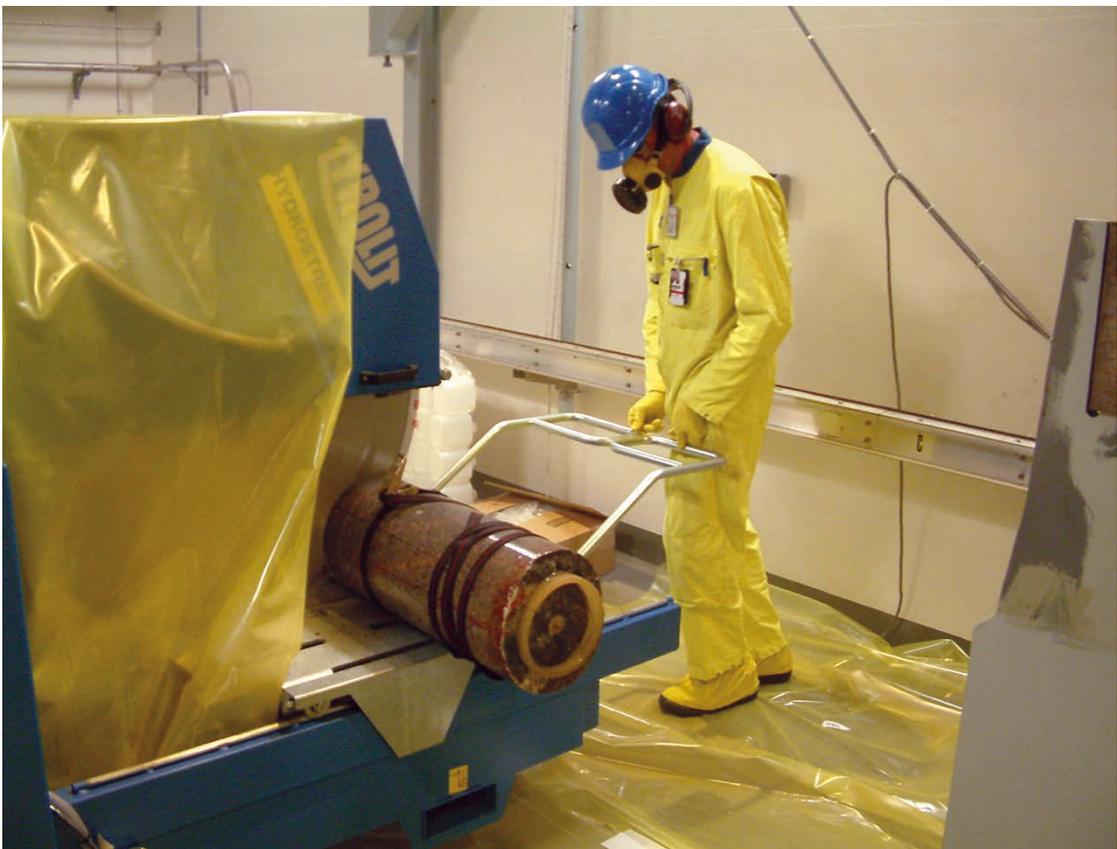
*Figure 4-5. Cutting of the core.*

The cutting was done with a diamond saw with water flushing at 0.65 m from the natural fracture surface (11.387 m), perpendicular to the length axis. The cutting action is illustrated in Figure 4-5.

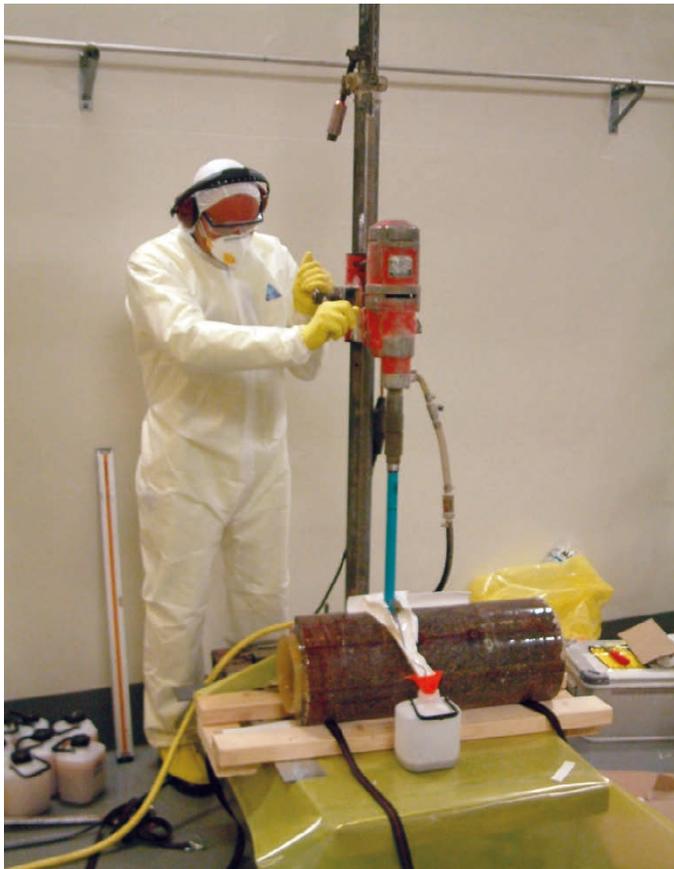
*Figure 4-6. Drilling of a D core sample.*

The diameter of each core sample is 24 mm and the drill used had a diameter of 28 mm.

Drilling water and drilling debris were collected in order to enable an investigation of any potential contamination during the sample extraction phase, see Figure 4-6 and Figure 4-7. After a hole had been drilled, it was plugged with rubber cork in order to prevent flushing water from flowing into the hole and contaminate the sampled rock. For the same reason, the drill bits and core barrel were carefully cleaned with water using first a brush for the outside of the drill bit/core barrel and a bottle brush for the inside the drill bit/core barrel. Thereafter the same procedure was repeated using ethanol followed by rinsing with ethanol. This procedure was followed for all of the core sample drillings. A collection of photographs showing drilling of core samples is presented in Appendix 11. Notes from drilling of core samples are presented in Appendix 12.

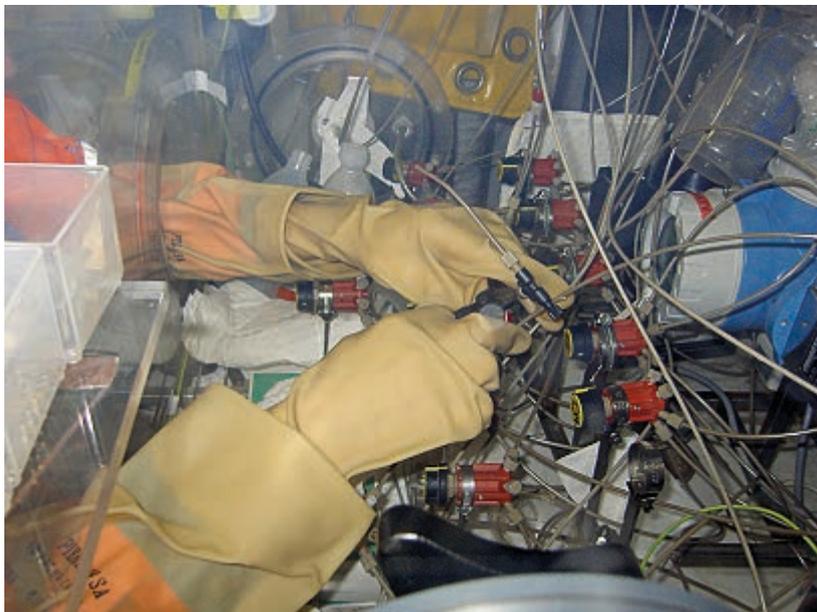
*Figure A6-1. Disconnecting circulation tubes in glove box in experimental container (C1) before removal and dismantling of borehole equipment.*

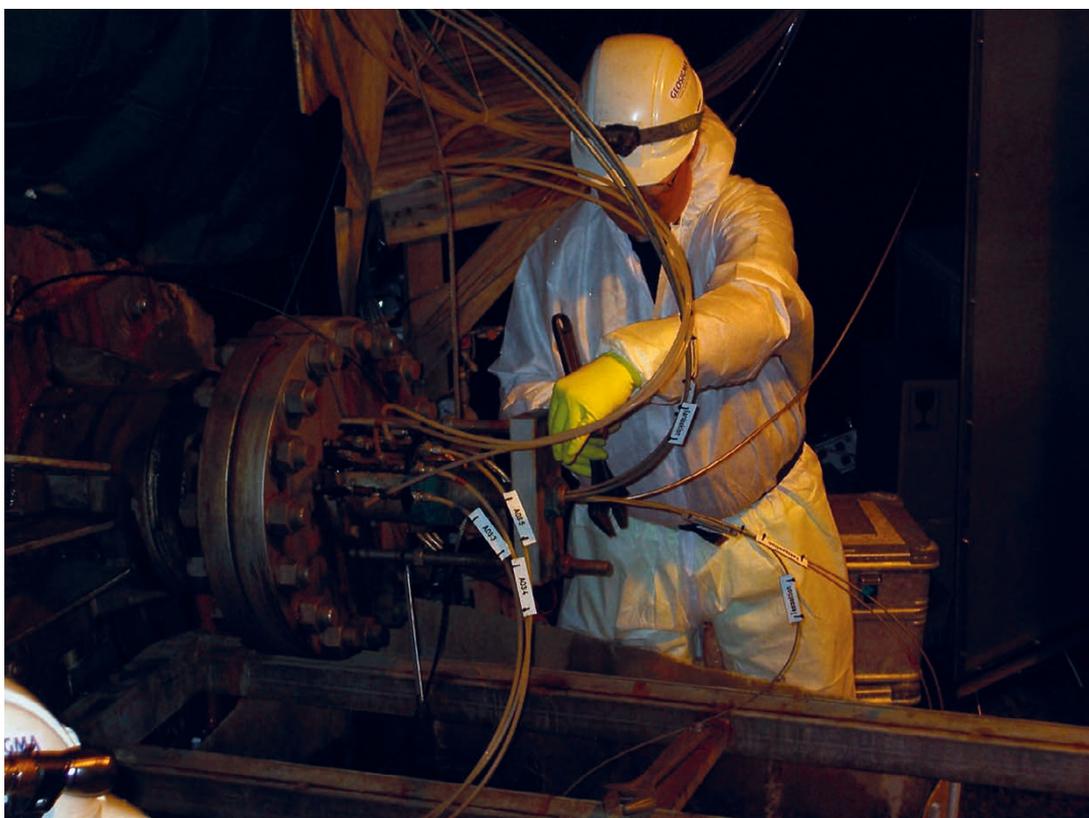
*Figure A6-2. Tubes and fittings being disconnected before the lid at KA3065A03 borehole collar is removed.*

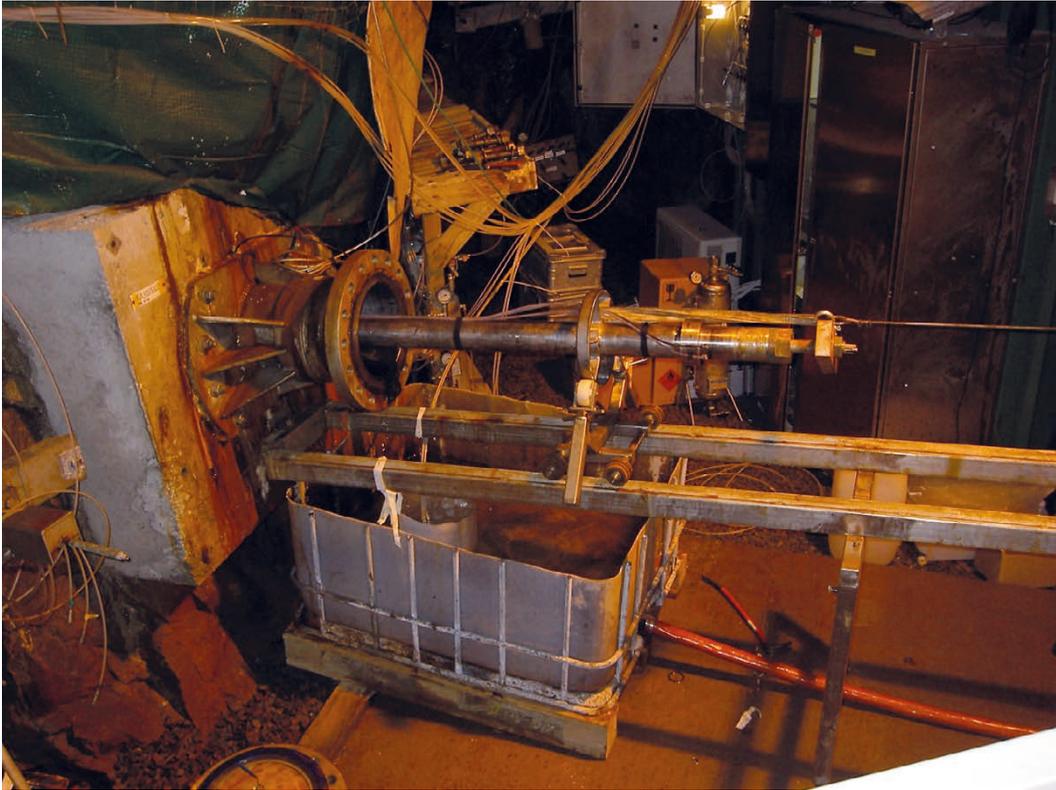
**Figure A6-3.** Lid at borehole collar removed and packer system is hauled out of borehole KA3065A03. Container beneath borehole collar, where water was sampled and monitored for  $\gamma$ -radiation, is also shown in the photo.
