**P-16-12**

Äspö Hard Rock Laboratory

# Long Term Sorption Diffusion Experiment (LTDE-SD)

## Over-core drilling and extraction of core samples

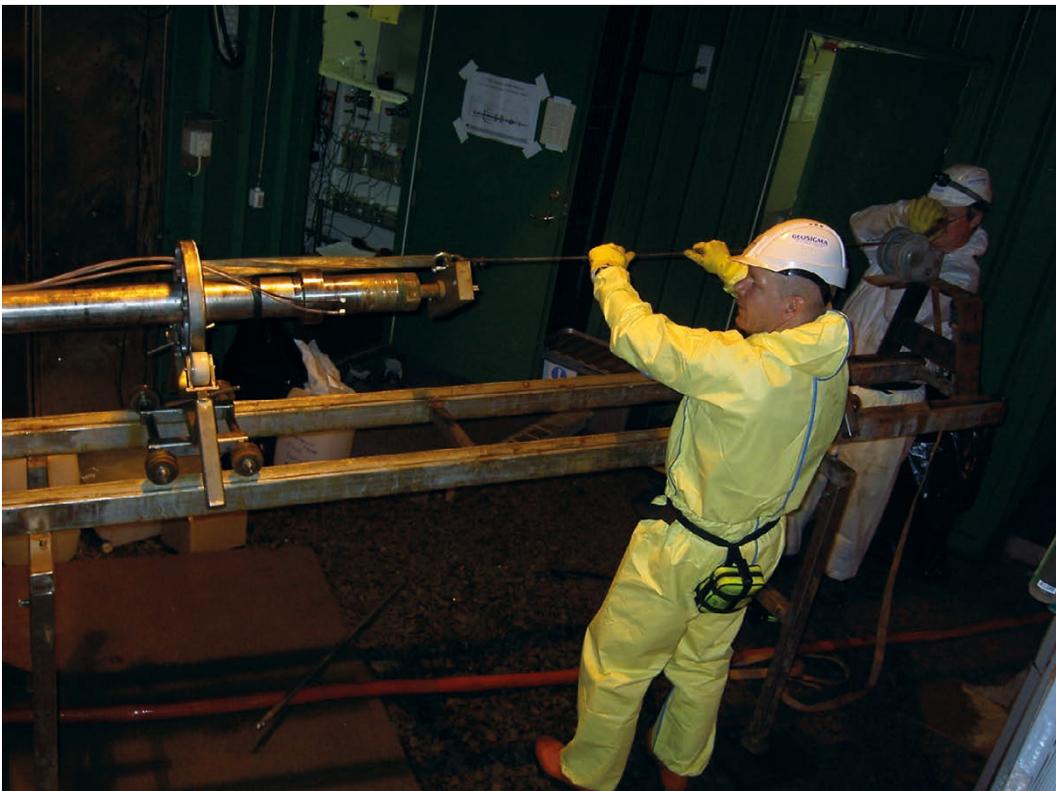
**Figure A6-4.** First phase of hauling is coming to final. Special protective clothing is used due to potential risk of contamination from radionuclides used in the experiment.

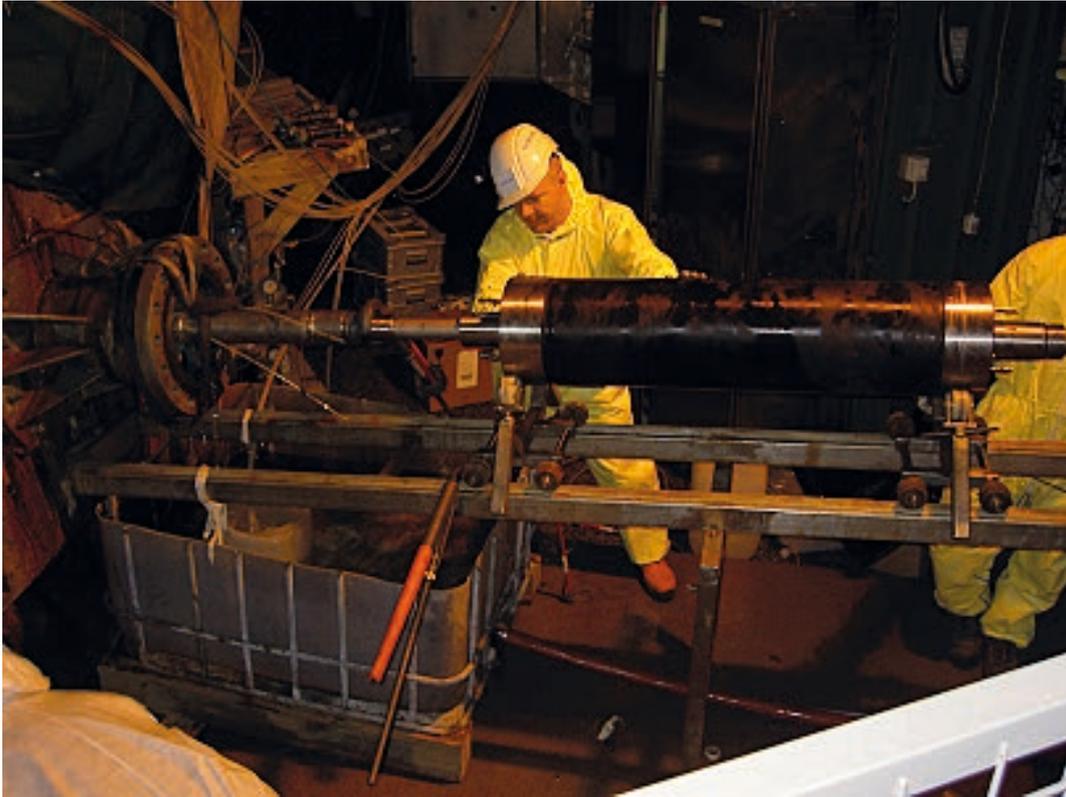
*Figure A6-5. Hydraulic packer being disconnected from outer pipe.*

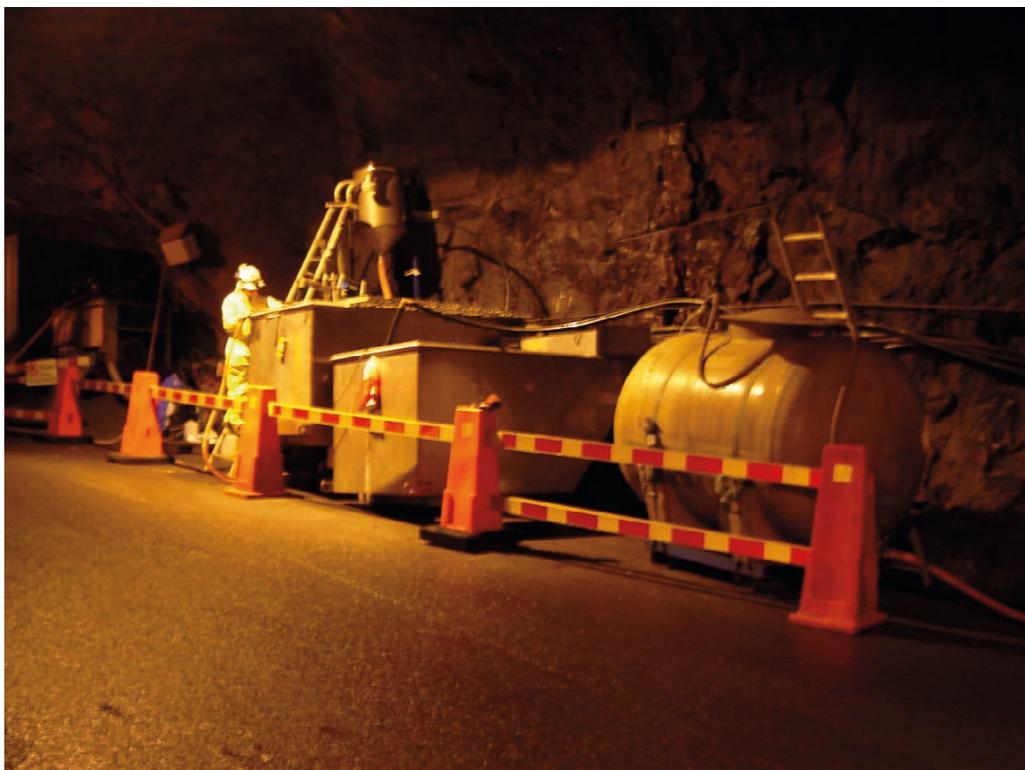
*Figure A7-1. System for handling backwashing water. Degasser (cyclone) on top of sedimentation container 1.*

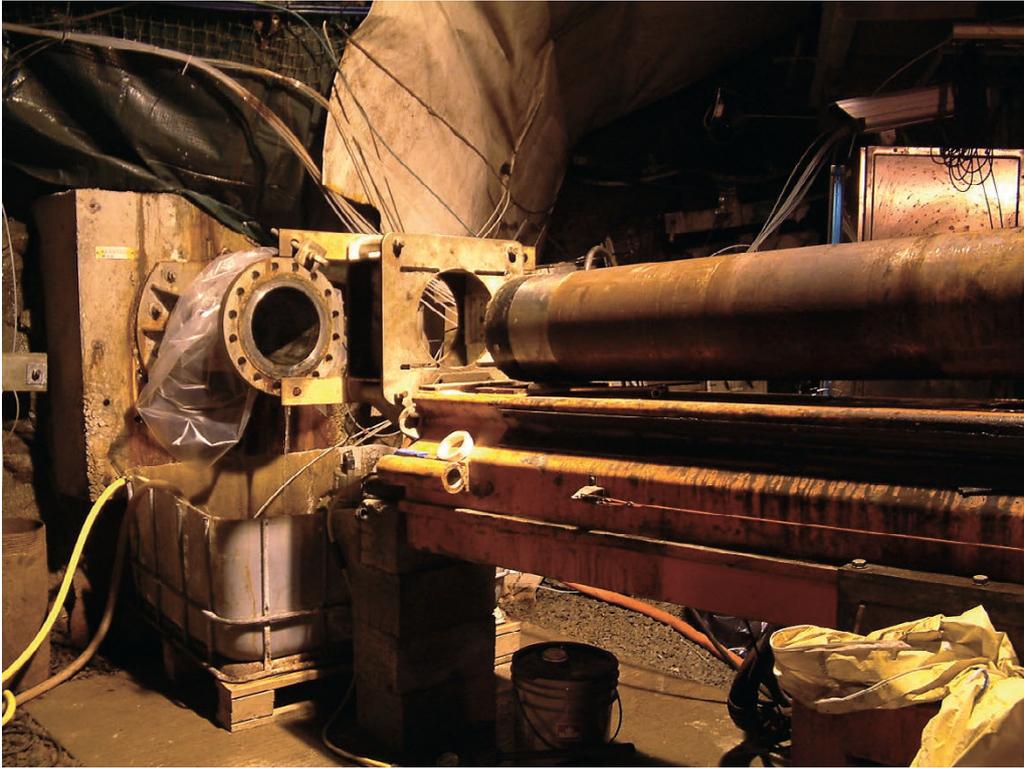
*Figure A7-3. Drill bit and core barrel attached and ready for over-core drilling KA3065A03.*

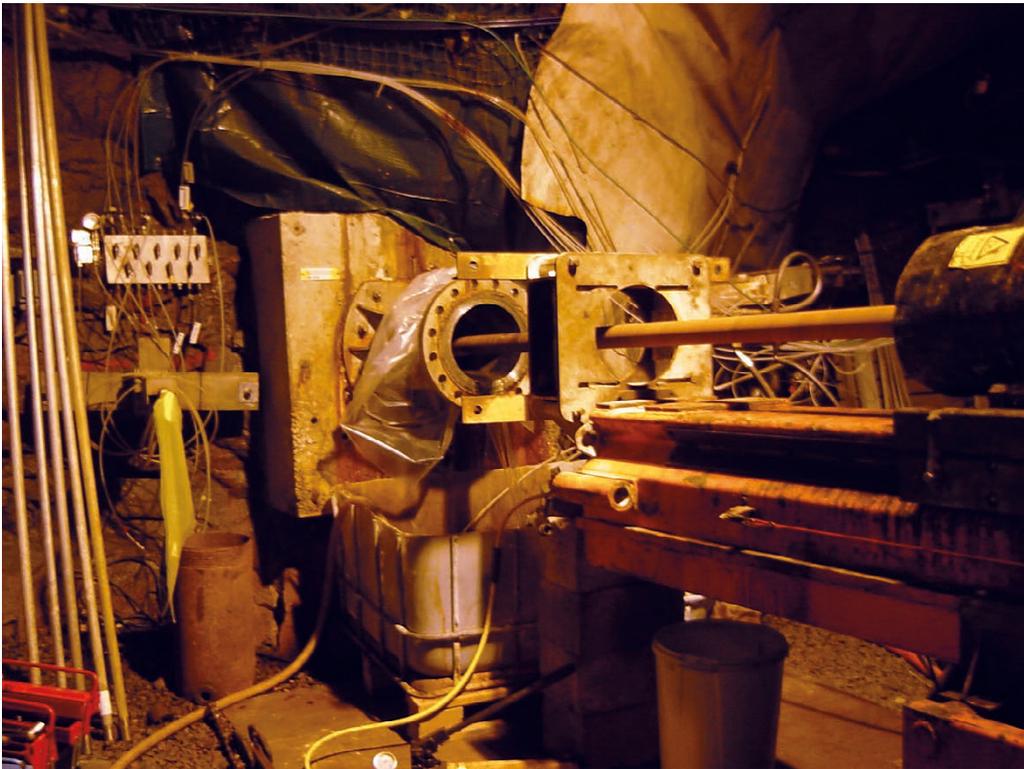
*Figure A7-4. Ongoing over-core drilling. Drill pipe and drilling machine.*

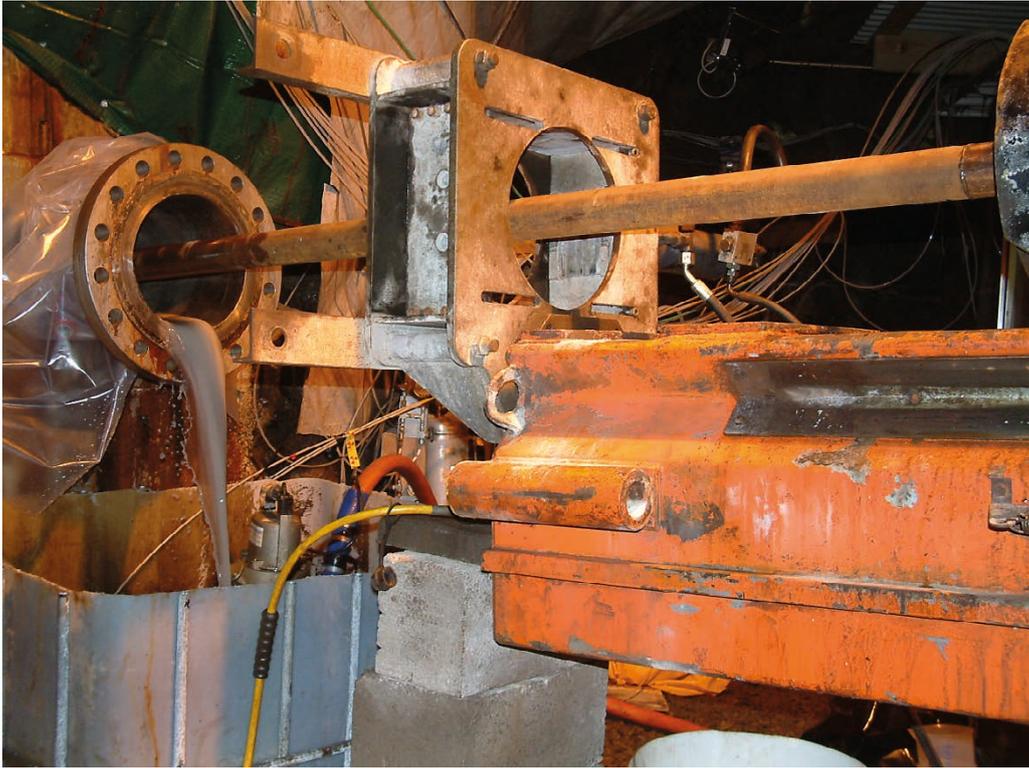
*Figure A7-5. Ongoing over-core drilling. Backwashing water with drilling debris flowing into container beneath borehole collar.*

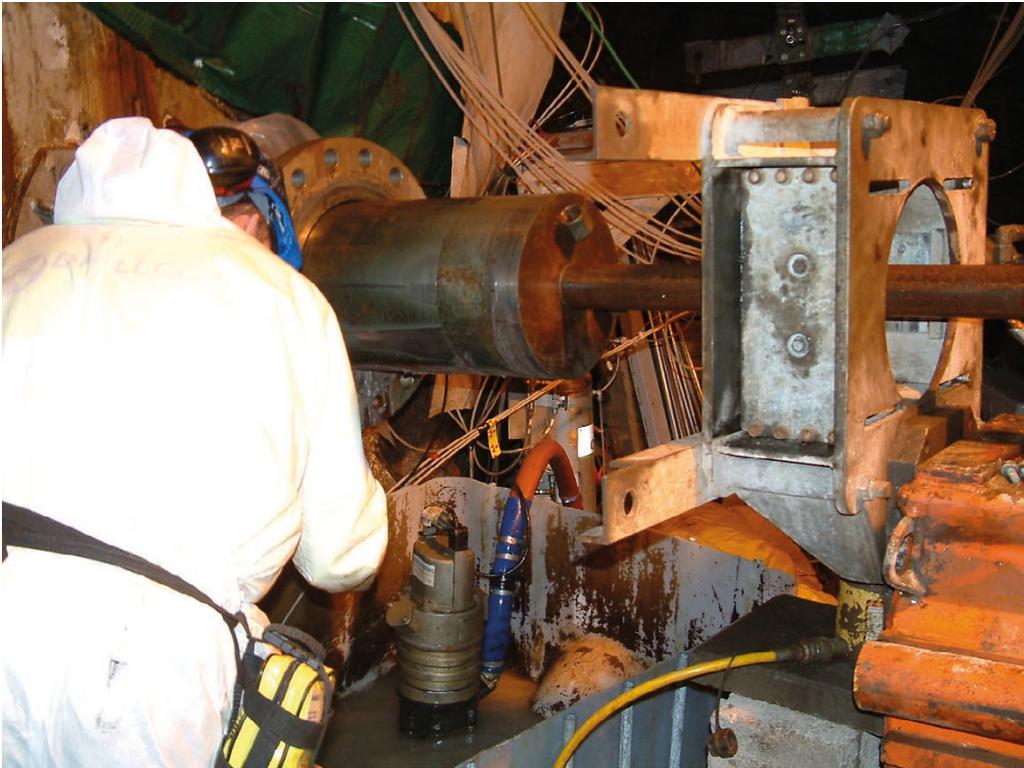
*Figure A7-8. Core barrel coming out of borehole.*

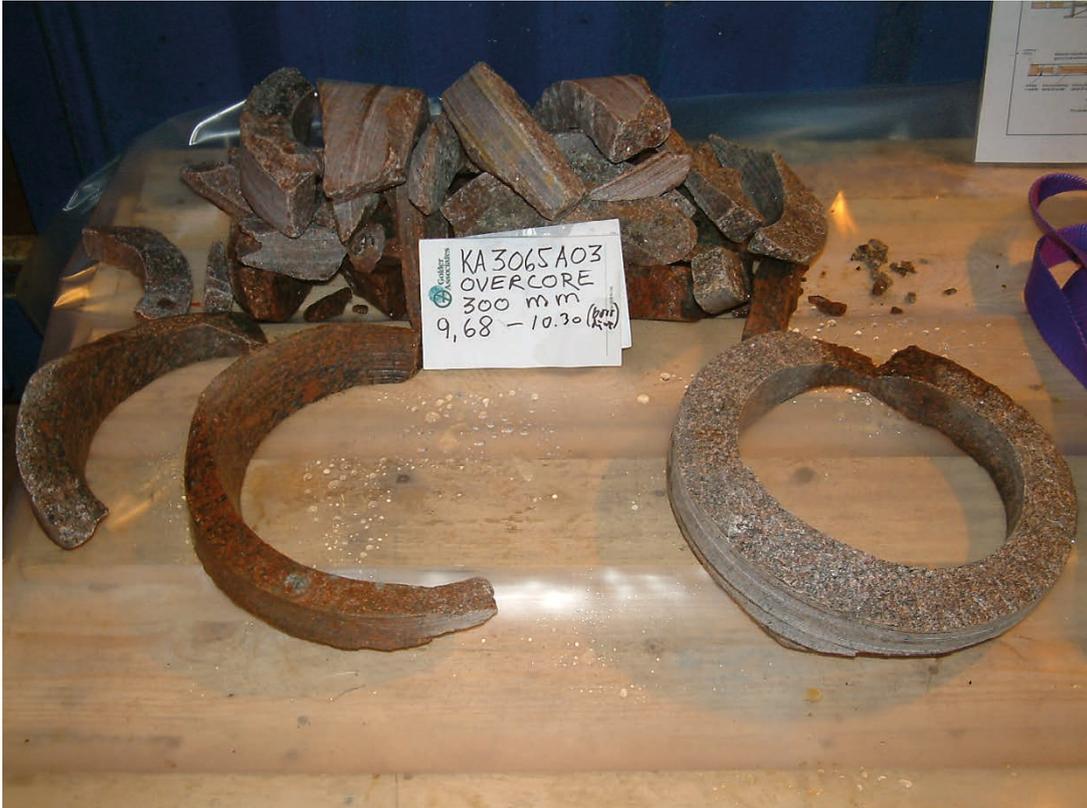
*Figure A7-9. The over-core of drill phase 1, chainage 9.67 to 10.3 m.*

Drill phase 1 comprised chainage 9.67 to 10.8 metres. It was planned to drill in two core runs; 1) 9.67 to 10.3 breaking the core at a natural fracture, and 2) 10.3 to 10.8 where the target section begins. As the borehole was already drilled with a diameter of 196.5 mm, the core could, at best, be retrieved as a hollow cylinder of rock with 4 cm thick walls. The retrieved cores in both runs were, however, broken into pieces by drilling, the appearance being similar to core dinking which occur during rock stress measurements with the over-coring method. Subsequently, the remaining core stub was inspected, revealing that the PEEK lid had loosened from the cylindrical PU sealing. It was retrieved together with small amounts of core fragments by means of the core barrel.

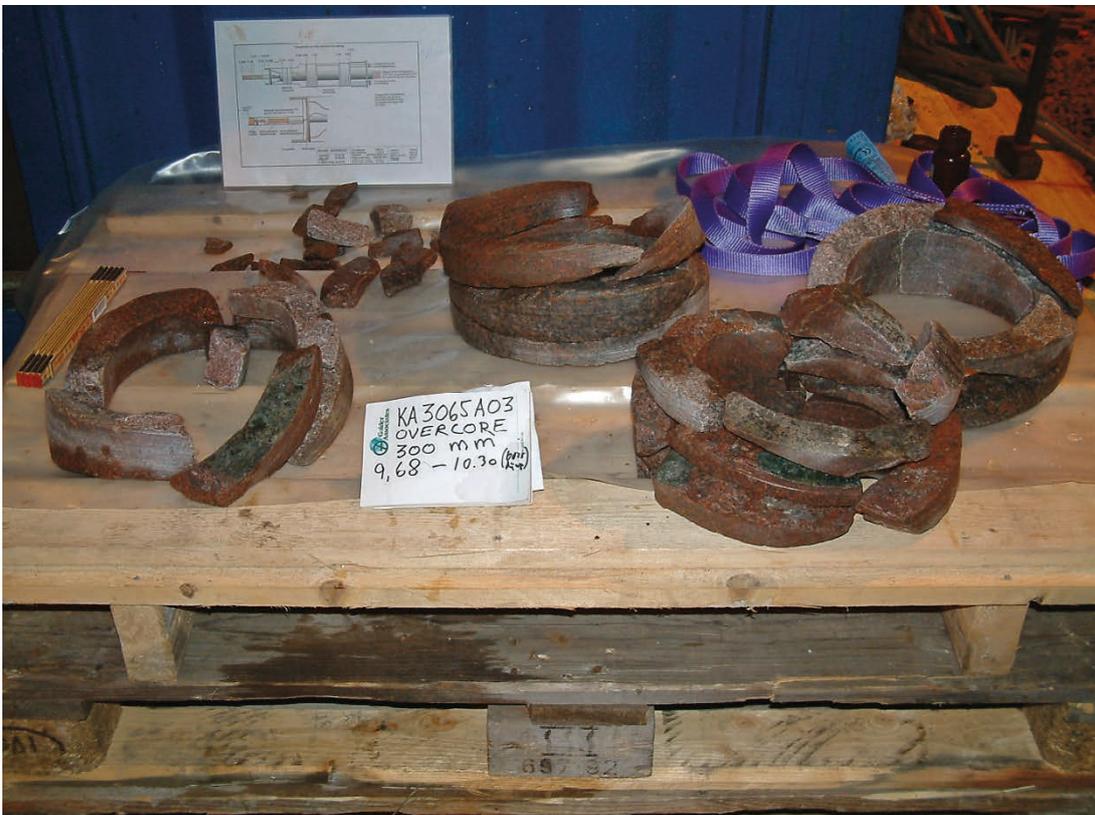
*Figure A7-10. The over-core of drill phase 1, chainage 9.68 to 10.3 m. Core pieces are joined to re-create a hollow cylinder.*

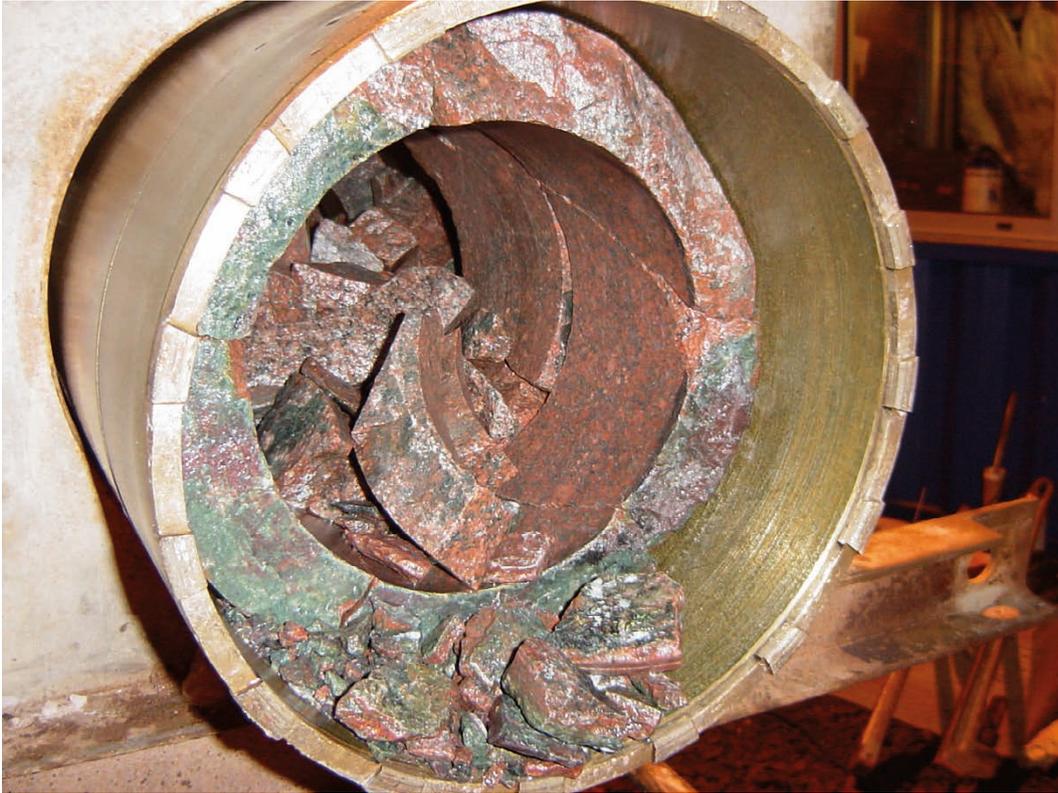
*Figure A7-11. Core retrieval of drill phase 1, chainage 10.3 to 10.8 m. Fracture at 10.74 m, facing towards the drill bit, is ending the core.*

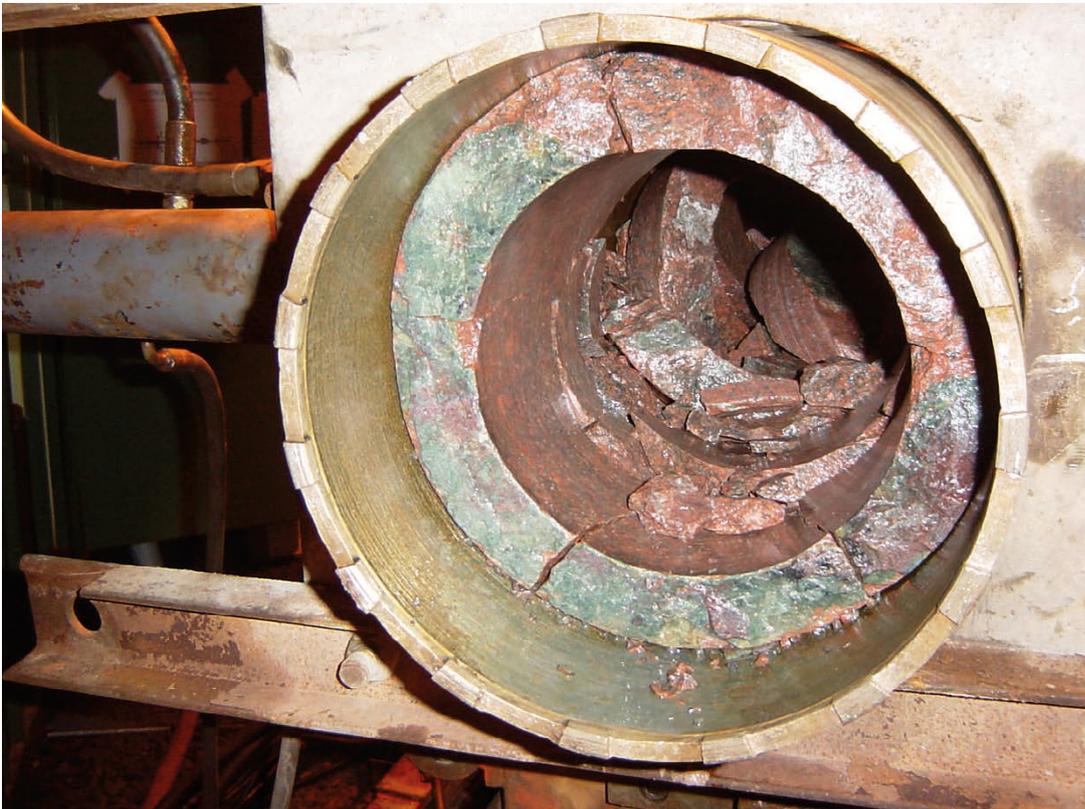
*Figure A7-12. Core retrieval of drill phase 1, chainage 10.3 to 10.8 m. Fracture at 10.74 m, facing towards the drill bit, is ending the core. Cf Figure A7-11, photo from another visual angle.*

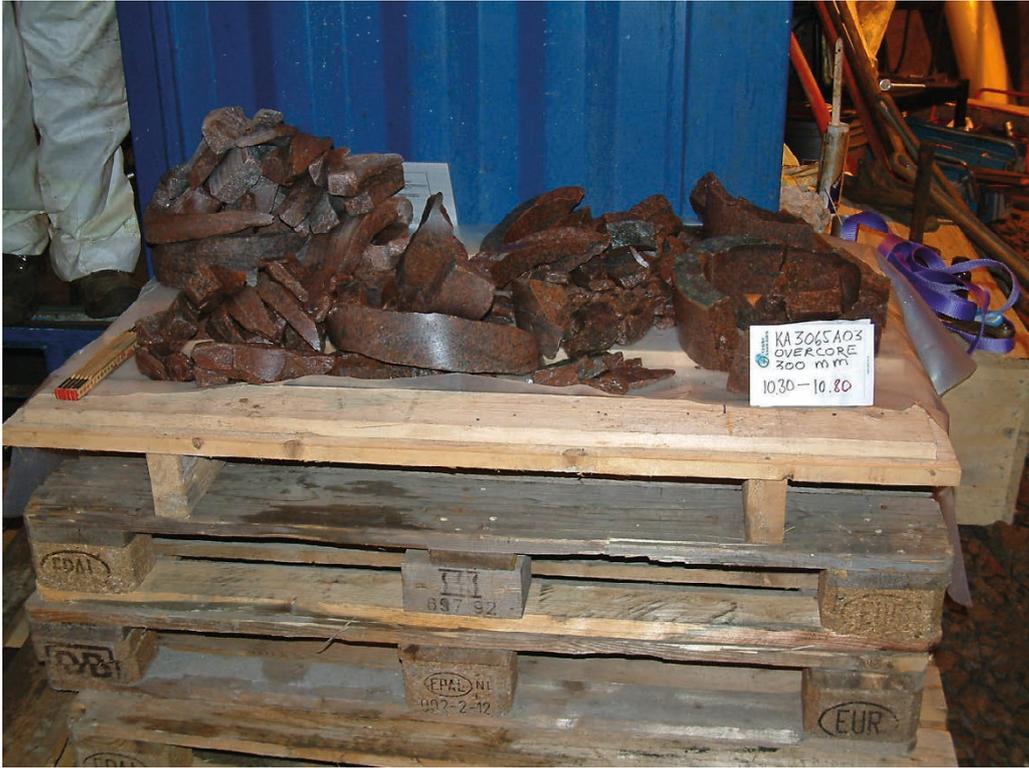
*Figure A7-13. The over-core of drill phase 1, chainage 10.3 to 10.8 m.*

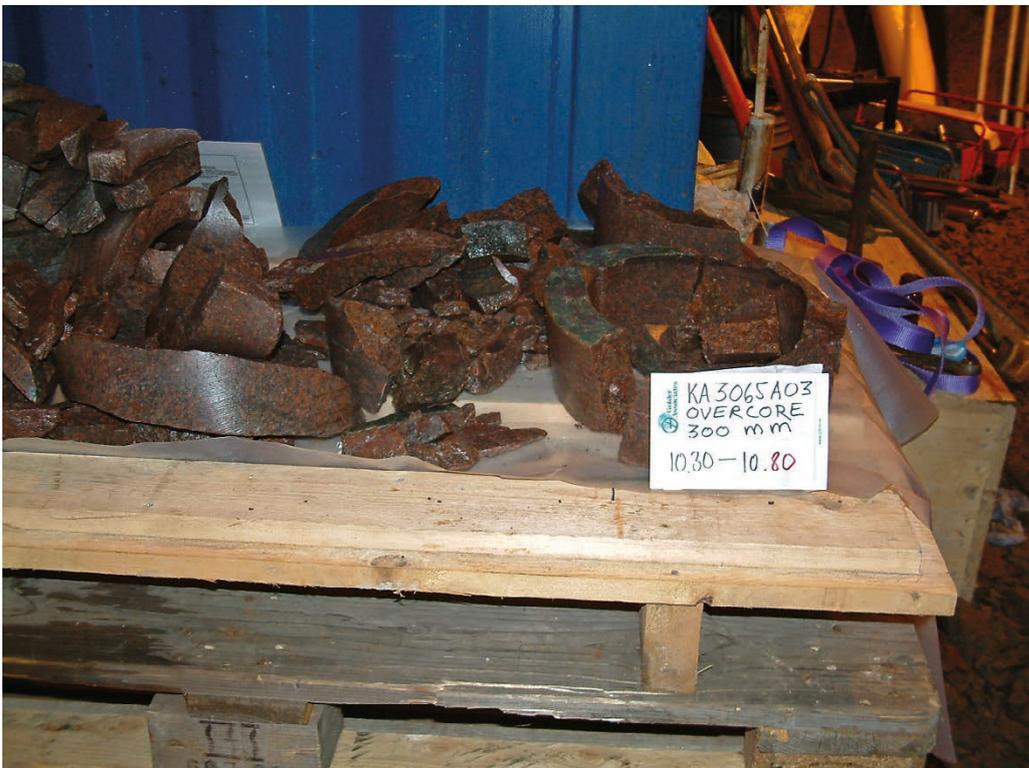
*Figure A7-14. The over-core of drill phase 1, chainage 10.3 to 10.8 m.*

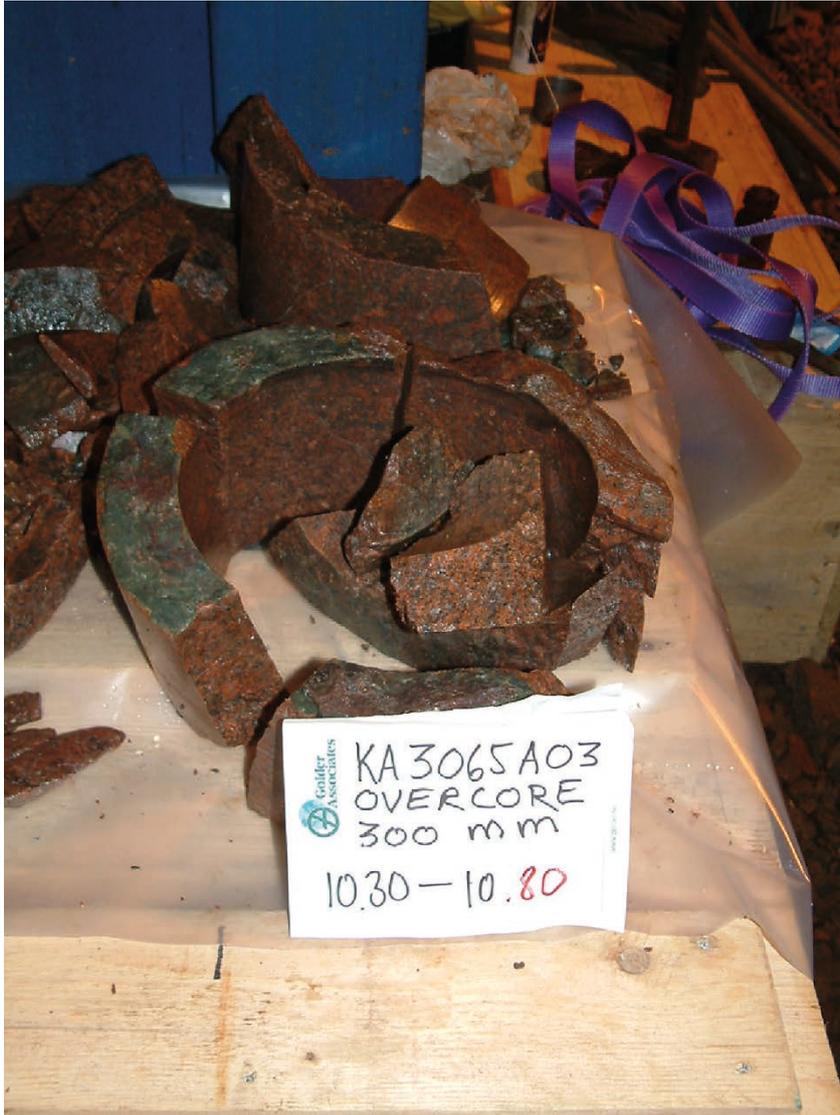
*Figure A7-15. The over-core of drill phase 1, chainage 10.3 to 10.8 m. Core pieces are joined to re-create a hollow cylinder. The fracture at 10.74 m, ending the core, is facing upwards.*

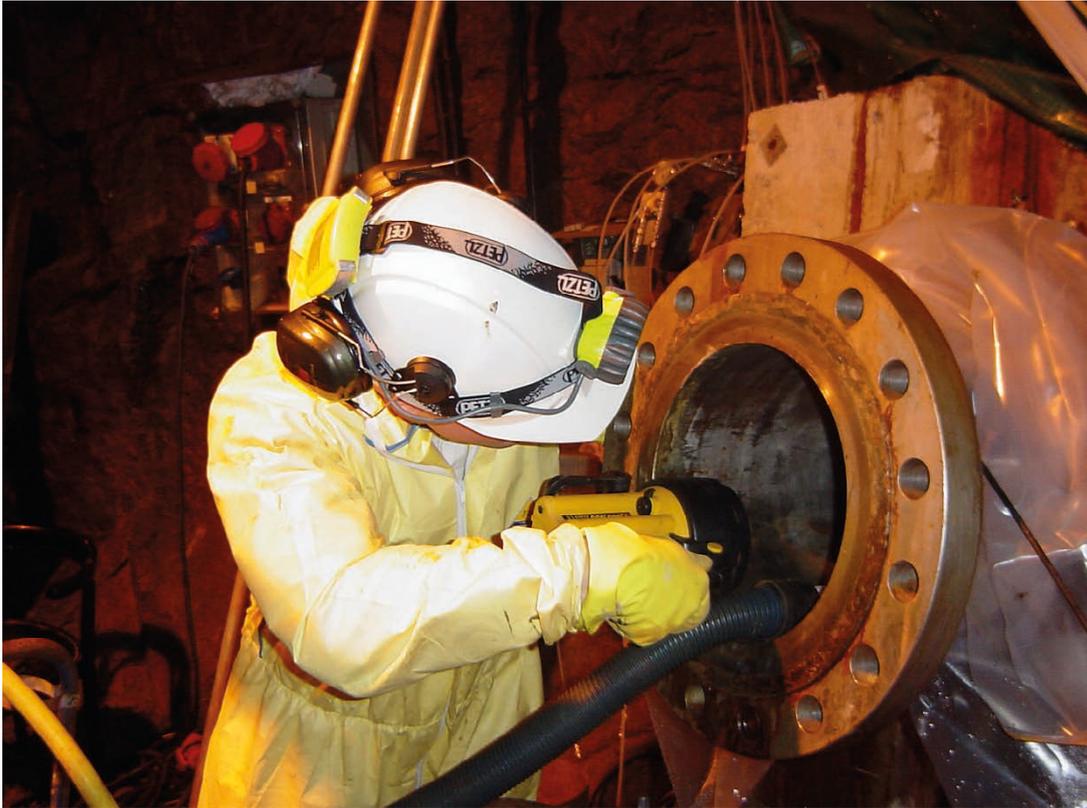
*Figure A7-16. Borehole is drained by suction pump and inspected before start of drill phase 2.*

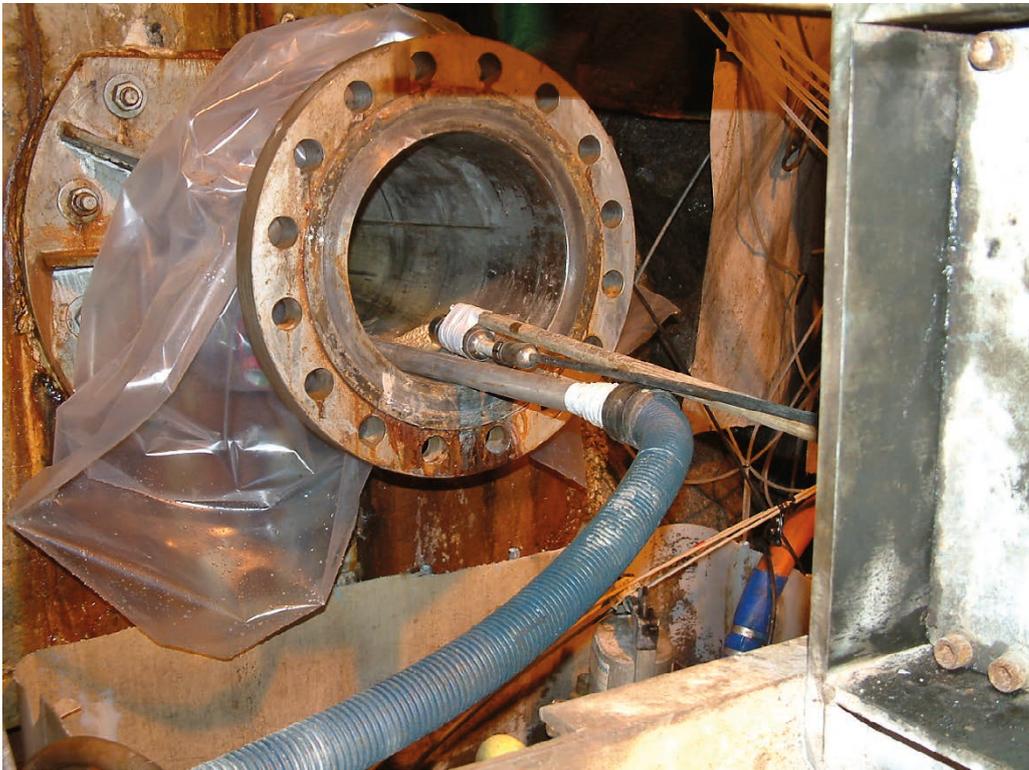
*Figure A7-17. Borehole is drained by suction pump and inspected with borehole camera before start of drill phase 2.*

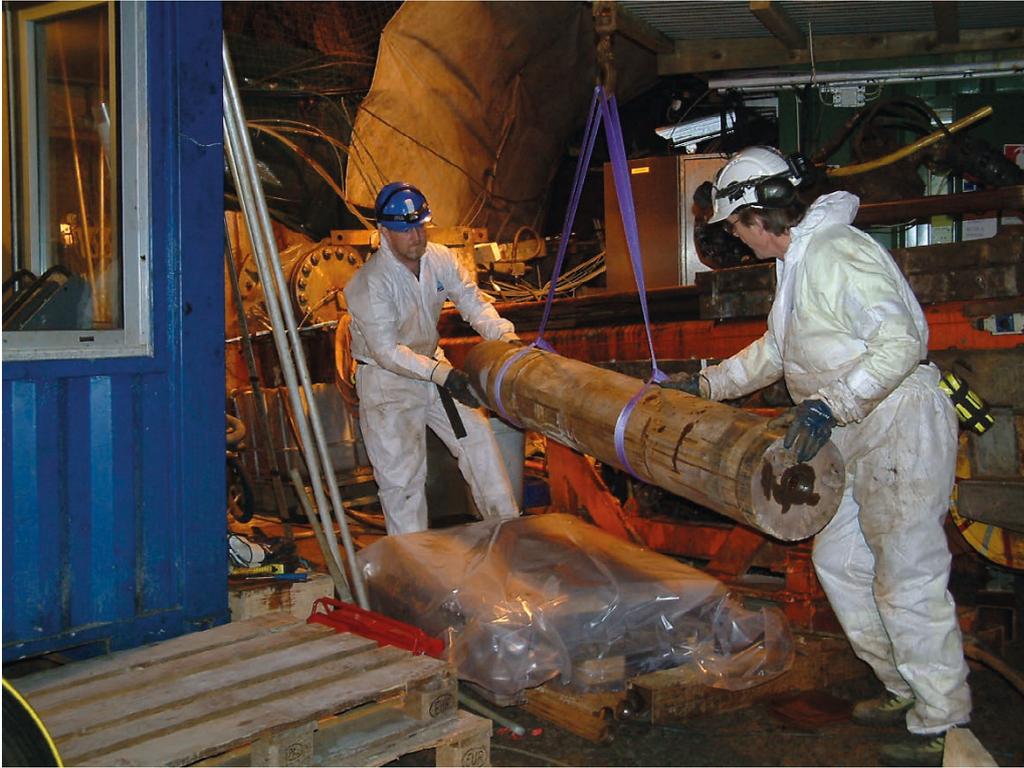
*Figure A7-18. Core barrel containing retrieved core from drill phase 2 is removed from the drilling machine.*

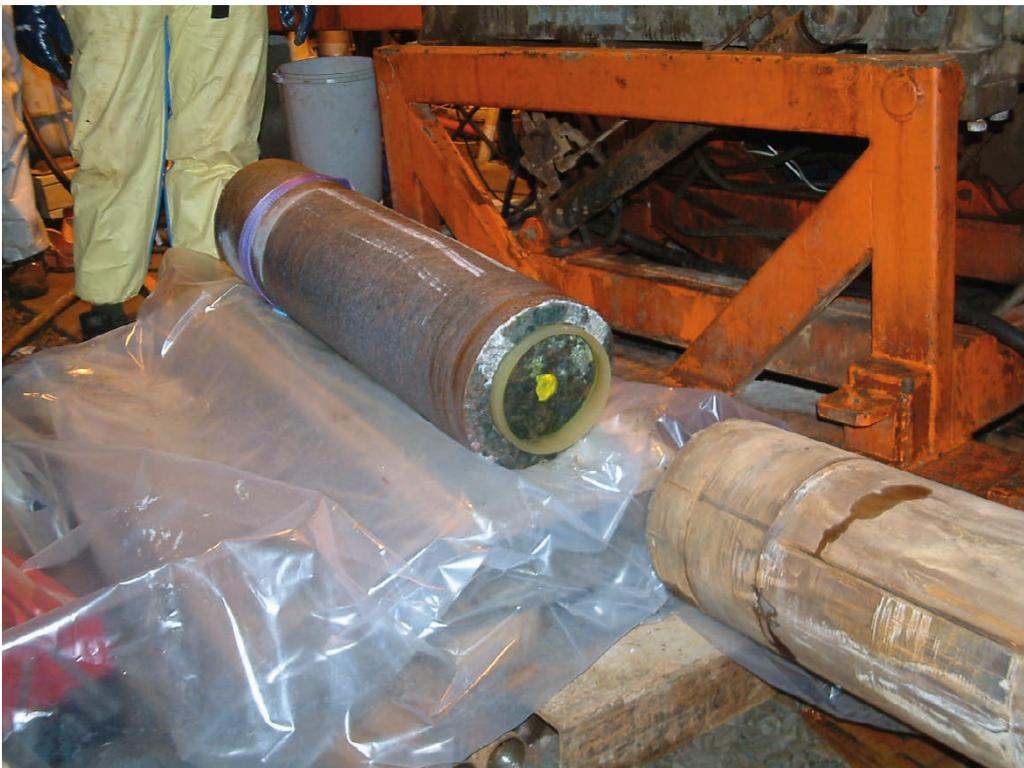
*Figure A7-19. Over-core 10.74 m to 11.82 m pulled out of core barrel. Target fracture at 10.74 m is facing towards the core barrel.*

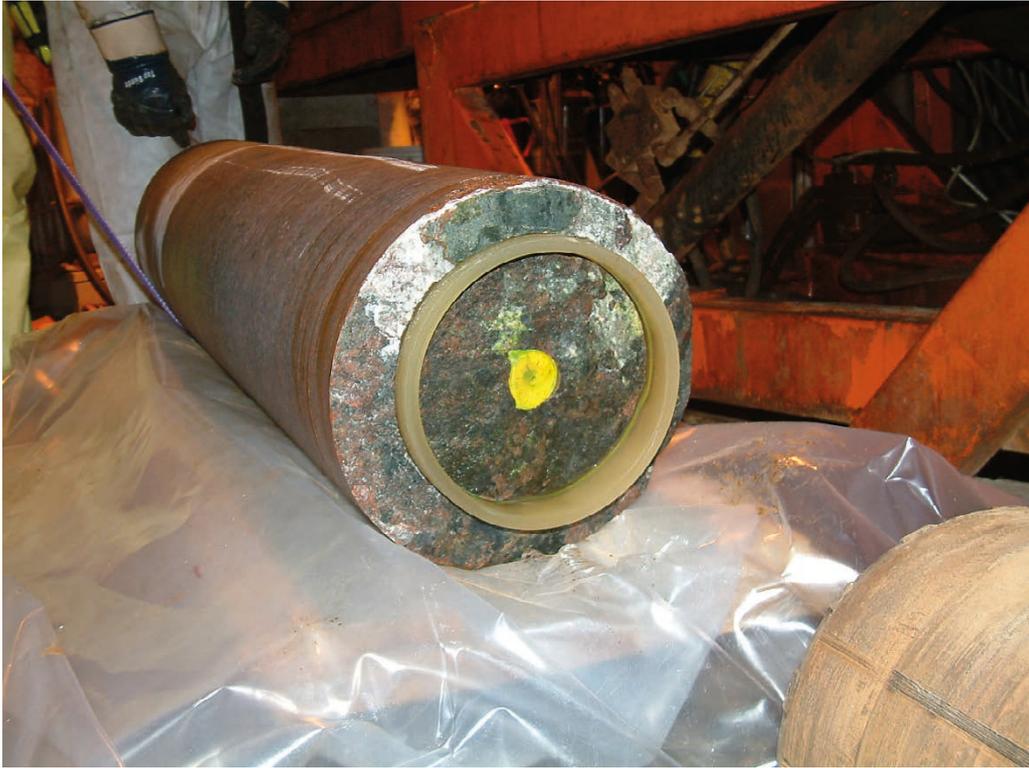
**Figure A7-20.** Over-core 10.74 m to 11.82 m. Target fracture at 10.74 m with the 177 mm diameter core stub inside the cylindrical PU sealing, where radionuclide tracers were circulated.

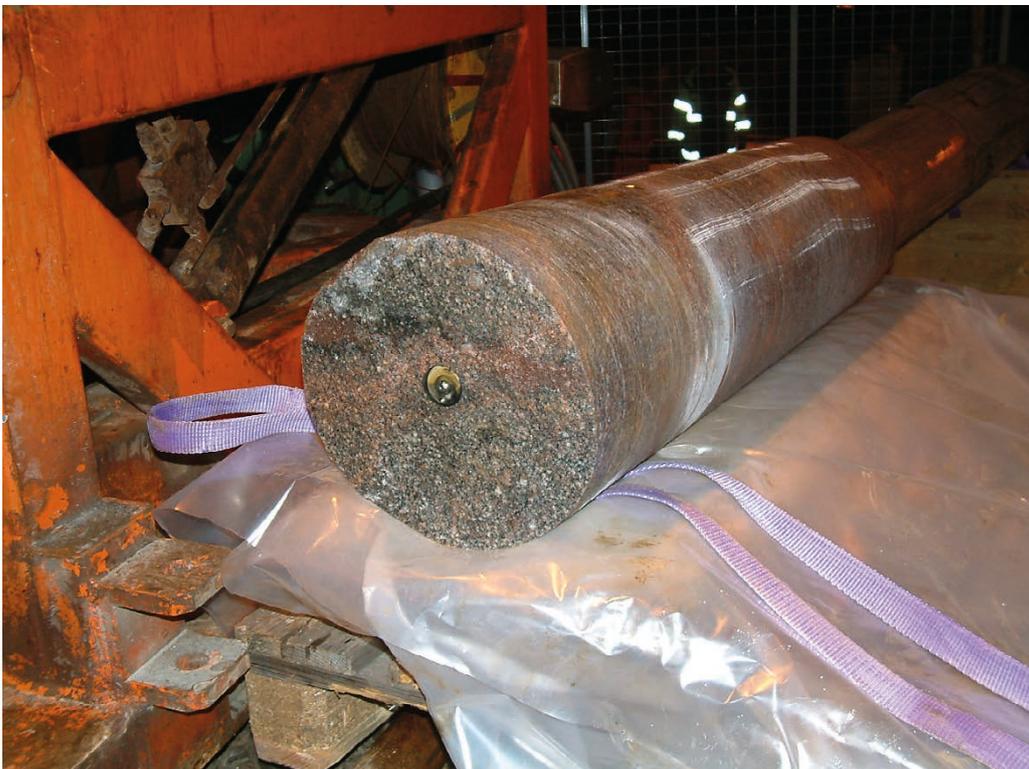
**Figure A7-21.** Over-core 10.74 m to 11.82 m. Breached end at 11.82 m, 36 mm borehole with parts of the special packer used to restrict the slim hole test section is seen in centre of core.

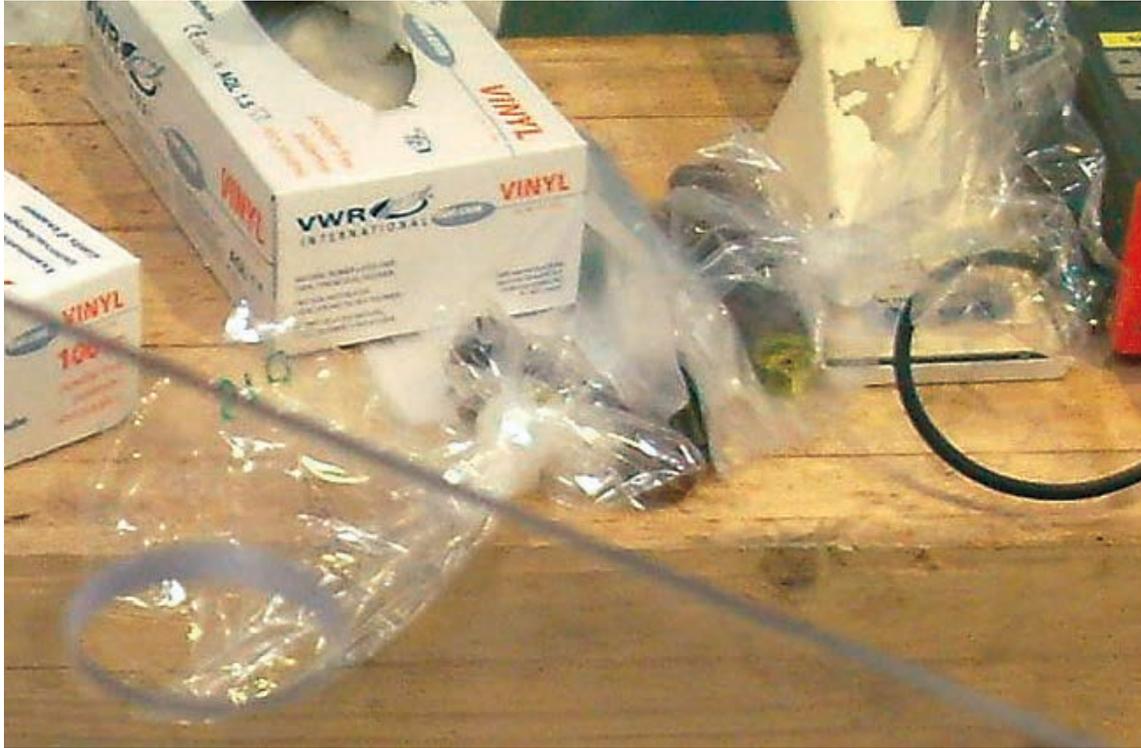
*Figure A9-1. Rock core samples contained in thin plastic bags, mainly to avoid cross-contamination during cutting, drilling and storage of rock core samples. Plastic bags were not primarily used to prevent drying of the pore water and air was not evacuated from them during storage.*

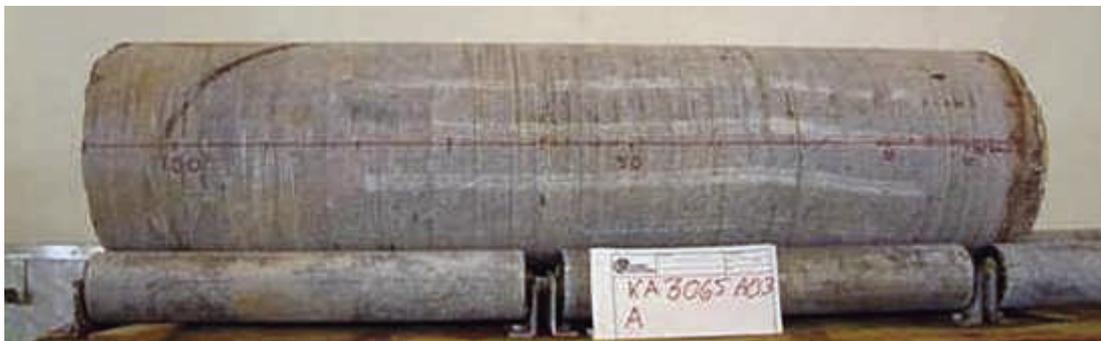
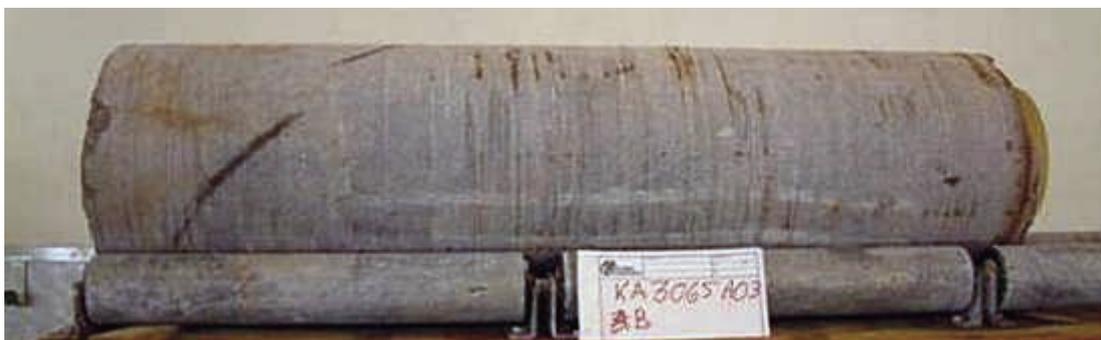
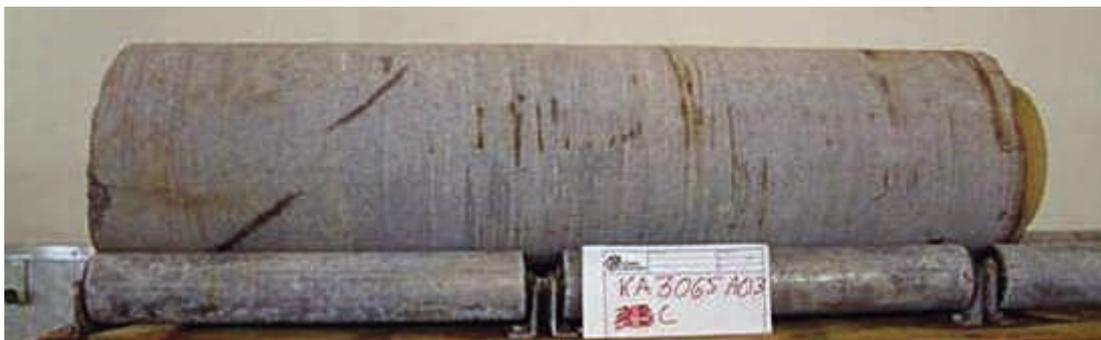
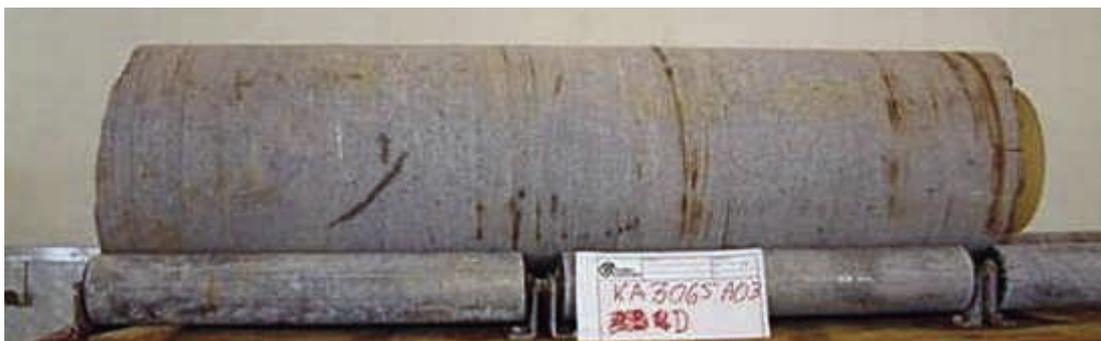
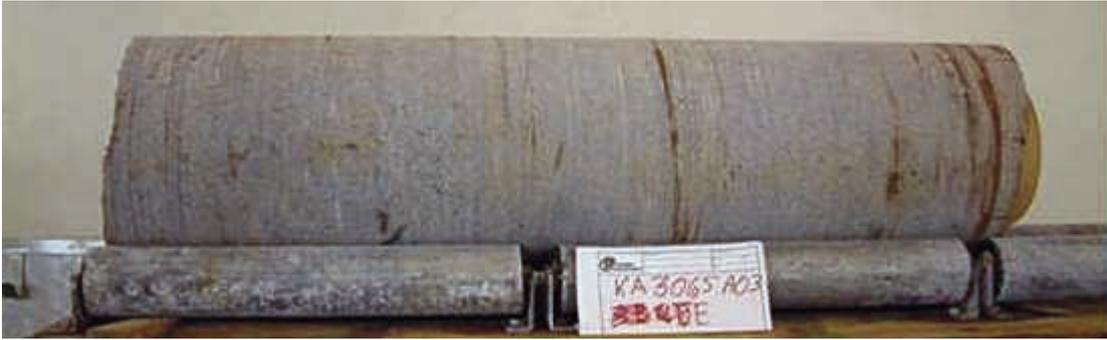
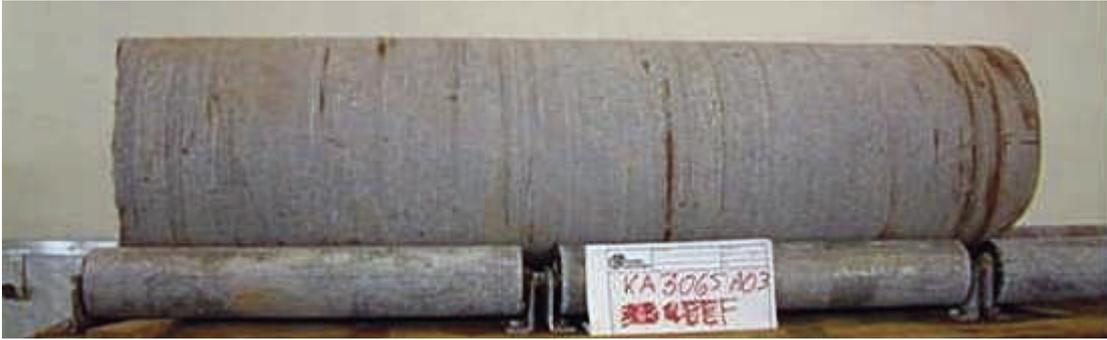
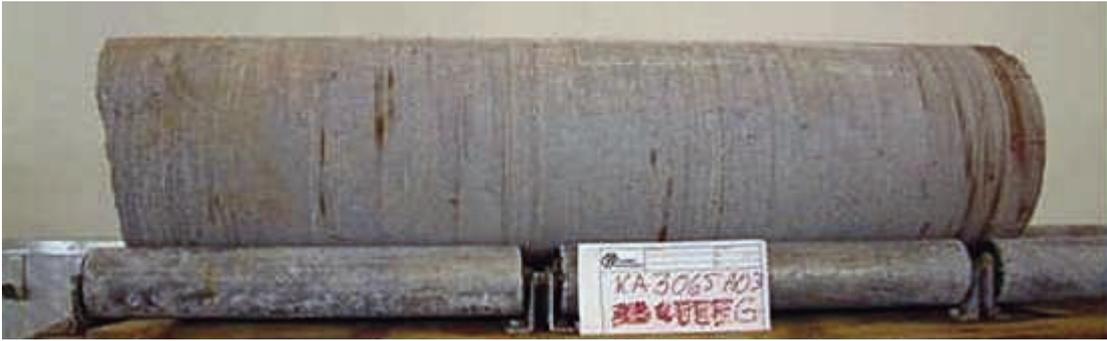
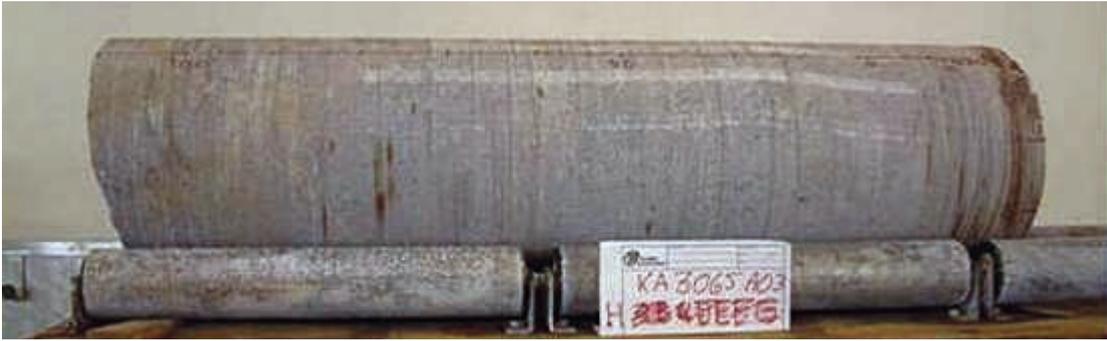
Photographs of dry core. The core is rotated in such way that each photo faces the letters A to H, respectively.

Photographs of the entire core were taken with the core in dry and wet condition, in each case from eight positions, with the markings A to H facing the camera. Core photography comprises also details of fractures and the photographs are shown in Appendix 9. It may be possible to merge the photographs to show the entire unfolded envelope surface of the core, similar to a BIPS image. Photographs of details such as fractures are shown in Section 3.4, where these features are treated further.

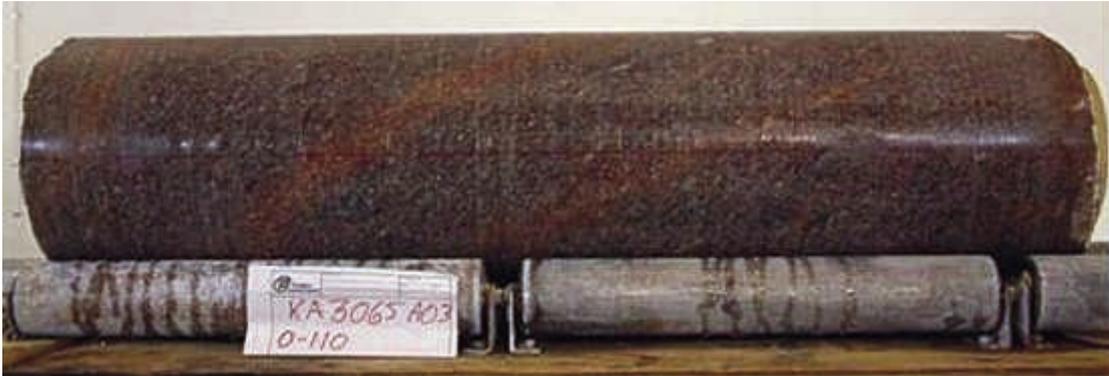
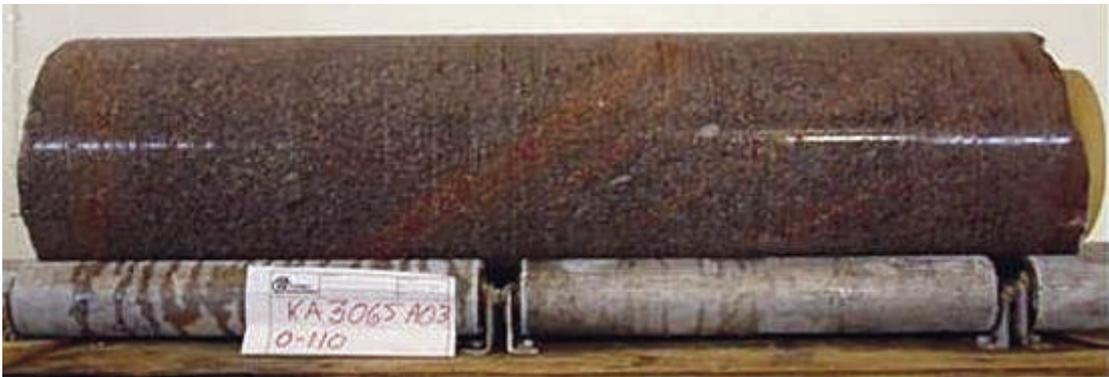
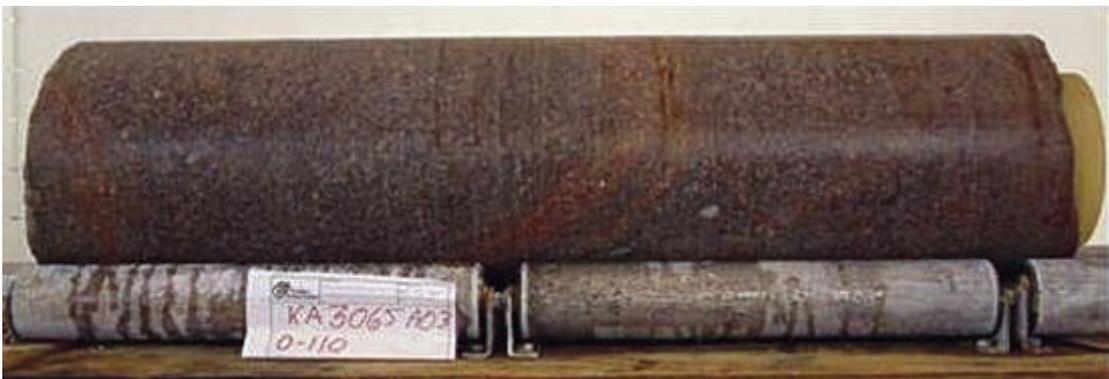
Photographs of wet core. The core is rotated in such way that each photo faces the letters A to H, respectively.
