**P-16-12**

Äspö Hard Rock Laboratory

# Long Term Sorption Diffusion Experiment (LTDE-SD)

## Over-core drilling and extraction of core samples

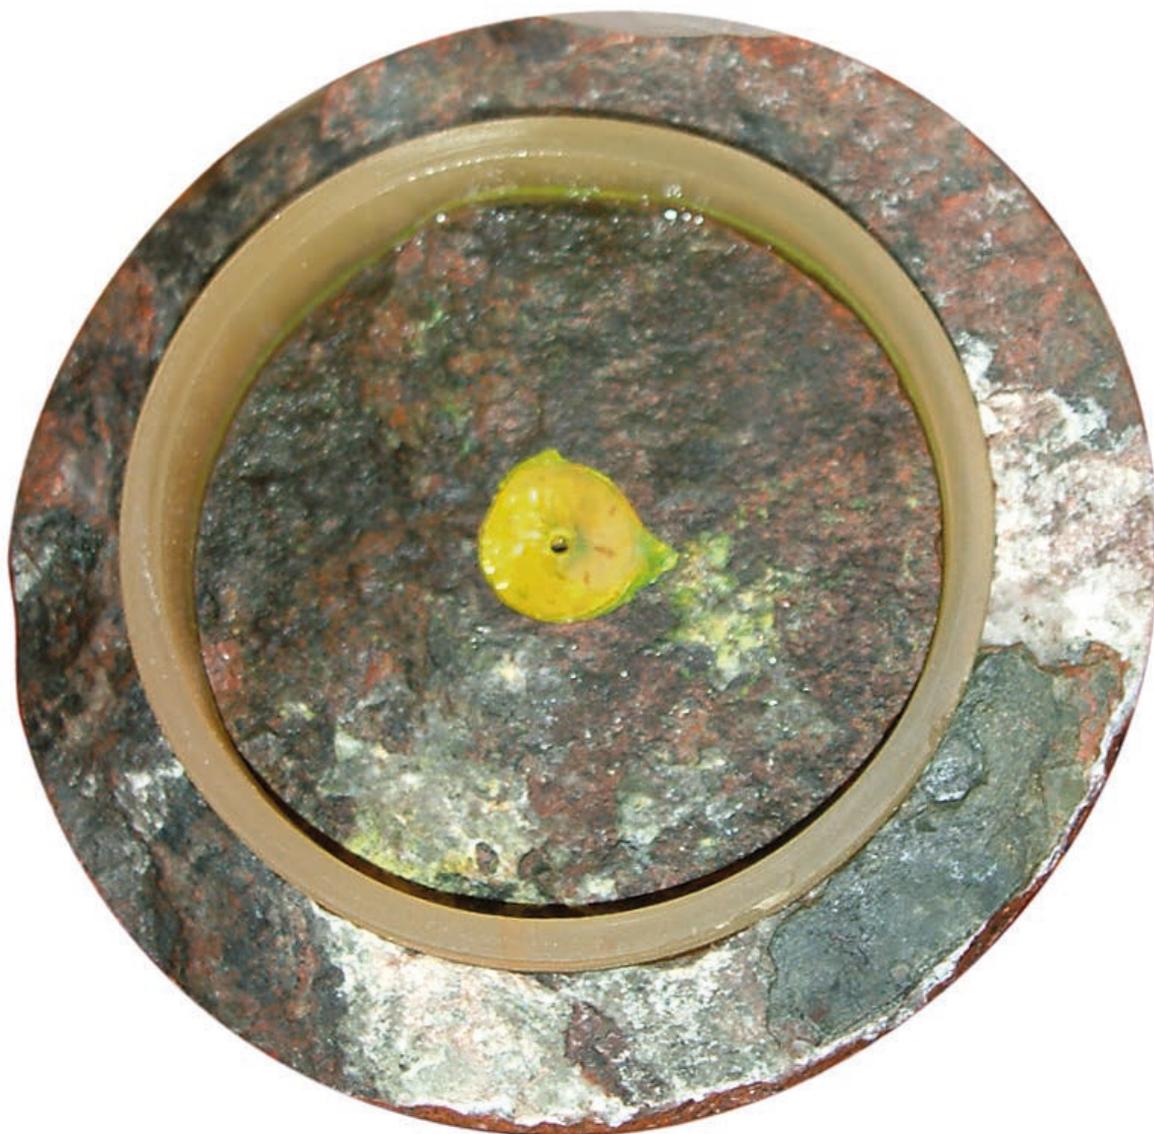
**Figure A11-1.** Target fracture at 10.74 m with the 177 mm diameter core stub inside the cylindrical PU sealing. The core is rotated to show the orientation in the borehole, i.e. the core low side is down. The photo is taken immediately after core extraction at the experimental site NASA3067A in the Äspö HRL, cf Figure A7-20.

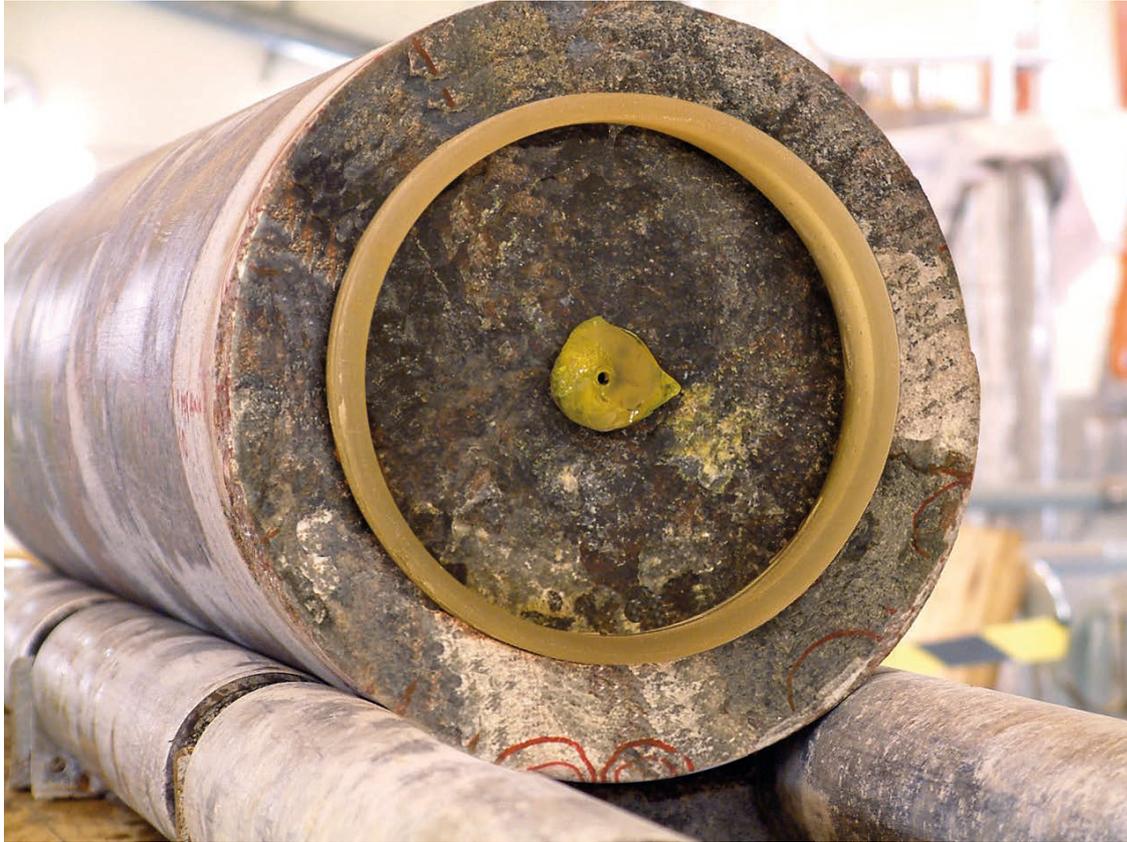
**Figure A11-2.** Target fracture at 10.74 m with the 177 mm diameter core stub inside the cylindrical PU sealing. The core is rotated to show the orientation in the borehole, i.e the core low side is down. The photo is taken at Clab in connection with the first marking of the core. See Section 3.1 and Figure 3-4.

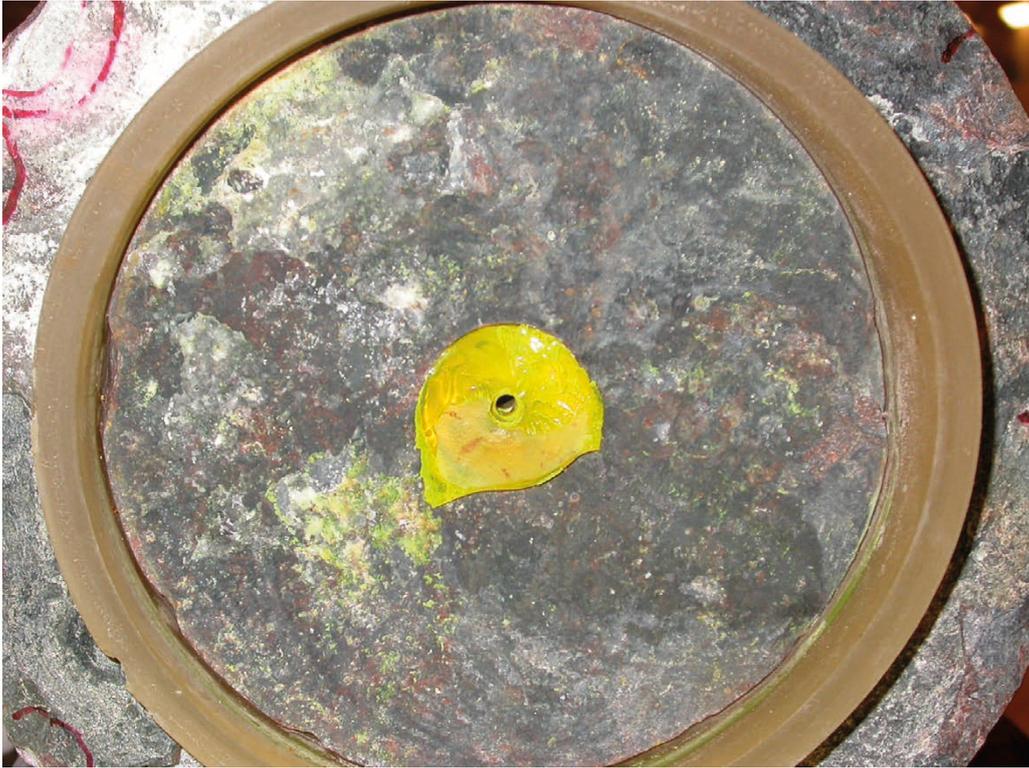
**Figure A11-3.** Target fracture at 10.74 m with the 177 mm diameter core stub inside the cylindrical PU sealing. The photo is taken at Clab in connection with the first marking of the core. See Section 3.1. Remains of the loosened yellow epoxy resin can be seen on the fracture surface.

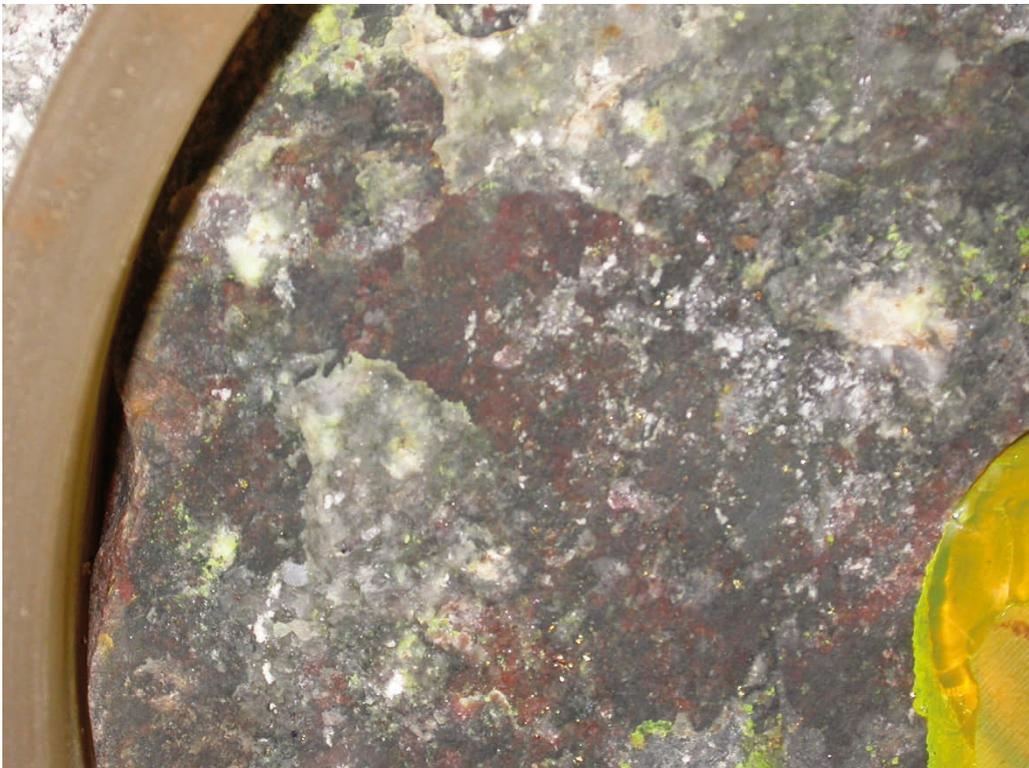
**Figure A11-4.** Close up of target fracture at 10.74 m with the 177 mm diameter core stub inside the cylindrical PU sealing.

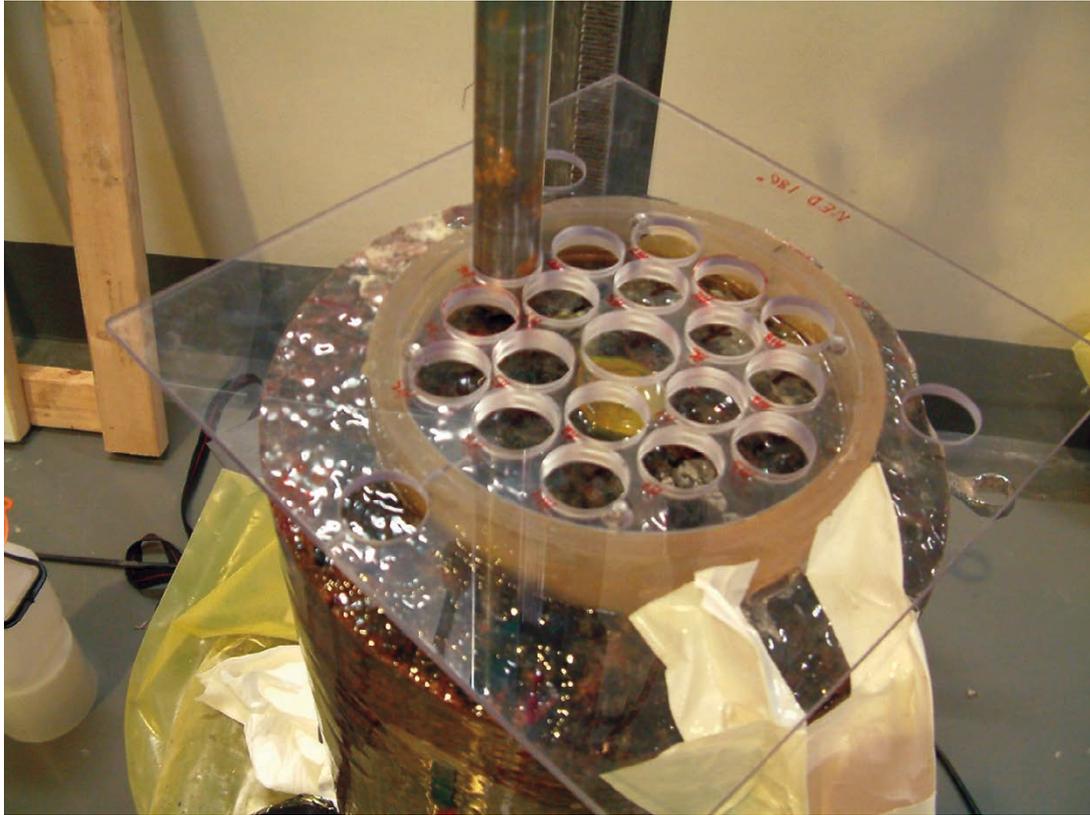
*Figure A12-2. Fastening of over-core before drilling of A-core samples.*

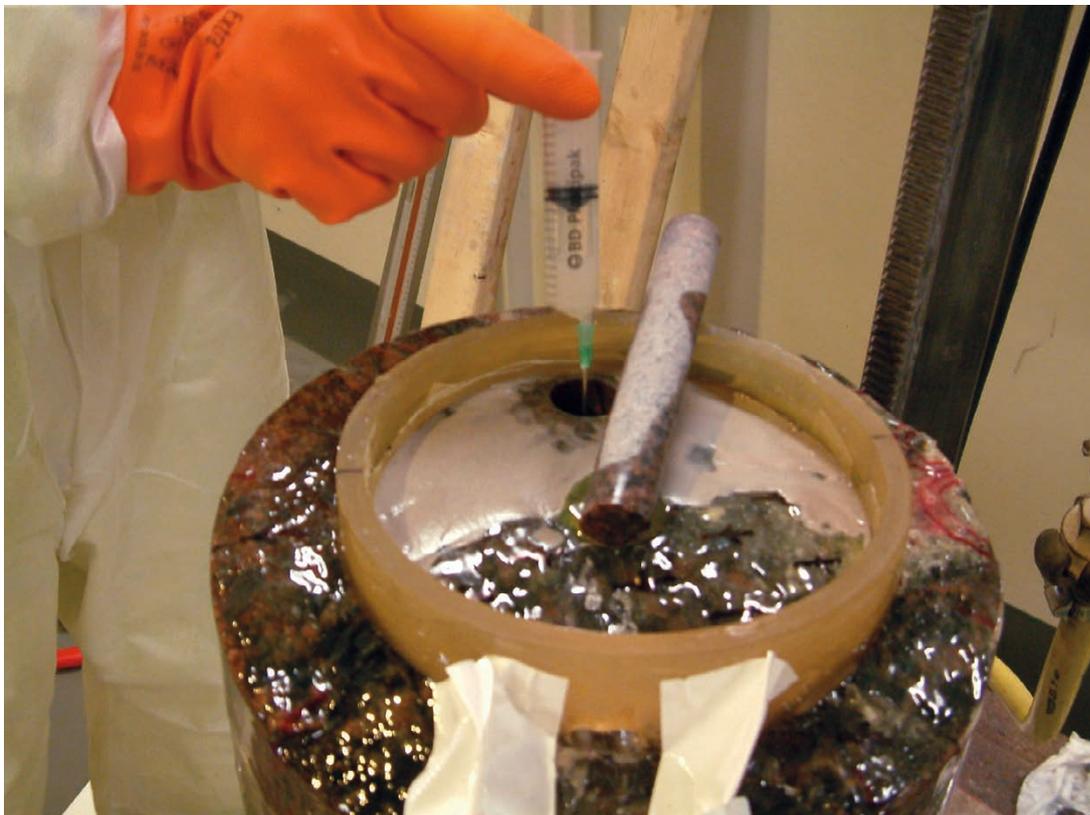
*Figure A12-3. Jig used to achieve the correct positioning of the A-core samples. Drilling of core sample A-16 is to be started.*

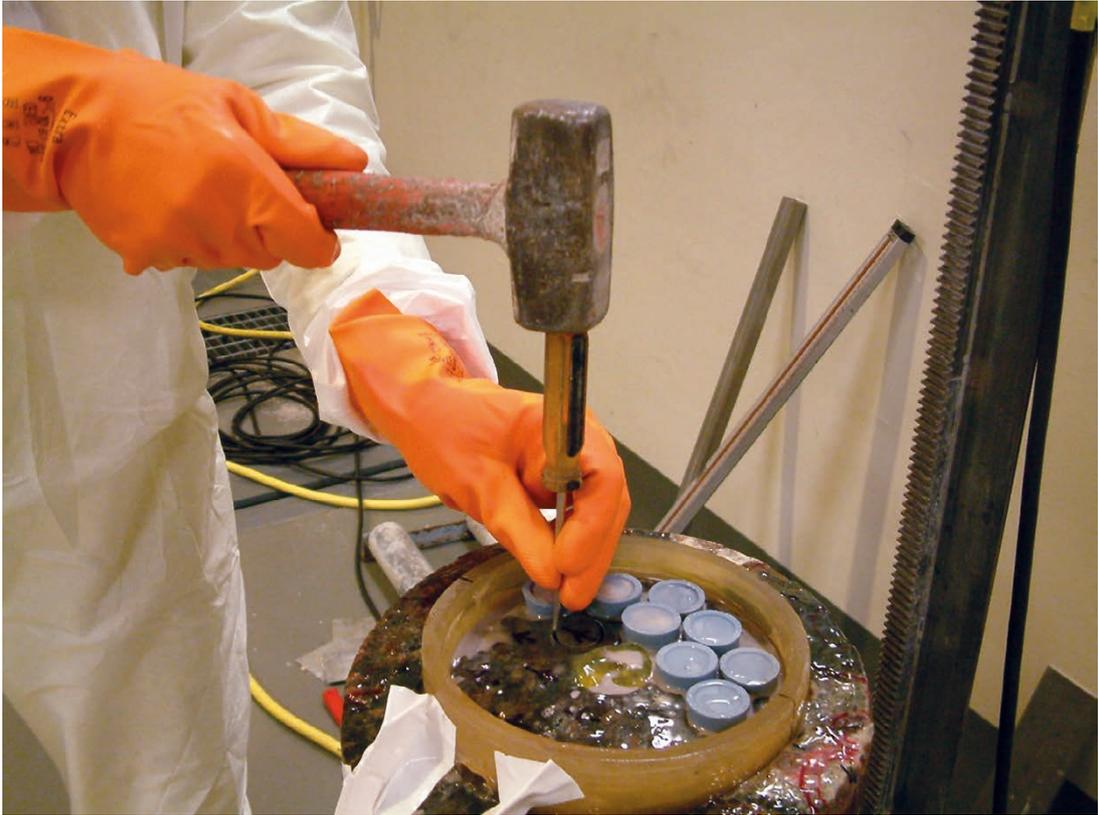
*Figure A12-4. Drill hole of sample A-16 is emptied from drilling water, before plugged by rubber cork.*

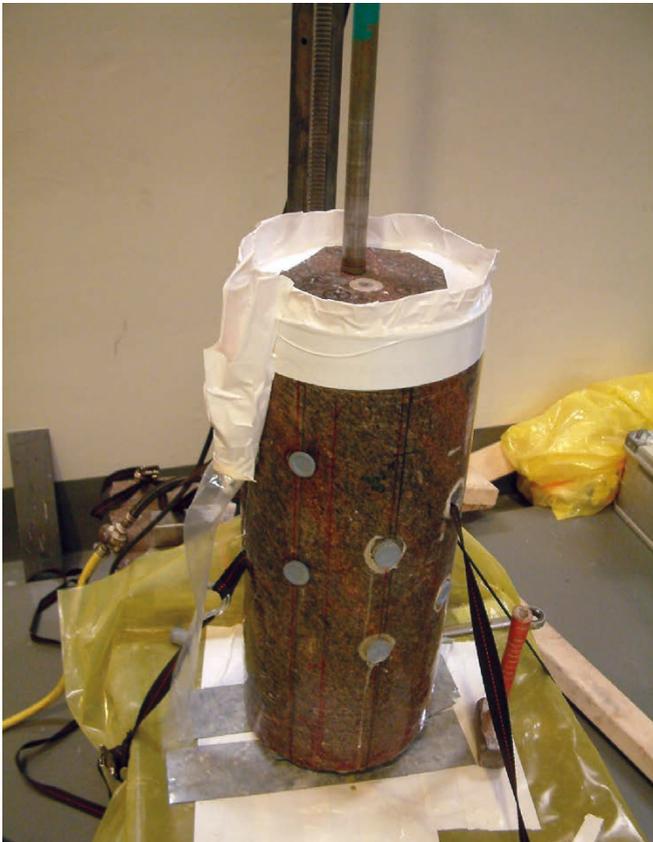
*Figure A12-5. Core breaking and retrieval of sample A-4. Drill holes of samples A-12, 6, 5, 10, 18, 11, and A-17 are plugged by rubber corks.*

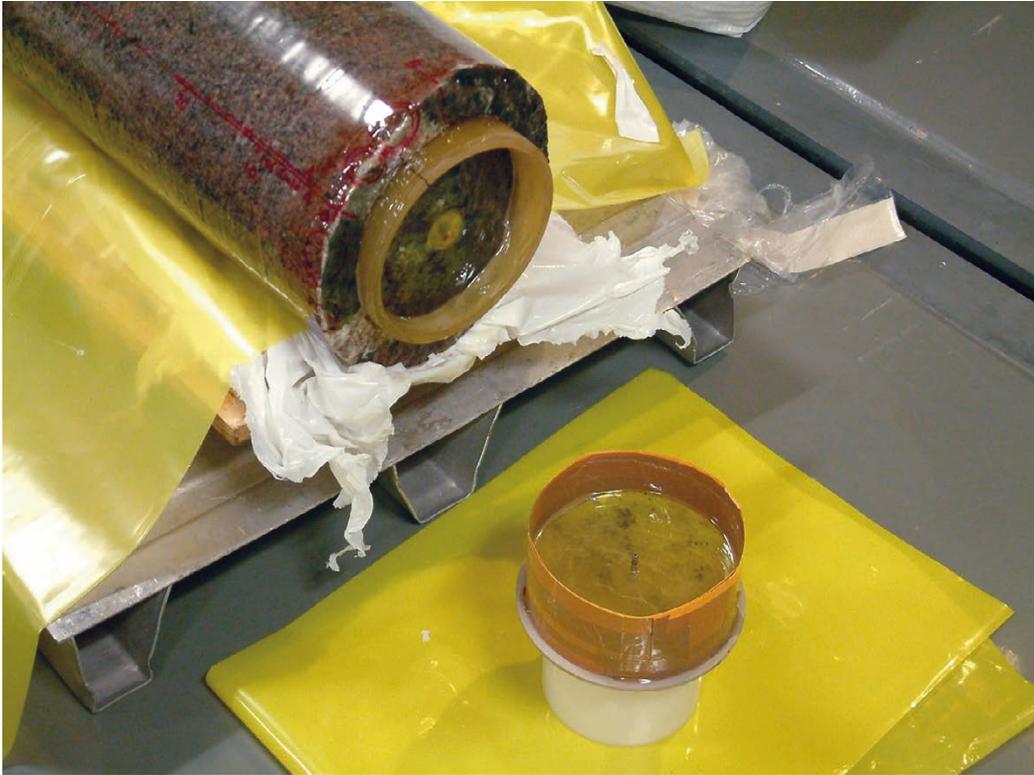
*Figure A14-1. Protective colourless epoxy (EpoTec 302) cast on top of yellow marked epoxy and PEEK lid.*

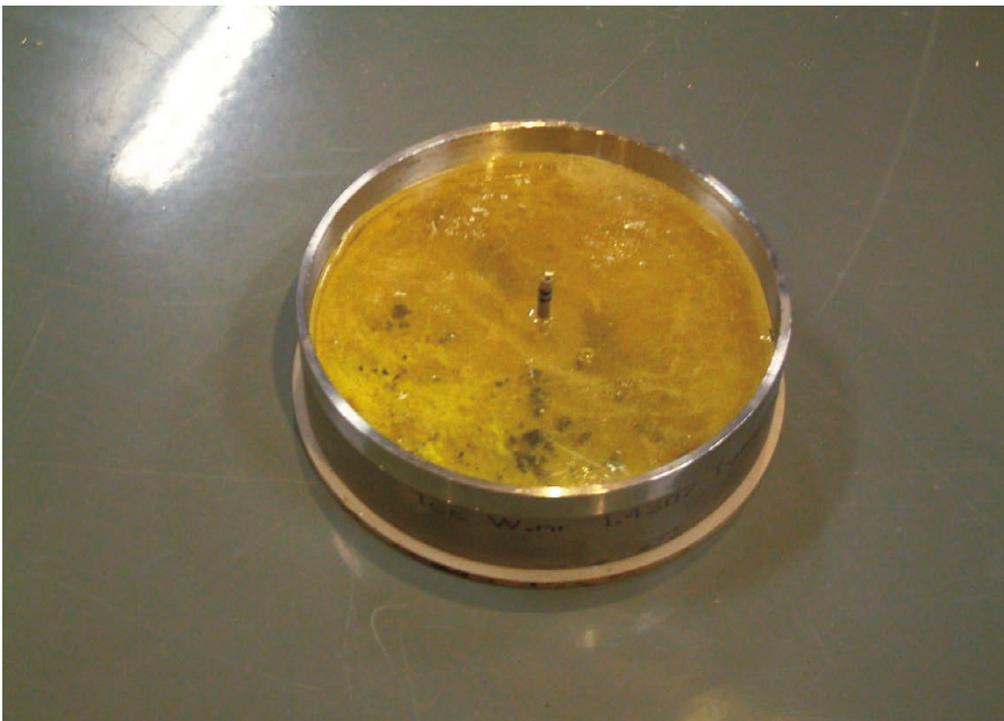
*Figure A14-2. Casting mould replaced by stainless steel ring to support the drilling jig.*

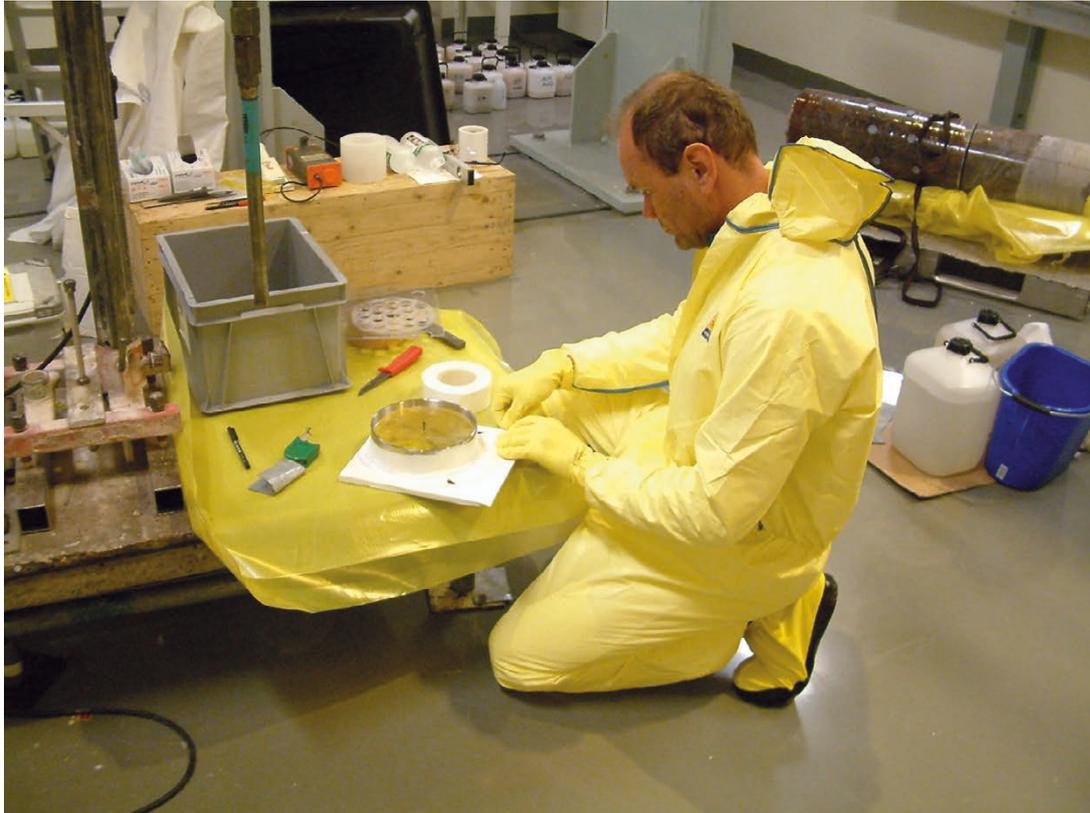
*Figure A14-3. PEEK lid with (injected) yellow marked epoxy and protective coating of colourless epoxy is fastened to a stiff plate before drilling of the B-core samples.*

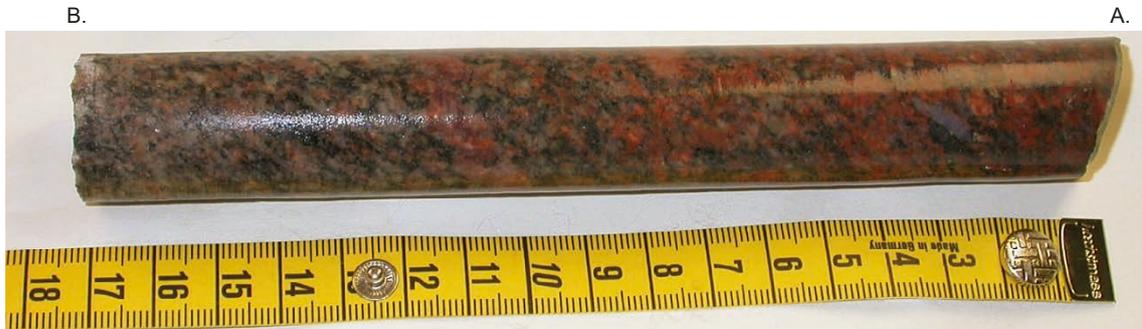
## A1

Remaining epoxy on the fracture surface, c 80 %.

Partially, 0–1 mm width between the epoxy and the fracture surface.

About 50 % coverage of fracture minerals, with a thickness of  $\leq 0.5$  mm.

- a) Increasing amount of microfractures, mainly sealed, from about 4 cm and towards the fracture surface (A). The last cm = a fine-meshed network of very thin sealed and partly open microfractures
- b) At about 10.5 cm core length, two thin sealed fractures ( $\leq 1$  mm width) with surrounding oxidation at an angle of approximately  $45^\circ$  to the borehole axis.

Red staining as well as weak albitization, are visible with decreasing intensity from the fracture surface and inwards, about 11.5 cm. In microscope, weak degree of alteration is discernible throughout the whole core.

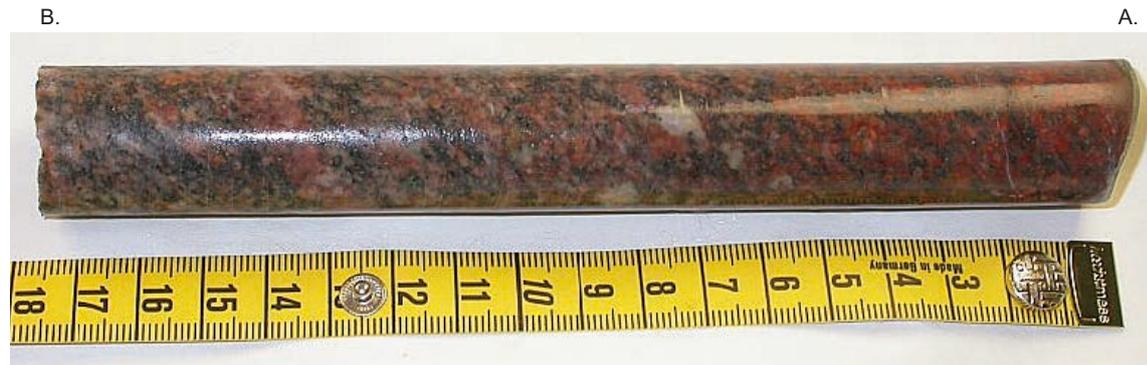
## A2

Fracture surface covered with epoxy (100 %).

Fracture coating only indicated as a white rim at single points. Approximately  $\leq 20$  % coverage, with a thickness of  $\leq 0.5$  mm.

- a) Close to the fracture surface, (2–3 mm distance) 1 sealed fracture with calcite/chlorite.
- b) Sealed fracture about 1 cm from the surface.
- c) Small microfractures in network (but less than for core sample A1).
- d) Single microfractures, possibly partly opened, throughout the whole core. No dominating orientation. Nevertheless, microfractures close to A (the surface) are more parallel to the fracture surface than the microfractures at distance.

Red staining, faint to medium degree, increasing towards fracture surface.

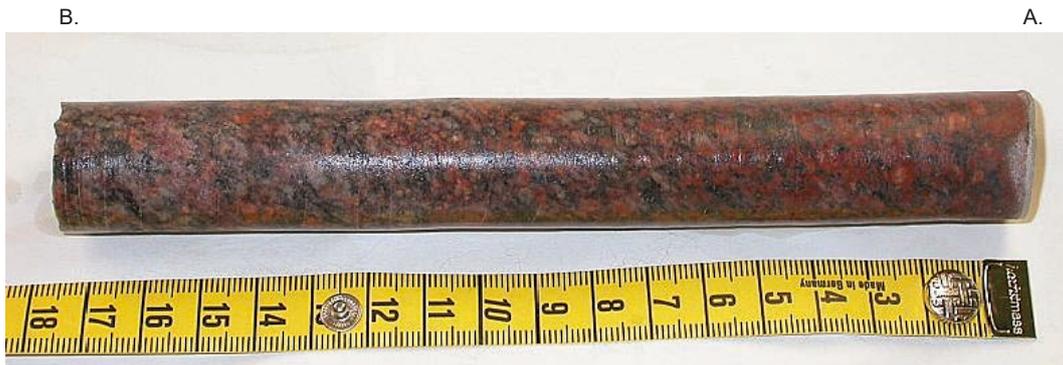
### A3

Epoxy covers 100 % of the fracture surface.

About 50 % of thin fracture coating at the fracture surface (A).

Red-staining from faint (B) to medium (A).

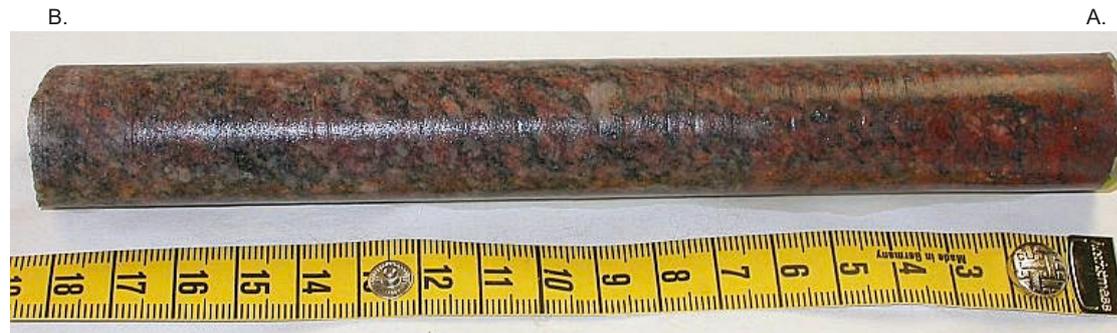
## A4

Remaining epoxy on the fracture surface, 100 %.

A 0–2 mm thick fracture coating covers approximately 70 % of the fracture surface.

Faint to medium degree of red staining, increasing towards the fracture surface (A).

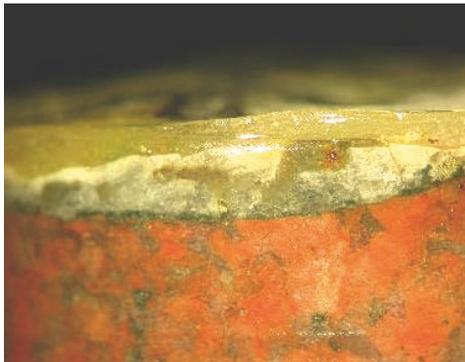
Fracture surface coating (A): chlorite, calcite, chalcocopyrite ± pyrite ± epidote (see photo below).

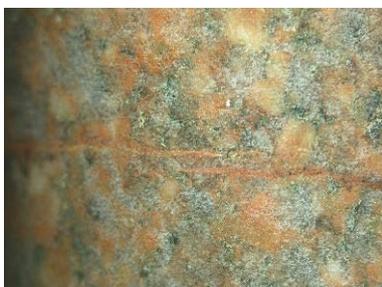
- Sealed, more or less parallel with the fracture surface (A). The largest one 3 cm from the fracture surface (A). These fractures form a circle around the core, but do not close the ends (see photo a) below). Red coloured according to small hematite grains in calcite.
- Very thin sealed or partly open microfractures. Can be seen anywhere and at different orientations at the rock core (see photo b) below).

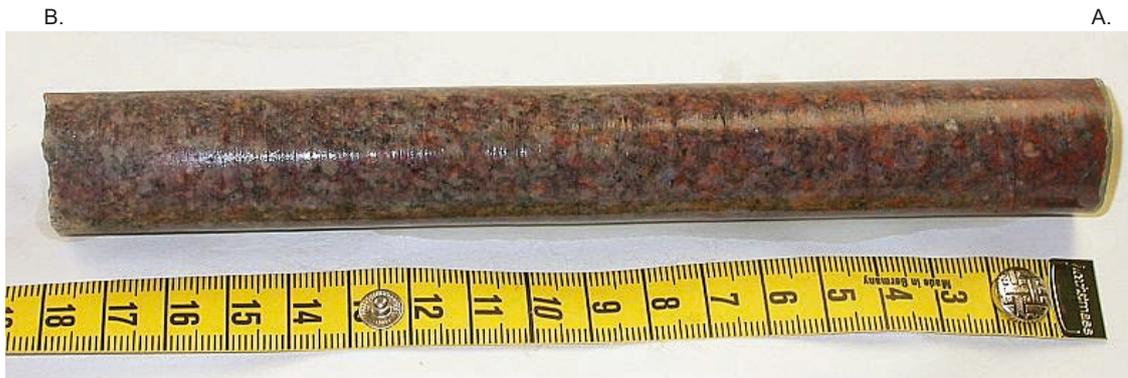
## A5

Fracture surface covered with epoxy (100 %).

Approximately 50 % of the fracture surface has a thin ( $\leq 0.5$  mm) fracture coating.

- a) Sealed fracture 2 cm from, and parallel with, fracture surface (A). Forms a circle, which does not close the ends (as illustrated for rock core A4).
- b) Sealed fracture 5.5 cm from (A) but at angle to the borehole axis.
- c) Small microfractures close to the fracture surface (A).

Red staining, faint to medium. Faint degree, irregular at the second part of the rock core (towards B).

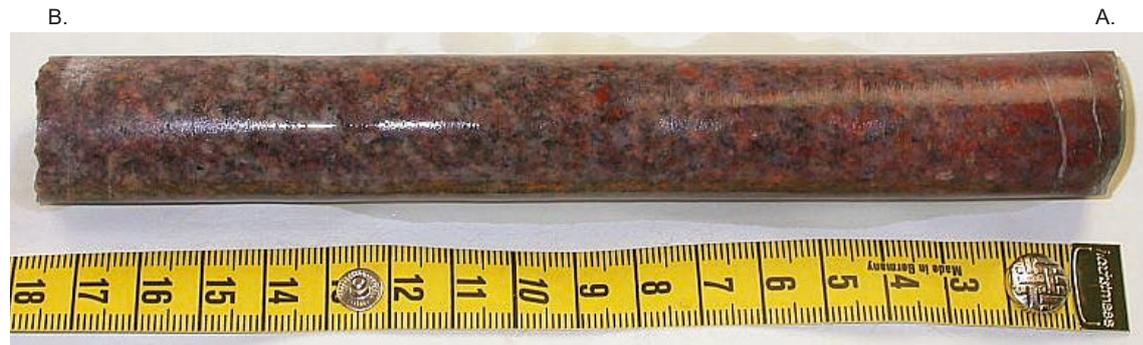
## A6

Epoxy covers 100 % of the fracture surface.

The fracture surface coating is 0–2 mm thick and covers c 95 % of the surface.

- a) Sealed fractures, 0.5 and 1 cm from fracture surface (A).
- b) 2 fractures c 45° to the borehole axis between the “0.5” and “1 cm fractures” described in a).  
Not visible round the whole core.
- c) Very thin microfractures at c 8 cm distance from the fracture surface (A). No specific orientation.

Faint to medium (possibly strong) degree of oxidation, i.e. red staining.

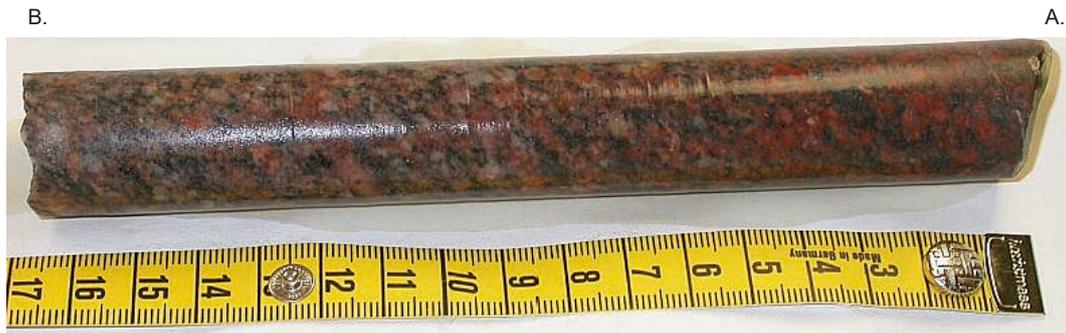
## A7

Epoxy covers 100 % of the fracture surface.  
Fracture coating at about 75 % of the surface (A).

- a) Sealed fracture at 0–1 cm distance from the fracture surface (A), i.e. not parallel to the fracture surface.
- b) Minor amount of microfractures except from a couple of thin and short partly open fractures around the described fracture above.

Varying degree from A to B (see figure above); the first 6 cm = medium, 6–11 cm = weak, 11–13 cm = faint, 13–16.5 cm = no alteration.

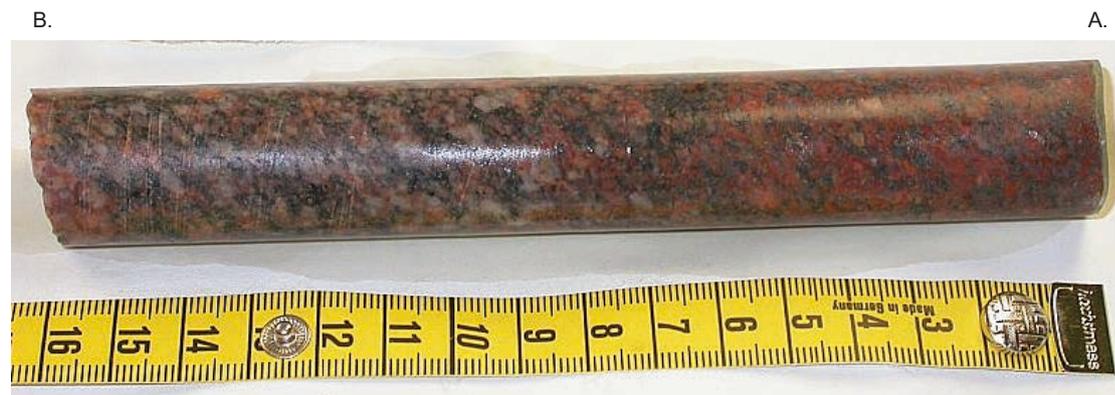
## A8

Epoxy covers 100 % of the fracture surface.

The fracture coating is thin ( $\leq 0.2$  mm) and covers about 70 % of the surface area.

Faint to medium oxidation, i.e. red staining.

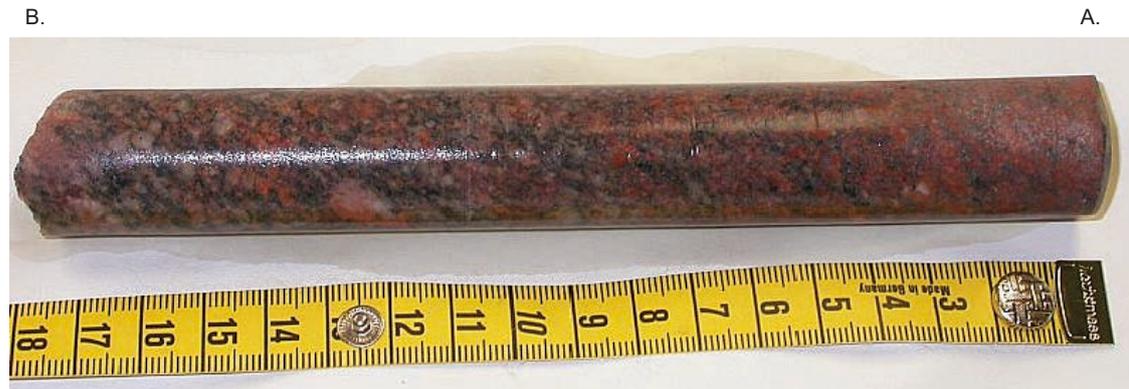
## A9

Epoxy covers 100 % of the fracture surface.

50 % of the fracture surface has a thin ( $\leq 0.5$  mm) fracture coating.

Red staining, faint to medium degree, increasing towards fracture surface (A).

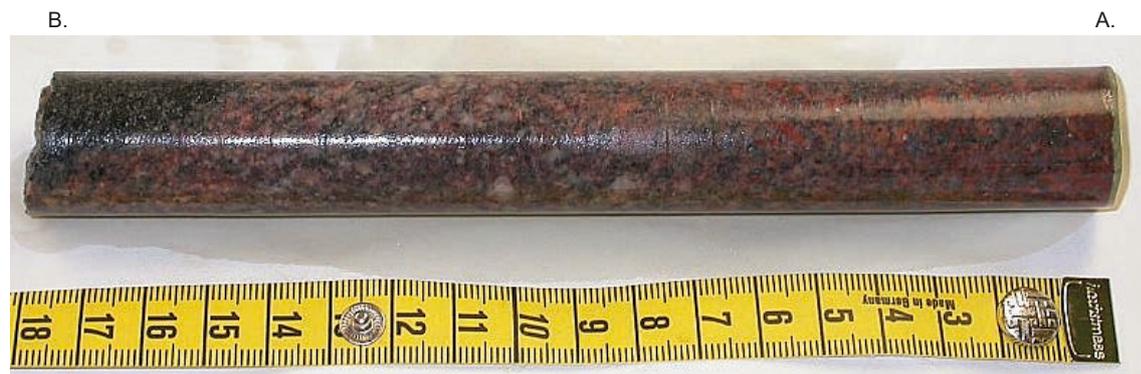
## A10

Epoxy covers 100 % of the fracture surface.

Weak to strong red staining with increasing intensity towards the fracture surface (A).

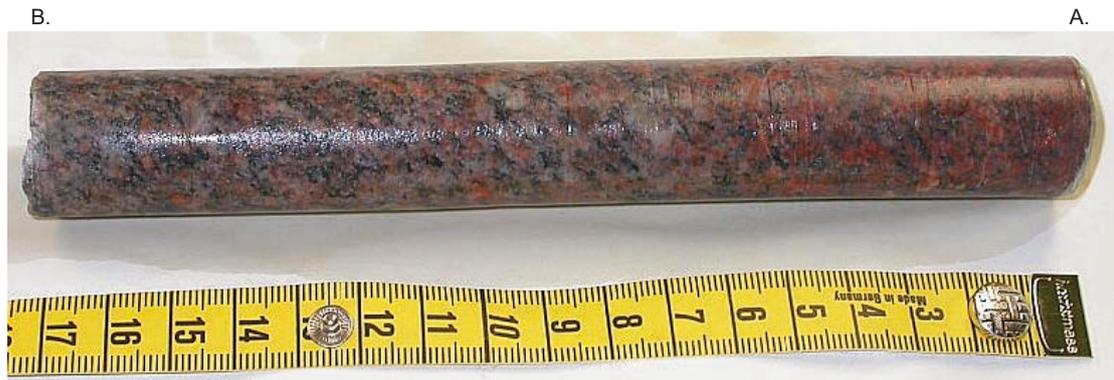
## A11

Epoxy covers 100 % of the fracture surface. Generally thin ( $\leq 0.5$  mm), but irregular, fracture coating is observed at about 60 % of the fracture surface (A). Remaining 40 % seems to be without fracture coating.

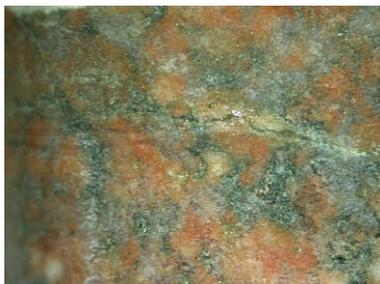
- Partly open fracture at about 1.5 cm from the fracture surface (see photo a) below). Parallel (or sub-parallel) to (A).
- A few sealed microfractures close to the fracture surface (A). Diagonal relative to the borehole axis.
- Sealed and thin calcite filled fracture at  $45^\circ$  relative to the borehole axis.

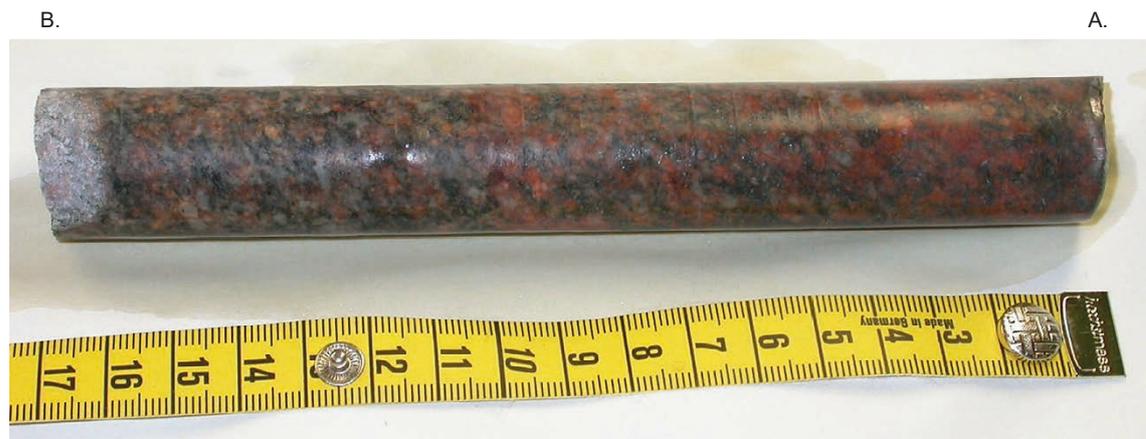
## A13

Epoxy covers 85 % of the fracture surface.

Faint to medium degree of oxidation (red staining).

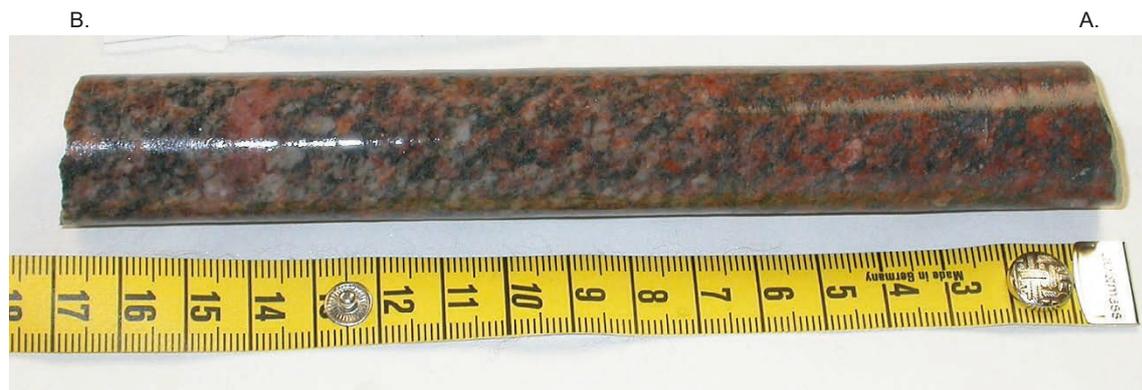
## A14

Epoxy covers 100 % of the fracture surface.

Faint to weak/medium oxidation.

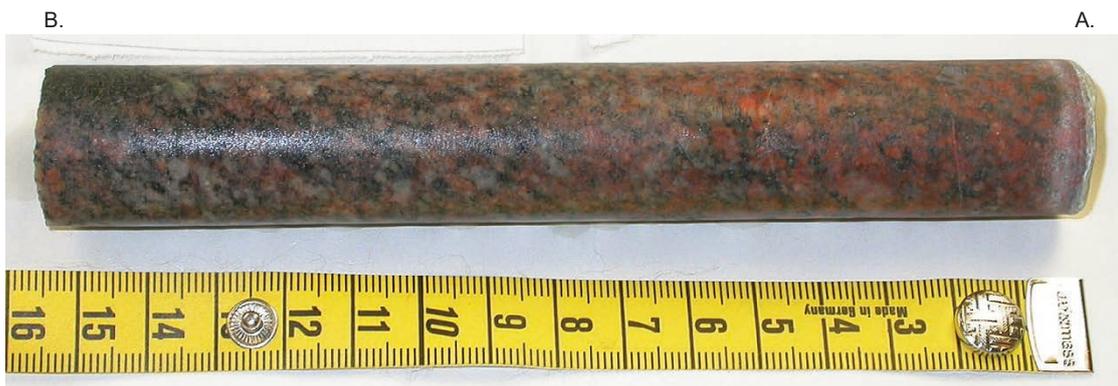
## A17

100 % epoxy covers the fracture surface.

- a) Several small subparallel fractures and microfractures close to the fracture surface (A).
- b) 3 parallel sealed fractures at about 2, 2.5 and 4.5 cm distance from fracture surface (A), respectively.

Weak to medium degree of oxidation (red staining) at A, gradually decreasing towards B where no visible alteration is seen.

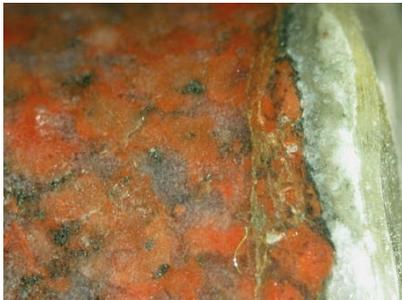
*Illustration of thick fracture coating (epoxy covered) as well as small chlorite/calcite filled fractures close to the fracture surface (A).*

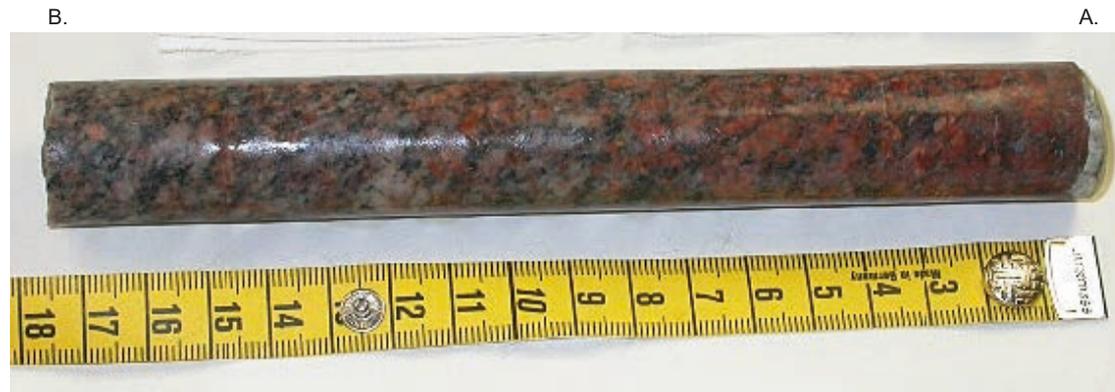
## A18

Epoxy covers 100 % of the fracture surface.

- a) Several sealed thin fractures and microfractures which are close to, and sub-parallel to the fracture surface (A). Some of them in connection to the fracture surface.
- b) 3 sealed fractures at approximately 2, 2.5 and 4.5 cm distance from fracture surface (A) respectively (parallel orientation with respect to (A)).

Faint to strong (at 5 mm close to the fracture surface (A)) degree of oxidation (red staining).

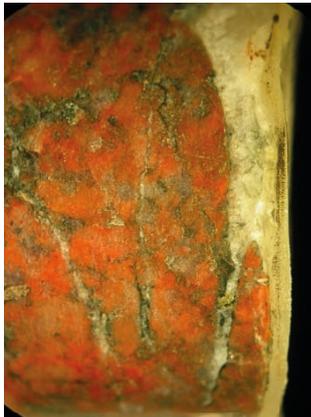
*Illustration of the irregular fracture coating, mainly consisting of calcite, at (A) (epoxy covered). Small chlorite/calcite filled sealed fractures close to the fracture surface can be seen as well.*

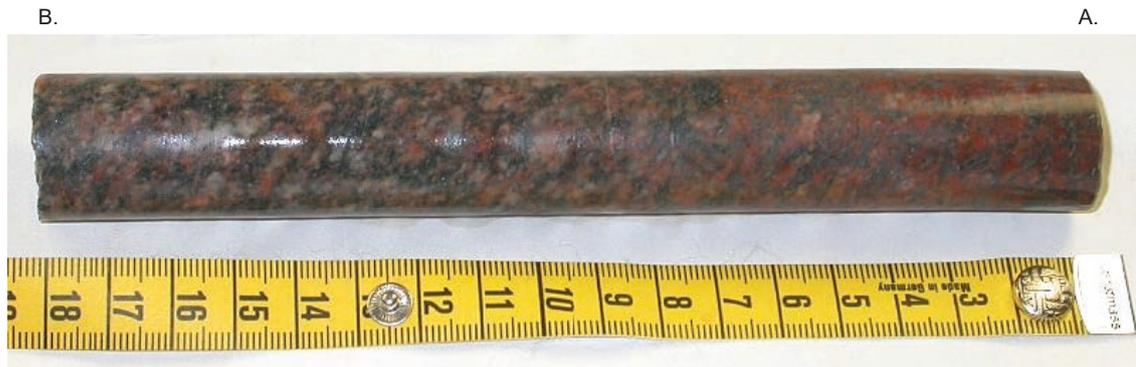
## A19

No epoxy on the fracture surface. This rock core is drilled outside the PU-cylinder, i.e. outside the experiment area. No fracture coating at the surface (A).

Faint to medium degree of oxidation (red staining).

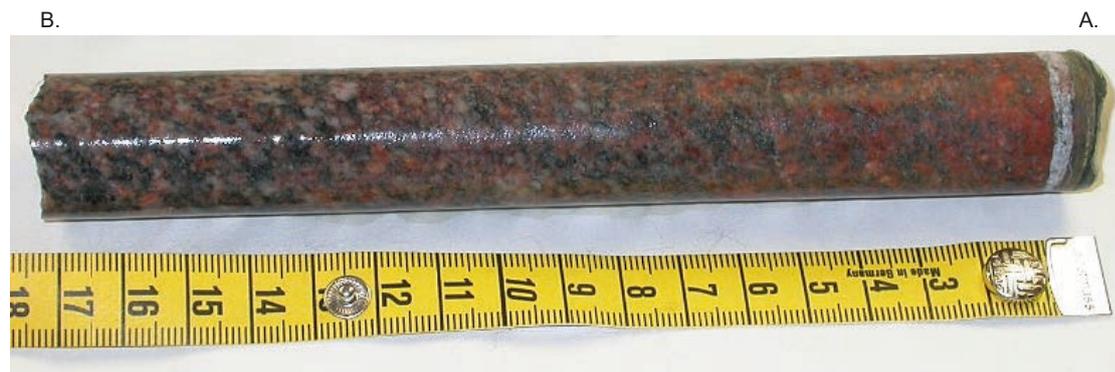
### General:

Epoxy covers 100 % of the fracture surface. This rock core is drilled outside the experiment area, i.e. outside the cylindrical PU sealing.

Medium degree of oxidation (red staining) at (A) decreasing to no visible alteration at (B).

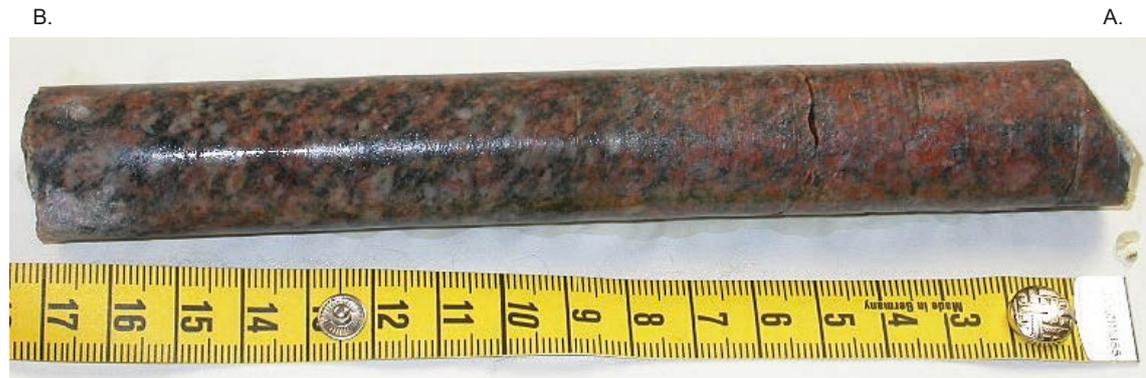
## A21

Epoxy covers 100 % of the fracture surface. This drillcore is placed outside the PU cylinder, i.e. outside the test area.

Weak/medium degree of oxidation (red staining) at (A) decreasing to no visible alteration at (B).

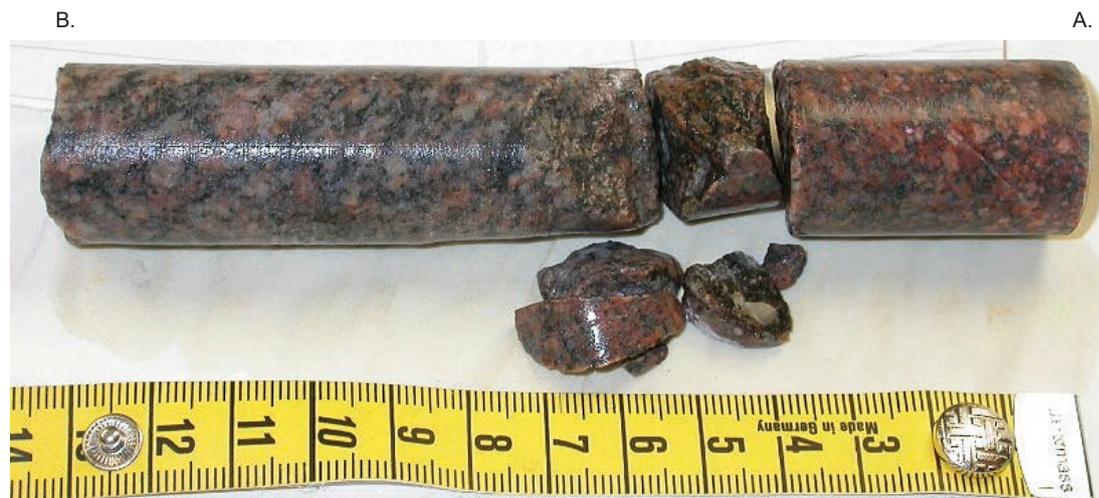
## C1

The core is broken at c 3.5 and 5.5 cm, the position of discontinuous, partly open fractures. Mechanical damage of the core is visible in connection to these breaks.

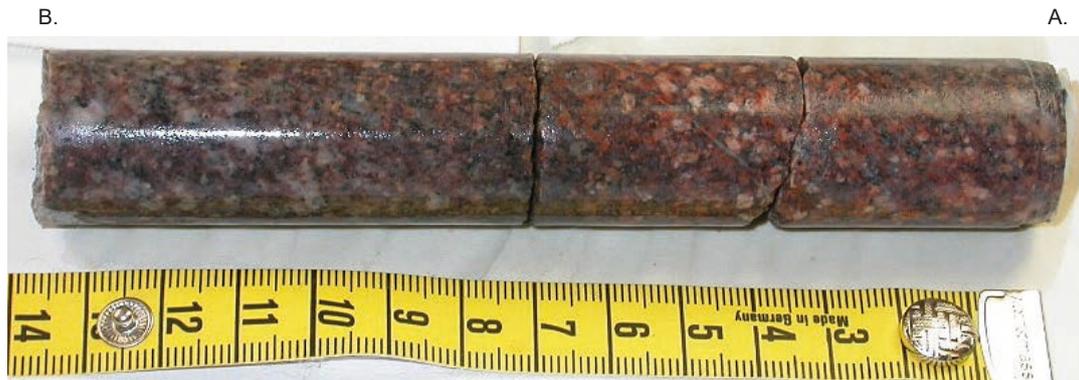
## C2

The core is broken during drilling at c 3.5 cm, i.e. the position of a discontinuous partly open fracture. The break at 7 cm is supposed to be a natural fracture as well.

- a) Open/partly open fractures in connection with the mechanical break 3.5 cm and 7 cm from (A).
- b) Sealed fracture with an angle ( $\alpha$ ) of about  $45^\circ$  to the borehole axis, visible at c 0.6 to 7 cm from (A).
- c) Microfractures occur around, and are parallel to, the sealed fracture described in b) as well as sporadically throughout the whole core. One microfracture is cross-cutting the sealed fracture b).

Weak to medium oxidation (red staining), 0–7 cm from (A). Faint oxidation in the last part of the core, 7–14 cm (towards B).

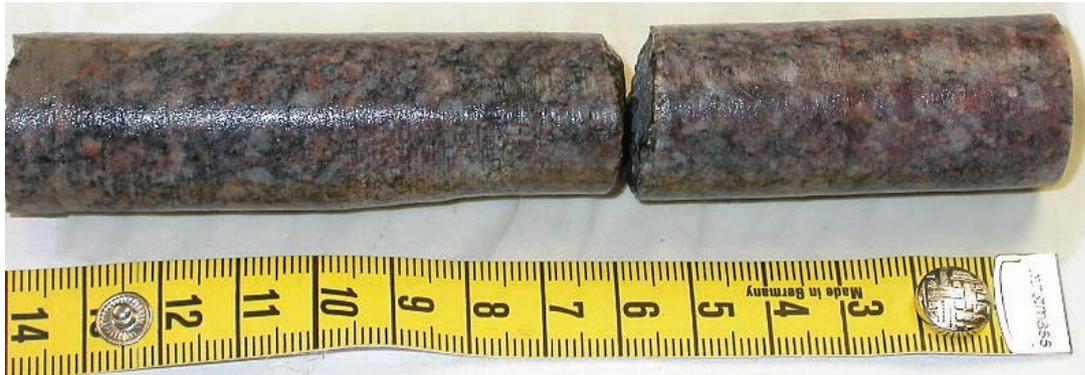
Break at a natural fracture, 5.8 cm from (A), with adjacent drill induced damage at 6 to 8.5 cm.

- a) Open fracture at the break at 5.8 cm.
- b) One open/partly open microfracture in the second part of the broken rock core.

Faint oxidation/albitization at 0–3 cm from (A), but no visible alteration of the remaining rock core. Some rust colour in grain boundaries is visible in stereomicroscope.

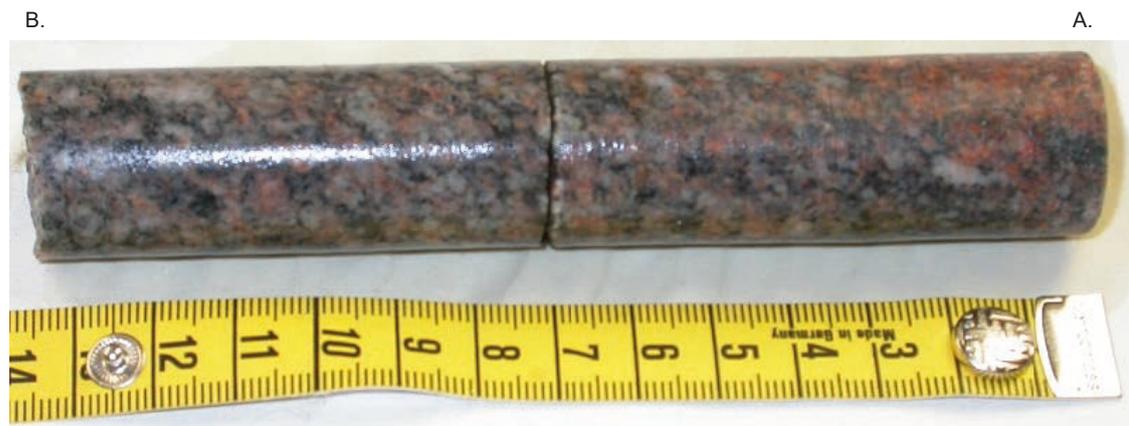
## C4

The core is broken at a natural fracture, 7 cm from (A).

- a) Open fracture at 7 cm from (A).
- b) Sealed fracture with an angle ( $\alpha$ ) of about  $60^\circ$  to the borehole axis, visible at c 0–1 cm.
- c) Partly open fracture at 4 cm, perpendicular to the borehole axis.

Faint to weak oxidation (red staining), 0–7 cm from (A). No alteration in the last part of the core, 7–14 cm.

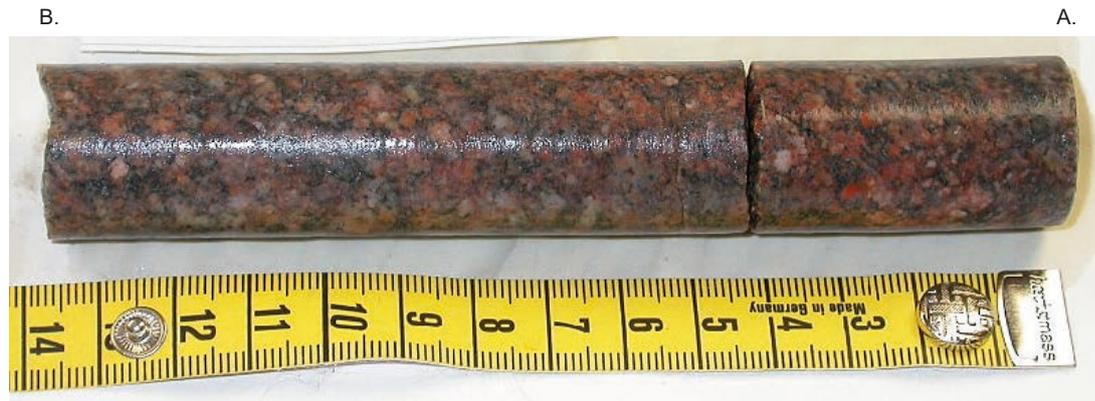
## C5

The core is broken at c 4 cm, at the position of discontinuous partly open fracture.

- a) Sealed fracture with an angle ( $\alpha$ ) of about  $50^\circ$  to the borehole axis, at c 2.4 – 4.5 cm.  
Core rotation  $180-360^\circ$ .
- b) Open/partly open fracture at 4 cm, crosscutting fracture a).

Faint to weak irregular oxidation (red staining), 0–4 cm from (A). No alteration to faint alteration in the last part of the core, 4–14 cm.
