**P-16-12**

Äspö Hard Rock Laboratory

# Long Term Sorption Diffusion Experiment (LTDE-SD)

## Over-core drilling and extraction of core samples

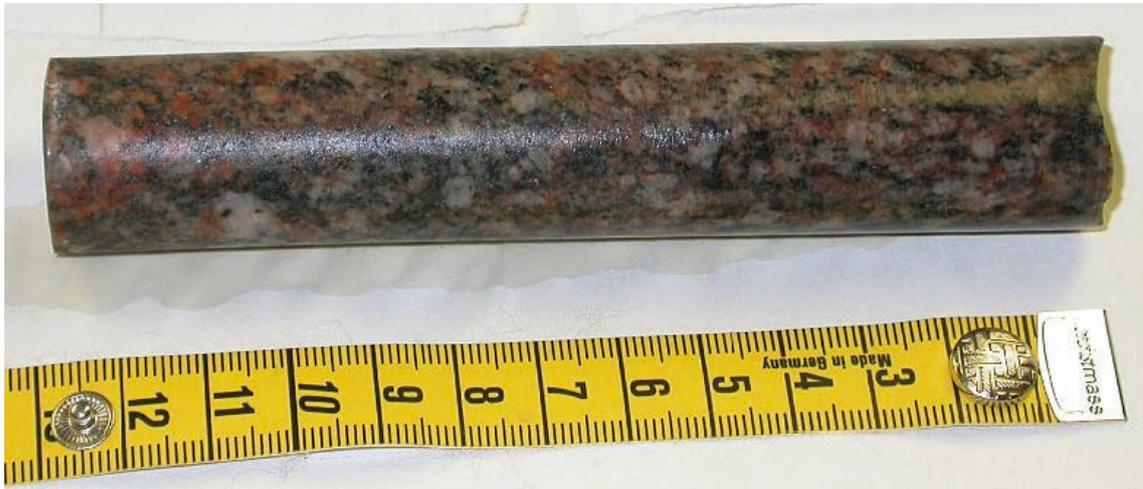
K-feldspar to varying extent albitized, biotite partially altered to chlorite and plagioclase is partially saussuritized, i.e. altered to epidote, sericite and albite. Titanite is probably hematite stained, visible as rusty colour around some of the mineral grains.

- a) Sealed thin fracture (rotation 80° on core), subparallel with the borehole axis.
- b) Signs of sealed fracture close to B, visible as red-staining.

Faint degree of oxidation (red-staining) at (B) quickly decreasing to no visible alteration at (A).

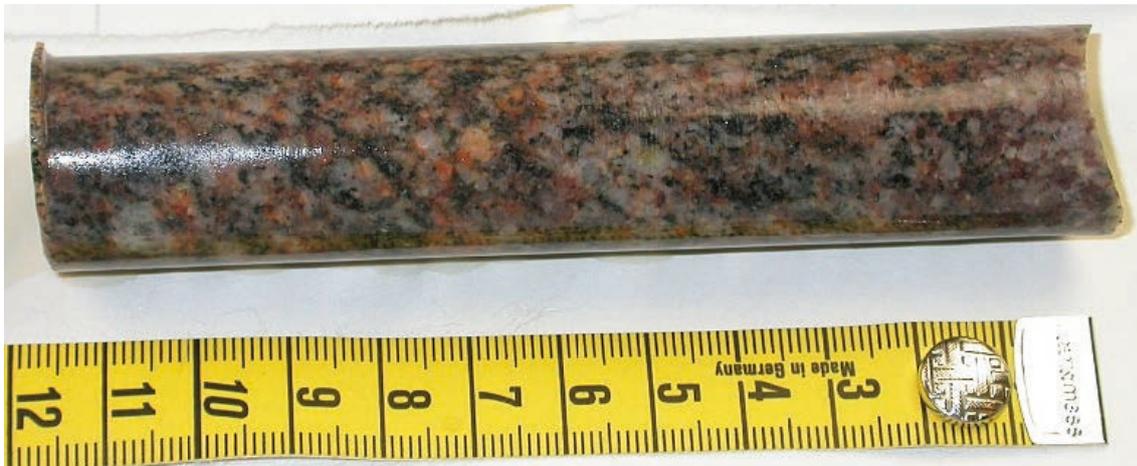
One partly open fracture (rotation 90–180° on core), the angle ( $\alpha$ ) is 45° to the borehole axis.

Weak to medium degree of alteration close to the slimhole (A), visible as albitization and rust colouring in grain boundaries. Bleached appearance with distinct demarcation (not so clear in the photo).

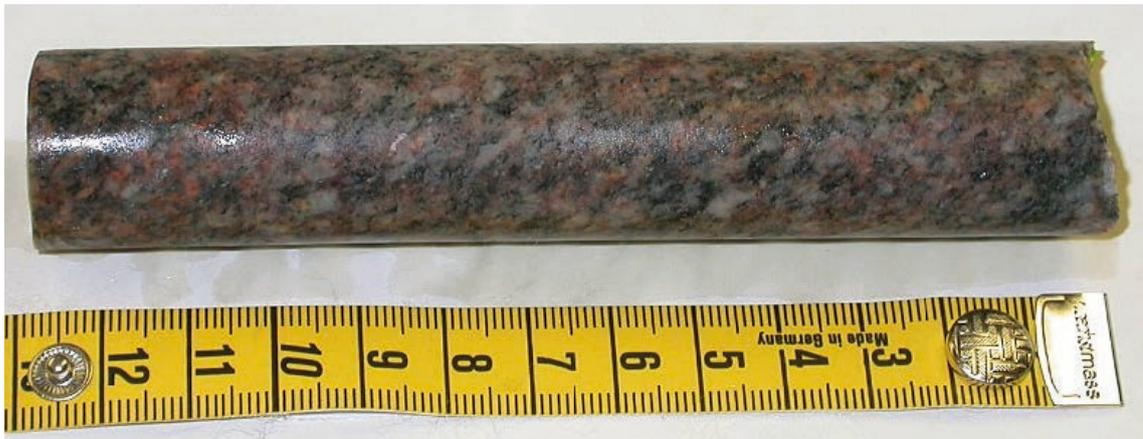
No detected fractures.

No alteration, except for the last 2.5 cm (towards B) which has a medium degree of oxidation (red staining).

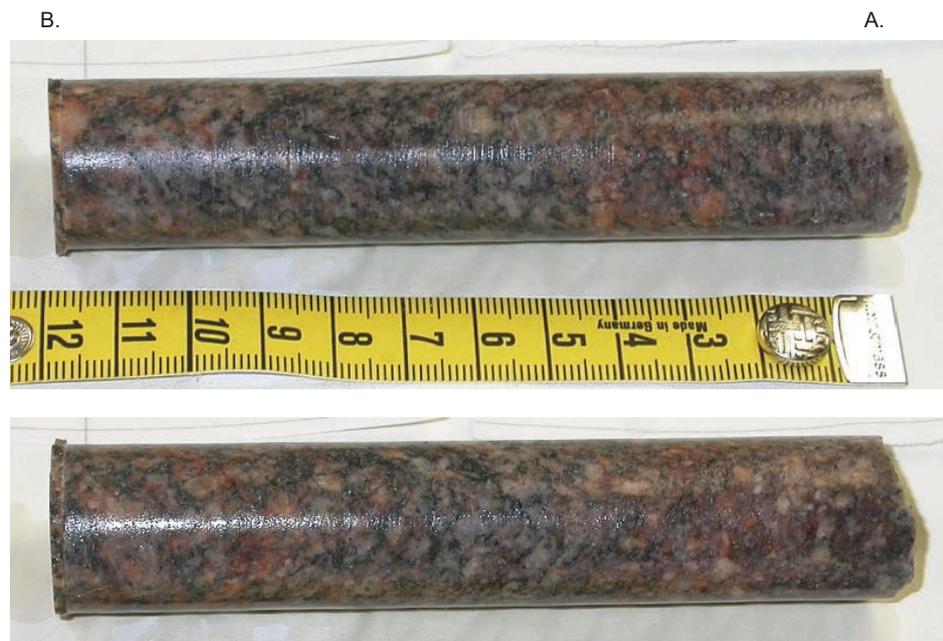
## D4

Rock core D4 with orientation 0°–180° (upper picture) as well as orientation 180°–360° (lower picture).

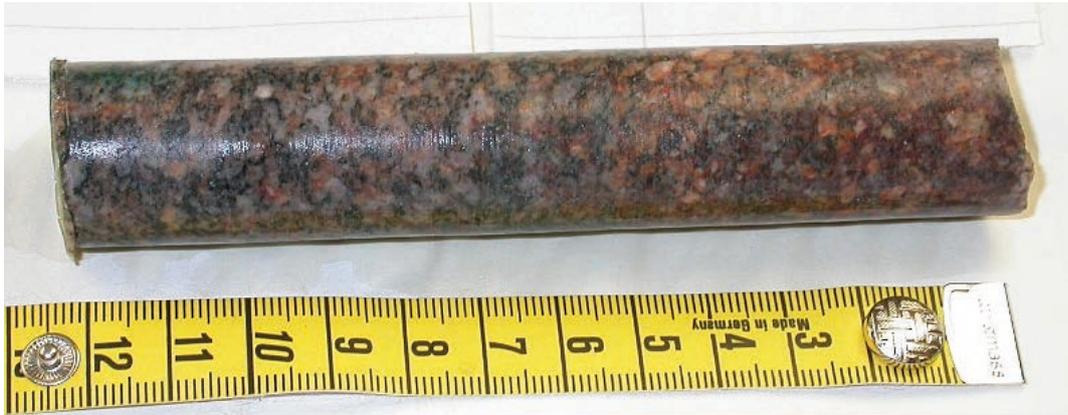
Thin sealed fractures (with irregular outshoots) at 2.5, 3.5 and 4.5 cm respectively, at an angle of 65° to the borehole axis.

Faint to weak alteration, 0–6 cm (i.e. near the slimhole).

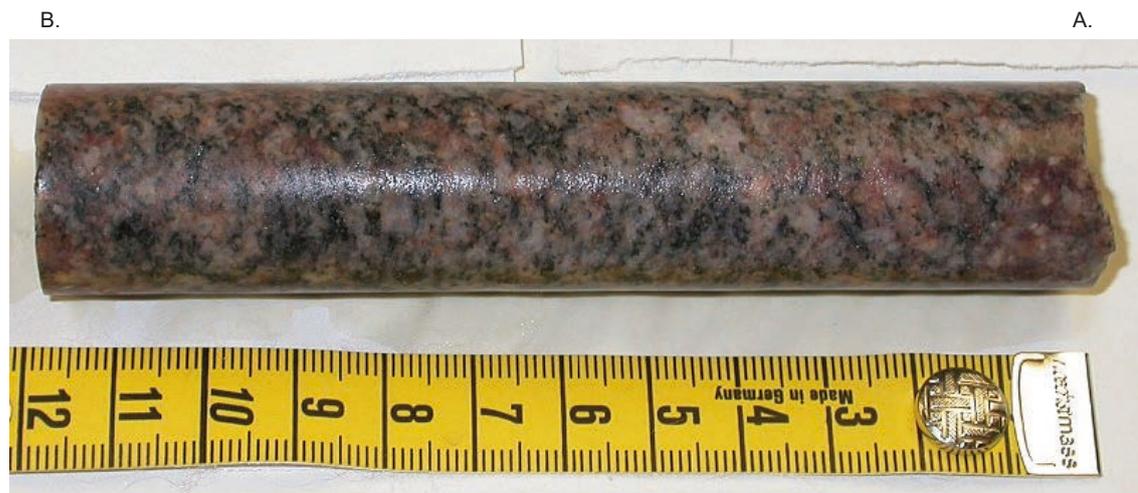
## D7

- a) Sealed fracture at about 6 cm distance from (A). The angle is approximately  $20^\circ$  to the borehole axis.
- b) Small microfractures at 0.5–1 mm from the slimhole (A) when the core is rotated  $160^\circ$ .  
Possibly drill-induced microfractures.

No clear signs of alteration, except for small areas around sealed fractures.

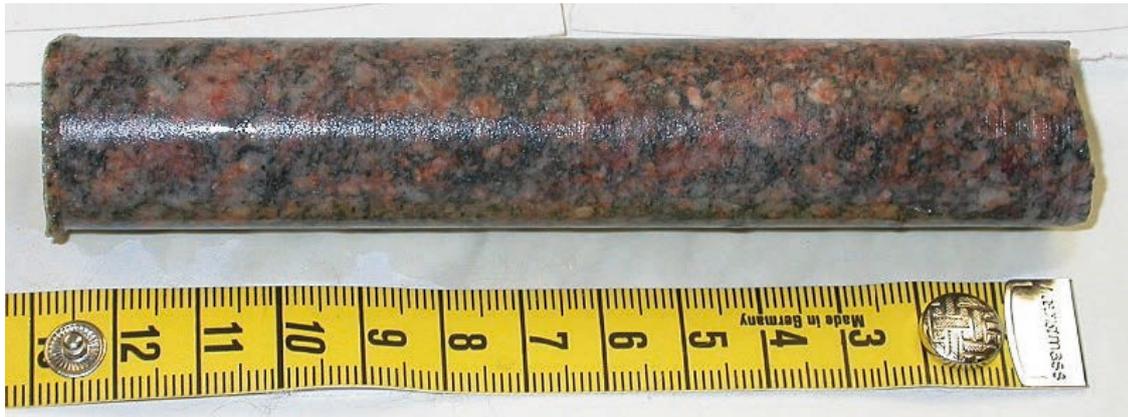
- a) Sealed fracture at about 3 cm distance from (A). The angle is approximately  $20^\circ$  to the borehole axis.
- b) Several small microfractures at 0.5–1 mm from the slimhole (A). Possibly drill induced microfractures.

Faint to weak oxidation (red staining). Most of the red-staining probably originate from sealed fractures.

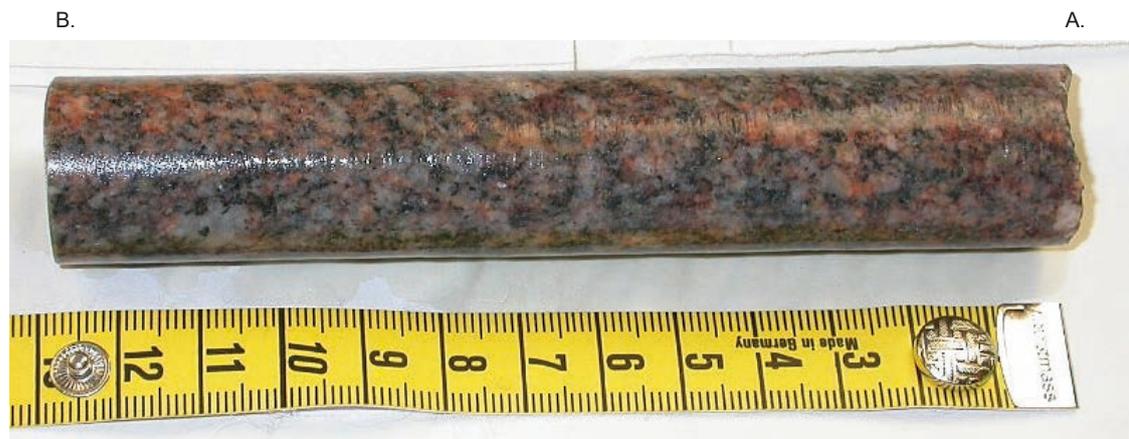
## D9

Fracture filling, sealed fracture: Calcite and hematite.

Faint to weak oxidation (red-staining). Most of the red staining probably originates from sealed fractures.

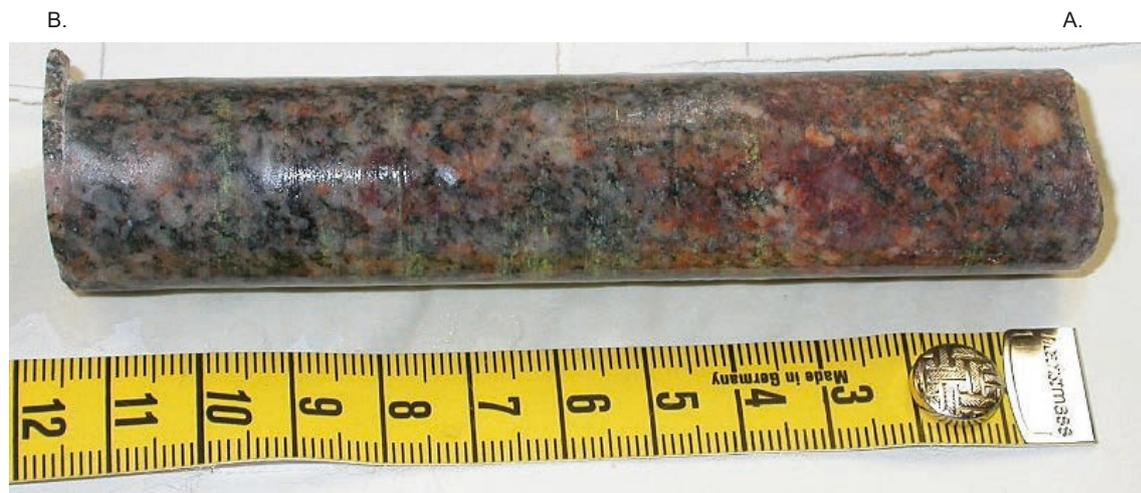
## D10

Minor amount of epoxy at the core mantle (yellow-green coloured); i.e. a contamination rest from the drilling process.

- 2 parallel sealed fractures, visible at the surface in the slimhole (A) and 3.5 cm inwards the core (rotation on core 120–295°),  $\alpha$ -angle about 40°.
- 1 sealed fracture intersecting the fractures described in a). At an angle ( $\alpha$ ) of about 70° to the borehole axis, visible from c 1 to 3 cm.
- Sealed fracture at an angle of c 12° to the borehole axis. Intersects the fractures in a) at the core surface in the slimhole (A).

Weak to medium oxidation (red staining), 0–4.5 cm from the slimhole (A). Most of the red-staining is supposed to originate from sealed fractures.

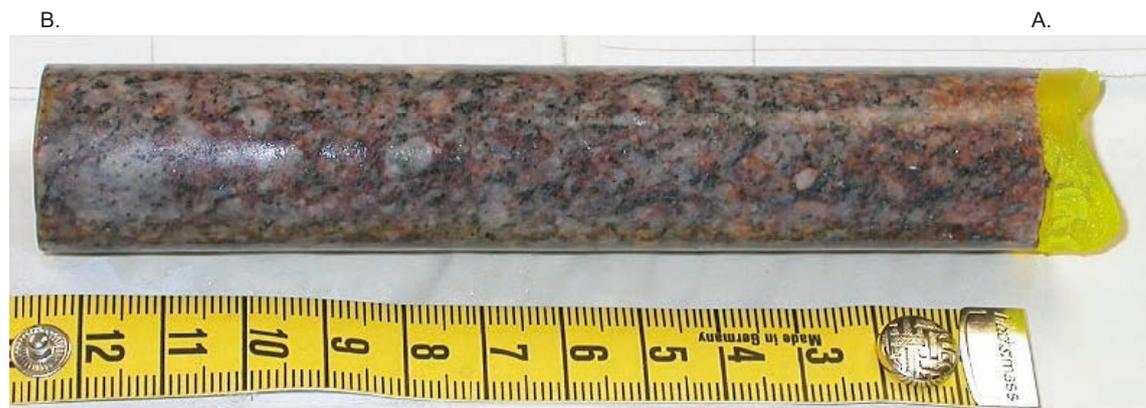
## D11

Epoxy at the surface towards slimhole (yellow).

- a) 3 parallel sealed fractures, visible at core rotation 85–200°, 1.5 cm from (A).

Faint oxidation (red staining), 0–2 cm from the slimhole (A).

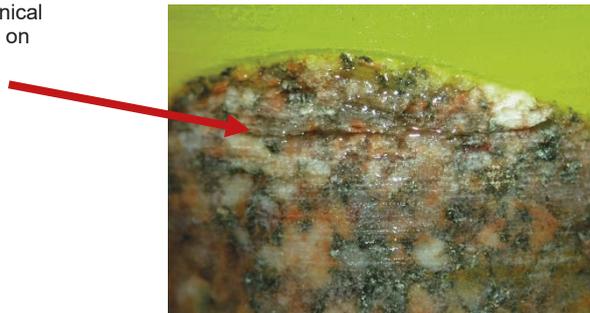
- b) 1 open or partly open fracture (or mechanical break) 0.5 cm from the slimhole (rotation on core 90°). Subhorizontal.

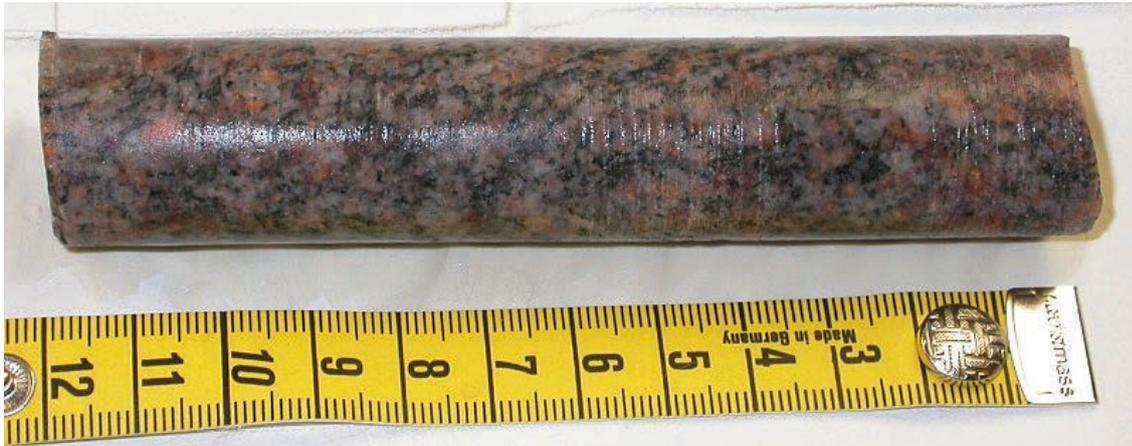
Minor amounts of remaining epoxy on the core at the surface towards the slimhole (A).

Nearly no signs of alteration. Single mineral grains are slightly red stained or albitized.

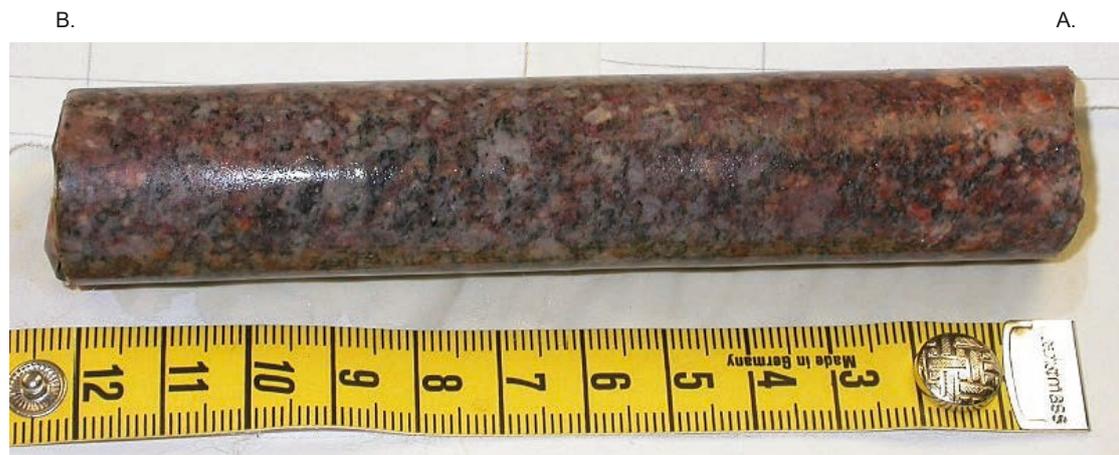
## D13

- a) Open (or partly open) microfracture at the slimhole surface (A).
- b) 2 sealed fractures with different orientations (cross cutting), visible in the upper part of the core (1–4 cm).
- c) Microfractures around the fractures described in b).

Red staining, only around sealed fractures.

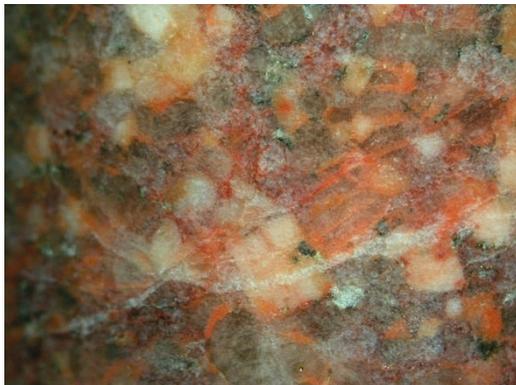
*Illustration of the two sealed fractures described in b).*

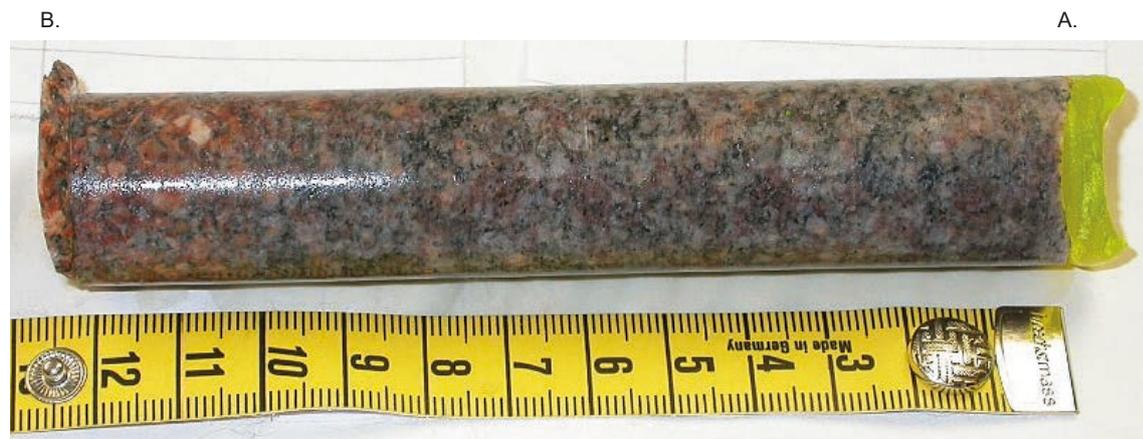
## D14

Epoxy at the surface towards slimhole (yellow).

2 sealed fractures with different orientations (cross cutting), visible with core rotation 135–315° and 2.3 cm from (A). Both fractures split up and have small splays.  $\alpha$ -angle is about 60–70°.

Faint to weak oxidation (red-staining) in the last part of rock core, from about 9 to 12 cm (close to B).

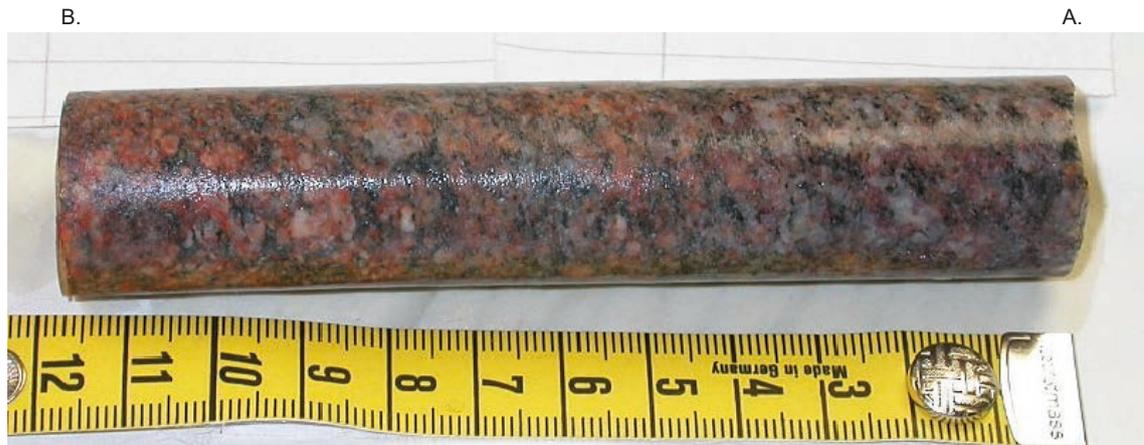
## D15

b) Sealed fracture visible at approximately 2.5 cm from (A), when core is rotated 0–135°. Angle, c 60° to the borehole axis.

c) Partly open microfracture cuts the fracture described in b).

Faint to weak oxidation (red staining) in the last part of rock core, c 7–12 cm (towards B).
