TR-22-06

Large scale gas injection test (Lasgit) performed at the Äspö Hard Rock Laboratory

Final report

SVENSK KÄRNBRÄNSLEHANTERING AB

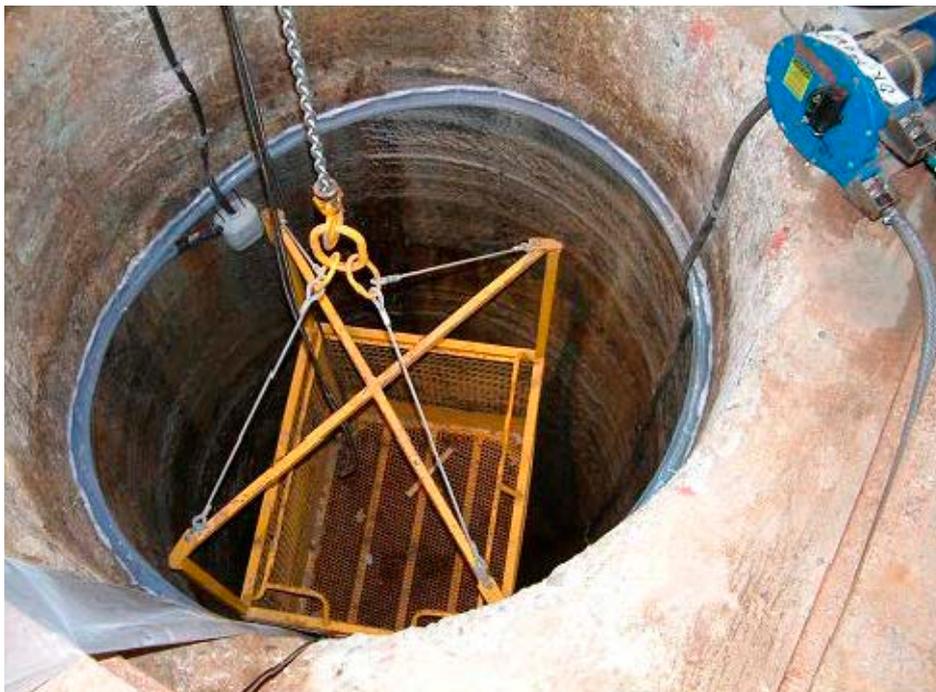
Figure 2-6. Deposition hole DA3147G01 with the circular drain and small plastic container (greyish) used to collect inflowing water.

The inflow of water into the Lasgit hole was measured using the setup shown in Figure 2-6. Water originating from the surrounding tunnel floor (termed "external water") was prevented from entering the deposition hole and was measured separately. Ingress of water to the Lasgit hole, entering through the fractures and the rock mass of the hole wall and bottom ("internal water"), was measured by using a level indicator to study the rise of the water level over time.

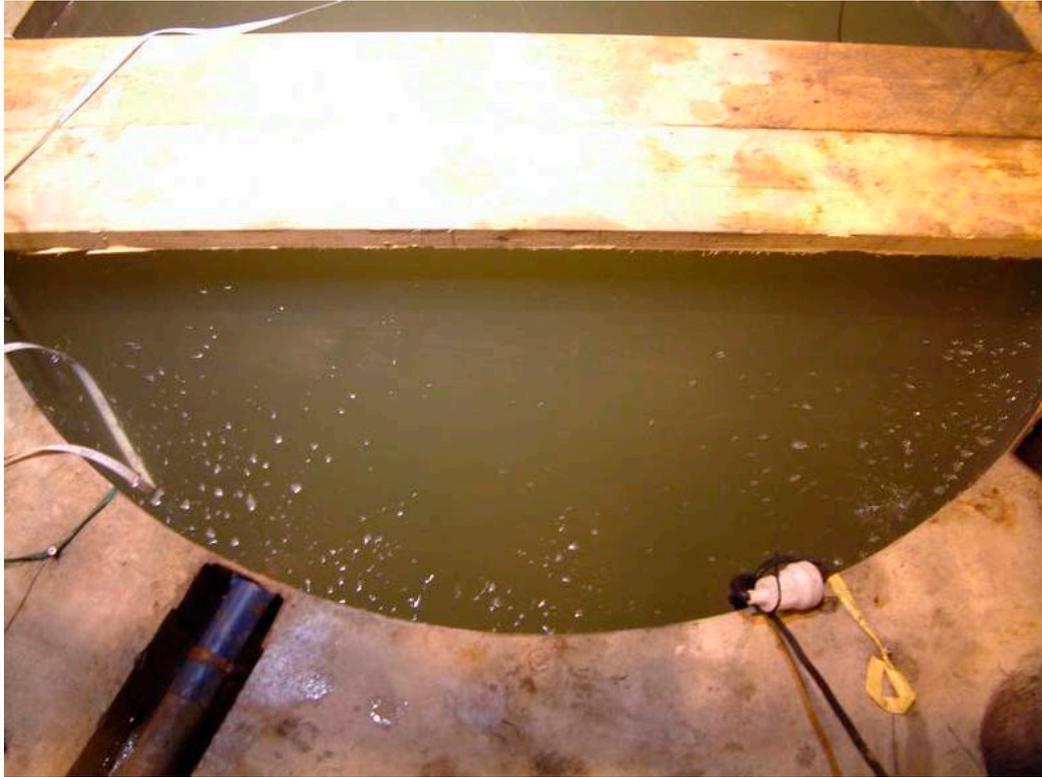
Figure 2-9. Gas bubbles on the water surface in the Lasgit hole.

A gas leakage test was performed in six of the ten anchor holes in order to investigate whether there were any connections between the anchor holes and the water filled Lasgit hole. Anchor holes were incrementally pressurised. Gas leakage was seen as bubbles on the water surface in the Lasgit hole, as shown in Figure 2-9, and in the neighbouring anchor holes. With the help of a video camera the gas leakage was located on the wall of the Lasgit hole and registered on drawings; one example is shown in Figure 2-10. Results from these tests clearly demonstrated that a number of fractures intersected both the neighbouring anchor holes and the Lasgit deposition hole. Table 2-10 summarises the observations during the gas leakage tests.

It can also be seen that pressurising the rock anchors on one side of the deposition hole often resulted in gas leakage on the opposite side of the hole. This shows that the fracture network is complex and that gas does not always flow to the nearest fracture in the deposition hole, but follows a path of least resistance. The varying results of the respective pressure tests are likely to be because of variations in fracture geometry and transmissivity as well as the geospatial distribution of boreholes along the various features. Leakage between packer and hole walls is, however, another possibility and cannot be ruled out.

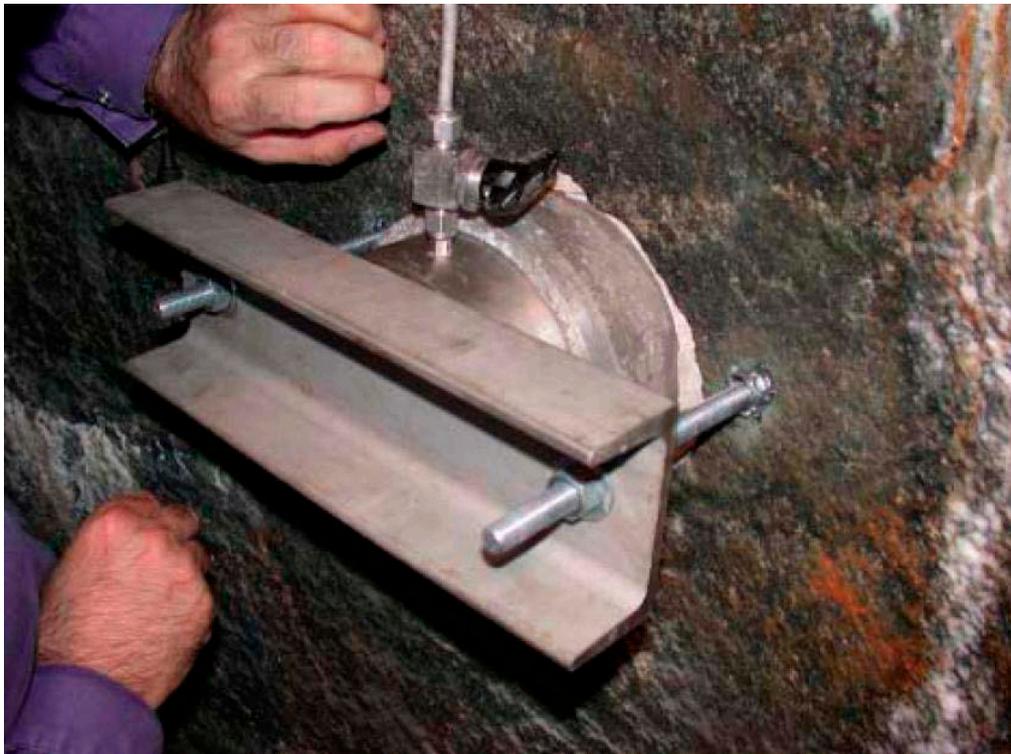
Figure 2-11. The surface packer system of BGR shown in situ ready for the start of a test.

A photograph of the surface packer system is shown in Figure 2-11 and as a schematic in Figure 2-12. The packer comprised a circular metal unit sealed to the rock surface using bentonite which was held in place by fixing bolts attached within the rock. Water or gas was introduced and pressure decay was monitored. For the measurements within the Lasgit deposition hole only local water was used as an injection fluid.

Tests were planned at two positions with water-bearing fractures in the deposition hole and on one position without visible fractures. The tests on the fractured positions failed. Instead of swelling, the bentonite was washed out of the furrow during the hydration stage by the inflowing water from the fracture. A similar response was noted during the initial hydration stage of the main Lasgit experiment (Chapter 5). The asperities on the wall of the deposition hole on these positions turned out to be too rough.

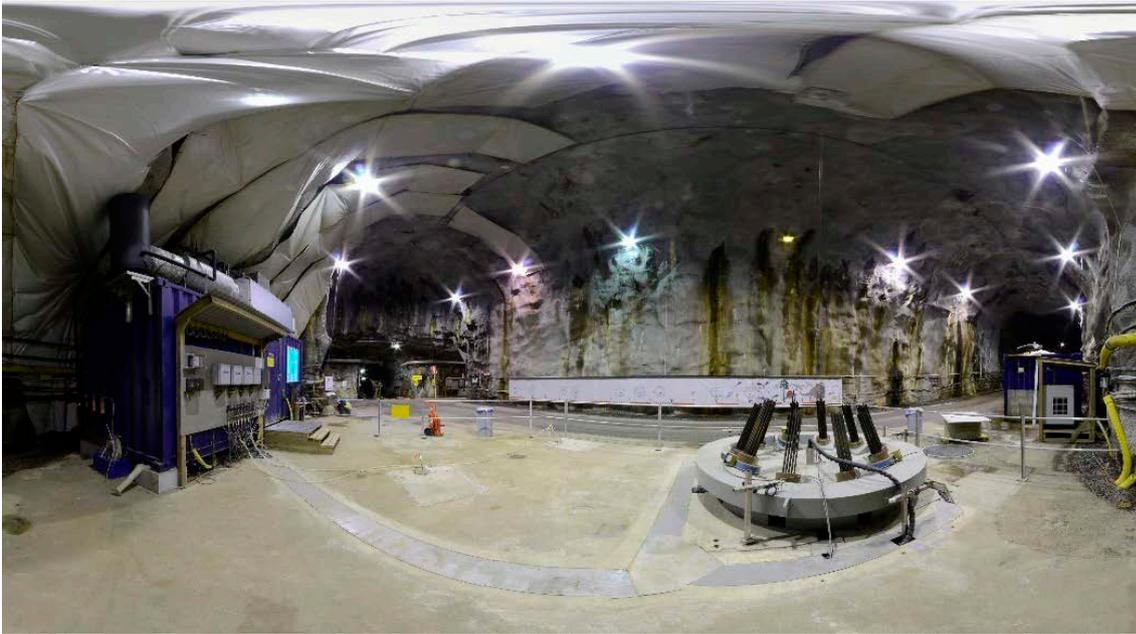
Figure 3-2. A panoramic view of the Large-scale gas injection test (Lasgit) 420 m below ground at the Äspö Hard Rock Laboratory in Sweden.

Figure 3-1 shows the location of the deposition hole DA3147G01 within the Äspö Hard Rock Laboratory and Figure 3-2 shows a photograph of the test site following the installation stage. Lasgit was situated within the TBM assembly Hall at the 420 m depth as highlighted in Figure 3-1a. Within the assembly hall, the position of DA3147G01 is shown. The orientation of the reference direction is taken from the local coordinate system, with 0° parallel with the direction of the tunnel system (Figure 3-1b). For mapping purposes, this was deemed direction A. Figure 3-1c shows the deposition hole coordinate system with the position of all sensors defined as a height z above the bottom of the deposition hole, at a distance r from the centre of the deposition hole, at an angle of α to the Lasgit reference direction.

The pressure that would be exerted by the backfill as the tunnel gallery was closed was generated using a heavy 2600 mm diameter SS2172 carbon steel lid; this also prevented an uncontrolled expansion of the bentonite. At the top of the buffer, a waterproof and sealed rubber mat was placed, upon which a conical shaped concrete plug was poured using K 40 quality concrete to close the deposition hole, the top of which was level with the TBM assemble floor. On top of this plug, the steel lid was anchored to the rock by 10 anchor cables. The lid and rock anchors can be seen in Figure 3-2.

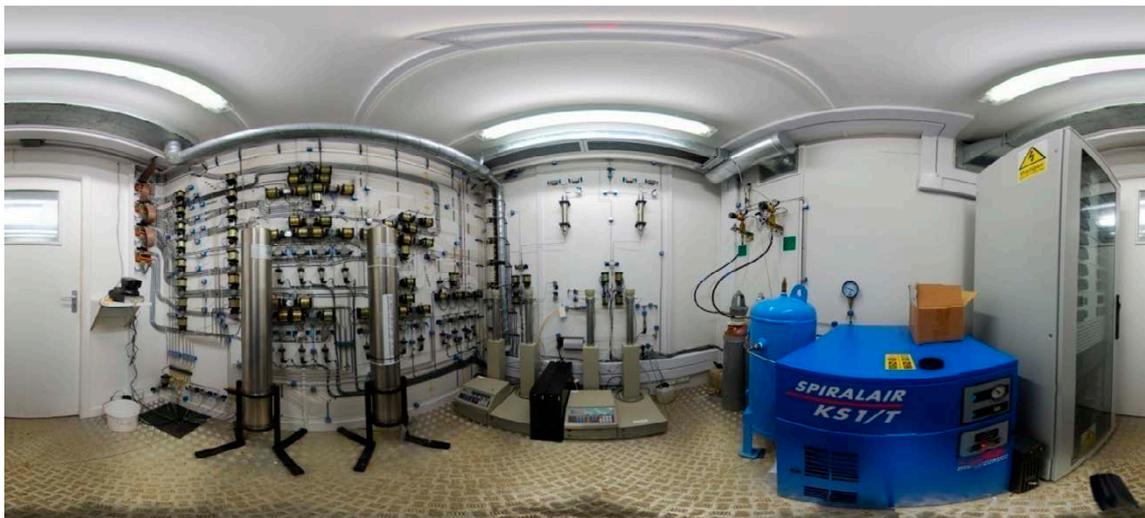
Figure 3-3. A panoramic view of the Lasgit gas laboratory.

The shipping container housing the Gas Laboratory was partitioned into two sections. The first comprised the office area and contained the workstation plus general office furniture, telemetry system, and main electrical consumer unit. The second area contained all of the experimental apparatus, test circuits, and data acquisition systems. Figure 3-3 shows a full 360° panorama inside the gas laboratory.

Temperature in both the office and laboratory sections was controlled by two independent air conditioning systems. The temperature set point in the Laboratory section was 14 °C, similar to the ambient conditions within the Lasgit deposition hole; the air-conditioning achieved a mean temperature of 15.8 °C. To prevent overloading of the air-conditioning system the temperature in the office compartment was reduced after Day 750 and although temperature oscillated on an annual basis the mean temperature reduced to 15.0 °C. To maintain a flow-through of air and help to minimise condensation, the air was continuously replaced, and its humidity controlled to prevent damage to test systems. Temperature sensors located in both compartments of the Gas Laboratory were continuously monitored by the data acquisition software and by the Alpha Alarm system at Äspö, the latter providing 24 hr support in the event of a system failure.

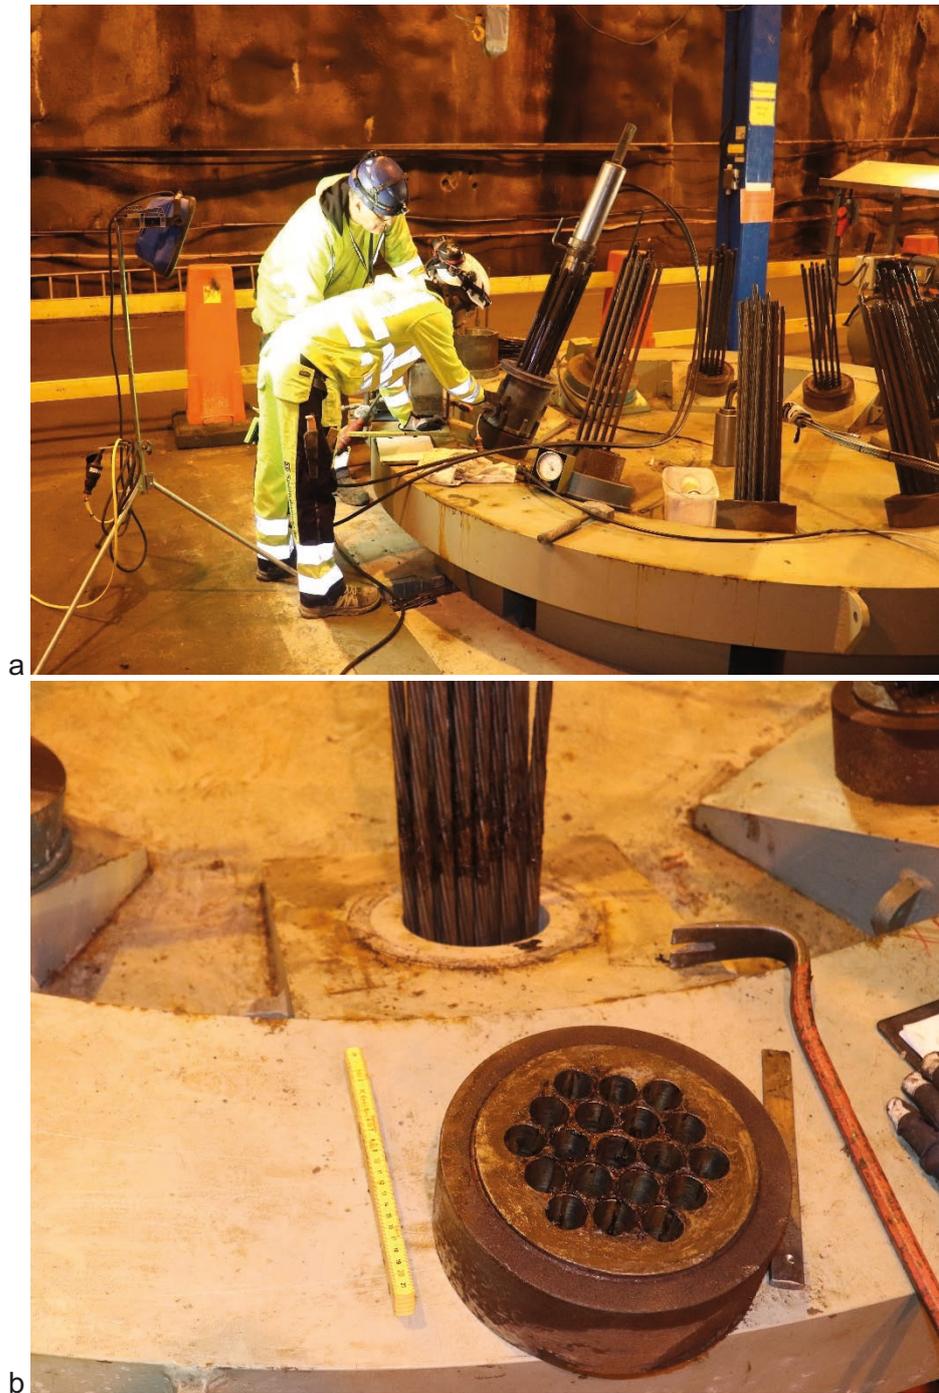
Figure 15-17. Removal of the anchor system. a) Loosening the anchor cable stop using a hydraulic tool; b) Anchor cable stop after removal.

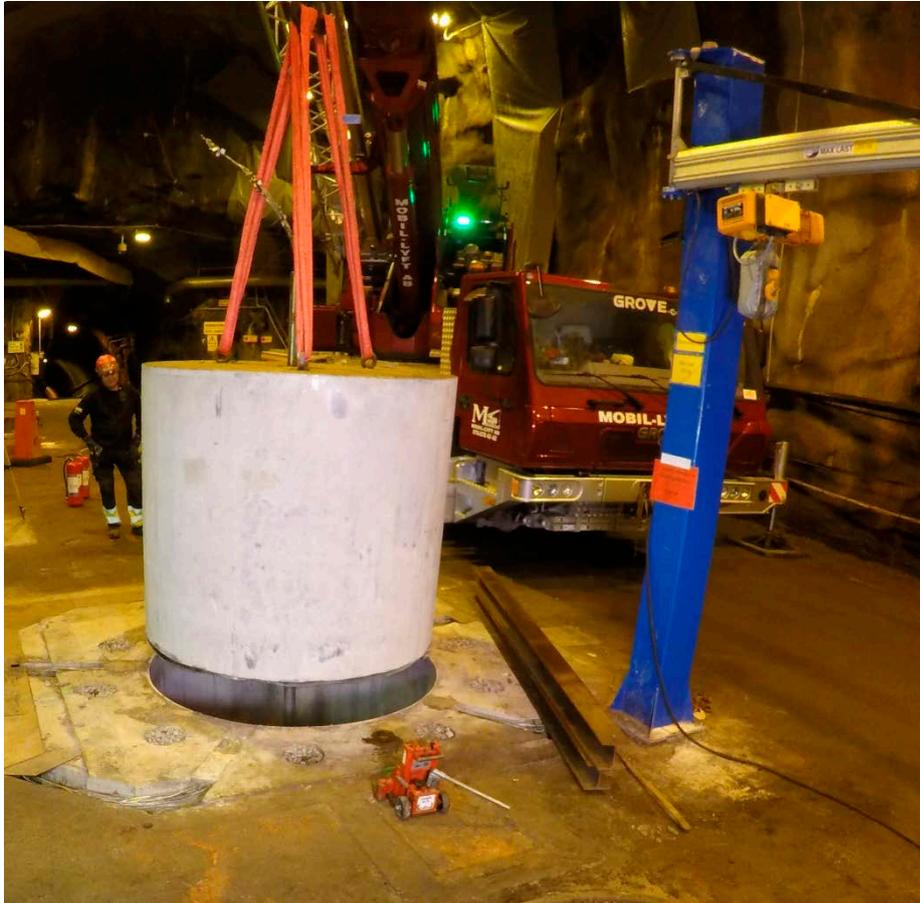
Figure 15-18. Lift of the concrete plug using a crane.

Once the rock anchor cables were loosened, first the steel cover and then the underlying concrete plug were removed with the help of a mobile crane. Figure 15-18 shows the lift of the concrete plug, the blue pillar swing crane to the right was used for lowering personnel down the hole using a safety harness and for lifting materials during sampling and removal of bentonite.

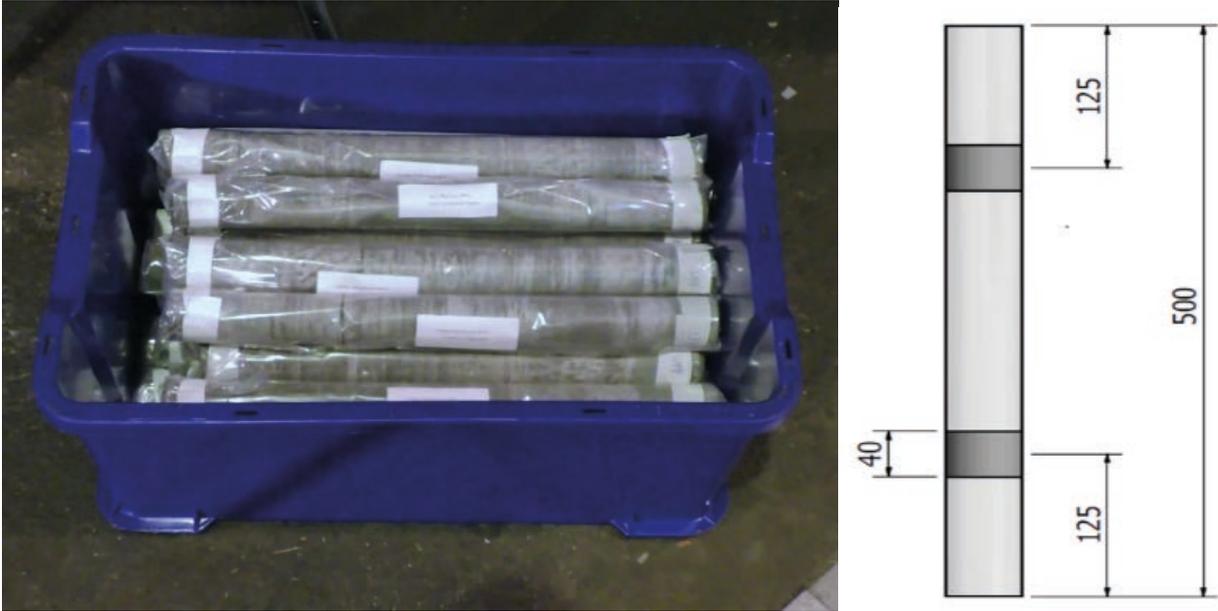
Figure 15-20. Labelled cores and position for samples to be analysed.

The entire buffer stack was sampled by core drilling each block layer according to a predetermined pattern, the template used in the drilling is shown in Figure 15-21a. For complete blocks at angles of 0, 90, 180, and 270° samples were taken every 50 mm between 75 and 825 mm from the centre of the hole. An additional sample was taken at 850 mm within the pellets. In order to achieve a separation of 50 mm the cores were taken on alternate sides of the centre line (see Figure 15-21). At angles of 45, 135, 225, and 315° samples were taken at 100 mm separation between 575 and 850 mm from the centre of the hole. For ring blocks at angles of 0, 90, 180, and 270° samples were taken every 50 mm between 575 and 825 mm from the centre of the hole. An additional sample was taken at 850 mm within the pellets. At angles of 45, 135, 225, and 315° samples were taken at 100 mm separation between 575 and 850 mm from the centre of the hole. Cores were drilled through the full height of each block with a height of ~500 mm. Immediately after drilling, the cores were packaged in plastic and labelled with their unique position before being sent for analysis. From each core, two samples were sawn, both were analysed for water content and dry density at the Äspö Laboratory. Labelled cores and position of the samples on a core drill sample are shown in Figure 15-20.

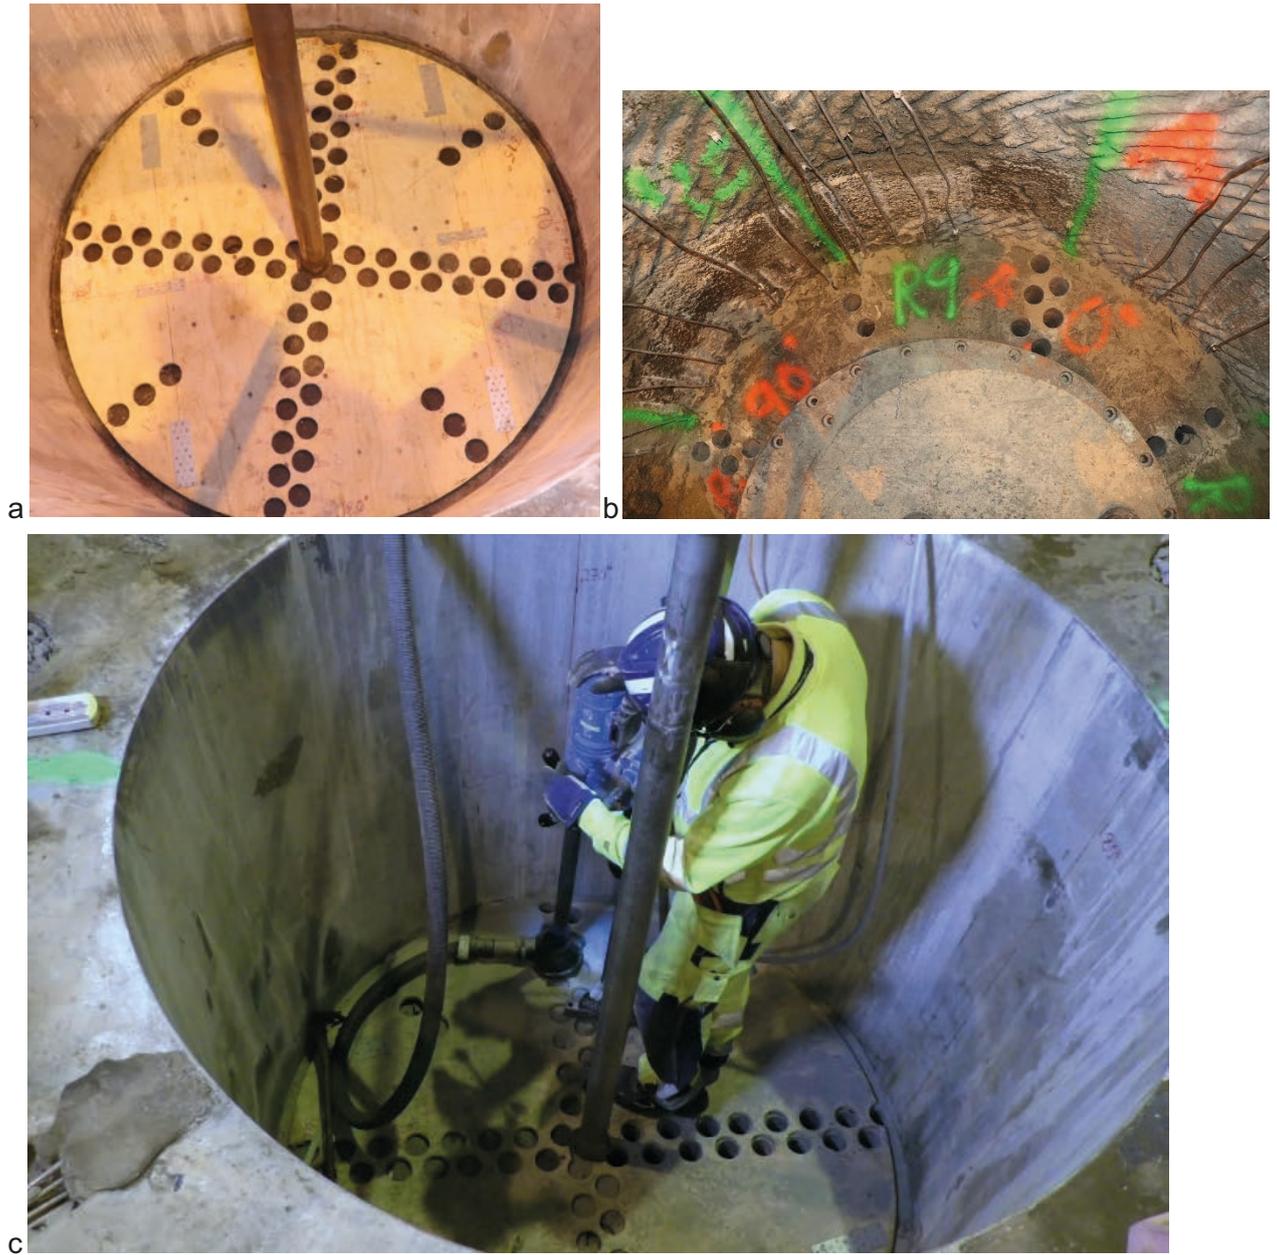
Figure 15-21. Drilling template and sampling of bentonite by core drilling. a) Drill template for complete blocks; b) Sampling of a bentonite ring; c) Drilling of samples.

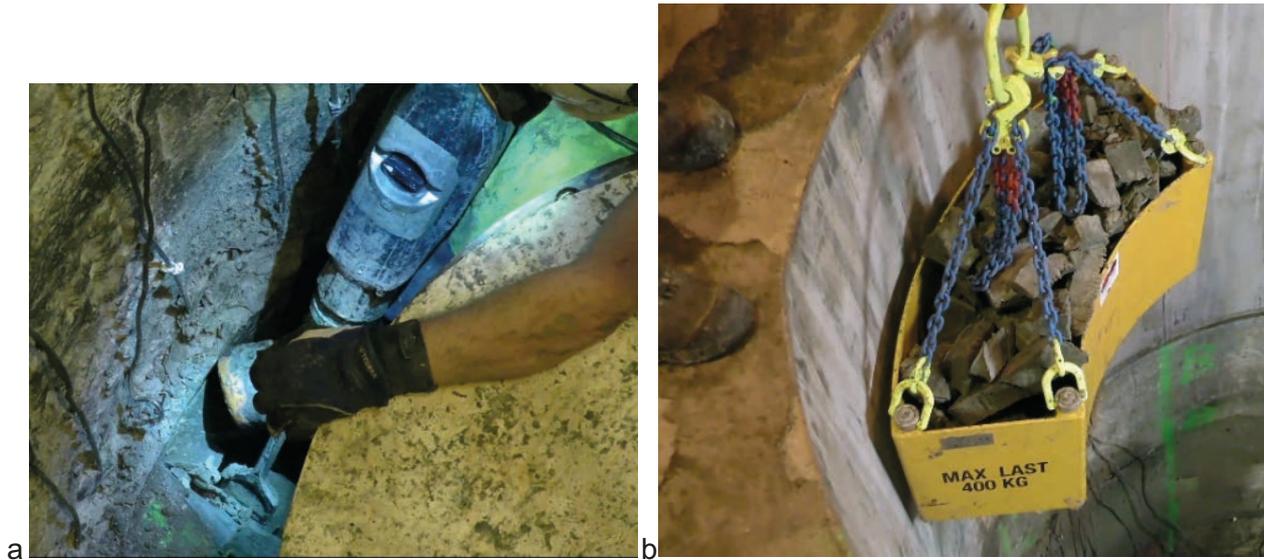
Figure 15-22. Removal of the buffer. a) Jack hammers were necessary to break the bentonite; b) Removed material was craned to the surface for disposal.

When all cores had been drilled in the block layer, the remaining bentonite was removed and disposed of (Figure 15-22). The work of removing the bentonite was very time-consuming, as the bentonite had saturated and a swelling pressure had thus formed. This made it impossible to lift the canister before the surrounding bentonite had been removed. To remove ring R-blocks, personnel had to work in a gap between the rock and the canister that was no wider than 350 mm. Figure 15-23a shows how the canister was secured in order to allow staff to work safely without the risk of the canister moving, while Figure 15-23b shows how restricted the area was to work in. The saturated bentonite blocks were hard and difficult to remove, the best method was to use an electric chisel hammer to break it into small pieces (Figure 15-22a). To bring removed material to the surface, a specially adapted basket was used that fitted in the gap around the canister (Figure 15-22b).

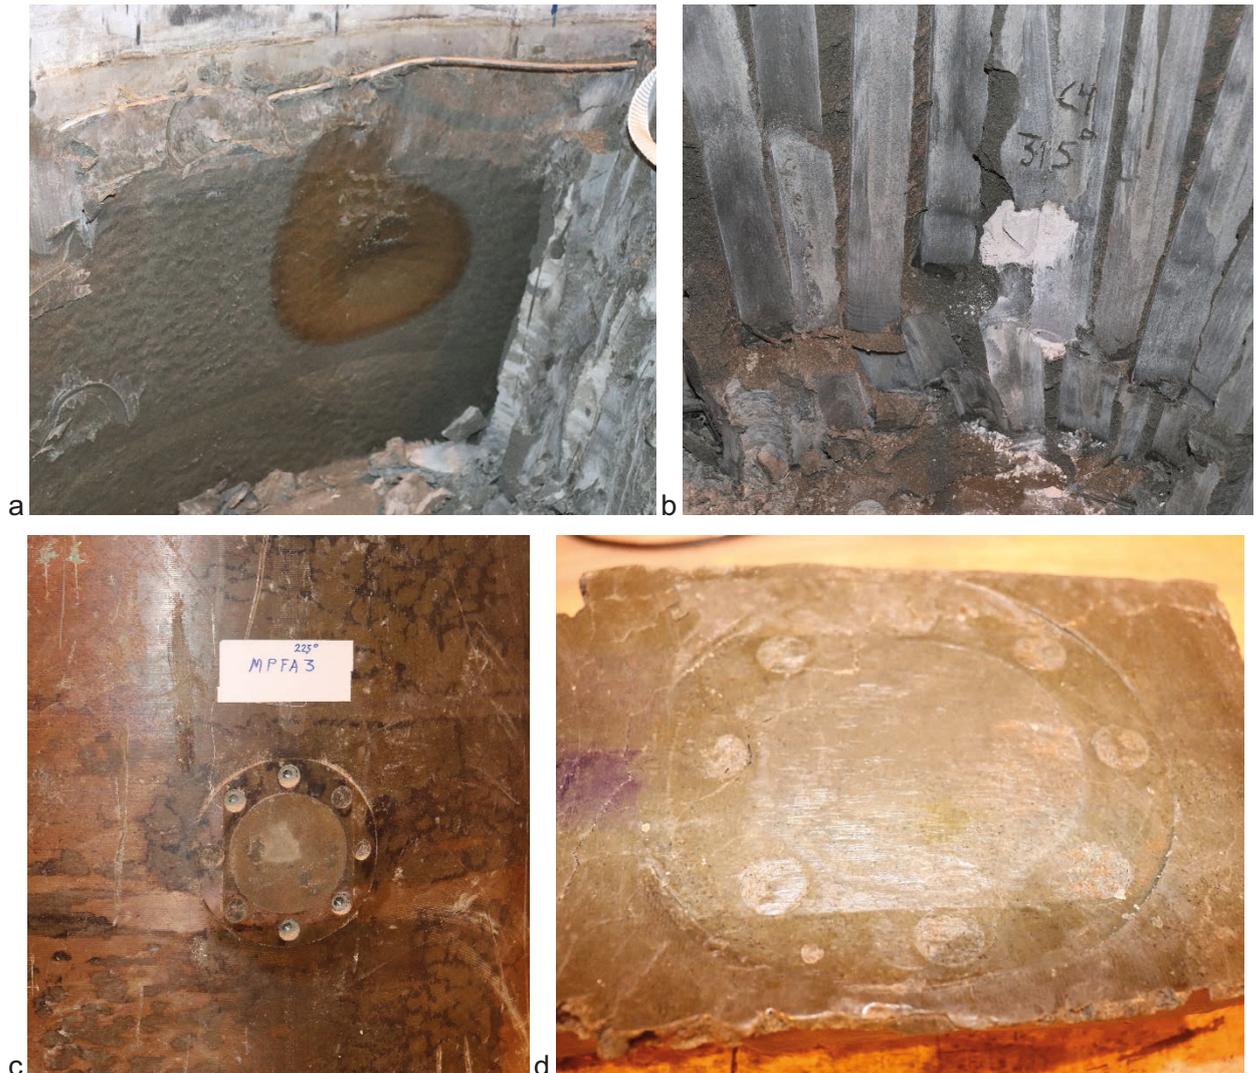
Figure 15-24. Observations during buffer removal. See text for description.

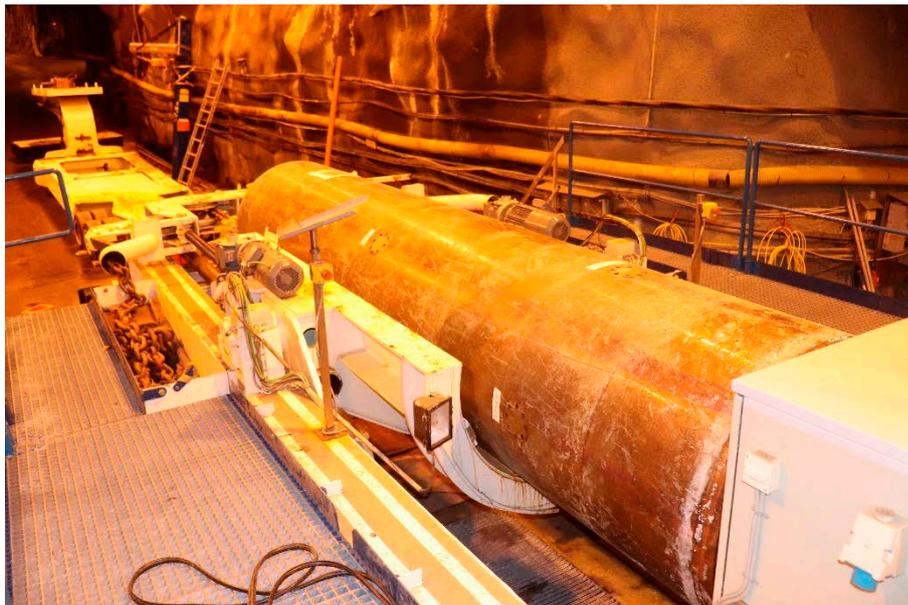
Figure 15-26. The canister removed from the deposition hole.

After removing all of the bentonite around the canister, it was possible to lift the canister. Figure 15-25 and Figure 15-26 show the machine used in Lasgit to lift and remove the canister.

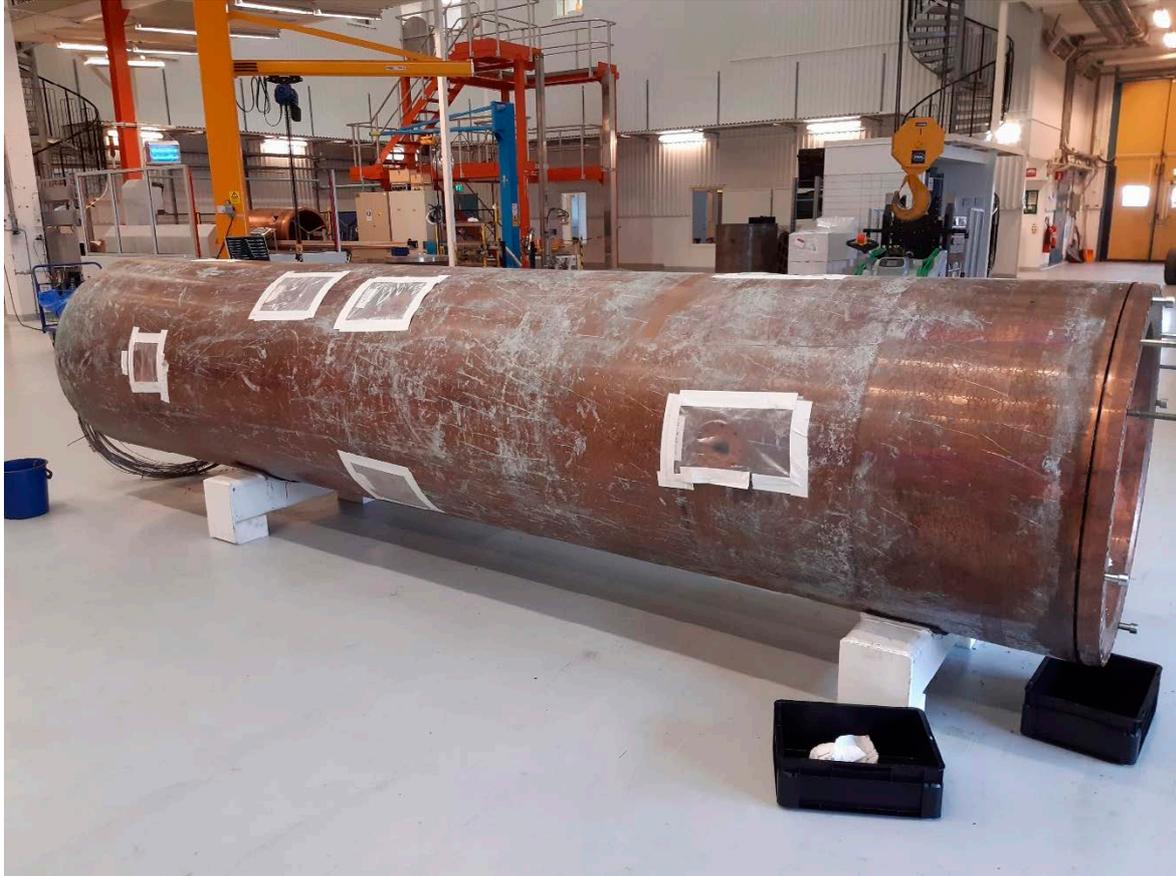
Figure 15-29. The Lasgit canister seen within the Äspö laboratory. White taped area cover the removed canister filter housings or stress sensor housings.

The canister was brought to the surface at Äspö and carefully examined. In this section we only introduce features that may help to describe the movement of gas within Lasgit. Figure 15-29 shows the canister at the Äspö laboratory. It shows many features on the canister surface of interest.

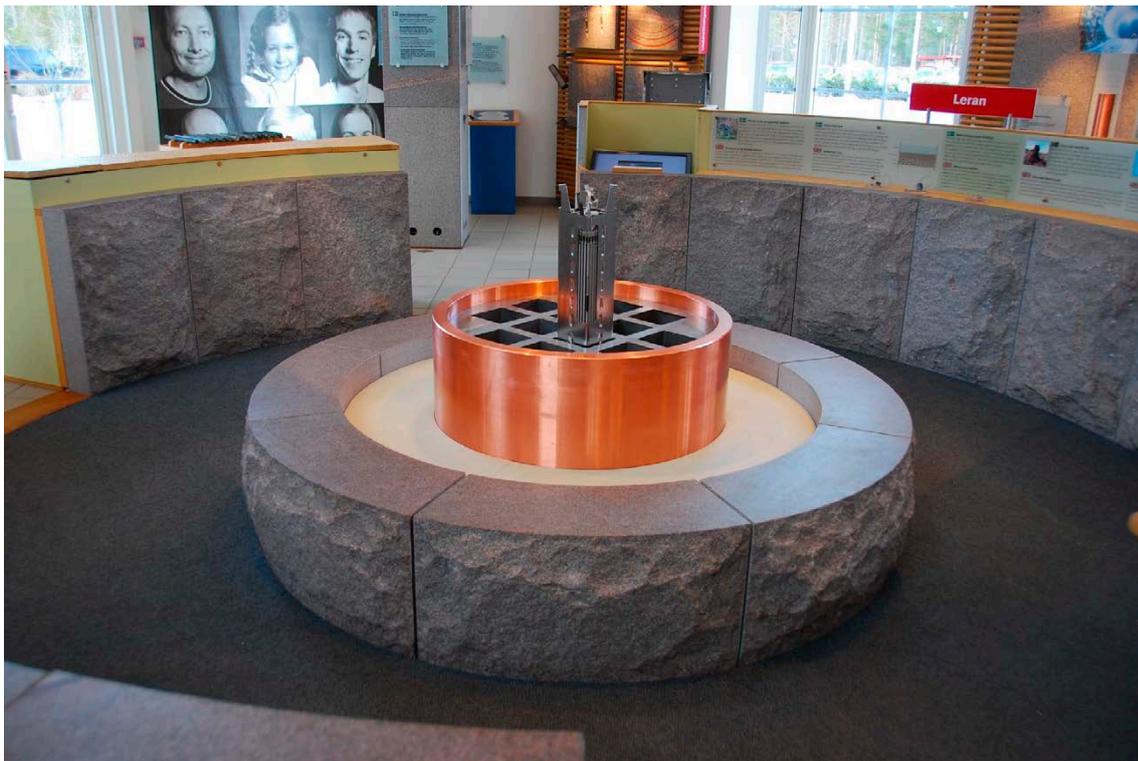
Figure 18-1. The KBS-3 disposal concept. Fuel rod assemblies are held within an iron insert, inside a copper canister. Surrounding this is pre-compacted bentonite rings isolating the canister from the crystalline wall rock.

If a canister used for the encapsulation of radioactive waste (Figure 18-1) should become defective such that groundwater could penetrate through the copper shell, the cast iron insert will corrode, resulting in the formation of hydrogen gas. If more hydrogen is produced than can be dissolved in the water present in the canister and surrounding buffer, a separate gas phase will form.
