Post-test examination of a copper electrode from deposition hole 5 in the Prototype Repository

Bo Rosborg, Rosborg Consulting

April 2013

SKB R-13-14

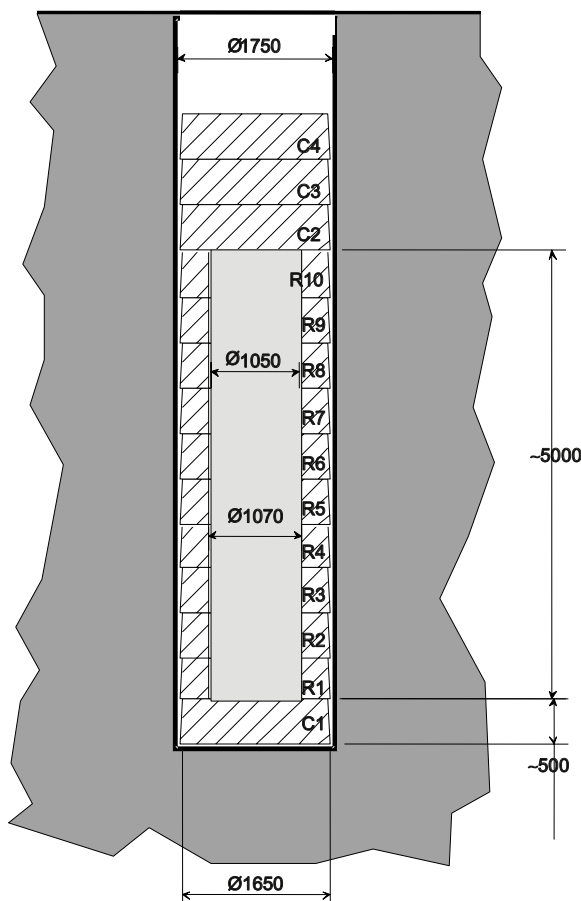
Figure 1-1. A canister in its deposition hole surrounded by bentonite rings and blocks. (The copper electrodes were positioned in the upper bentonite block C4.)

Electrical heaters generated the heat output from the canisters. The deposition holes are 8 m deep and just under 2 m in diameter. Each deposition hole is lined with blocks and rings of bentonite, see Figure 1-1. The original dimensions of the bentonite blocks and rings were about $\text{Ø}1.65 \times 0.50$ m and $\text{Ø}_{\text{outer}} 1.65 \times \text{Ø}_{\text{inner}} 1.07 \times 0.50$ m respectively.

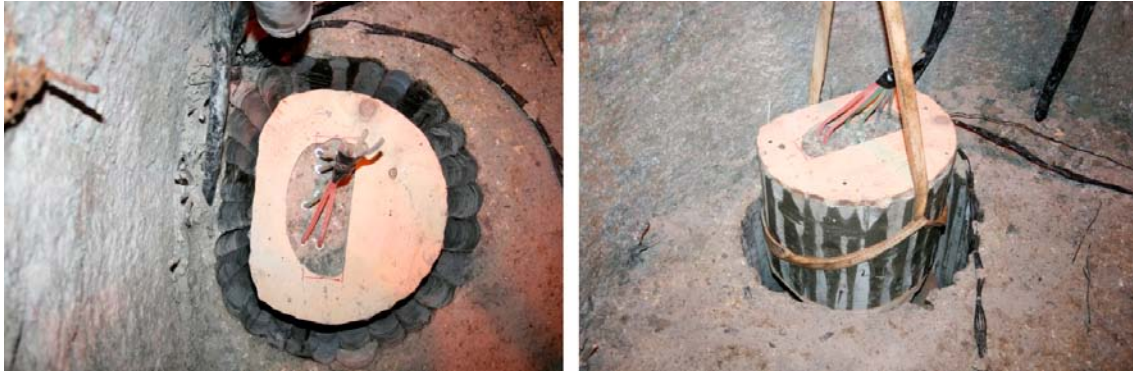
Figure 1-2. End result of stitch drilling around the copper electrodes in bentonite block C4 and uplift of the released smaller bentonite block.

Stitch drilling to let loose a smaller bentonite block containing the copper electrodes from bentonite block C4 was initiated on 2011-09-19. A series of holes was drilled around the place for the three electrodes, the bentonite block was broken loose from block C4 by bending, and the released bentonite block with the electrodes was lifted up the following day, see Figure 1-2.

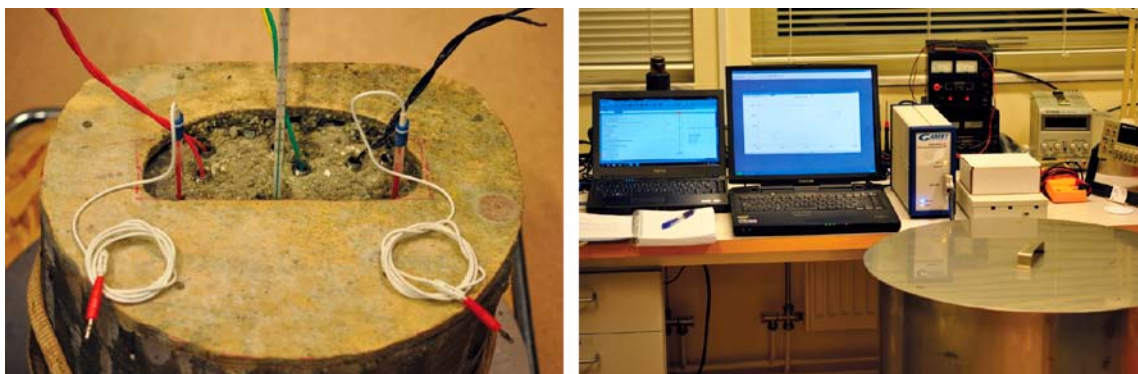
Figure 2-1. Experimental set-up for final electrochemical measurements. (Left) Top of the retrieved bentonite block with its electrode leads to the copper electrodes and two installed reference electrodes with a thermometer in between, (right) the retrieved bentonite block with its electrodes placed in a Faraday's cage (lower right in the picture).

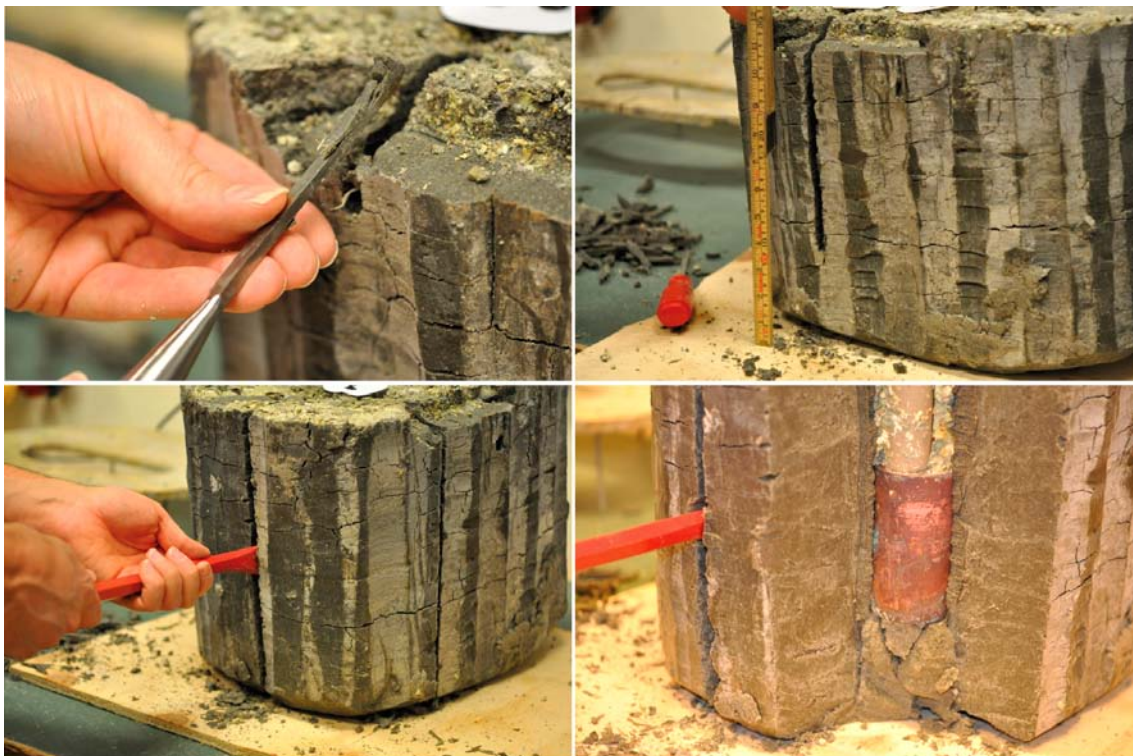
Figure 2-2. Procedure used for removal of the copper electrode from the small bentonite block. Vertical trenches were first made in the bentonite block by means of a chisel, and then bentonite pieces were broken free in the way shown in the figure. (Flashlight was unfortunately used for the lower right figure.)

On November 16 copper electrode “Black” was removed from the small bentonite block. By means of a narrow chisel deep vertical trenches were made in the bentonite block and a few bentonite pieces were broken loose as shown in Figure 2-2. A loose bentonite piece was immediately stored in double evacuated tri-laminate bags and placed in a glove-box. In this way two fairly large bentonite pieces were broken loose and stored. Finally a third smaller piece was broken loose after which the copper electrode could be removed from the bentonite block. One of the photographs in Figure 2-3 shows the copper electrode still in place in the bentonite block after removal of the three bentonite pieces, and the other shows the electrode during removal from the bentonite block. (After the copper electrode had been removed, the bentonite block with the remaining two copper electrodes was again sealed in its tri-laminate bags.)

It was obvious from the appearance of the copper electrode, when part of the surrounding bentonite had been removed, see Figures 2-2 and 2-3, that both Cu(I) and Cu(II) corrosion products existed on the electrode surface. The blue-green Cu(II) corrosion products were not evenly distributed on the surface; they were more abundant on part of the electrode. Corrosion products were also found on the adjacent bentonite after removal of the copper electrode from the bentonite block, see Figure 3-1, thus revealing a better adherence to the bentonite on part of the surface. A series of photographs was taken of the electrode after it had been removed from the bentonite block, and four are seen in Figure 3-2. Close-ups from a few places on the electrode are shown in Figures 3-3 through 3-5. In Figure 3-4 both exposed and non-exposed areas on the top surface of the copper electrode are shown – the latter were covered by the PEEK distance pieces seen in Figure 2-3.

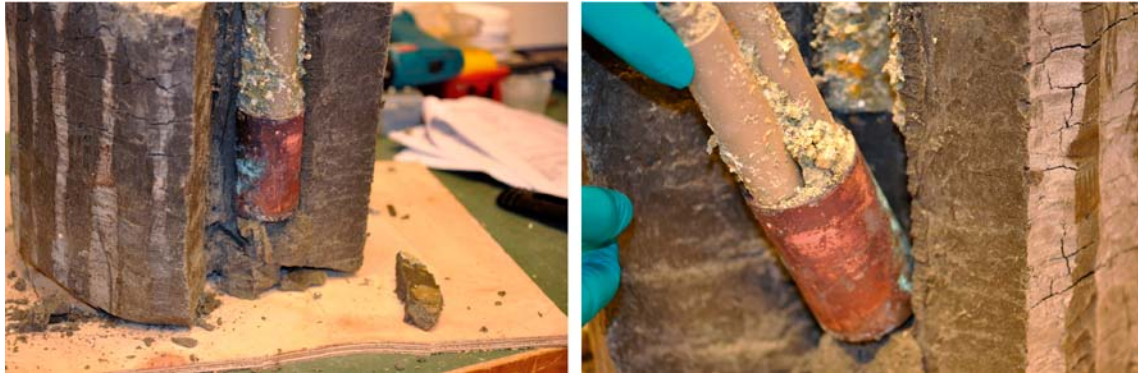
Figure 2-3. Removal of the copper electrode from the bentonite block. (Left) The copper electrode just about to be removed, and (right) being removed from the bentonite block.

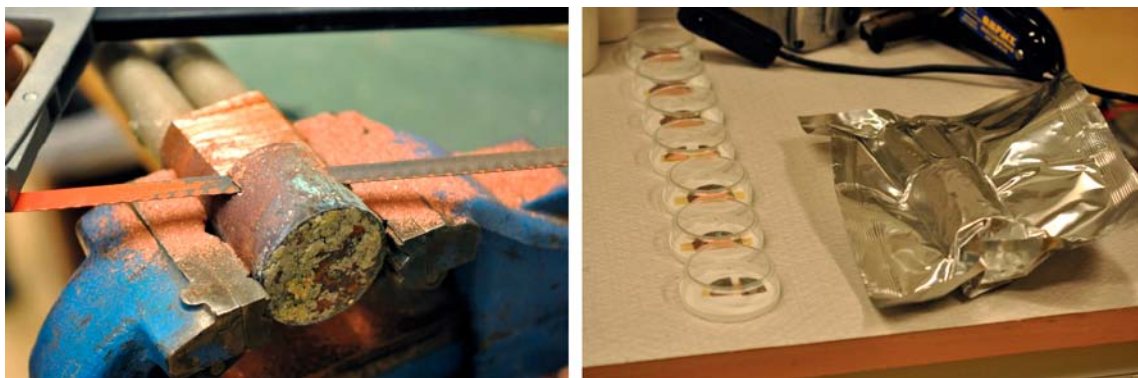
Figure 2-4. (Left) Cutting out samples from the copper electrode, and (right) temporary storage of samples from the copper electrode.

Samples were cut from the copper electrode in the following way. The copper electrode was first tightly fastened in a vice, see Figure 2-4, and then a horizontal cut was made by a handsaw and step by step vertical cuts were made to release samples of suitable size. (The sides of the copper electrode, that of necessity were damaged, were later picked for sampling of corrosion products.)

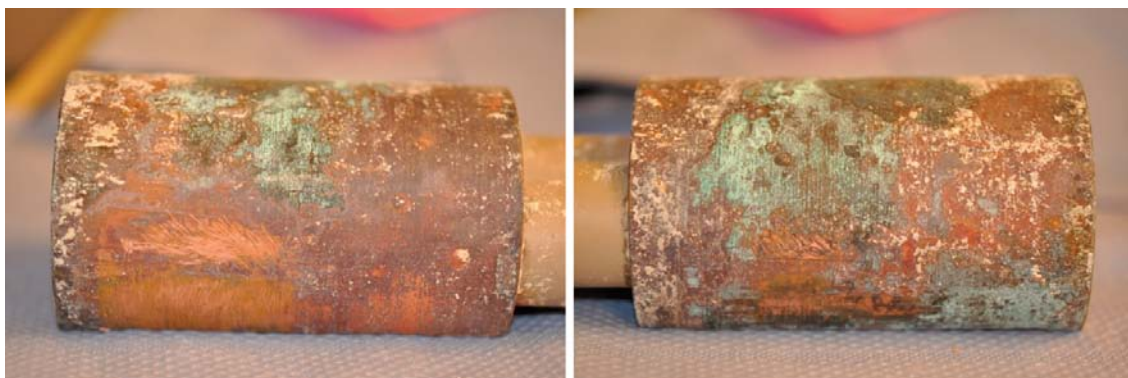
Figure 2-5. The two photographs show where corrosion products were scraped off from the copper electrode. (Left) Sample area H with mainly brownish and (right) sample area V with also blue-green corrosion products.

Corrosion products for XRD measurements and FTIR spectroscopy were scraped off from two areas of the copper electrode surface, see Figure 2-5; one that contained mainly brownish corrosion products, and another that also contained blue-green corrosion products. FTIR and Raman spectroscopy have also been applied on corrosion products remaining on the electrode surface.

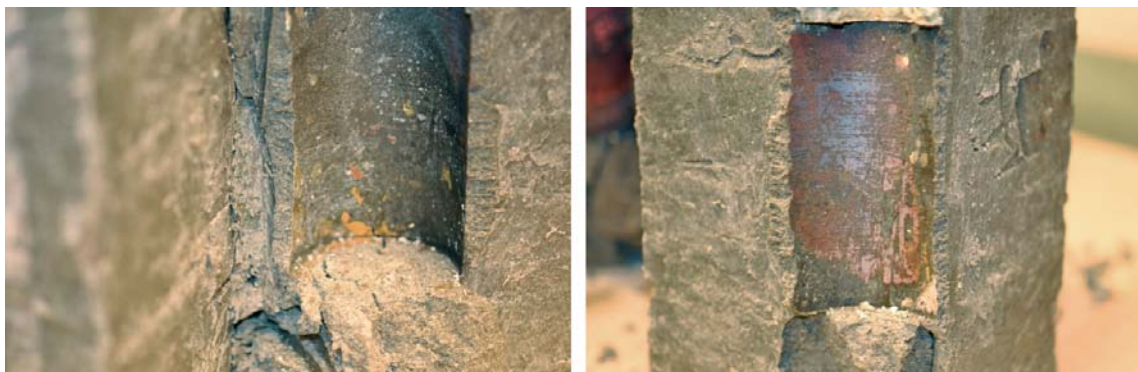
Figure 3-1. Corrosion products still remaining on adjacent bentonite after removal of the electrode.

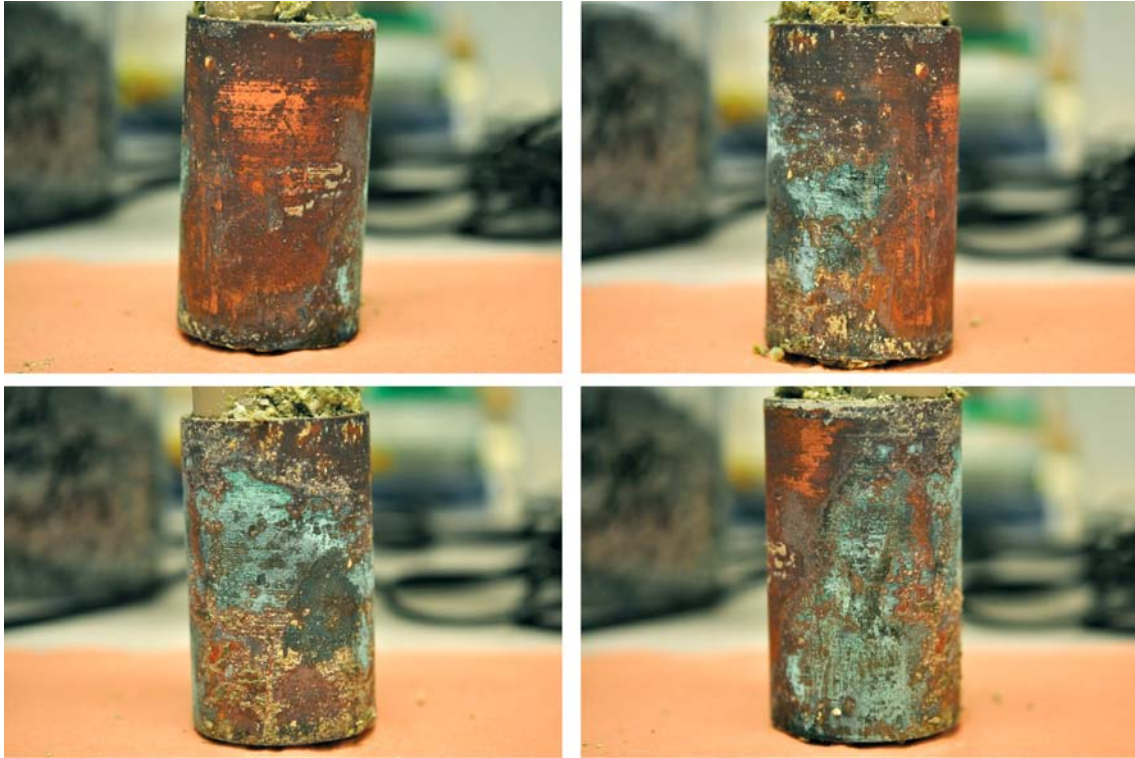
Figure 3-2. Appearance of copper electrode "Black" immediately after removal from the bentonite block.

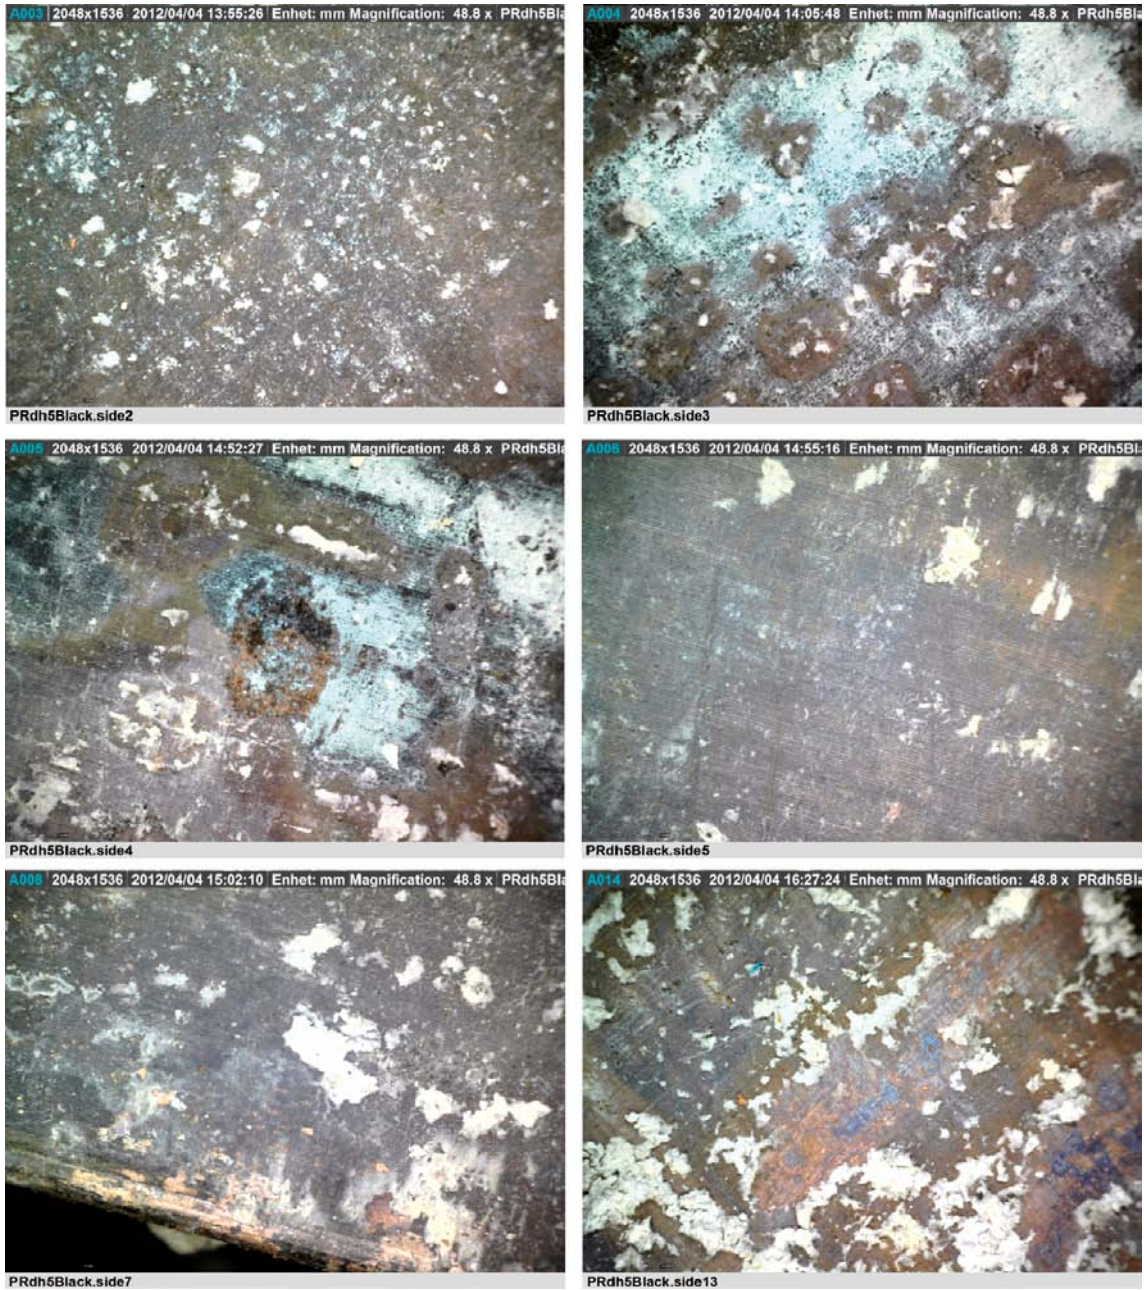
Figure 3-3. Close-ups from the cylindrical vertical surface of the copper electrode after exposure. The whitish remains on the surface in the pictures are bentonite. (magnification about 50x).

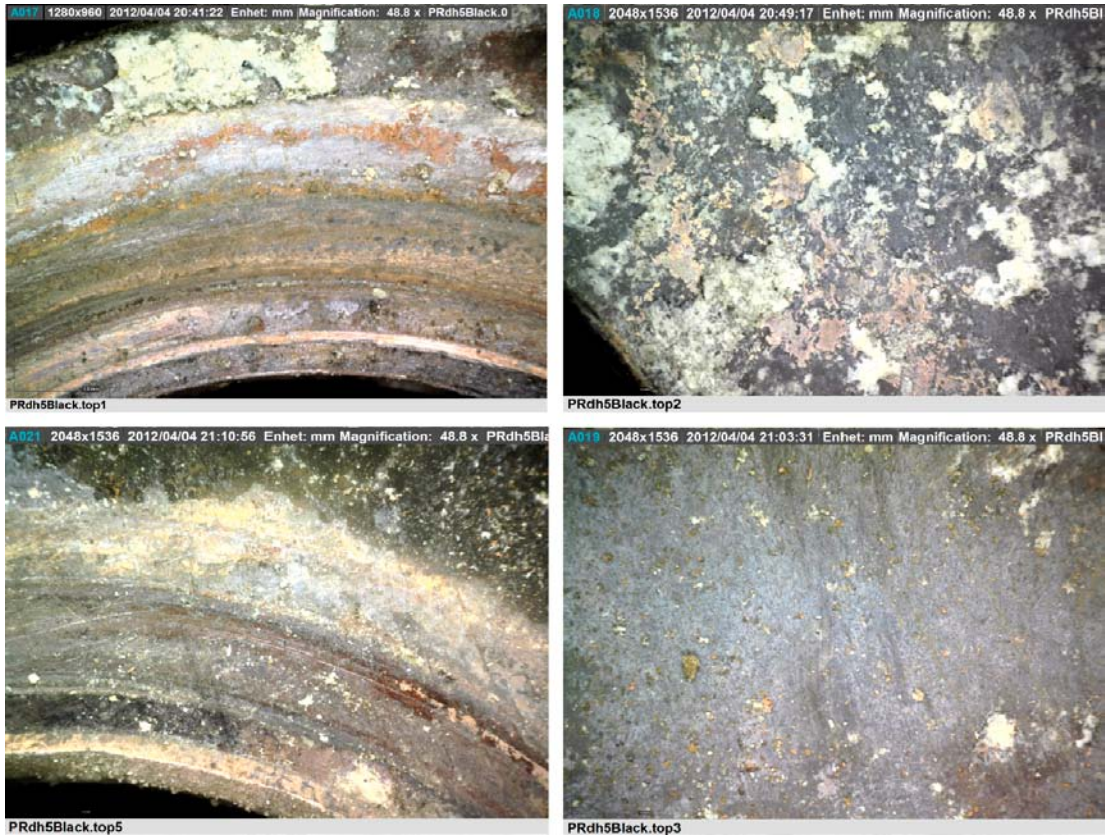
Figure 3-4. Close-ups from the top surface of the copper electrode after exposure. Part of the surface in the left pictures has been covered by PEEK distance pieces. (magnification about 50x).

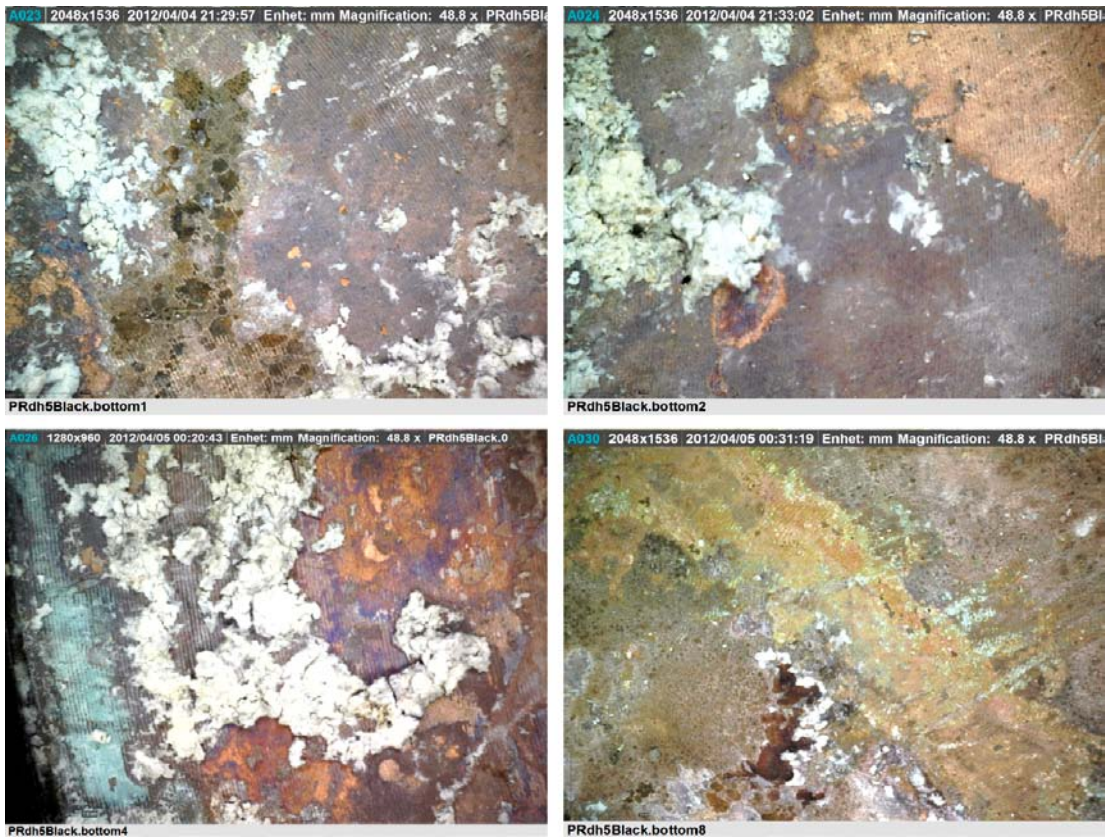
Figure 3-5. Close-ups from the bottom surface of the copper electrode. (magnification 50x).

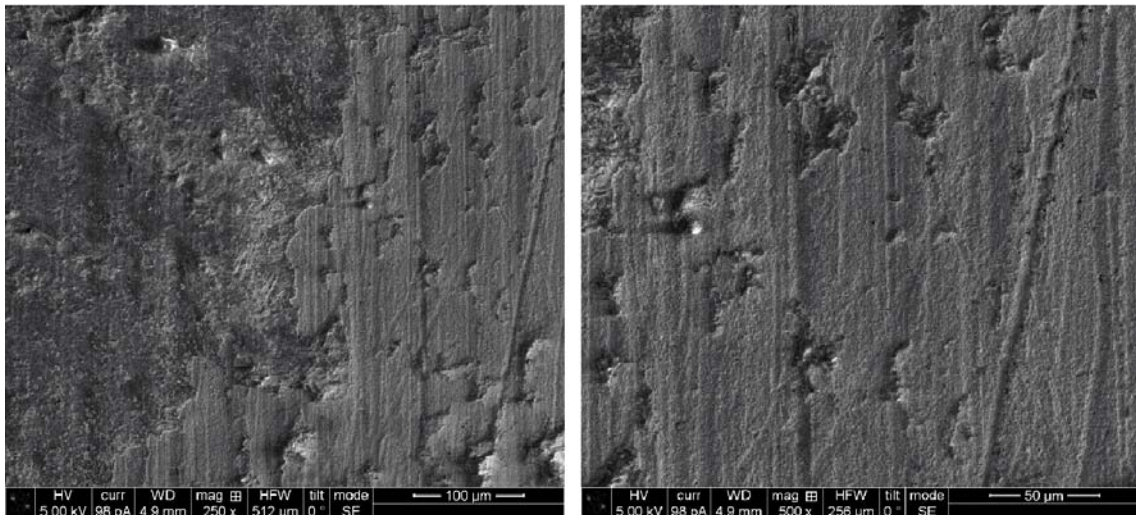
Figure 3-6. The surface of the copper electrode in higher magnification (sample 4; SEM). (magnification left 250x and right 500x).

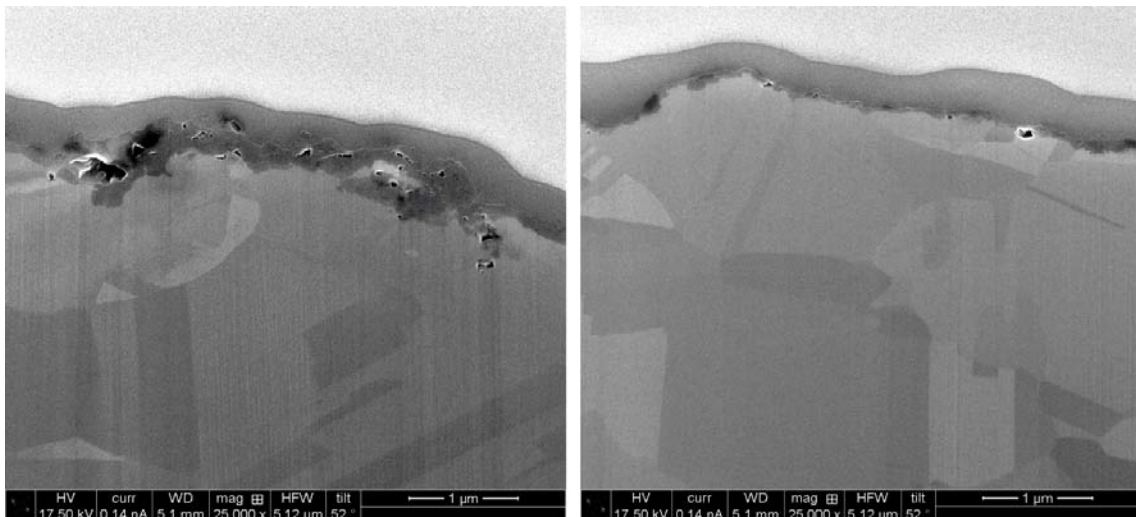
Figure 3-7. Micro cross-sections from the copper electrode (SEM/FIB microscopy; sample 4). (The quite irregular dark-grey area in between the two platinum deposits on top, one grey and one pale-grey, and the copper metal below constitutes the corrosion product layer.) (magnification 25,000x).

The appearance of the copper electrode reminds of the coupons from the LOT test parcels (Karlund et al. 2009), but is different from the appearance of the surface on full-size canisters (Taxén et al. 2012). For the latter blue-green Cu(II) products have only been observed on one or a few single spots from visual examination immediately after removing the surrounding bentonite. Differences that can have a marked influence on the corrosion behaviour between the exposed small samples and the big components exist. The most convincing is that lubricants were used in manufacturing of the full-size bentonite blocks and rings (so available machines could handle the required pressure); lubricants have not been used for the copper electrodes in the Prototype Repository, nor for the copper coupons in the LOT test parcels. The surface of the electrode is shown in more detail in Figure 3-6. The machining marks are visible and part of the corrosion product film seems missing. It might have been lost during the removal of the electrode from the bentonite block. Micro cross-sections through the corrosion product layer on the electrode surface are shown in Figure 3-7. Both figures reveal that the corrosion product layer appears quite uneven and porous.

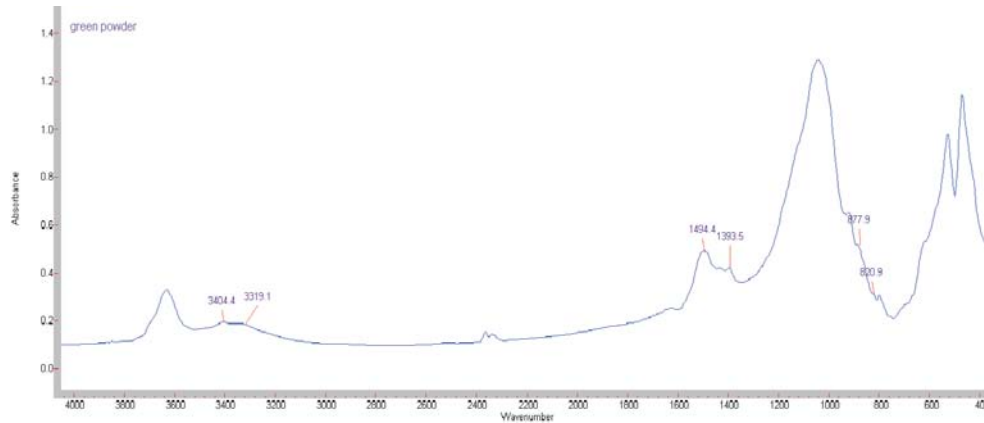
Figure 3-9a. FTIR transmission spectrum from Sample V with blue-green corrosion products. (Peaks from malachite are marked with their wave numbers.)

The performed FTIR and Raman spectroscopy confirmed these observations. The FTIR spectra from the KBr transmission measurements on corrosion products from sample areas V and H are shown in Figures 3-9a and 3-9b respectively. The spectra are dominated by bands from bentonite (strong bands from Si-O vibrations at 1,000–1,100 cm^{-1} and OH bands at 3,600 cm^{-1}), but the spectra have also bands from malachite and cuprite. Malachite was present in the blue-green corrosion products. Malachite has also been identified by means of reflection measurements on selected places on top of the electrode, see example in Figure 3-10. For Raman spectra verifying the presence of malachite and the (most probable) absence of paratacamite, see Figure 3-11.

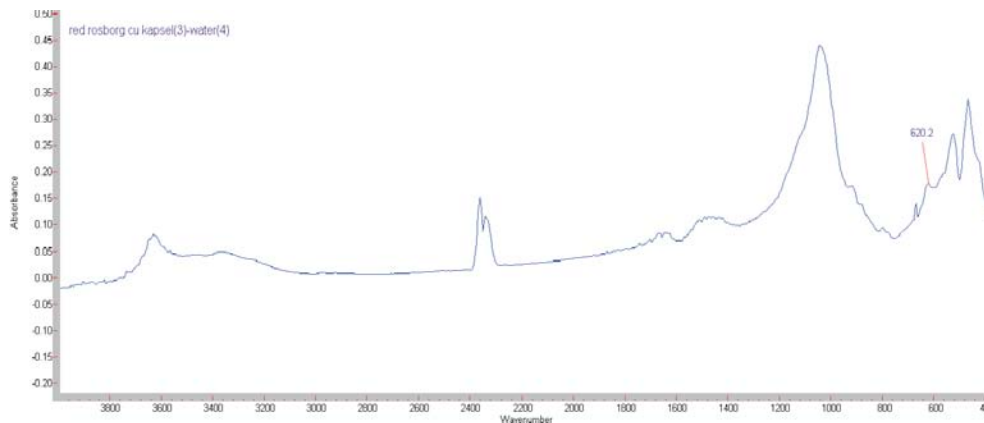
Figure 3-9b. FTIR transmission spectrum from Sample H with brownish corrosion products. (A peak that most probably originates from cuprite is marked with its wave number.)

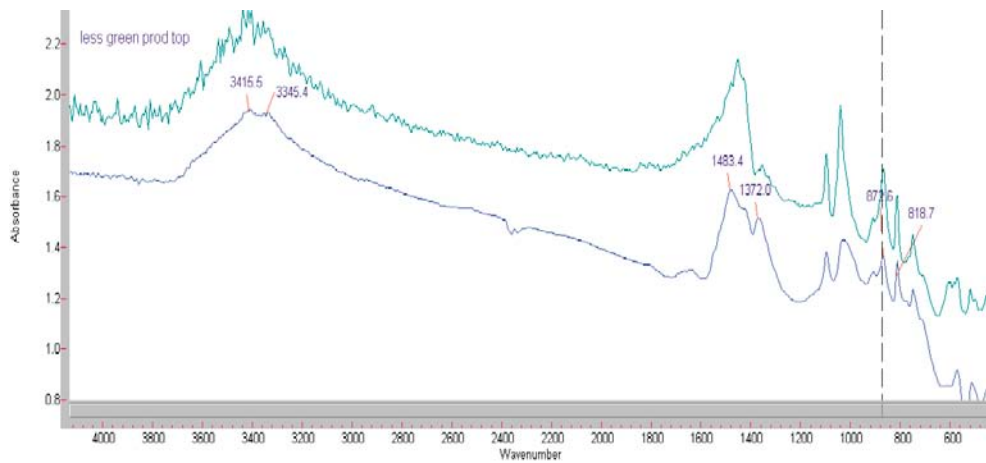
Figure 3-10. FTIR reflection spectra taken with a FTIR microscope from blue-green corrosion products on two places on top of the copper electrode seen in Figure 7.

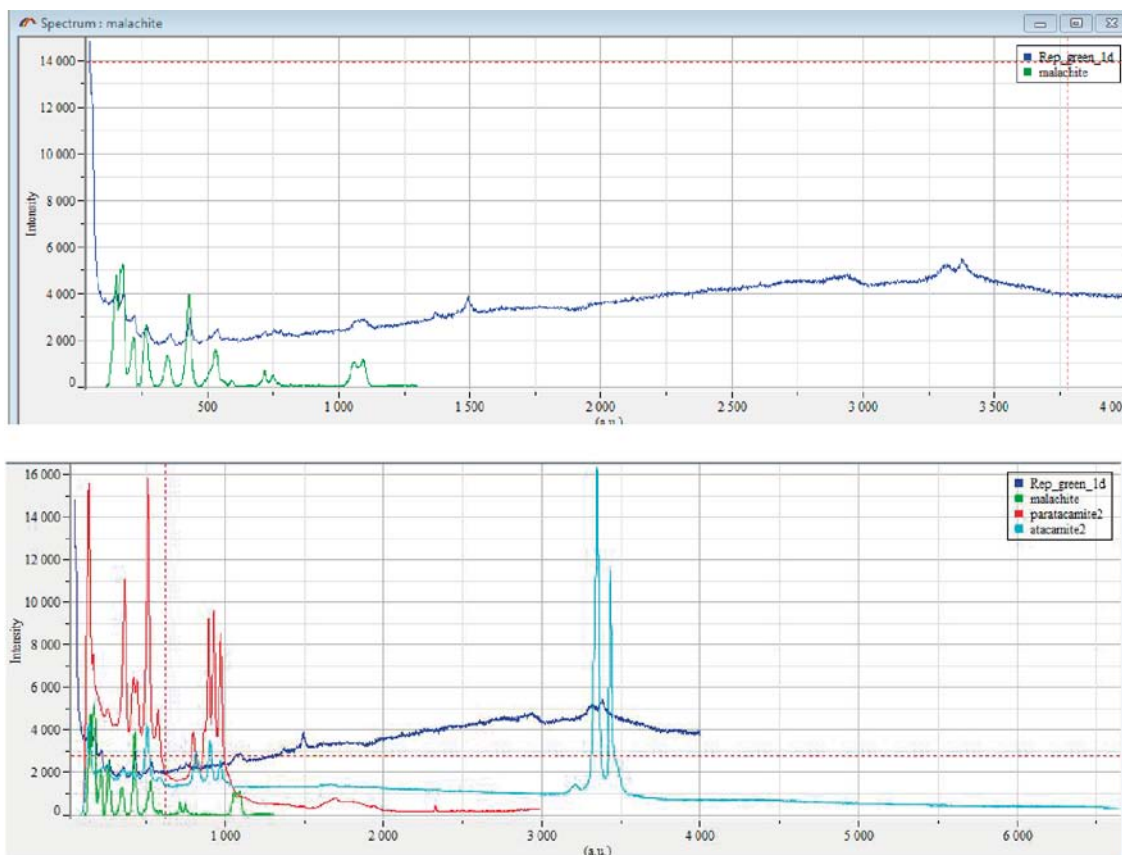
Figure 3-11. Raman spectra verifying the presence of malachite.

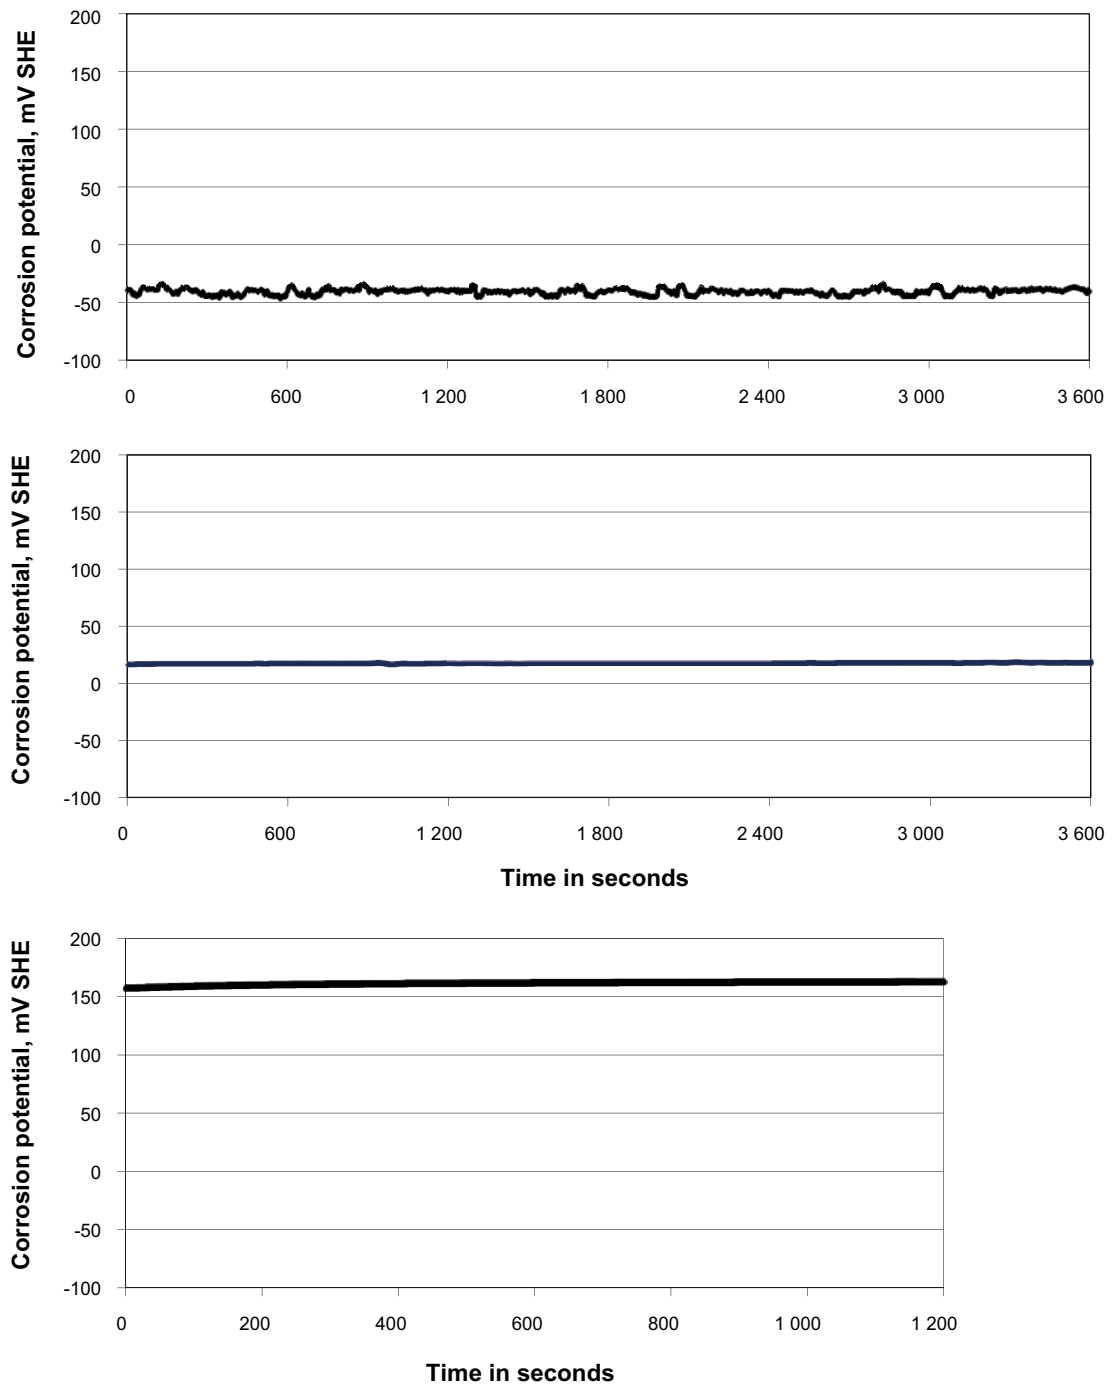
Figure 3-12. The corrosion potential of copper electrode “Black” on three occasions during 2011: (top) 2011-02-04, (middle) 2011-09-12, and (bottom) 2011-11-15.

Just before cutting loose the copper electrode from the small bentonite block the corrosion potential of the electrode was as high as 165 mV SHE, see the potential-time plot (for 2011-11-15) in Figure 3-12. As a comparison the corrosion potential was –40 mV SHE (2011-02-04) when part of the concrete plug to the outer section had been removed and 25 mV SHE (2011-09-12) about a week before retrieval of the small bentonite block with the electrodes from the upper bentonite block in dh 5.

The corrosion potential of the copper electrode merely increased by 6 mV over night from November 15 to the next day; thus, an abrupt change of well over 100 mV in a few hours after opening the tri-laminate bag on November 15 is not expected. Most likely the air ingress occurred during retrieval of the bentonite block. (In Figure 2-2 cracks are seen in the bentonite block below the copper electrode. However, it is not certain if these were formed during the removal of the copper electrode, or if they were already present from the retrieval of the small bentonite block.)

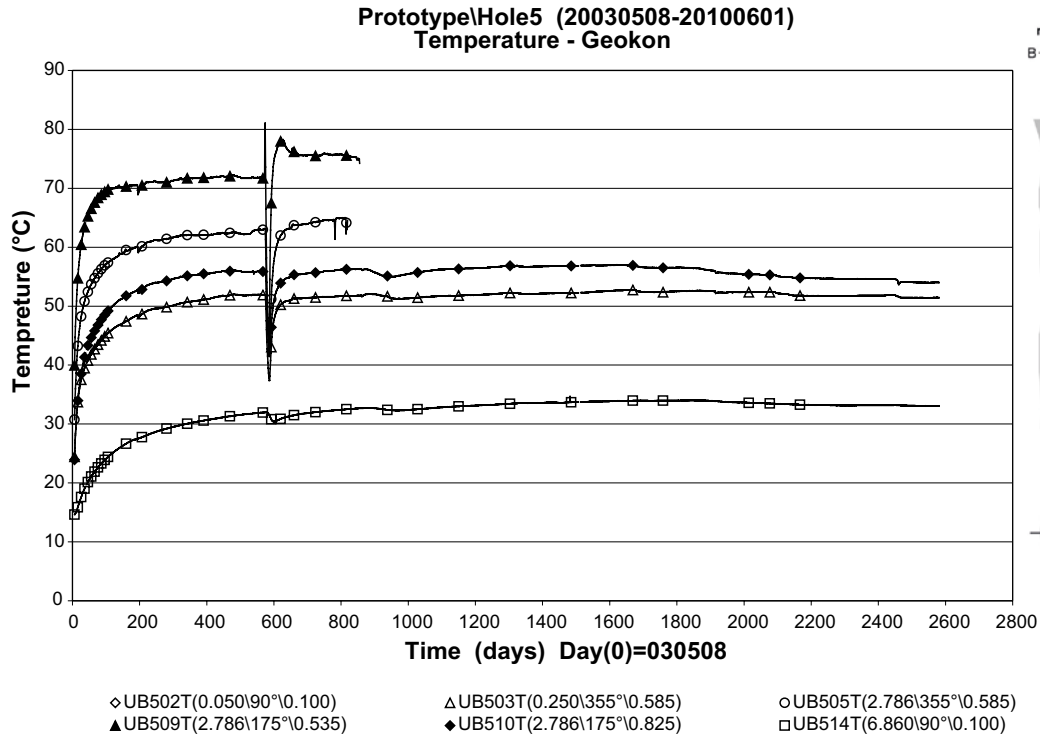
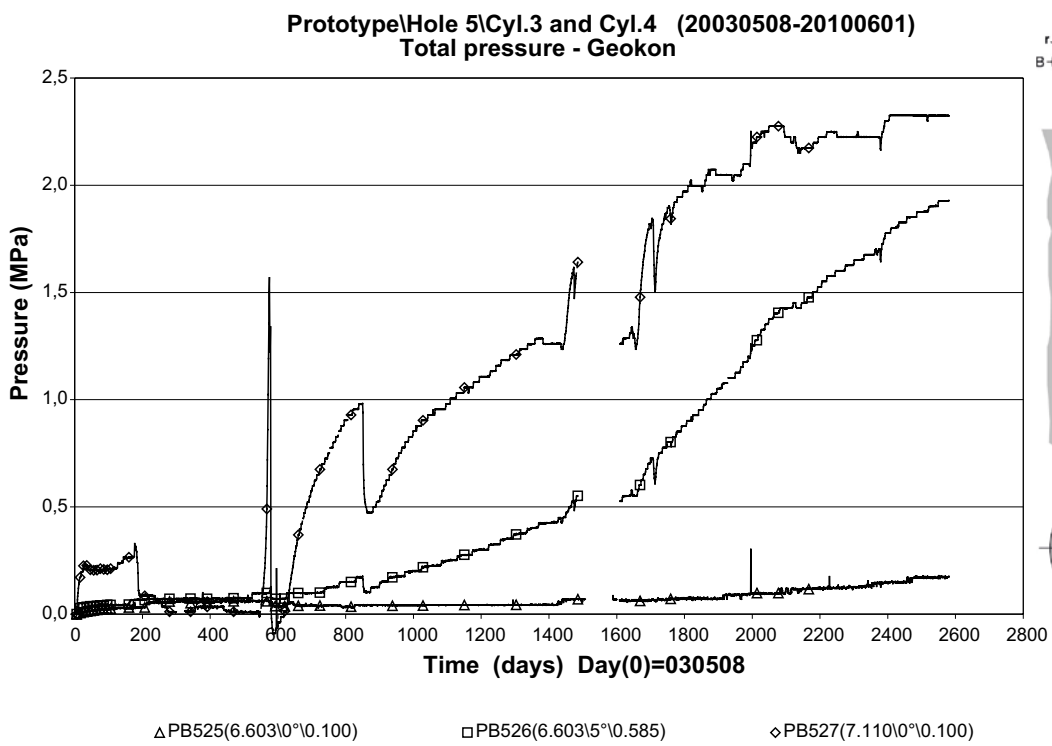
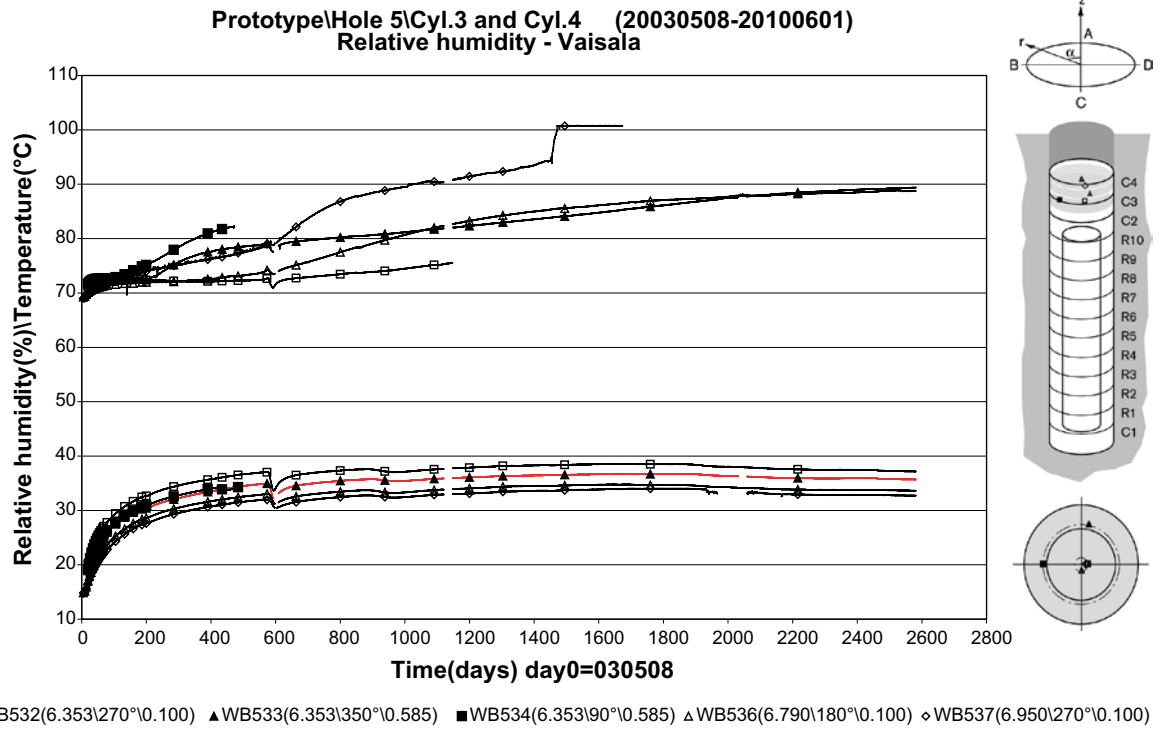
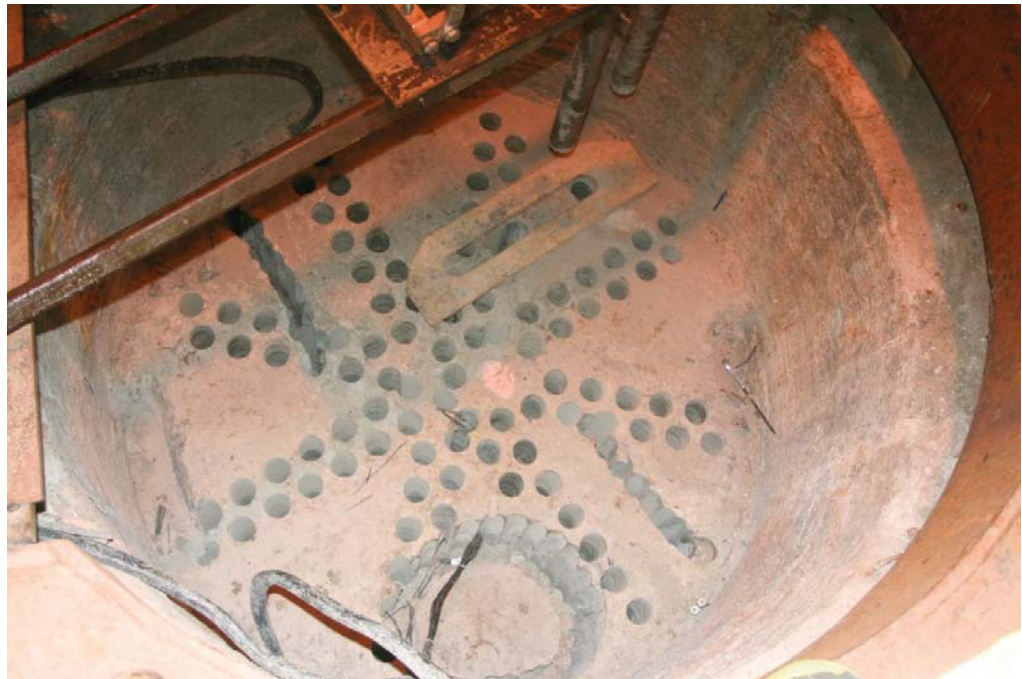
The diagrams below contain information about the conditions in dh 5 during exposure that relates to bentonite block C4.

△ PB525T(6.603\0°\0.100) □ PB526T(6.603\5°\0.585) ◇ PB527T(7.110\0°\0.100)
