Technical Report

TR-12-06

Fundamental aspects of stress corrosion cracking of copper relevant to the Swedish deep geologic repository concept

March 2013

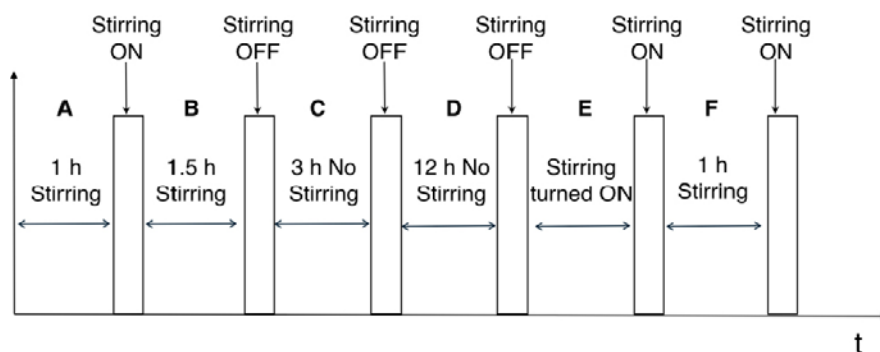
Figure 2-2. Stirring control in the impedance measurement in synthetic seawater with addition of 10 mM Na_2S at room temperature. The 6 legends at the top indicate the timing and conditions for the impedance measurements shown later (Figure 3-10).

EIS in the range of 100 kHz–0.1 Hz was applied at ± 10 mV vs. corrosion potential in synthetic seawater with addition of 10 mM Na₂S at room temperature following the procedure in Figure 2-2, to examine the effect of stirring on sulfide film development. Impedance measurements were conducted at points A to F. The specimen was made of SKB copper.

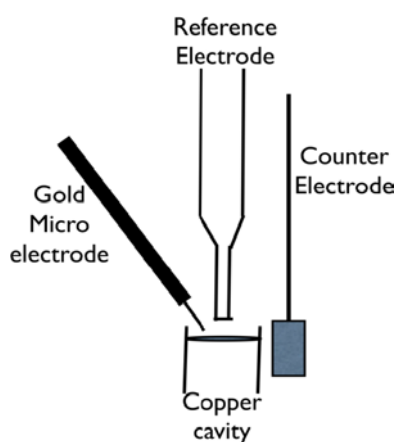
Figure 2-3. Schematic illustration of the corrosion cell set up with a gold sensor electrode.

To study the possibility of soluble (or transiently soluble) corrosion products in sulfide-containing solutions, a gold microelectrode probe was adopted. The gauge part of a tensile specimen as shown in Figure 2-1 was cut out and mounted in epoxy resin. One end of the sample was abraded to expose the copper. Then this end was immersed in 70 wt.% HNO₃ for 30 minutes to create a 2.5 mm deep cavity. A small gold disk electrode of 0.25 mm diameter was placed approximately 2 mm from the copper surface of the cavity as shown in Figure 2-3. The whole setup was then placed in a 300 ml beaker containing synthetic seawater. After purging with nitrogen for one hour, 10 mM Na₂S was added to the solution. The gold microelectrode was connected to the working electrode lead of a potentiostat and cyclic voltammetry was carried out. A scan rate of 50 mV/s was used in the potential window of –1.2 to 0.1 V vs. SCE. A separate voltammetry scan was carried out under the same conditions in the absence of the copper sample.

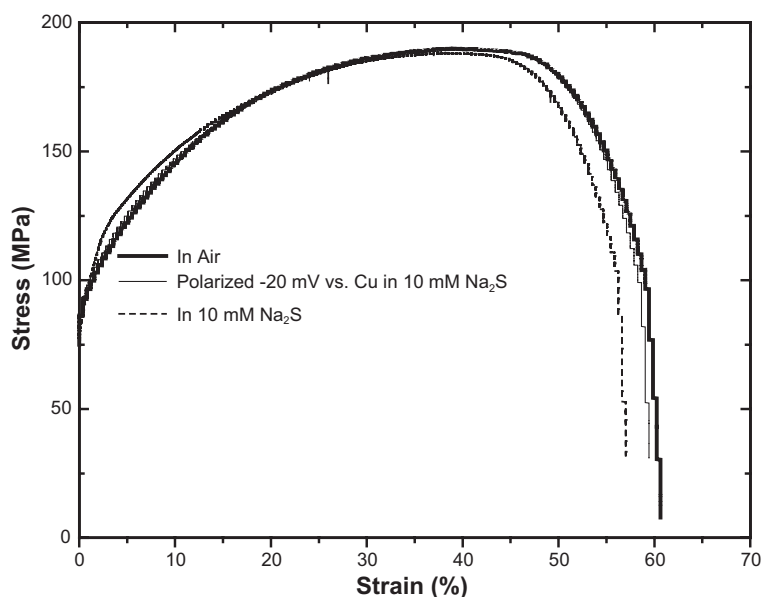
Figure 3-1. Stress-strain curves obtained from Test C, Test 21 and Test 22 in synthetic seawater with addition of 10 mM Na₂S at room temperature. In test 22, cathodic polarization was applied.

In some tests, cathodic or anodic polarization was applied during testing, to explore possible artefacts in the procedure of Taniguchi and Kawasaki. As can be seen in Table 3-1, no SCC was found in any test. Typical stress-strain curves obtained are showed in Figure 3-1, which are based on Test C, Test 21 and Test 22, and in Figure 3-2, which are based on Test 24, Test 25 and Test 26. The potentials applied in Test 24, Test 25 and Test 26 were based on the polarization curve as shown in Figure 3-3. There was never any significant difference in elongation between specimens tested in solution and air.

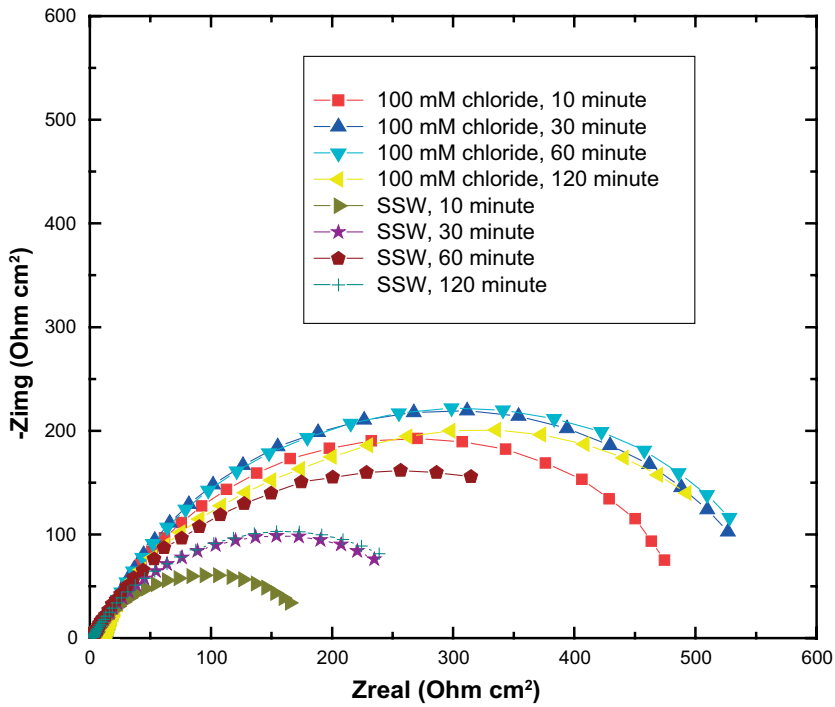
Figure 3-8. Nyquist electrochemical impedance spectra for SKB copper at different immersion times in 100 mM NaCl solution and in synthetic sea water (SSW, ca 500 mM chloride) with addition of 10 mM Na_2S at room temperature. Frequency range: 100 kHz – 0.1 Hz. The pH was unadjusted in both solutions.

Corresponding to Figure 3-6, electrochemical impedance data at different immersion times at room temperature in 100 mM NaCl solution and synthetic sea water, both with addition of 10 mM Na_2S , are shown in Figure 3-8. It can be seen that, in 100 mM NaCl solution, the polarization resistance increased quickly at the initial stages and became relatively stable after 30 minutes; while in synthetic sea water, it increased quickly and continuously during 60 minutes, and then decreased up to 120 minutes. Based on these data, it is reasonable to think that the corrosion film in the former solution could be relatively more compact, whereas in the latter it is coarser and looser, more easily spalled off. This was also consistent with the observation that, in 100 mM NaCl solution (with addition of Na_2S), the corrosion film was adherent and could not be easily removed for examination of the underlying metal surface. Nevertheless, the data do not give any contradictory information to the notion that corrosion is diffusion-controlled by inward diffusion of sulfide – a lower corrosion rate can always be rationalized by assuming that the dominant diffusion path is through pores in the sulfide film. But it would be unusual to observe a grain orientation effect on corrosion rate, but then conclude that all the corrosion is really diffusion controlled, but that the different corrosion rates on different grains are due to diffusion control through films of different porosity (not that this is impossible in principle). Normally such grain orientation effects are ascribed to different reaction kinetics.

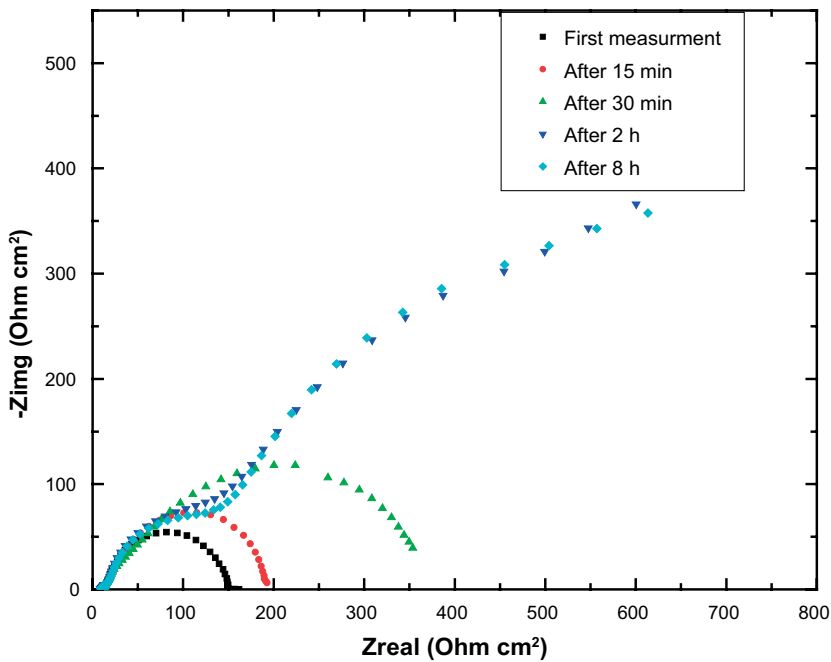
Figure 3-9. Impedance spectra of SKB copper specimen after longer immersion in 100 mM NaCl solution with addition of 5 mM Na_2S at room temperature. Frequency range: 100 kHz–0.1 Hz.

Impedance spectra from a longer immersion test in 100 mM NaCl solution with the addition of 5 mM Na_2S are shown in Figure 3-9. Such data tend to confirm that the corrosion film was relatively compact and that the corrosion process was under diffusion control, predominantly within the pores of this film, after some duration of corrosion.

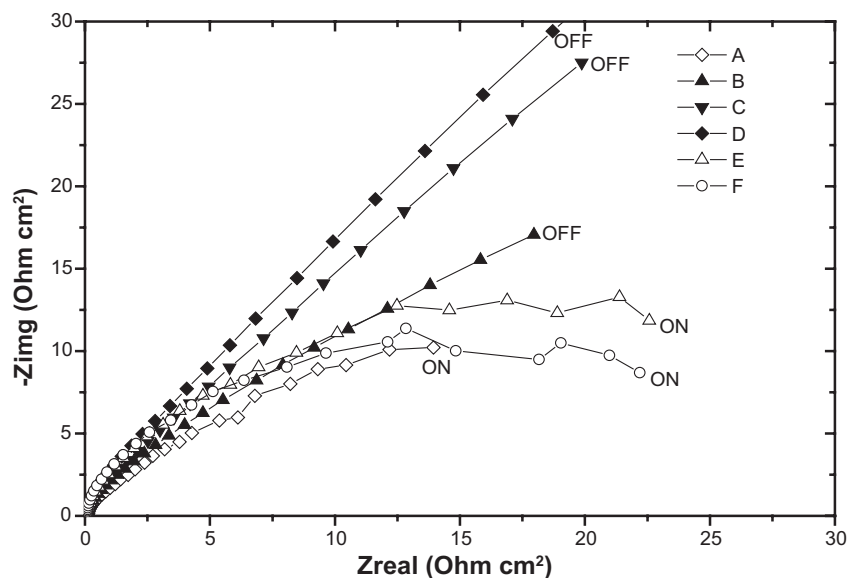
Figure 3-10. Effect of stirring on the impedance behavior of the SKB copper specimen in synthetic seawater with addition of 10 mM Na₂S at room temperature, according to the programme shown in Figure 2-2. Frequency range: 100 kHz–0.1 Hz.

The effect of stirring on the impedance spectra in synthetic sea water with the addition of 10 mM Na_2S is shown in Figure 3-10. The stirring control procedure was shown in Figure 2-2. Generally speaking, such data show that stirring relieves the diffusion control of the corrosion reaction, but the interpretation can be complex, because stirring also reduces the film growth (deposition?) rate and even shears off the more fragile outer part of the film, so that the effect of an on-off cycle of stirring may not be reversible.

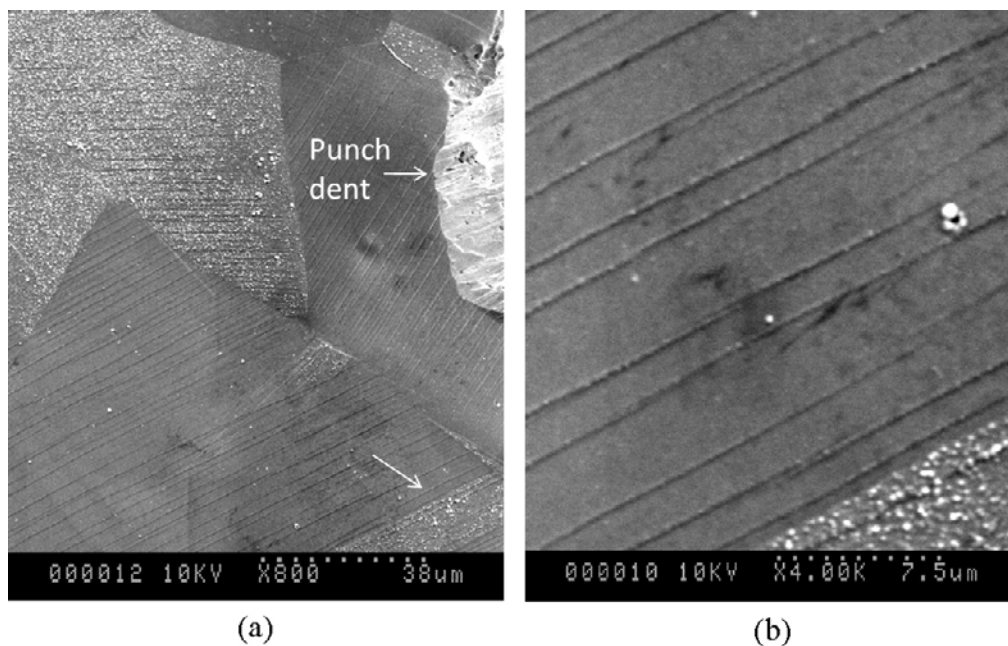
Figure 3-18. The surface morphology near the punch dent of the specimen after immersion in synthetic sea water with addition of 2 mM Na_2S ; (b) – area indicated by arrow in (a).

No cracking was found in the electropolished, then punched, specimens in synthetic sea water with addition of 2 mM, 10 mM or 50 mM Na₂S. The surface morphology near the punch dent of the specimen in synthetic sea water with addition of 2 mM Na₂S is shown in Figure 3-18. The difference in film thickness on differently oriented grains is clearly seen.

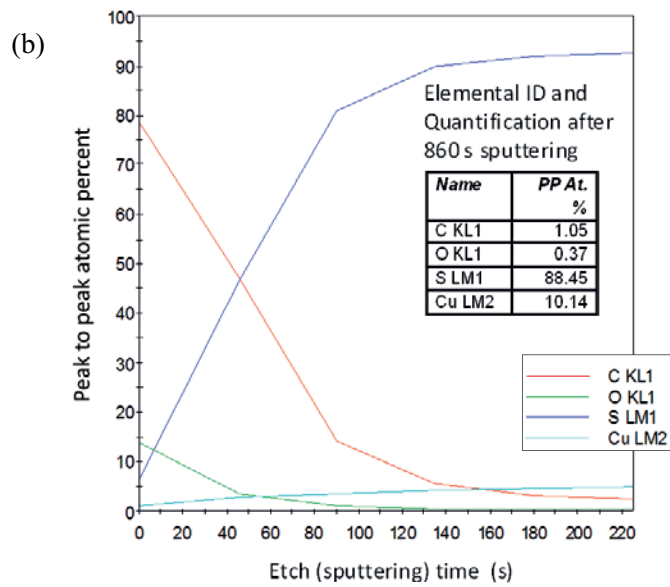
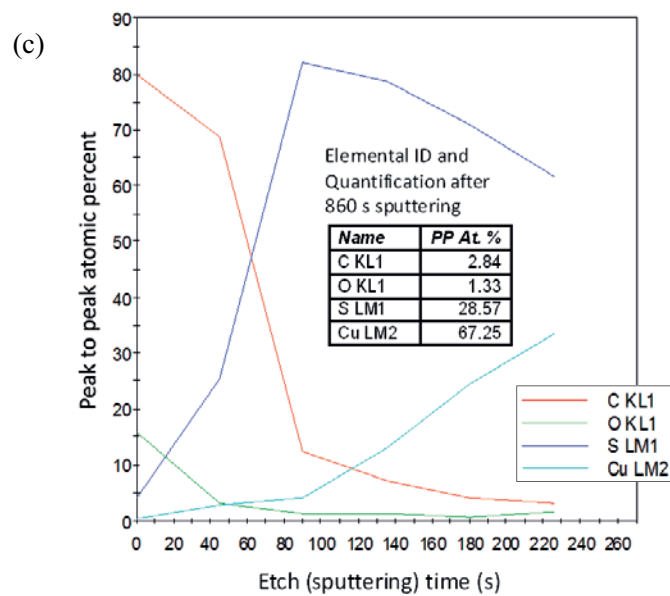
Figure 3-20. AES analysis on the surface of the specimen immersed in synthetic sea water with addition of 2 mM Na_2S ; (a) – analyzed areas; (b) and (c) – sputter depth profiles in areas 1 (thicker film) and 2 (thinner film).

The same specimen was also analyzed with AES in a number of areas. The first analyzed area and set of AES data are shown in Figure 3-20 – the darker area corresponds to a thinner film. This specimen had already been carbon coated for SEM before AES analysis, so the carbon signal is very strong before sputtering. The oxygen signal is weak, particularly after sputtering. The main elements existing in the surface film are S and Cu. With sputtering (depth), in area 2, the sulfur signal decreased after a while; while in area 1, the sulfur signal was almost constant. This confirms that the thickness of the Cu_2S corrosion film was different depending on grain orientation. No attention should be paid to the atomic percentages of S and Cu quoted in Figure 3-20b–c – standards were not available for proper calibration.

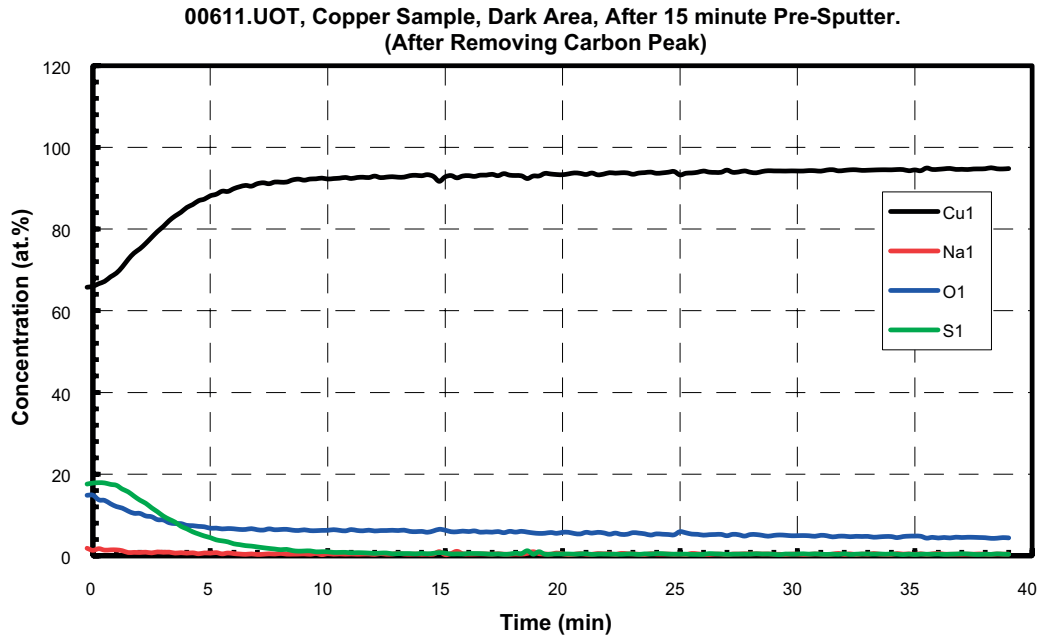
Figure 3-21. AES sputter depth profile for a darker area (thinner film) with carbon removed. Quantification is obviously affected by the presence of carbon, but the extent of the film is well shown.

A further campaign on the same specimen produced the data in Figure 3-21 to Figure 3-23. Now the carbon has been removed from the analysis, and the differences in film thickness are clearly shown. One aspect that is not clear is the correlation between the AES and the EDX analyses. The AES showed only a difference of about a factor of 3 between the thinnest and thickest areas, whereas EDX showed much larger differences. This may be related to the different area analyzed and/or to differential sputtering of the compact and loose, particulate, films. It is also possible that when analyzing a porous surface, SEM-EDX has a kind of projection effect where the incident electrons strike the bottom of many or all of the pores.

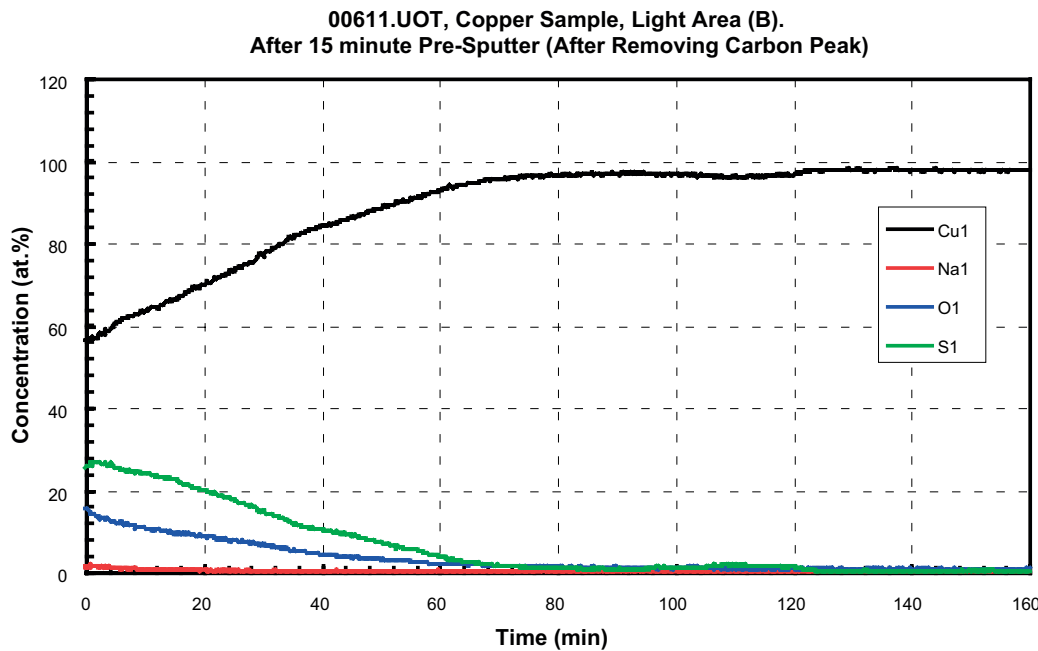
Figure 3-22. AES sputter depth profile for a lighter area (thicker film) with carbon removed. Quantification is obviously affected by the presence of carbon, but the extent of the film is well shown.

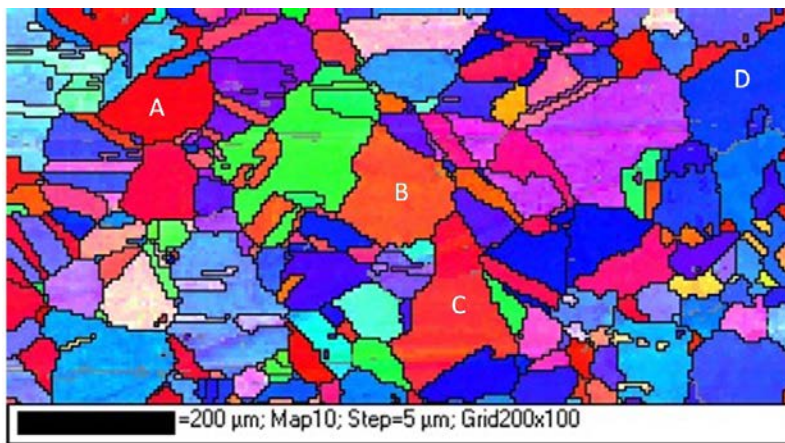
(a) – EBSD image before light electropolishing and immersion testing

(b) – surface morphology after immersion testing

Figure 3-27. Example of successful correlation of grain surface orientation with corrosion morphology, for electropolished SKB copper immersed in artificial seawater with 2 mM Na_2S added for 48 hours.

In brief, thin sulfide films were seen on grain faces with orientations close to (100) as defined by the colour code shown in Figure 3-26, but also on higher-index faces, and no conclusive overall correlation was found. Figure 3-27 shows one example, while Figure 3-28 illustrates the level of detail that can be achieved. Figure 3-29 shows an example of a particular film morphology that is strongly related to the substrate orientation.

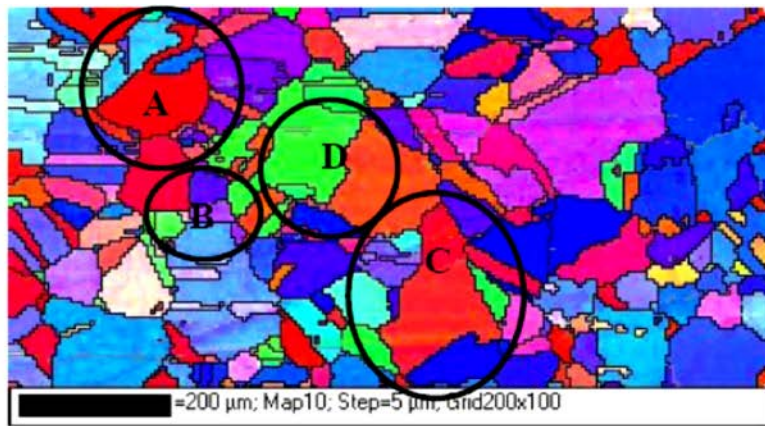
Figure 3-28. As Figure 3-27, but with detailed characterization of individual areas. A complete set of such analyses is available – see Appendix B.

Figure 3-28 (continued). As Figure 3-27, but with detailed characterization of individual areas. A complete set of such analyses is available – see Appendix B.

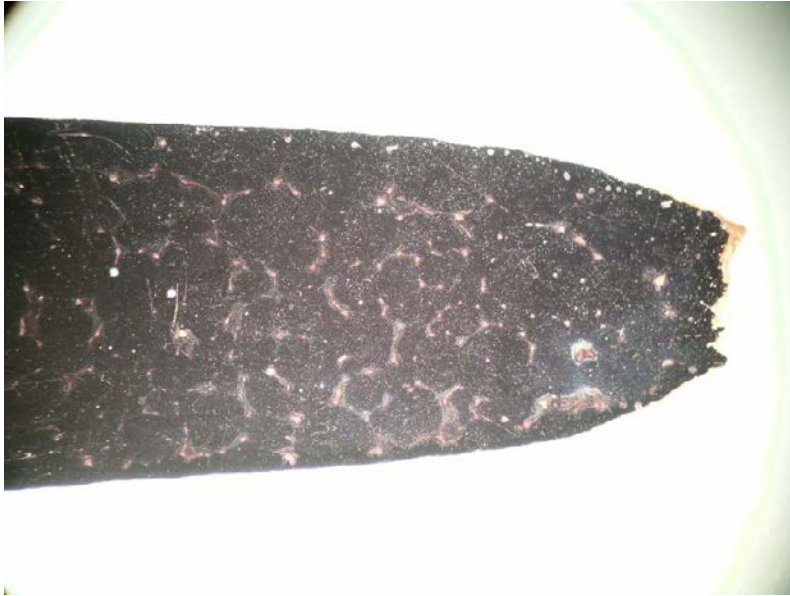
Figure A-1. Apparent granular network on the polished, unetched surface of sample SSRT-1 described in Table A-1. The gauge diameter was 3 mm.
