Prototype Repository

Method for opening and retrieval of the outer section

Lars-Erik Johannesson, Clay Technology AB

SKB P-13-15

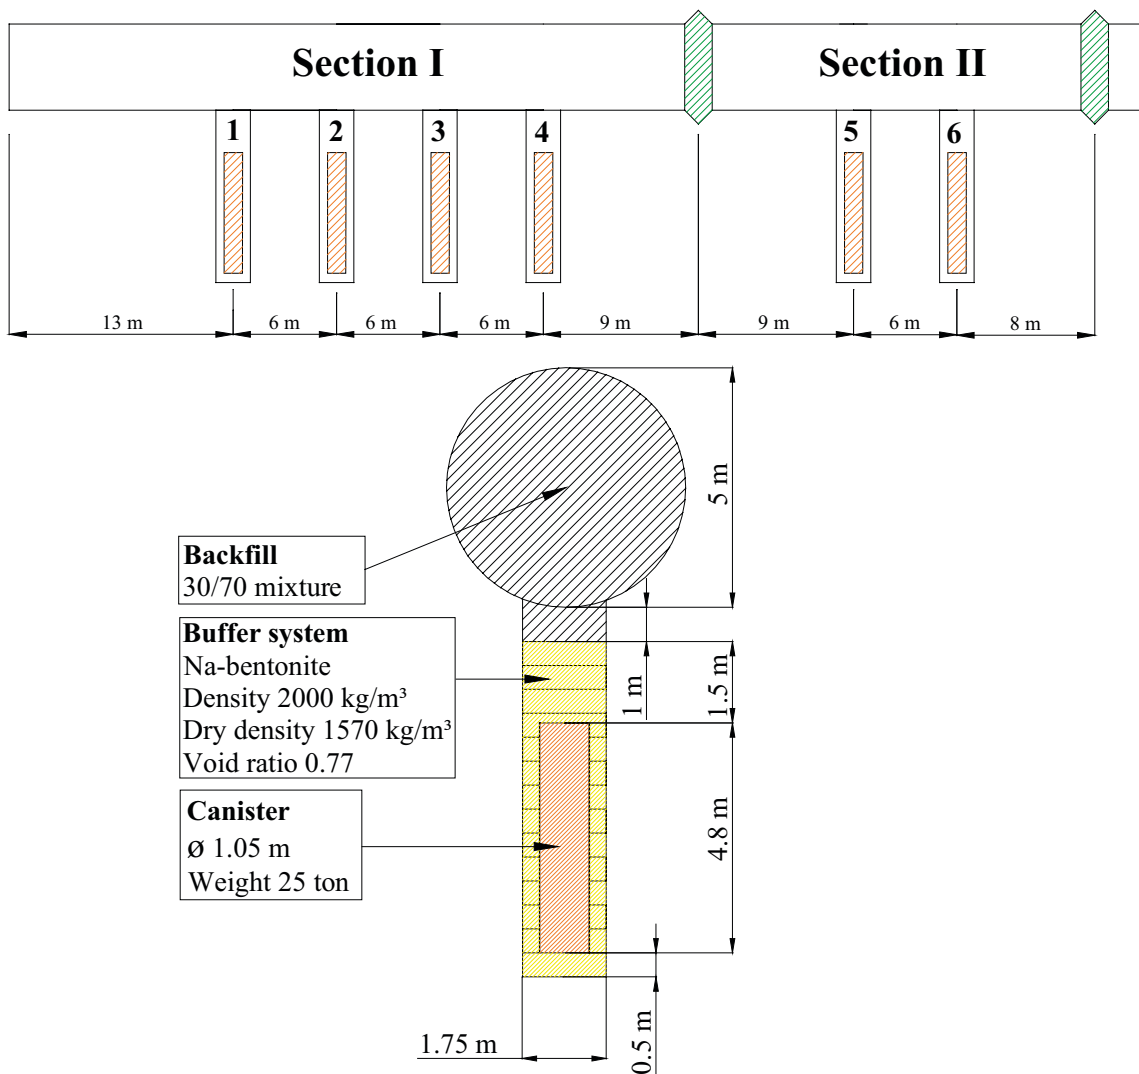
Figure 1-1. Schematic drawing of the deposition tunnel and the deposition holes of the Prototype Repository.

Prototype Repository is a large-scale trial installed at Äspö. The trial consists of six full-scale deposition holes in the TBM-tunnel, depth 450 metres. Each deposition hole is installed with full-scale bentonite buffer (MX-80) and full-scale canister. The canisters are equipped with heaters to simulate heat from a canister containing spent fuel. The trial is divided into two sections, in which the inner section consists of four deposition holes installed with buffer and canister and the outer section consisting of two deposition holes also installed with buffer and canisters. The deposition tunnel is backfilled with a mixture of crushed rock and bentonite (30% bentonite). The trial also includes two concrete plugs which end each section. Furthermore, sensors were installed in the rock, backfill and buffer to monitor pressure build-up and wetting of buffer and backfill. The trial is described in detail by Persson and Broman (2000) and in Svemar and Pusch (2000). The dimensions of the tunnel and the deposition hole are shown in Figure 1-1.

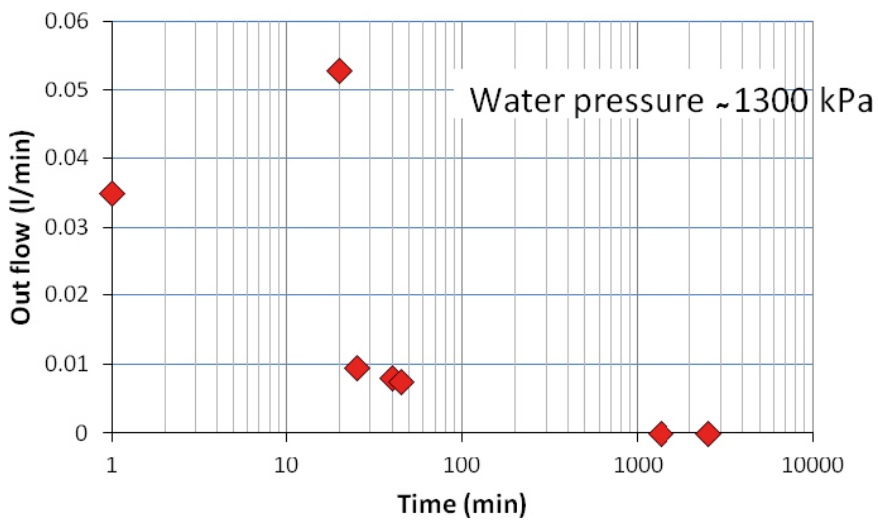
Figure 2-4. The measured outflow through the plug.

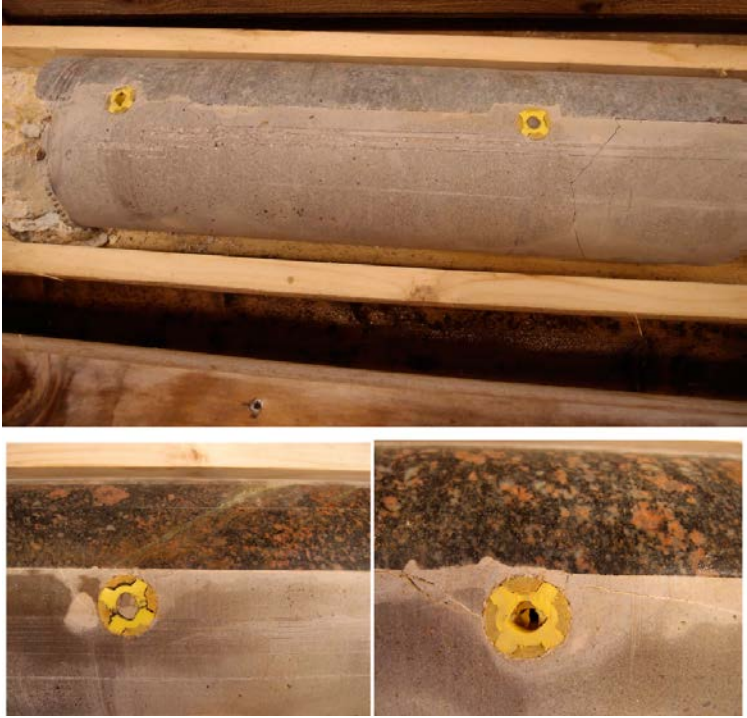
Figure 2-6. Close up pictures of the cores taken from the interface between the concrete plug and the rock. The yellow grouting tubes are embedded in grout.

Four samples were taken of the plug for investigating the interaction between the concrete and the rock surface in the slot of the plug especially to study the outcome of the contact grouting. The samples were core drilled with a boring machine placed in a rig as shown in Figure 2-5. The cores had a diameter of 120 mm. Three of the taken core samples could be recovered for evaluation. The fourth core hit the reinforcement structure and was split into smaller pieces. The examination of the taken cores indicate that the grouting made after casting of the plug filled up very well the gap between the concrete and the rock surface. See photos in Figure 2-6.

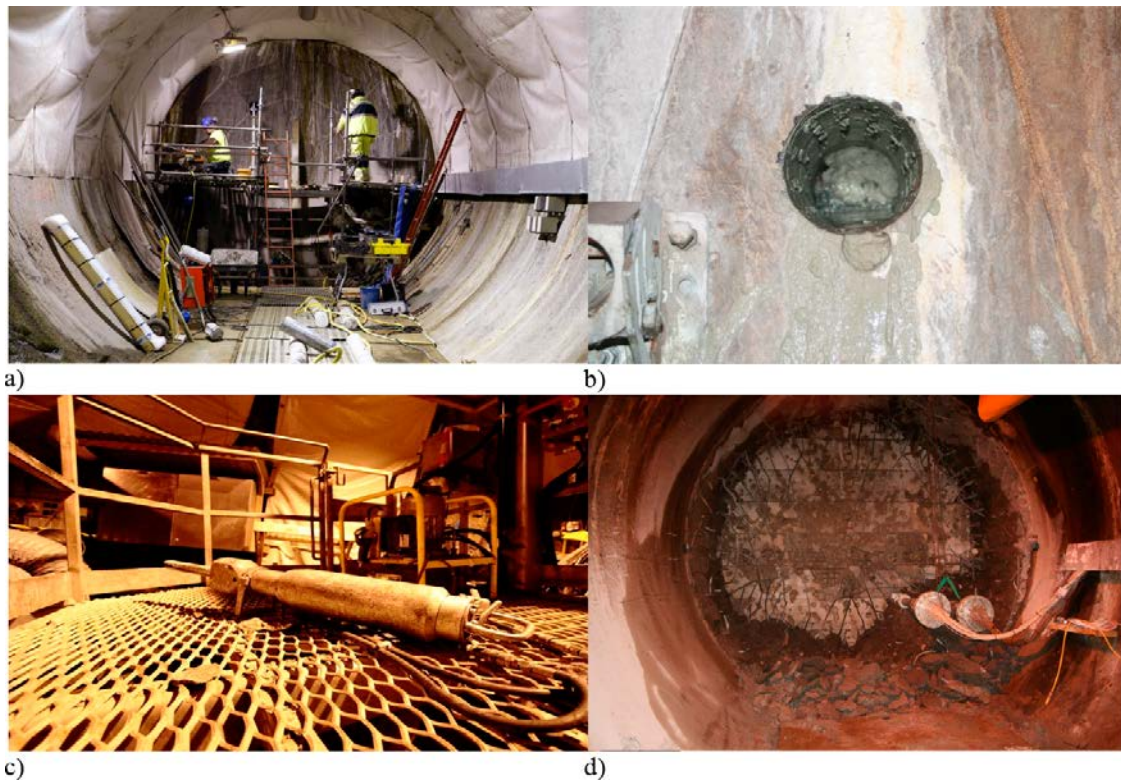
Figure 2-7. a) The drilling machines placed on the rig. b) Backfill material squeezed out through a drilled hole in the concrete plug. c) The hydraulic breaker used at the demolition of the plug. d) Remaining of the concrete plug and its reinforcements together with the retaining wall. The cables placed in tubes passing through the plug are visible on the right side.

The breaching of the plug started in December 2010 and the work was finalized at the end of February 2011. The core drilling was made, at the most intensive phase with two rigs placed in a frame as shown in Figure 2-7a. The diameter of the drilled holes was 150 mm. A smaller hole was first drilled through the entire plug to ensure that no water pressure was acting on the inner plug surface. The first hole with the planned diameter was drilled through both the concrete plug and the retaining wall, which resulted in a leakage of backfill material through the hole, see Figure 2-7b. In order to minimize the risk of further leakage of material during the drilling, it was decided that the rest of the drilled holes should not enter the retaining wall. The drilling part of the work was handled by two workers and took about 2 months to finalize. The demolishing continued with mechanical impact on the plug with a hydraulic hammer and a hydraulic breaker as described in Section 2.2, see Figure 2-7c. At this part of the demolishing, water was spread over the plug to minimize the dust. This part of the work took about 1 month. Another 2 weeks were used for demolishing the retaining wall, see Section 2.2. The demolishing of the plug was impeded by the desideratum to save the cables lead through tubes placed in the plug, see Figure 2-2.

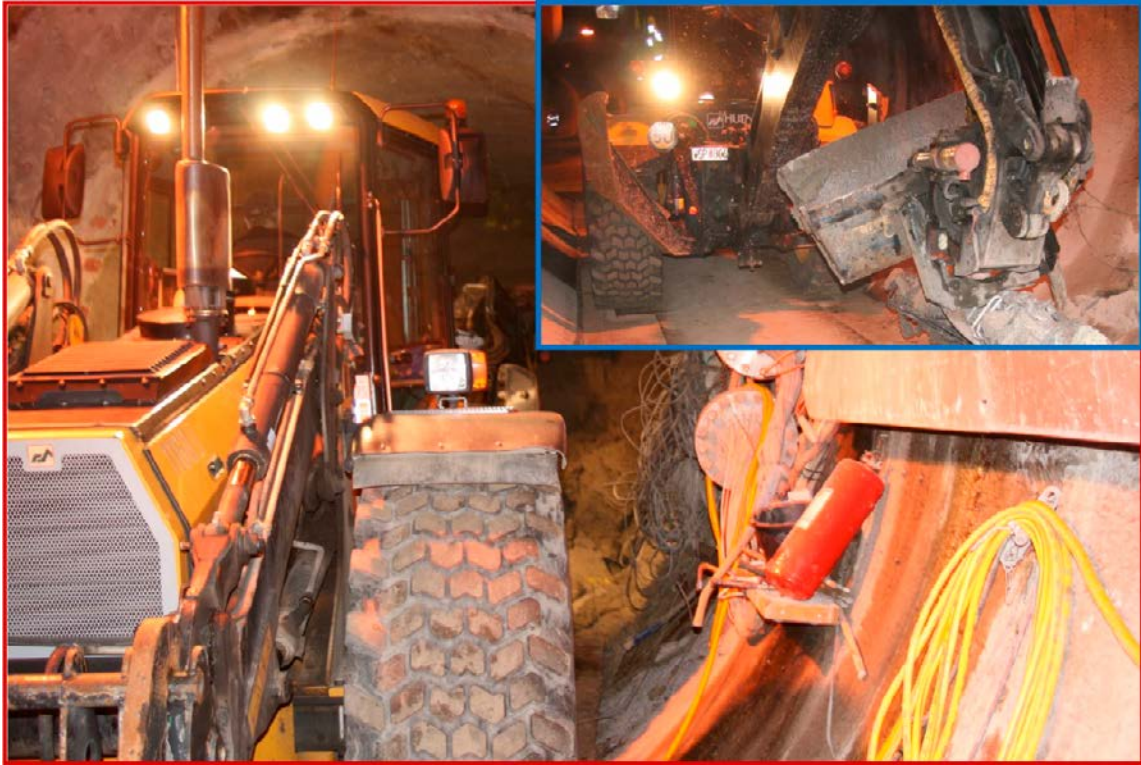
Figure 3-2. The backhoe loader used at the excavation.

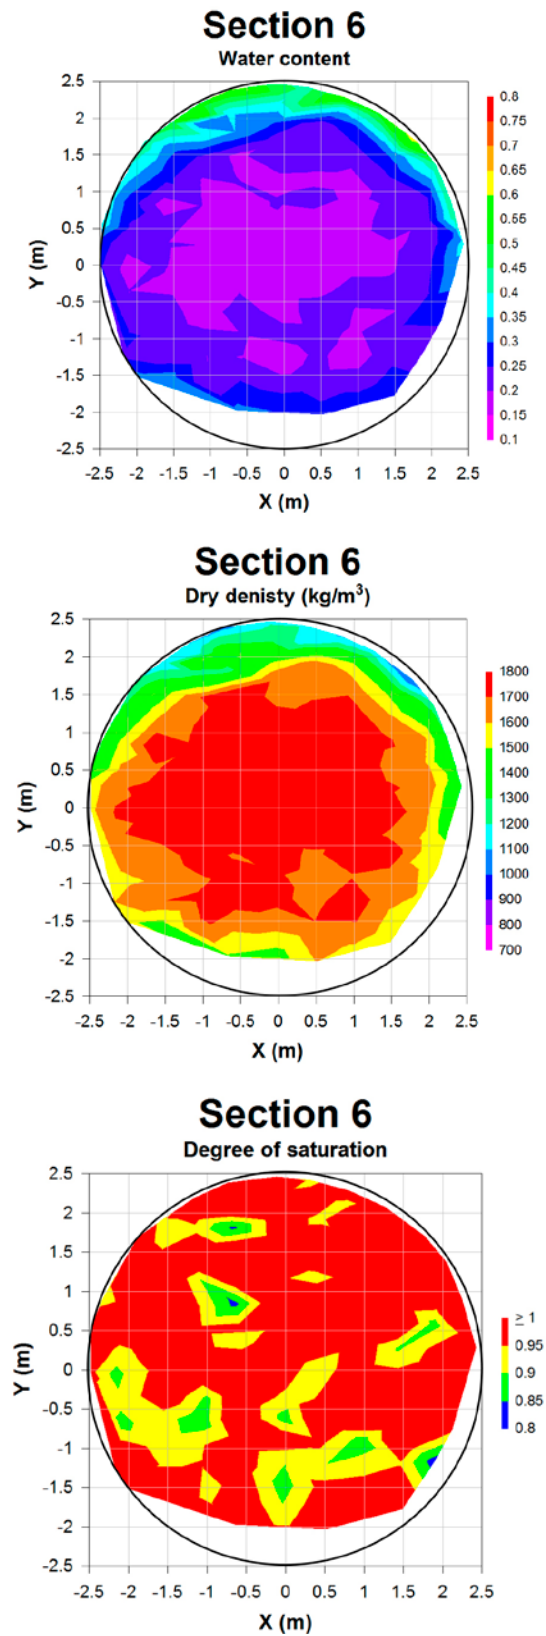
Figure 3-5. Examples of data from the determinations of water content, density and degree of saturation on samples taken from section No 6 of the backfill (from Johannesson 2013).

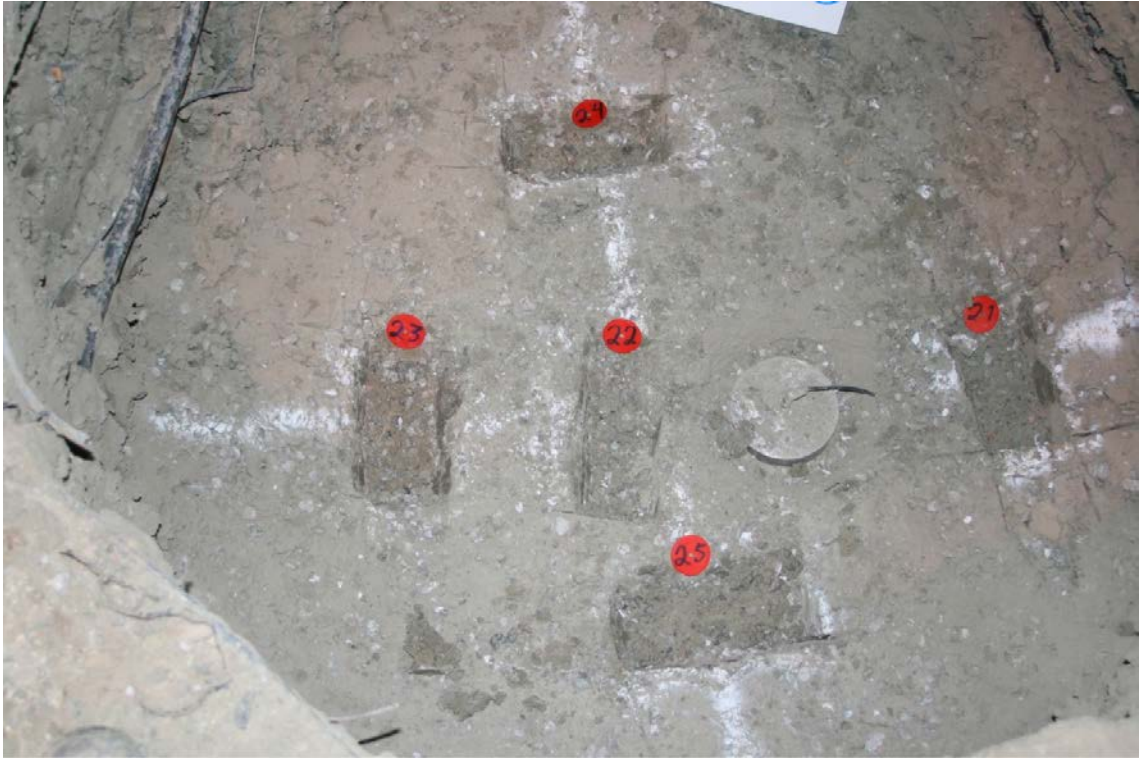
Figure 3-6. Samples taken from the tunnel backfill inside a deposition hole together with an installed sensor.

The backfill material placed inside the two deposition holes above the last installed buffer block in each of the deposition holes were excavated by hand, after the material was loosened with a pneumatic hammer. Some samples were also taken from this part of the tunnel backfill on which the water content and the density were measured, see Figure 3-6.

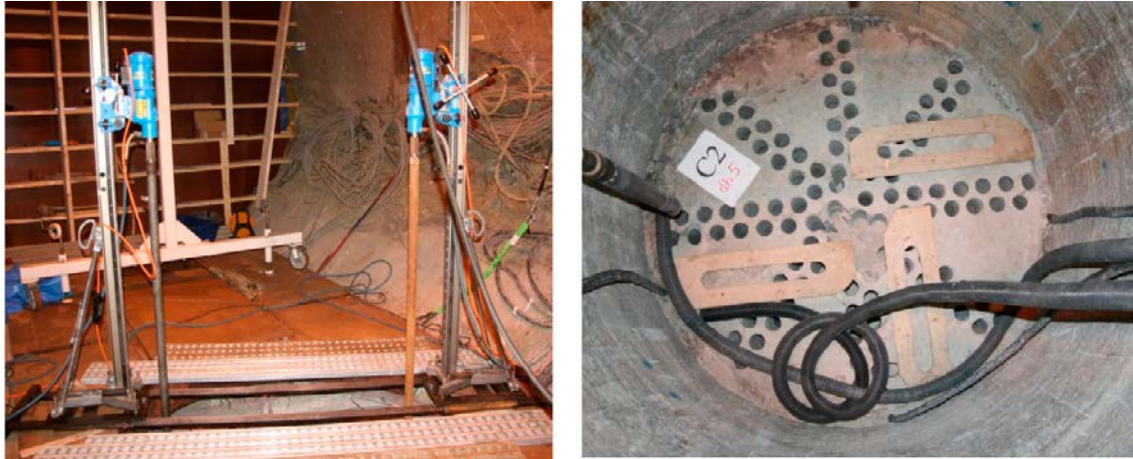
Figure 4-1. a) The core drilling machines standing on the tunnel floor. b) Holes from cores taken from a buffer block. Wooden templates were used to position the drill bit.

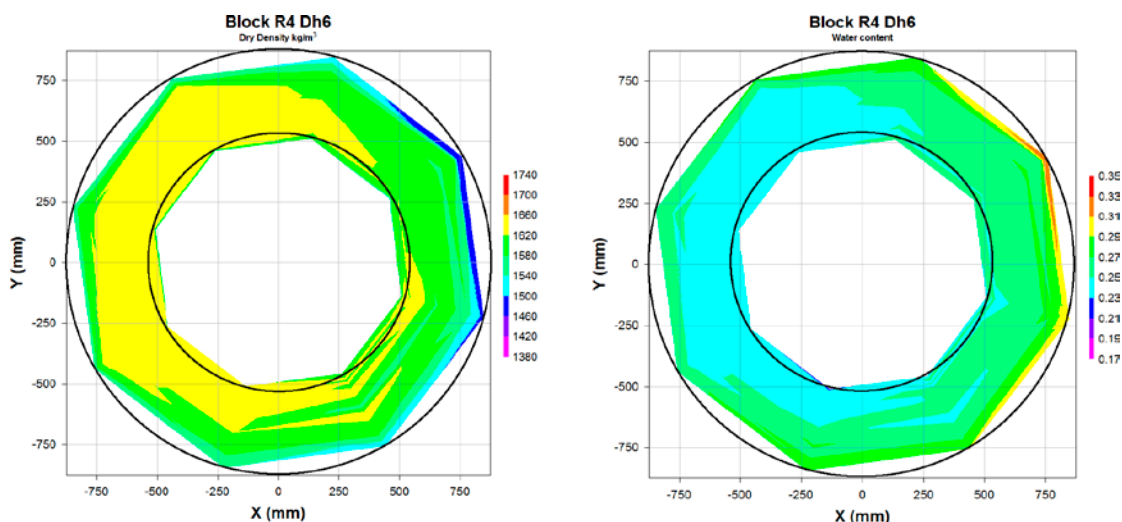
Figure 4-4. Examples of data from the determination of water content and density on the samples taken of the buffer in deposition hole 6 (from Johannesson 2013).

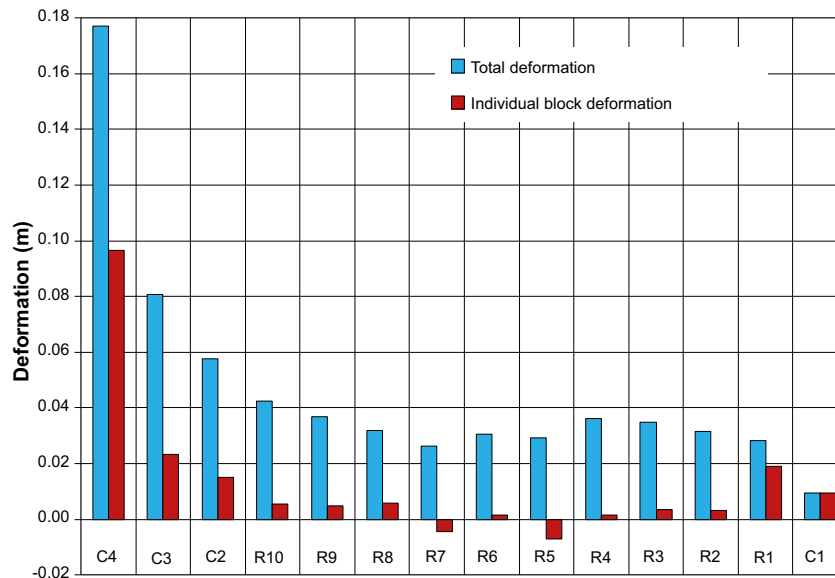
Figure 4-6. The measured deformation of the individual blocks (red) together with the accumulated deformation (blue) for the 14 installed bentonite blocks in deposition hole 6.

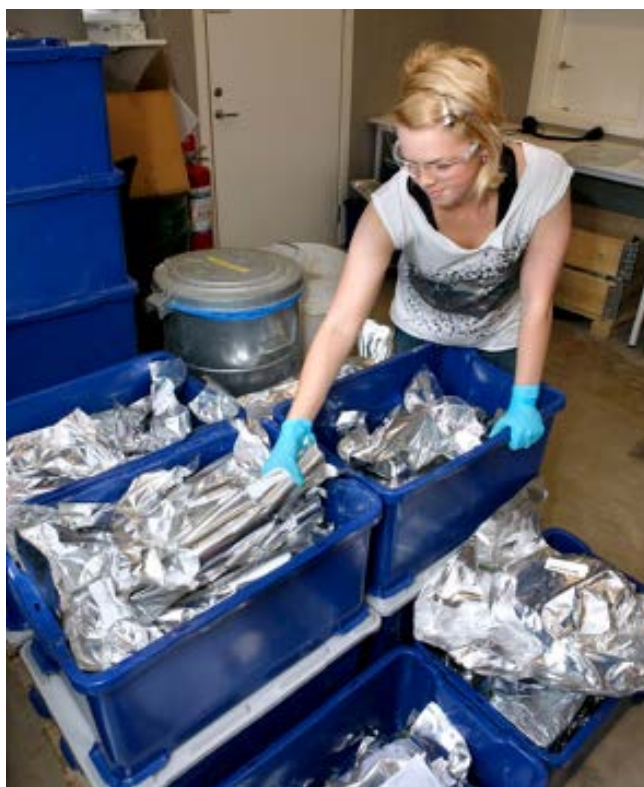
Figure 6-1. Samples taken from the buffer and delivered to the laboratory at the ground level.

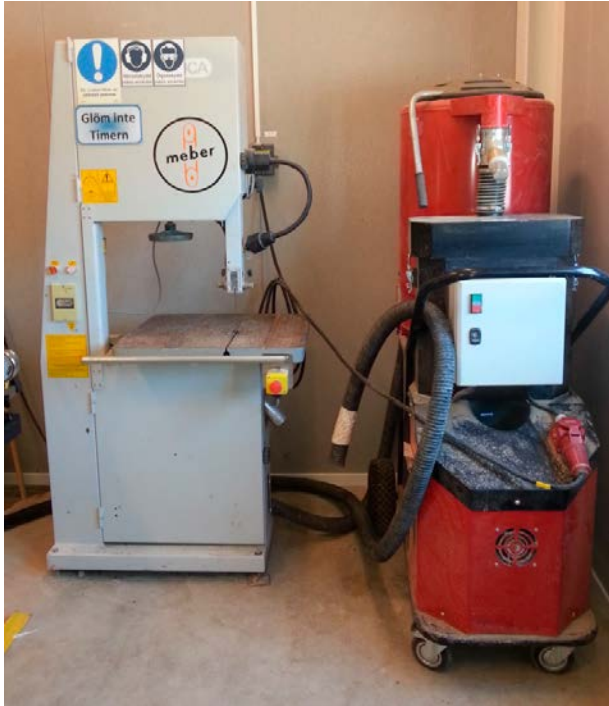
Figure 6-2. The band saw used for sawing the samples.

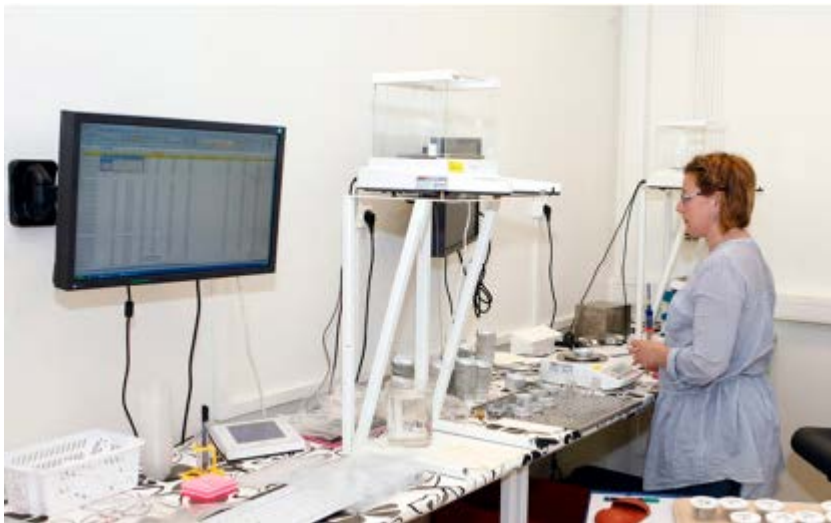
Figure 6-3. The equipment used for determining the density of the samples.

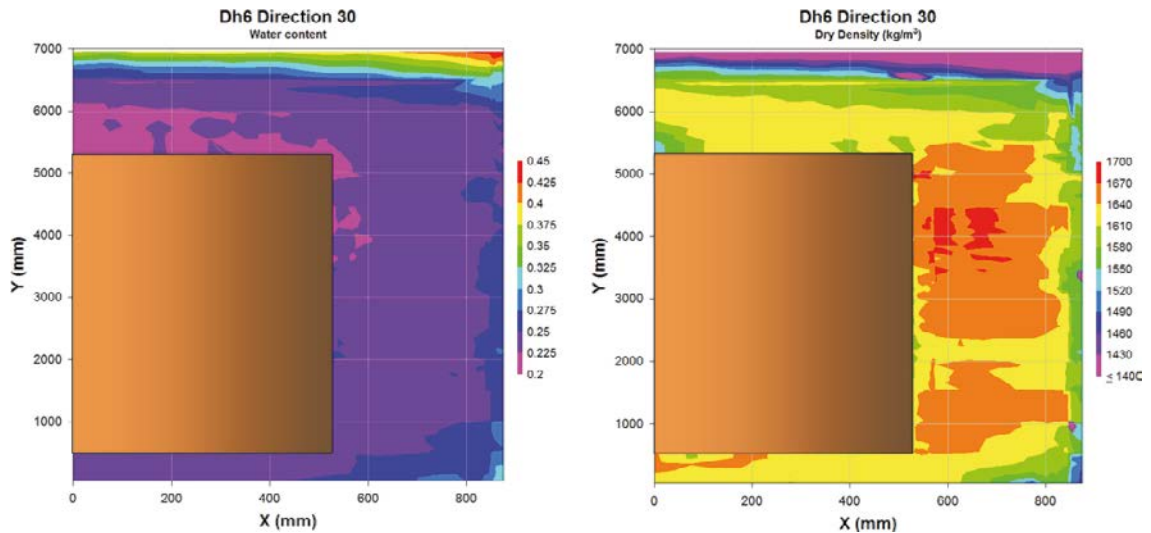
Figure 6-4. The water content and density of the buffer in deposition hole 6, direction 30° (from Johannesson 2013).

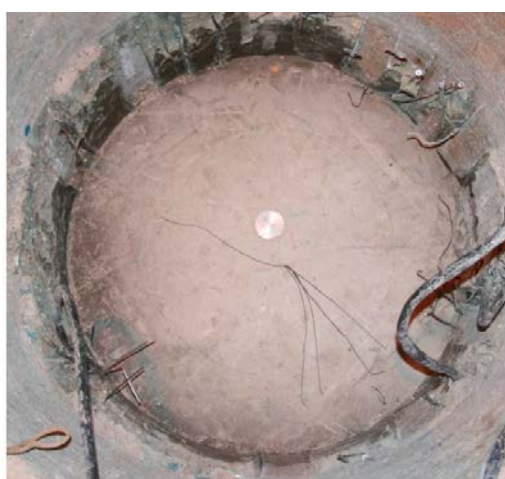
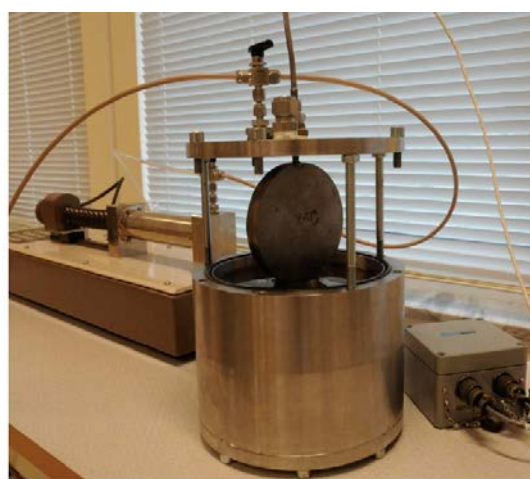
Figure 7-1. a) A total pressure sensor placed in block C3 in deposition hole 5. b) The vessel filled with water used for validating the total pressure sensors.

Figure 7-1 shows a picture of an installed sensor at the excavation of the buffer together with the device constructed for validating sensors. In Table 7-1 are the numbers of retrieved and tested sensors from the buffer and the backfill listed. The validation/control of the retrieved sensors is described in detail in a separate report (Nilsson 2013).
