**Technical Report**

**TR-09-20**

**Miniature canister corrosion  
experiment – results of operations  
to May 2008**

**Svensk Kärnbränslehantering AB**

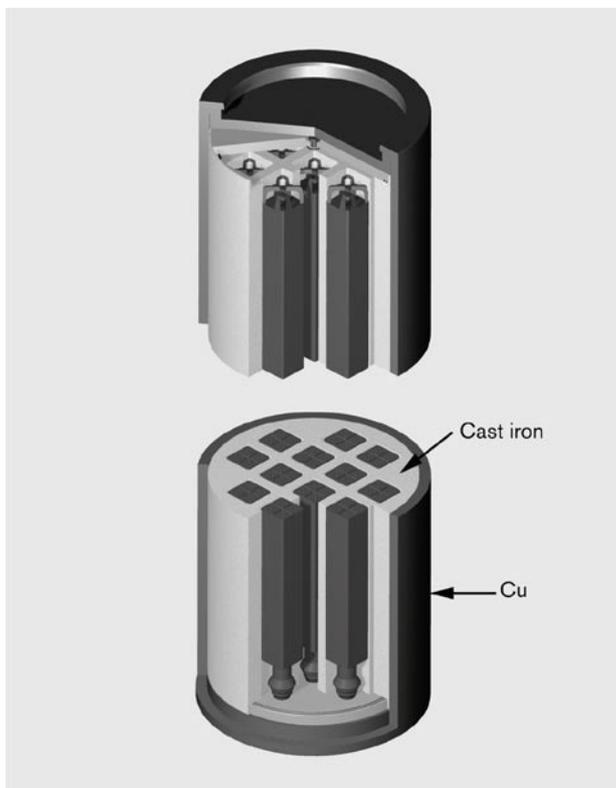
*Figure 1-1. Schematic diagram of SKB Copper-Iron Canister.*

To ensure the safe encapsulation of spent nuclear fuel rods for geological disposal, SKB of Sweden are considering using the Copper-Iron Canister, which consists of an outer copper canister and a cast iron insert, as shown schematically in Figure 1-1. A programme of work has been carried out over a number of years to investigate a range of corrosion issues associated with the canister, including the possibility of expansion of the outer copper canister as a result of the anaerobic corrosion of the cast iron insert. Experimental work using stacks of copper and iron test specimens has not shown any evidence of corrosion-induced expansion /1/. However, as a further step in developing an understanding of the likely performance of the canister in a repository environment, Serco Technical and Assurance Services has set up a series of experiments in SKB's Äspö Hard Rock Laboratory (HRL) using inactive model canisters, in which leaks were deliberately introduced into the outer copper canister while surrounded by bentonite, with the aim of obtaining information about the internal corrosion evolution of the internal environment /2/.

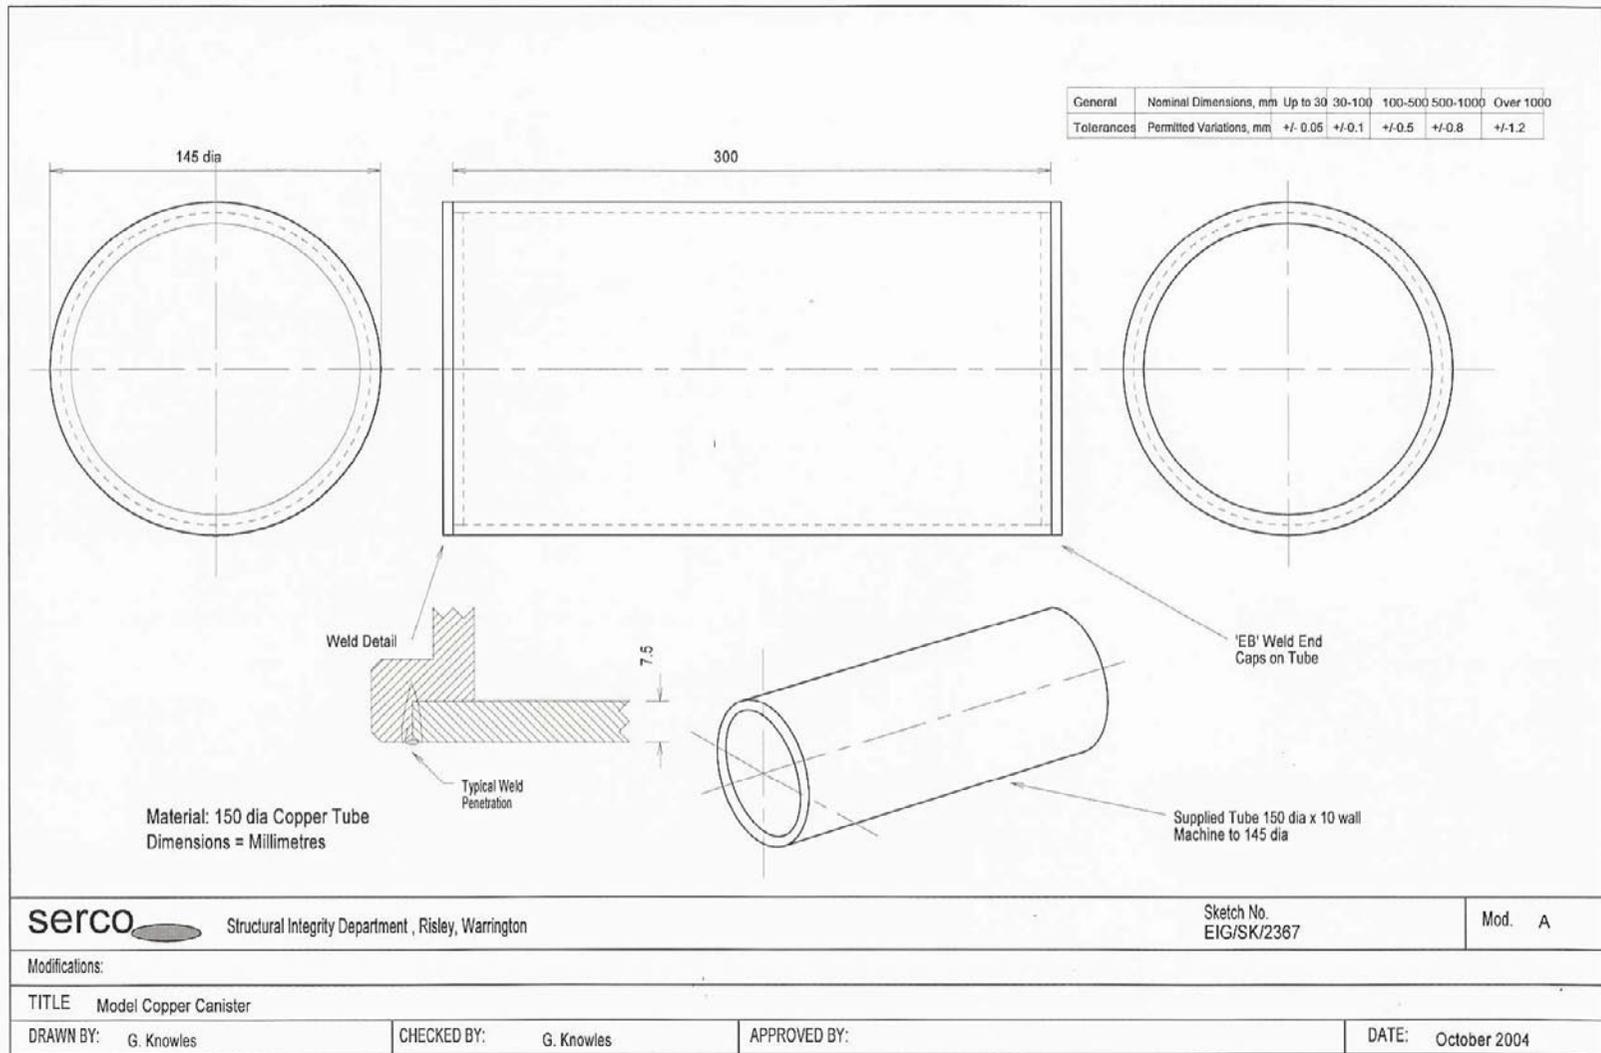
Figure 3-1. Design of model canister – body of model canister.

The design of the model canister is shown in Figure 3-1 to Figure 3-4 and the components after manufacture are shown in Figure 3-5 and Figure 3-6. After machining from 150 mm outside diameter (OD) stock material with a 10 mm wall thickness, the OD of the copper canister was 145 mm, with an internal diameter (ID) of 130 mm and a wall thickness of 7.5 mm. This wall thickness is in scale with the 145 mm outer diameter. The diameter of the cast iron insert was nominally 129 mm, but it was machined to give a loose push fit into the outer copper canister, such that the width of the annulus was in the range 10–30  $\mu\text{m}$  (based on actual measurements of the inner cast iron insert and the outer copper canister body). The annulus needed to be large enough to allow water entry, but narrow enough to allow the annulus to fill with corrosion product on a realistic timescale. Capillary action will encourage wetting of the surface of the cast iron. The surface of the insert will also be exposed to water vapour, which is sufficient to cause anaerobic corrosion /5/. The overall length of the model canister was 315 mm with a further protrusion of a centre insertion stub of 35 mm long at one end (see Figure 3-1 and Figure 3-2).

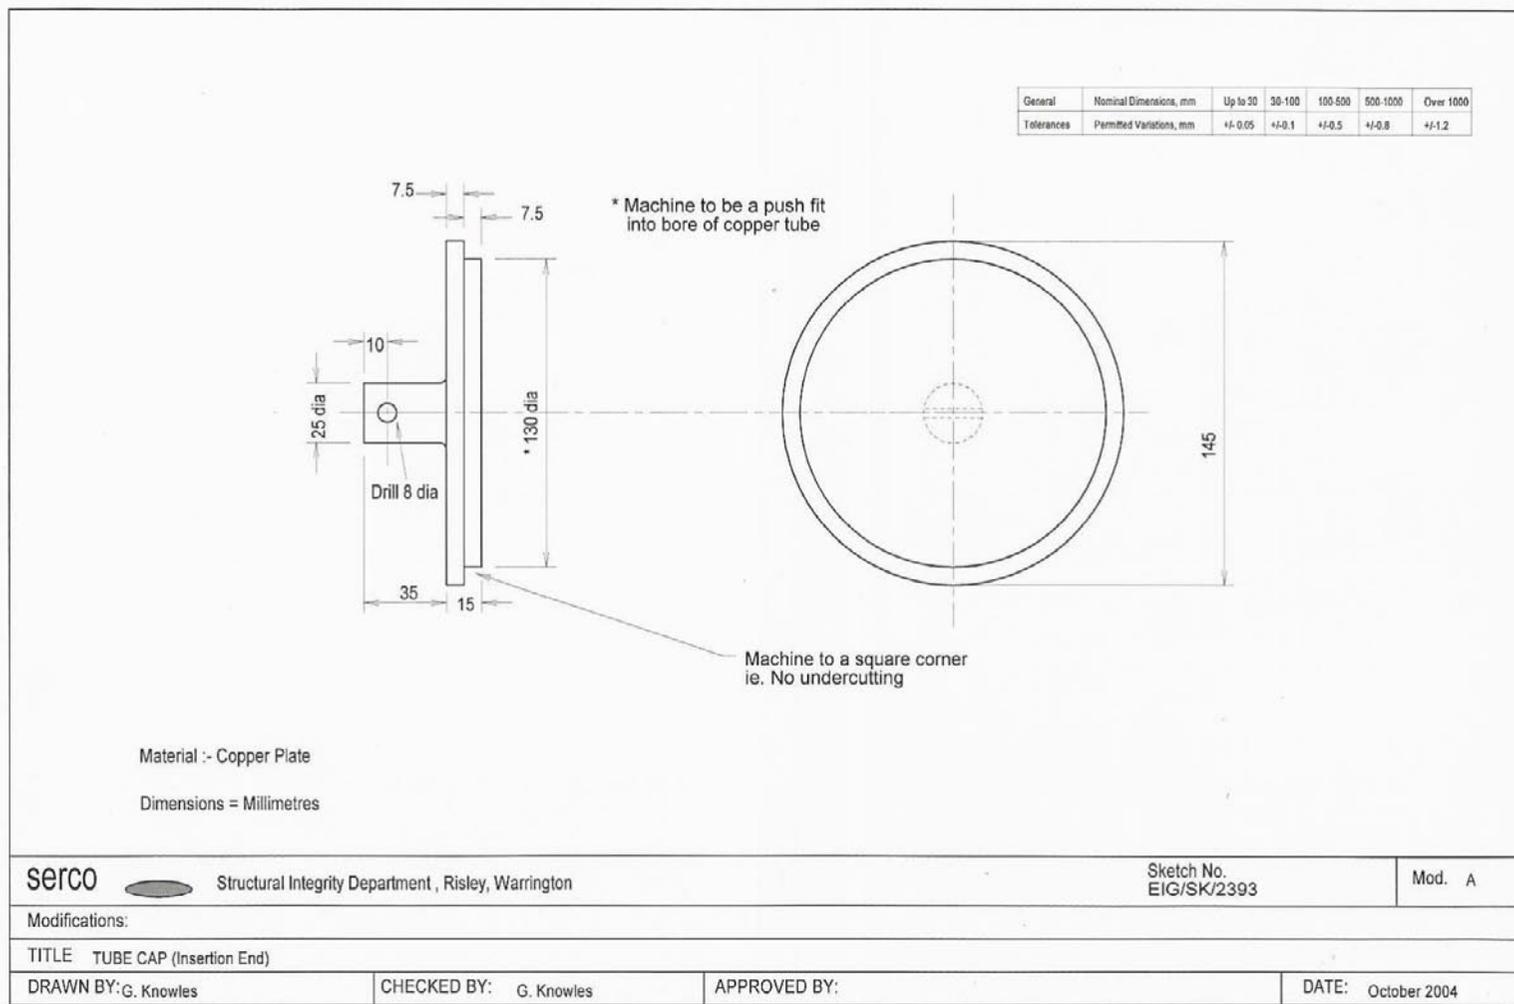
Figure 3-2. Design of model canister – end cap with connector.

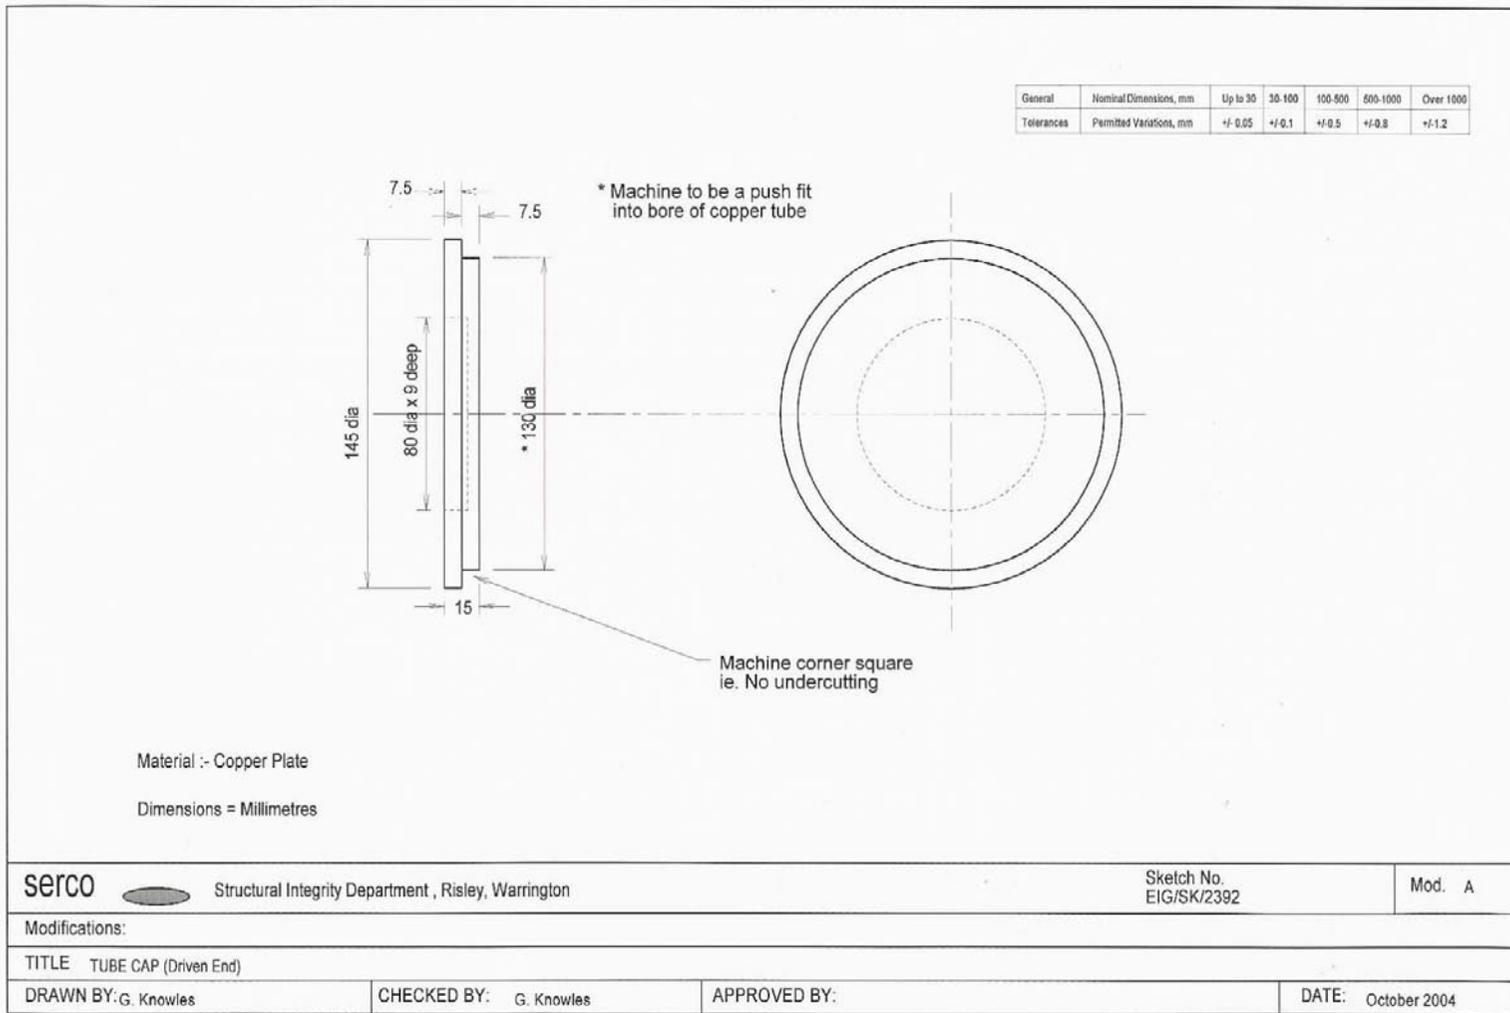
Figure 3-3. Design of model canister – end cap without connector.

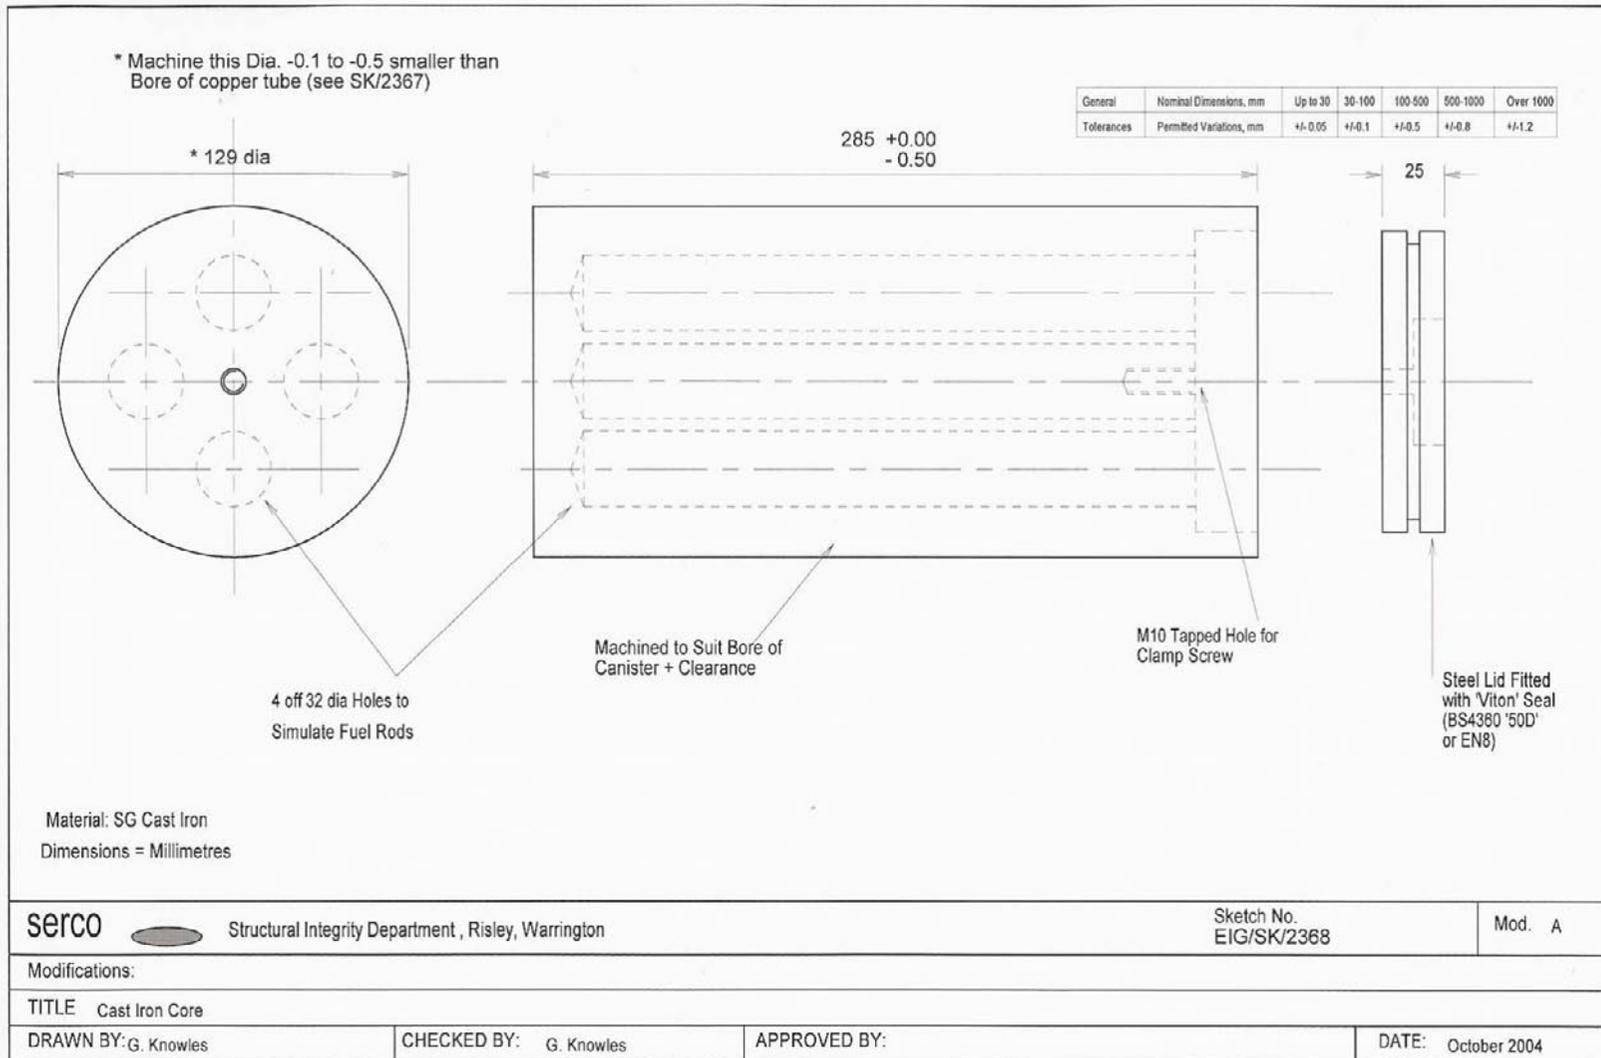
Figure 3-4. Design of cast iron insert.

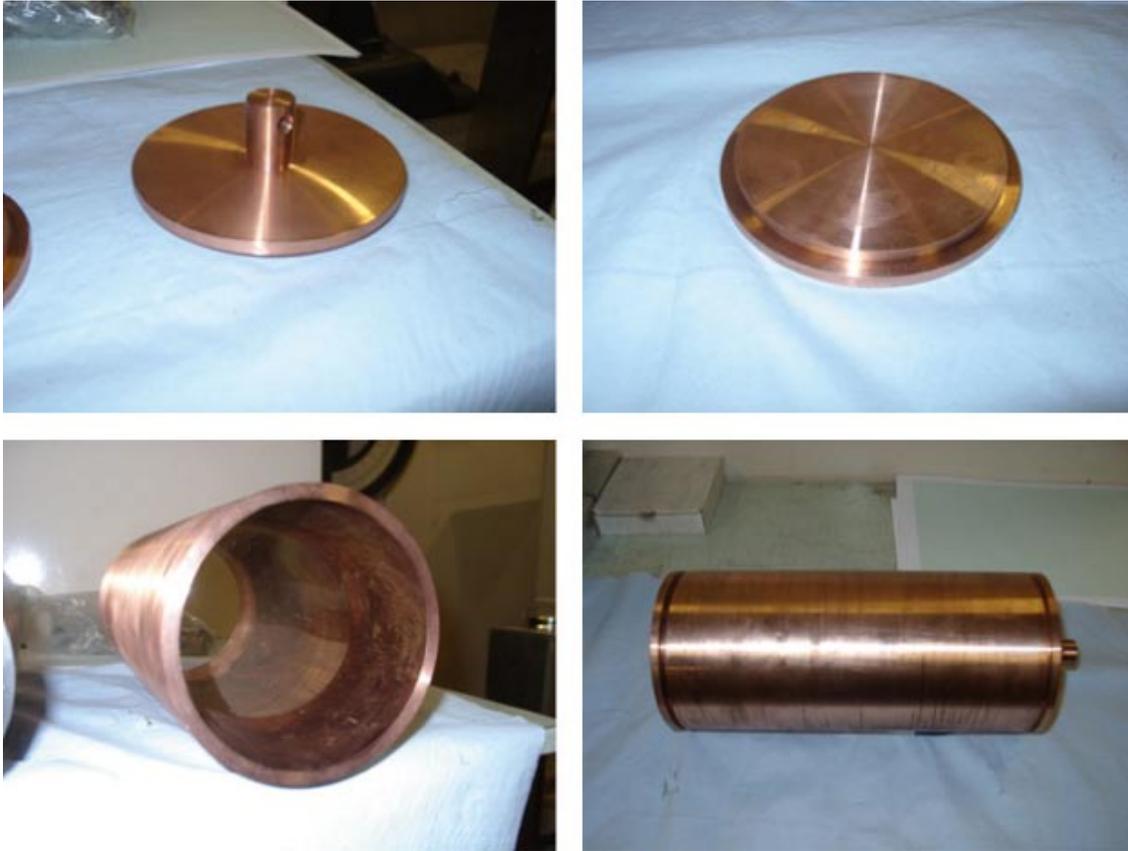
*Figure 3-5. Copper components of miniature canisters.*

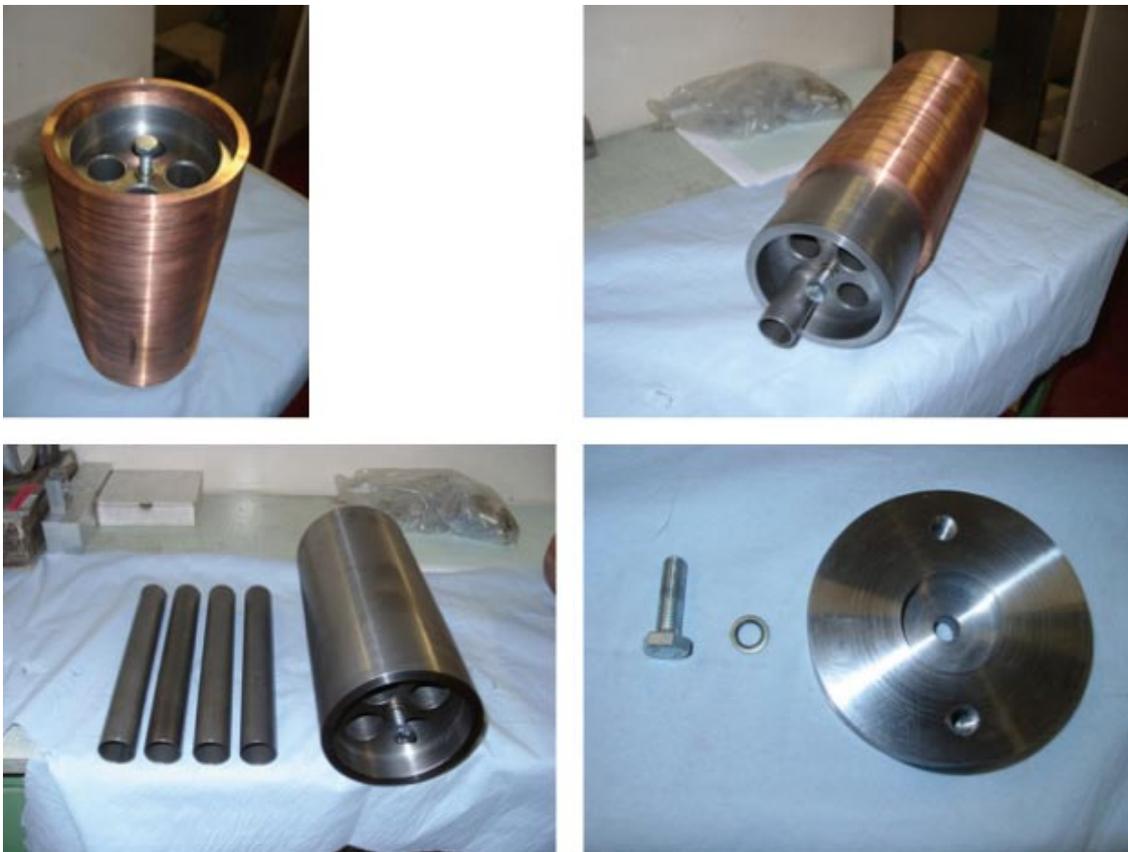
*Figure 3-6. Components of miniature canisters.*

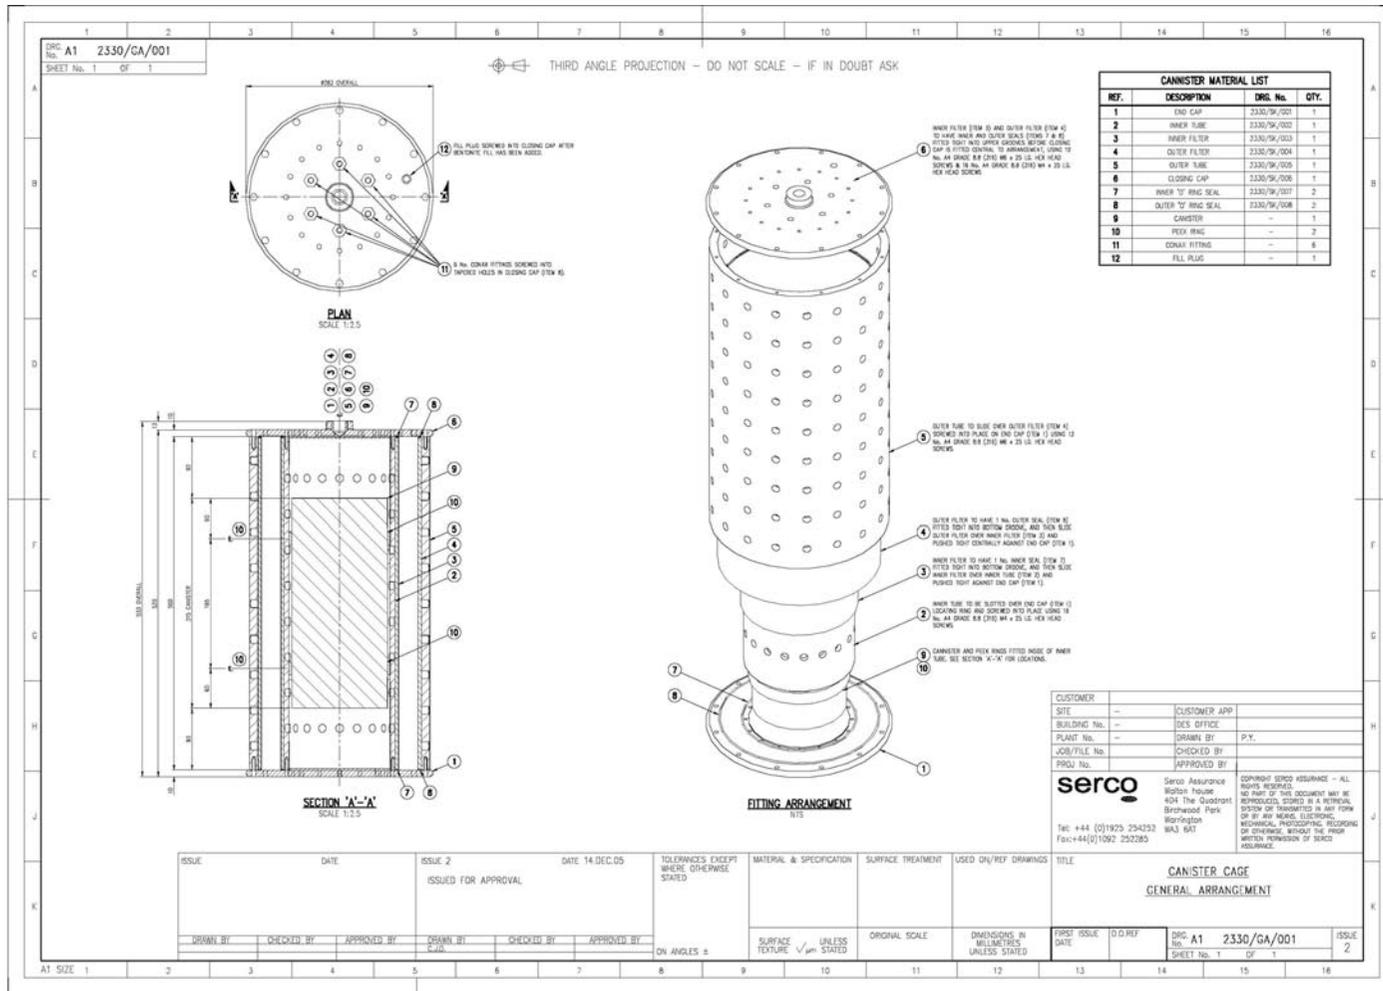
Figure 3-7. Support cage – general arrangement.

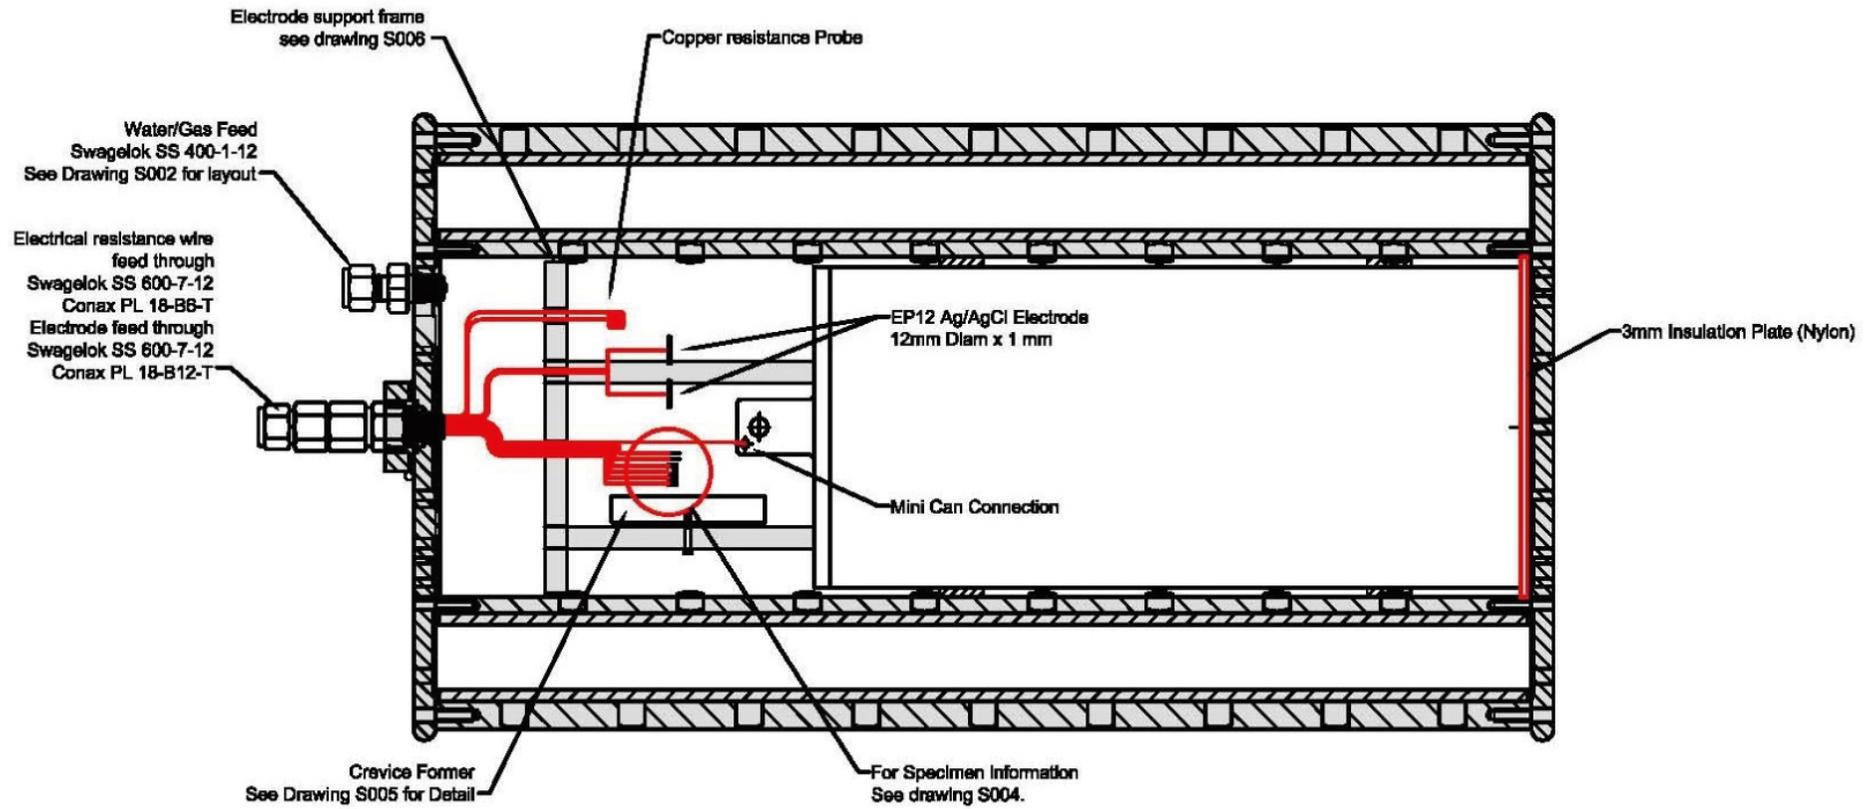
Figure 3-8. Layout of model canister and sensors inside support cage.

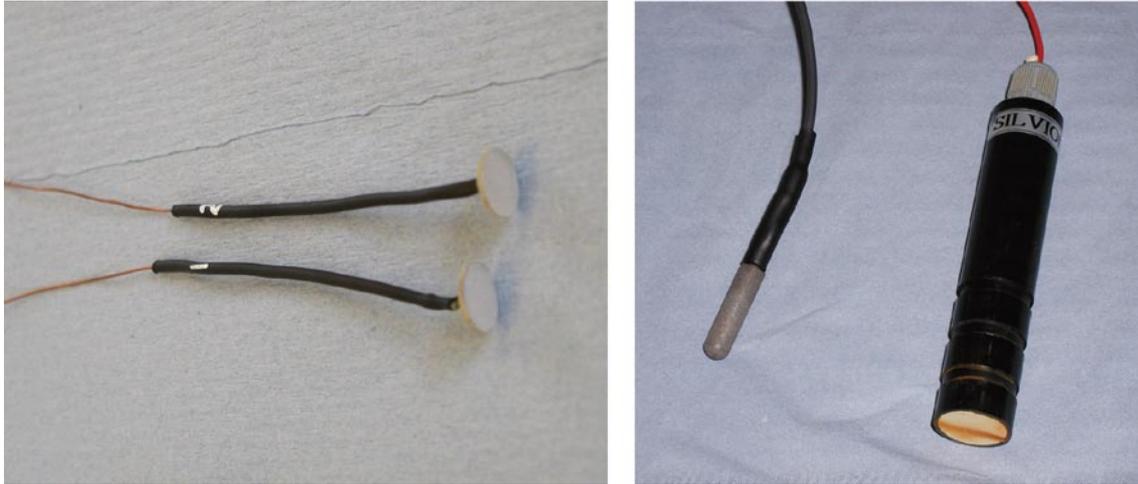
**Figure 4-1.** Reference electrodes and Eh probes used in model canister experiments. Left – WPI Ag/AgCl reference electrode; Right (LHS) Mixed metal  $E_h$  probe, (RHS) Silvion silver-silver chloride reference electrode.

After carrying out the laboratory trials it was decided to use two small disc silver-silver chloride reference disc electrodes in each experiment, which were mounted inside the support cage, together with a large Silvion reference electrode outside the support cage, but inside the borehole as backup in case of any failures of the more delicate, less robust disc electrodes. These reference electrodes are shown in Figure 4-1.

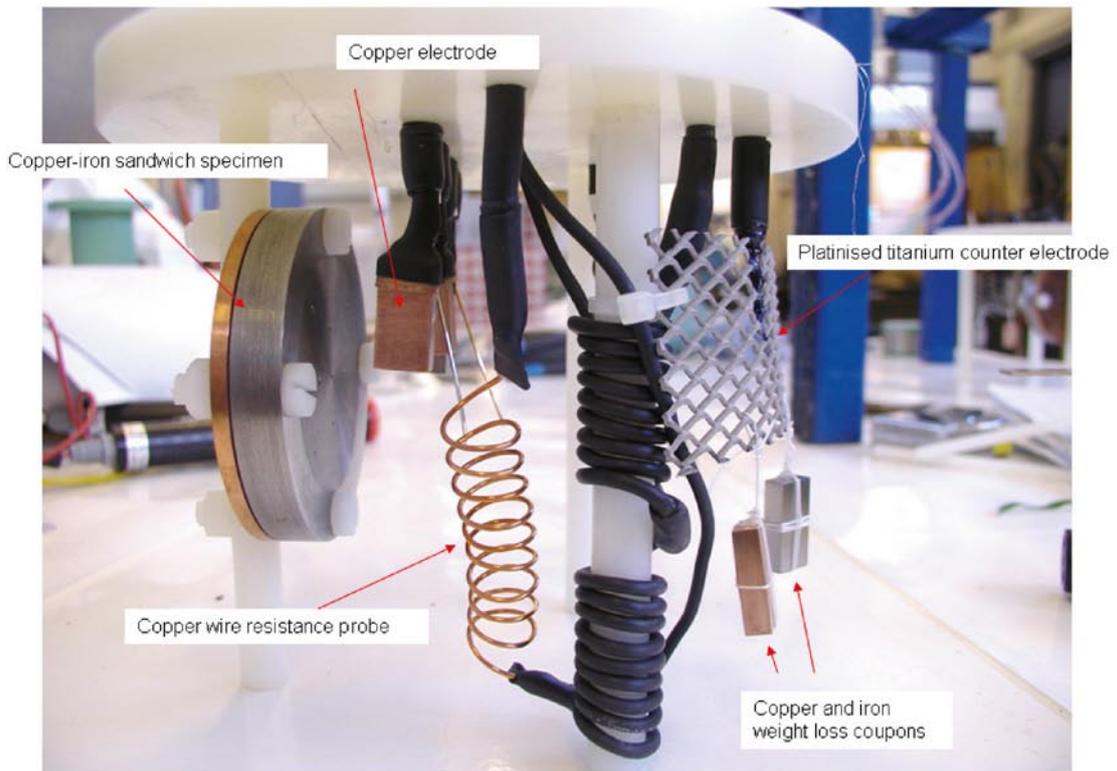
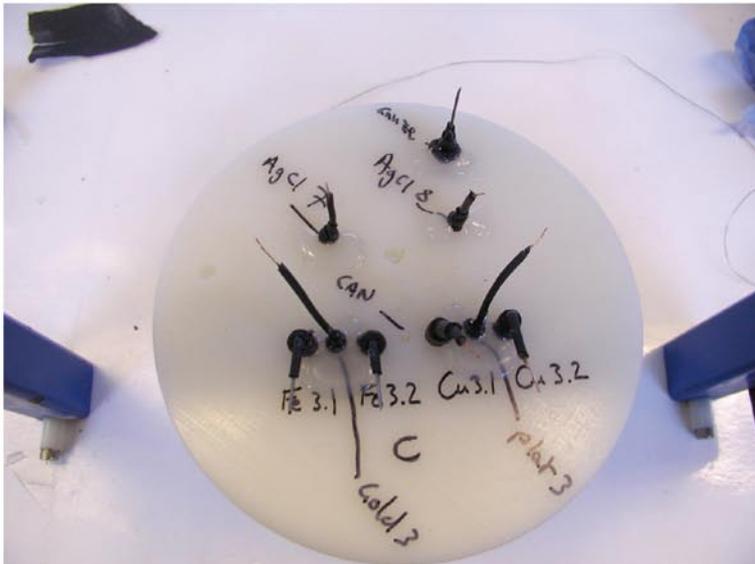
**Figure 4-2.** a) Nylon support rack for sensors and corrosion test pieces mounted inside support cage, b) Top view.

- *Plain corrosion coupons of copper and cast iron.* The corrosion rate of the materials will be determined from weight loss measurements at the end of experiments. Duplicate weight loss samples were installed in each experiment. These coupons were suspended from the nylon mounting rack using polypropylene thread (see Figure 4-2).

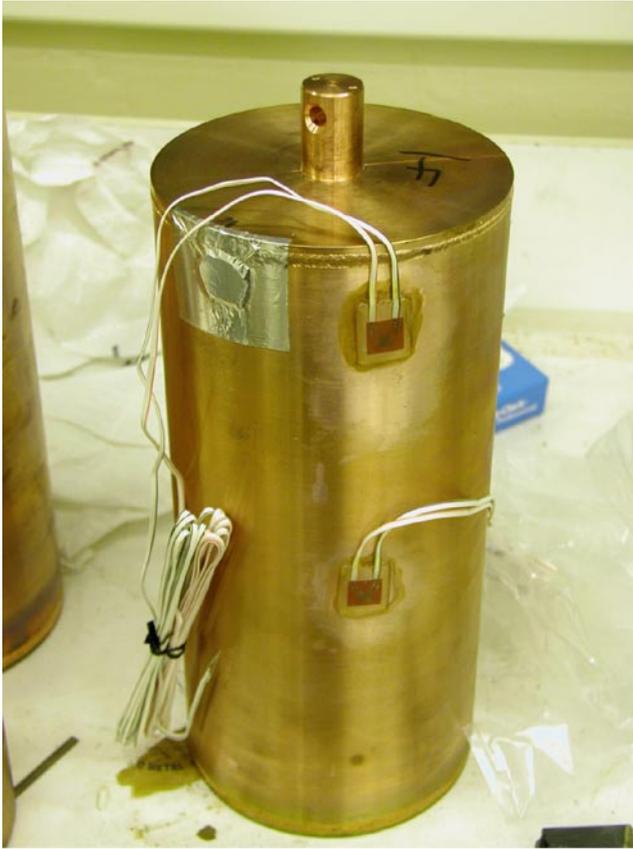
Figure 4-3. Strain gauges mounted on model canister.

Strain gauges were applied to measure changes in the strain on the outer surface of two of the copper canisters (Tests 1 and 4). The aim of these measurements was to provide an indication of whether expansion caused by internal corrosion has caused any dimensional changes. Standard strain gauge monitoring technology using bi-axial strain gauges was applied (e.g. Techni-Measure Ltd) using cyanoacrylate adhesives and protected with waterproof coatings (see Figure 4-3).

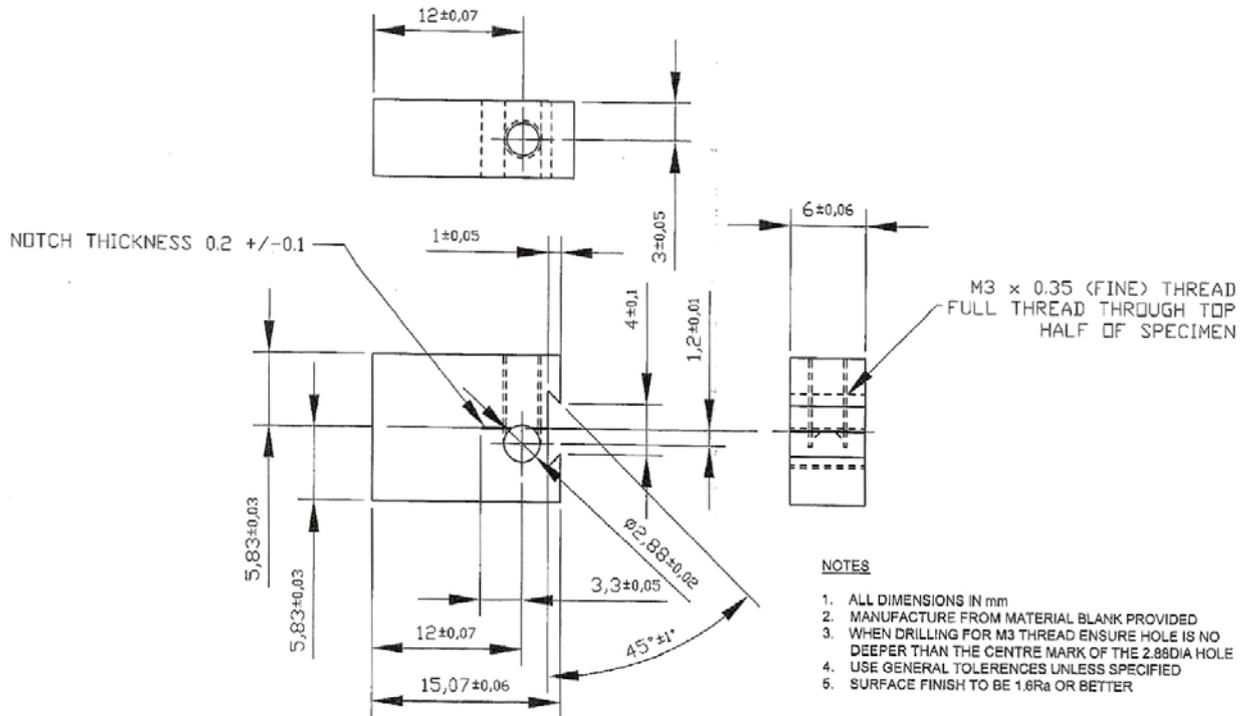
Figure 4-4. Design of Wedge Opening-loaded (WOL) specimens.

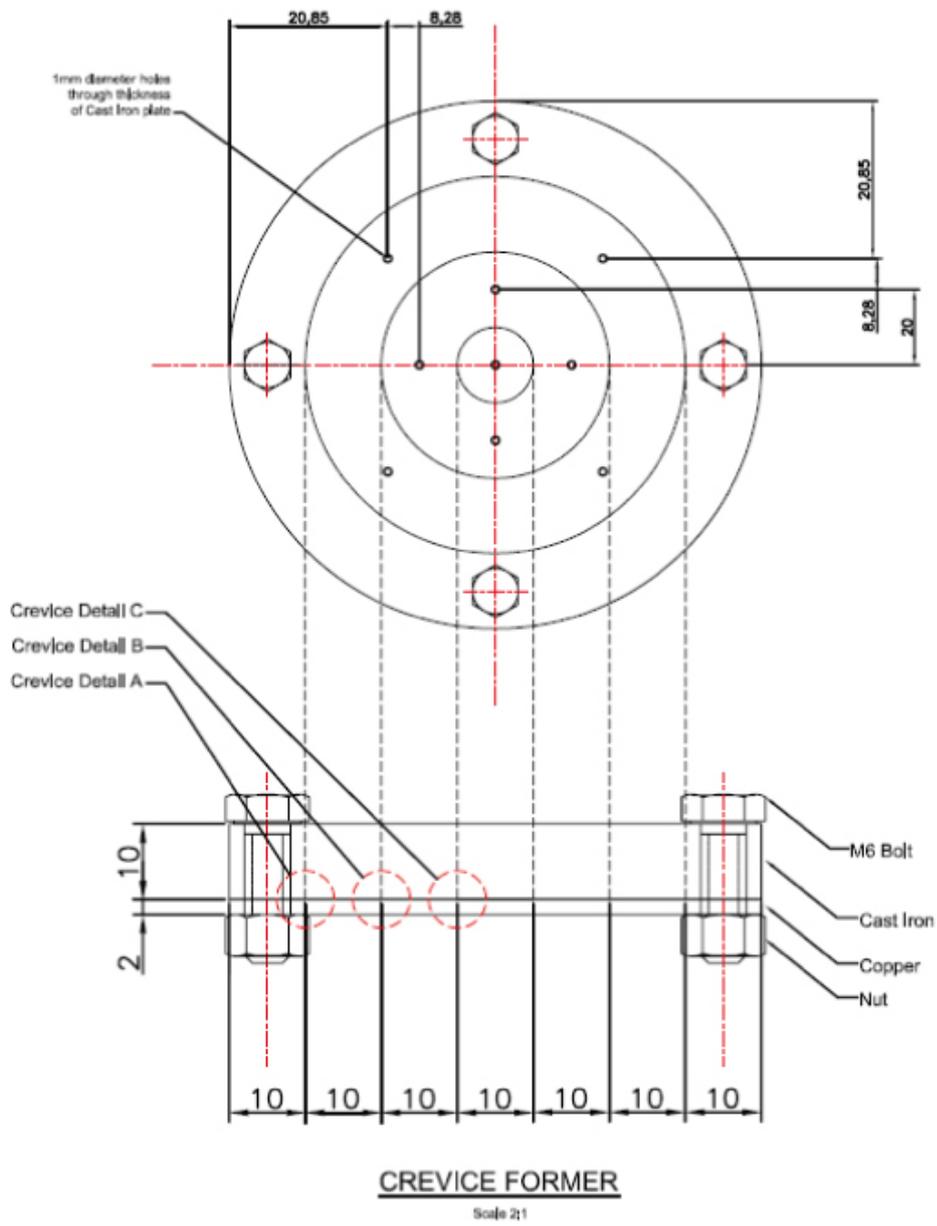
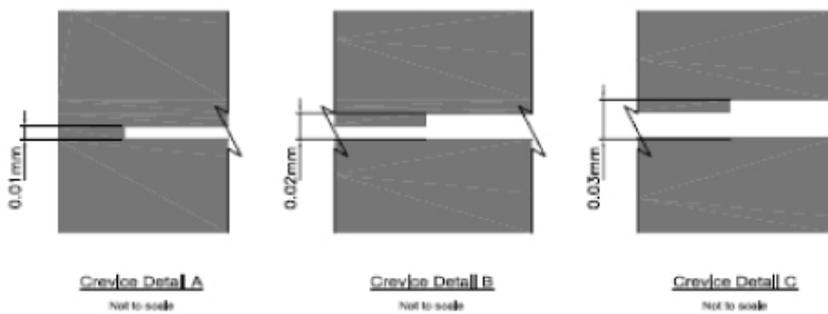
Figure 4-5. Design of copper-iron sandwich (crevice expansion) specimens.

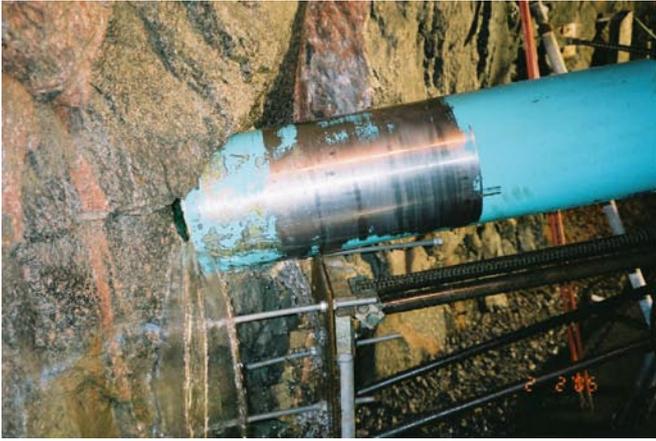
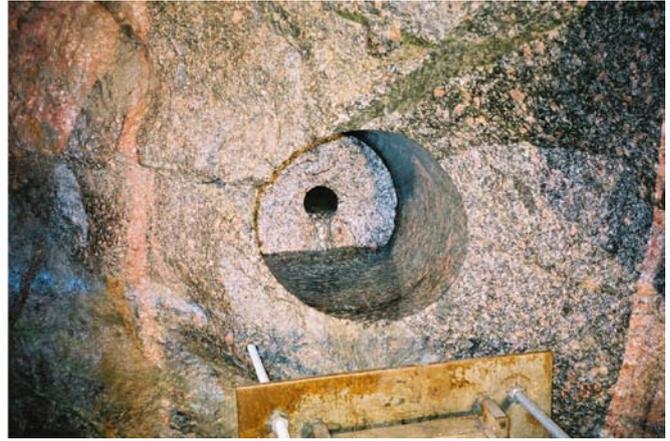
Figure 5-1. Preparation of boreholes for miniature canister experiments.

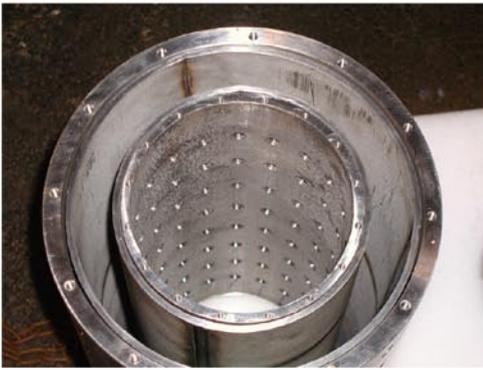
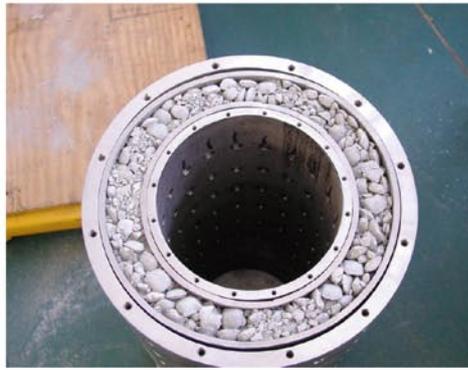
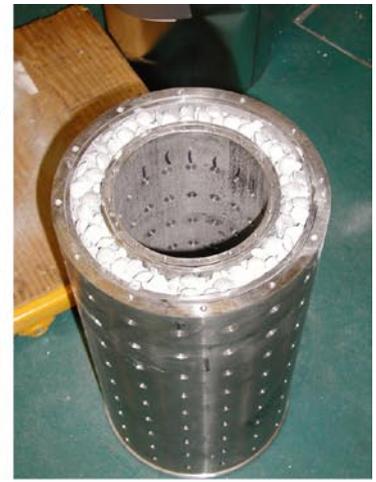
Figure 5-2. Positioning of bentonite pellets inside annulus of support cage.

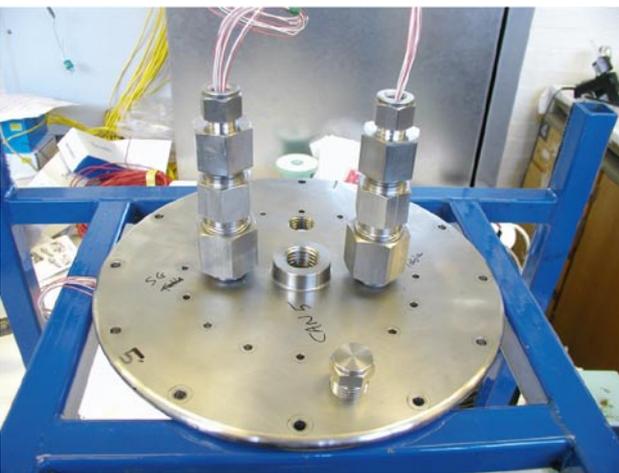
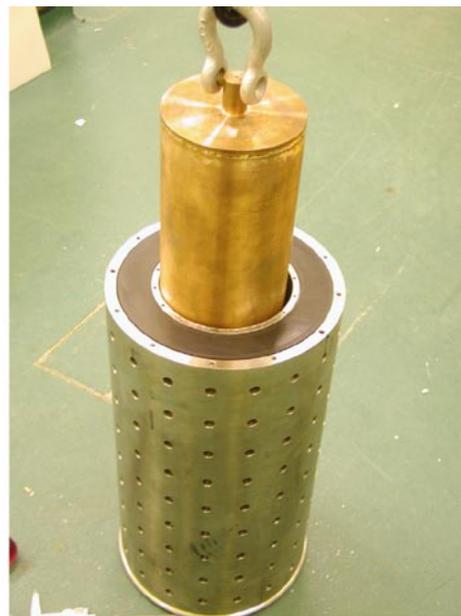
Figure 5-3. Left: top flange for support cage. Right: insertion of model canister assembly into support cage.

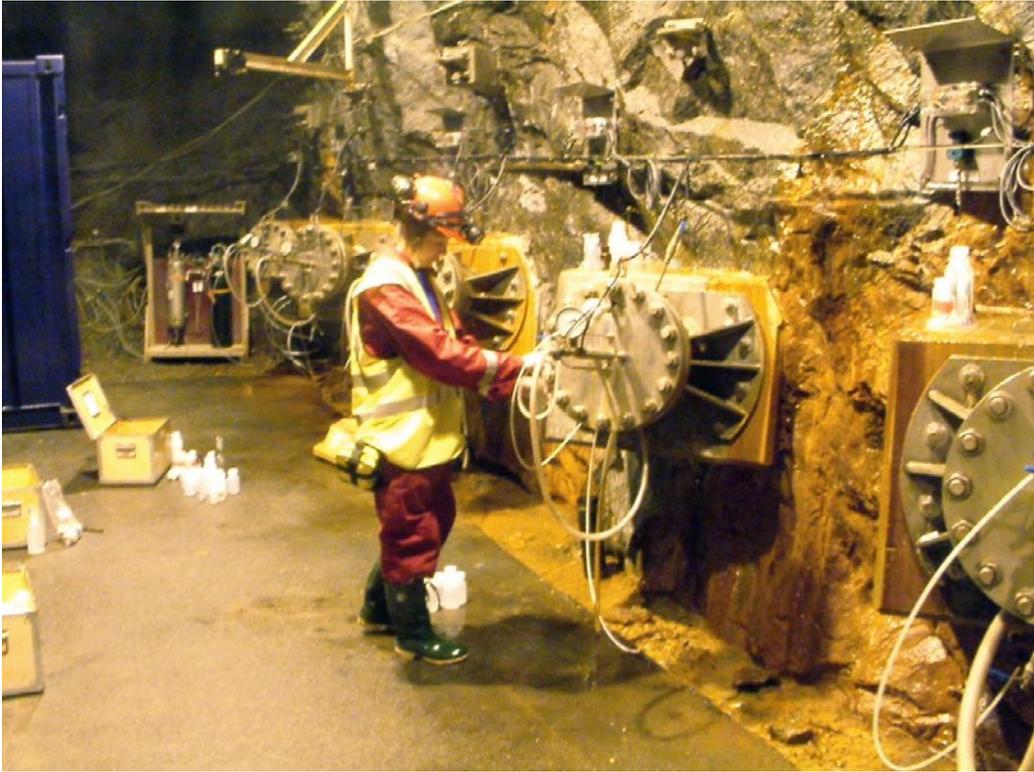
*Figure 5-6. Complete Minican experimental installation at Äspö Hard Rock Laboratory, showing water samples being collected for analysis. The experiments are installed in five separate boreholes, with a control room located in an ISO container at the rear left hand corner of the tunnel.*

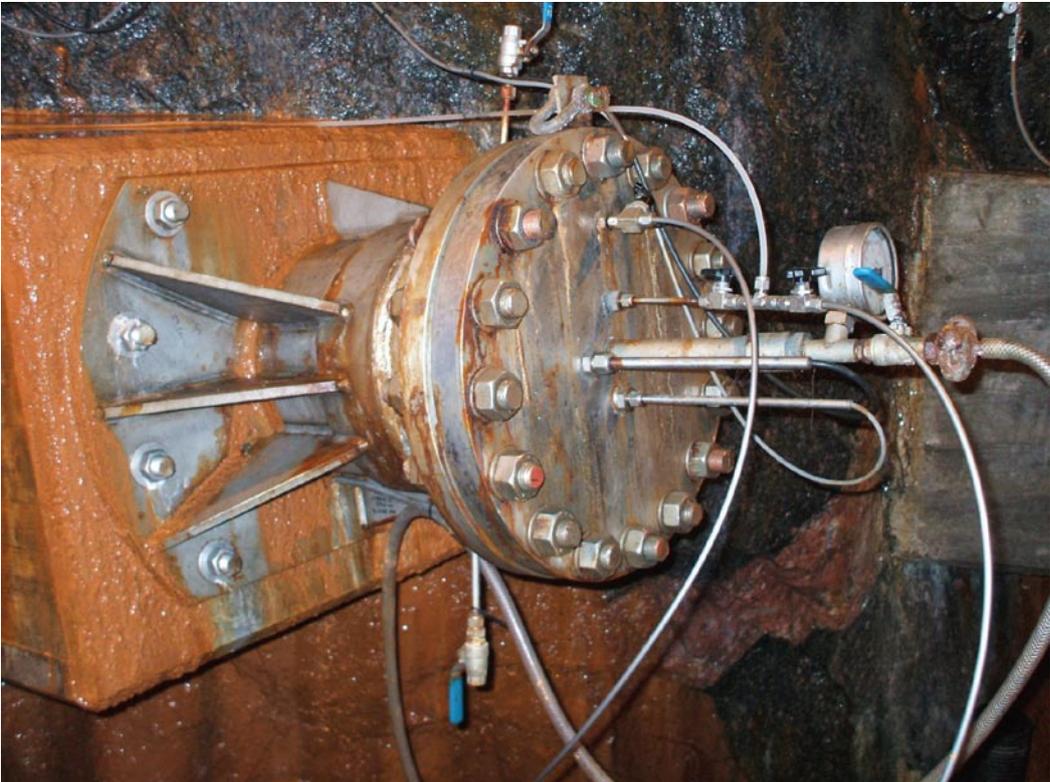
*Figure 5-7. Brown slime around experiment on rock face around borehole.*

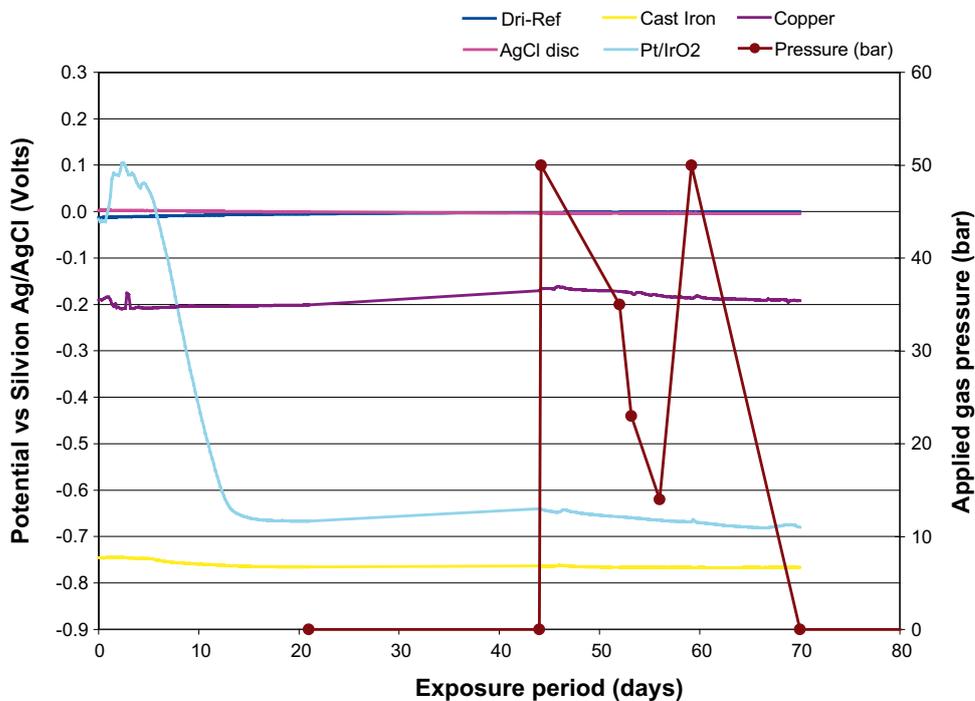
**Figure 6-1.** Results of preliminary laboratory trials on reference electrodes, Eh electrode, copper and cast iron in an autoclave containing Äspö groundwater that was pressurised with nitrogen.

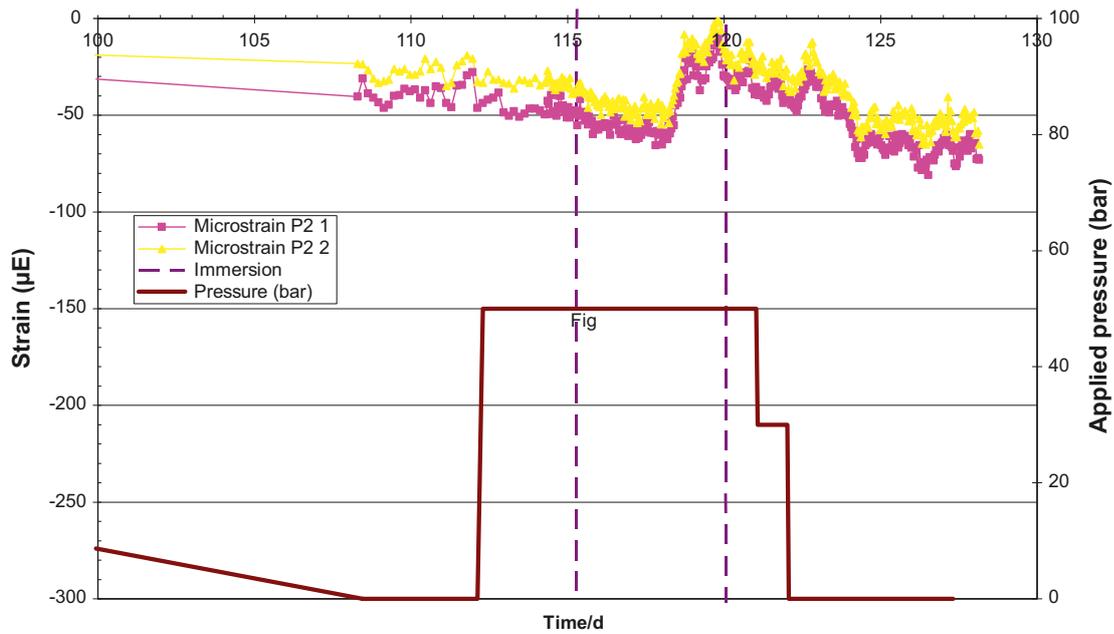
**Figure 6-2.** Results of preliminary laboratory trials on strain gauges mounted on copper coupons using polysulphide rubber adhesive (Technimeasure Ltd P-2) in an autoclave containing Äspö groundwater that was pressurised with nitrogen.

The pressure had little effect on either bonding system (see Figure 6-2 and Figure 6-3). The CN bonded system showed a slight susceptibility to pressure but it still functioned after the pressure was removed. The CN bonding agent was not thought to be the reason for the pressure sensitivity. Both strain gauges were examined and found to be intact. It was decided to use the CN bonding agent and the nitrile rubber coating (M-Coat B) only on the strain gauges attached to the model canisters for use in Äspö, as the thick PVC coating already on the sensors was sufficient protection.
