**Technical Report**

**TR-09-20**

**Miniature canister corrosion  
experiment – results of operations  
to May 2008**

**Svensk Kärnbränslehantering AB**

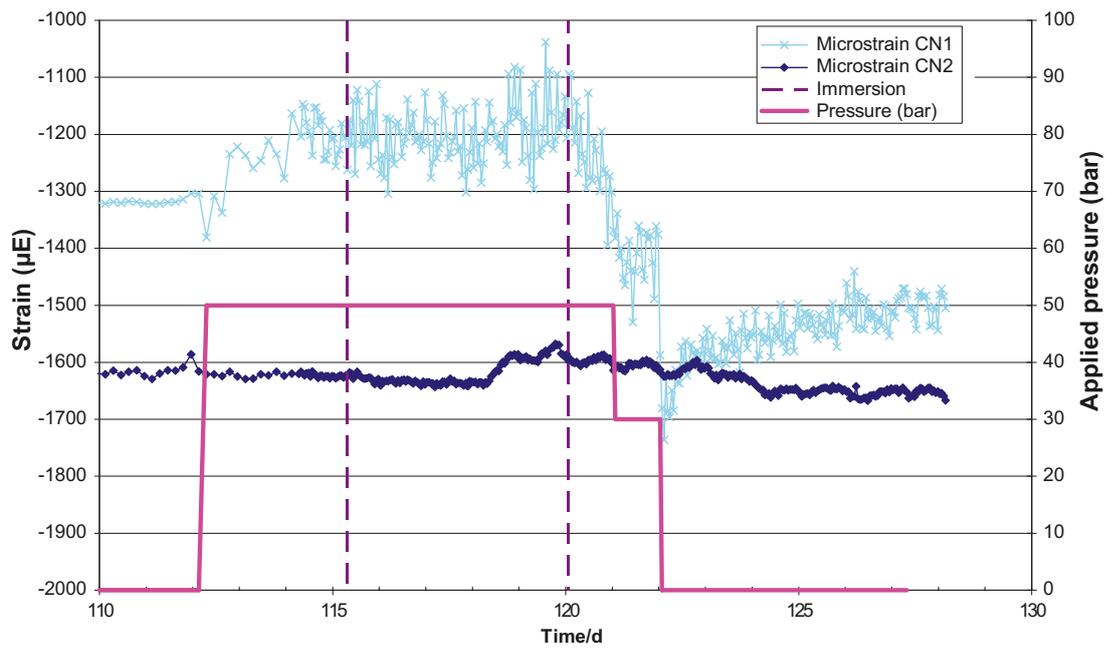
**Figure 6-3.** Results of preliminary laboratory trials on strain gauges mounted on copper coupons using a cyanoacrylate adhesive (Technimeasure Ltd CN) in an autoclave containing Äspö groundwater that was pressurised with nitrogen.

The pressure had little effect on either bonding system (see Figure 6-2 and Figure 6-3). The CN bonded system showed a slight susceptibility to pressure but it still functioned after the pressure was removed. The CN bonding agent was not thought to be the reason for the pressure sensitivity. Both strain gauges were examined and found to be intact. It was decided to use the CN bonding agent and the nitrile rubber coating (M-Coat B) only on the strain gauges attached to the model canisters for use in Äspö, as the thick PVC coating already on the sensors was sufficient protection.

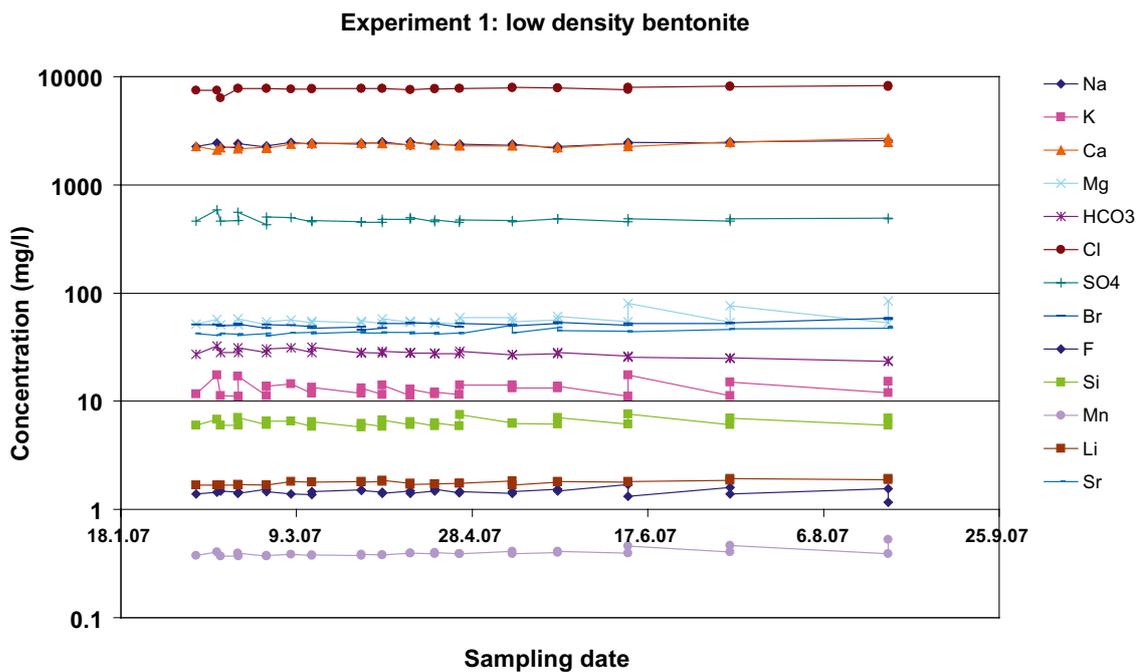
**Figure 6-4.** Summary of water analyses: Experiment 1. For any given sampling date the first concentration shown when approaching along the line from the left hand side of the diagram refers to the analysis in the borehole, but outside the support cage, and the second point refers to the concentration on the inside of the support cage. The results of the iron analyses are shown in Figure 6-10.

The results from the water analyses for the five boreholes are shown in Figure 6-4 to Figure 6-8. These plots are a compilation of analyses for water samples taken from both within the support cage and external to the support cage in the borehole. A slight variation in the internal and external water compositions was observed. The plots do not show the barium concentrations, which were in the range 70–100  $\mu\text{g/L}$  in all the measurements. The sulphide concentrations were in the range 0.006 to 0.223  $\text{mg/L}$  (see Figure 6-9); the values are generally low (at least three orders of magnitude less than the sulphate concentration). The greatest variation between the internal and external ion concentrations was found in the dissolved iron analyses and these data are presented separately in Figure 6-10. They show that in the case of the experiments with low density bentonite (Experiments 1 to 3), or no bentonite at all (Experiment 5), the dissolved iron concentration inside the support cages was greater than external to the support cage. The pH of the water samples taken from inside and outside the support cages are shown in Figure 6-11. These data show a decrease in the pH of water inside the support cages compared to the water in the boreholes. The conductivity of the water was in the range 1,690 to 3,050  $\text{mS/m}$  (i.e. 16,900 to 30,500  $\mu\text{S/cm}$ ), as shown in Figure 6-12. These conductivity values can be compared to that of seawater, which has a conductivity of approximately 5,300  $\text{mS/m}$ . It is interesting to note that there are variations in conductivity between the boreholes and also between the conductivity of the water inside the support cage and the corresponding borehole outside the support cage (this is particularly pronounced in Experiment 5).

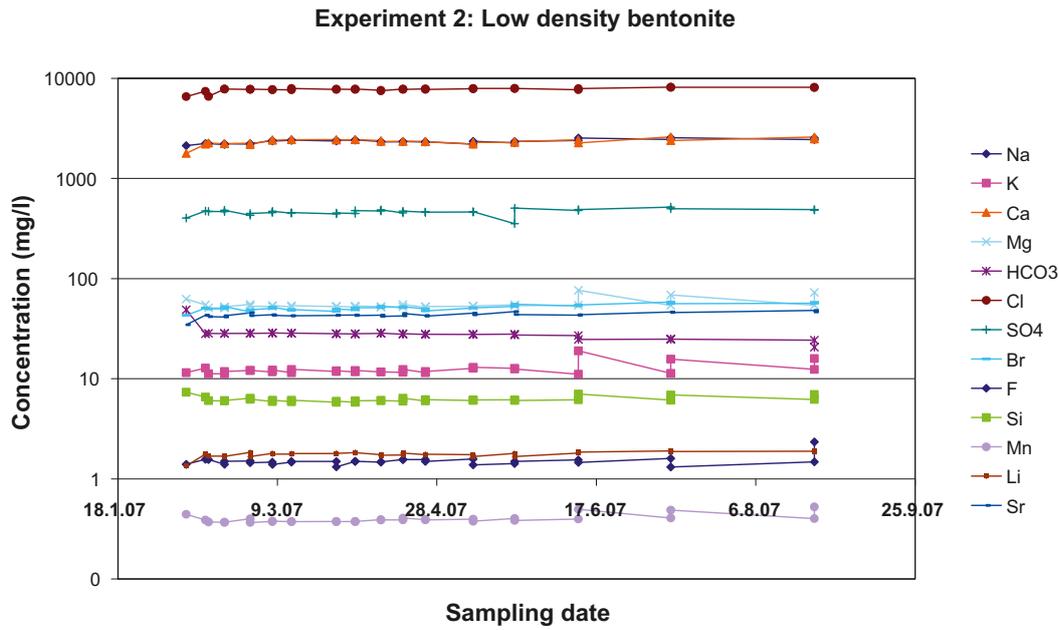
**Figure 6-5.** Summary of water analyses: Experiment 2. For any given sampling date the first concentration shown when approaching along the line from the left hand side of the diagram refers to the analysis in the borehole, but outside the support cage, and the second point refers to the concentration on the inside of the support cage. The results of the iron analyses are shown in Figure 6-10.

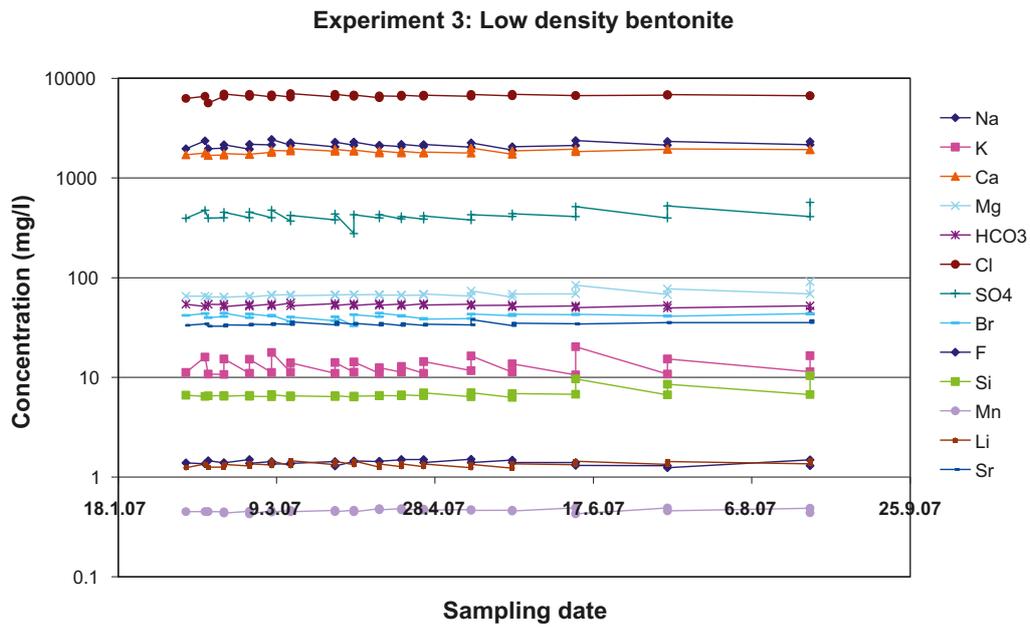
**Figure 6-6.** Summary of water analyses: Experiment 3. For any given sampling date the first concentration shown when approaching along the line from the left hand side of the diagram refers to the analysis in the borehole, but outside the support cage, and the second point refers to the concentration on the inside of the support cage. The results of the iron analyses are shown in Figure 6-10.

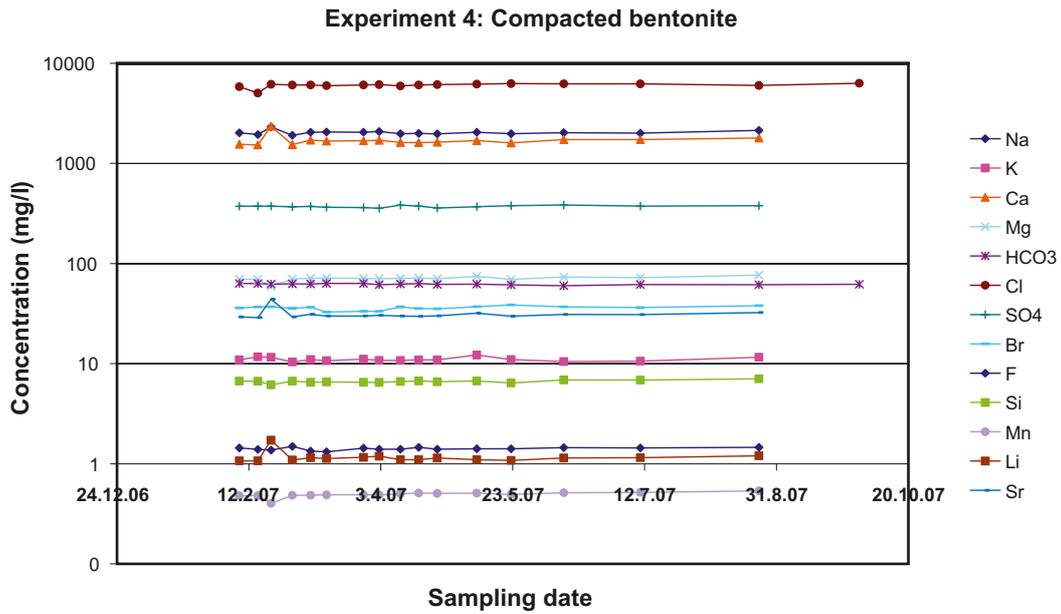
**Figure 6-7.** Summary of water analyses: Experiment 4. It was not possible to remove any water from inside the support cage for analysis, so all data refer to a water sample taken from the borehole outside the support cage. The results of the iron analyses are shown in Figure 6-10.

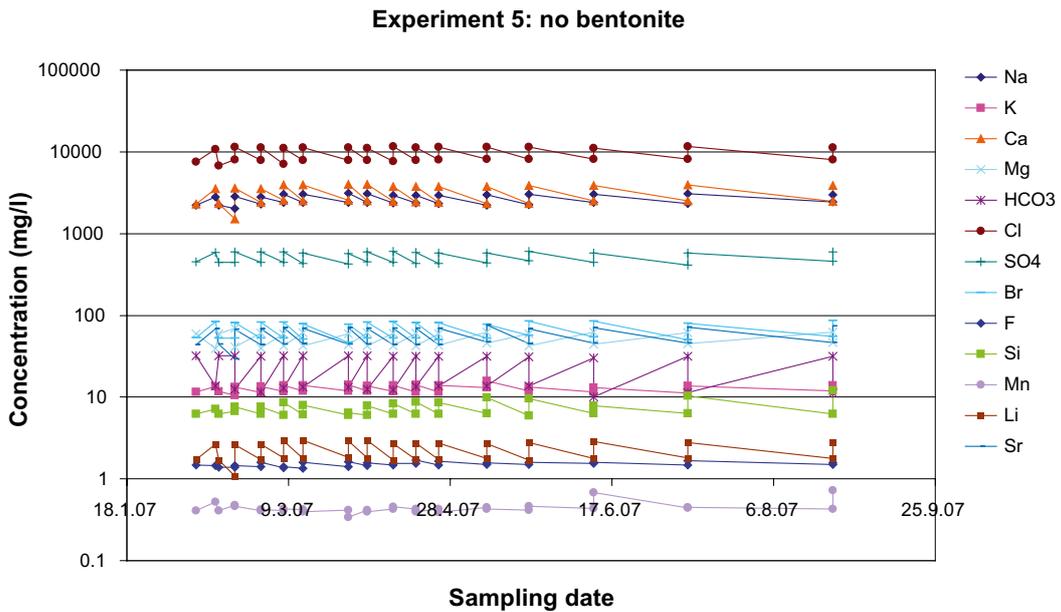
**Figure 6-8.** Summary of water analyses: Experiment 5. For any given sampling date the first concentration shown when approaching along the line from the left hand side of the diagram refers to the analysis in the borehole, but outside the support cage, and the second point refers to the concentration on the inside of the support cage. The results of the iron analyses are shown in Figure 6-10.

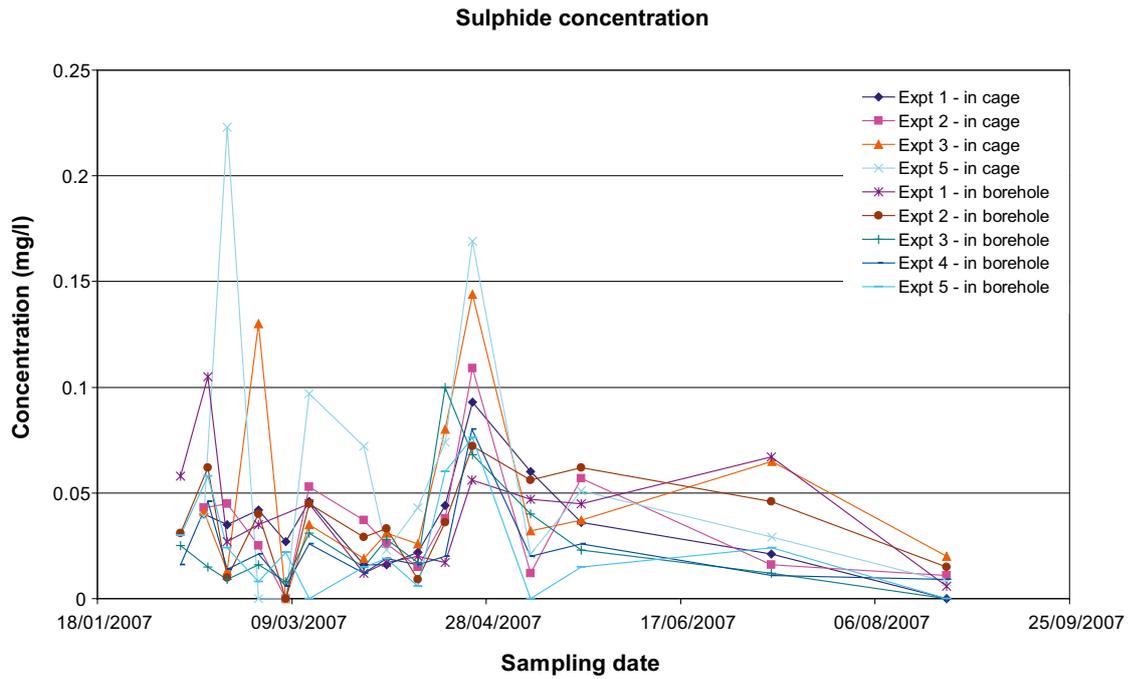
Figure 6-9. Summary of sulphide concentration in water samples.

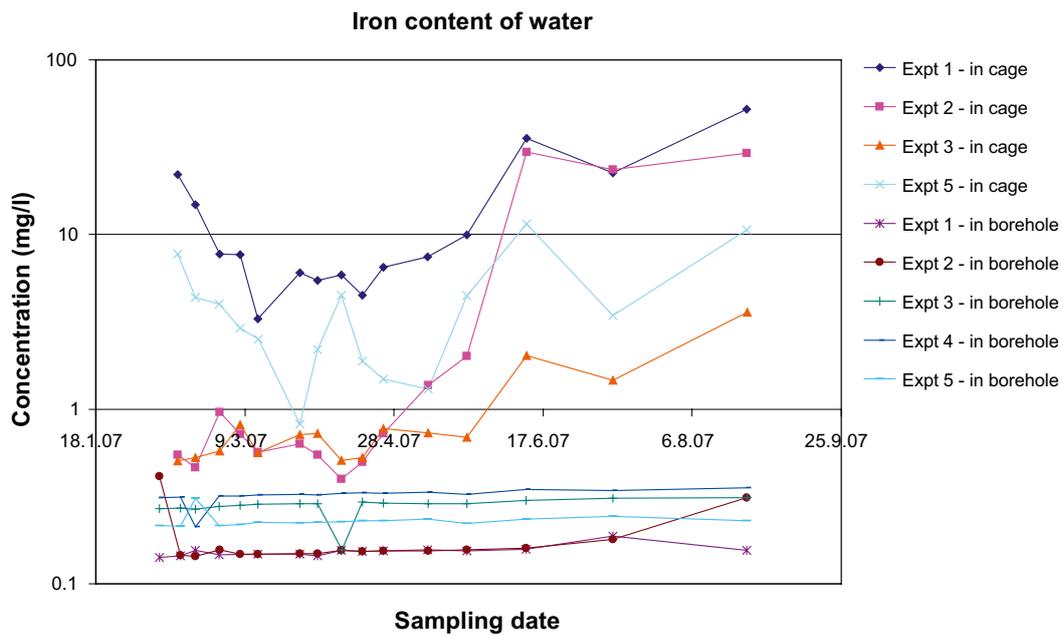
Figure 6-10. Summary of iron analysis in water samples.

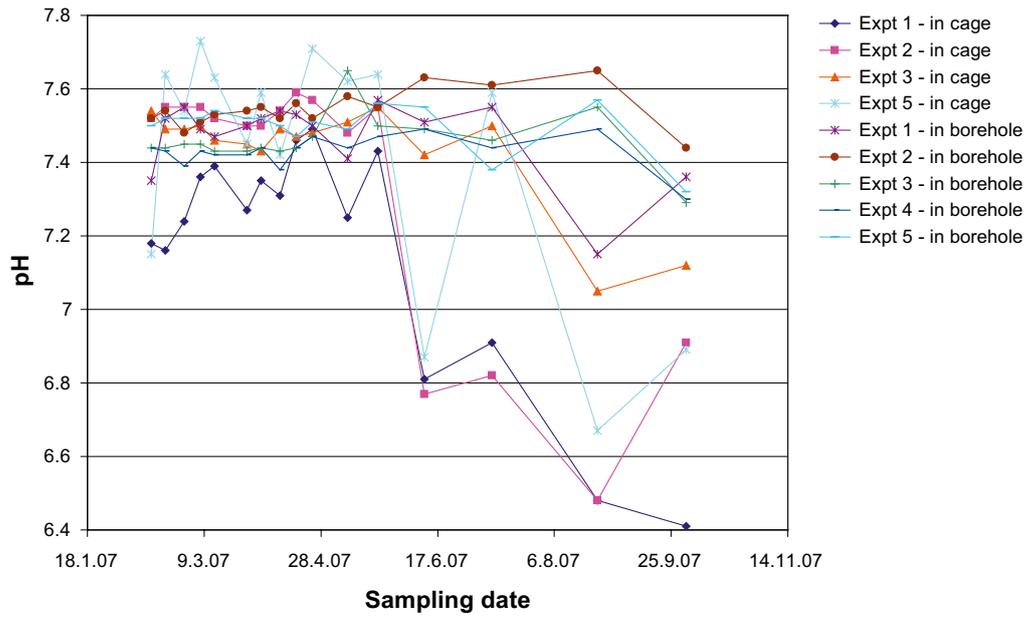
Figure 6-11. pH of water samples taken from model canister experiments.

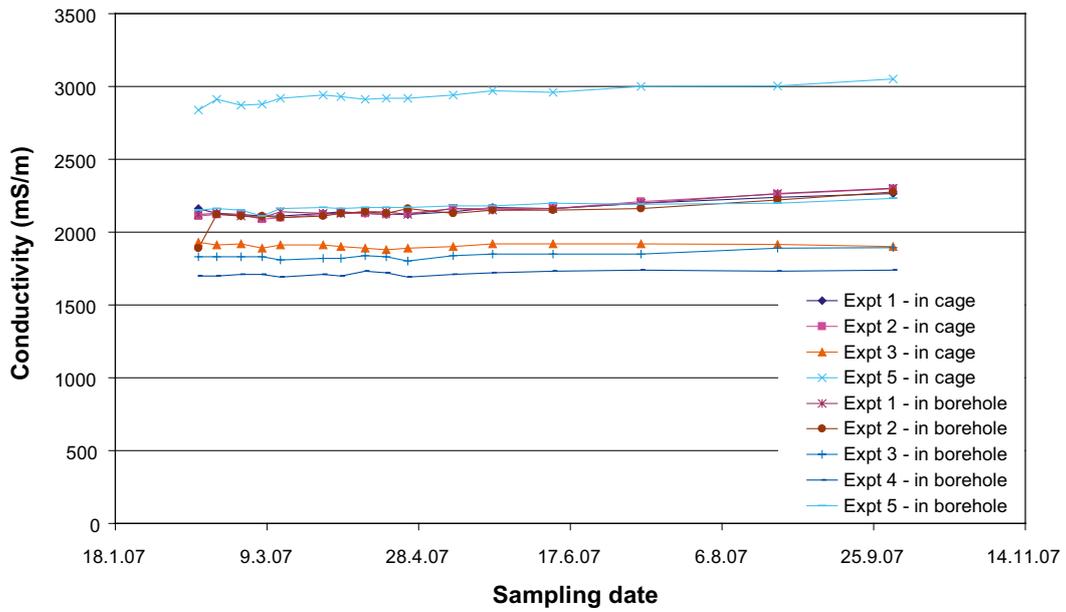
Figure 6-12. Conductivity of water samples.

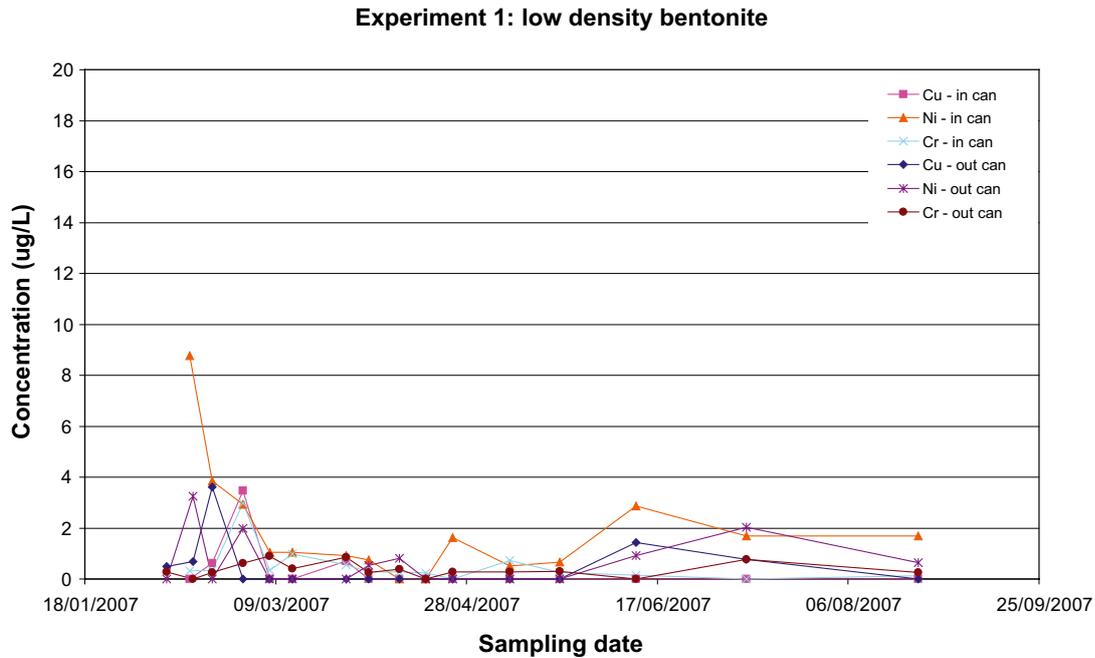
Figure 6-13. Results of trace element analyses in Experiment 1 (low density bentonite).

The results of the trace element analyses (copper, nickel and chromium) are shown in Figure 6-13 to Figure 6-17. The concentration of these elements outside the support cage was very low (typically less than 5 µg/L). However, raised concentrations of nickel and chromium were observed inside the support cage. Although the actual levels are still low, they are significantly higher than external to the support cages and this is an indication of enhanced corrosion of the stainless steel support structure. Most copper measurements were below the detection limit of the analytical technique (0.5 µg/L), but measurements slightly above the detection limit were observed near the start of the experiments, suggesting that copper corrosion (i.e. corrosion of the model canisters) was slightly more active while residual oxygen was still present.

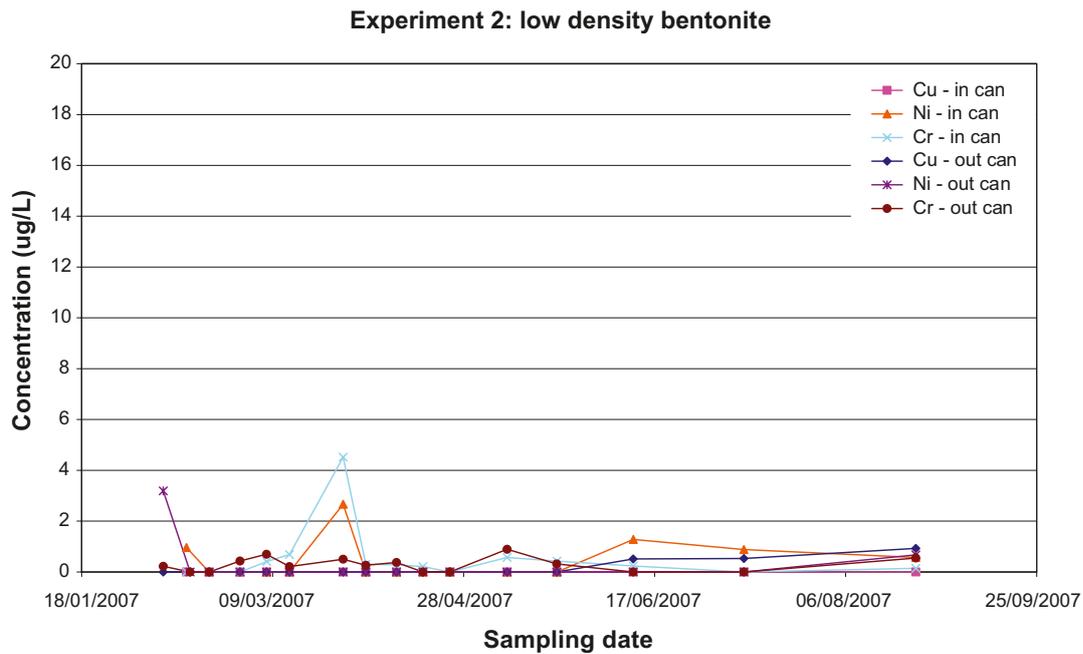
Figure 6-14. Results of trace element analyses in Experiment 2 (low density bentonite).

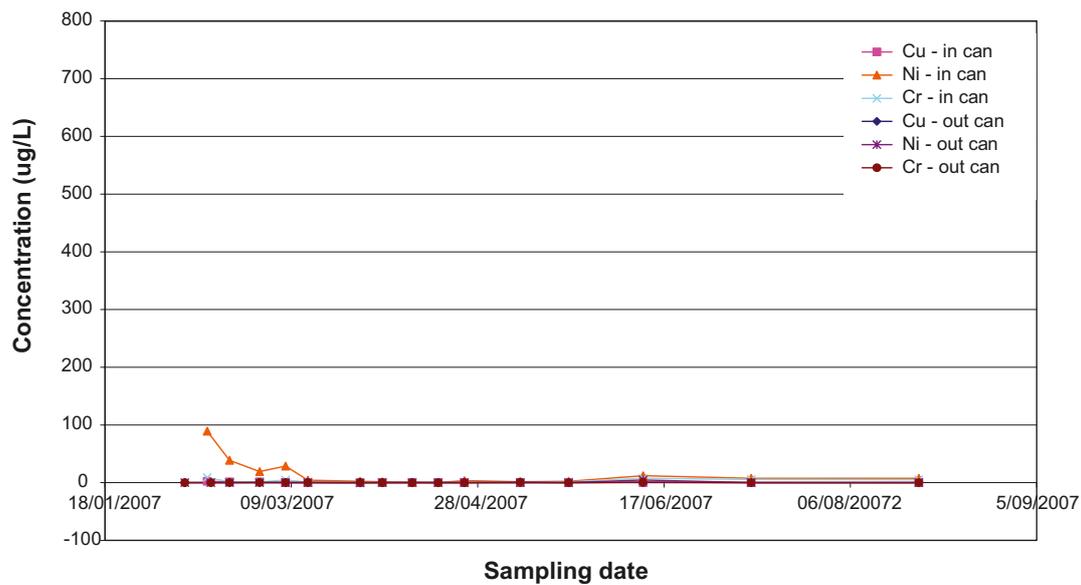
Figure 6-15. Results of trace element analyses in Experiment 3 (low density bentonite).

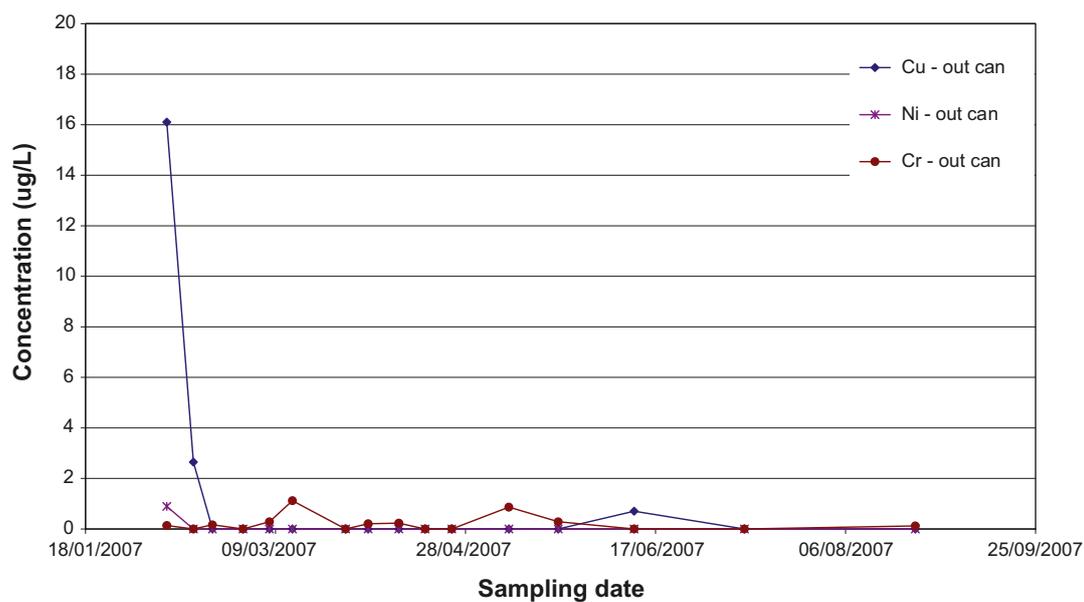
Figure 6-16. Results of trace element analyses in Experiment 4 (compact bentonite).

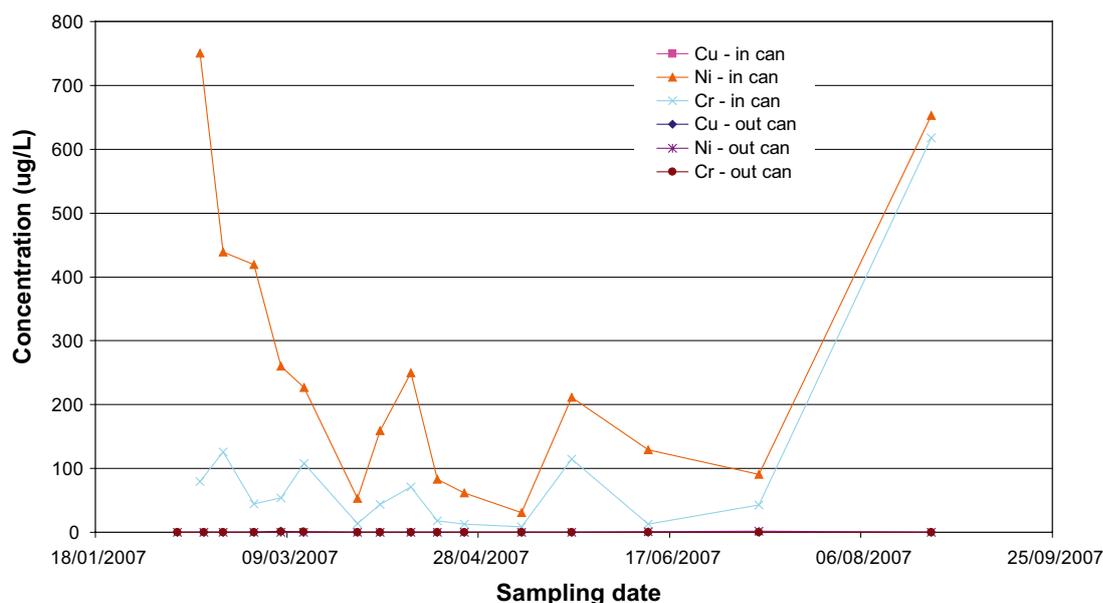
Figure 6-17. Results of trace element analyses in Experiment 5 (no bentonite).

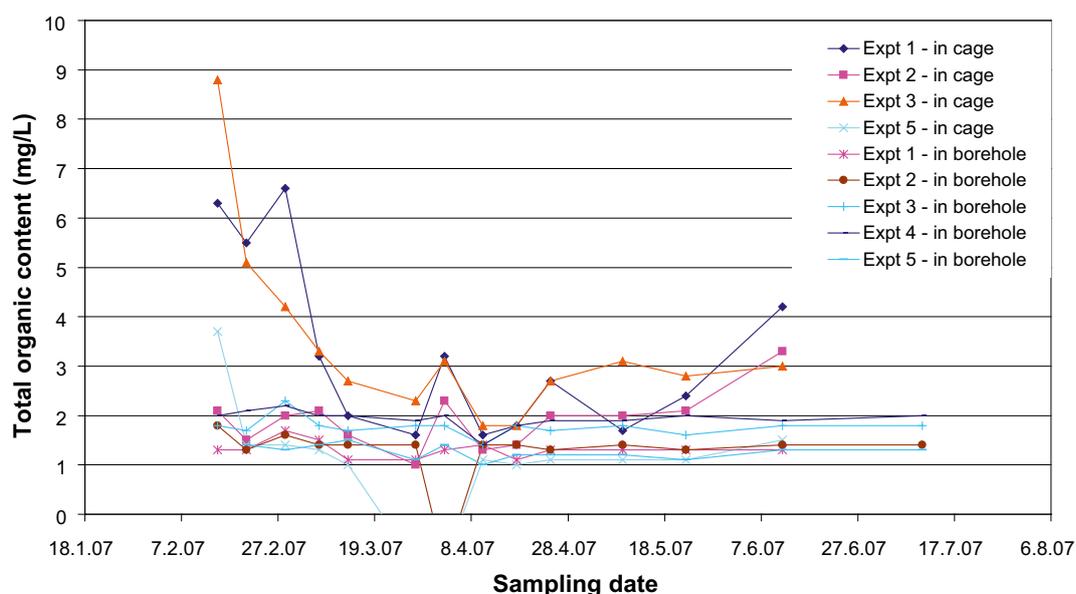
Figure 6-18. Results of total organic content analysis.

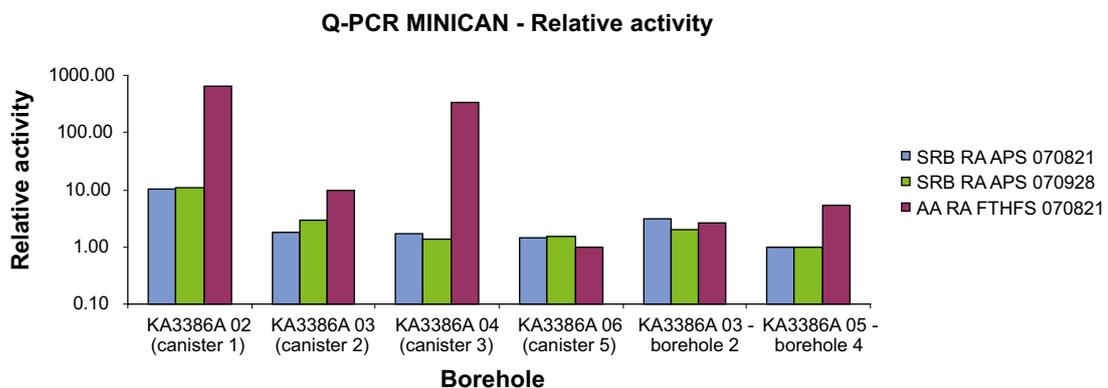
**Figure 6-19.** Summary of results from microbial analysis (SRB = sulphate reducing bacteria; AA = autotrophic acetogens).

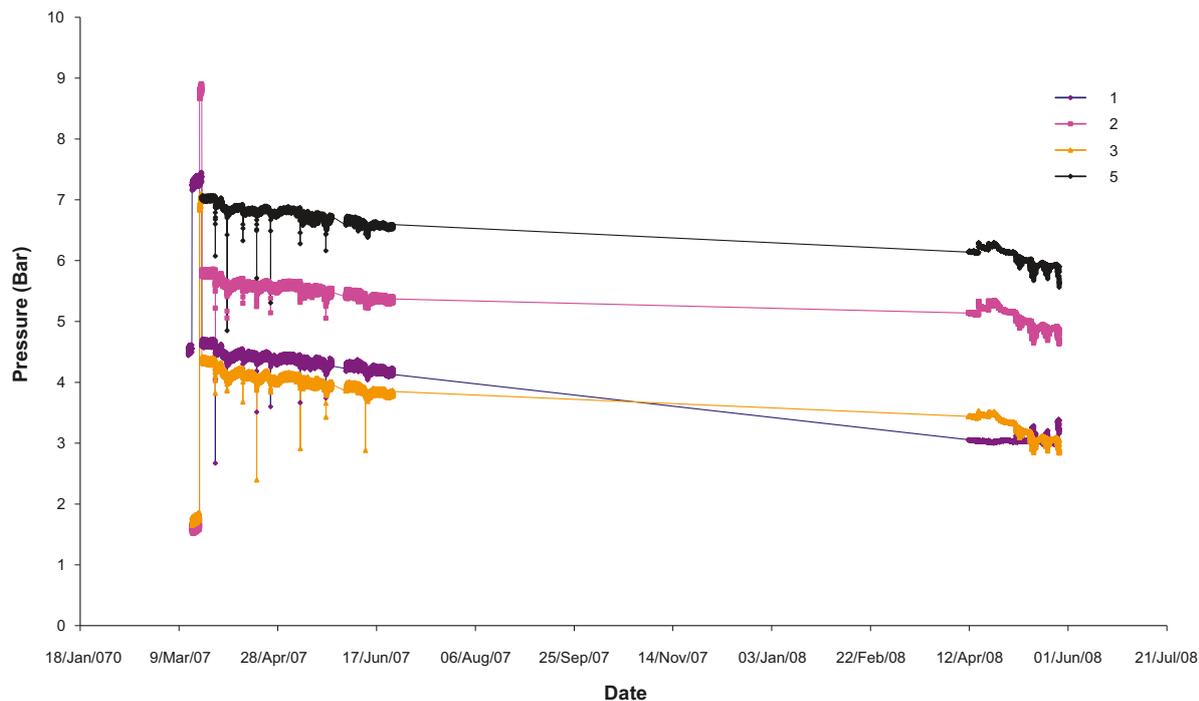
Figure 6-20. Pressure readings for boreholes 1 to 5.

The results from the pressure gauges in the boreholes are shown in Figure 6-20. Unfortunately there was a loss of data due to a fault with the datalogging system during the winter of 2007/8. The data show that there is a general tendency for the pressure to fall with time. The low pressure is mainly due to water loss through the rock face surrounding the boreholes.

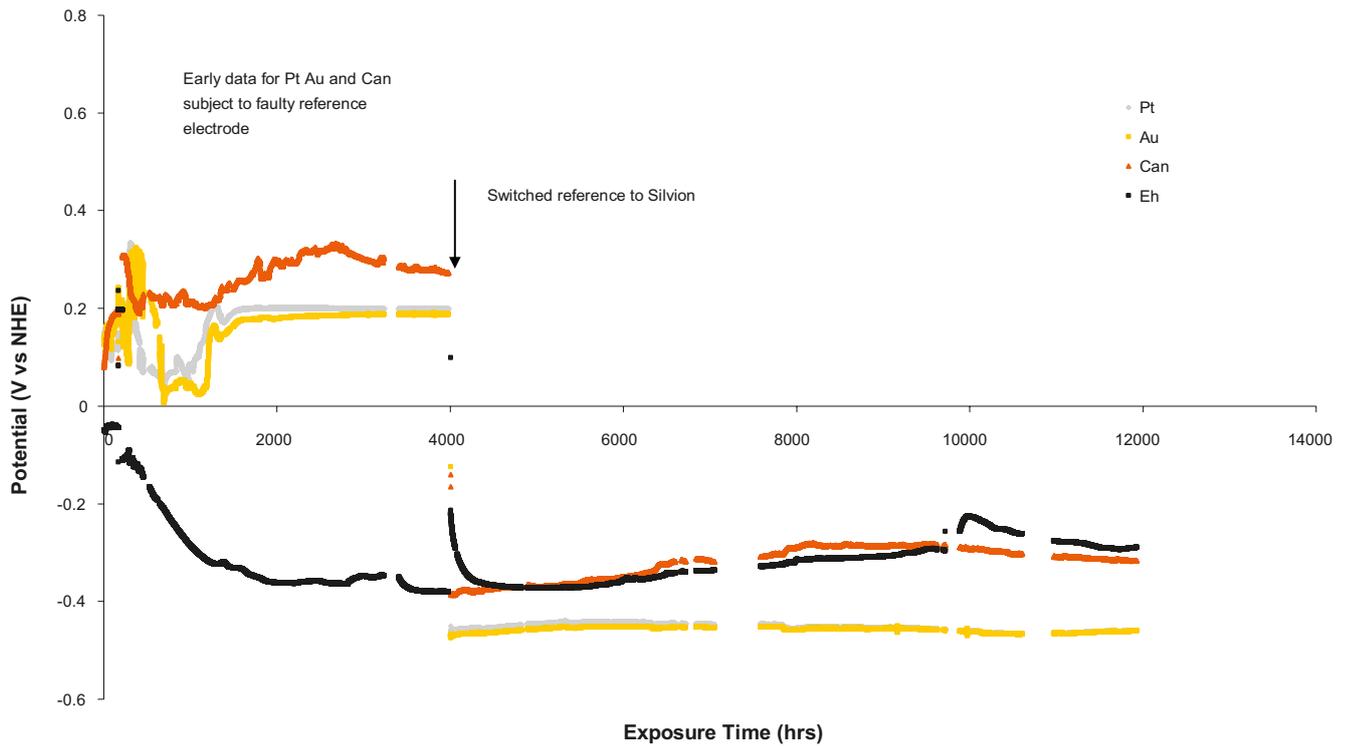
Figure 6-21. Results of Eh and can potential measurements from Experiment 1 (low density bentonite).

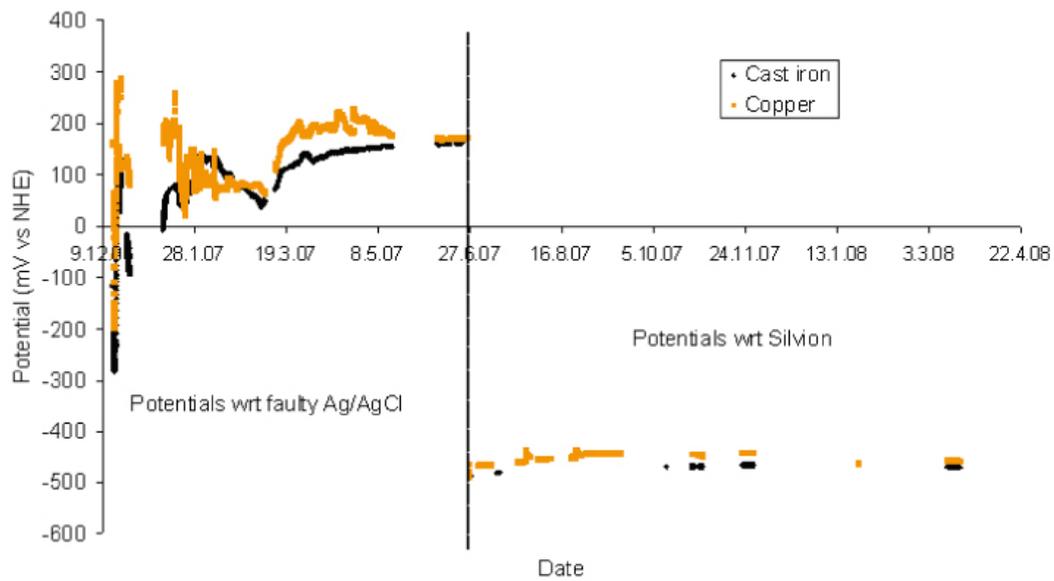
Figure 6-22. Results of corrosion potential measurements for cast iron and copper electrodes in Experiment 1 (low density bentonite).

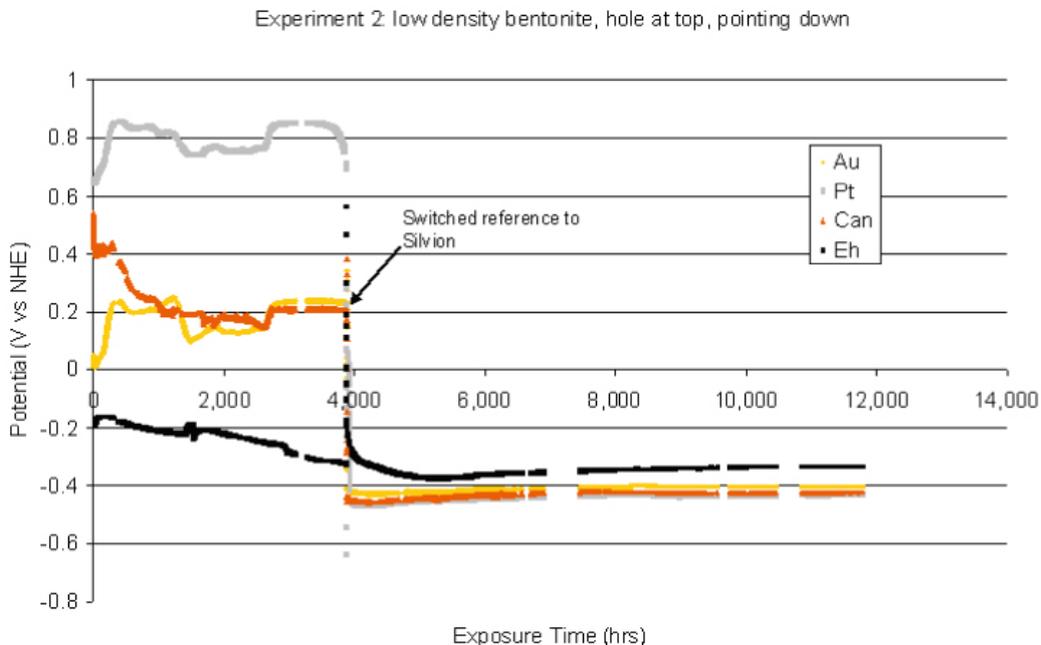
Figure 6-23. Results of Eh and can potential measurements from Experiment 2 (low density bentonite).

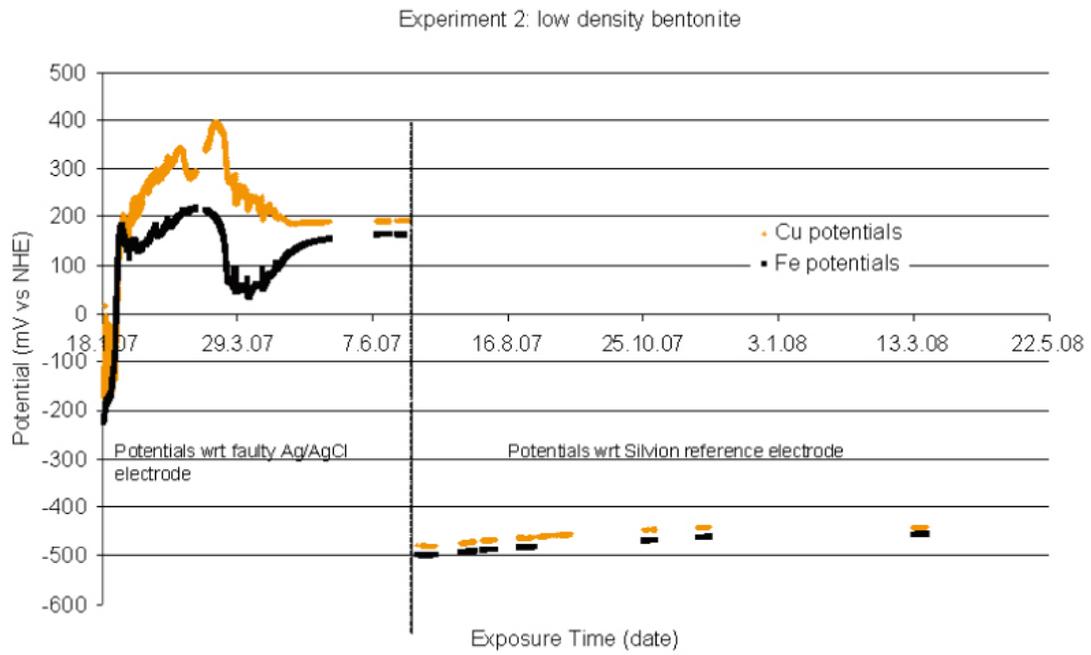
**Figure 6-24.** Results of corrosion potential measurements for cast iron and copper electrodes in Experiment 2 (low density bentonite).

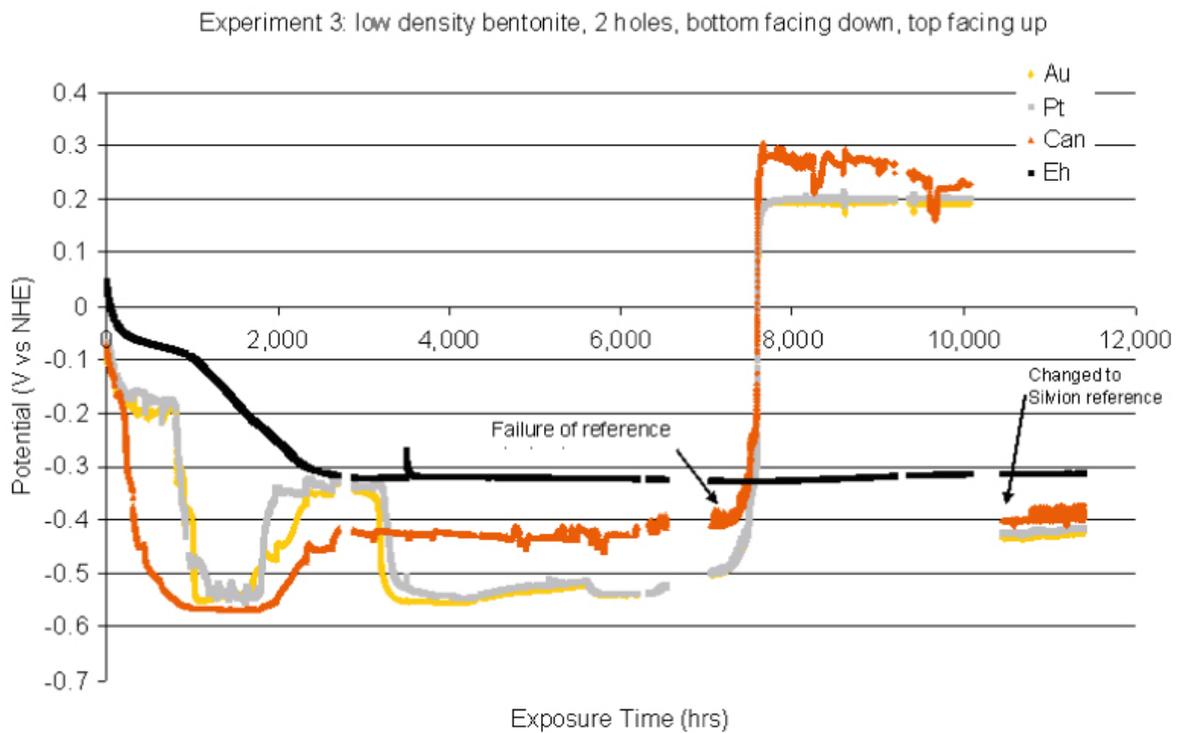
**Figure 6-25.** Results of Eh and can potential measurements from Experiment 3 (low density bentonite).

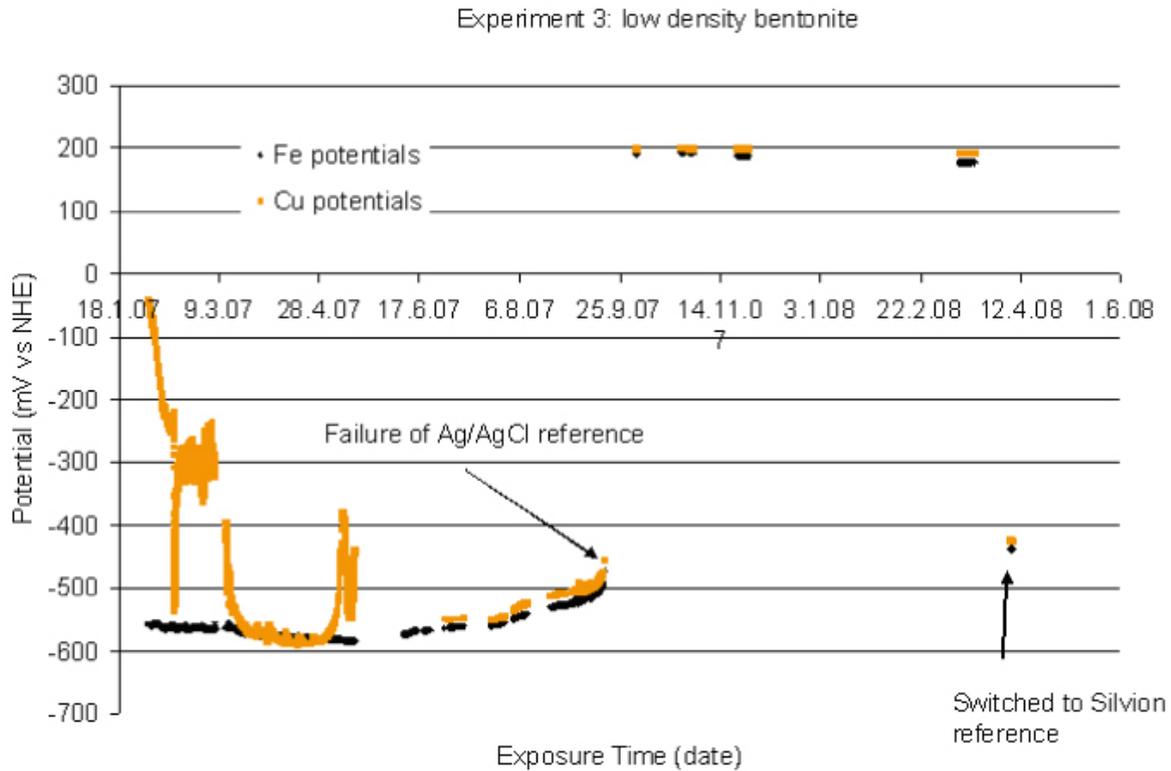
**Figure 6-26.** Results of corrosion potential measurements for cast iron and copper electrodes in Experiment 3 (low density bentonite).

The electrochemical potential values for iron and copper in Experiment 3 are shown in Figure 6-26. These data show a decrease in the corrosion potential of the copper initially, stabilising at highly negative values. The potentials were subsequently measured against Silvion after failure of the internal silver-silver chloride reference electrodes after approximately 7,500 hours.

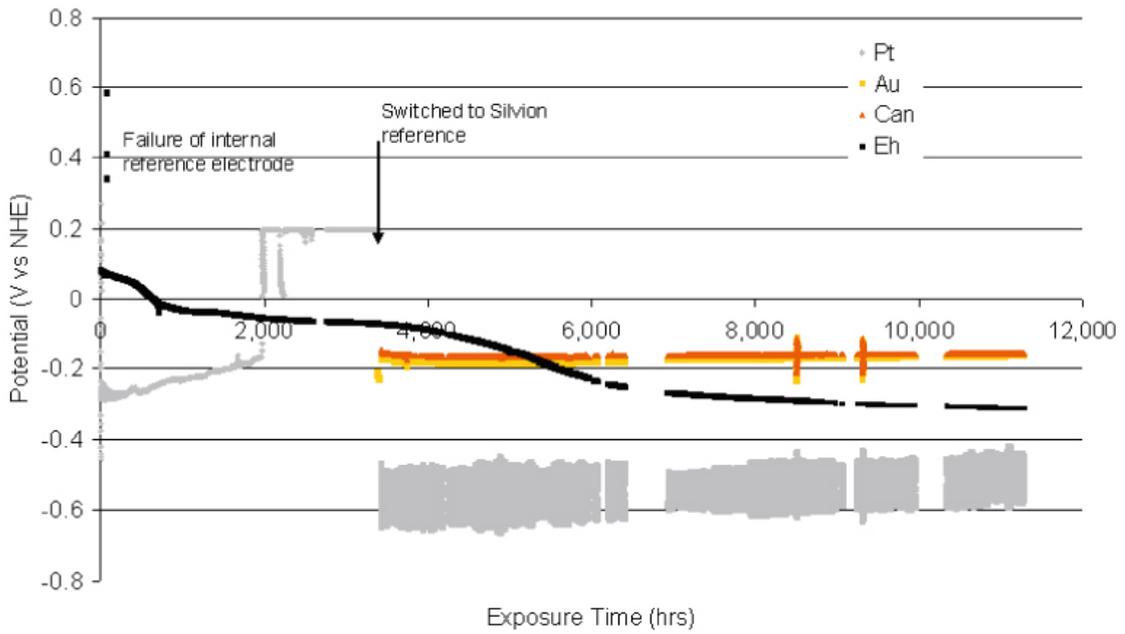
Figure 6-27. Results of Eh and can potential measurements from Experiment 4 (compact bentonite).

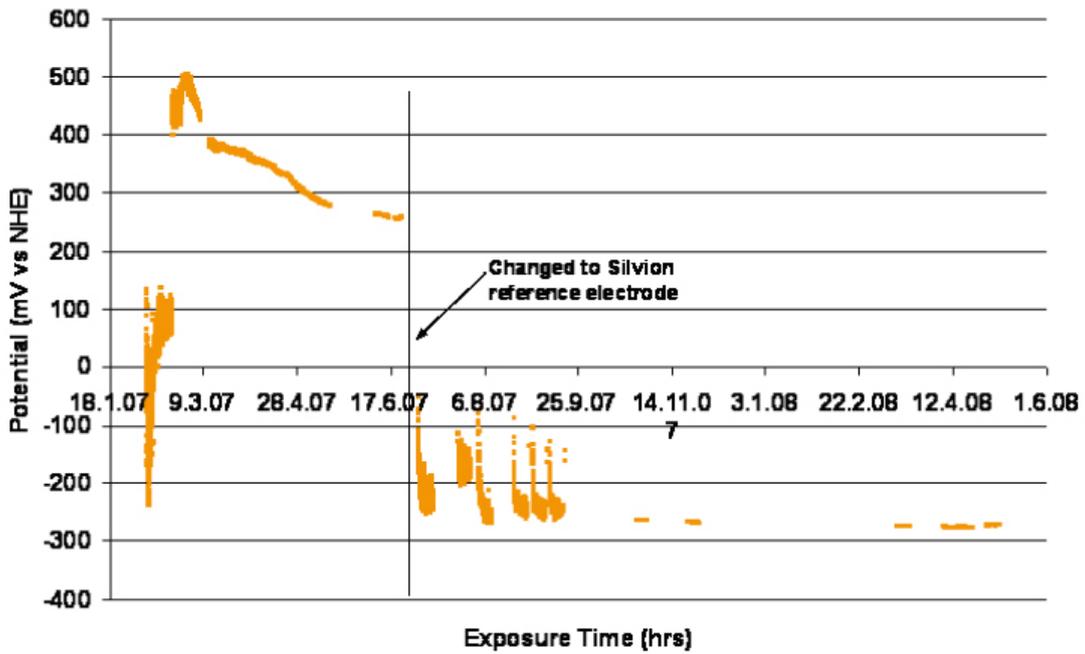
Figure 6-28. Results of corrosion potential measurements for copper electrodes in Experiment 4 (compact bentonite).

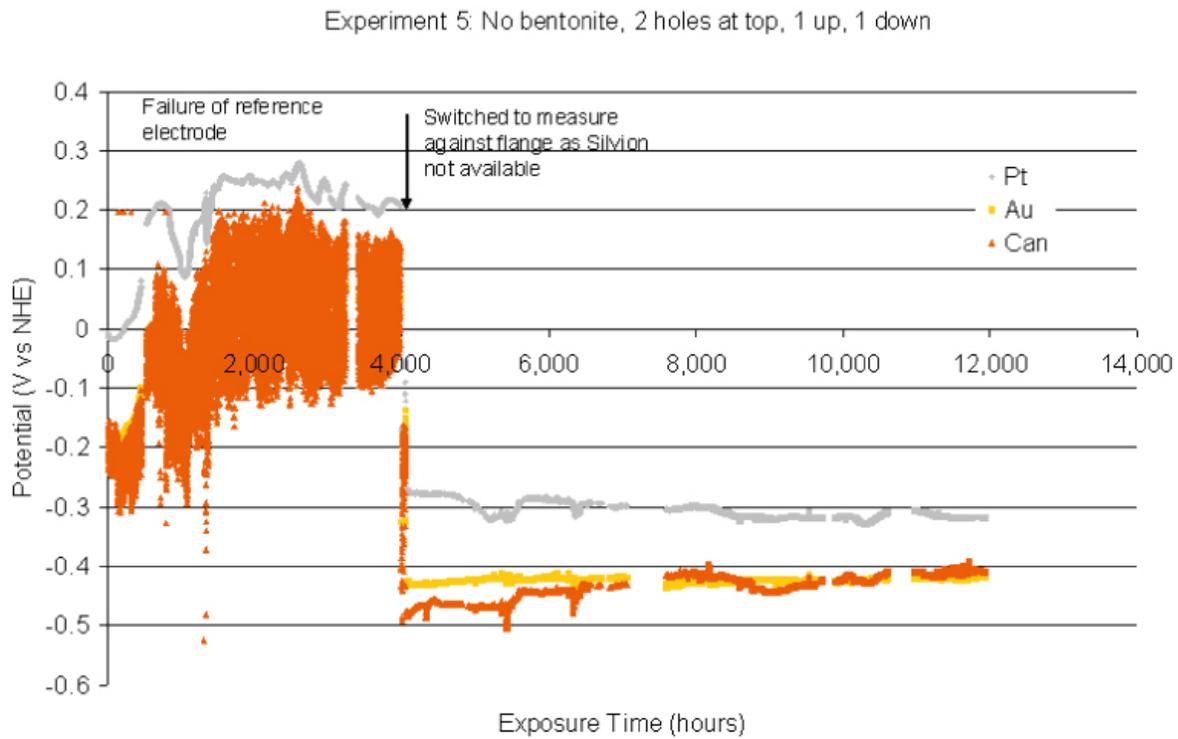
**Figure 6-29.** Results of Eh and can potential measurements from Experiment 5 (no bentonite).

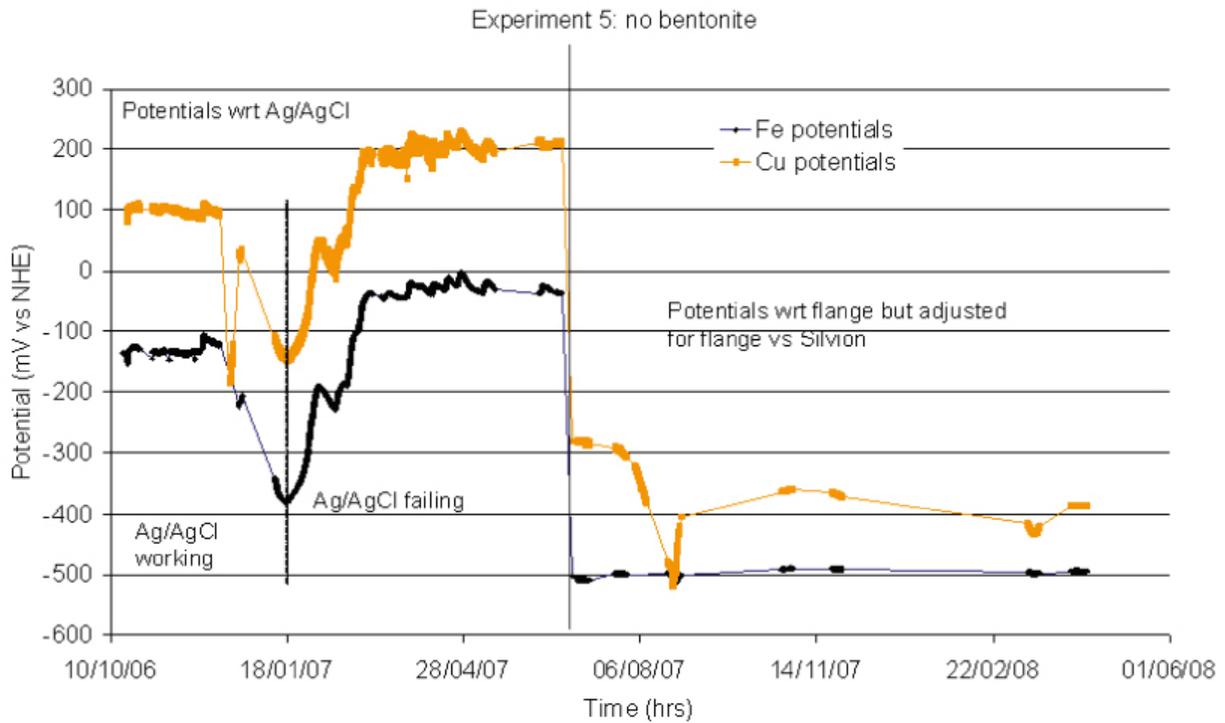
**Figure 6-30.** Results of corrosion potential measurements for cast iron and copper electrodes in Experiment 5 (no bentonite; wrt = 'with respect to').
