**Technical Report**

**TR-09-20**

**Miniature canister corrosion  
experiment – results of operations  
to May 2008**

**Svensk Kärnbränslehantering AB**

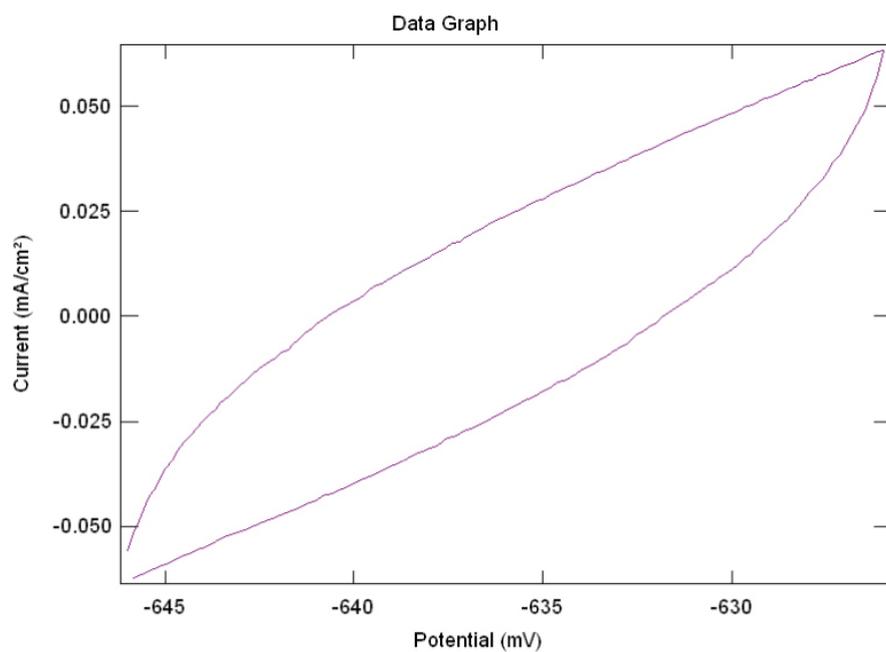
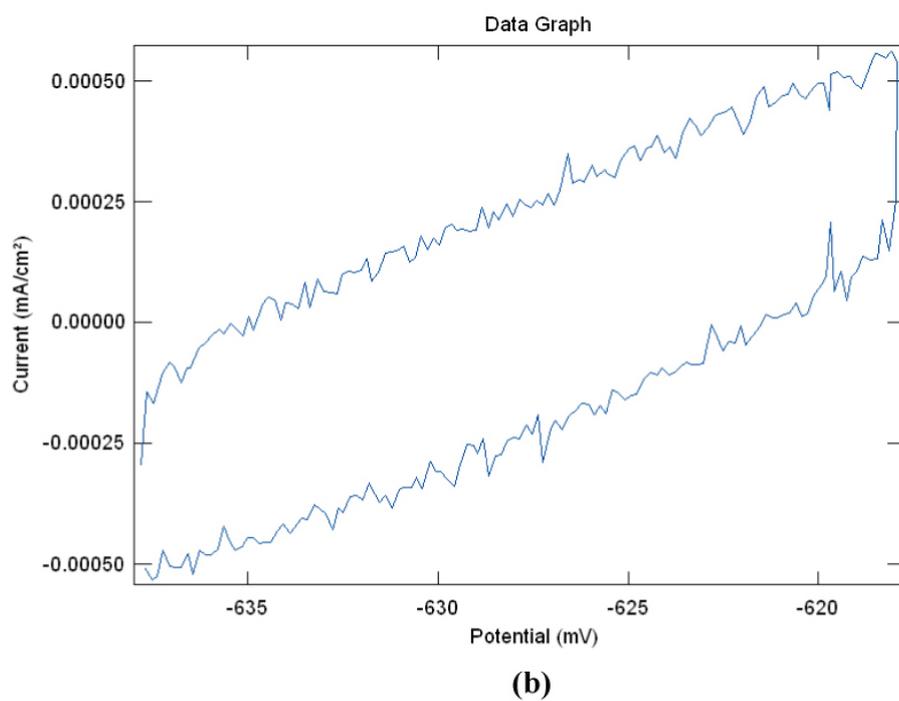
**Figure 6-31.** Typical examples of linear polarisation resistance (LPR) measurements on Experiment 3 : (a) cast iron, (b) copper

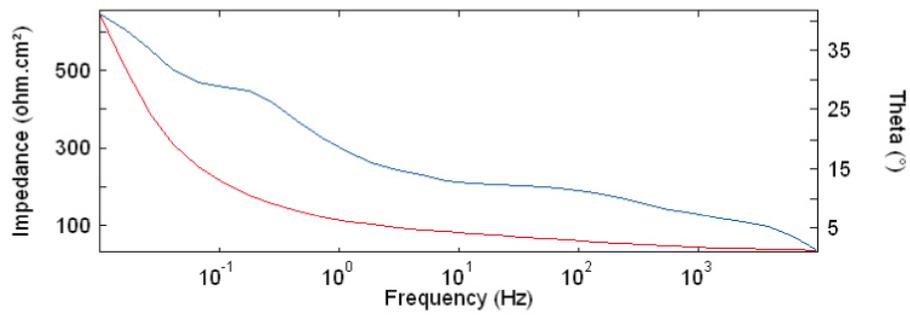
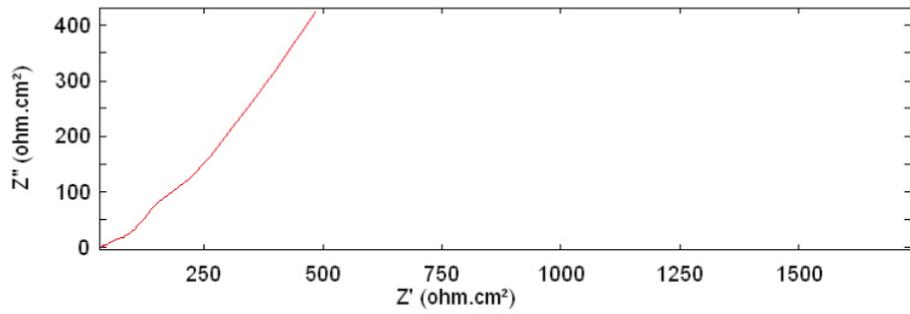
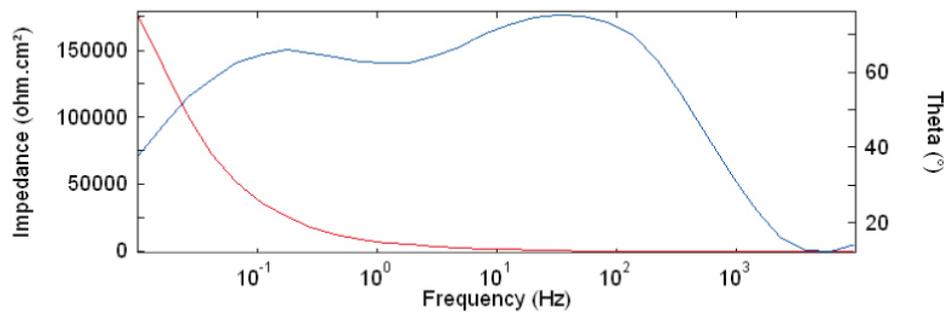
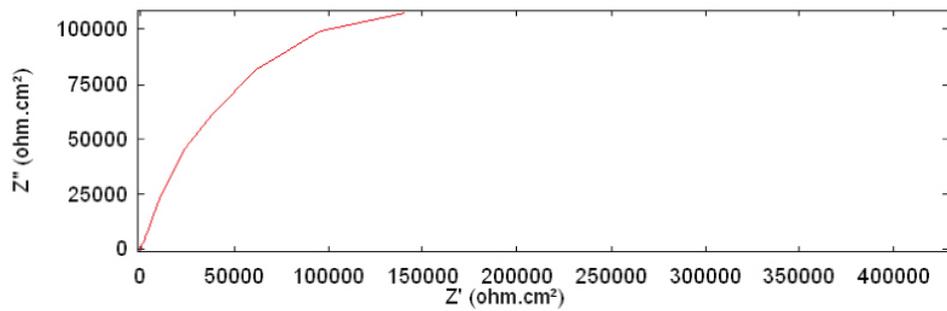
**Figure 6-32.** Typical examples of AC impedance measurements (ACI) on Experiment 1: (a) cast iron, (b) copper. Top figure: blue line = theta plot; red line = impedance plot.

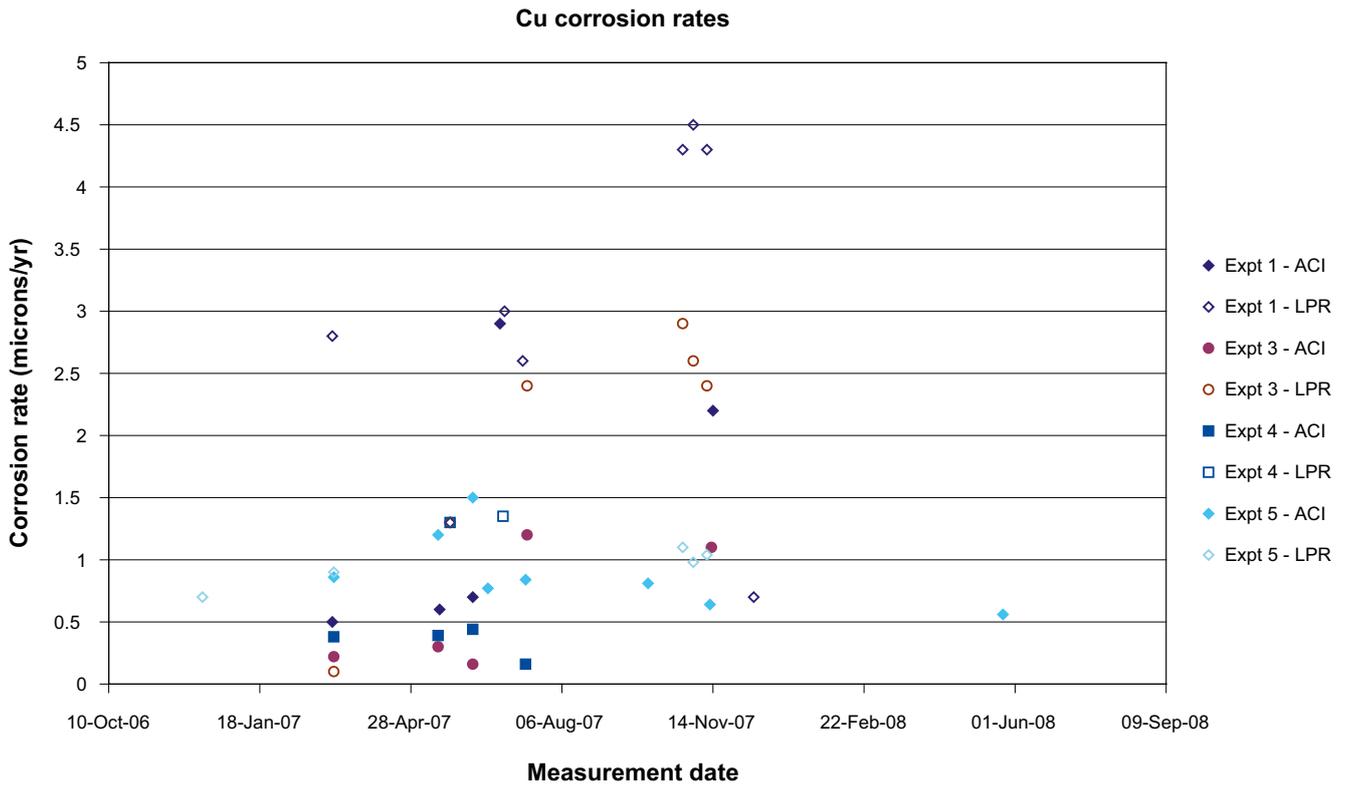
Figure 6-33. Summary of copper corrosion rates obtained by AC impedance and LPR measurements.

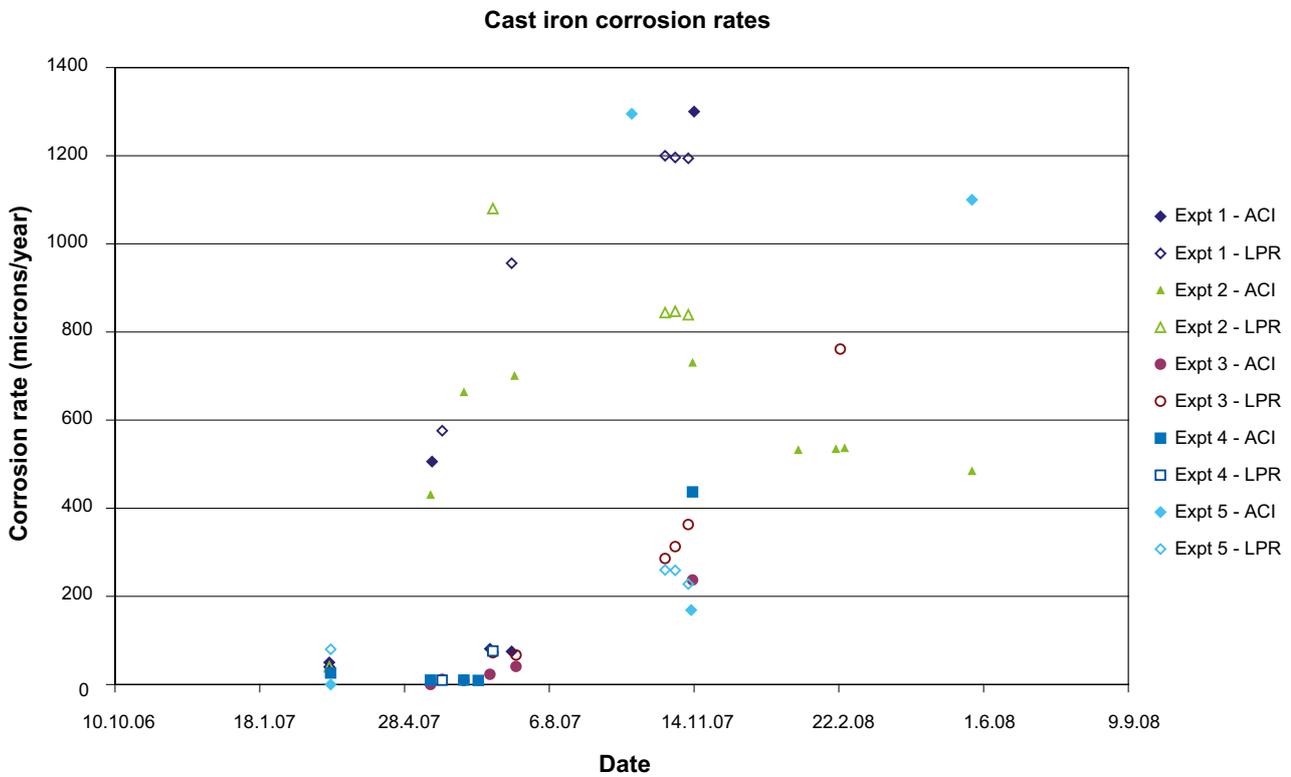
Figure 6-34. Summary of iron corrosion rates obtained by AC impedance and LPR measurements.

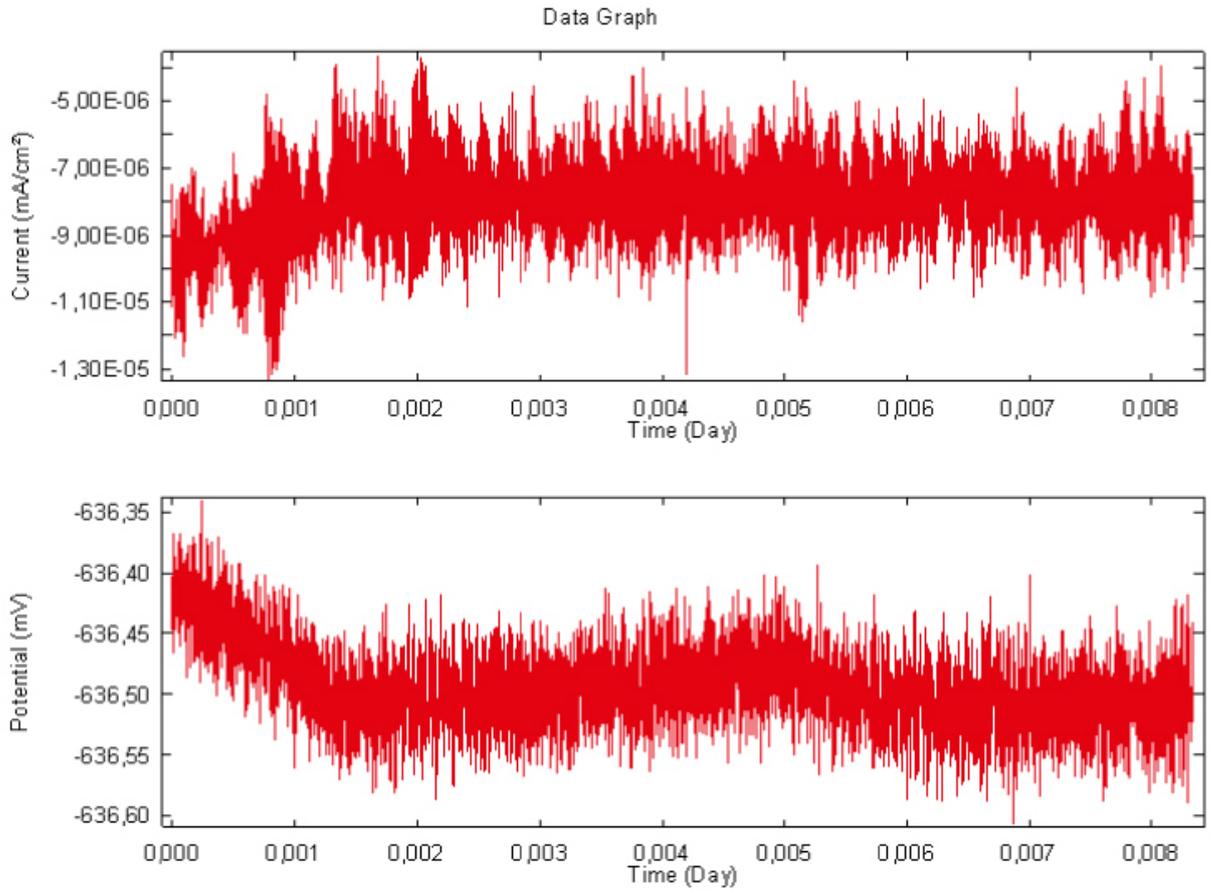
**Figure 6-35.** Results from electrochemical noise measurements for a pair of copper electrodes in Experiment 2 (low density bentonite).

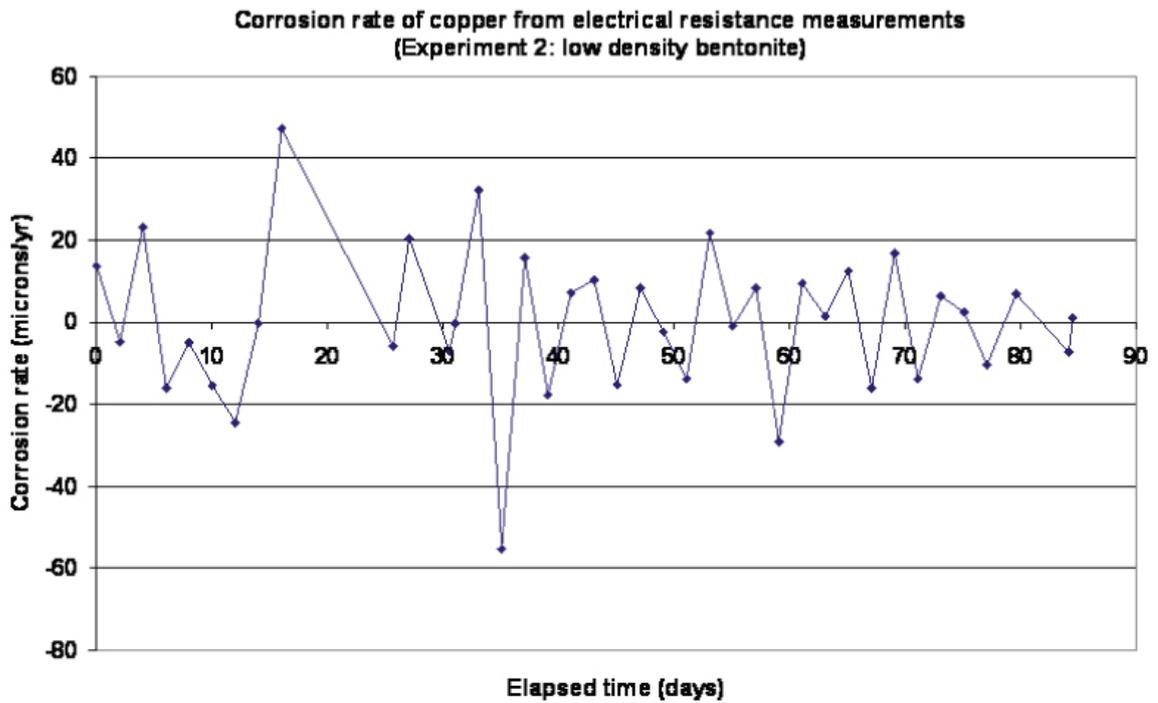
**Figure 6-36.** Results of corrosion rate measurements from copper wire electrical resistance measurements (experiment 2: low density bentonite).

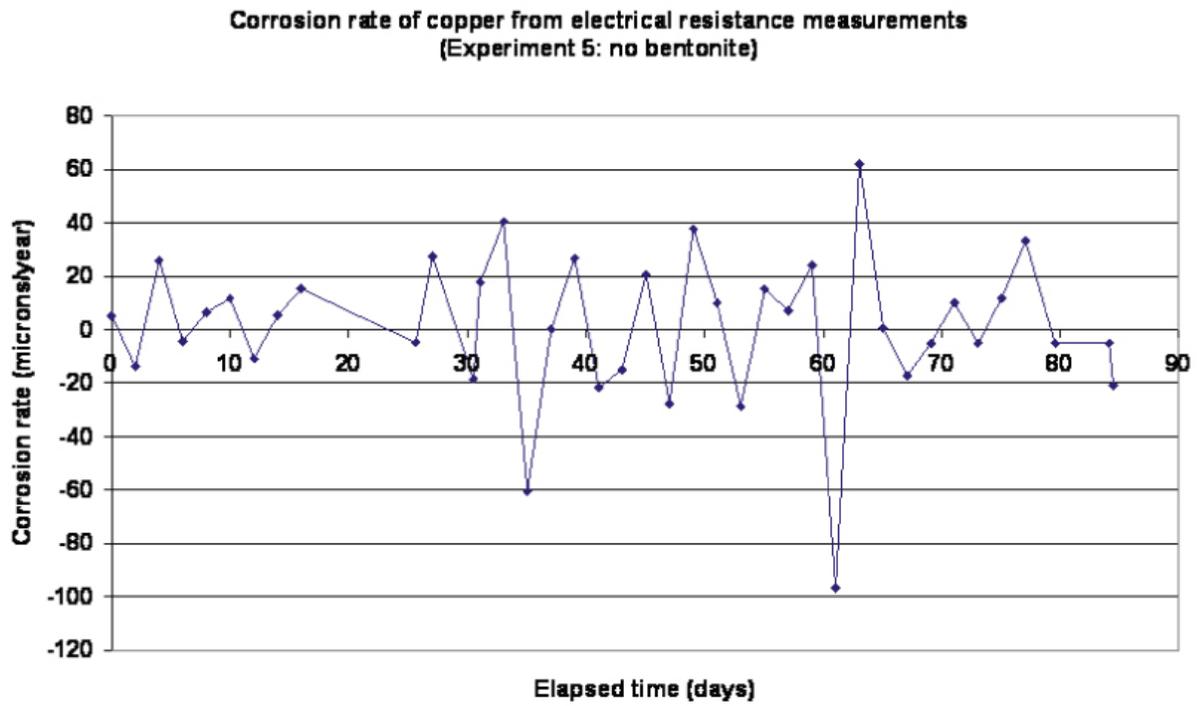
*Figure 6-37. Results of corrosion rate measurements from copper wire electrical resistance measurements (experiment 5: no bentonite).*

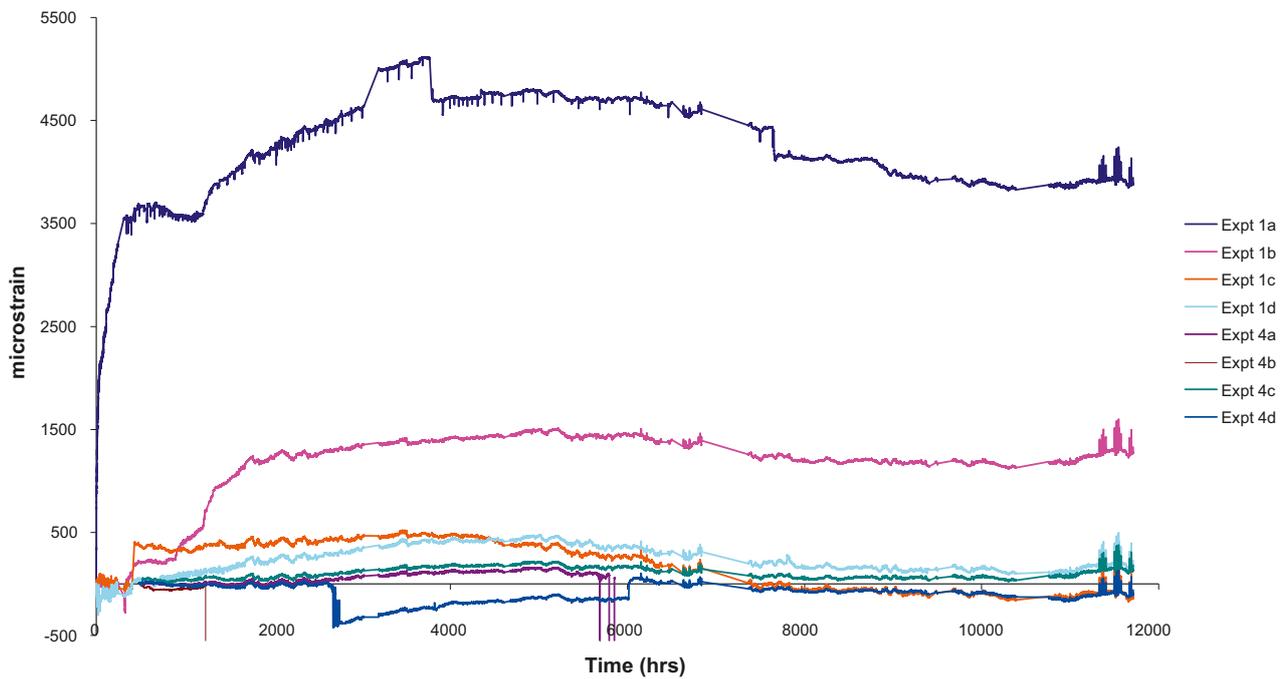
*Figure 6-38. Strain gauge results from Experiments 1 and 4.*

The strain gauge results for Experiments 1 and 4 are shown in Figure 6-38. Gauges 1a and 1b are showing an initial increase in tensile strain and we are not clear about the explanation for this behaviour. It seems to be too early to be due to expansion caused by a corrosion process.

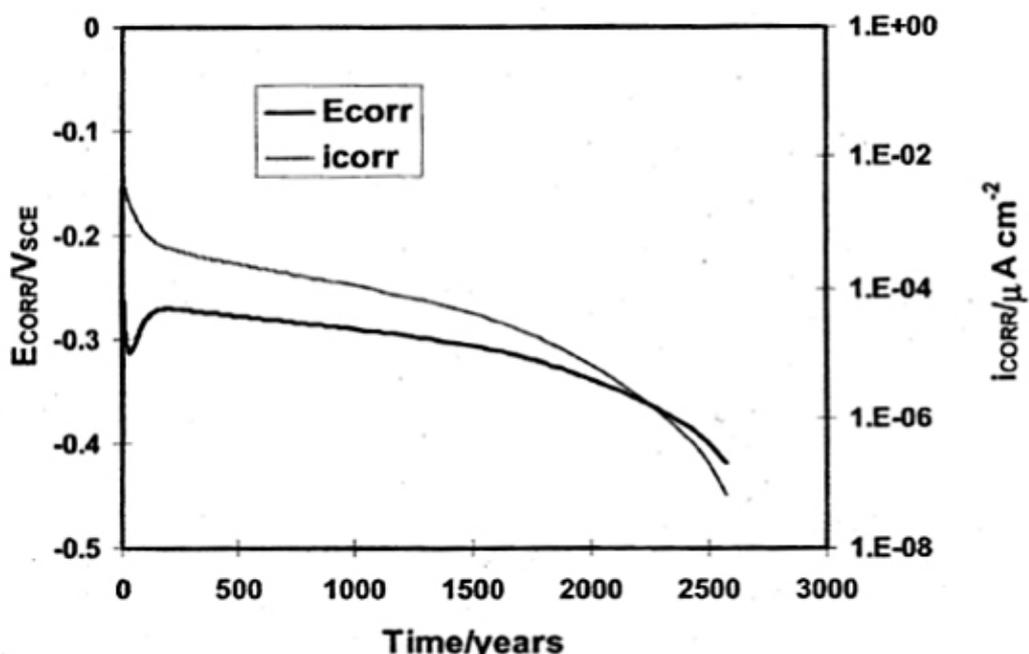
**Figure 7-1.** Predicted time dependence of the corrosion potential ( $E_{corr}$ ) and corrosion current ( $i_{corr}$ ) of a copper canister in a Canadian repository [18].

The corrosion potential of the copper and the model canisters can be compared with other measurements and modelling activities /18/; for example the predicted long-term corrosion potential of a copper canister in compacted bentonite is shown in Figure 7-1 (NB: this calculation was for an initially aerated repository). These modelling calculations show that the predicted short-term corrosion potential for a
