Svensk Kärnbränslehantering AB
Kapsellaboratoriet
Box 925
572 29 OSKARSHAMN

Residual stress measuring by incremental hole drilling technique

1 Test object

A half BWR insert tube Ø950 mm and 2000 mm long. The sample was marked I56.

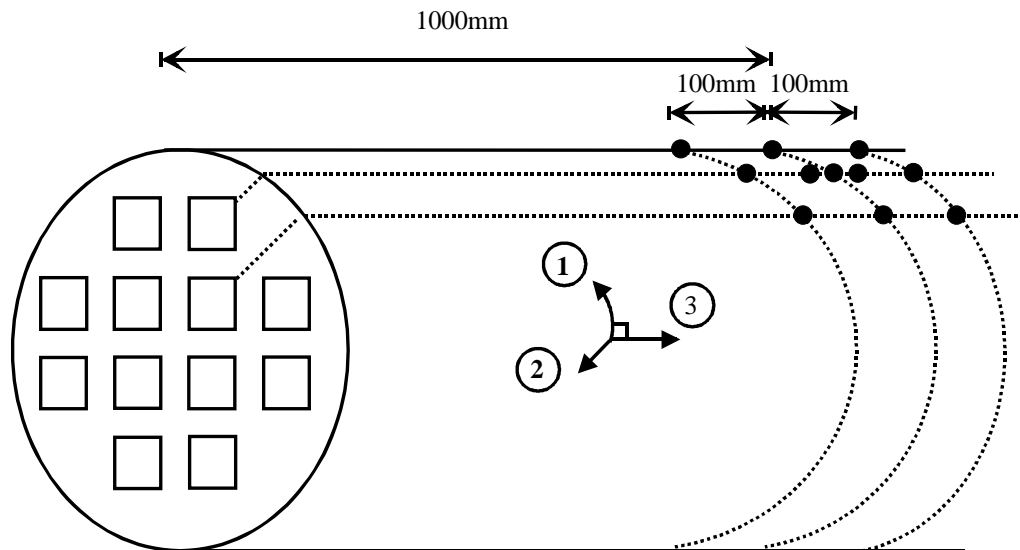
Figure 1 A schematic sketch of the insert tube showing the location of the measuring locations and the orientations of the three strain gages. The gages in the upper line are from left 1, 2 & 3, in the middle line 4, 5a, 5, 5b & 6 and in the lower line 7, 8 & 9.

A schematic sketch showing the insert tube and the measuring locations is given in *Figure 1*. The layout of the strain gages are shown on *Figure A3:1* in *Appendix 3*.

During the drilling at location 5 the reading from the strain gages suddenly increased with a large step. This was probably caused by bending from the cutter when it hit some hard inclusion in the material. The measuring was aborted and a new measurement 15mm to the left was done. Even this measuring was disturbed and a third measuring was done 15mm to the right of the original point 5.

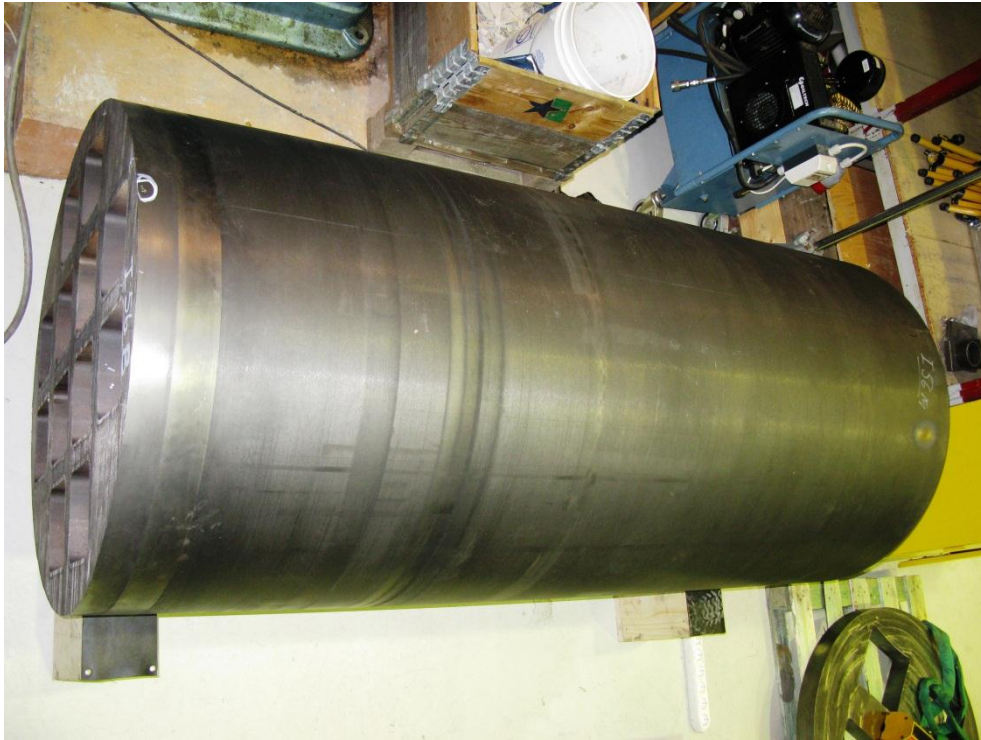
Figure A1:1 The sample lying on the packing pallets in the SP laboratory before the start of the measurement.

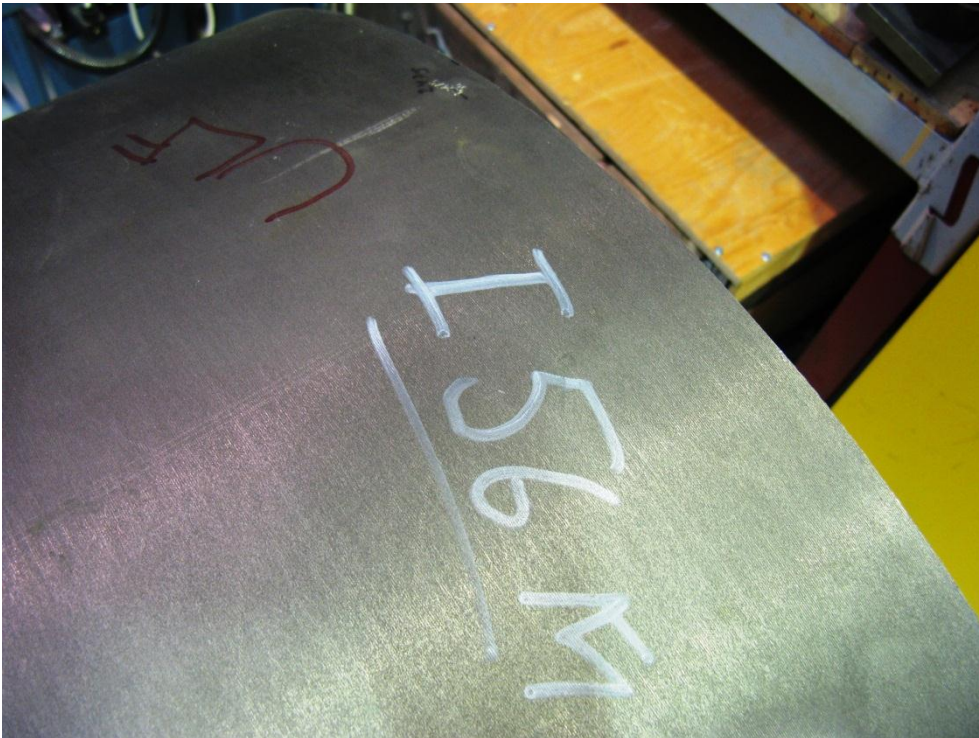
Figure A1:2 The marking on the sample.

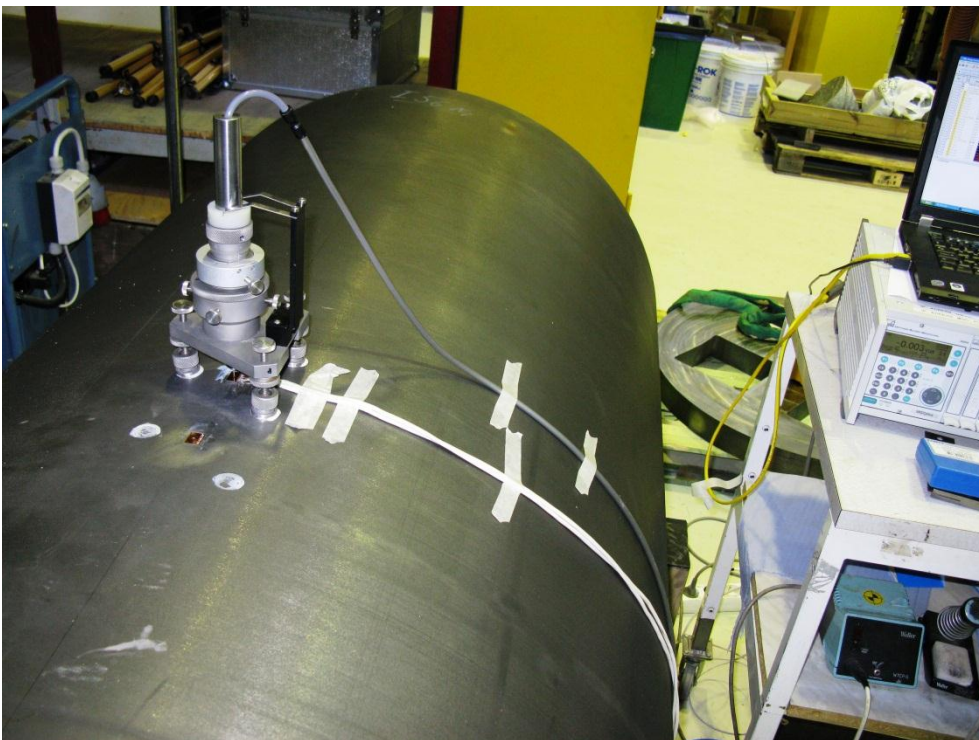
Figure A1:3 The hole drilling rig cemented to the sample.

The stand of the drilling equipment must be very rigidly fixed to the sample when the hole is drilled. The stand has three feet which are mounted in pads cemented to the sample. After doing a drilling and measurement these pads had to be removed and used at the next measurement location. This was done by striking them in a transverse direction. If the pads had been poorly cemented to the surface of the sample, it should be observed when they were removed. No such fault was observed.

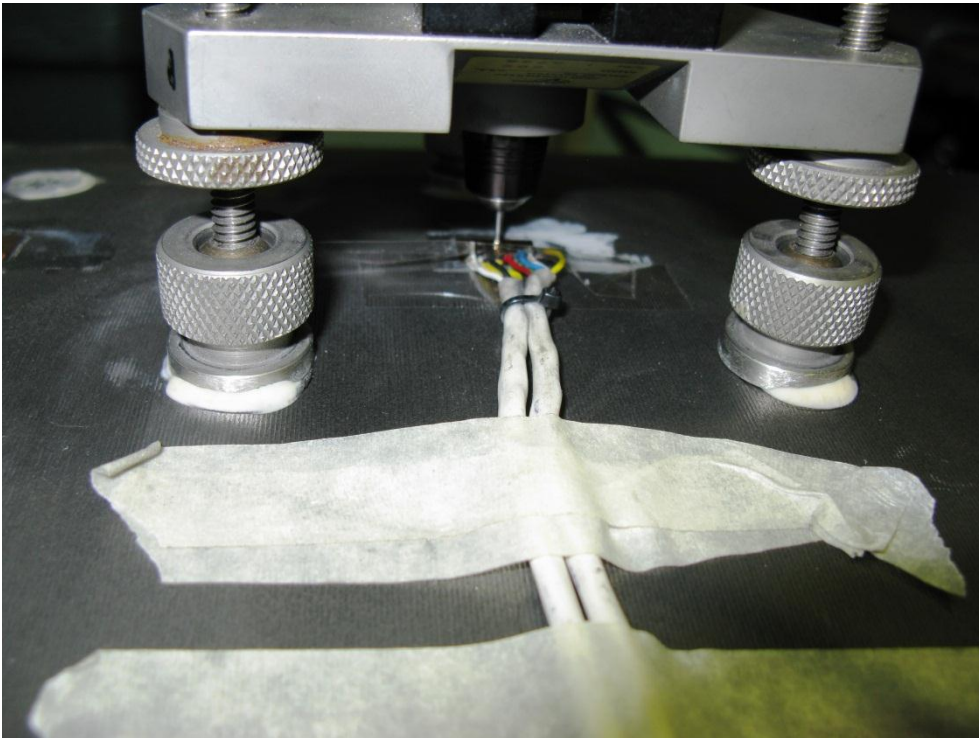
Figure A1:4 A second photograph showing the hole drilling rig cemented to the sample.

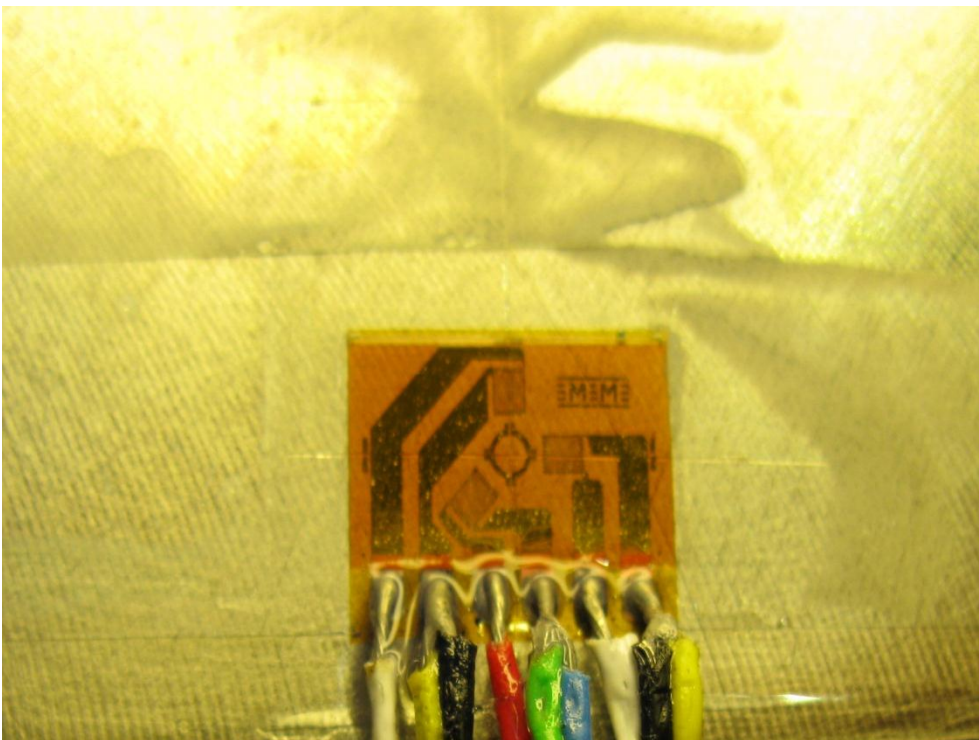
Figure A1:5 The 062UL strain gage bonded to the sample just before the drilling.

The strains were measured by CEA-06-062UL-120 gages. This type of gages is manufactured by the supplier of the hole drilling equipment and recommended for this type of tests.

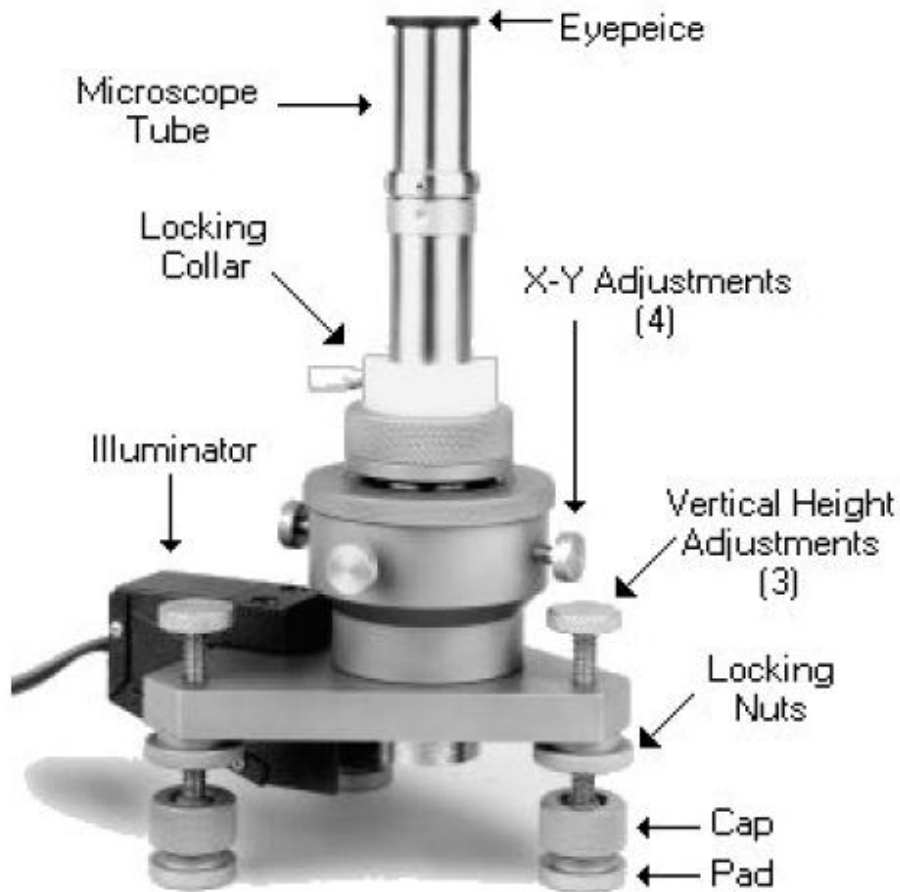
Figure A1:6 A picture of the milling guide supplied by the manufacture. A microscope is inserted in the milling guide so the guide can be by the X-Y adjusting screws positioned over the centre of the gage.

A Milling Guide Model RS-200 from Measurements Group was used for drilling the holes. According to recommendation from the supplier of the equipment a high-speed air turbine and carbide-tipped 1.6mm cutters were used.

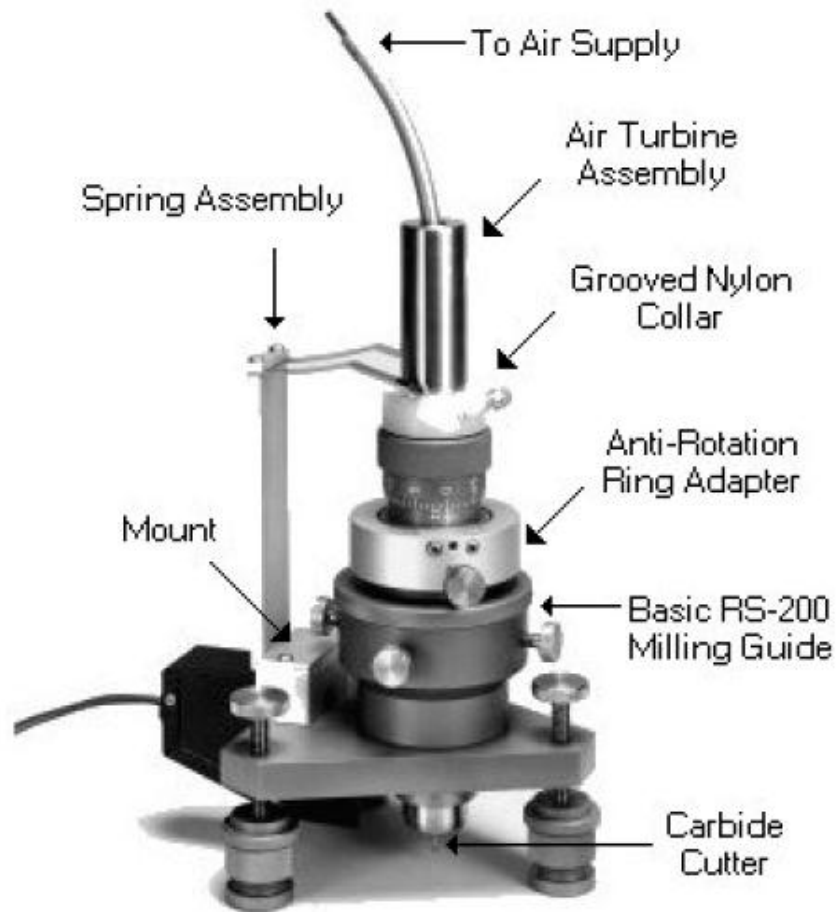
Figure A1:7 A picture of the milling guide supplied by the manufacture. A high speed air turbine is mounted in the guide.

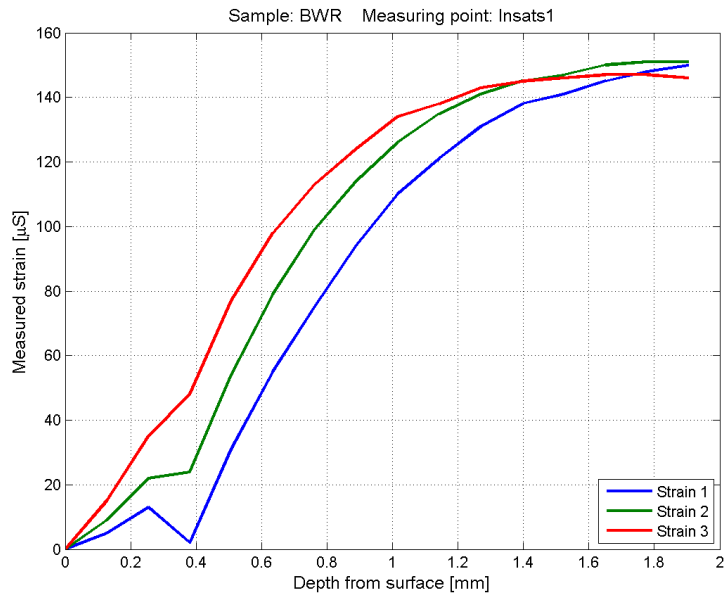
Figure A2:1 Raw data from measurement point BWRinsats1. There is a rather small jump in the measured strains between the readings at 0.25mm and 0.38mm. The jump is probably caused by bending from the cutter when it hit some hard inclusion in the material.

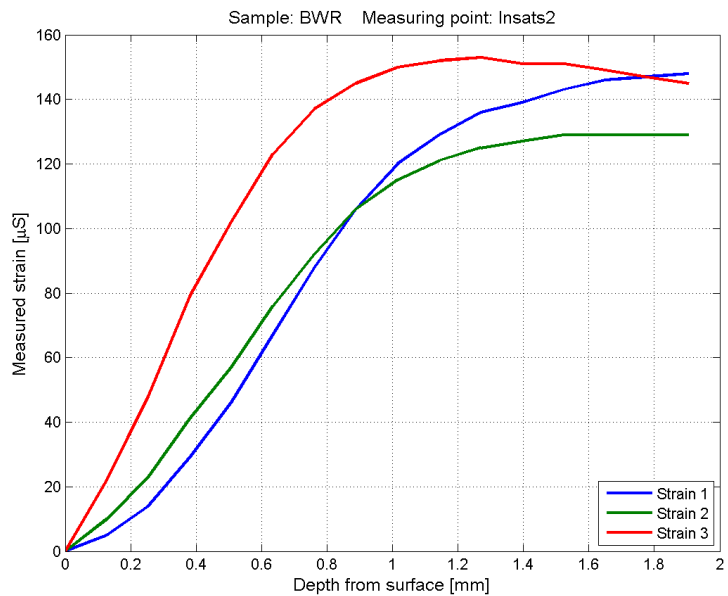
Figure A2:2 Raw data from measurement point BWRinsats2

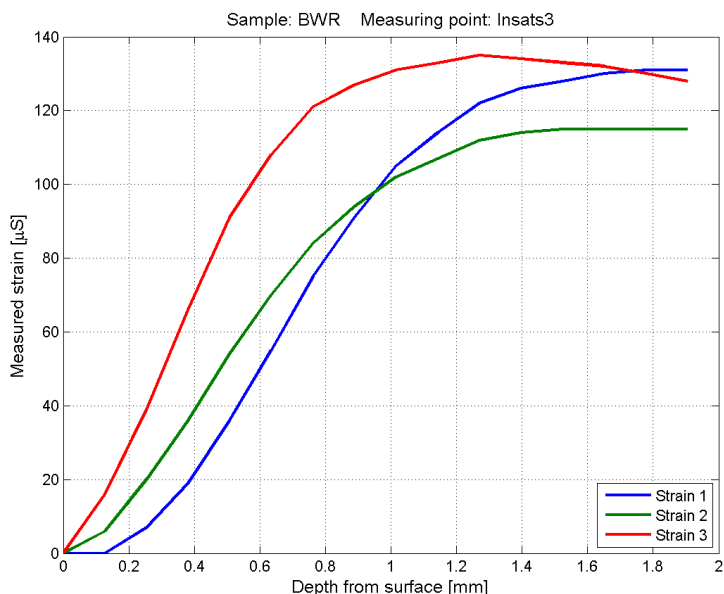
Figure A2:3 Raw data from measurement point BWRinsats3

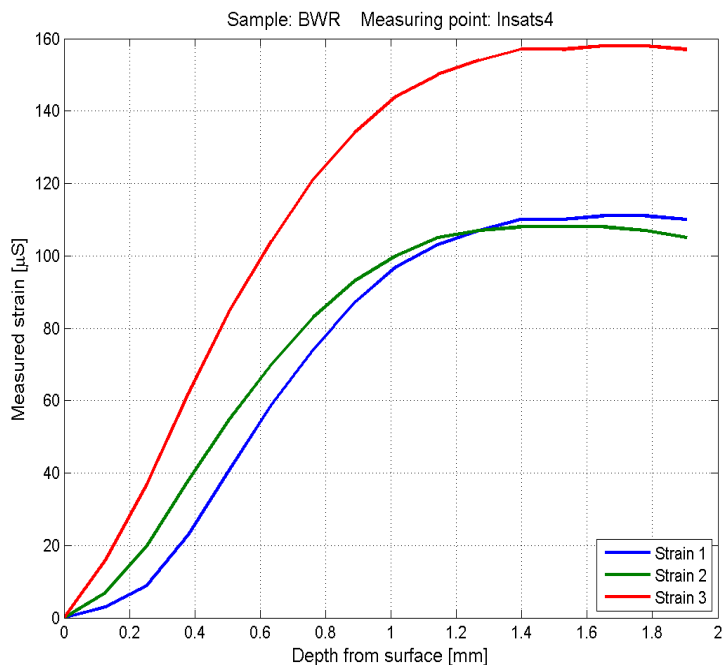
Figure A2:4 Raw data from measurement point BWRinsats4

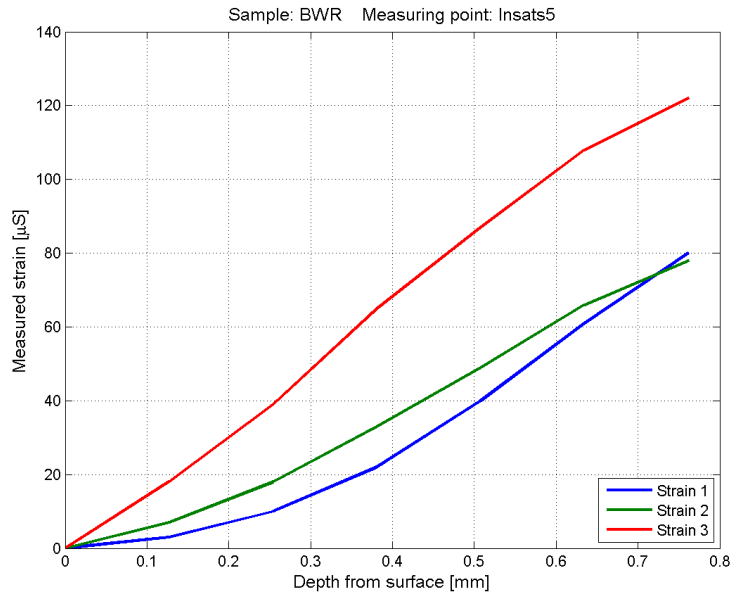
Figure A2:5 Raw data from measurement point BWRinsats5

During the drilling at location 5 the reading from the strain gages suddenly increased with a large step. This was probably caused by bending from the cutter when it hit some hard inclusion in the material. The measuring was aborted and a new measurement to the left was done. Even this measuring was disturbed and a third measuring was done to the right of the original point 5. Also the measurements from point 6 was disturbed and had to be aborted before the hole depth 1.91mm was reached. However, the measured values at location 5, 5a and 5b presented in this report are measured before the steps occurred and are therefore correct.

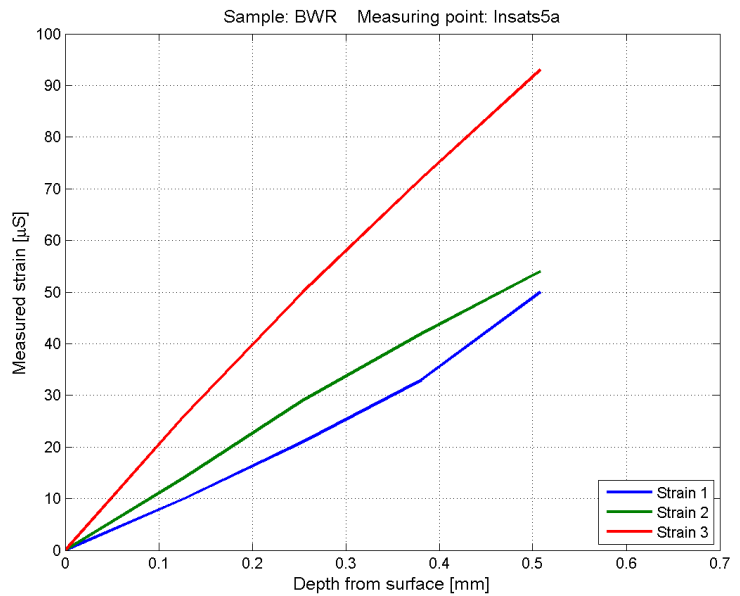
Figure A2:6 Raw data from measurement point BWRinsats5a

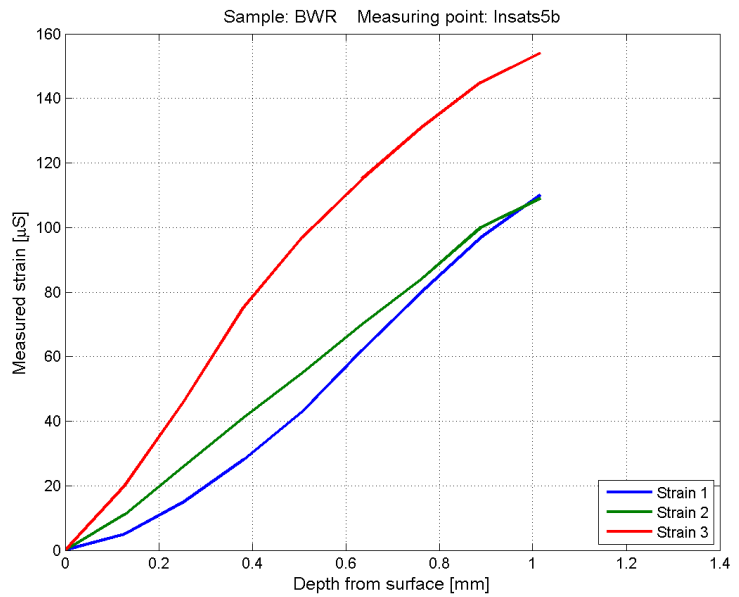
Figure A2:7 Raw data from measurement point BWRinsats5b

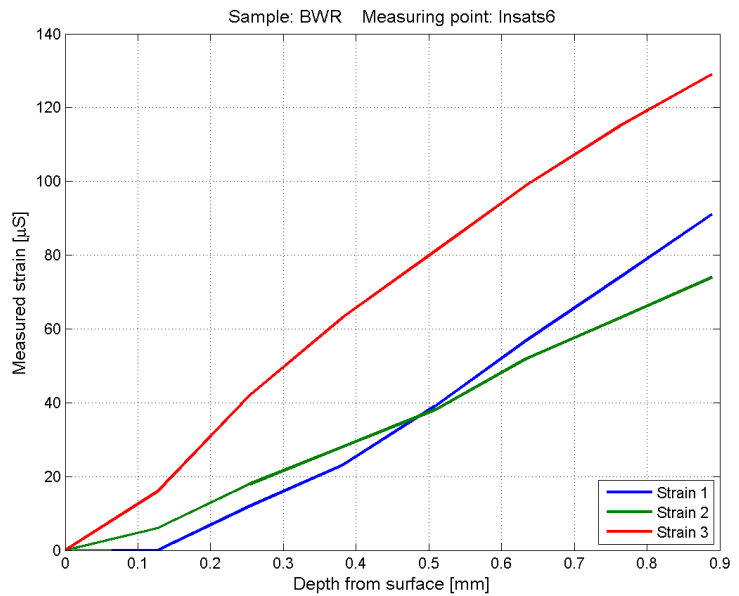
Figure A2:8 Raw data from measurement point BWRinsats6

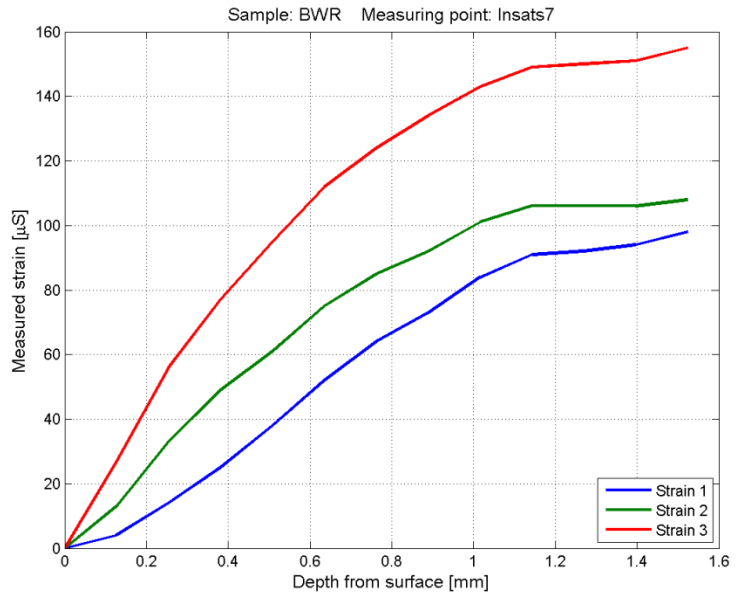
Figure A2:9 Raw data from measurement point BWRinsats7

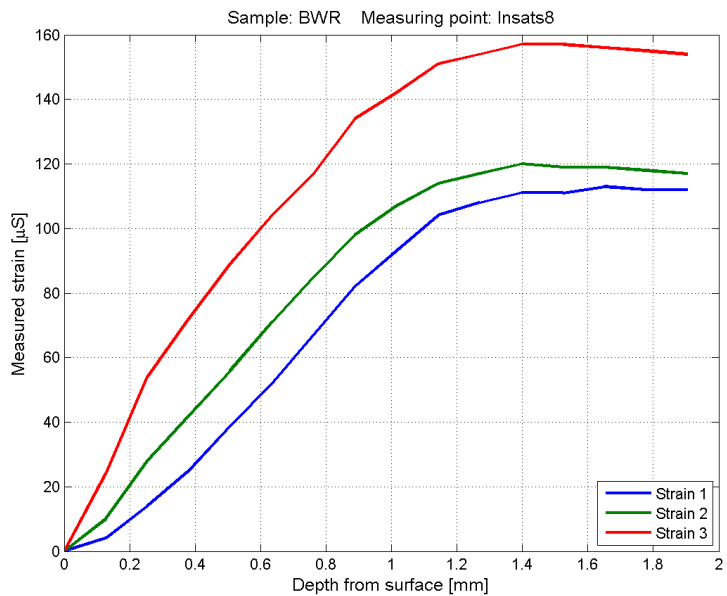
Figure A2:10 Raw data from measurement point BWRinsats8

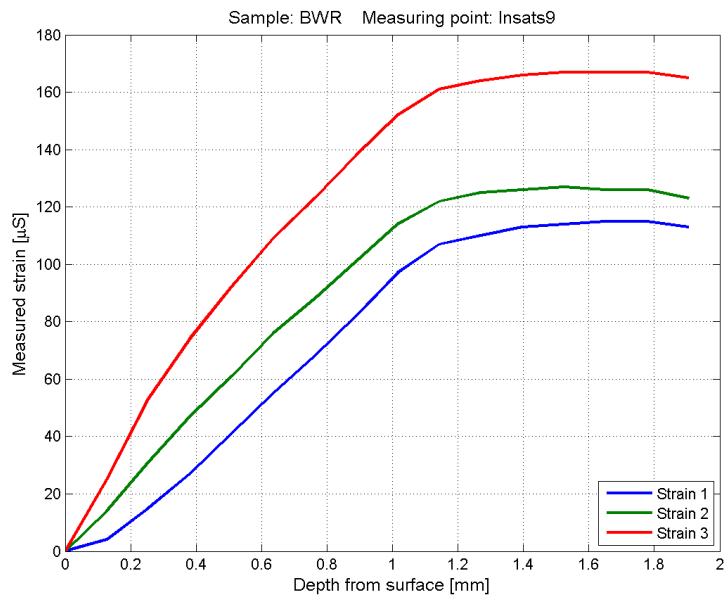
Figure A2:11 Raw data from measurement point BWRinsats9

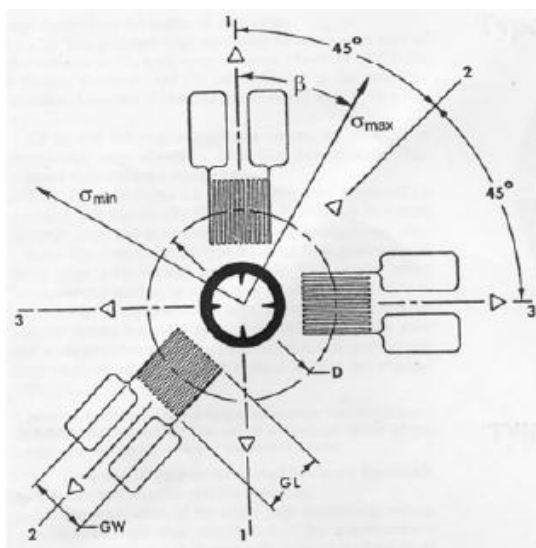
Figure A3:1 A sketch showing the orientations of the three strain gages and the definition of the angle β

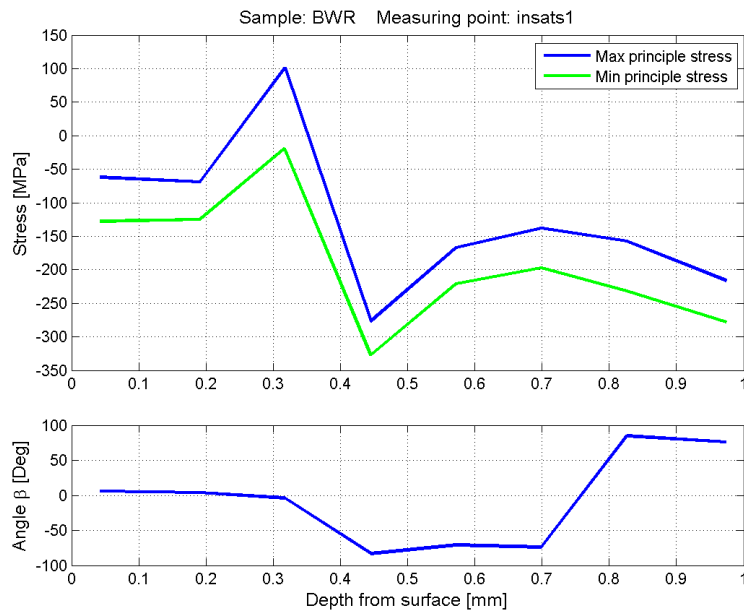
Figure A3:2 Principal stresses calculated for the measuring point insats1 on the sample. As can be seen from the raw data (Figure A2:1 in Appendix 2) there was a relative small jump in the measured strains. The tension stresses at the depth 0.32 mm are caused by the disturbances caused by this jump and are therefore not reliable. For the other shaded stresses the von Mises effective stress is larger than 70% of the yield stress and therefore they are not reliable..

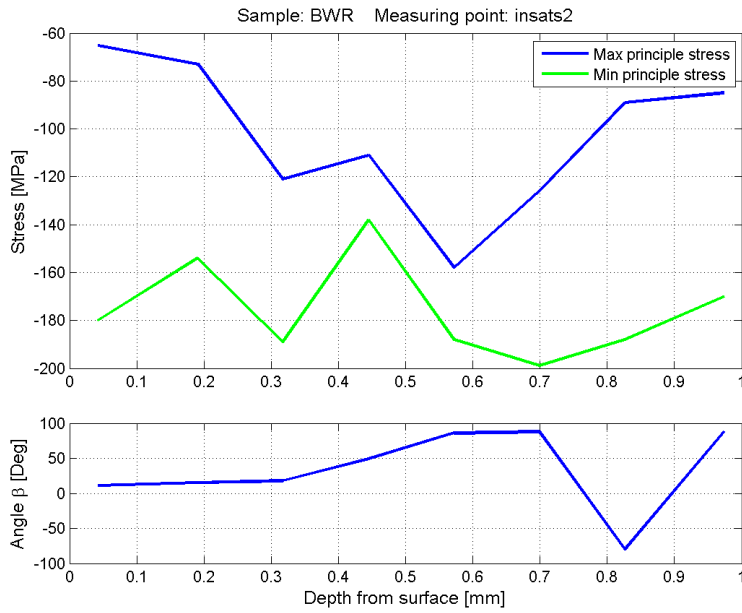
Figure A3:3 Principal stresses calculated for the measuring point *insats2* on the sample.

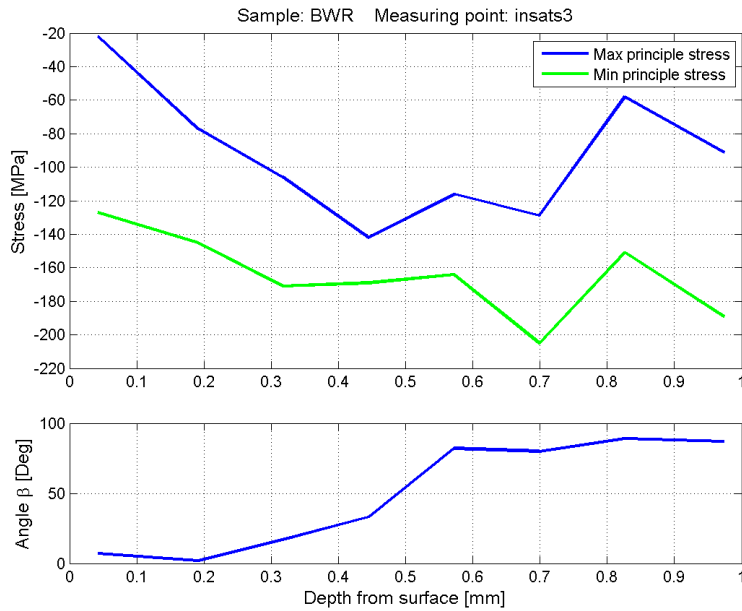
Figure A3:4 Principal stresses calculated for the measuring point *insats3* on the sample.

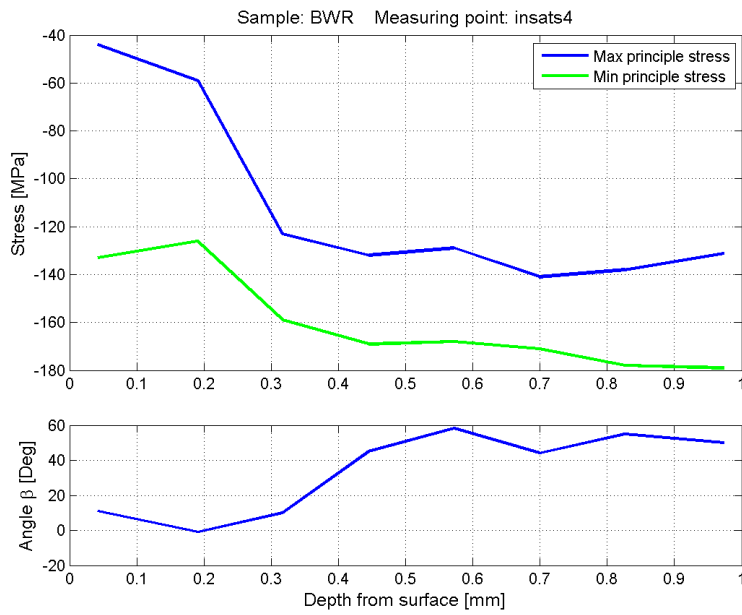
Figure A3:5 Principal stresses calculated for the measuring point *insats4* on the sample

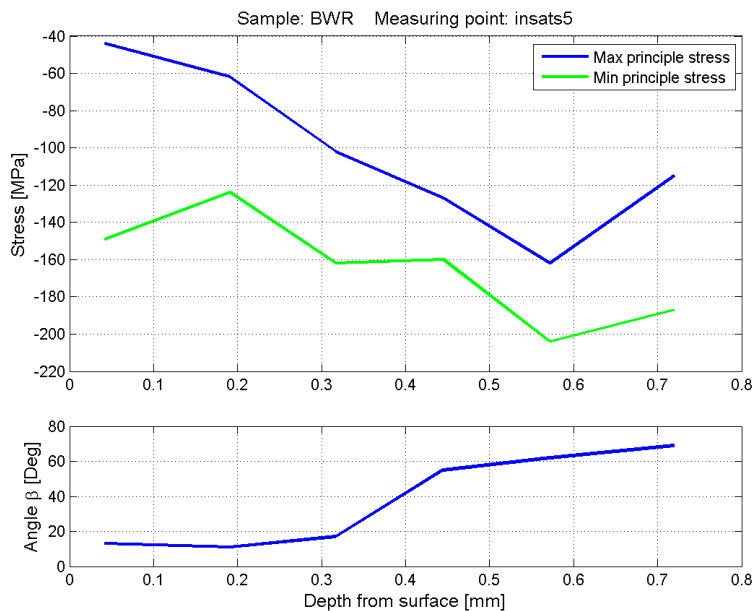
Figure A3:6 Principal stresses calculated for the measuring point *insats5* on the sample.

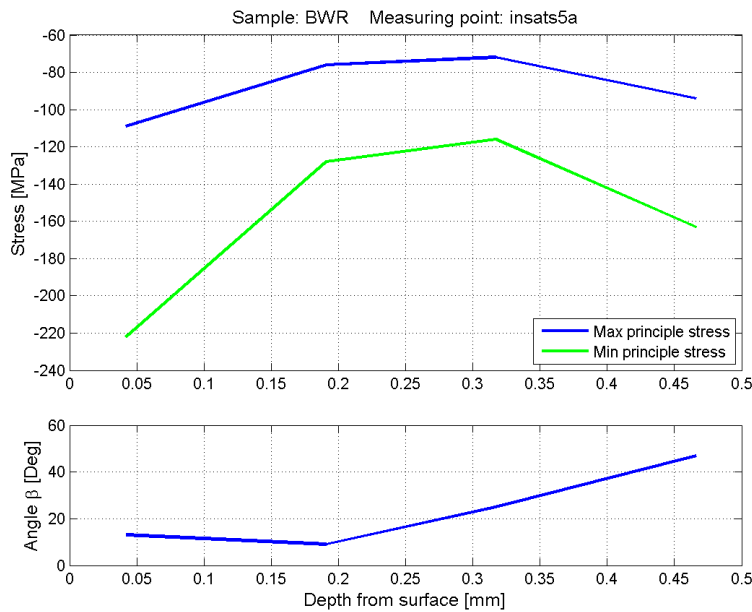
Figure A3:7 Principal stresses calculated for the measuring point *insats5a* on the sample.

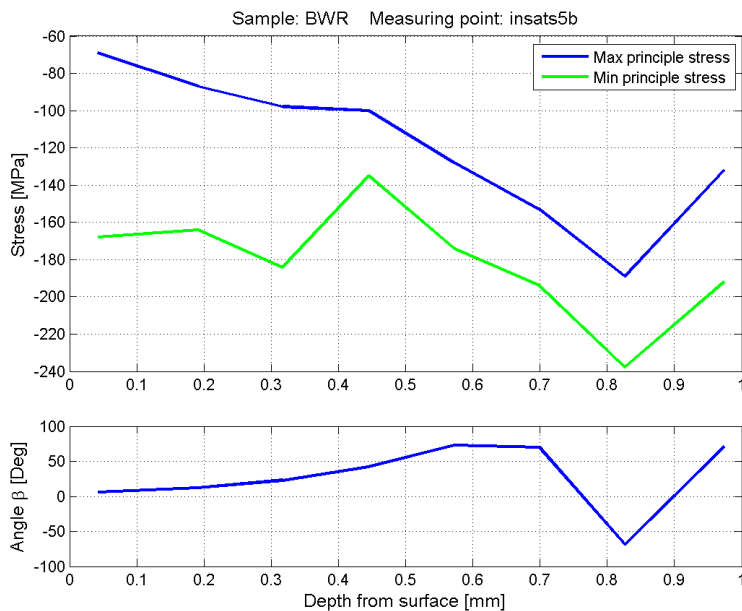
Figure A3:8 Principal stresses calculated for the measuring point *insats5b* on the sample. For the shaded stresses the von Mises effective stress is larger than 70% of the yield stress and therefore they are not reliable.

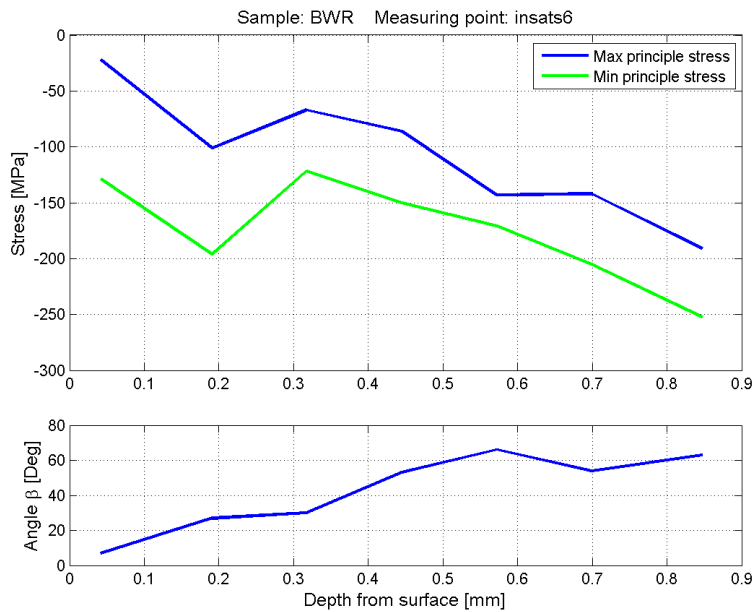
Figure A3:9 Principal stresses calculated for the measuring point *insats6* on the sample. For the shaded stresses the von Mises effective stress is larger than 70% of the yield stress and therefore they are not reliable.

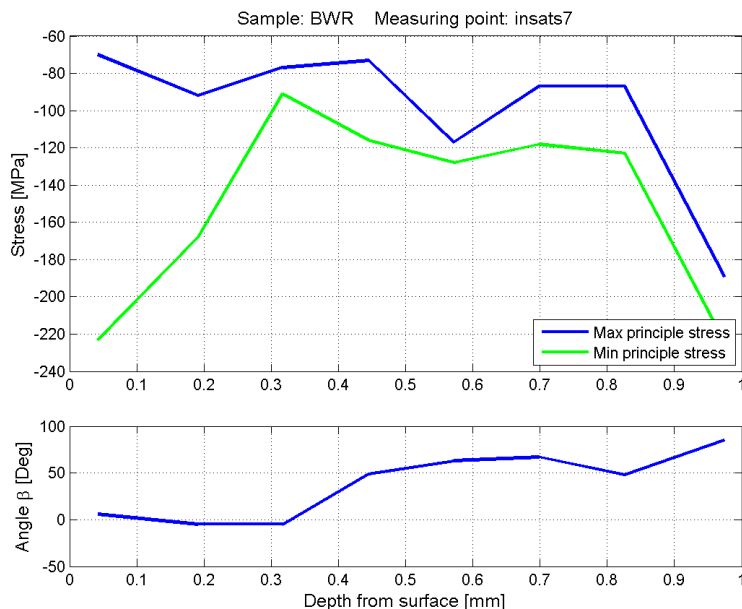
Figure A3:10 Principal stresses calculated for the measuring point *insats7* on the sample. For the shaded stresses the von Mises effective stress is larger than 70% of the yield stress and therefore they are not reliable.

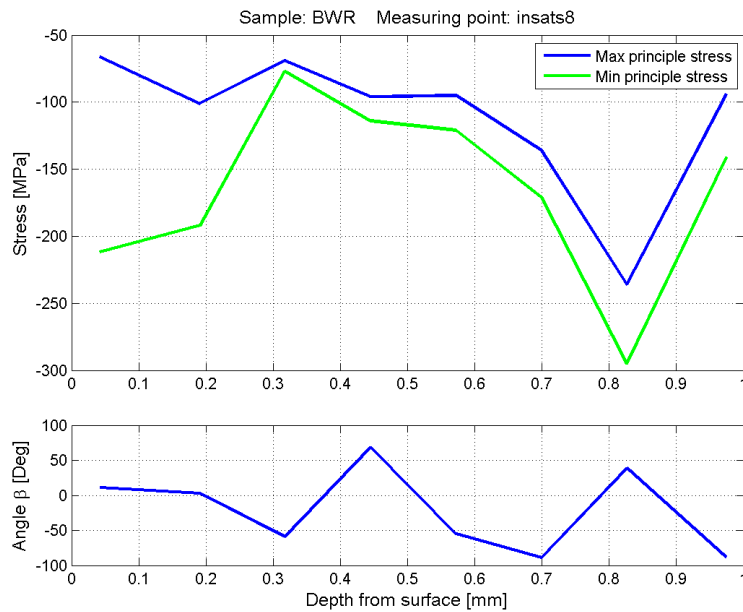
Figure A3:11 Principal stresses calculated for the measuring point *insats8* on the sample. For the shaded stresses the von Mises effective stress is larger than 70% of the yield stress and therefore they are not reliable.

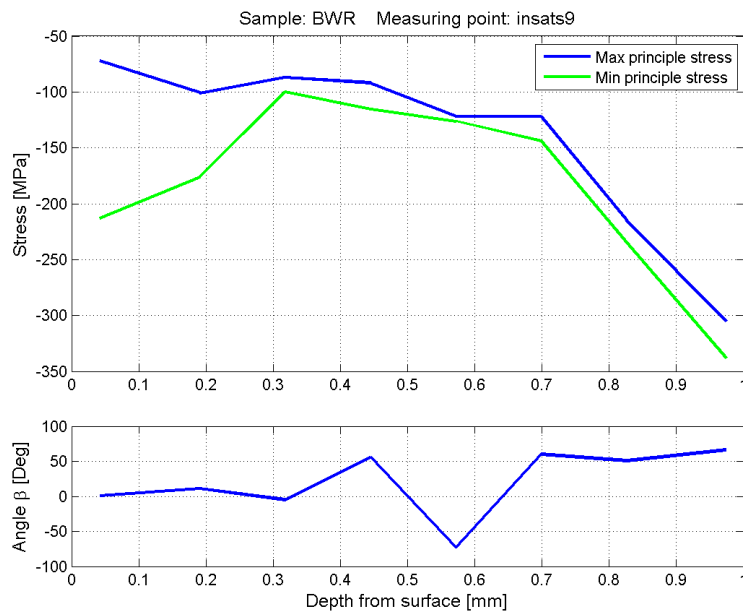
Figure A3:12 Principal stresses calculated for the measuring point *insats9* on the sample. For the shaded stresses the von Mises effective stress is larger than 70% of the yield stress and therefore they are not reliable.

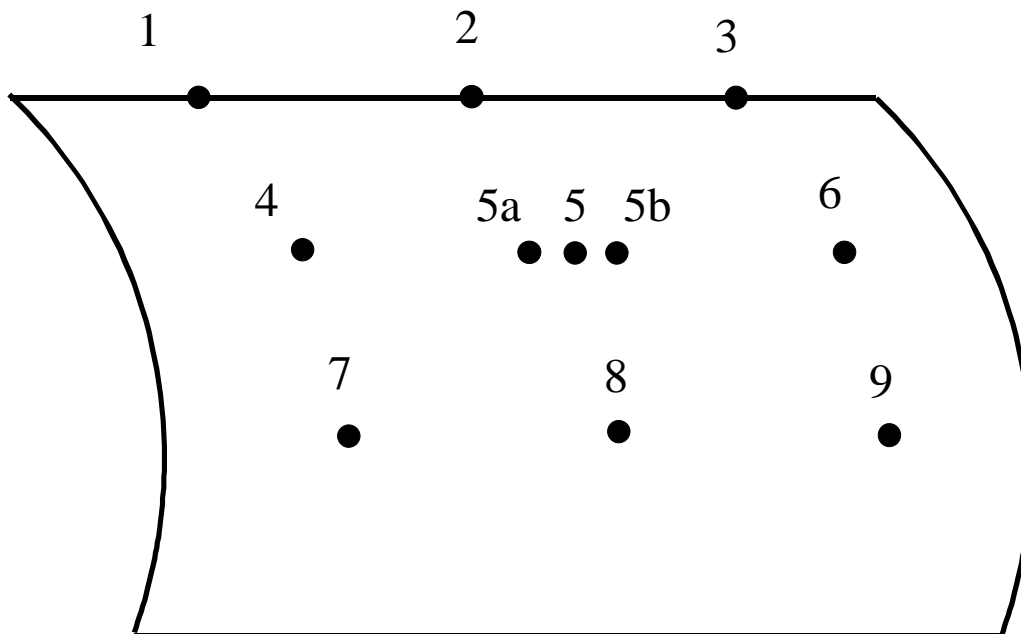
Figure A3:13 A summary of the results from the measurement. For each measurement point the maximum calculated stress (the minimum compressive stress) is given. The aim of this table is to give a quick view of the results and it will not replace the results given in the previous figures. The tension stresses at the location BWRinsats1 are not reliable; see the captions to *Figure A2.1* (in *Appendix 2*) and *Figure A3:2*(in this appendix). According to the main report the uncertainty in the reported values is 15-20%

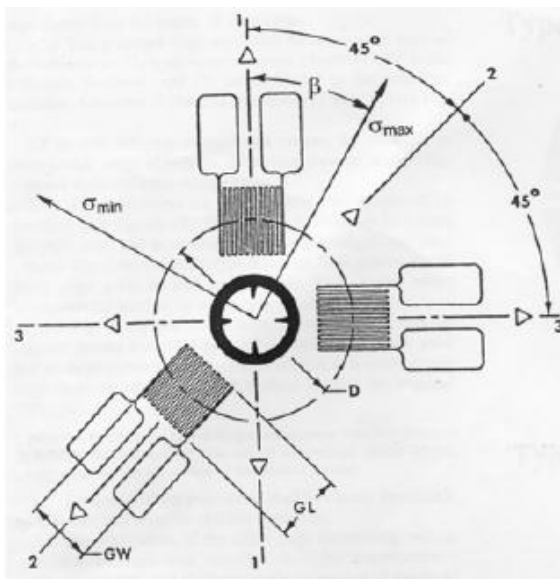
Figure A4: 1 A sketch showing the orientations of the three strain gages and the definition of the angle β .

The gages in the rosette are named Strain gage 1, Strain gage 2 and Strain gage 3 according to Figure A4: 1

In this report the X-direction is the direction of Strain gage 1 and the Y-direction is the direction of Strain gage 3. The angle β is the clockwise angle between Strain gage 1 and the maximum principle stress. With these directions the stresses in the local coordinate system can be calculated from Figure A4: 2

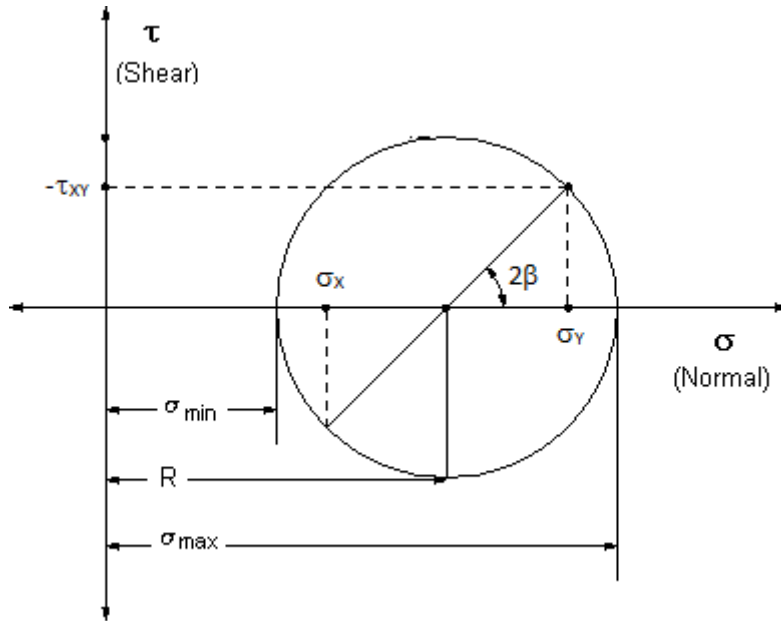
Figure A4: 2 Mohrs circle, with the directions and angles defined in Figure A4: 2. Mohrs circle is used for calculating the stresses in the local coordinate system.

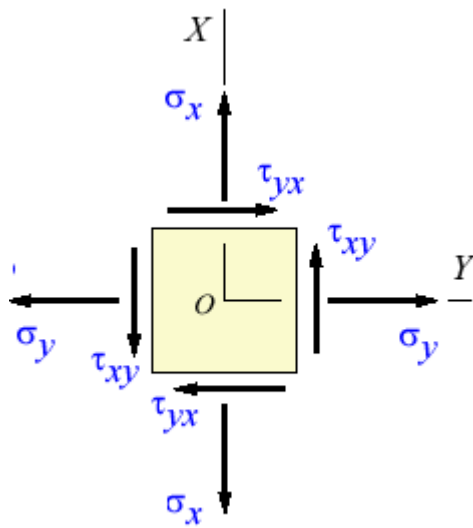
Figure A4: 3 Definition of the directions for the local stresses.

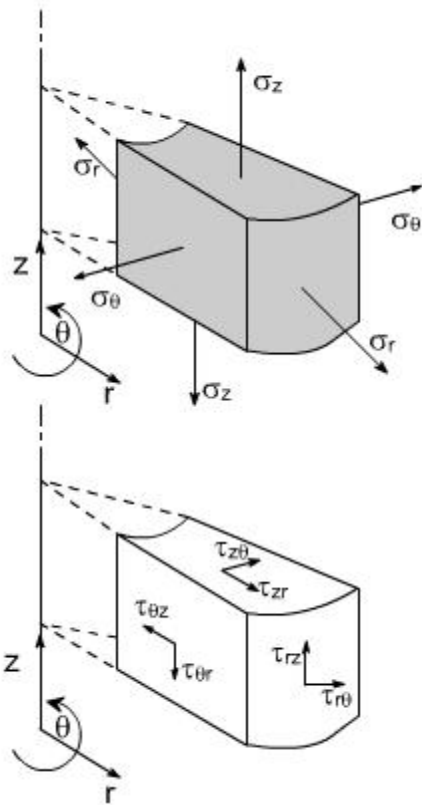
Figure A4: 4 The global coordinate referring to the insert tube, The hoop direction is named θ , the axial z and the radial r .

As global coordinate system for the insert tube, cylindrical coordinates (r, θ, z) are used, see Figure A4: 4.

At the measurements done at SP, all gages were bonded so that the X-direction corresponds to the θ -direction (hoop) and the Y-direction to the z -direction (axial).

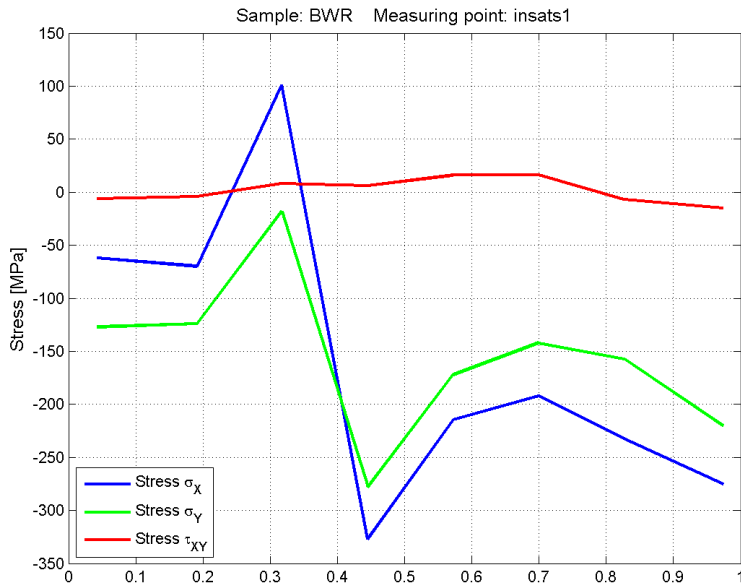
Figure A4: 5 Stresses calculated for the measuring point insats1 on the sample. As can be seen from the raw data (Figure A2:1 in Appendix 2) there was a relative small jump in the measured strains. The tension stresses at the depth 0.32 mm are caused by the disturbances caused by this jump and are therefore not reliable. For the shaded stresses the von Mises effective stress is larger than 70% of the yield stress and therefore they are not reliable.

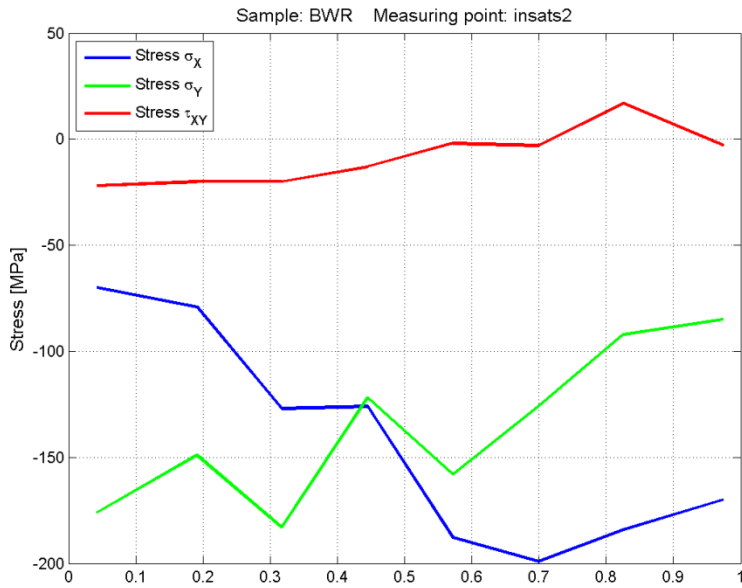
Figure A4: 6 Stresses calculated for the measuring point *insats2* on the sample.

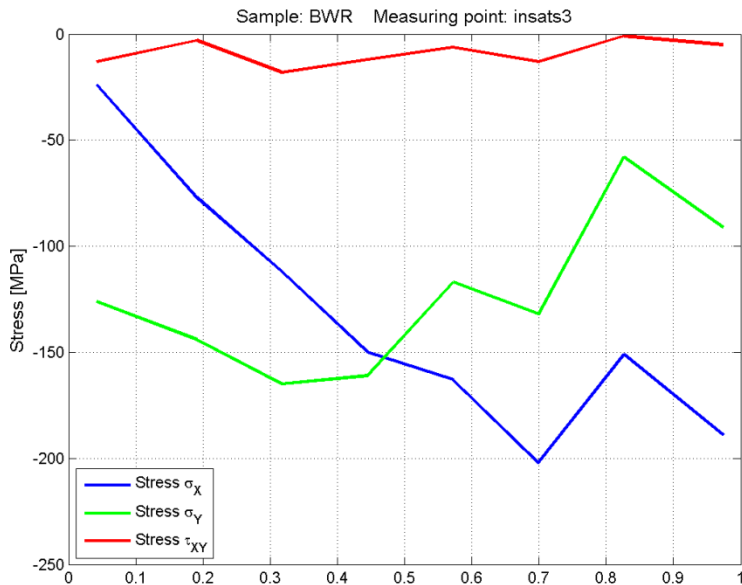
Figure A4: 7 Stresses calculated for the measuring point *insats3* on the sample.

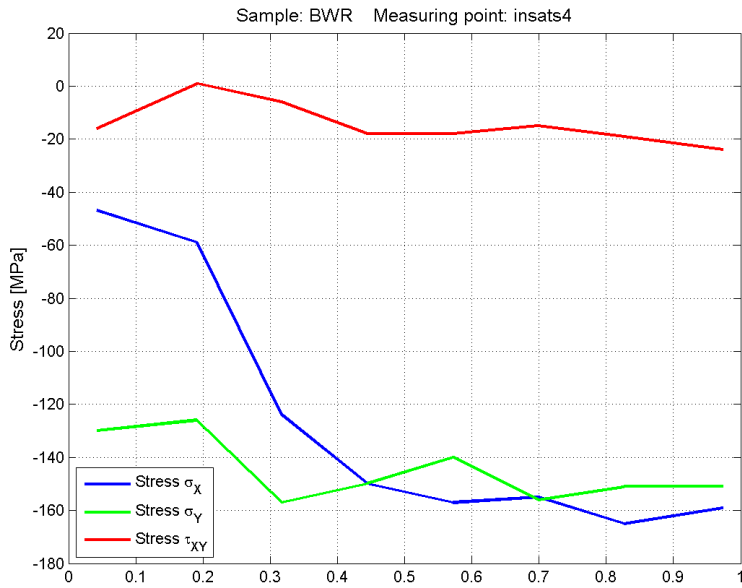
Figure A4: 8 Stresses calculated for the measuring point *insats4* on the sample.

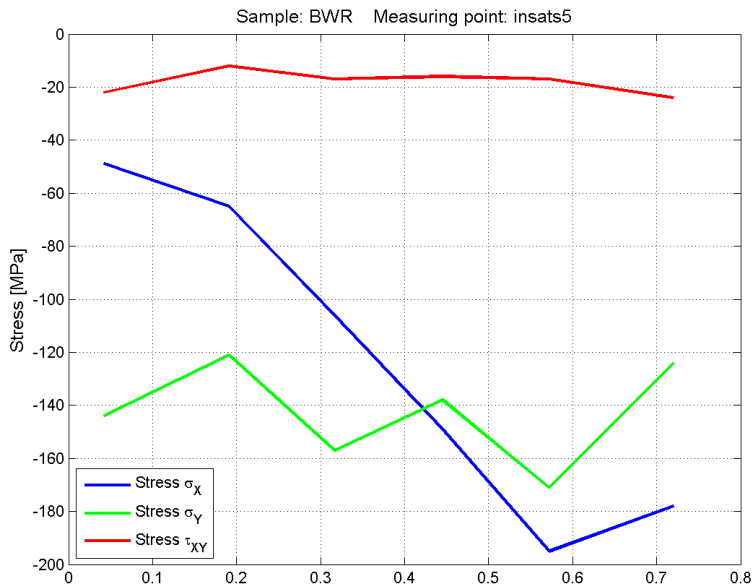
Figure A4: 9 Stresses calculated for the measuring point *insats5* on the sample.

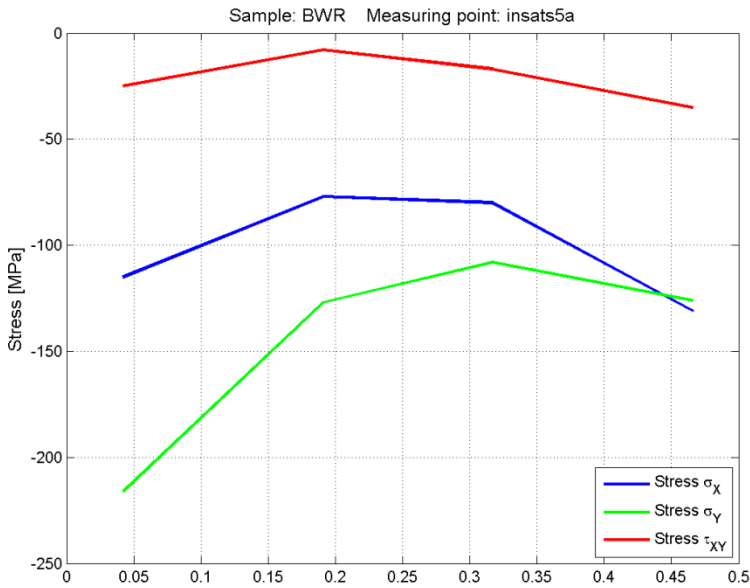
Figure A4: 10 Stresses calculated for the measuring point *insats5a* on the sample.
