Svensk Kärnbränslehantering AB
Kapsellaboratoriet
Box 925
572 29 OSKARSHAMN

Residual stress measuring by incremental hole drilling technique

1 Test object

A half BWR insert tube Ø950 mm and 2000 mm long. The sample was marked I56.

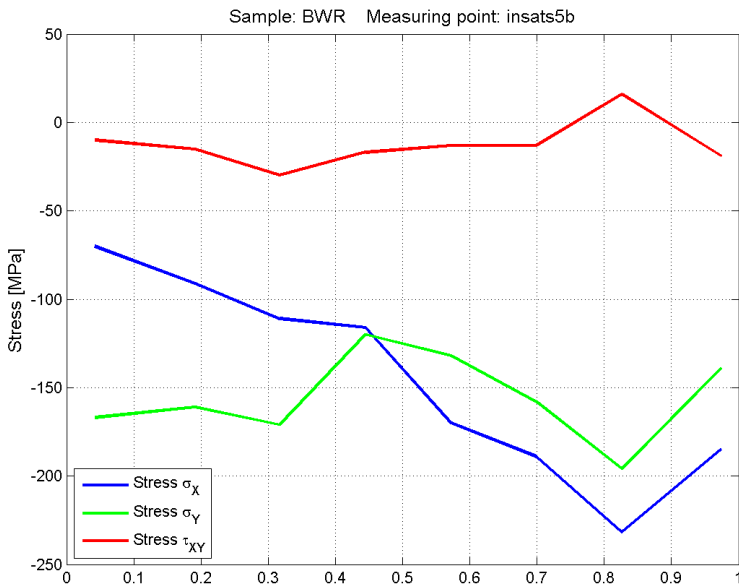
Figure A4: 11 Stresses calculated for the measuring point *insats5b* on the sample. For the shaded stresses the von Mises effective stress is larger than 70% of the yield stress and therefore they are not reliable.

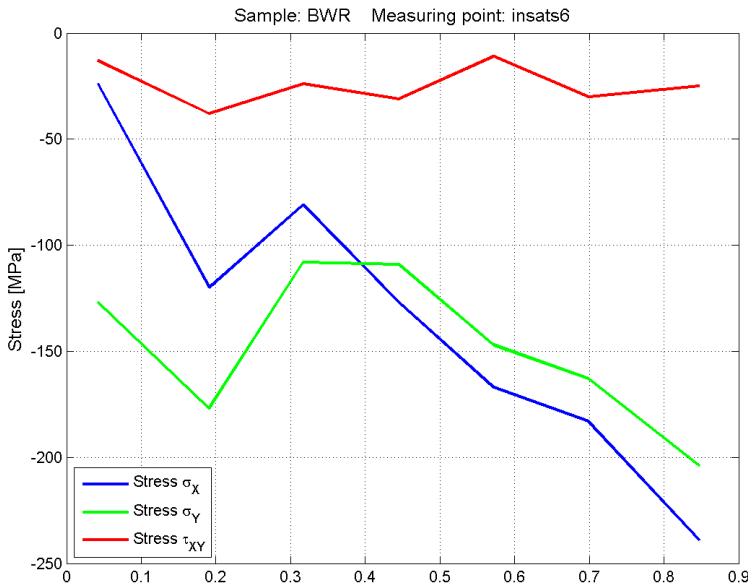
Figure A4: 12 Stresses calculated for the measuring point *insats6* on the sample. For the shaded stresses the von Mises effective stress is larger than 70% of the yield stress and therefore they are not reliable.

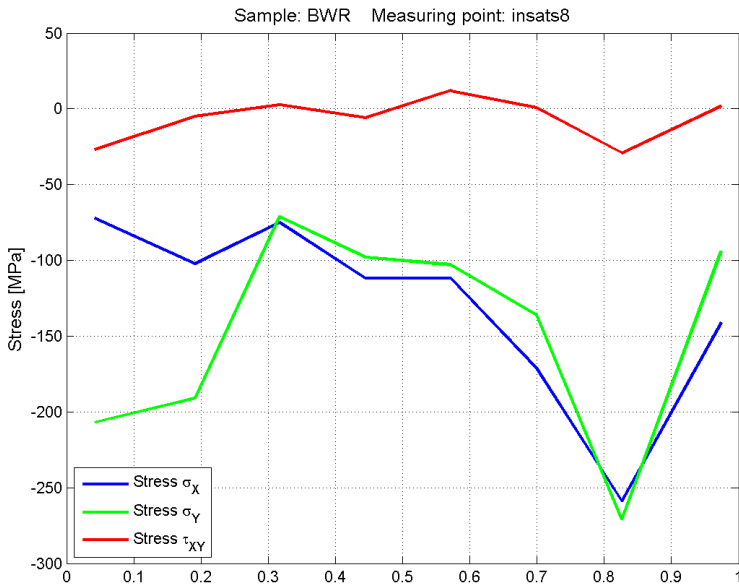
Figure A4: 14 Stresses calculated for the measuring point *insats8* on the sample. For the shaded stresses the von Mises effective stress is larger than 70% of the yield stress and therefore they are not reliable.
