Oskarshamn site investigation

Investigations of goethite-bearing fractures in cored boreholes Laxemar subarea

Henrik Drake, Isochron Geoconsulting HB
Eva-Lena Tullborg, Terralogica AB

March 2009

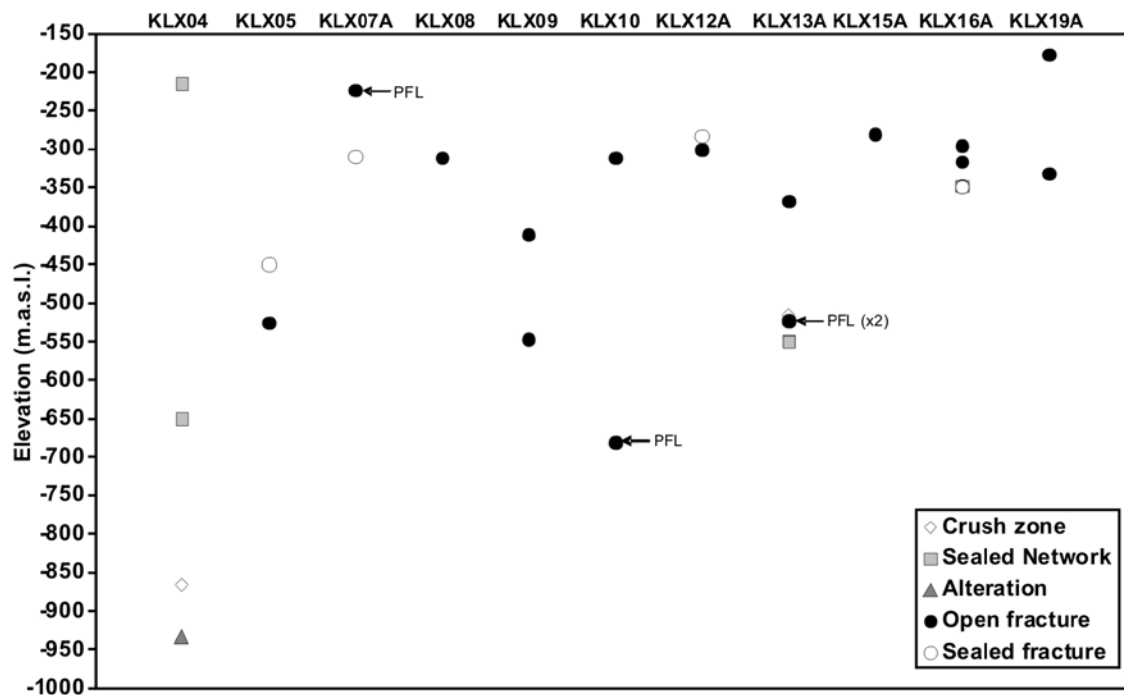
Figure 4-1. Depth distribution of all mapped goethite occurrences from greater depth than -150 m above sea level (as listed in Table 4-1 to Table 4-4). “PFL” = Fracture is in water conductive section (PFL anomaly) but is not listed as best choice fracture in the Sicada data.

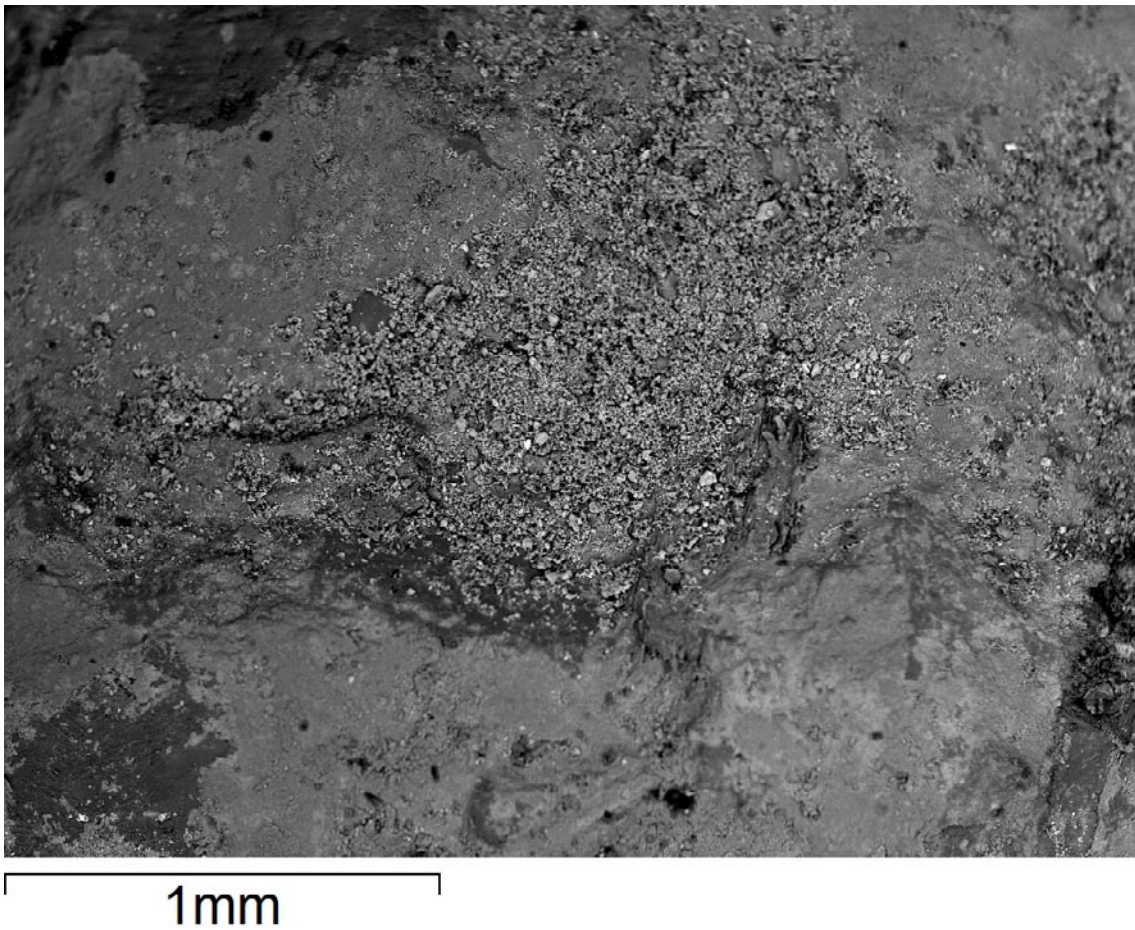
Description: The mapped goethite occurrence is found in an open fracture as a fine-grained, brown powder on the fracture surface and on the fresh drill core surface (Figure 5-5). The powder is made up of fine-grained, angular mineral fragments of common rock forming minerals such as quartz and feldspars but also of chlorite, clay minerals and Fe-oxides (which give the colouration, Figure 5-6 and Figure 5-7). EDS analyzes indicate a significant amount of Zn, Mn, C, Si and Cl on the surface of these minerals (especially related to Fe-oxides and Fe-rich chlorite/clay minerals, Figure 5-8). Zn, Mn, as well as C and Si might originate from the drilling equipment and Cl may be a remnant from the mapping (HCl used for calcite identification). This fine-grained powder is only found in morphological depressions on the fracture surface, which indicate that it has been emplaced after the drilling (and have not been precipitated on the fracture surface). These observations indicate that the fine-grained powder mapped as goethite, is drilling induced and is recommended to be removed from the mapping data. Additional minerals to be included in the mapping file are pyrite and chalcopyrite.

Figure 5-6. Back-scattered SEM-image of the fracture surface of open fracture KLX08: 388.561 m.

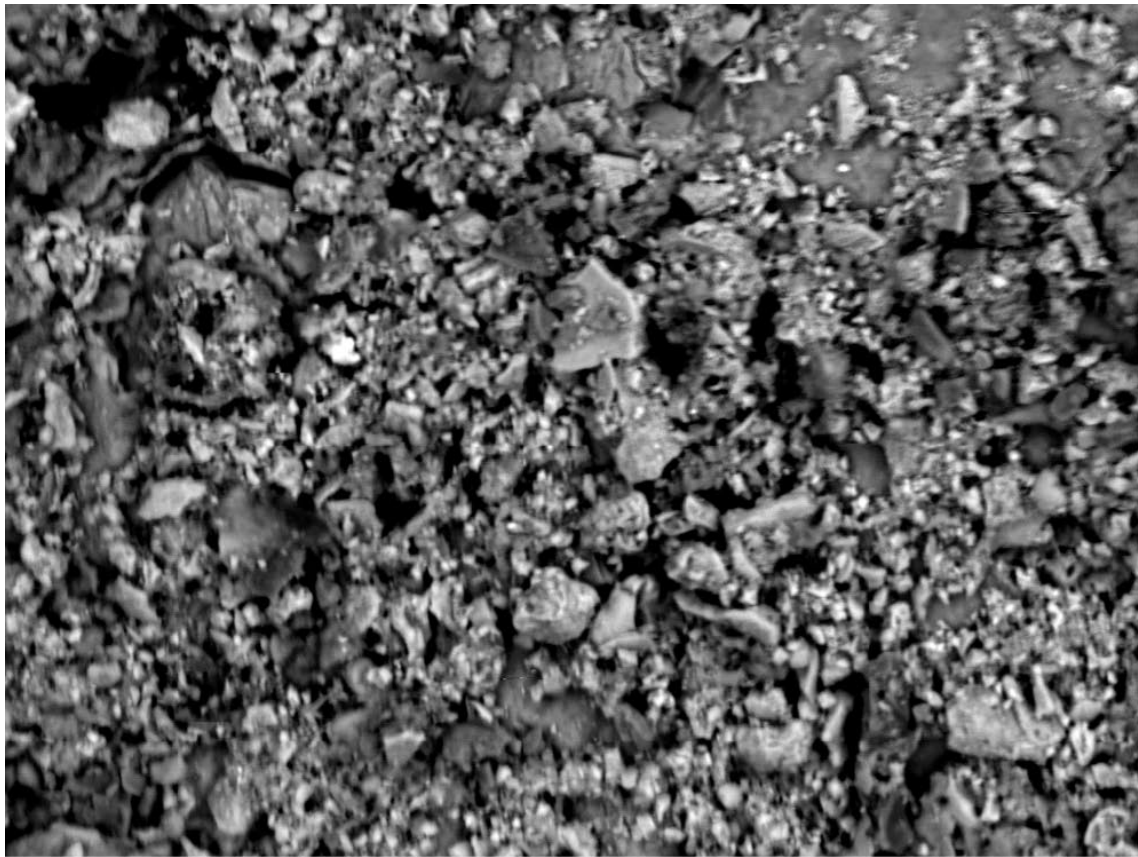
Figure 5-7. Back-scattered SEM-image of the fracture surface of open fracture KLX08: 388.561 m.

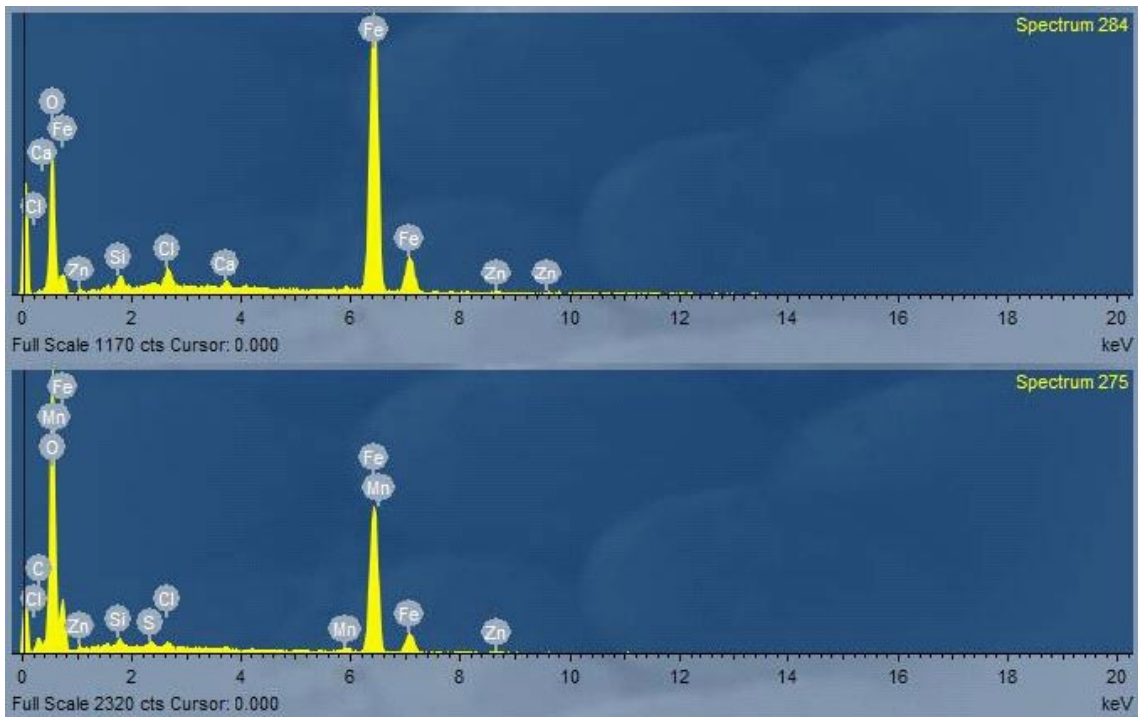
Figure 5-8. EDS-spectra for Fe-oxides (Spectrum 284 and Spectrum 275) from fracture KLX08: 388.561 m. Note the peaks for C, Cl, Zn and Mn.

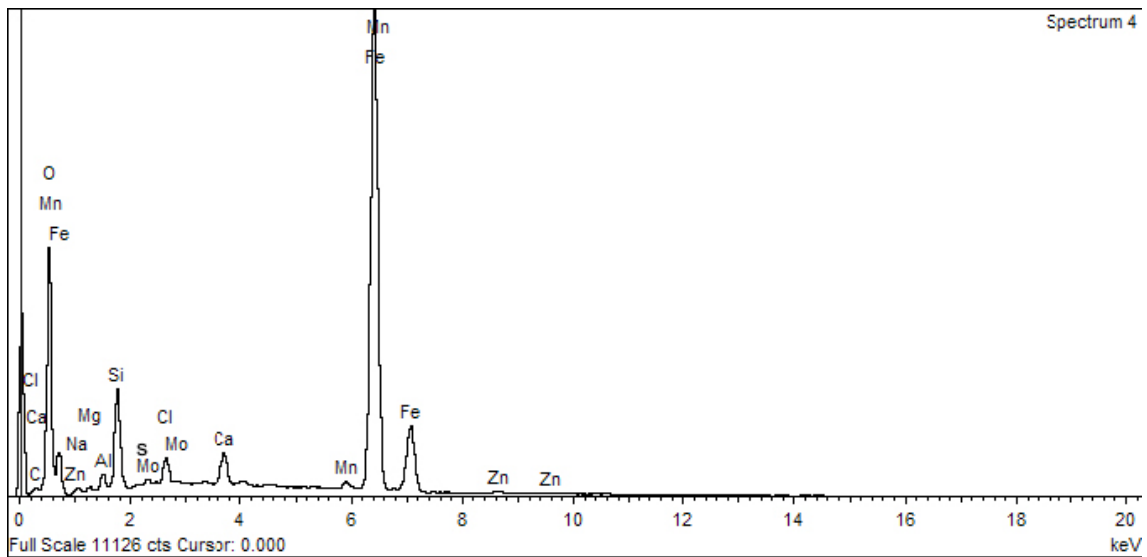
Description: The mapped goethite occurrence is found in an open fracture (Figure 5-9) as fine-grained, scattered spots with metallic lustre (Figure 5-10). The spots are partly corroded. They are interpreted to be fragments from the drilling equipment because they resemble metallic fragments which have corroded (as shown in the SEM-images Figure 5-11, Figure 5-12). In addition, the EDS-analyses show that these fragments are made up of Fe mainly, but include some Si, Zn, Mn, S, Mo, C and Cl as well (Figure 5-13). This further supports an origin from the drilling equipment, which is Fe-dominated and have trace amounts of e.g. Mn, Mo and Si. Furthermore, metallic markings on the core, resulting from drill wear, adjacent to this fracture (Figure 5-9) indicate that the drilling has been experiencing some difficulties at this stage and it is therefore even more likely that fragments from the drilling equipment has been emplaced on the fracture surface. During the drill core mapping, these metallic spots were identified as pyrite crystals, which have been partly altered to goethite. SEM-investigations show that no pyrite is present. Instead, the spots are interpreted to be fragments from the drilling equipment and both pyrite and goethite should therefore preferably be removed from the mapping data.

Figure 5-13. EDS-spectrum for metallic fragment on the surface of fracture KLX09: 437.210 m.

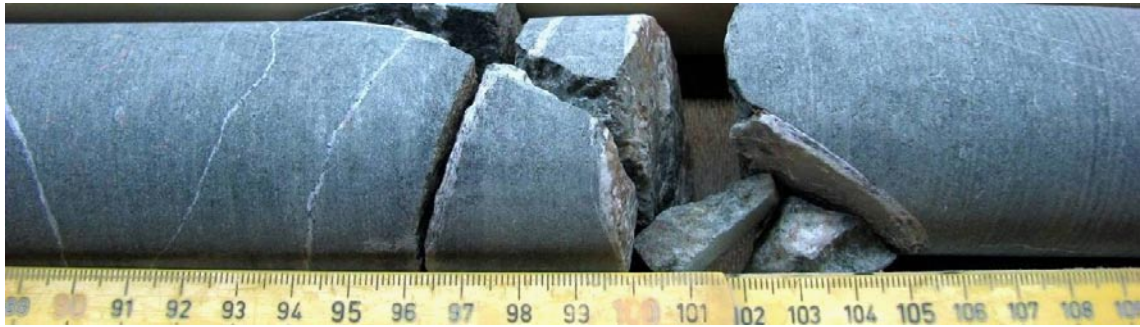
This sample contains two fractures with mapped goethite occurrences (sample is shown in Figure 5-14).

Figure 5-14. Photograph of sample KLX10: 331.97–332.02 m (the two pieces in the centre of the photograph).

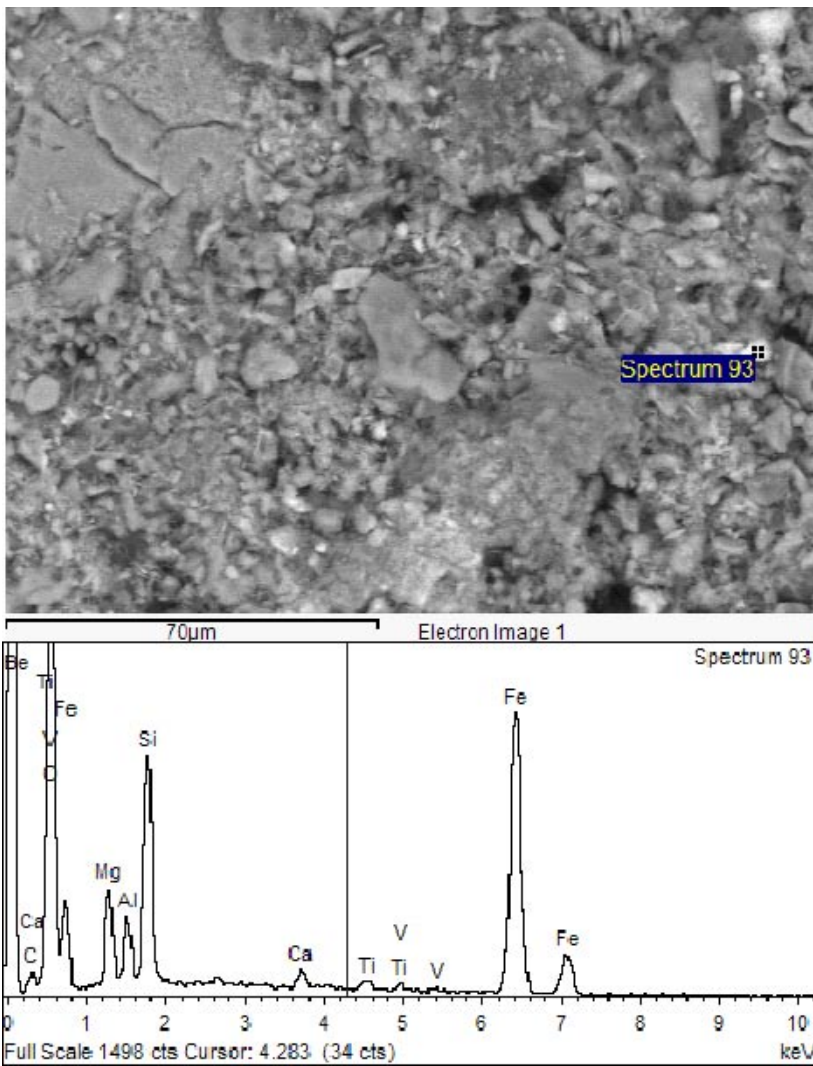
Description: The mapped goethite occurrence is found in an open fracture as a fine-grained, brown powder on the fracture surface, especially around the drill core edges, which may indicate that it is drilling induced powder (Figure 5-15). The powder consists of fine-grained, angular mineral fragments (Figure 5-16 and Figure 5-17). These fragments are made up of common rock forming minerals such as quartz and feldspars but also of chlorite, clay minerals and Fe-oxides (which give the colouration). EDS analyzes indicate a significant amount of V, Ti, Ca, Cl on the surface of these minerals (especially related to Fe-oxides and Fe-rich chlorite/clay minerals, Figure 5-8). Some of these elements might originate from the drilling equipment. Some of the parts of the filling show typical hematite colour (cf. /Drake and Tullborg 2004, 2007/, and hematite is therefore suggested to replace goethite in the mapping data, because goethite is probably emplaced as a drilling induced powder on the fracture surface. This interpretation is based on the angular fragments of this coating and by the position of the powder on the fracture surface, i.e. mostly at the drill core rim, as well as partly by the chemistry of the powder, i.e. rich in elements which generally are rare in fracture coatings cf. /Drake and Tullborg 2008abc/).

Figure 5-16. Back-scattered SEM-image and related EDS-spectrum for Fe-rich clay mineral (or chlorite) (Spectrum 93) in powder of fine-grained angular mineral fragments from open fracture KLX10: 331.987 m.

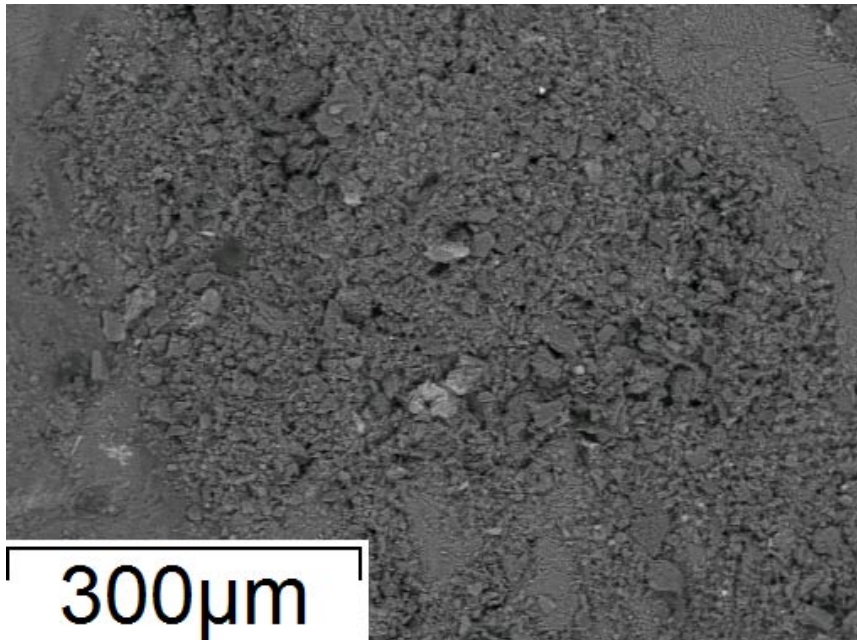
Figure 5-17. Back-scattered SEM-image of powder of fine-grained angular mineral fragments from open fracture KLX10: 331.987 m.

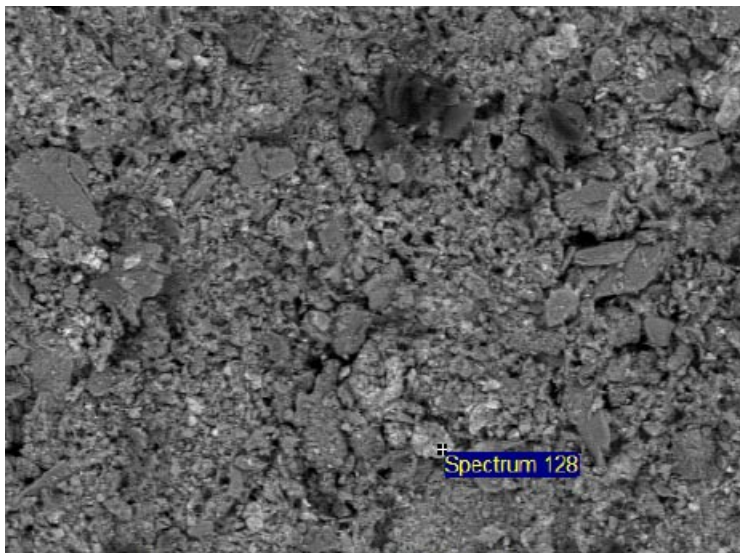
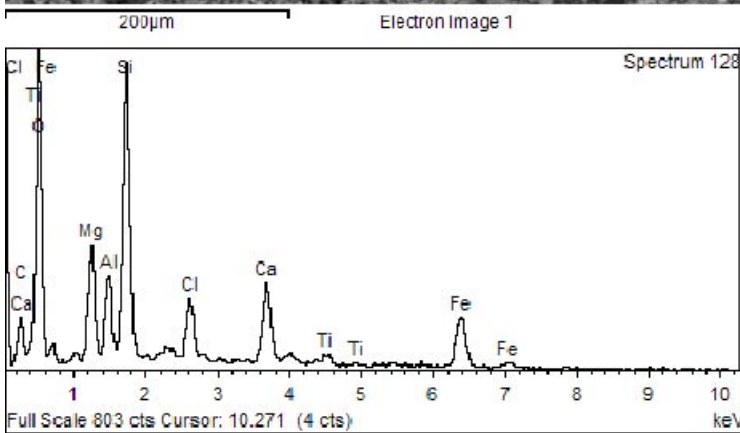
Description: The mapped goethite occurrence is found in an open fracture as a fine-grained, brown powder on the fracture surface especially around the drill core edges, which may indicate that it is drilling induced powder (Figure 5-18). The powder consists of fine-grained, angular mineral fragments (Figure 5-19 and Figure 5-20). These fragments are made up of quartz and feldspars but also of chlorite, clay minerals and Fe-oxides (which give the colouration). EDS analyzes indicate a significant amount of Mn, Ti, Ca, Cl on the surface of these minerals (especially related to Fe-oxides and Fe-rich chlorite/clay minerals, Figure 5-8). Some of these elements (e.g. Mn) may originate from the drilling equipment. Parts of the filling show typical hematite colour (cf. /Drake and Tullborg 2004, 2007/). Goethite is interpreted to have been emplaced as a drilling induced powder on the fracture surface (as indicated by the angular fragments of this coating and by the position of the powder on the fracture surface, i.e. at the drill core rims and where originally present minerals have been damaged and removed during drilling, as well as partly by the chemistry of the powder, i.e. rich in elements which are rare in fracture coatings otherwise, cf. /Drake and Tullborg 2008abc/). Furthermore, fresh unaltered pyrite is present on the fracture surface, indicating prevailing reducing conditions in the fracture. These observations indicate that the fine-grained powder mapped as goethite, is drilling induced and is therefore recommended to be removed from the mapping data. Clay minerals and pyrite should be included in the mapping data.

Figure 5-19. Back-scattered SEM-image and related EDS-spectrum for Fe-rich and Ca-rich clay mineral (Spectrum 128) in powder of fine-grained angular mineral fragments from open fracture KLX10: 332.012 m.

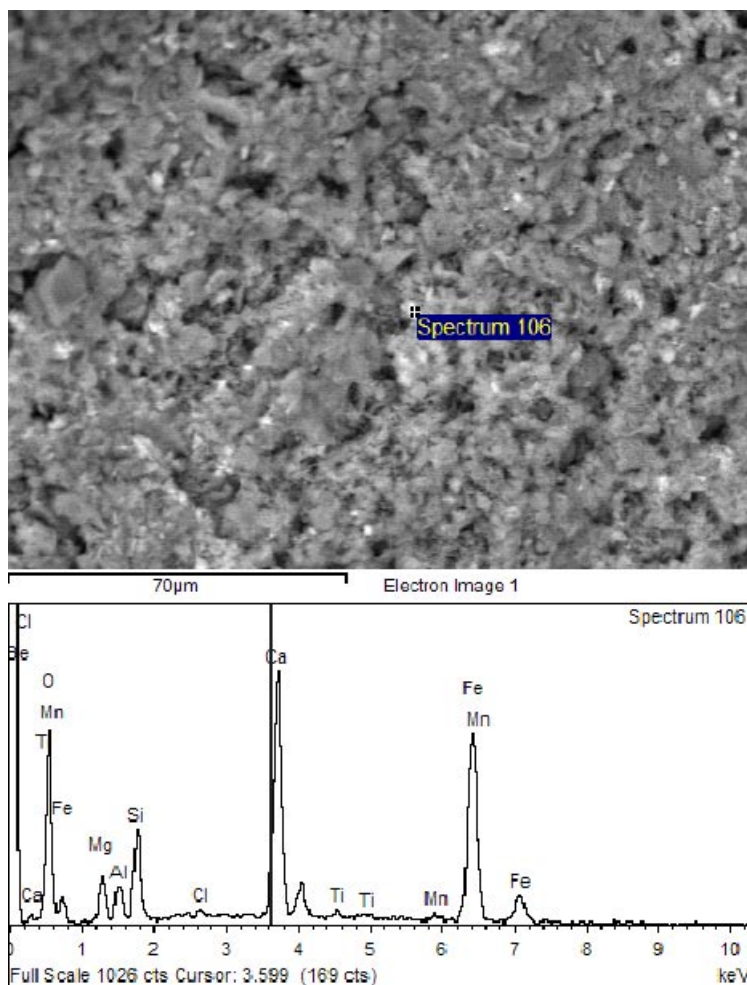
Figure 5-20. Back-scattered SEM-image and related EDS-spectrum for a mixture of Fe-rich clay mineral and calcite (Spectrum 106) in powder of fine-grained angular mineral fragments from open fracture KLX10: 332.012 m.

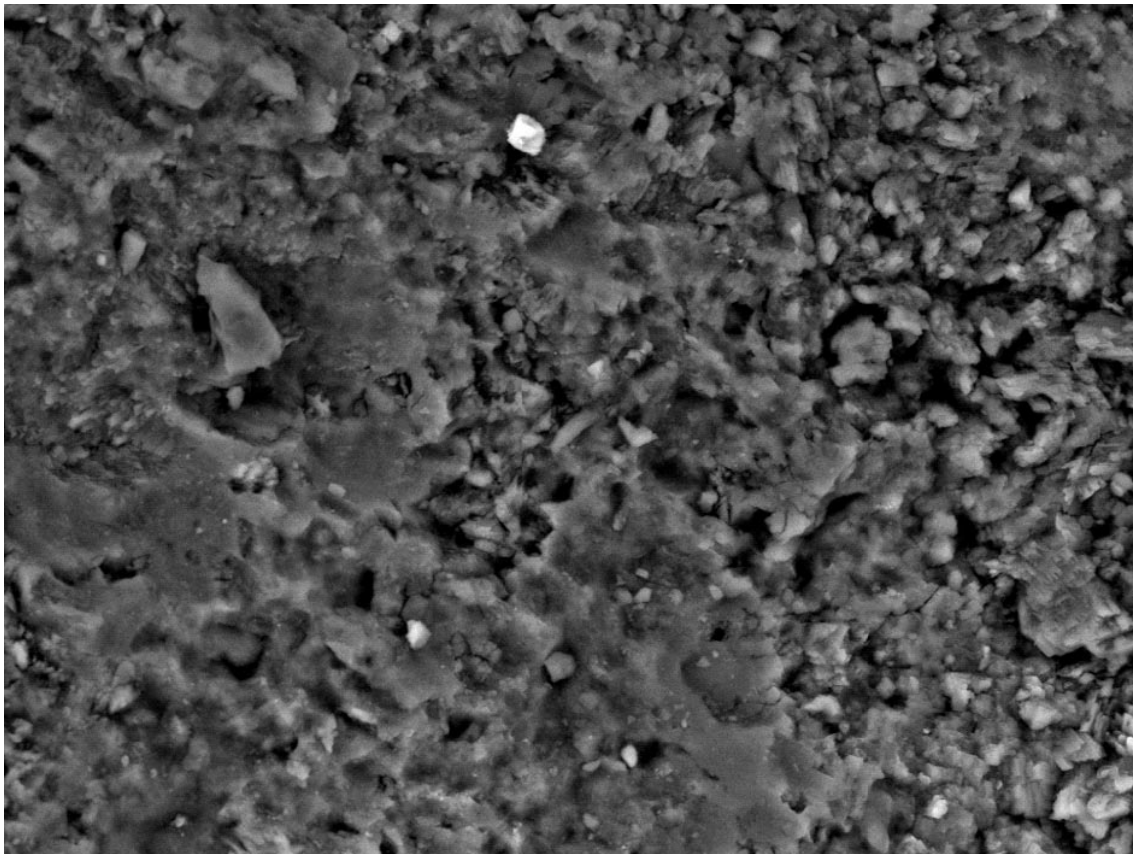
Description: The mapped goethite occurrence is found in an open fracture as a fine-grained, brown powder on the surface of an older fracture mineral coating (Figure 5-21). Detailed SEM-EDS investigations reveal that no Fe-rich minerals (except fresh pyrite) are present in the coating. Most of the coating is made up of calcite, illite and adularia (possibly hematite-stained, but no hematite was identified) with minor amount of pyrite (Figure 5-22). Therefore it is suggested that goethite is removed from the mapping data.

Figure 5-22. Back-scattered SEM-image of illite and adularia coating (dark) with a bright pyrite crystal on the fracture surface of open fracture KLX10: 704.339 m.

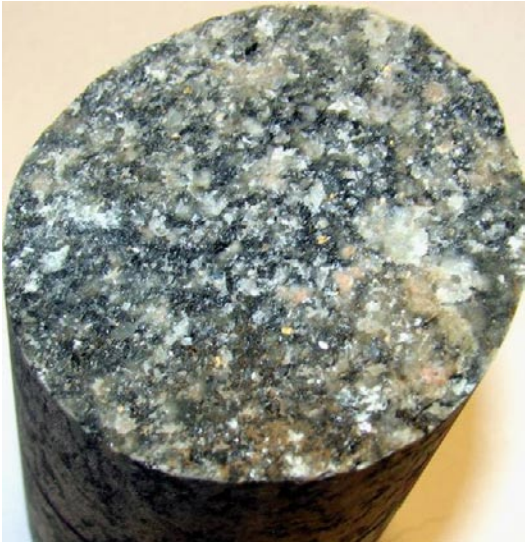
Description: The mapped goethite occurrence is found in an open fracture as a fine-grained, brown powder on the fracture surface, as well as on the side of drill core and at the fracture-drill core edges, which may indicate that it is drilling induced powder (Figure 5-23 and Figure 5-24). The powder consists of fine-grained, angular mineral fragments (Figure 5-25 and Figure 5-26). These fragments are made up of common rock forming minerals such as quartz and feldspars but also of chlorite, clay minerals and Fe-oxides (which give the colouration). EDS-analyses indicate a significant amount of e.g. Mn, Ca, Si on the surface of these minerals (especially related to Fe-oxides and Fe-rich chlorite/clay minerals). Goethite is interpreted to have been emplaced as a drilling induced powder on the fracture surface (as indicated by the angular fragments of this coating and by the position of the powder on the fracture surface, i.e. at the fracture-drill core rims and at the drill core side). Furthermore, fresh pyrite is present on the fracture surface indicating prevailing reducing conditions in the fracture. These observations indicate that the fine-grained powder mapped as goethite, is drilling induced and is recommended to be removed from the mapping data and that pyrite should be included instead.

Figure 5-24. Photograph of the fracture surface of open fracture KLX12A: 332.221 m.

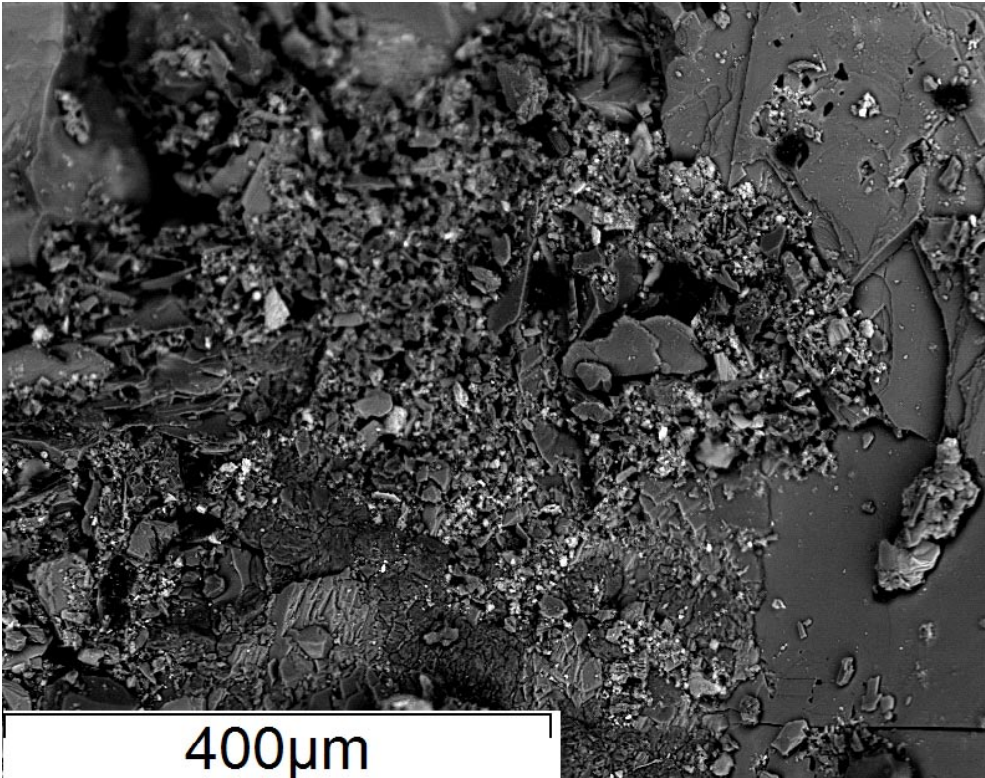
Figure 5-25. Back-scattered SEM-image of fine-grained powder consisting of angular mineral fragments on the rather smooth fracture surface of open fracture KLX12A: 332.221 m.

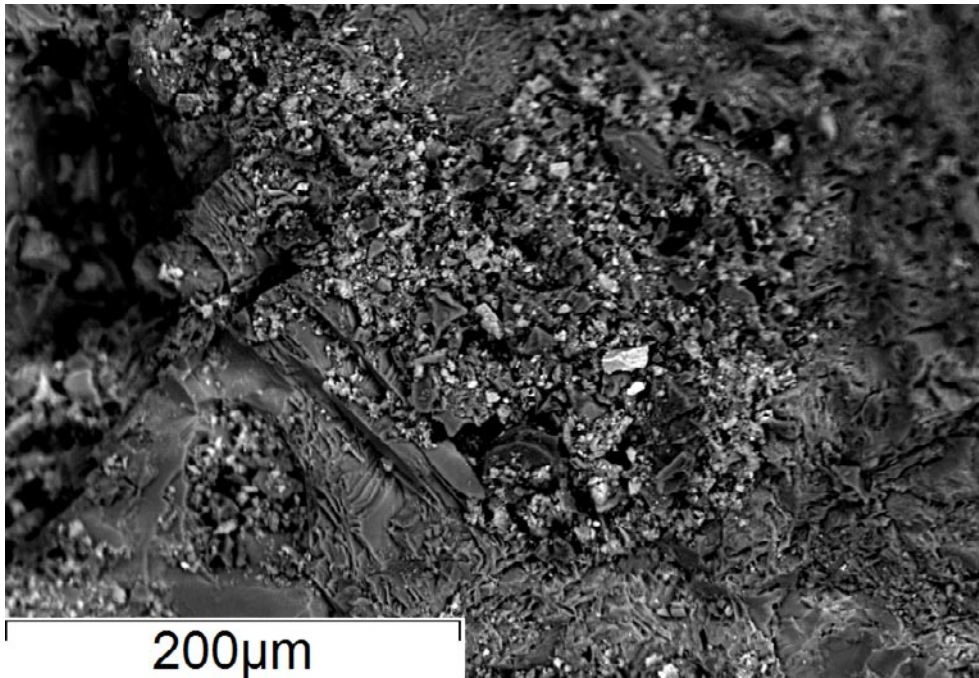
Figure 5-26. Back-scattered SEM-image of fine-grained powder consisting of angular mineral fragments on the rather smooth fracture surface of open fracture KLX12A: 332.221 m.

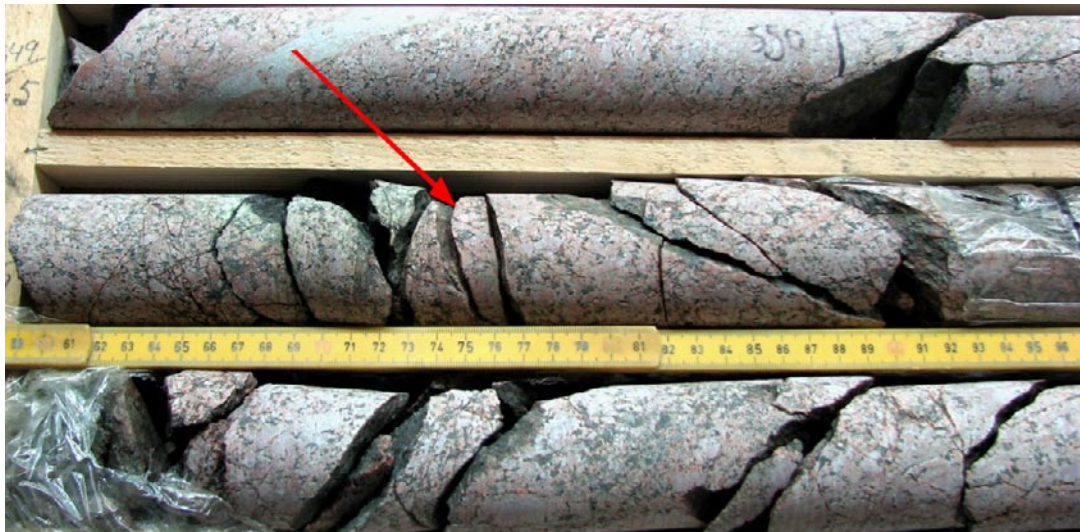
This sample contains two fractures with mapped goethite occurrences (sample is shown in Figure 5-27).

Figure 5-27. Photograph of drill core sample KLX13A: 550.74–550.75 m (arrow).

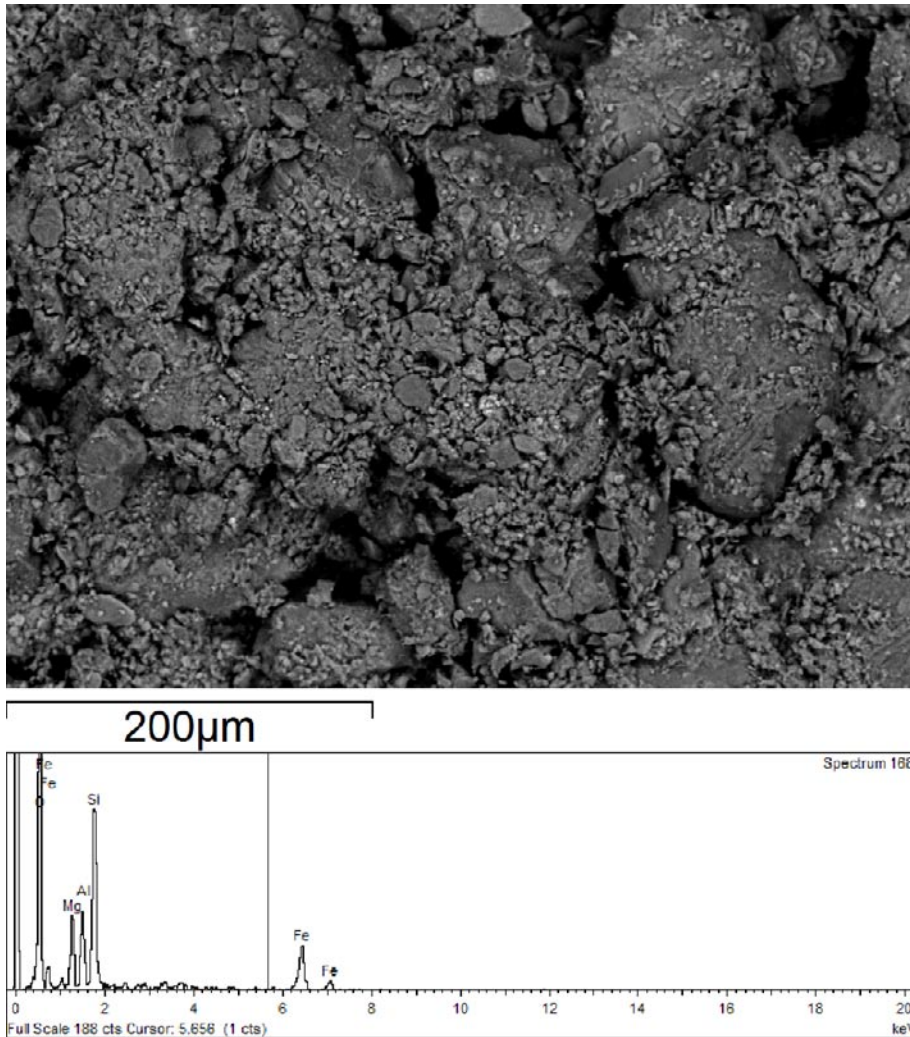
Figure 5-29. Back-scattered SEM-image with related EDS-spectrum of a chlorite-dominated part of the fracture coating of open fracture KLX13A: 550.762 m.

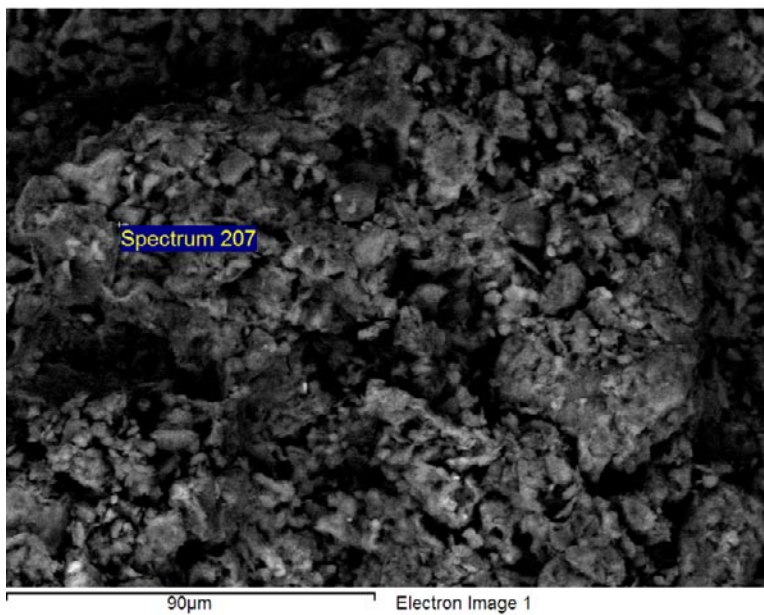
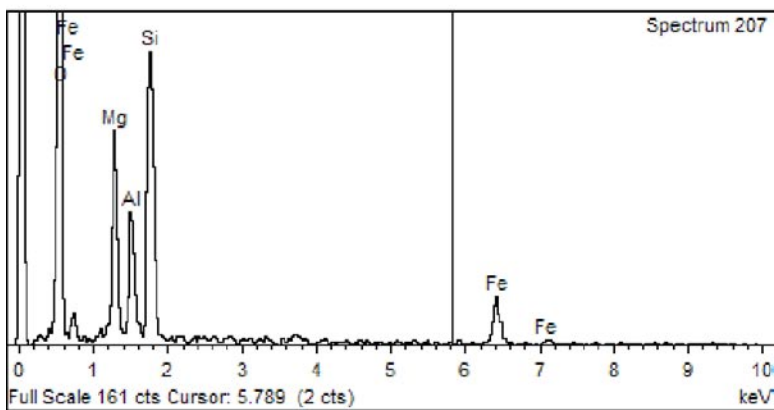
Description: This open fracture is located in a highly fractured section in KLX13A (Figure 5-31). The coating is dominated by clay minerals and chlorite, with their characteristic dark green to green colour. Some parts of the filling are more brownish, similar to hematite-stained fracture coatings described in other samples above and from earlier studies in the area (cf. /Drake and Tullborg 2004, 2005, 2006, 2007, 2008abc/). This colouration is darker than the colour of goethite, and is mainly due to hematite-staining/pigmentation of fracture chlorite (cf. /Drake and Tullborg 2008d/). Therefore it is suggested that hematite, should replace goethite in the mapping file. The amount of hematite is very small, even in the brown coloured parts of the coating. Figure 5-32 shows an SEM-image on a related EDS-spectrum of Mg-rich chlorite in a brown coloured part of the filling. Very few, if any, Fe-rich spots (hematite) are visible. Other minerals to be included in the mapping data are calcite, pyrite and barite.

Figure 5-32. Back-scattered SEM-image and related EDS-spectrum for brown coloured fracture coating dominated by chlorite (Mg-rich). No Fe-oxides are visible. Sample KLX13A: 551.30–551.41 m.

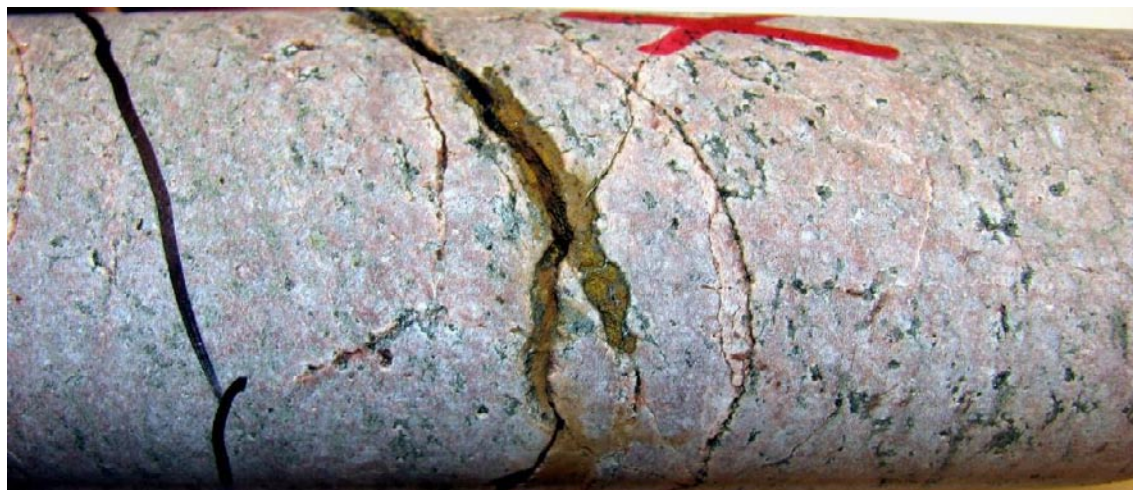
Description: The fracture coating in this open fracture is made up of soft dark green (chlorite and clay minerals) and brown minerals (dark, brick red hematite and bright brown goethite, as well as clay minerals), as well as some whitish calcite (Figure 5-33 and Figure 5-34). As seen in Figure 5-33, a brown coloured powder, similar to the fracture coating is also visible on the side of the drill core. In contrast to the metallic markings on the core, resulting from drill wear, described for other samples above, the powder on the drill core side in this sample is probably originating from the fracture coating, especially since the fracture coating is made up of minerals that have clearly grown from the fracture surface (and is not emplaced as a loose powder) (Figure 5-35 and Figure 5-36). The brown coloured parts of the filling are made up of Fe-oxides/oxyhydroxides (“1” in Figure 5-35 and the bright parts of Figure 5-36) and spherulitical aggregates of corrensite (“2” in Figure 5-35, which has been reported earlier from this area, cf. /Drake and Tullborg 2007/). The Fe-oxides/oxyhydroxides are both pure Fe-oxide (hematite) and Fe-oxyhydroxides containing some Si and Al as well (see EDS-spectrum in Figure 5-35), which resembles to EDS-analyses of goethite from earlier studies in the Laxemar subarea (/Drake and Tullborg 2008d/).

Figure 5-33. Photograph of sample KLX15A: 379.39–379.63 m.

Clay minerals and barite should be added to the comment file.

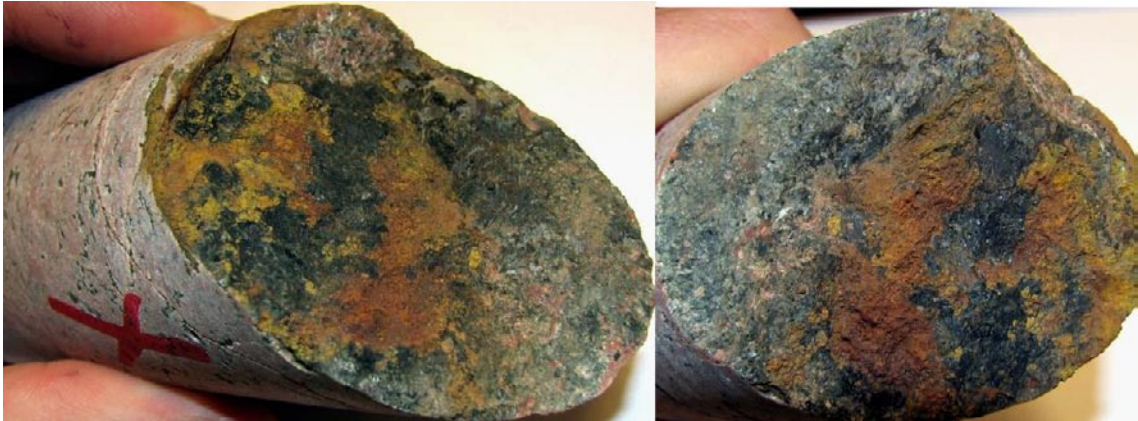
Figure 5-34. Photograph of the two fracture surfaces of open fracture KLX15A: 379.524 m (sample KLX15A: 379.39–379.63 m).

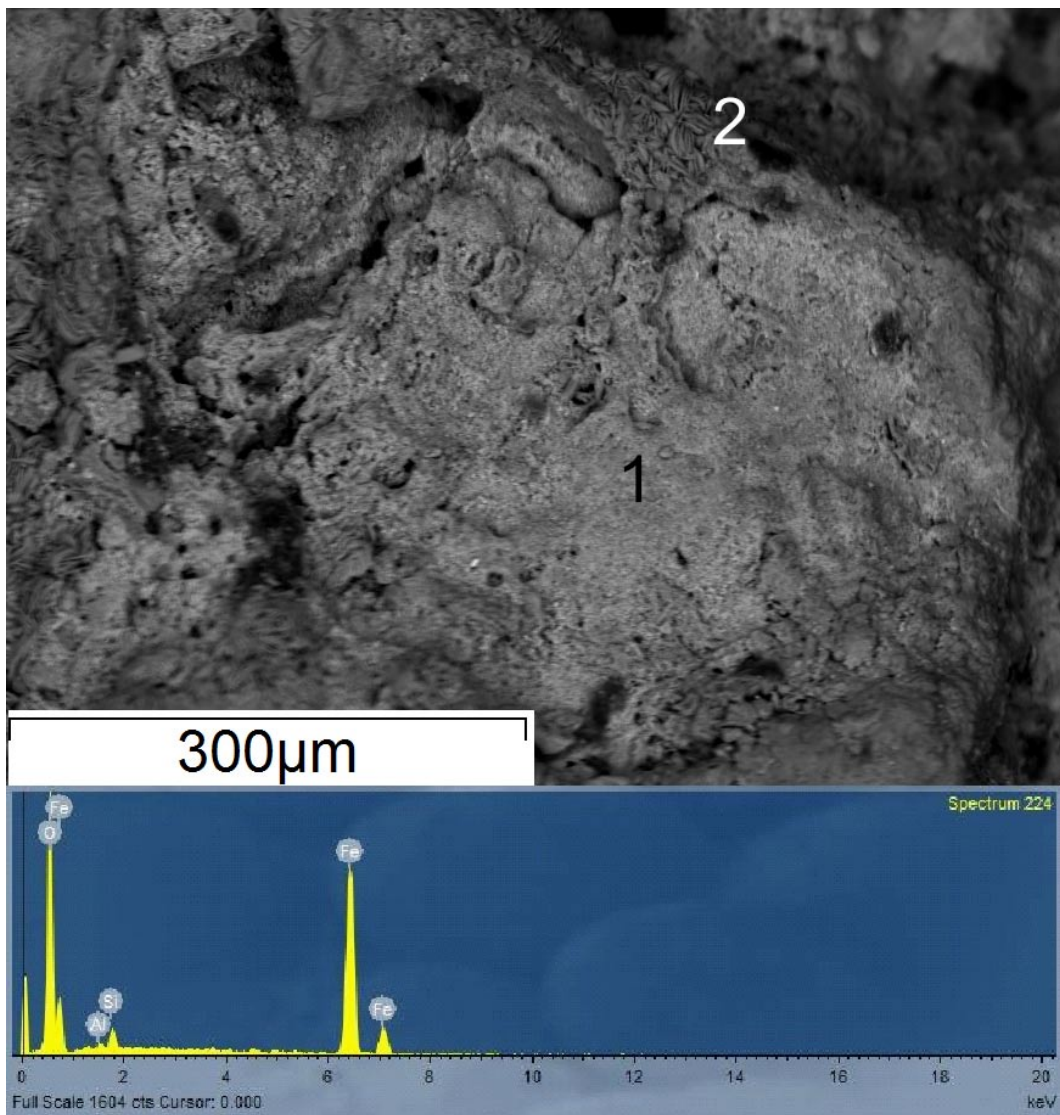
Figure 5-35. Back-scattered SEM-image and related EDS-spectrum of brown-coloured minerals: Fe-oxides/-oxyhydroxides (“1”, with related EDS-spectrum: “Spectrum 224”) and corrensite (“2”). From open fracture KLX15A: 379.524 m (sample KLX15A: 379.39–379.63 m).

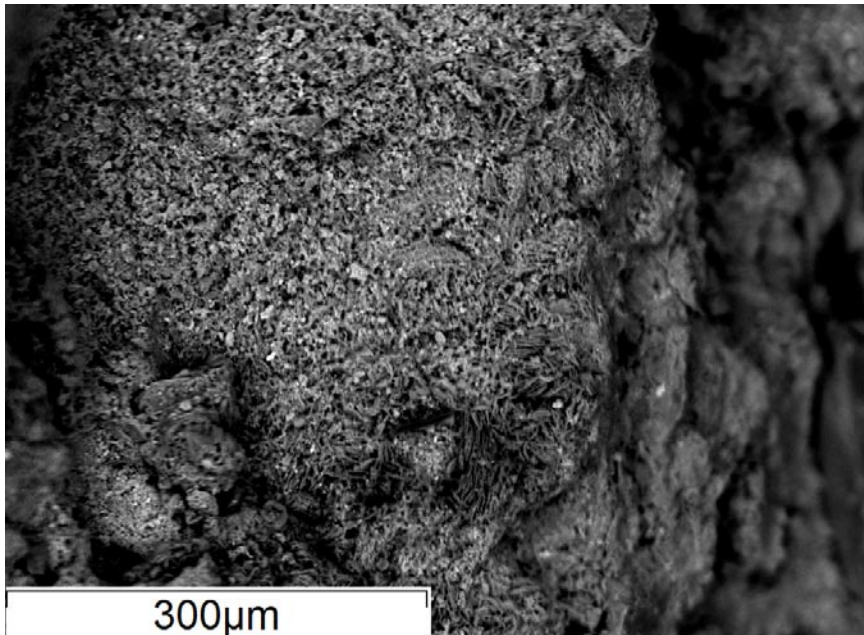
Figure 5-36. Back-scattered SEM-image brown-coloured minerals: Fe-oxides/-oxyhydroxides (bright parts) and corrensite (darker parts). From open fracture KLX15A: 379.524 m (sample KLX15A: 379.39–379.63 m).

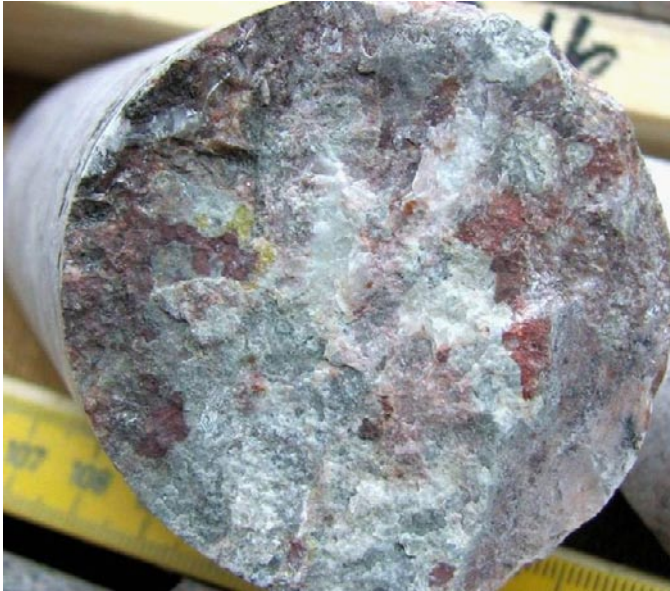
Figure 5-38. Photograph of the fracture surface of open fracture KLX16A: 348.067 m from drill core sample KLX16A: 348.01–348.14 m.

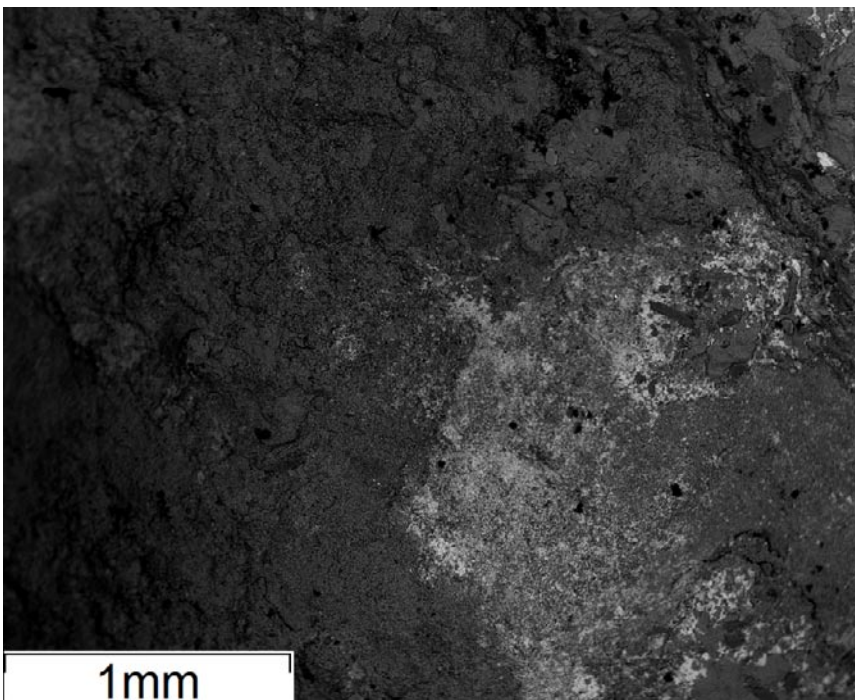
Description: Open fracture with a coating of calcite, epidote, hematite, clay minerals and prehnite (Figure 5-48). Minor yellow coloured areas of the coating have been mapped as goethite. However, SEM-investigations show that these areas are made up of calcite and illite and not by goethite. A plausible explanation is that the yellow discolouration is due to staining from acid used during the mapping to identify calcite. It is therefore suggested that goethite should be removed from the mapping data. Clay minerals and prehnite should be added in the mapping data.

Figure 5-39. Back-scattered SEM-image of hematite-stained part (bright area) on the fracture surface of open fracture KLX16A: 348.067 m, from drill core sample KLX16A: 348.01–348.14 m. The dark area to the upper left, surrounding the hematite-stained part is the yellow-coloured area in Figure 5-39. This area is mainly consists of calcite and illite.

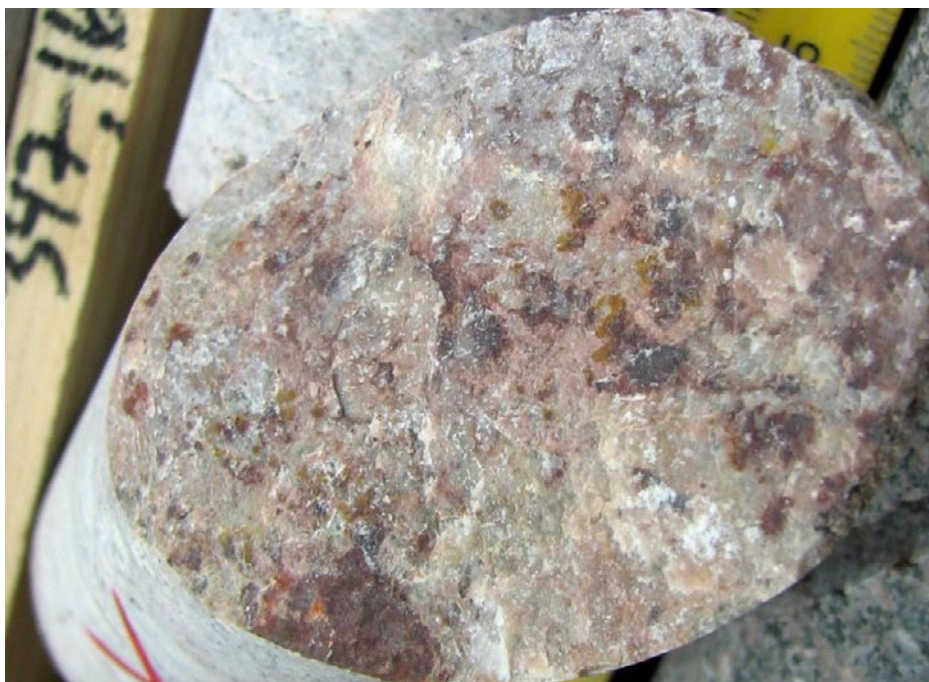
Description: Open fracture with a coating of calcite, hematite, goethite and clay minerals (suggested to be added to the mapping data) (Figure 5-40). Two noteworthy features indicating signs of oxidizing conditions sometime in the history of the fracture are present on the fracture surface: 1) typical hematite-stained, brownish red parts and 2) bright yellow to brown parts. SEM-investigations show that 1) is made up of Fe-oxides (probably hematite) and Fe-rich chlorite and clay minerals (probably due to staining of this minerals by small hematite crystals); 2) is made up of Fe-rich clay minerals, calcite and Fe-oxide/oxyhydroxide (Figure 5-41), which might be both hematite and goethite. Both pure Fe-oxide (probably hematite) and Fe-oxide with a significant amount of Si (a common feature of goethite /Deer et al. 1992/), are identified, which further indicates that hematite and goethite are present together in this sample. More investigations are needed to make a proper identification of potential origin.

Figure 5-40. Photograph of the fracture surface of fracture KLX16A: 348.173 m from drill core sample KLX16A: 348.01-348.14 m.

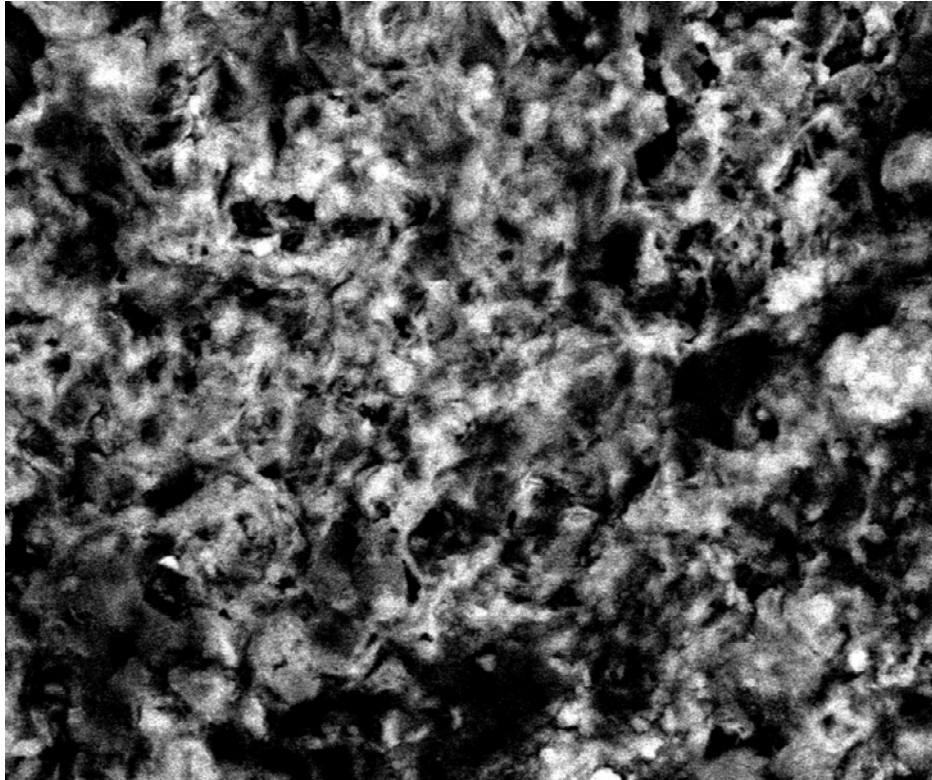
Figure 5-41. Back-scattered SEM-image of Fe-oxide-stained part (bright area) on the fracture surface of open fracture KLX16A: 348.173 m (drill core sample KLX16A: 348.01–348.14 m). Width of image is ~70 µm.

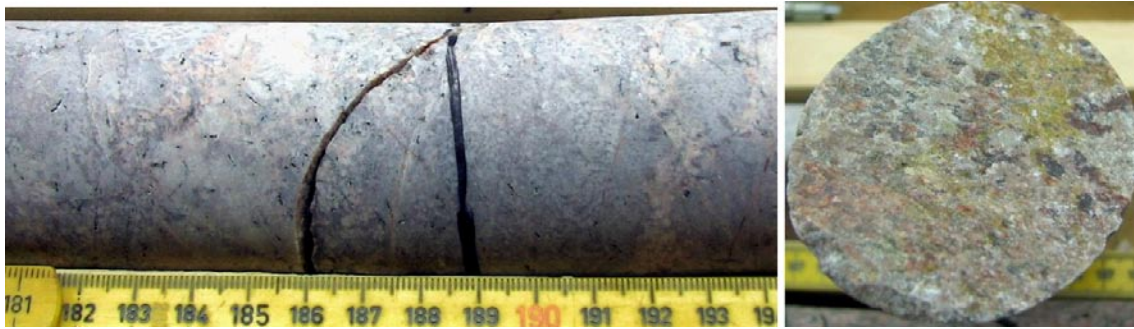
Description: Open fracture with a thin fracture coating (Figure 5-42), which is dominated by white to grey coloured calcite, brick red hematite-stained adularia and a bright brown to yellow coating (mapped as goethite). SEM-investigations show that the latter part of the coating is made up of Fe-oxide-stained adularia, and clay minerals. The Fe-oxide crystals are occasionally quite large (Figure 5-43, Figure 5-44 and Figure 5-45). EDS-analyses of these crystals show significant amounts of e.g. Si (Figure 5-43, Figure 5-44 and Figure 5-45), indicates the presence of goethite on the fracture coating, as goethite may incorporate significant amount of e.g. Si in the crystal structure /Deer et al. 1992/. Additional minerals to be added to the mapping data are clay minerals, adularia, quartz, albite and barite.

Figure 5-42. Photographs of drill core sample KLX16A: 371.85–371.93 m (left) and of the fracture surface of open fracture KLX16A: 371.851 m (right).

Adularia, quartz, albite and barite should be added as additional minerals in the Boremap comment file.
