Oskarshamn site investigation

Investigations of goethite-bearing fractures in cored boreholes Laxemar subarea

Henrik Drake, Isochron Geoconsulting HB
Eva-Lena Tullborg, Terralogica AB

March 2009

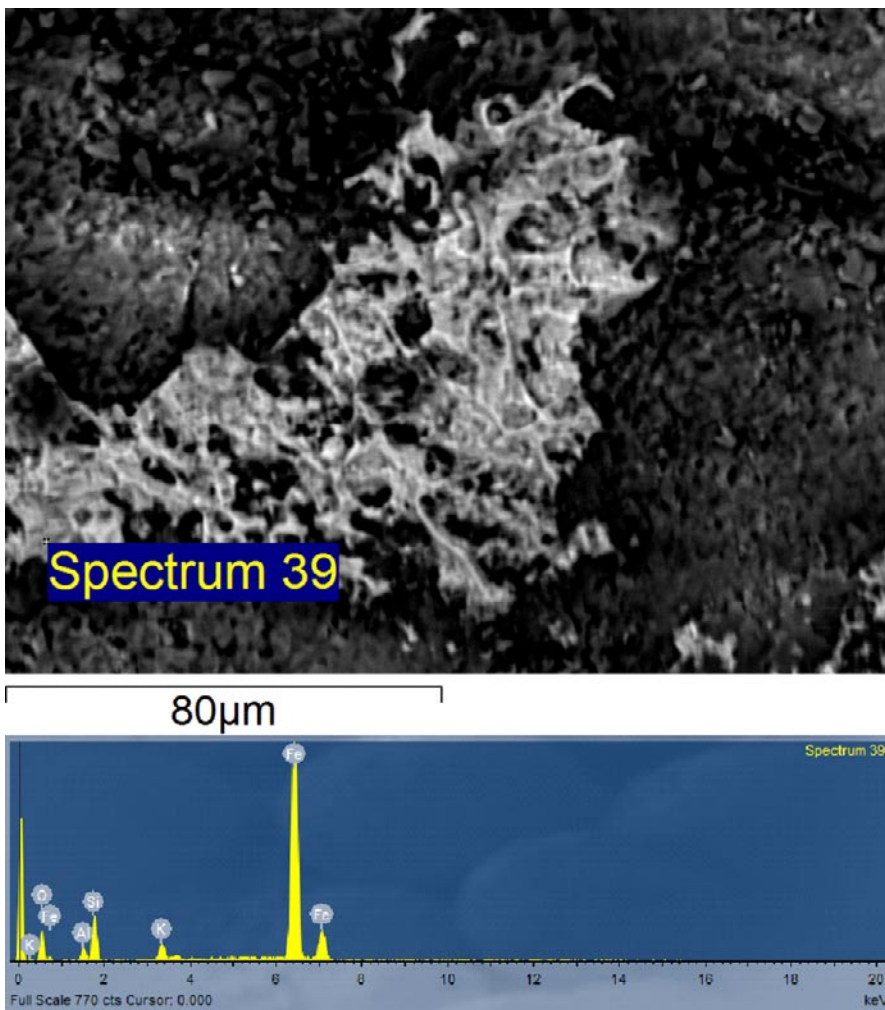
Figure 5-43. Back-scattered SEM-image and EDS spectrum (of a Fe-rich mineral) on the fracture surface of open fracture KLX16A: 371.851.

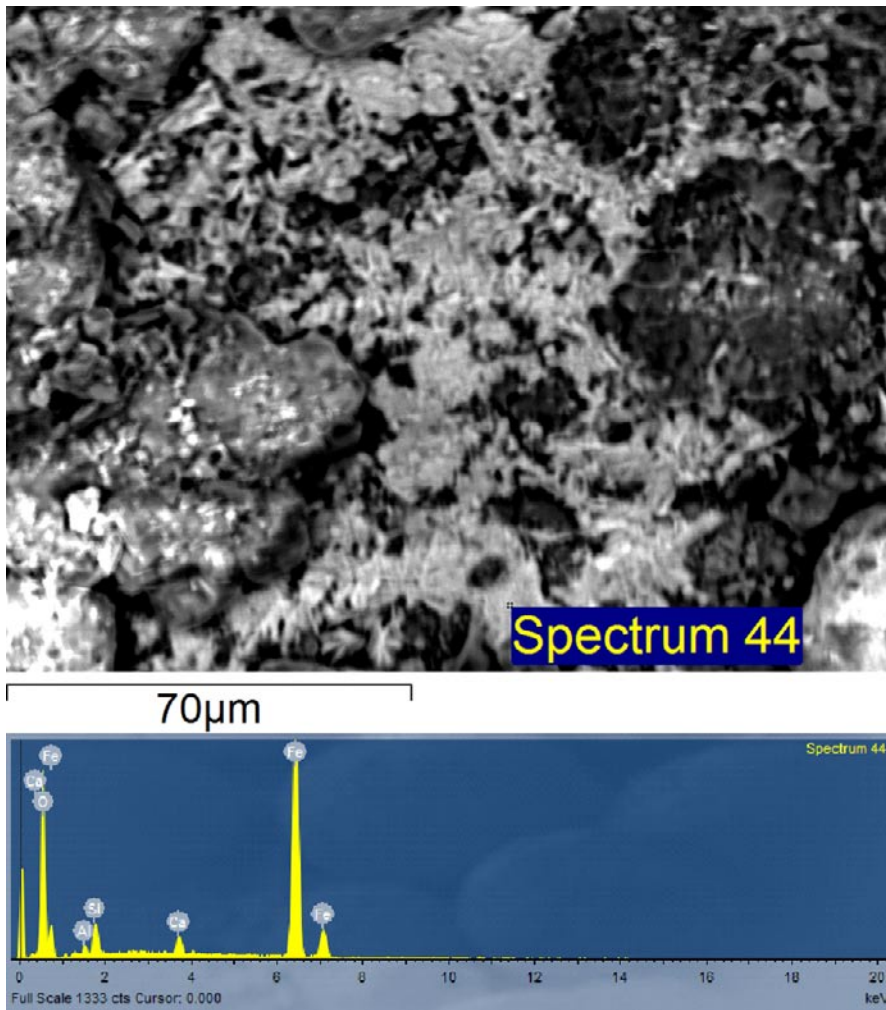
Figure 5-44. Back-scattered SEM-image and EDS spectrum (of a Fe-rich mineral) from the fracture surface of open fracture KLX16A: 371.851 m.

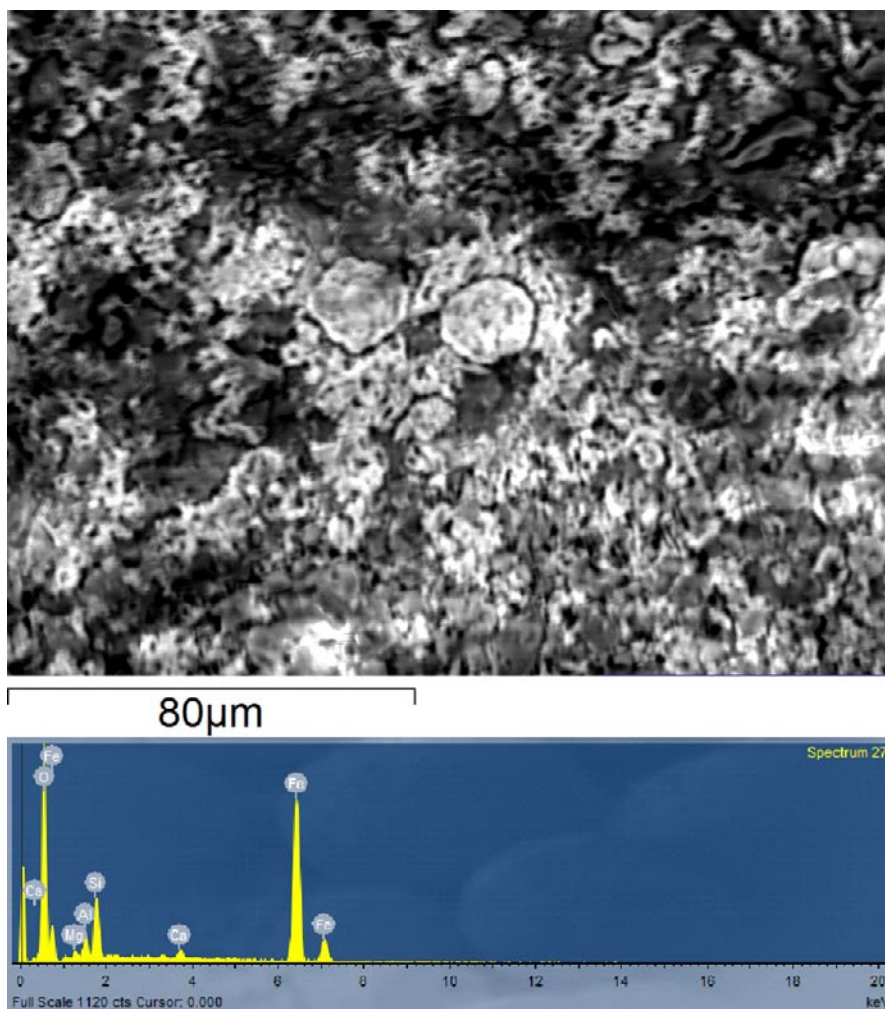
Figure 5-45. Back-scattered SEM-image and EDS spectrum (of a Fe-rich mineral) of the fracture surface of open fracture KLX16A: 371.851 m, from sample KLX16A: 371.85–371.93 m.

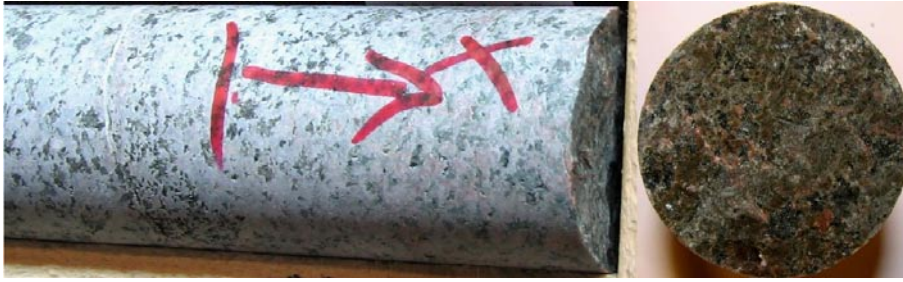
Description: No goethite is present on the fracture surface (shown in Figure 5-486). Minerals in addition to calcite and chlorite are clay minerals (Figure 5-47), pyrite, and adularia. Therefore, it is suggested that the mapping data is updated by removing goethite and adding clay minerals, pyrite and adularia.

Figure 5-46. Photographs of sample: KLX19A: 229.44–229.51 m (left) and the fracture surface of open fracture KLX19A: 229.510 m (right).

Adularia is added to comment file.

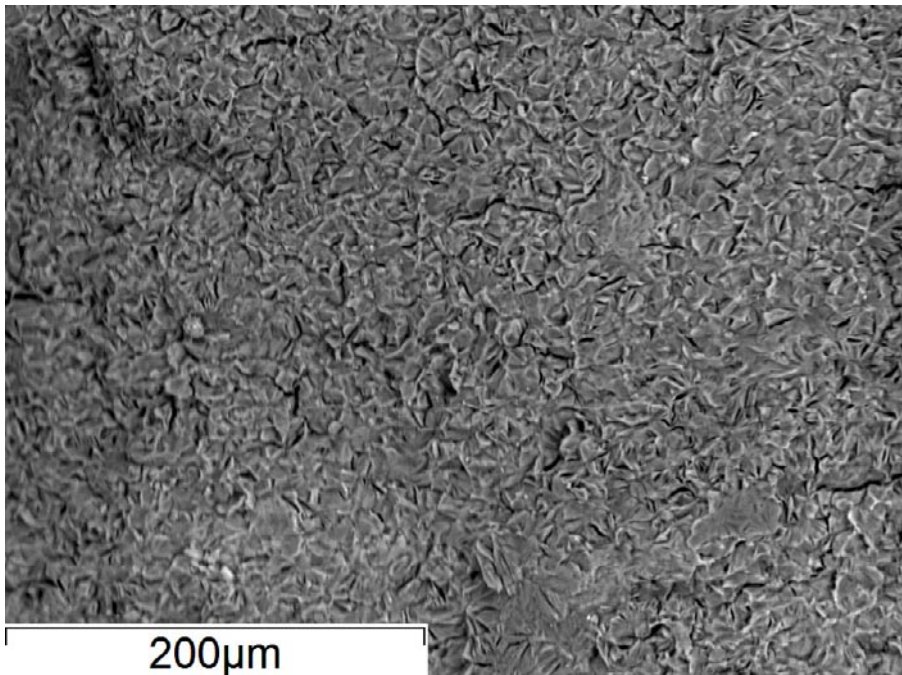
Figure 5-47. Back-scattered SEM-image of Mg-rich chlorite/clay minerals coating open fracture KLX19A: 229.510 m.

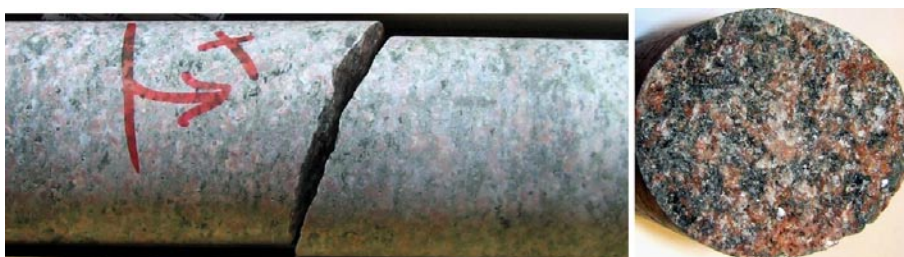
Description: No goethite is present on the fracture surface (fracture and fracture surface is shown in Figure 5-48). Minerals in addition to calcite and chlorite are laumontite, adularia, epidote, hematite, clay minerals, quartz, galena and pyrite. Therefore, it is suggested that the mapping data is updated by removing goethite and adding laumontite, adularia, epidote, hematite, clay minerals, quartz, galena and pyrite.

Figure 5-48. Photograph of drill core sample KLX19A: 414.48–414.55 m (left) with the fracture surface of open fracture KLX19A: 414.363 m (right).

Epidote, hematite, clay minerals, quartz, galena and pyrite should be added in the comment file (bm_comment).

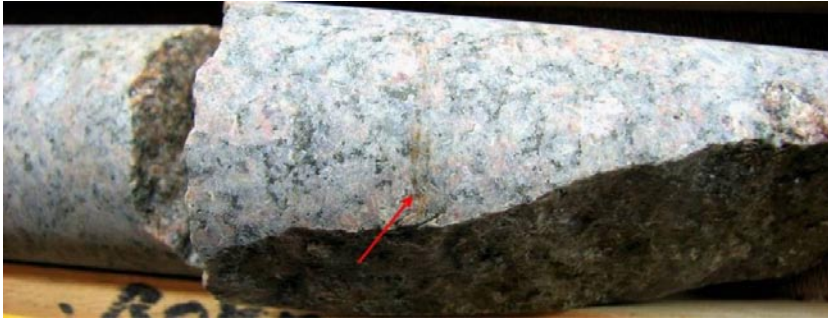
Description: Small areas of fine-grained powder on the fracture surface (Figure 5-49) and on the drill core (perpendicular to the drill core length axis, Figure 5-50). This powder is made up of angular mineral fragments (Figure 5-51). The fragments are common rock forming minerals quartz and feldspars but barite, illite, Fe-rich chlorite and Fe-stained chlorite are also present. The powder is interpreted to be drilling induced because 1) similar powder is found on the side of the fresh drill core as typical drilling induced marks, 2) because of the characteristics and position of the powder (angular fragments in morphological depressions of the fracture surface) and 3) the fracture is interpreted to be sealed and therefore the powder has most probably been emplaced after the fracture was broken during the drilling. Clay minerals are added to the mapping data because it is interpreted to belong to an earlier generation of fracture minerals (along with calcite and chlorite) present in the fracture.

Figure 5-50. Photograph of drill core sample KLX07A: 432.15–432.27 m. Arrow indicates powder on the side of the drill core (same as the powder on the fracture coating in Figure 5-49).

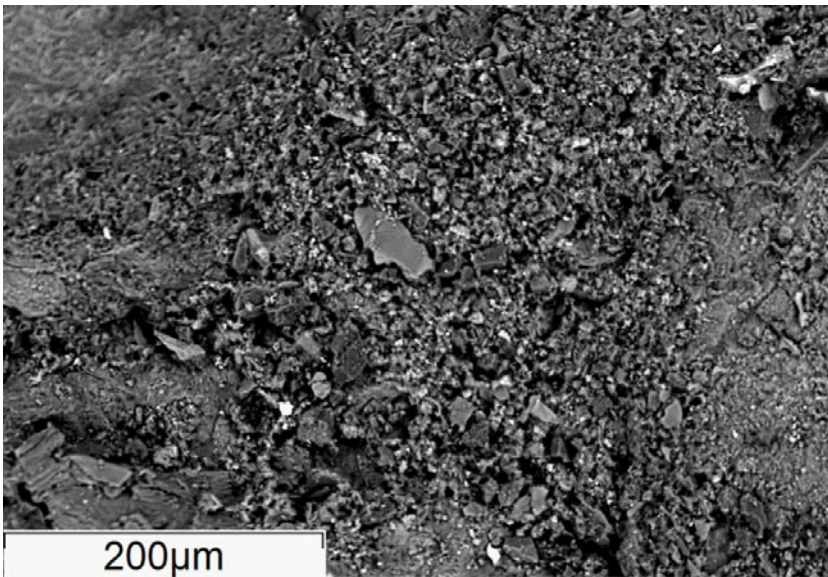
Figure 5-51. Back-scattered SEM-image of fine-grained brown filling from the fracture surface of open fracture KLX07A: 432.144 m.

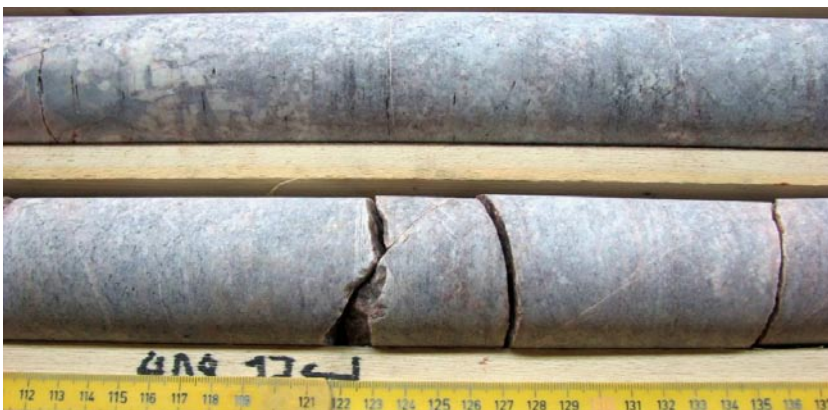
Figure 5-52. Photograph of drill core sample KLX16A: 408.23–408.27 m (lower drill core, centre drill core piece).

Description: Sealed fracture (presently partly open, Figure 5-55). The mapping only identified hematite (dark brownish red) and goethite (bright brown). SEM-investigations show that clay minerals and calcite are present. The bright brown parts are made up of Fe-rich clay minerals, calcite and Fe-oxide (Figure 5-54), with a plate-like shape, typical for hematite, of relatively pure Fe-oxide composition (i.e. hematite). Goethite is suggested to be removed from the mapping data. Furthermore, since the fracture is mapped as “sealed” it is not probable that the Fe-oxides have been formed recently. There are markings on the core, resulting from drill wear at this fracture (Figure 5-52).

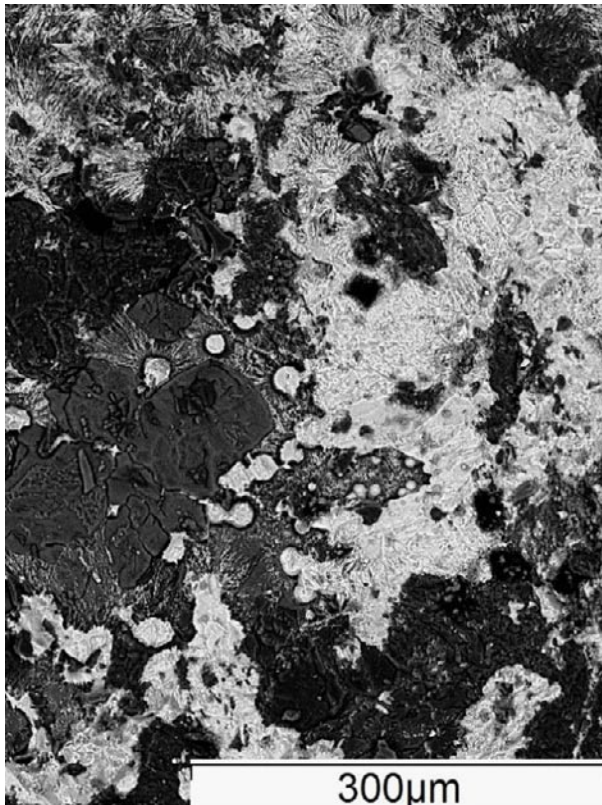
Figure 5-54. Back-scattered SEM-images of hematite (bright, plate-like minerals) from fracture KLX16A: 408.241 m, from drill core sample KLX16A: 408.23–408.27 m.

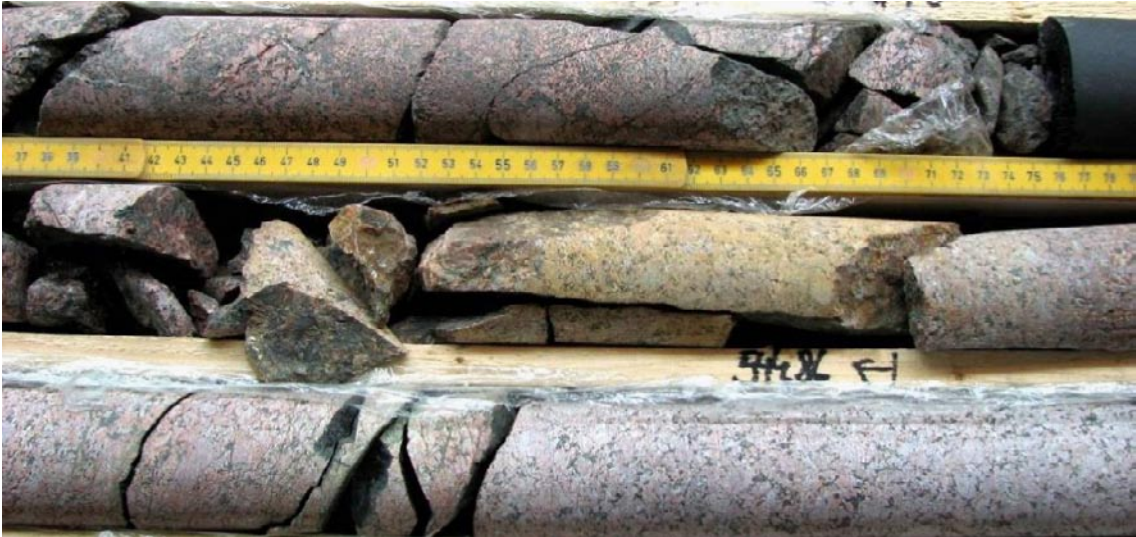
Figure 5-55. Photograph of drill core sample KLX13A: 544.44–544.7 m.

Description: This drill core section has been highly oxidized during drilling as shown by the discolouration of the whole drill core pieces in the interval (Figure 5-55 and Figure 5-56). The brown coloured part of the fracture coating (mapped as goethite) has a significant amount of Fe but also e.g. Zn and C (Figure 5-57), which is a further indication that this colouration is related to the drilling activity. Therefore, it is suggested that goethite is removed from the mapping data. Adularia should be added to the mapping data.

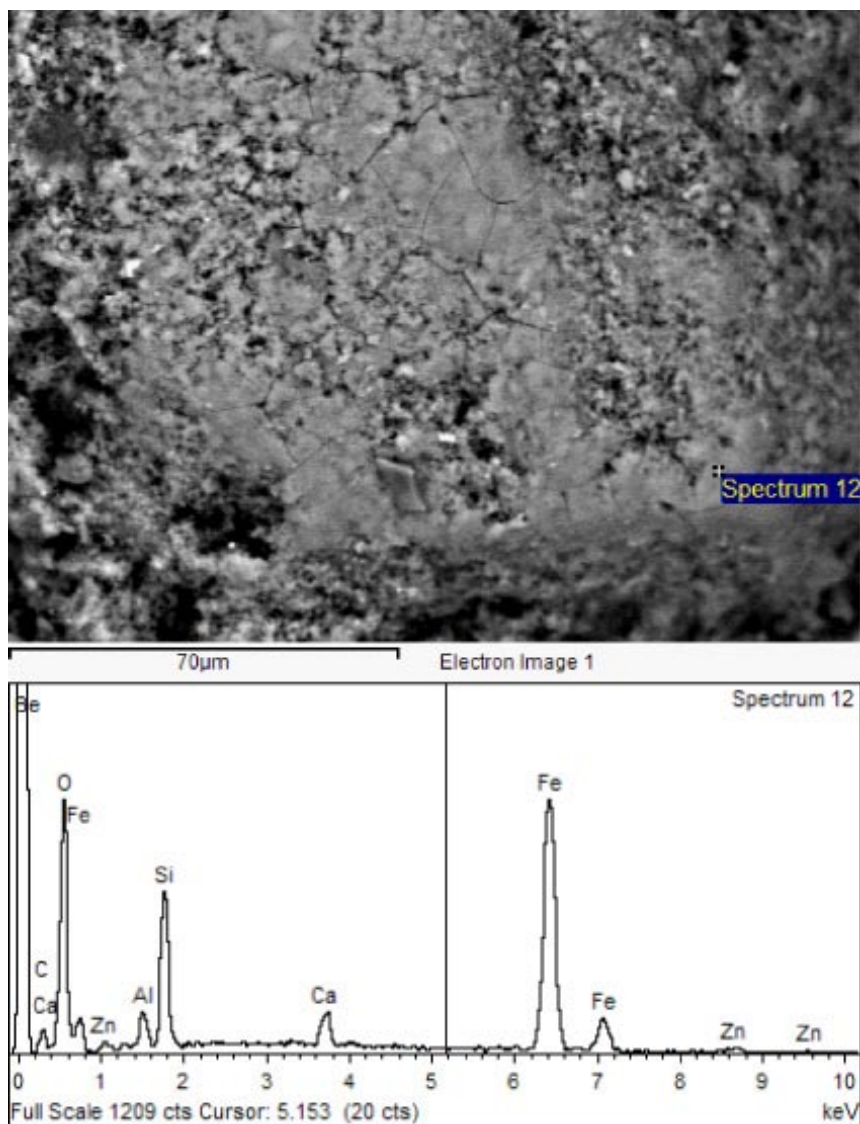
Figure 5-57. Back-scattered SEM-image and related EDS-spectrum for a mixture of Fe-rich coating on top of the fracture minerals (Spectrum 12) from fracture KLX13A: 543.969 m. Note the peaks for Zn and C.

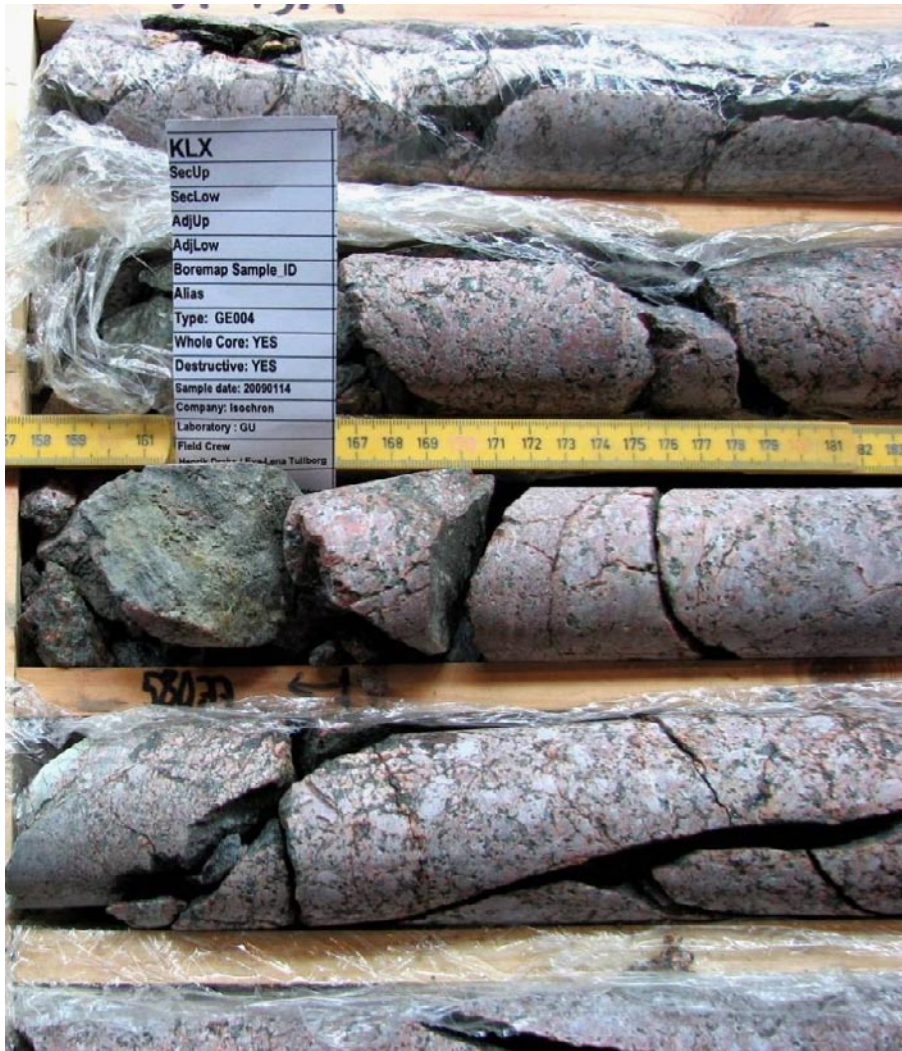
Figure 5-58. Photograph of sealed network section KLX13A: 578.330–583.590 m.

Interpretation: No goethite present. Goethite should be removed from Boremap comment file (bm_comment).

**Goethite suggested to be removed from the Boremap comment file (bm_comment in data delivery Sicada_08_062), other minerals remain.

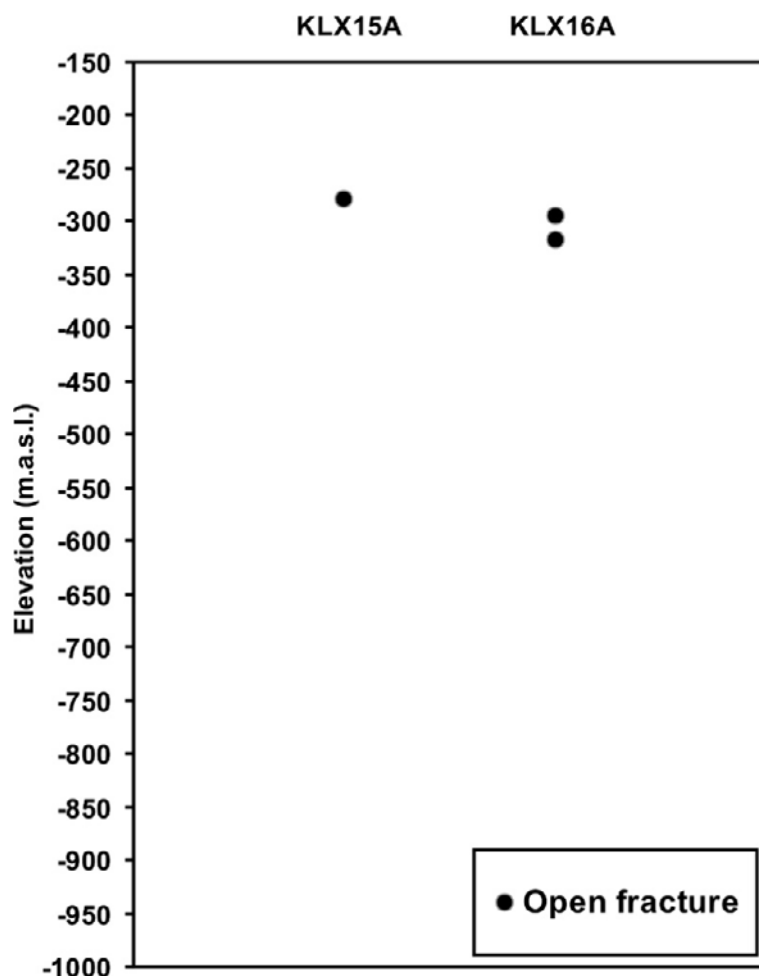
The three goethite occurrences that remain in the mapping file after these updates are listed in Table 5-5 and shown versus elevation in Figure 5-59. The occurrences are either from a deformation zone (ZSMNE107A in KLX16A) or from a possible deformation zone (in KLX15A), but not in any water-conducting sections (“PFL”-anomalies). The deepest occurrence is from -316.20 m above sea level (KLX16A).

Figure 5-59. Depth distribution of goethite occurrences from greater depth than -150 m above sea level (as listed in Table 5-1 to Table 5-4).

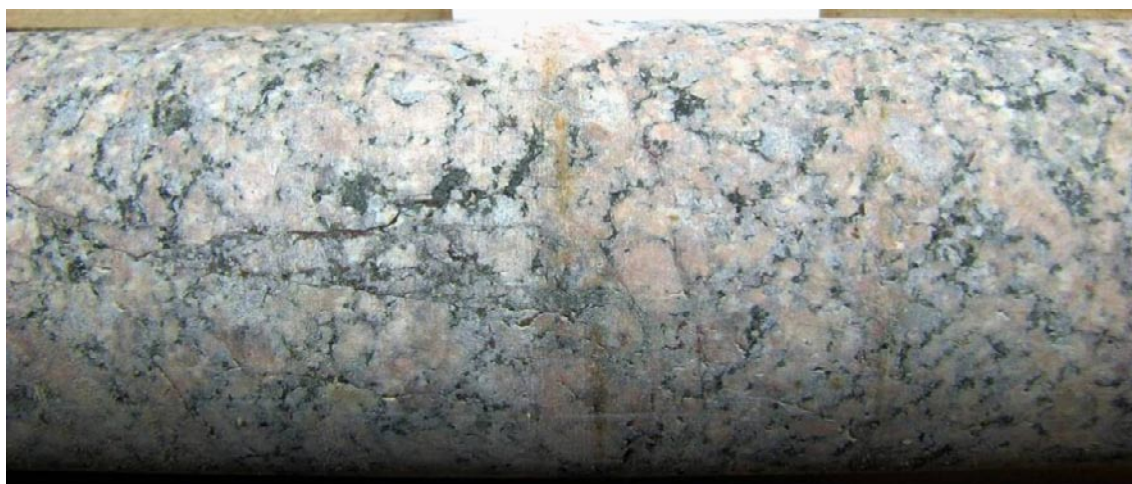
Photograph of sealed network section KLX04: 239.554–239.652 m.

Interpretation: Section of corroded, metallic markings on the core, perpendicular to the drill core length axis, resulting from drill wear. These marks have nothing to do with the sealed network and therefore goethite should be excluded in the mapping file.

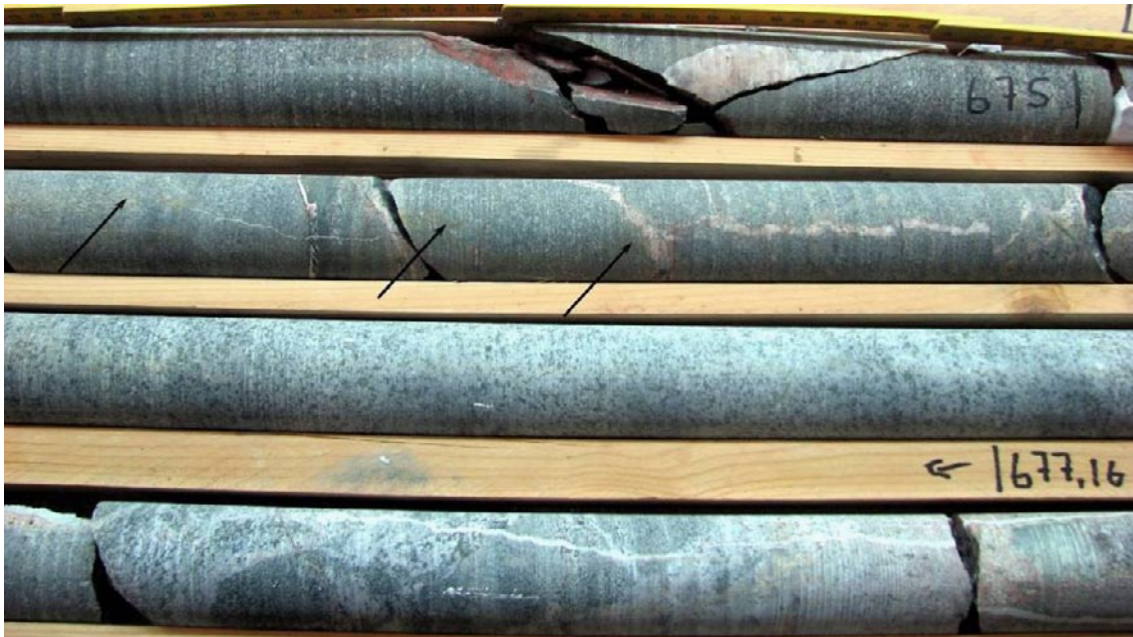
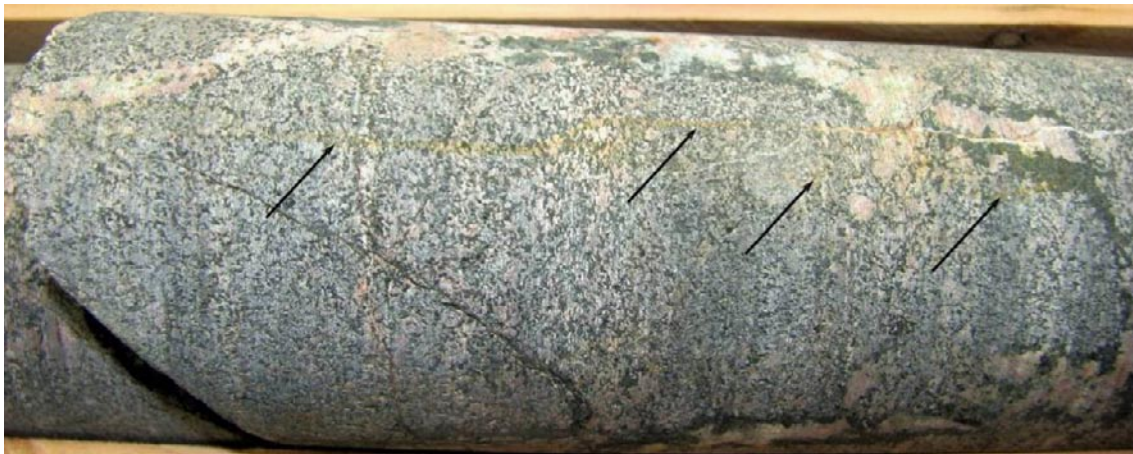
Photograph of sealed network section KLX04: 674.848–676.405 m.

Interpretation: Section of corroded, metallic markings on the core, parallel with the drill core length axis, resulting from drill wear. These marks have nothing to do with the sealed network and therefore goethite should be excluded in the mapping file.

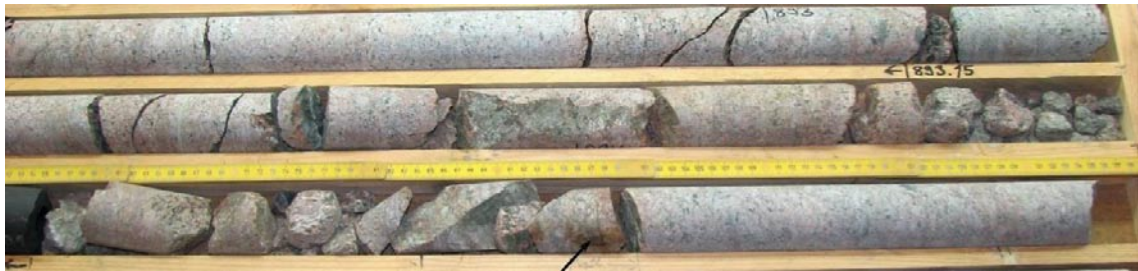
Photograph of crush zone section KLX04: 894.446–895.104 m.

Interpretation: Drill core section with an iron-rich film covering most of the drill core pieces, resulting from drill wear, or other drilling or post-drilling activity. Therefore goethite should be excluded in the mapping file. Furthermore, hematite and adularia should be added to the mapping file.

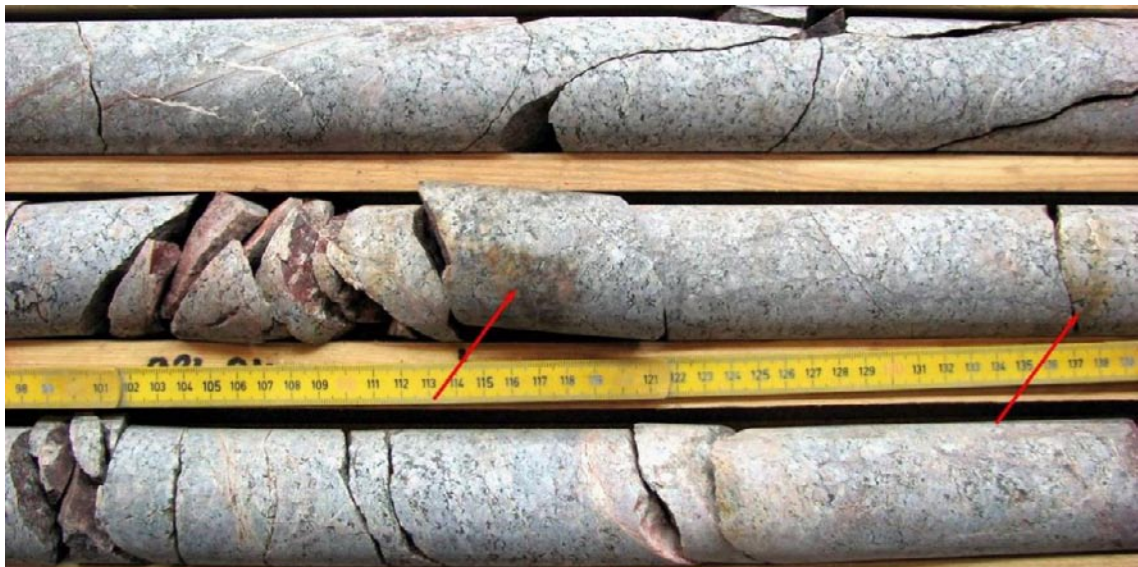
Interpretation: Drill core section with an iron-rich film covering a large part of the side of the drill core, as result of drill wear. Therefore, goethite should be excluded from the mapping data.

Photograph of section KLX04: 963.19–963.26 m for which goethite is included in the comment file for the alteration features.

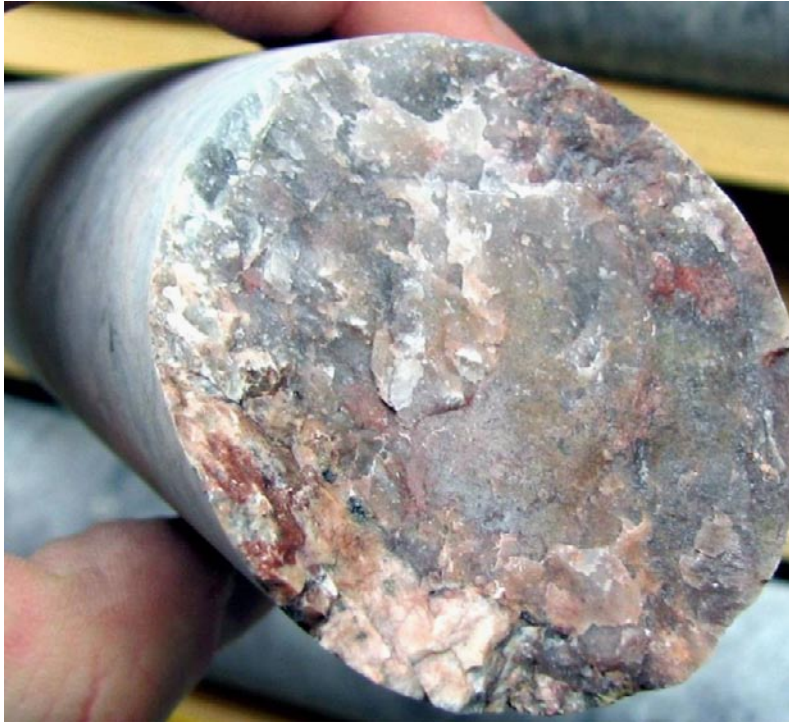
Photograph of open fracture KLX05: 518.300 m.

Interpretation: No goethite on the fracture surface.

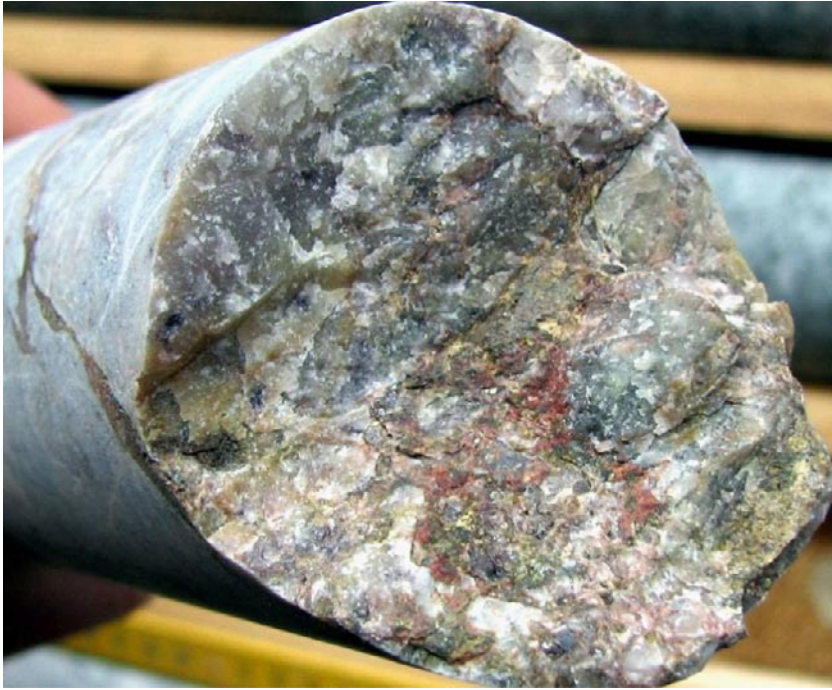
Photograph of open fracture KLX05: 602.397 m.

Interpretation: No goethite on the fracture surface. Minerals to be added to the mapping data: epidote and titanite.

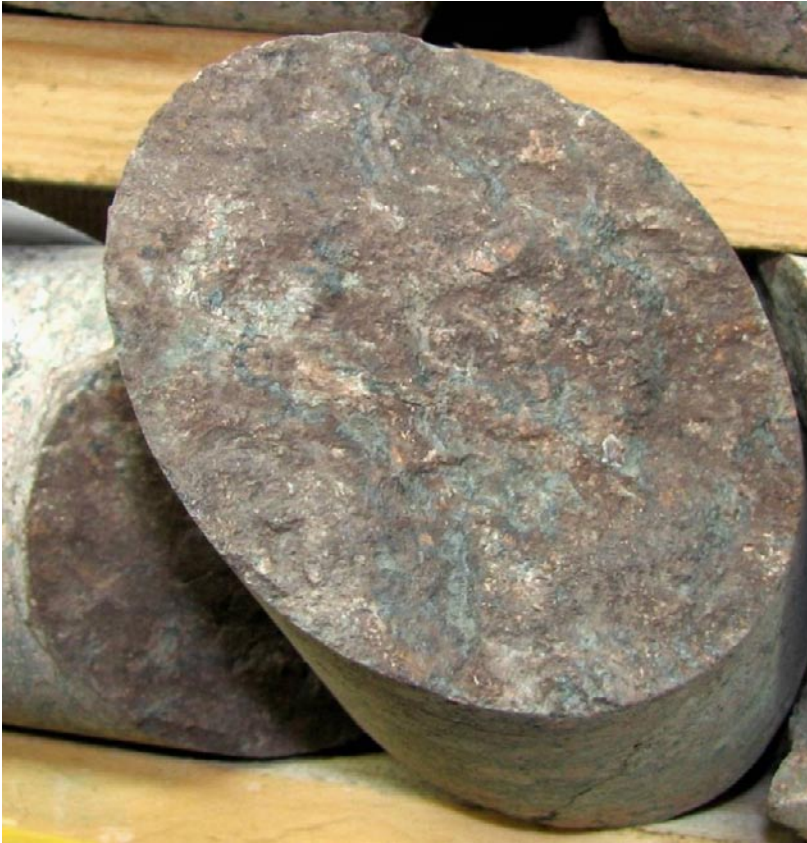
Photograph of open fracture KLX07A: 311.414 m.

Interpretation: No goethite on the fracture surface. Minerals to be added to the mapping data: hematite, adularia and laumontite.

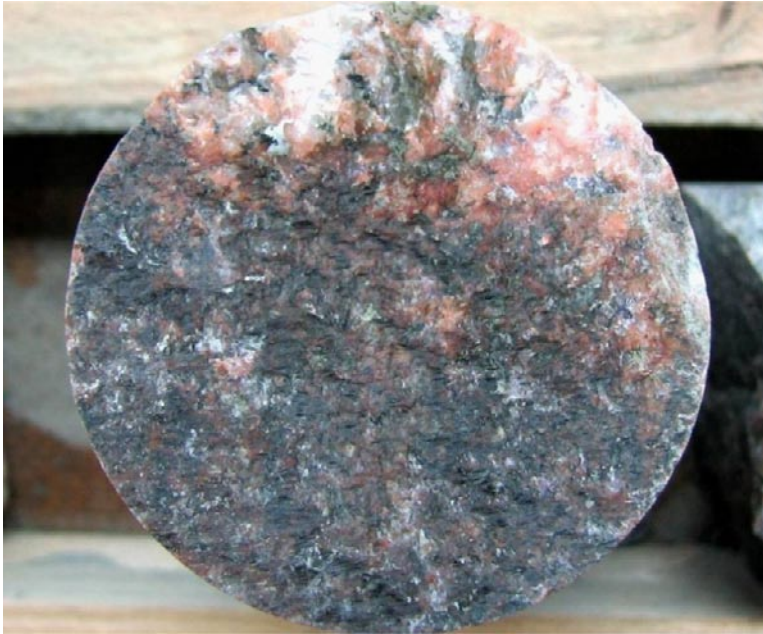
Photograph of open fracture KLX09: 574.242 m.

Interpretation: No goethite on the fracture surface. Minerals to be added to the mapping data: hematite and adularia.

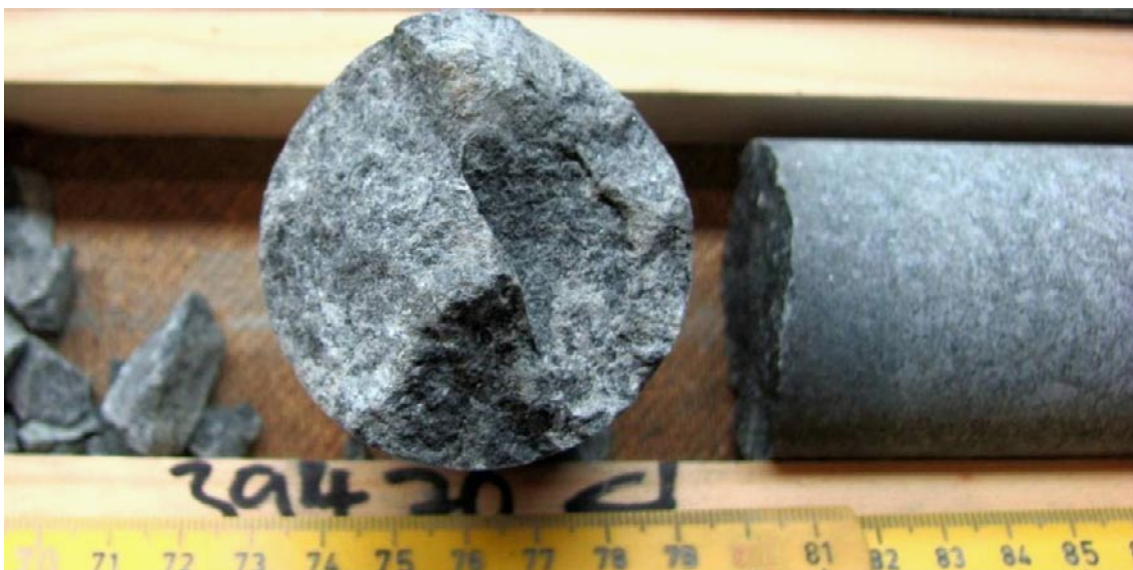
Photograph of open fracture KLX13A: 394.712 m.

Interpretation: No goethite on the fracture surface.

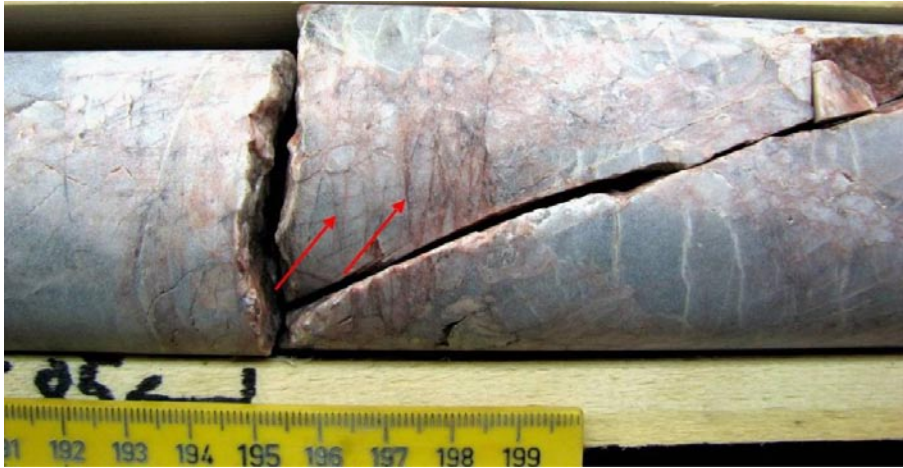
Photograph of sealed network section KLX16A: 406.600–407.100 m.

Interpretation: No goethite in the sealed network. The red colour of the filling is typical for hematite, as shown in earlier studies in the area.

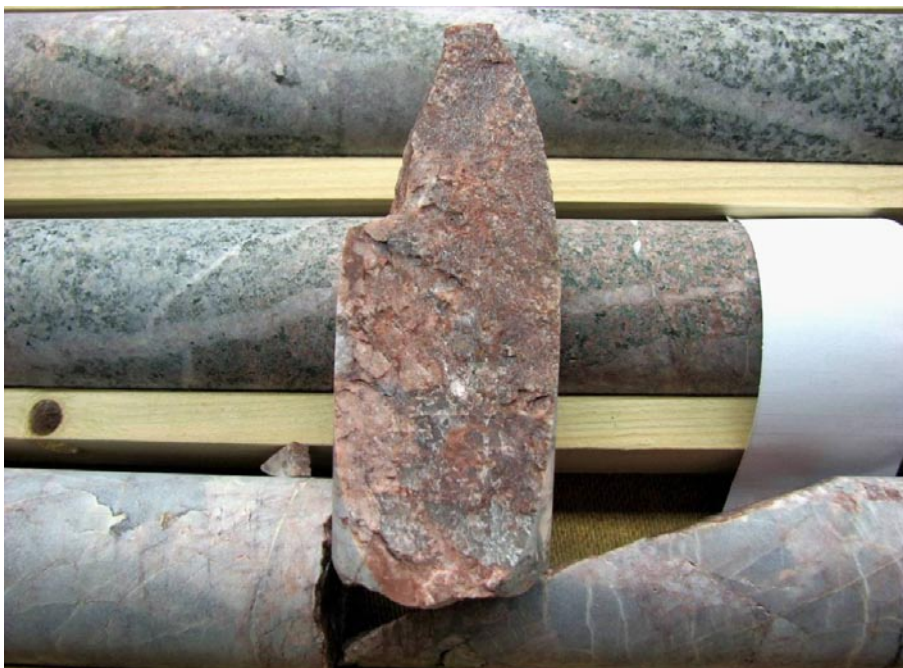
Photograph of open fracture KLX16A: 406.842 m.

Interpretation: No goethite on the fracture surface. The red colour of the filling is typical for hematite, as shown in earlier studies in the area.
