Assessment of fractures classified as non-mineralised in the Sicada database

Lillemor Claesson Liljedahl, Raymond Munier
Svensk Kärnbränslehantering AB

March 2011

Svensk Kärnbränslehantering AB

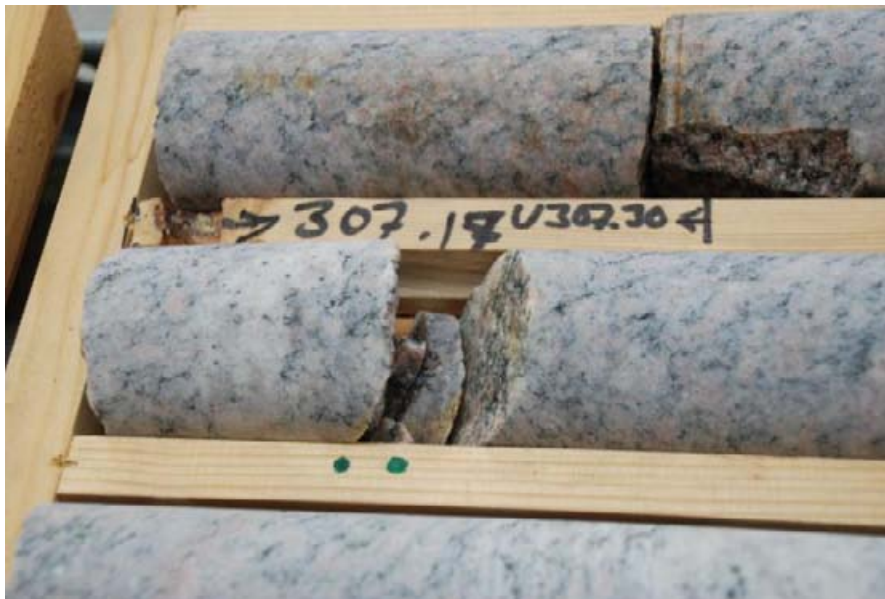
Group 1 includes fractures where either part of the fracture surface, the entire fracture, or part of the core is missing (Figure 5-4). Handling of the core might have caused the loss of material, but more likely the material sections were lost during to drilling (e.g. material was destroyed when two adjacent core sections were rotated towards in the core barrel). However, even if parts or all of Group 1 fractures was missing they were visible in BIPS.

Figure 5-4. Photo of core KFM06A (fracture ID 60D642D98A327BFD). This fracture is a typical Group 1 fracture: it is clearly visible in BIPS, and the missing material in the core coincides with drilling disturbances. The diameter of the drill cores is 50 mm.

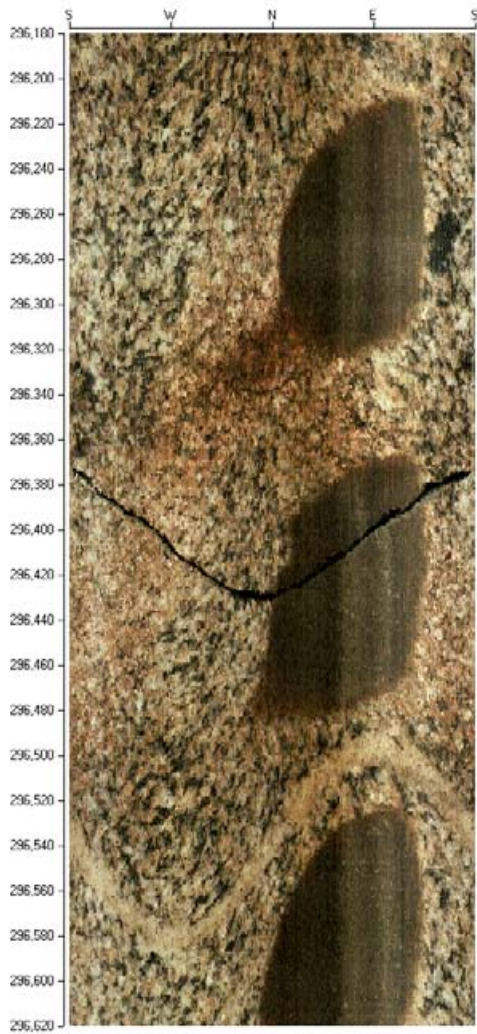
Group 5 represents non-mineralised fractures, where no mineral coating could be observed (Figures 5-8 and 5-9). We consider these fractures to have been correctly logged.

Figure 5-9. BIPS image of core KFM06A (fracture ID 945642D98A3485D4), with a distinct visible fracture. This fracture is a typical non-mineralised fracture, and is furthermore a PFL fracture.

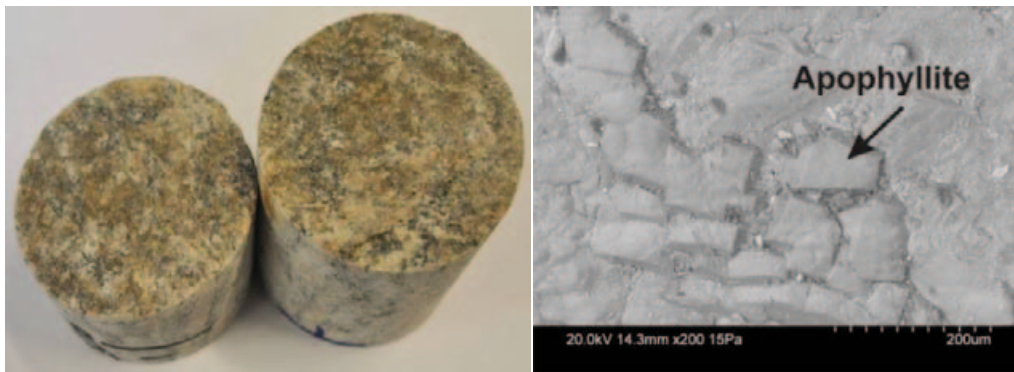
The identified minerals on fractures surfaces classified as non-mineralised in Sicada occur as small crystals on the fracture surface and are very difficult to distinguish macroscopically (Figures 5-15 and 5-16). The fracture minerals identified include; hydroxyapophyllite, corrensite, quartz, calcite, barite and pyrite (see Appendix 1). This mineral paragenesis is diagnostic for the Palaeozoic fracture mineral generation 3 at Forsmark (Table 5-6) /Sandström et al. 2008a, 2009/, although hydroxyapophyllite previously only has been identified in a few fractures /Sandström et al. 2004/.

Figure 5-15. Open fracture with small crystals of hydroxyapophyllite. The diameter of the drill core is c. 5 cm. The right figure is an electron image, sample KFM01B 208.093 m. The diameter of the drill cores is 50 mm.

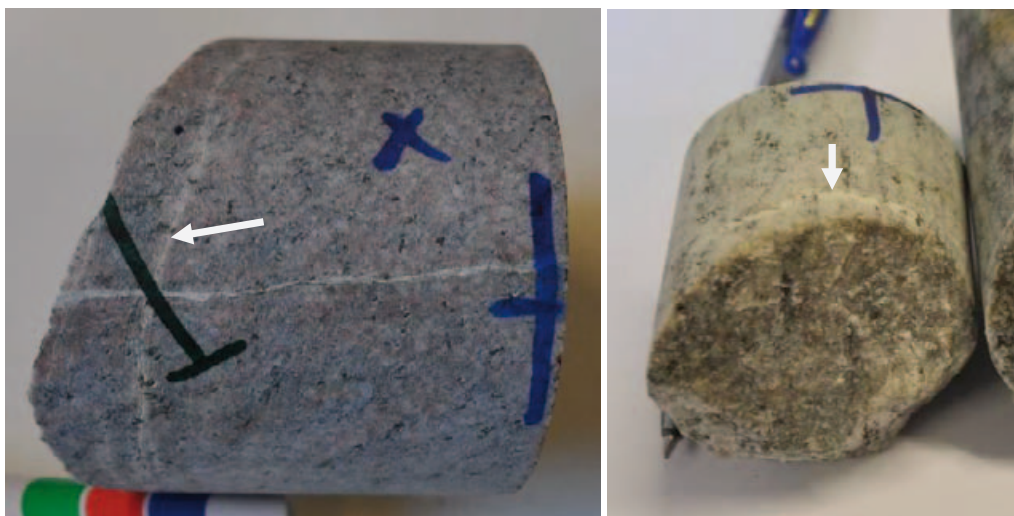
Figure 5-16. Left figure shows an open fracture with no detected fracture mineral (sample KFM05A 166.372 m). Right figure is an open fracture (non-mineralised in Sicada) on which hydroxyapophyllite was identified (sample KFM08A 111.198 m). Observe the similar appearance of the bands of micro-fractures parallel to the open fracture surfaces (see arrows). The diameter of the drill cores is 50 mm.

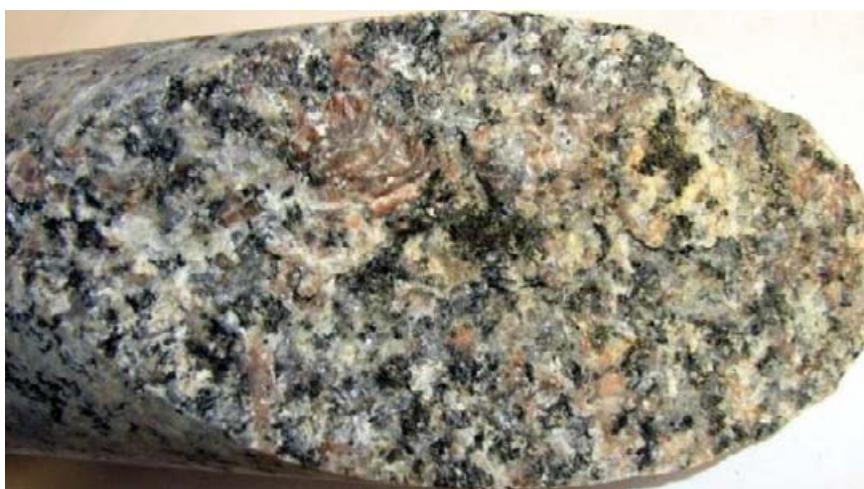
The identified minerals occur as small crystals on the fracture surface and are very difficult to distinguish macroscopically (Figure 5-26). However, when the surfaces were examined with SEM-EDS, minerals could in most cases readily be identified (e.g. Figure 5-27). The fracture minerals identified include; quartz, calcite, barite, pyrite, adularia, REE-carbonate, illite and harmotome.

Figure 5-26. Photo of KLX18A (fracture ID: 8098478B0A171FDD) showing a fracture with no visible mineral coating (i.e. a group 5 fracture). Pyrite crystals were observed when the surface was examined using SEM-EDS, see Figure 5-27.

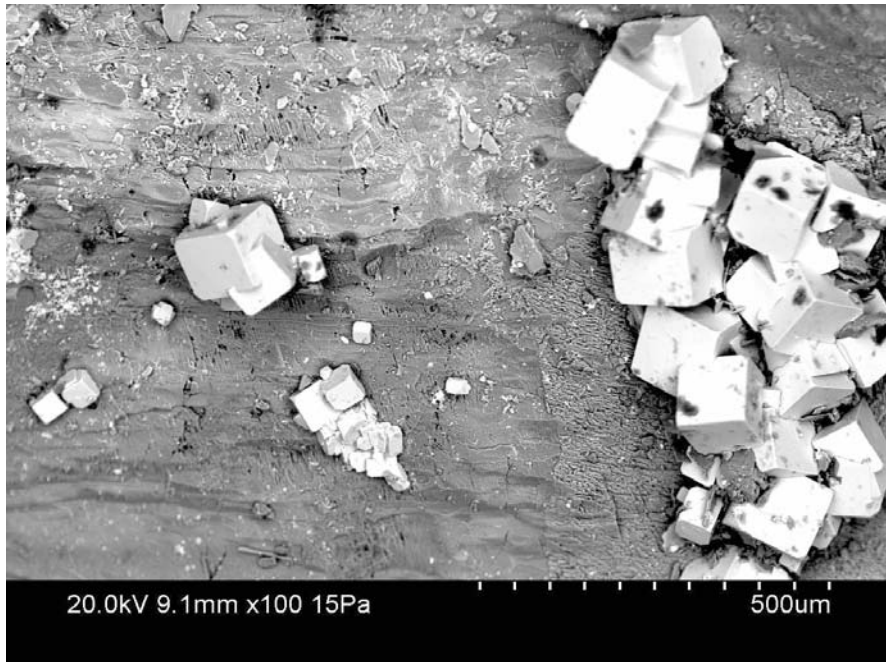
Figure 5-27. Back-scattered SEM-image of pyrite (bright, cubic crystals) from KLX18A.

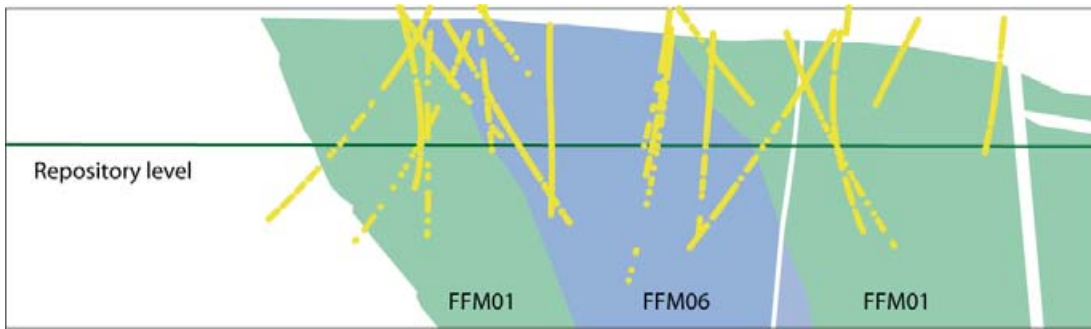
Figure 5-29. Cross section through the fracture domains in Figure 5-28 showing the borehole intersections of all non-mineralised fractures (yellow dots) at Forsmark.

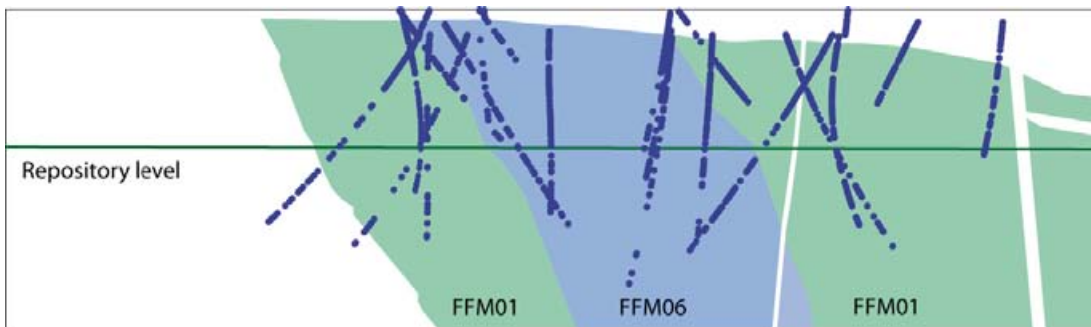
Figure 5-30. Cross section through the fracture domains in Figure 5-28 showing the borehole intersections of all non-mineralised fractures visible in BIPS (blue dots) at Forsmark.

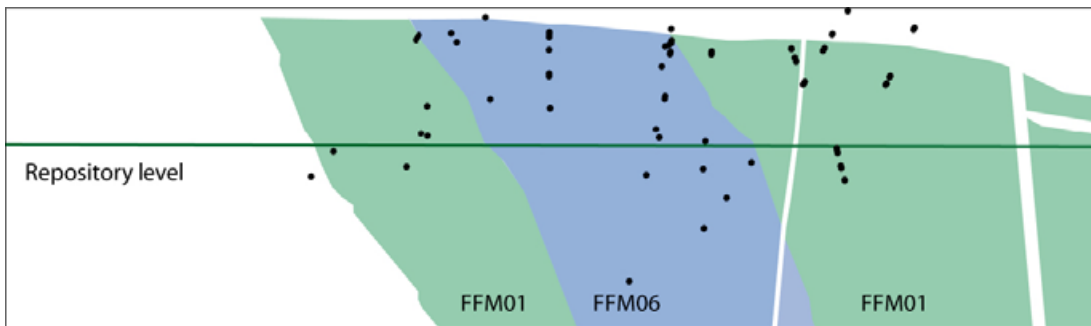
Figure 5-31. Cross section through the fracture domains in Figure 5-28 showing the borehole intersections of the inspected non-mineralised fractures (black dots) at Forsmark.

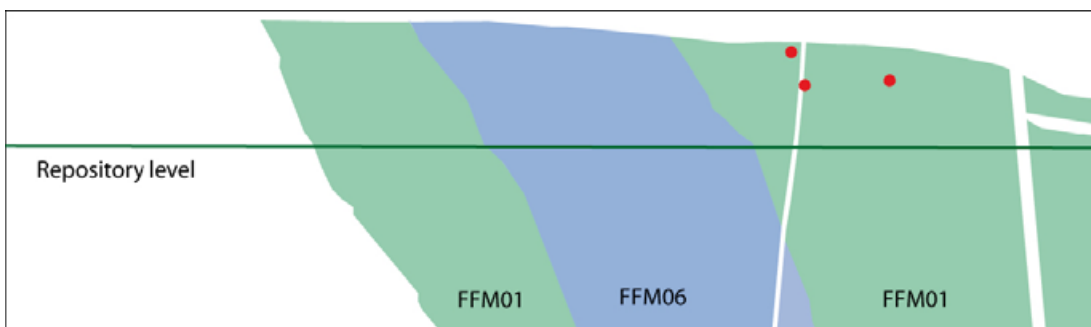
Figure 5-32. Cross section through the fracture domains in Figure 5-28 showing the borehole intersections of the five confirmed non-mineralised fractures (red dots) at Forsmark. Note, two of the confirmed non-mineralised fractures occur very close to each other, which is why it appears as if only three non-mineralised fractures were confirmed.

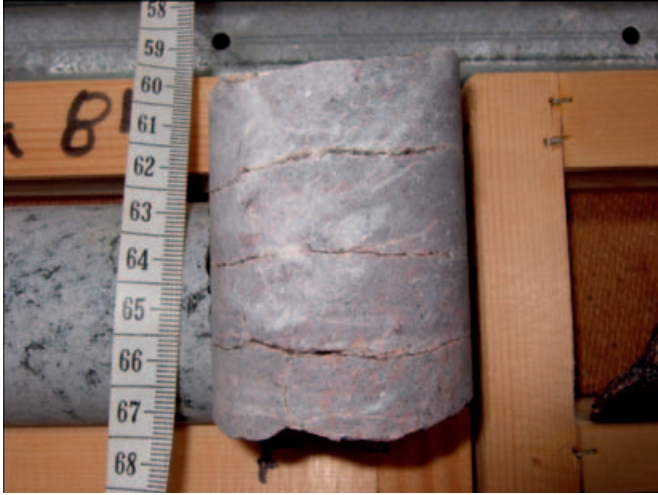
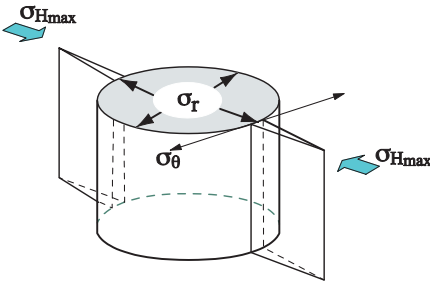
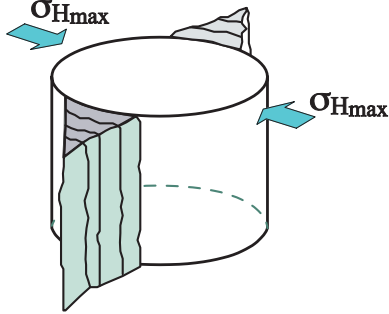
Figure 6-1. Types of fracture patterns that can be induced during drilling.

Figure 6-1 illustrates the three types of fractures noted above that can be drill-induced or at least enhanced by the drilling-induced stresses. As seen in Figure 6-1, drilling-induced fracture patterns do not resemble the non-mineralised fractures detected at Forsmark. From the appearance of core disking fractures one might think that these fracture could propagate into the wall of the borehole. However, these core-disking fractures are caused by excessive compressive stress and these compressive stresses cause borehole breakouts on the wall of the borehole. Hence, core disking and borehole breakouts usually occur together, i.e. stress-induced disking of the core and stress-induced breakouts on the borehole wall. In conclusion, drilling induced stresses cannot be used to explain the occurrence of non-mineralised fractures observed both in the drill cores and in the wall of the boreholes at Forsmark.

Core Fractures	Borehole Wall Fractures
<p>Core Disking</p> <p>Core diskings fractures are normal to the core axis. In the figure below from Forsmark, the diskings fractures intersect and interact with the naturally induced inclined fractures.</p>

<p>Core diskings is caused by tensile stresses induced in the core stub close to the drill bit. The tensile stresses are induced by very high compressive stresses that get turned into tension by the geometry of the core stub. The stresses can be artificially induced during drilling by excessive heat from the drill bit.</p> <p>Core diskings and breakouts are commonly found together.</p>	<p>Borehole Wall Fractures</p> <p>Tensile Fracture (Hydraulically induced)</p>

<p>These fractures form when the stress applied to the borehole hole induces a tangential stress that exceeds the tensile strength of the rocks. These process can be caused by excessive fluid pressure, induced either during drilling or hydraulic fracturing.</p> <p>Borehole Breakout</p>

<p>These fractures form when the stress applied to the borehole hole induces a tangential stress that exceeds the compressive (spalling) strength of the rocks. The stresses can be artificially induced during drilling by excessive heat from the drill bit.</p>

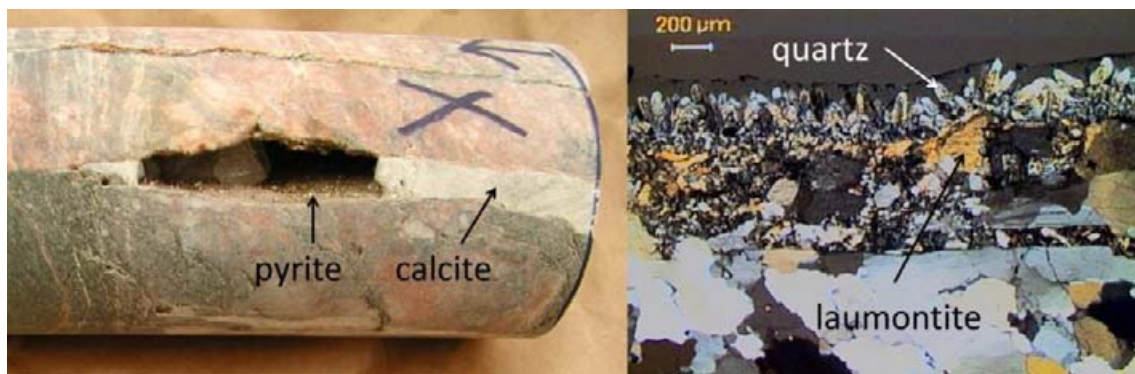
Figure 6-2. In the photograph to the left, evidence of dissolution of fracture minerals can be seen as a cavity. In adjacent parts of the drill core, hydrothermal laumontite and calcite are still present. Following dissolution, younger fracture minerals such as Palaeozoic calcite and pyrite have precipitated in the cavity. In the photomicrograph from the same sample to the right, remnants of the partly dissolved laumontite can be seen. Quartz has later precipitated on the etched surface. Although this fracture has been exposed to dissolution under hydrothermal conditions, remnants of the older fracture minerals can still be found when the fracture is studied under the microscope. Sample KFM04A 306.40–306.55 m, modified after /Sandström and Tullborg 2005/.

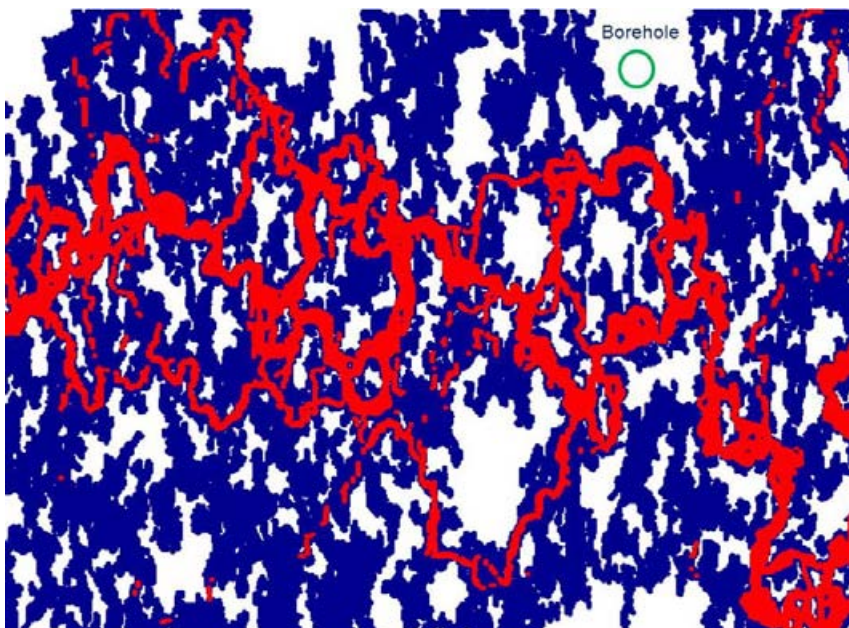
Another scenario relating to opening of the fractures/micro-fractures is that the fractures represent non-connected, partly sealed, parts of a fracture plane (Figure 6-4). Given that roughness and aperture of a fracture plane can vary, water flows preferentially through “channels” in the fracture plane. The more narrow parts of the fracture plane might be accessible to fluids only by diffusion. Thus, a fracture is seldom evenly coated and the coating appears patchy and the parts of the fracture plane where solute transport mainly is controlled by diffusion can be left non-mineralised. It is therefore possible that previously non-transmissive (i.e. non-connected) and non-mineralised parts of the fracture plane were intercepted and opened up during the drilling process. This would allow connection and enabled flow in the fracture, resulting in a non-mineralised PFL-fracture. However, given that the fracture part has not been open for a long time, fracture mineral precipitation has not occurred (Figure 6-4). We emphasize that the sampled fracture surfaces represent a very small area (diameter c. 5 cm) of the actual fracture plane. Therefore, if this process is feasible, it can be expected that some drill cores will intercept a non-mineralised part of the fracture plane.

Figure 6-4. Channelled flow theory. The figure show flowing (red) and stagnant (blue) water and areas where the fracture surfaces are in contact, i.e. no water (white). The borehole (green circle) has intersected the fracture plane where the surfaces are in contact (non-mineralised). Figure modified from /SKB 2010/. One possible reason for the uneven mineral coating of the fracture plane is channelled flow, i.e. the circulating fluid has only accessed parts of the fracture plane (red and blue) due to e.g. aperture differences. In this scenario minerals have been precipitated on the parts of the fracture plane where fluids have been circulating. If a borehole penetrates a part of the fracture plane, which has not been accessed by circulating fluids (white), this part is consequently non-mineralised. However, it may, due to e.g. glacial unloading or core drilling activity, have been opened up and just recently been accessed by circulating fluids. Given that the fluid has circulated in the fracture for a relatively short time period, this part of the fracture surface is left non-mineralised but still transmissive.

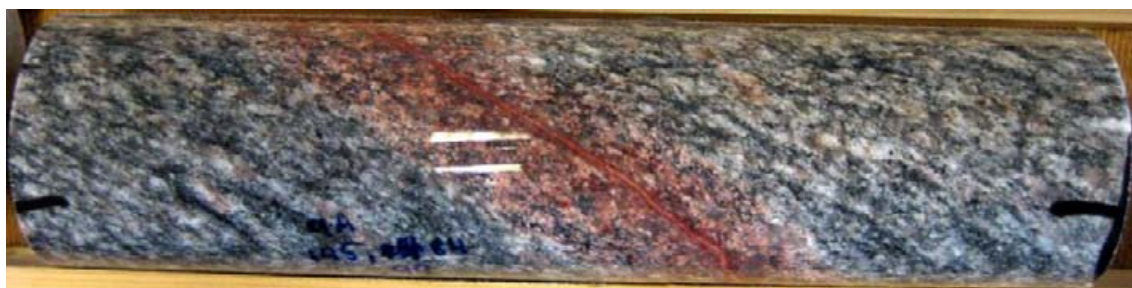
- Hydrothermal alteration of the wall rock is a characteristic feature found adjacent to fractures which were subjected to fluid circulation prior to 1,000 Ma (Figure 6-5). This alteration was caused by chemical re-equilibrium processes under hydrothermal conditions at temperatures > 200°C /Sandström et al. 2010/. This type of alteration is not found adjacent to the non-mineralised fractures, indicating that no fluids circulated in these fracture prior to 1,000 Ma.
- The non-mineralised fractures probably did not conduct water during the Palaeozoic events of fluid migration in the Forsmark area, which caused abundant mineral precipitation within fractures /Sandström et al. 2009/. Therefore, a maximum age of 277 Ma (the age of the late stage of precipitation of generation 3 minerals (Table 5-6) for water flow in these fractures is postulated.

Figure 6-5. Red-stained hydrothermally altered wall rock adjacent to a fracture sealed with laumontite. Sample KFM09A 150.67 m, figure from /Sandström et al. 2008b/. The diameter of the drill core is c. 5 cm.

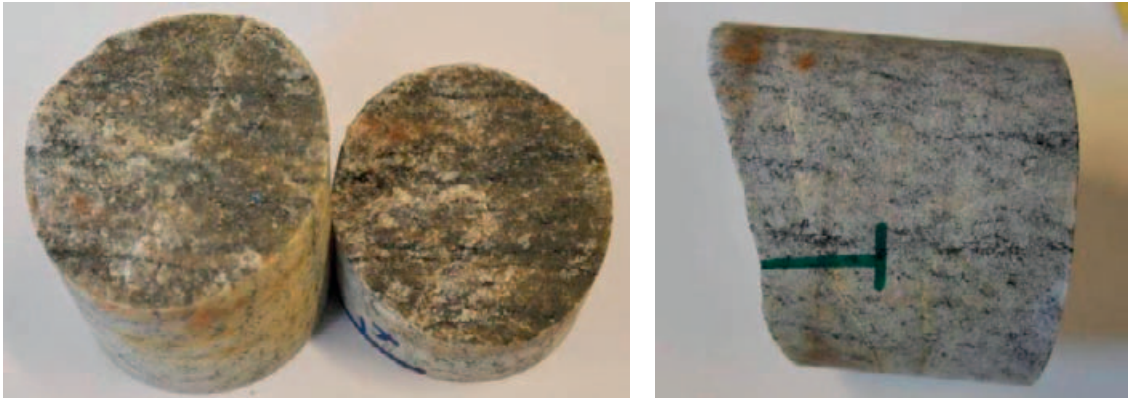
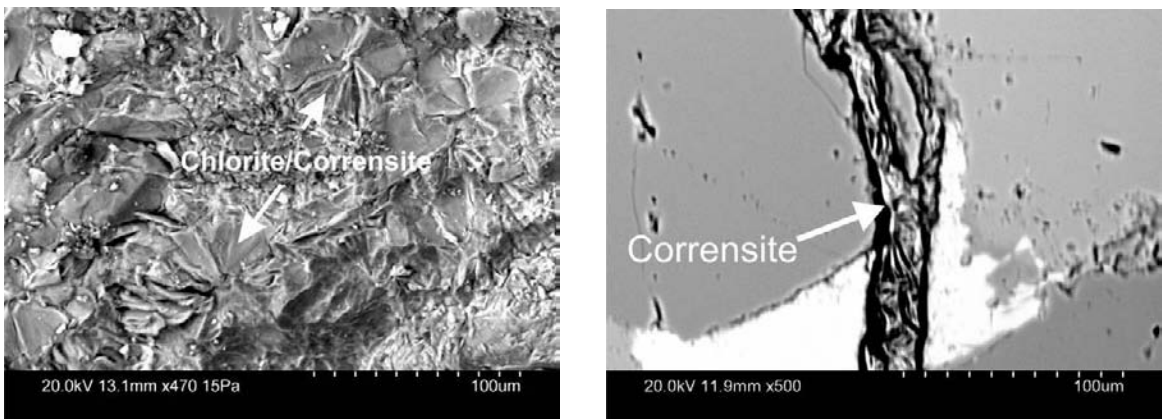
The open fracture is parallel with a micro-fracture with clay mineral (probably corrensite).

Photographs of drill core and fracture surface.

Back-scattered SEM-image of corrensite on fracture surface and in micro-fracture.

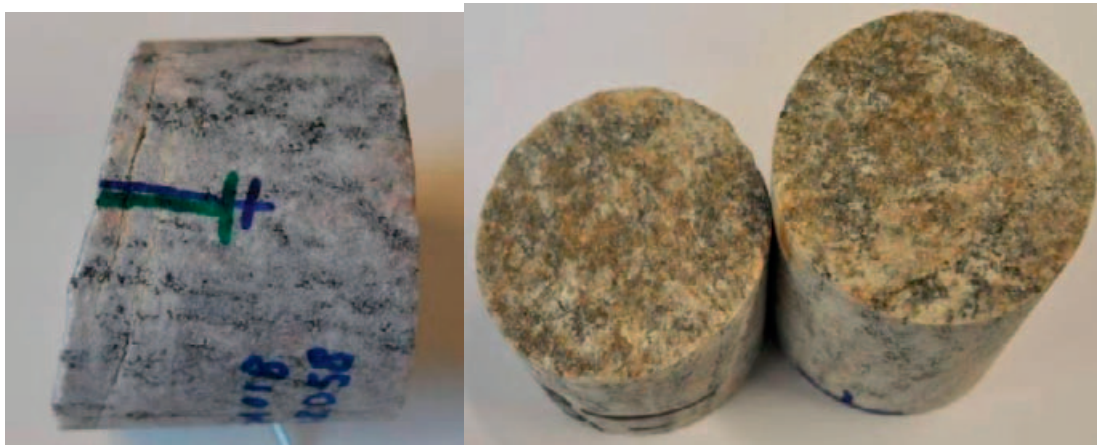
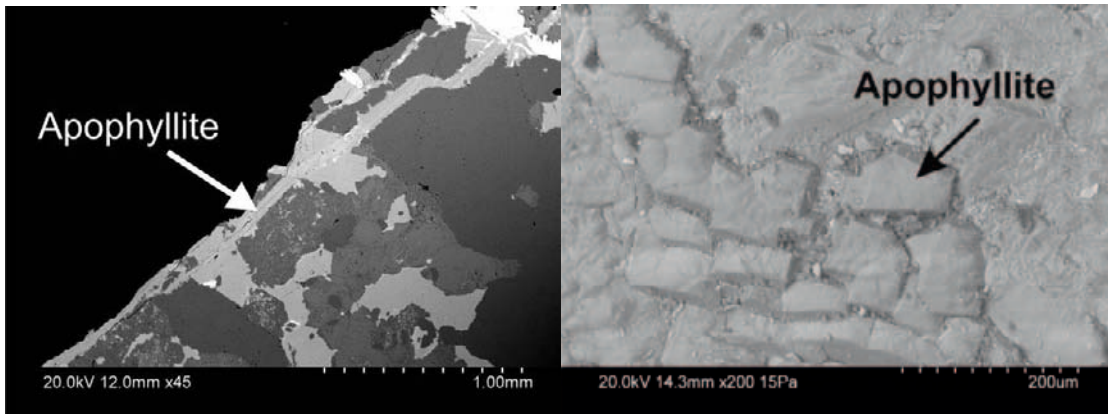
Wall rock: Saussuritised plagioclase but fresh unaltered biotite.

The fracture has been opened along a micro-fracture sealed with hydroxyapophyllite.

Back-scattered SEM-image of apophyllite on fracture surface and in micro- fracture.

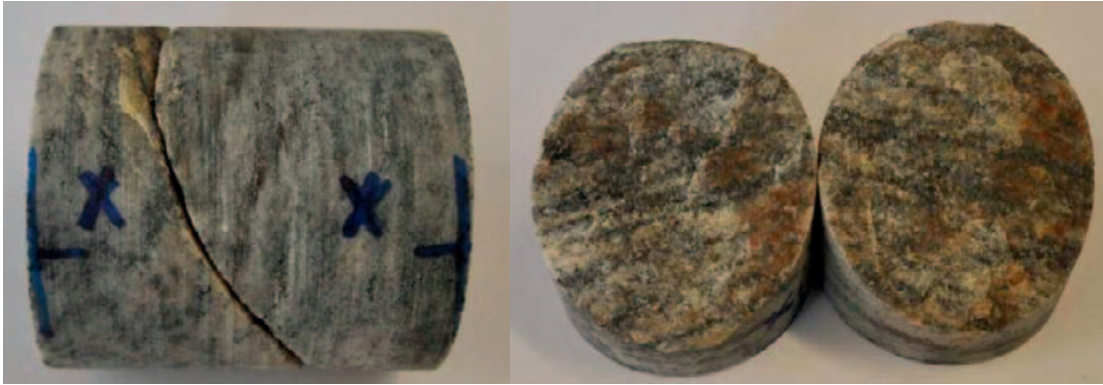
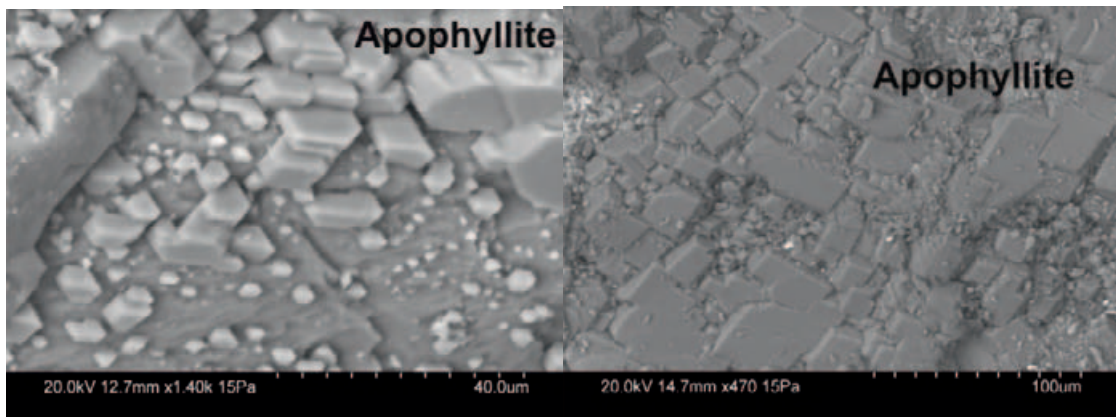
Fracture minerals: Hydroxyapophyllite, clay mineral (probably corrensite).

Wall rock: Fresh biotite and relatively unaltered plagioclase.

Back-scattered SEM-image of apophyllite on fracture surface.

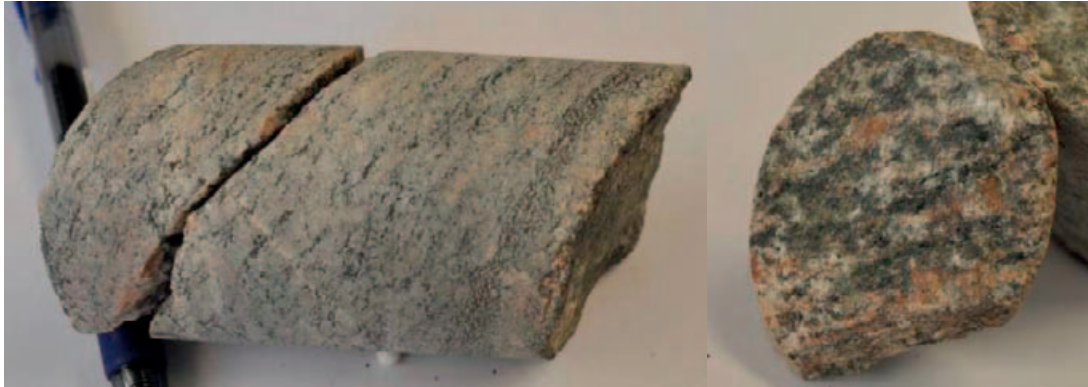
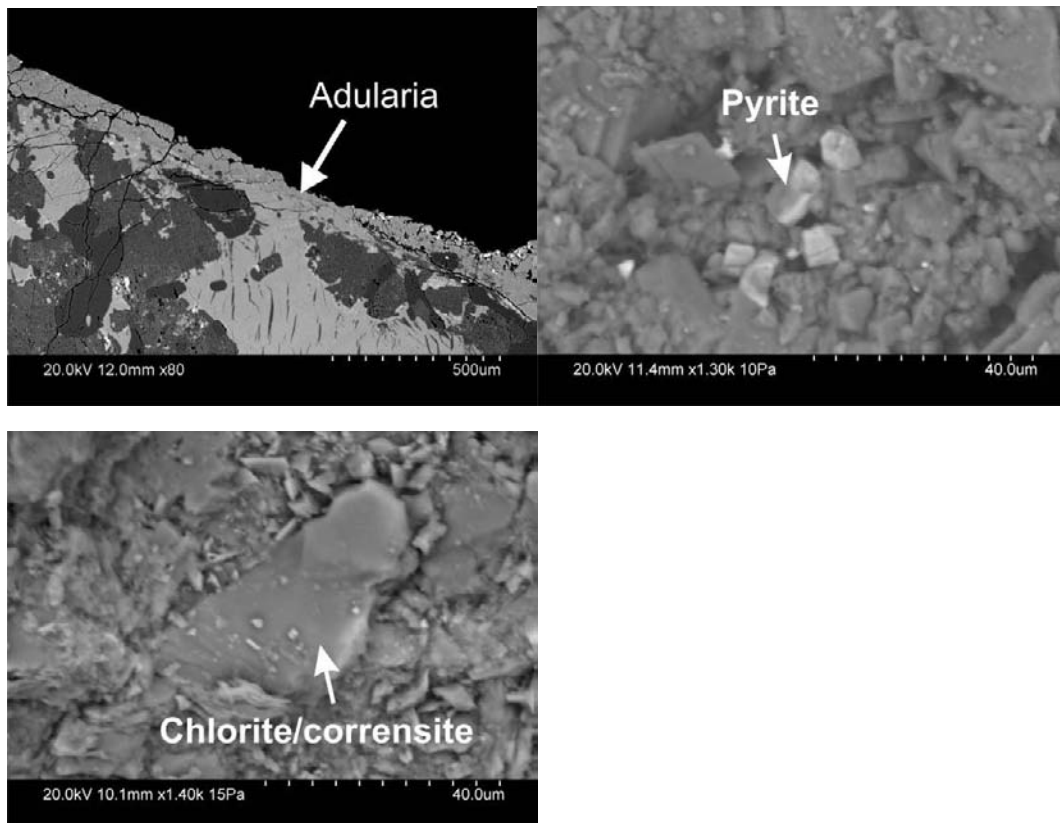
Fracture minerals: Adularia, chlorite/corrensite, pyrite.

Wall rock alteration: Saussuritized plagioclase, unaltered biotite.

Back-scattered SEM-image of adularia, pyrite and chlorite/corrensite on fracture surface.

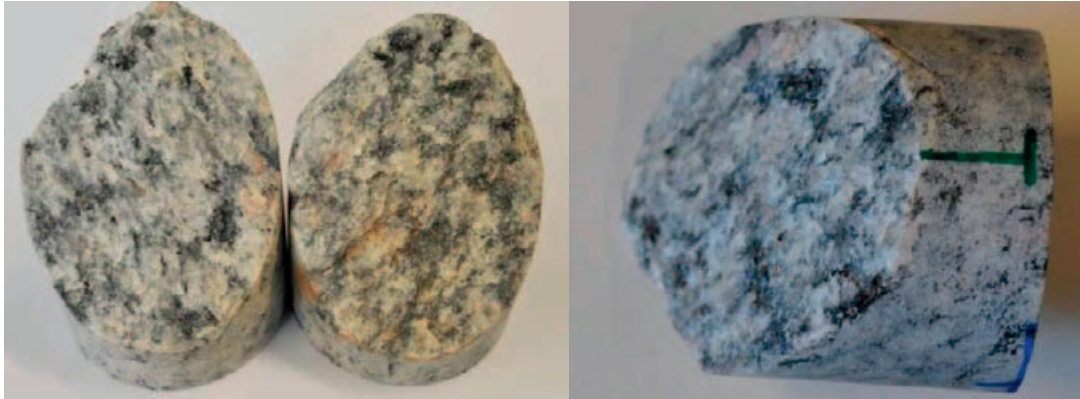
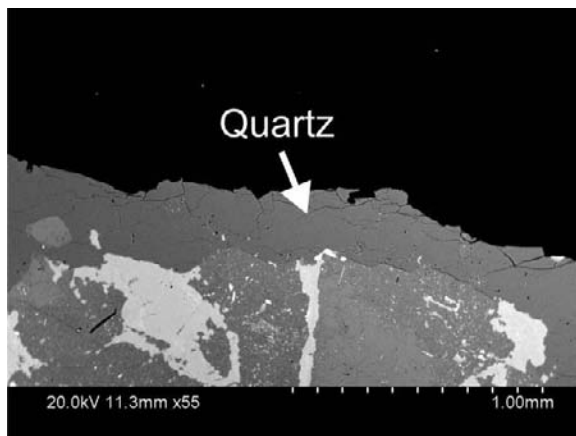
Fracture mineral: Quartz.

Wall rock: Unaltered biotite and plagioclase.

Back-scattered SEM-image of quartz on fracture surface

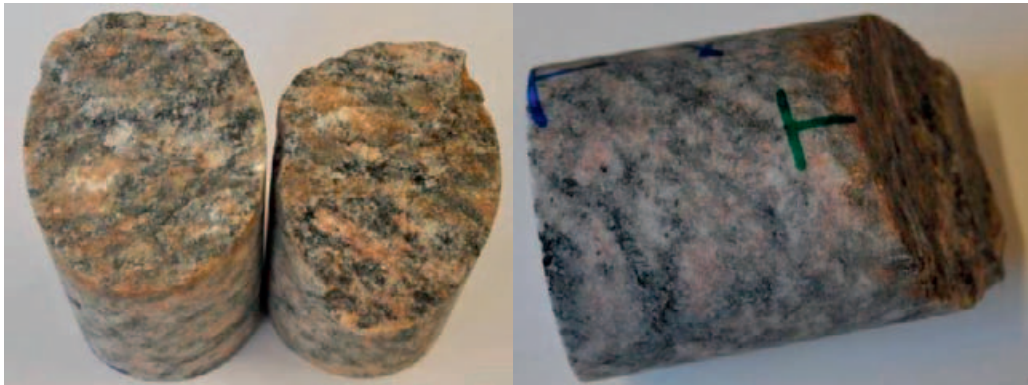
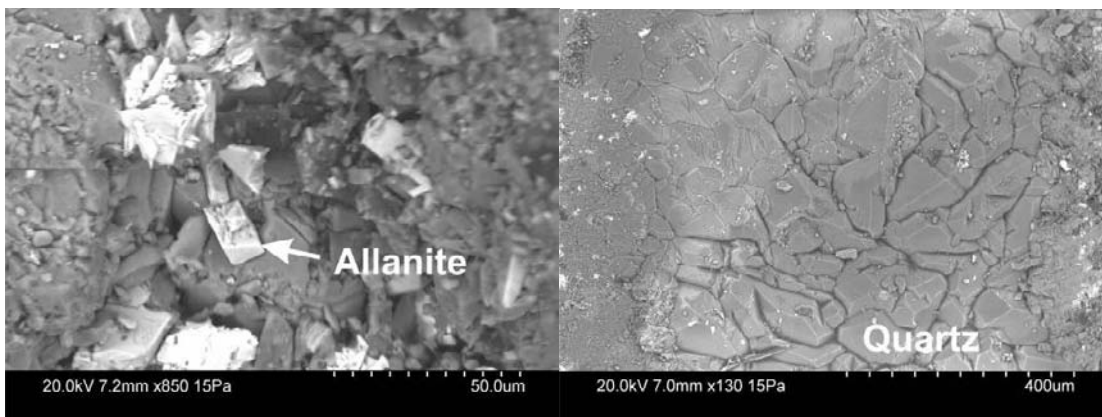
The fracture has opened along a micro-fracture sealed with quartz, clay mineral (probably corrensite) and allanite.

Back-scattered SEM-image of quartz and allanite on fracture surface.

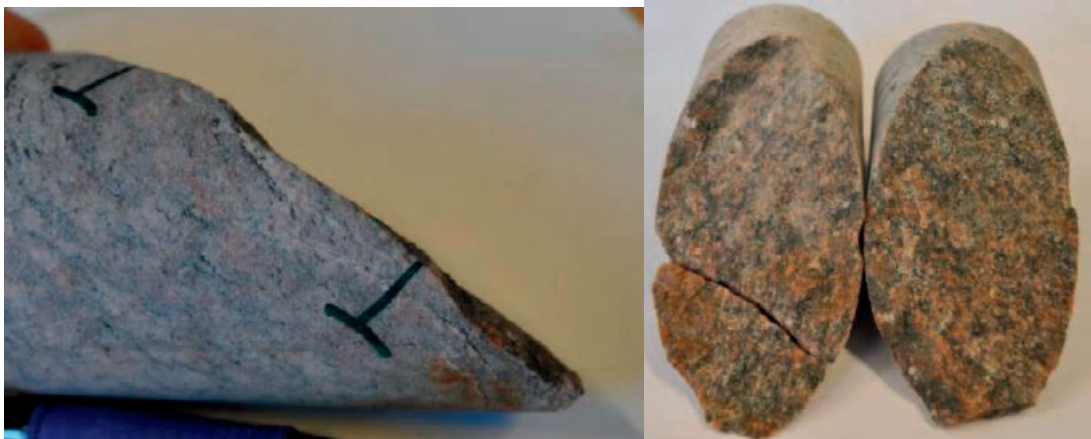
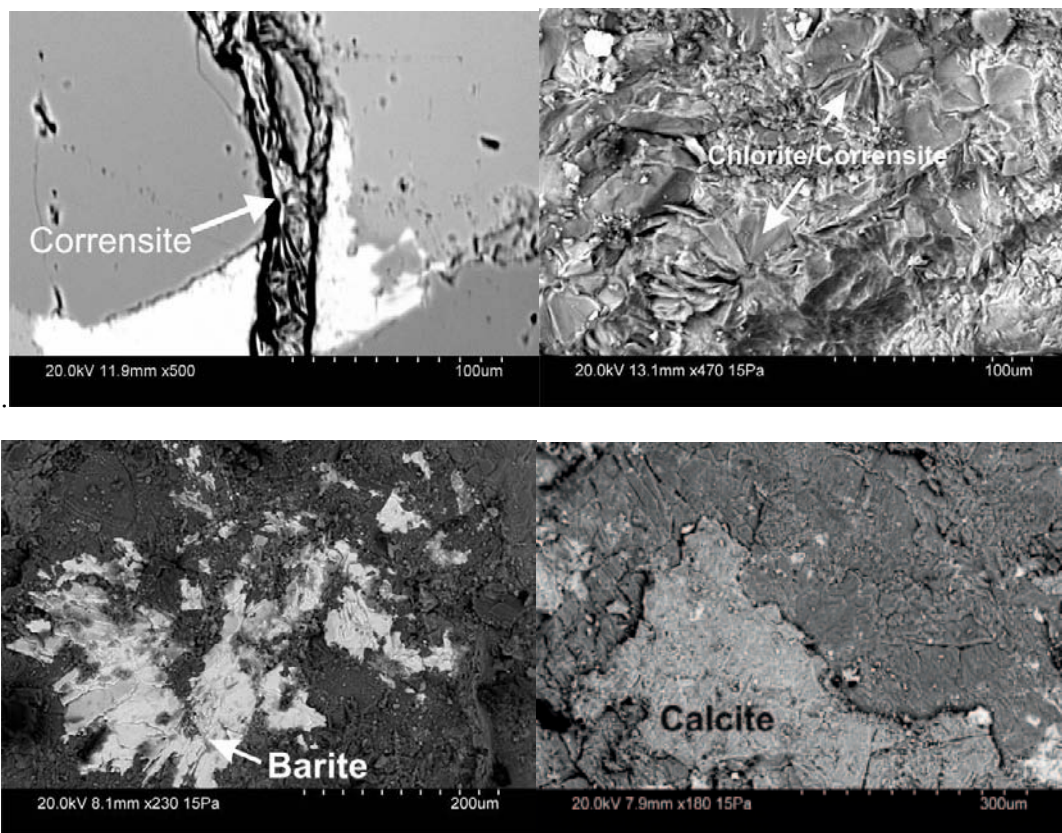
Fracture parallel to a micro-fracture sealed with clay mineral (probably corrensite).

Back-scattered SEM-image of corrensite on fracture surface.

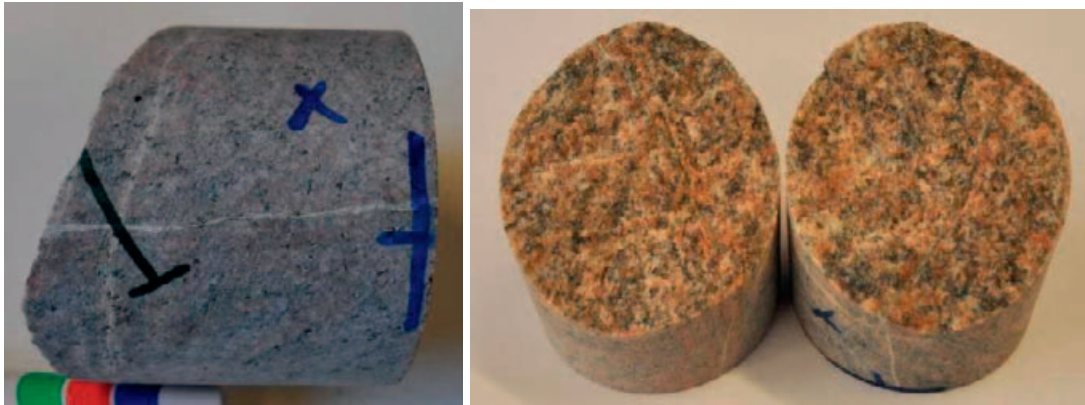
Fracture parallel to micro-fractures sealed with calcite, quartz and adularia

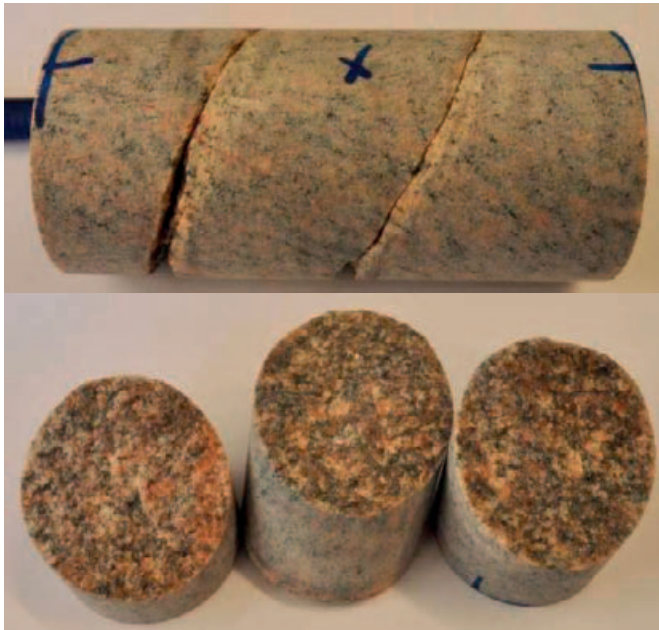
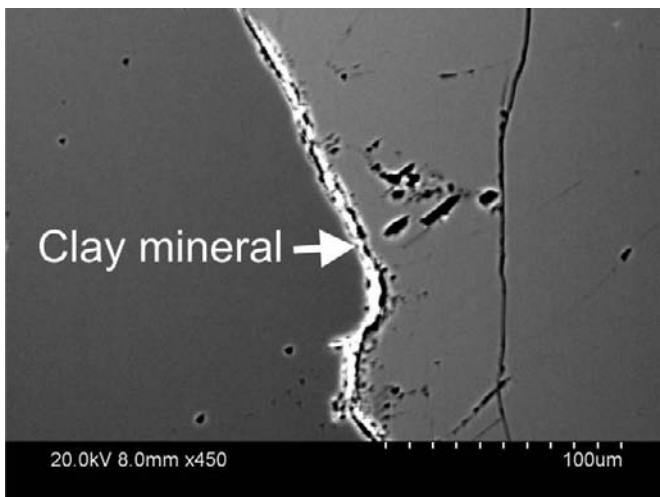
Fractures parallel to micro-fractures with clay mineral.

Back-scattered SEM-image of clay mineral on fracture surface.

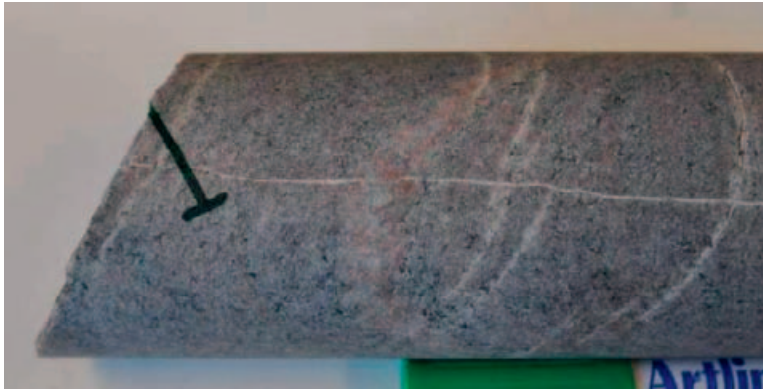
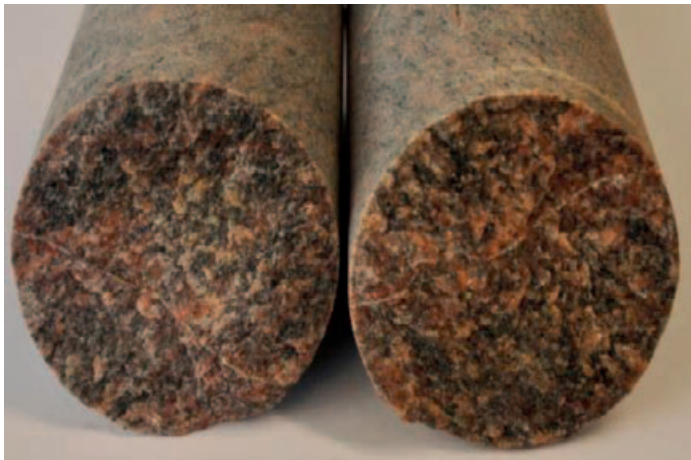
Fracture parallel to bands of micro-fractures, sealed with calcite and pyrite.

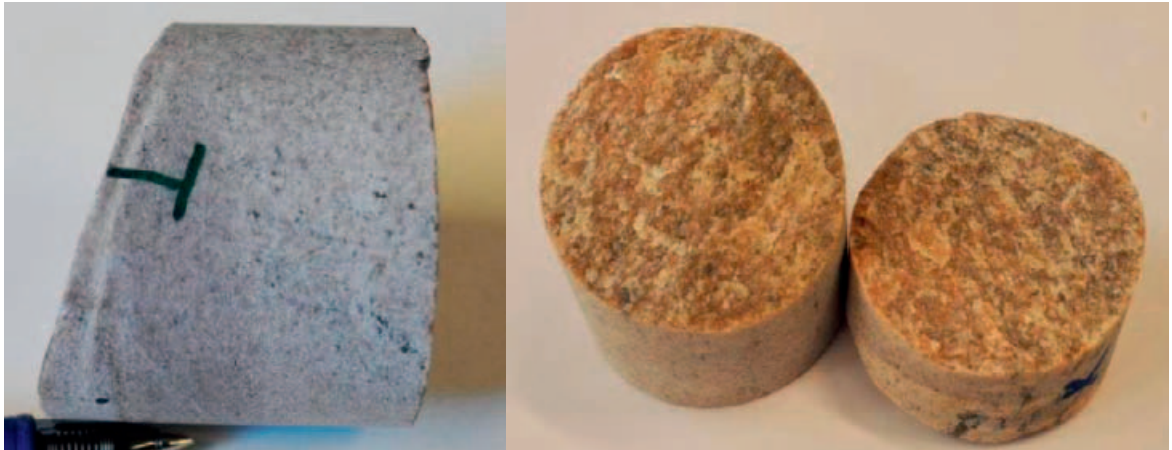
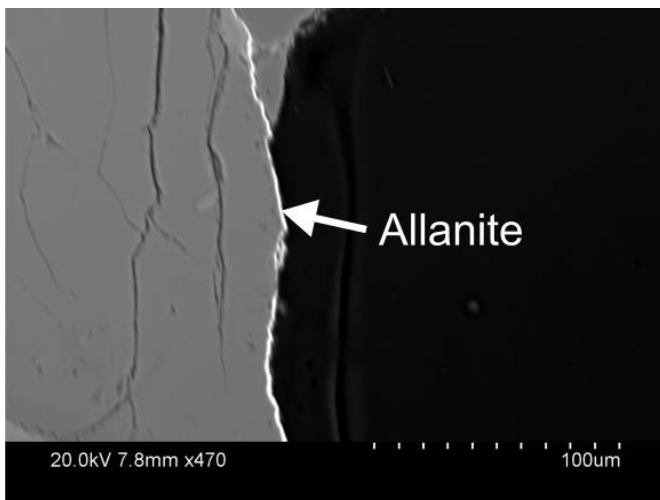
Fracture parallel to micro-fractures with pyrite and adularia.

Back-scattered SEM-image of allanite on fracture surface.

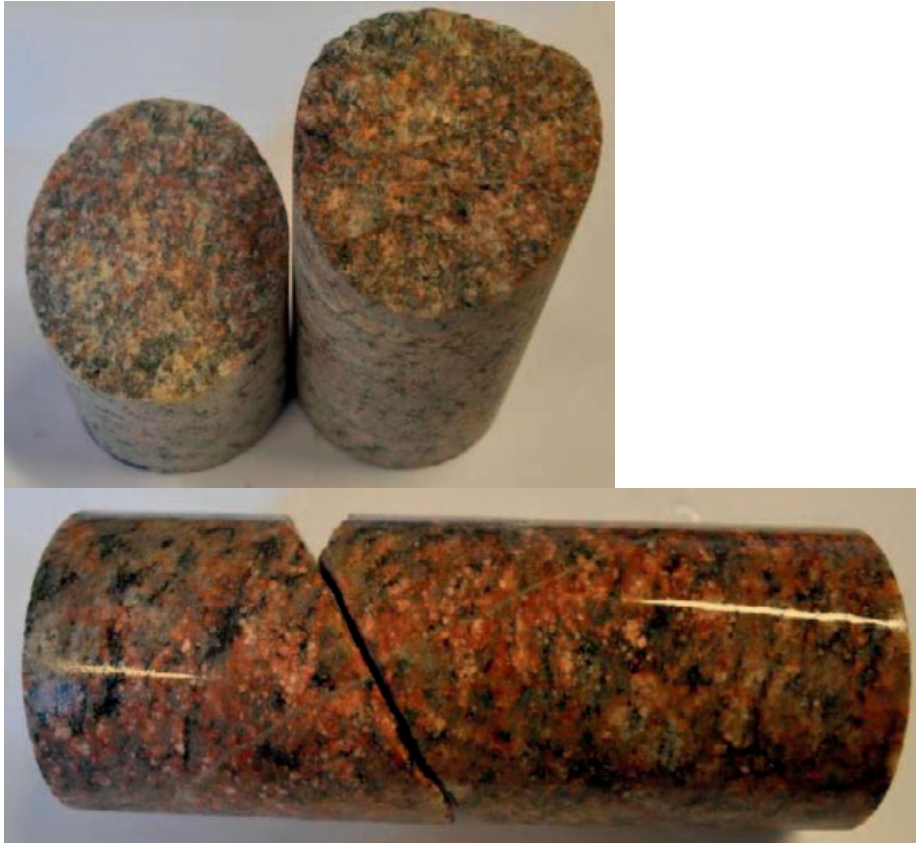
Fracture minerals: No detected minerals.

Wall rock: Chloritised biotite and saussuritised plagioclase.

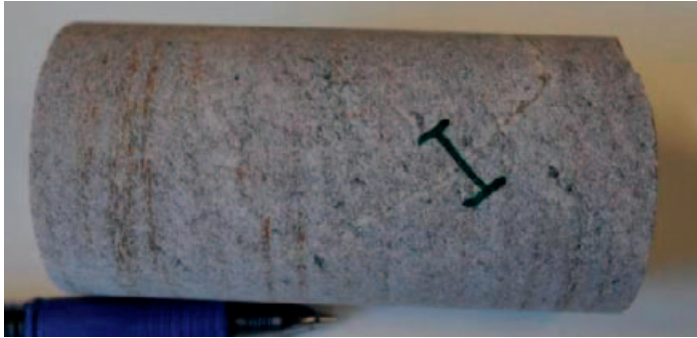
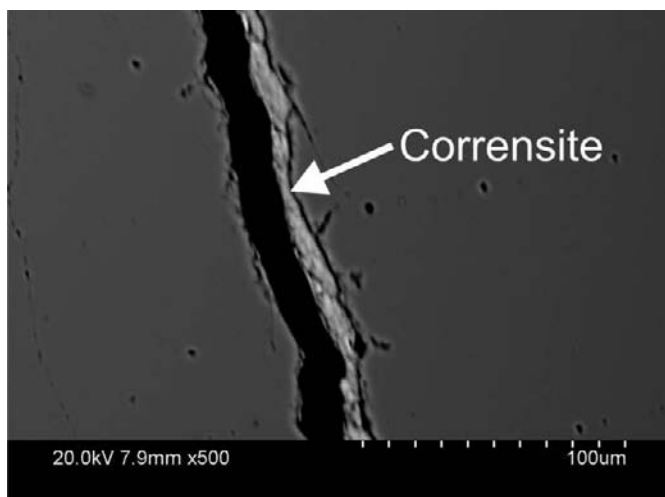
Fracture minerals: Clay mineral (probably corrensite).

Back-scattered SEM-image of corrensite in micro-fracture.

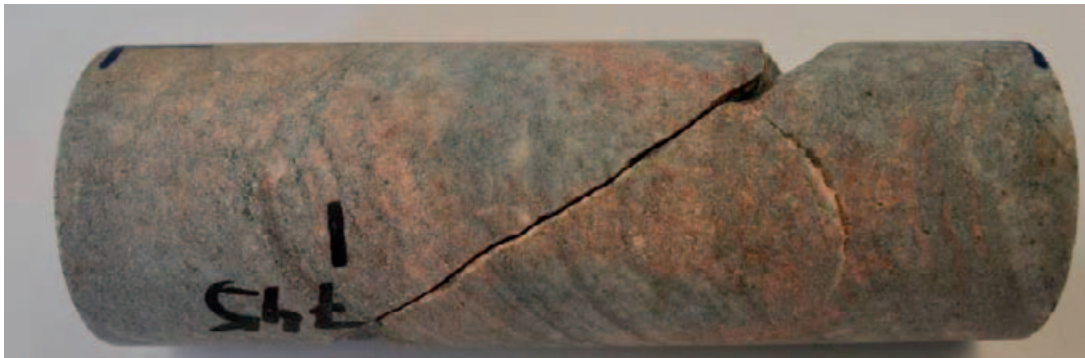
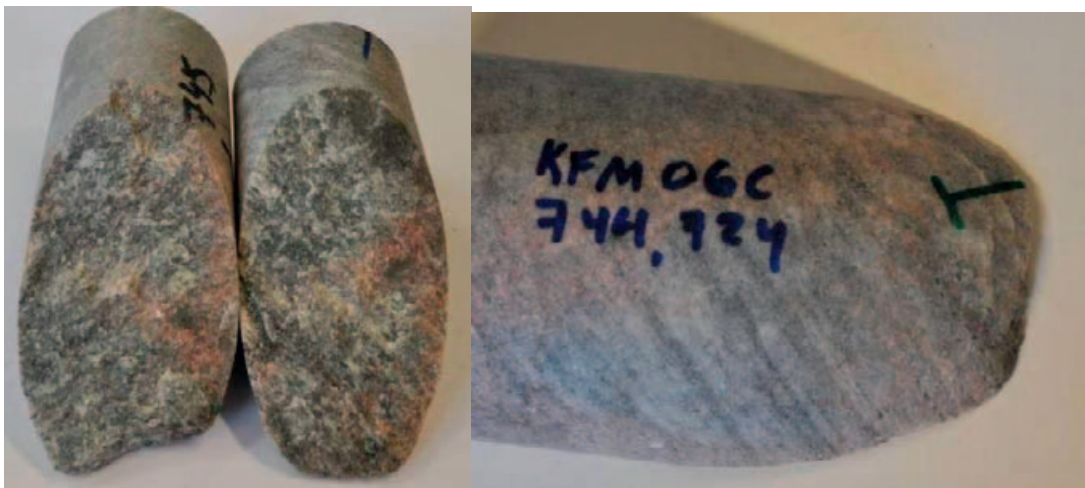
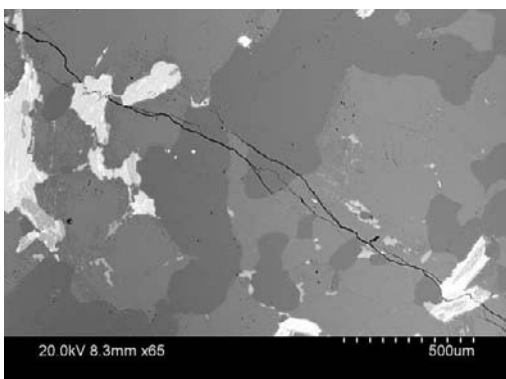
Fracture parallel to micro-fractures with no mineral.

Back-scattered SEM-image of micro-fracture.

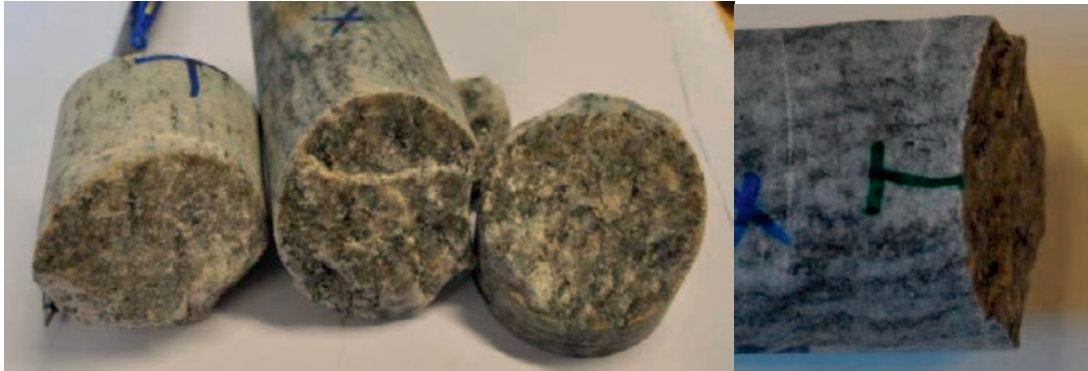
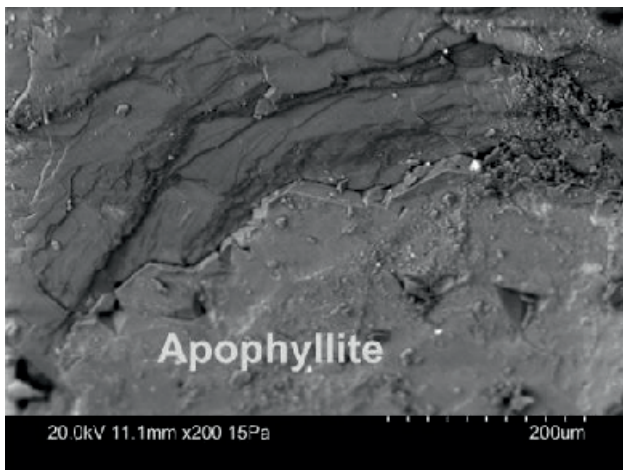
Fracture minerals: Hydroxyapophyllite.

Back-scattered SEM-image of apophyllite on fracture surface.
