Assessment of fractures classified as non-mineralised in the Sicada database

Lillemor Claesson Liljedahl, Raymond Munier
Svensk Kärnbränslehantering AB

March 2011

Svensk Kärnbränslehantering AB

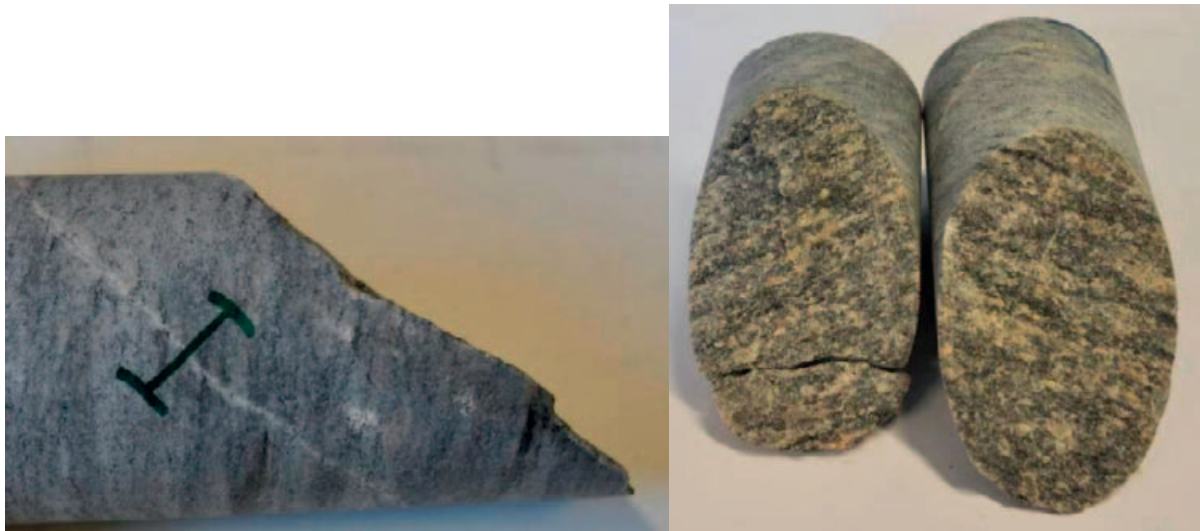
Fracture parallel to micro-fractures with no mineral.

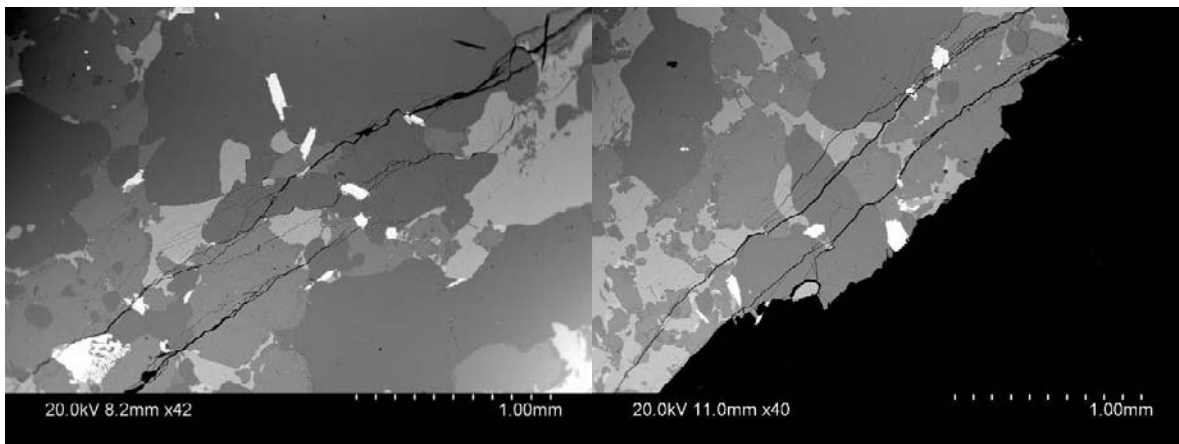
Fracture minerals: No detected mineral in the parallel micro-fracture.

Back-scattered SEM-image of micro-fractures.

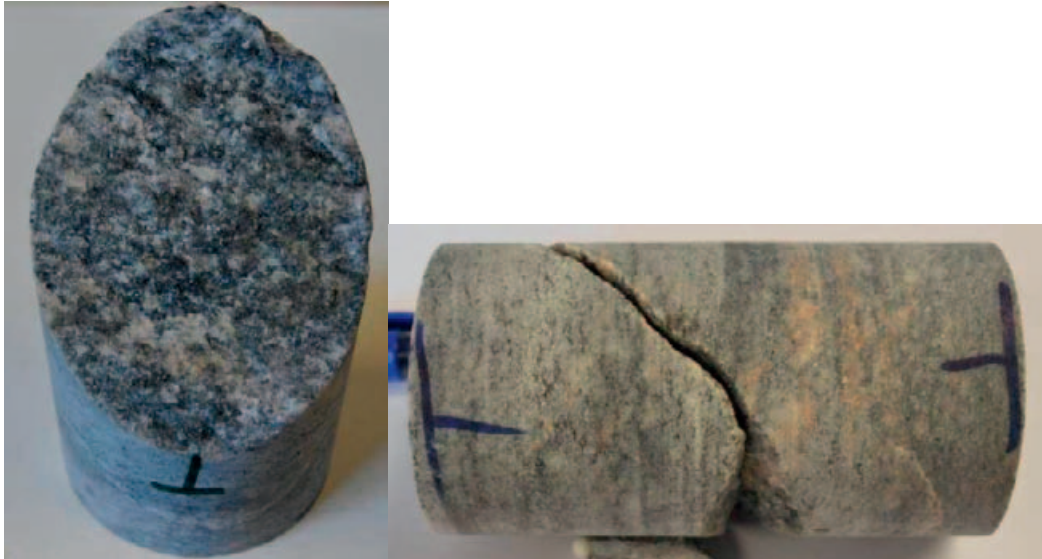
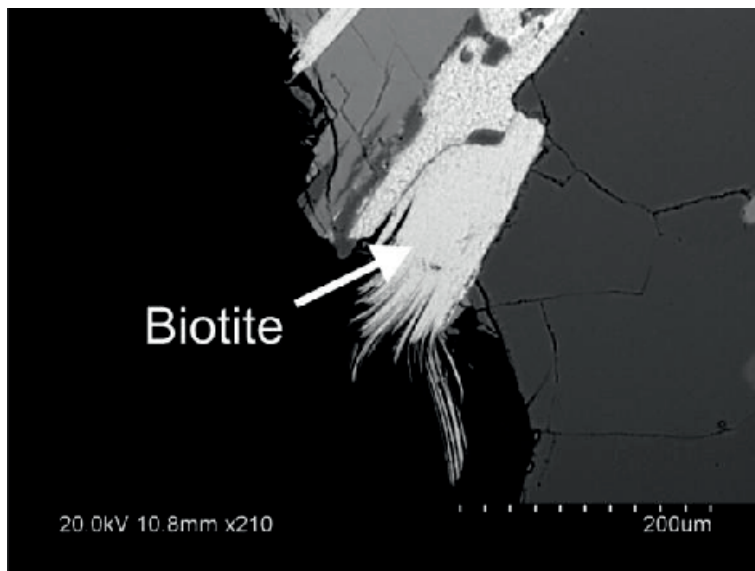
KFM10A 334.430 m

Open fracture

Fracture minerals: No detected mineral.

Wall rock: Unaltered biotite and plagioclase.

Back-scattered SEM-image of biotite in wall rock.

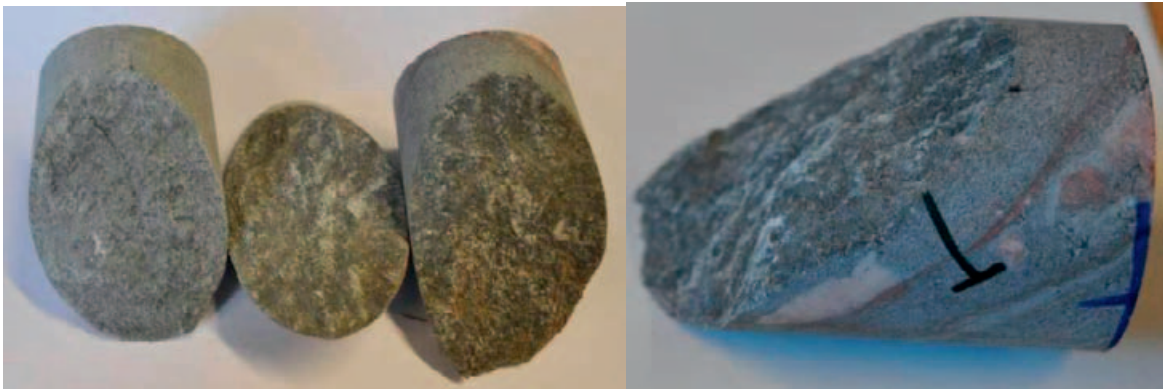
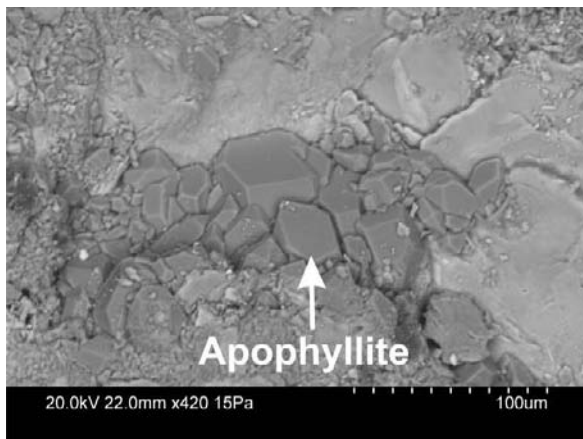
KFM11A 395.37 m

Open fracture

Fracture minerals: Hydroxyapophyllite.

Wall rock: Chloritised biotite and saussuritised plagioclase, mylonite texture.

The open fracture is parallel to a laumontite-sealed fracture.

Back-scattered SEM-image of apophyllite on fracture surface.

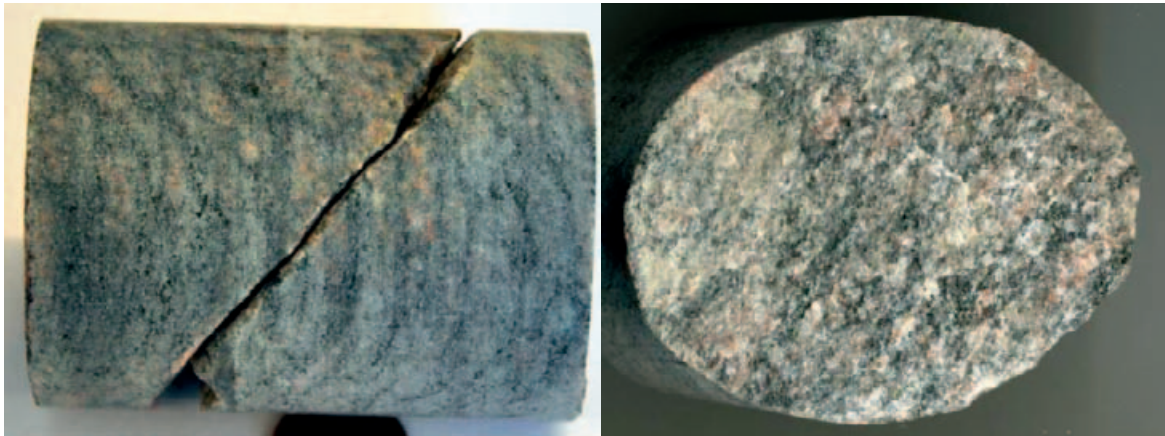
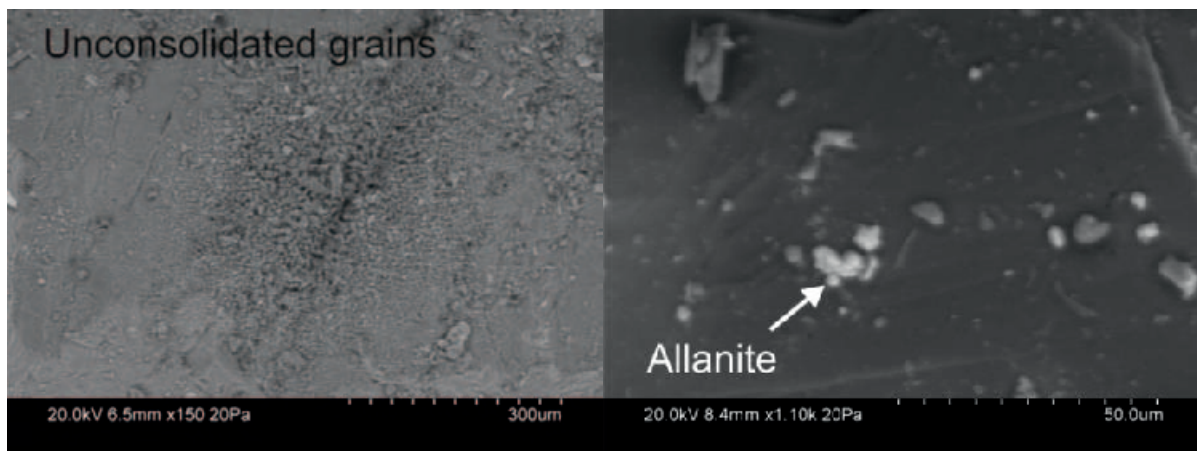
Open fracture

Fracture minerals: Unconsolidated material consisting of grains of biotite, plagioclase, K-feldspar, quartz, chlorite. Small crystals of allanite.

Wall rock: Unaltered, fresh biotite.

Back-scattered SEM-images of allanite on fracture surface.

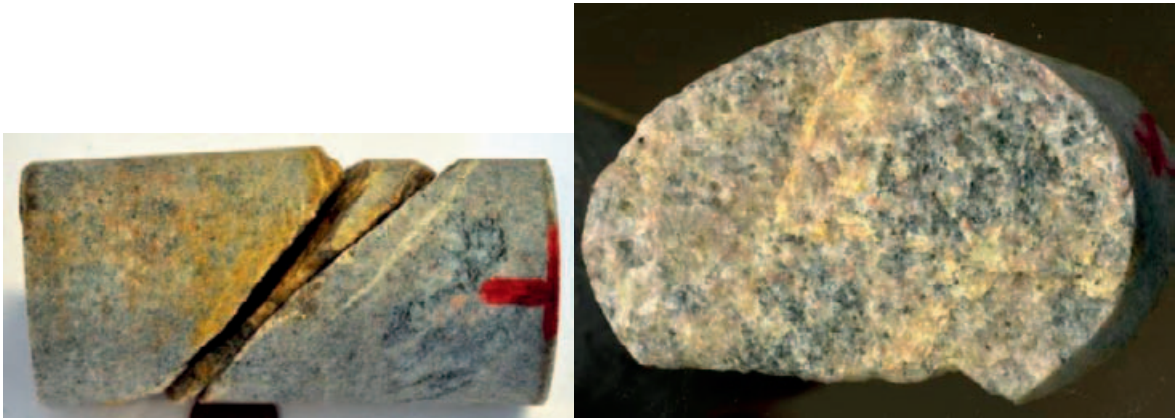
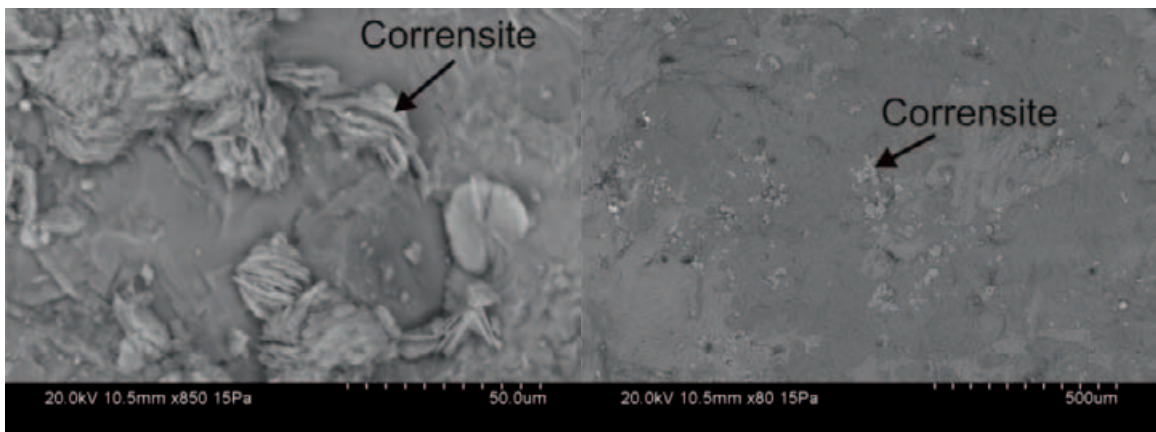
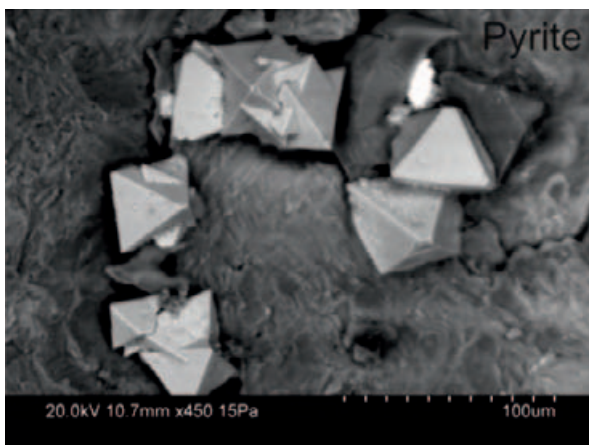
KFM02B 330.696 m

Open fracture

Fracture minerals: Corrensite, pyrite.

Wall rock: Unaltered, fresh biotite.

Parallel to micro-fractures with a few pyrite crystals.

Back-scattered SEM-image of corrensite and pyrite on fracture surface.

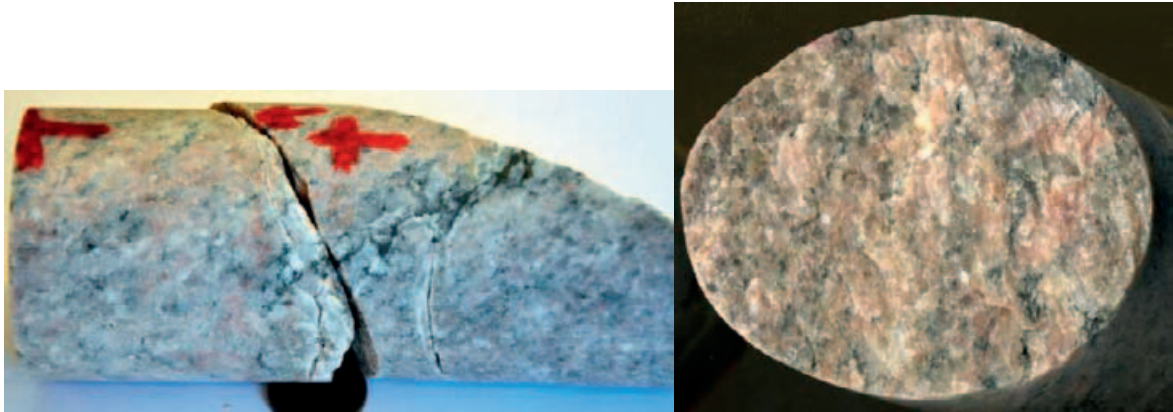
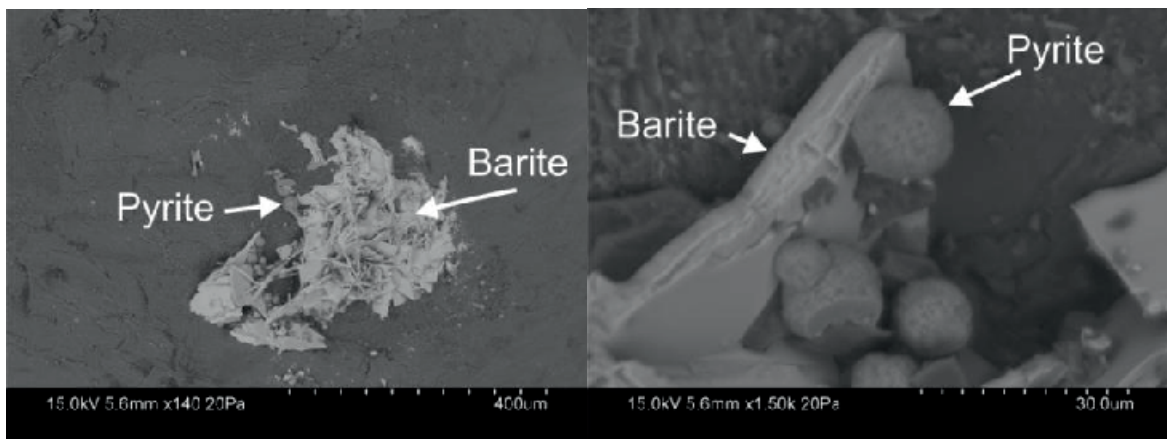
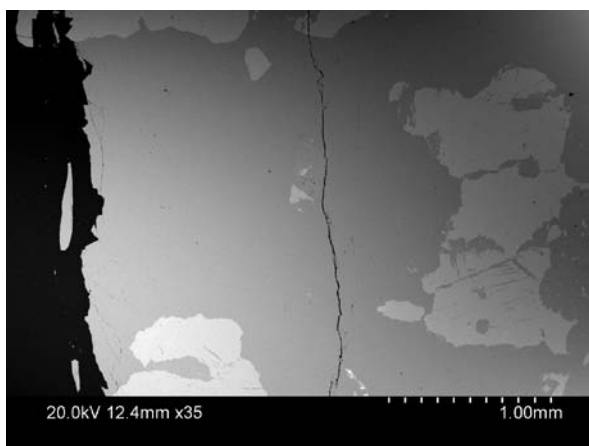
KFM02B 413.066 m

Open fracture

Fracture minerals: Barite, pyrite.

Wall rock: Altered, chloritised biotite.

Back-scattered SEM-image of pyrite and barite on fracture surface.

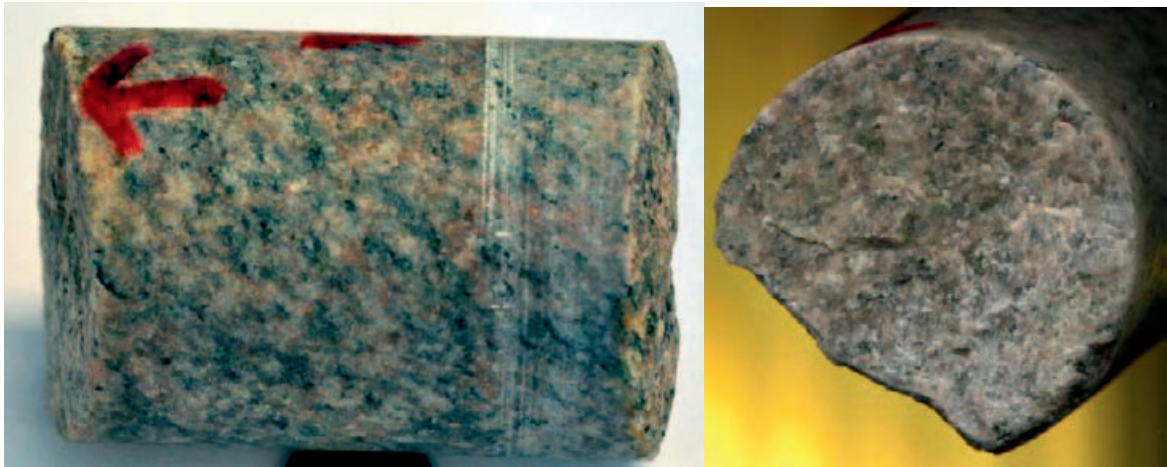
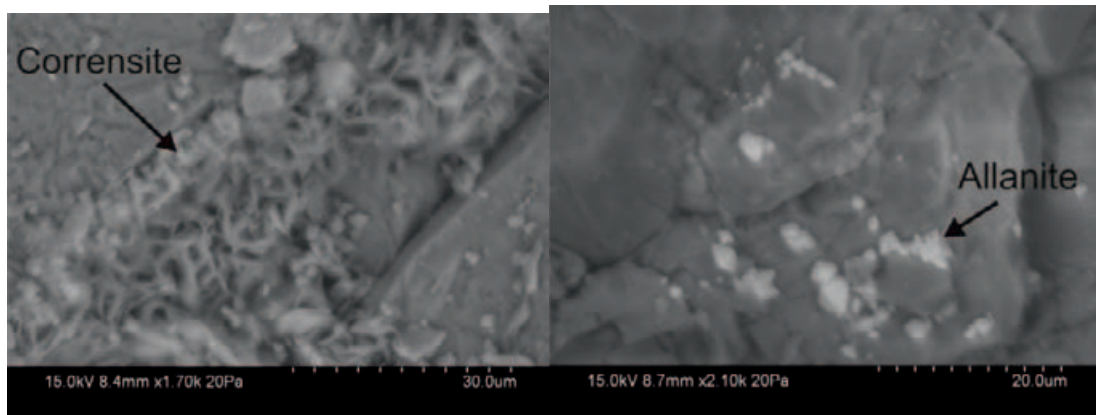
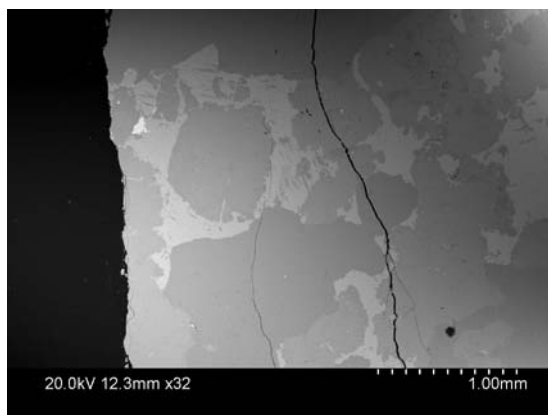
KFM02B 423.349 m

Open fracture

Fracture minerals: Corrensite, allanite.

Wall rock: Altered, chloritised biotite.

Parallel to micro-fractures with no detected mineral.

Back-scattered SEM-image of corrensite and allanite on fracture surface.

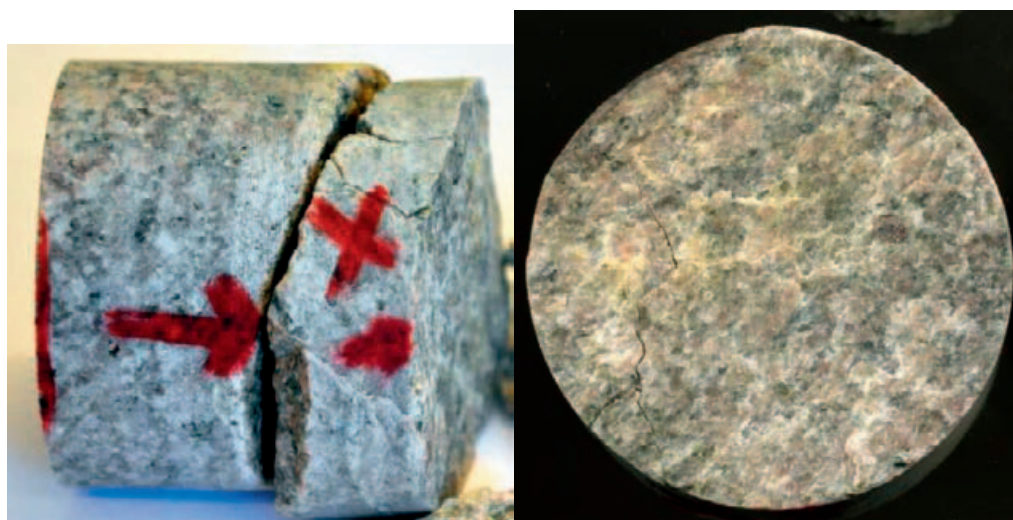
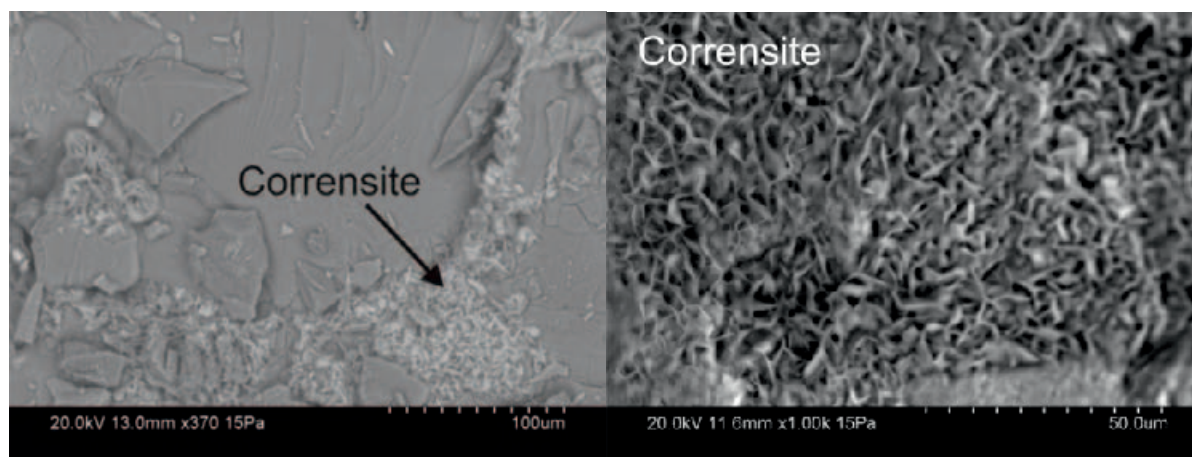
KFM02B 426.132 m

Open fracture

Fracture minerals: Corrensite.

Wall rock: Partly chloritised biotite.

Sample cut by numerous micro-fractures without detected minerals.

Back-scattered SEM-image of corrensite on fracture surface.

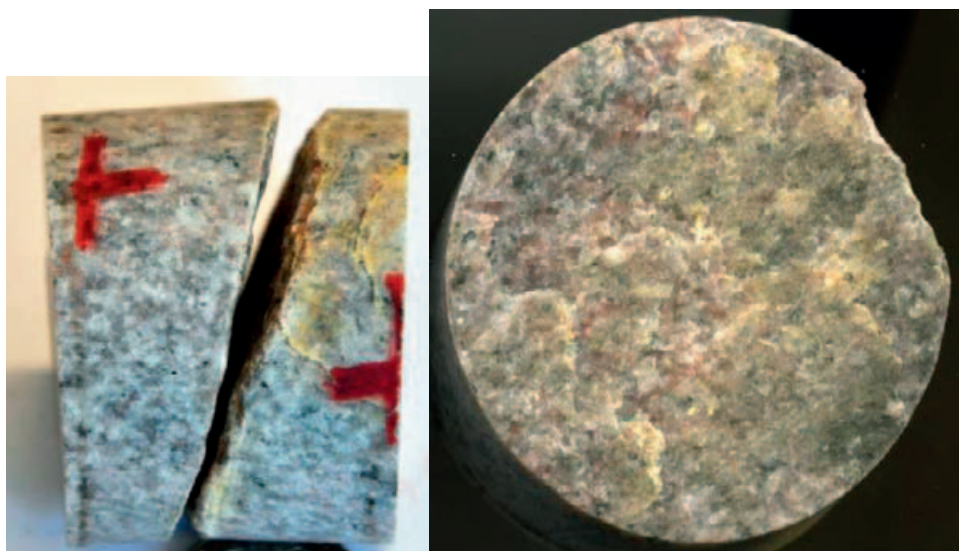
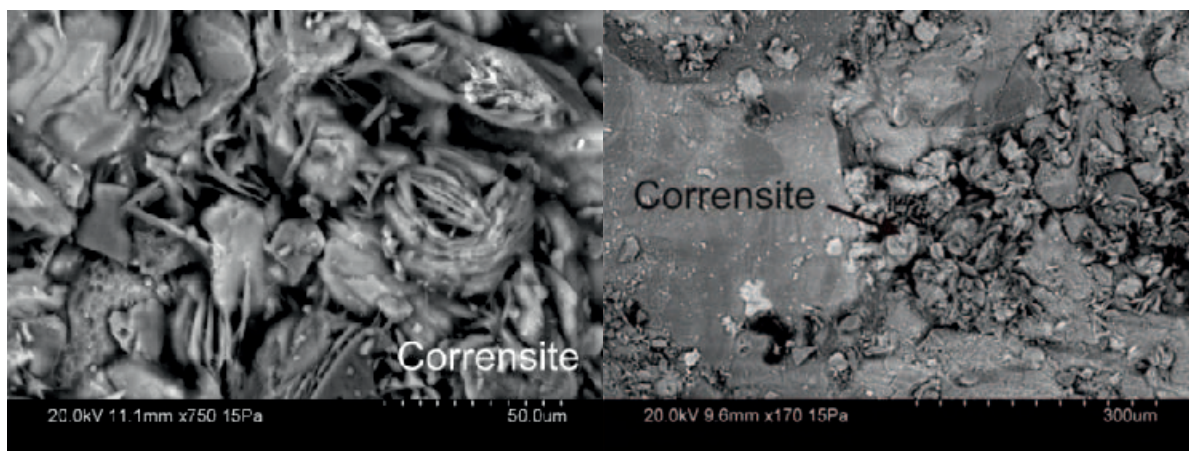
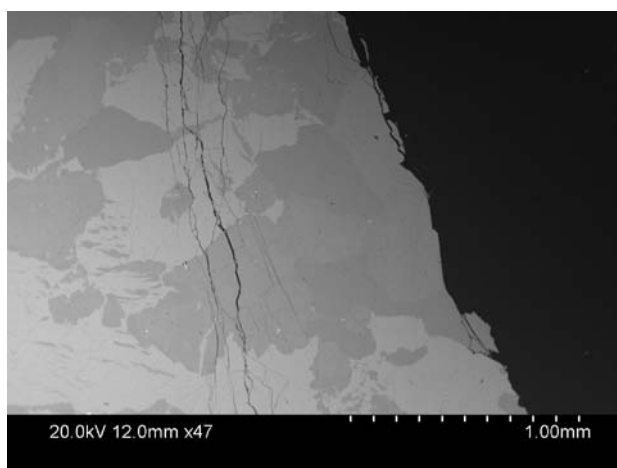
KFM02B 426.354 m

Open fracture

Fracture minerals: Corrensite.

Wall rock: Altered, chloritised biotite.

Parallel to micro-fractures with no detected mineral.

Back-scattered SEM-image of corrensite on fracture surface.

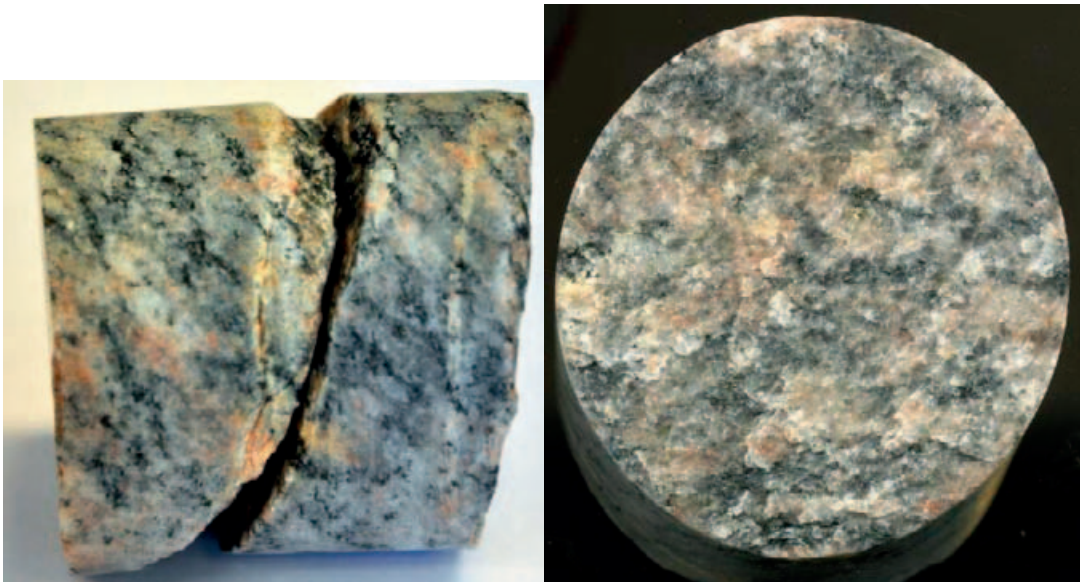
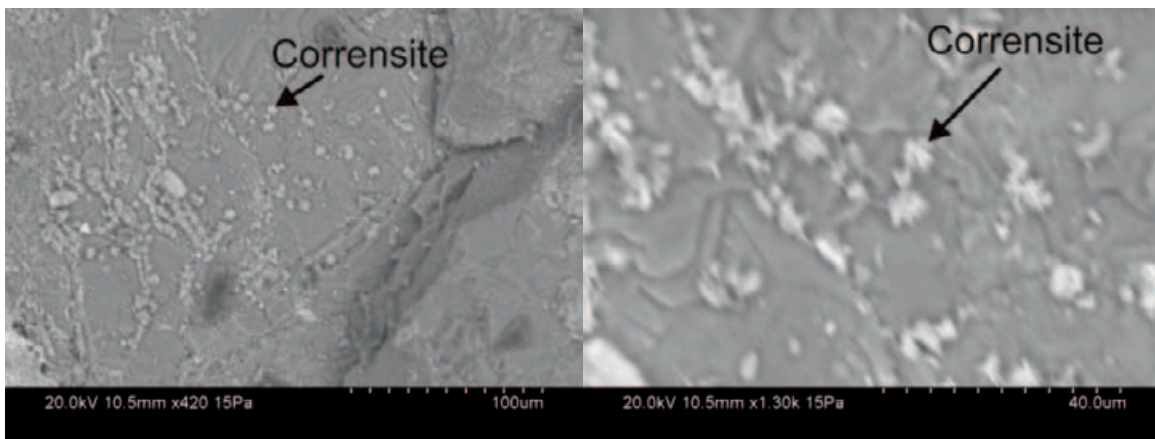
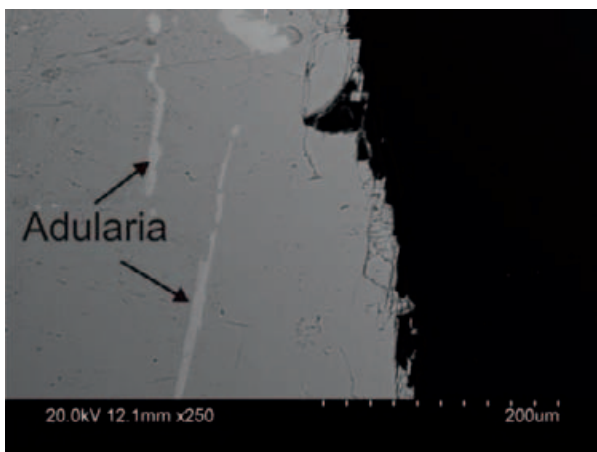
KFM02B 429.508 m

Open fracture

Fracture minerals: Corrensite.

Wall rock: Unaltered, fresh biotite.

Sub-parallel to micro-fractures partly sealed with adularia.

Back-scattered SEM-image of corrensite and adularia on fracture surface.

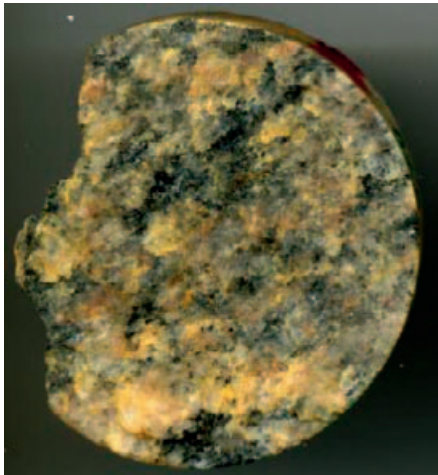
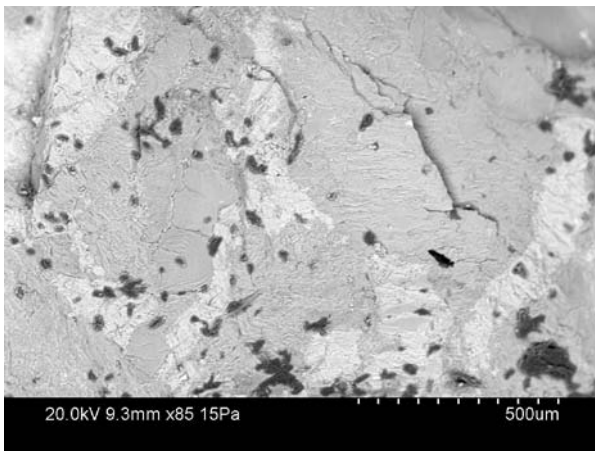
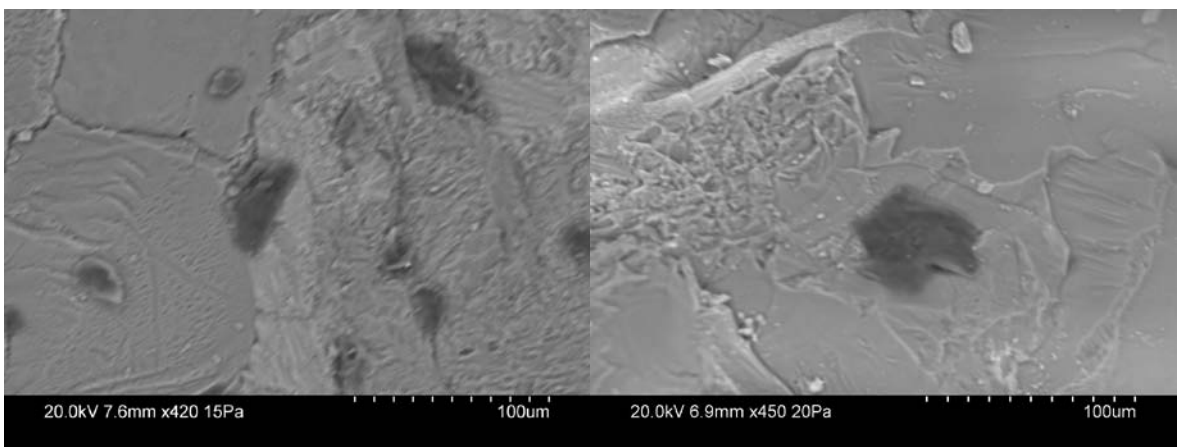
KFM02B 429.603 m

Open fracture

Fracture minerals: Unknown coating with C and Cl, possibly from drilling or HCl during mapping.

Wall rock: Unaltered fresh biotite.

Back-scattered SEM-image of unknown mineral coating on fracture surface.

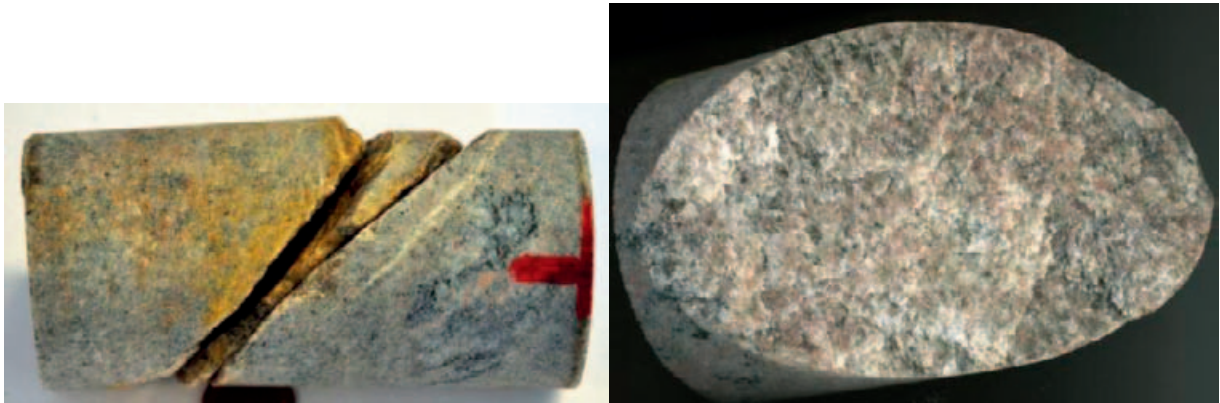
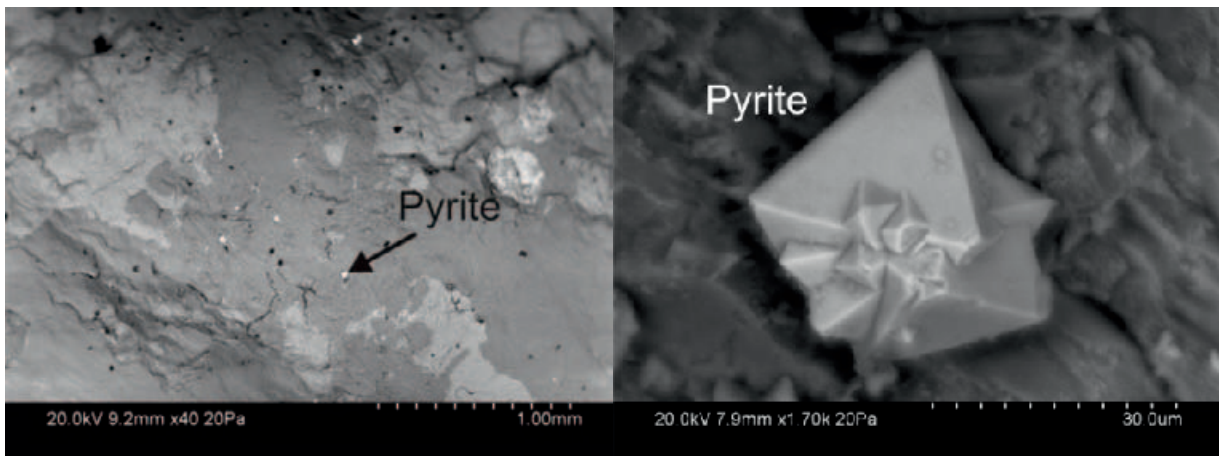
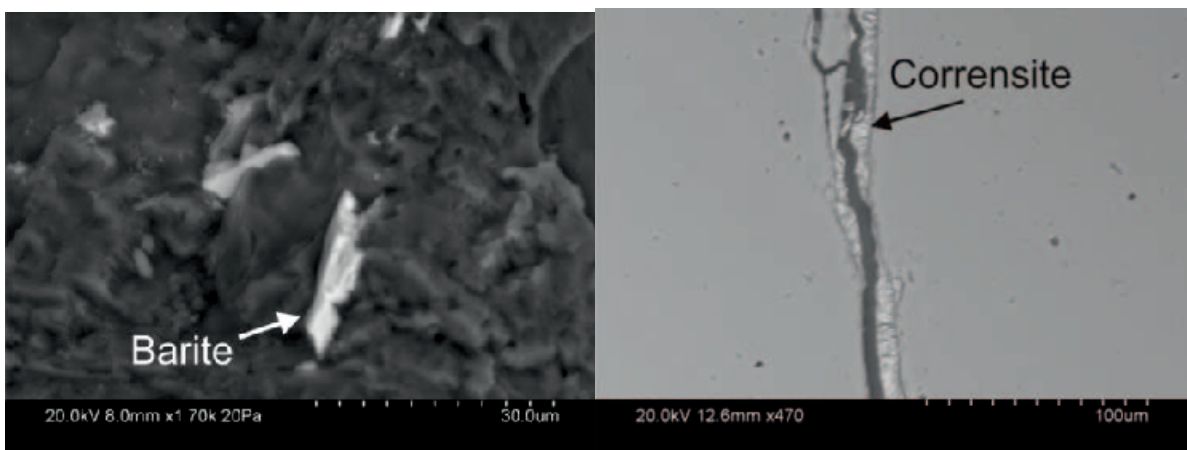
KFM02B 436.367 m

Open fracture

Fracture minerals: Pyrite, barite.

Wall rock: Altered, chloritised biotite.

Parallel to micro-fractures sealed with corrensite and allanite.

Back-scattered SEM-image of corrensite, barite and pyrite on fracture surface.

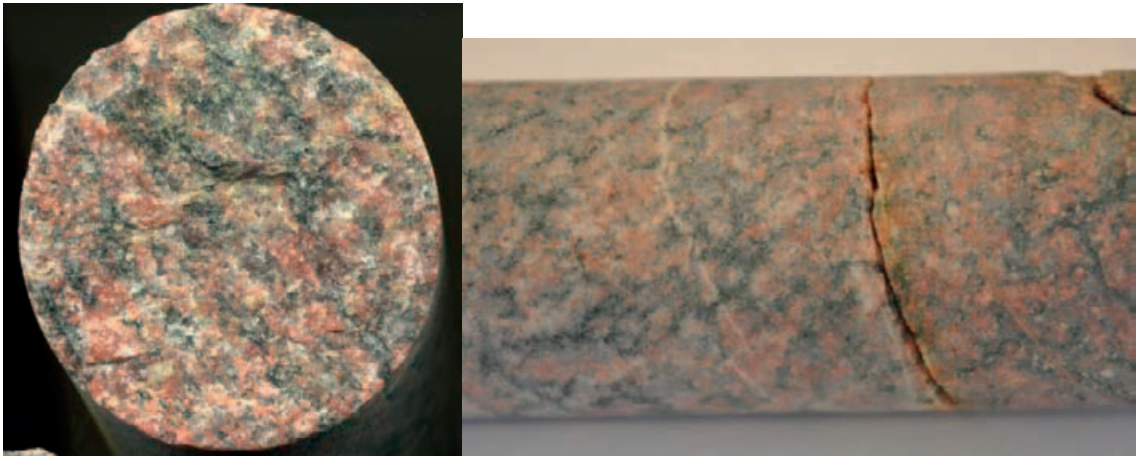
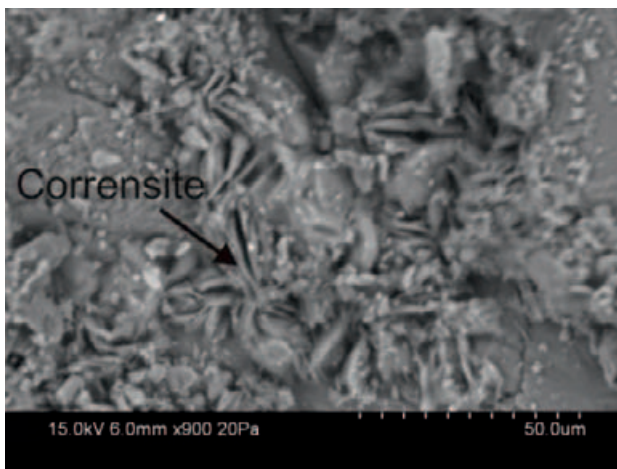
KFM02B 497.092 m

Open fracture

Fracture minerals: Corrensite.

Wall rock: Altered, chloritised biotite.

Parallel to micro fractures sealed with prehnite and adularia.

Back-scattered SEM-image of corrensite on fracture surface.

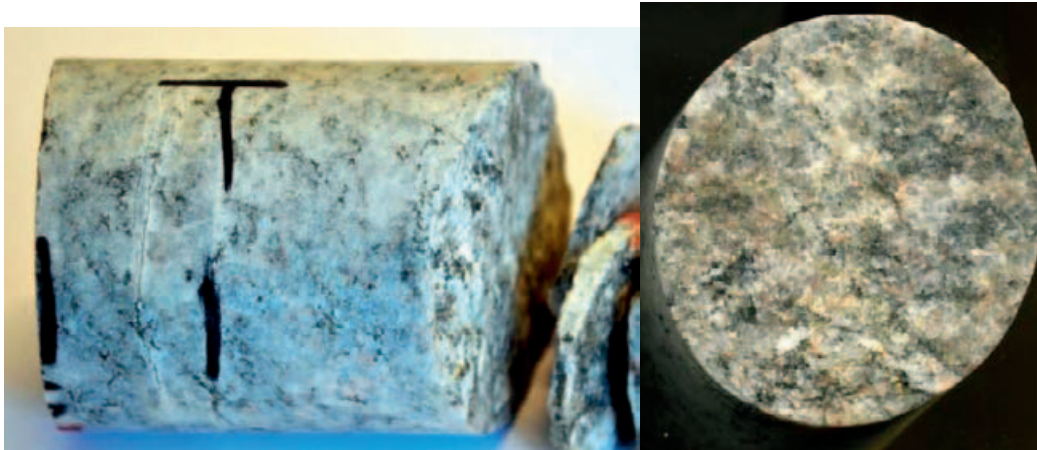
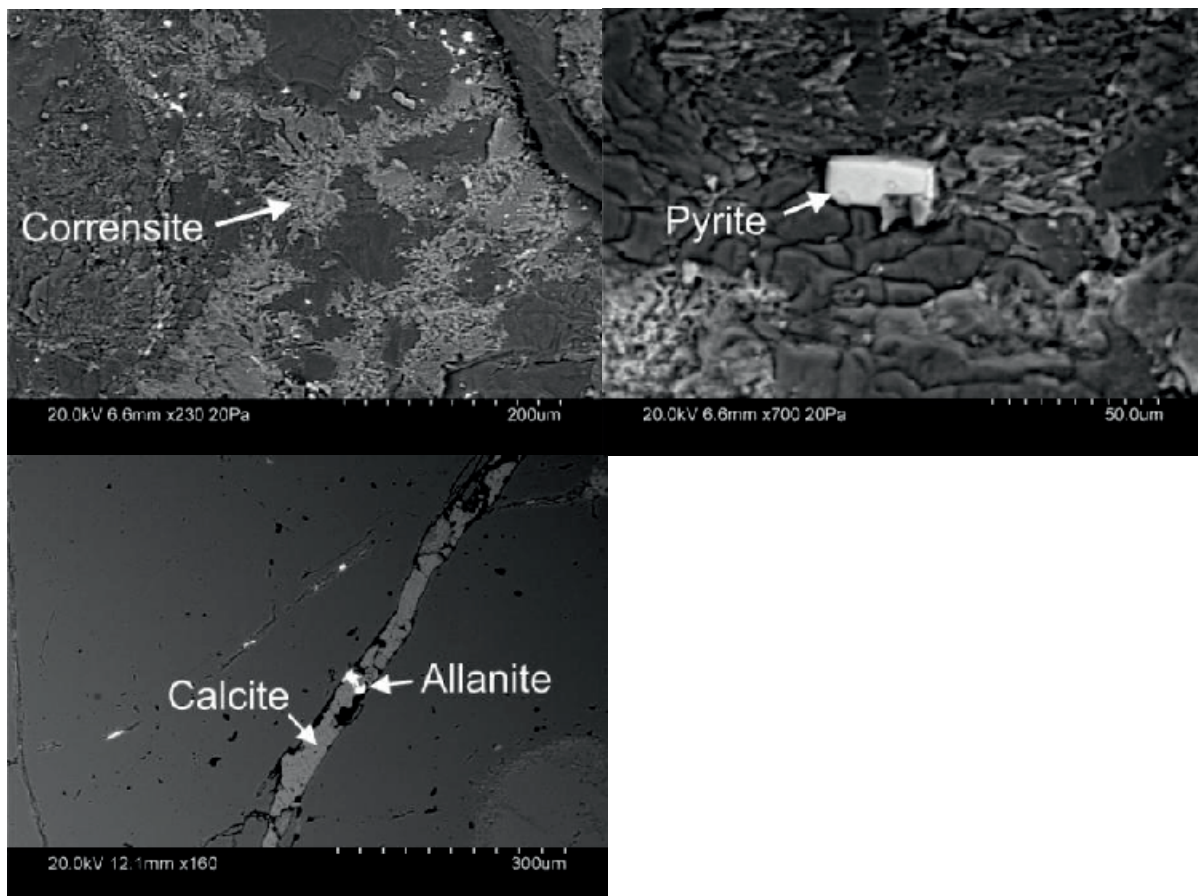
KFM03A 515.936 m

Open fracture

Fracture minerals: Corrensite, pyrite.

Wall rock: Altered biotite.

Fracture parallel to fracture sealed with calcite, allanite, adularia, corrensite.

Back-scattered SEM-image of corrensite, pyrite, calcite and allanite on fracture surface and in micro-fracture.

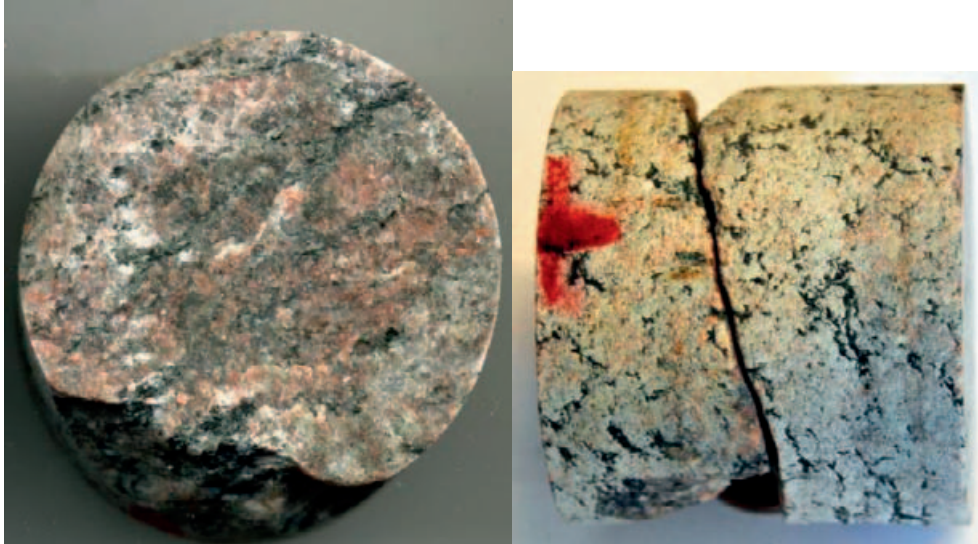
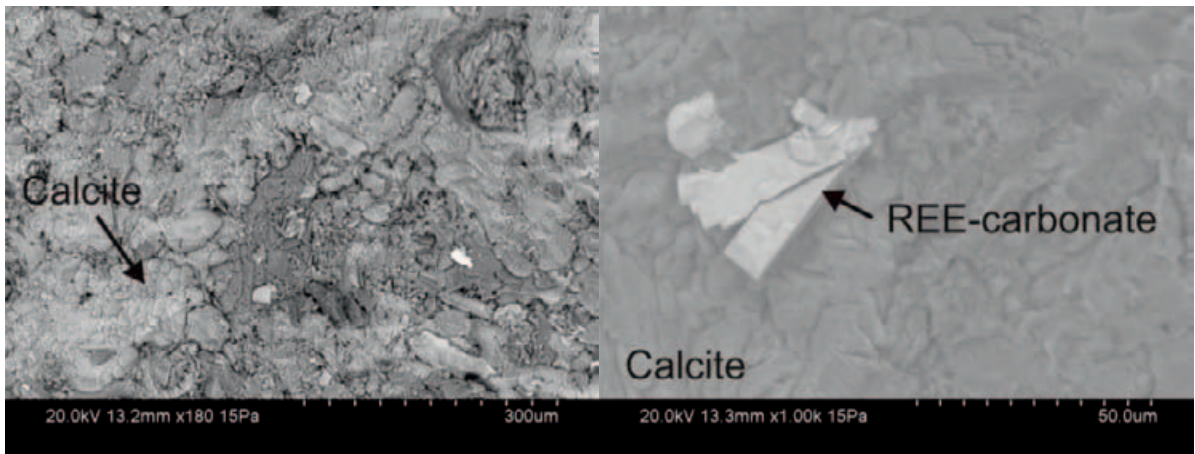
KFM03A 846.04 m

Open fracture

Fracture minerals: Calcite, corrensite, REE-carbonate.

Wall rock: Partly chloritised biotite closest to fracture.

Back-scattered SEM-image o calcite and REE-carbonate on fracture surface.

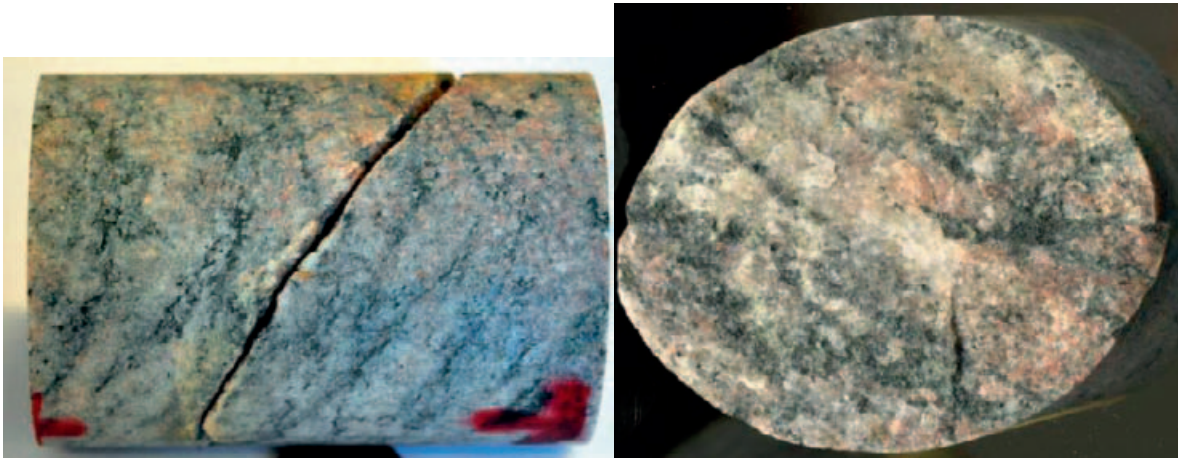
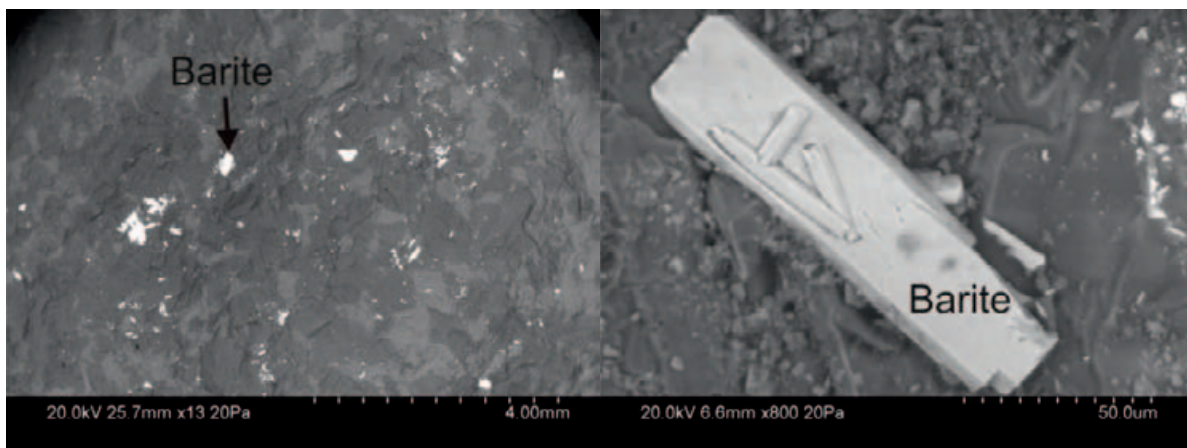
KFM08D 109.218 m

Open fracture

Fracture minerals: Barite.

Wall rock: Altered, chloritised biotite.

Fracture parallel to micro-fracture with wall rock fragments.

Back-scattered SEM-image of barite on fracture surface.

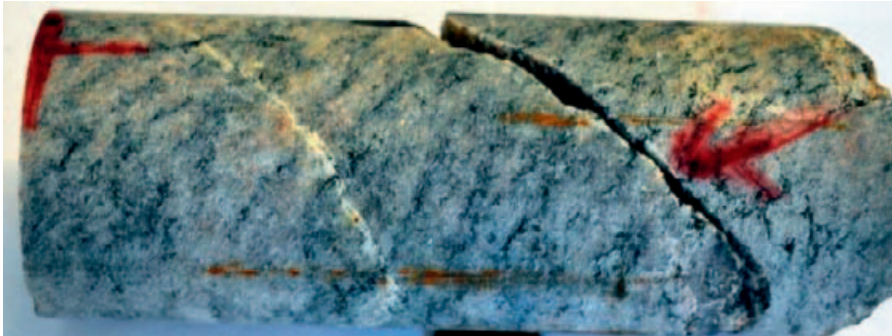
KFM08D 147.957 m

Open fracture

Fracture minerals: Barite.

Wall rock: Altered, chloritised biotite.

Fracture parallel to micro-fractures with no detected fracture minerals.

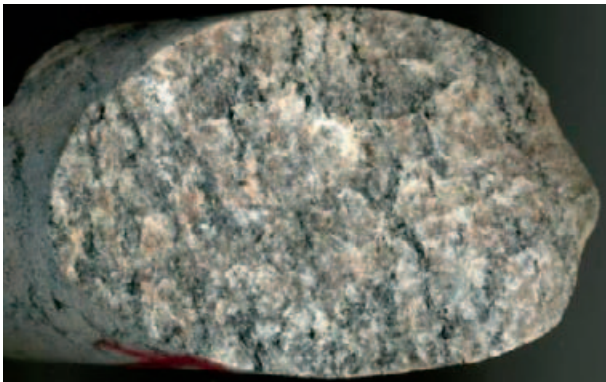
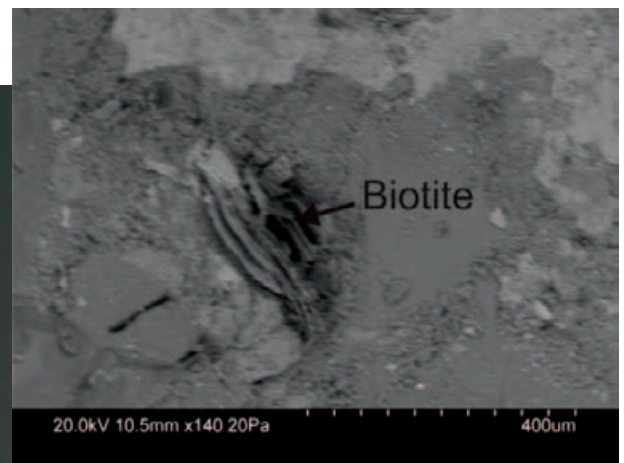
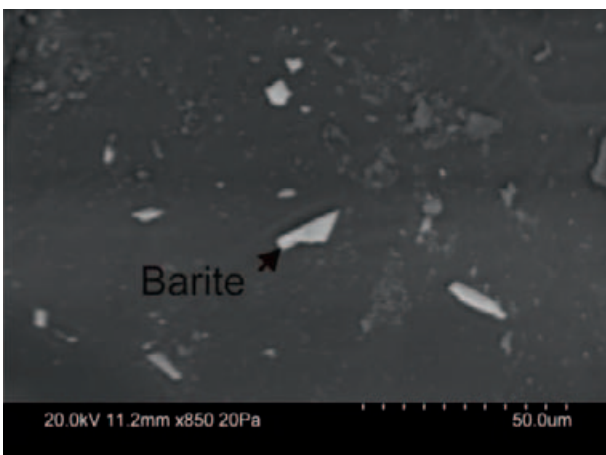
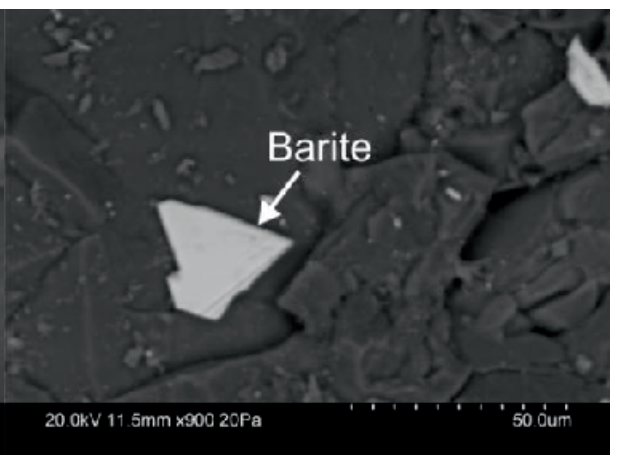
Photographs of drill core and fracture surface.

Back-scattered SEM-image of barite and biotite on fracture surface.

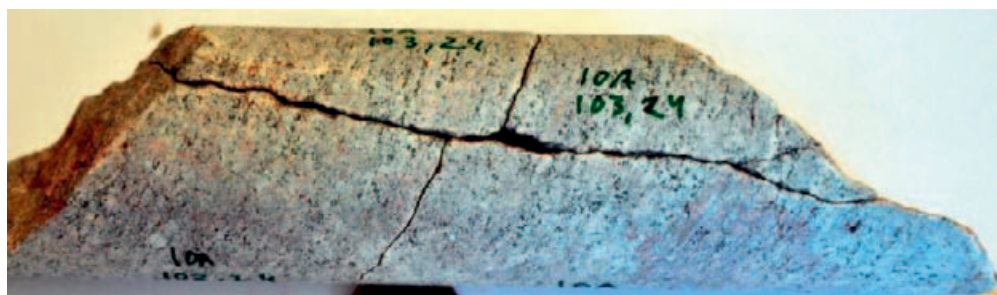
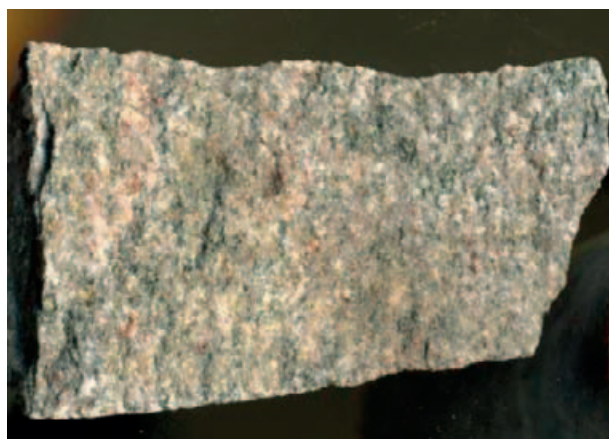
KFM10A 103.241 m

Open fracture

Fracture minerals: Pyrite, clay mineral.

Wall rock: Altered, chloritised biotite.

Parallel to micro-fractures with no detected fracture mineral.

Photographs of drill core and fracture surface.

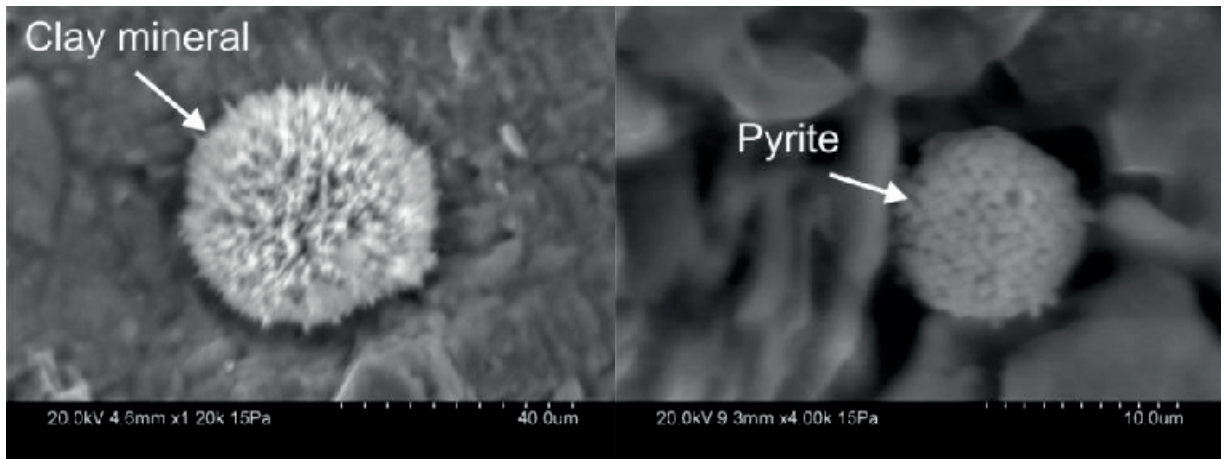
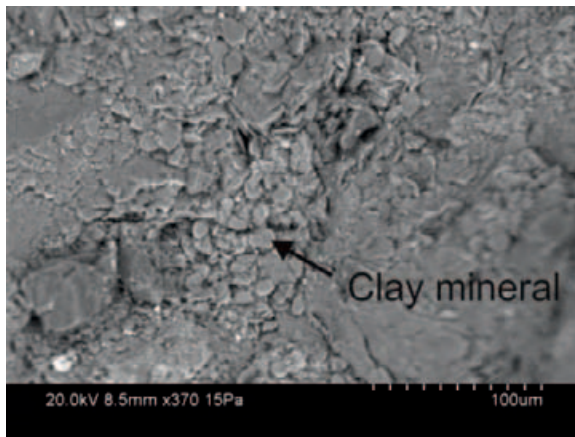
Back-scattered SEM-image of clay mineral and pyrite on fracture surface.

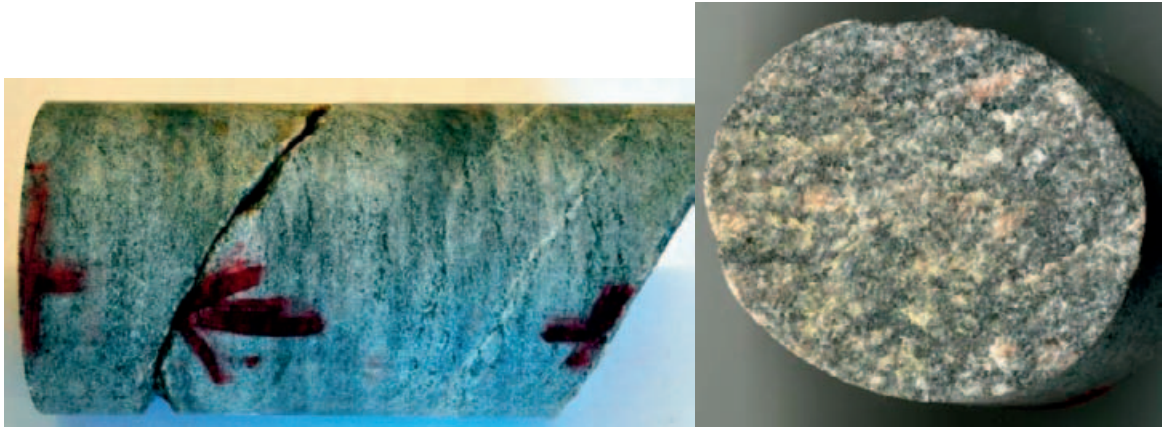
KFM10A 328.076 m

Open fracture

Fracture minerals: Barite.

Wall rock: Unaltered, fresh biotite.

Parallel to micro-fractures with no detected mineral.

Photographs of drill core and fracture surface.
