Assessment of fractures classified as non-mineralised in the Sicada database

Lillemor Claesson Liljedahl, Raymond Munier
Svensk Kärnbränslehantering AB

March 2011

Svensk Kärnbränslehantering AB

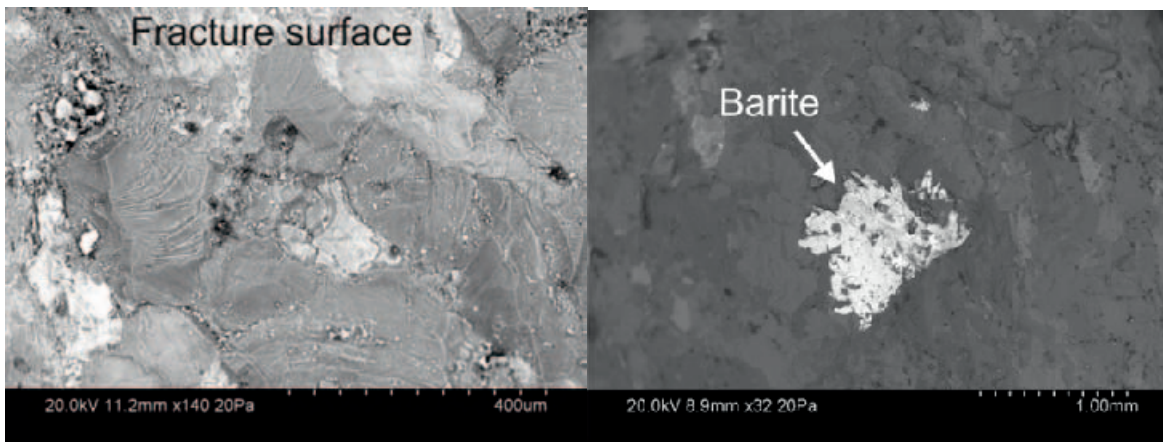
Back-scattered SEM-image of barite on fracture surface.

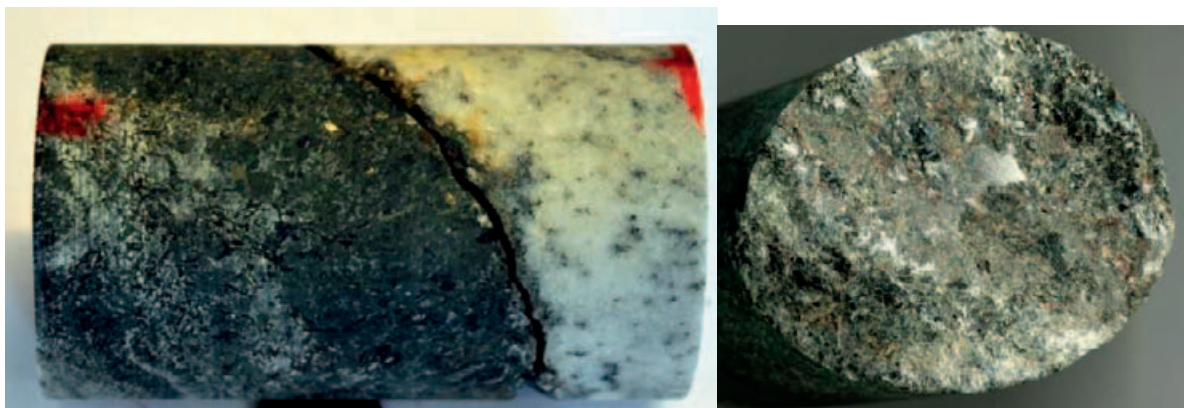
KFM10A 328.723 m

Open fracture

Fracture minerals: Corrensite, biotite, epidote, fluorite.

Wall rock: Partly altered biotite.

Photographs of drill core and fracture surface.

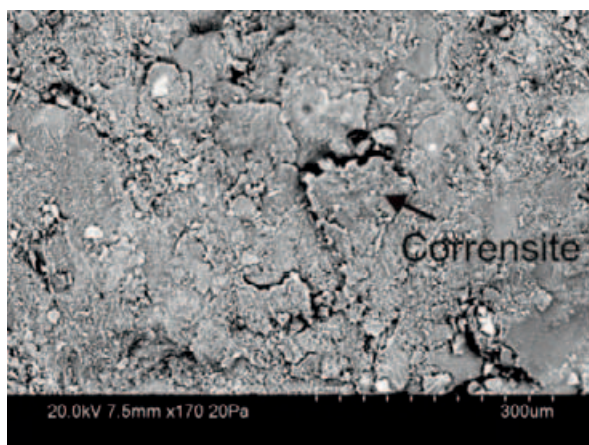
Back-scattered SEM-image of corrensite on fracture surface.

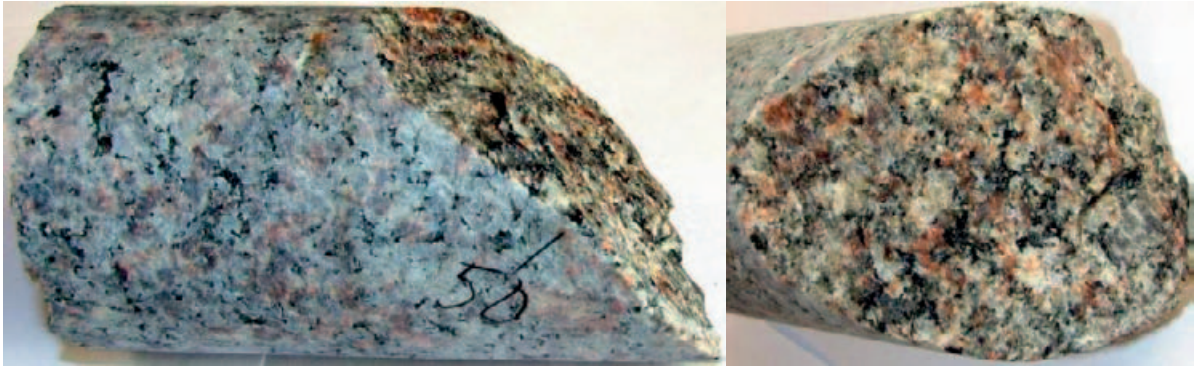
Fracture minerals: REE-carbonate and quartz.

Wall rock: Magnetite is fresh in the whole sample. The wall rock shows no increasing alteration towards the fracture. Biotite crystals are altered at the fracture edge. There are some micro-fractures parallel to the fracture.

Photograph of drill core and fracture surface.

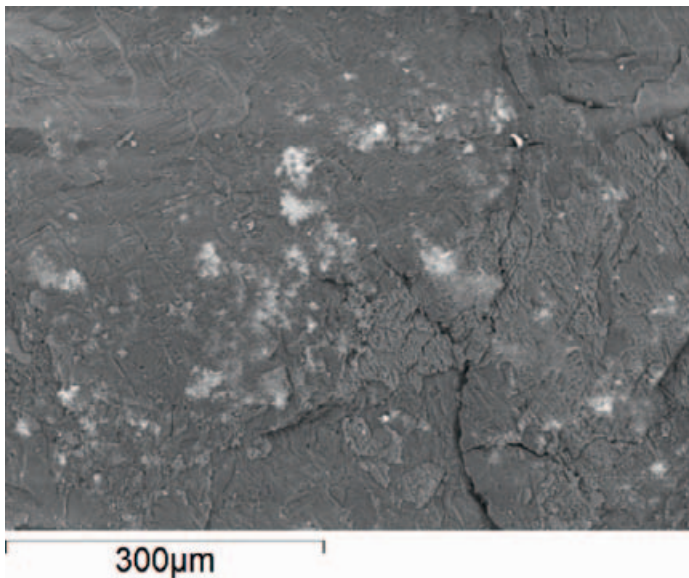
Back-scattered SEM-image of REE-carbonate (bright spots) on fracture surface.

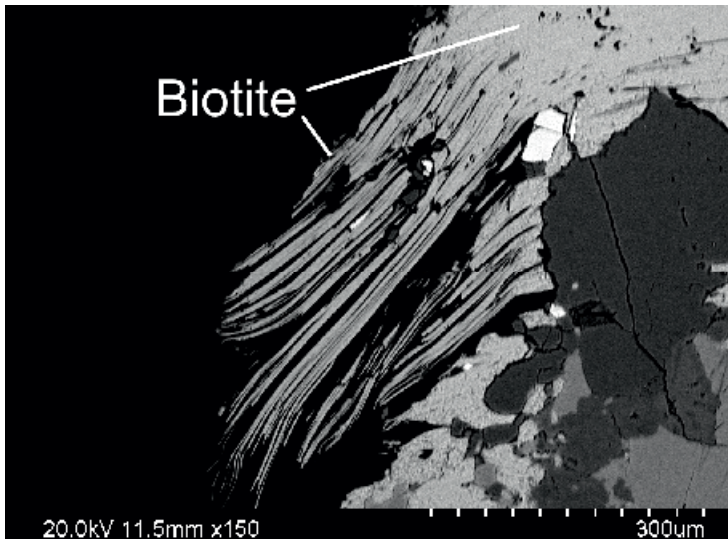
Back-scattered SEM-image of altered biotite at the fracture edge.

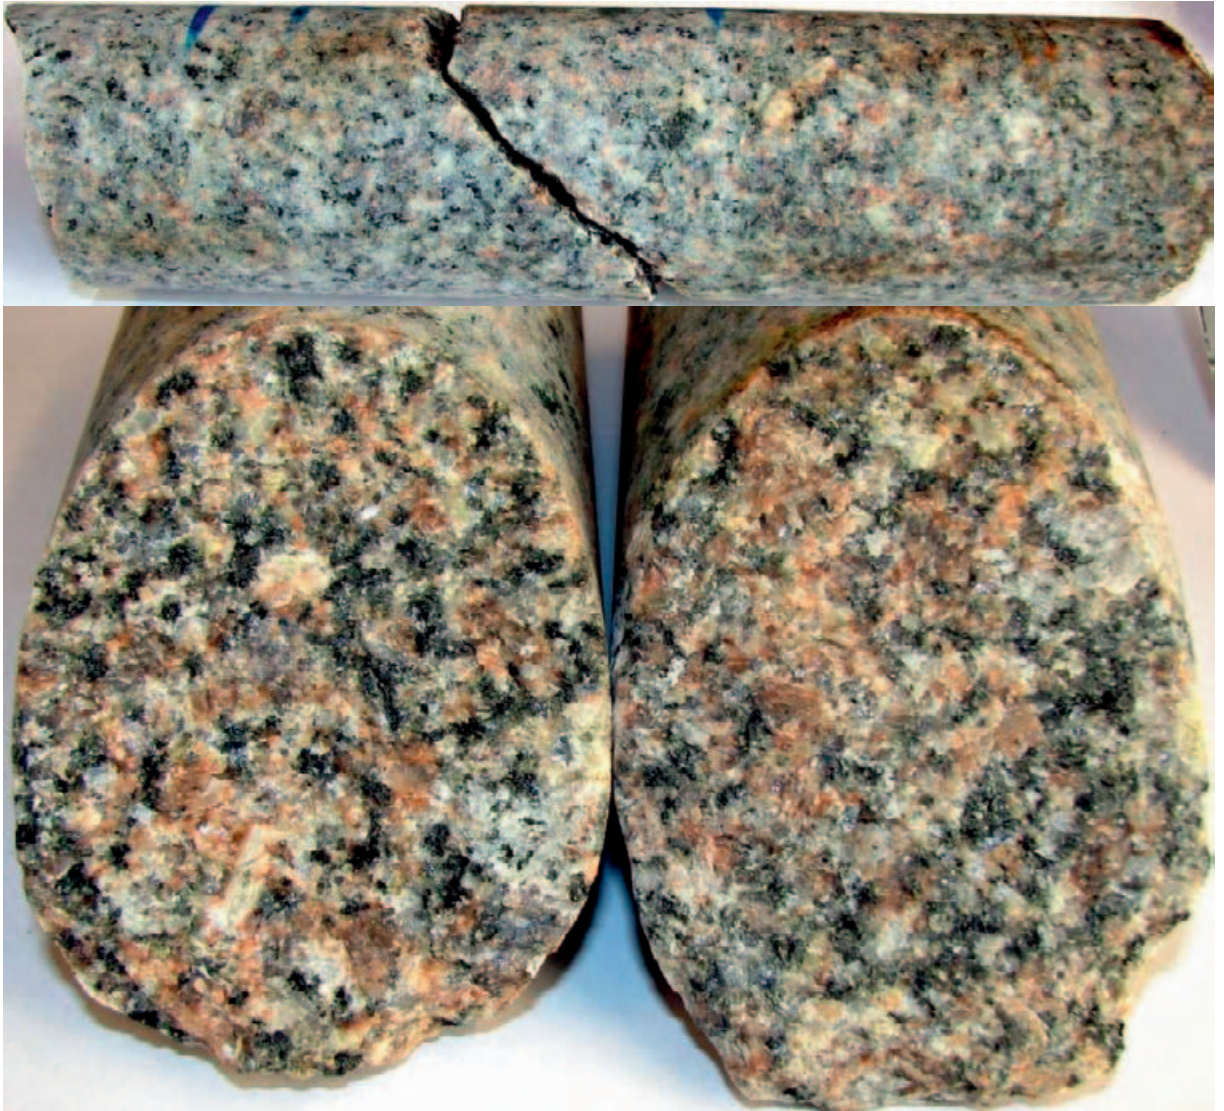
KLX05: 143.527 m

Fracture minerals: Pyrite and harmotome

Wall rock: Magnetite is fresh in the whole sample. No wall rock alteration intensity towards the fracture. No typical red-staining alteration. Local biotite alteration at the fracture rim.

Photographs of drill core and fracture surfaces.

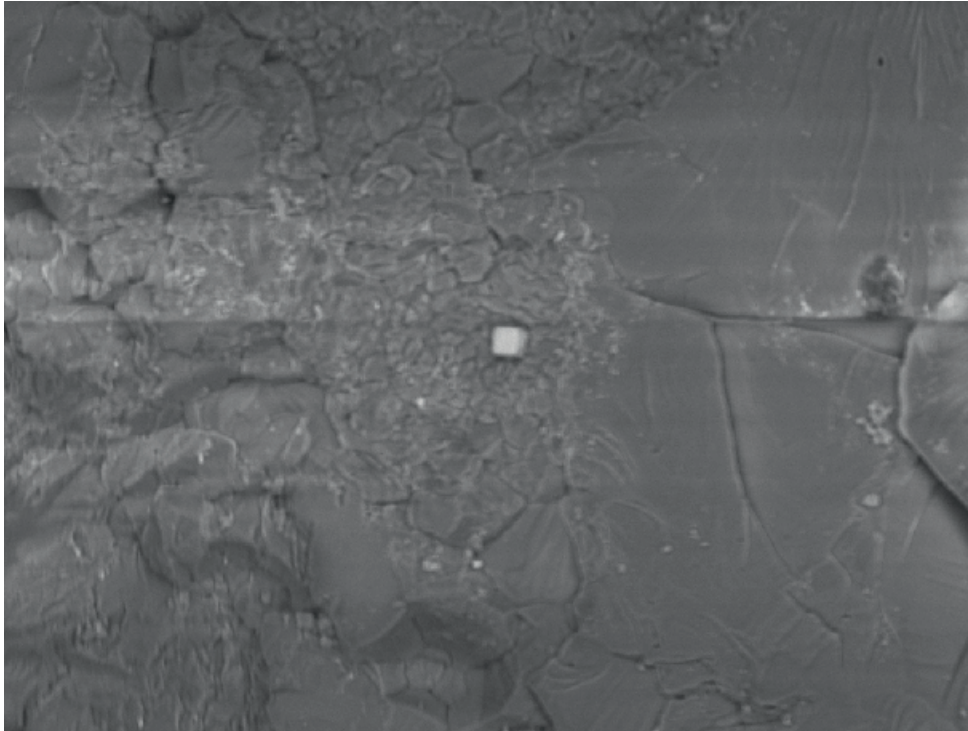
Back-scattered SEM-image of pyrite (bright cubic crystal).

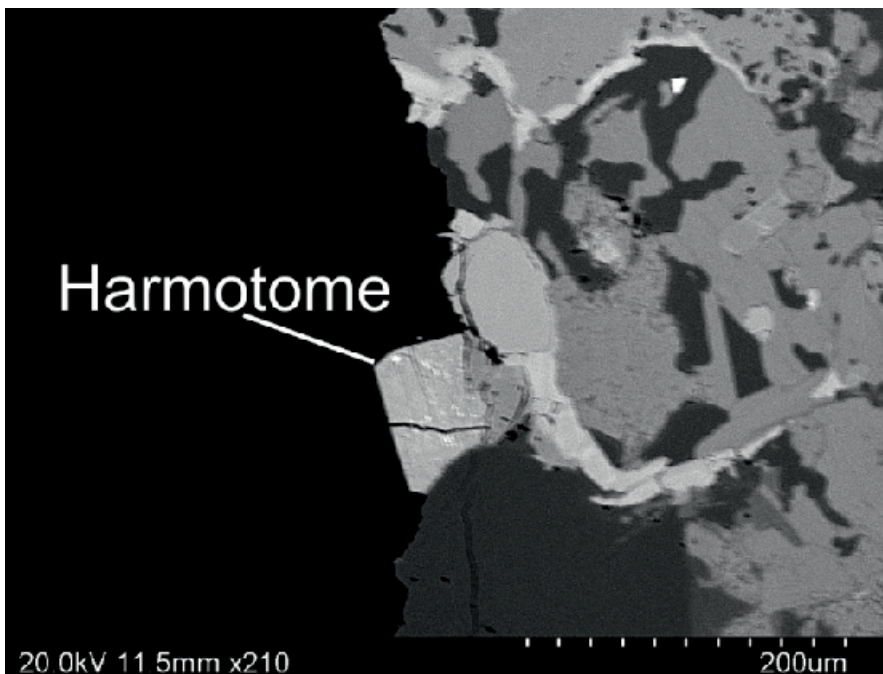
Back-scattered SEM-image of the fracture mineral harmotome (in the thin section). Wall rock is to the right, fracture to the left.

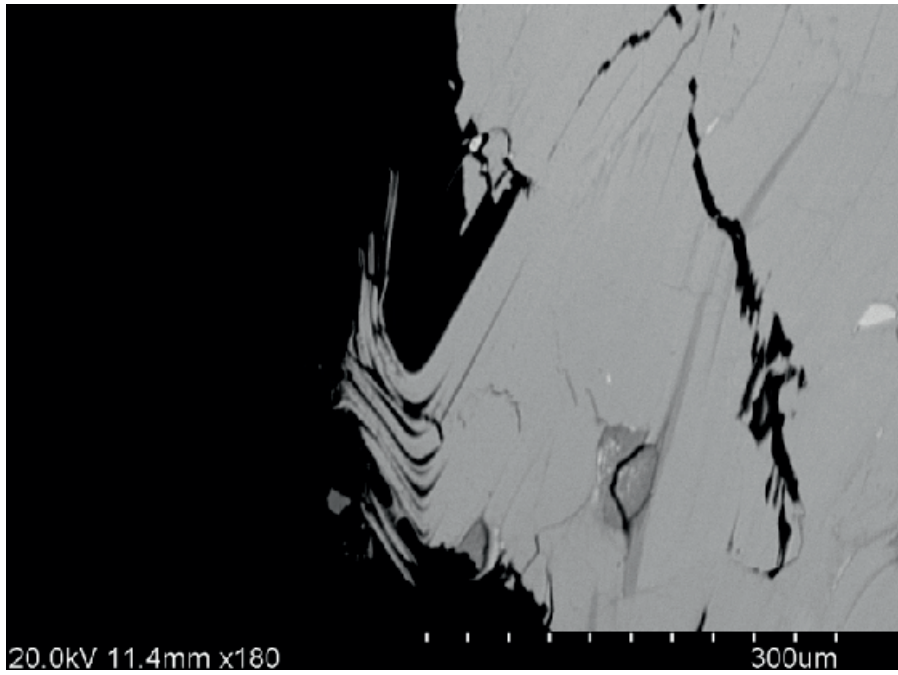
Back-scattered SEM-image of the biotite, which is altered at the fracture edge (to the left).

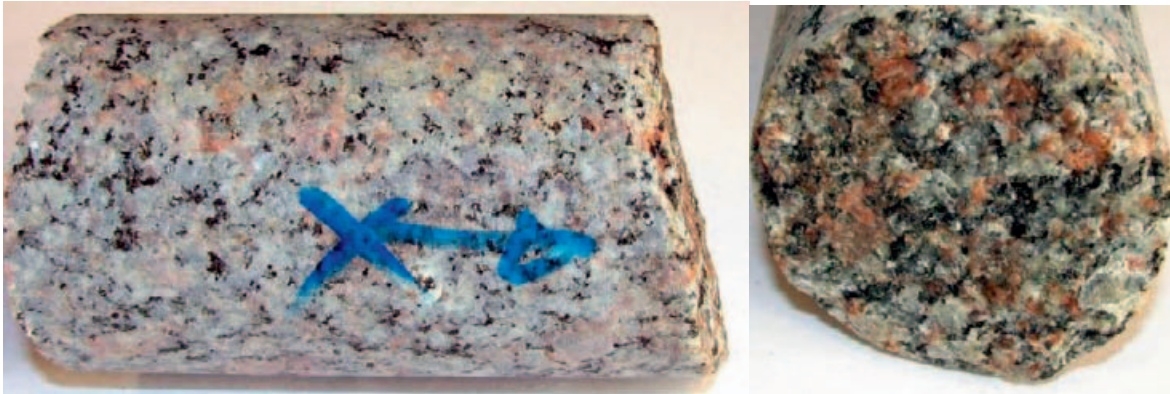
KLX06: 271.515 m

Fracture minerals: Calcite and pyrite.

Wall rock: Magnetite is fresh in the whole sample. No increase in wall rock alteration towards the fracture. No typical red-staining alteration. Biotite alteration is evident at the fracture rim. Parallel micro-fractures are observed close to the fracture.

Photographs of drill core and fracture surface.

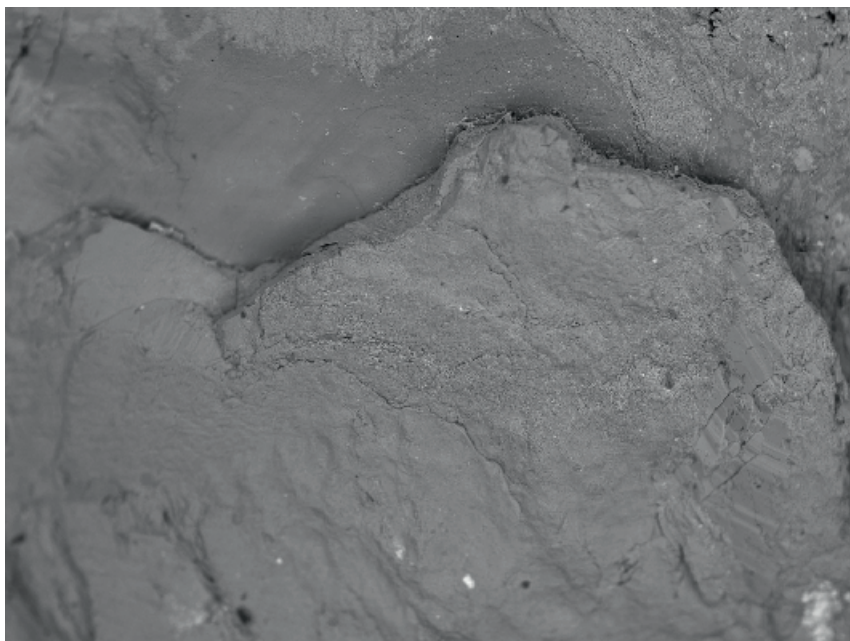
Back-scattered SEM-image of calcite. Pyrite is also present (small crystals).

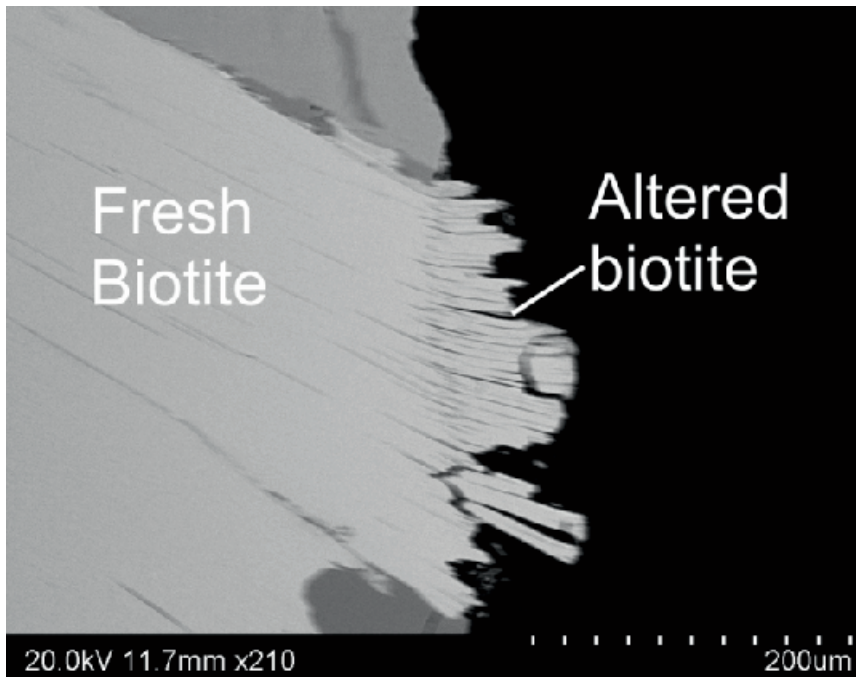
Back-scattered SEM-image of biotite alteration close to the fracture.

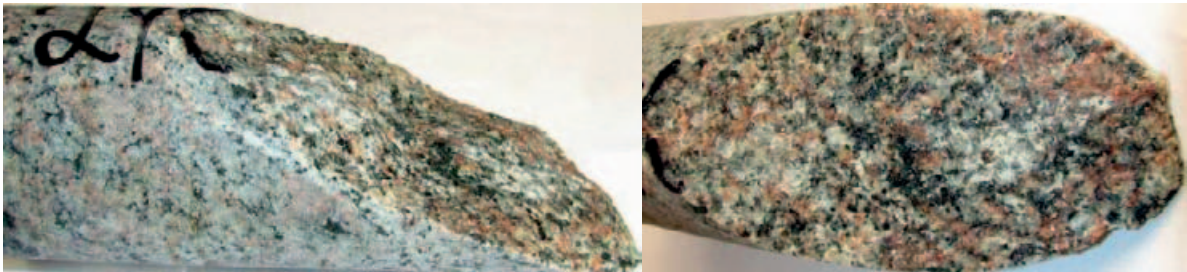
KLX06: 296.037 m

Fracture minerals: REE-carbonate, barite and adularia.

Wall rock: Magnetite is fresh in the whole sample. No increase in wall rock alteration towards the fracture. No typical red-staining alteration. Some indications of biotite alteration at the fracture rim. Parallel micro-fractures close to the fracture, partly filled with e.g. pyrite.

Photographs of drill core and fracture surface.

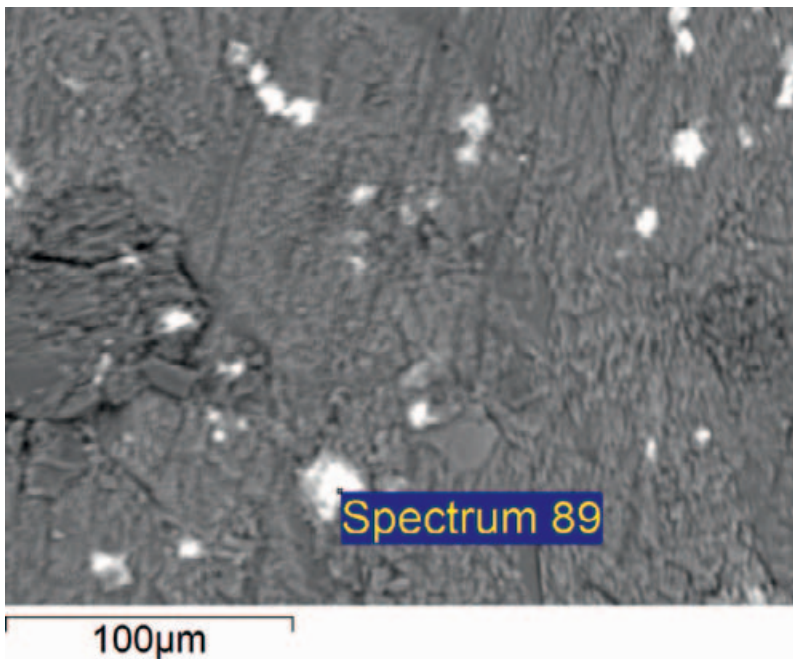
Back-scattered SEM-image of REE-carbonate (bright spot, EDS analyses indicate mixture with chlorite).

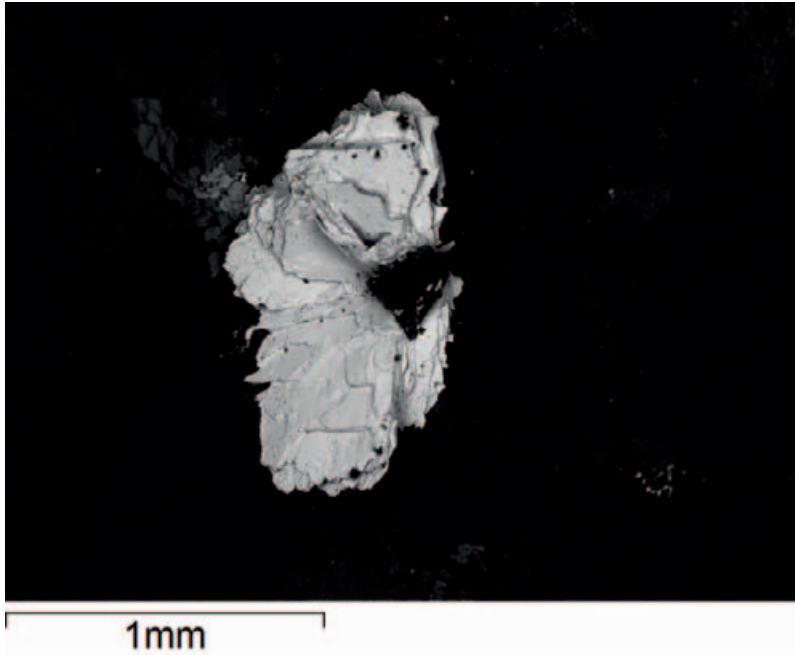
Back-scattered SEM-image of barite.

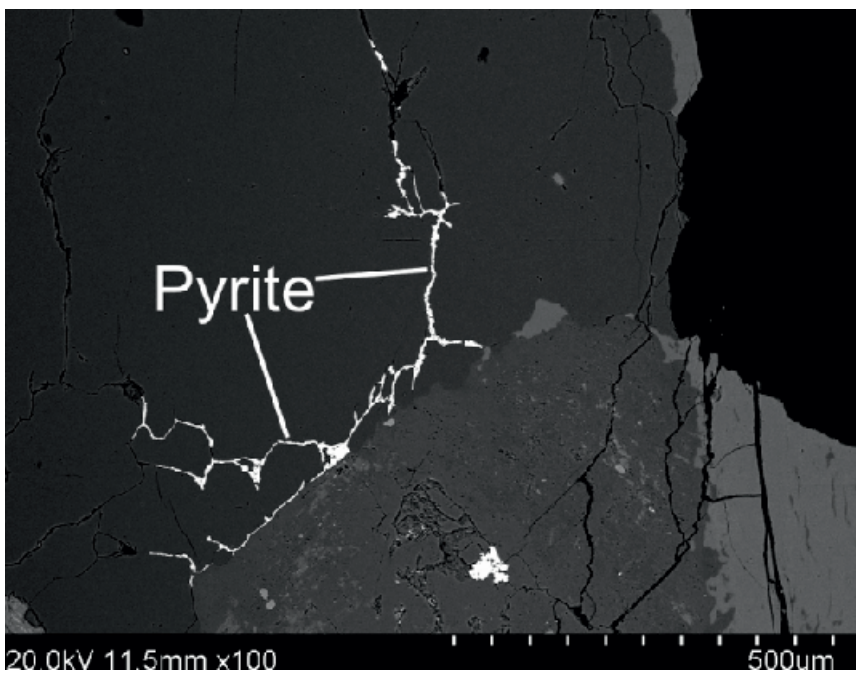
Back-scattered SEM-image of pyrite-filled micro-fracture in the wall rock. Main fracture is to the right.

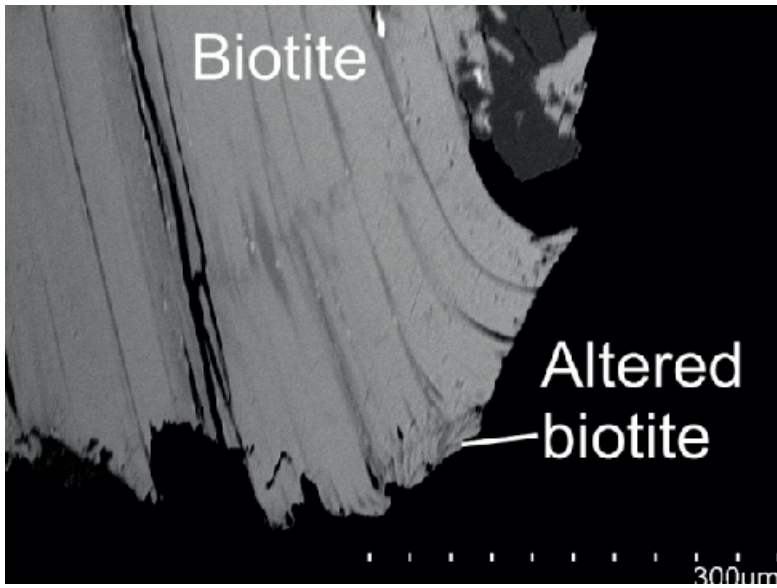
Back-scattered SEM-image of biotite alteration at the fracture edge.

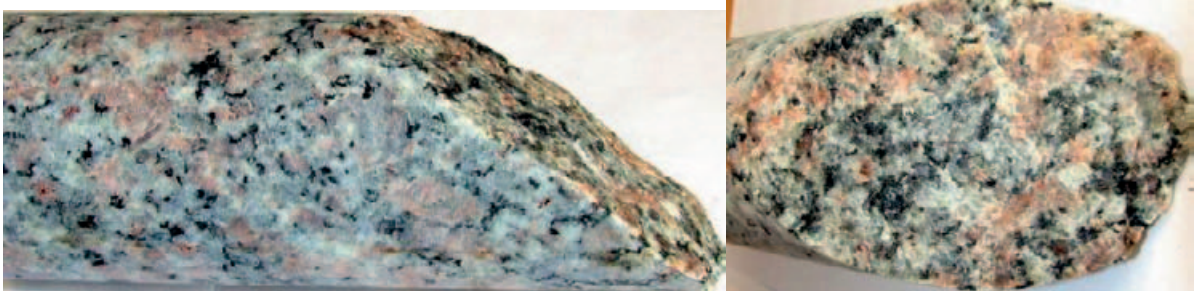
KLX06: 561.074 m

Fracture mineral: Pyrite

Wall rock: Magnetite is fresh in the whole sample. No wall rock alteration intensity towards the fracture. No typical red-staining alteration. Some indications of biotite alteration at the fracture rim. Micro-fractures close to the fracture, e.g. filled with adularia and REE-carbonate.

Photographs of drill core and fracture surface.

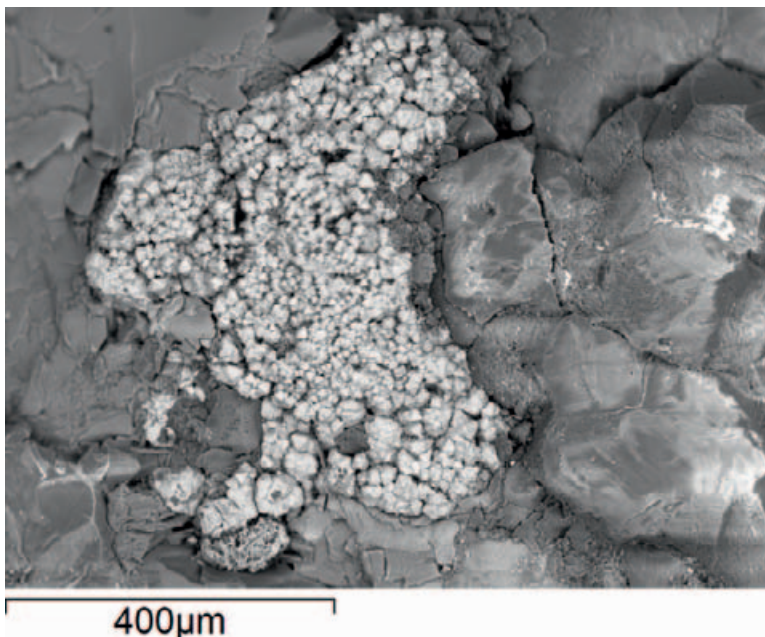
Back-scattered SEM-image of pyrite (bright crystals).

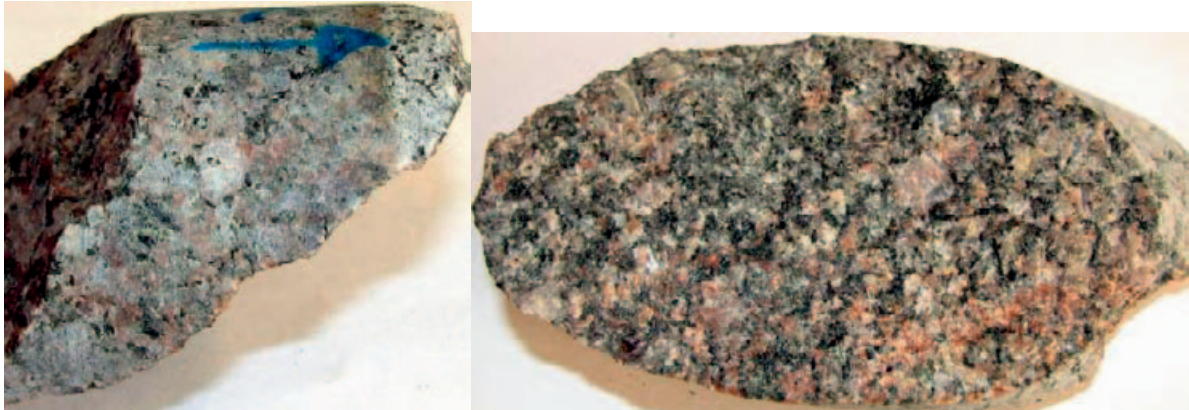
KLX07A: 341.026 m

Fracture minerals: Pyrite, barite and illite

Wall rock: Magnetite and pyrite are fresh in the whole sample. No increase in wall rock alteration towards the fracture, and no typical red-staining alteration. Some indications of biotite alteration at the fracture rim. Parallel to the fracture is a calcite-filled fracture (other rim of thin section), also including albite and barite. Micro-fractures are present and are sub-parallel to the main fracture.

Photographs of drill core and fracture surface.

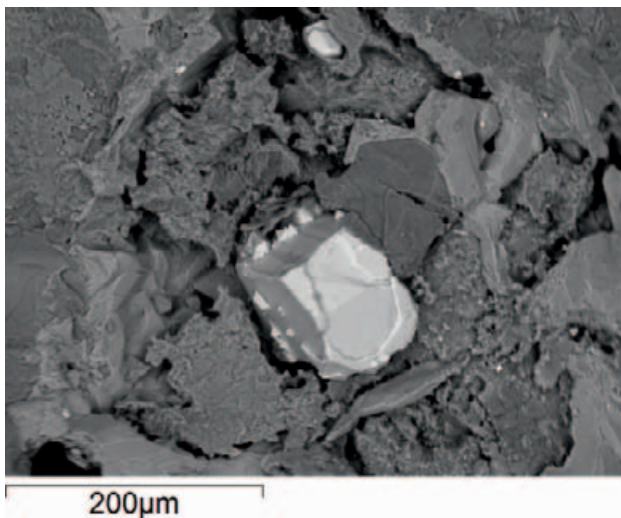
Back-scattered SEM-image of pyrite (bright crystal).

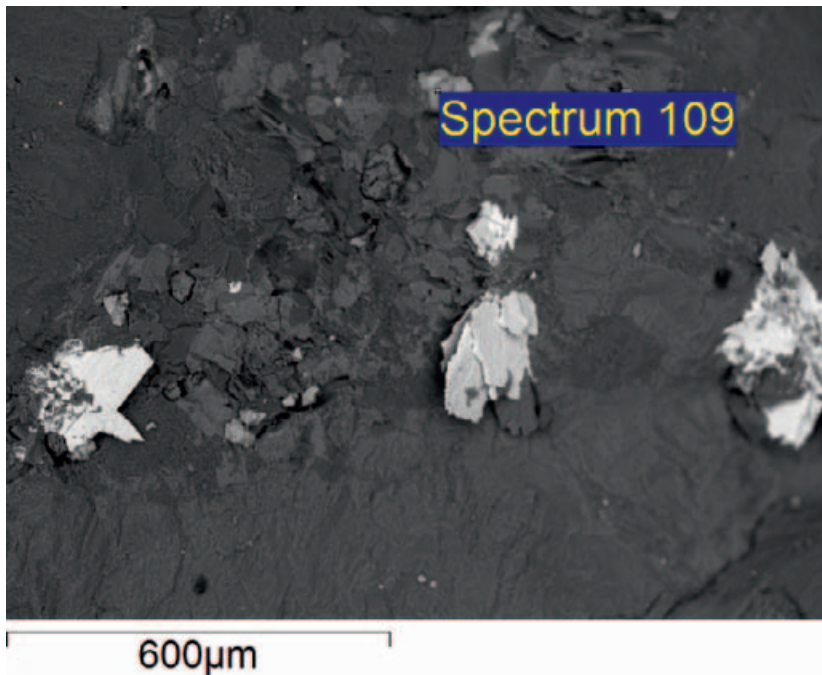
Back-scattered SEM-image of barite (Spectrum 106, brightest crystals) and pyrite (Spectrum 109, slightly darker crystals than barite).

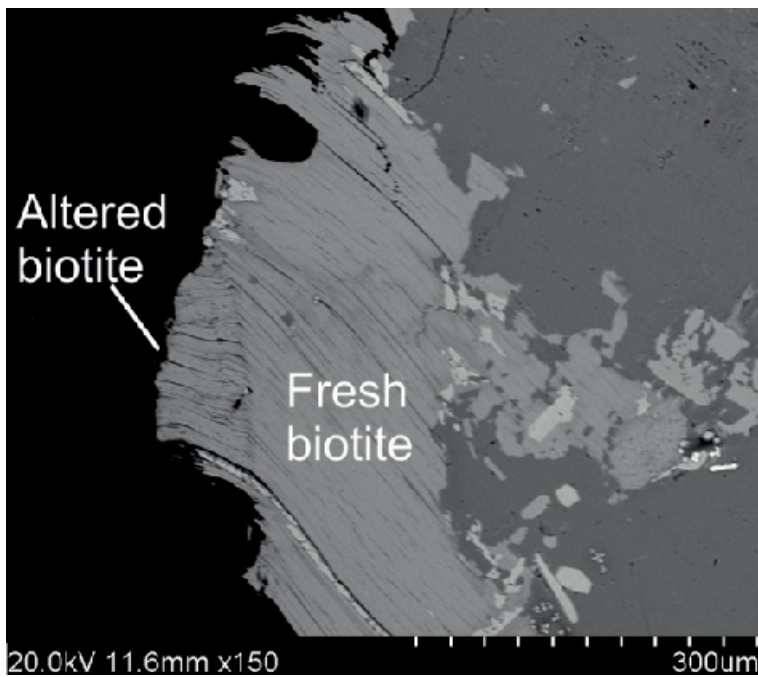
Back-scattered SEM-image of biotite alteration at the fracture edge.

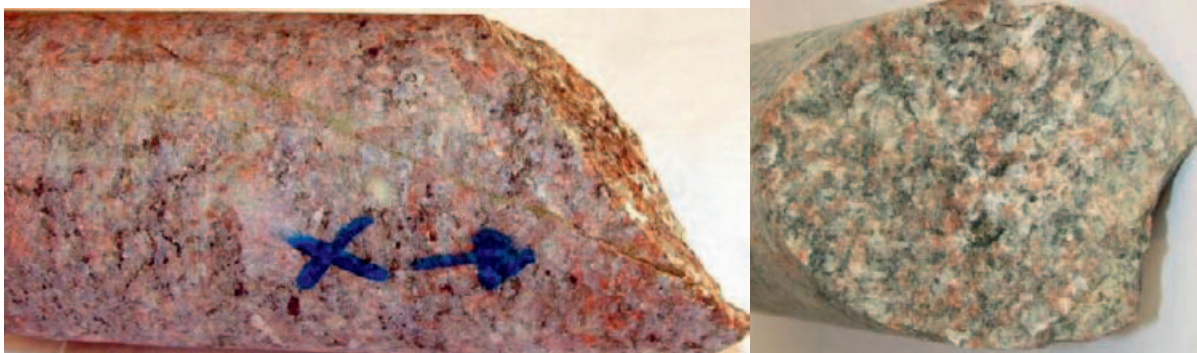
KLX07A: 396.319 m

Fracture minerals: Calcite and clay minerals.

Thin section: Magnetite and pyrite crystals are fresh in the whole sample. No increased wall rock alteration towards the fracture. This sample has typical red-staining alteration, e.g. red-staining of plagioclase crystals and chloritization of biotite (except for hematitization of magnetite). Parallel micro-fractures are observed close to the fracture.

Photographs of drill core and fracture surface.

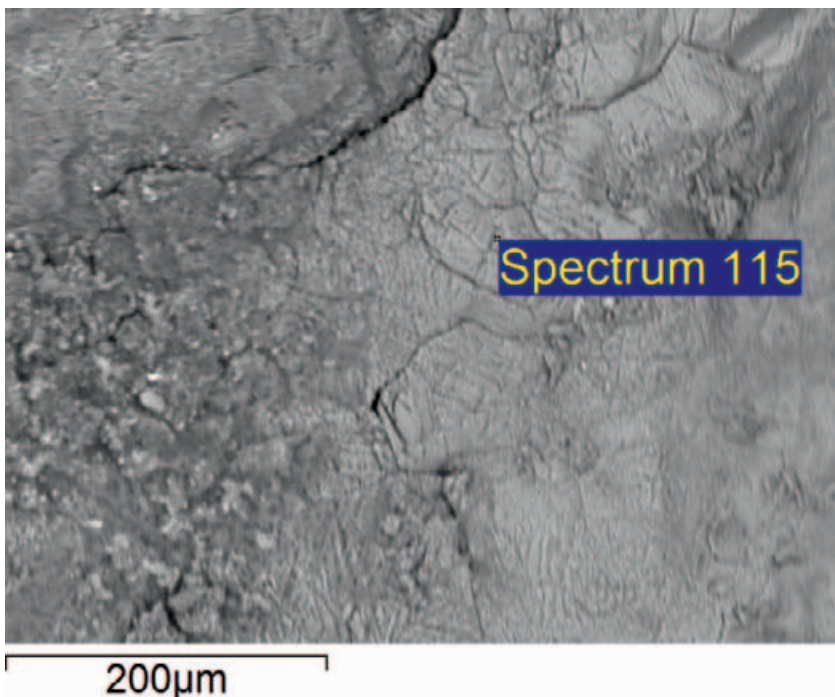
Back-scattered SEM-image of calcite.

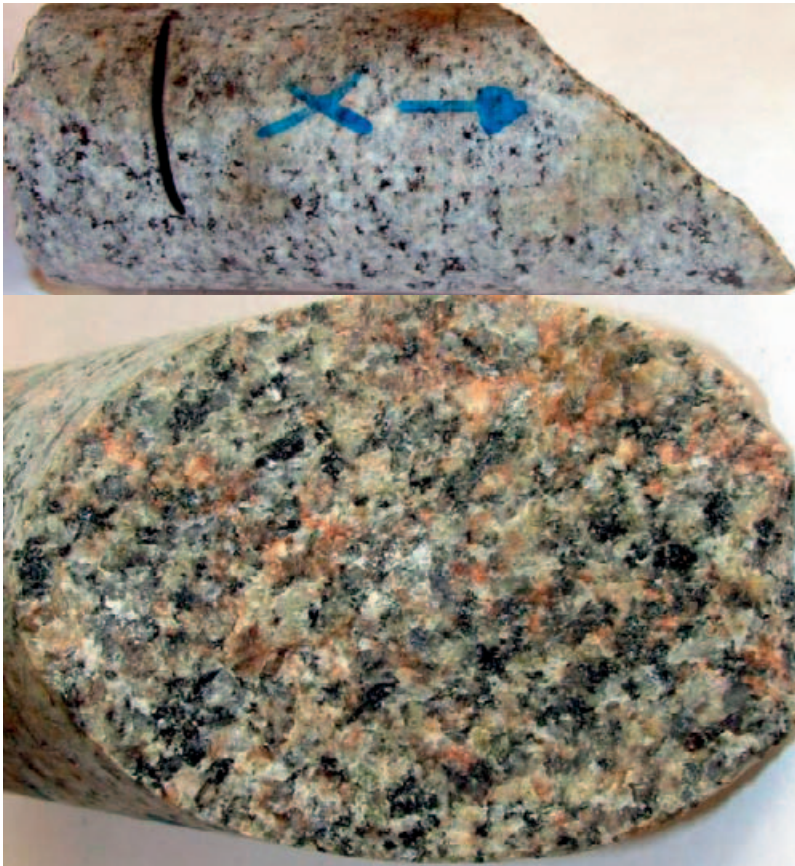
KLX08: 303.912 m

Fracture minerals: Harmotome, pyrite and REE-carbonate.

Wall rock: Magnetite is fresh in the whole sample. No increased wall rock alteration towards the fracture, but typical red-staining alteration is evident, e.g. plagioclase alteration and chloritization of biotite. An apophyse to the main fracture is filled with epidote and calcite and this indicates that the fracture has a hydrothermal precursor, with related hydrothermal alteration.

Photographs of drill core and fracture surface.

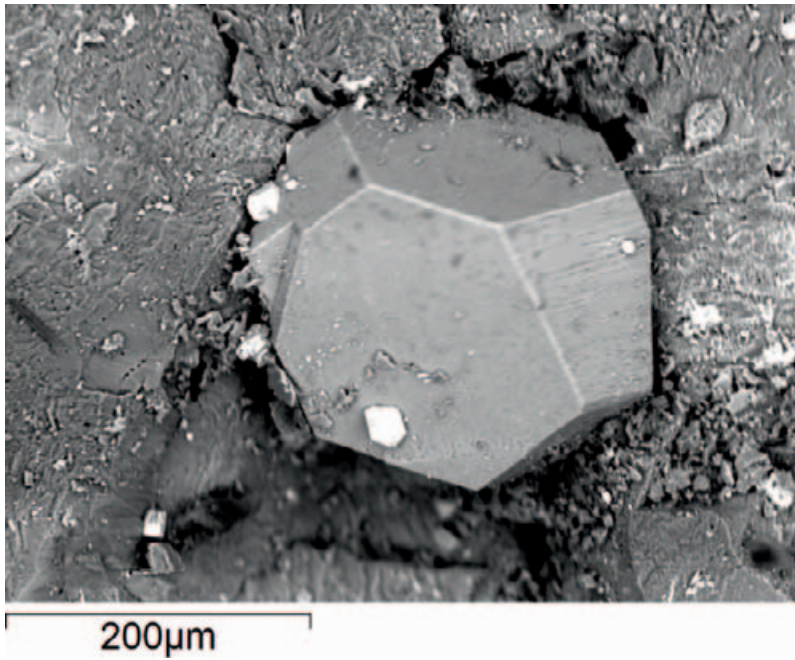
Back-scattered SEM-image of harmotome (big crystal). Small bright crystals are pyrite.

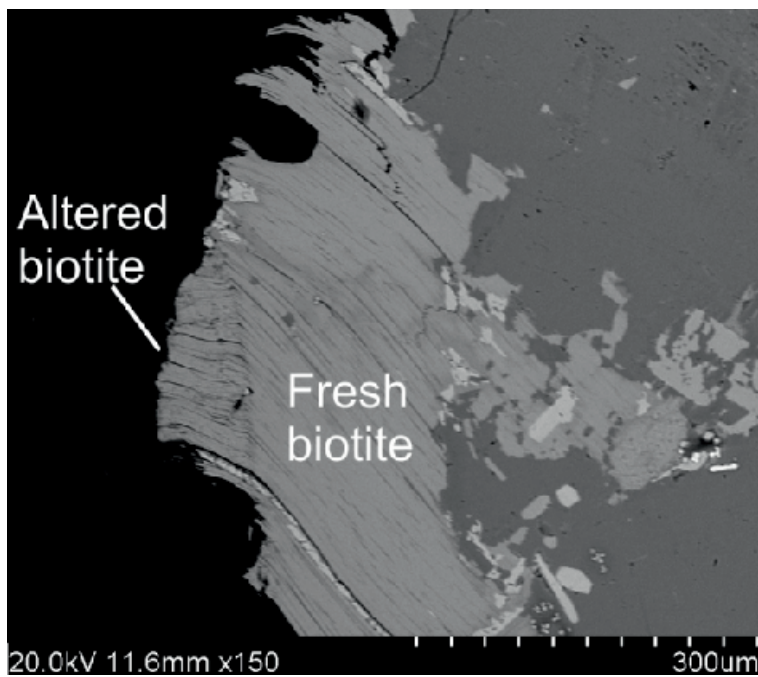
Back-scattered SEM-image of biotite alteration at the fracture edge.

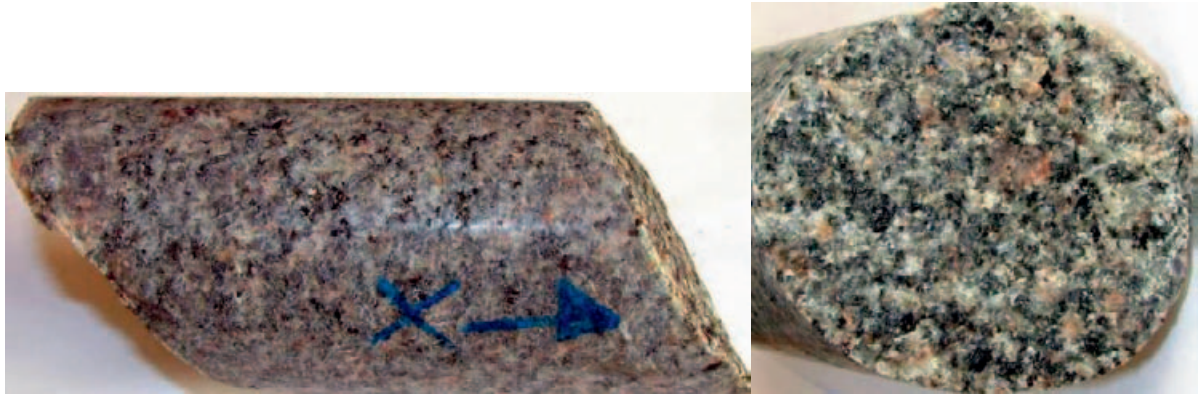
KLX08: 361.701 m

Fracture minerals: Pyrite and barite.

Wall rock: Magnetite is fresh in the whole sample. No increased wall rock alteration towards the fracture and no typical red-staining alteration. Some indications of biotite alteration at the fracture rim. Parallel micro-fractures exist and are filled with e.g. adularia.

Photographs of drill core and fracture surface.

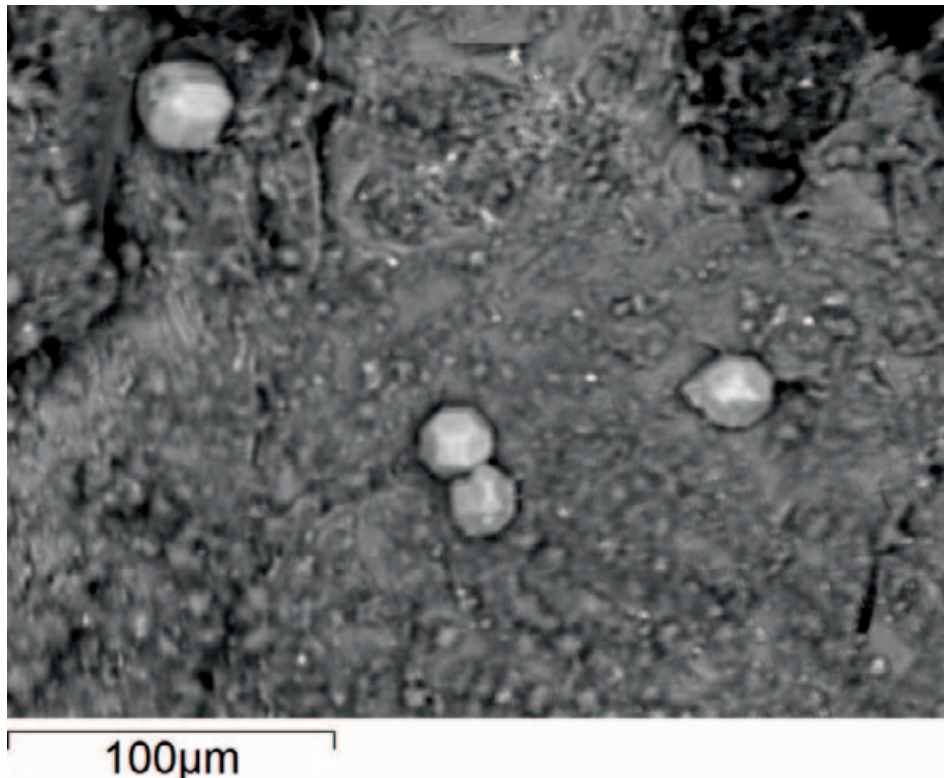
Back-scattered SEM-image of pyrite.

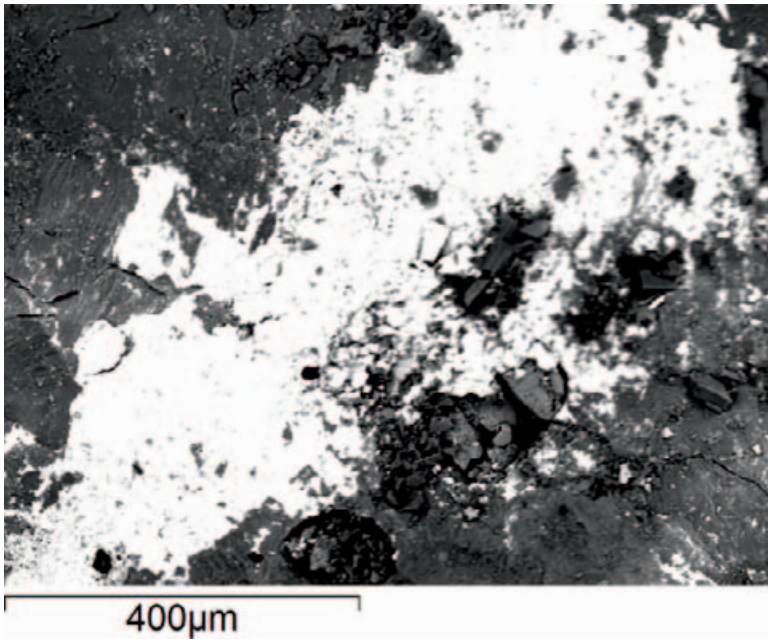
Back-scattered SEM-image of barite (bright mineral).

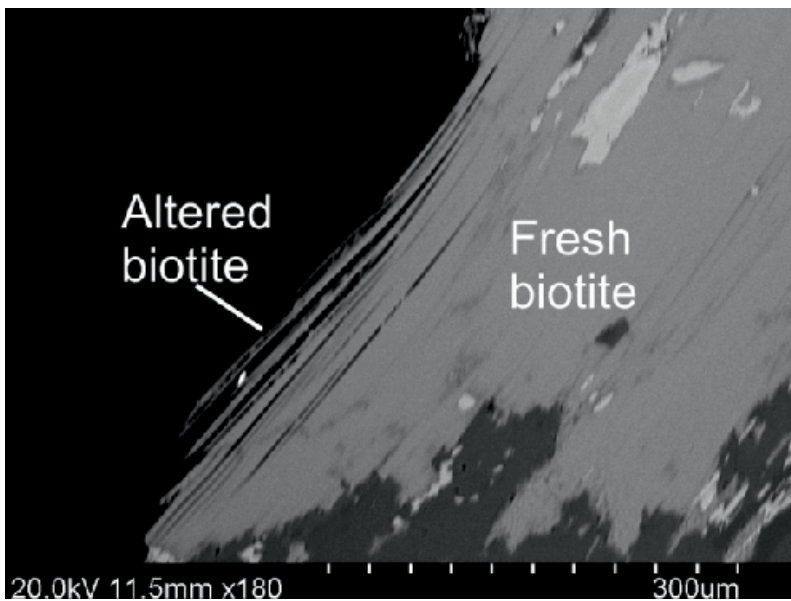
Back-scattered SEM-image of biotite alteration at the fracture edge.

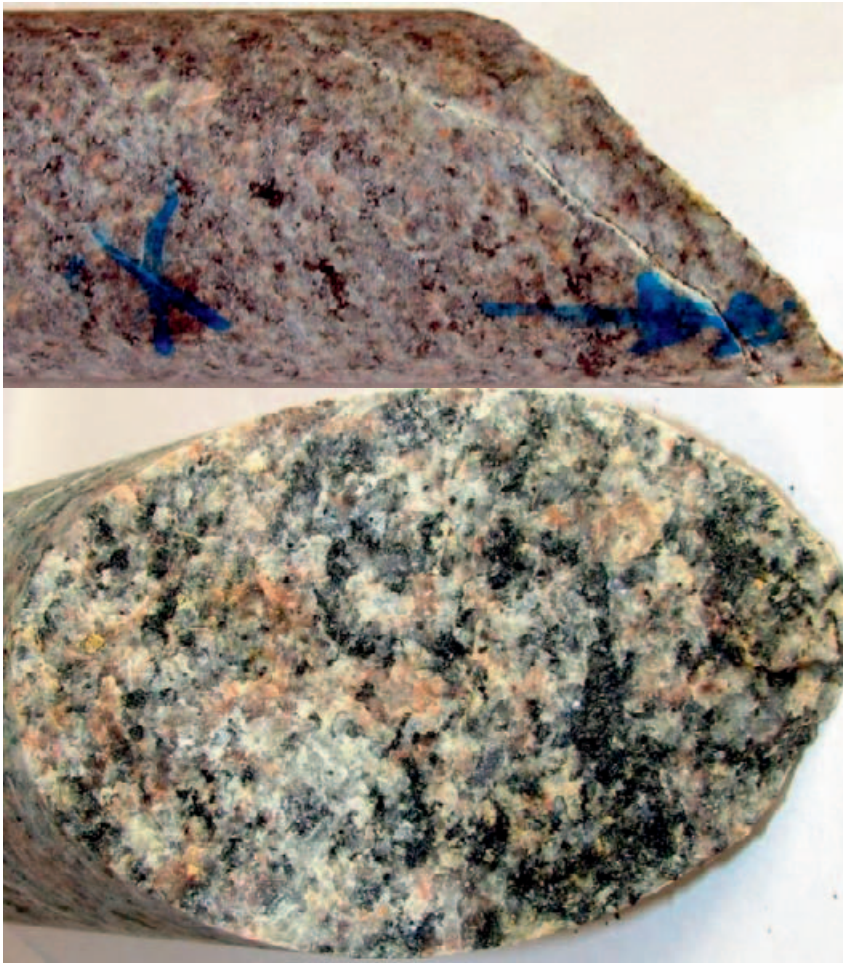
KLX08: 491.453 m

Fracture minerals: Pyrite and REE-carbonate.

Wall rock: Magnetite is fresh in the whole sample. No wall rock alteration intensity towards the fracture. No typical red-staining alteration. Biotite alteration is observed at the fracture rim. Micro-fractures exist and are partly filled with e.g. pyrite. There is also a macroscopically visible sealed fracture sub-parallel to the open fracture. This fracture has a bleached rim.

Photographs of drill core and fracture surface.

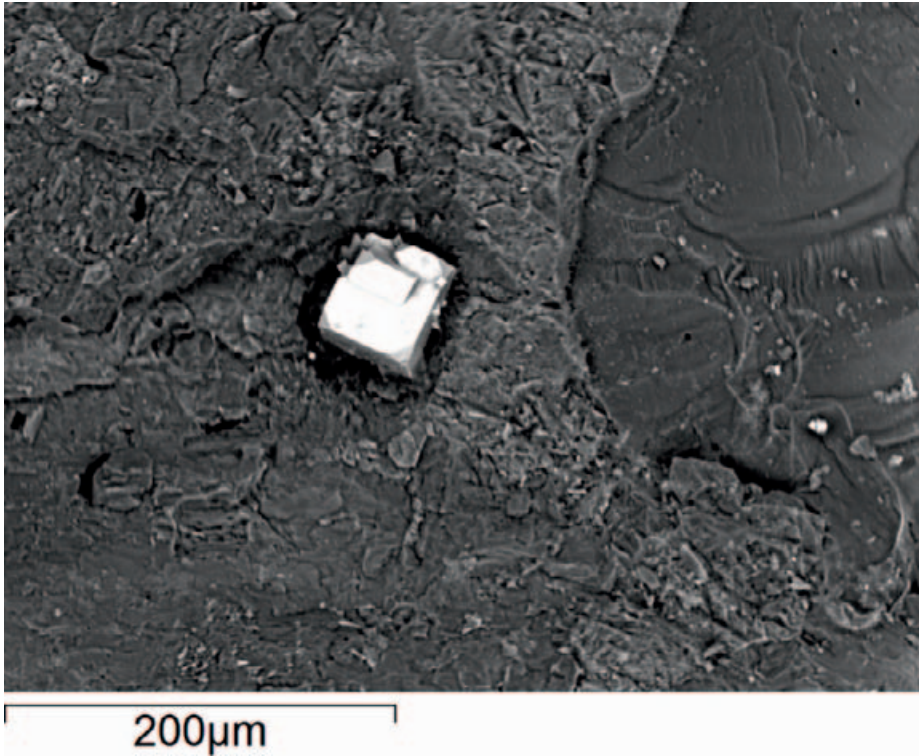
Back-scattered SEM-image of pyrite.

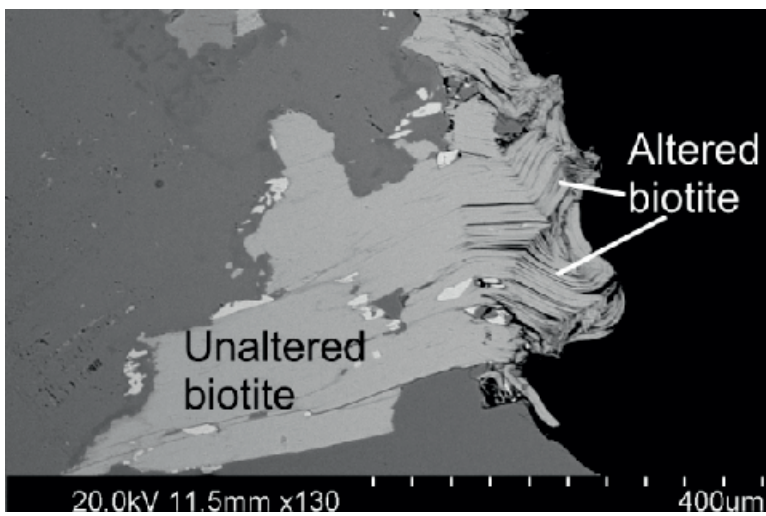
Back-scattered SEM-image of biotite alteration at the fracture edge.

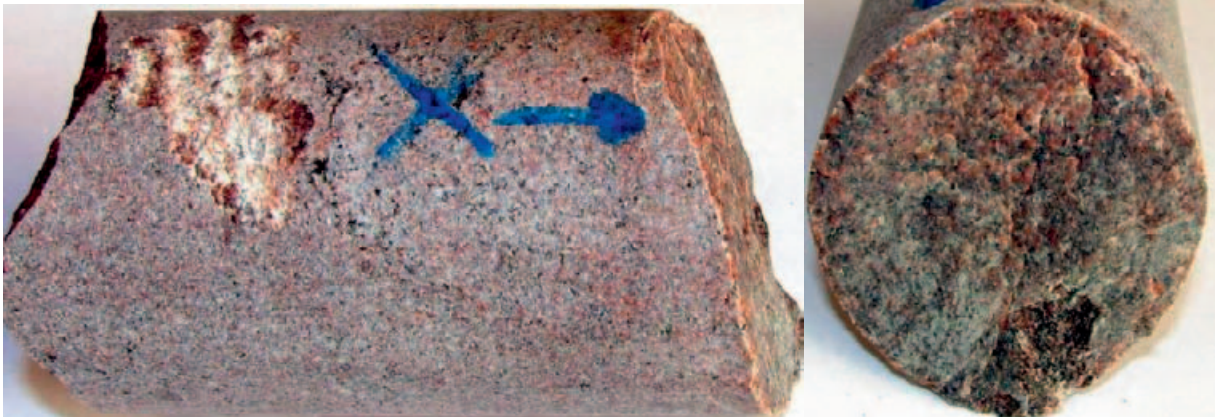
KLX10: 284.245 m

Fracture minerals: Calcite, REE-carbonate and galena.

Wall rock: Magnetite and pyrite are fresh in the whole sample. No increased wall rock alteration towards the fracture. Typical red-staining alteration exist (e.g. plagioclase alteration, chloritization of biotite). Micro-fractures running sub-parallel to the open fracture are partly filled with e.g. REE-carbonate.

Photographs of drill core and fracture surface.

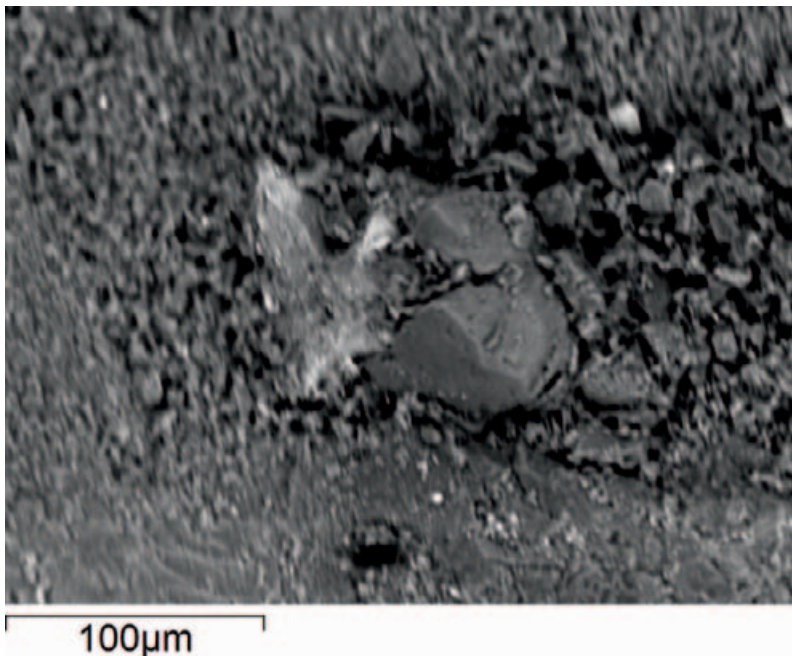
Back-scattered SEM-image of calcite (dark crystal)

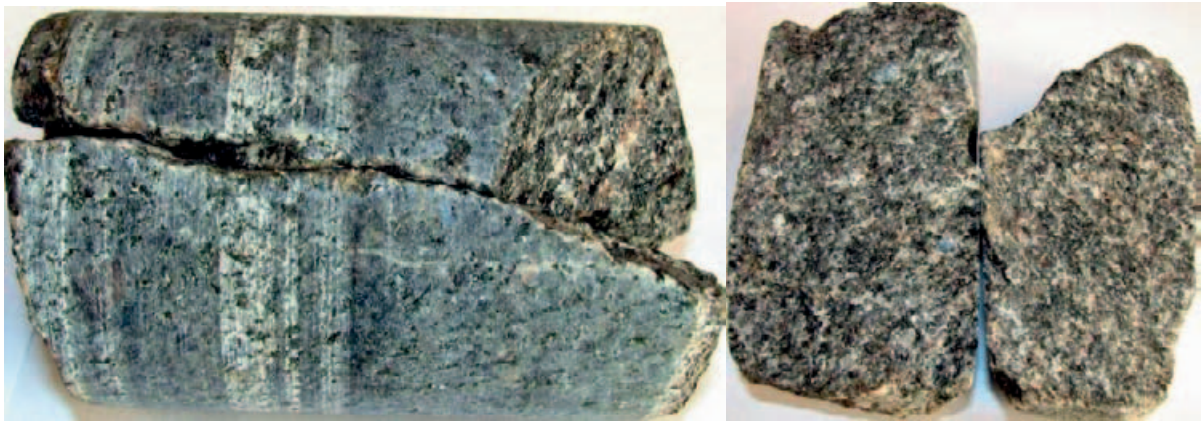
KLX13A: 465.239 m

Fracture minerals: Pyrite and barite.

Wall rock: The wall rock is generally quite fresh and unaltered. No increased wall rock alteration is observed towards the fracture. No typical red-staining alteration. Biotite alteration is observed at the fracture rim. Non-mineralised micro-fractures run parallel with the main fracture.

Photographs of drill core and fracture surface.

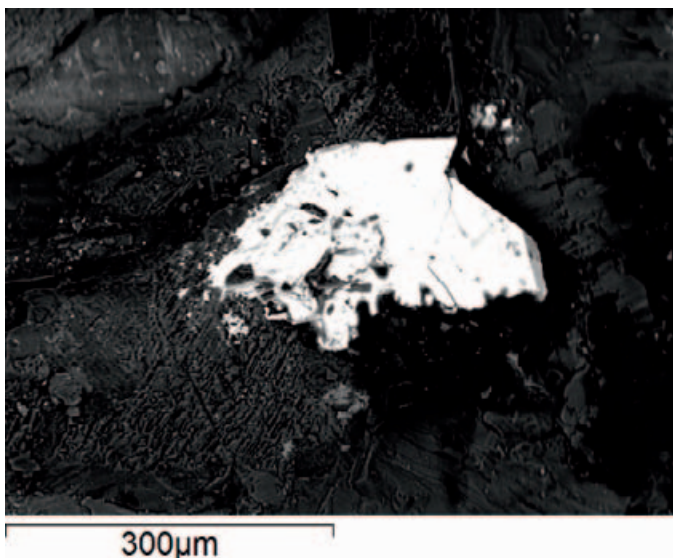
Back-scattered SEM-image of barite (bright crystal).
