Assessment of fractures classified as non-mineralised in the Sicada database

Lillemor Claesson Liljedahl, Raymond Munier
Svensk Kärnbränslehantering AB

March 2011

Svensk Kärnbränslehantering AB

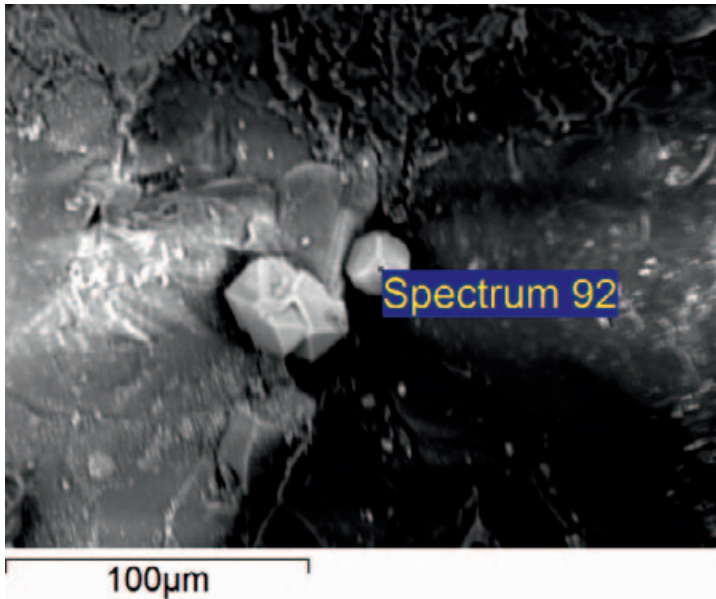
Back-scattered SEM-image of pyrite.

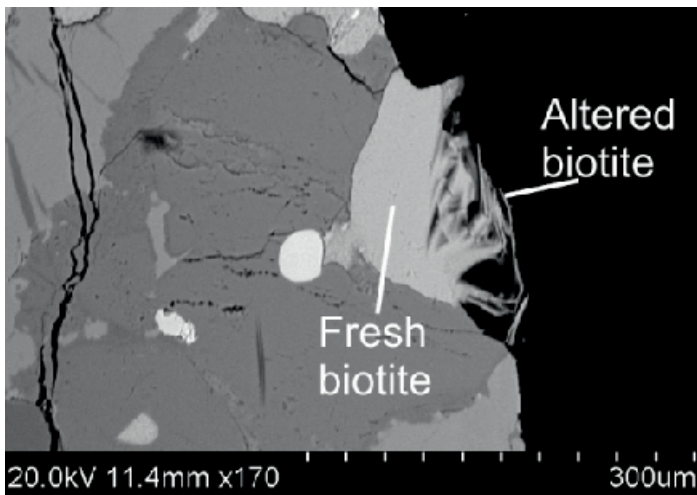
Back-scattered SEM-image of biotite alteration at the fracture edge.

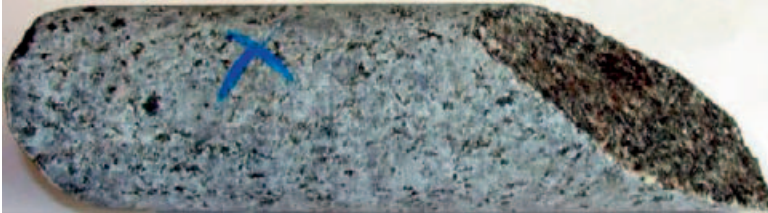
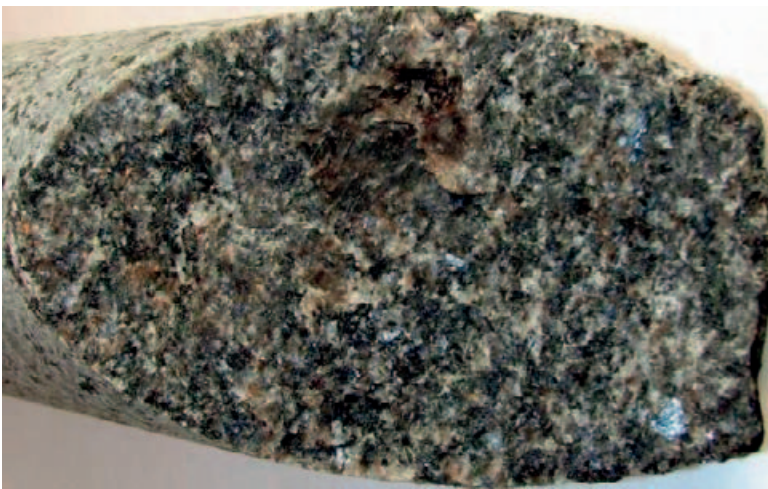
KLX13A: 470.658 m

Fracture minerals: Barite, calcite and adularia.

Thin section: The wall rock is generally quite fresh and unaltered. No increase in wall rock alteration towards the fracture. No typical red-staining alteration. Some indications of biotite alteration at the fracture rim. K-feldspar shows indications of alteration at the fracture rim and secondary K-feldspar (adularia) is formed. Very few micro-fractures.

Photographs of drill core and fracture surface.

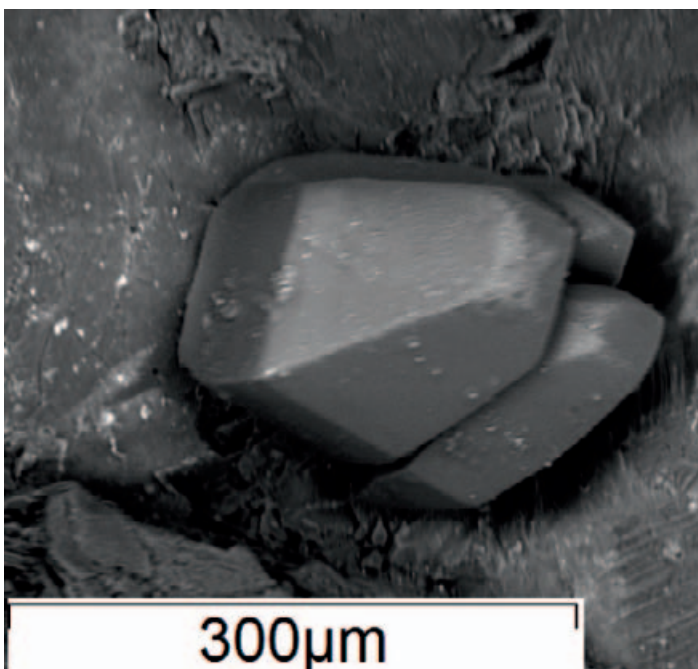
Back-scattered SEM-image of REE-carbonate.

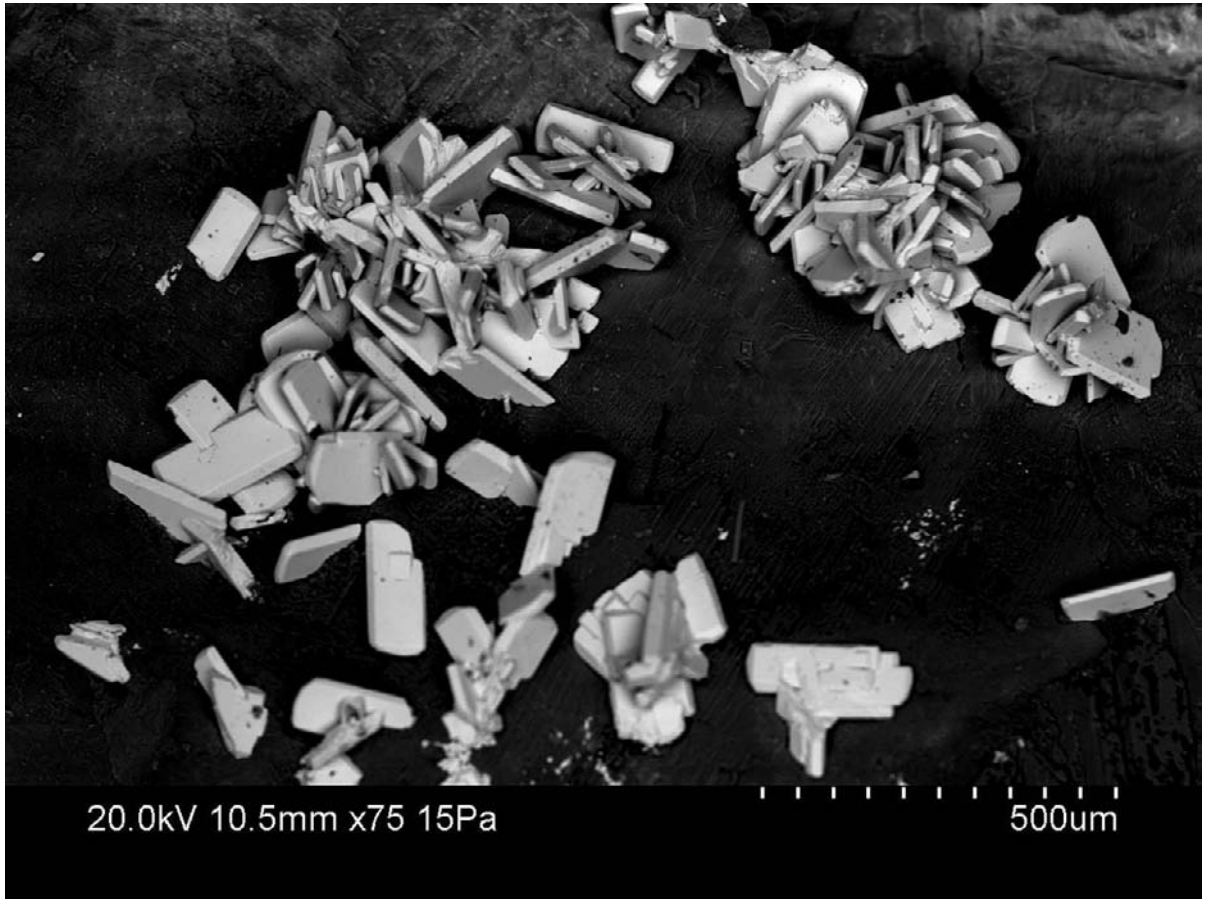
Back-scattered SEM-image of barite (bright crystals).

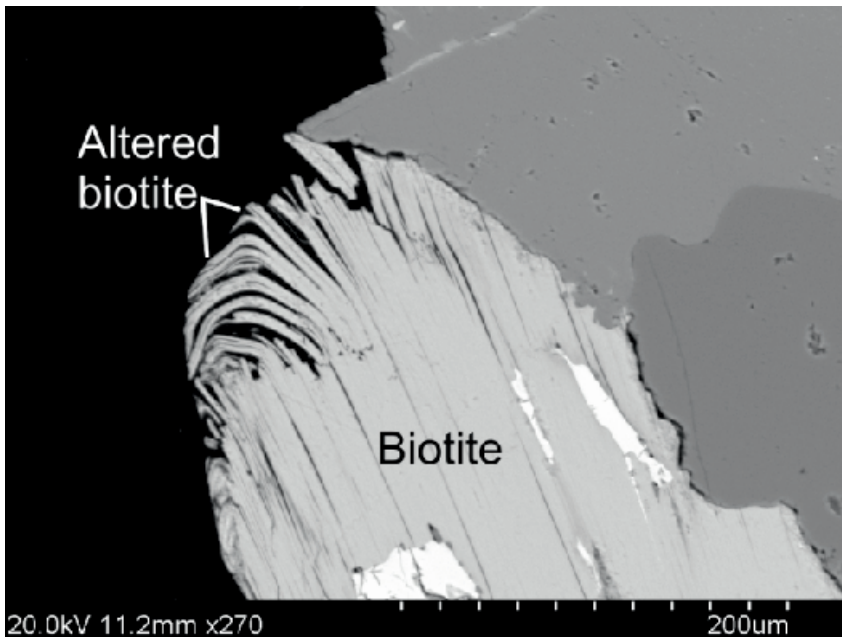
Back-scattered SEM-image of biotite alteration at the fracture edge.

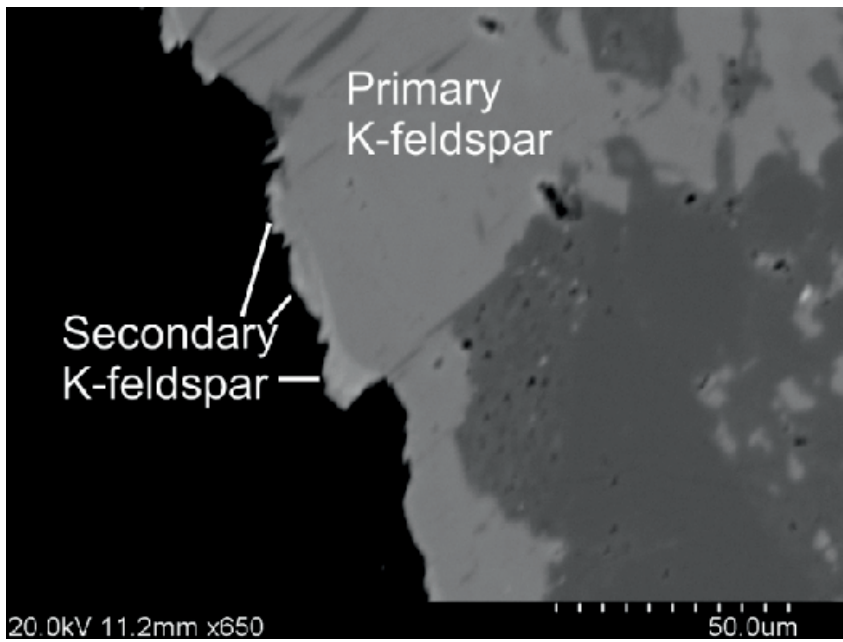
Back-scattered SEM-image of overgrowths of secondary K-feldspar (adularia) on primary K-feldspar at the fracture edge.

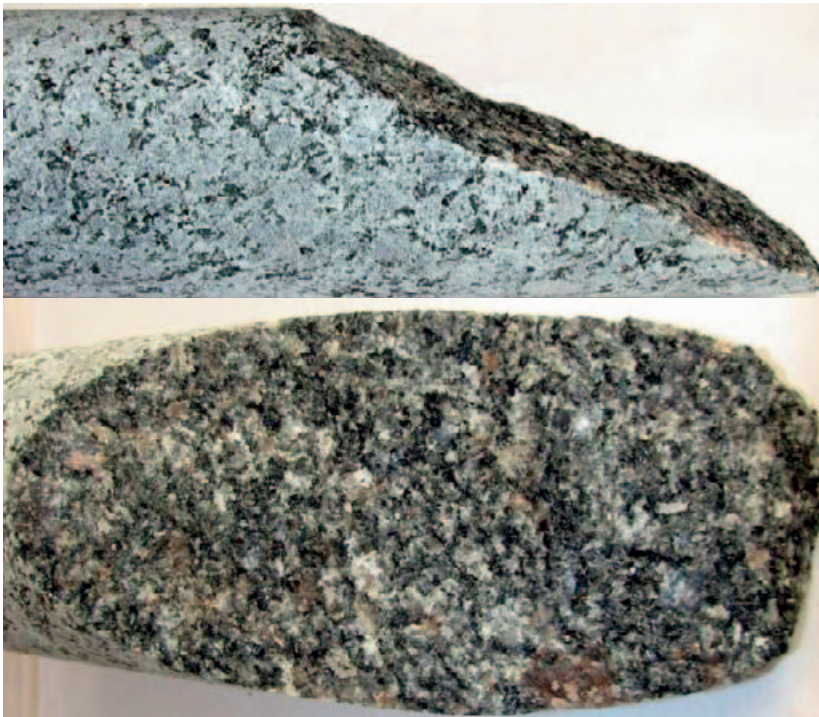
KLX18A: 309.503 m

Fracture minerals: Barite and calcite, prehnite and quartz.

Wall rock: The wall rock is generally quite fresh and unaltered (e.g. fresh magnetite, pyrite and chalcopyrite). No increase in wall rock alteration towards the fracture. No typical red-staining alteration. Some indications of biotite alteration at the fracture rim. Sub-parallel micro-fractures exist close to the fracture and are filled with e.g. quartz. Prehnite, calcite and quartz exist in an apophyse to the main fracture, and prehnite also borders to the main fracture. This indicates that the fracture is an old hydrothermal fracture (but without intense wall rock alteration) that has been re-activated during the Paleozoic when barite was formed.

Photographs of drill core and fracture surface.

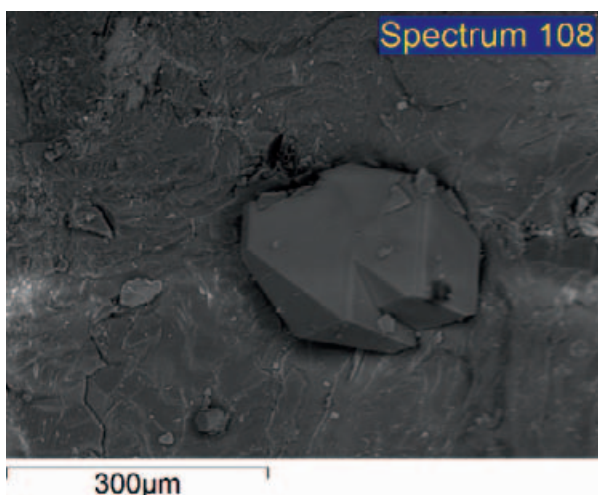
Back-scattered SEM-image of calcite.

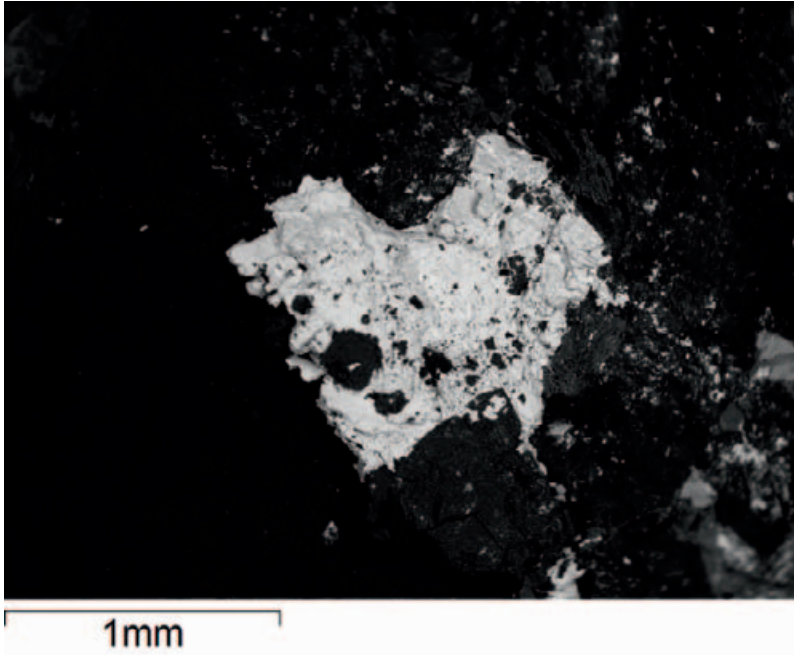
Back-scattered SEM-image of barite (bright mineral).

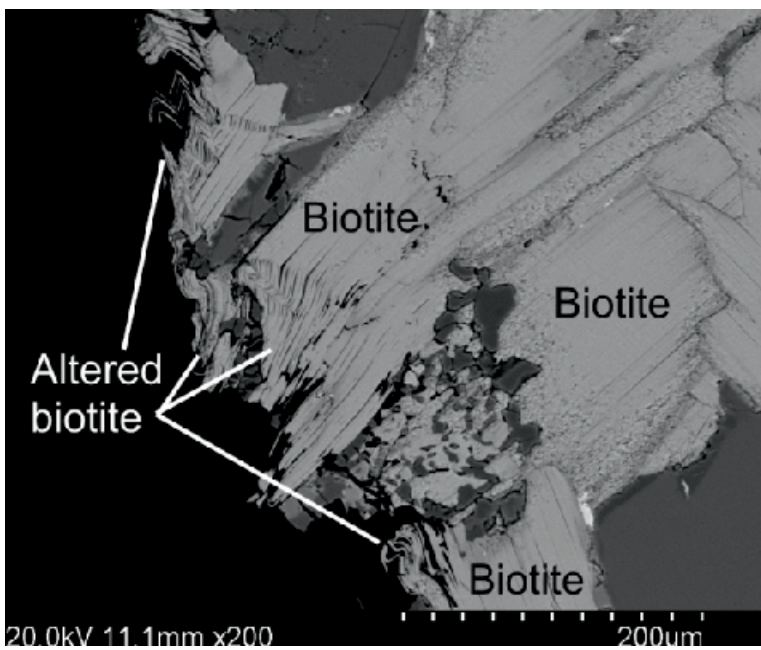
Back-scattered SEM-image of biotite alteration at the fracture edge.

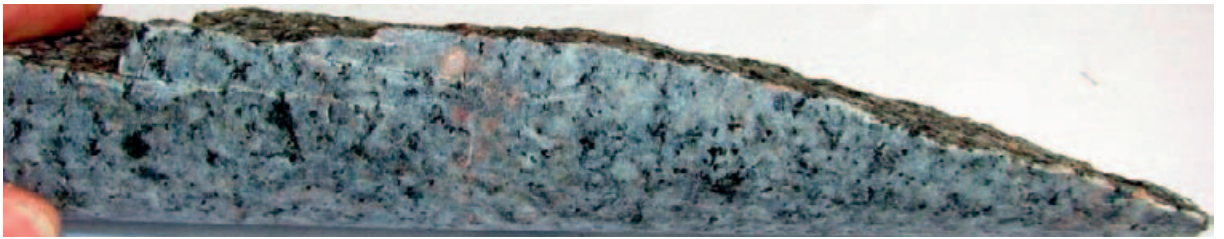
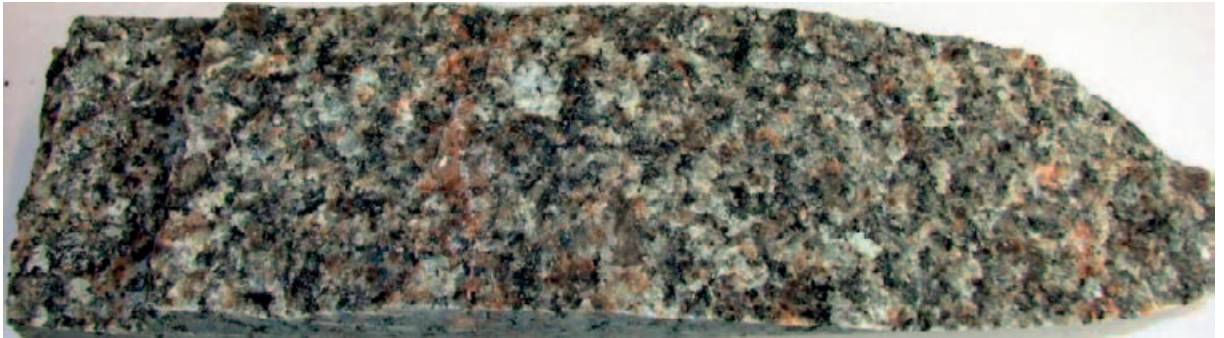
KLX18A: 382.470 m

Fracture minerals: Barite and adularia.

Wall rock: The wall rock is generally quite fresh although alteration of plagioclase is evident. Wall rock minerals biotite and magnetite are generally fresh and unaltered. No increase in wall rock alteration towards the fracture is observed. No typical red-staining alteration exists. Some indications of biotite alteration at the fracture rim. Micro-fractures exist parallel to the main fracture, but also perpendicular to the fracture. These are partly filled, e.g. with pyrite and adularia. Secondary adularia has grown on primary K-feldspar at the fracture edge.

Photographs of drill core and fracture surface.

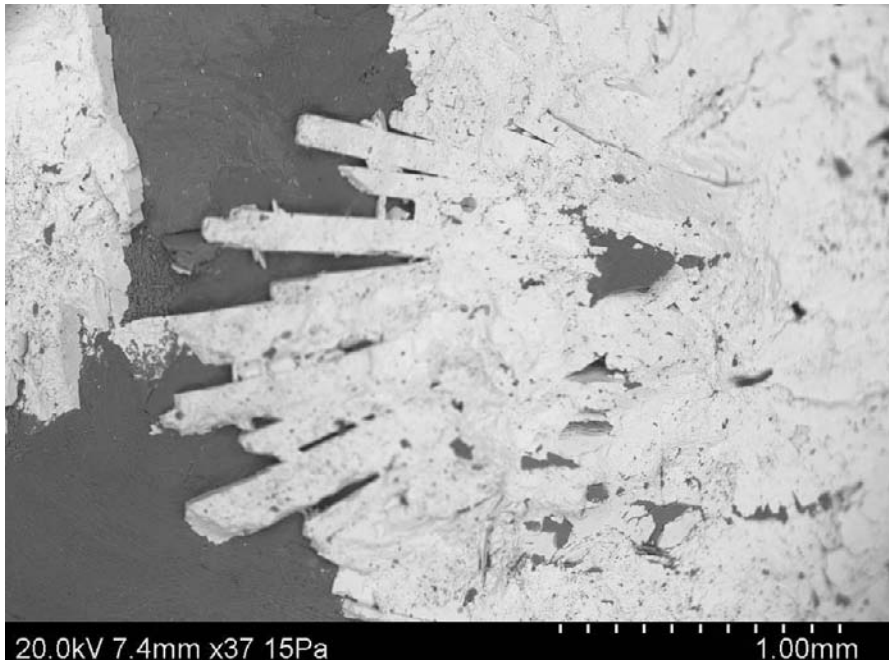
Back-scattered SEM-image of REE-carbonate (bright mineral).

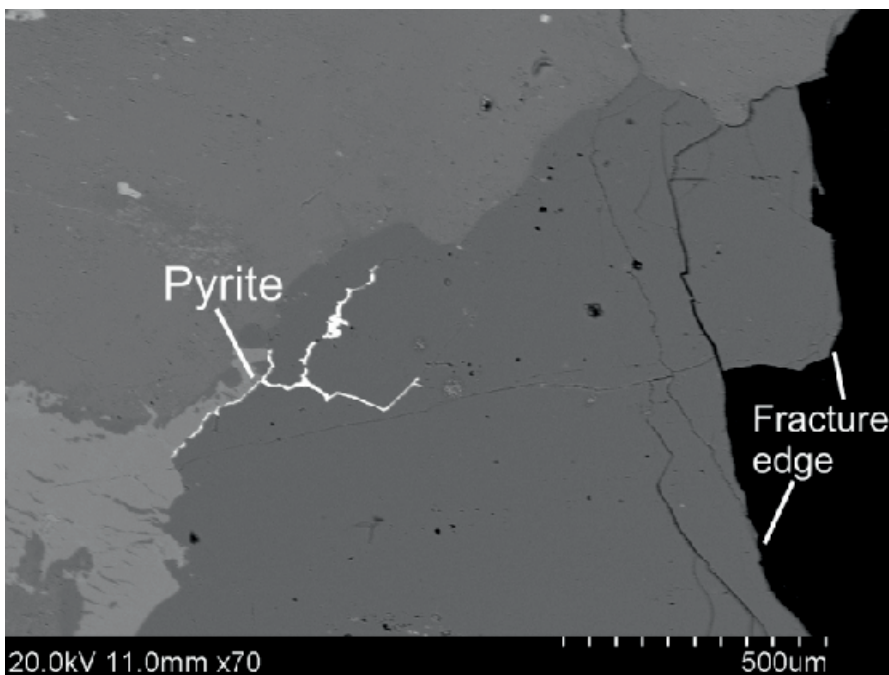
Back-scattered SEM-image of pyrite in micro-fractures close to the main fracture.

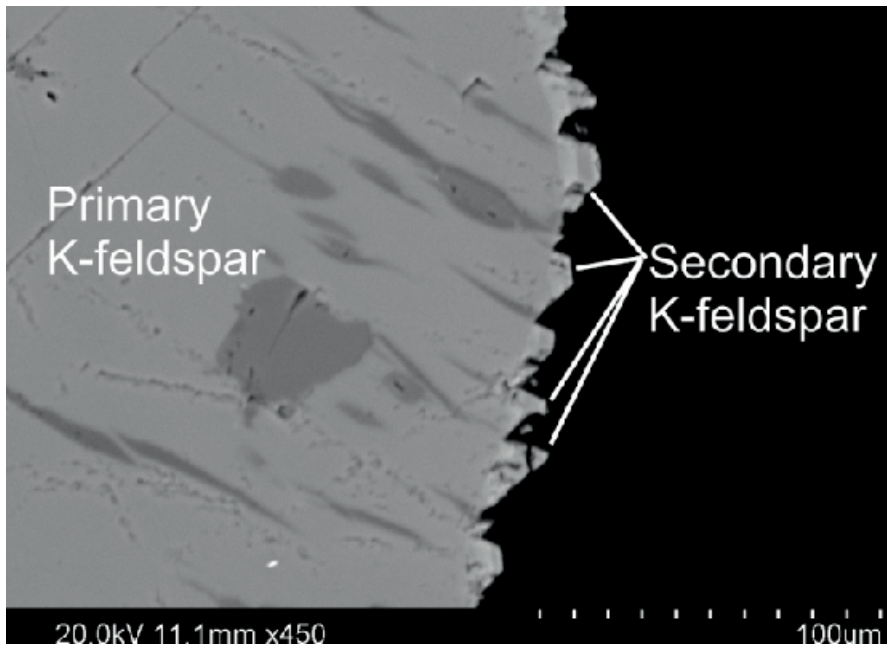
Back-scattered SEM-image of overgrowths of secondary K-feldspar (adularia) on primary K-feldspar at the fracture edge.

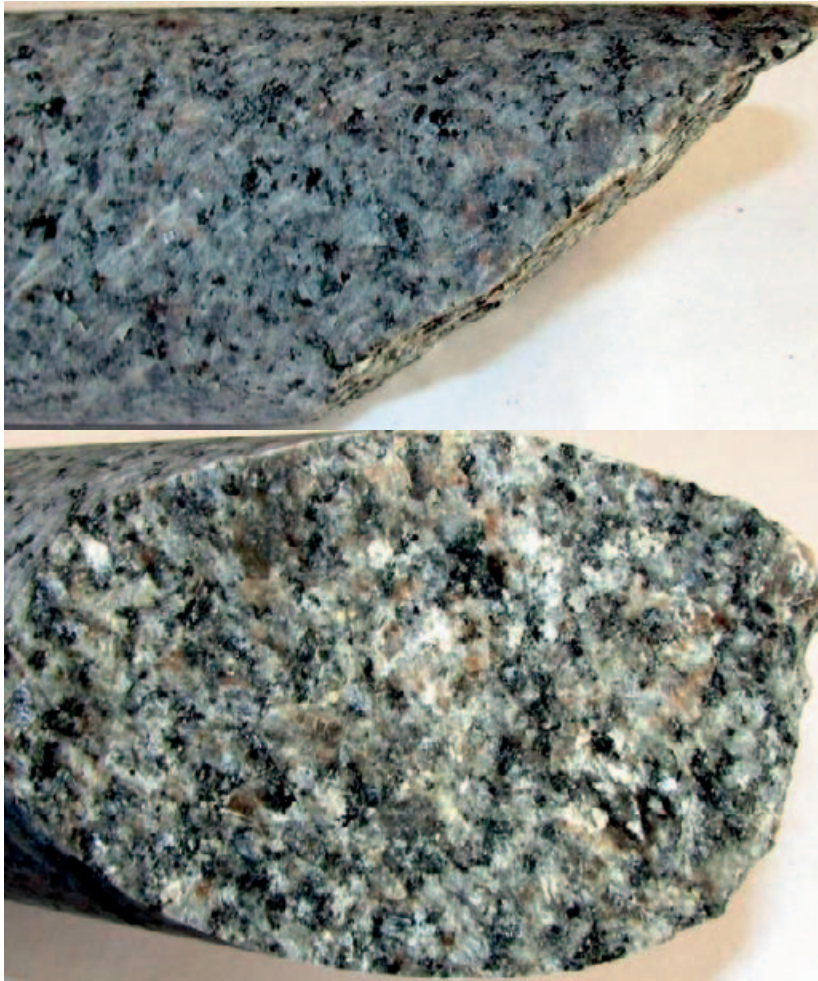
KLX18A: 421.006 m

Fracture minerals: Calcite and adularia.

Wall rock: The wall rock is generally quite fresh and unaltered. No increase in wall rock alteration towards the fracture is observed. No typical red-staining alteration exists. Some indications exist of biotite alteration at the fracture rim. Micro-fractures parallel to the main fracture are filled with adularia and epidote. Euhedral adularia has grown as a secondary mineral from primary K-feldspar at the fracture edge.

Photographs of drill core and fracture surface.

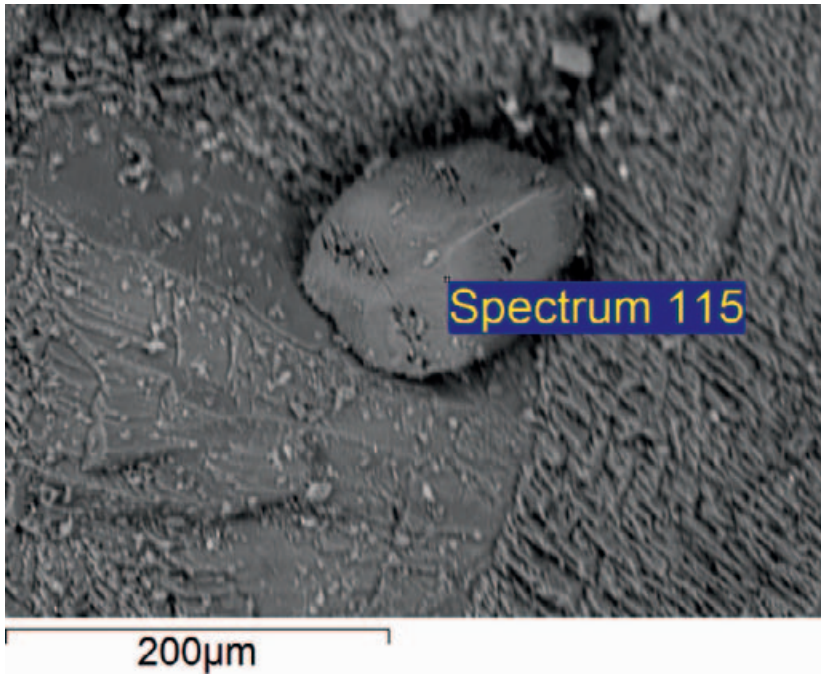
Back-scattered SEM-image of calcite.

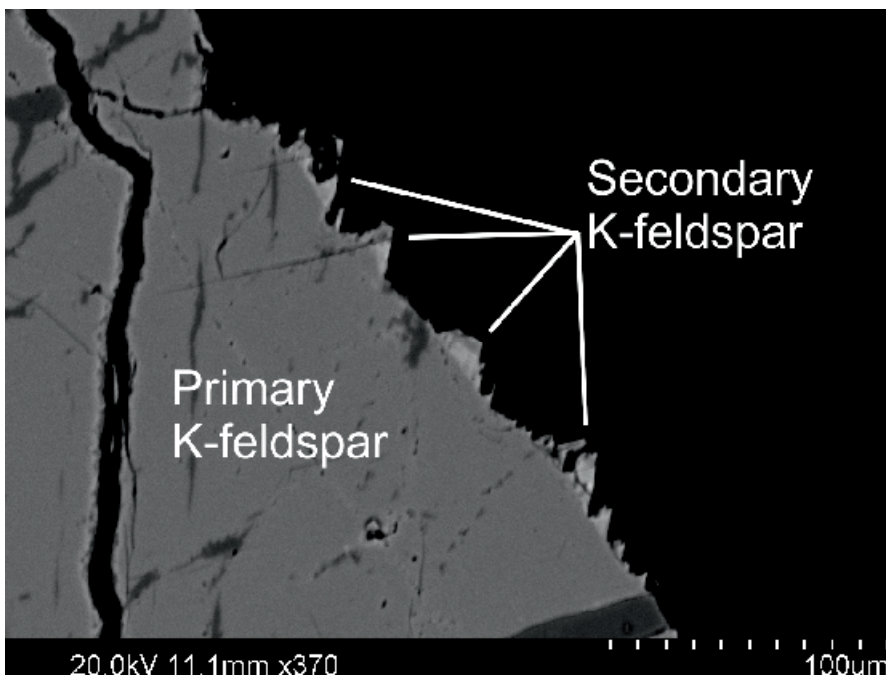
Back-scattered SEM-image of overgrowths of secondary K-feldspar (adularia) on primary K-feldspar at the fracture edge.

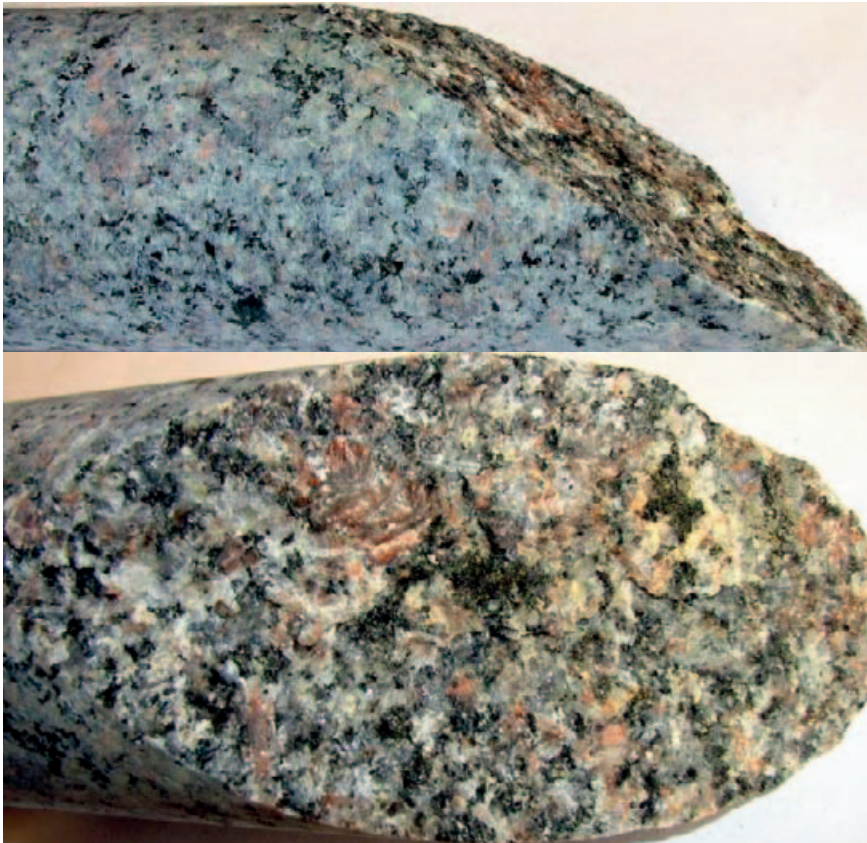
KLX18A: 468.079 m

Fracture mineral: Pyrite and chlorite.

Wall rock: The wall rock is generally quite fresh and unaltered. No increase in wall rock alteration is observed towards the fracture and no typical red-staining alteration is observed. There are no significant indications of biotite alteration at the fracture rim. Micro-fractures parallel to the main fracture are partly filled with e.g. chlorite.

Photographs of drill core and fracture surface.

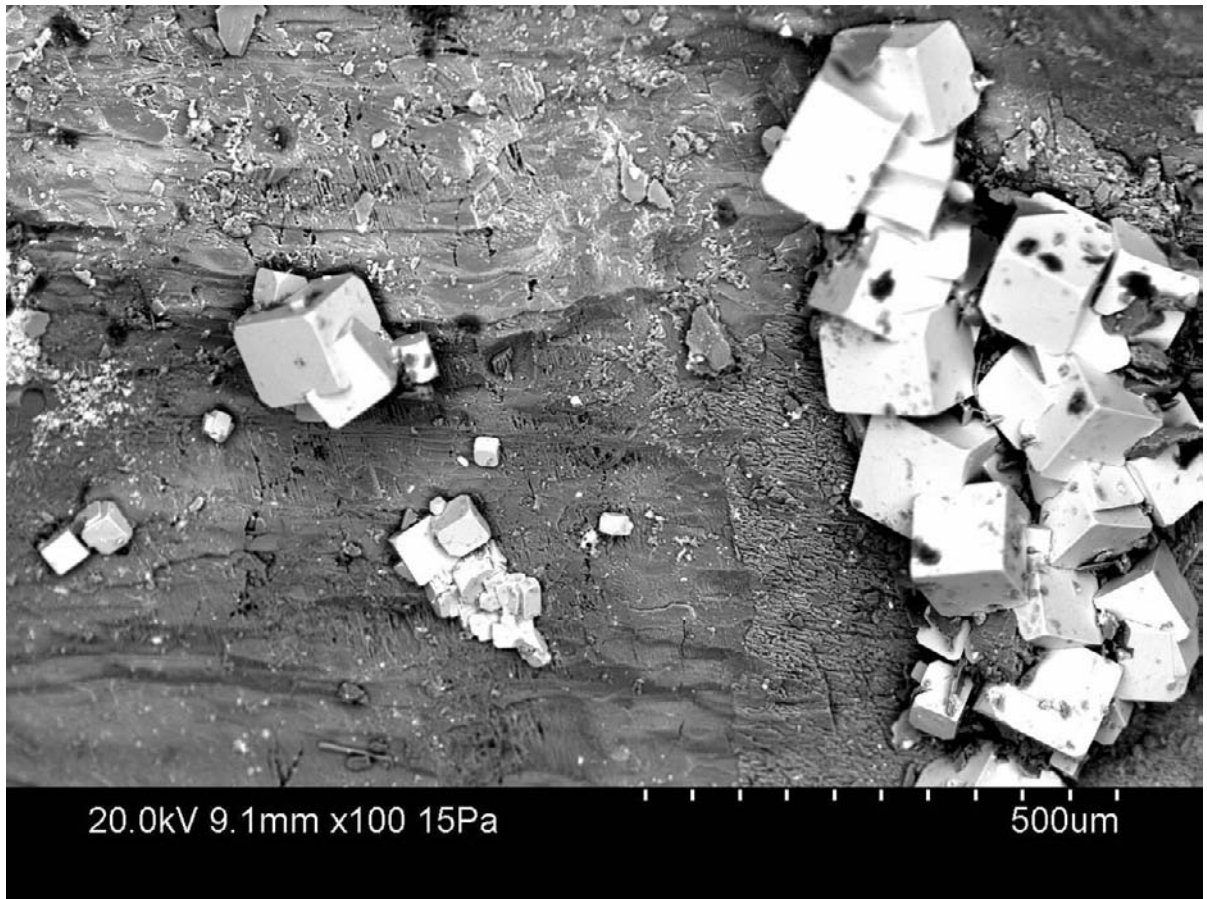
Back-scattered SEM-image of pyrite (bright, cubic crystals).

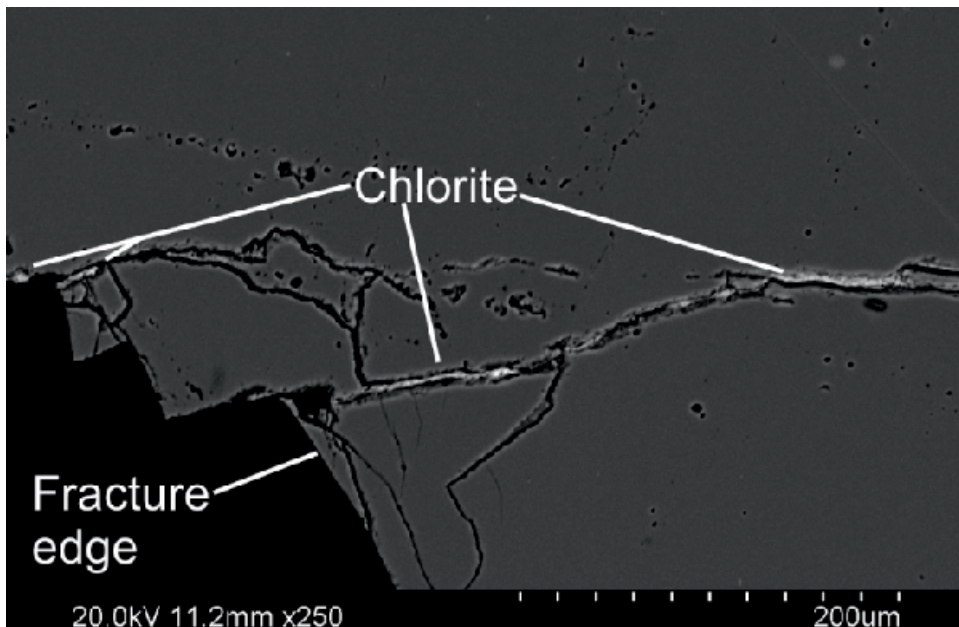
Back-scattered SEM-image of chlorite in the main fracture and in micro-fractures close to the main fracture.

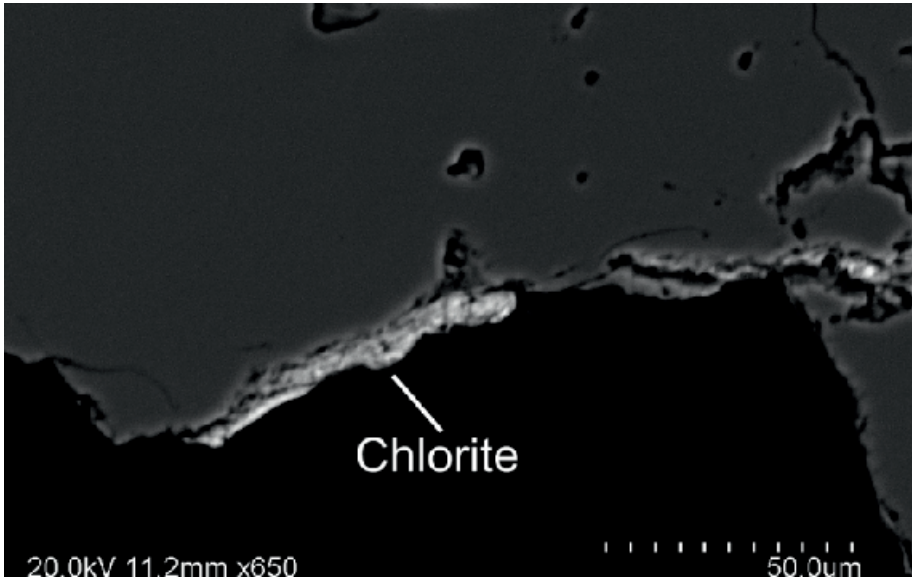
Back-scattered SEM-image of chlorite coating the fracture wall of the main fracture.

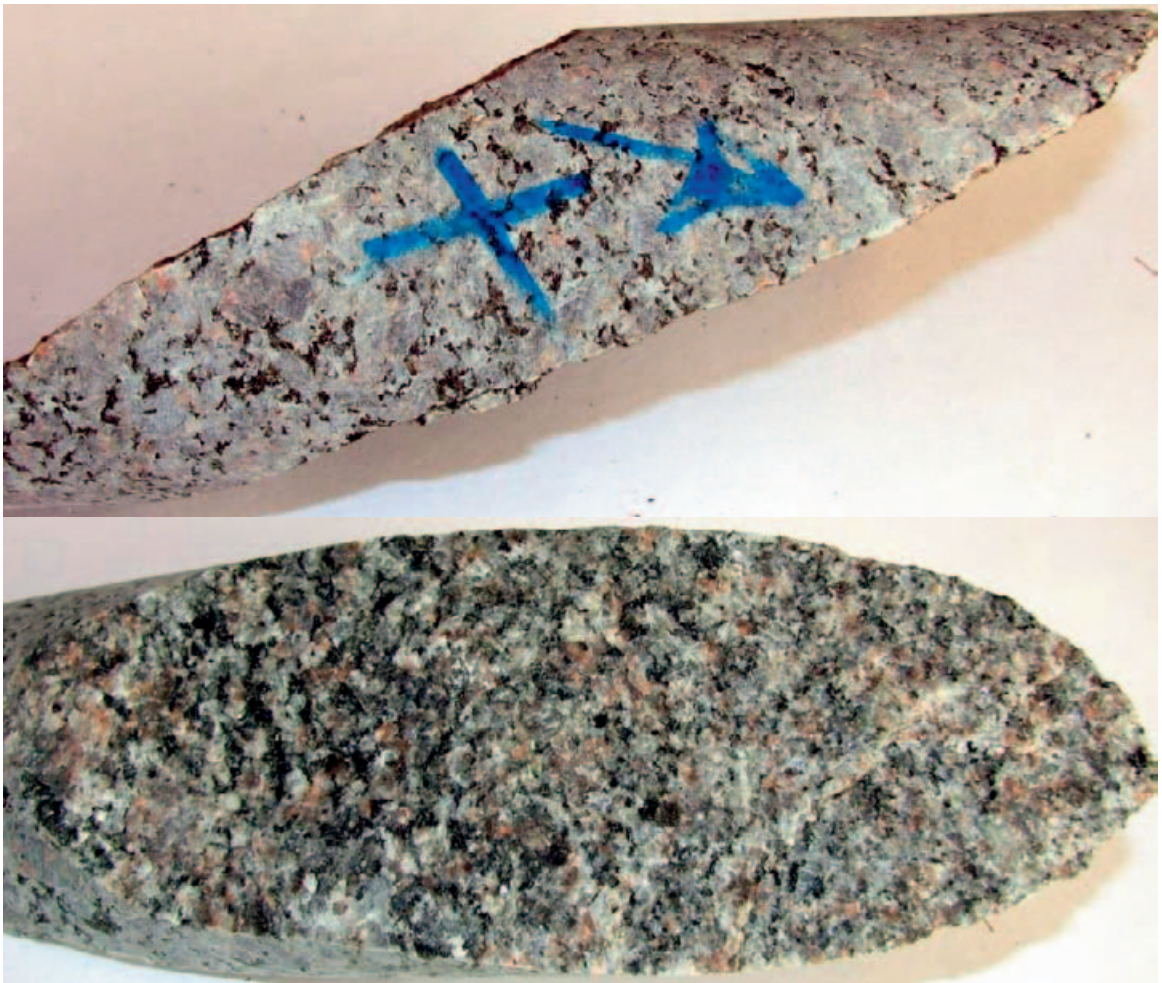
KLX18A: 554.815 m

Fracture minerals: Pyrite, chalcopyrite and REE-carbonate.

Wall rock: The wall rock is generally quite fresh and unaltered. Magnetite is preserved and one fresh pyrite crystal is observed at the fracture surface. There is no increase in wall rock alteration towards the fracture and no typical red-staining alteration is observed. Biotite alteration is observed close to the fracture. There are four sets of parallel micro-fractures at different distance to the fractures (but very close to the fracture). These fractures are partly filled with e.g. pyrite.

Photographs of drill core and fracture surface.

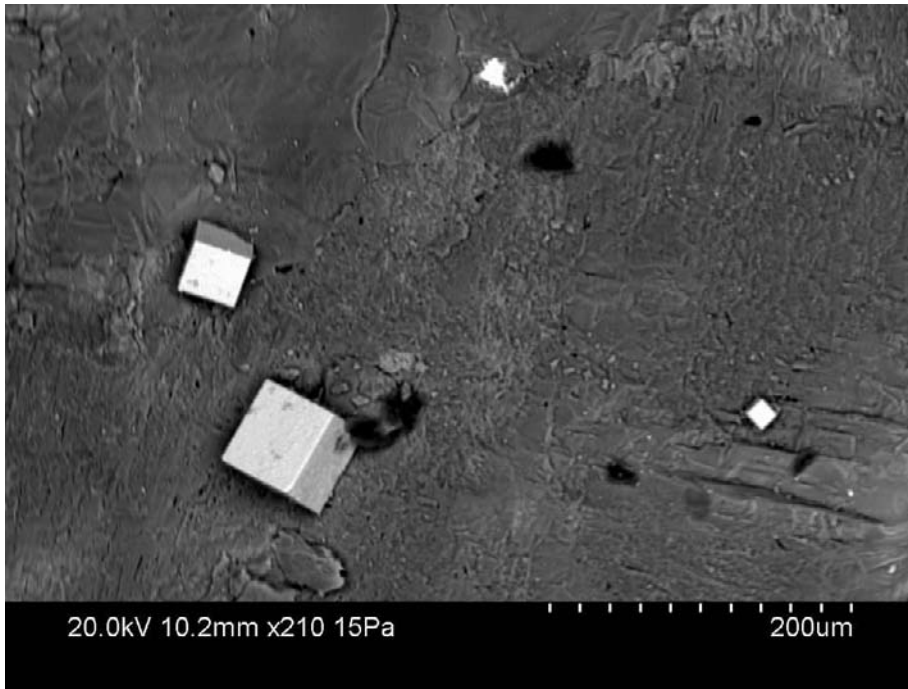
Back-scattered SEM-image of pyrite (bright, cubic crystals).

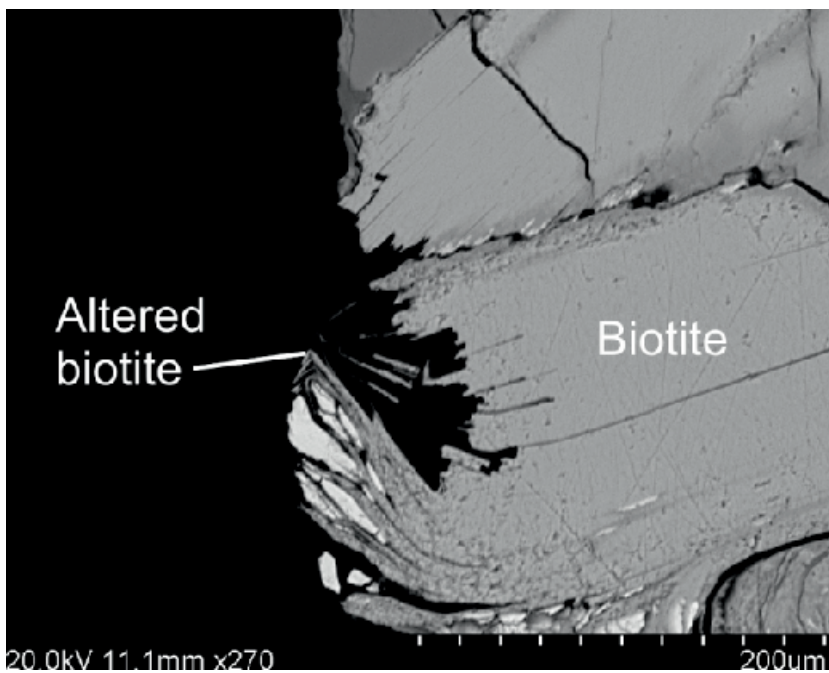
Back-scattered SEM-image of biotite alteration at the fracture edge.

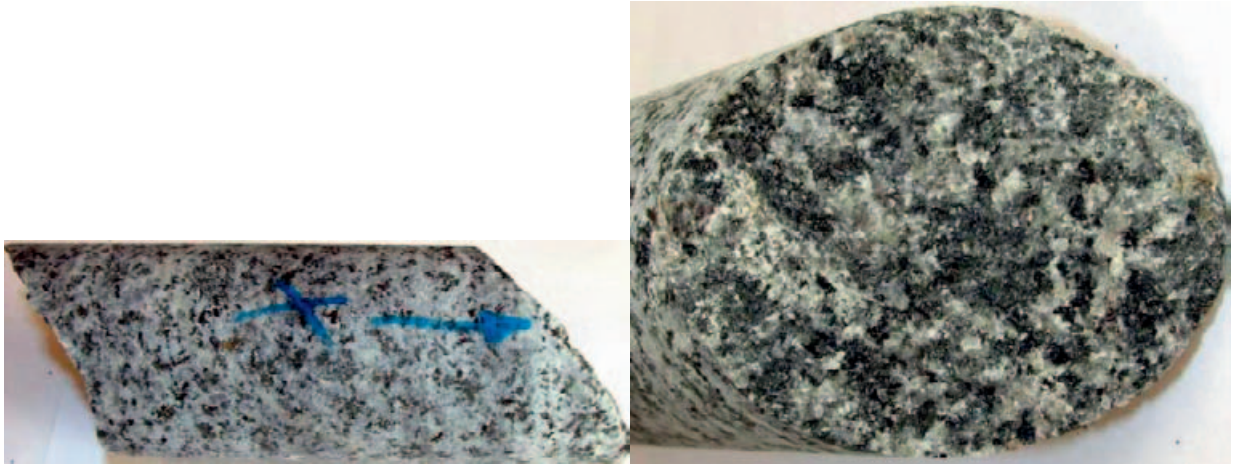
KLX19A: 684.759 m

Fracture minerals: Barite, pyrite, adularia and albite.

Wall rock: The wall rock is generally quite fresh and unaltered. There is no increase in wall rock alteration towards the fracture and no typical red-staining alteration is observed. Biotite alteration at the fracture edge is indicated.

Photographs of drill core and fracture surface.

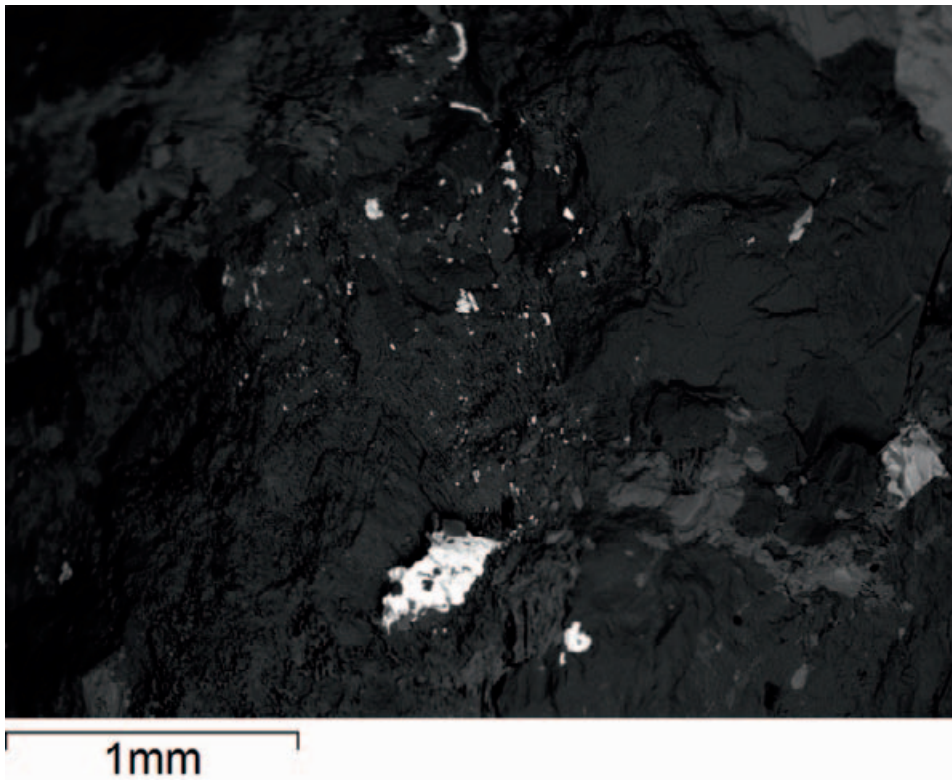
Back-scattered SEM-image of barite (bright crystals).

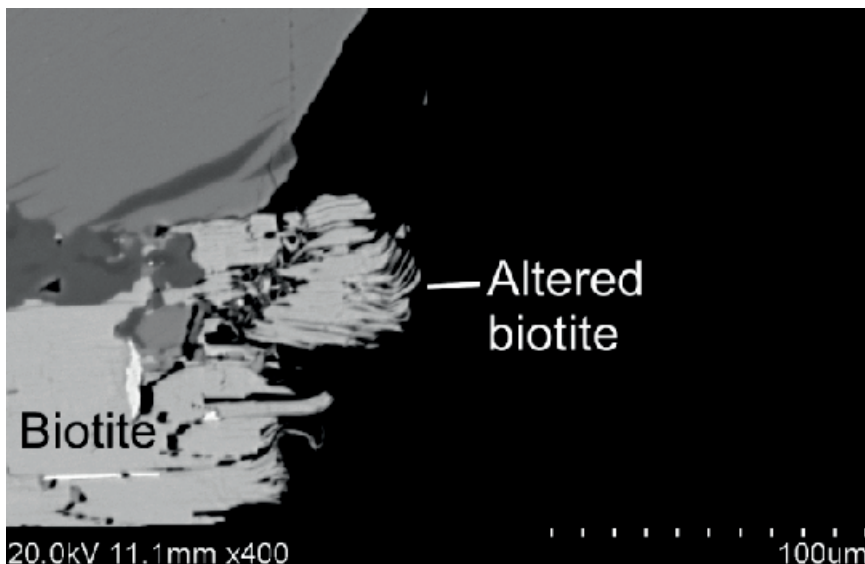
Back-scattered SEM-image of biotite alteration at the fracture edge.

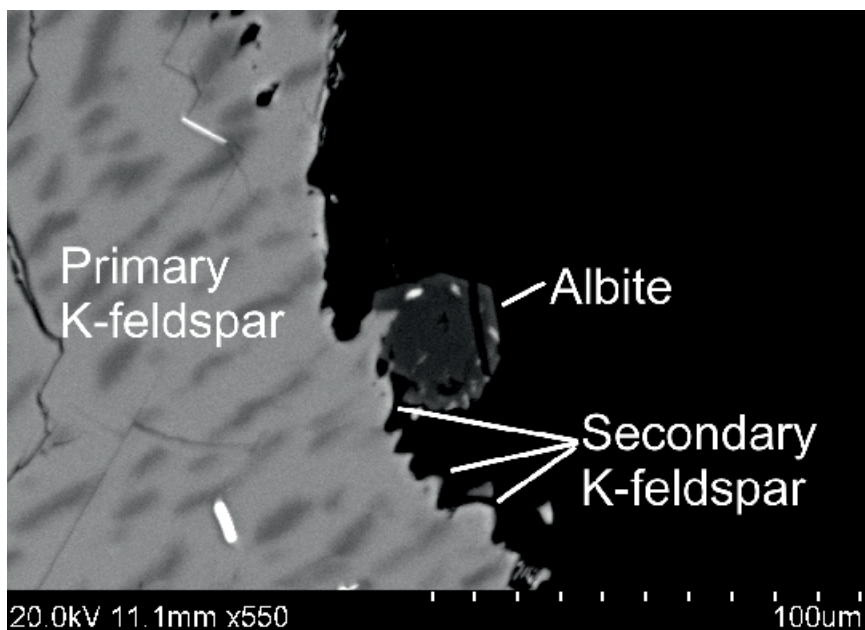
Back-scattered SEM-image of overgrowths of secondary K-feldspar (adularia) and albite on primary K-feldspar at the fracture edge.

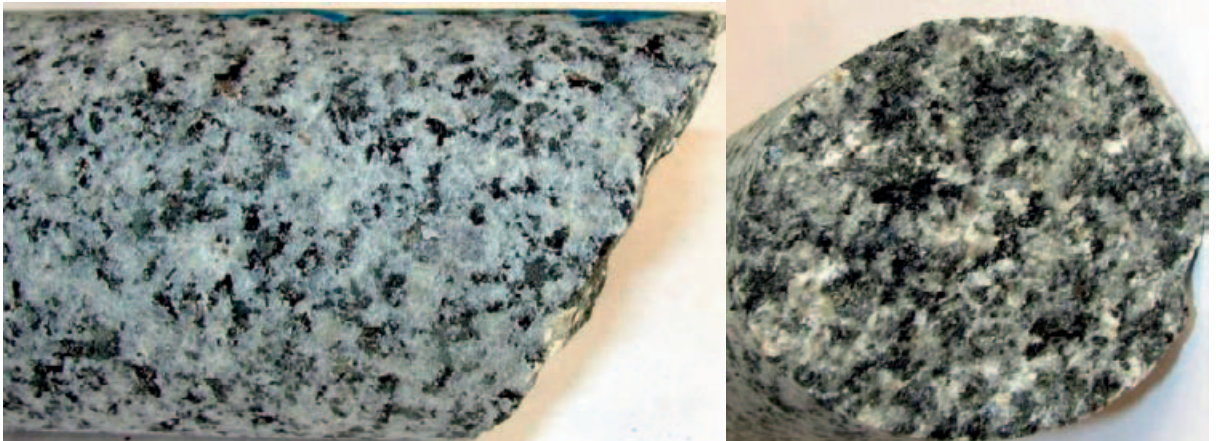
Fracture minerals: Pyrite and Na-zeolite.

Wall rock: The wall rock is generally quite fresh and unaltered. Magnetite and pyrite is fresh, biotite is generally fresh, but plagioclase is partly altered. There is no increase in wall rock alteration towards the fracture. Some very clear indications of biotite alteration at the fracture rim exist. Empty micro-fractures run parallel with the main fracture.

Photographs of drill core and fracture surface.

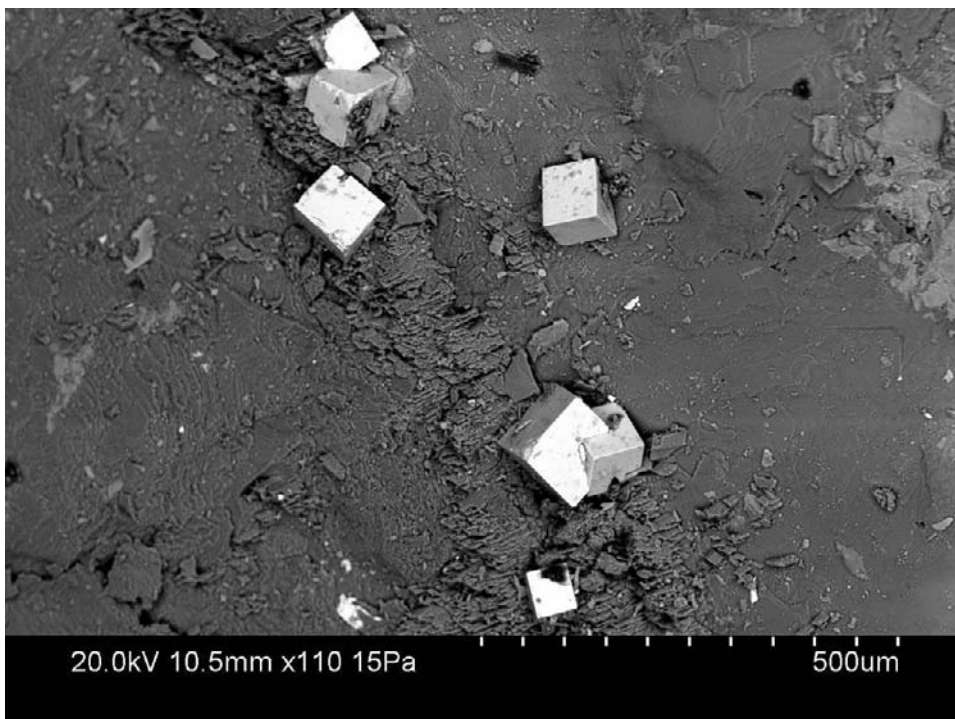
Back-scattered SEM-image of pyrite (bright, cubic crystals).

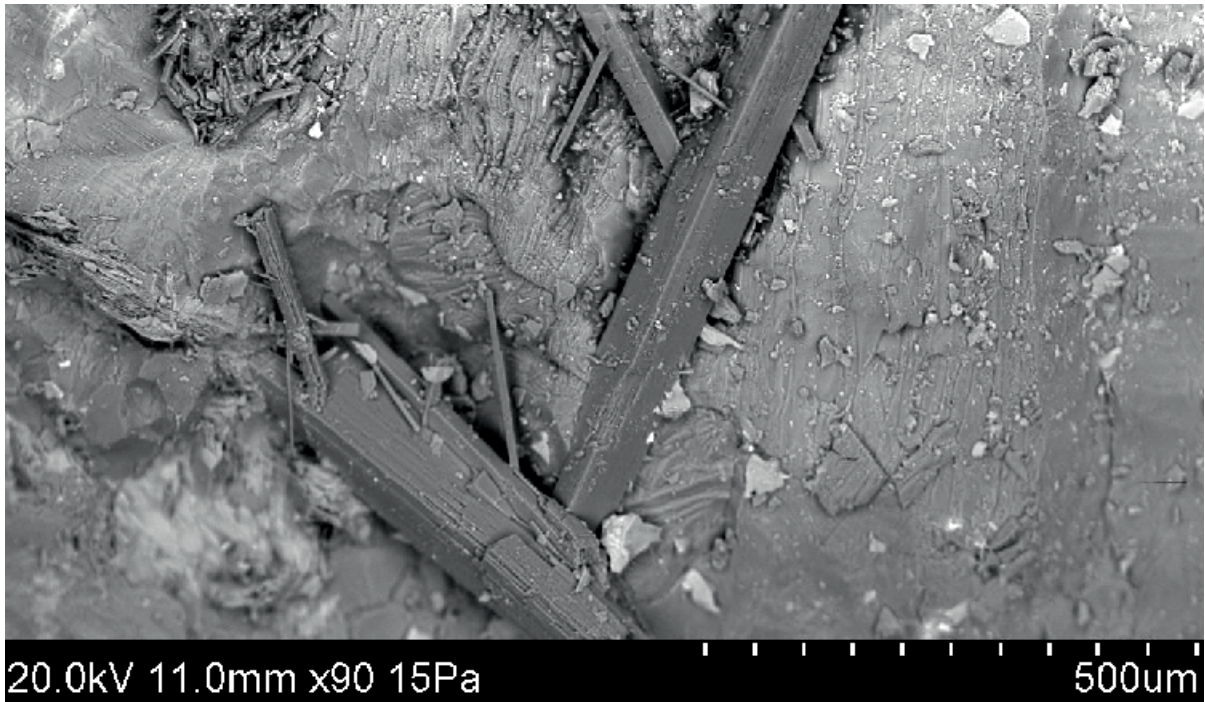
Back-scattered SEM-image of Na-zeolite (euhedral crystals).

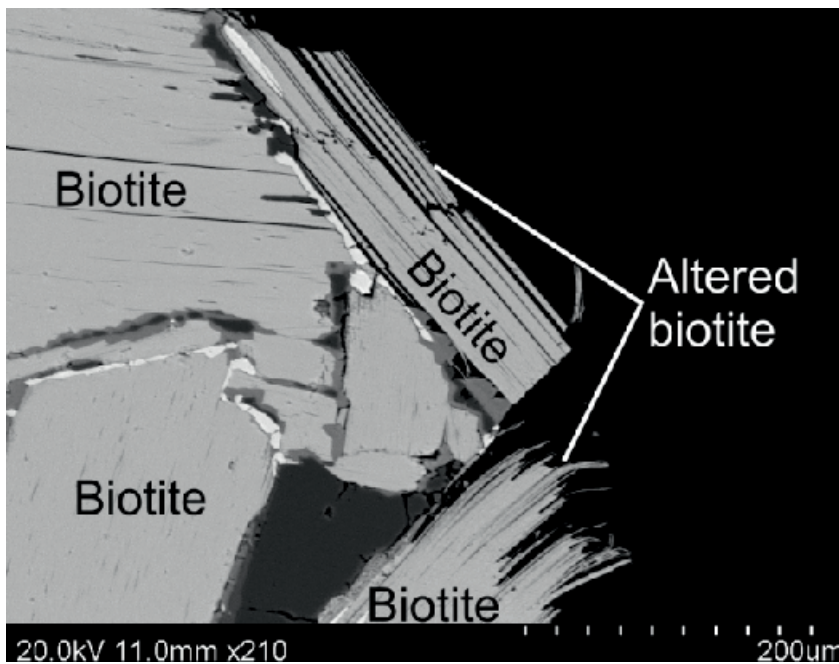
Back-scattered SEM-image of biotite alteration at the fracture edge.

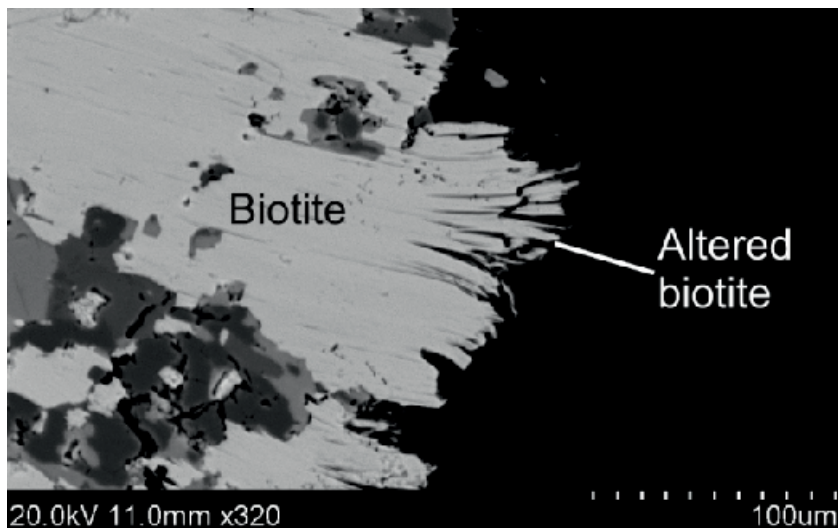
Back-scattered SEM-image of biotite alteration at the fracture edge.
