Iron hydroxide occurrences and redox capacity in bedrock fractures in the vicinity of SFR

December 2014

SKB R-12-11

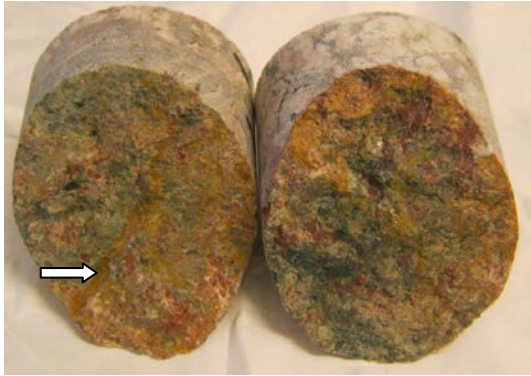
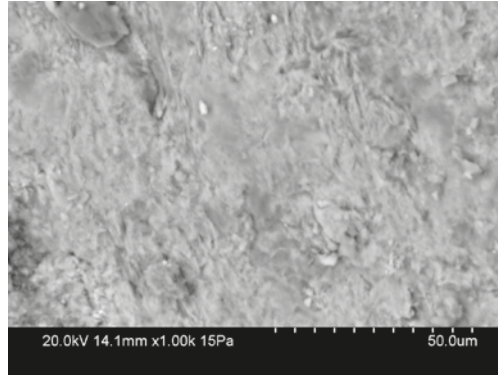
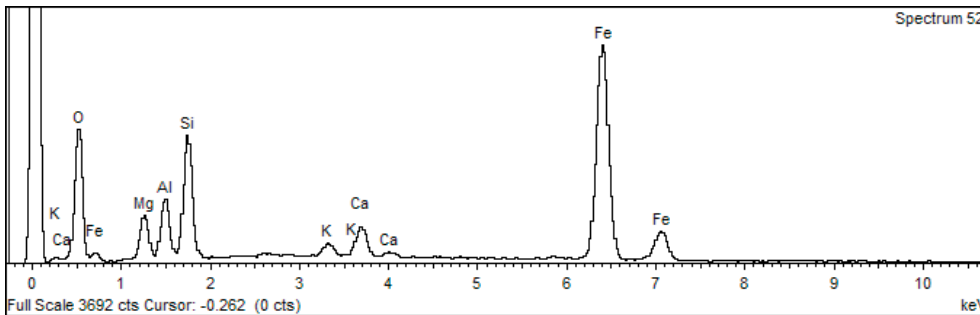
- The most common rust-coloured mineral mistaken for iron hydroxide during the drill core mapping is Fe-rich mixed layer clay (Figure 5-1). (10 of 26 fractures mapped as iron hydroxide-bearing.)
- A significant number of fractures mapped as iron hydroxide-bearing with a brown or green-yellow coating were actually coated with U-silicate, U-oxide or U-phosphate (Figure 5-2). (7 of 26 fractures mapped as iron hydroxide-bearing.)
- A few of the fractures mapped as iron hydroxide-bearing contained rust-coloured metallic iron or iron oxides from the drilling process (Figure 5-3). (4 of 26 fractures mapped as iron hydroxide-bearing.)
- Other minerals mistaken for iron hydroxide during the drill core mapping include hematite-stained adularia and albite. (3 of 26 fractures mapped as iron hydroxide-bearing.)

Photo of fracture surface with rust-brown colour.

Backscattered electron image of mixed layer clay on fracture surface.

EDS-spectra of Fe-rich mixed layer clay.

Figure 5-1. Fracture from KFR104 25.03–25.09 m. The rust-brown mineral mapped as iron hydroxide in Sicada is a Fe-rich mixed layer clay.

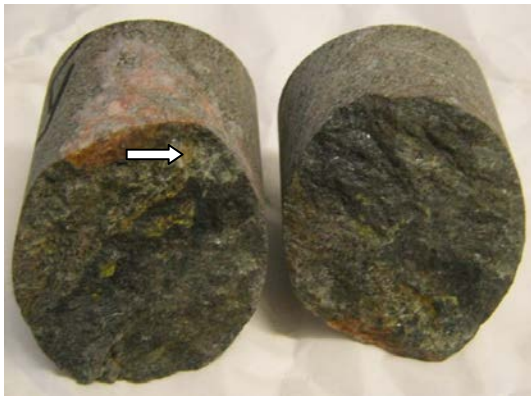
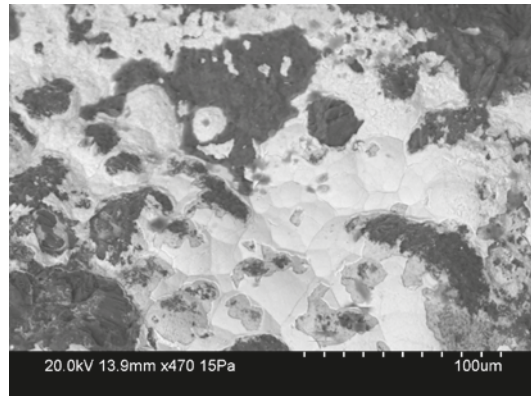
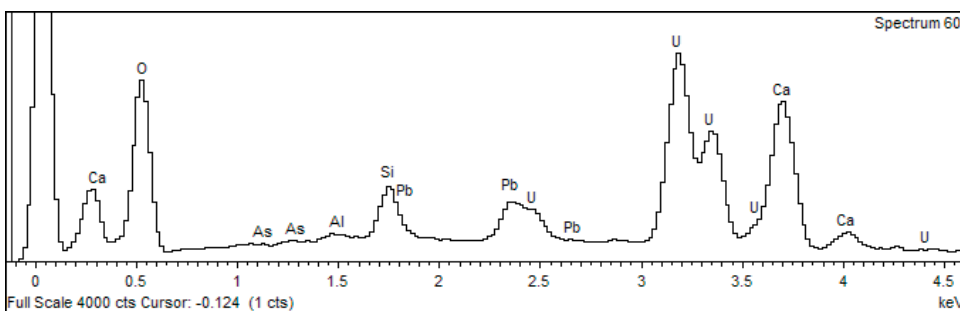
Photo of fracture surface green-yellow mineral coating.

Backscattered electron image of U,Ca-oxide on fracture surface.

EDS-spectra of U,Ca-oxide.

Figure 5-2. Fracture from KFR104 21.57–21.66 m. The green-yellow mineral mapped as iron hydroxide in Sicada is an (U,Ca)-oxide.

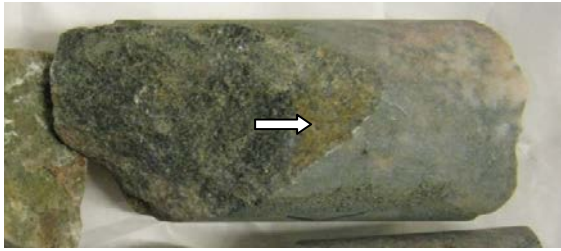
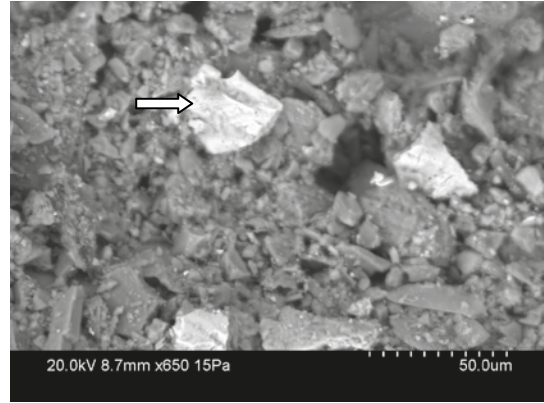
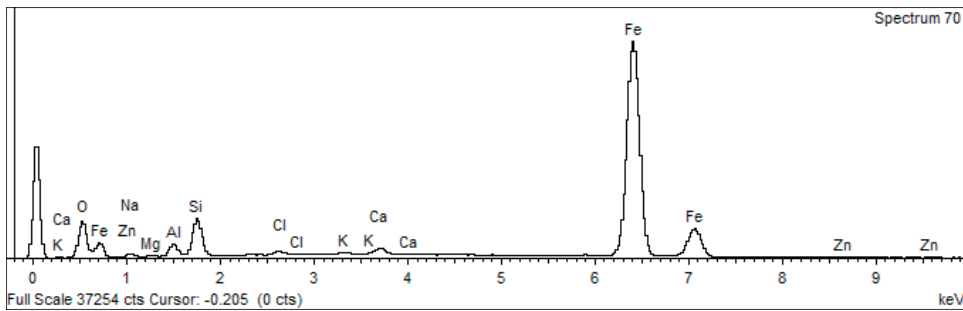
Photo of fracture surface with rust-brown mineral coating.

Backscattered electron image of fragments of metallic iron on the fracture surface.

EDS-spectra of metallic iron.

Figure 5-3. Fracture from KFR102B 113.56–113.88 m. The rust-brown coating mapped as iron hydroxide in Sicada consists of fragments of metallic iron from the drilling process.

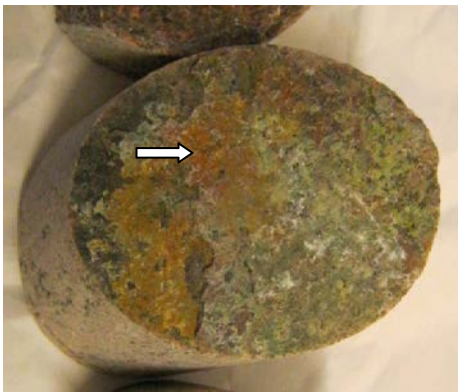
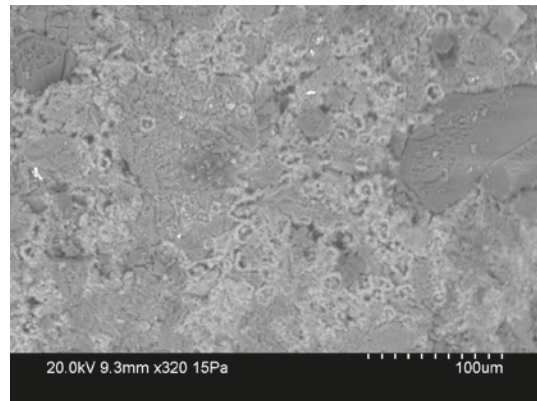
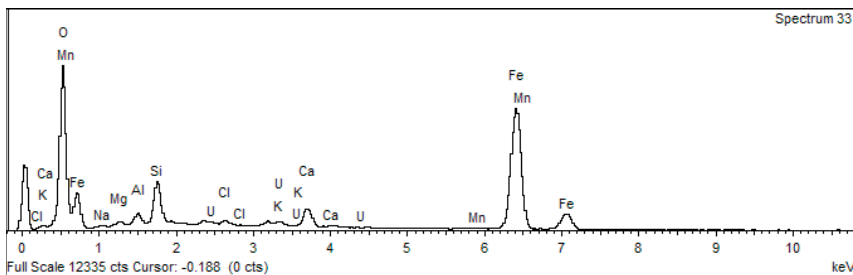
Only two of the sampled fractures mapped as iron hydroxide-bearing in Sicada were actually coated with a mineral which possibly can be iron hydroxide (Table 5-3). The elevations of the two samples are –45.06 m and –78.03 m.

Photo of fracture surface with rust-brown mineral coating.

Backscattered electron image of potential iron hydroxide.

EDS-spectra of iron hydroxide.

Figure 5-4. Fracture from KFR104 99.32–99.42 m. The rust-brown precipitate may be iron hydroxide.

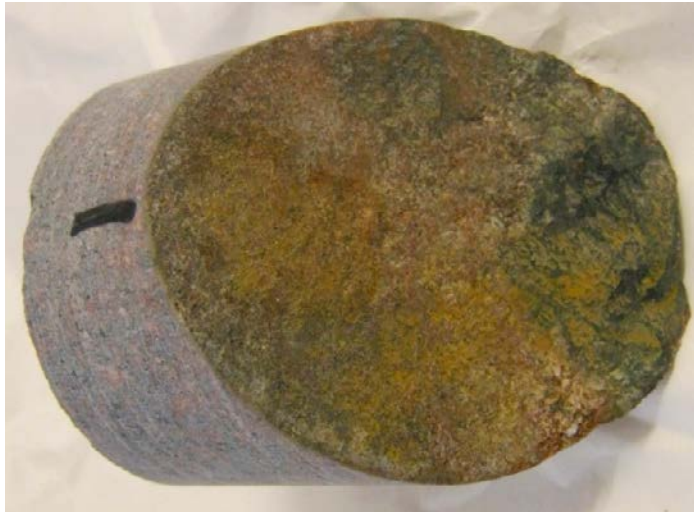
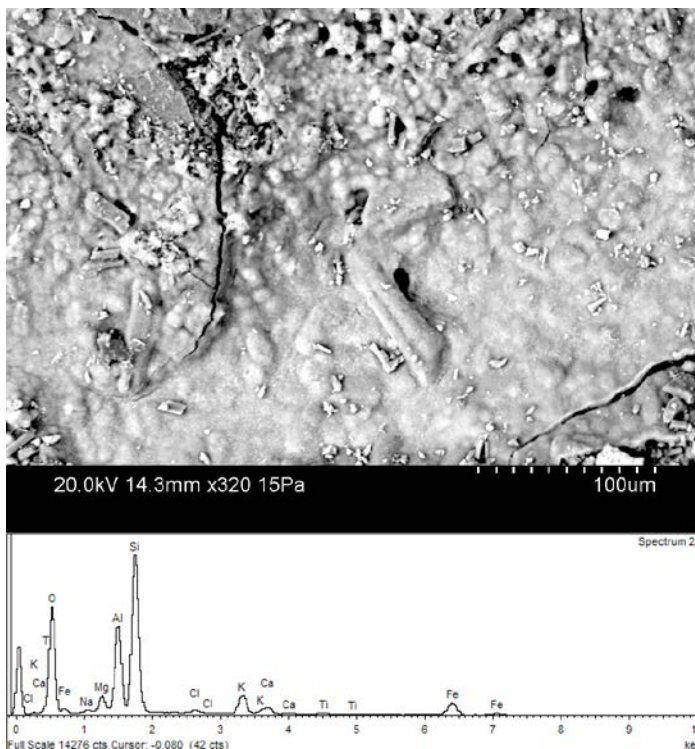
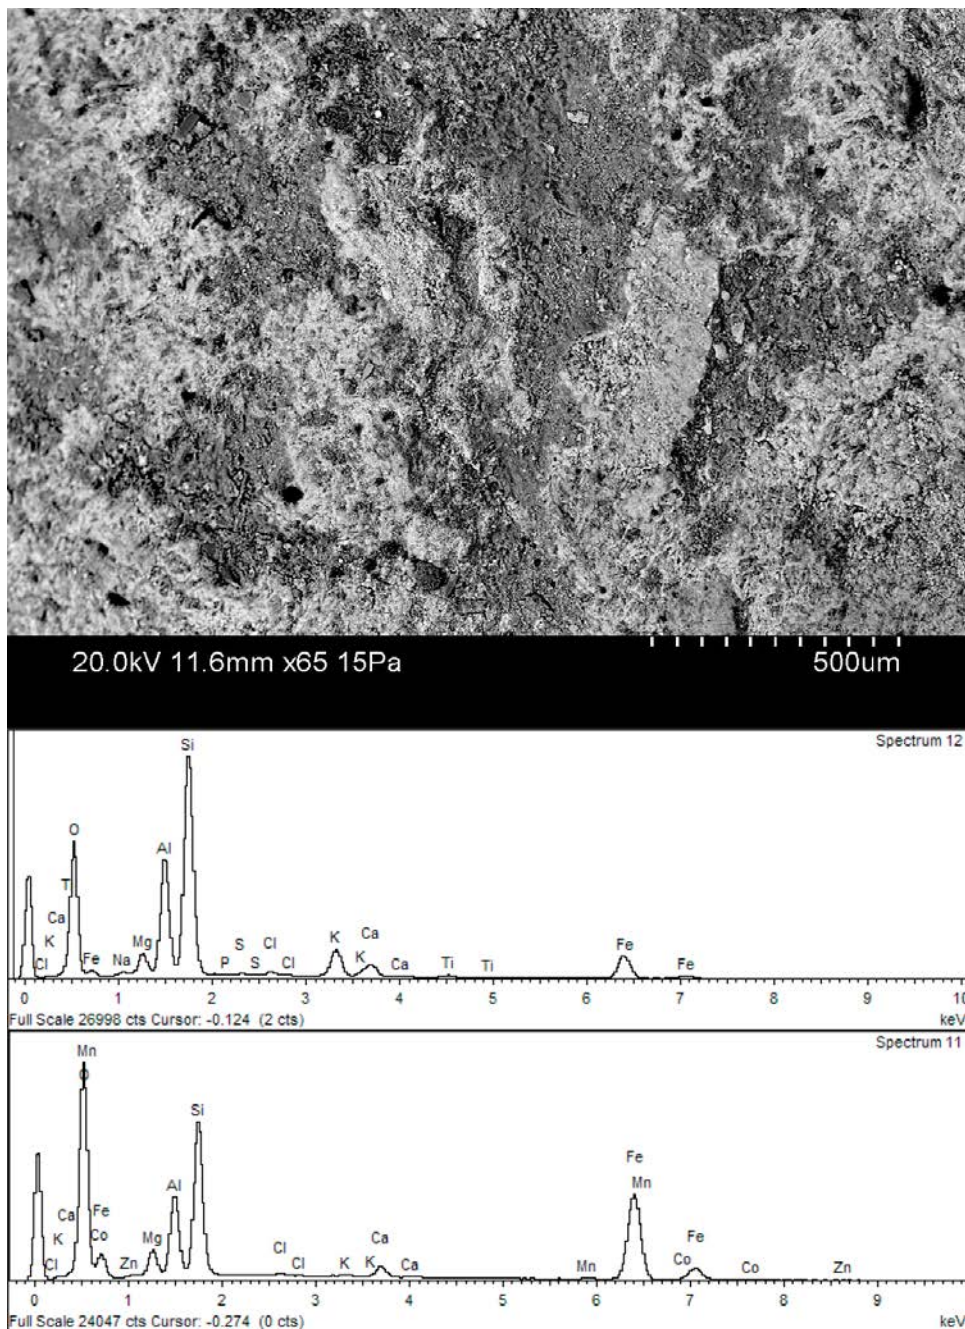
Figure A1-1. Photo of the sampled fracture from KFR102B 17.45–17.49 m.

The fracture surface is dominated by two varieties of mixed layer clay. The rust-brown parts of the surface are richer in the Fe-rich variant. Small amounts of a Ca-Al-silicate, probably prehnite and amorphous (Ca,REE)PO₄ (monazite?) were also identified. No iron hydroxide was found in the fracture.

Figure A1-2. BSE-image and EDS-spectra of clay-mineral from KFR102B 17.45–17.49 m.

Figure A1-3. BSE-image and EDS-spectra of two clay minerals from KFR102B 17.45–17.49 m, the bright mineral in the BSE-image and the lower spectrum is the Fe-rich clay mineral.

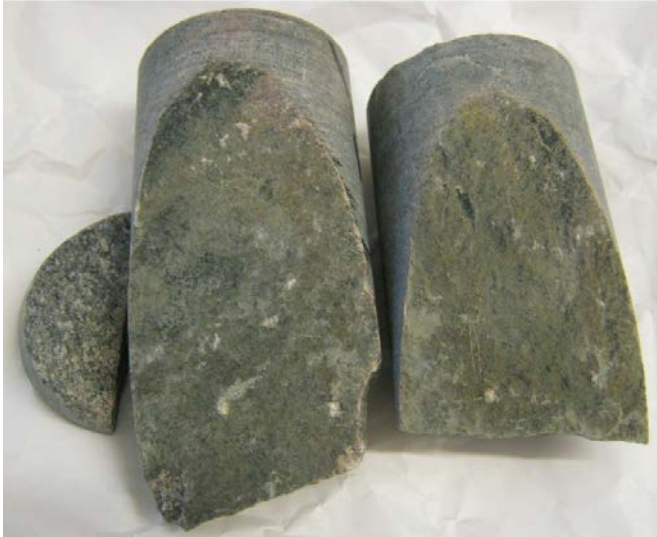
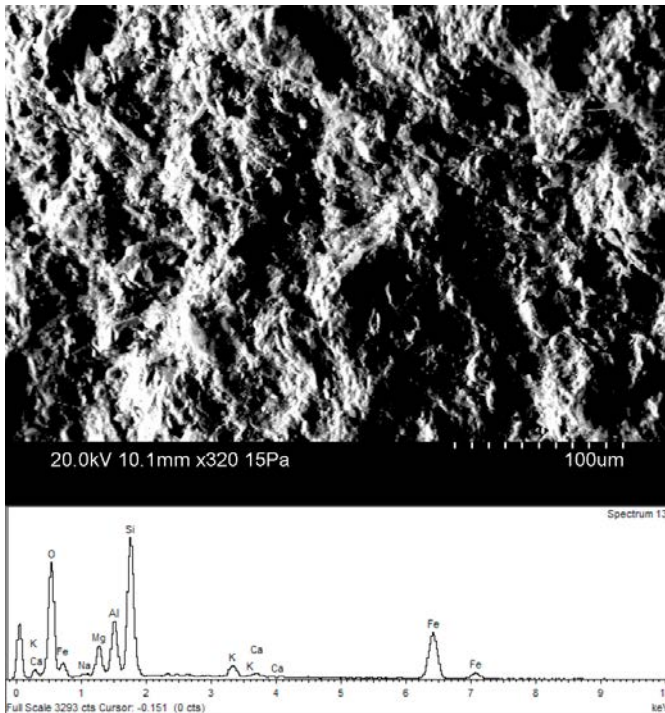
Figure A1-4. Photo of the sampled fractures from KFR102B 26.67–26.91 m.

The fracture surface is coated with mixed layer clay, adularia and calcite. The rust-brown mineral consists of mixed layer clay. No iron hydroxide was found in the fracture.

Figure A1-5. SEM image and EDS-spectra of mixed layer clay from KFR102B 26.67–26.91 m.

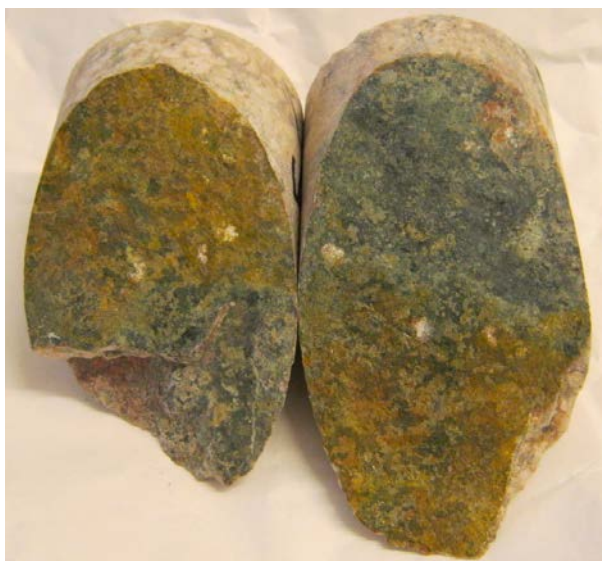
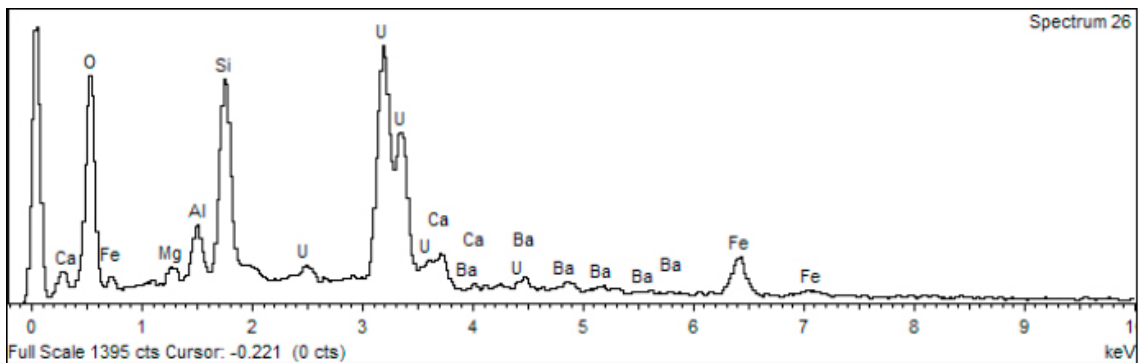
Figure A1-21. Photo of the sampled fracture from 25.51–25.62 m.

The fracture is coated with mixed layer clay and barite. U-silicate occurs closely related to the barite. A few minute-grains of galena and monazite are also present on the surface. In the rust-brown parts of the sample, the clay mineral is very Fe-rich (up to approximately 50–60wt% Fe_2O_3 total) and is the cause of the rust-brown colour on the fracture surface. No iron hydroxide was found in the fracture.

Figure A1-26. EDS-spectra of U-silicate from 25.51–25.62 m.

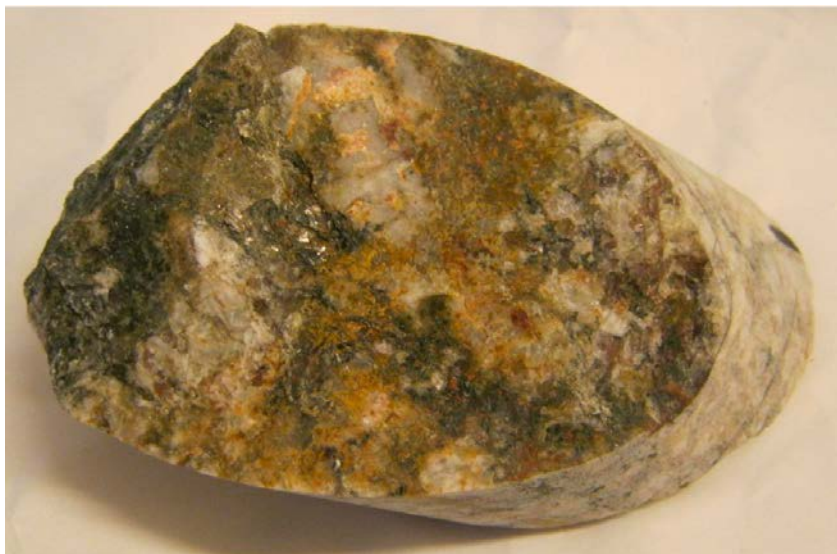
Figure A1-32. Photo of the sampled fracture from KFR104 30.20–30.28 m.

The fracture coating is dominated by laumontite, chlorite and mixed layer clay. The rust-brown mineral is hematite. No iron hydroxide was found in the fracture.

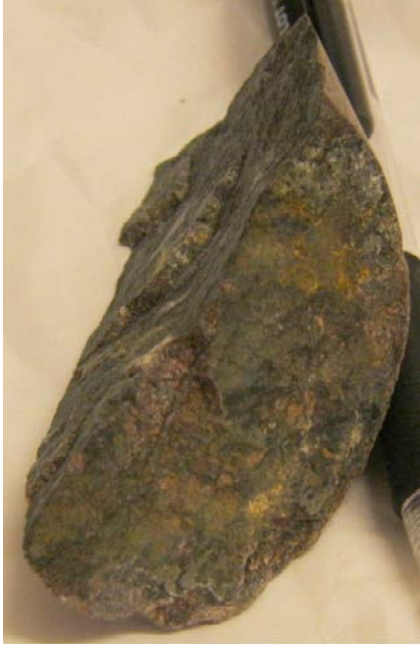
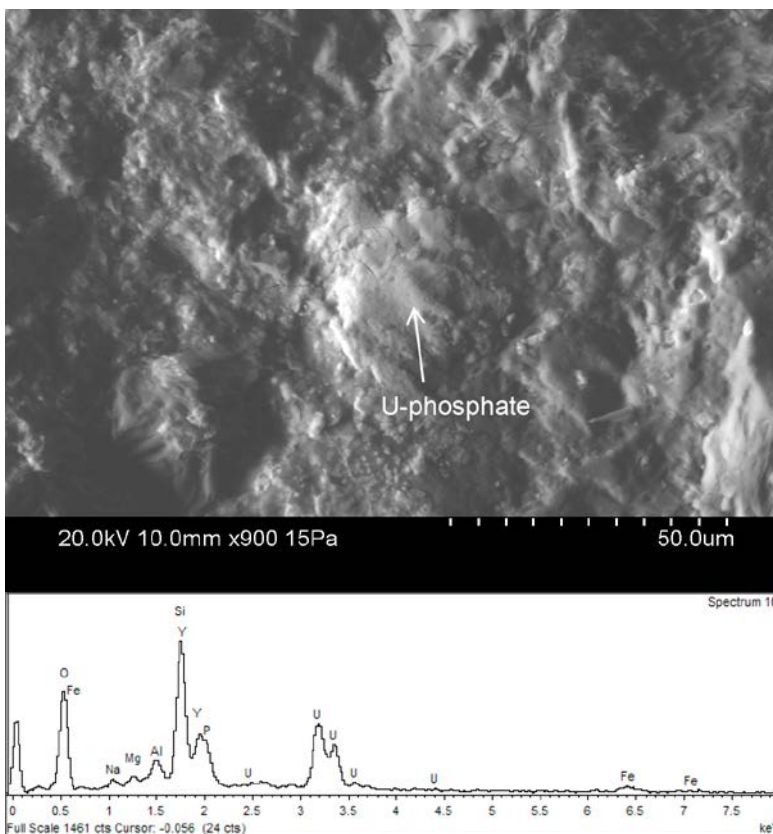
Figure A1-33. Photo of the sampled fracture from KFR104 32.67–32.76 m.

The fracture coating is dominated by mixed layer clay. Small amounts of U-phosphate are also present on the fracture (green-brown). No iron hydroxide was found in the fracture.

Figure A1-34. SEM image and EDS-spectra of U-phosphate on fracture surface from KFR104 32.67–32.76 m.

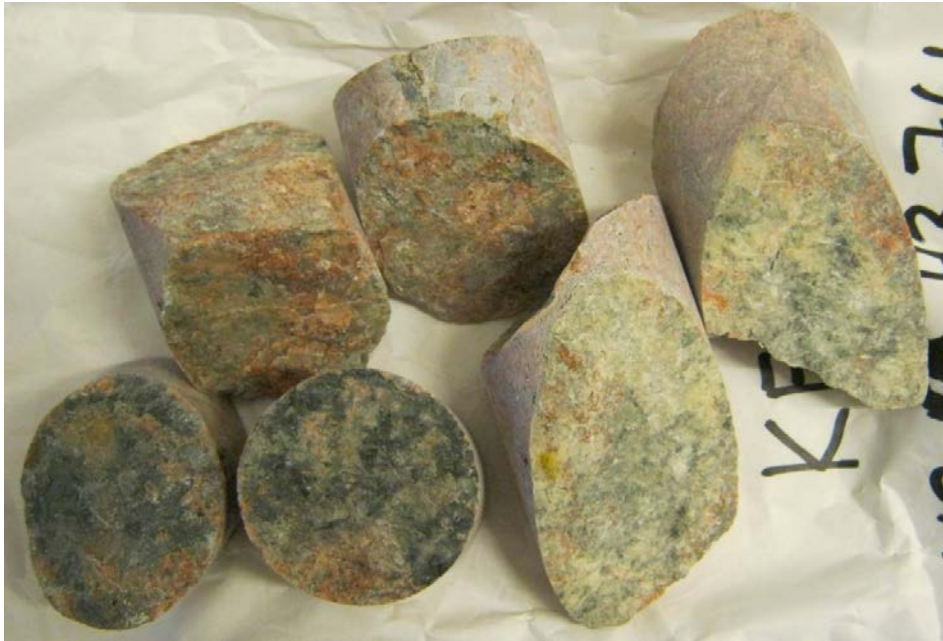
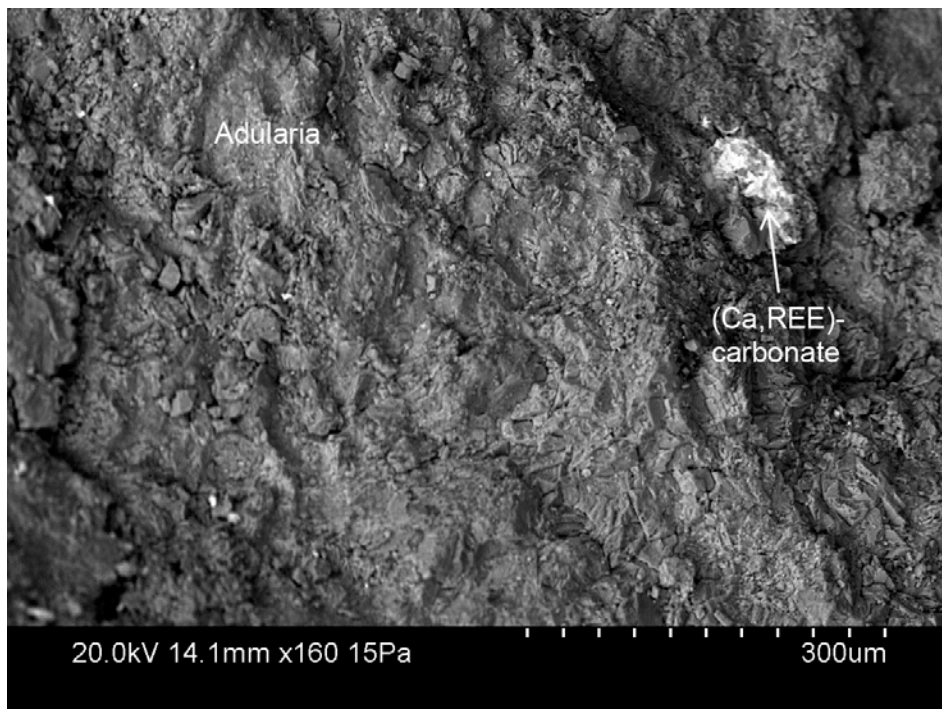
Figure A1-35. Photo of the sampled fractures from KFR104 43.53–43.76 m.

The red-coloured mineral is hematite-stained albite and adularia. These minerals are part of older sealed fractures which have been reactivated and coated with mixed layer clay. Small grains of (Ca,REE)-carbonate are also found on the fracture surface. No iron hydroxide was found in the fracture.

Figure A1-36. BSE-image of (Ca,REE)-carbonate on adularia from KFR104 43.53–43.76 m.

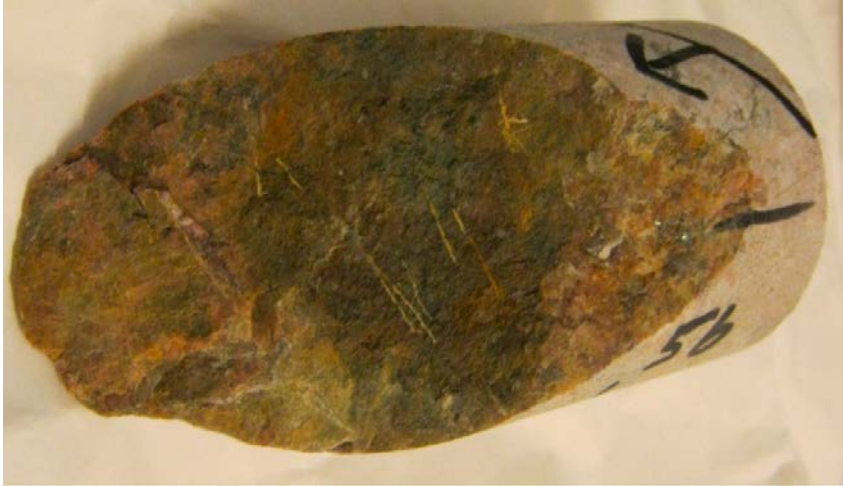
Figure A1-37. Photo of the sampled fractures from KFR104 55.95–56.04 m.

The fracture surface is coated with mixed layer clay and illite, the rust-brown parts of the fracture surface consists of Fe-rich mixed layer clay. No iron hydroxide was found in the fracture.

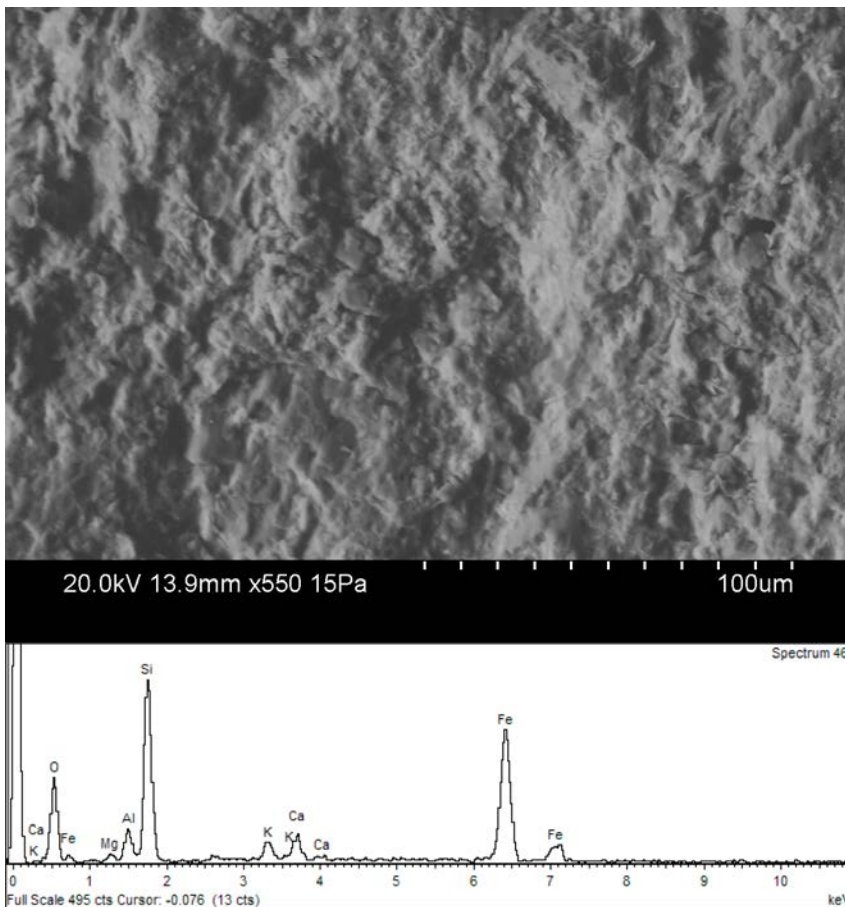
Figure A1-38. SEM image and EDS-spectra of Fe-rich mixed layer clay from KFR104 55.95–56.04 m.

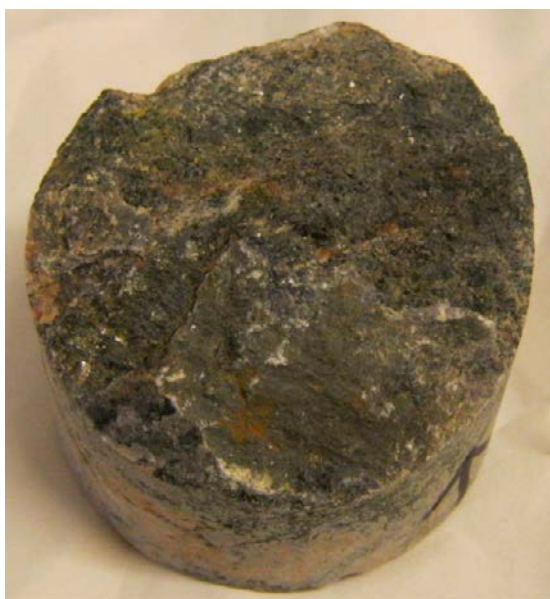
The fracture surface is coated with mainly mixed layer clay and calcite. Small grains of metallic iron (< 10 µm) are present on the fracture surface and there are drilling marks on the side of the drill core. The rust-brown parts of the fracture surface consist of Fe-rich mixed layer clay. No iron hydroxide was found in the fracture.

Figure A1-42. Photo of the sampled fracture from KFR104 59.71–59.75 m.

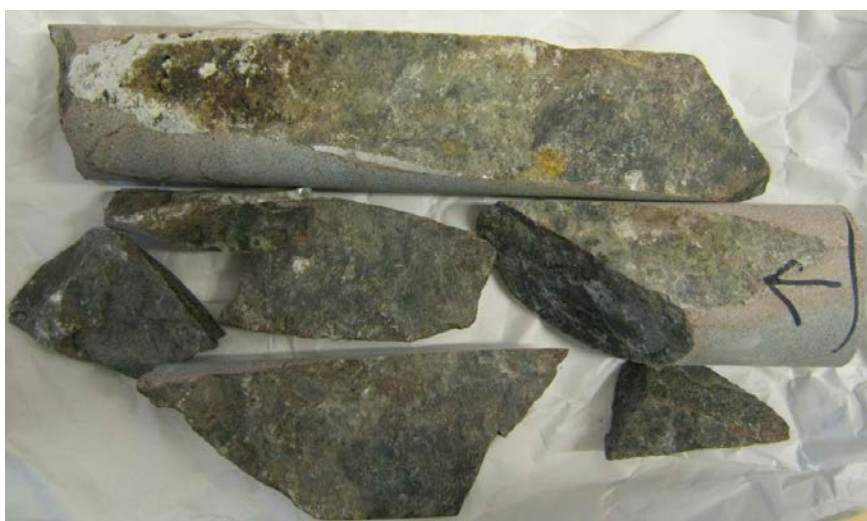
The fractures are dominated by mixed layer clay (corrensite) and calcite. Small amounts of asphaltite, pyrite, galena, sphalerite, Zn-oxide (with small Cl-peak in EDS-spectra) are also present. Well-preserved pyrite crystals are found on the surface. No iron hydroxide was found in the fracture.

Figure A1-44. Photo of the sampled fractures from KFR104 61.55–61.93 m.

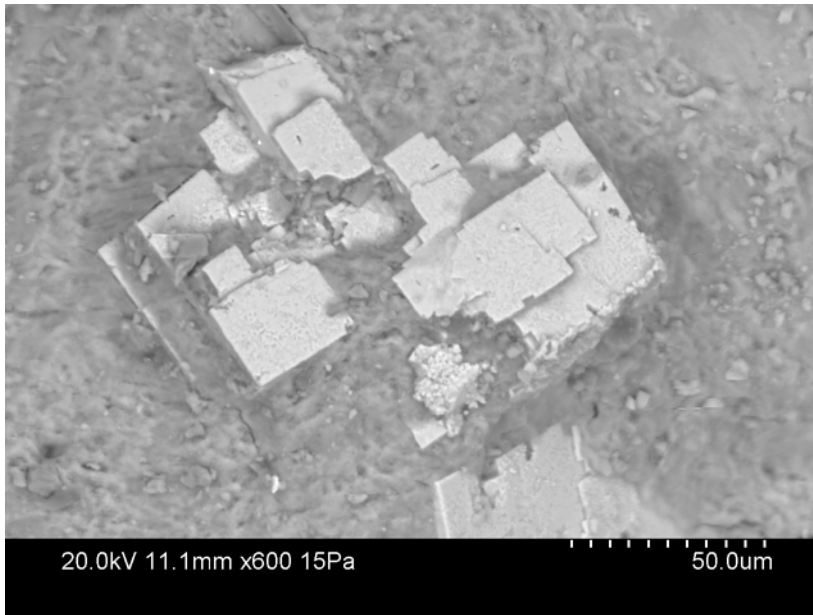
Figure A1-45. BSE-image of well-preserved cubic pyrite crystals in mixed layer clay from KFR104 61.55–61.93 m.

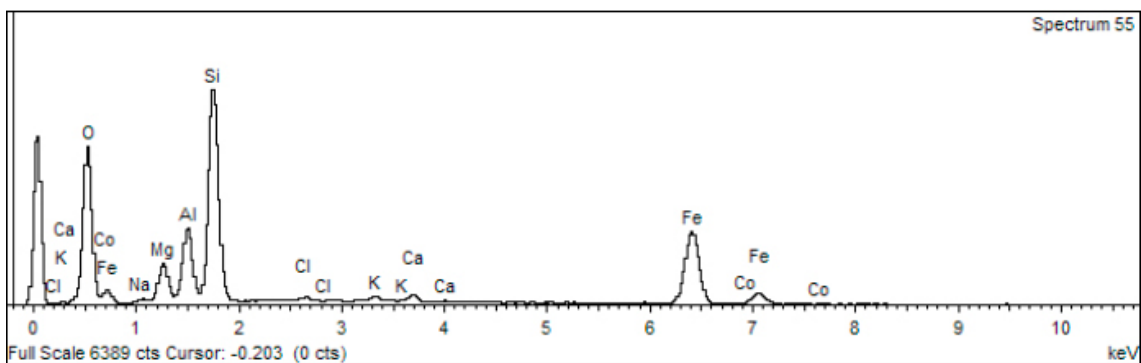
Figure A1-46. EDS-spectra of the mixed layer clay from KFR104 61.55–61.93 m.

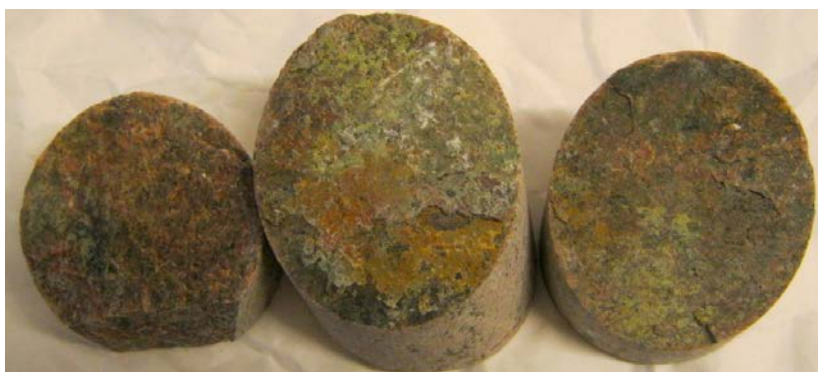
The fracture surface is coated with mixed layer clay, laumontite, U-silicate, possible iron hydroxide and (Ca,REE)-carbonate.

Figure A1-47. Photo of the sampled fractures from KFR104 99.32–99.42 m.

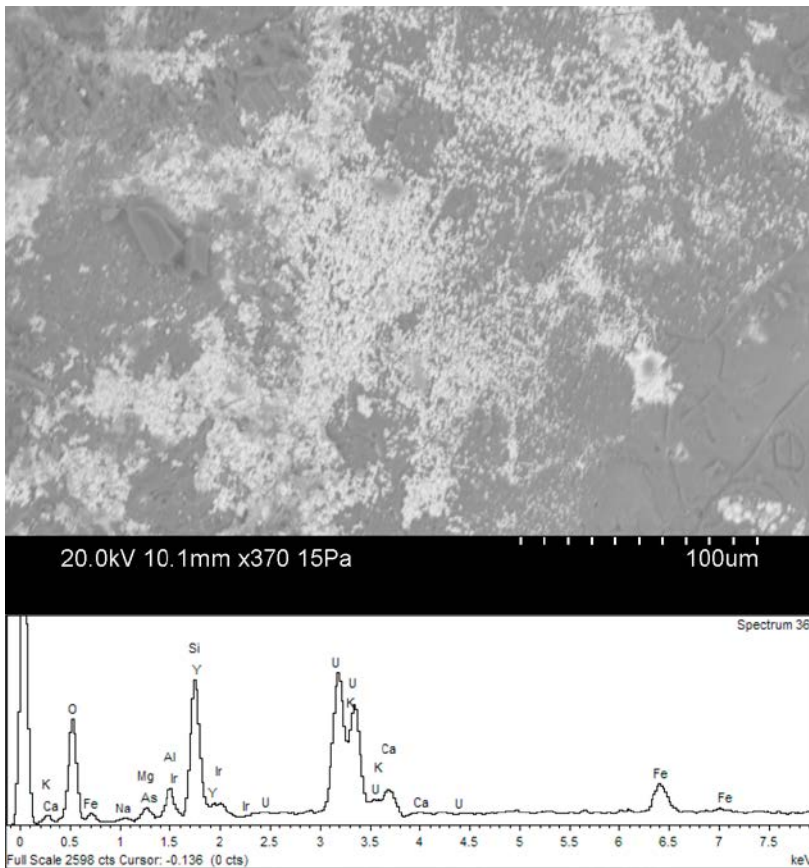
Figure A1-49. BSE-image and EDS-spectra of U silicate from KFR104 99.32–99.42 m.

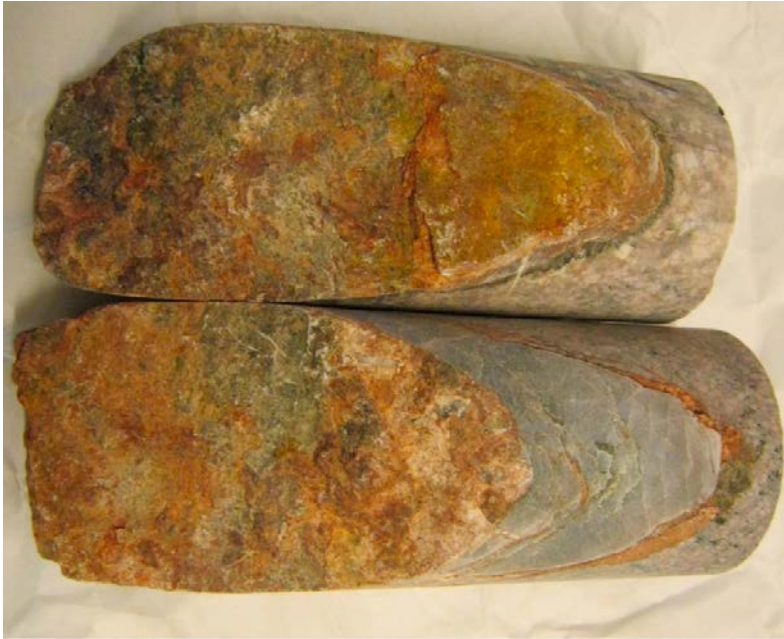
The fracture surface is coated with laumontite and mixed layer clay. No iron hydroxide was found in the fracture.

Figure A1-50. Photo of the sampled fracture from KFR104 107.64–107.83 m.

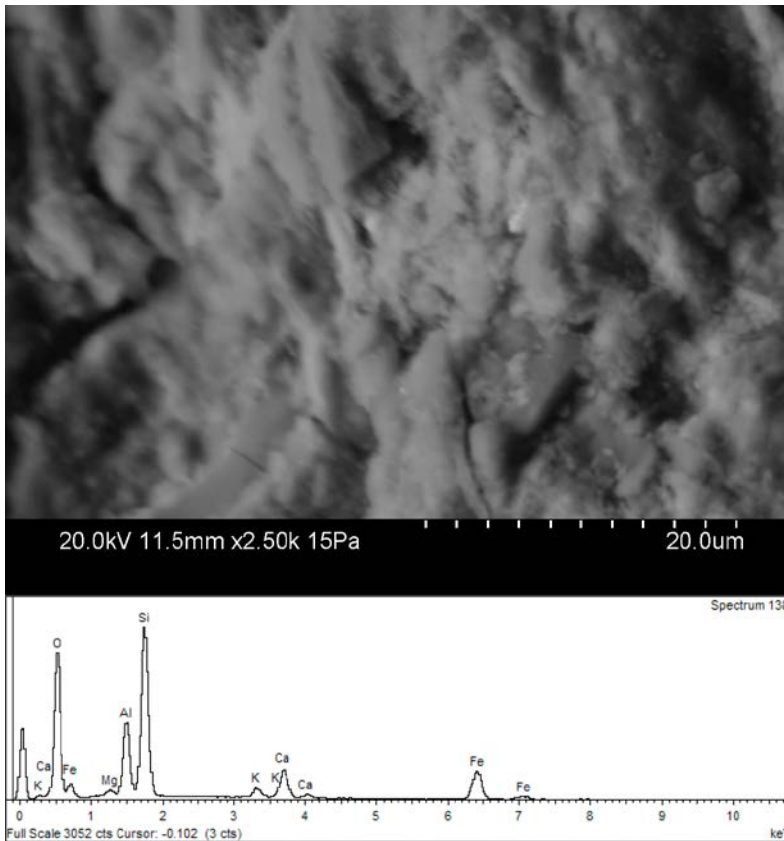
Figure A1-51. BSE-image and EDS-spectra of mixed layer clay from KFR104 107.64–107.83 m.

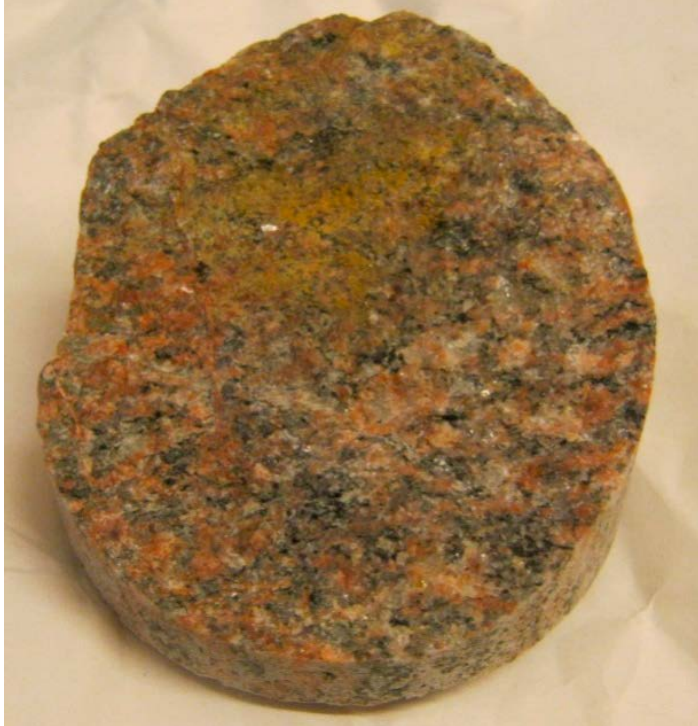
Well preserved pyrite crystals are present on the fracture surface. The rust brown parts of the fracture surface consist of debris from the drilling process. No iron hydroxide was found in the fracture.

Figure A1-52. Photo of the sampled fracture from KFR104 122.52–122.56 m.

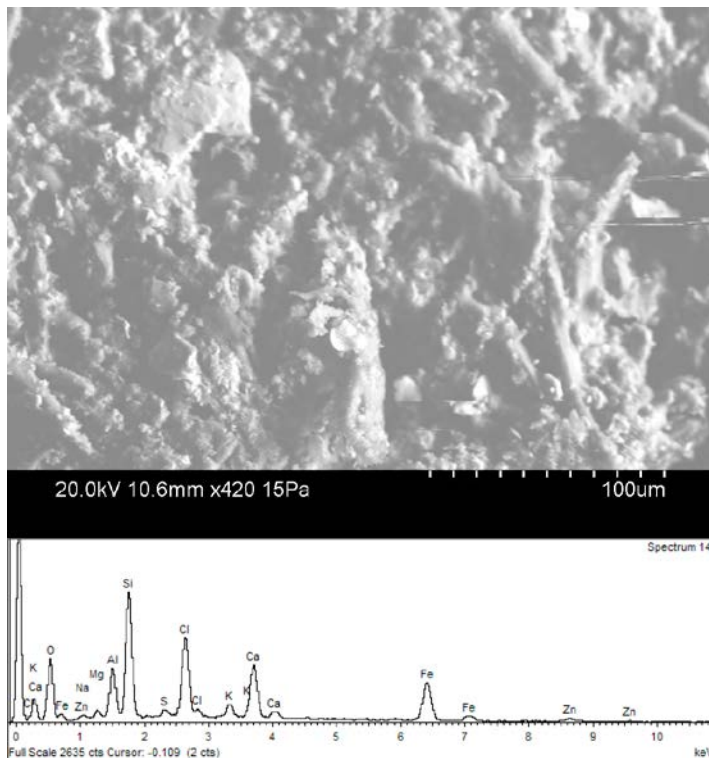
Figure A1-53. SEM image and EDS-spectra of debris on the surface from KFR104 122.52–122.56 m.

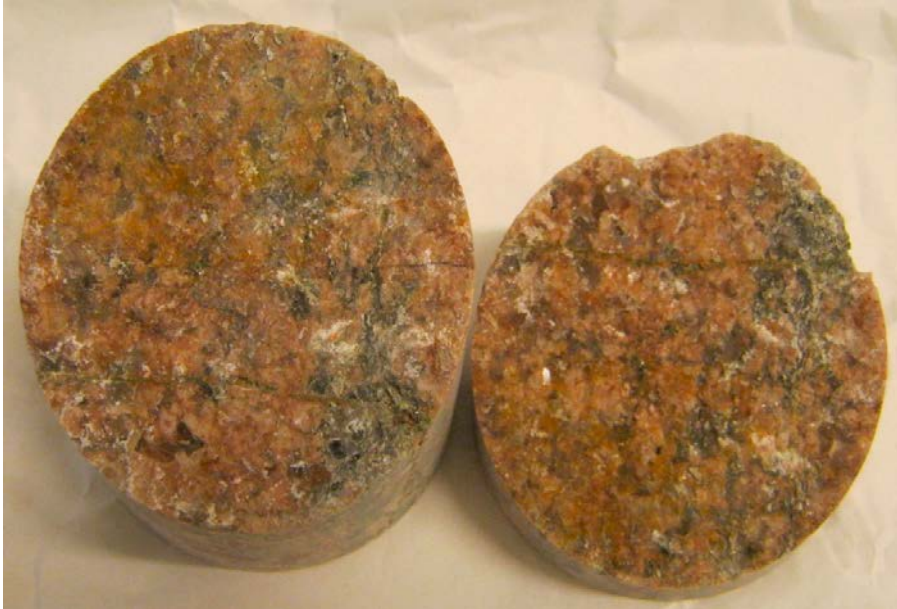
The fracture is coated with laumontite, calcite and adularia. The rust-brown mineral consists of adularia. No iron hydroxide was found in the fracture.

Figure A1-54. Photo of the sampled fracture from KFR104 134.70–134.75 m.

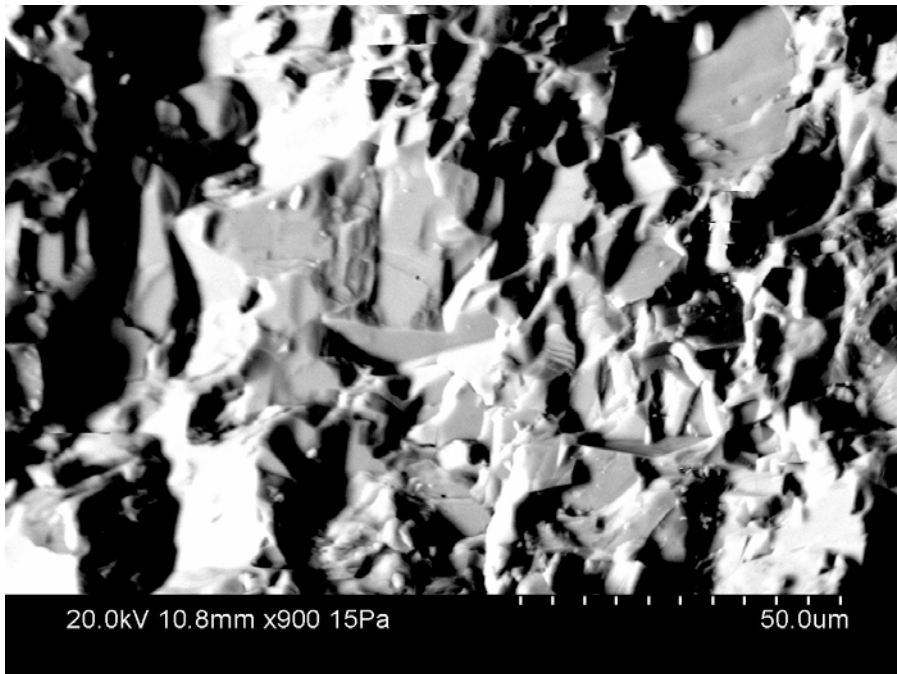
Figure A1-55. SEM image of mixed layer clay from KFR104 134.70–134.75 m.

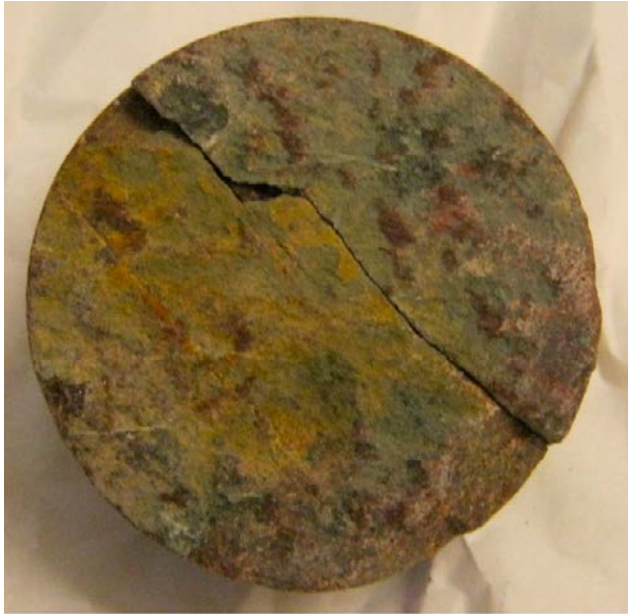
The fracture surface is coated with prehnite, hematite-stained adularia, and Fe-rich mixed layer clay. The rust-brown parts of the fracture consist of a mixture of prehnite and mixed layer clay. No iron hydroxide was found in the fracture.

Figure A1-56. Photo of the sampled fracture from KFR104 270.17–270.23 m.

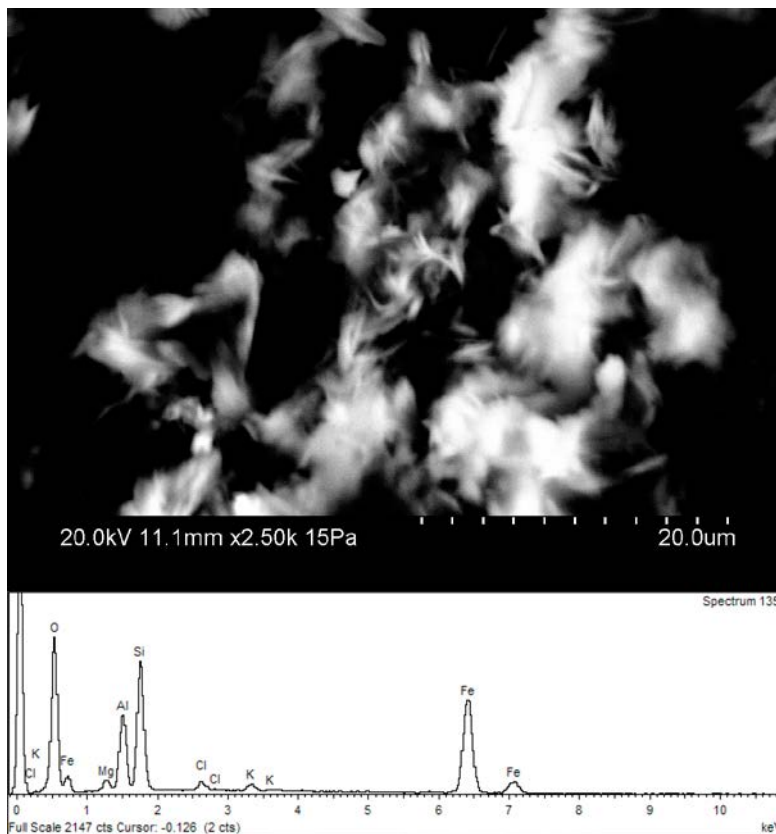
Figure A1-57. SEM image and EDS-spectra of mixed layer clay from KFR104 270.17–270.23 m.

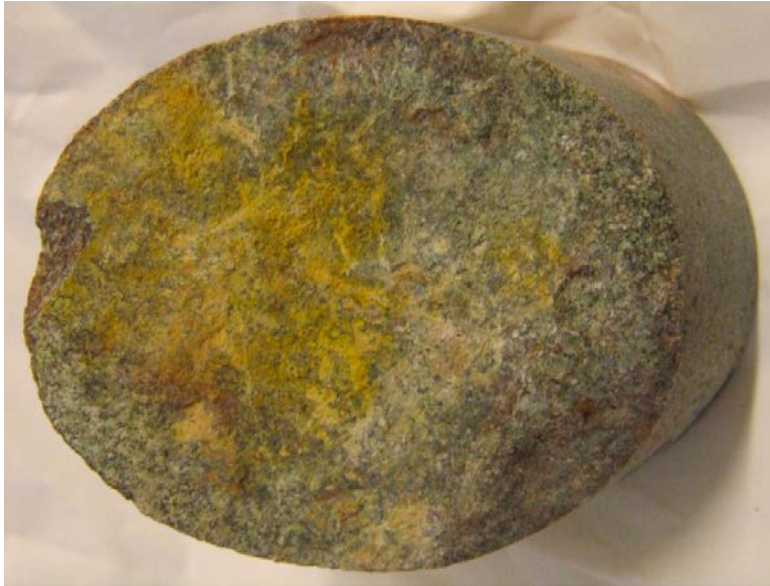
The fracture surface is coated with mixed layer clay and illite, small grains of Fe-oxide are also present on the surface. Based on the presence of Co in the EDS-spectra, it is inferred that the Fe-oxide grains are an artefact from the drilling process.

Figure A1-60. Photo of the sampled fracture from KFR104 293.23–293.29 m.

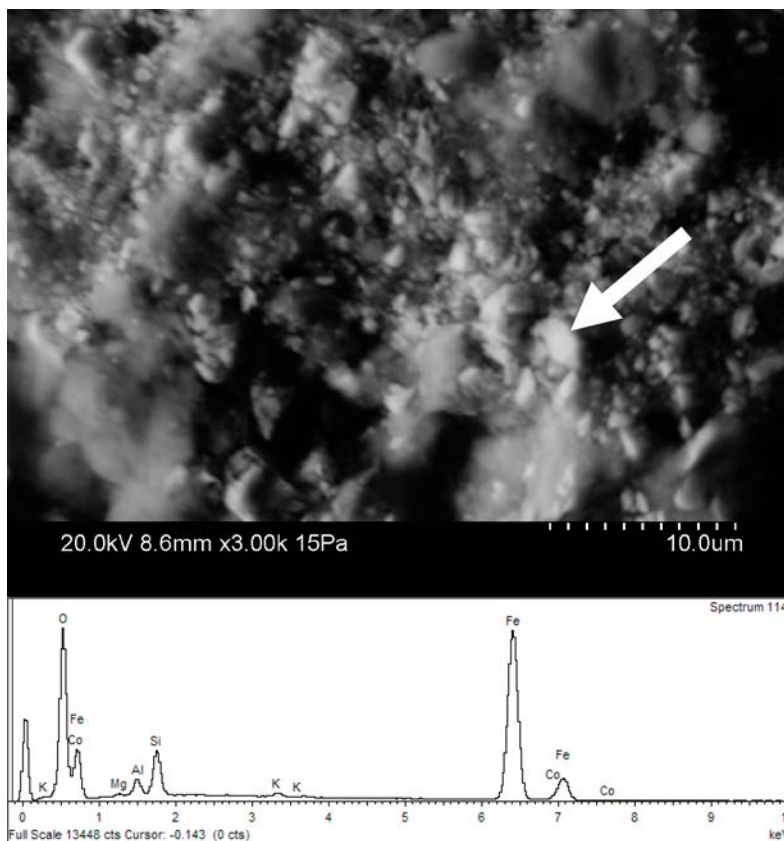
Figure A1-61. BSE-image and EDS-spectra of Fe-grains (arrow) on mixed layer clay from KFR104 280.54–280.61 m.

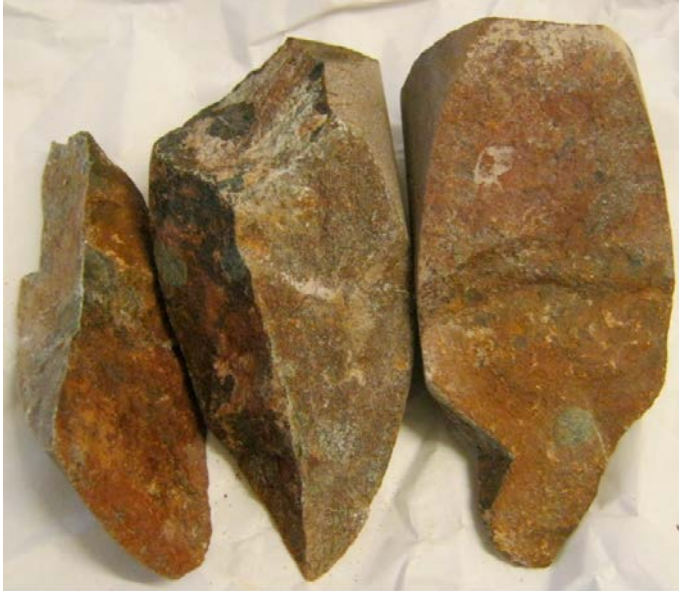
The fracture surface is coated with hematite-stained adularia, albite, chlorite/corrensite, clay minerals and pyrite. No iron hydroxide was found in the fracture.

Figure A1-62. Photo of the sampled fractures from KFR104 294.02–294.15 m.

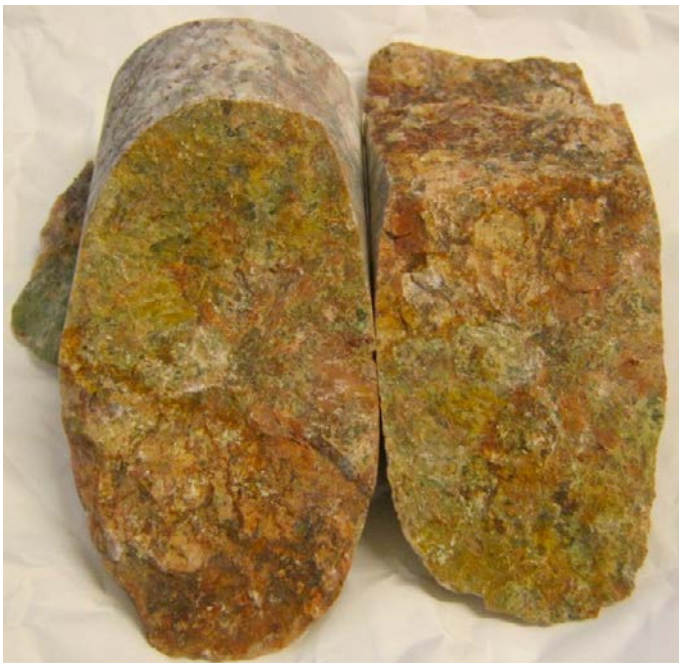
The fracture surface is coated with mixed layer clay and small amount of U-silicate. No iron hydroxide was found in the fracture.

Figure A1-63. Photo of the sampled fracture from KFR104 328.75–328.86 m.

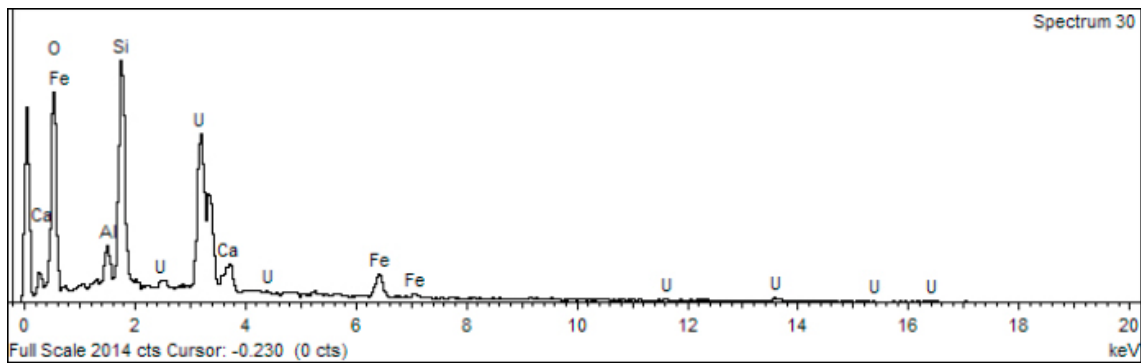
Figure A1-64. EDS-spectra of U-silicate from KFR104 328.75–328.86 m.

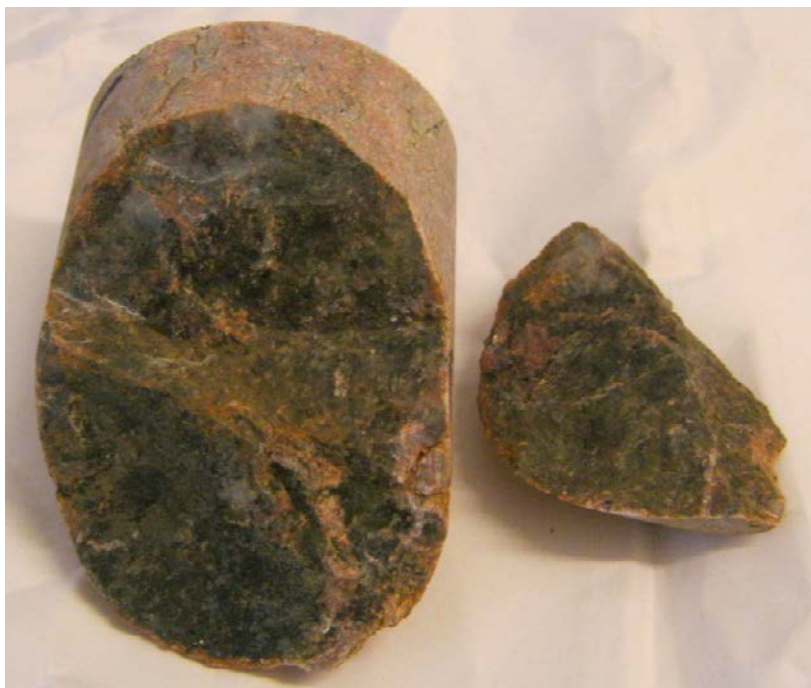
Mixed layer clay, adularia, U-silicate, pyrite. Small grains of metallic iron with etched surface. The metallic iron is also present on the side of the drill core. No iron hydroxide was found in the fracture.

Figure A1-65. Photo of the sampled fracture from KFR104 389.97–390.03 m.
