Iron hydroxide occurrences and redox capacity in bedrock fractures in the vicinity of SFR

December 2014

SKB R-12-11

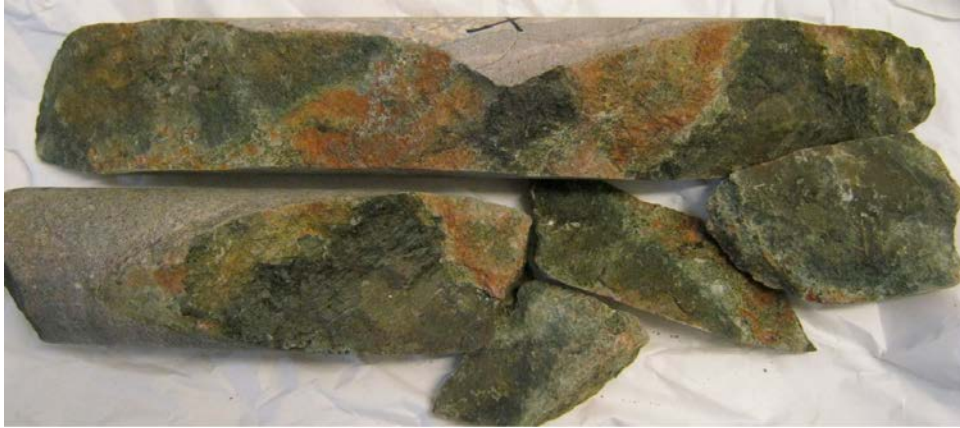
The sample is dominated by mixed layer clays (corrensite and illite/smectite). The red-coloured parts of the clay mineral contain around 30–35 wt% Fe_2O_3 total. Small grains of galena are found on the surface of the Fe-rich clay mineral. No iron hydroxide was found in the fracture.

Figure A1-68. Photo of the sampled fractures from KFR104 416.96–417.35 m.

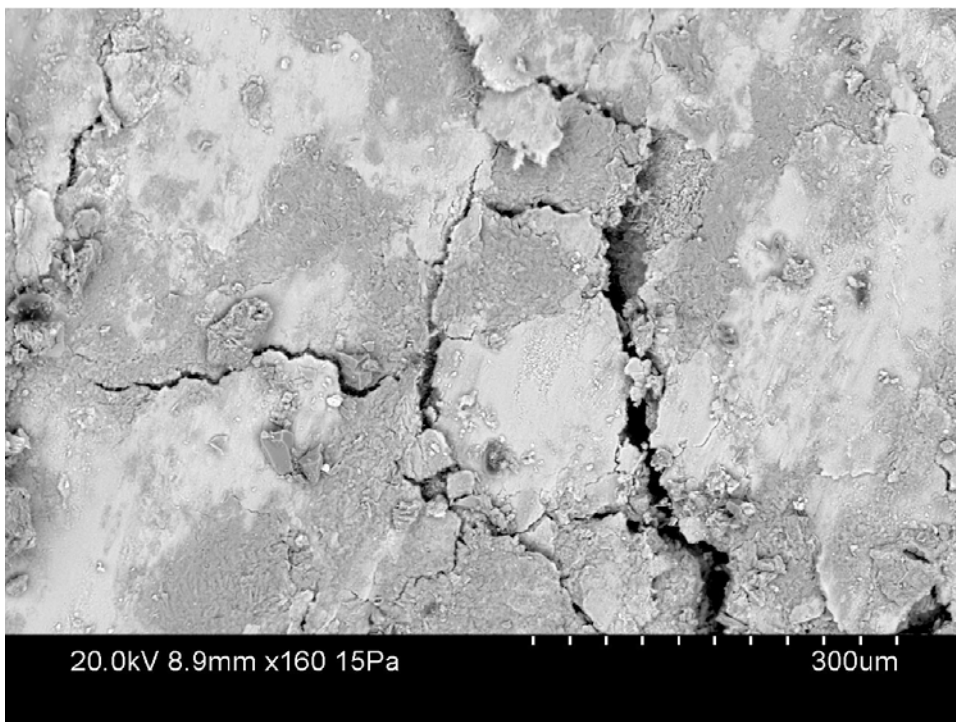
Figure A1-69. BSE-image of mixed layer clay from KFR104 416.96–417.35 m, the brighter parts are more Fe-rich.

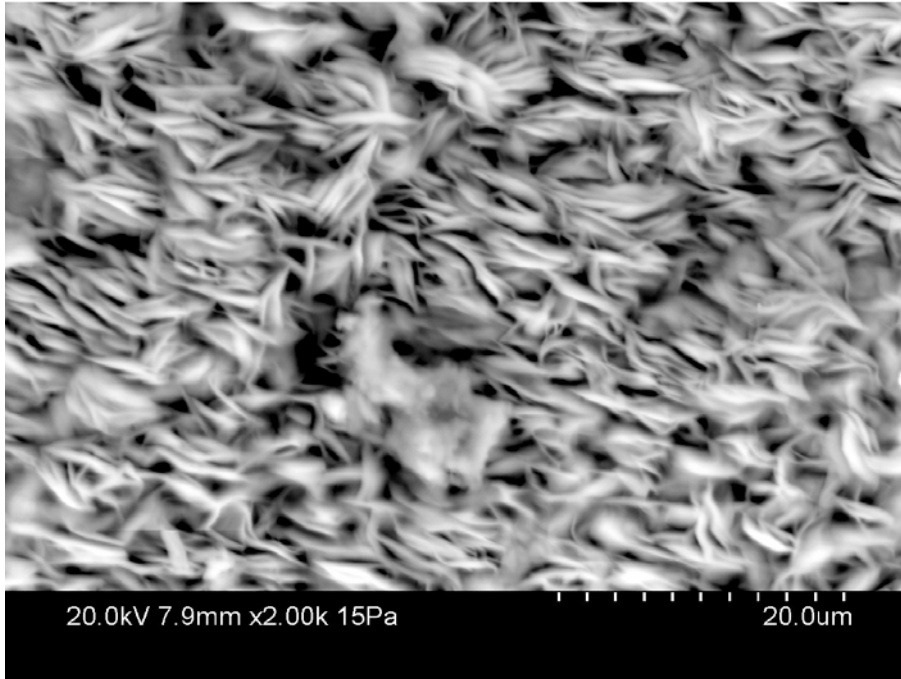
Figure A1-70. BSE-image of mixed layer clay from KFR104 416.96–417.35 m.

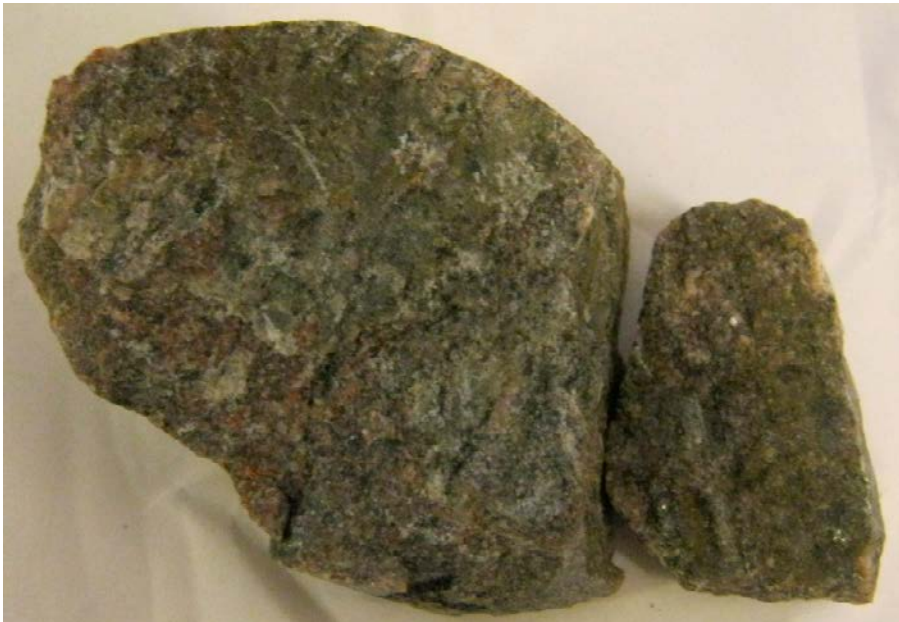
The fracture surface is coated with Fe-rich mixed layer clay. No iron hydroxide was found in the fracture.

Figure A1-71. Photo of the sampled fracture from KFR106 9.72–9.77 m.

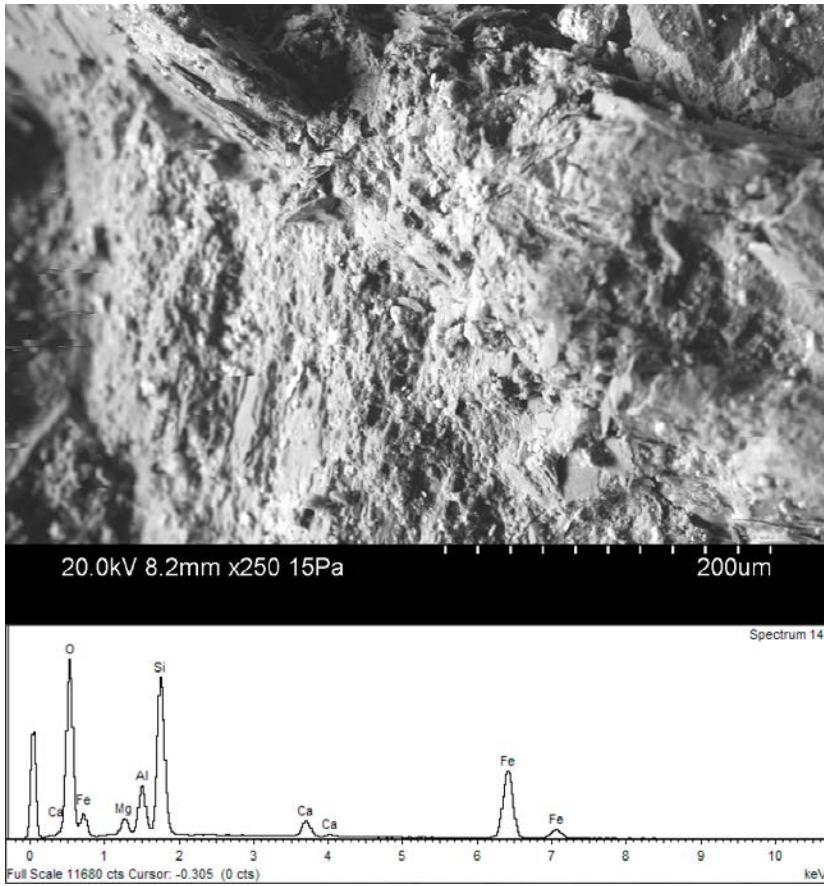
Figure A1-72. BSE-image and EDS-spectra of mixed layer clay from KFR106 9.72–9.77 m.
