Äspö Hard Rock Laboratory

Select-2

Evaluation of fracture candidates in boreholes
KA2865A01 and KA3065A02.

Location of experimental site for the long term
diffusion experiment

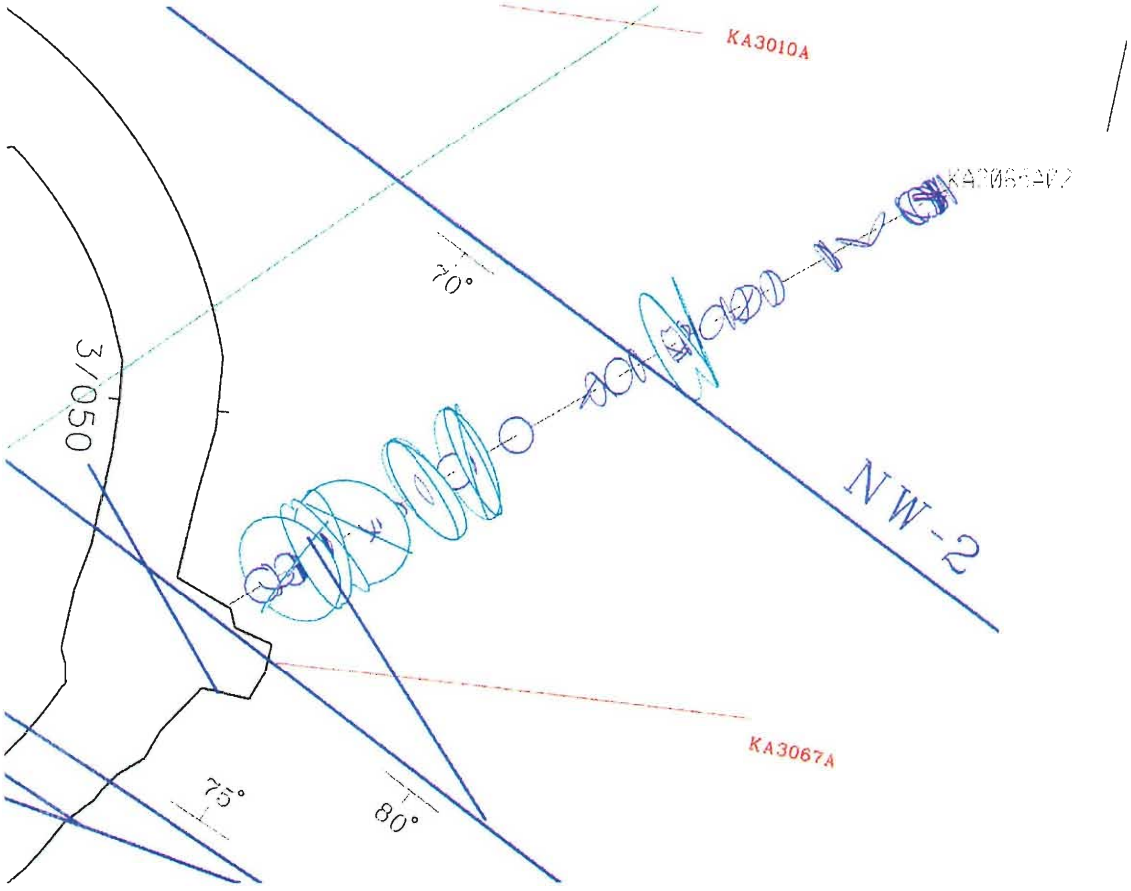
Figure 3-2 Structures at the identified inflow points in KA3065A02.

This borehole has 13 candidate sections with appropriate hydraulic conditions as shown in Chapter 2. Green discs in Figure 3-2 represent natural fractures interpreted to be the conductors in the respective section. Blue lines indicate areas where larger structures intersect. The deeper conductors seem to be part of the zone NW-2 and could be in indirect contact with the TRUE-1 site.

The first two targets are considered to be too close to the tunnel to completely avoid the draw down. At 9.40 m a large package of fractures is intersected. This section gives 16 l/min and is geologically complex with faults and splays. As the experimental setup is in need of good rock directly beneath the target fracture, this section is considered unsuitable on geological grounds.

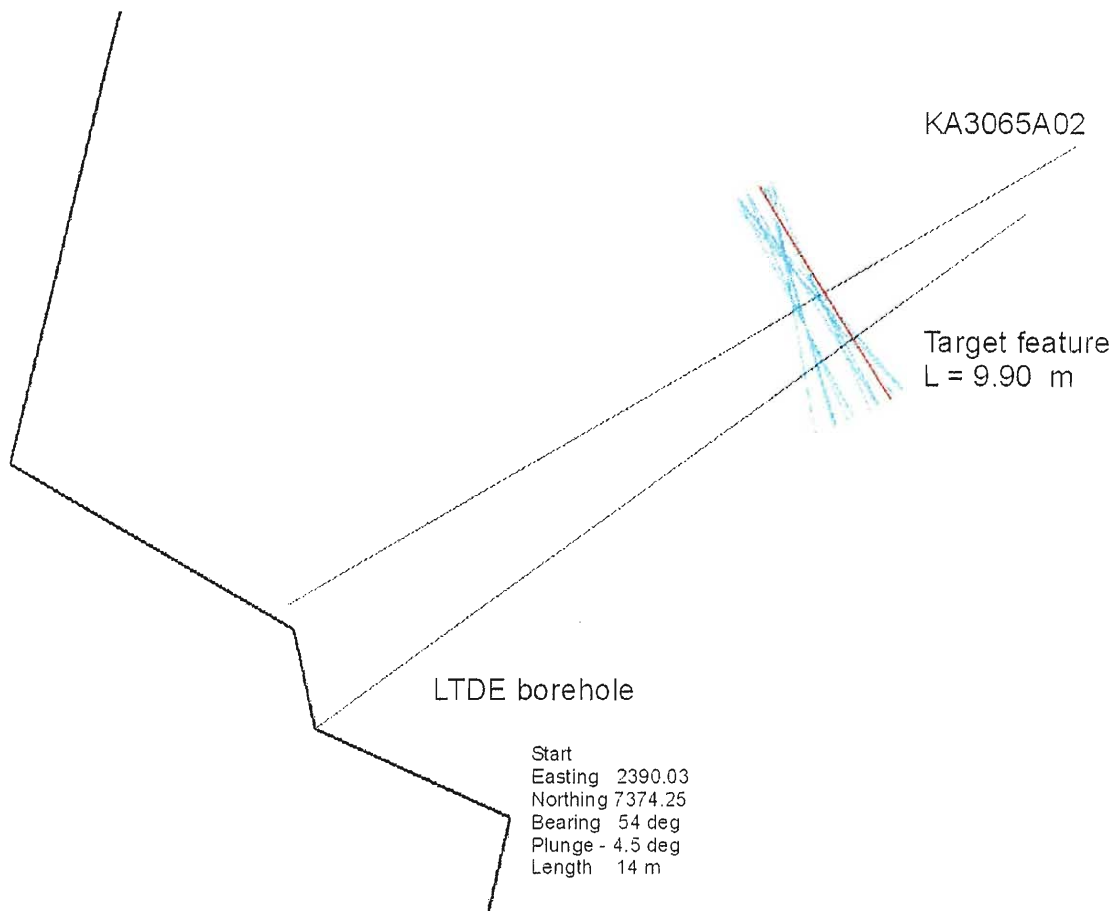
Figure 3-4 Proposed LTDE experimental borehole to intersect the target fracture identified at L=9.90 m in KA3065A02.

Based on the identified target fracture in KA3065A02 a tentative geometry for a large diameter LTDE experimental borehole is proposed. The target fracture is orthogonal to KA3065A02. To maintain an orthogonal intercept, an experimental borehole is therefore best drilled sub-parallel to the pilot borehole. A simplistic detailed model of
