Methodology study for documentation and 3D modelling of blast induced fractures

Mats Olsson, Swebrec

Svensk Kärnbränslehantering AB

SKB Rapport R-08-90

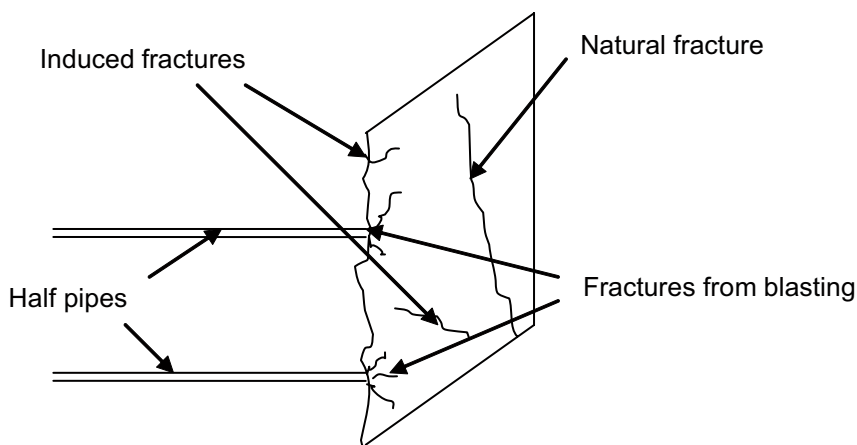
Figure 1-1. Typical fracture pattern /Olsson et al. 2004/.

For the identification and measuring of blast induced fractures there has to be at least one visible half-pipe. A typical fracture pattern is shown in Figure 1-1 where there are some fractures originating from the half-pipe (blasting fractures) and other fractures, induced or natural, inside the rock mass. The lengths of the blasting fractures are influenced by the explosive itself, the coupling ratio (diameter of charge/diameter of hole), the delay time, spacing, natural fractures, the rock and presence or absence of water. Induced fractures are fractures starting near the tunnel contour but not originating from the hole itself. These fractures are probably caused by the high stresses and released by the blasting process or by the redistribution of stresses due to excavation of the tunnel. The natural fractures are determined by geological conditions. They could be opened or filled by some minerals. During the blasting process these fractures might expand. The natural fractures often seem to have the same direction in the walls.

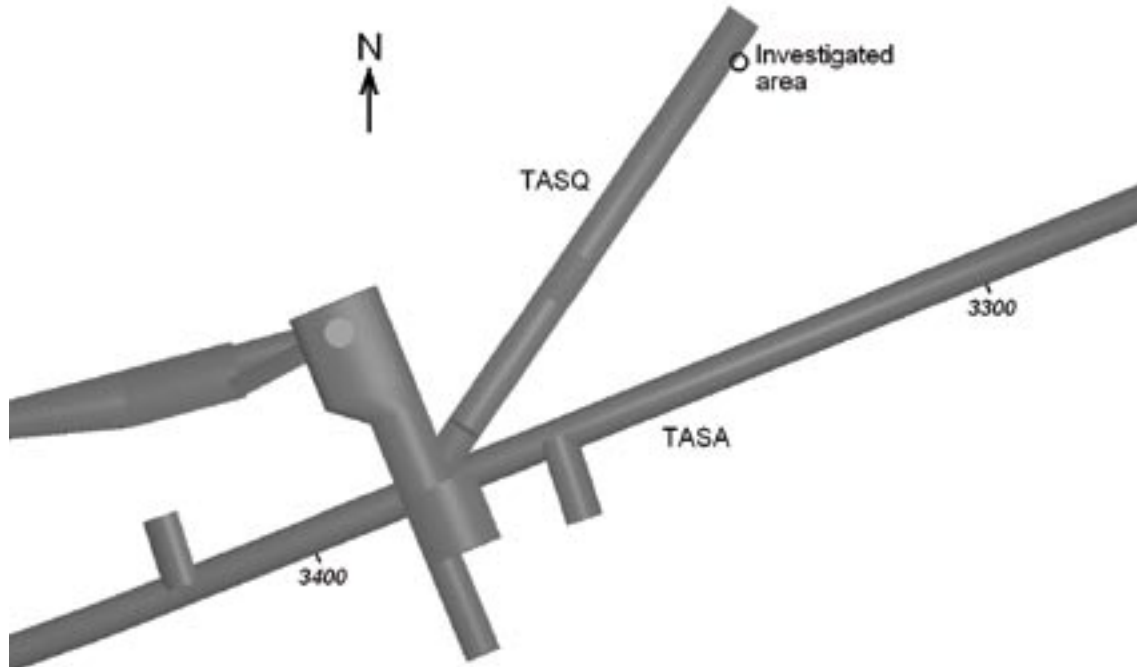
Figure 1-2. The investigated tunnel area in the Q tunnel at Äspö HRL.

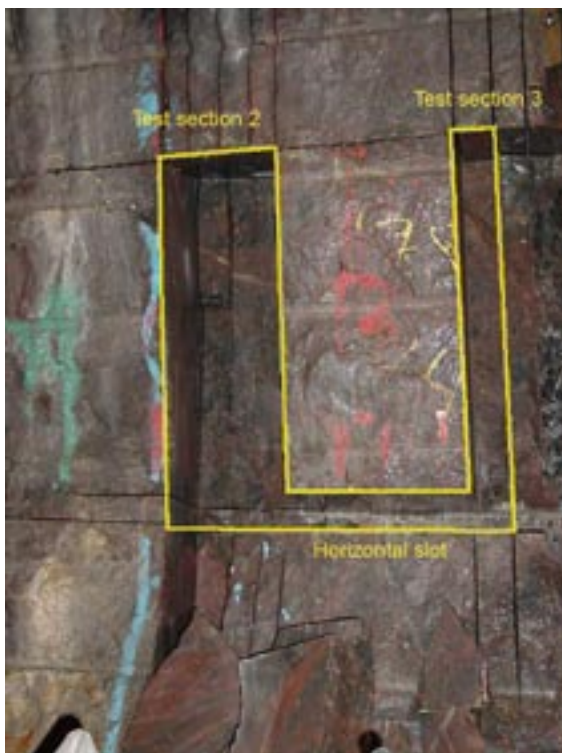
Figure 2-1. Test area with some of the slabs.

In this investigation the task was to examine the EDZ once again in order to see if fractures could be digitized and modelled in 3D. For this the former test sections 2 and 3 /Olsson et al. 2004/ and the horizontal slot between these sections were chosen. All the test sections are situated on the right wall of the tunnel. Test section 2 covers the first part of round 33 in the tunnel and test section 3 covers an area roughly 2 m further on in the round. Between these two areas there also is a horizontal slot, see Figure 2-1, Figure 2-2 and Figure 2-3.

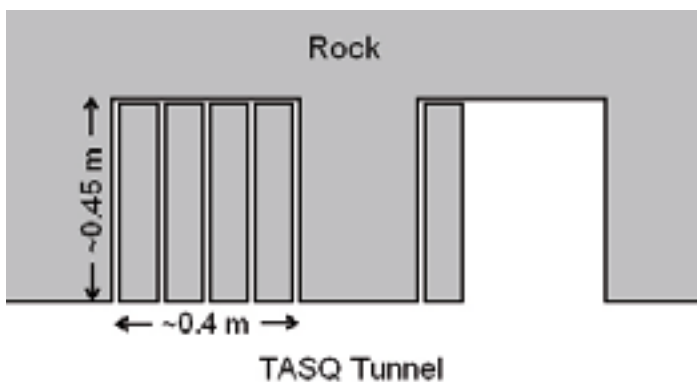
Figure 2-2. Schematic horizontal section through the investigated area.

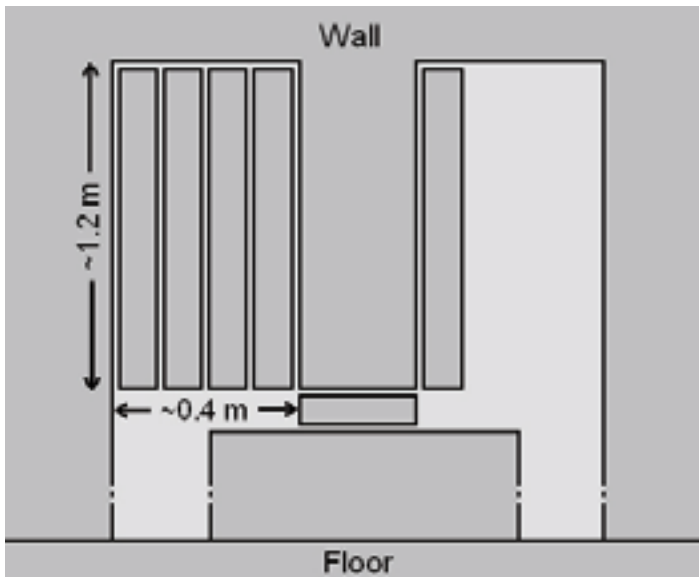
Figure 2-3. Schematic vertical view of the investigated area.

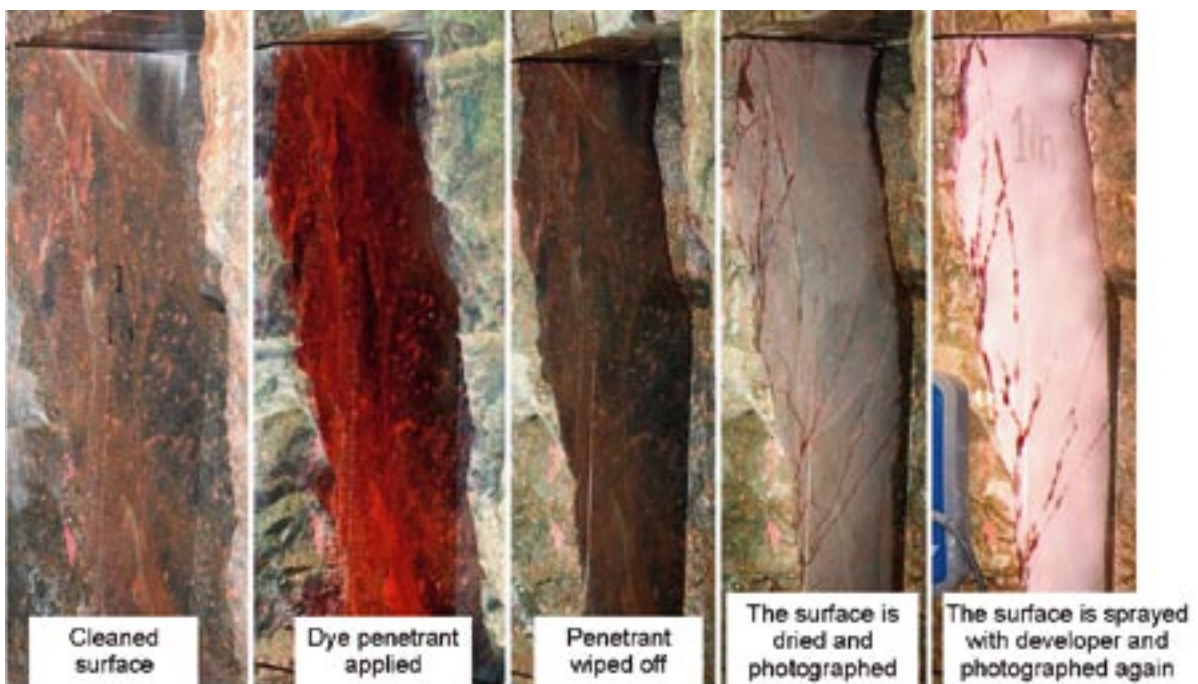
Figure 2-4. The different steps from washed surface to photographing.

In preparation, a scaffold was constructed in front of the slots and the slots were cleaned by high pressure water. However, it was not possible to clean the fractures completely from the color of the old penetrant. After cleaning, the surfaces of the slots were dried by fans and a heat gun. Markers were placed on the surfaces and the distances between these markers were measured. The markers were later used for rectification. Photos were taken and then penetrants were sprayed on the vertical surfaces to identify the fractures. In some of the surfaces we had problems with water leakage from the tunnel roof. As soon as the penetrants had dried, photos were taken on the surfaces. Unfortunately it was not possible to use penetrants on the surfaces of the horizontal slot as these surfaces could not be properly cleaned.

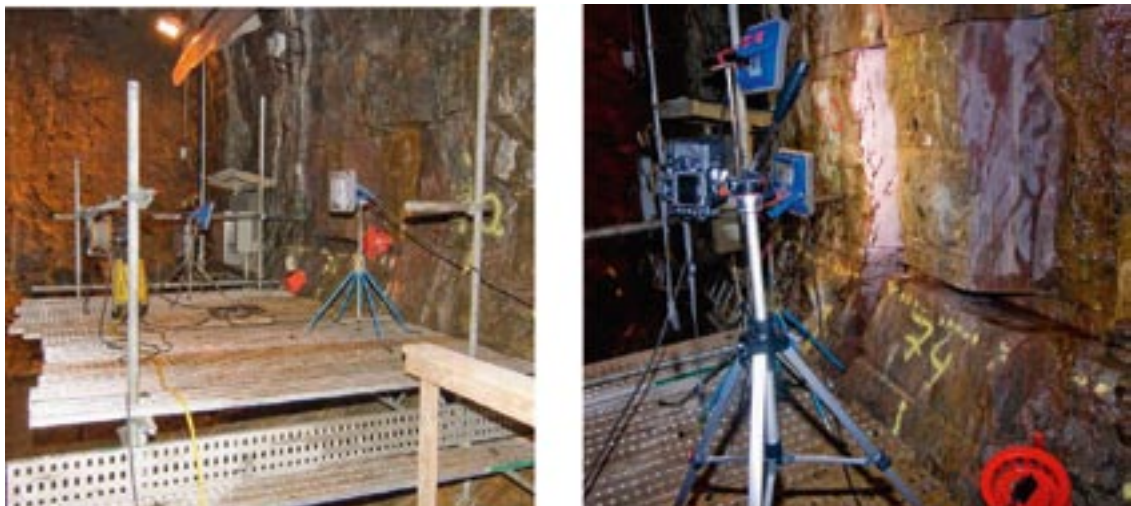
Figure 2-5. Photo arrangement in the tunnel.

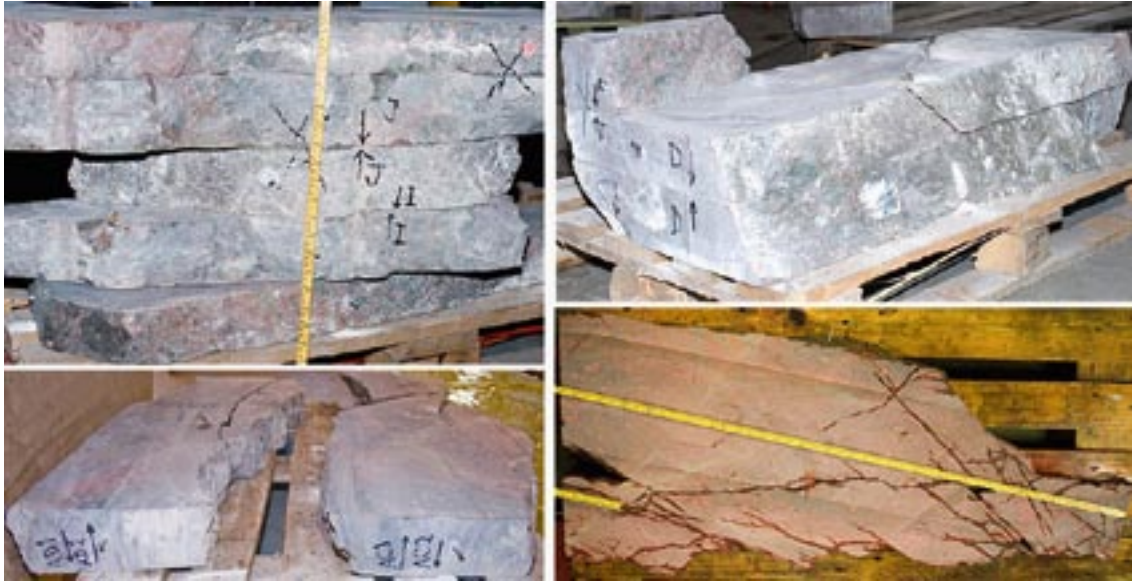
Figure 2-6. Pieces of the slabs.

The slabs from the earlier sawing have been stored in a tent at Äspö since the last investigation. The slabs from our test area (test sections 2 and 3) were transported to the car washing hall at Äspö. Here the slabs were washed and labelled. Small holes were drilled around the edges of the slabs and expansion-shell bolts were attached, to be used as reference points during the 3D fitting of the opposing sides of the slabs. Some of the slabs were damaged and it was a puzzle job to put all pieces together, see Figure 2-6.

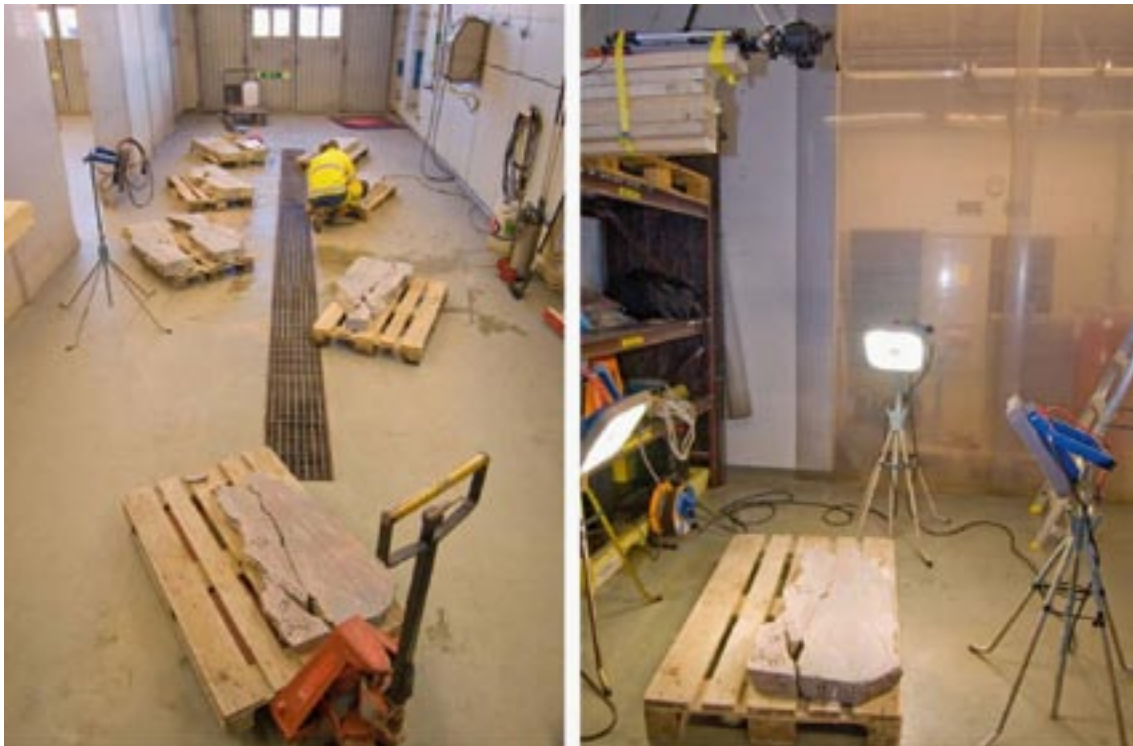
Figure 2-7. The photo arrangement of the slabs.

The camera was mounted at a height that gave a field of view that accommodated the largest slab. The camera was then aimed with a laser sight and a plumb line to make sure that the camera was pointing absolutely vertically in order to minimize the distortion of the images. This installation also has the benefit that all the images of the slabs have the same scale and that rectification can be avoided, see Figure 2-7.

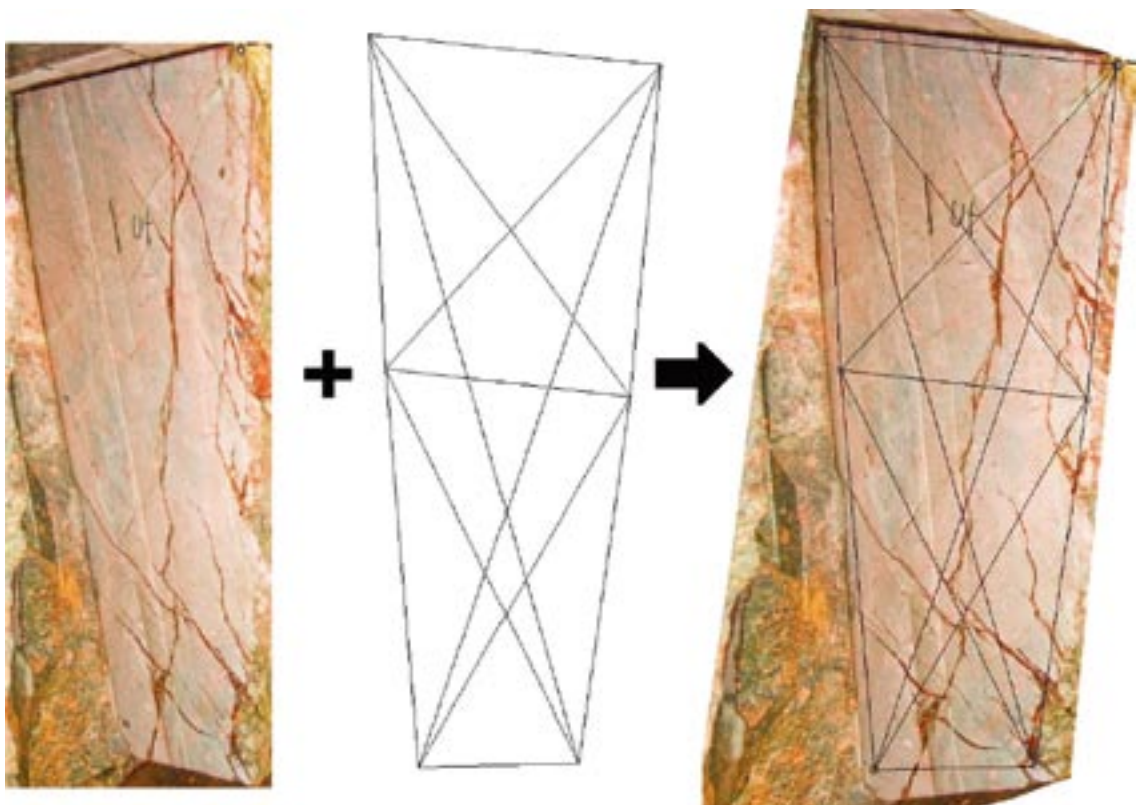
Figure 2-8. Example of section photo, before and after rectification.

Six points on each section side were marked in ink before photographing and the distances between them were measured and recorded. In a 2D CAD file the pattern of the markers were recreated as a basis for the rectification of the photos, see Figure 2-8.

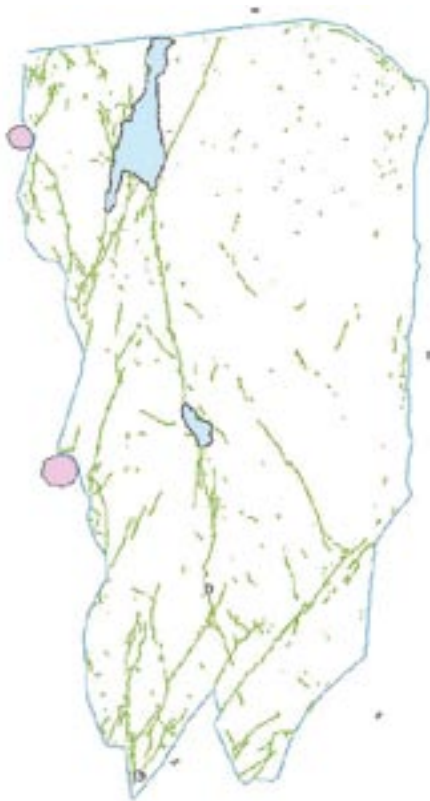
Figure 2-9. Vectorized section from a rock slab.

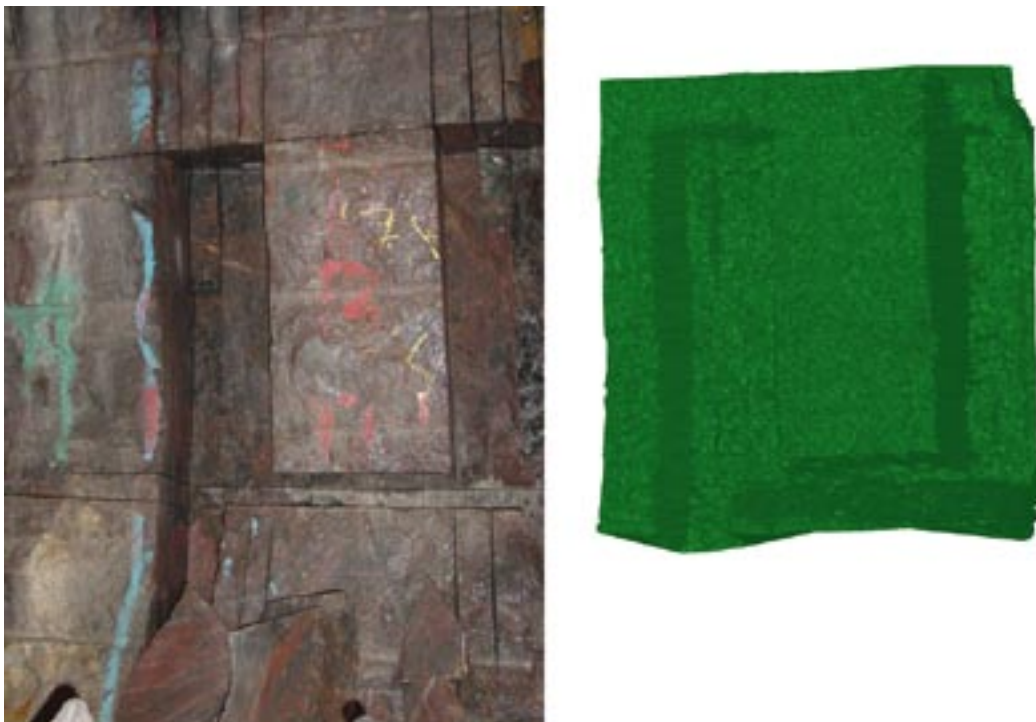
Figure 2-11. The investigated area, photo and mesh created from laser data.

The laser data was triangulated using RVS surface modelling functions. These are not ideal for these kinds of data since they are triangulating using a 2D projection of the 3D data. The surface becomes very rough and with triangles as long needles near the edges of the cutting slots, see Figure 2-11.

The position of the two outer slot walls in test section 2 and the only investigated slot wall in test section 3 investigated down in the tunnel, could be roughly recreated using the RVS triangulated mesh, representing the measured tunnel walls, see Figure 2-11. The accuracy of the position of the surfaces representing the outer slot walls is estimated to be $c. \pm 1$ cm.

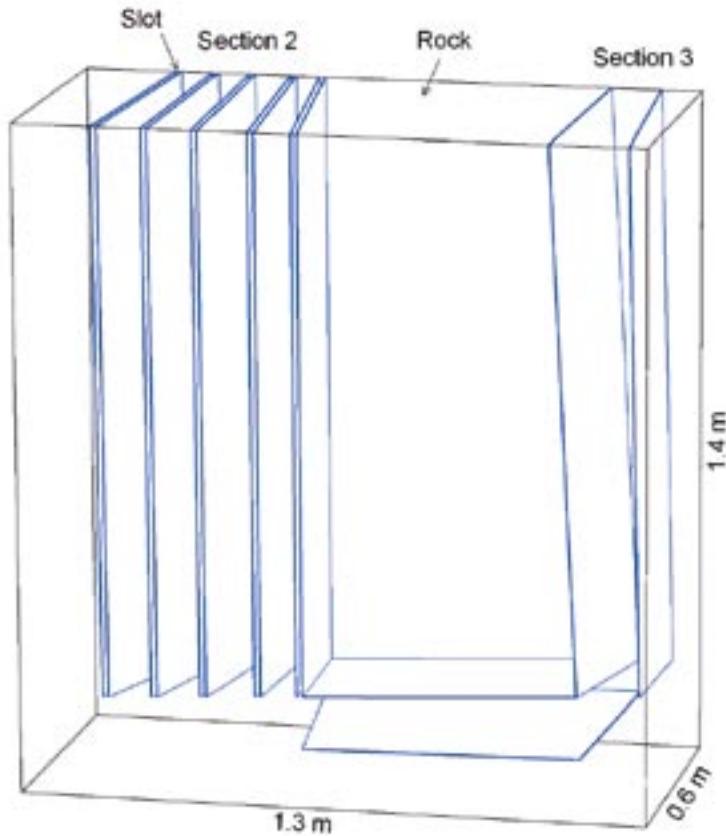
Figure 2-12. 2D planes in 3D space representing the position sides of the cutting slots.

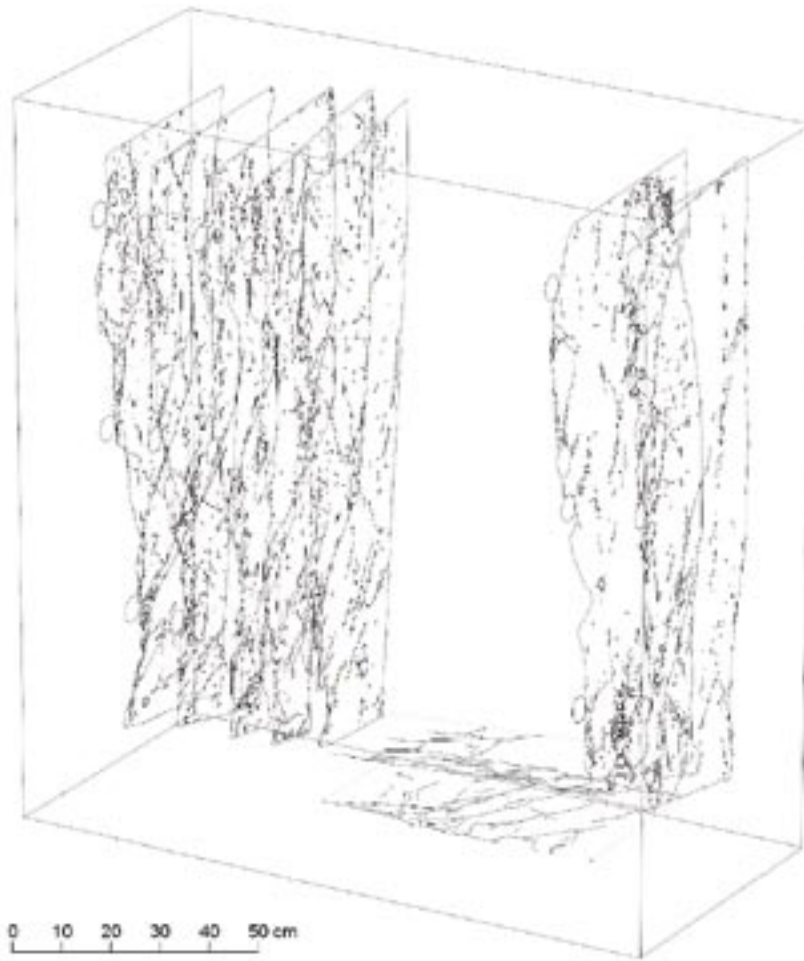
Figure 2-13. The scanned and vectorized sections moved into 3D space. The bore-pipes on the tunnel wall are visible as small circles.

The vectorized sections were then placed on the 3D planes, representing the slot walls, and each section had to be scaled, rotated and moved on the plane to fit correctly in 3D space. Also here, the laser modelled surface was used as a basis but also the marked position of the bore-pipes. The fitting was visual and the accuracy again estimated to be $c. \pm 1$ cm.

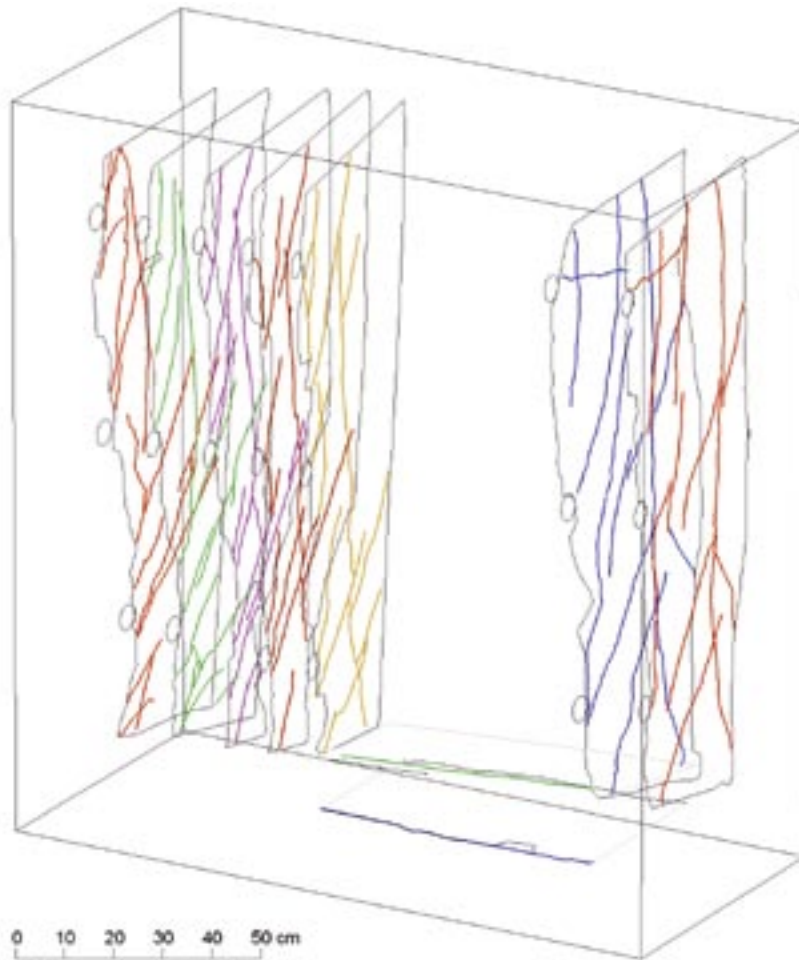
Figure 2-14. All selected fracture traces in 3D space.

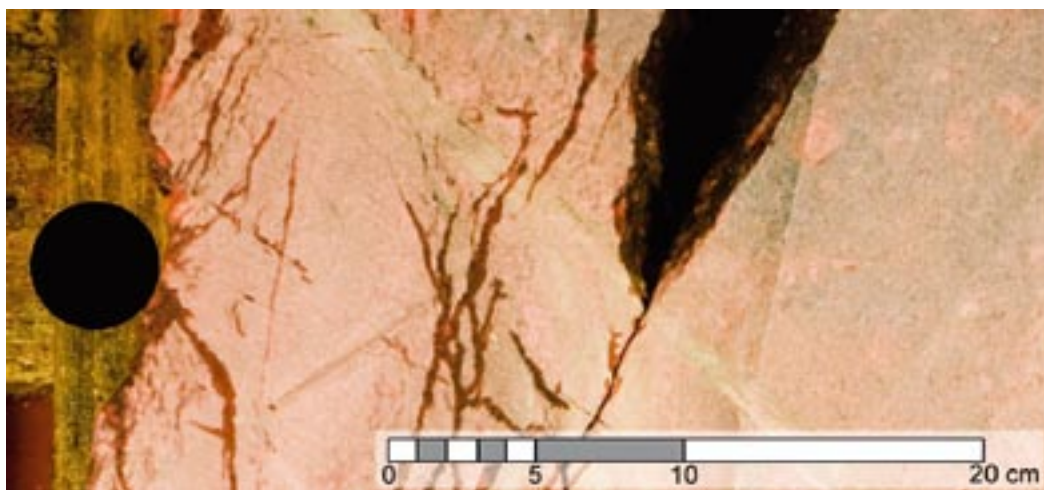
Figure 2-15. The fracture pattern is clearly denser close to the bore pipes.

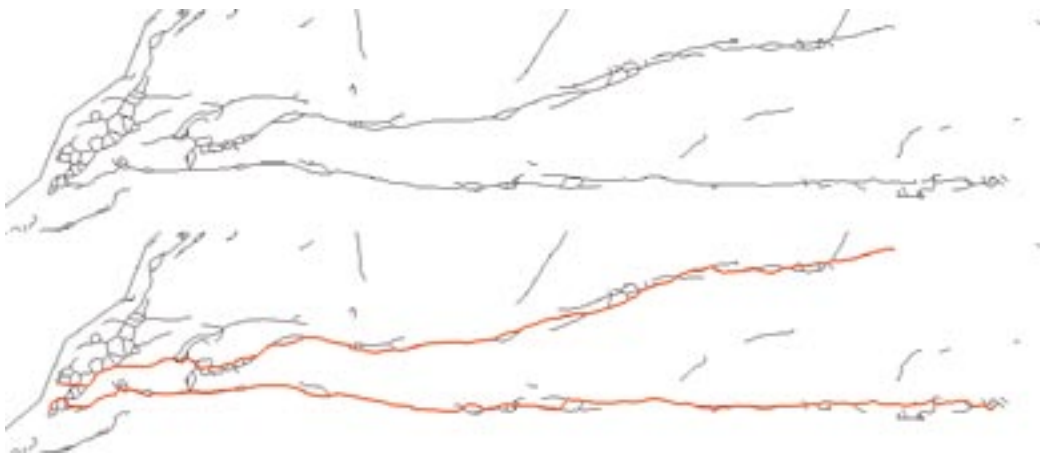
Figure 2-16. “Swarms” of smaller fractures shown above, simplified into two continuous fracture traces, shown below in red.

When the fracture traces are selected and connected, fracture swarms can be represented by a single, continuous fracture trace. This is done when the small fractures are connected and together acting as one continuous fracture; see also Chapters 3.5.1 and 5.5 below.

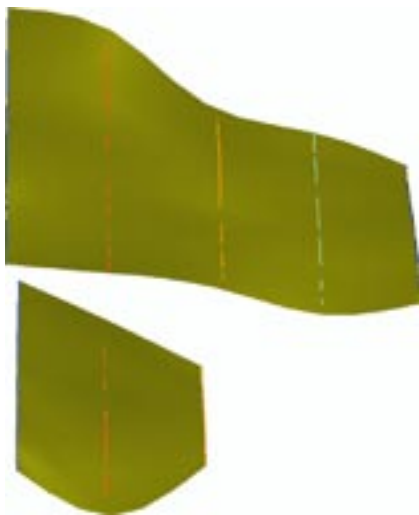
Figure 2-17. Example of two modelled fractures where one stretches over five sections and the other over three.

When modelling in 3D, the vectorized and selected fracture traces are connected to form undulating, modelled fracture planes, see Figure 2-17. Before this can be done, however, the small line segments (see Chapter 2.3 above) must be connected into longer linestrings or polylines. This is a suitable opportunity to make a selection and classification of the different fracture traces to use as a basis for the 3D interpretation.

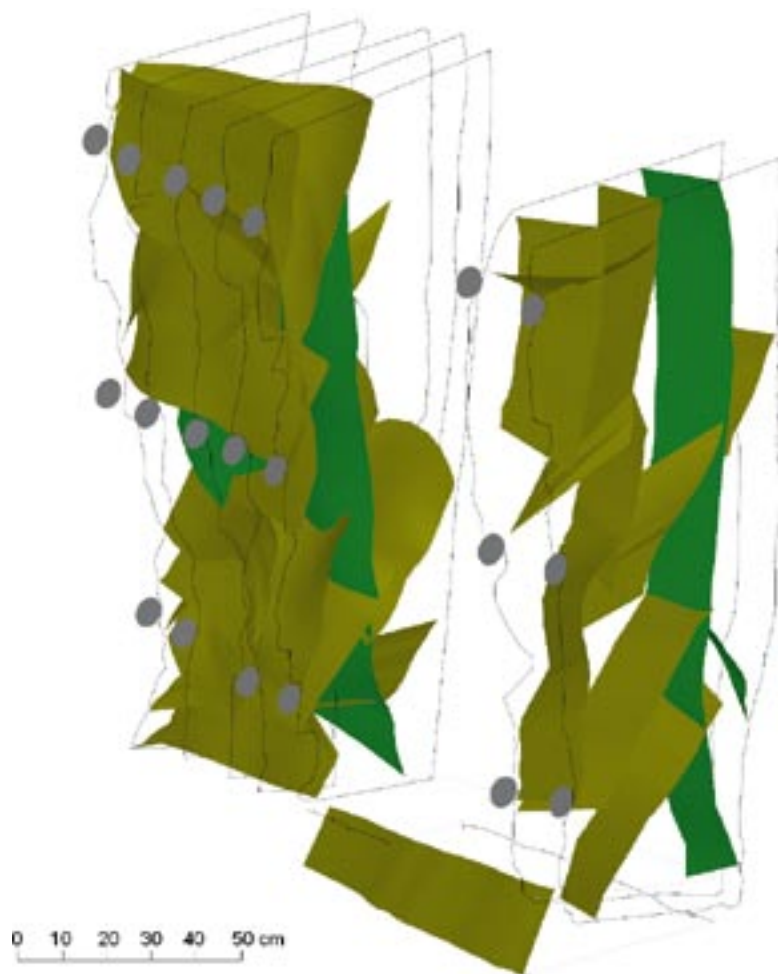
Figure 2-18. The complete model created. Fractures interpreted as blast induced in yellow and natural fractures in green.

A total number of 31 fractures have been modelled. Of those, 19 fractures are in test section 2, where we have investigated 4 rock slabs; 11 are in test section 3, where we have investigated 1 rock slab and 1 is in the horizontal opening between test sections 2 and 3, where 1 rock slab has been extracted.

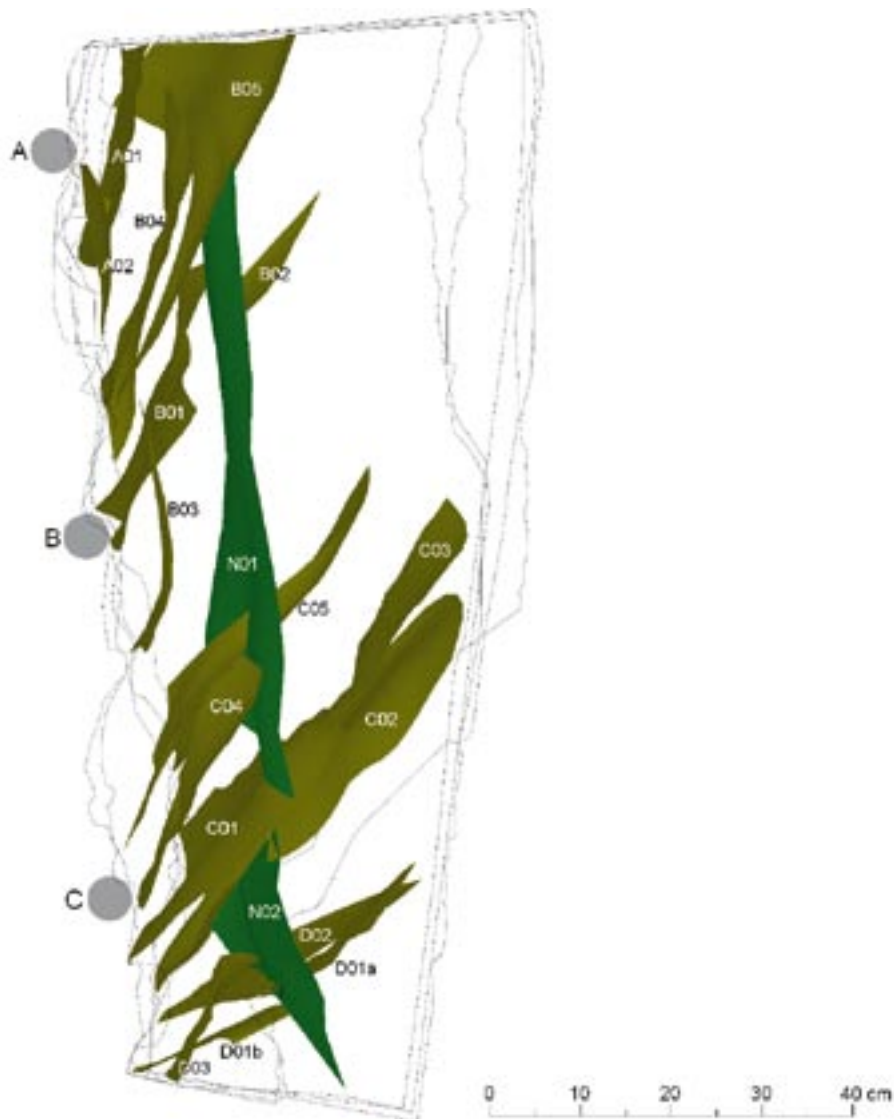
In test section 2, 17 fractures were modelled which were interpreted as blast induced fractures. Two fractures, interpreted as natural fractures, were also modelled. Four drill-pipes affect the evaluated rock slabs, called A to D from top to bottom. The modelled fractures are named A, B, C and D after the drill-pipe from which they extend. The natural fractures are named N.

2 fractures originate from drill-pipe A, 5 fractures from drill-pipe B, 6 from drill-pipe C, 4 from drill-pipe D and 2 are interpreted as natural fractures.

Figure 2-19. Side view of all modelled fractures in test section 2.

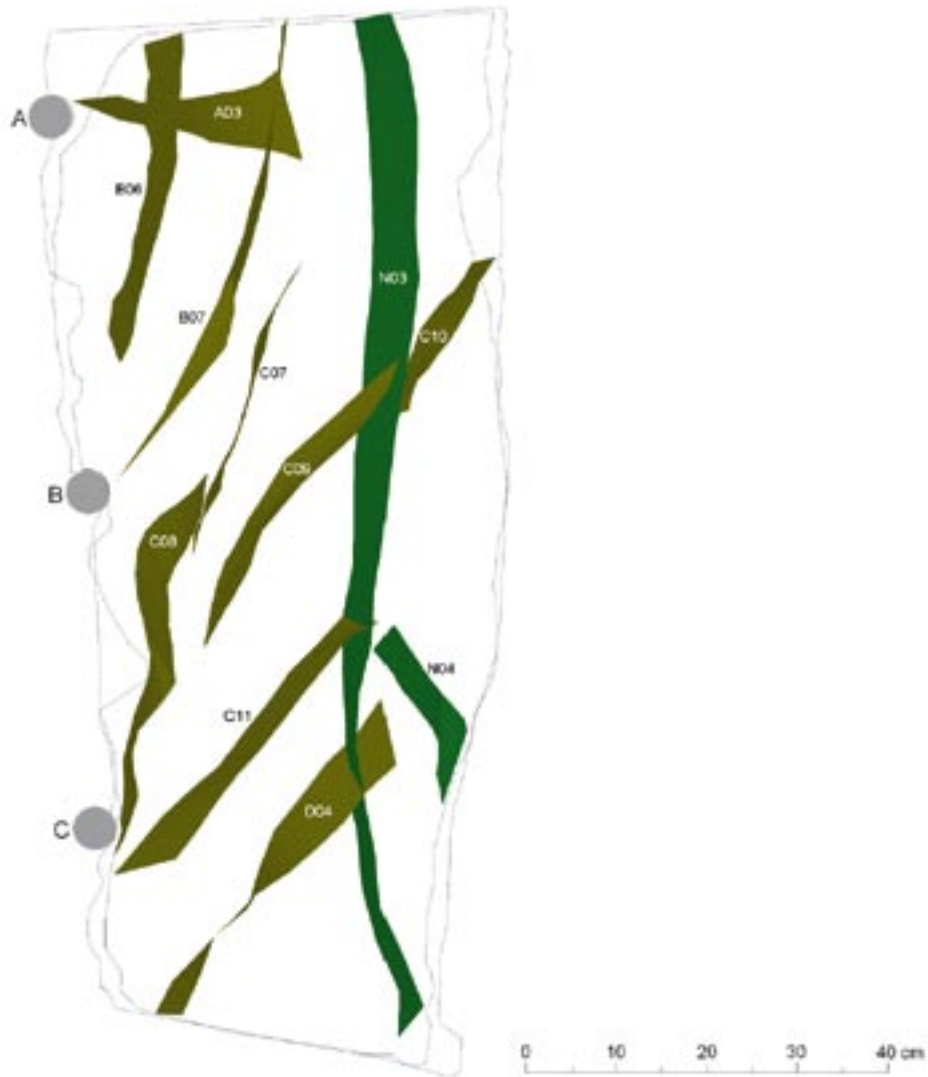
In test section 3 there were only two sections to connect, hence there were fewer fractures. Here we modelled 9 fractures which were interpreted as blast induced and 2 fractures interpreted as natural fractures. Of the blast induced fractures, 1 fracture originates from drill-pipe A, 2 from drill-pipe B, 5 from drill-pipe C and 1 from drill-pipe D.

Figure 2-20. Side view of all modelled fractures in test section 3.

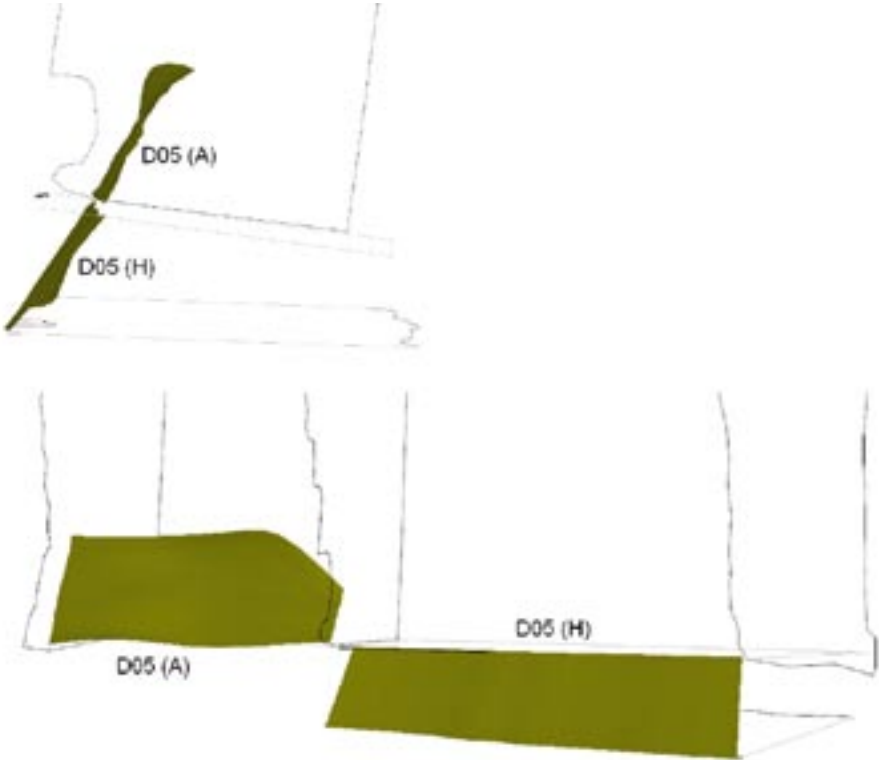
This fracture is probably the same as a fracture modelled in test section 2. Even though they are detected in different places and modelled completely separately, with no common fracture traces, they fit exactly in strike and dip.

The fracture clearly terminates against an intersecting fracture, shortly before test section 3 and is hence not visible in the section in test section 3 closest to the horizontal slot. This can be taken as an indication of that the fracture’s lateral extent is limited.

Figure 2-21. The fracture modelled in the horizontal slot, D05(H), shown together with one of the fractures from test section 2, D05(A).

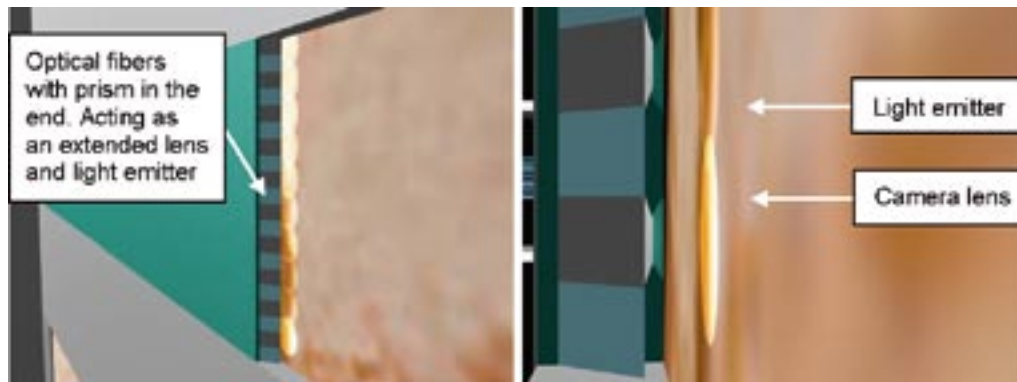
Figure 6-1. Hypothetical design of a scanning device showing the parts inside the slot.

This would enable the fitting such optics to a camera that could be placed outside of the saw cut thus enabling the use of bigger components than the 5 mm cut otherwise would allow. And by using another fibre core to lead the light into the saw cut the light source needed to take the photo can also be placed outside the saw cut, enabling the use of an inexpensive strong light source without having to worry about size or heat emissions.

This device could be mounted in a frame that would be used to move the device around and make it work like mix between a flatbed scanner and an old fashion plotter. After fixing the frame, a couple of points on the frame would be measured with a total station, thus enabling each pixel to be given a coordinate in 3D space.

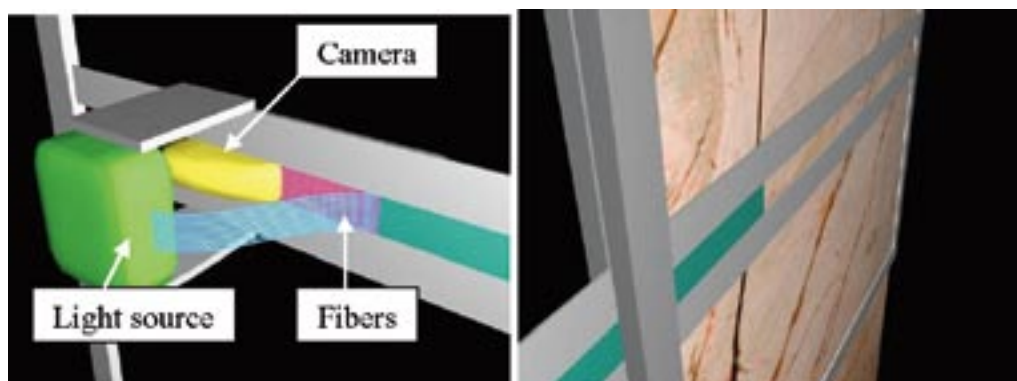
Figure 6-2. Hypothetical design of a scanning device, showing the parts outside the slot.

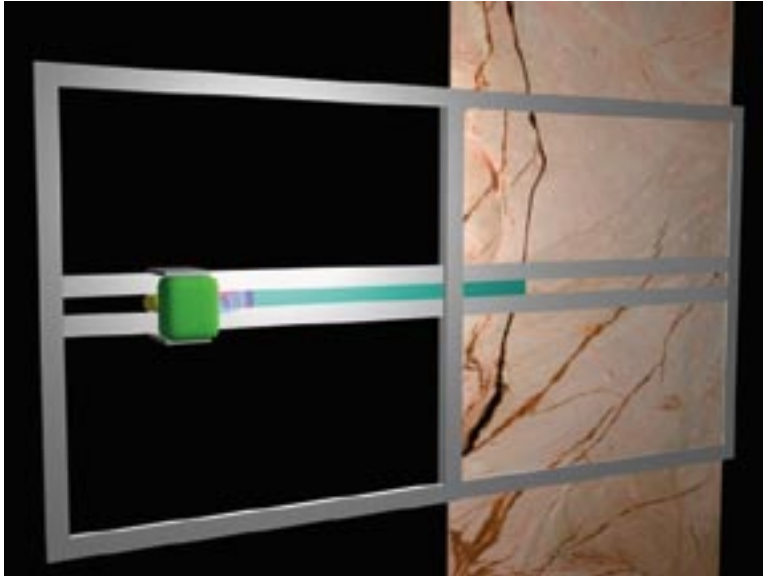
Figure 6-3. Hypothetical design of a scanning device, showing the entire device.
