IPR-01-42

**TRUE Block Scale project
Preliminary characterisation stage**

**September 1998 Structural model;
Update using characterisation data
from KI0023B**

This report presents an update of the Oct'97 structural model of the TRUE Block Scale volume. This update includes new geological, geophysical and hydraulic information from borehole KI0023B as well as extensive re-workings of data from boreholes KA2563A, KA2511A, KA3510A and KI0025F.

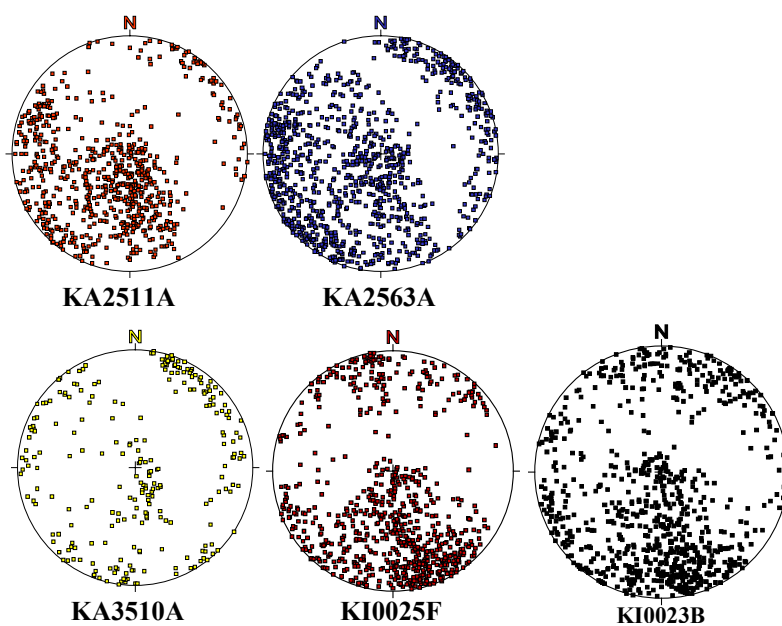
Fracture orientations in all boreholes can be subdivided into three fairly well defined sets, steeply dipping NW and NNE trending and a sub-horizontal set. The sub-horizontal fracturing is most pronounced in KA2511A, whereas few sub-horizontal fractures are intersected in KI0025F and KI0023B as seen in Figure 1-2.

Figure 1-2 Fracture orientations in the TRUE Block Scale boreholes.

Note that the apparent orientation in Figure 1-2 is influenced by a bias in orientation, which originates from sampling the 3 D network with a linear object such as a borehole.
